Hydraulic Laboratory Report HL-2019-04

Physical Hydraulic Model Study of Debris Management Alternatives for Hogback Diversion Dam

U.S. Department of the Interior
Bureau of Reclamation
Technical Service Center
Hydraulic Investigations and Laboratory Services Group
Denver, Colorado

August 2019

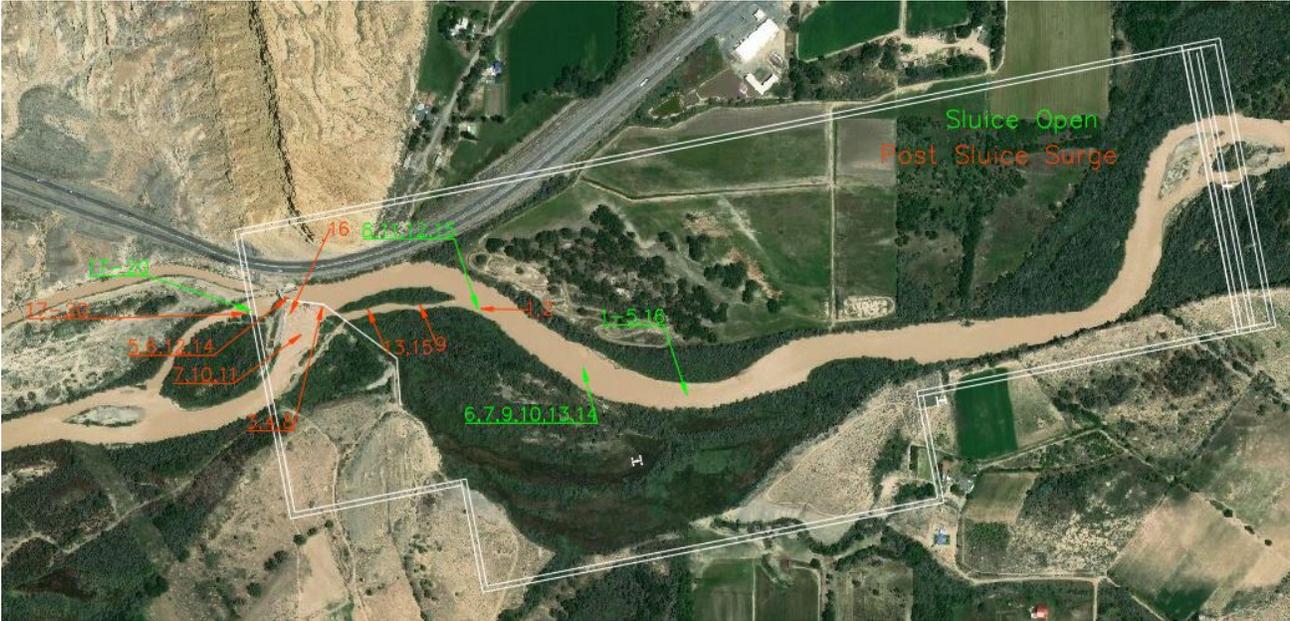
Image of debris capture location of the river modeled at the RS2 condition with River Q 2500 cfs and Canal Q 0 cfs, with sluice gates open.

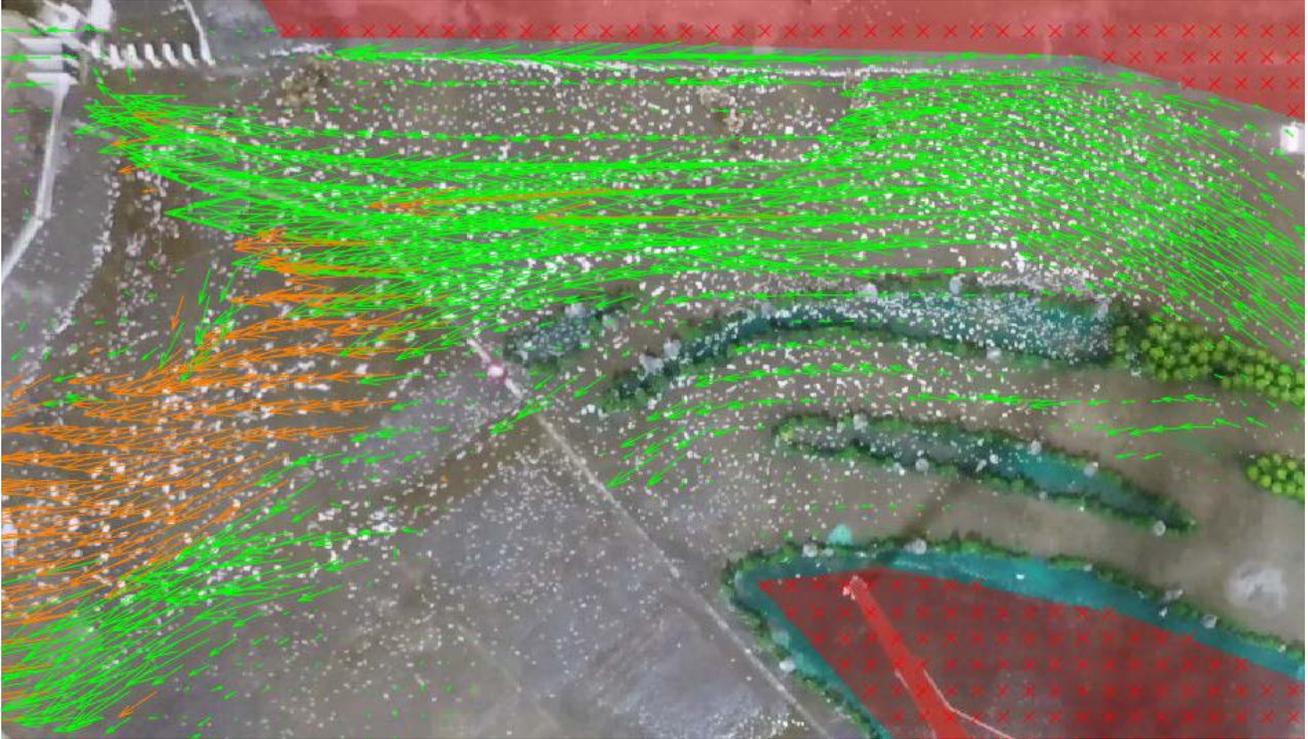
Image of RS2 with LSPIV mean velocity vector at River Q 5,000 cfs, Dam Q 4500 cfs, Canal Q 500 cfs, with sluice gates closed.

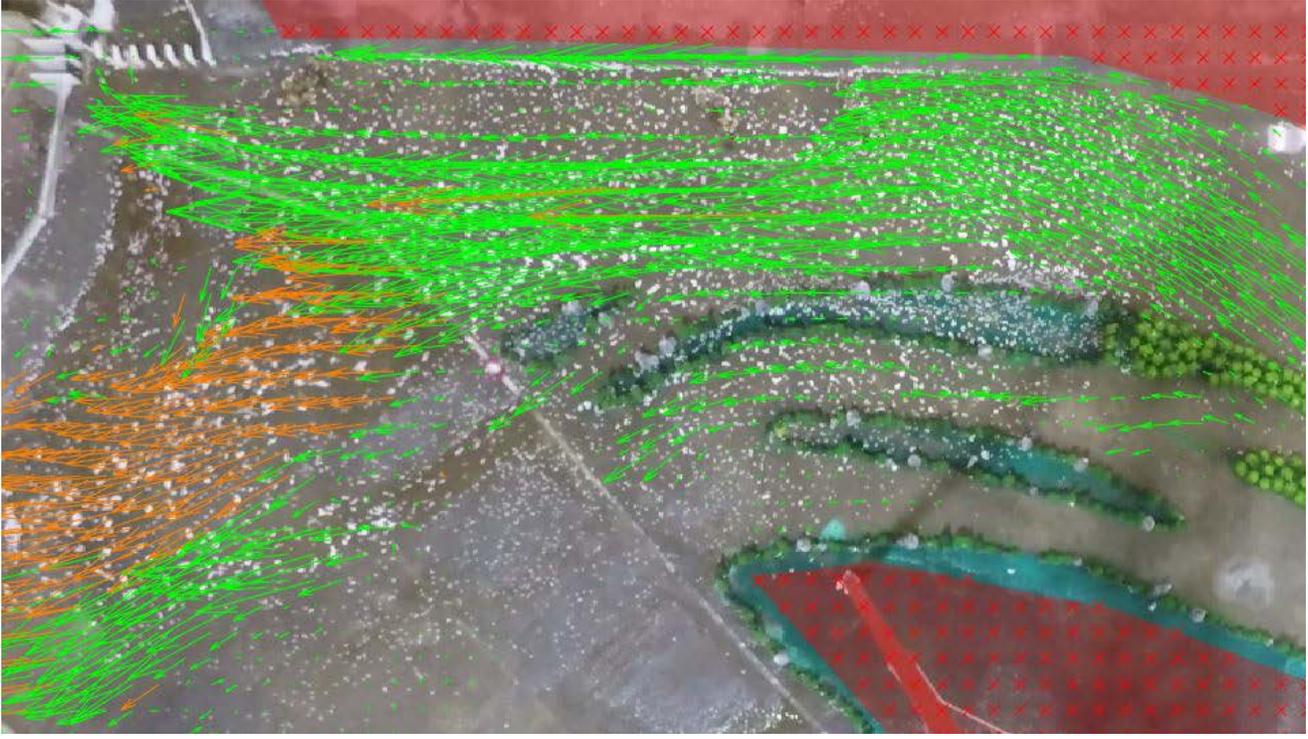
Image of RS2 with LSPIV mean velocity vector at River Q 5,000 cfs, Dam Q 5,000 cfs, Canal Q 0 cfs, with sluice gates open.

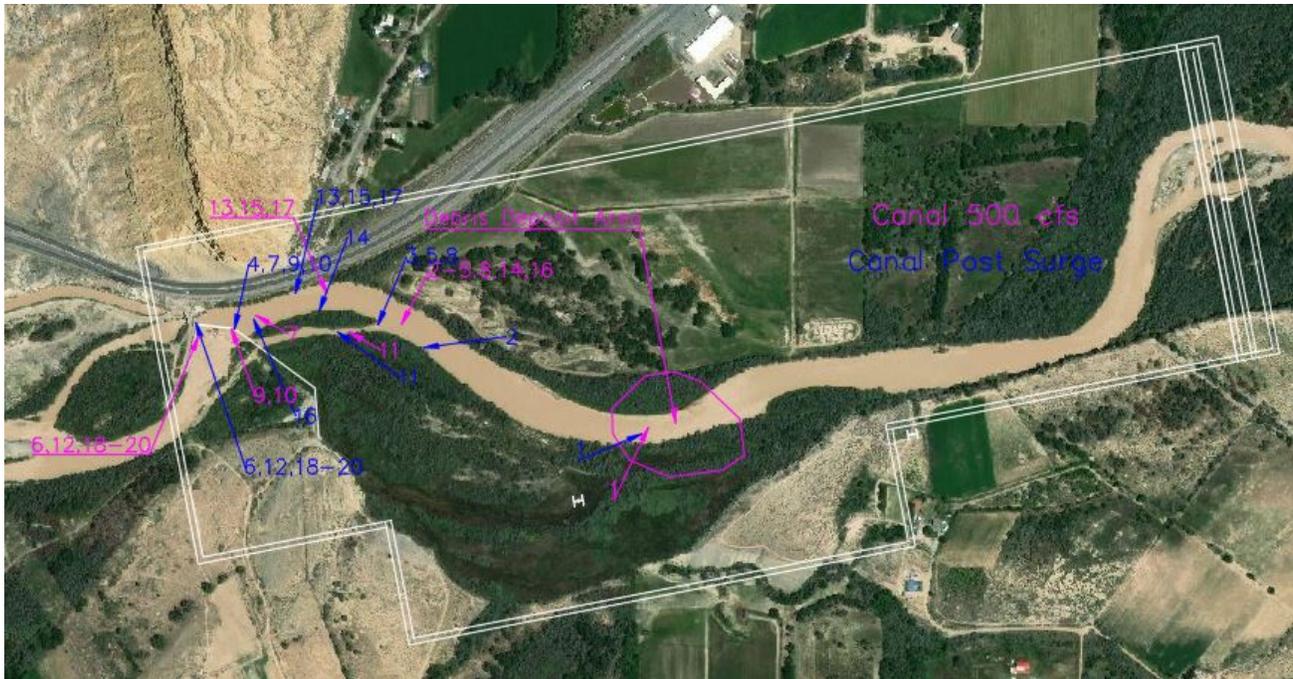
Image of debris capture location of the river modeled at the RS2 condition with River Q 5000 cfs and Canal Q 500 cfs, with sluice gates closed.

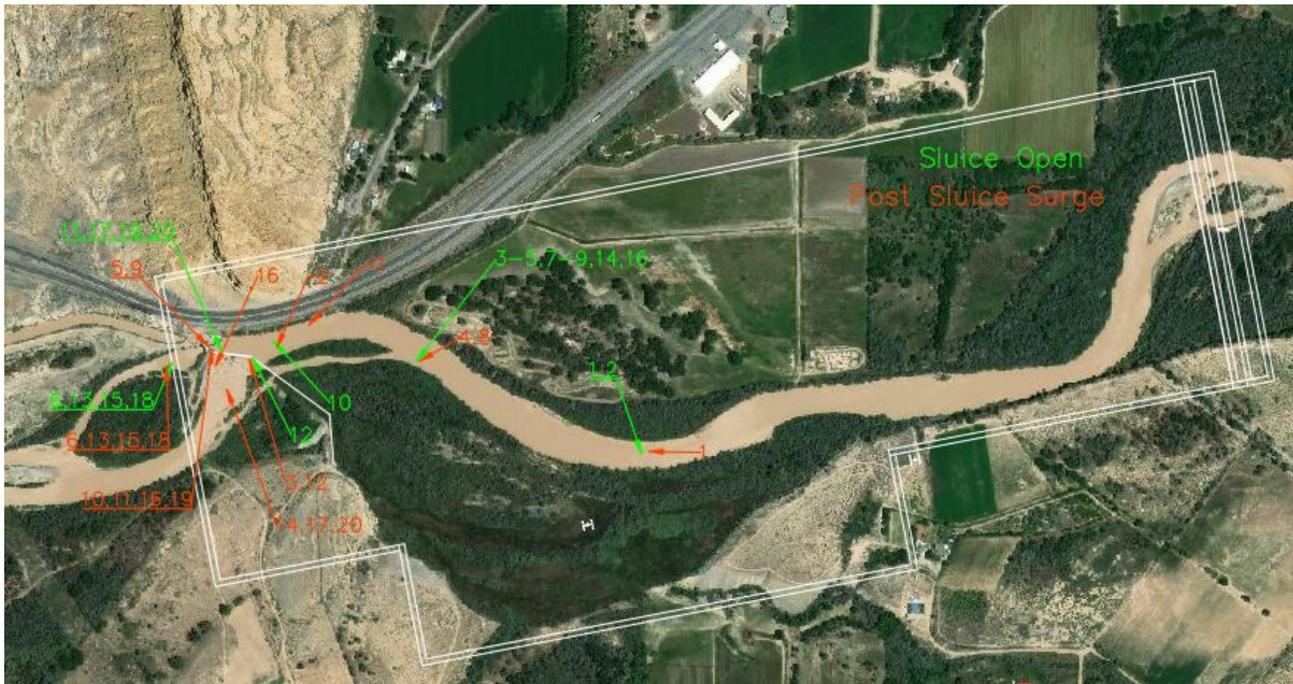
Image of debris capture location of the river modeled at the RS2 condition with River Q 5000 cfs and Canal Q 0 cfs, with sluice gates open.

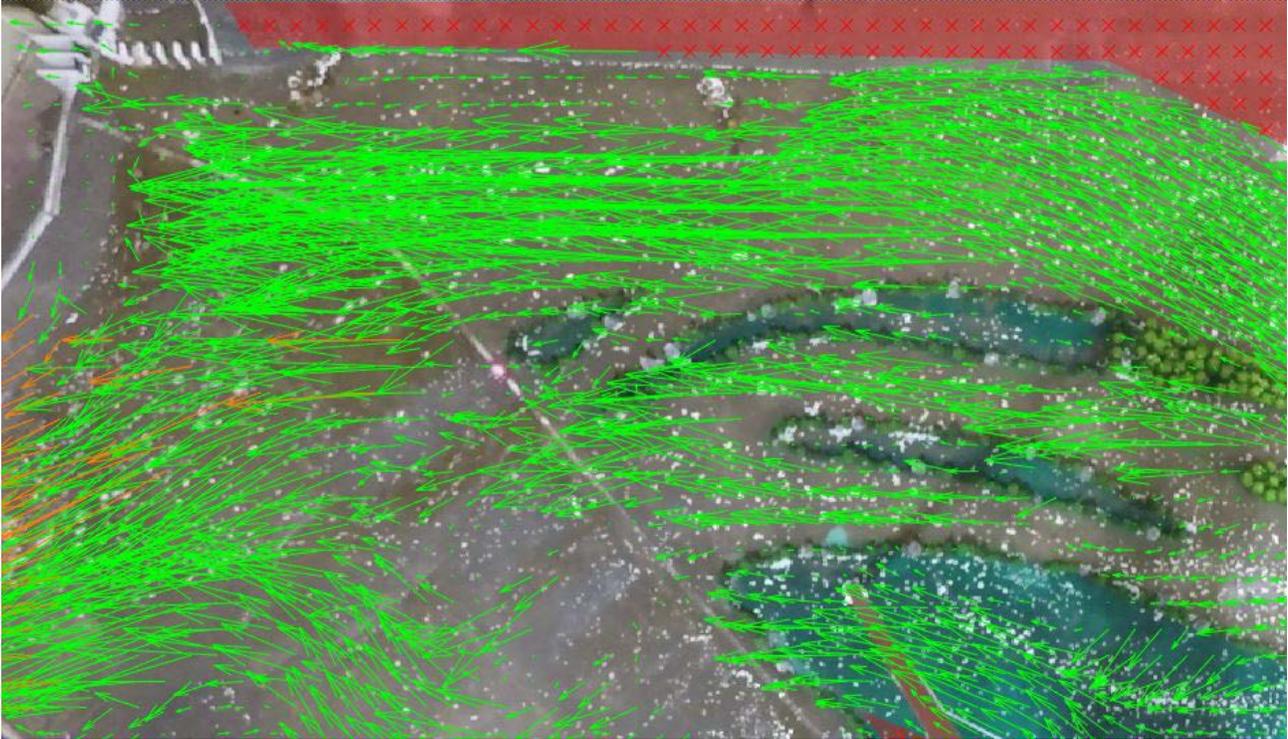
Image of RS2 with LSPIV mean velocity vector at River Q 12,000 cfs, Dam Q 11400 cfs, Canal Q 600 cfs, with sluice gates closed.

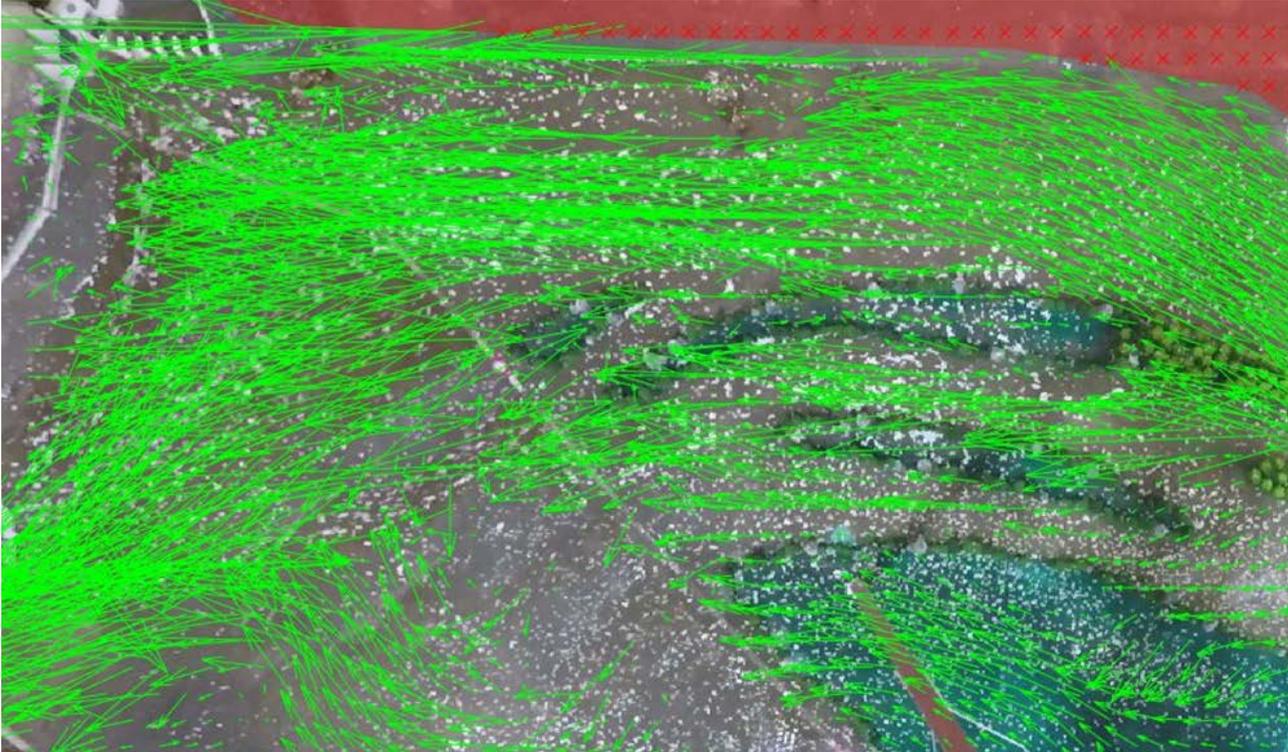
Image of RS2 with LSPIV mean velocity vector at River Q 12,000 cfs, Dam Q 12,000 cfs, Canal Q 0 cfs, with sluice gates open.

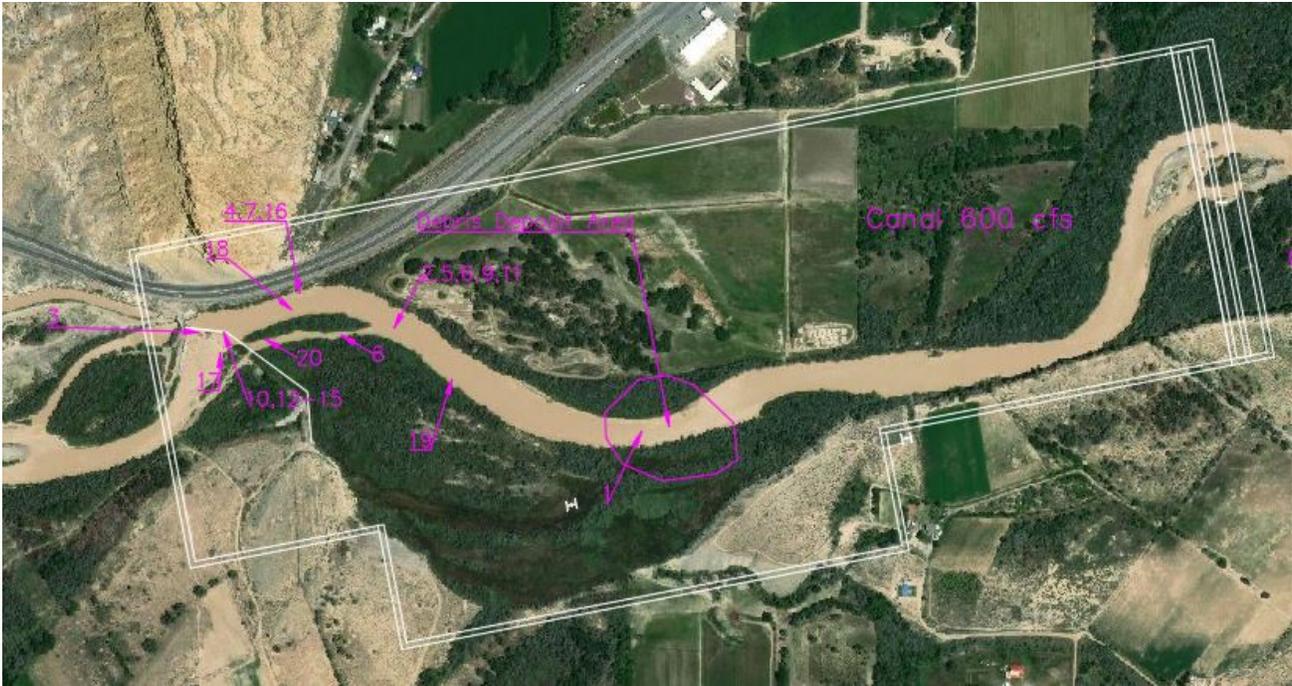
Image of debris capture location of the river modeled at the RS2 condition with River Q 12000 cfs and Canal Q 600 cfs, with sluice gates closed.

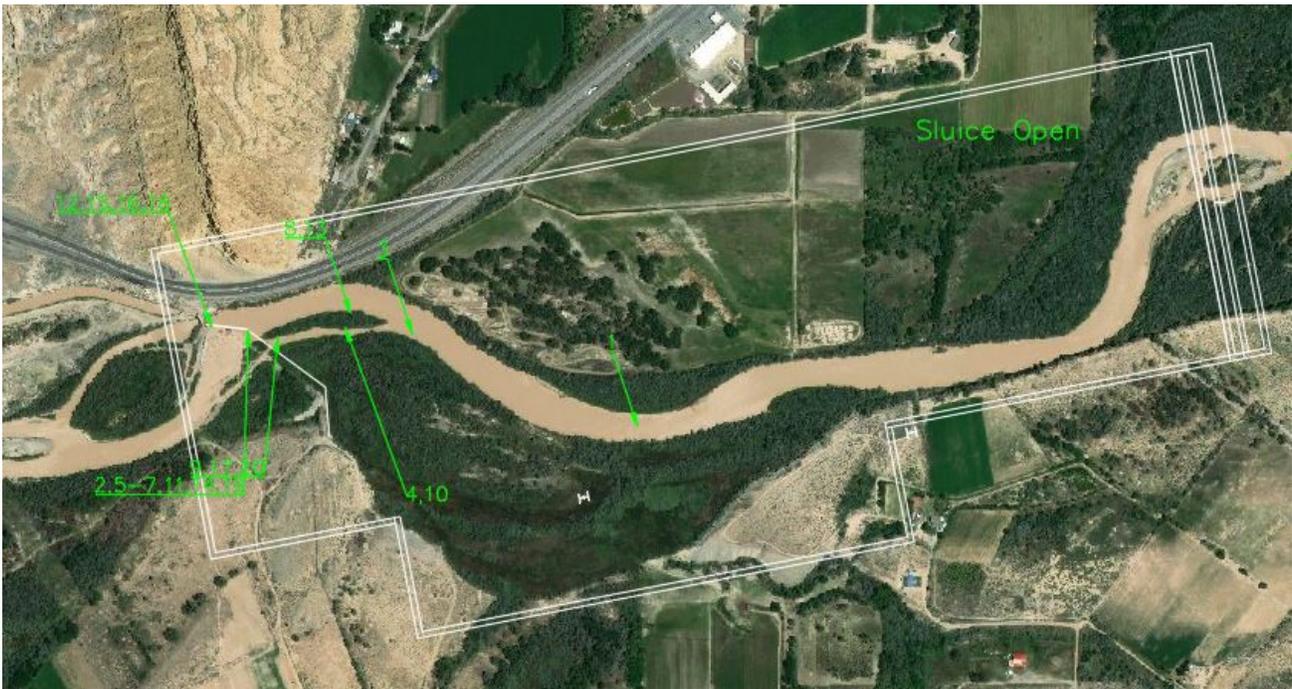
Image of debris capture location of the river modeled at the RS2 condition with River Q 12000 cfs and Canal Q 0 cfs, with sluice gates open.
