Hydraulic Laboratory Report HL-2019-05

Cle Elum Spillway Energy Dissipation Basin Splitter Wall Configurations

1:52 Scale Physical Model Study

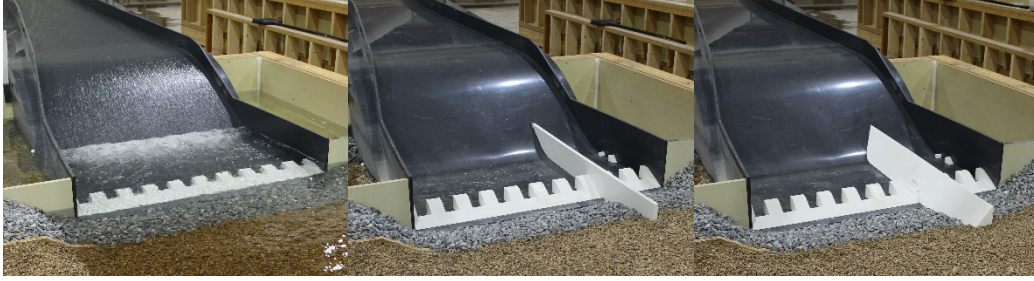
Figure 1. The three energy dissipation basin configurations tested in the physical model, as built (left), splitter wall (center), gravity wall (right).

- Evaluate the hydraulics in the energy dissipation basin for three configurations:
 - As built conditions (to verify the performance of the existing basin)
 - Proposed vertical splitter wall (see drawings 33-D-60282 through 33-D-60287 in Appendix A)
 - Proposed gravity wall (see drawing 33-D-60285b in Appendix A)
- Suggest modifications to the basin if:
 - The basin does not perform adequately to protect the downstream channel
 - If scour develops around the structures that might impact their structural integrity.
- For each configuration evaluate flows of:
 - 5,000 ft³/sec
 - 10,000 ft³/sec
 - 20,000 ft³/sec
 - 40,000 ft³/sec
- For each configuration evaluate the extent and location of any scour that occurs in the downstream river channel.

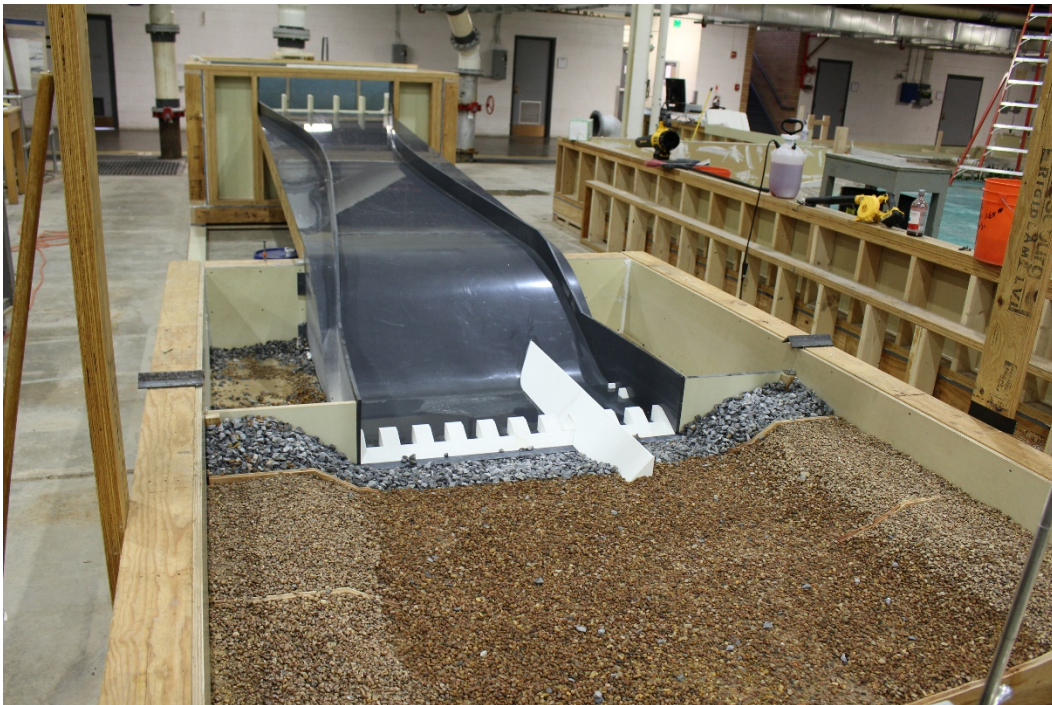
Figure 4. Photograph of spillway, energy dissipation basin with baffle blocks and gravity wall installed and downstream river channel.

A 1:52 scale physical hydraulic model was tested at Reclamation's Hydraulics Laboratory in Denver, Colorado to ensure that the energy dissipation basin of the Cle Elum dam spillway would function as originally intended. The model was constructed of wood and plastic materials and represented part of the upstream reservoir, the entrance channel, crest, piers (Figure 2), spillway chute with training walls (Figure 3), energy dissipation basin (Figure 4), and the downstream river to the existing gauging station.

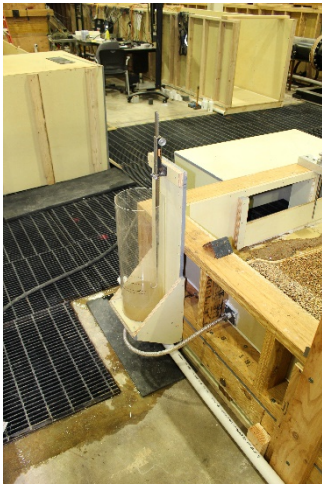
Figure 5. Photograph of stilling well attached to piezometer tap in the center of the downstream river channel.

One piezometer tap was attached to a stilling well (Figure 5) and was equipped with a lory point gauge accurate to 0.001-ft. The piezometer tap was in the center of the downstream channel at the approximate location where the river gauge would be located. This piezometer tap was utilized to set the necessary tailwater in the channel.

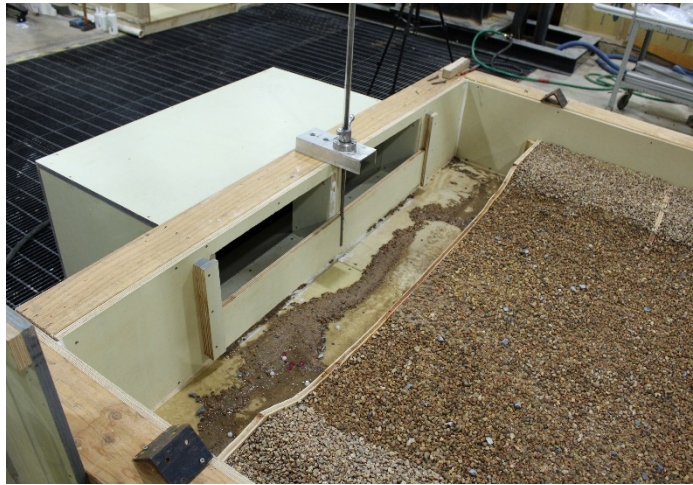
Figure 6. Photograph of downstream overflow weir used to set the tailwater depth of the model.

Tailwater was set with a downstream adjustable overflow weir (Figure 6).

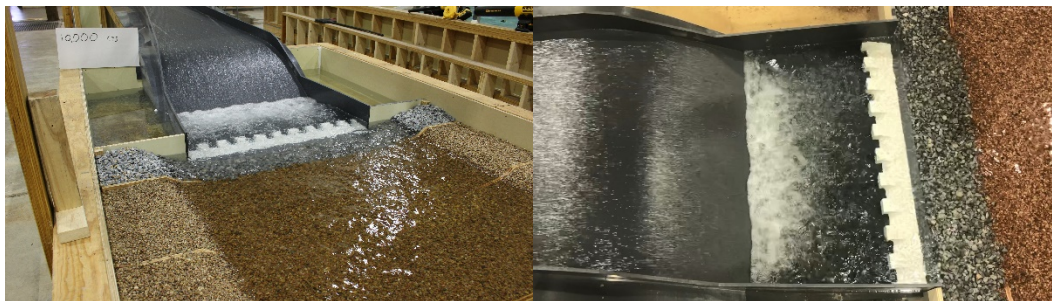
Figure 7. Photographs of as built configuration for 5,000 ft³/sec the left image is looking from the downstream river right, and the right image is looking at a plan view with flow from left to right.

Figure 7 through Figure 10 provide photographs of each of the four flow rates tested for the as built configuration from a right bank and plan view perspective. Figure 11 provides a pre-test contour map of bed elevations in prototype feet and represents the undisturbed bed topography prior to any flow entering the model. Figure 12 provides a post-test contour map of the bed topography in prototype feet. Comparing the two contour plots shows that only a very small amount of surface particles immediately downstream of the baffle blocks mobilized over the duration of the testing, and no scour was present after the testing was completed. The basin functions properly through the design 40,000 ft³/sec.

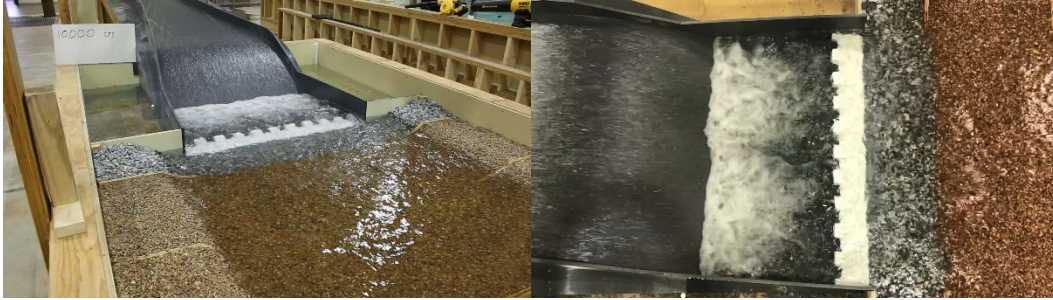
Figure 8. Photograph of as built configuration for 10,000 ft³/sec, the left image is looking from the downstream river right, and the right image is looking at a plan view with flow from left to right.

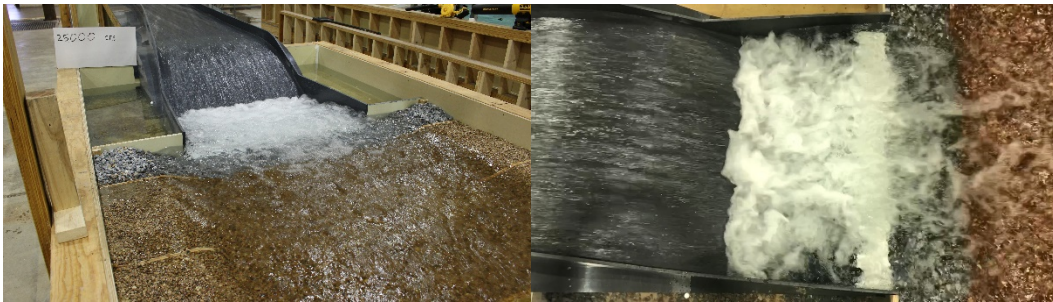
Figure 9. Photograph of as built configuration for 25,000 ft³/sec, the left image is looking from the downstream river right, and the right image is looking at a plan view with flow from left to right.

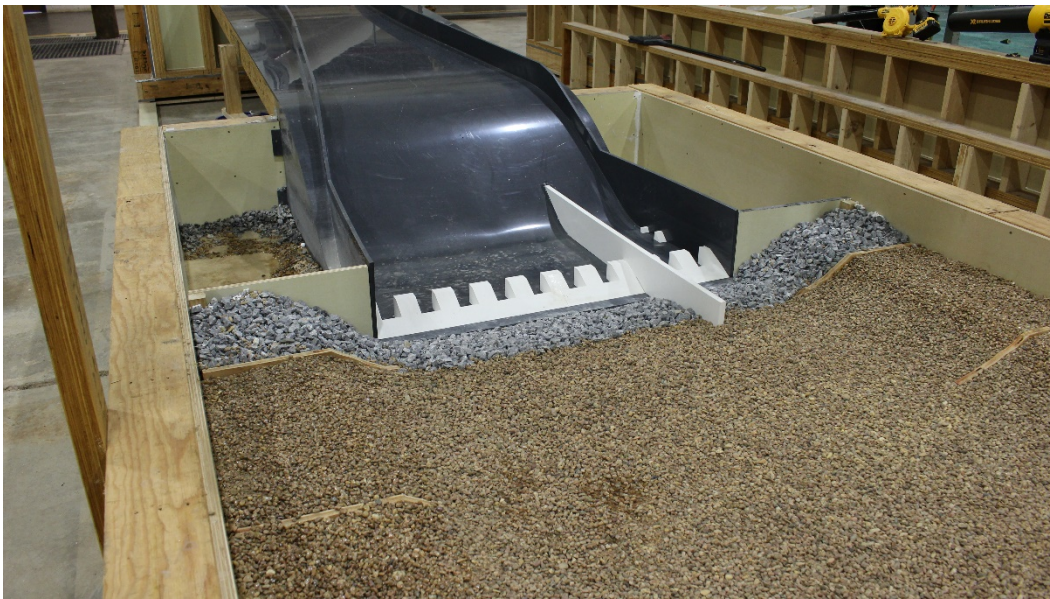
Figure 13. Photograph of splitter wall pre-test image looking from the downstream river right.

Figure 13 and Figure 14 show the splitter wall installed prior to any flow being introduced into the model. Figure 15 through Figure 18 provide photographs from the right bank and plan view of each of the four flow rates tested for the splitter wall configuration. Figure 19 provides a pre-test contour map of bed elevations in prototype feet and represents the undisturbed bed contours prior to any flow entering the model. Note that the bed had been re-graded after the as-built tests and installation of the splitter wall. Figure 20 provides a post-test contour map of the bed elevations in prototype feet and represents the disturbed bed contours after the model was operated. Comparing the two models shows no difference, which indicates that the bed has not scoured or deposited. Figure 21 is an image taken after the flow drained from the basin, a few rocks are present that have moved upstream onto the apron that extends beyond the energy dissipation blocks. These few rocks are not alarming and indicate that separation off the dissipation blocks is causing an upstream velocity over the riprap section of the downstream channel.

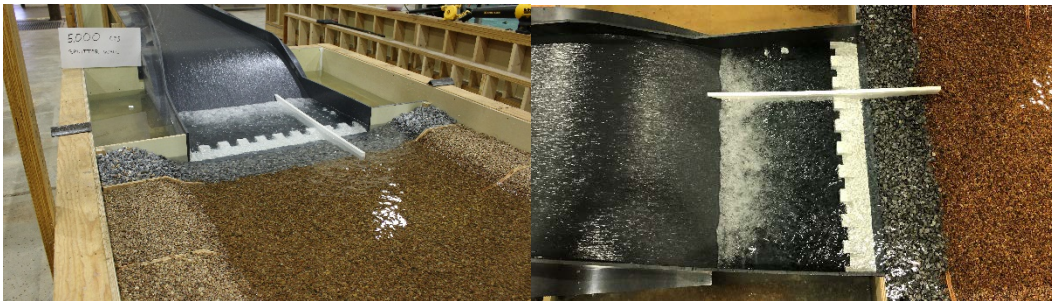
Figure 15. Photograph of splitter wall configuration for 5,000 ft³/sec, the left image is looking from the downstream river right, and the right image is looking at a plan view with flow from left to right.

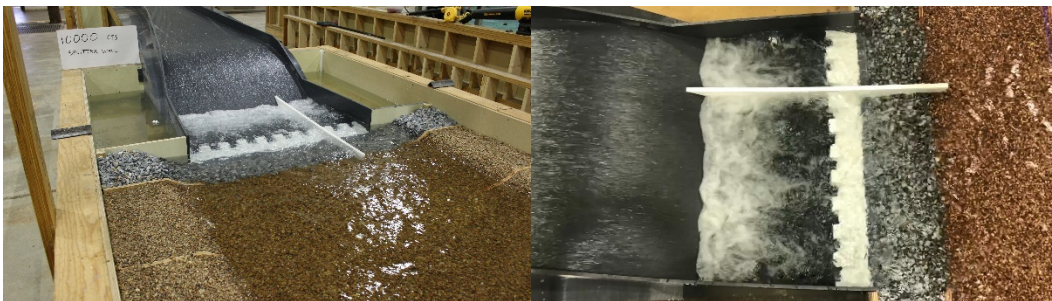
Figure 16. Photograph of splitter wall configuration for 10,000 ft³/sec, the left image is looking from the downstream river right, and the right image is looking at a plan view with flow from left to right.

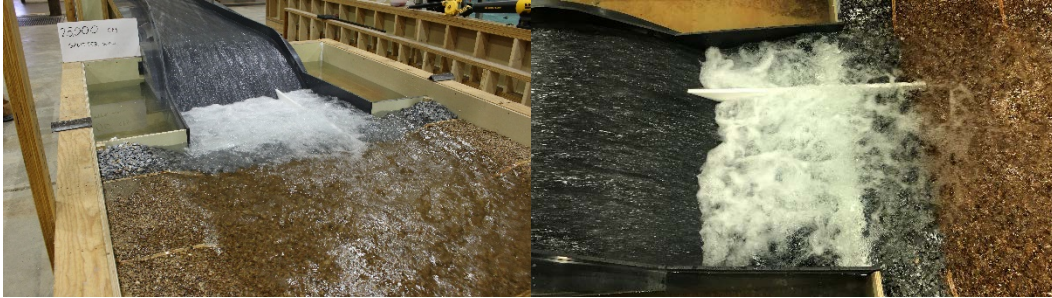
Figure 17. Photograph of splitter wall configuration for 25,000 ft³/sec, the left image is looking from the downstream river right, and the right image is looking at a plan view with flow from left to right.

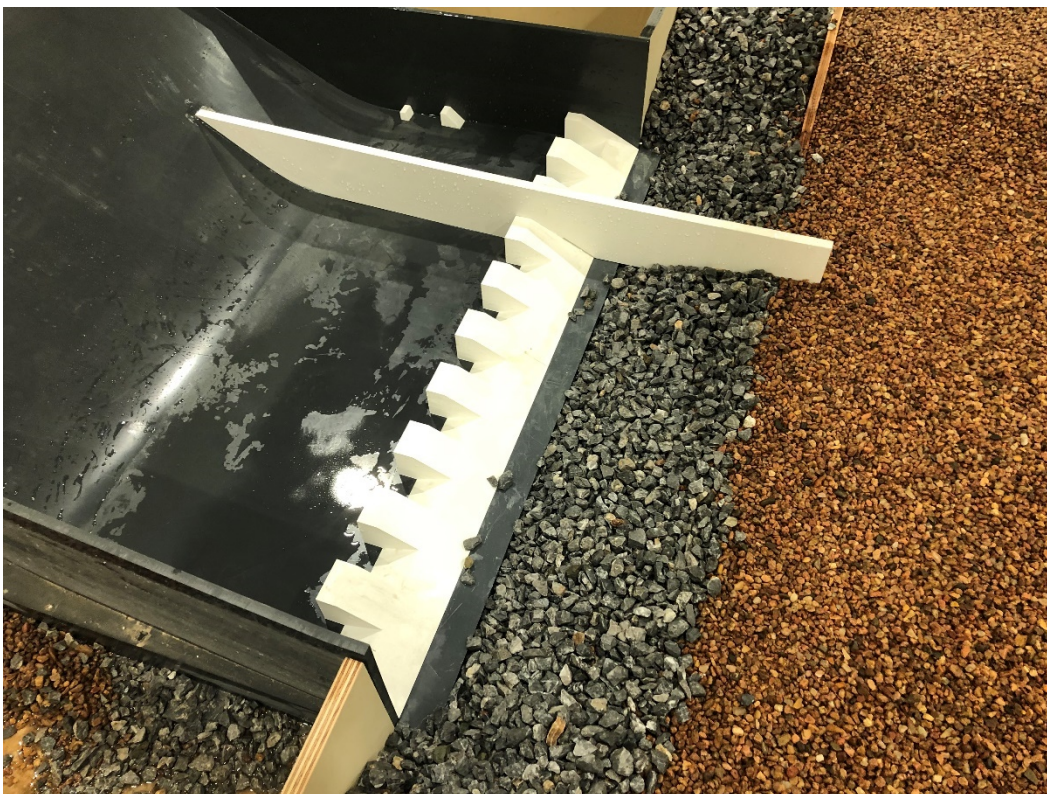
Figure 21. Photograph of splitter wall post-test downstream bed showing that a few rocks moved upstream onto the apron that extends beyond the energy dissipation blocks in the basin.

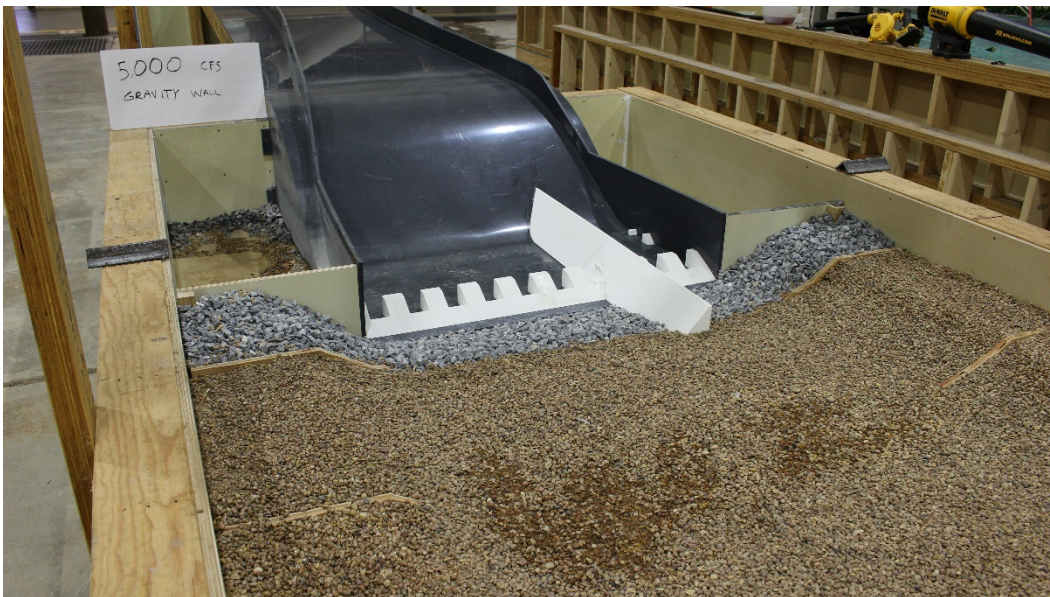
Figure 22. Photograph of gravity wall pre-test installation viewed from downstream river right.

Figure 22 and Figure 23 show the gravity wall installed prior to any flow being introduced into the model. Figure 24 through Figure 27 provide photographs from the right bank and plan view of each of the four flow rates tested for the gravity wall configuration. Figure 28 and Figure 29 provide post-test images of the downstream channel after the water was drained from the model. Figure 30 is the pre-test contour map of bed elevations in prototype feet and represents the undisturbed bed contours prior to any flow entering the model. As with the splitter-wall testing, the downstream bed was regraded following the installation of the gravity wall. Figure 31 provides a post-test contour map of the bed elevations in prototype feet and represents the disturbed downstream channel after the simulations were modeled.

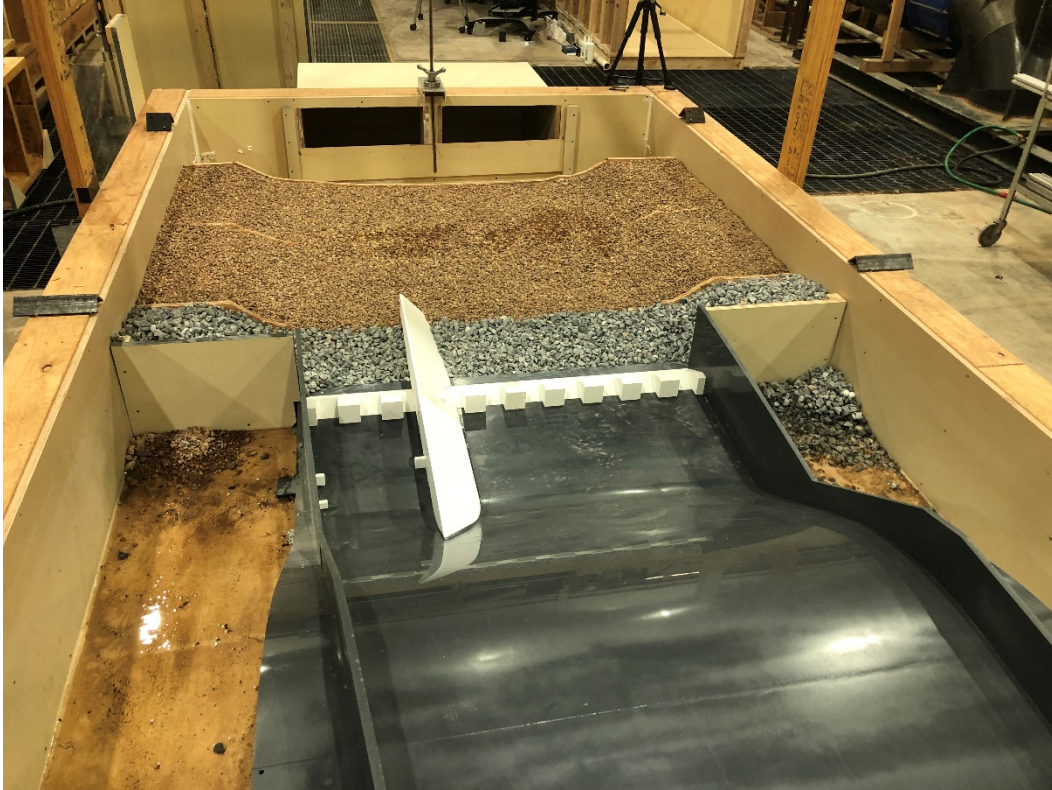
Figure 23. Photograph of gravity wall pre-test installation viewed from upstream center of spillway.

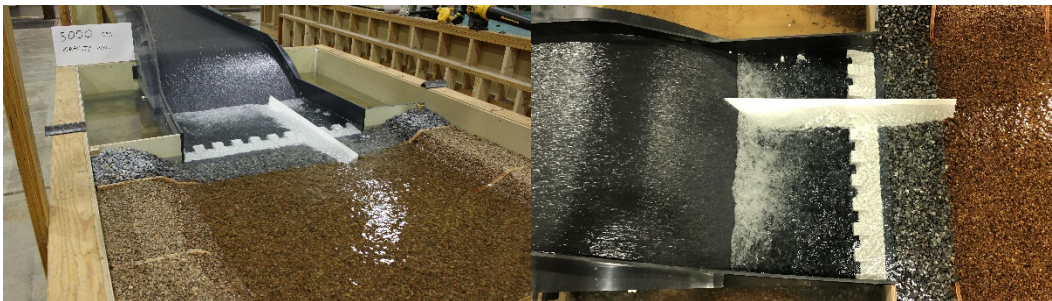
Figure 24. Photograph of gravity wall configuration for 5,000 ft³/sec, the left image is looking from the downstream river right, and the right image is looking at a plan view with flow from left to right.

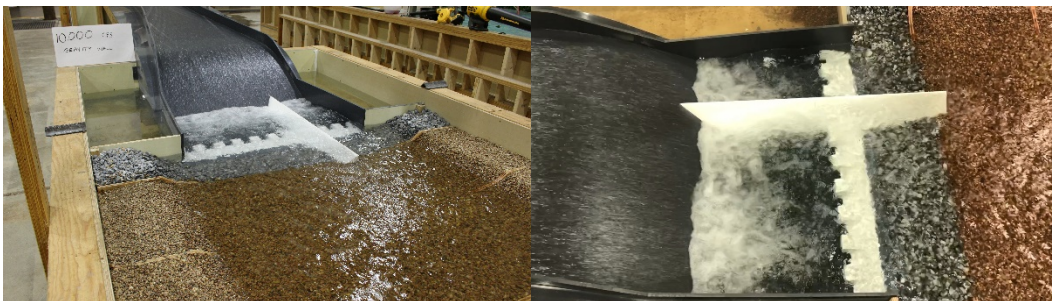
Figure 25. Photograph of gravity wall configuration for 10,000 ft³/sec, the left image is looking from the downstream river right, and the right image is looking at a plan view with flow from left to right.

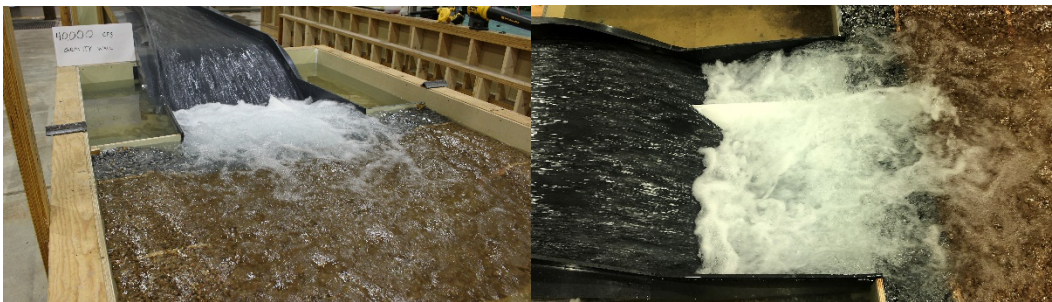
Figure 27. Photograph of gravity wall configuration for 40,000 ft³/sec, the left image is looking from the downstream river right, and the right image is looking at a plan view with flow from left to right.

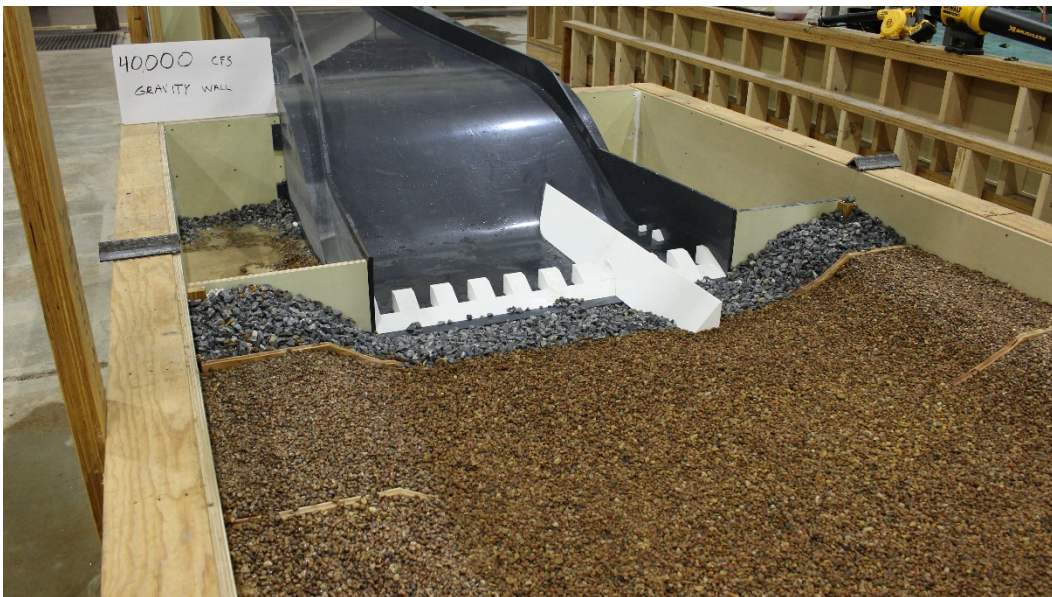
Figure 28. Photograph of gravity wall post-test viewed from downstream river right.

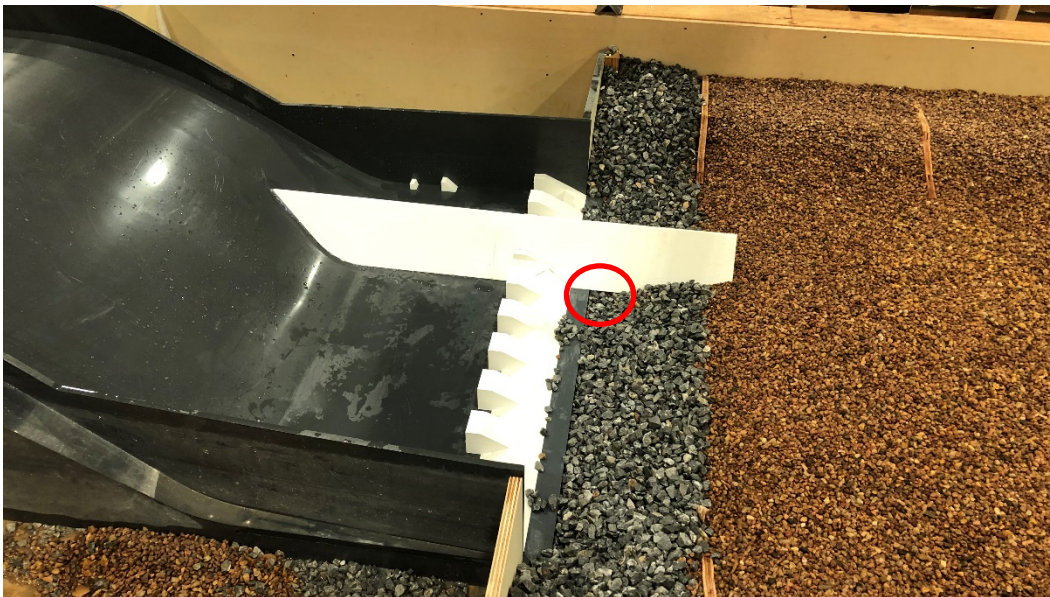
Figure 29. Photograph of gravity wall post-test viewed from river right, red circle indicates location of scour that should be mitigated with a shallow cutoff wall.

The area immediately downstream of the stilling basin apron experienced scour depths up to approximately 1 foot deep prototype. While much of this area experienced some scour, the primary scour was concentrated at the joining of the apron and the toe of the gravity wall. To prevent this scour from undermining the gravity wall, it is recommended to install a cutoff wall (a minimum of 3-ft-deep) that extends along the bottom of the gravity wall a distance of at least 10 feet. A cutoff wall already exists at the end of the stilling basin apron.
