Collaborative Studies to Reduce Flow-Induced Damage on Concrete Hydraulic Surfaces

**Science and Technology Program
Research and Development Office
Final Report No. ST-2020-1885-01
Hydraulic Laboratory Report HL-2020-05**

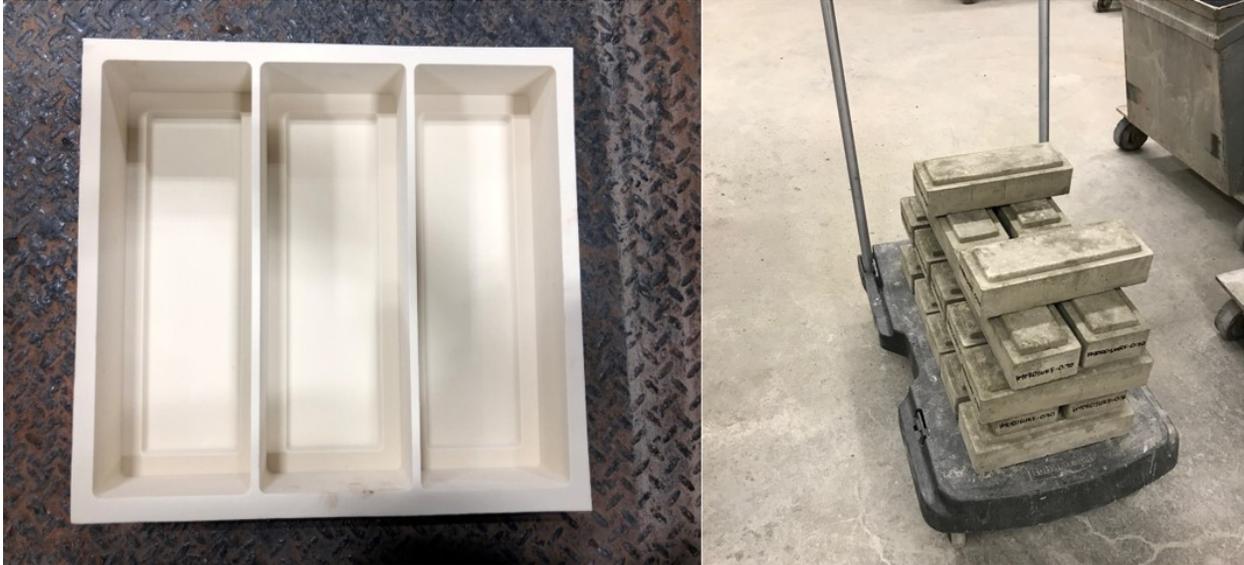
Figure 4 High density foam mold used for casting concrete test samples (left) and load of concrete samples ready for cavitation testing (right).

Laboratory tests included the design and mixing of concrete samples, hydraulic measurements of cavitation conditions within the venturi facility and cavitation damage testing where concrete blocks of different strengths were exposed to cavitation under the same hydraulic conditions for 4 hours each (Table 1). The concrete samples featured a raised test surface, 3 inches by 10.5 inches and 3 inches thick, that fit flush with the inner surface of the cavitation machine with the bottom formed side of the concrete is exposed to the water flow (Figure 4).

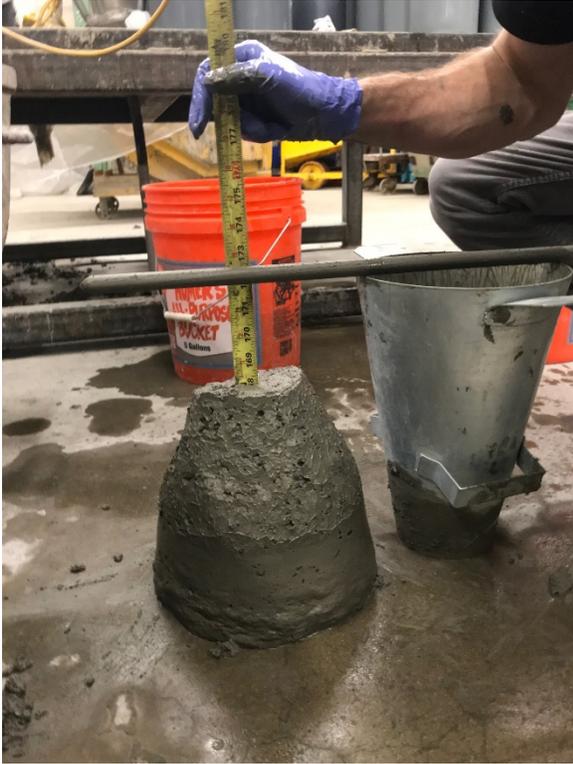
Figure 6. Concrete trial batch with a 4-inch slump

All concrete contained ASTM C150 Type I/II cement. Lower strength concrete contained a slightly higher percentage of sand compared to the mixtures ranging from 6,000 to 10,000 psi (20 -70 MPa). Reclamation decided to add one high strength concrete mix for the US research to set a higher strength upper boundary. This mix contained ASTM C1240 Silica Fume, which is not widely available in Brazil. Concrete contained a mid-range or high-range water reducing admixture in order to achieve a slump of 4 to 5 inches (100 to 125 mm) when tested in accordance with ASTM C143 as shown in Figure 6. Trial batches were made prior to casting the final specimens, with results plotted in Figure 7.

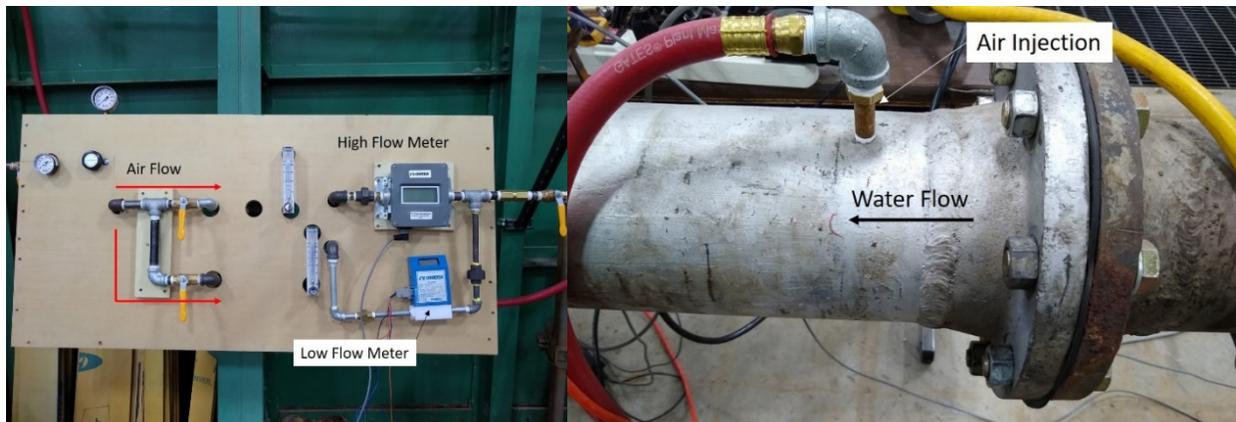
Figure 9 Air injection and measurement system (left) and air injection tap immediately upstream cavitation facility.

Water discharge was measured using a venturi meter and mercury manometer upstream from the cavitation facility. Air was injected into the water pipe immediately upstream from the cavitation venturi (and downstream from the venturi meter) from the building's house compressed air system and was controlled and measured using the system shown in Figure 9. Water discharge was recorded manually from the mercury manometer and all other pressure and air flow measurements were recorded with an analog to digital converter data acquisition system and laptop computer. Descriptions of instrumentation used for hydraulic measurements are shown in Table 2.
