Hydraulic Laboratory Report HL-2022-03

Physical Hydraulic Modeling of the Freeman Diversion Hardened Ramp Fish Passage Alternative

Freeman Diversion

United Water Conservation District, Ventura County, California

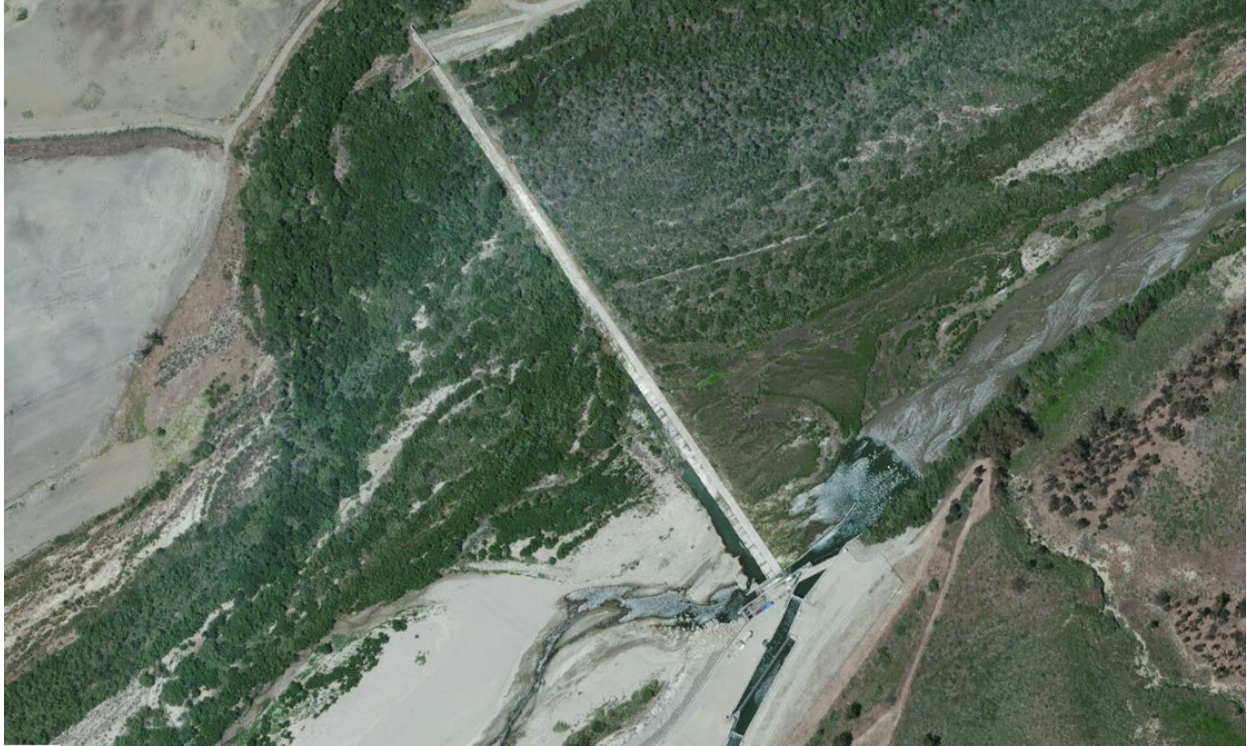
Figure 2. Aerial imagery of Freeman Dam facilities.

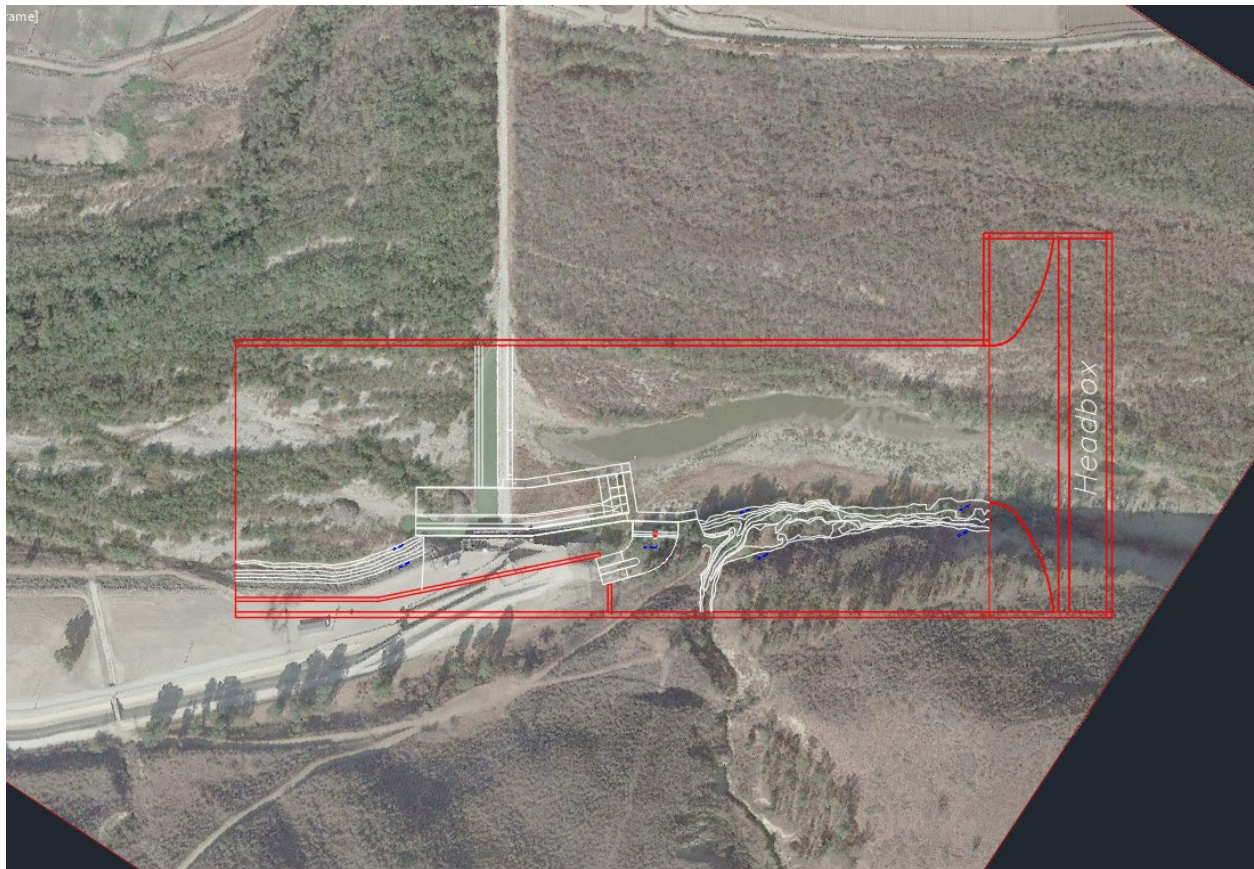
Figure 3. Overlay of 1:24 scale physical model box (red) on aerial photo of site showing model extents.

The 1:24 scale model extended approximately 1,070 ft upstream and 620 ft downstream from the dam crest and 300 ft to the right of the hardened ramp wall (Figure 3). The model included 300 ft of the dam crest, the hardened ramp, flushing channel, and the canal intake with approximately 120 ft of its downstream extents. The left bank topography was represented with a hardened layer of concrete overlayed on plywood contours between elevations 160 ft to 190 ft (upstream of the ramp) and 146 ft to 166 ft (downstream of the ramp). The rest of the model to the right represented the active river channel with mobile sediment material (Figure 4).

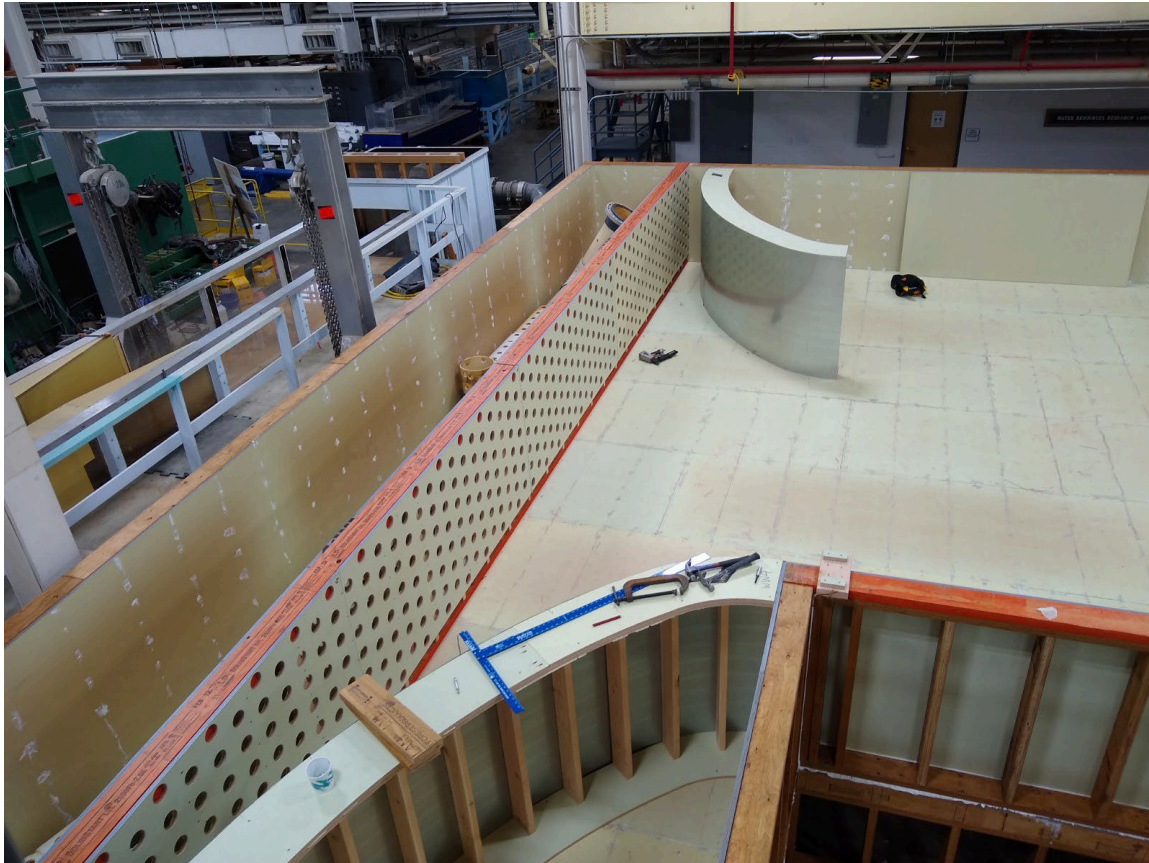
Figure 5. Baffle wall in 1:24 model with 3-inch hole “honey-comb” pattern for flow conditioning and sediment passage as well as curved baffle walls to direct flow into the upstream extents of the model.

The upstream boundary condition of the model was controlled by discharge coming into the model box. A large baffle wall with a “honey-comb” pattern 3-inch holes and curved entrance walls were used to distribute and condition the flow coming into the upstream extents of the model while still allowing sediment to transport with the incoming flow (Figure 5).

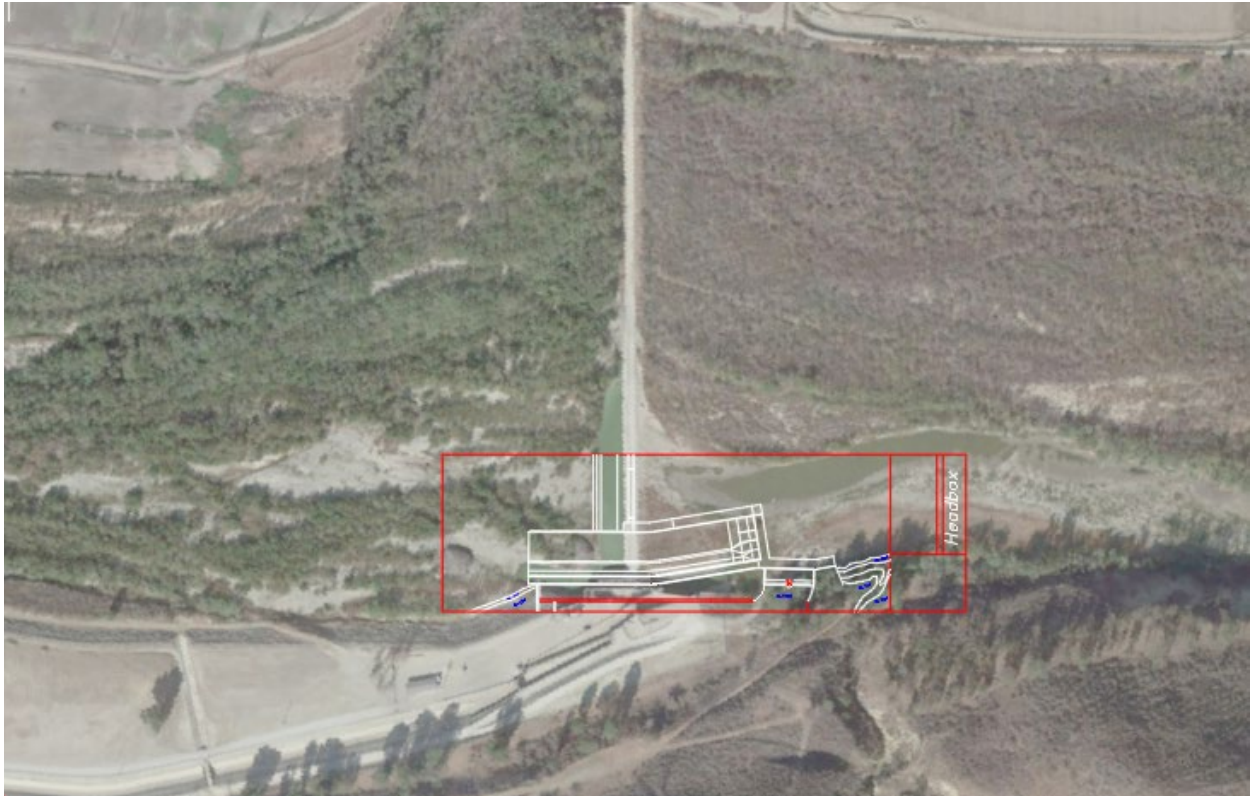
Figure 6. Overlay of 1:12 physical model box (red) on aerial photo of site showing model extents.

The 1:12 scale model extends about 530 ft upstream and 390 ft downstream from the dam crest and 140 ft to the right of the hardened ramp wall (Figure 6). The model included 140 ft of the dam crest, the hardened ramp, flushing channel, and the canal intake with approximately 50 ft of its downstream extents. The left bank topography was represented with a hardened layer of concrete overlayed on plywood contours for elevations from 160 ft to 170 ft upstream of the ramp and 146 ft to 150 ft downstream of the ramp. The rest of the model to the right represented the active river channel with mobile sediment material (Figure 6 and Figure 7).

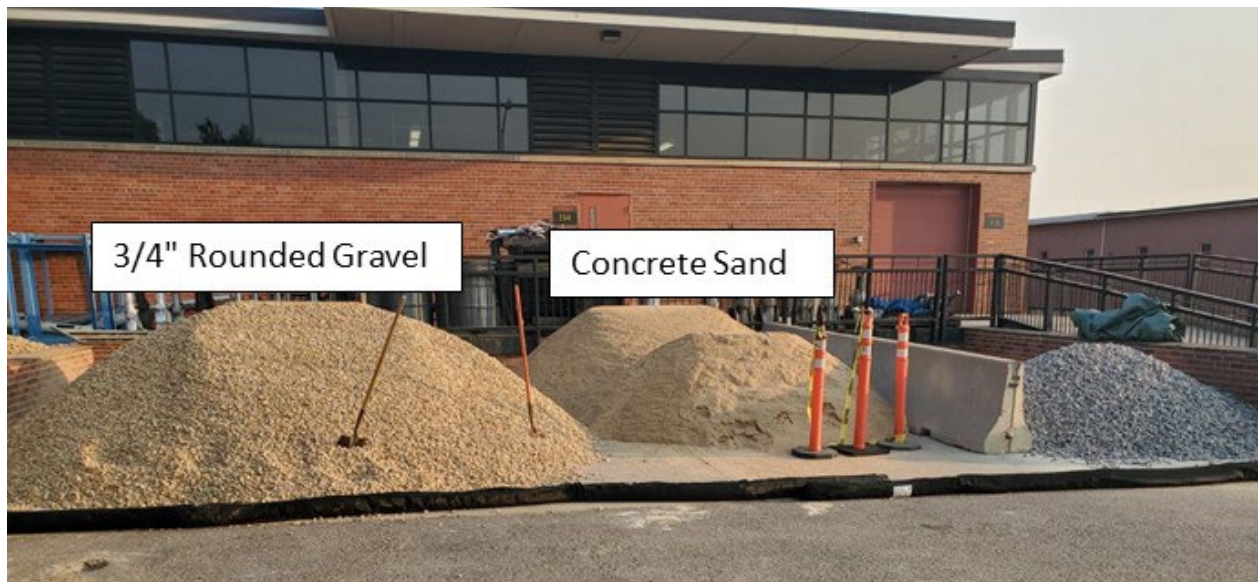
Figure 10. Photograph of materials used for the 1:24 model sediment blend.

Figure 10, Figure 11, and Figure 12 show photographs of the materials used for blended sediment gradations at the lab for each model scale.

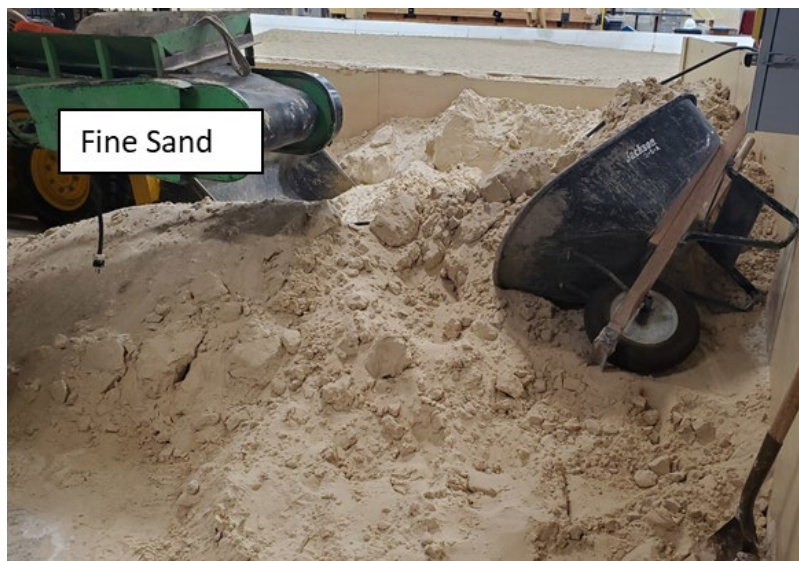
Figure 11. Photograph of fine sand used for both sediment blends.

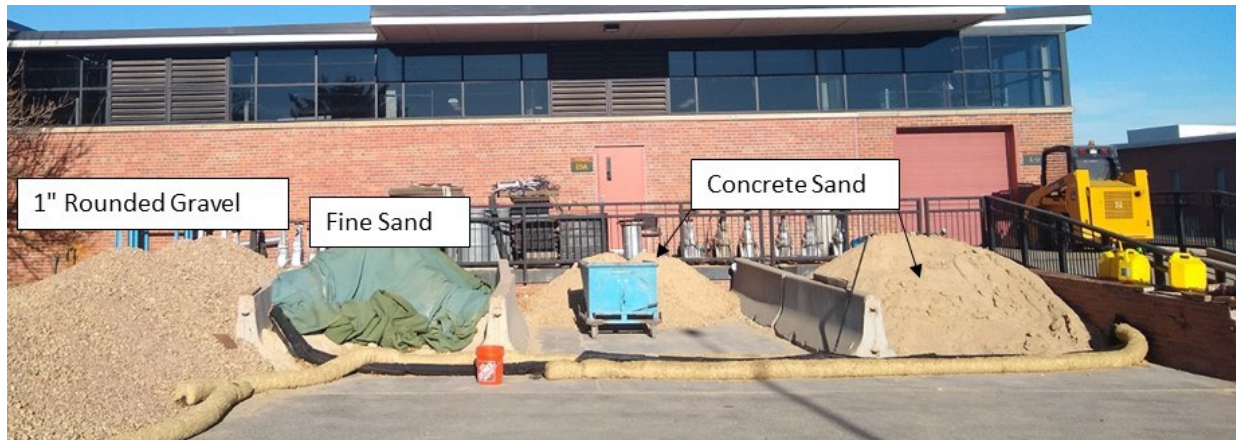
Figure 12. Photograph of materials used for the 1:12 model sediment blend.

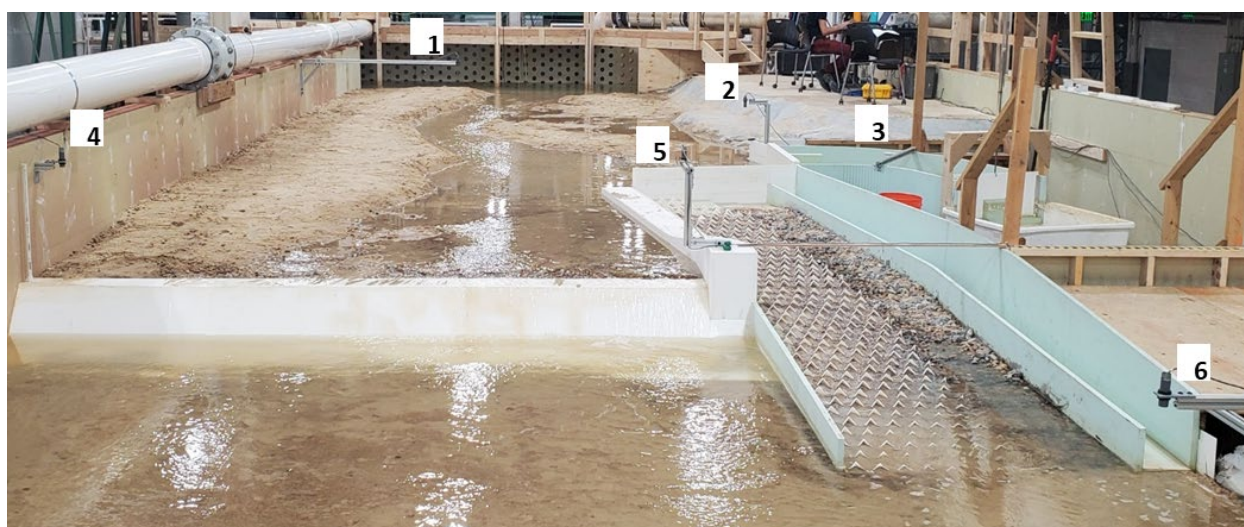
Figure 15. View of water level sensor locations on 1:24 model (looking upstream).

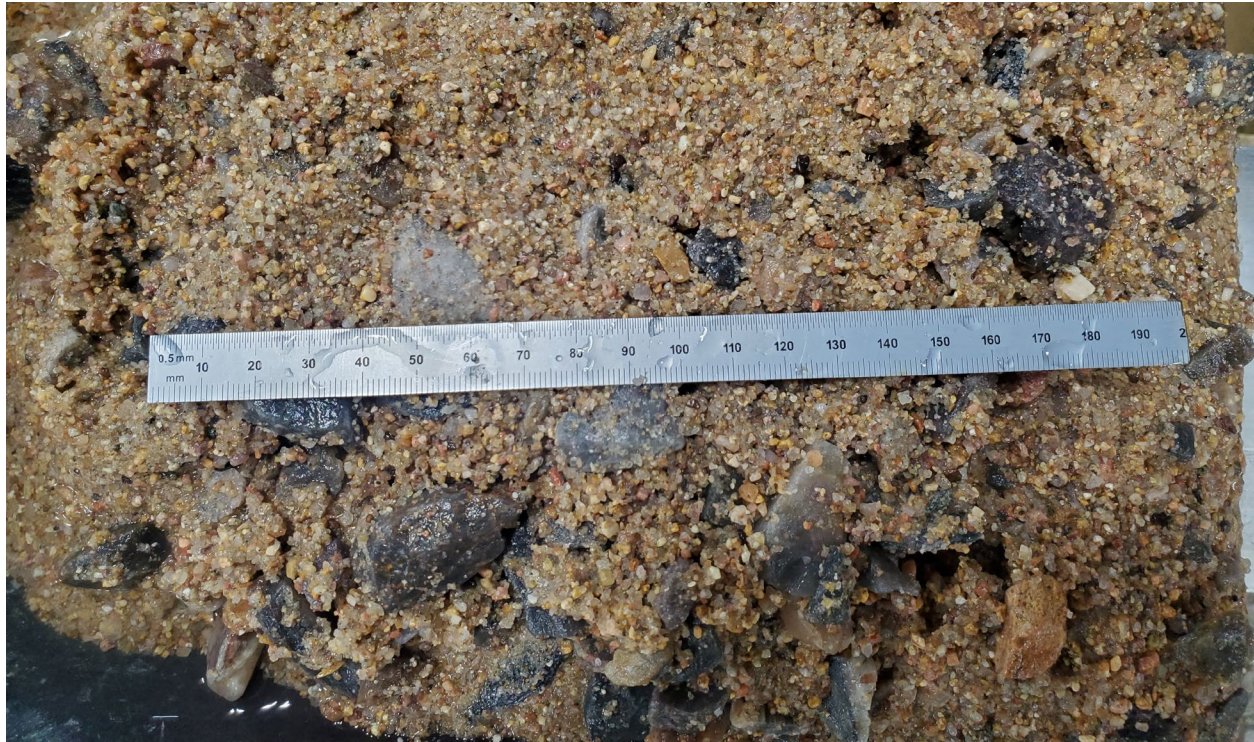
Figure 18. Photograph of ruler and 1:24 scale sediment blend used for visualization of sediment movement.

Initial shakedown testing began while the 1:24 scale physical model was still under construction. Simple tests were conducted in the Hydraulics Laboratory’s 3-ft tilting flume to confirm sediment transport characteristics of the 1:24 scale designed sediment blend before large volumes of the sediment materials were acquired. A sample of the designed sediment blend was placed in the flume with a representative bed slope of 0.002. A range of velocities and corresponding “critical” material sizes expected to begin mobilization were observed in the flume (Table 6). A ruler was secured to the bottom of the test section to help identify approximate material sizes that began to be transported (Figure 18). Visual observations were recorded with video.

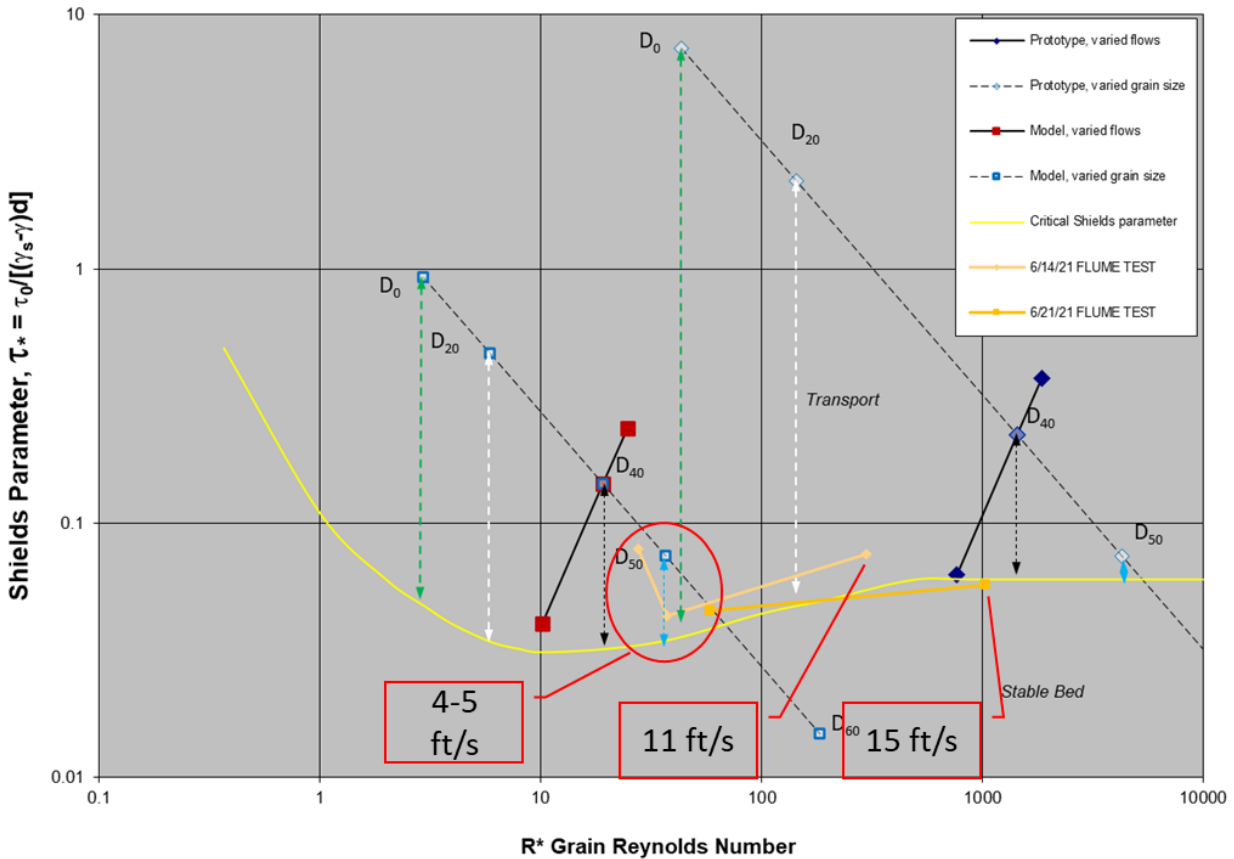
Figure 19. Critical grain sizes that began to mobilize near the critical Shield's parameter (yellow) adding confidence that the 1:24 sediment blend was designed correctly for the range of prototype velocities expected.

Sediment particle sizes that began to mobilize in the flume tests were plotted on Shield's diagram at their corresponding velocity (Figure 19) to be compared to the critical parameter for material transport. In other words, data points represent particles that are either beginning to move or have already started moving and fall very close to the critical Shield's parameter (yellow line). These observations helped add confidence that the designed sediment blend would transport appropriately for the expected range of river discharges and velocities. Due to these initial results and observations, this flume test was not repeated for the 1:12 sediment blend. Shield's diagram and parameter and their relevance to the sediment design of the current study are discussed in detail in Appendix A.

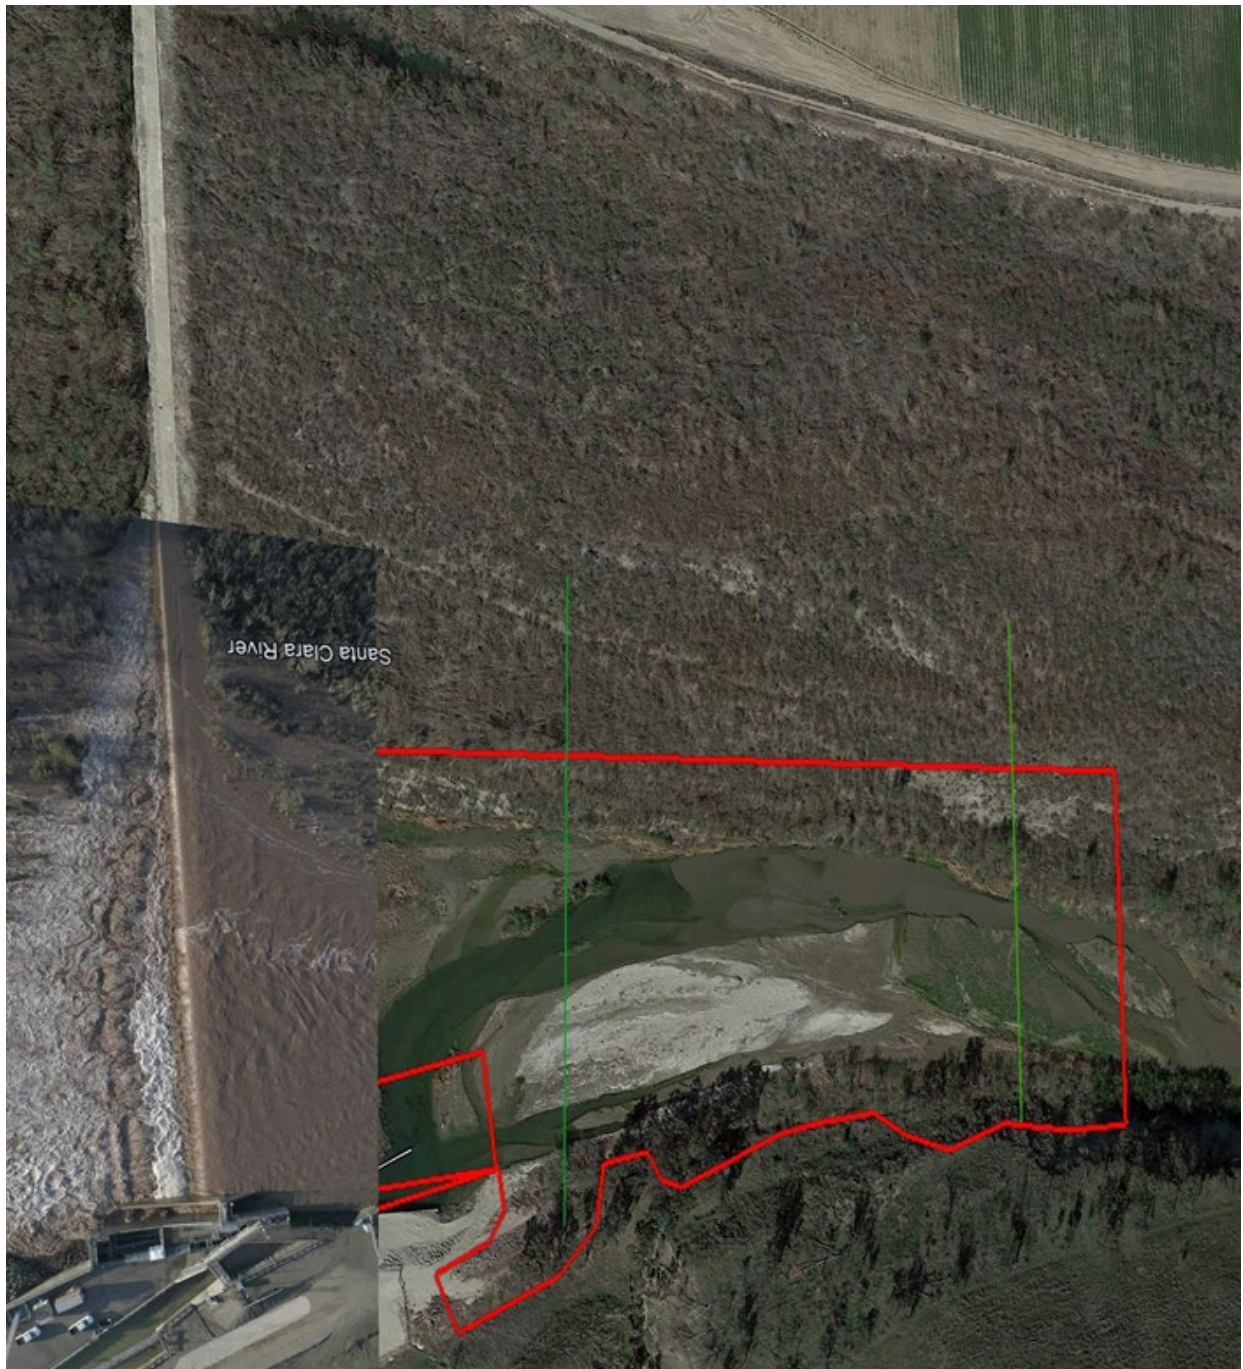
Figure 20. Aerial footage of 23,000 ft³/s discharge over the dam crest, overlaid on a lower-flow aerial image and approximate upstream extents of the 1:24 model, outlined in red.

Initial test runs in the 1:24 model focused on upstream flow conditions approaching the hardened ramp and dam. Velocity profiles from NHC's two dimensional (2D) HEC-RAS models as well as video observations from previous flows over Freeman Dam were used to adjust the upstream river topography to provide flow conditions more realistic of the prototype site. Visual observations were made in the model of flow passing over the dam in a manner similar to that shown in Figure 20 where flow is skewed to the left due to the vegetation and channelization of the river.

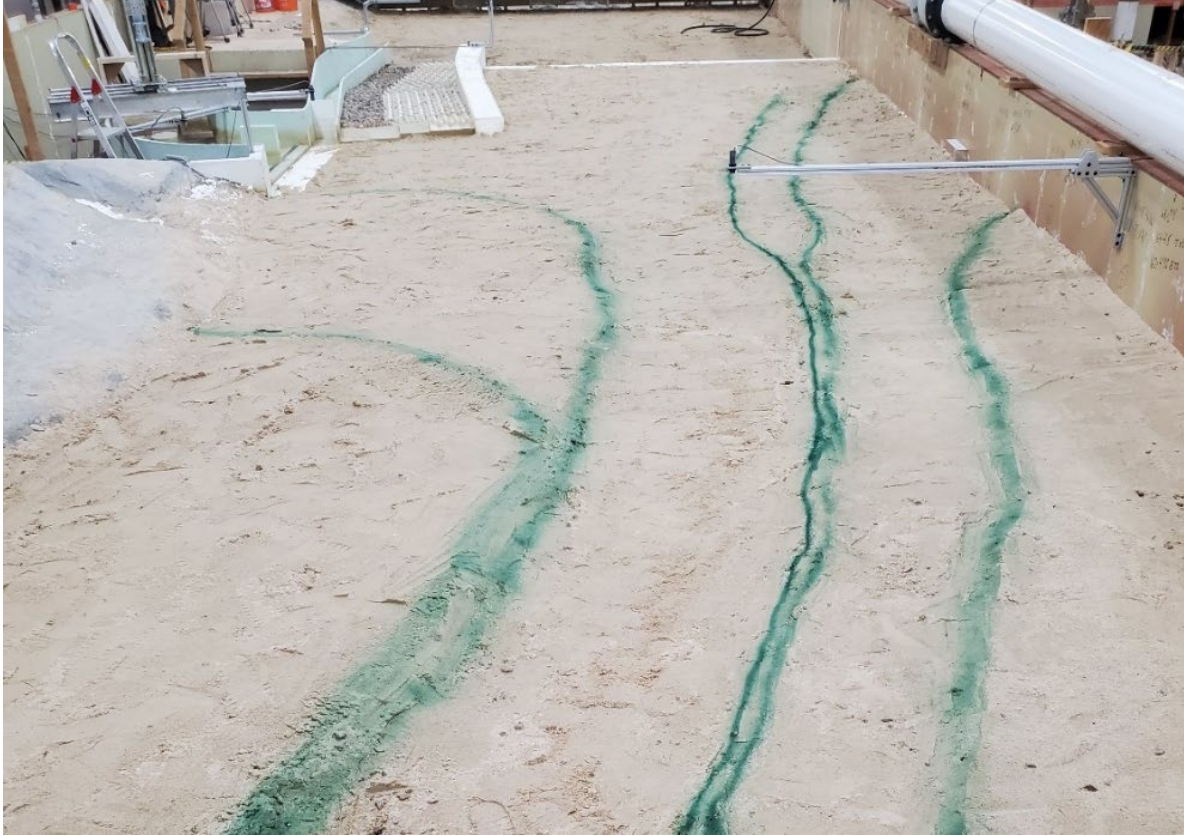
Figure 22. Photograph of upstream topography that was manually set before testing (looking downstream).

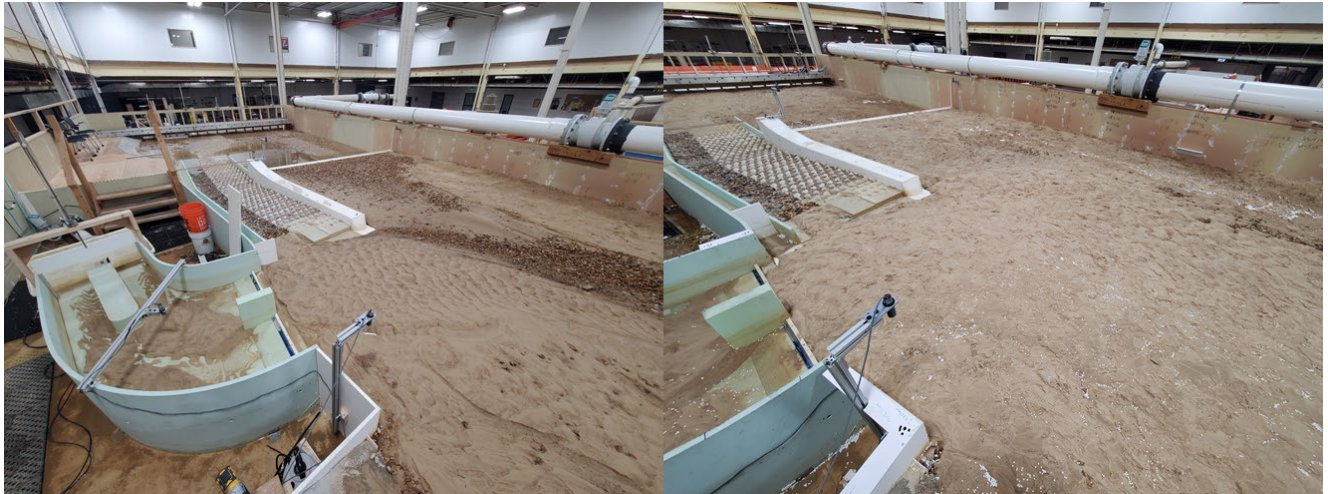
Figure 23. Photographs of the bed material comparisons near the beginning (left) and end (right) of shakedown testing where additional fine materials were added to the top layer for more realistic sediment conditions expected for a flow range of 1,000 to 12,000 ft³/s.

Once the approach conditions were confirmed, the focus of shakedown testing shifted to proper sediment transport in the model. Visual observations from the field were helpful in ensuring the sedimentation was representative. Initial tests showed that the ratio of larger cobbles and boulders was too high in the model and that there were insufficient sands and cobbles present to accurately represent sediment behaviors in the river. Additional blends of fine and concrete sand were added to provide more smaller materials that tend to transport over the primary discharge range to be used for testing in this model (up to 12,000 ft³/s). This agreed with observations of sediment transport in initial flume tests as well as with visual observations of the material size range that most commonly transports in the prototype. Figure 23 compares bed materials upstream of the hardened ramp near the beginning and end of shakedown testing to show the increase of smaller materials.

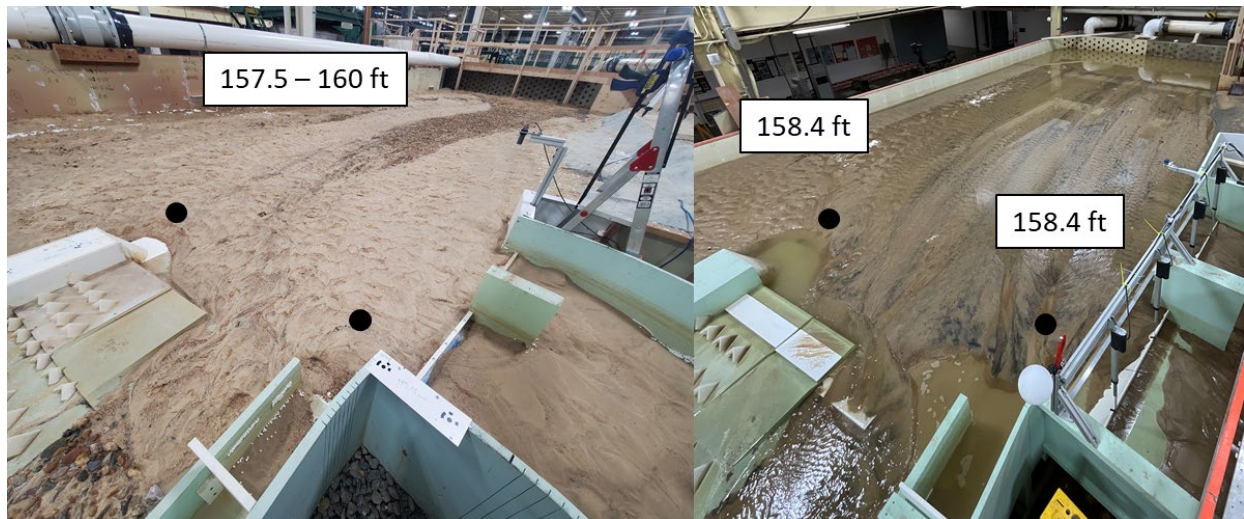
Figure 24. Photographic comparisons of sediment patterns after 6,000 ft³/s in the 1:24 model (left) and 1:12 model (right).

Observations of sedimentation patterns were also made and compared at both scales. Photographs in Figure 24 show similar sediment patterns following a discharge of 6,000 ft³/s upstream of the hardened ramp and canal intake, including deposits on gates 1 and 2 of the hardened ramp as well as

the canal intake gates. Point elevations of the bed at the same locations produced similar results. Scour upstream of the hardened ramp wall bullnose is another prominent feature that was repeatable at both model scales.

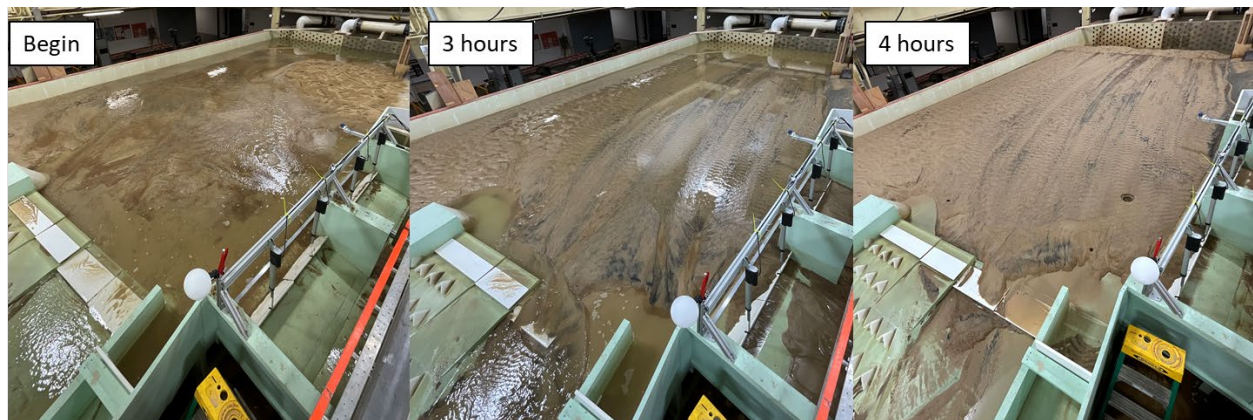
Figure 25. Timelapse photographs of the 1:12 model at 6,000 ft³/s to determine run times required for sediment patterns to reach equilibrium.

Experience testing the 1:24 model during shakedown and baseline testing showed that time durations could be shortened by “pre-loading” the model with sediment loads near the canal intake and hardened ramp exit. Run time durations to reach quasi-steady state were tested in the 1:12 model during shakedown and the following run times were determined (e.g., 6,000 ft³/s in Figure 25).

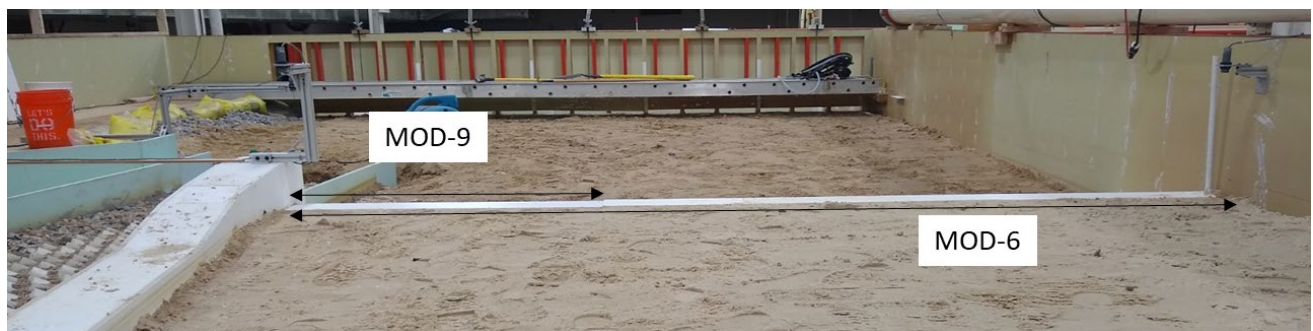
Figure 26. Dam crest configuration comparing MOD-6 (400 ft notch) to MOD-9 (100 ft notch) design configurations in 1:24 model.

The main differences in these design configurations are the elevation of the upstream end of the hardened ramp, the length of the hardened ramp, the elevation of the sill of the canal intake, and elevations and extents of a notch made into the existing dam crest. Elevations for both configurations are compared in Table 8. The difference in extents of the notch in the dam crest is shown in Figure 26. Dimensions and elevations of the MOD-9 notch are shown for the 1:12 model in Figure 27.

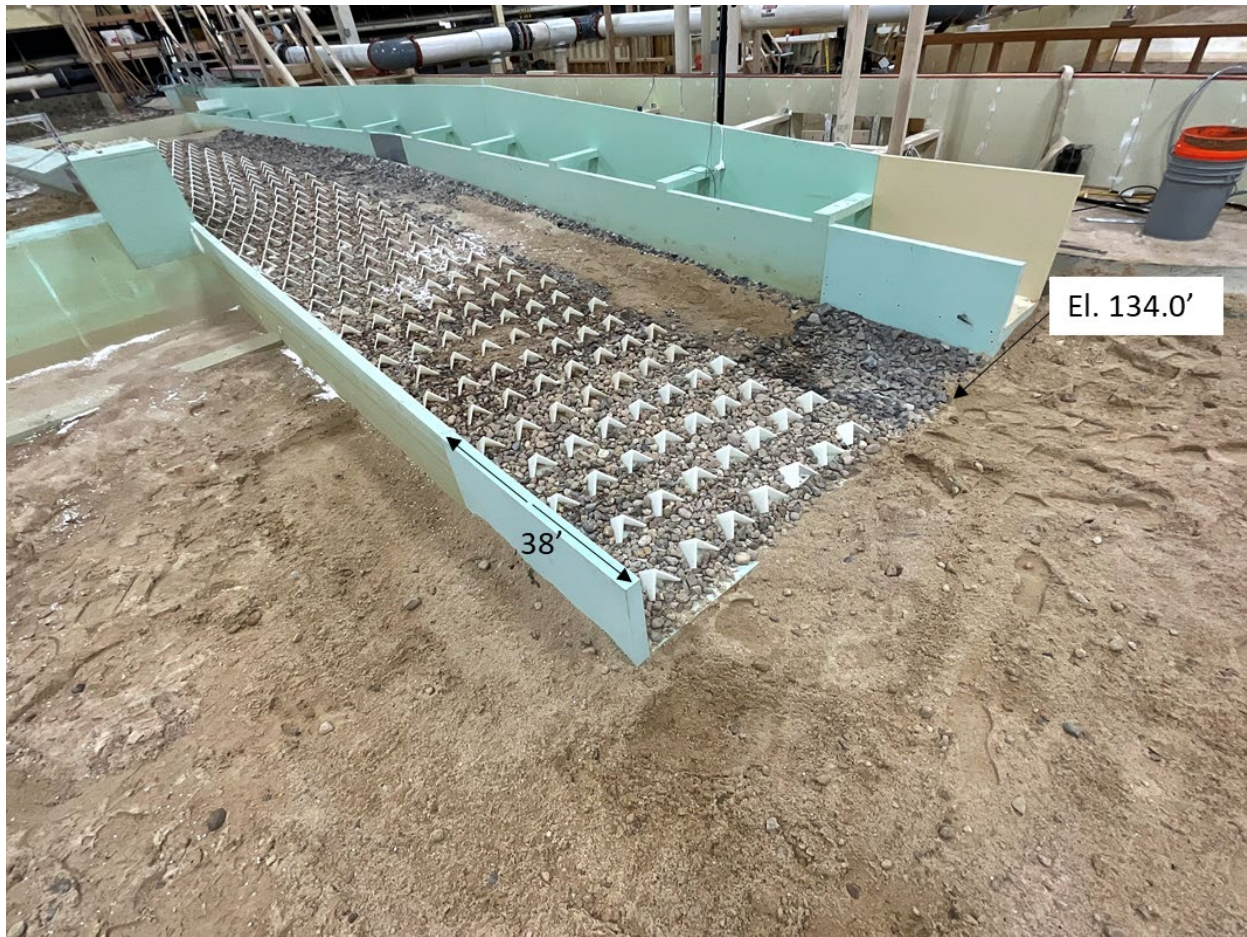
Figure 28. Photograph showing the 38-ft downstream extension of the hardened ramp in the 1:12 scale model for the MOD-9 design configuration.

Figure 27. The 100-ft notch in the crest for the MOD-9 configuration in the 1:12 scale model. The hardened ramp was extended about 38 ft downstream to maintain the same slope of 5% and downstream invert elevation of 134.0 ft. This modification in the 1:12 model is shown in Figure 28.

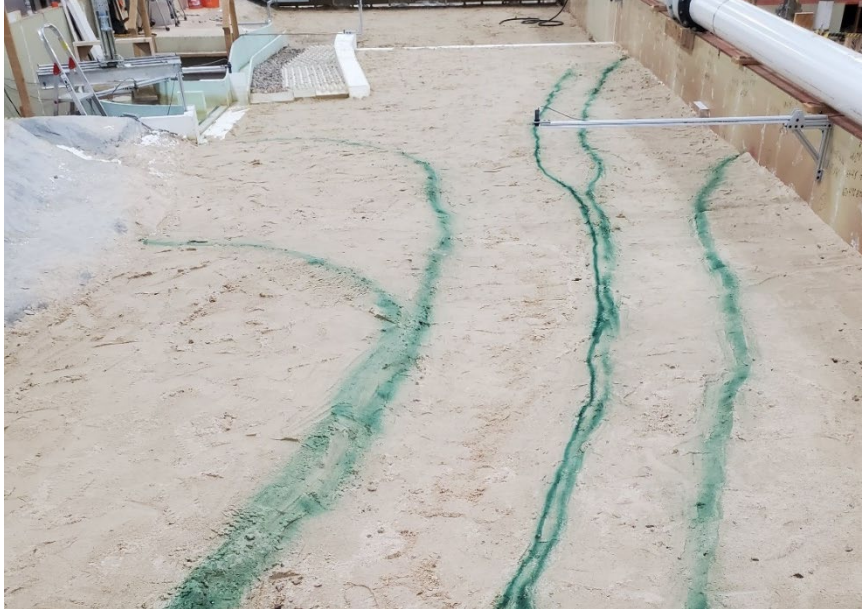
Figure 32. Upstream topography with flushing channel for MOD-6 design configuration.

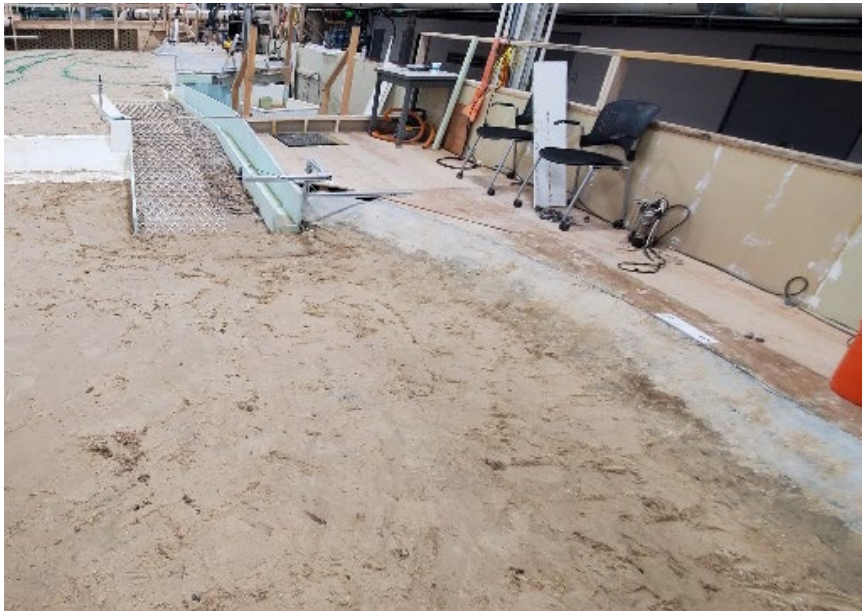
Figure 33. Downstream topography with flushing channel installed for MOD-6 design configuration, looking upstream.

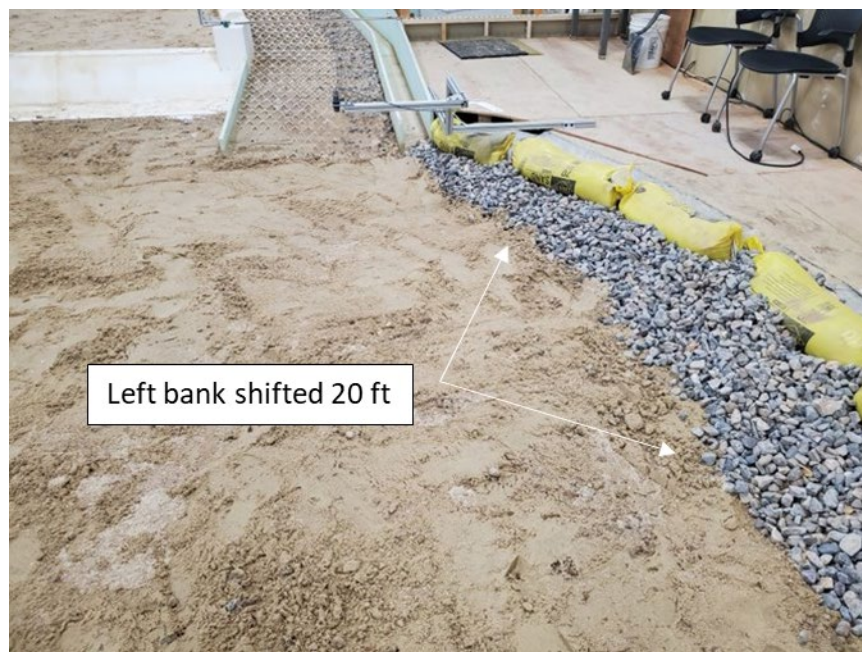
Figure 35. Downstream topography modification with flushing channel removed for MOD-6 design configuration, looking upstream.

The flushing channel was controlled by a 15-ft-wide slide gate that was either fully open or fully closed (Figure 30). To represent the configuration with the flushing channel removed, the canal intake structure and apron were moved 20 ft into the river so that the flushing channel was blocked off. The upstream left bank topography was also shifted into the channel by 20 ft and the baseline bathymetry was adjusted accordingly. The model configurations both with and without a flushing channel are shown in Figure 34 through Figure 35.

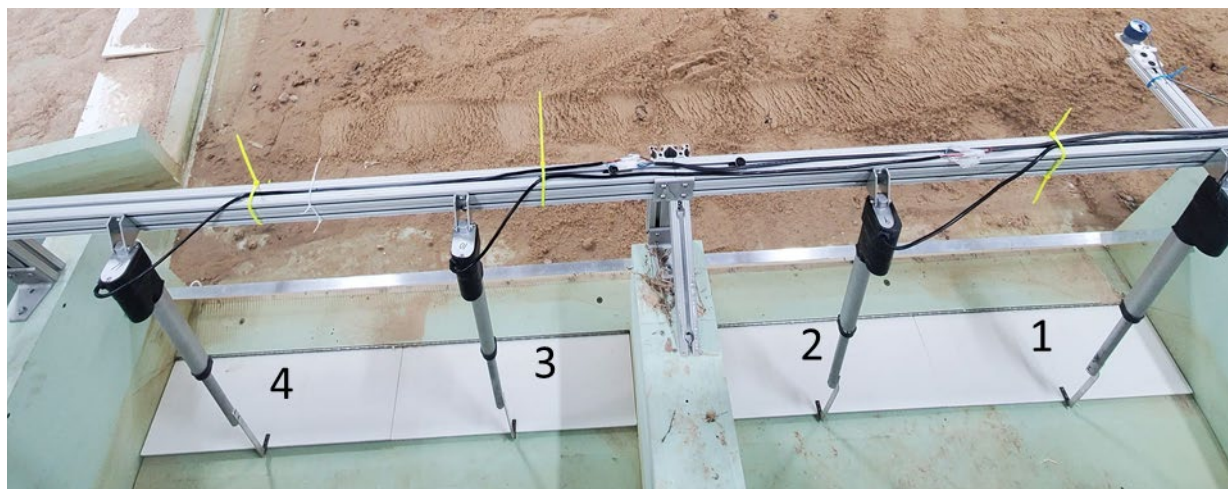
Figure 36. Canal intake gates (looking upstream from intake) with individual actuators to adjust gate settings remotely.

Similar to the 1:24 model, the 1:12 model baseline included river topography upstream, 140 ft of the dam crest, the hardened ramp structure, an adjacent flushing channel, and the canal intake structure with intake gates. During baseline testing the canal intake gates were operated with electric actuators that controlled the diversion discharge for each test (Figure 36). Gate elevation settings to set and evenly distribute the target diversion flow are shown in Table 12.

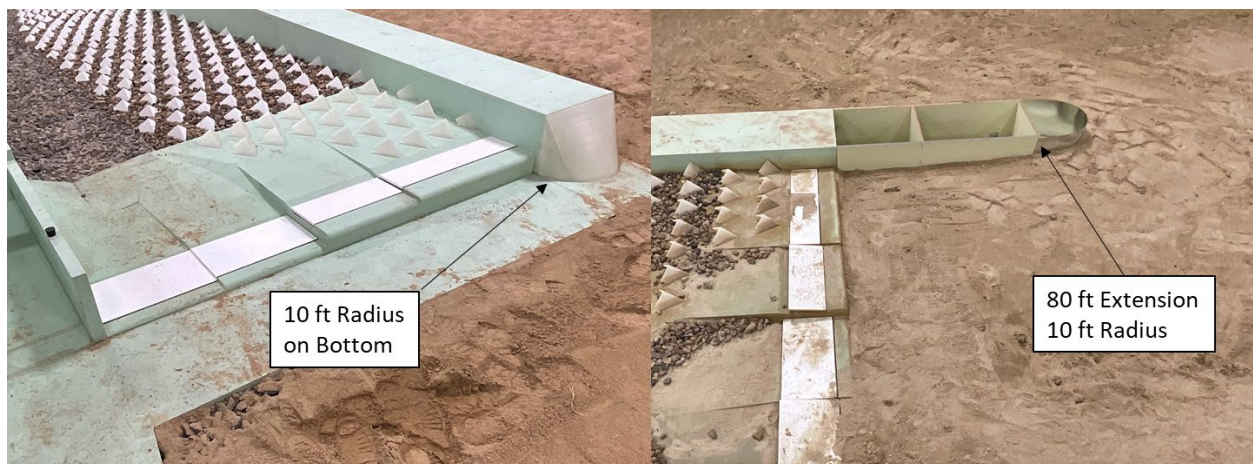
Figure 38. Photographs of the 1:12 physical model comparing the original design of the bullnose for baseline testing (left) with the extension tested in the design development phase (right).

The first modification to the design was to extend the right wall of the hardened ramp upstream 80 ft and add a fully rounded shape (bullnose) to the end in both the 1:24 and 1:12 models. Details are shown in Figure 37 and Figure 38 compared to the original design. This modification was maintained as other design changes were made throughout the design development phase.

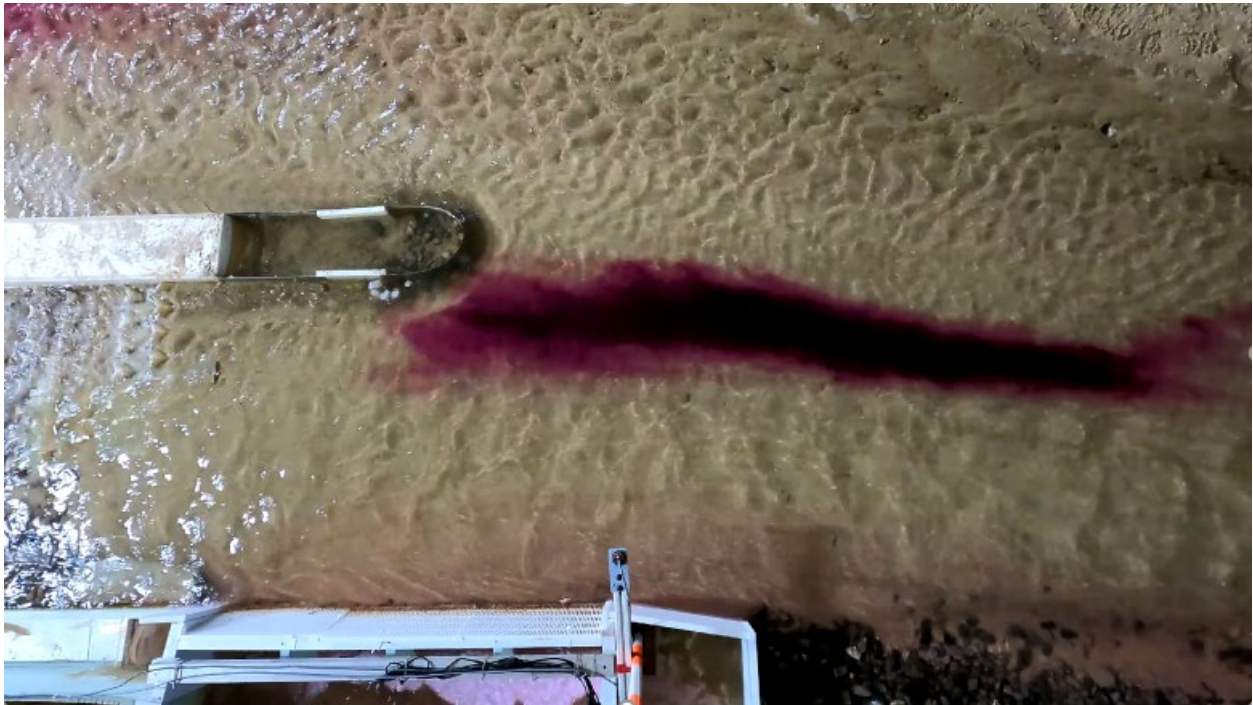
Figure 42. Photograph of dye approaching the hardened ramp without a flushing channel at 6,000 ft³/s.

Observations of flow patterns with dye, PIV results, photographs, and bedform contour maps of the remaining sediment patterns for the initial no flushing configuration are shown in Figure 42 through Figure 56. These results include flows of 6,000, 3,000, and 1,500 ft³/s. Results showed that flow approaching the hardened ramp was generally more streamlined compared to baseline results. Flow streamlines followed the left bank and curved slightly toward the left at the approach to the hardened ramp exit and canal intake. A significant bed form developed in the area upstream of and on the hardened ramp exit and canal intake. Localized scour developed upstream of the bullnose on the hardened ramp right wall and left wall connecting with the downstream sill of the intake.

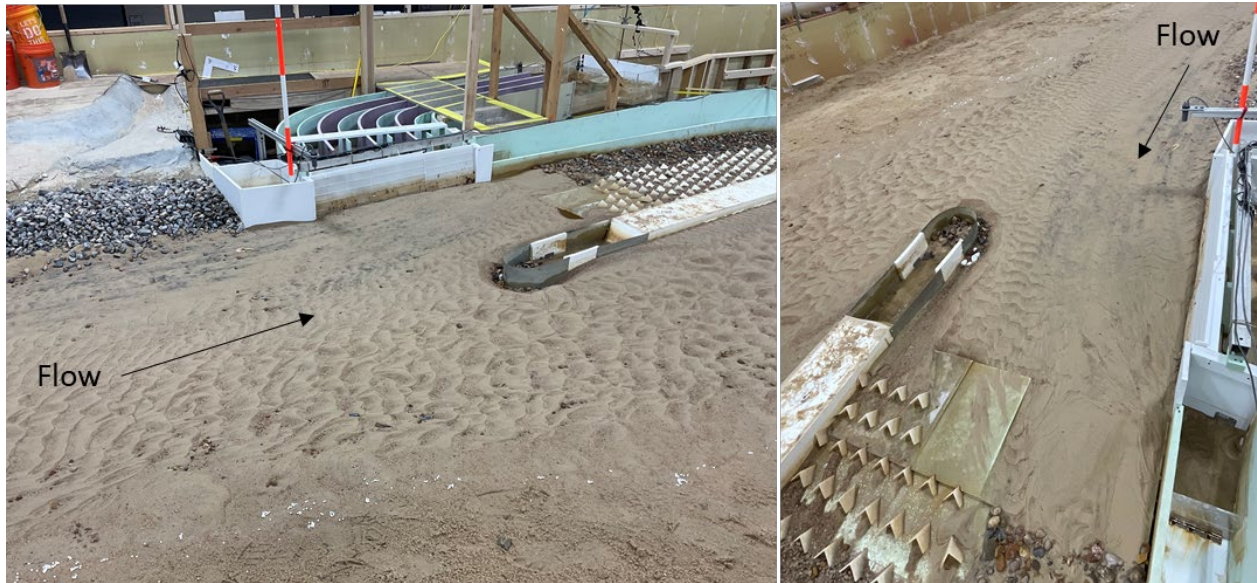
Figure 44. Photographs of the sediment bedforms upstream of hardened ramp without a flushing channel at 6,000 ft³/s.
