Hydraulic Laboratory Report HL-2022-03

Physical Hydraulic Modeling of the Freeman Diversion Hardened Ramp Fish Passage Alternative

Freeman Diversion

United Water Conservation District, Ventura County, California

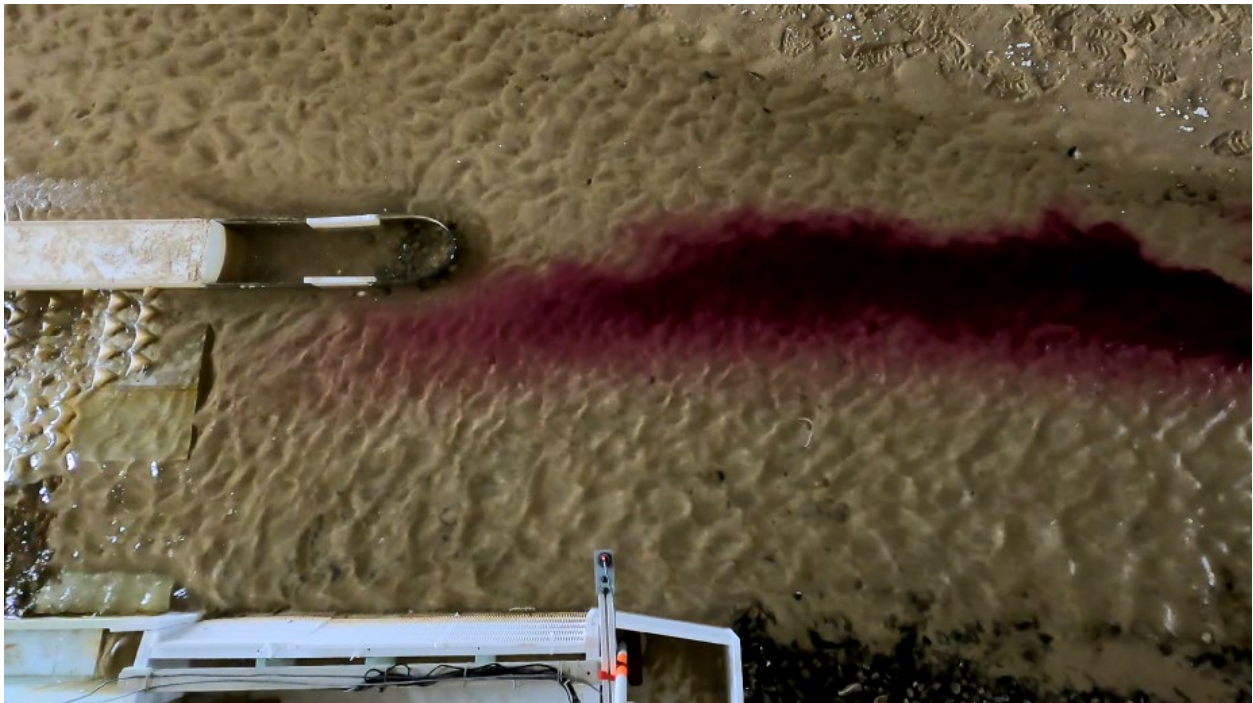
Figure 47. Photograph of dye approaching the hardened ramp without a flushing channel at 3,000 ft³/s.

Observations of flow patterns with dye, PIV results, photographs, and bedform contour maps of the remaining sediment patterns for the initial no flushing configuration are shown in Figure 42 through Figure 56. These results include flows of 6,000, 3,000, and 1,500 ft³/s. Results showed that flow approaching the hardened ramp was generally more streamlined compared to baseline results. Flow streamlines followed the left bank and curved slightly toward the left at the approach to the hardened ramp exit and canal intake. A significant bed form developed in the area upstream of and on the hardened ramp exit and canal intake. Localized scour developed upstream of the bullnose on the hardened ramp right wall and left wall connecting with the downstream sill of the intake.

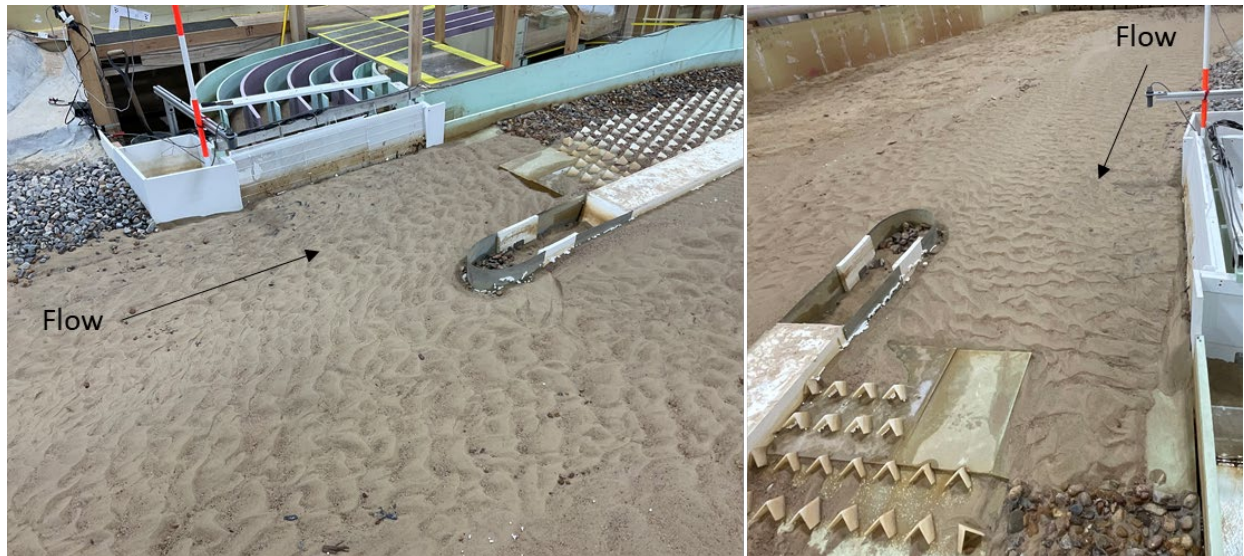
Figure 49. Photographs of the sediment bedforms upstream of hardened ramp without a flushing channel at 3,000 ft³/s.

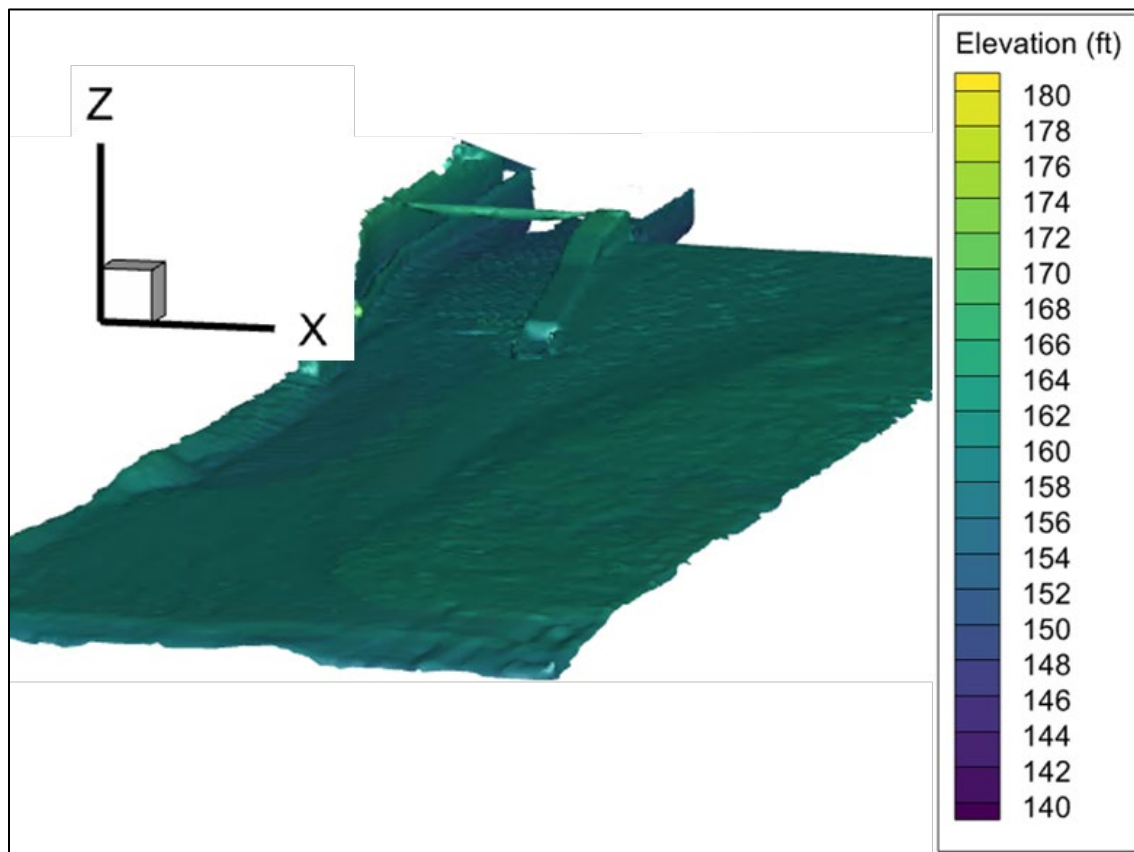
Figure 51. Isometric color contour map of upstream bedform elevations without a flushing channel at 3,000 ft³/s. Looking downstream.

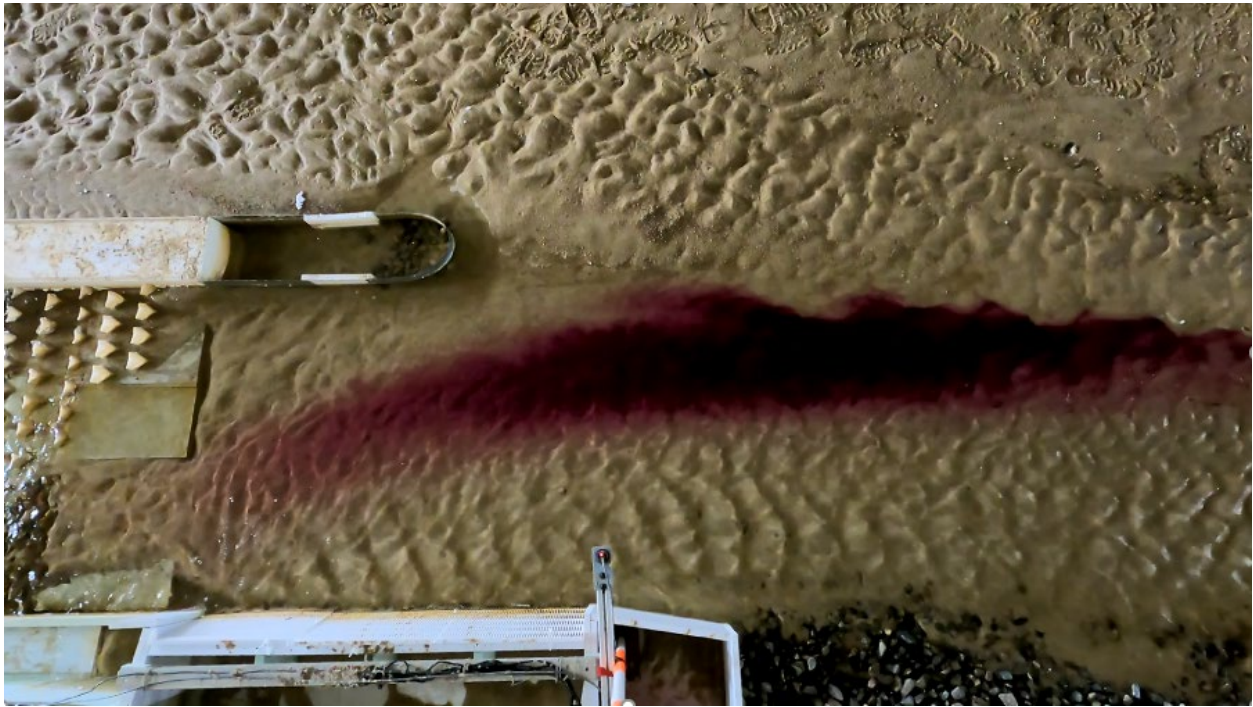
Figure 52. Photograph of dye approaching the hardened ramp without a flushing channel at 1,500 ft³/s.

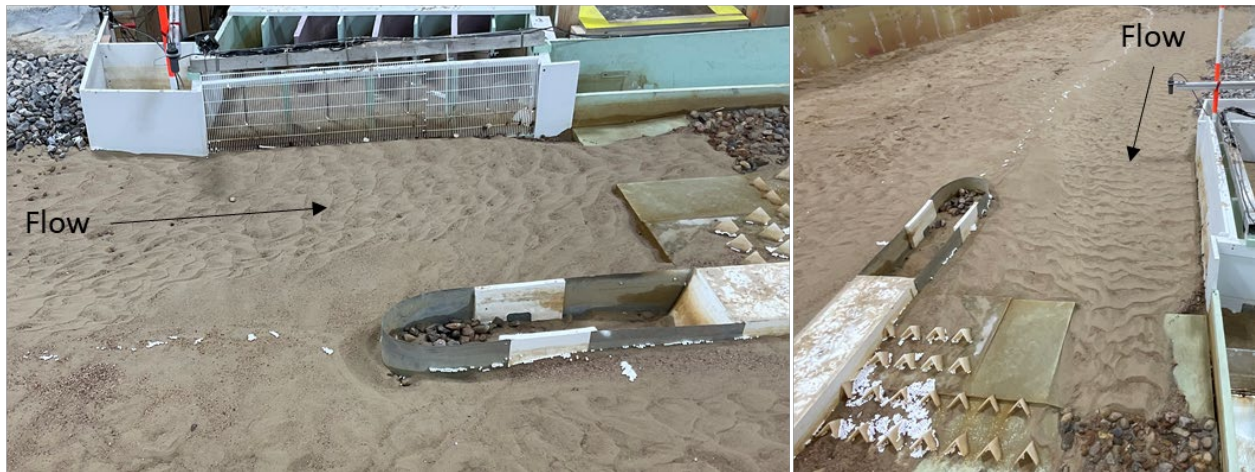
Figure 54. Photographs of the sediment bedforms upstream of hardened ramp without a flushing channel at 1,500 ft³/s.

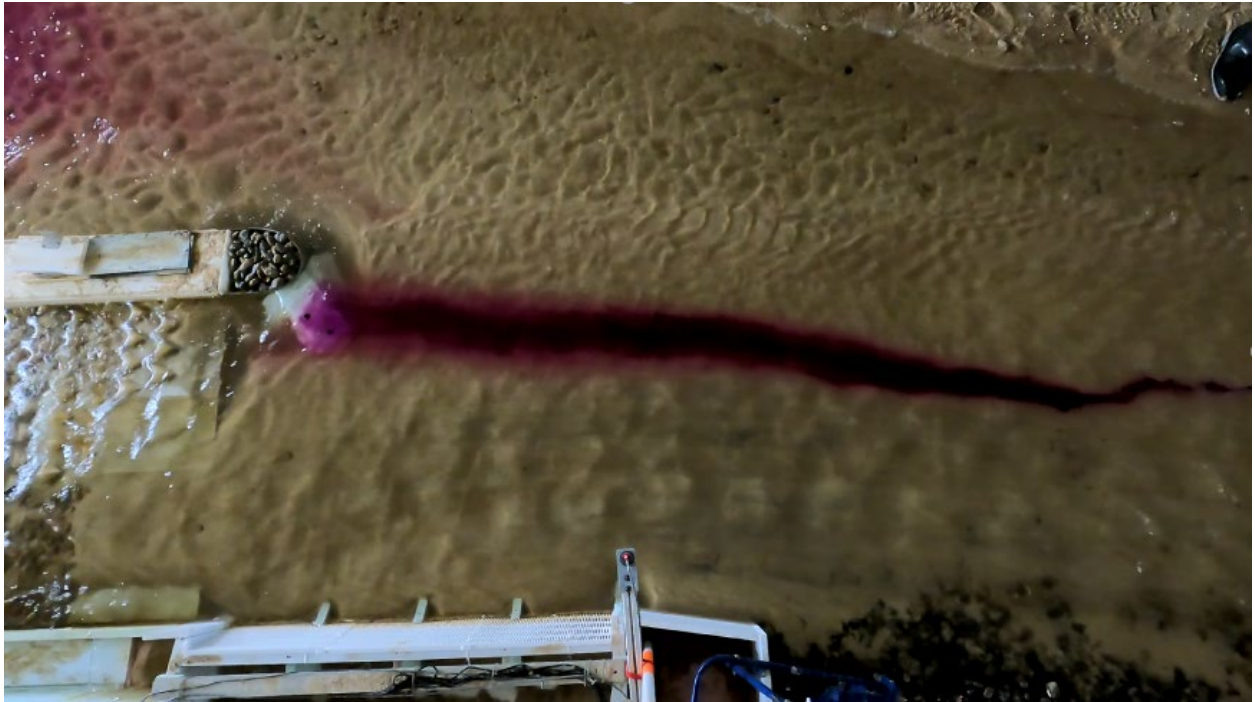
Figure 57. Photograph of dye approaching the hardened ramp without a flushing channel at 6,000 ft³/s with added sediment features.

Observations of flow patterns with dye, PIV results, photographs, and bed difference maps sediment patterns for the no flushing configuration with added turbulence generators and sloped vane wall are shown in Figure 57 through Figure 68. These results include flows of 6,000, 3,000, and 1,500 ft³/s. Similar to previous results without the sediment features, these results showed streamlined flow approaching the hardened ramp. A significant bedform developed in the same area upstream of and on the hardened ramp and canal intake.

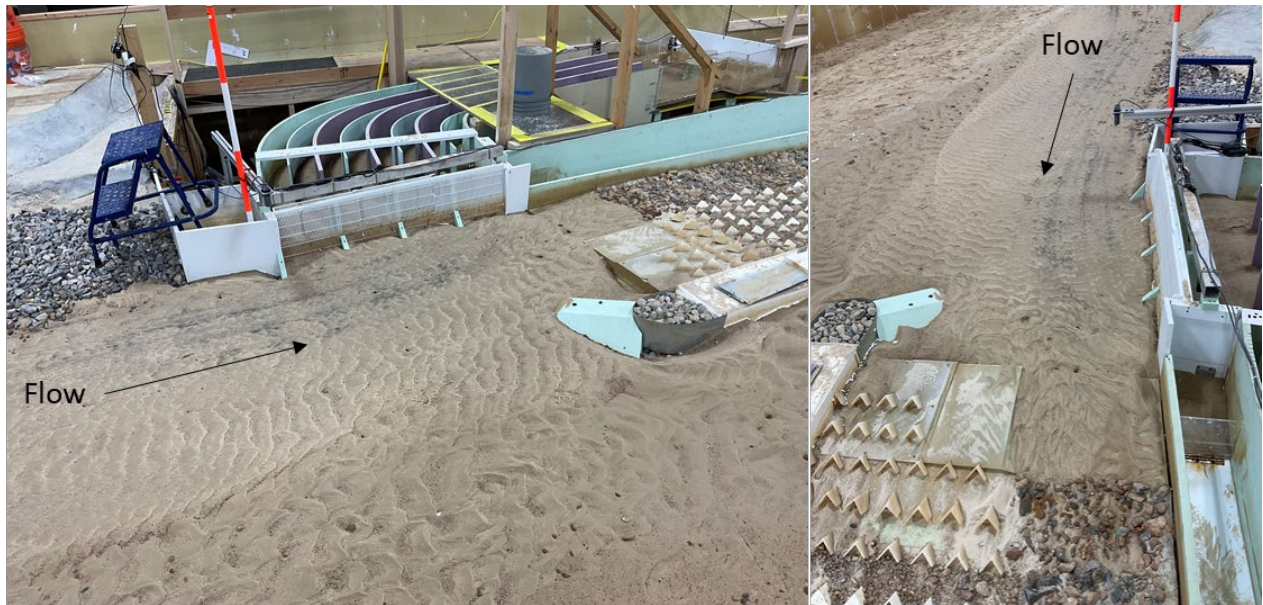
Figure 59. Photographs of the sediment bedforms upstream of hardened ramp without a flushing channel at 6,000 ft³/s with added sediment features.

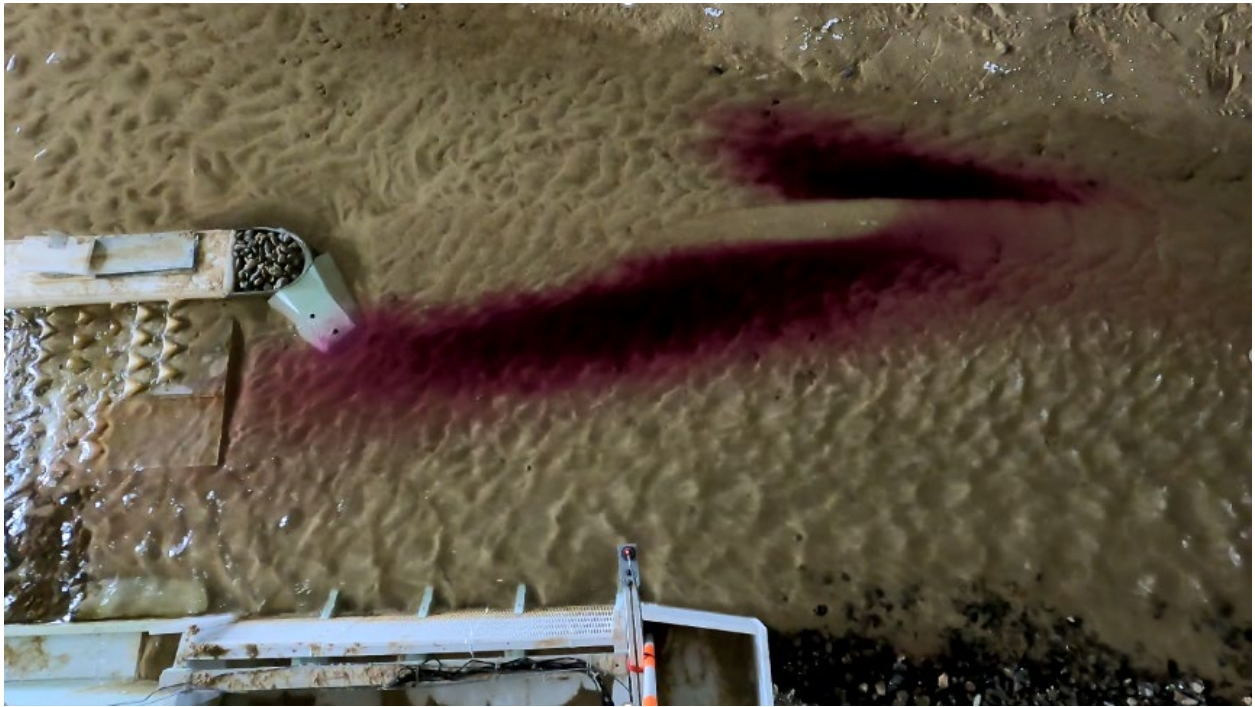
Figure 61. Photograph of dye approaching the hardened ramp without a flushing channel at 3,000 ft³/s with added sediment features.

The main difference was sand bar formation along the right side of the main flow channel approximately parallel to and upstream of the right wall bullnose. This sand bar was especially prominent at 3,000 ft³/s which began to split the flow at a point further upstream compared to the initial test configuration (Figure 61). This feature did not have a major effect on hydraulics at the fishway exit of the hardened ramp as shown by depth and velocity measurements. Other differences include additional scour near the right side of the hardened ramp exit along the canal intake. Scour along the intake was most prominent at 1,500 ft³/s as water levels dropped. Though not measured nor a focus of this testing, anecdotal evidence from visual observations suggested that more sediment accumulated in the canal intake with the turbulence generators located along the intake sill.

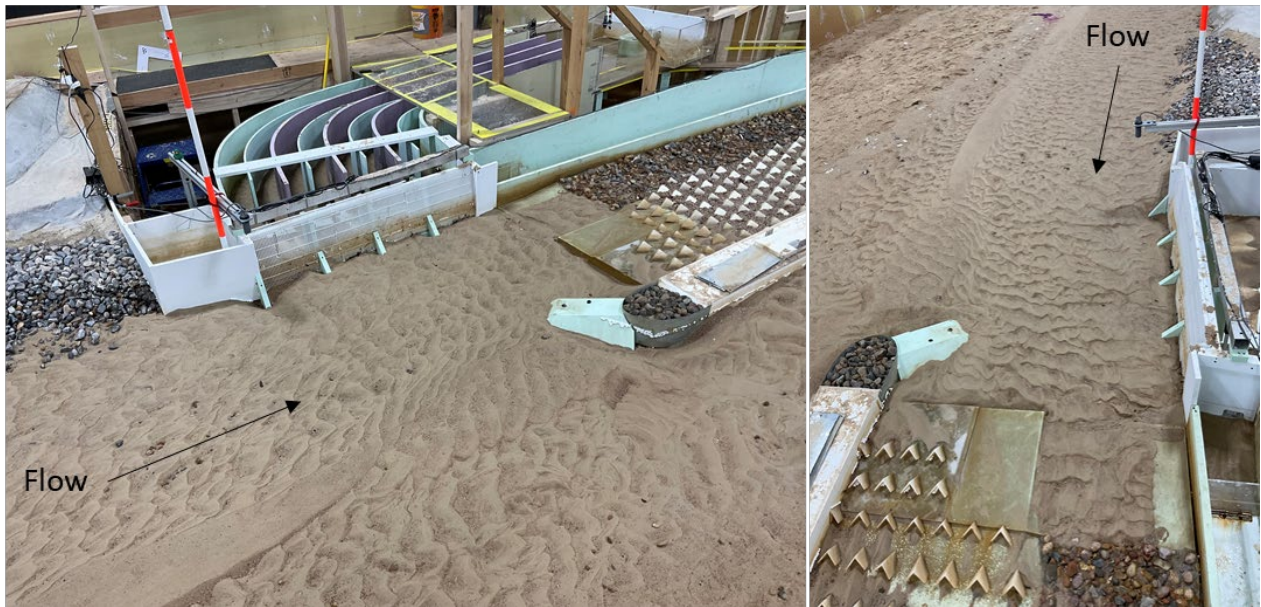
Figure 63. Photographs of the sediment bedforms upstream of hardened ramp without a flushing channel at 3,000 ft³/s with added sediment features

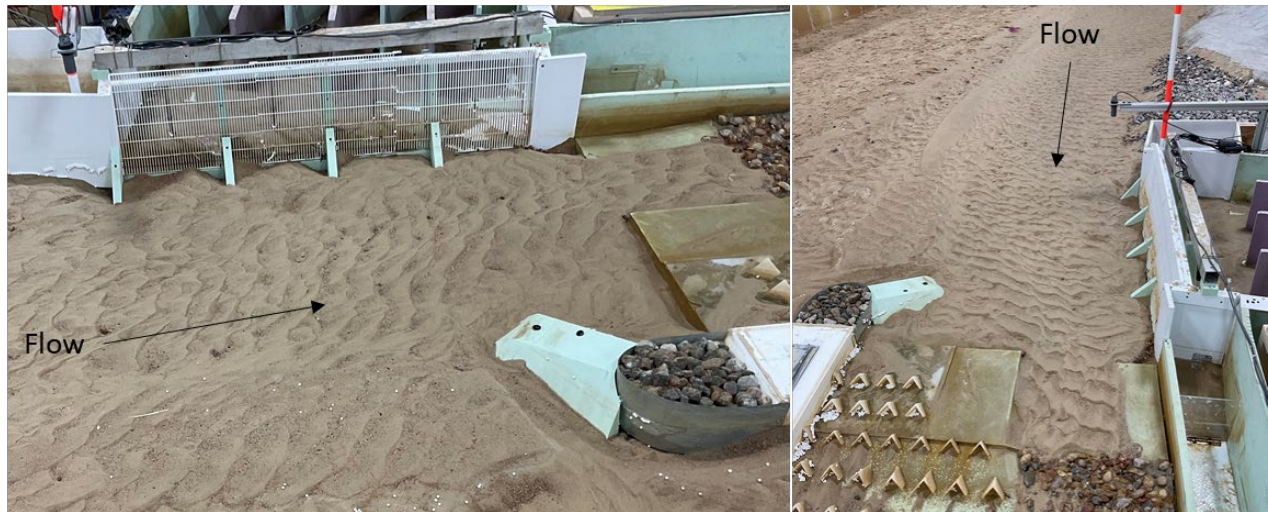
Figure 67. Photographs of the sediment bedforms upstream of hardened ramp without a flushing channel at 1,500 ft³/s with added sediment features.

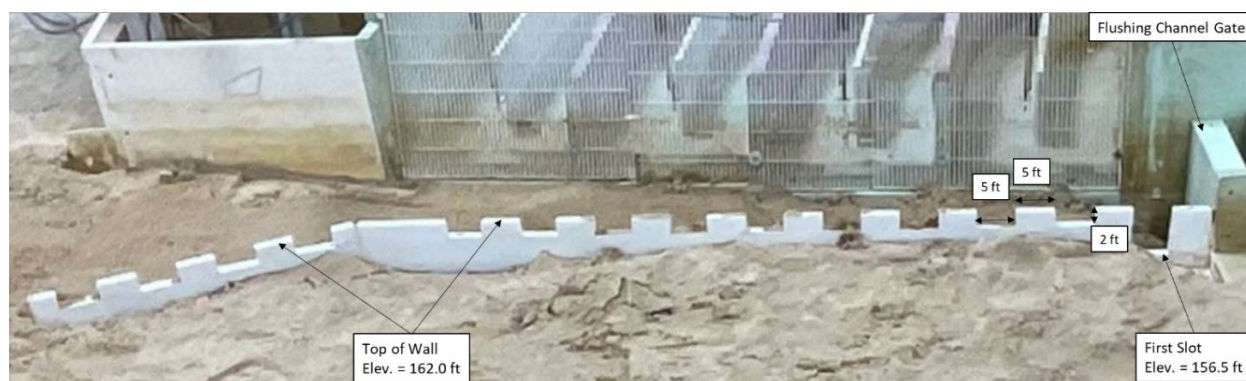
Figure 72. Photograph showing the castle training wall in the 1:24 model.

Training wall configurations were also added to the design and tested in the 1:24 model in conjunction with flushing channel tests. Layouts and dimensions for each configuration are shown in Figure 69 through Figure 72. Each configuration included a 20-degree flare wall on the upstream end that extended approximately to the upstream end of the apron. Elevations of the top wall started low (156.5 ft) and were increased until effective flushing operations were achieved. The final tested configuration was 25-ft wide and included slots on the top as shown in Figure 72 (the “castle training wall”). The top elevation of the wall was 162 ft and the slots were 2 ft deep, except the most downstream slot which was 5.5 ft deep. The flushing channel gate was also moved upstream to where the upstream end of the left wall of the hardened ramp meets the downstream end of the training wall to prevent areas of stagnant recirculation at the inlet to the flushing channel. All training wall configurations were tested first in the 1:24 model while only the 25 ft wide versions were included in the 1:12 model. Tests included visual observations of flow patterns and sediment removal from the canal intake and apron. A bed scan of the adjacent riverbed upstream was made for the final configuration in the 1:24 model.

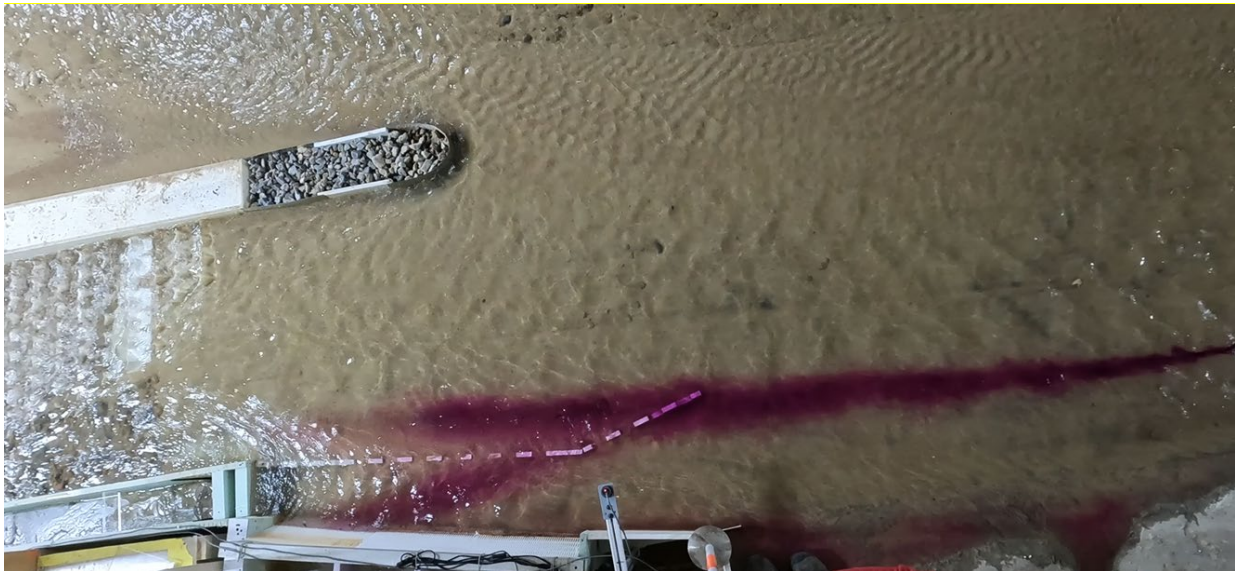
Figure 73. Photograph of dye approaching the hardened ramp with a castle training wall and flushing channel at 6,000 ft³/s.

Observations of flow patterns with dye, PIV results, photographs, and bedform contour maps of sediment patterns are shown in Figure 73 through Figure 87. These results include flows of 6,000, 3,000, and 1,500 ft³/s. Results showed flow approaching the hardened ramp was more streamlined compared to baseline results. Flow streamlines were basically parallel with the hardened ramp walls across the full width at the upstream end of the ramp. A divergence of flow toward the canal intake began near the upstream end of the training wall and continued over and through the castle slots

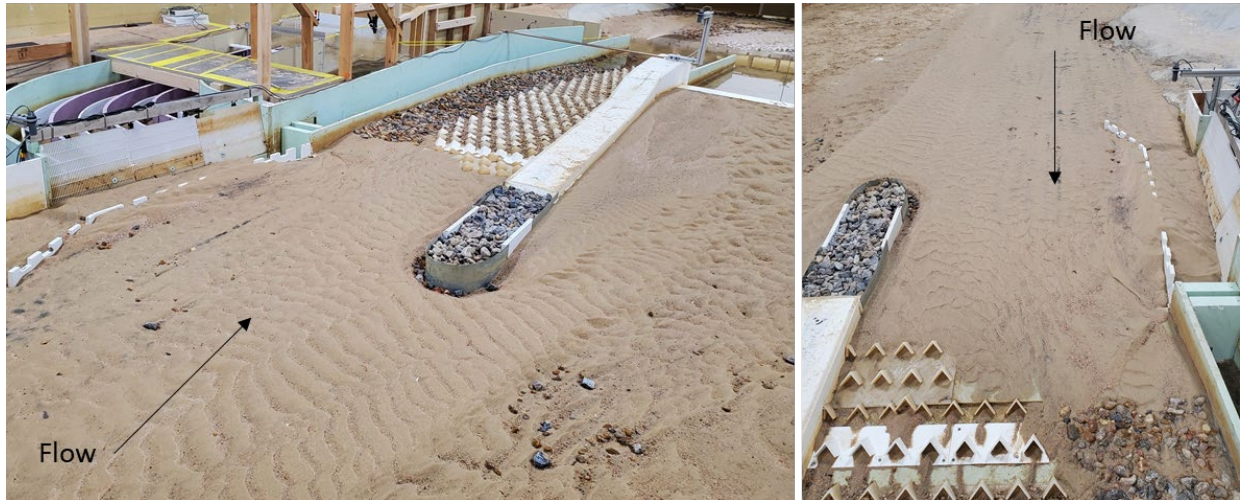
Figure 75. Photographs of the sediment bedforms upstream of hardened ramp with a castle training wall and flushing channel at 6,000 ft³/s.

A significant bed form developed in the area upstream of and on the hardened ramp exit and canal intake. Localized scour developed upstream of the bullnose on the hardened ramp right wall with deposition downstream toward the dam crest as previously noted. The castle training wall was mostly inundated with sediment at 6,000 ft³/s but produced local scour on both sides of the wall from flow at lower water surface elevations as the flow receded to 3,000 ft³/s and then 1,500 ft³/s which reduced sediment elevations at each flow as seen in the photographs.

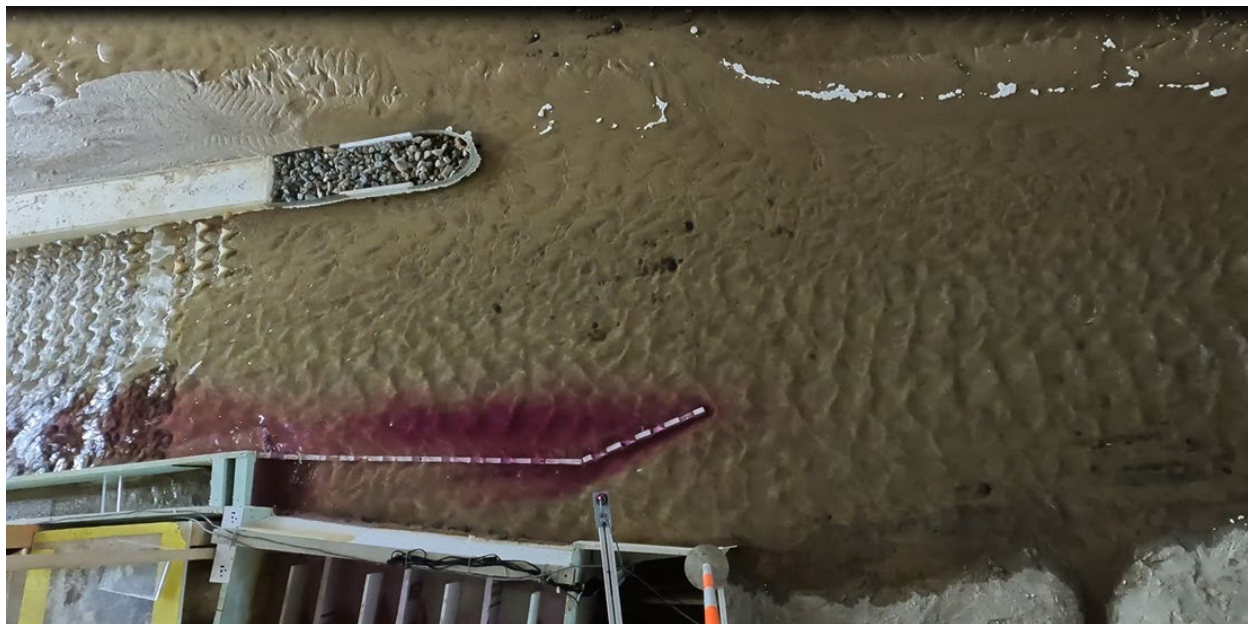
Figure 78. Photograph of dye approaching the hardened ramp with a castle training wall and flushing channel at 3,000 ft³/s.

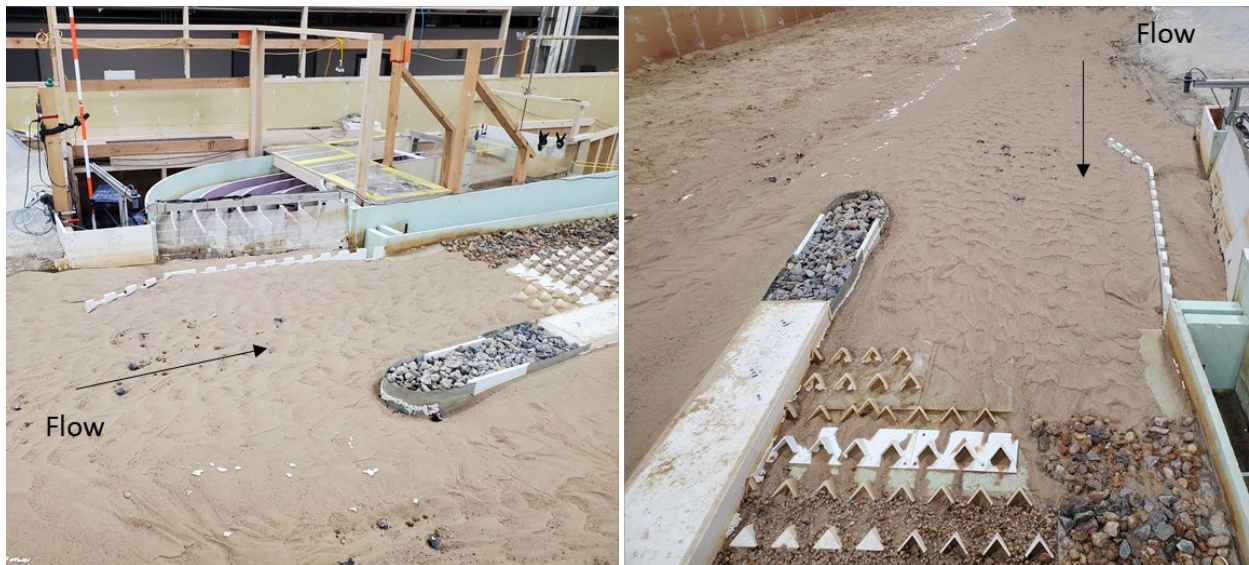
Figure 80. Photographs of the sediment bedforms upstream of hardened ramp with a castle training wall and flushing channel at 3,000 ft³/s.

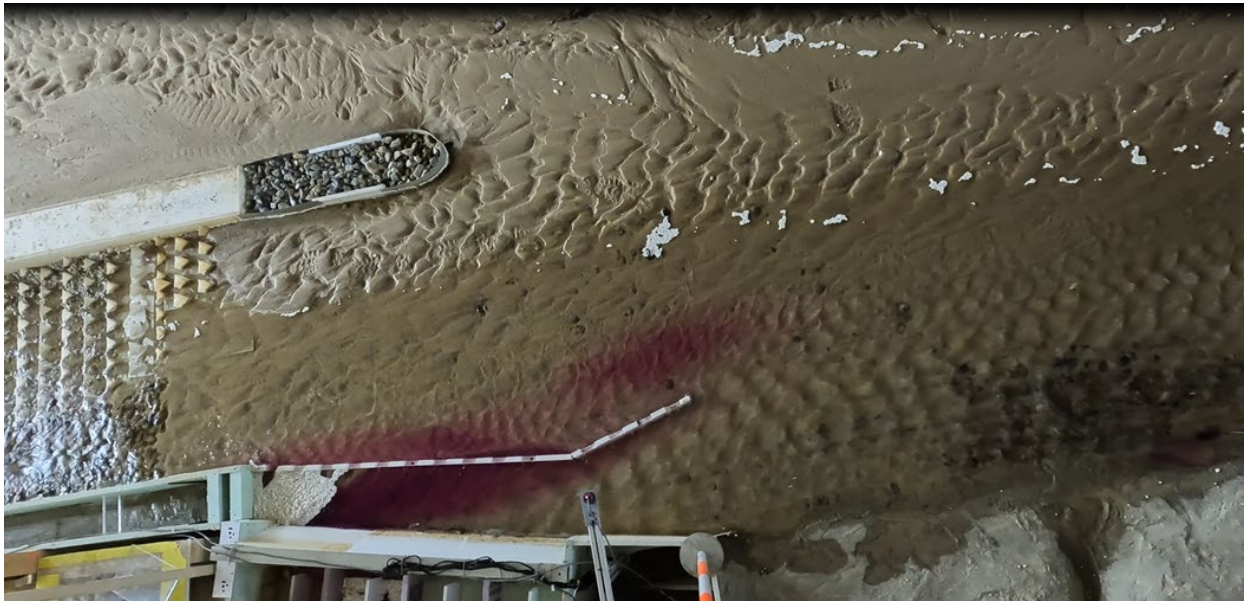
Figure 83. Photograph of dye approaching the hardened ramp with a castle training wall and flushing channel at 1,500 ft³/s.

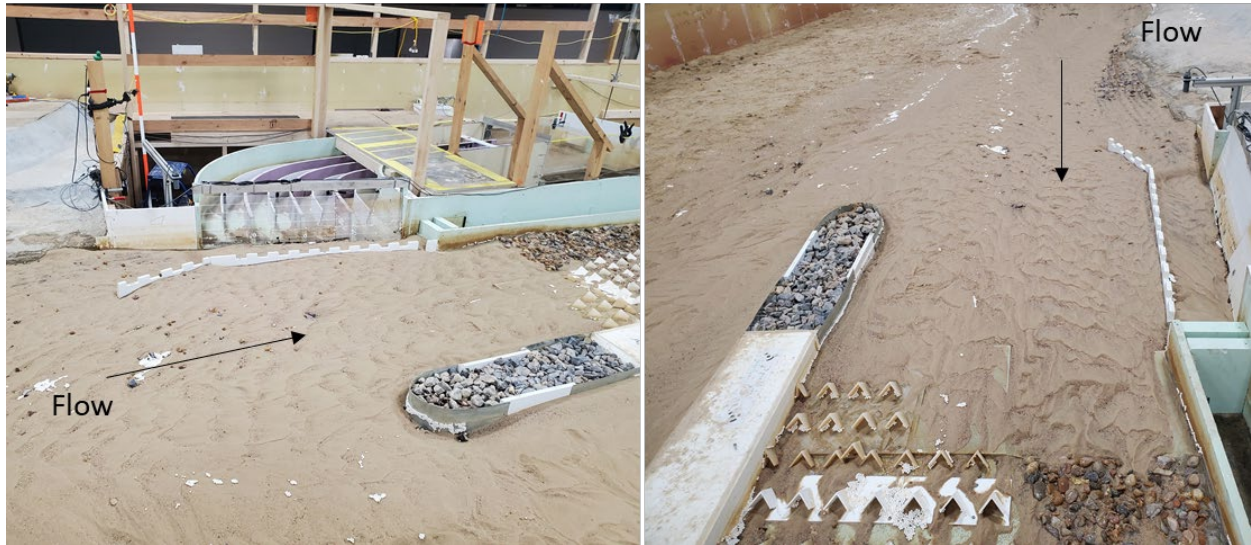
Figure 85. Photographs of the sediment bedforms upstream of hardened ramp with a castle training wall and flushing channel at 1,500 ft³/s.

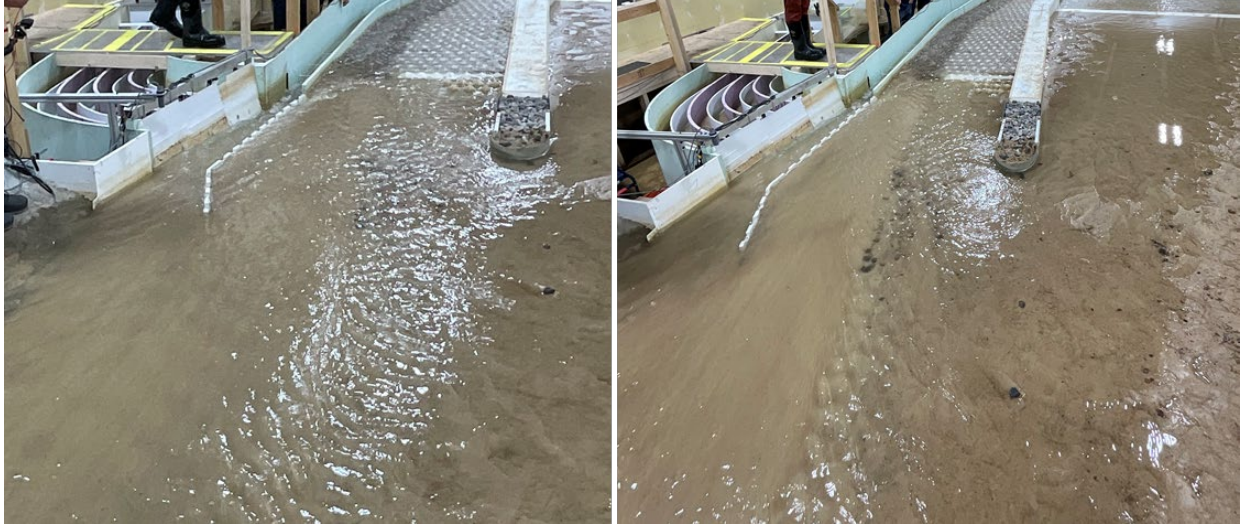
The hardened ramp remained submerged during flushing operations at 3,000 ft³/s and above as well as some flow over the dam crest (Figure 88). Flow remained in the low flow section of the hardened ramp but not within the baffled section for flushing operations at 1,500 ft³/s. Flow splits for flushing tests were not measured.

Figure 88. Photographs of a flushing operation at 3,000 ft³/s near the beginning of flushing (left) and midway through flushing (right). Looking downstream.

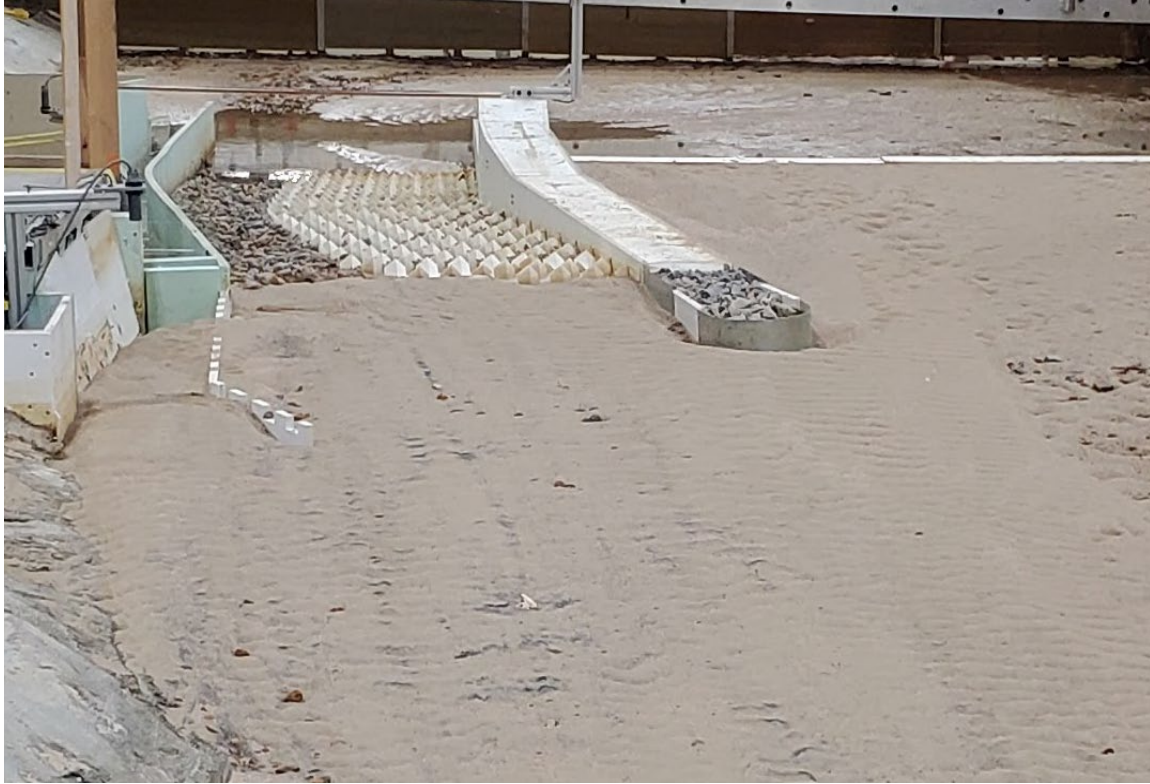
Figure 89. Photograph of bedform upstream of the hardened ramp and canal intake after 6,000 ft³/s river flow and 825 ft³/s diversion.

Flushing operations with the 5.2% downward slope and castle training wall effectively removed the sediment deposited upstream of the hardened ramp and canal intake. Figure 89 and Figure 90 show bedforms deposited upstream of the hardened ramp and intake following flows of 6,000 ft³/s and 3,000 ft³/s prior to flushing. The photograph and contour plots in Figure 91 through Figure 93 show that the bedform was removed following a flushing operation at 3,000 ft³/s. The flushing operation was performed for 15 minutes on the model (on the order of 1.5 hrs prototype assuming Froude scaling) before the flushing channel gate was again closed and then the model shutdown and drained to observe the bed upstream. While the invert of the apron was not completely cleared from the flushing event, the floor was visible at many locations. Local scour along the right side of the training wall was observed along its entire length caused by turbulence of flow passing through the castle slots towards the flushing channel. Flushing also had an affect upstream where sediment was removed along the left bank for up to an additional 100 ft upstream of the training wall.

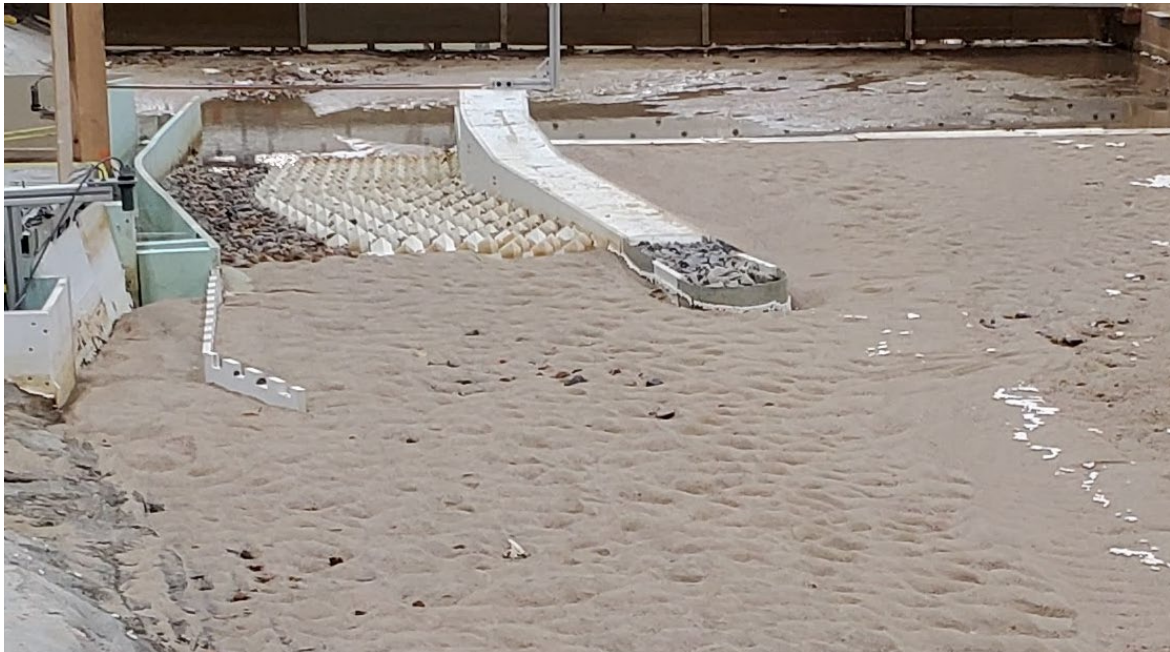
Figure 90. Photograph of bedform upstream of the hardened ramp and canal intake after 3,000 ft³/s river flow and 825 ft³/s diversion before flushing operations.

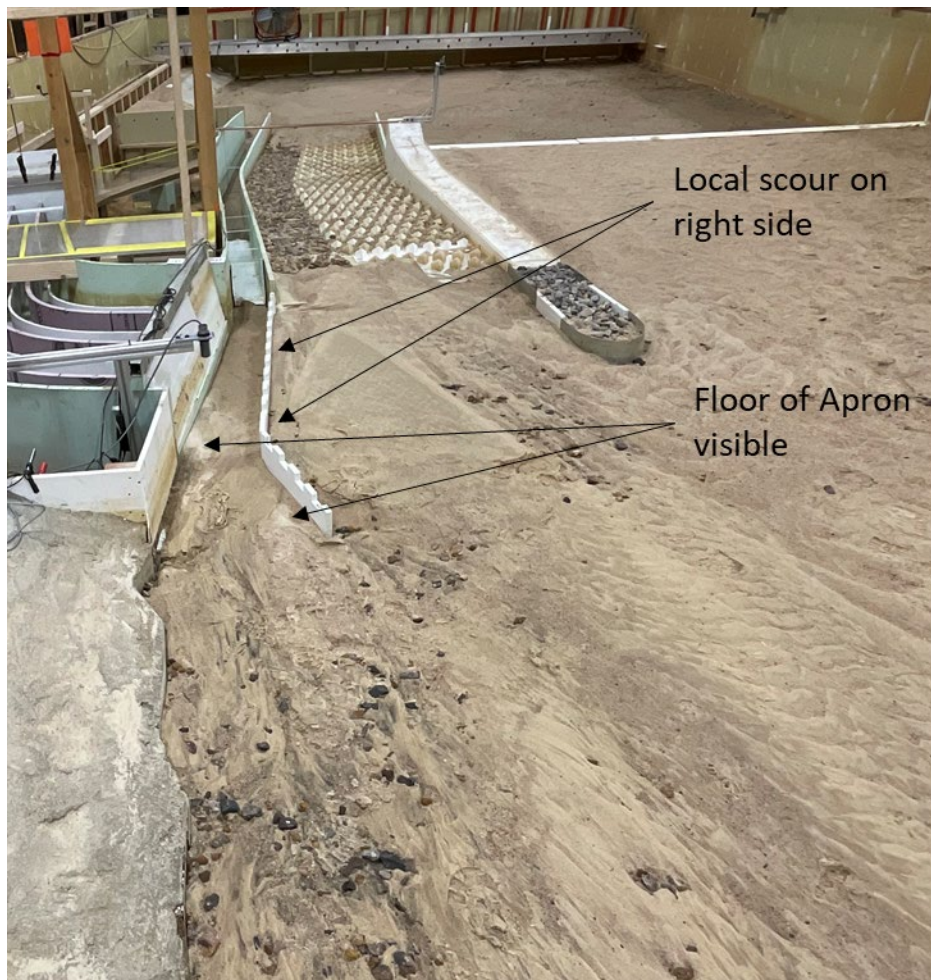
Figure 91. Photograph of bedform upstream of the hardened ramp and canal intake after a flushing operation at 3,000 ft³/s.

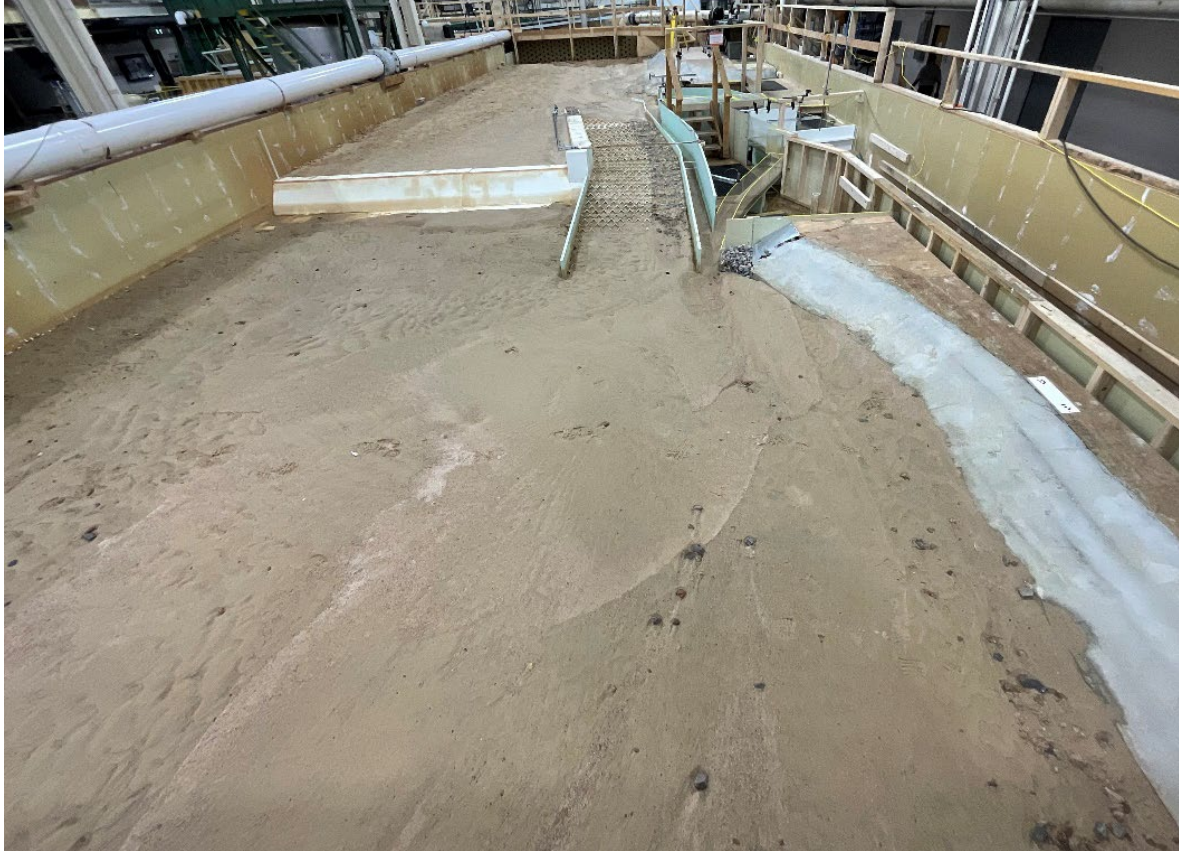
Figure 94. Photograph of bedforms downstream of the hardened ramp following combined flushing and sediment sluicing operations. Looking upstream.

Downstream of the hardened ramp scour operations produced local scour near the outlet of the flushing channel and a plume of sediment distributed from the left bank across to the right side of the hardened ramp. These features are shown in the contour plots Figure 92 and Figure 93 as well as the photograph of Figure 94. A flow of 6,000 ft³/s ran for 20 minutes in the model after the flushing operation and reformed the deposition downstream of the hardened ramp so that the flow stream lines became parallel to the left bank as was seen in previous runs (Figure 95).

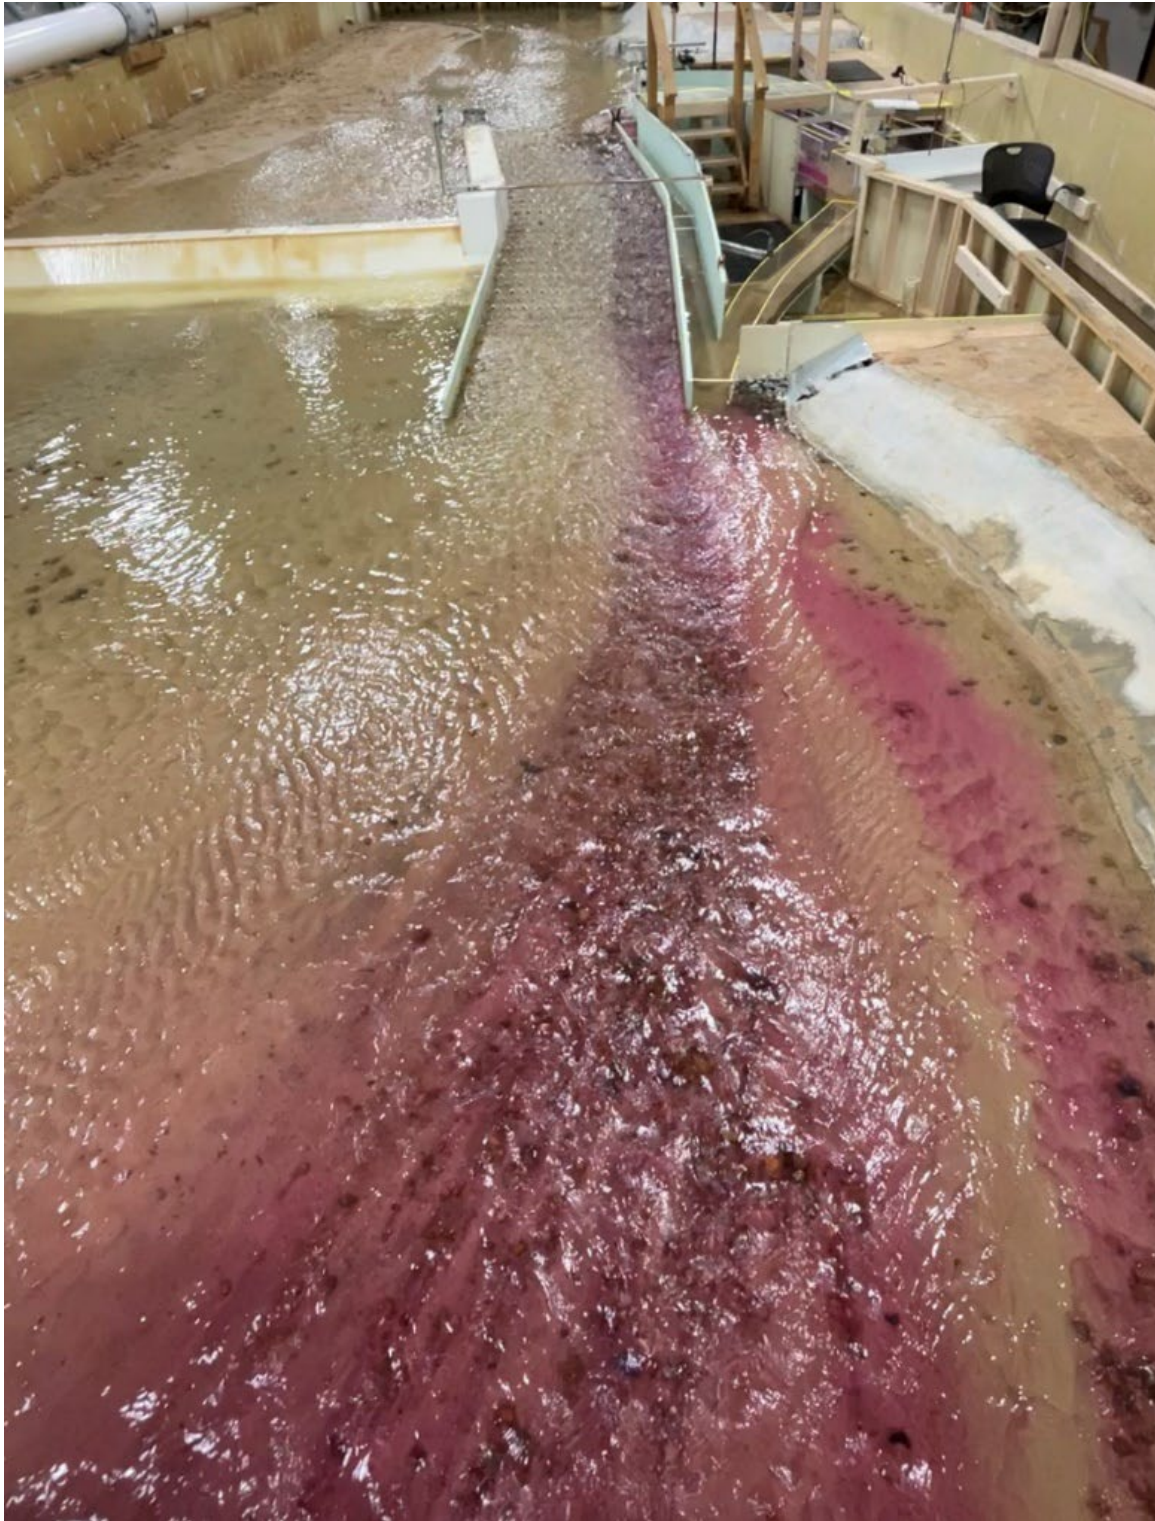
Figure 95. Photograph of flow streamlines on the downstream end of the hardened ramp at 6,000 ft³/s following a flushing operation. Looking upstream.

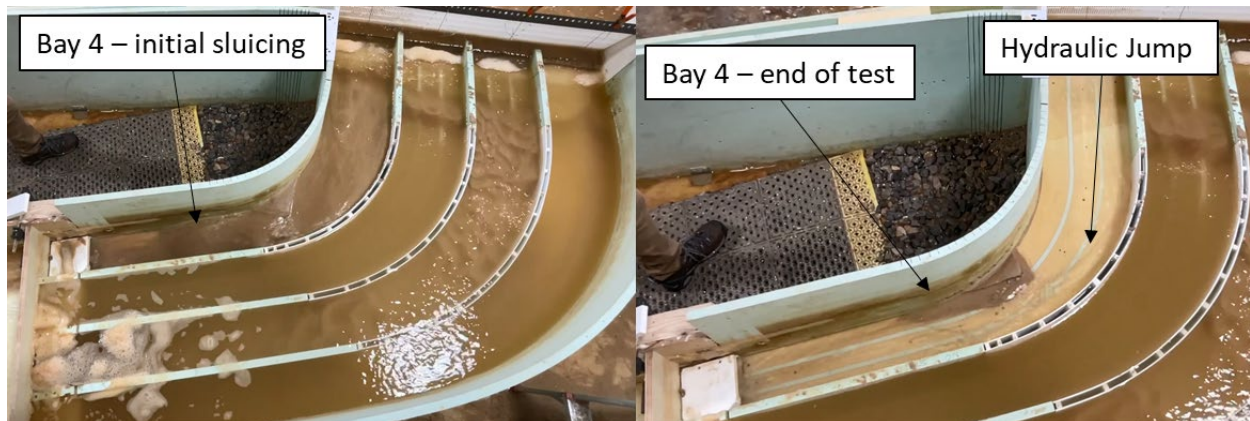
Figure 101. Photographs showing sluicing flows in Bay 4 without guide walls.

Test results of the first version of the desander concept compared the efficacy of sluicing sediments within the canal intake with different guide wall configurations. Resulting rates of sediment sluicing by volume are shown in Table 21. Visual observations (Figure 100 through Figure 105) showed that desander bays without internal guide walls were ineffective and that there were minor differences between one or two guide walls for each independent bay. Due to Version 1 test results, Versions 2 and 3 of the desander system included a single inner guide wall for each bay.
