Hydraulic Laboratory Report HL-2022-03

Physical Hydraulic Modeling of the Freeman Diversion Hardened Ramp Fish Passage Alternative

Freeman Diversion

United Water Conservation District, Ventura County, California

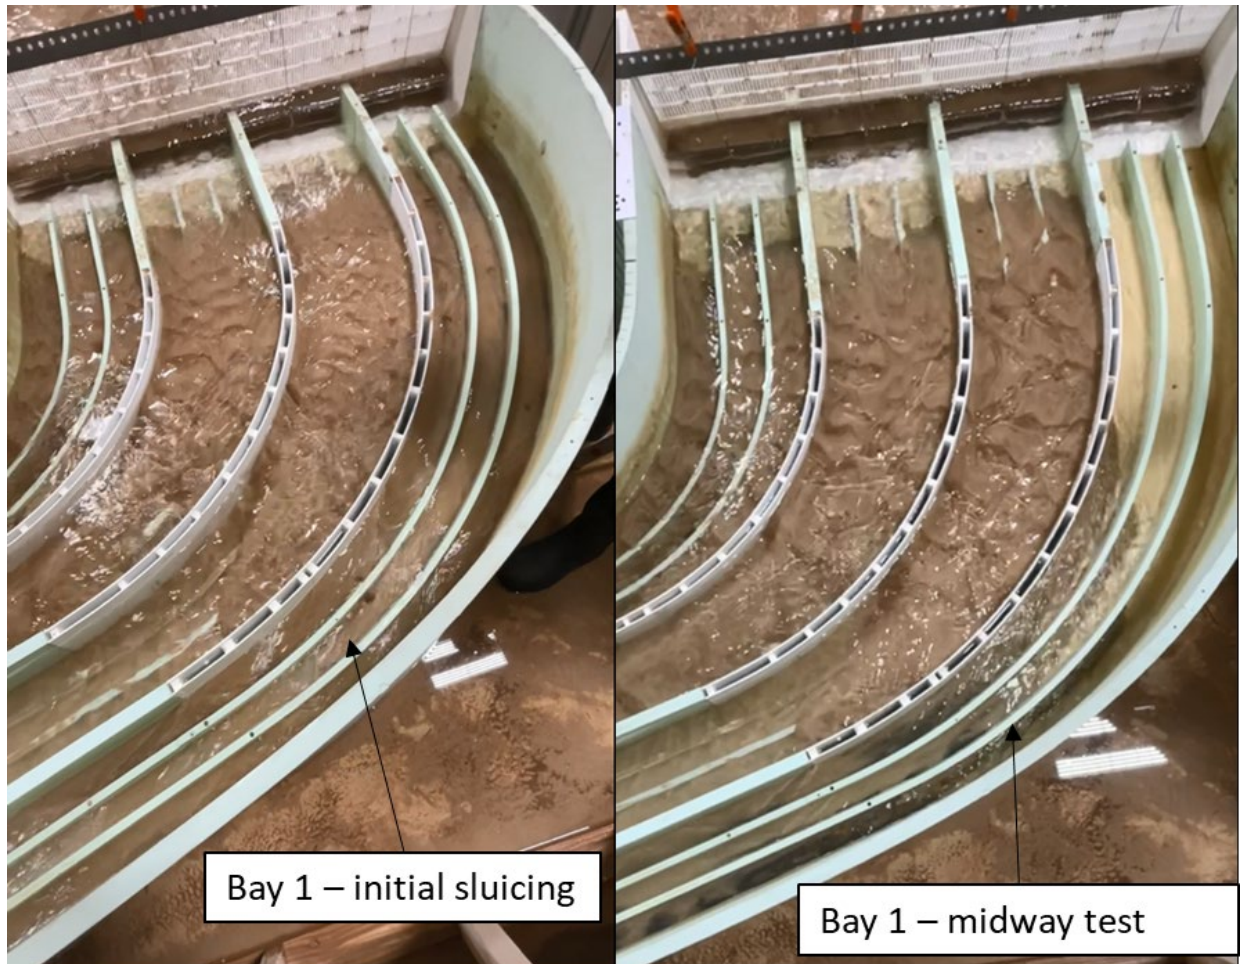
Figure 102. Photographs showing sluicing flows in Bay 1 with dual guide walls.

Test results of the first version of the desander concept compared the efficacy of sluicing sediments within the canal intake with different guide wall configurations. Resulting rates of sediment sluicing by volume are shown in Table 21. Visual observations (Figure 100 through Figure 105) showed that desander bays without internal guide walls were ineffective and that there were minor differences between one or two guide walls for each independent bay. Due to Version 1 test results, Versions 2 and 3 of the desander system included a single inner guide wall for each bay.

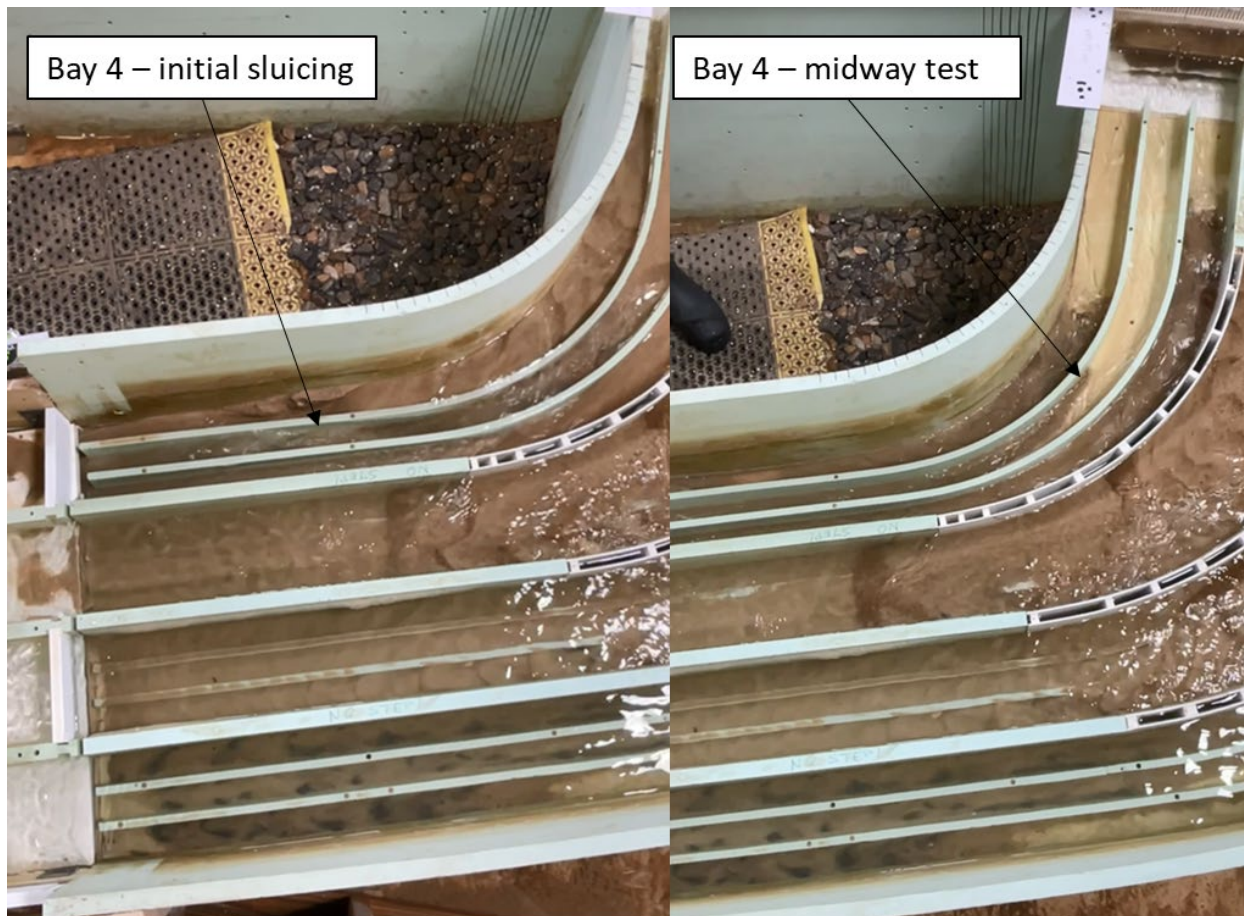
Figure 103. Photographs showing sluicing flows in Bay 4 with dual guide walls.

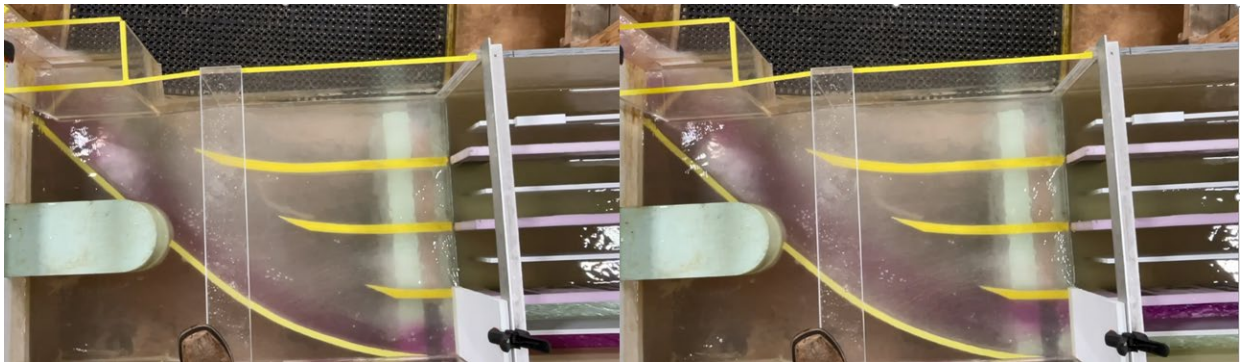
Figure 108. Photographs showing flow patterns with dye exiting the outside (left) and inside (right) channels of Bay 1. Sluicing flow was approximately 200 ft³/s.

Visual observations within the Version 3 sluicing culvert demonstrated that the flow conditions were improved compared to Version 2. Photographs of dye flow patterns in Figure 108 through Figure 111 show flow exiting the desander and passing through the culvert for each bay. The updated geometry of Version 3 helped turn the flow to the right downstream with reduced impact to the left wall and minimal flow separation and recirculation.

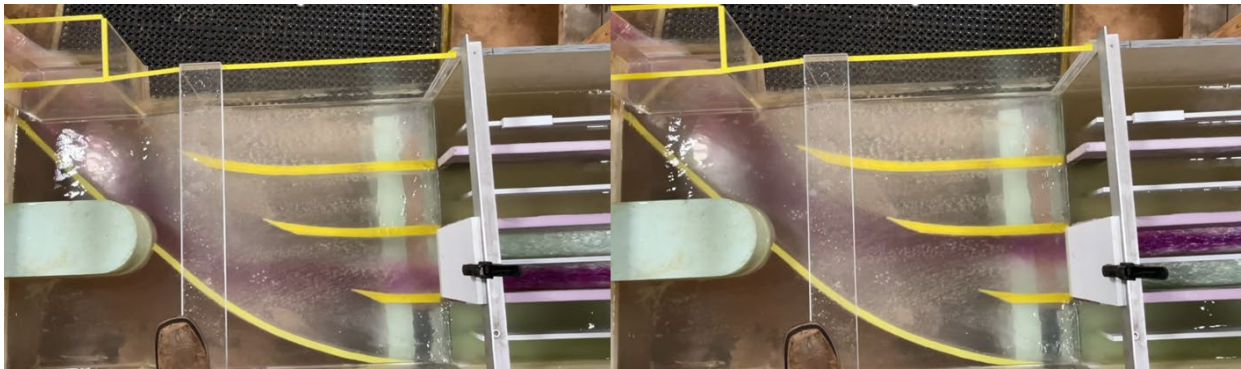
Figure 109. Photographs showing flow patterns with dye exiting the outside (left) and inside (right) channels of Bay 2. Sluicing flow was approximately 200 ft³/s.

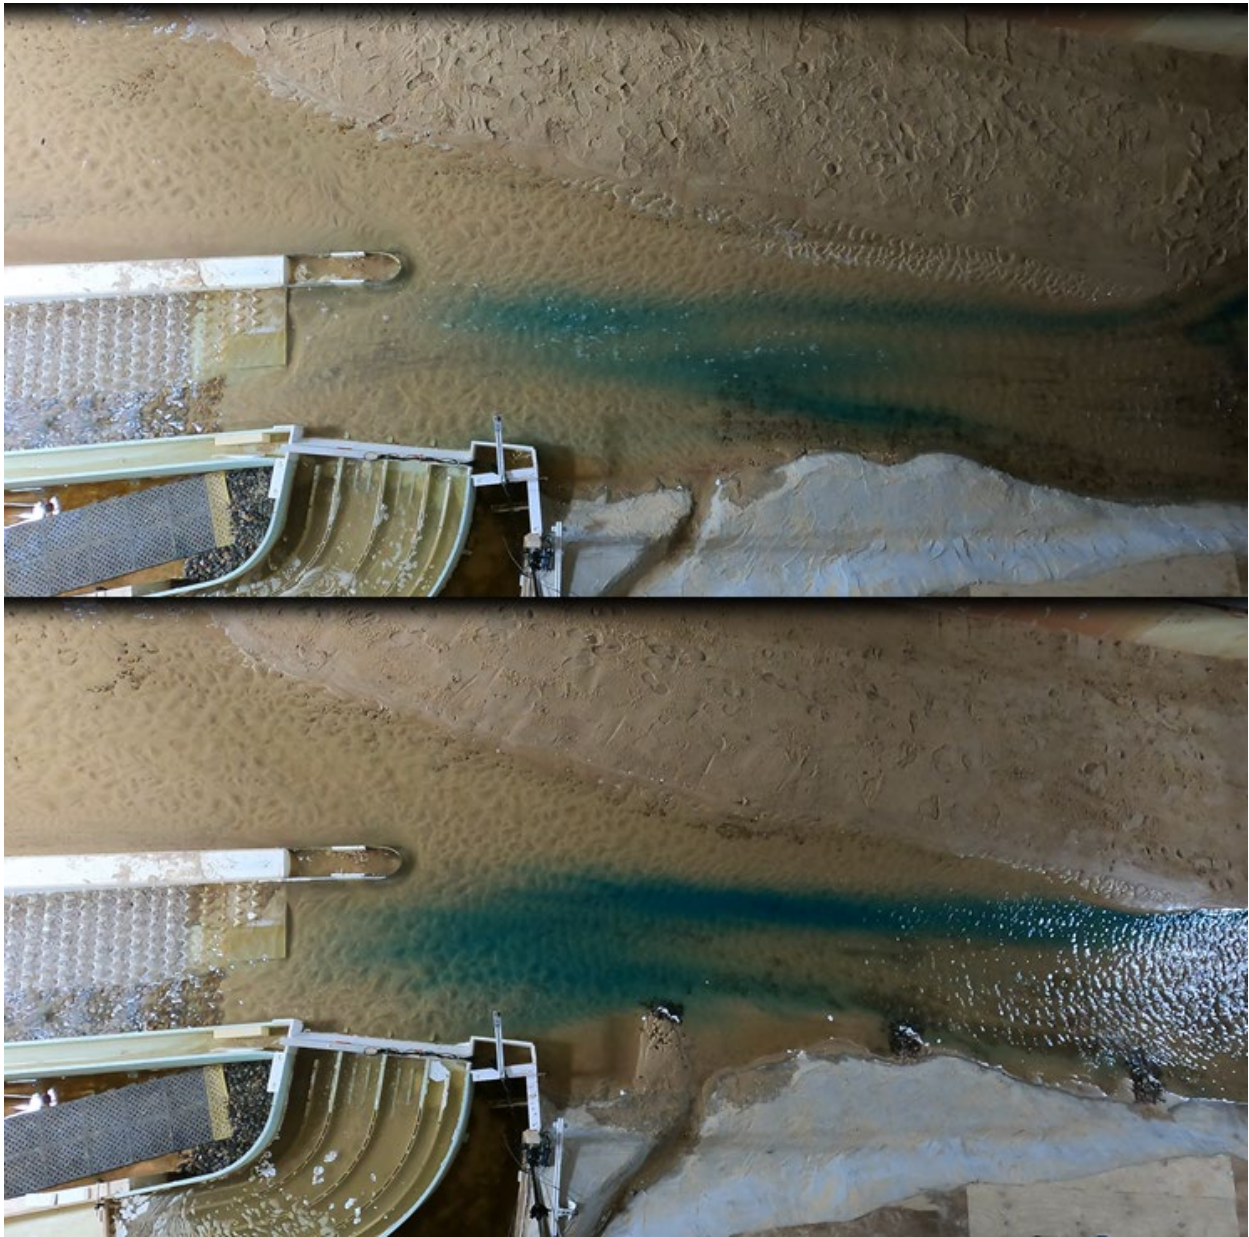
Figure 119. Photographs of flows with dye approaching the hardened ramp without groynes (top) and with groynes (bottom) at 3,000 ft³/s.

Observations of flow patterns with dye, photos, and bed difference maps of the quasi-equilibrium sediment patterns for the upstream riverbank are shown in Figure 116 through Figure 124. These results include flows of 6,000, 3,000, and 1,500 ft³/s. The difference map of 6,000 ft³/s shows a significant reduction in bed elevations upstream of the hardened ramp especially near the right wall (Figure 118). This difference was not observed for 3,000 ft³/s and 1,500 ft³/s. Results showed that the groynes generally produced additional sediment deposition along the left bank and reduced bed elevations in the center and right side of the active flow channel upstream. Bedforms at the hardened ramp exit and canal intake were not significantly affected. These differences in bed elevations were not sufficient to notably alter flow patterns and flow splits as previously shown.

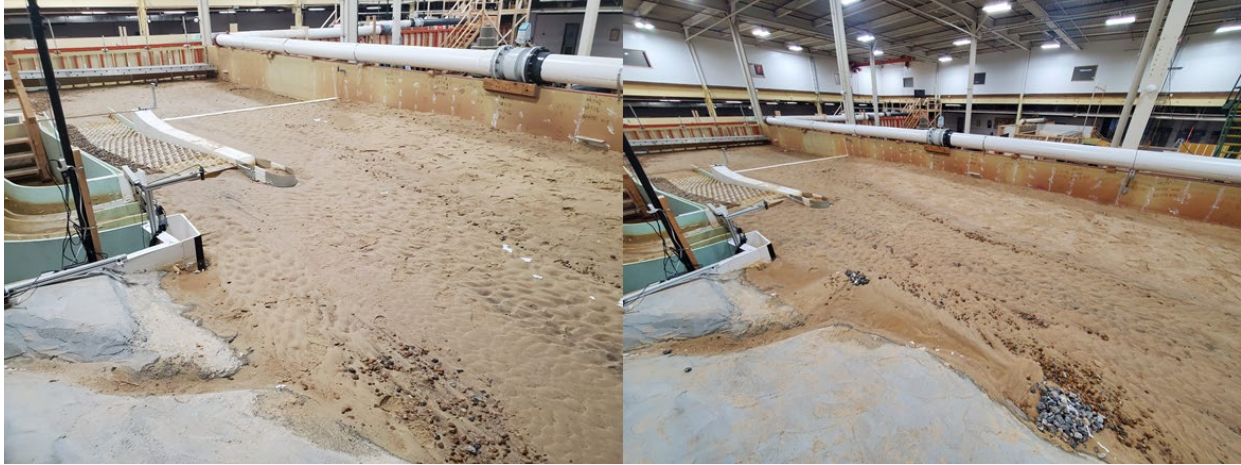
Figure 120. Photographs of sediment bedforms upstream of the hardened ramp without groynes (left) and with groynes (right) at 3,000 ft³/s.

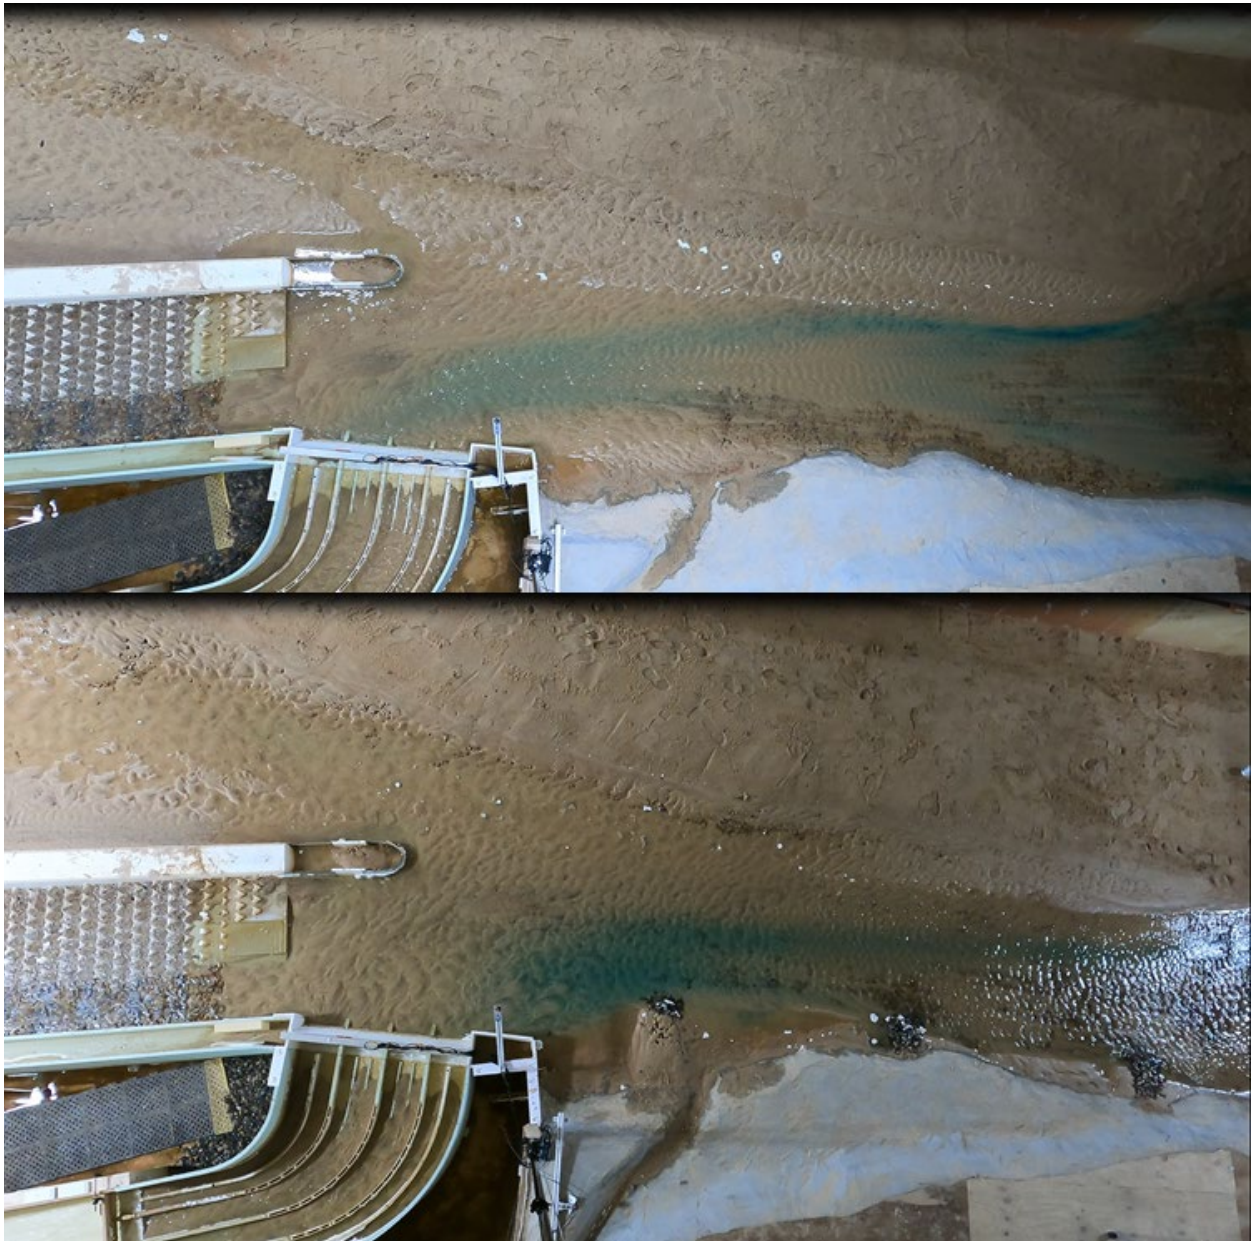
Figure 122. Photographs of flows with dye approaching the hardened ramp without groynes (top) and with groynes (bottom) at 1,500 ft³/s.

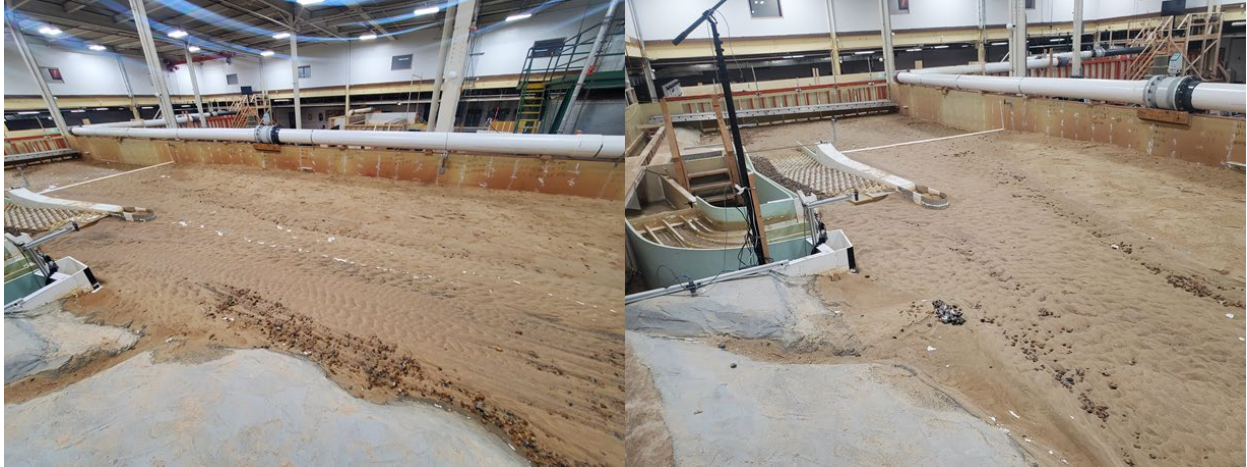
Figure 123. Photographs of sediment bedforms upstream of the hardened ramp without groynes (left) and with groynes (right) at 1,500 ft³/s.

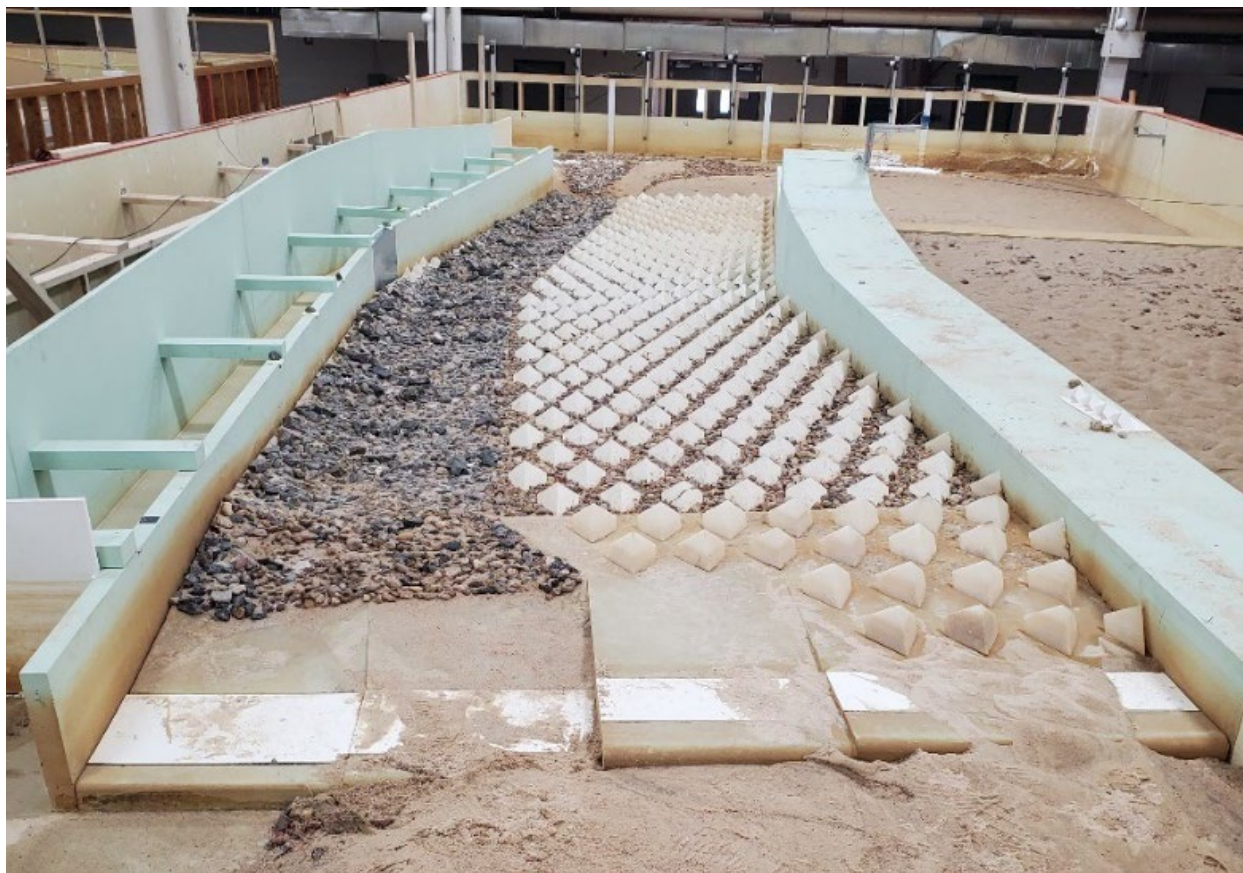
Figure 125. Original hardened ramp roughness configuration.

The hardened ramp contains two sections to provide fish passage over a range of flow conditions. For low flows less than 600 ft³/s, a 30-ft wide triangular low-flow section was designed for fish passage. This low-flow section was lined with approximately 1- to 2-ft-diameter rocks with larger 3-ft-diameter rocks placed every 20 ft. As flows rise, adjacent to the low-flow channel is a 60-ft-wide baffled ramp designed with 5-ft-wide vee-shaped sloped steel baffle plates with a 2.5-ft slot width. In between and behind these baffles, ¾- to 1-ft-diameter rocks were placed to increase roughness. These rock placement patterns continued until the four upstream-most rows of baffles (Figure 128). This design represents the original configuration of the hardened ramp and was tested for fish passage at both the 1:12 and 1:24 scale (Appendix B: Summary of 1:24 Scale Baseline Results and Appendix C: Summary of 1:12 Scale Baseline Results).

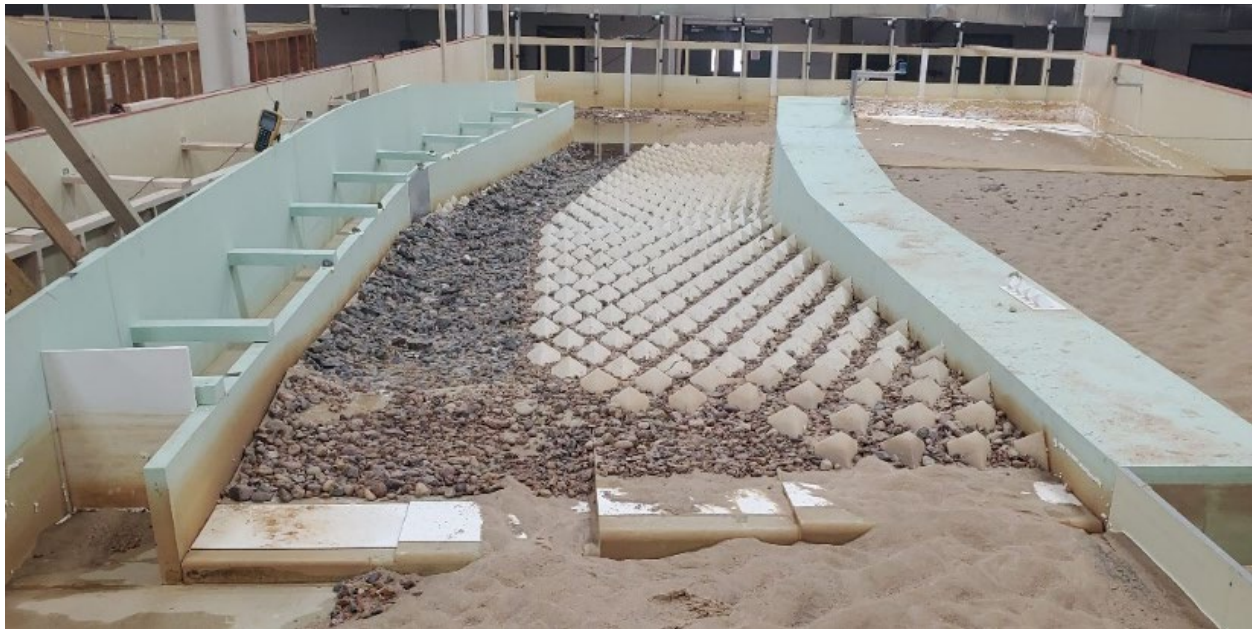
Figure 128. Hardened ramp with 1- to 2-ft-diameter rocks filled in to just downstream of the hardened ramp gates (looking downstream).

After the initial baseline tests were completed, the hardened ramp low flow channel and baffled area was filled with rocks up to the hardened ramp gates (Figure 128). Velocity and depth data were collected at the hardened ramp gates and in the first four rows of baffles to compare the impact of the change in roughness in those areas. Changing the roughness in these locations did not have a significant impact on velocity or depth (Table 24). The additional rocks lowered the velocity over hardened ramp gates 1-3, but the lower velocity caused flow to spread over gate 4, causing an increase in velocity over gate 4. This pattern of lowered velocities in central sections but increased

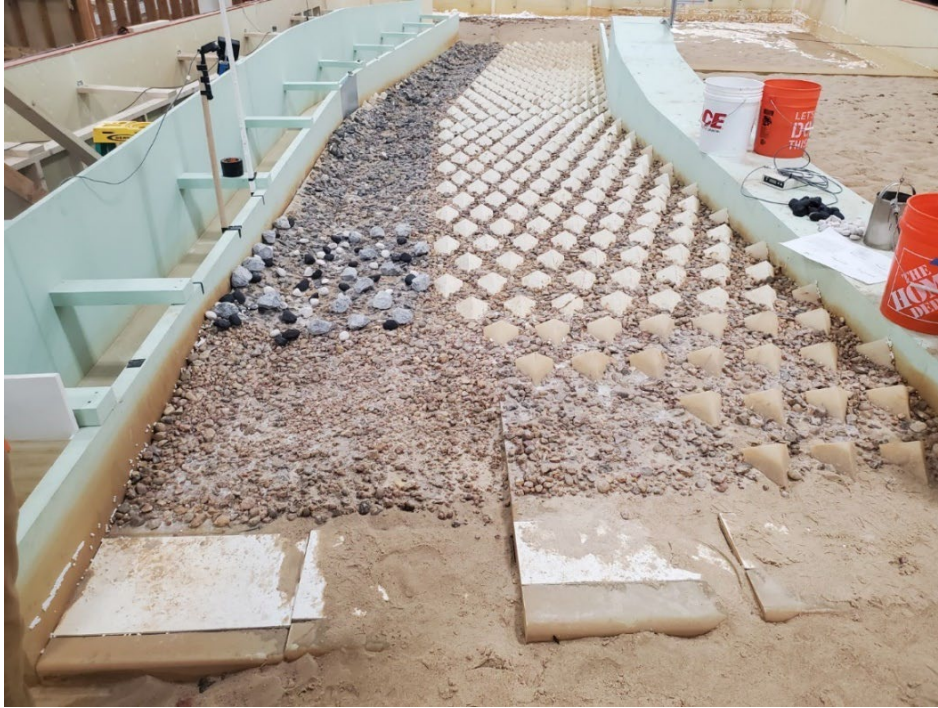
Figure 130. Version 1 of the low flow section of rocks added in for one cycle (40-ft) on the hardened ramp (looking downstream).

After the roughness on the upstream portion of the hardened ramp was increased, large rocks were added to the low flow section of the ramp to improve resting conditions during low flows of 600 ft^3/s or less. These rocks were larger than the original lining of the hardened ramp, with the largest rock size representing 30 – 40 inches prototype. The first iteration of this design, referred to as Version 1, included the installation of one “cycle” of rocks. Each cycle represented a 40-ft section of the hardened ramp before it is repeated (Figure 129 and Figure 130). Version 1 was tested at 100 – 400 ft^3/s , with only velocity measurements made. Another iteration of rock design, Version 2, was installed for the entire low flow section of the hardened ramp and tested for flows ranging from 100 – 600 ft^3/s with both PIV surface data collected and point velocity data collected with a Nixon meter due to the low depth of flow (Figure 131 and Figure 132).

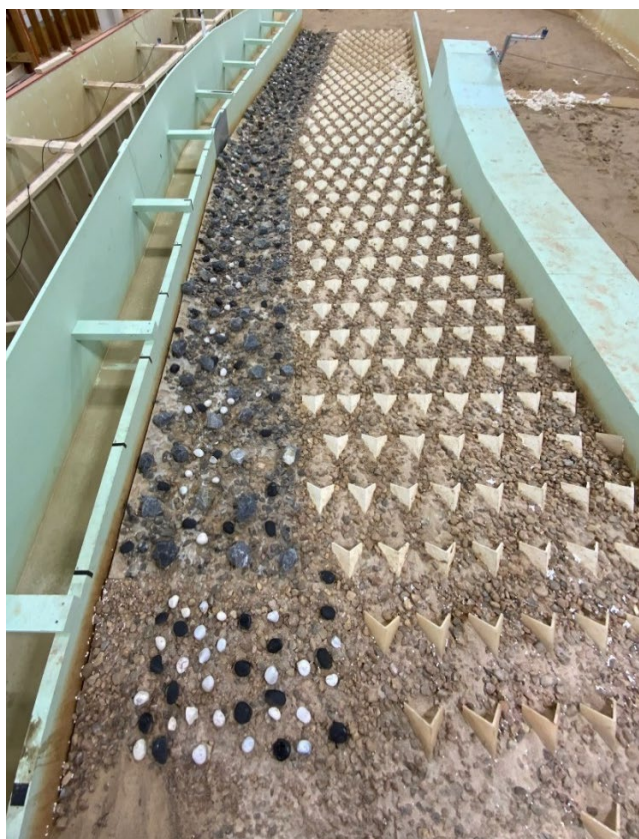
Figure 132. Version 2 of low flow channel rocks shown extending down the hardened ramp.

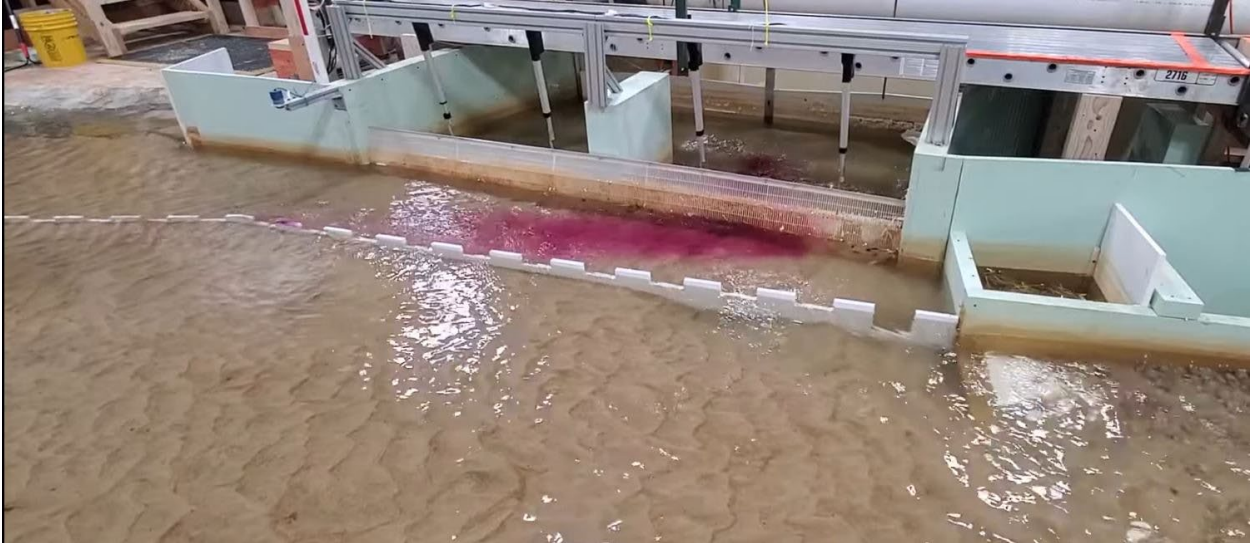
Figure 152. Dye test of the castle training wall structure upstream of intake. River flow was set to 1,500 ft^3/s , with approximately 750 ft^3/s diverted into the intake. At this flow, all dye was drawn into the intake. This was potentially caused by flow from the hardened ramp going towards the over the lowered notch at the downstream portion of the castle training wall and into the intake.

Water on the left side of the wall closest to the diversion intake and the right side leading to the hardened ramp had minimal cross flow through the slots until the downstream lowered notch for all flows (Figure 152 through Figure 161). Flow remained divided on each side of the castle training wall until the lowest notch, when flow would spill over towards the hardened ramp. This caused a scour hole immediately downstream of the lowered notch. As such, dye followed the flow on the intake side of the training wall before crossing over to the hardened ramp until flow increased to 1,500 ft³/s. At 1,500 ft³/s, all dye entered the intake before reaching the lowest notch, indicating a recirculation zone surrounding the lowered notch. This is reflected in the PIV and point velocity analysis (Table 28). On the intake side of the lower notch, velocity was lower (0.4 ft/s) at 1,500 ft³/s than at 100 ft³/s (1.1 ft/s).

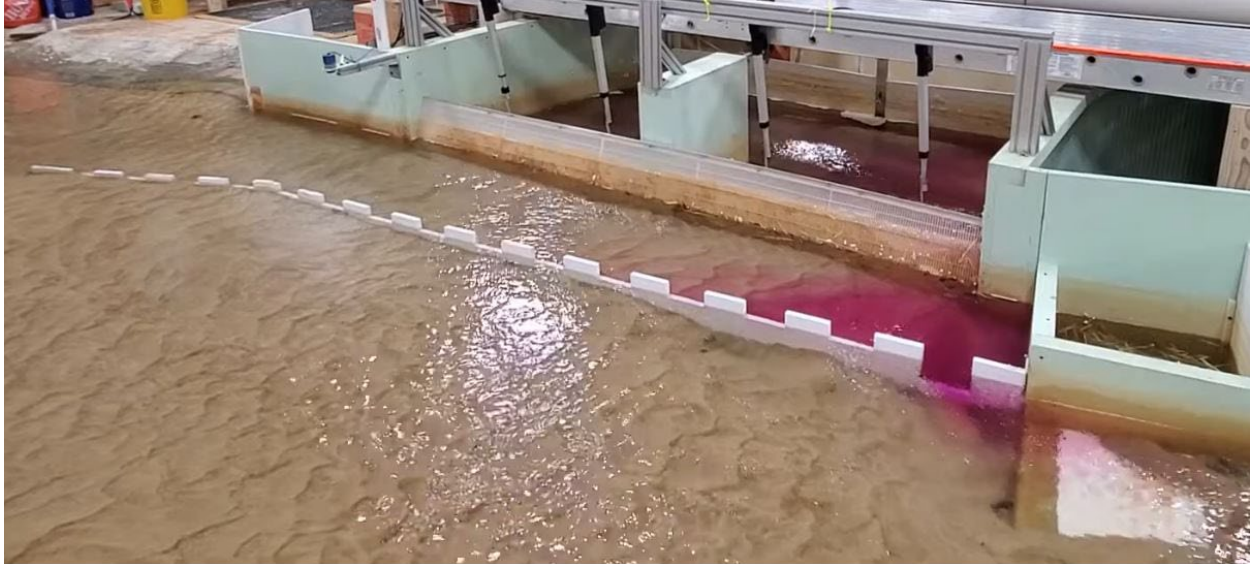
Figure 154. Dye test of the castle training wall structure upstream of intake. River flow was set to 800 ft³/s, with approximately 400 ft³/s diverted into the intake.

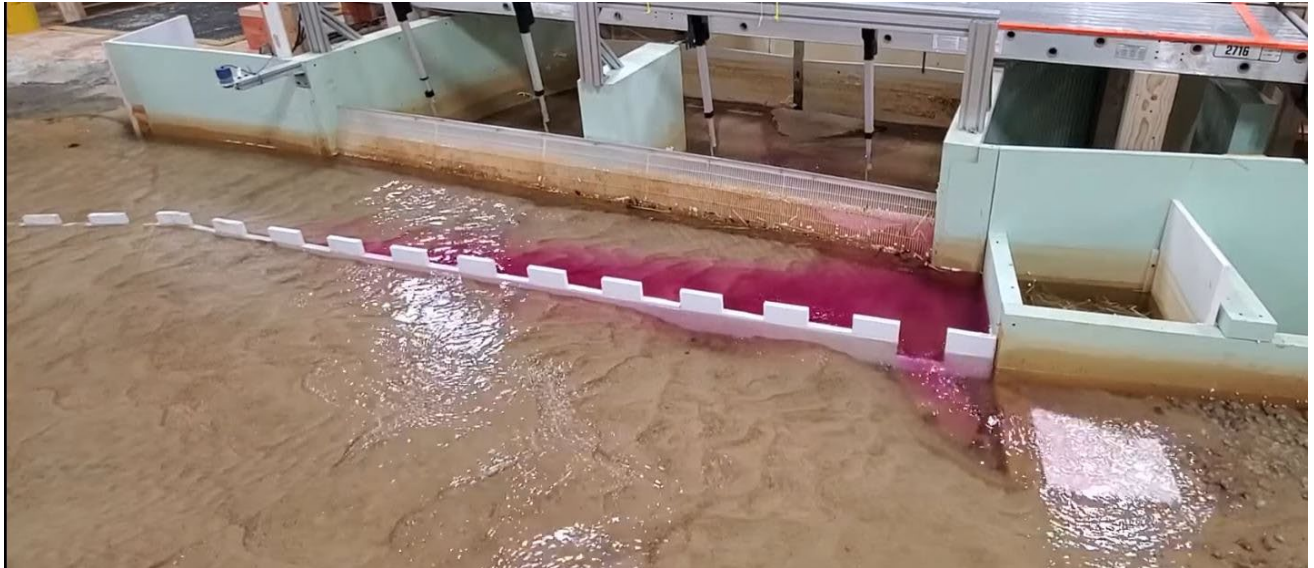
Figure 156. Dye test of the castle training wall structure upstream of intake. River flow was set to 400 ft³/s, with approximately 200 ft³/s diverted into the intake.

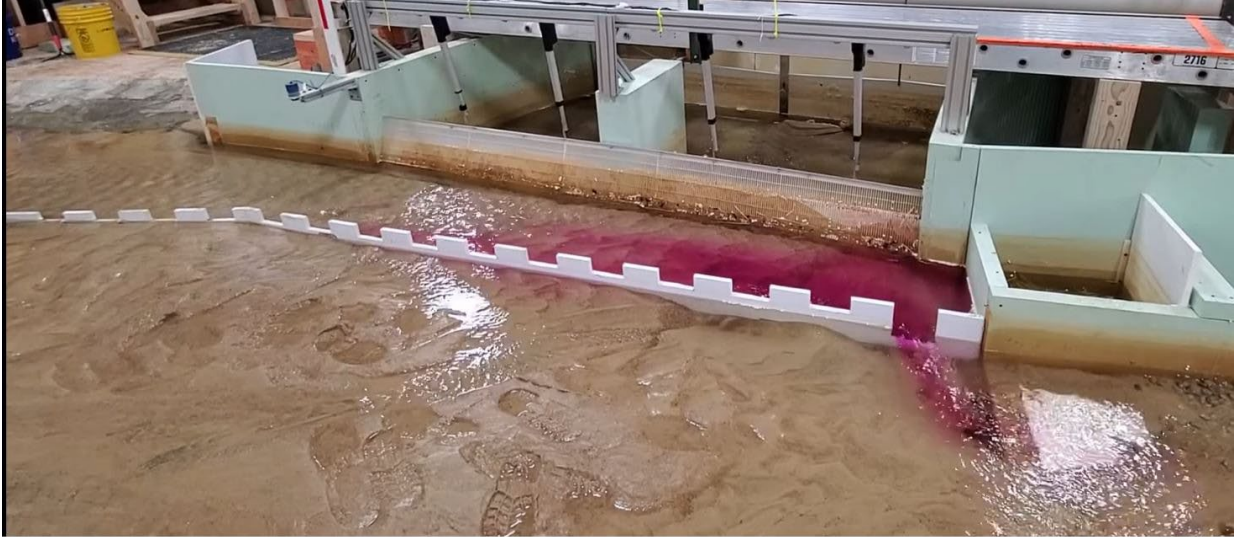
Figure 158. Dye test of the castle training wall structure upstream of intake. River flow was set to 200 ft³/s, with approximately 100 ft³/s diverted into the intake.

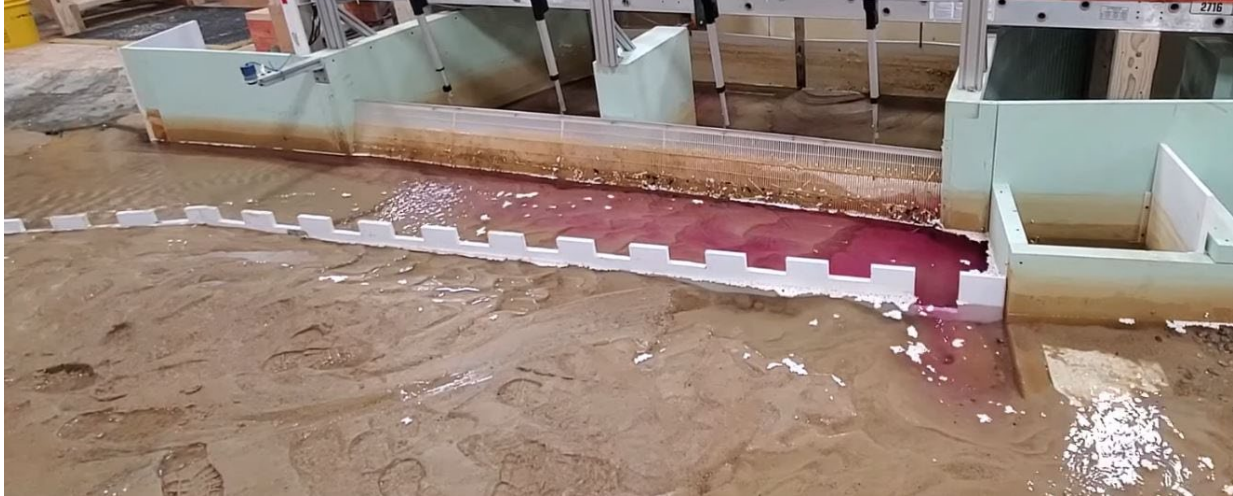
Figure 160. Dye test of the castle training wall structure upstream of intake. River flow was set to $100 \text{ ft}^3/\text{s}$, with approximately $50 \text{ ft}^3/\text{s}$ diverted into the intake.

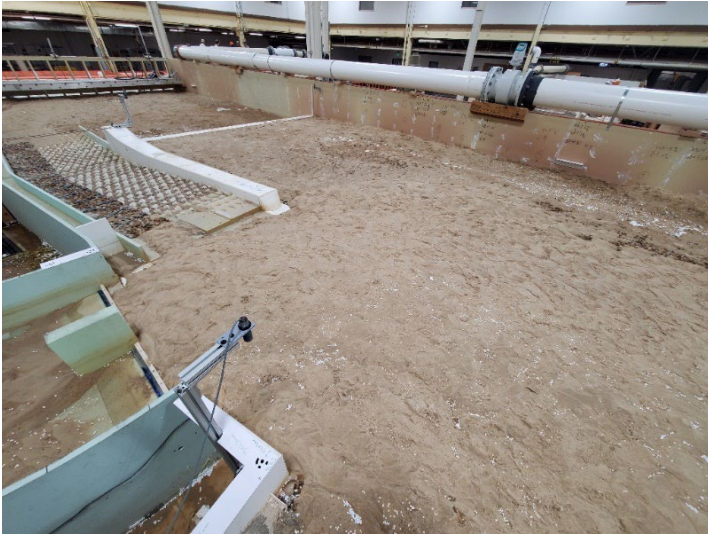
Figure B-1. View looking downstream after dewatering for MOD-6 design with flushing channel closed at 3,000 ft³/s.

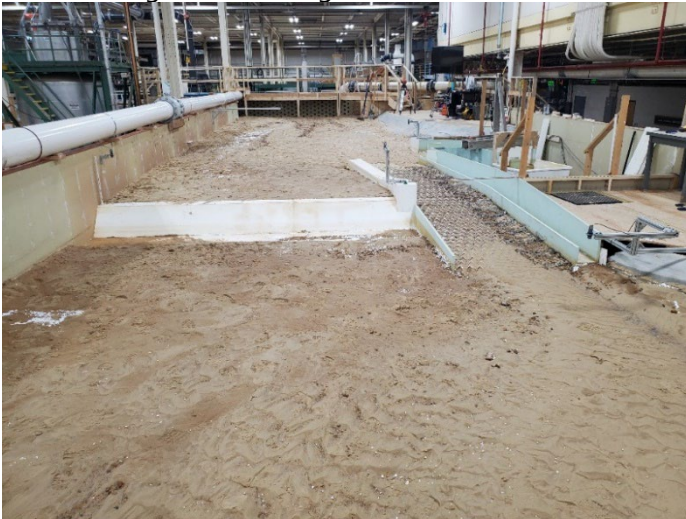
Figure B-2. View looking upstream for MOD-6 design with flushing channel closed after 3,000 ft³/s flow rate.

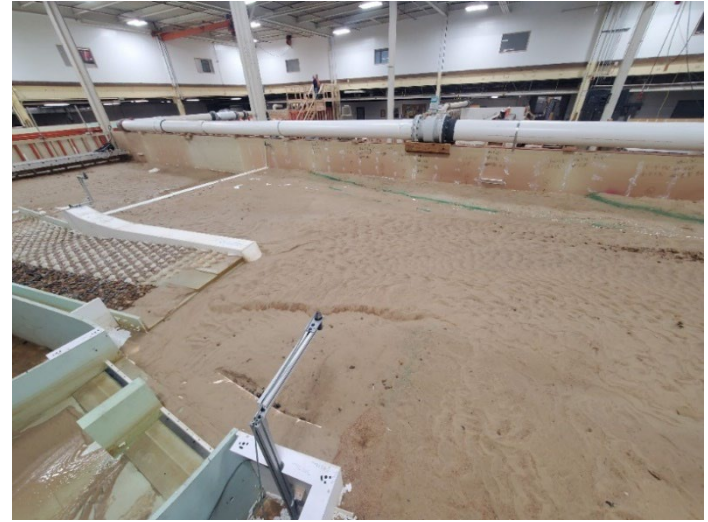
Figure B-3. View looking downstream after dewatering for MOD-9 design with flushing channel closed at 3,000 ft³/s.

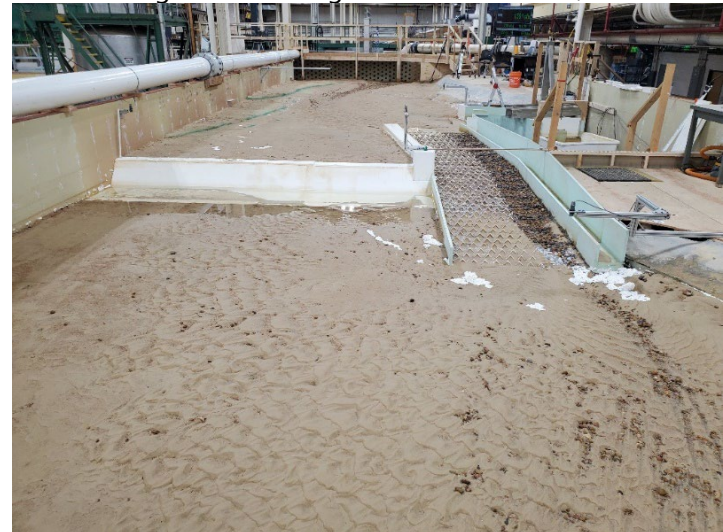
Figure B-4. View looking upstream for MOD-9 design with flushing channel closed after 3,000 ft³/s flow rate.

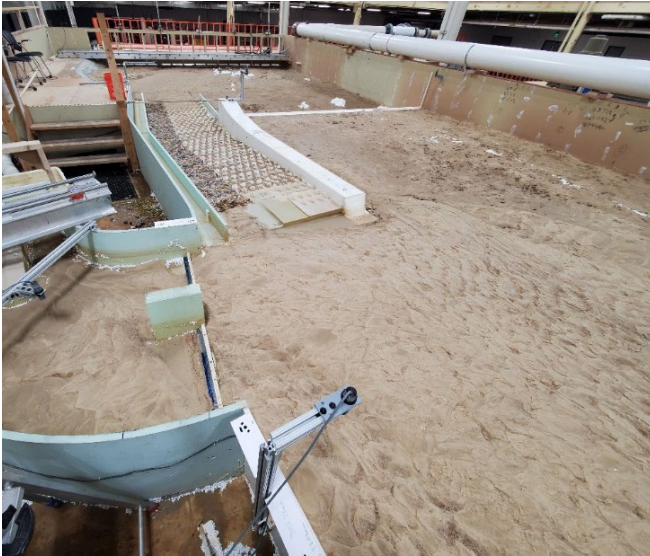
Figure B-5. View looking downstream after dewatering for MOD-6 design with flushing channel open at 3,000 ft³/s.

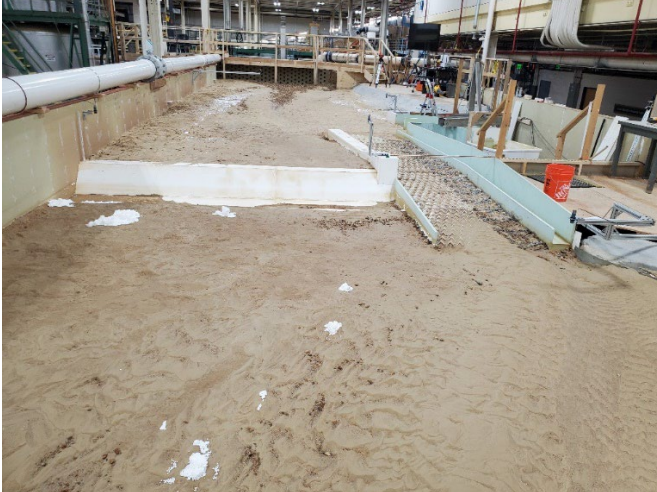
Figure B-6. View looking upstream for MOD-6 design with flushing channel open after 3,000 ft³/s flow rate.

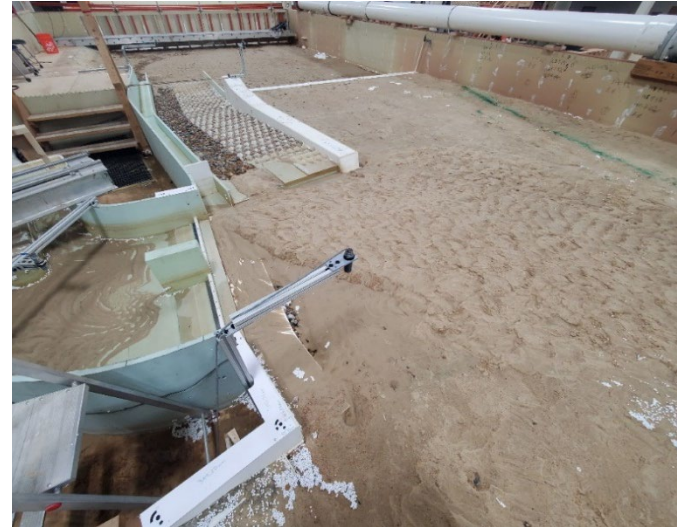
Figure B-7. View looking downstream after dewatering for MOD-9 design with flushing channel open at 3,000 ft³/s.

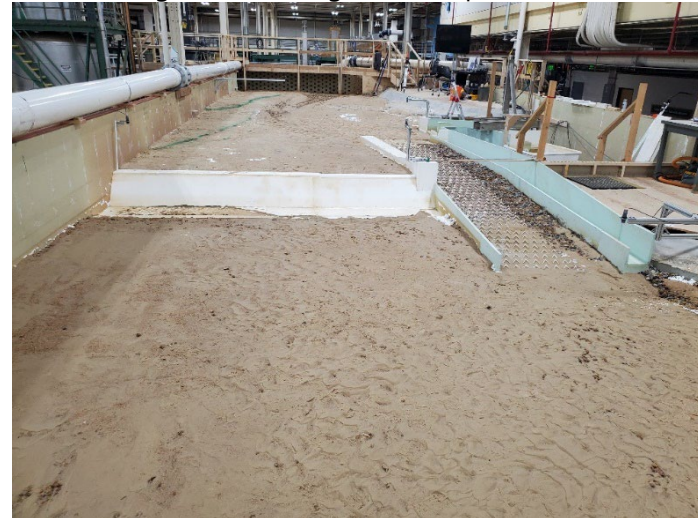
Figure B-8. View looking upstream for MOD-9 design with flushing channel open after 3,000 ft³/s flow rate.

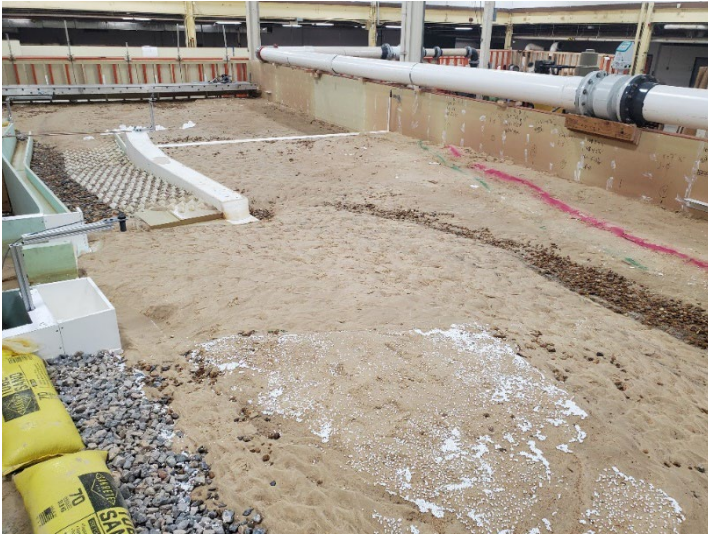
Figure B-9. View looking downstream after dewatering for MOD-6 design with flushing channel removed at 3,000 ft³/s.

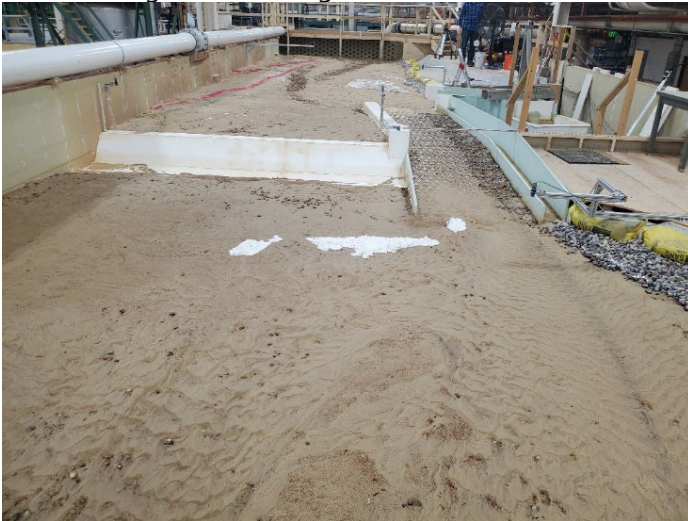
Figure B-10. View looking upstream for MOD-6 design with flushing channel removed after 3,000 ft³/s flow rate.

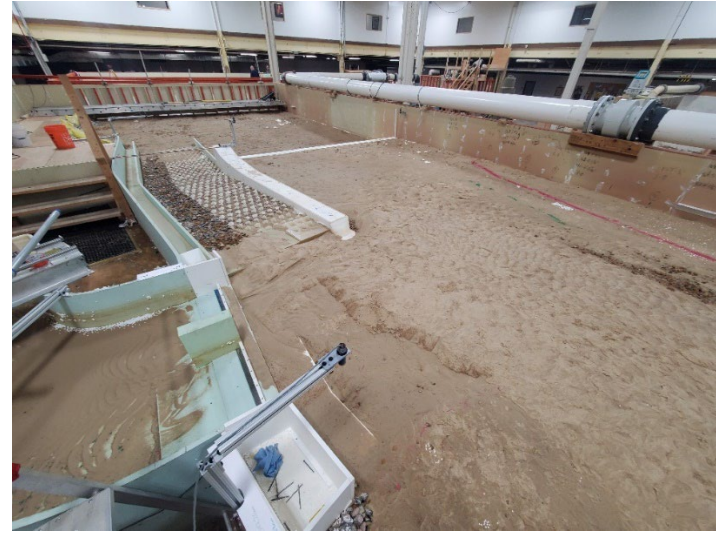
Figure B-11. View looking downstream after dewatering for MOD-9 design with flushing channel removed at 3,000 ft³/s.

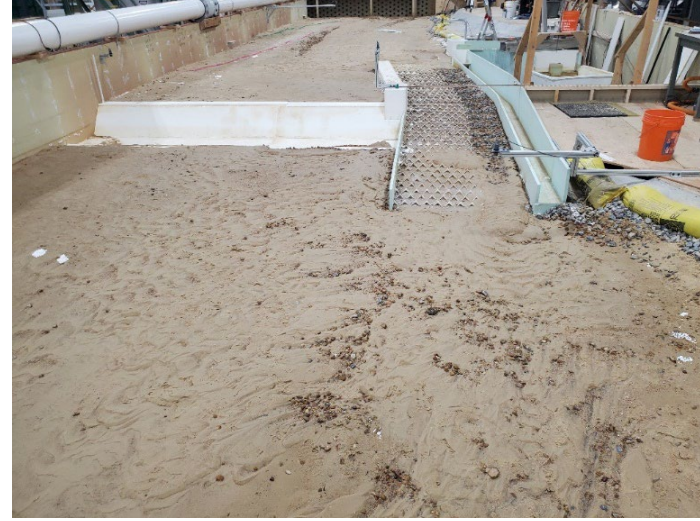
Figure B-12. View looking upstream for MOD-9 design with flushing channel removed after 3,000 ft³/s flow rate.

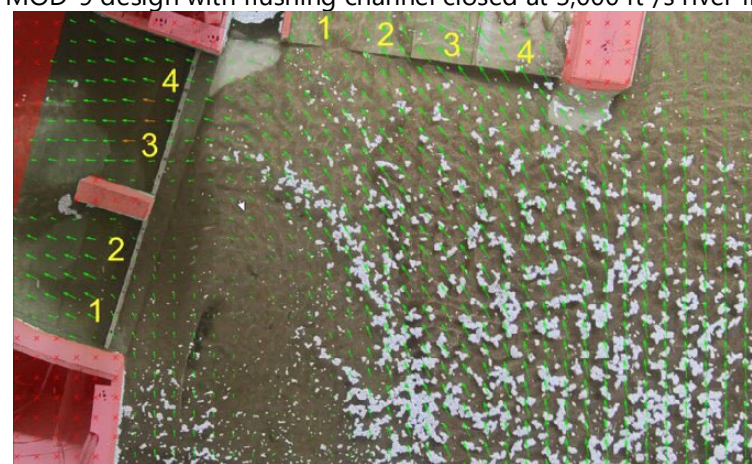
Figure B-16. Surface velocity vector map in area upstream of diversion intake (left) and hardened ramp (right) for MOD-9 design with flushing channel closed at 3,000 ft³/s river flow.

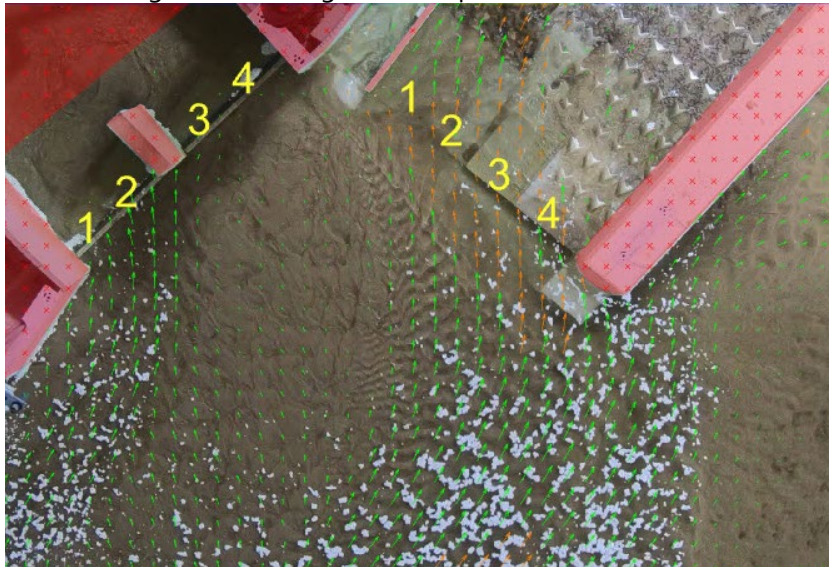
Figure B-18. Surface velocity vector map in area upstream of diversion intake (left) and hardened ramp (right) for MOD-6 design with flushing channel open at 3,000 ft³/s river flow.

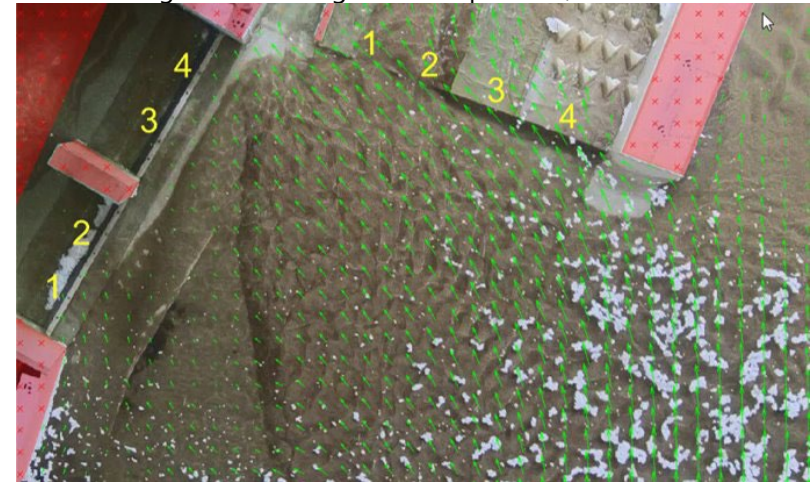
Figure B-20. Surface velocity vector map in area upstream of diversion intake (left) and hardened ramp (right) for MOD-9 design with flushing channel closed at 3,000 ft³/s river flow.

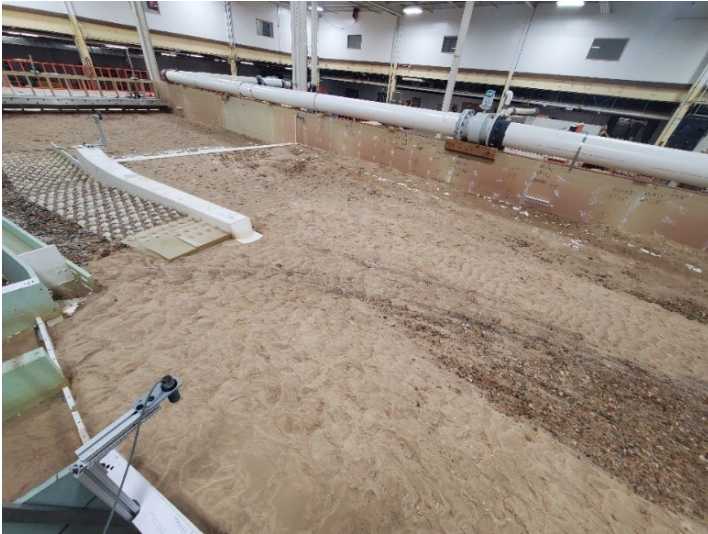
Figure B-31. View looking downstream after dewatering for MOD-6 design with flushing channel closed at 6,000 ft³/s.
