Hydraulic Laboratory Report HL-2022-03

Physical Hydraulic Modeling of the Freeman Diversion Hardened Ramp Fish Passage Alternative

Freeman Diversion

United Water Conservation District, Ventura County, California

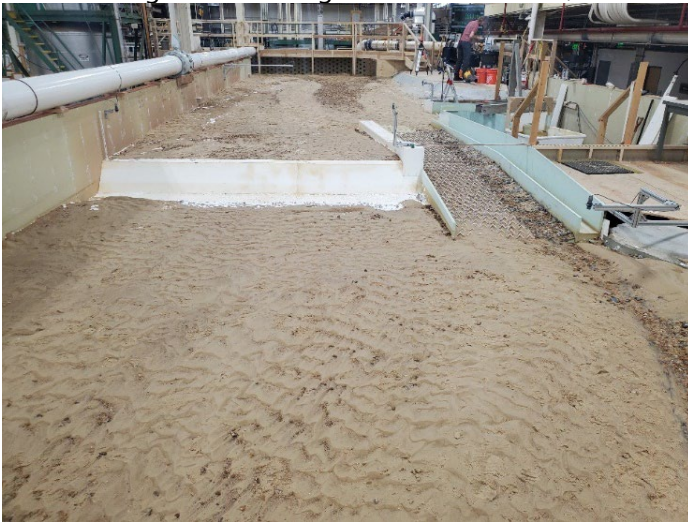
Figure B-32. View looking upstream for MOD-6 design with flushing channel closed after 6,000 ft³/s flow rate.

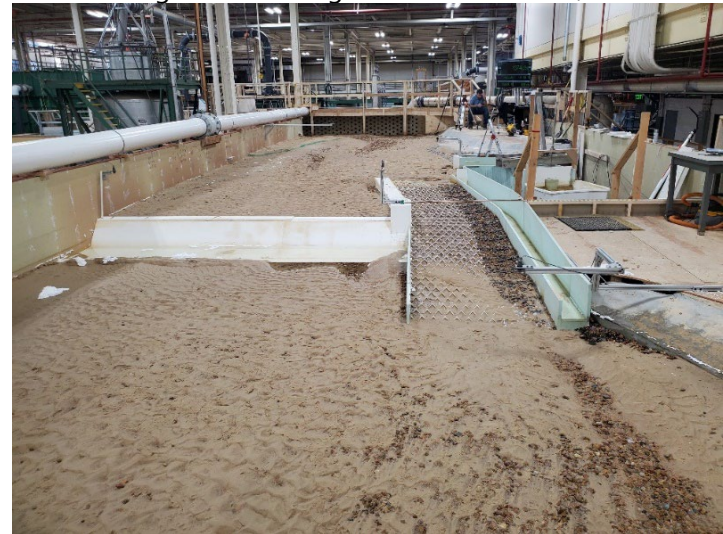
Figure B-34. View looking upstream for MOD-9 design with flushing channel closed after 6,000 ft³/s flow rate.

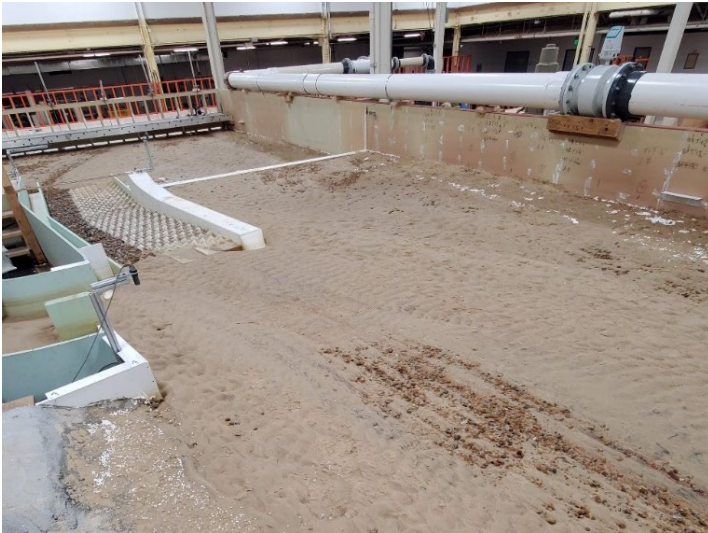
Figure B-35. View looking downstream after dewatering for MOD-6 design with flushing channel open at 6,000 ft³/s.

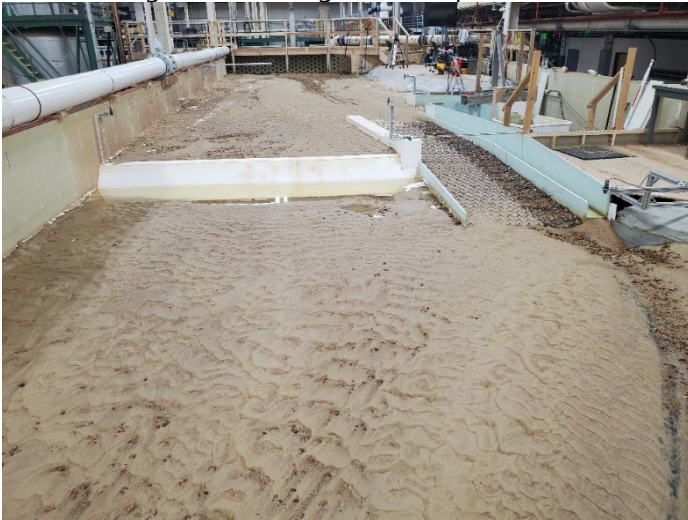
Figure B-36. View looking upstream for MOD-6 design with flushing channel open after 6,000 ft³/s flow rate.

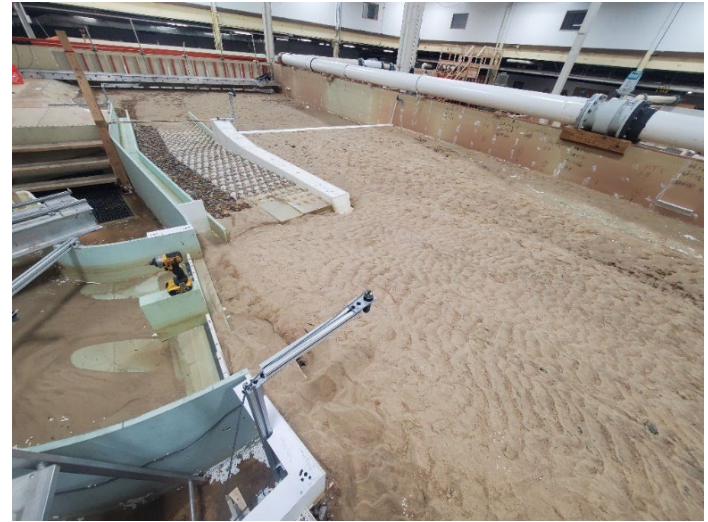
Figure B-37. View looking downstream after dewatering for MOD-9 design with flushing channel open at 6,000 ft³/s.

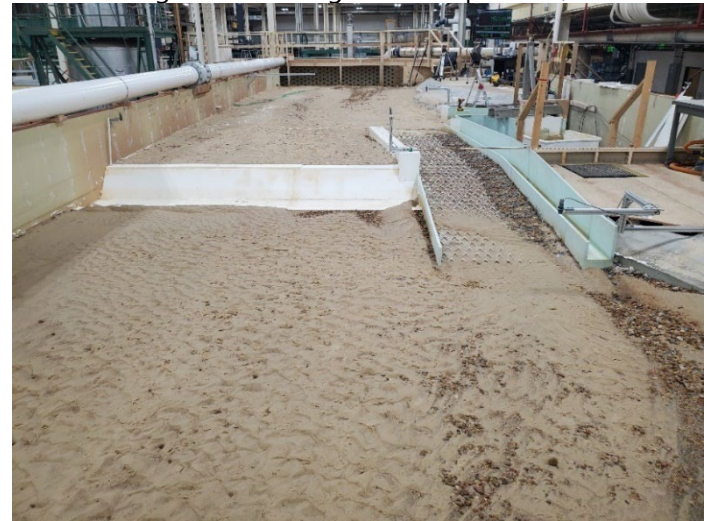
Figure B-38. View looking upstream for MOD-9 design with flushing channel open after 6,000 ft³/s flow rate.

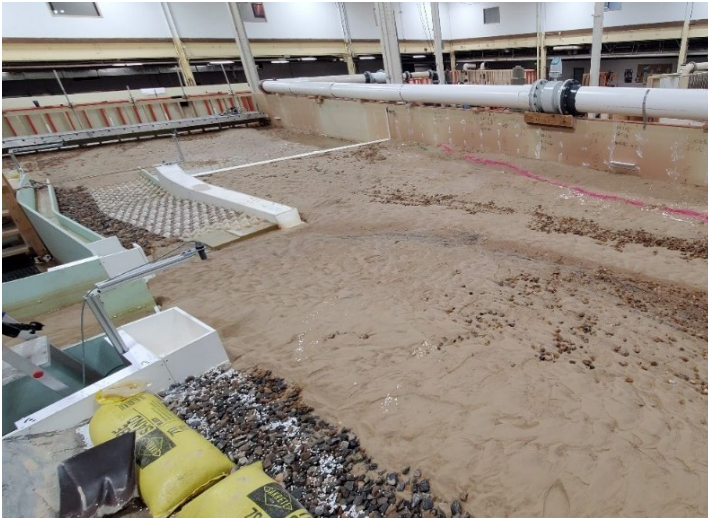
Figure B-39. View looking downstream after dewatering for MOD-6 design with flushing channel removed at 6,000 ft³/s.

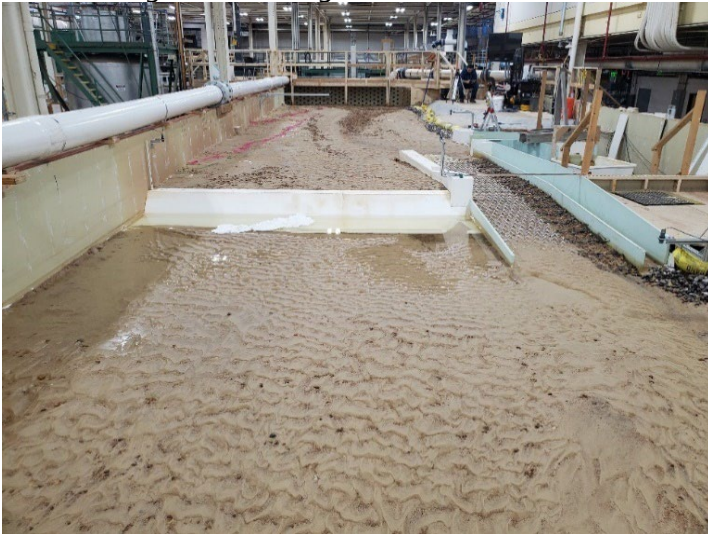
Figure B-40. View looking upstream for MOD-6 design with flushing channel removed after 6,000 ft³/s flow rate.

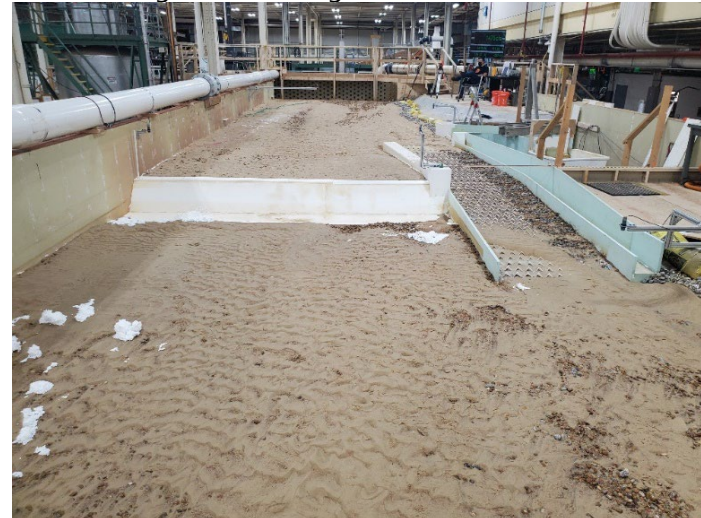
Figure B-42. View looking upstream for MOD-9 design with flushing channel removed after 6,000 ft³/s flow rate.

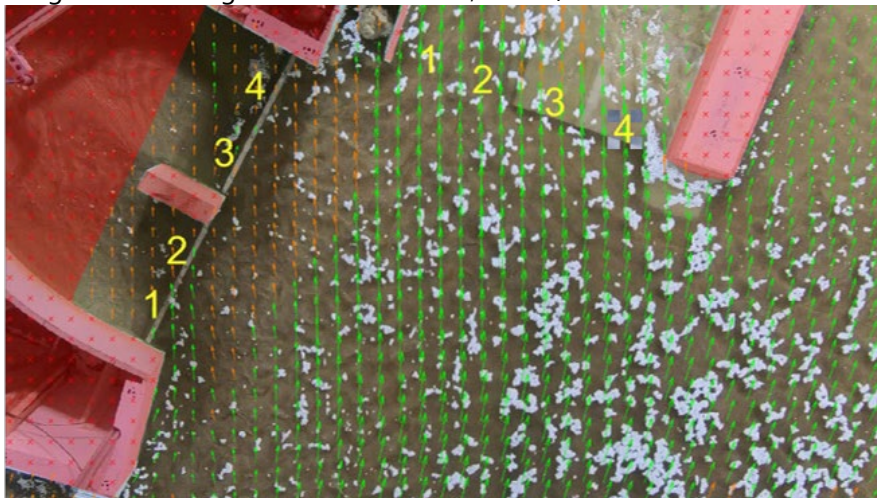
Figure B-44. Surface velocity vector map in area upstream of diversion intake (left) and hardened ramp (right) for MOD-6 design with flushing channel closed at 6,000 ft³/s river flow.

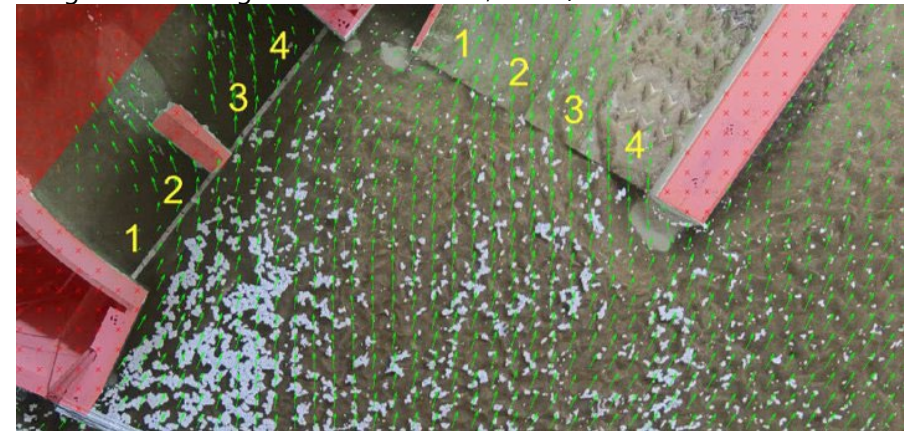
Figure B-46. Surface velocity vector map in area upstream of diversion intake (left) and hardened ramp (right) for MOD-9 design with flushing channel closed at 6,000 ft³/s river flow.

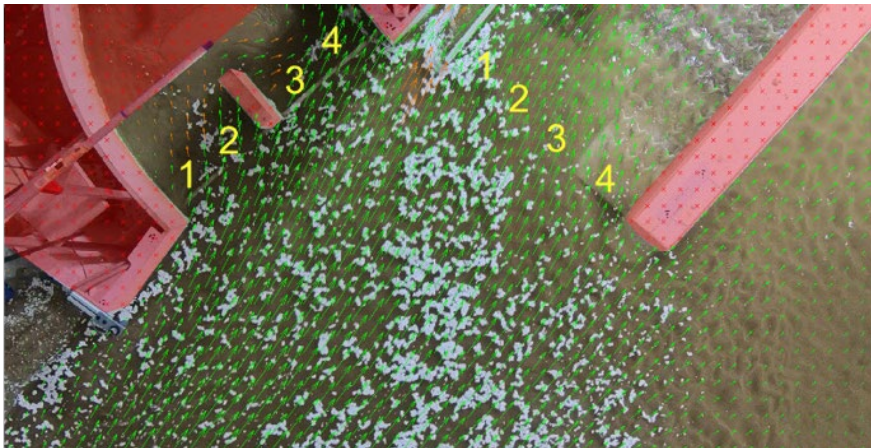
Figure B-48. Surface velocity vector map in area upstream of diversion intake (left) and hardened ramp (right) for MOD-6 design with flushing channel open at 6,000 ft³/s river flow.

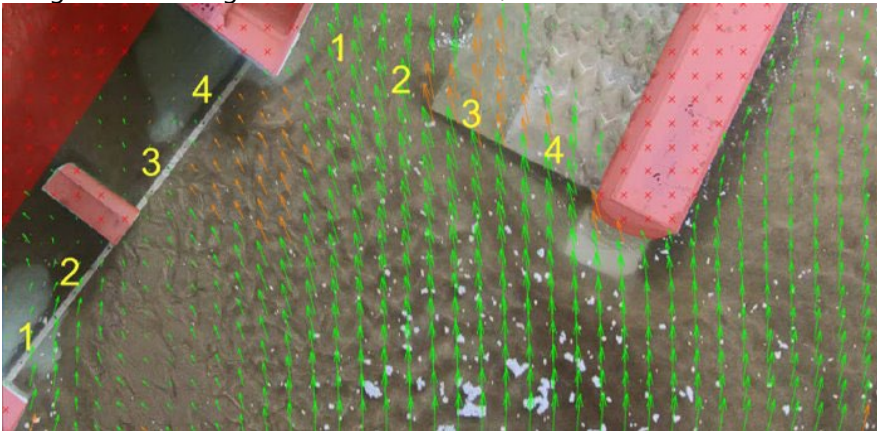
Figure B-52. Surface velocity vector map in area upstream of diversion intake (left) and hardened ramp (right) for MOD-6 design with flushing channel removed at 6,000 ft³/s river flow.

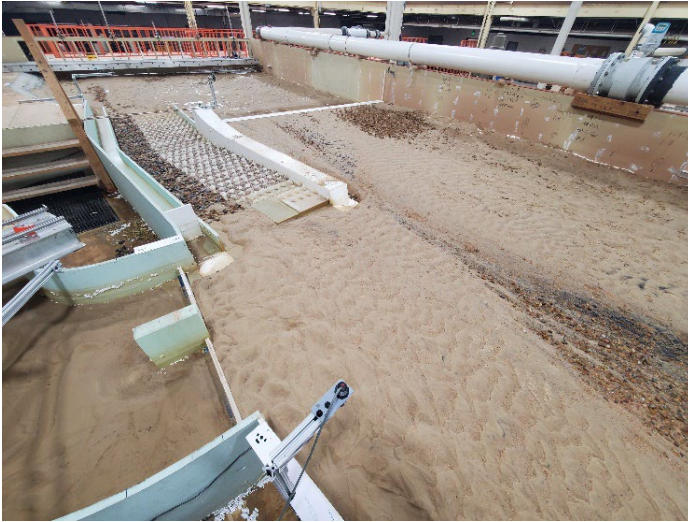
Figure B-61. View looking downstream after dewatering for MOD-6 design with flushing channel closed at 12,000 ft³/s.

At 12,000 ft³/s the main river channel shifted to the left, more in line with the bullnose of the hardened ramp wall. The portion of the left depositional area that remained became uniform in elevation, level with the entrance to the hardened ramp. This caused sediment to accumulate uniformly in front of the hardened ramp and intake, with some of the apron exposed in front of the closed flushing channel.

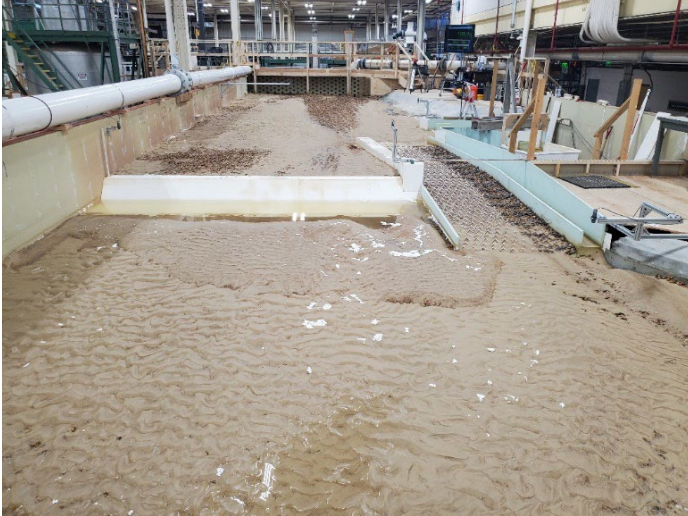
Figure B-62. View looking upstream for MOD-6 design with flushing channel closed after 12,000 ft³/s flow rate.

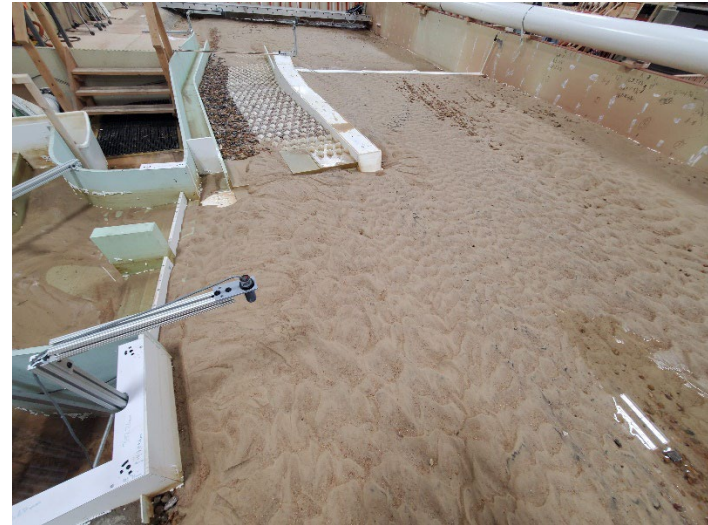
Figure B-63. View looking downstream after dewatering for MOD-9 design with flushing channel closed at 12,000 ft³/s.

At 12,000 ft³/s, the main upstream river channel divided into two dominant channels: one towards the left that aligned with the bullnose and one following the right topography elevation 164 ft to the dam crest similar to the MOD-6 configuration with the flushing channel removed. The new sand bar that separated these two channels may have caused more flow to be diverted to the dam crest. Sediment filled in the apron in front of the intake; however, the sill in front of the gates remained clear. Sediment also deposited on the apron of the hardened ramp as a continuation of the left depositional area.

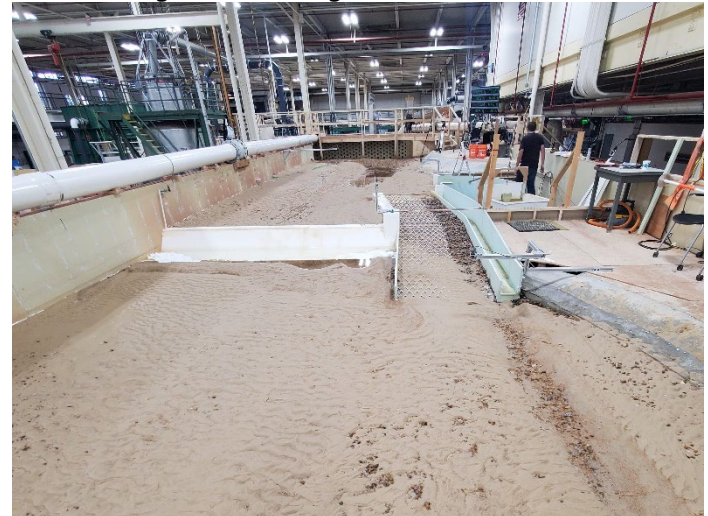
Figure B-64. View looking upstream for MOD-9 design with flushing channel closed after 12,000 ft³/s flow rate.

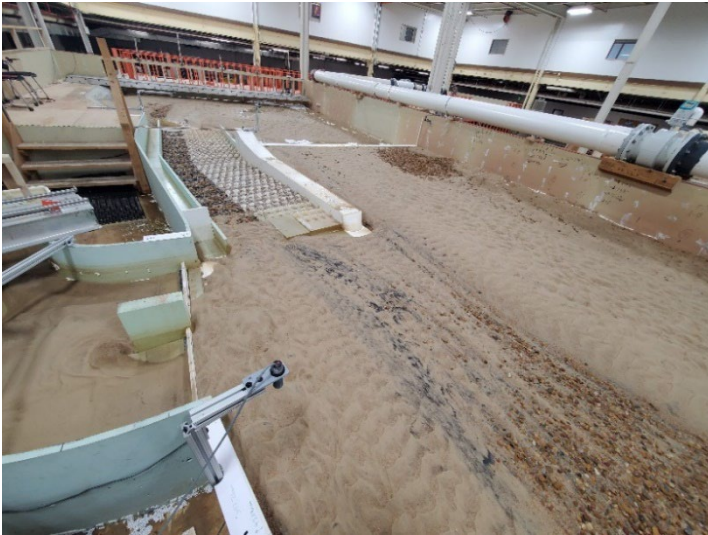
Figure B-65. View looking downstream after dewatering for MOD-6 design with flushing channel open at 12,000 ft³/s.

The main upstream river channel divided into two dominant channels: one towards the left that aligned with the bullnose and one following the right topography elevation 164 ft to the dam crest. The new sand bar that separated these two channels may have caused more flow to be diverted to the dam crest than when the flushing channel was included. All the intake gates were partially buried by sediment deposition and sediment deposited in front of the low flow channel.

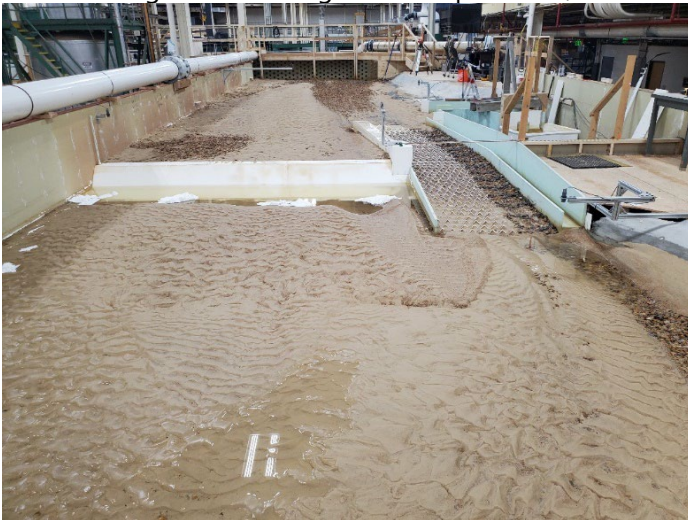
Figure B-66. View looking upstream for MOD-6 design with flushing channel open after 12,000 ft³/s flow rate.

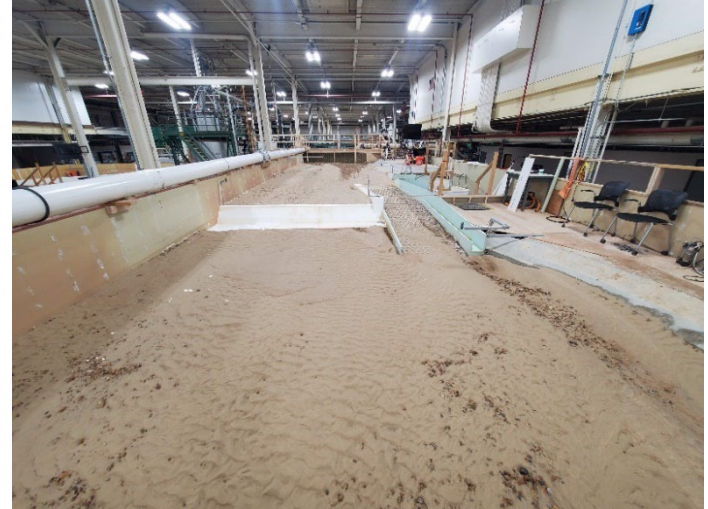
Figure B-68. View looking upstream for MOD-9 design with flushing channel open after 12,000 ft³/s flow rate.

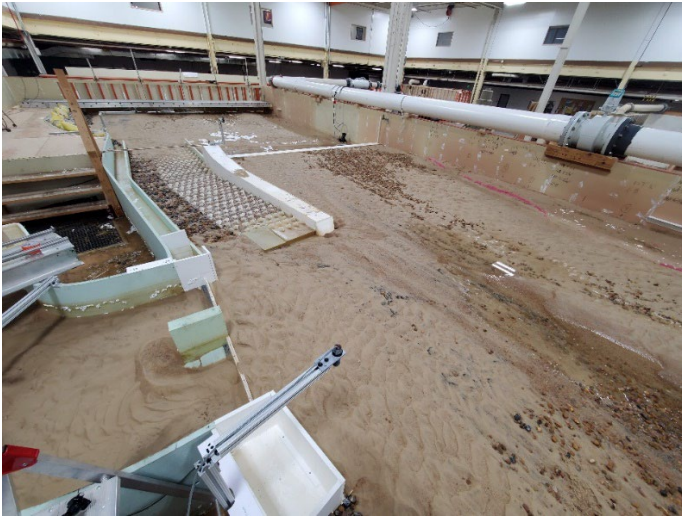
Figure B-69. View looking downstream after dewatering for MOD-6 design with flushing channel removed at 12,000 ft³/s.

After the flushing channel was removed, flow patterns and sediment deposition patterns upstream of the dam were similar to the MOD-6 configuration with the flushing channel closed. The main upstream river channel divided into two dominant channels: one towards the left that aligned with the bullnose and one following the right topography elevation 164 ft to the dam crest. The new sand bar that separated these two channels may have caused more flow to be diverted to the dam crest. Sediment deposition reached the top of intake gates 1-2 and filled in the upstream end of the hardened ramp low flow channel. The sill in front of intake gate 4 remained clear of sediment due to the scour around the edge of the upstream wing wall.

Approximately one third of the baffles and low flow channel on the hardened ramp were filled with sediment downstream in a diagonal sandbar. Only baffles along the sandbar were covered with the surrounding baffles were still exposed. A scour hole developed downstream of the low flow channel and continued to the end of the model extents.

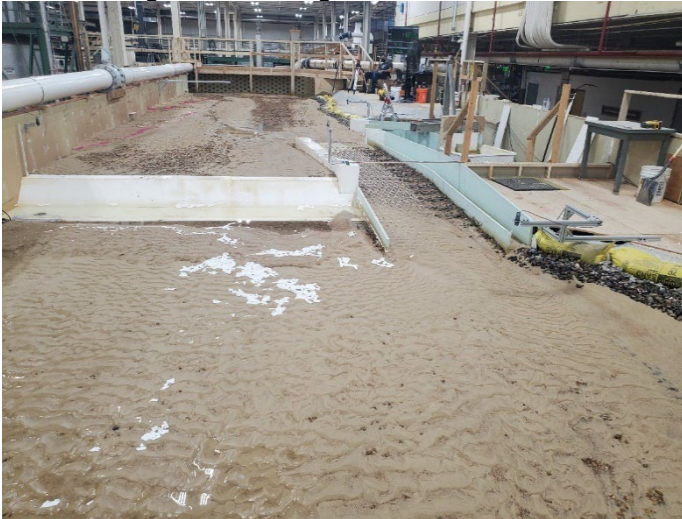
Figure B-70. View looking upstream for MOD-6 design with flushing channel removed after 12,000 ft³/s flow rate.

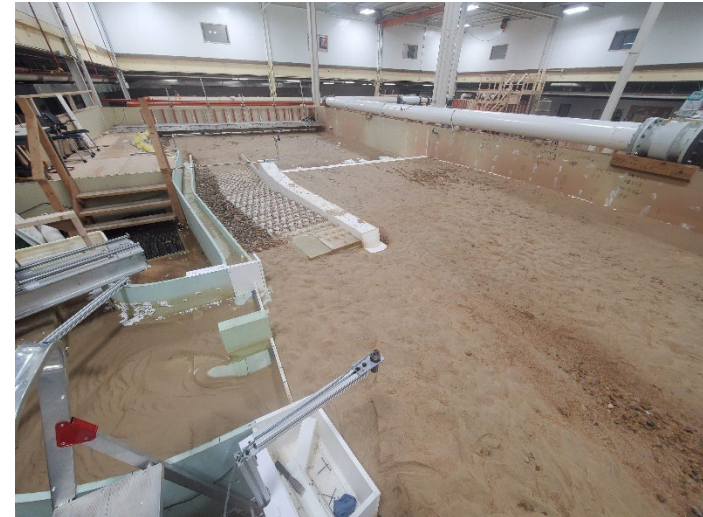
Figure B-71. View looking downstream after dewatering for MOD-9 design with flushing channel removed at 12,000 ft³/s.

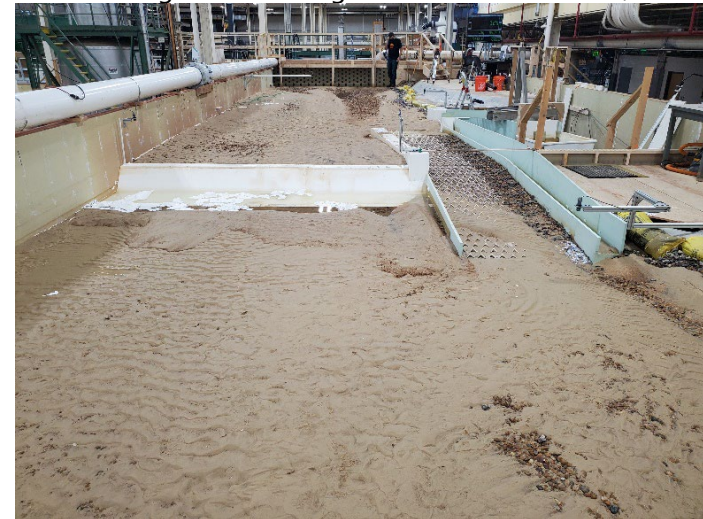
Figure B-72. View looking upstream for MOD-9 design with flushing channel removed after 12,000 ft³/s flow rate.

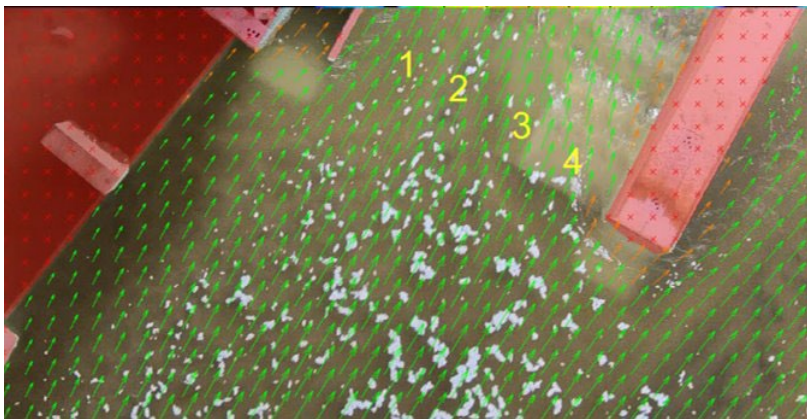
Figure B-74. Surface velocity vector map in area upstream of diversion intake (left) and hardened ramp (right) for MOD-6 design with flushing channel closed at 12,000 ft³/s river flow.

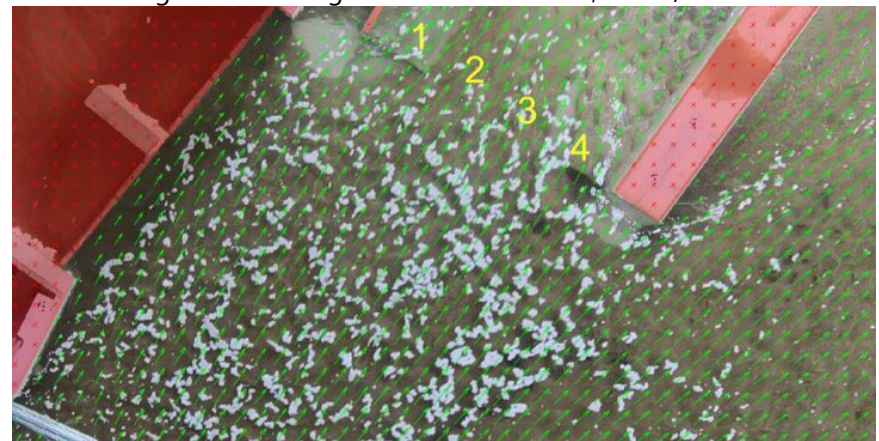
Figure B-76. Surface velocity vector map in area upstream of diversion intake (left) and hardened ramp (right) for MOD-9 design with flushing channel closed at 12,000 ft³/s river flow.

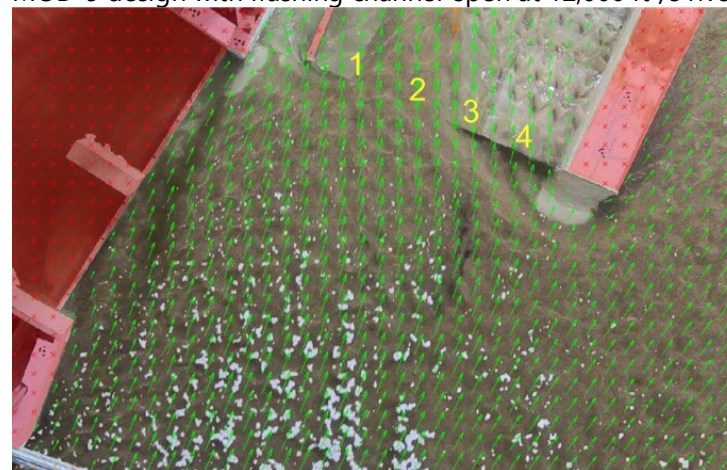
Figure B-80. Surface velocity vector map in area upstream of diversion intake (left) and hardened ramp (right) for MOD-9 design with flushing channel open at 12,000 ft³/s river flow.

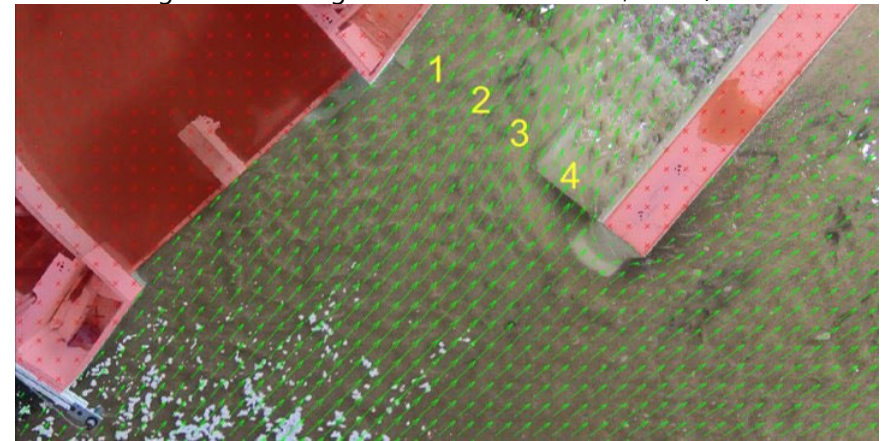
Figure B-84. Surface velocity vector map in area upstream of diversion intake (left) and hardened ramp (right) for MOD-9 design with flushing channel removed at 12,000 ft³/s river flow.

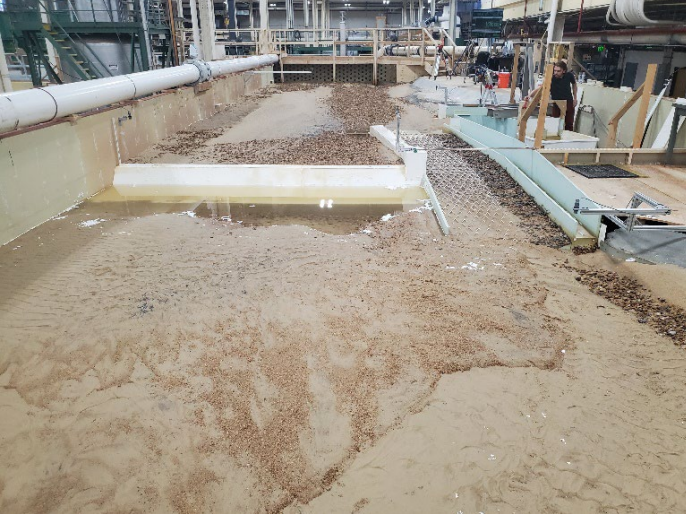
Figure B-92. View looking upstream for MOD-6 design with flushing channel closed after 30,000 ft³/s flow rate.

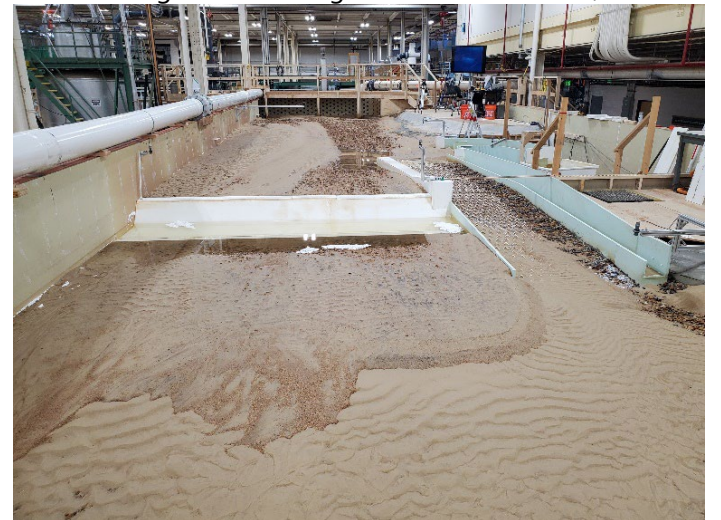
Figure B-94. View looking upstream for MOD-9 design with flushing channel closed after 30,000 ft³/s flow rate.

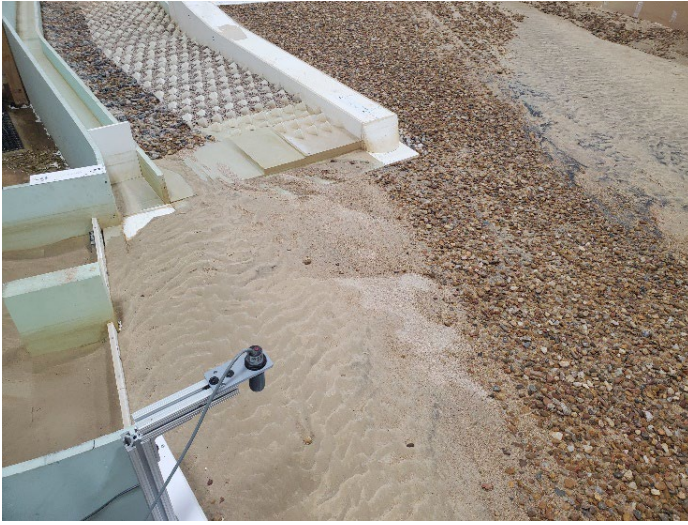
Figure B-95. View looking downstream after dewatering for MOD-6 design with flushing channel open at 30,000 ft³/s.

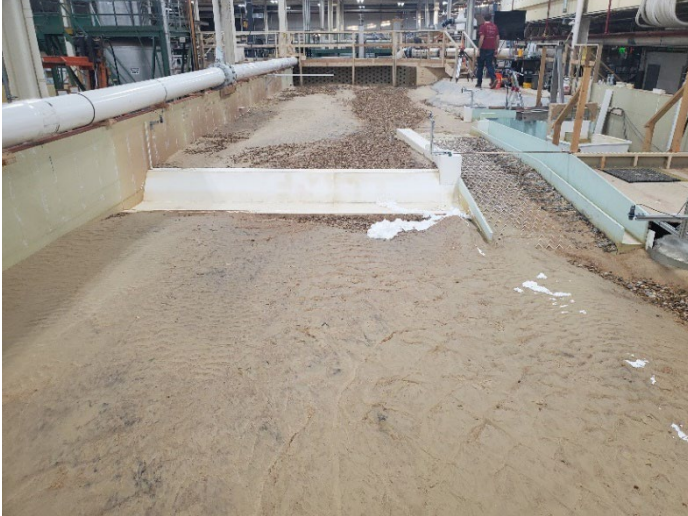
Figure B-96. View looking upstream for MOD-6 design with flushing channel open after 30,000 ft³/s flow rate.

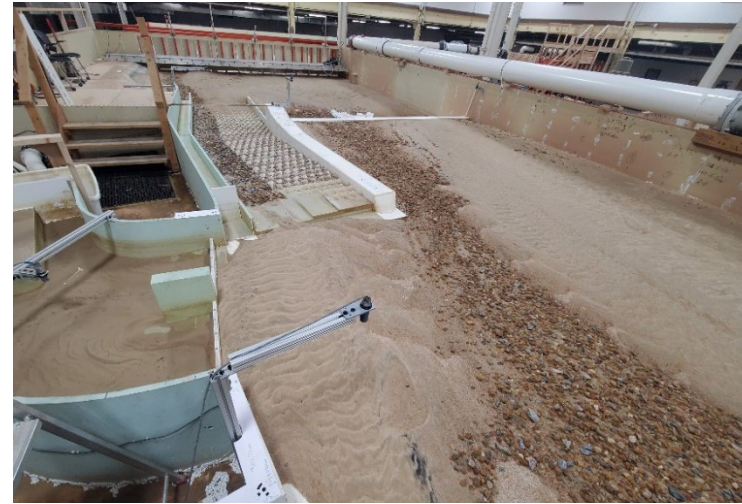
Figure B-97. View looking downstream after dewatering for MOD-9 design with flushing channel open at 30,000 ft³/s.

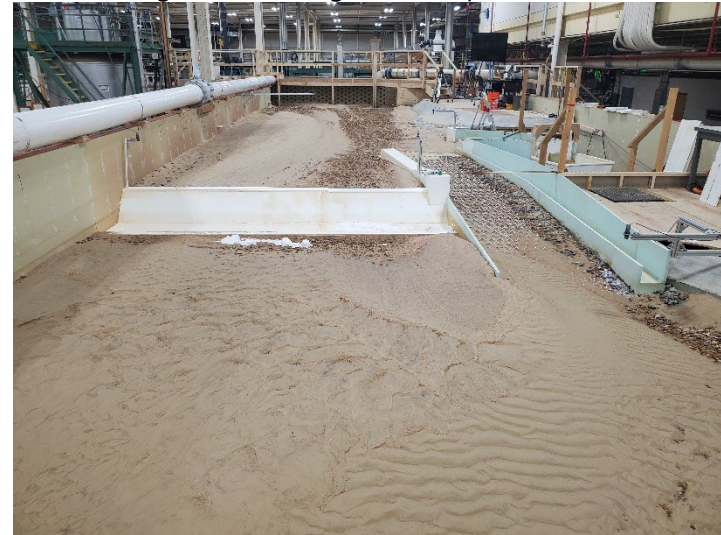
Figure B-98. View looking upstream for MOD-9 design with flushing channel open after 30,000 ft³/s flow rate.

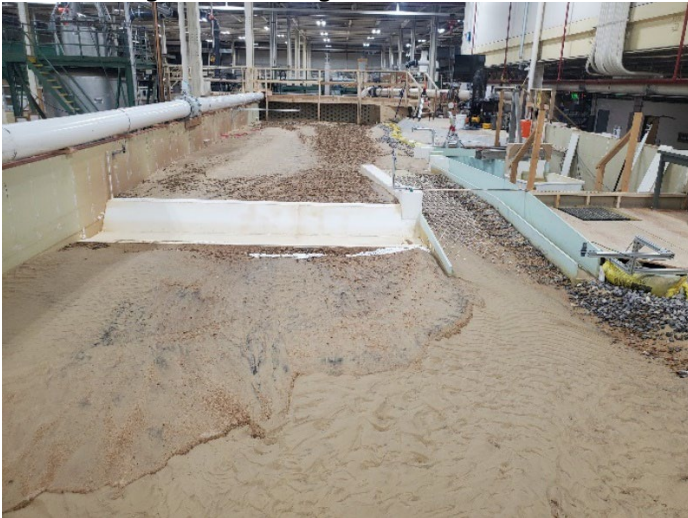
Figure B-100. View looking upstream for MOD-6 design with flushing channel removed after 30,000 ft³/s flow rate.

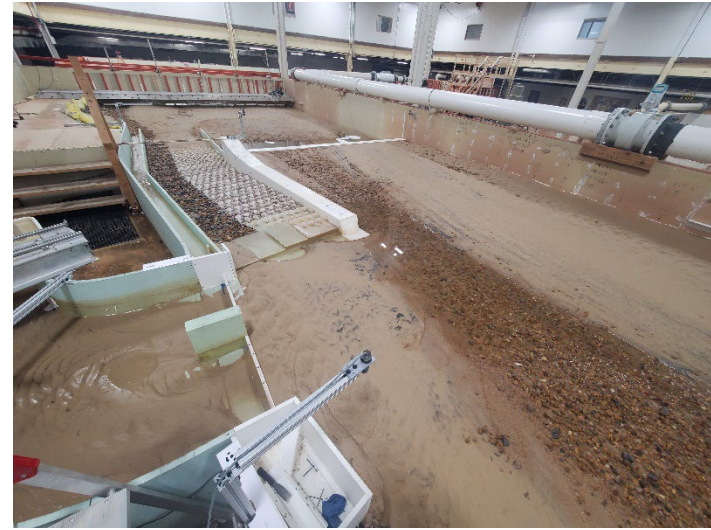
Figure B-101. View looking downstream after dewatering for MOD-9 design with flushing channel removed at 30,000 ft³/s.

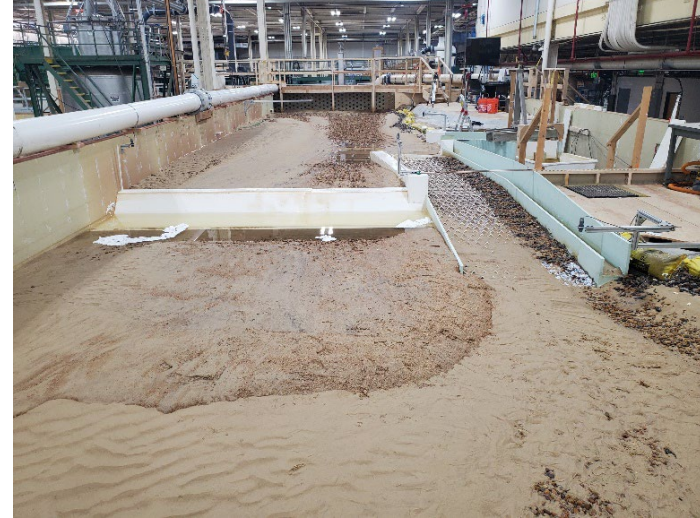
Figure B-102. View looking upstream for MOD-9 design with flushing channel removed after 30,000 ft³/s flow rate.

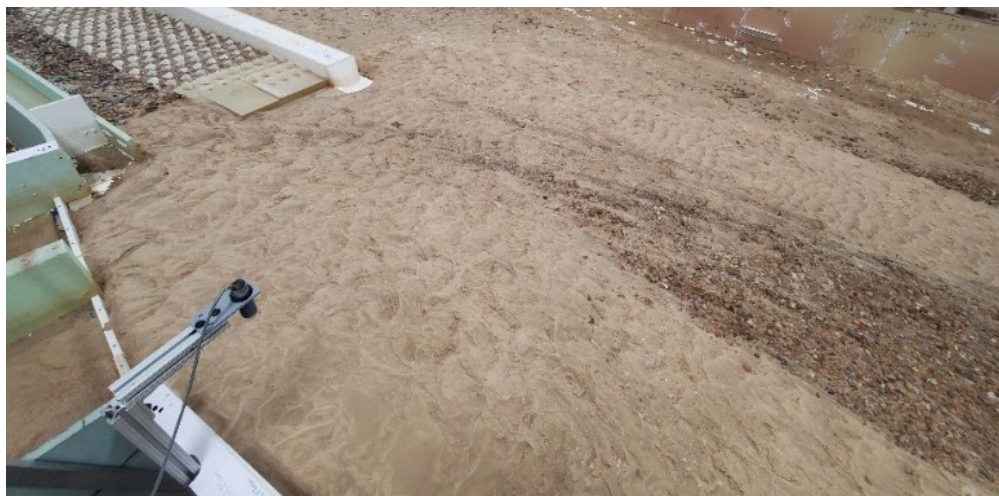
Figure B-121. MOD-6 flushing channel closed at 6,000 ft³/s after a 2 hr run duration.

seen with MOD-6. This trial had different initial bed conditions than the baseline runs but visually reached equilibrium within 6.5 hours and caused deposition on the diversion gates and on the upstream end of the hardened ramp very similar to the MOD-6 baseline runs (Figure B-121 to Figure B-123).

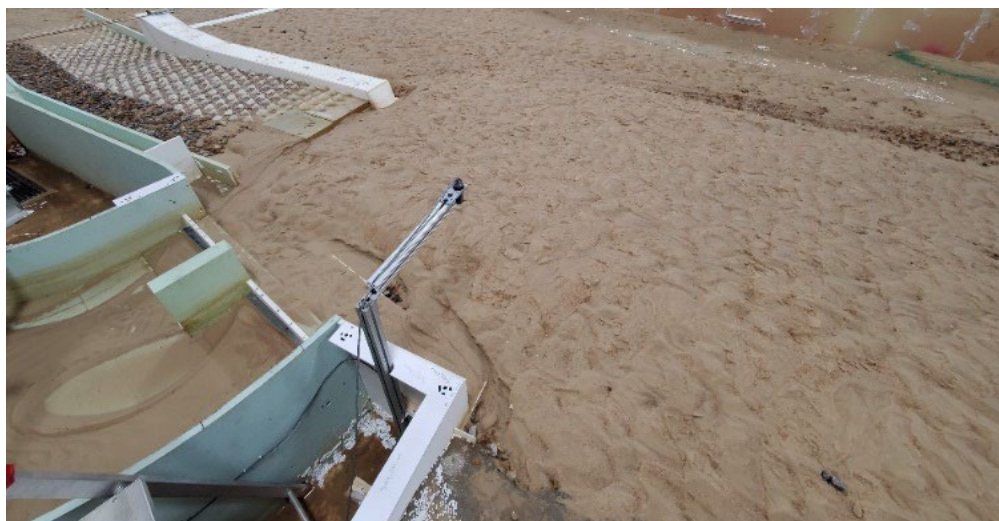
Figure B-122. MOD-9 flushing channel closed at 6,000 ft³/s after a 2 hr run duration.

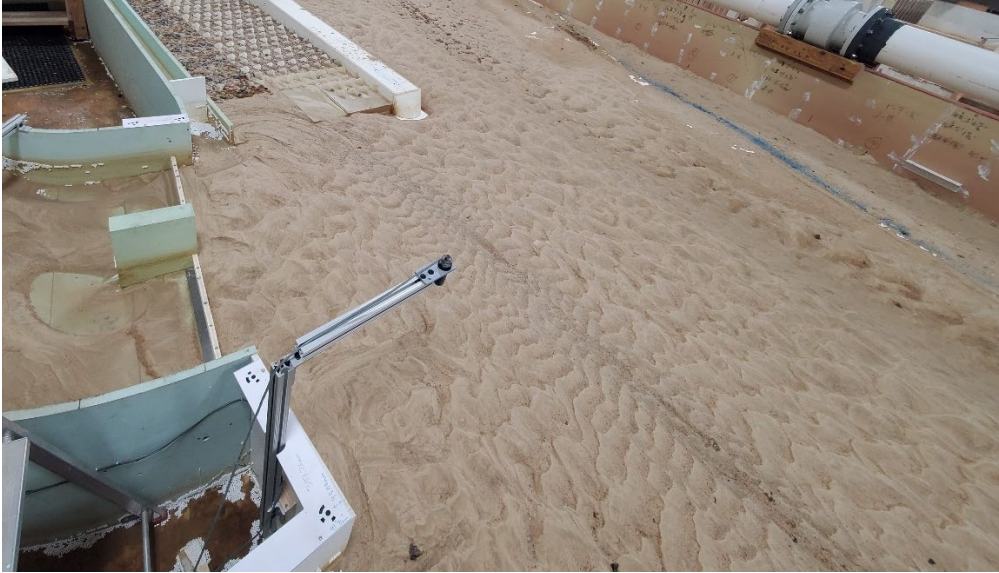
Figure B-123. MOD-9 flushing channel closed at 6,000 ft³/s after a 6.5 hr run duration.

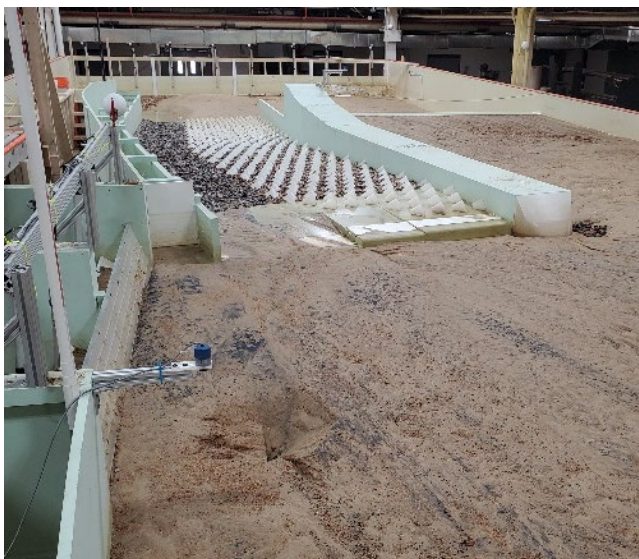
Figure C-1. View looking downstream after dewatering for MOD-6 design with flushing channel closed at 6,000 ft³/s.

At 6,000 ft³/s, the upstream portion of the model was submerged. The apron and gates of the hardened ramp remained relatively clear of sediment, even though the river deposited sediment immediately upstream of the low flow section of the hardened ramp in the bed form typically observed. As fine and coarse sediment approached the low flow section of the hardened ramp, it would be transported downstream without depositing on the hardened ramp.

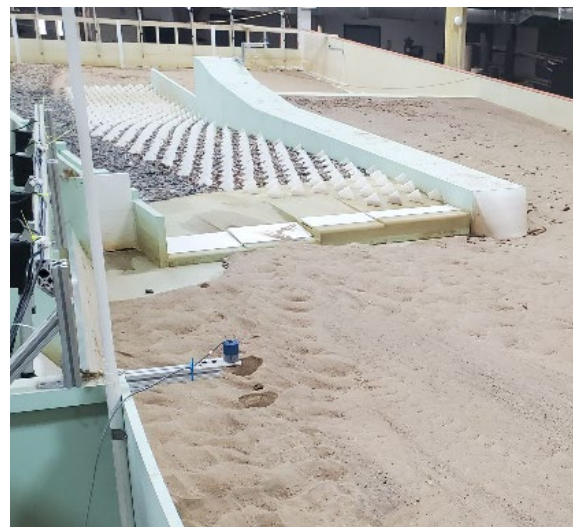
Figure C-3. View looking downstream after dewatering for MOD-9 design with flushing channel closed at 6,000 ft³/s.

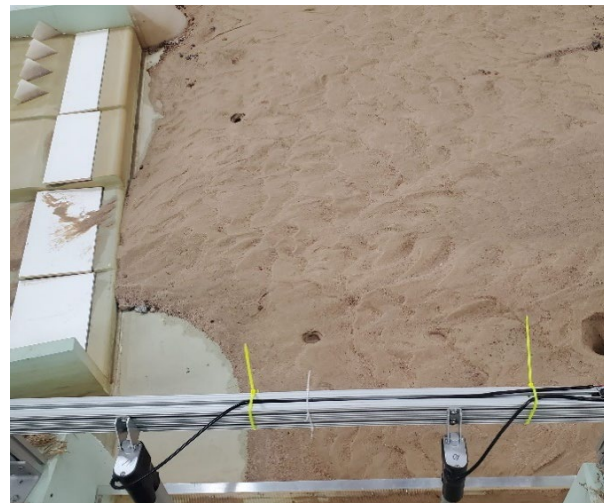
Figure C-4. View of ramp exit looking from left bank for MOD-9 design with flushing channel closed after 6,000 ft³/s flow rate.

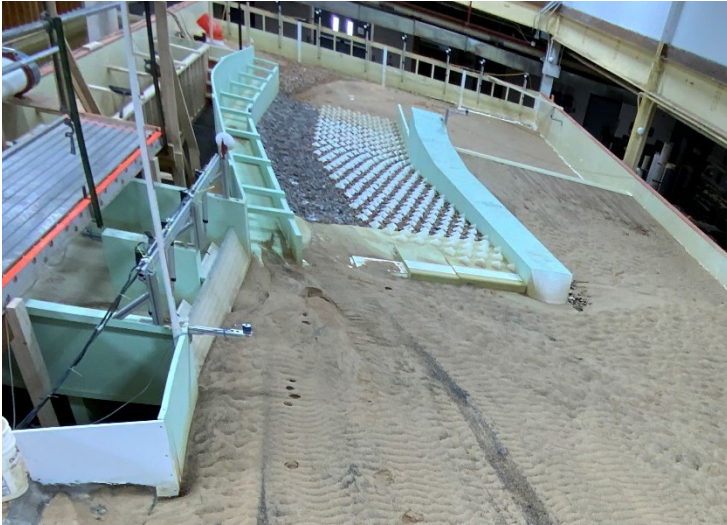
Figure C-5. View looking downstream after dewatering for MOD-6 design with flushing channel open at 6,000 ft³/s.

After the flushing channel was opened, the apron in front of intake gates 3-4 was cleared of sediment. The sand bar in front of the hardened ramp shifted left, with sediment deposition mostly upstream of the hardened ramp. Additionally, most sediment passed down hardened ramp and flushing channel without accumulating except in front of low flow section of the hardened ramp where waves from flushing channel and ramp gates overlapped and allowed sediment to drop on apron in front of gates 1-2.

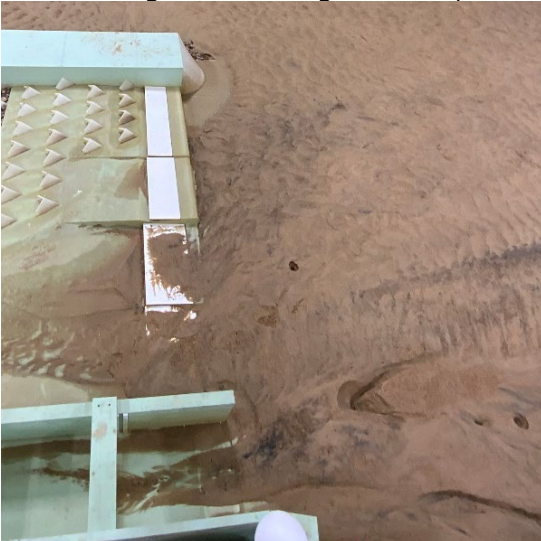
Figure C-6. View of ramp exit looking from left bank for MOD-6 design with flushing channel open after 6,000 ft³/s flow rate.

On the downstream portion of the hardened ramp, the sediment deposition pattern did not change from the flushing channel closed configuration, with a semi-transverse deposition pattern along the lower third of the ramp. The left end of the baffled area has a large recirculation area. Scour was concentrated immediately downstream of the low flow section of the hardened ramp and the flushing channel.

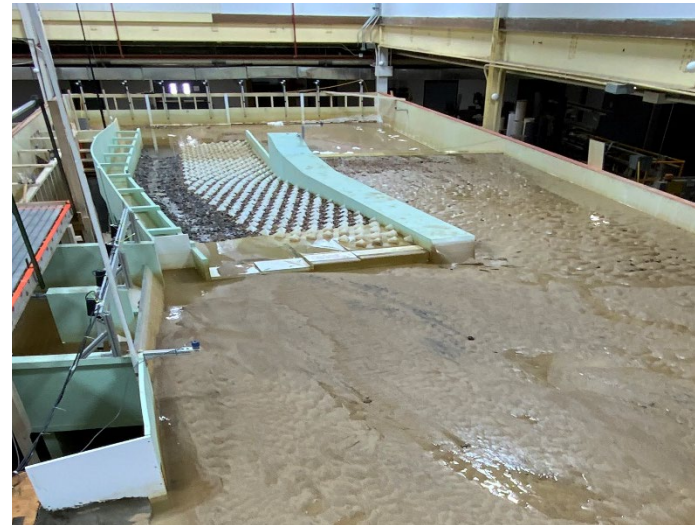
Figure C-7. View looking downstream after dewatering for MOD-9 design with flushing channel open at 6,000 ft³/s.

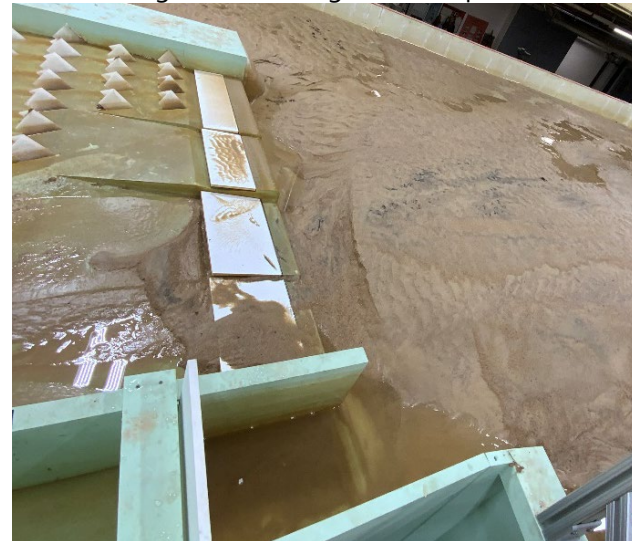
Figure C-8. View of ramp exit looking from left bank for MOD-9 design with flushing channel open after 6,000 ft³/s flow rate.

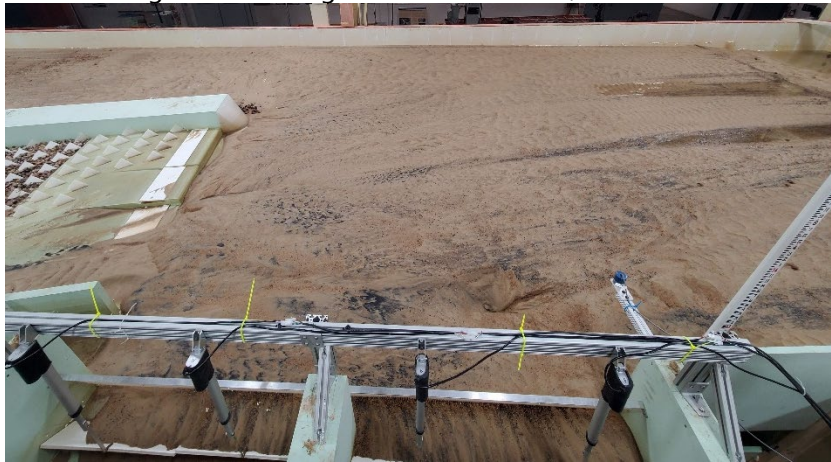
Figure C-10. Views looking upstream from diversion canal of area upstream of diversion intake (bottom) and hardened ramp (left) for MOD-6 design with flushing channel closed at 6,000 ft³/s river flow.

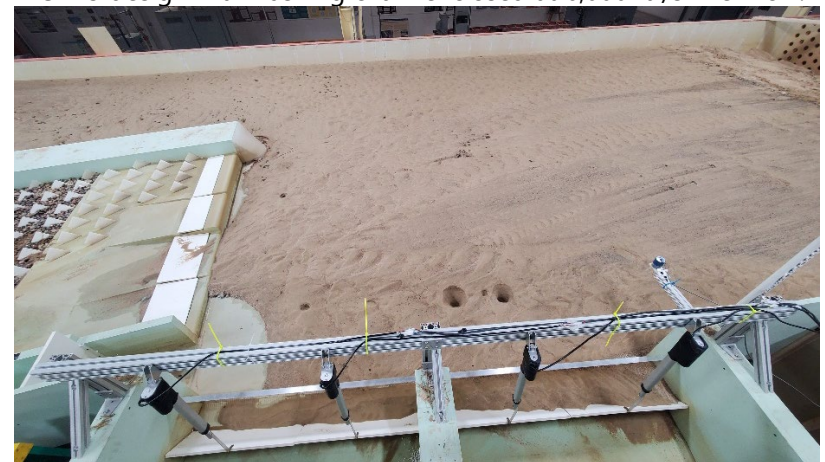
Figure C-12. Views looking upstream from diversion canal of area upstream of diversion intake (bottom) and hardened ramp (left) for MOD-9 design with flushing channel closed at 6,000 ft³/s river flow.

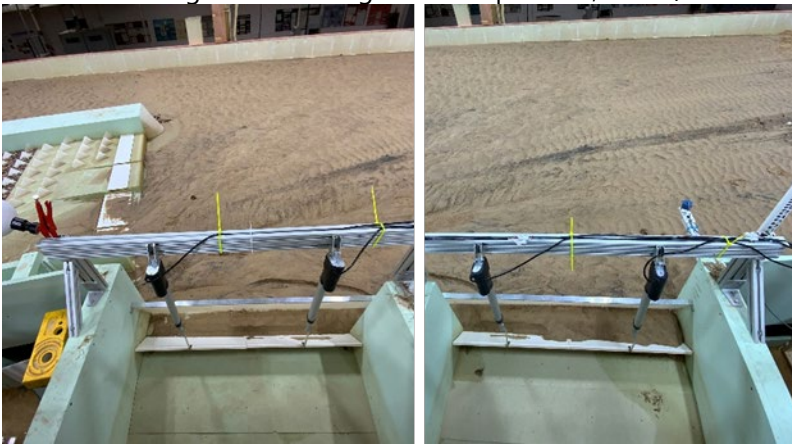
Figure C-14. Views looking upstream from diversion canal of area upstream of diversion intake (bottom) and hardened ramp (left) for MOD-6 design with flushing channel open at 6,000 ft³/s.

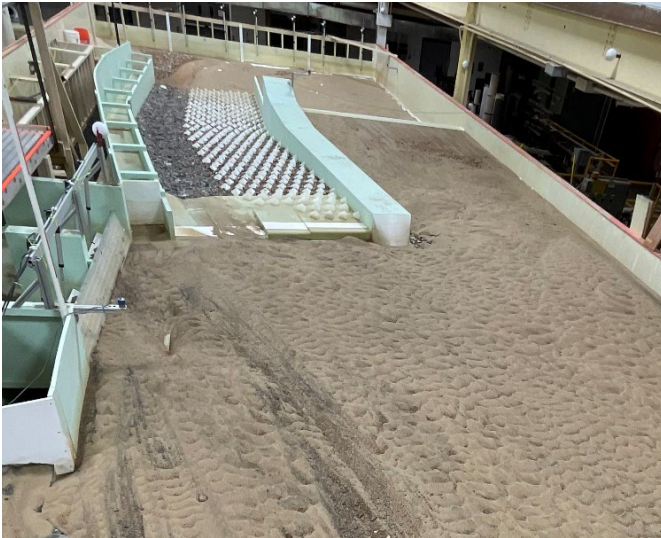
Figure C-17. View looking downstream after dewatering for MOD-6 design with flushing channel closed at 3,000 ft³/s.

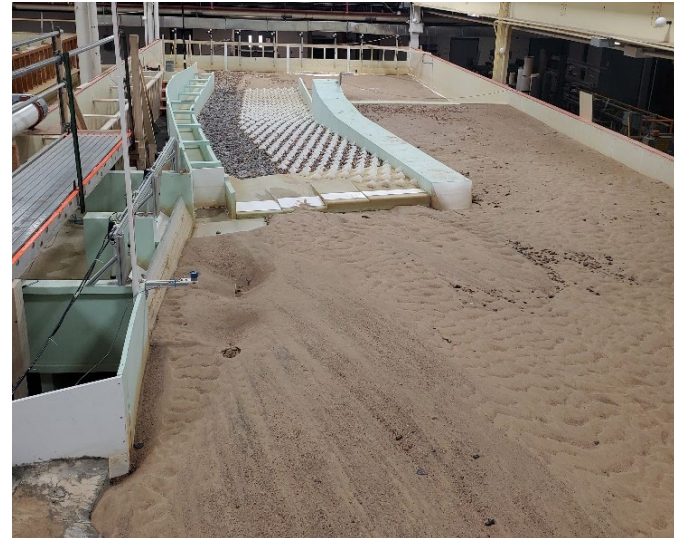
Figure C-19. View looking downstream after dewatering for MOD-9 design with flushing channel closed at 3,000 ft³/s.

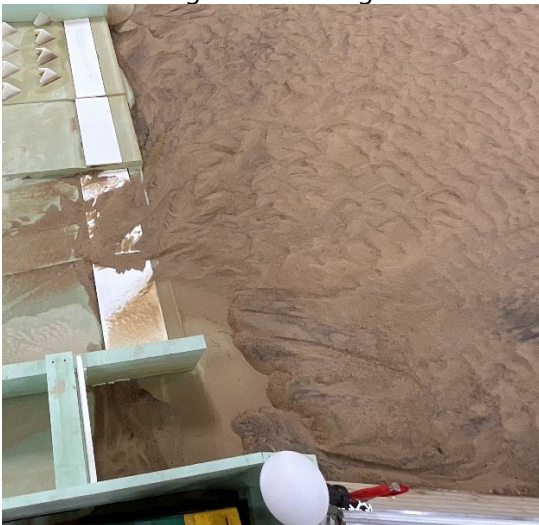
Figure C-18. View of ramp exit looking from left bank for MOD-6 design with flushing channel closed after 3,000 ft³/s flow rate.
