Hydraulic Laboratory Report HL-2022-03

Physical Hydraulic Modeling of the Freeman Diversion Hardened Ramp Fish Passage Alternative

Freeman Diversion

United Water Conservation District, Ventura County, California

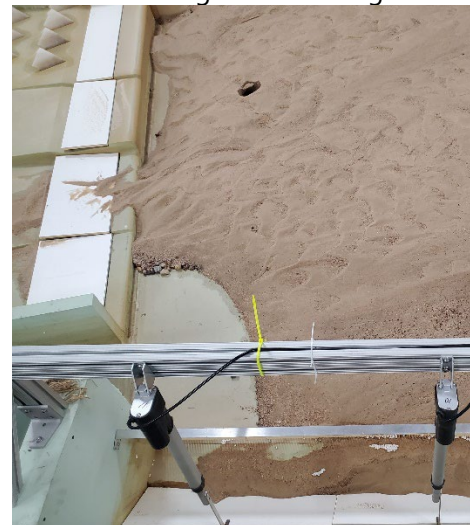
Figure C-20. View of ramp exit looking from left bank for MOD-9 design with flushing channel closed after 3,000 ft³/s flow rate.

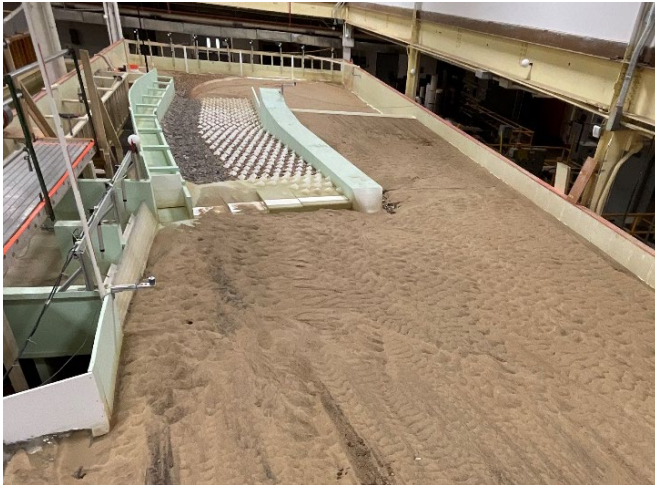
Figure C-21. View looking downstream after dewatering for MOD-6 design with flushing channel open at 3,000 ft³/s.

After the flushing channel was opened, the apron in front of flushing channel was immediately exposed. Flow split around the flushing channel wall caused turbulence at entrance, which enabled the flow to pull significant quantities of sediment. Very little sediment accumulated on the gates of the hardened ramp, however the apron in front of gate 3 to part of gate 4 was covered in sediment except for portion eroded by bullnose. Sediment remained relatively unchanged in front of the intake gates, except for gate 4 which was cleared.

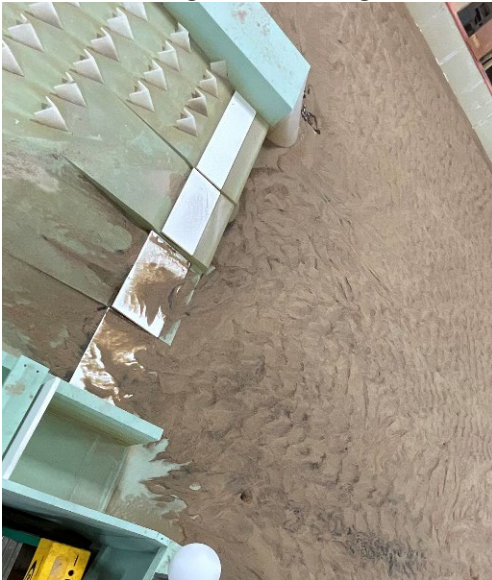
Figure C-22. View of ramp exit looking from left bank for MOD-6 design with flushing channel open after 3,000 ft³/s flow rate.

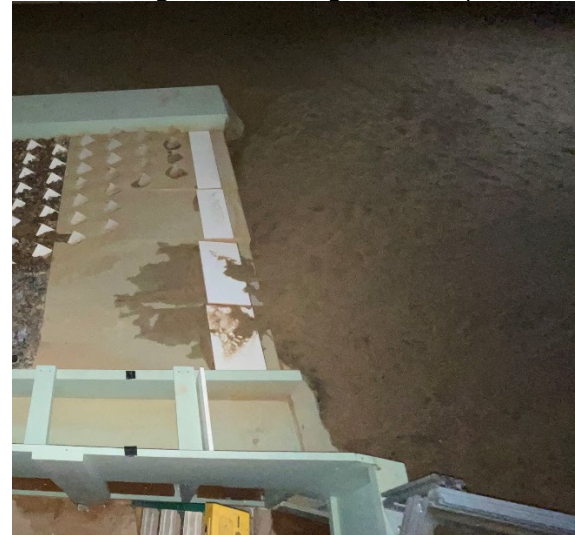
Figure C-24. View of ramp exit looking from left bank for MOD-9 design with flushing channel open after 3,000 ft³/s flow rate.

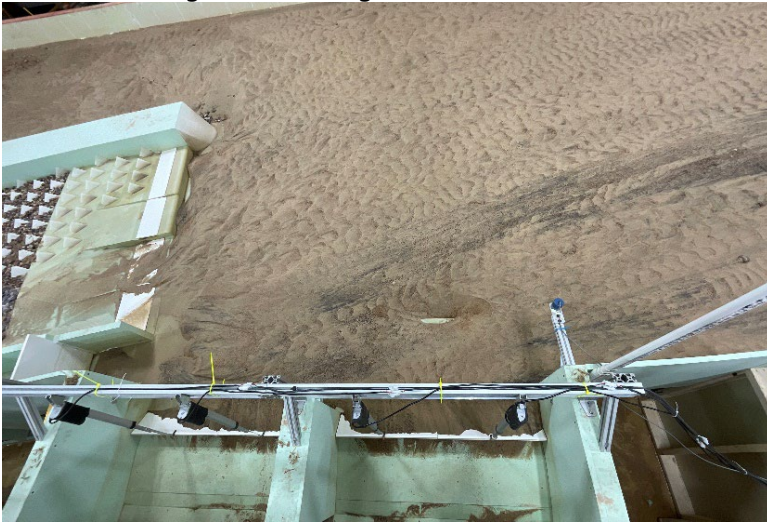
Figure C-26. View looking upstream from diversion canal of area upstream of diversion intake (bottom) and hardened ramp (left) for MOD-6 design with flushing channel closed at 3,000 ft³/s river flow.

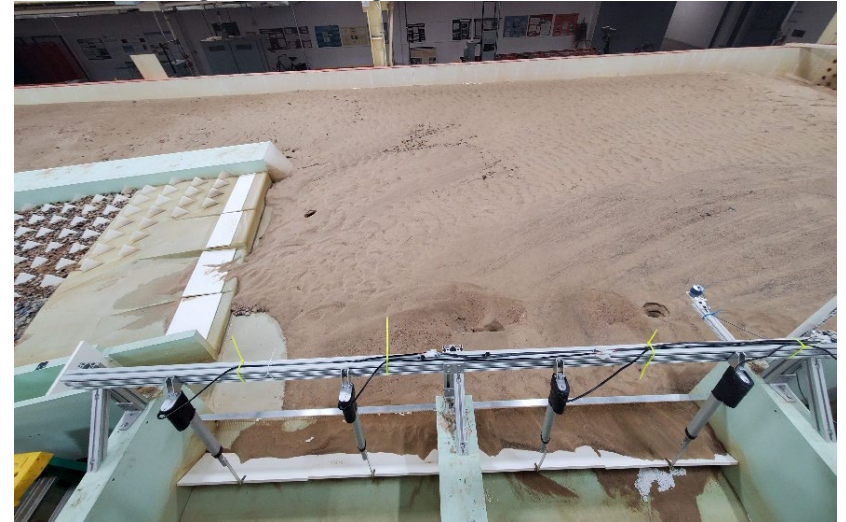
Figure C-28. View looking upstream from diversion canal of area upstream of diversion intake (bottom) and hardened ramp (left) for MOD-9 design with flushing channel closed at 3,000 ft³/s river flow.

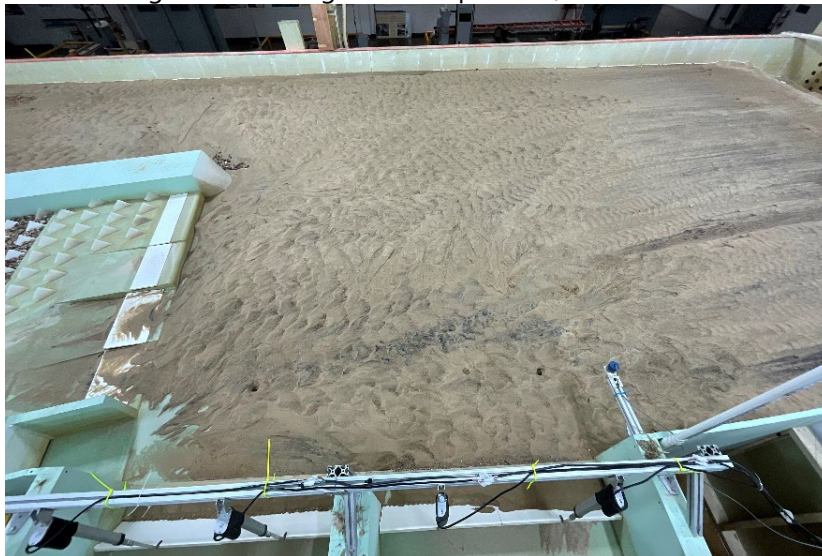
Figure C-30. View looking upstream from diversion canal of area upstream of diversion intake (bottom) and hardened ramp (left) for MOD-6 design with flushing channel open at 3,000 ft³/s river flow.

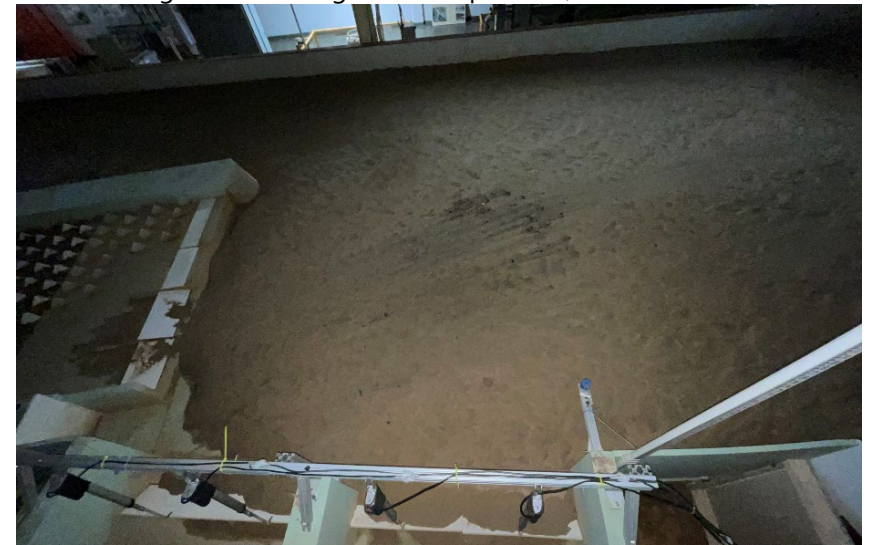
Figure C-32. View looking upstream from diversion canal of area upstream of diversion intake (bottom) and hardened ramp (left) for MOD-9 design with flushing channel open at 3,000 ft³/s river flow.

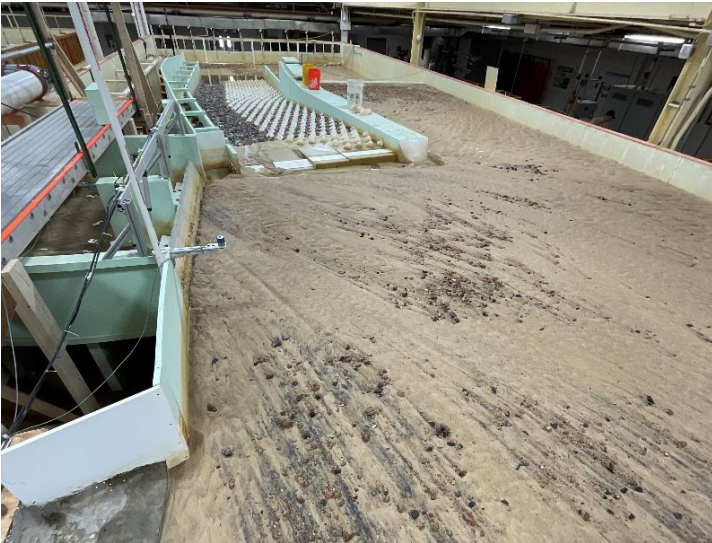
C-37. View looking downstream after dewatering for MOD-6 design with flushing channel closed at 1,500 ft³/s.

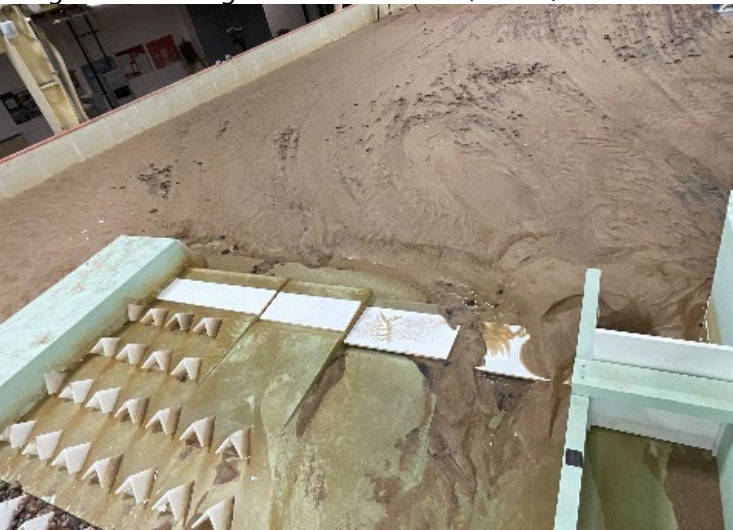
Figure C-38. View of ramp exit looking upstream from left bank for MOD-6 design with flushing channel closed after 1,500 ft³/s flow rate.

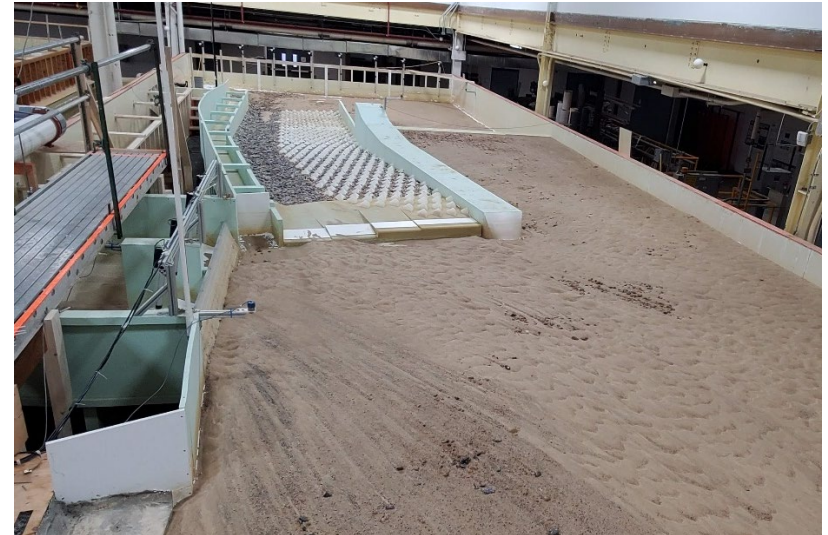
Figure C-39. View looking downstream after dewatering for MOD-9 design with flushing channel closed at 1,500 ft³/s.

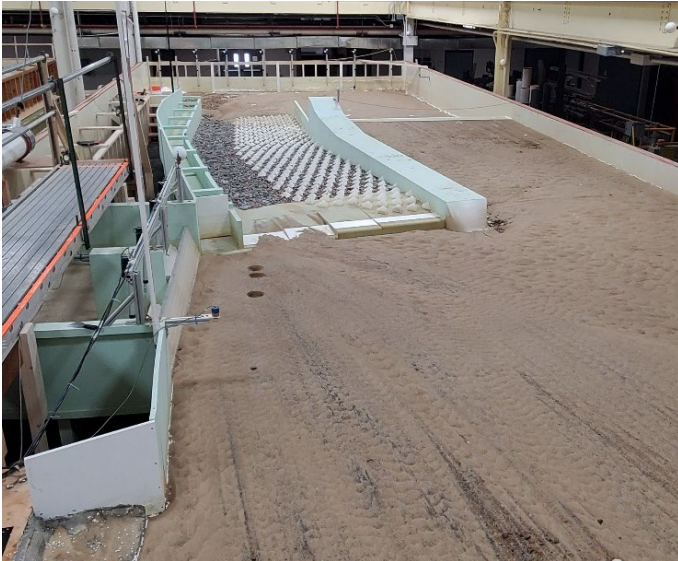
Figure C-41. View looking downstream after dewatering for MOD-6 design with flushing channel open at 1,500 ft³/s.

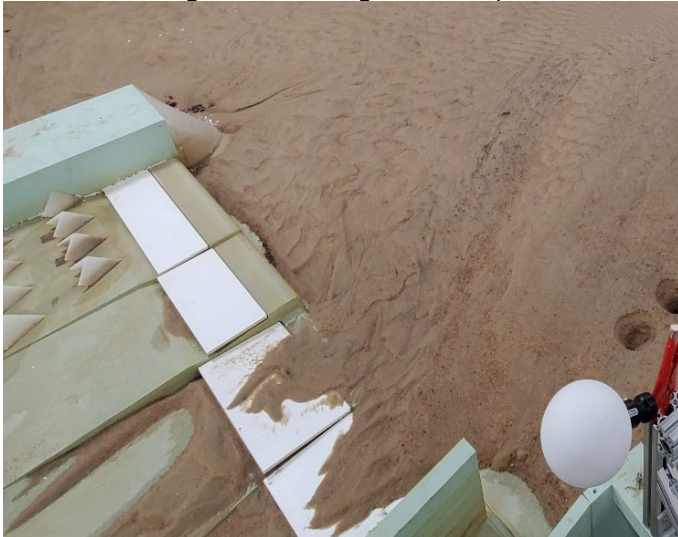
Figure C-42. View of ramp exit looking from left bank for MOD-6 design with flushing channel open after 1,500 ft³/s flow rate.

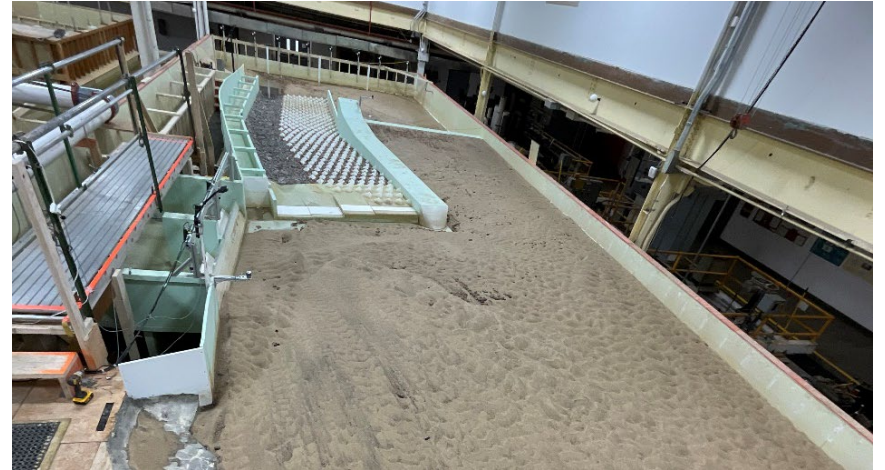
Figure C-43. View looking downstream after dewatering for MOD-9 design with flushing channel open at 1,500 ft³/s.

After the flushing channel was opened, the riverbed shifted left towards the flushing channel similar to previous tests. The highest point of the bedform was closer to the flushing channel as opposed to directly in front of the hardened ramp. Horseshoe shaped scour pattern developed around the left wall of the hardened ramp which caused some sediment to be cleared from intake gates 1 and 2 but did not affect sediment on the apron of the hardened ramp or the intake.

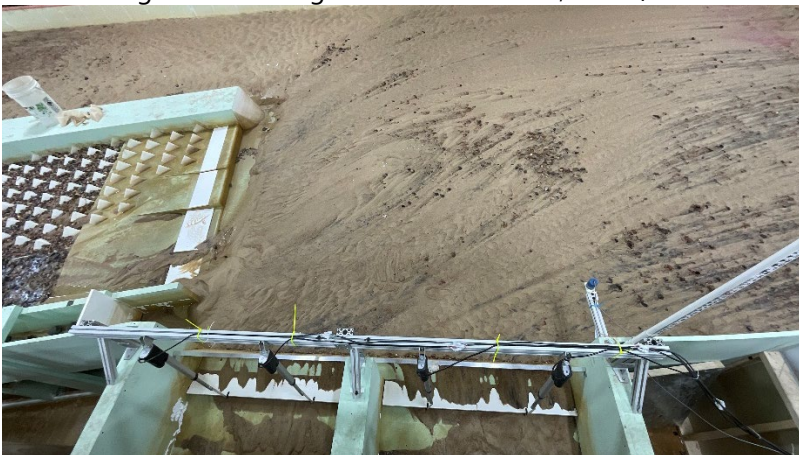
Figure C-45. View looking upstream from diversion canal of area upstream of diversion intake (bottom) and hardened ramp (left) for MOD-6 design with flushing channel closed at 1,500 ft³/s river flow.

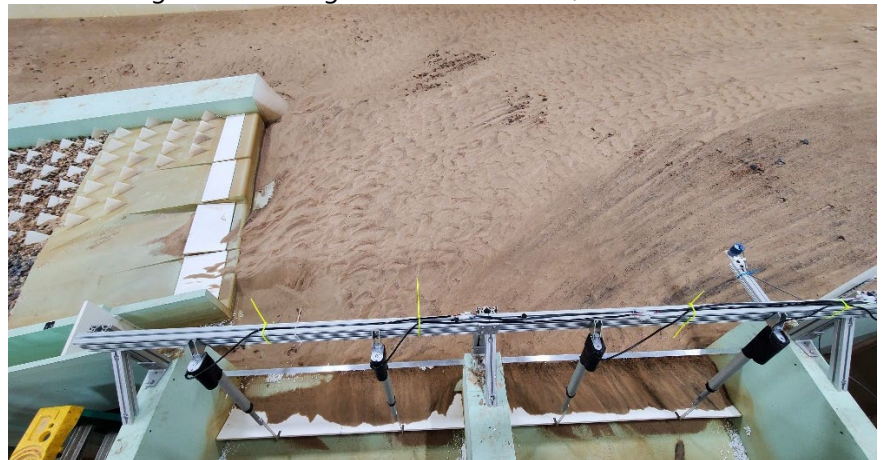
Figure C-47. View looking upstream from diversion canal of area upstream of diversion intake (bottom) and hardened ramp (left) for MOD-9 design with flushing channel closed at 1,500 ft³/s river flow.

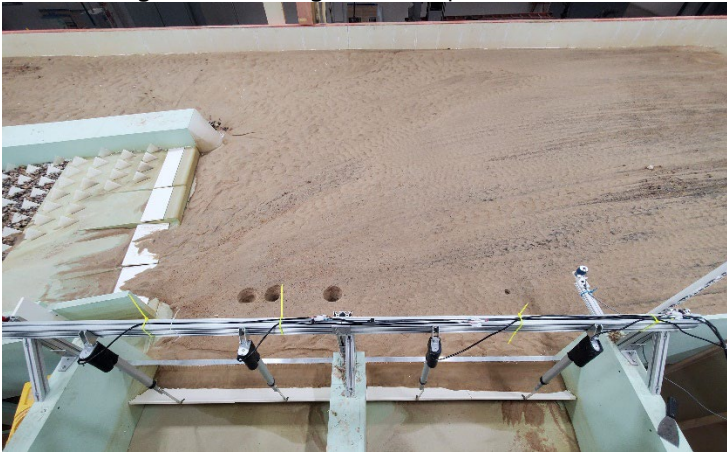
Figure C-49. View looking upstream from diversion canal of area upstream of diversion intake (bottom) and hardened ramp (left) for MOD-6 design with flushing channel open at 1,500 ft³/s river flow.

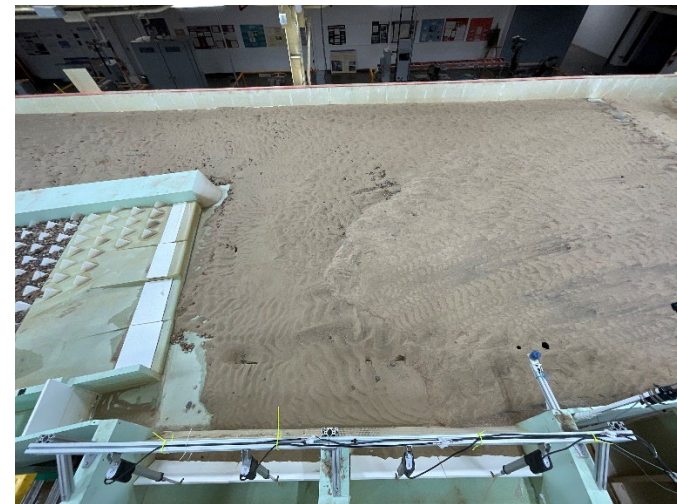
Figure C-50. View looking upstream from diversion canal of area upstream of diversion intake (bottom) and hardened ramp (left) for MOD-9 design with flushing channel open at 1,500 ft³/s river flow (PIV data not available).

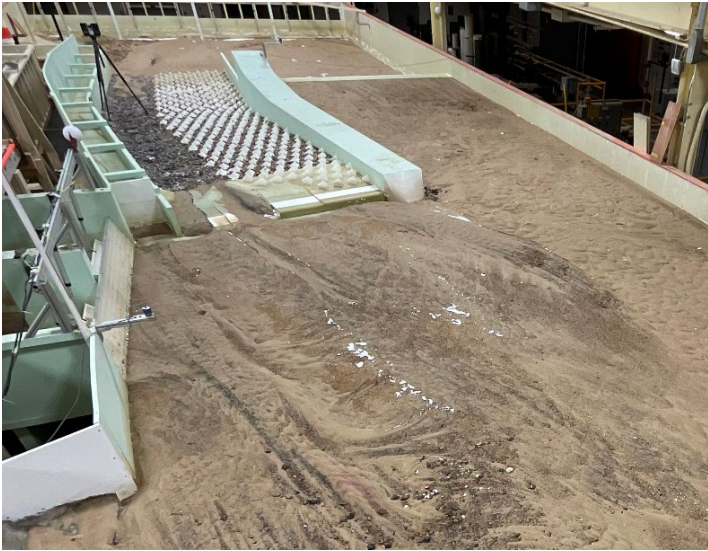
C-55. View looking downstream after dewatering for MOD-6 design with flushing channel closed at 270 ft³/s.

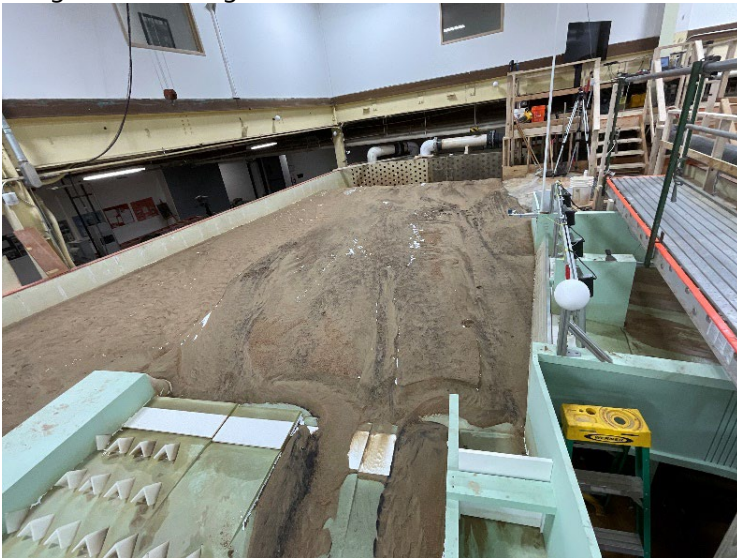
Figure C-56. View looking upstream for MOD-6 design with flushing channel closed after 270 ft³/s flow rate.

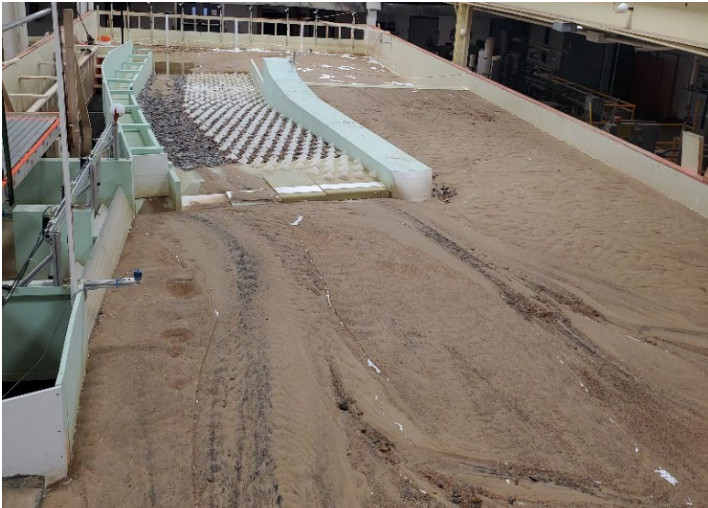
Figure C-57. View looking downstream after dewatering for MOD-6 design with flushing channel open at 270 ft³/s. The black features on top of the bedform are iron deposits from the sediment blend and are not larger cobble sized material.

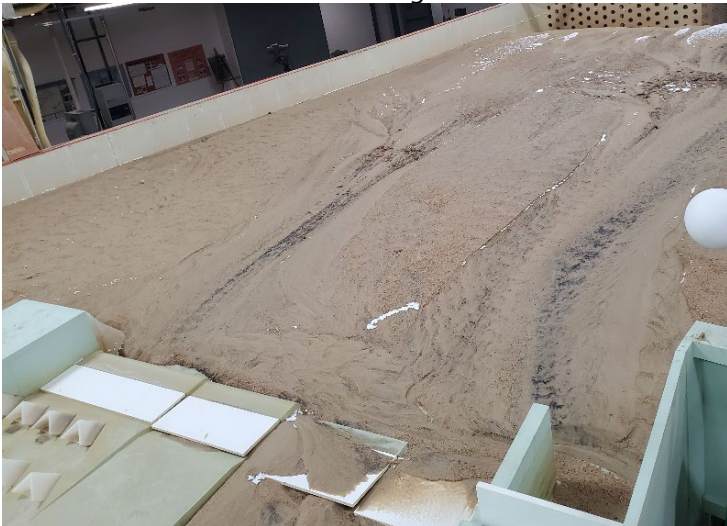
Figure C-58. View looking upstream for MOD-6 design with flushing channel open after 270 ft³/s flow rate.

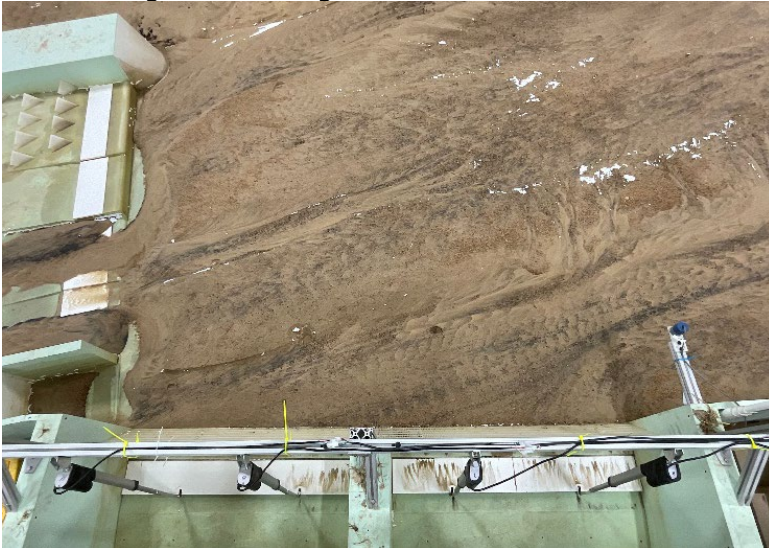
Figure C-60. View looking upstream from diversion canal of area upstream of diversion intake (bottom) and hardened ramp (left) for MOD-6 design with flushing channel closed at 270 ft³/s river flow.

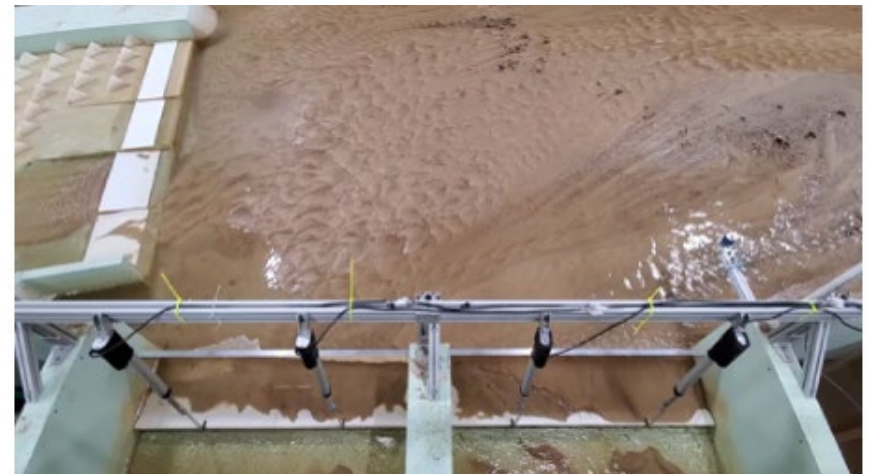
Figure C-62. View looking upstream from diversion canal of area upstream of diversion intake (bottom) and hardened ramp (left) for MOD-9 design with flushing channel closed at 270 ft³/s river flow.

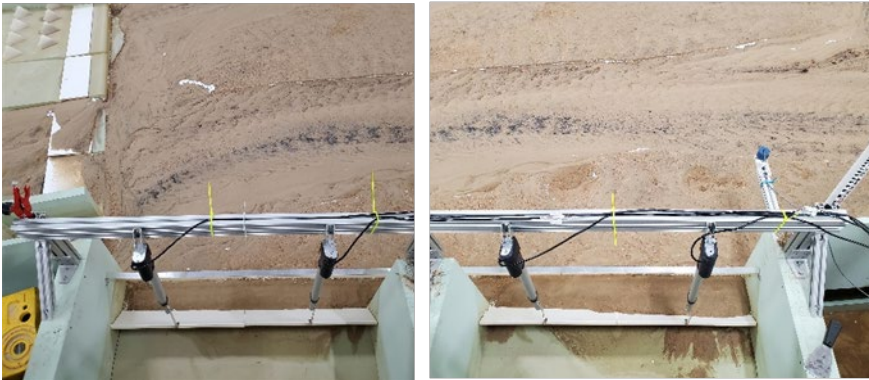
Figure C-64. Views looking upstream from diversion canal of area upstream of diversion intake (bottom) and hardened ramp (left) for MOD-6 design with flushing channel open at 270 ft³/s river flow.
