UNITED STATES
DEPARTMENT OF THE INTERIOR
BUREAU OF RECLAMATION

SUBJECT: MECHANICAL COMPOSITION OF EARTH DAM MATERIALS

HYDRAULIC LABORATORY REPORT NO. .1

TECHNICAL MEMORANDUM NO. 121

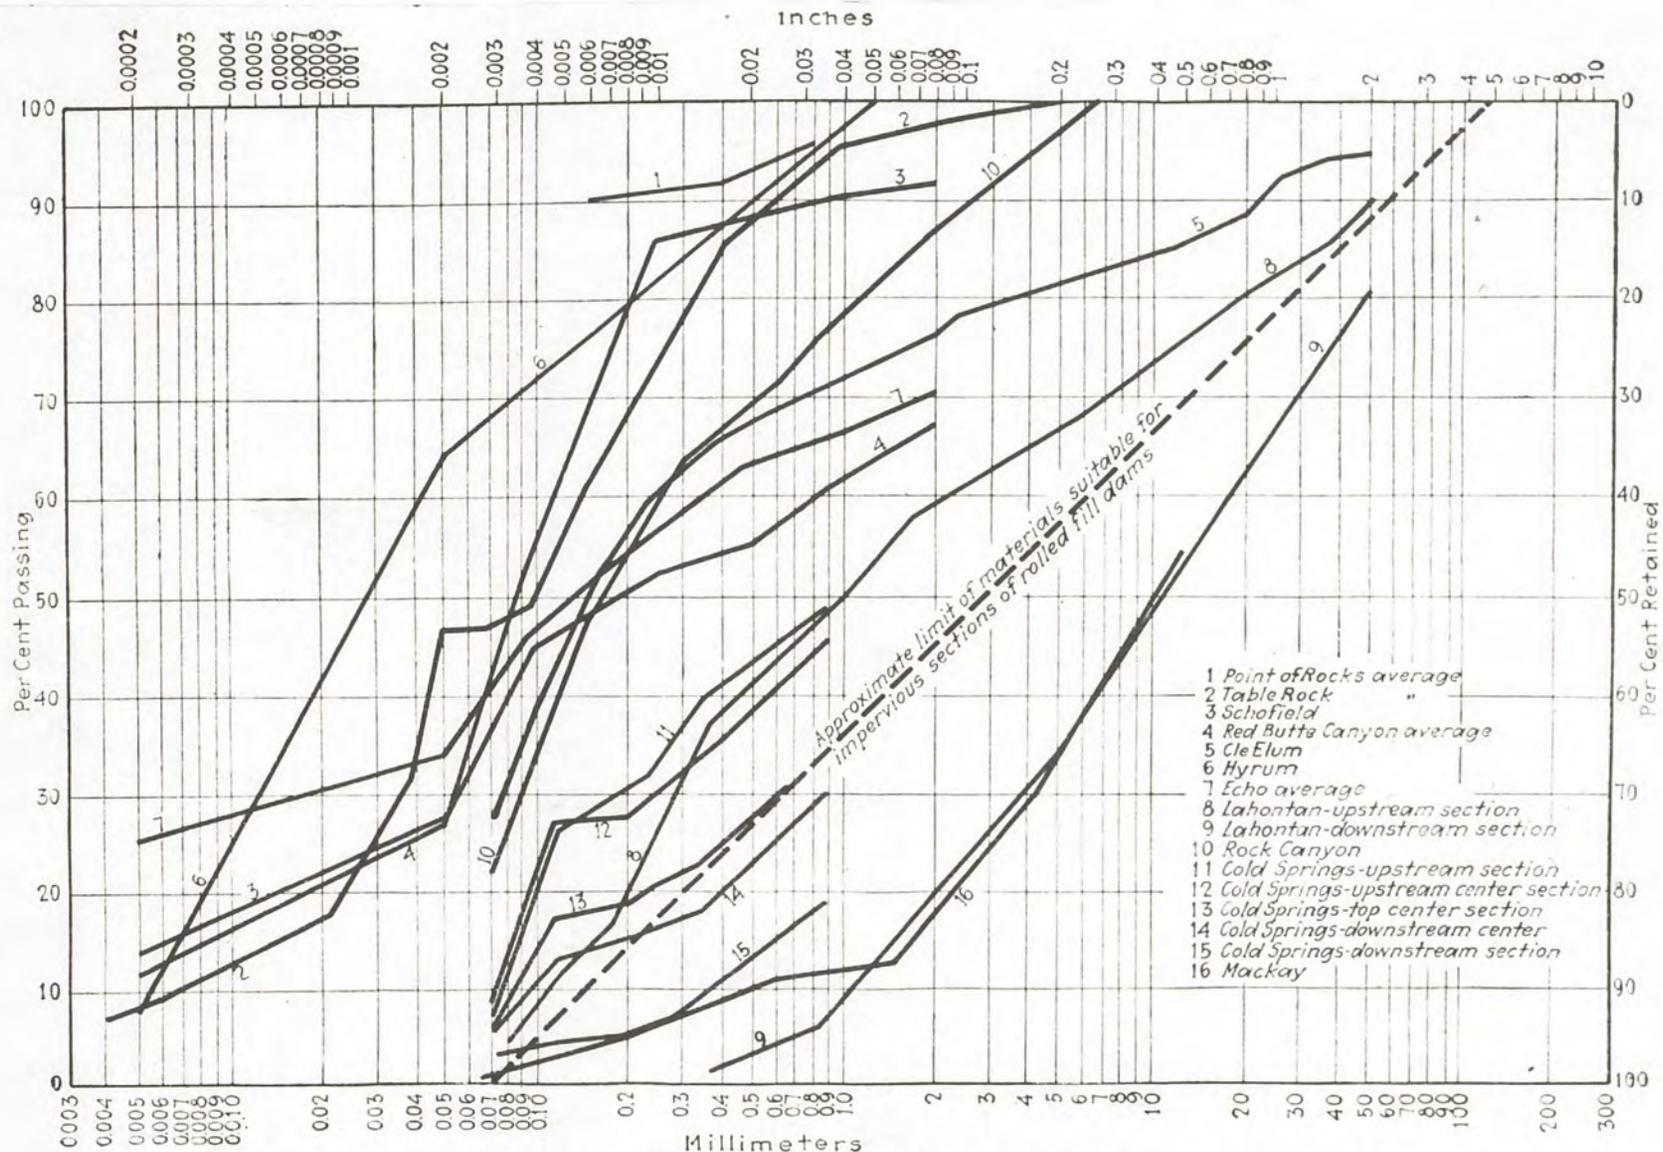
FIG. 1—MATERIALS OF ROLLED-FILL DAMS
Upper size limit suggested is somewhat coarser than the upstream material of the Lahontan Dam.

Cold Springs Dam, which are believed to represent about the upper limit of size of suitable materials, if a reasonably watertight dam is to be secured. For the porous material as frequently used in the downstream sections of dams to secure stability and drainage, there is no need of prescribing a limitation, for the material may be and frequently is, a rock fill including boulders of considerable size. The line given on Figure 1 does not represent a fixed limit beyond which a safe dam can not be built, but is believed to represent approximately the limits of material which can be used for dams of the cross sections ordinarily used to secure a dam without objectionable seepage.

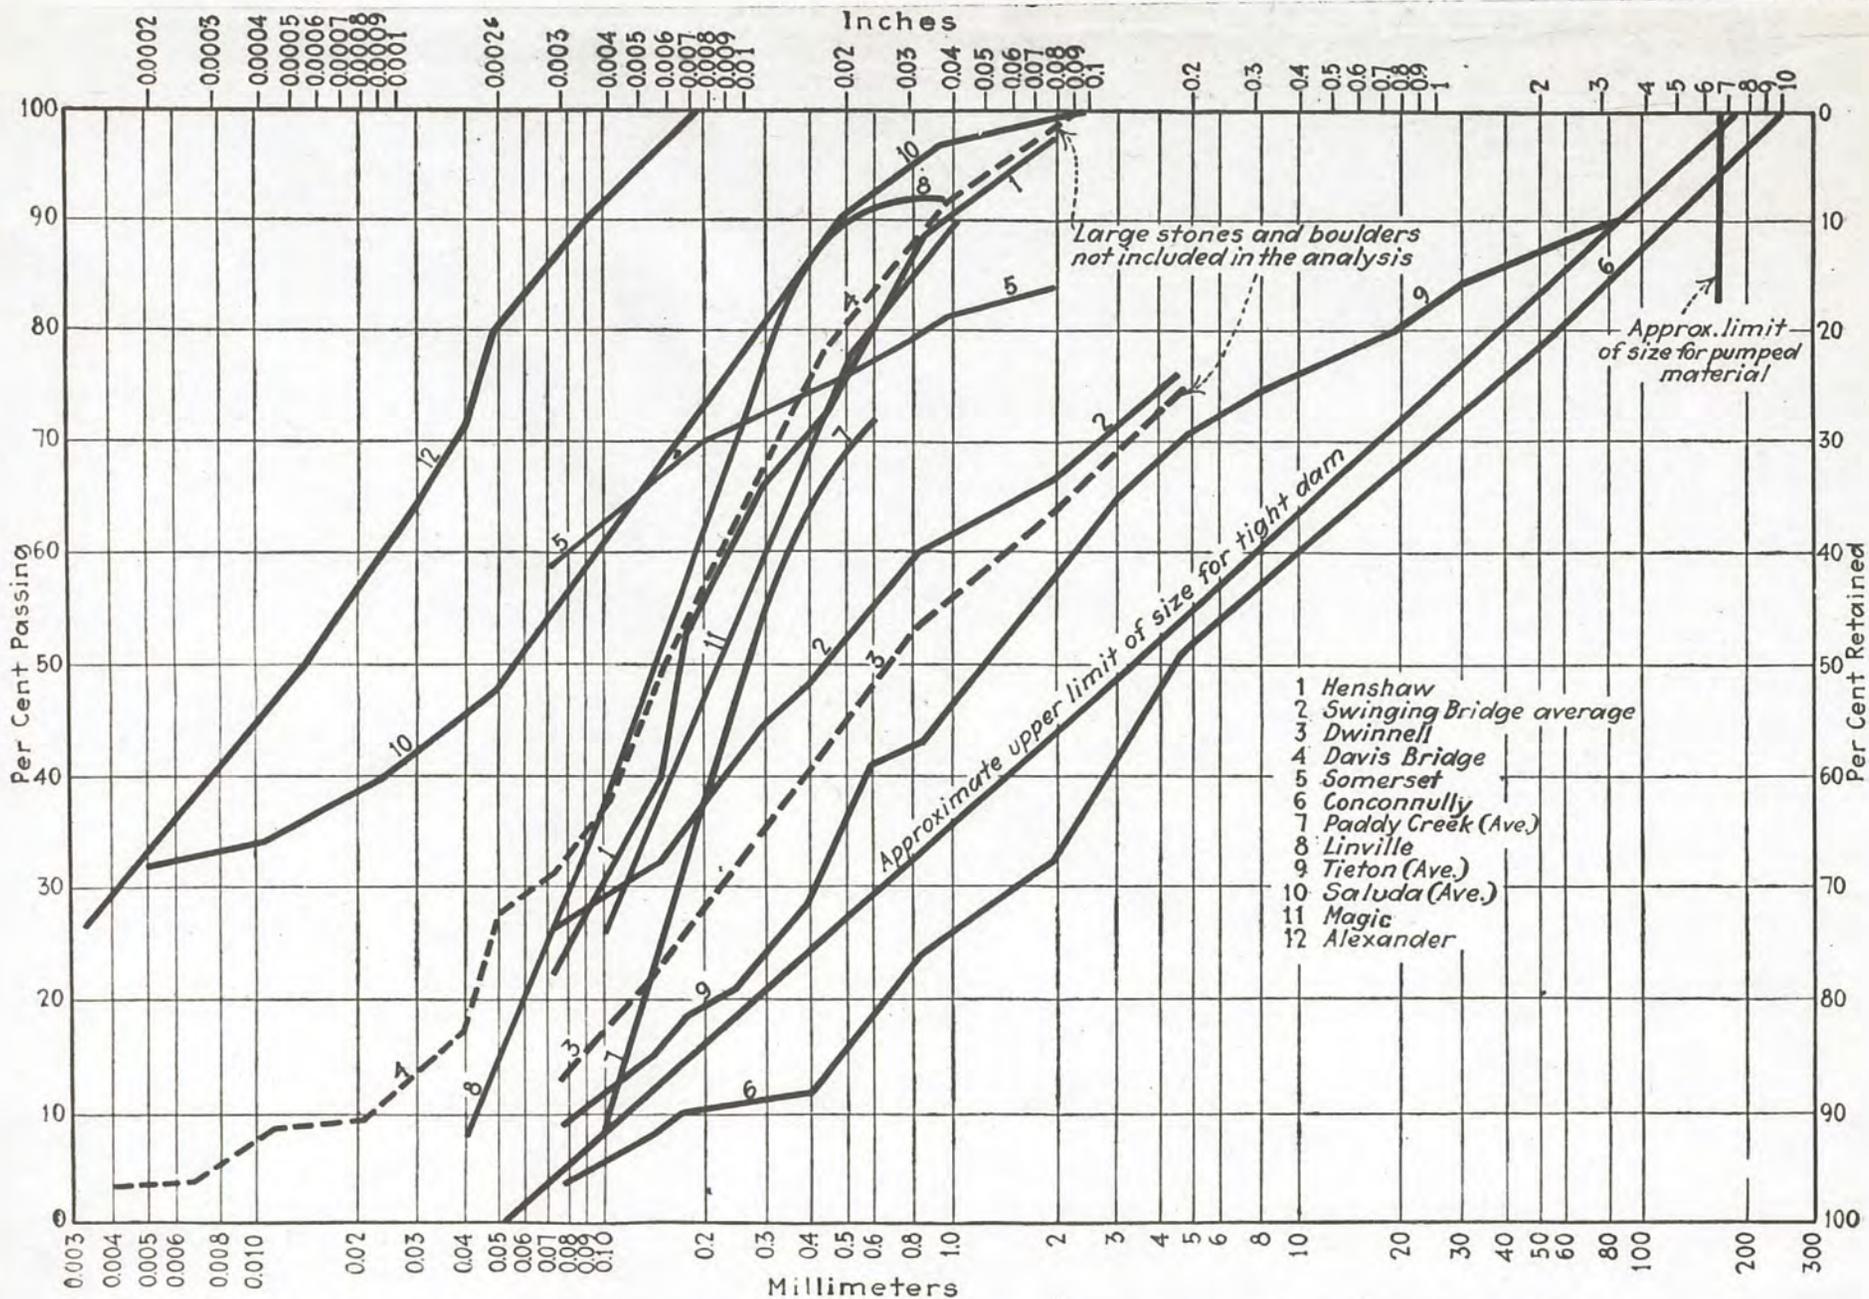
Upper size limit is between the material used in the Tieton Dam and that of the Conconnully Dam.

FIG. 2. BORROW PIT MATERIALS OF HYDRAULIC PILE DAMS

The analyses of borrow pit material for hydraulic fill dams is shown on Figure 2, and additional data and the sources of information regarding them is given on Table 2. The diagram shows that a wide range of material has been successfully used for hydraulic and semi-hydraulic fill dam construction. By hydraulic fill dams is meant those in which the earth is both transported to the dam and placed by the agency of water, while in semi-hydraulic fills the material is hauled by mechanical means and placed hydraulically. The data available is not sufficient to show that any difference exists in the requirements of material suitable for these two types of construction, and they have therefore been plotted on one diagram. Certain differences do exist, however. The maximum size of particle which can be handled by the hydraulic method, where the material passes through pumps, is limited by the size of the pump openings. On the Miami Conservancy Project, stones over $6\frac{1}{2}$ " diameter were screened out. Larger material is frequently used in semi-hydraulic fills. If there is a deficiency of fine material, it seems probable that a greater proportion of the fines coming from the borrow pit could be placed in the core by the hydraulic method than can be washed out of the material after it is dumped on the dam from cars in the semi-hydraulic process, since in the hydraulic process after the material passes through the flumes or pipes the fines are in suspension and do not deposit readily except in the core pool.

In the case of the Swinging Bridge and Henshaw dams (Nos. 2 and 1) those in charge of construction believed the borrow pits to contain too much fine material, and some was wasted. At the Taylorsville Dam (not shown on Figure 2) 60% of the material was retained on a 100-mesh sieve, and considerable of the finer material was wasted. On the other hand, at the Somerset Dam, the borrow pit material of which was much finer than any of those just named, an effort was made to retain all of the fines, alum being used to settle out the very fine particles. The experience with this dam* indicates

The fineness of the material allowable is influenced somewhat by the rate which it is expected to build the dam, the decision to waste fine material in the case of the Henshaw Dam being influenced by the fact that it was expected to build the dam very rapidly. To indicate roughly the maximum size of material which will make a tight dam, a line has been drawn on Figure 2, labeled "Approximate upper limit of size for tight dam." This line is somewhat arbitrarily drawn, having an effective size of 0.12 mm. and a uniformity coefficient of 60. This places it finer than the Conconnuly Dam, which permits considerable seepage, although not enough to in any way endanger the structure. This dam was built in 1910, when the construction of hydraulic fill dams was not as well understood as now. The fine material was only sufficient to form a core which is thin as compared with dams more recently constructed. The Tieton Dam contains a concrete core wall, and the fact that it is practically watertight does not prove that the puddle core itself is sufficient. The Dwinnell Dam (No. 3) was also constructed of coarse material. Before construction, it was expected that the volume of fine material would be insufficient, but this was not found to be the case. It is probable, therefore, that the material of this dam represents about the upper limit of

suitable material for a hydraulic fill dam. The analysis shown by line No. 3 does not include the large stones and boulder, and if these were included the proportion of these larger particles, judging from a photograph of a dam, would be sufficient to cause the line to fall fairly close to the limit set. It is probable that with more uniform material; i. e., a lower uniformity coefficient, a somewhat larger effective size would be allowable than shown by the limiting line on Figure 2, since this condition would give a greater proportion of fine material, and therefore a greater thickness of core. However, the data at hand is not sufficient to establish this hypothesis. As remarked in the discussion of rolled fill dams, this line should not be regarded as a definite limit, but as an approximate relation applying to dams of ordinary cross section.

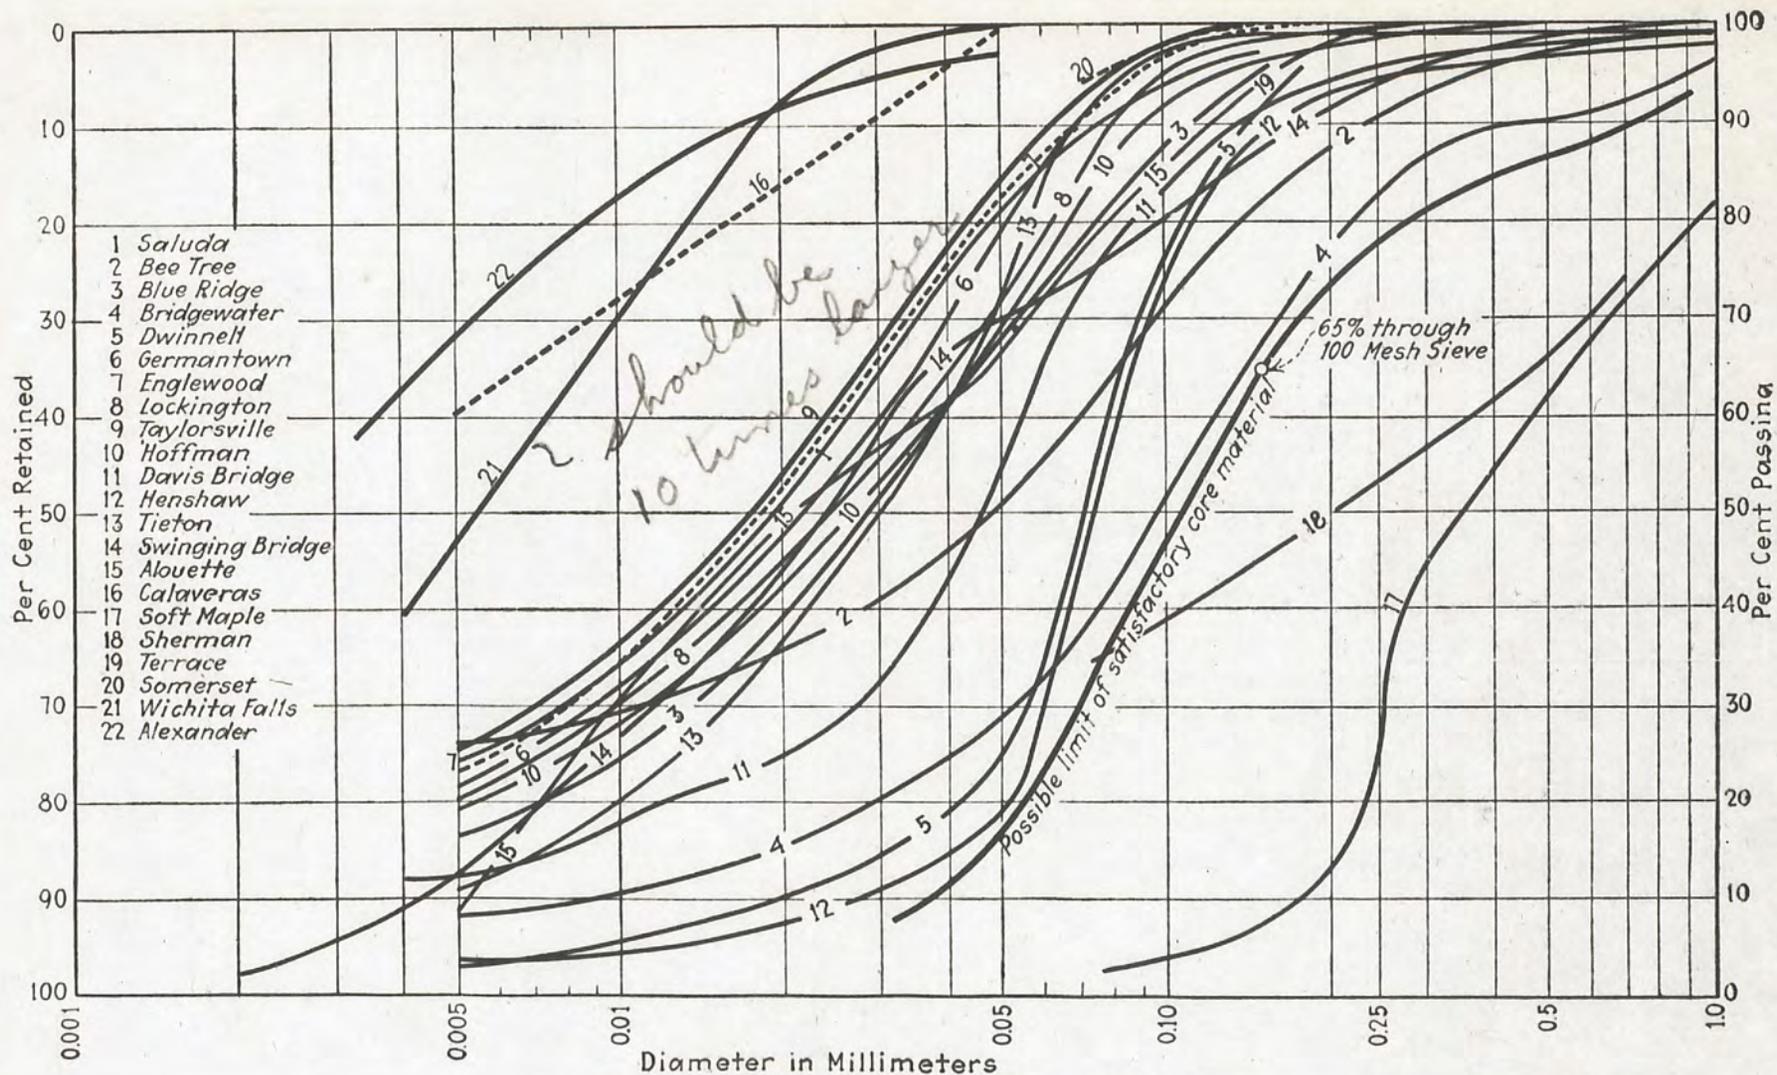
FIG. 3—ANALYSES OF CORE MATERIALS

Upper size limit is close to that of material of Bridgewater Dam.

Considerable data was secured on the composition of the core material of hydraulic fill and semi-hydraulic fill dams. On Figure 3 the analyses are shown graphically. The materials of successful dams vary over a wide range, the finest showing 50% coarser than 0.024 mm. and the coarsest 50% larger than 0.35, or a ratio of size of 1:14.6. The material forming the core of the Calavaras Dam (No. 16), which sloughed during construction due to the failure of the central core to consolidate with sufficient rapidity, is shown to be much finer than any of the others. The Calavaras Dam was built prior to the construction of most of the other dams shown, and its failure, together with that of the Nexcaxa Dam, caused the constructors of a number of dams to waste some of the fine material from their cores. This is particularly true of the Taylorsville Dam (No. 9), which, next to the Calavaras, had the finest core, even with much of the very fine material removed. Fines were also intentionally wasted at the Swinging Bridge Dam (No. 14) and the Hanshaw Dam (No. 12). In the latter case the core material is quite coarse, but this was believed to be necessary to secure consolidation of the core at a sufficient rate to permit a rapid construction of the dam. As previously stated, however, all fine material possible was retained at the Somersed Dam (No. 20) with apparently no bad effects.

It is not possible to determine with exactness the lower limit of size for safe core material. The line on Figure 3 labeled "Probable Limit of Safe Core Material," is somewhat arbitrarily placed roughly parallel to and indicating particles slightly smaller than those of the Taylorsville Dam core (No. 9). Although a dam might safely be built with finer core material than indicated by the line, especially if the rate of progress was slow, for ordinary progress rates, material finer than the limit indicated would hardly be conservative practice unless tests of the rate of consolidation were especially favorable.
