UNITED STATES  
DEPARTMENT OF THE INTERIOR  
BUREAU OF RECLAMATION

MEMORANDUM TO CHIEF DESIGNING ENGINEER  
(J. E. Warnock and J. W. Ball)

Subject: Limits of Riprap on River Banks below Tailraces of  
Grand Coulee Dam, Columbia Basin Project.

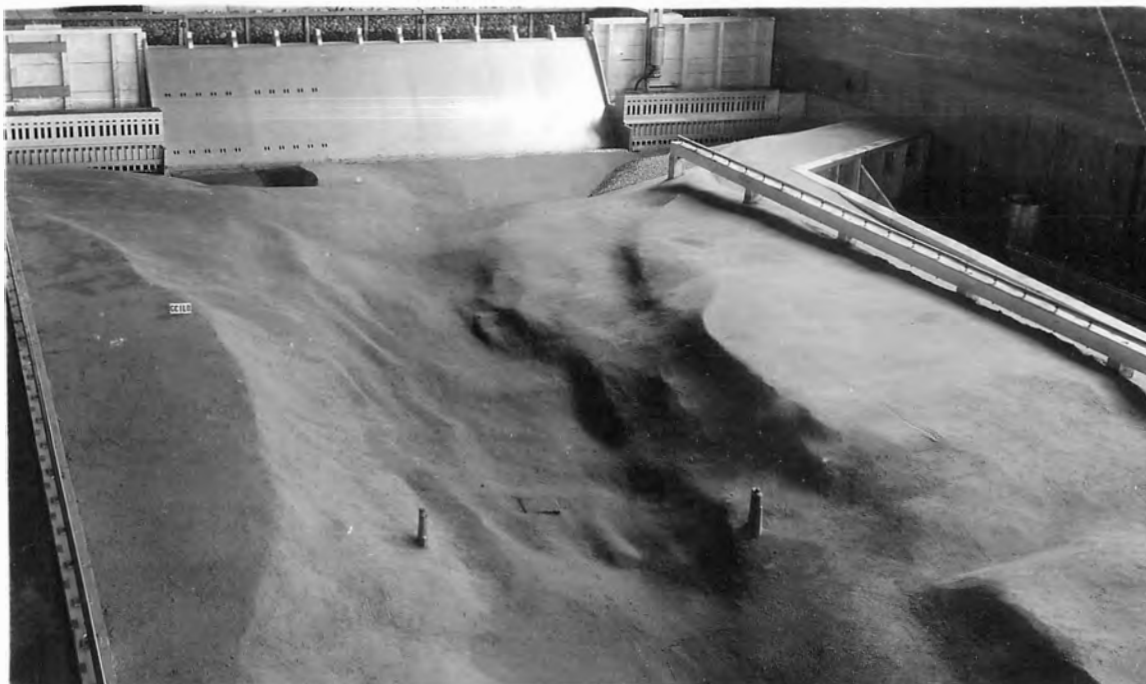
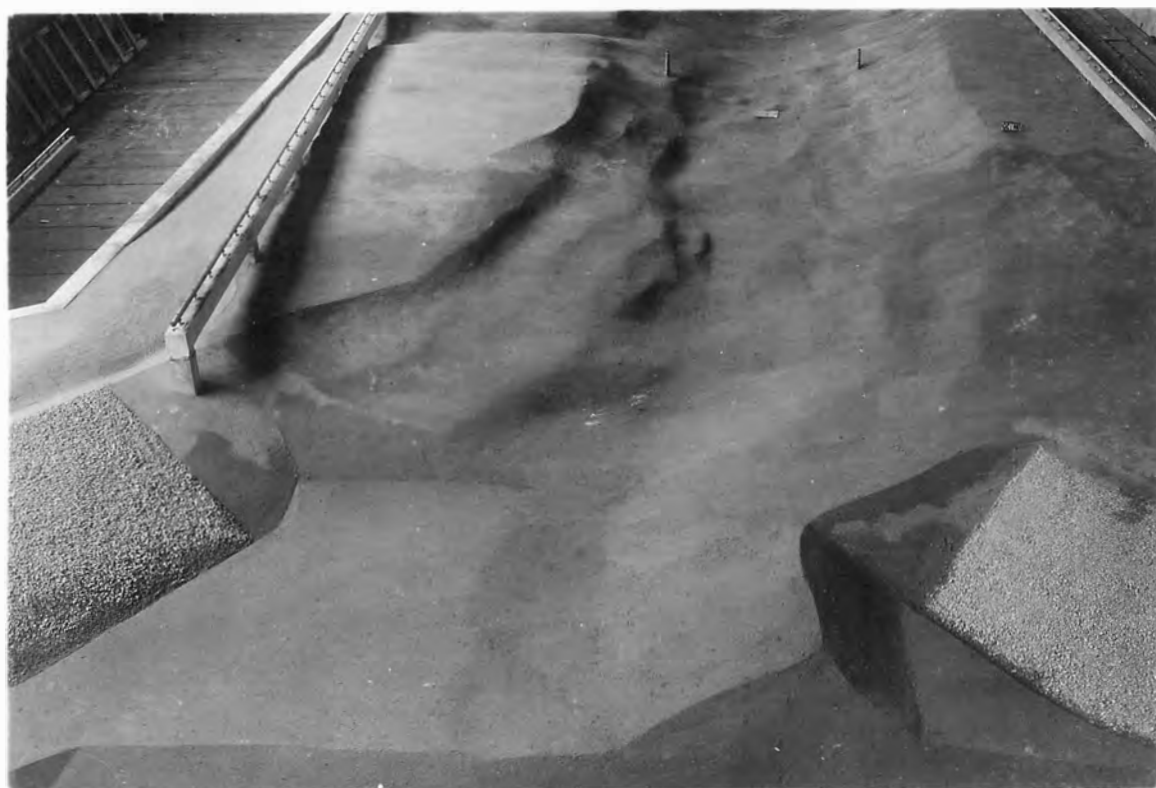
LOOKING UPSTREAM.

LOOKING DOWNSTREAM.

INITIAL RIVER BED FOR TEST 1.

5. Upon the completion of the preliminary tests, the topography of the river bed was restored to its initial shape (plate 1). The tailrace slopes were covered with riprap ten feet thick at the base and three feet thick at the top near the powerhouse roadway. This is according to the original recommendations of the Board. Riprap limits for test 1 are shown on figure 3 (the downstream limit in the west tailrace was that determined by tests on the 1:120 Grand Coulee diversion model). The tailwater-discharge relationship was maintained during any increase or decrease in discharge. The gates were operated to maintain an approximate reservoir elevation of 1288. The tailwater elevation, observed immediately upstream from the highway bridge, was regulated according

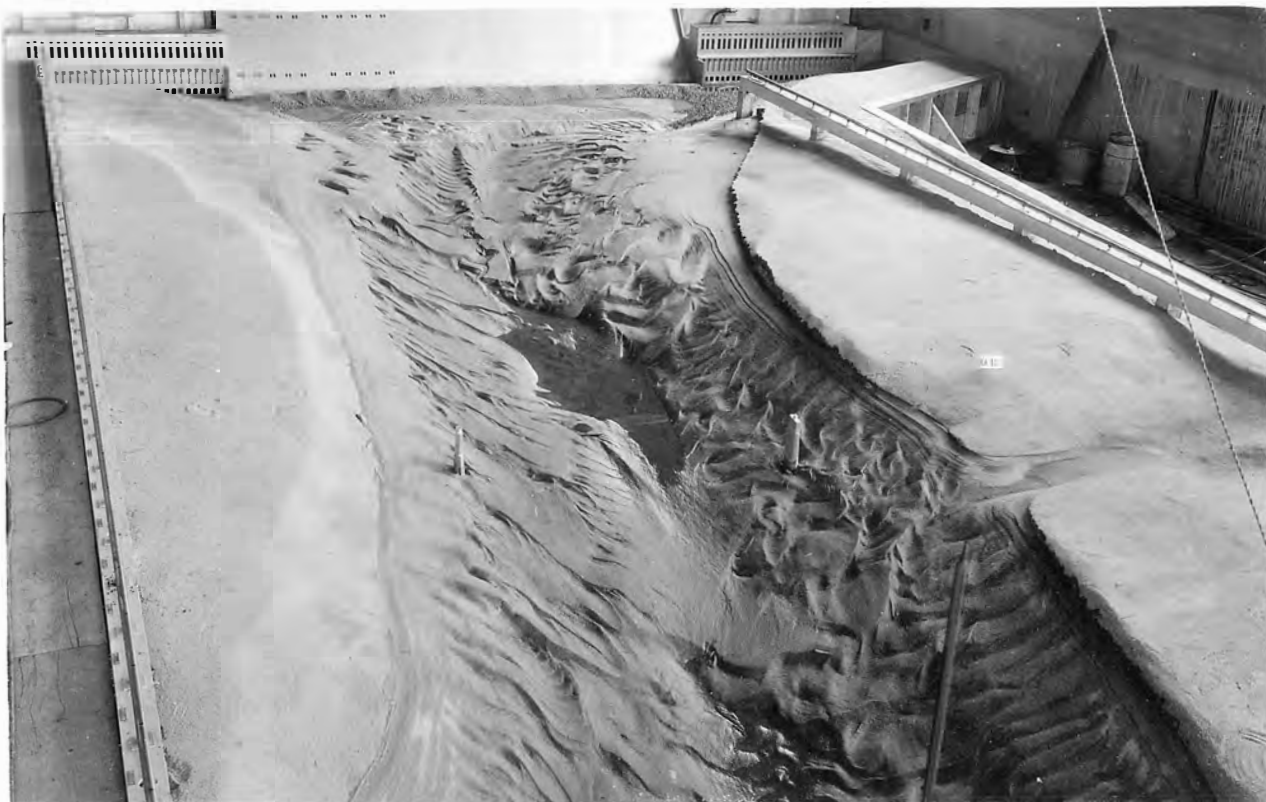
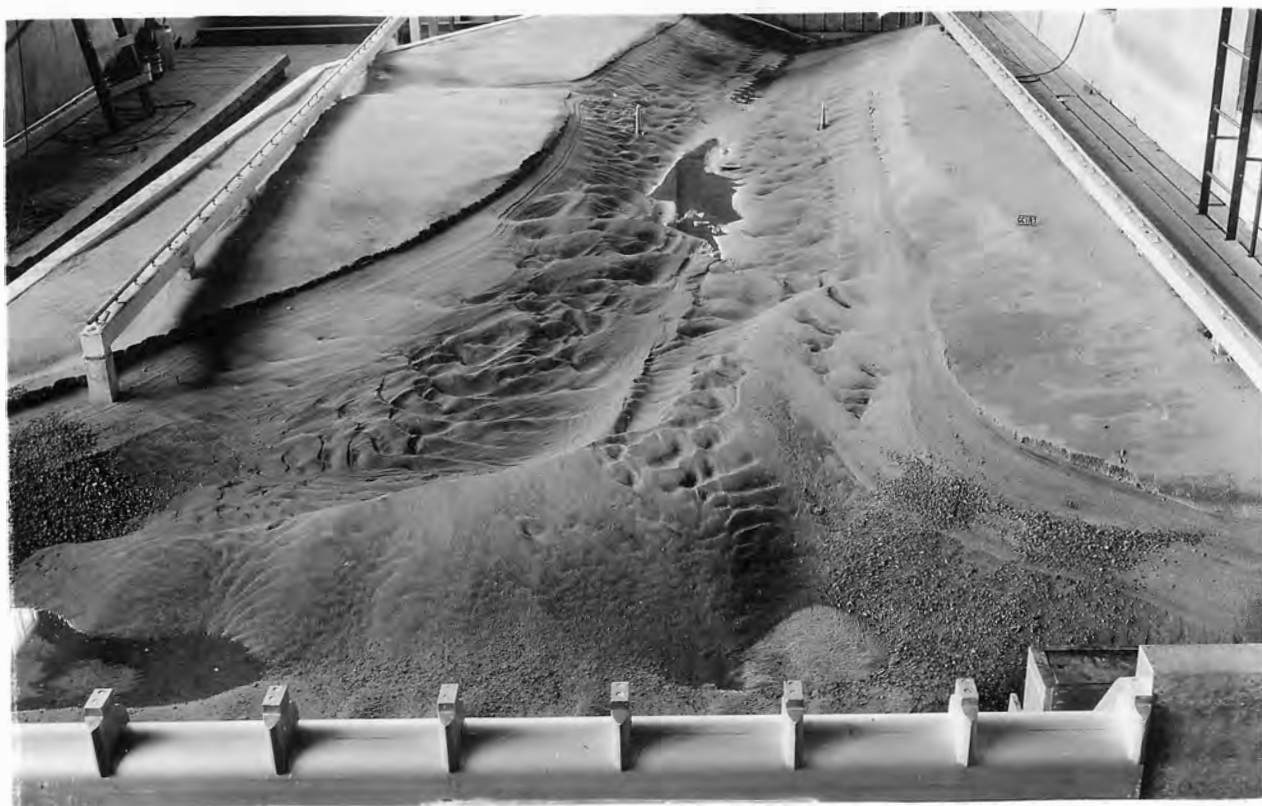
LOOKING UPSTREAM.

LOOKING DOWNSTREAM.

TEST 1

RIVER BED AFTER A FLOW OF 750,000 SECOND-FEET.

(c) Flow - 750,000 second-feet. The wave action became more severe and considerable erosion occurred along the river banks, particularly where they were steep (plate 2). The continuity of the tailrace riprap was broken by the wave action and a return flow along the bank deposited very fine sand on the slopes in front of the powerhouses (plates 4C and 5C). A portion of the riprap at

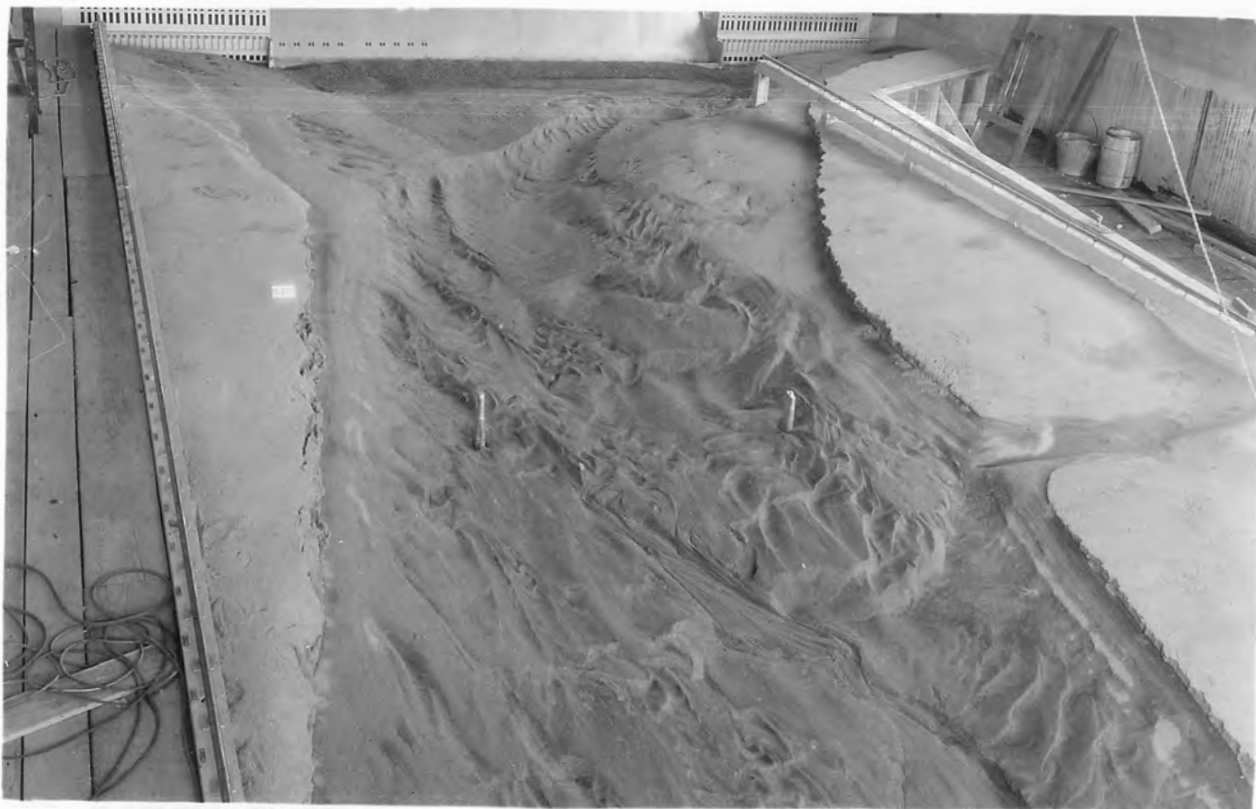
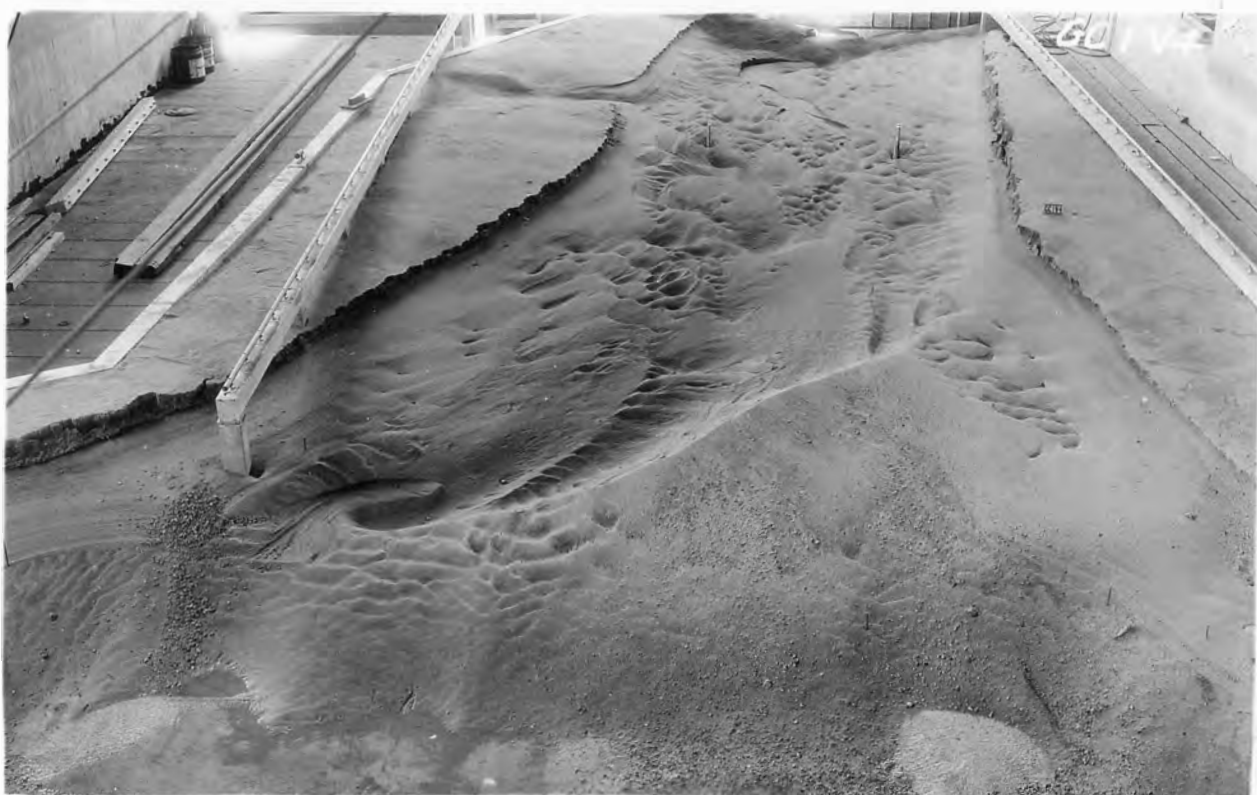
LOOKING UPSTREAM.

LOOKING DOWNSTREAM.

TEST 1

RIVER BED AFTER A FLOW OF 1,000,000 SECOND-FOOT.

(d) Flow - 1,000,000 second-feet. Very severe erosion occurred for this discharge. The run at this discharge was terminated after a seven-hour period, as movement of the bed material, except that caused by wave action (plate 7B) practically ceased. The tailrace slopes were seriously eroded and large piles of sand were deposited in front of the powerhouses, (plates 4D and 5D) but no sand was deposited in the draft tubes. Erosion of river banks near the highway bridge piers was severe but did not expose the tops of the two footings (plate 6D).

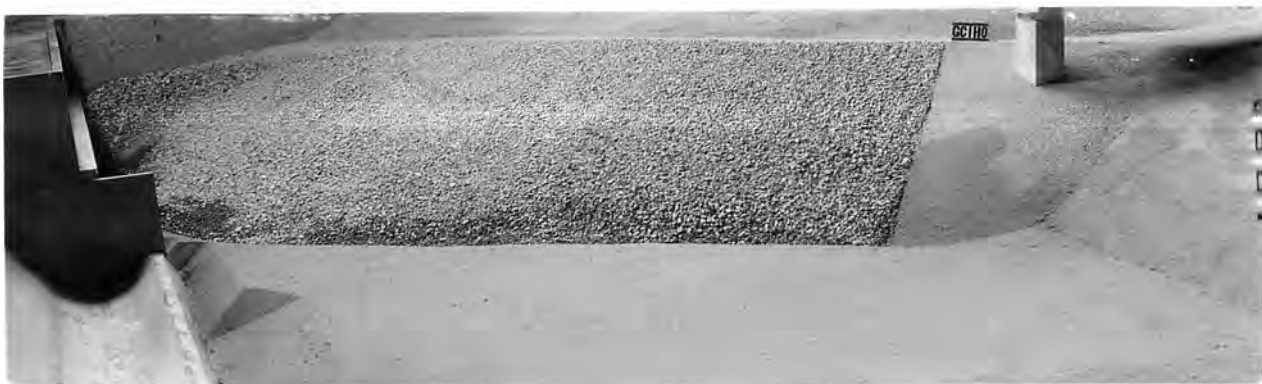
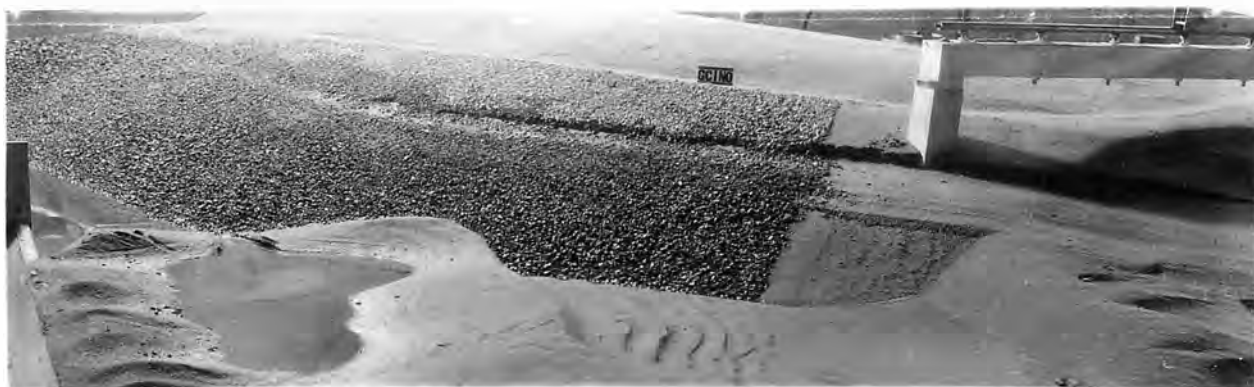
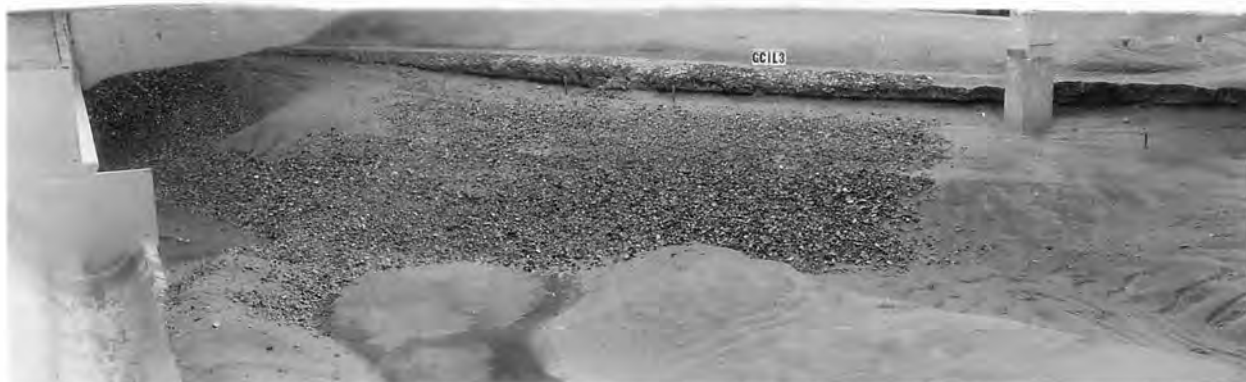
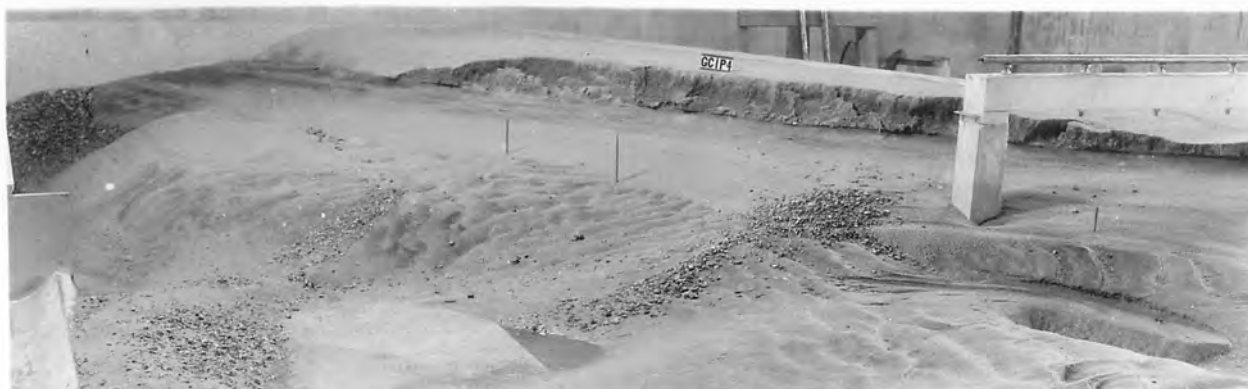
BEFORE TEST.

AFTER DISCHARGE OF 500,000 SECOND-FEET.

AFTER DISCHARGE OF 750,000 SECOND-FEET.

AFTER DISCHARGE OF 1,000,000 SECOND-FEET.

**TEST 1**

EROSION AT LEFT TAILRACE.

(b) Flow - 500,000 second feet. After a run of three hours the erosion increased downstream from the bucket. The wave action attacked the river banks but soon reached a stage of stability, ceasing to do further damage. The tailrace riprap was disturbed but was not carried away (plates 4B and 5B) and slight erosion occurred at the bridge piers (plate 6B).

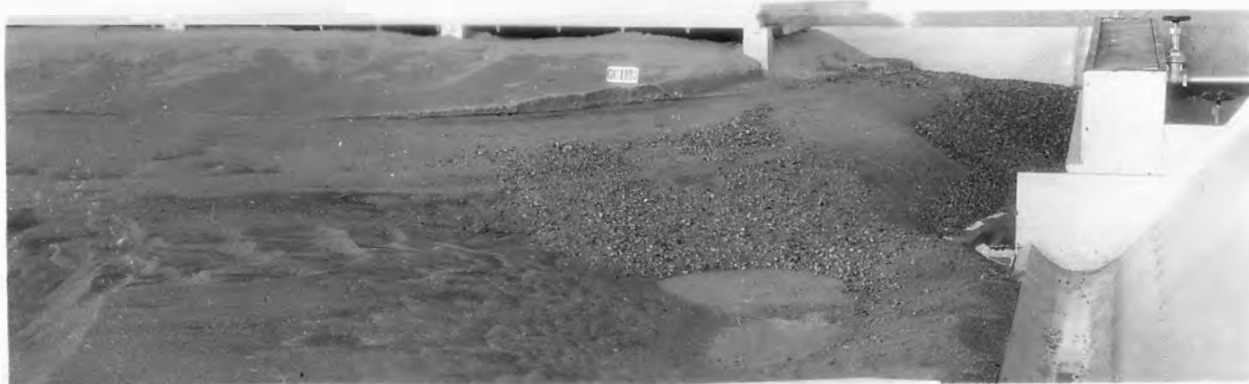
AFTER DISCHARGE OF 750,000 SECOND-FEET.

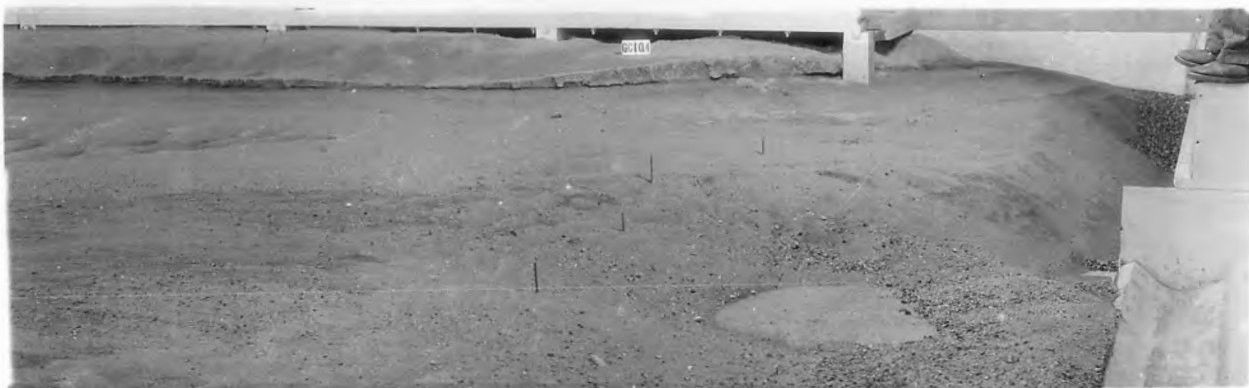
AFTER DISCHARGE OF 1,000,000 SECOND-FEET.

# TEST 1

EROSION AT RIGHT TAILRACE.

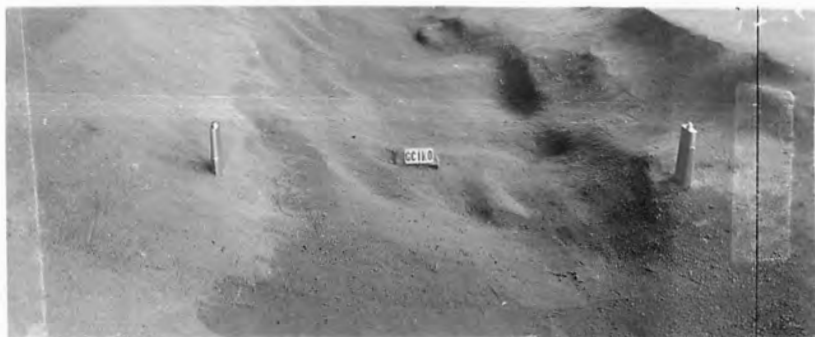
BEFORE TEST.

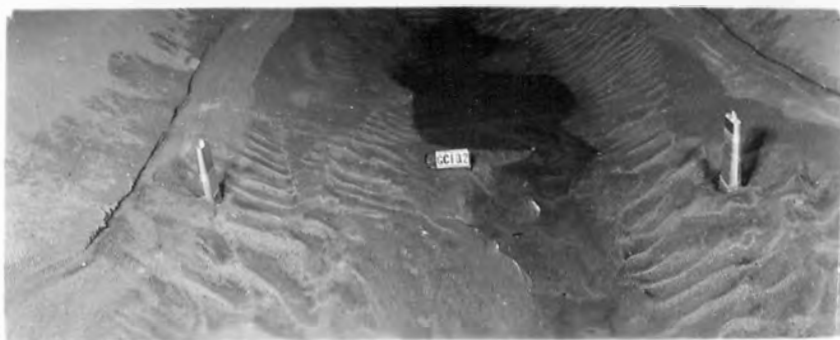
AFTER DISCHARGE OF 500,000 SECOND-FEET.

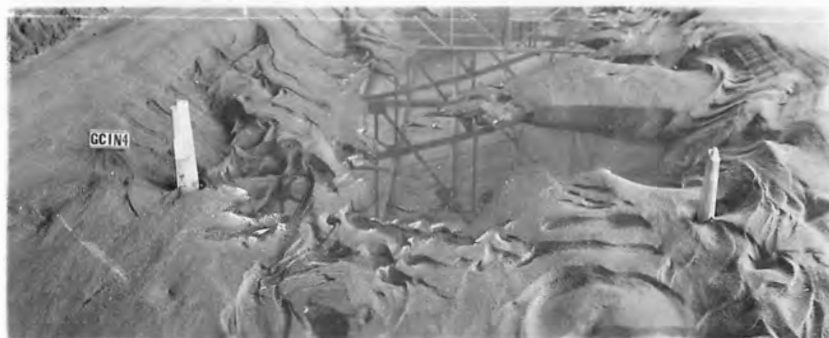
AFTER DISCHARGE OF 1,000,000 SECOND-FEET.

LOOKING UPSTREAM.

# TEST 1

EFFECT OF FLOW ON RIVER BANKS NEAR HIGHWAY BRIDGE PIERS 2

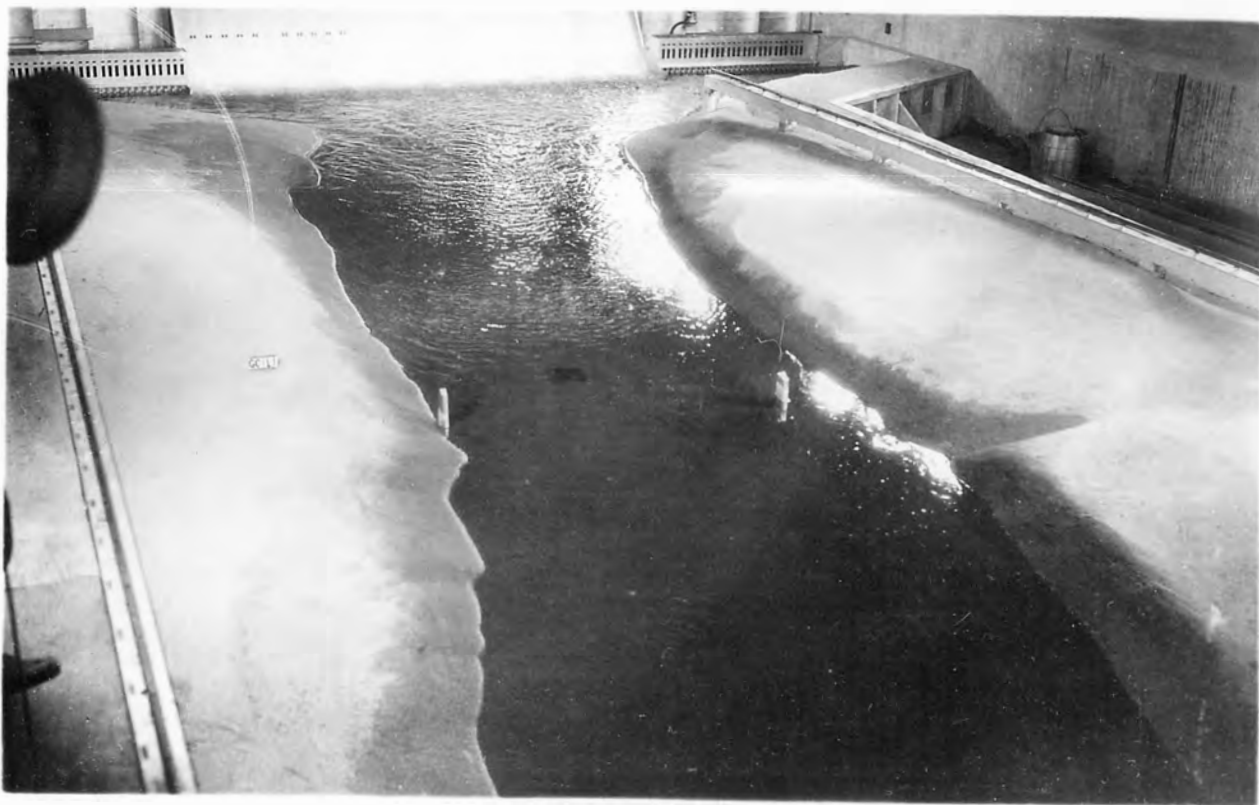
DISCHARGE OF 250,000 SECOND-FEET.

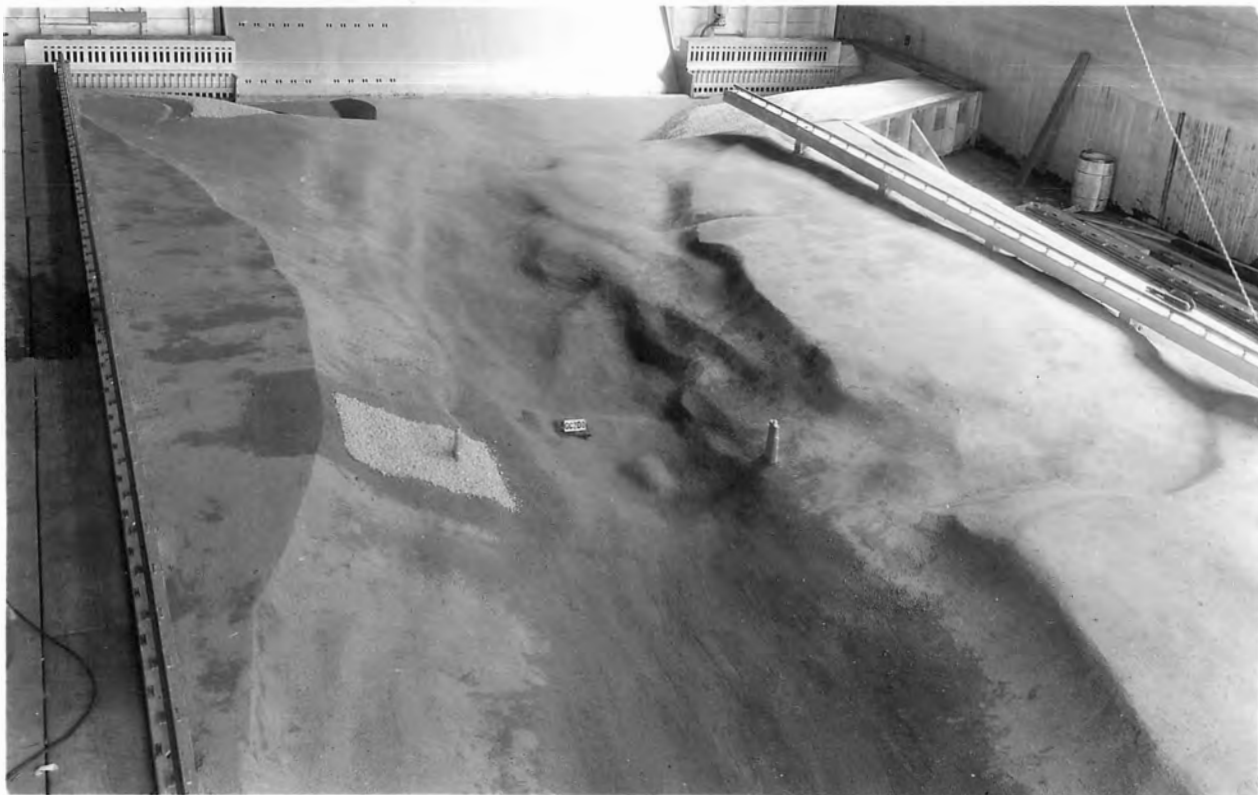
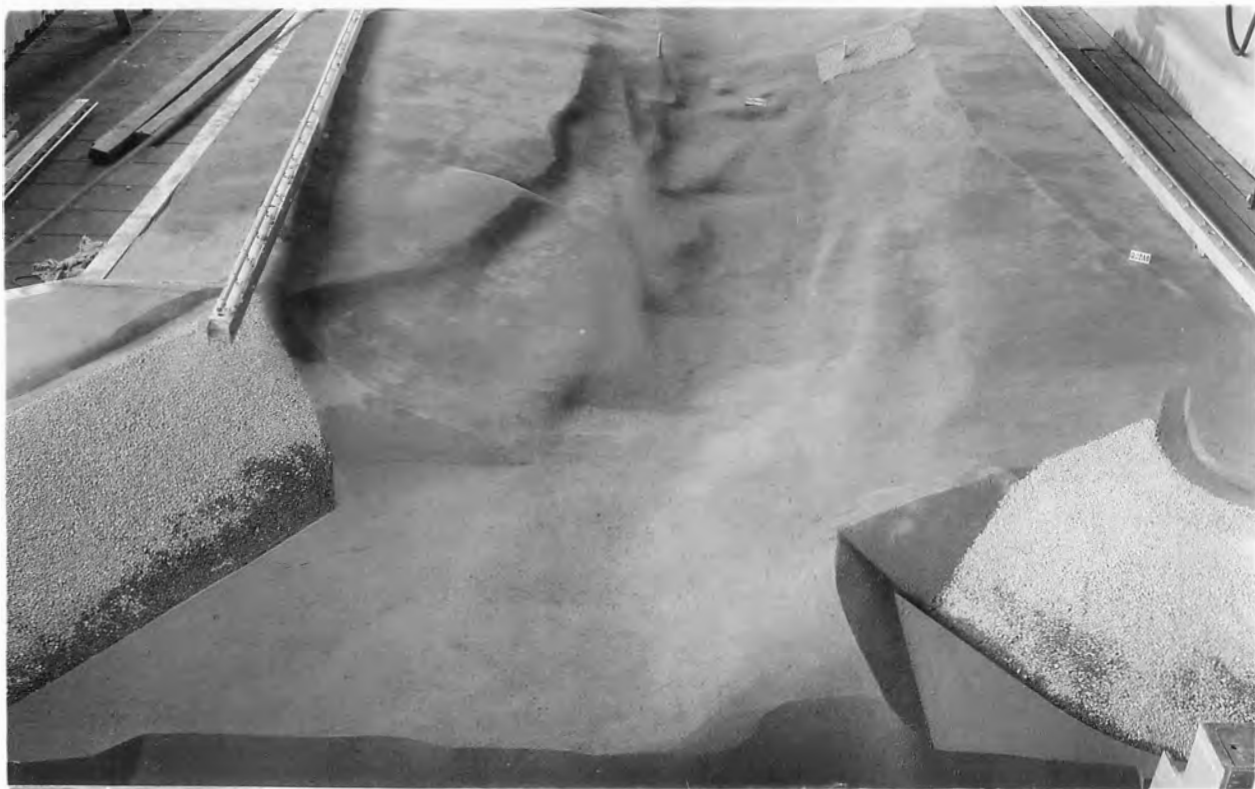
LOOKING UPSTREAM.

LOOKING DOWNSTREAM.

INITIAL RIVER BED FOR TEST 2.

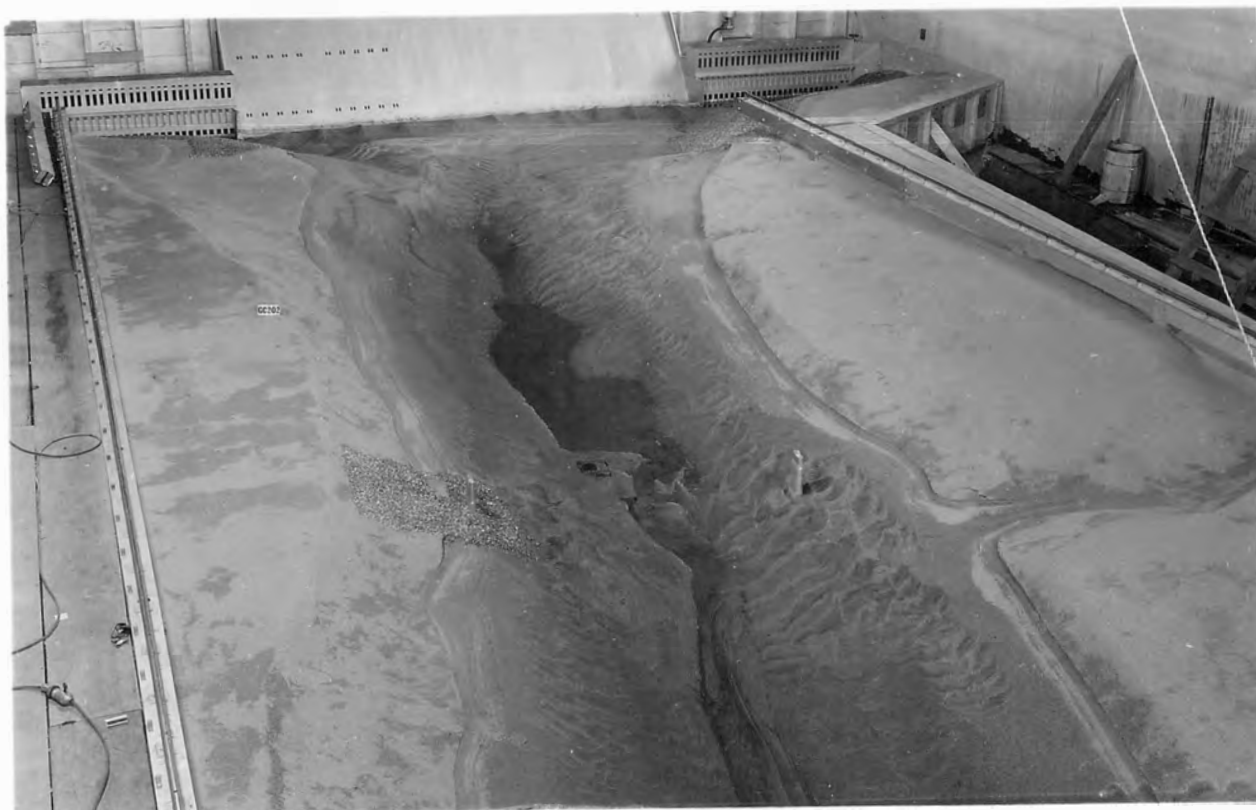
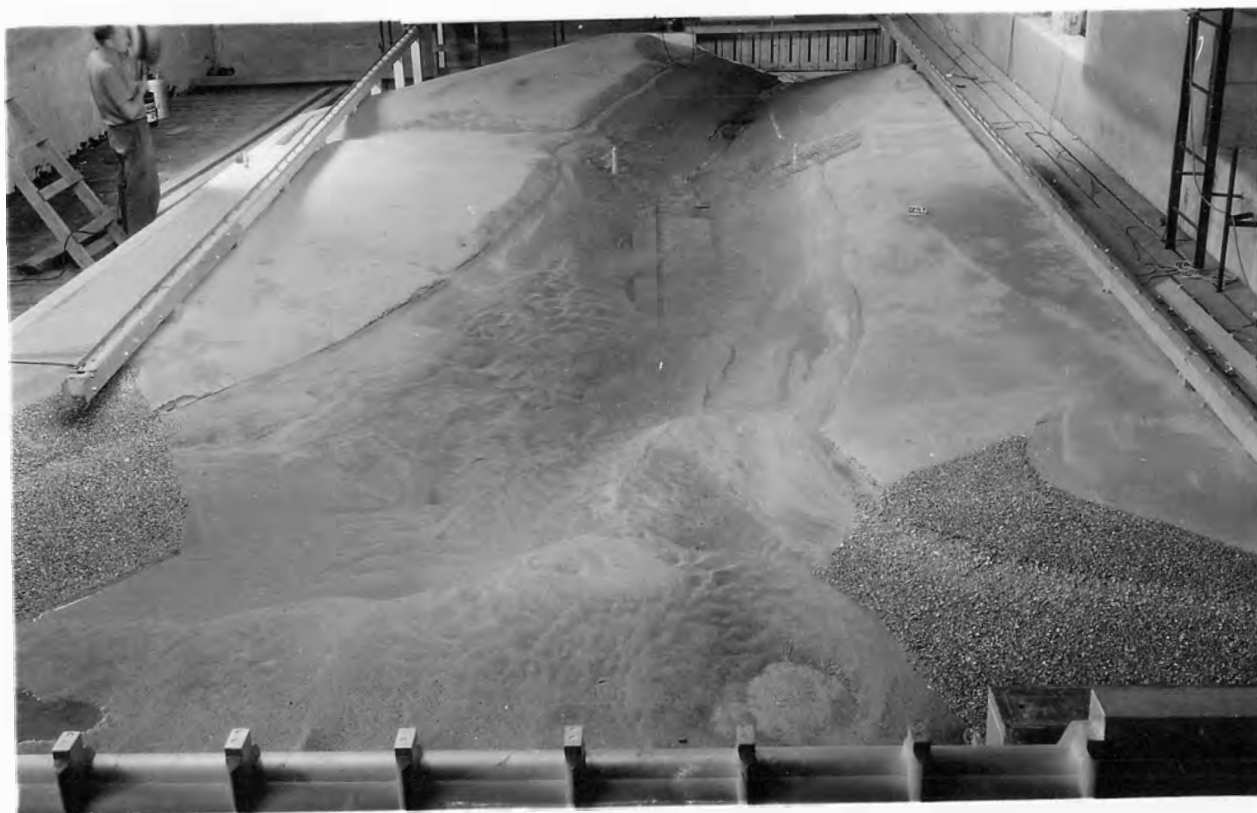
LOOKING UPSTREAM.

LOOKING DOWNSTREAM.

TEST 2

RIVER BED AFTER A FLOW OF 500,000 SECOND-FEET.

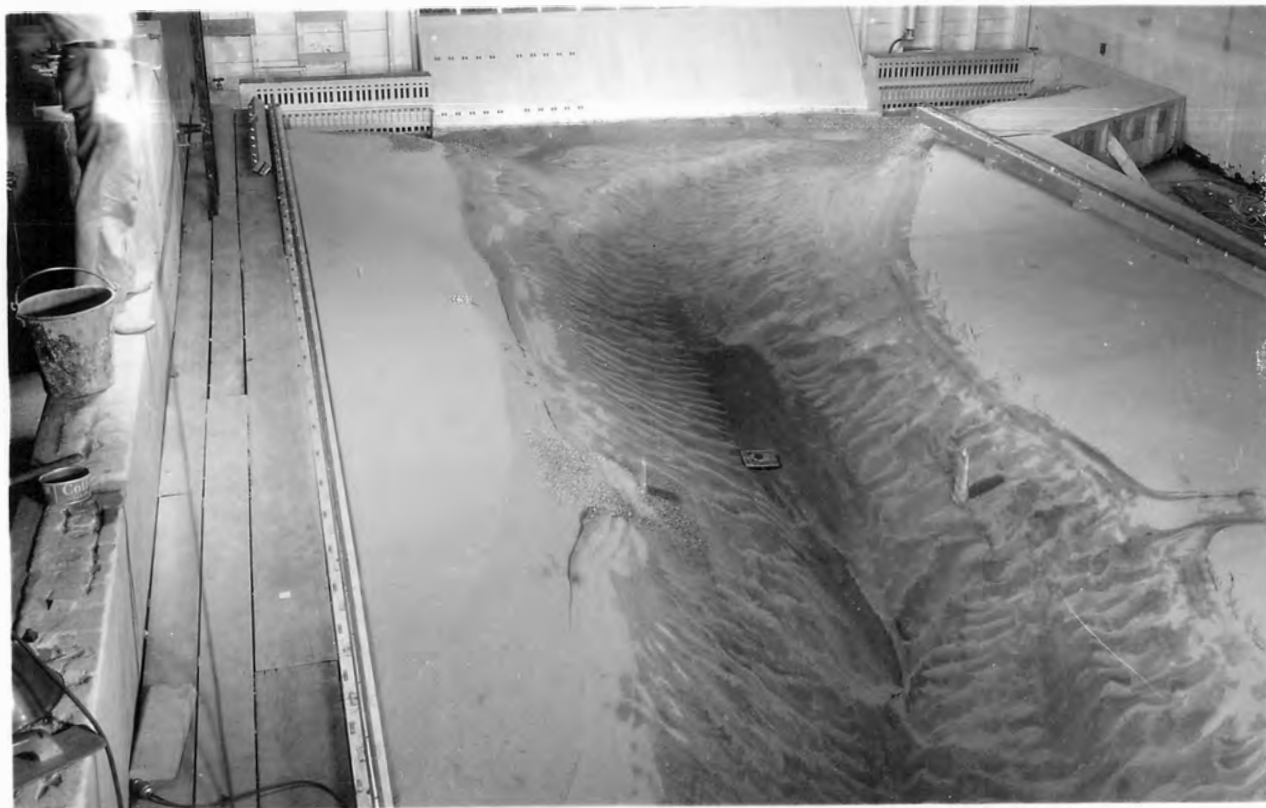
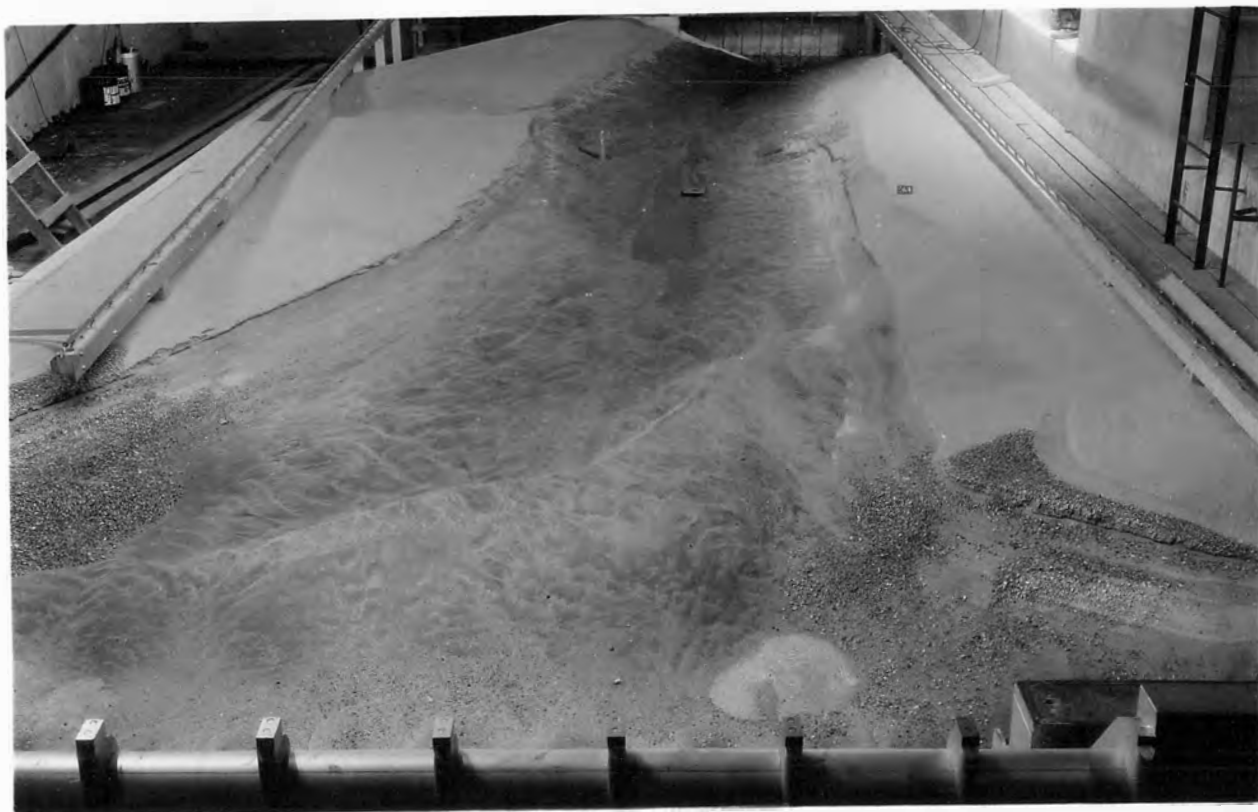
LOOKING UPSTREAM.

LOOKING DOWNSTREAM.

TEST 2

RIVER BED AFTER A FLOW OF 750,000 SECOND-FEET.

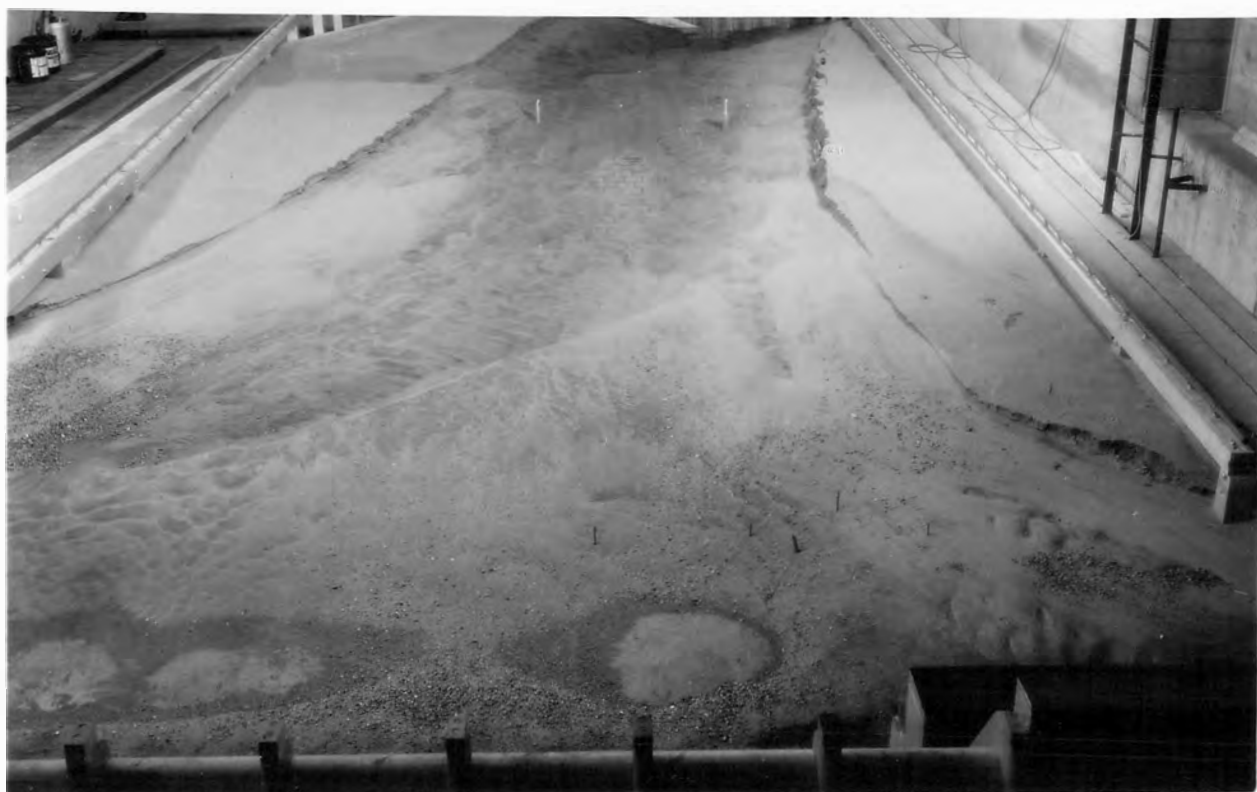
LOOKING UPSTREAM.

LOOKING DOWNSTREAM.

TEST 2  
RIVER BED AFTER A FLOW OF 1,000,000 SECOND-FEET.

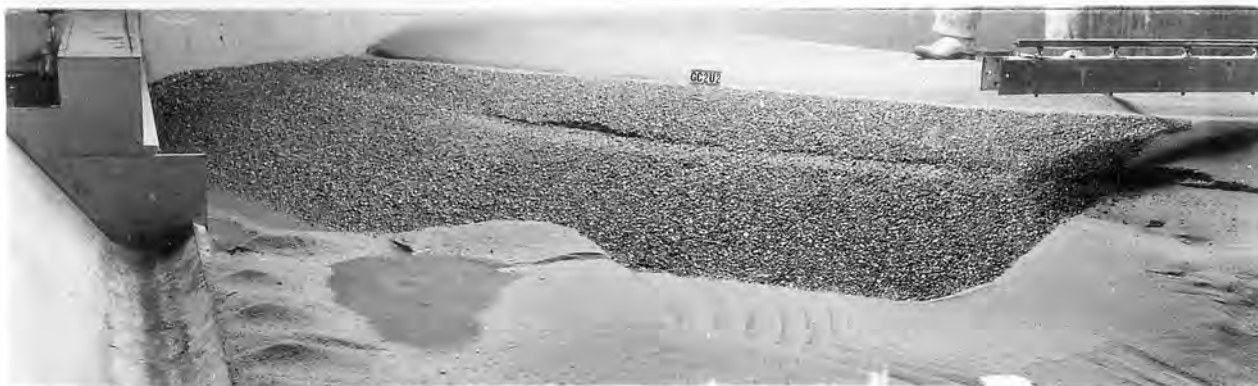
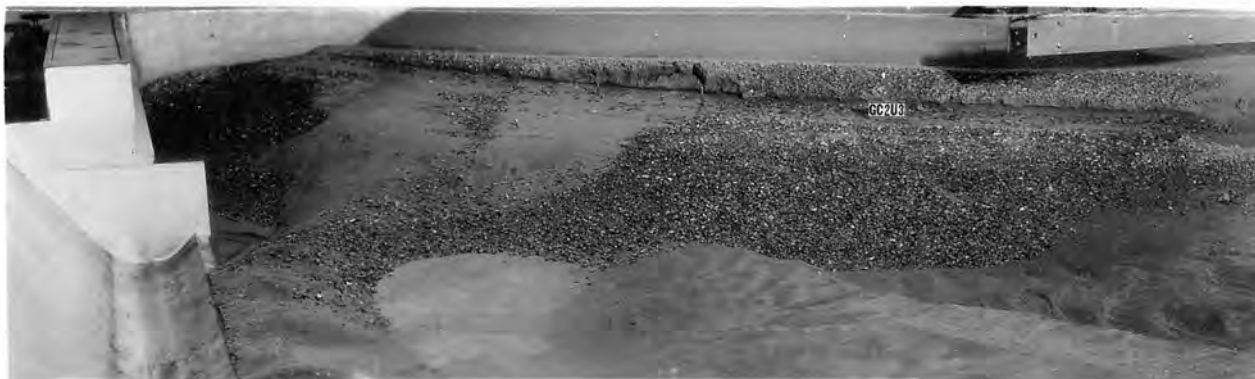
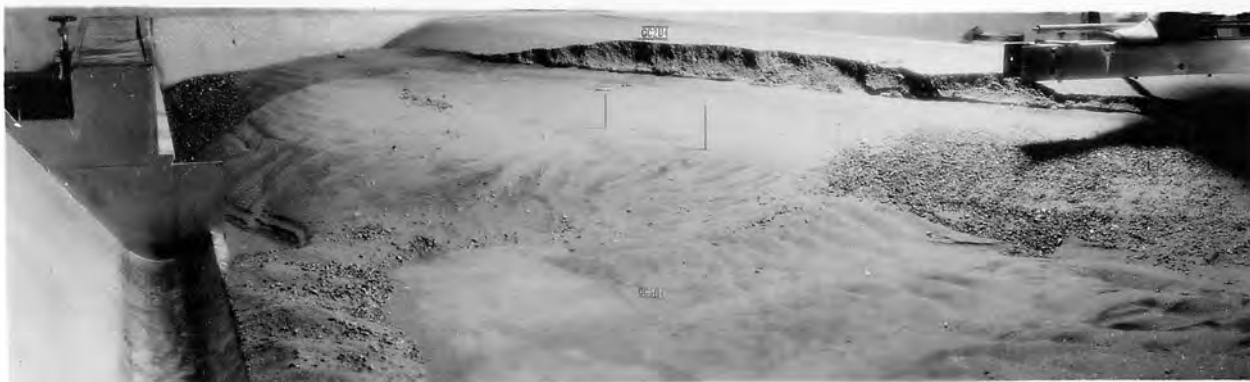
BEFORE TEST

AFTER A DISCHARGE OF 500,000 SECOND-FEET.

AFTER DISCHARGE OF 750,000 SECOND-FEET.

AFTER A DISCHARGE OF 1,000,000 SECOND-FEET.

## TEST 2

EROSION AT LEFT TAILRACE.

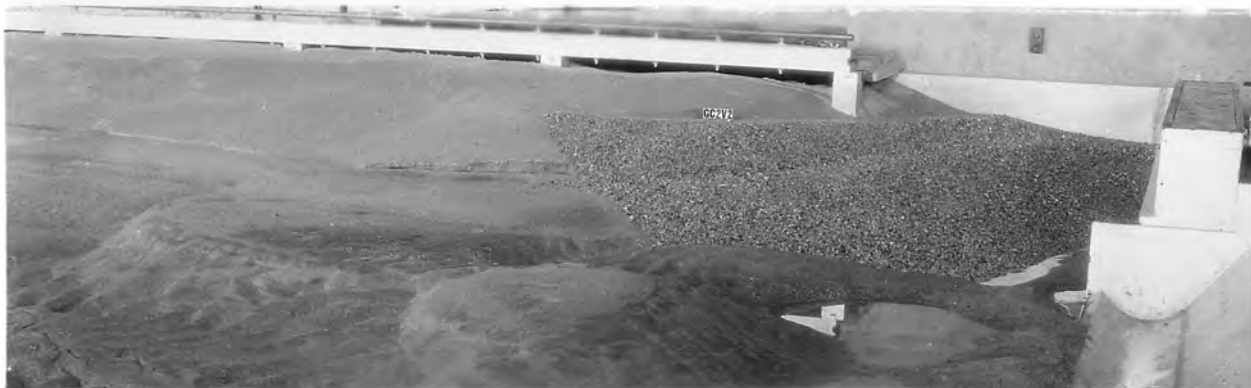
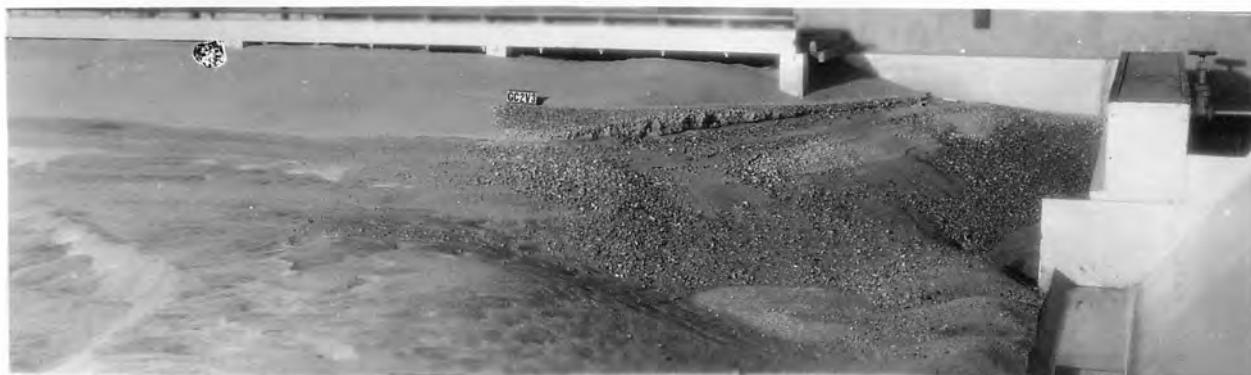
BEFORE TEST.

AFTER DISCHARGE OF 500,000 SECOND-FEET.

AFTER DISCHARGE OF 750,000 SECOND-FEET.

AFTER DISCHARGE OF 1,000,000 SECOND-FEET.

## TEST 2

EROSION AT RIGHT TAILRACE.

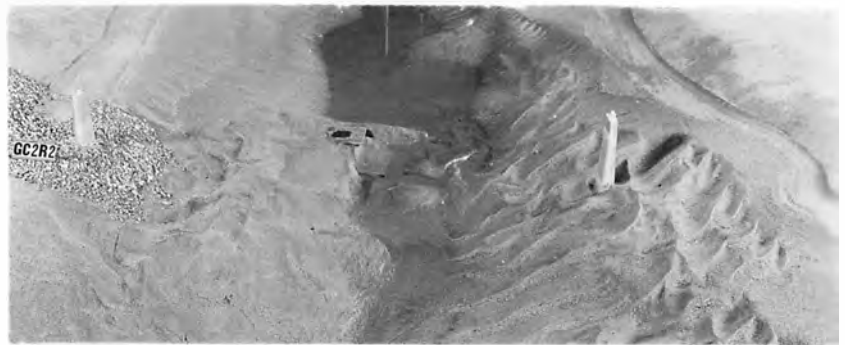
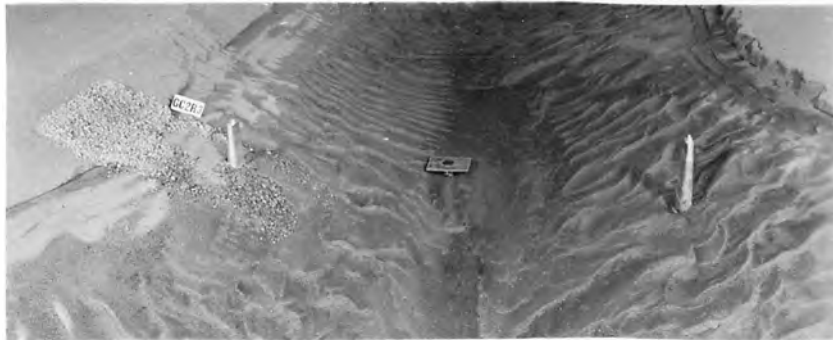
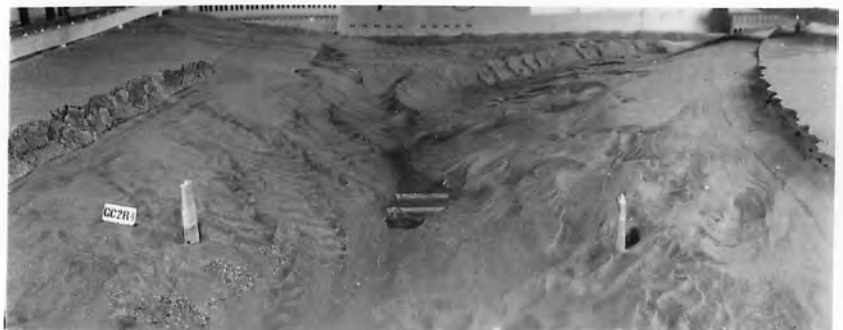
BEFORE TEST.

AFTER DISCHARGE OF 500,000 SECOND-FEET

AFTER A DISCHARGE OF 750,000 SECOND-FEET

AFTER DISCHARGE OF 1,000,000 SECOND-FEET.

LOOKING UPSTREAM

## TEST 2

EFFECT OF FLOW ON RIVER BANKS NEAR HIGHWAY BRIDGE PIERS 2 & 3.

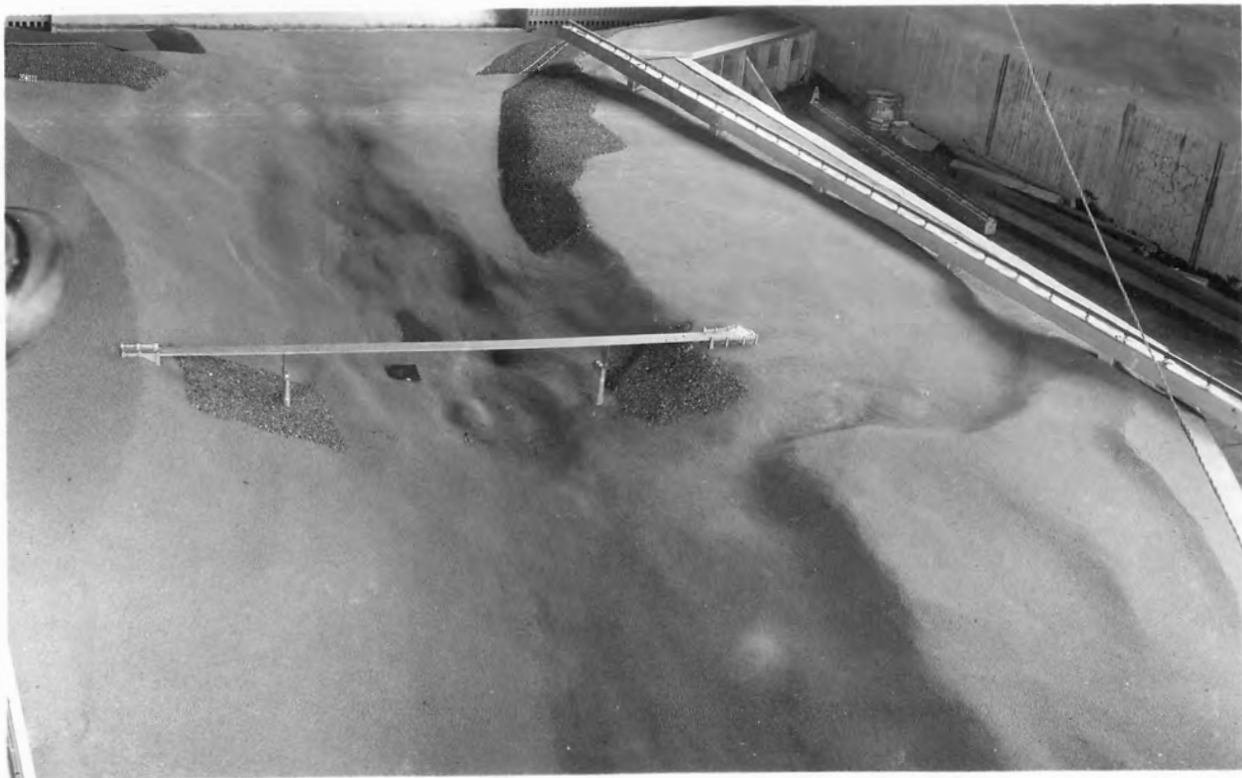
LOOKING UPSTREAM.

LOOKING DOWNSTREAM.

INITIAL RIVER BED FOR TEST 3.
