UNITED STATES  
DEPARTMENT OF THE INTERIOR  
BUREAU OF RECLAMATION

MEMORANDUM TO CHIEF DESIGNING ENGINEER  
(J. E. Warnock and J. W. Ball)

Subject: Limits of Riprap on River Banks below Tailraces of  
Grand Coulee Dam, Columbia Basin Project.

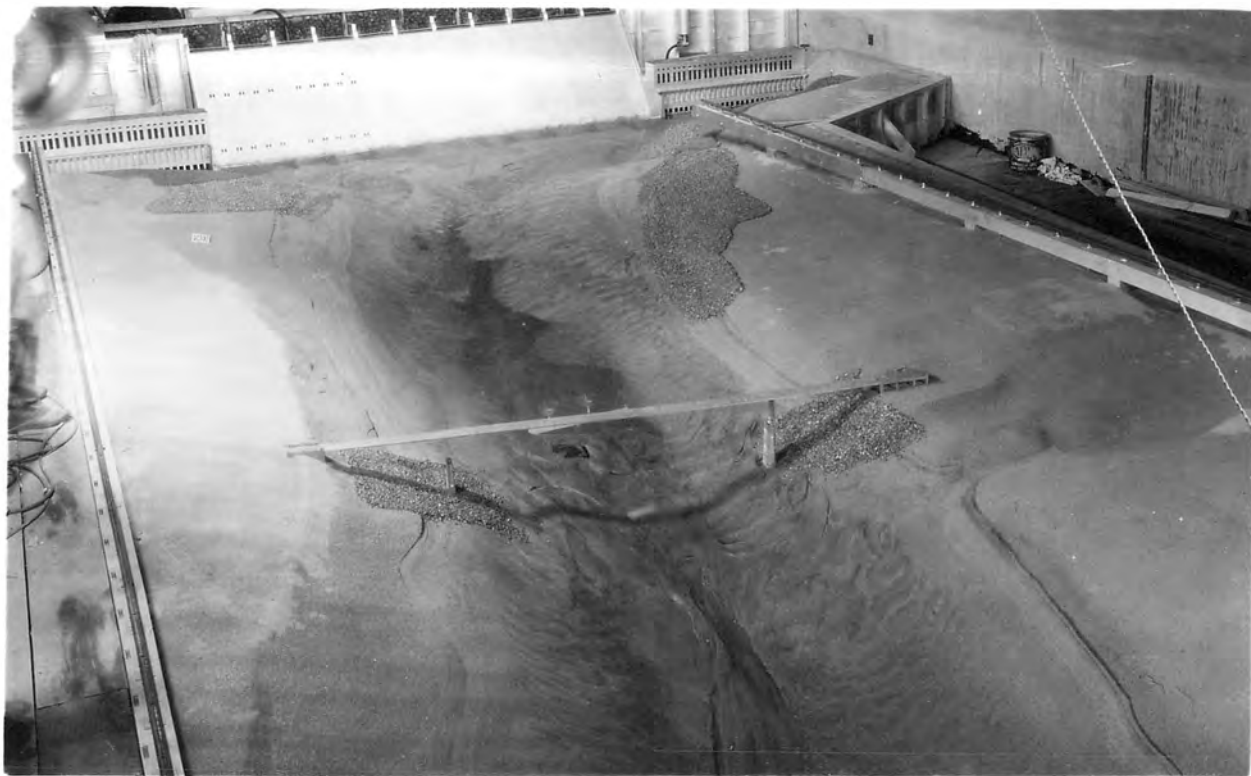
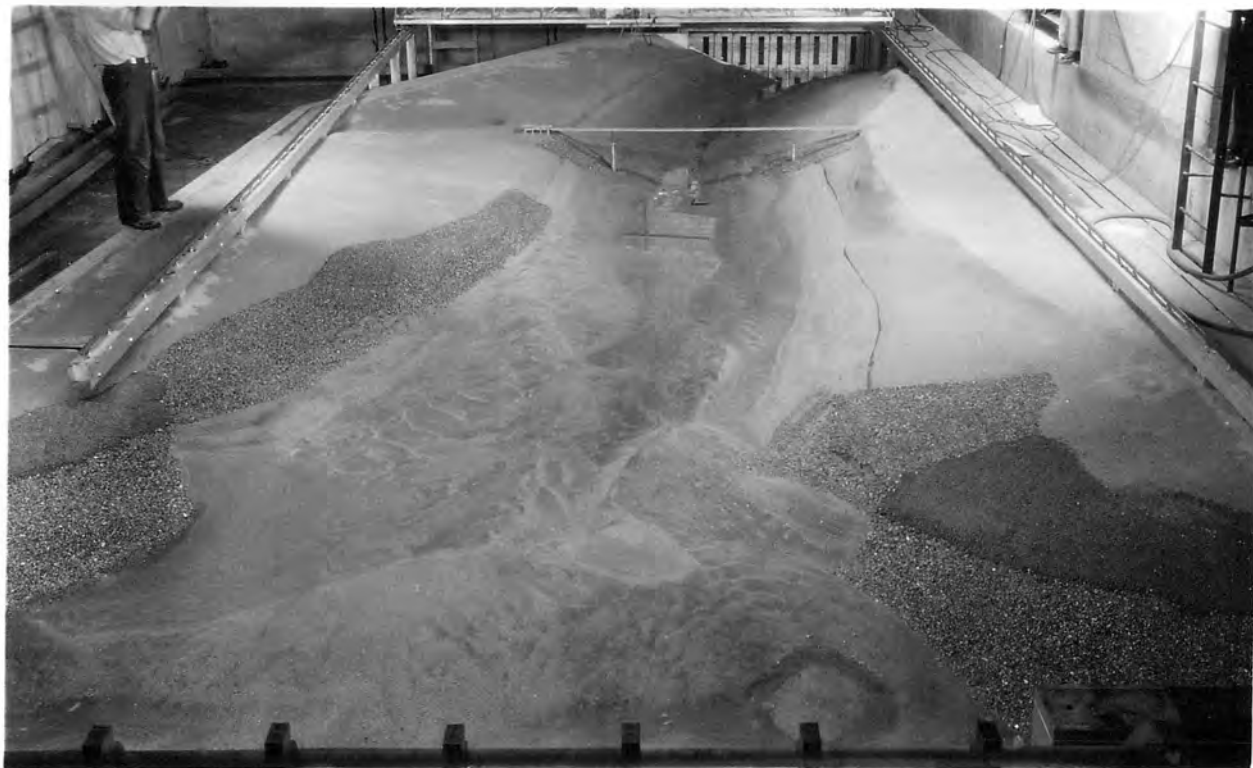
LOOKING UPSTREAM.

LOOKING DOWNSTREAM.

TEST 3 - RIVER BED AFTER A FLOW OF 500,000 SECOND-FEET.

(b) Flow 500,000 second-feet. The erosion immediately downstream from the bucket was increased. Some erosion due to the wave action was noted on both banks and immediately downstream from the sections of bonded riprap (plates 16, 19 B and 20 B). In general the conditions were the same as in tests 1 and 2 (plate 16).

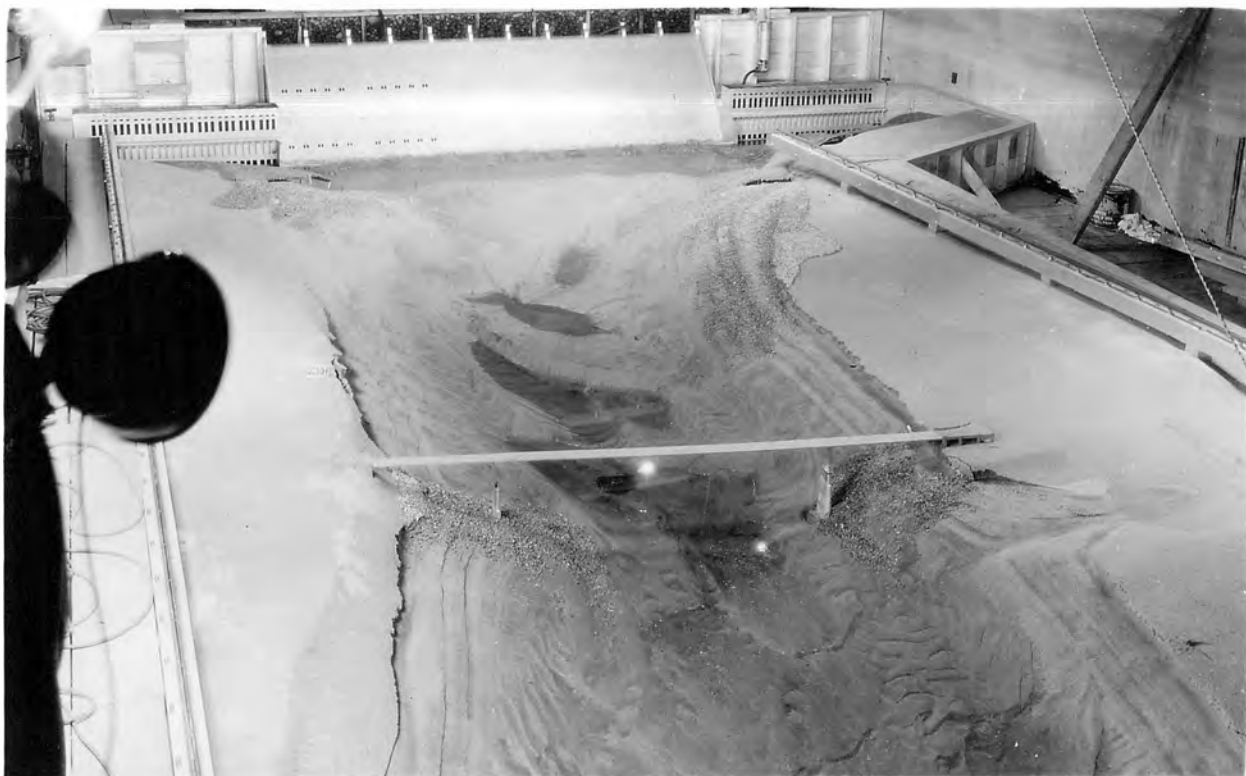
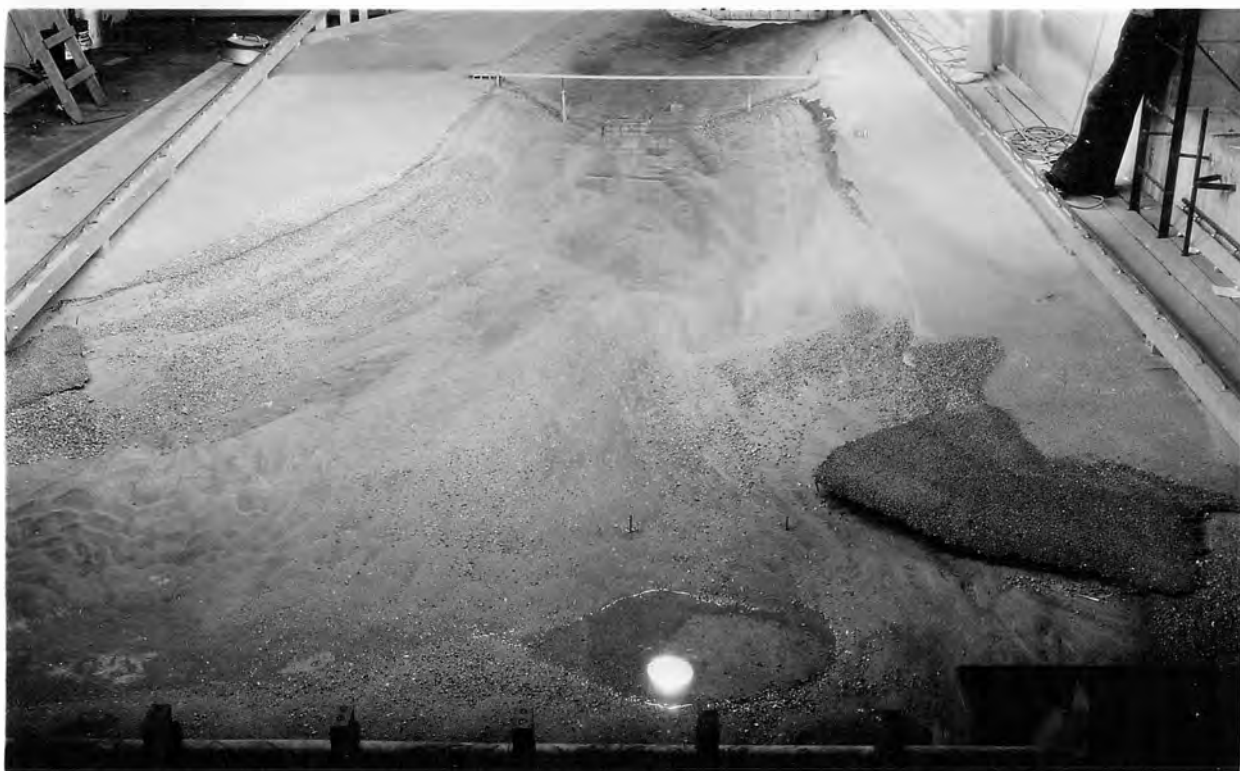
LOOKING UPSTREAM.

LOOKING DOWNSTREAM.

TEST 3 - RIVER BED AFTER A FLOW OF 1,000,000 SECOND-FEET.

(d) Flow 1,000,000 second-feet. Continued undermining of the bonded riprap sections was noted (plates 19 D and 20 D). The erosion became more severe but did not reach proportions comparable with those of test 1 and 2, (plate 18). Some sand was deposited on the tailrace slopes immediately downstream from the spillway end of both powerhouses (plates 19 D and 20 D). The riprap on the banks of the river at the ends of the highway bridge was not washed away. That near pier 1 settled slightly but was not overtopped (plate 21 D). Near pier 4 and the approach considerable settling was noted. The riprap settled below the water surface, sand was washed away and the footing exposed. The top of the rectangular base on pier 3 was also exposed.

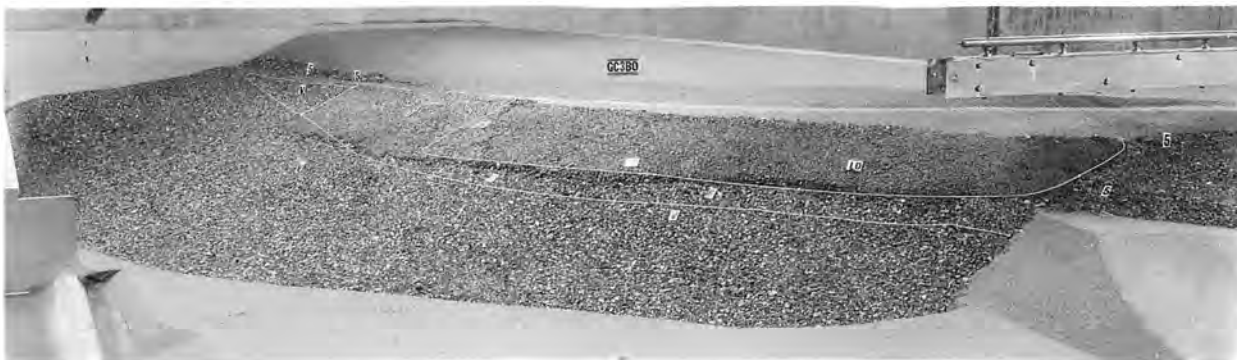
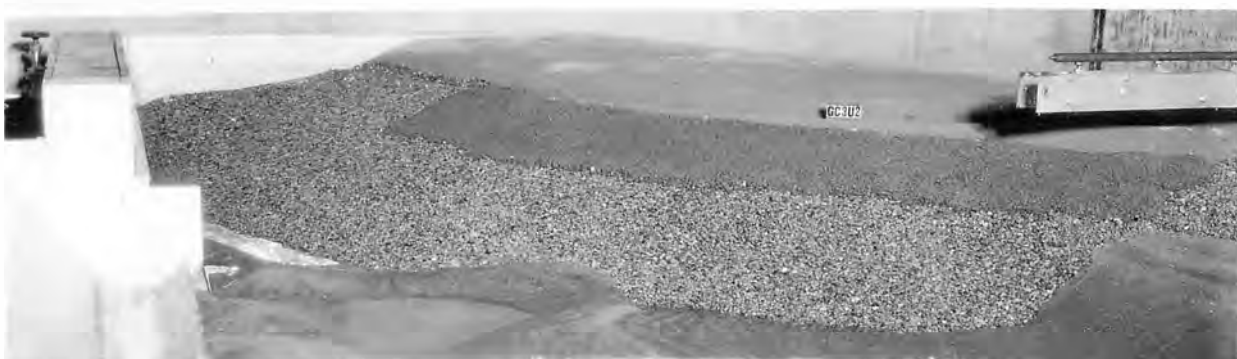
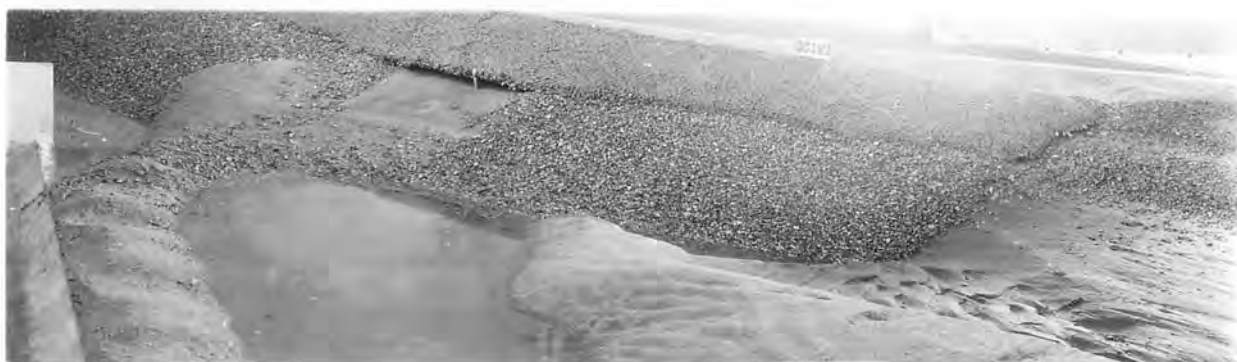
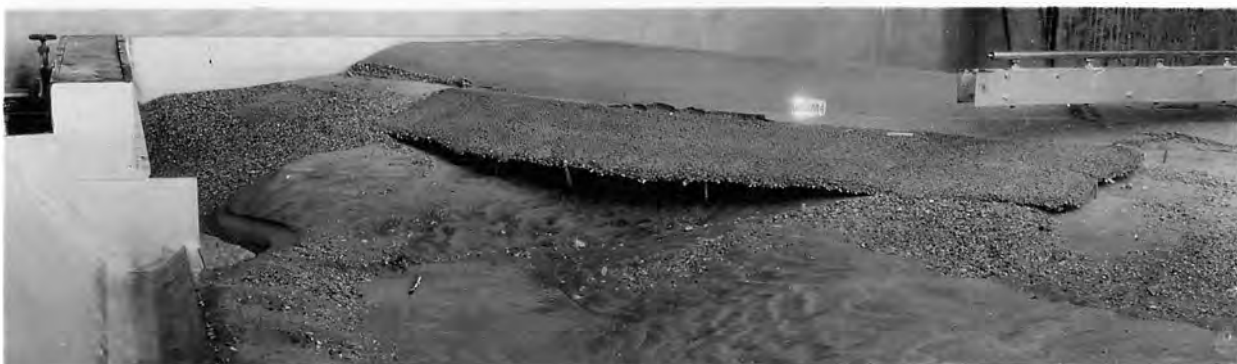
BEFORE TEST.

AFTER DISCHARGE OF 500,000 SECOND-FEET.

AFTER DISCHARGE OF 750,000 SECOND-FEET.

AFTER DISCHARGE OF 1,000,000 SECOND-FEET.

TEST 3 - EROSION AT LEFT TAILRACE.

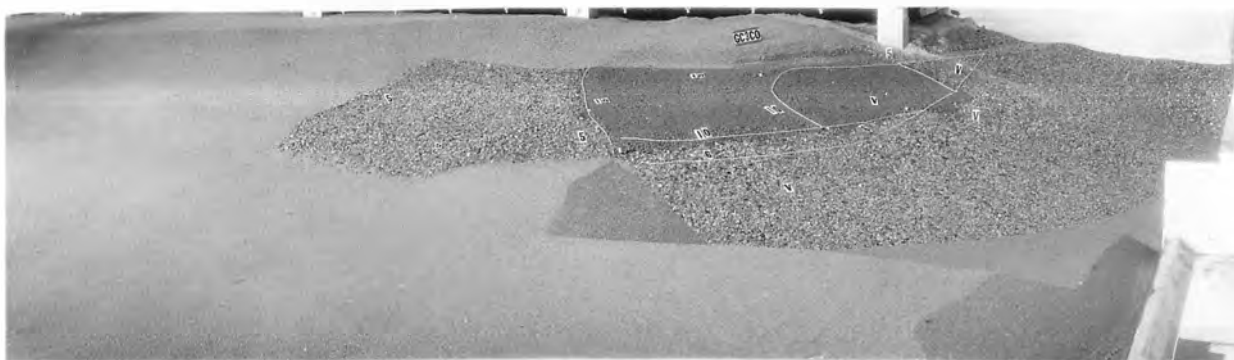
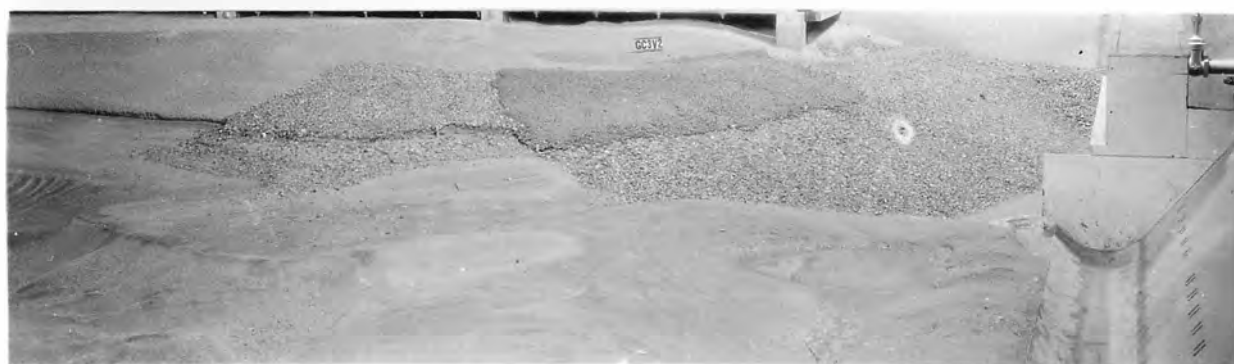
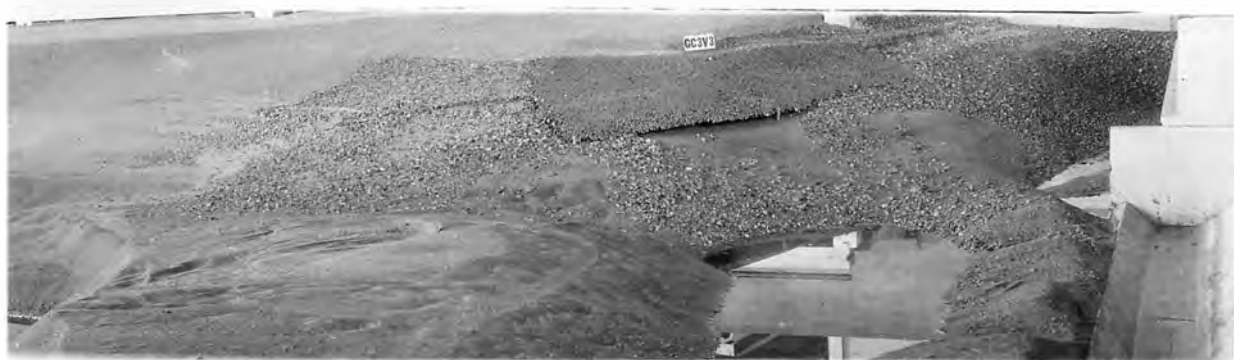
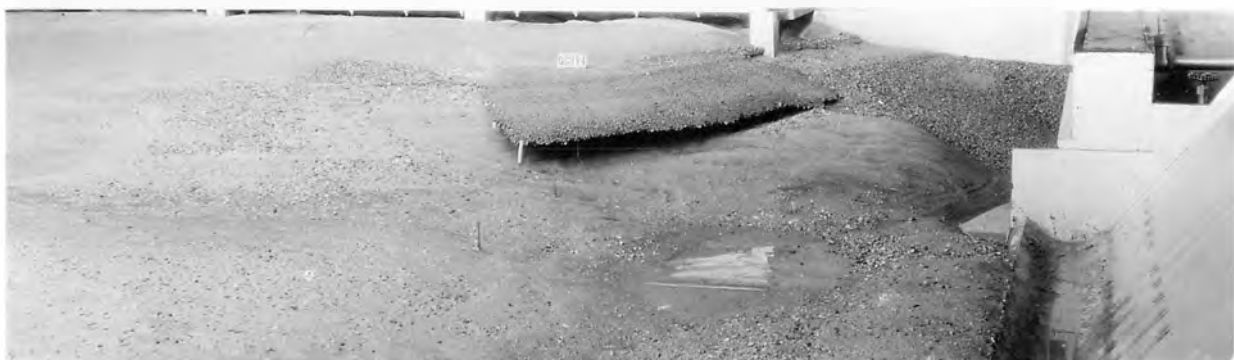
BEFORE TEST.

AFTER DISCHARGE OF 500,000 SECOND-FEET.

AFTER DISCHARGE OF 750,000 SECOND-FEET.

AFTER DISCHARGE OF 1,000,000 SECOND-FEET.

TEST 3 - EROSION AT RIGHT TAILRACE.

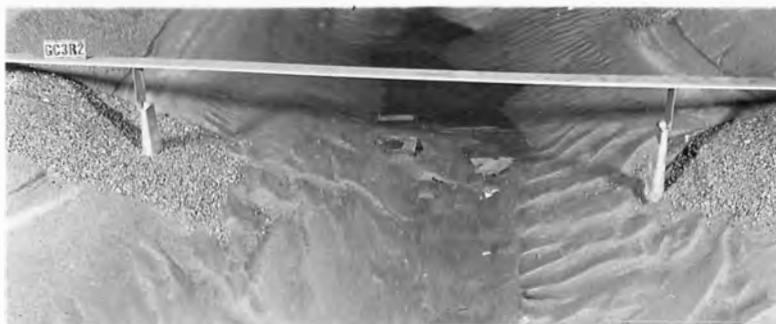
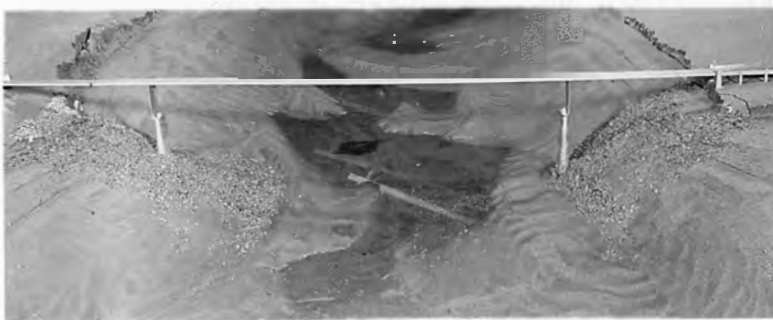
BEFORE TEST.

AFTER DISCHARGE OF 500,000 SECOND-FEET.

AFTER DISCHARGE OF 750,000 SECOND-FEET.

AFTER DISCHARGE OF 1,000,000 SECOND-FEET.

TEST 3 - LOOKING UPSTREAM - EROSION IN VICINITY OF BRIDGE PIERS.
