HYDRAULIC LABORATORY REPORT NO. 109

HYDRAULIC MODEL STUDIES OF
GRANBY DAM SPILLWAY
COLORADO - BIG THOMPSON PROJECT

Subject: Hydraulic Model Studies of Granby Dam Spillway -
Colorado-Big Thompson Project.

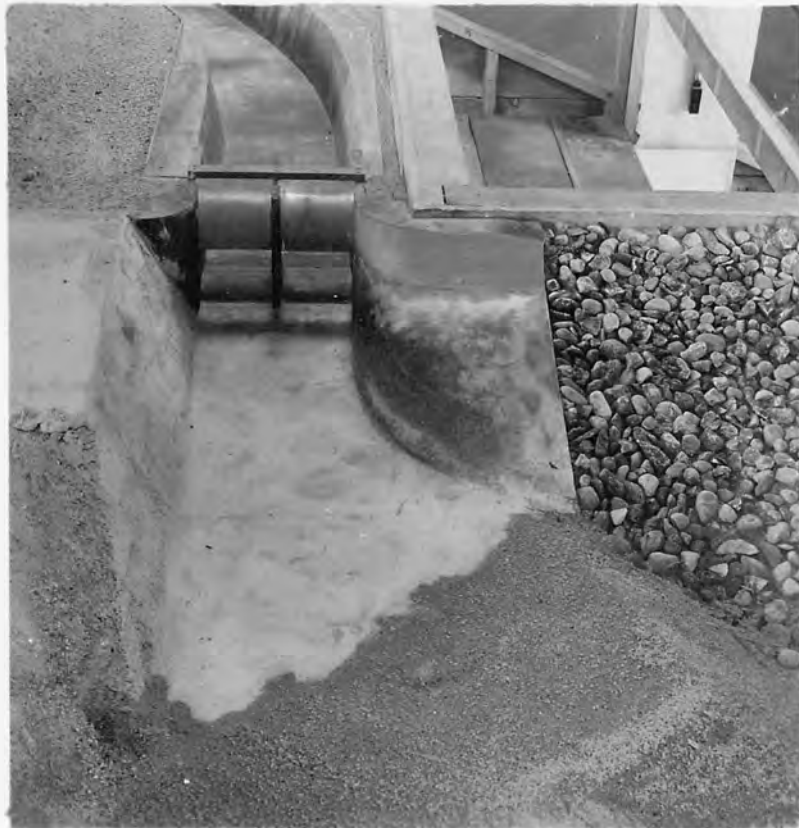
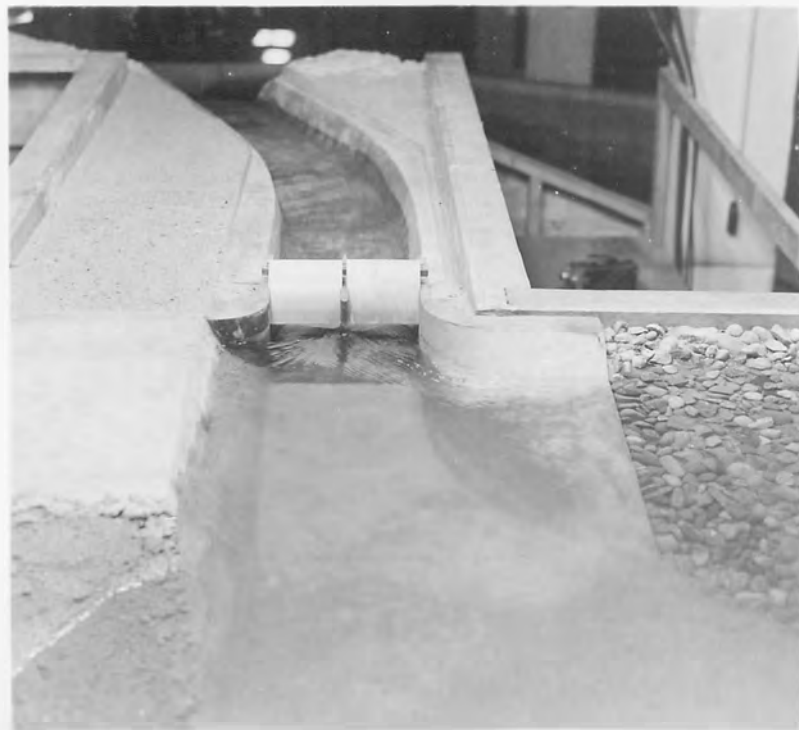
ORIGINAL DESIGN

ENTRANCE TO SPILLWAY

MAXIMUM FLOW OF 12,000 SECOND-FEET THROUGH ENTRANCE.

face of the dam (figure 4). It was this sharp break, extending from the floor of the approach channel to an elevation above that of the maximum water surface, which appeared to be responsible for the undesirable flow conditions obtained in the design. Excessive turbulence caused by the inability of the flow to accomplish such a rapid change in direction at relatively high velocities was apparent.

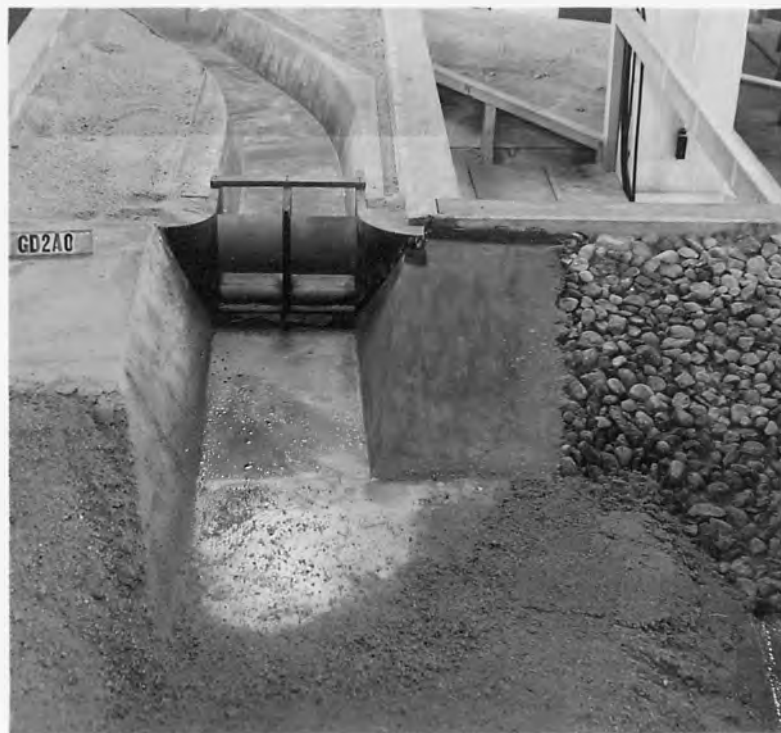
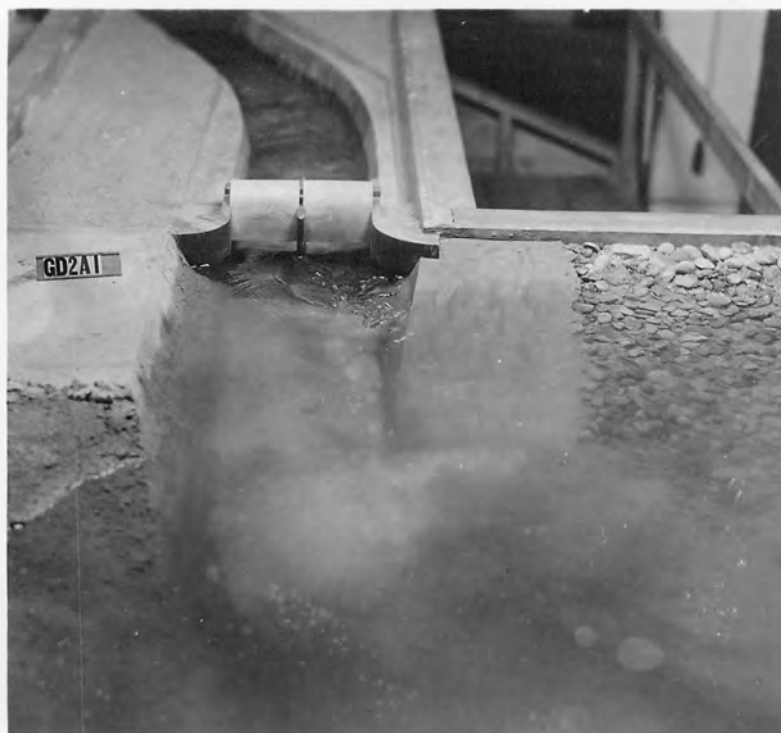
ENTRANCE TO SPILLWAY WITH WARP CHANGED TO SHARP CORNER.

MAXIMUM FLOW OF 12,000 SECOND-FEET THROUGH ENTRANCE.

Numerous designs were also tested in which flatter slopes were substituted for the 1/2:1 slope. These substitutions of flatter slopes were considered to be possible solutions because they placed the sharp corner formed by the intersection of the two slopes at a greater distance from the gate structure and made the drop from the 3:1 slope of the dam face to the floor of the entrance less abrupt. None of the variations tested reduced the unsatisfactory flow conditions to an extent deemed necessary for an adequate design.

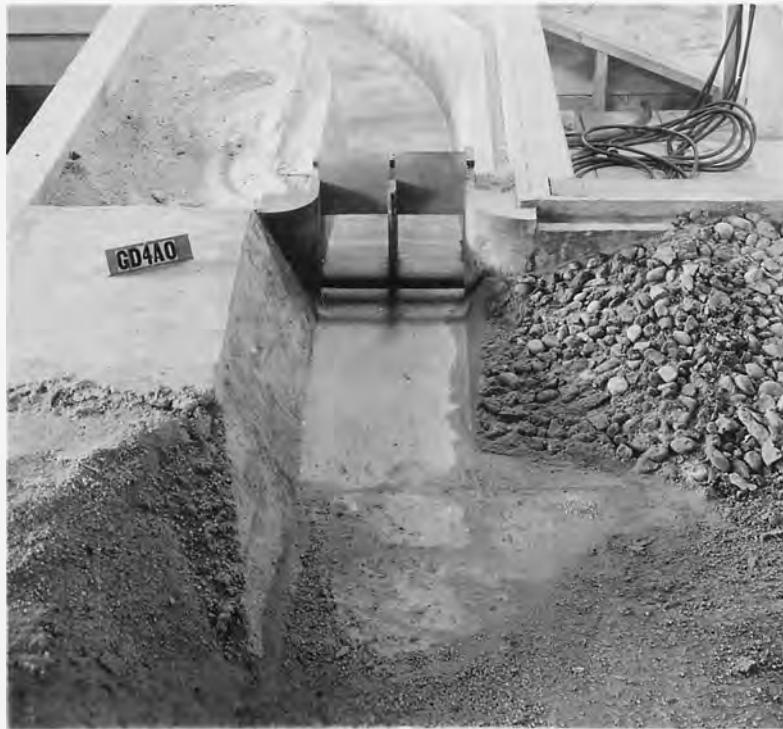
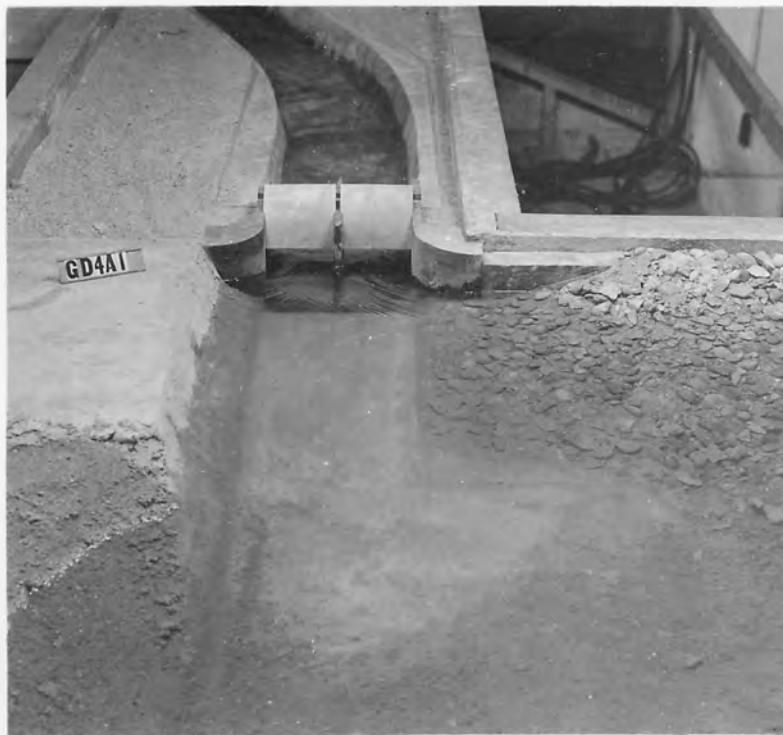
FINAL DESIGN

ENTRANCE TO SPILLWAY WITH TWO PLANE SURFACES SUBSTITUTED FOR WARP.

MAXIMUM FLOW OF 12,000 SECOND-FEET THROUGH ENTRANCE.

The final design differed in that an intermediate slope was used between the 1/2:1 and 3:1 slopes, thus reducing the abruptness of transition from one to the other (figures 5 and 15). It also allowed the highest point on the sharp break to be lowered to approximately elevation 8265.0, an elevation which is below the water surface of all flows above 4000 second-feet. Thus, under the conditions most conducive to high velocities and subsequent turbulence, the effect of the break was at least partially damped because of its origin within the body of liquid and not on the surface. More gradual increases in velocities also resulted from the less abrupt drop to the floor of the entrance and the less abrupt decrease in the cross sectional area of the approach.

(a) A spillway entrance transition consisting of a series of plane surfaces gave satisfactory results for all reservoir elevations. It was used to replace the warp shown in the original design because of its advantages of smaller initial cost and ease of construction (figure 15).

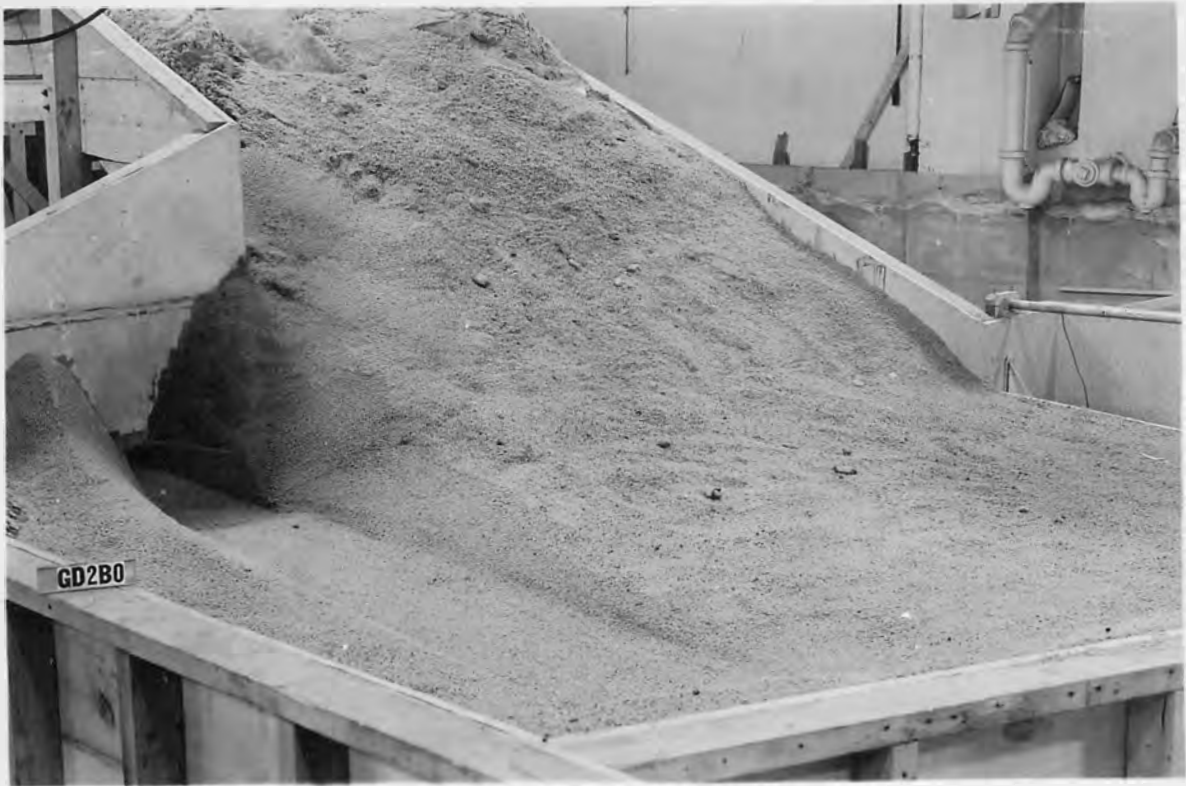
DOWNSTREAM END OF SPILLWAY AND OUTLET WORKS.

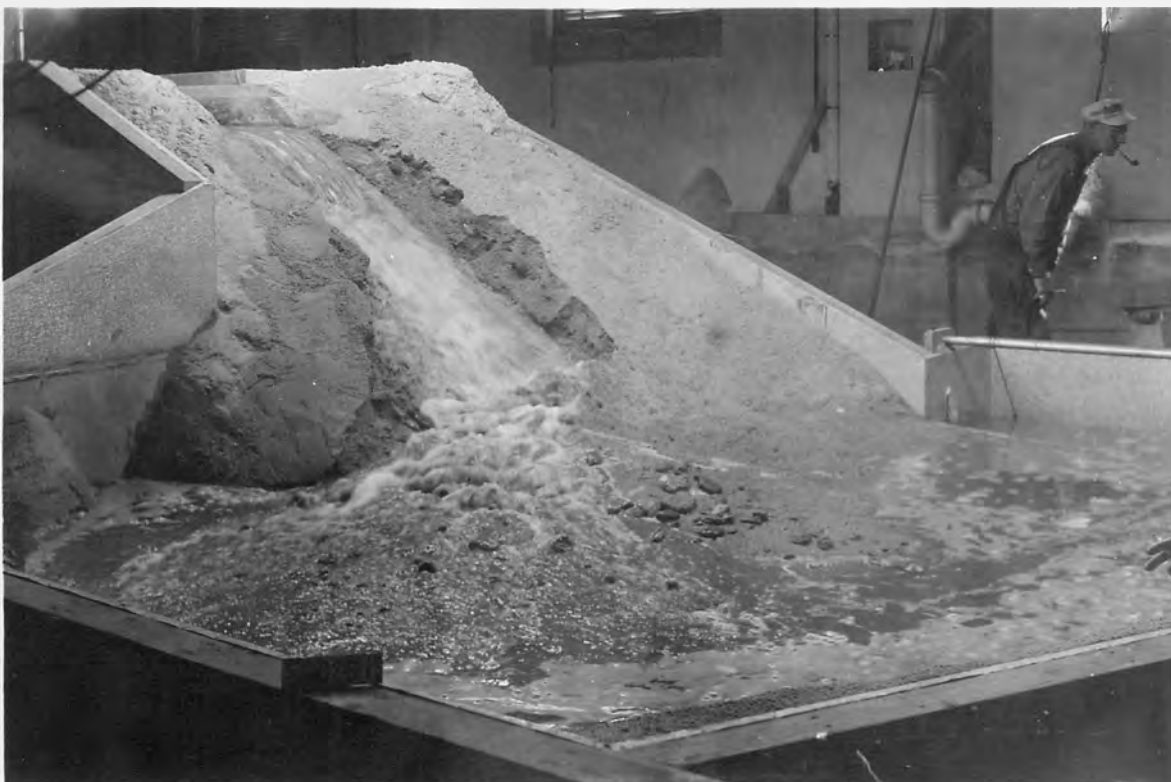
SECOND STEP IN EROSION CAUSED BY GRADUALLY OPENING SPILLWAY GATES.
MAXIMUM FLOW THROUGH OUTLET.

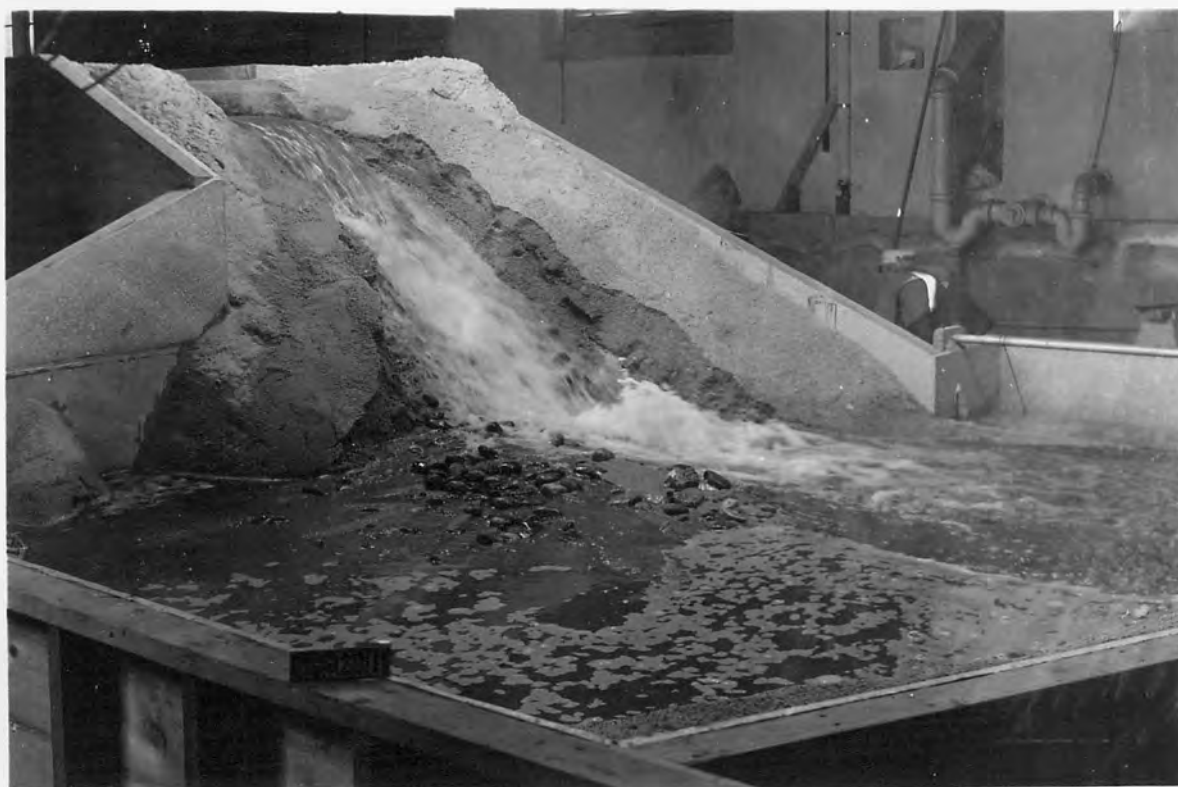
EROSION CAUSED BY MAXIMUM FLOW THROUGH SPILLWAY OF 12,000 SECOND-FEET.
MAXIMUM FLOW THROUGH OUTLET.

In testing, the outlet was operated at the maximum discharge of 500 second-feet and only the leakage from the gates was allowed to flow through the spillway. This condition was maintained for some time, and resulted in the erosion pattern shown in figure 8. The spillway gates were then slowly opened until the maximum discharge of 12,000 second-feet was flowing through the spillway (figure 9). After operating the model under this condition of maximum discharge for one-half hour, spillway gates were closed and the erosion and deposition observed (figure 10).

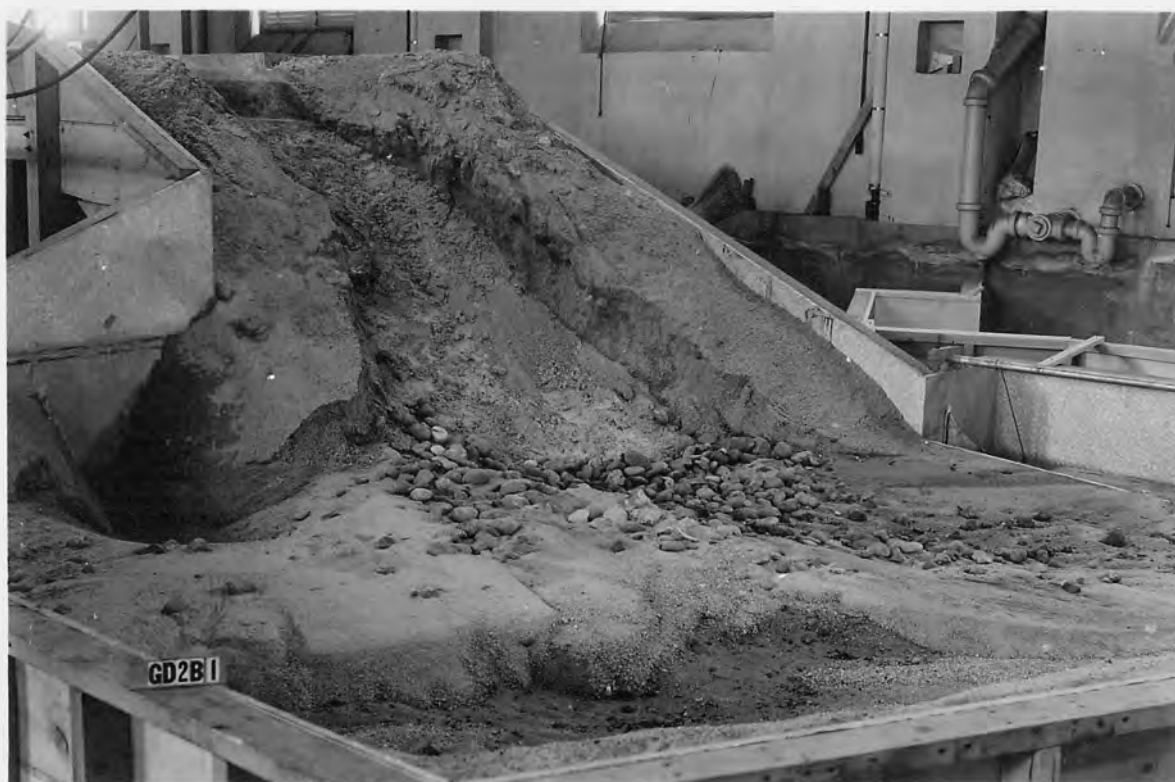
EROSION CAUSED BY MAXIMUM FLOW THROUGH SPILLWAY AND OUTLET.

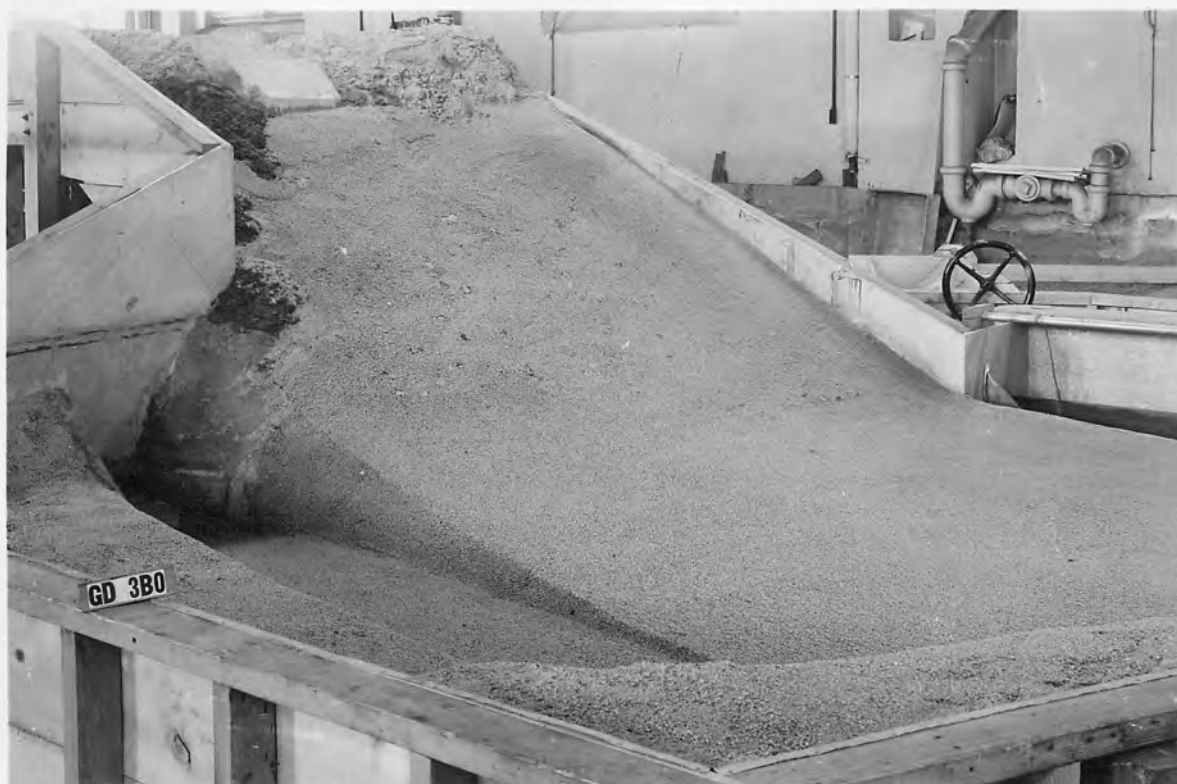
DOWNSTREAM END OF SPILLWAY AND OUTLET WORKS.

Since the model tests indicated that the conditions below the spillway depended on the authenticity of the bedrock and overburden contours, a request was made that more geological information concerning the site be furnished. Several test pits were dug in the area in question. The contours of the bedrock as defined by information from these test pits and rock outcrops as shown on a geologic map were incorporated in the model to make it more nearly simulate the prototype. The change had a tendency to decrease the slope of the surface toward the outlet, and it seemed probable that the location of deposition would not be as unfavorable.

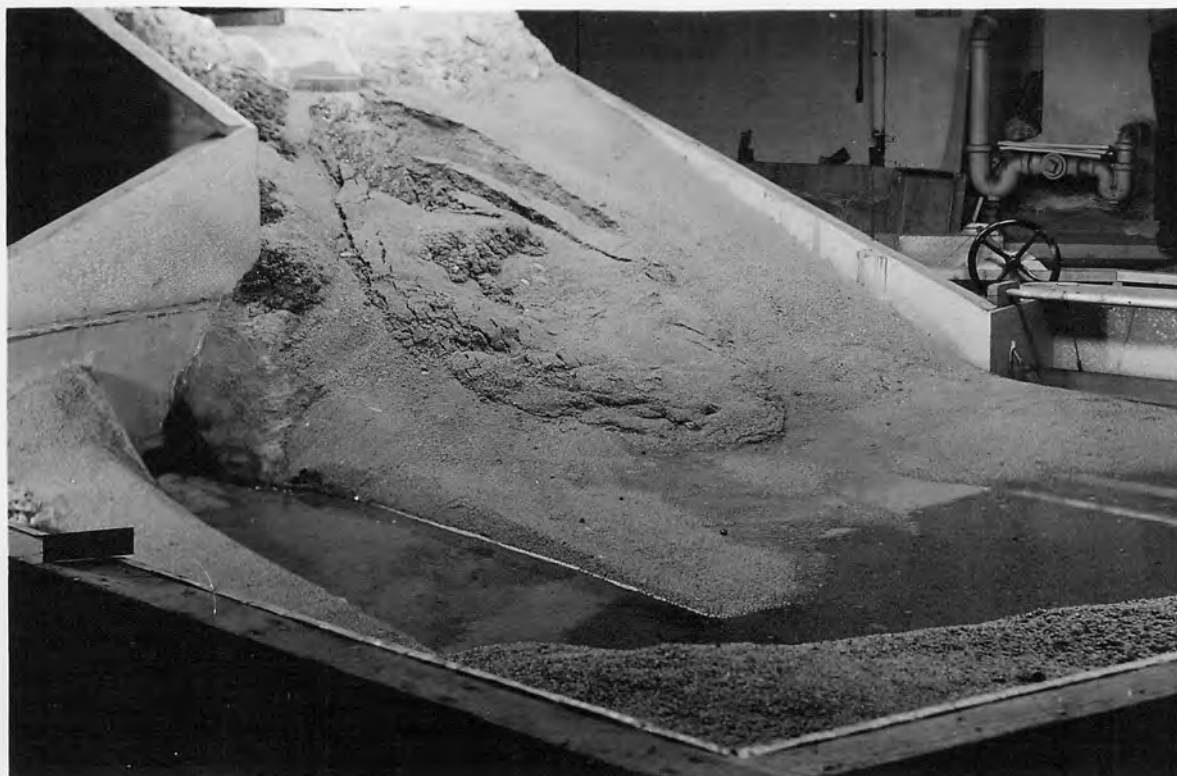
EROSION CAUSED BY MAXIMUM FLOW THROUGH OUTLET AND LEAKAGE THROUGH
SPILLWAY GATES.

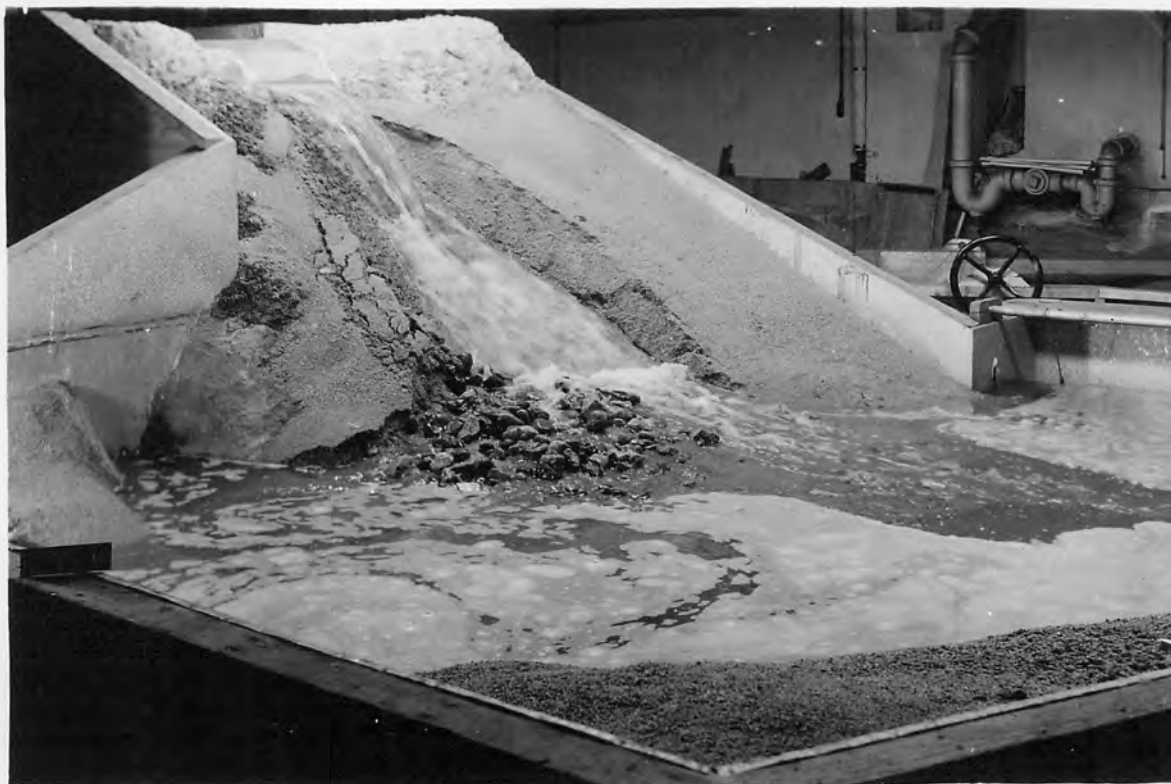
THIRD STEP IN EROSION CAUSED BY GRADUALLY OPENING SPILLWAY GATES.
MAXIMUM FLOW THROUGH OUTLET.

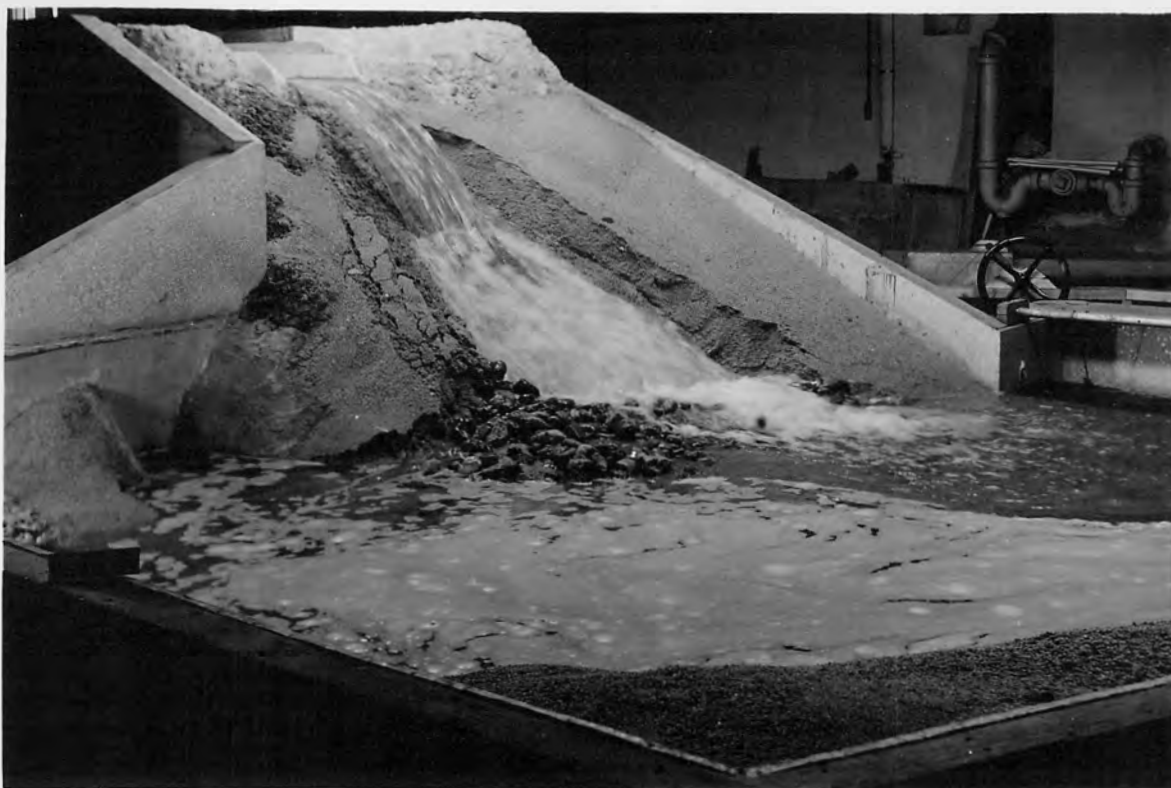
EROSION CAUSED BY MAXIMUM FLOW THROUGH SPILLWAY OF 12,000 SECOND-FOOT.
MAXIMUM FLOW THROUGH OUTLET.

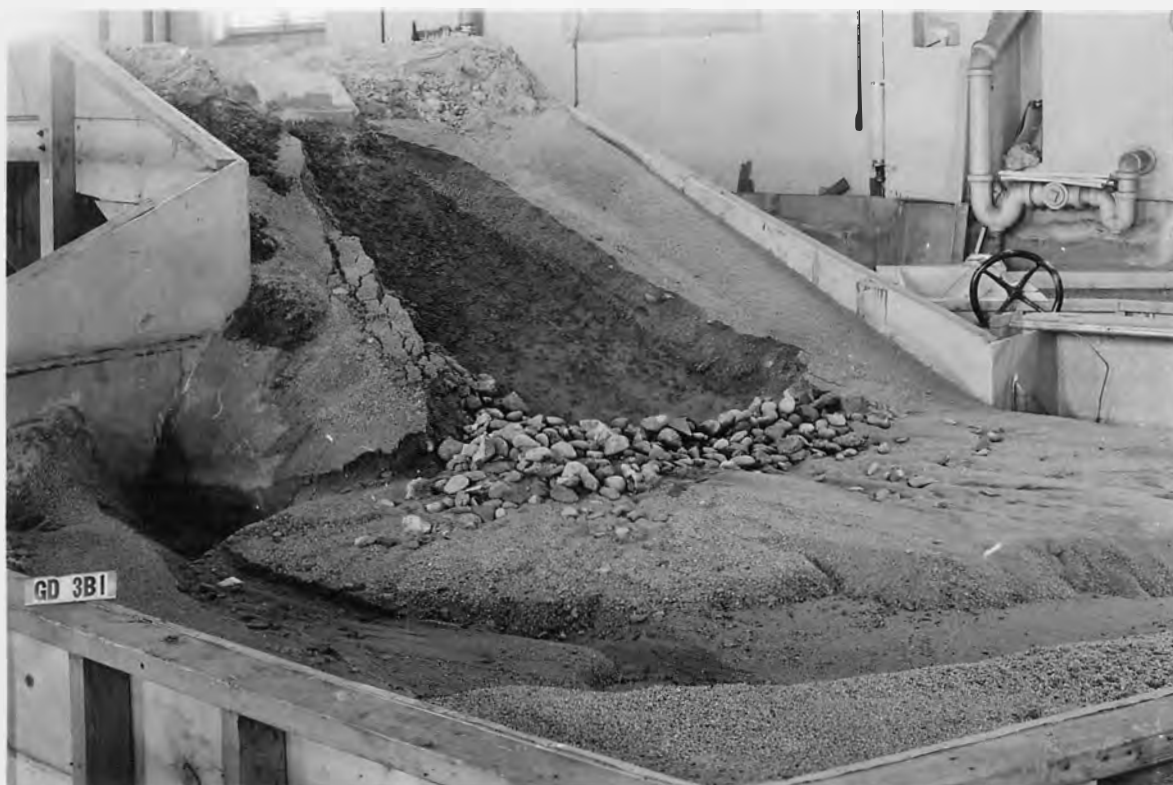
EROSION CAUSED BY GRADUALLY OPENING SPILLWAY GATES TO MAXIMUM DISCHARGE.

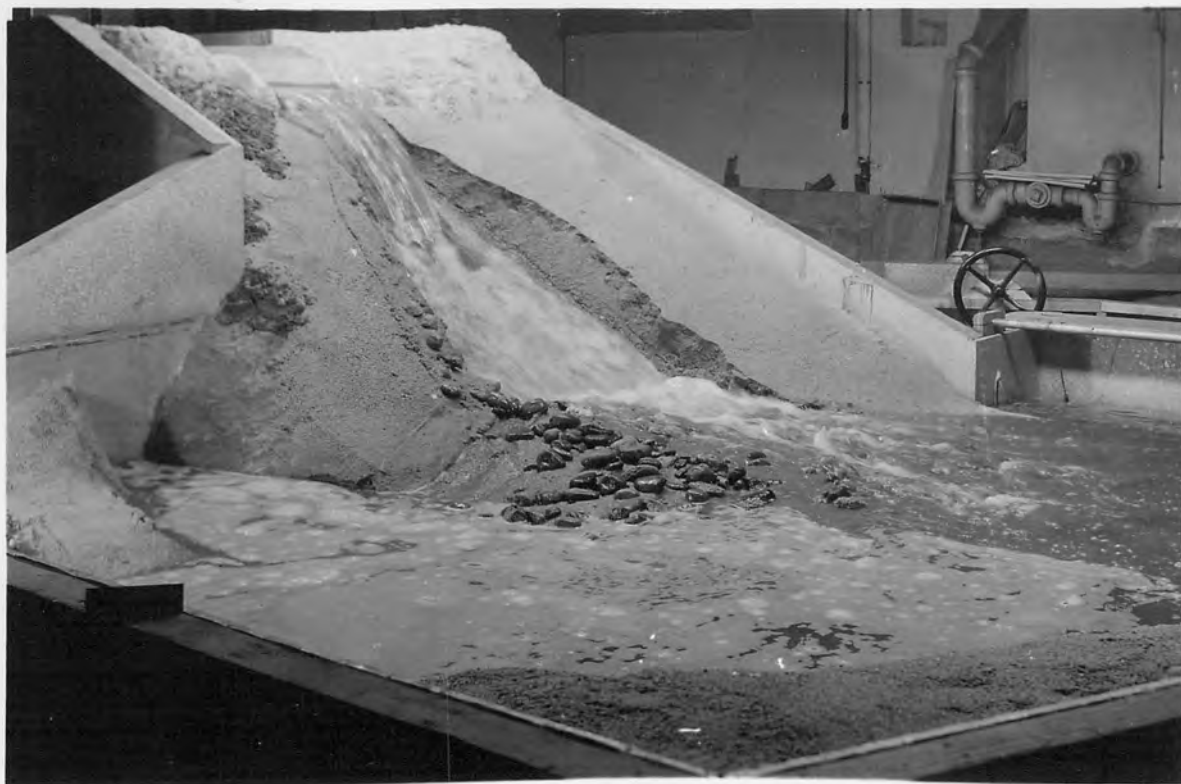
EROSION CAUSED BY MAXIMUM FLOW THROUGH SPILLWAY WHEN GATES ARE OPENED RAPIDLY. MAXIMUM FLOW THROUGH OUTLET.

It was also a matter of conjecture as to how the final erosion pattern would be changed if the gates were opened rapidly instead of slowly. The eroded material was replaced and the maximum flow of 12,000 second-

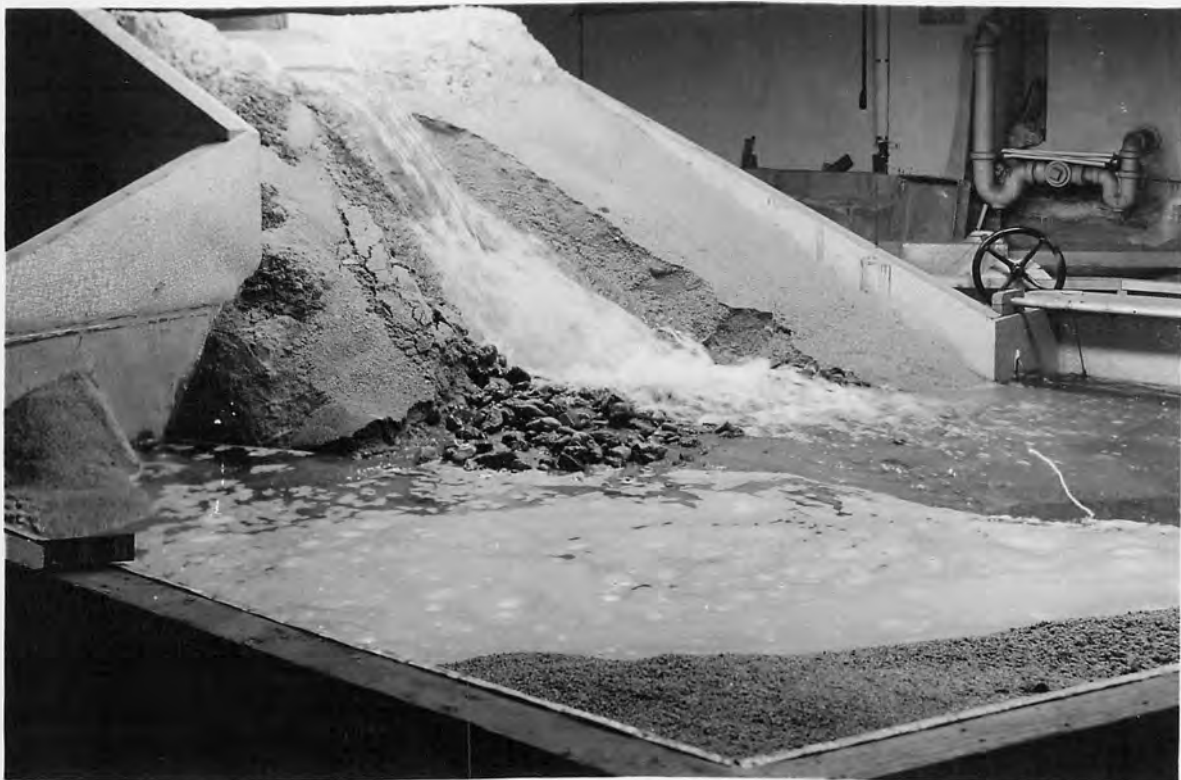
EROSION CAUSED BY MAXIMUM FLOW THROUGH SPILLWAY WHEN GATES ARE OPENED SLOWLY. MAXIMUM FLOW THROUGH OUTLET.

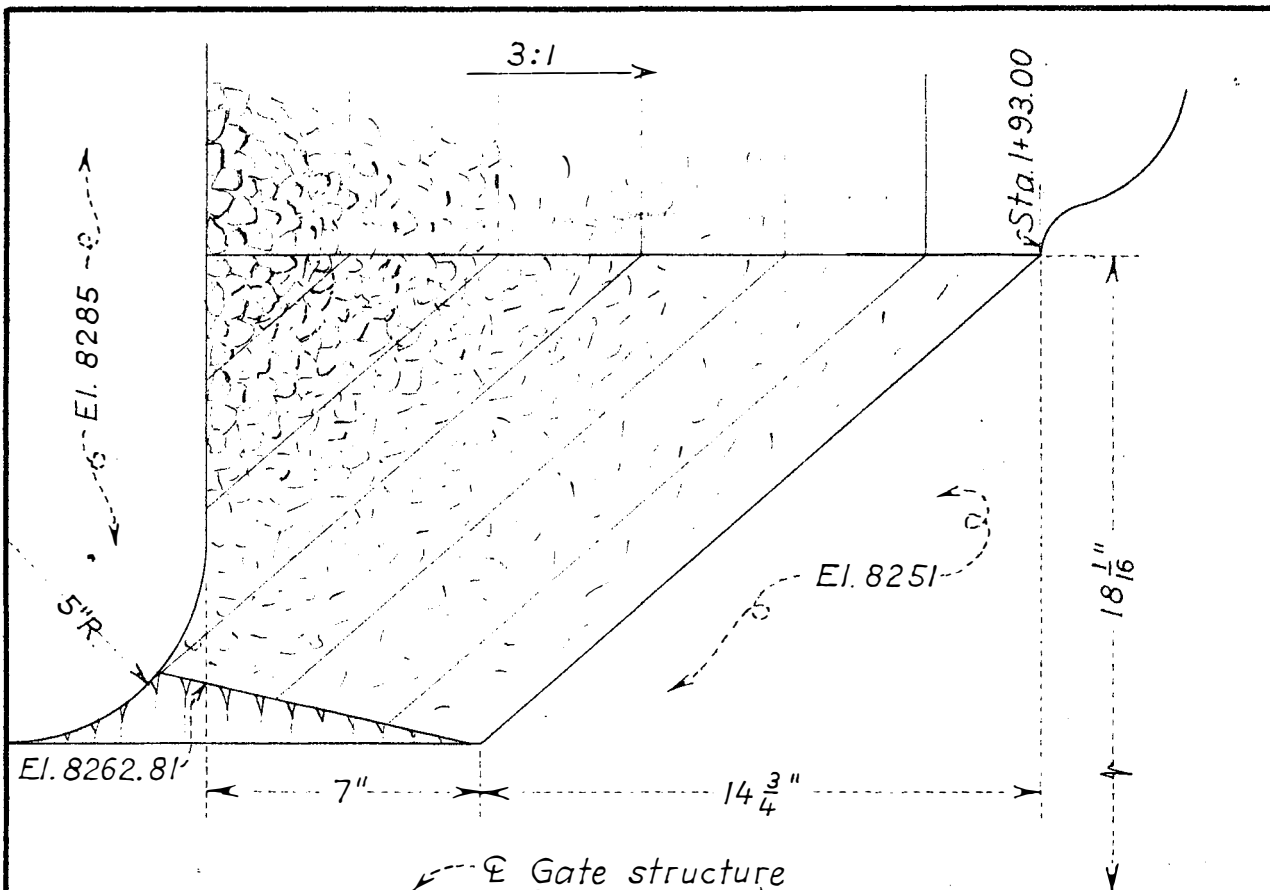
GRANBY DAM
MODEL ENTRANCE APPROACH-FINAL DESIGN
1:48 MODEL OF SPILLWAY

PLAN VIEW OF RIGHT HALF OF APPROACH

SECTION THRU APPROACH
