MEMORANDUM TO CHIEF DESIGNING ENGINEER

SUBJECT: HYDRAULIC MODEL STUDIES
RELATING TO THE DESIGN OF THE KESWICK DAM
SPILLWAY AND FISHWAY
CENTRAL VALLEY PROJECT -- CALIFORNIA

J. W. Ball, Associate Engineer
and
J. A. Lindsey, Assistant Engineer

Denver, Colorado
April 28, 1943

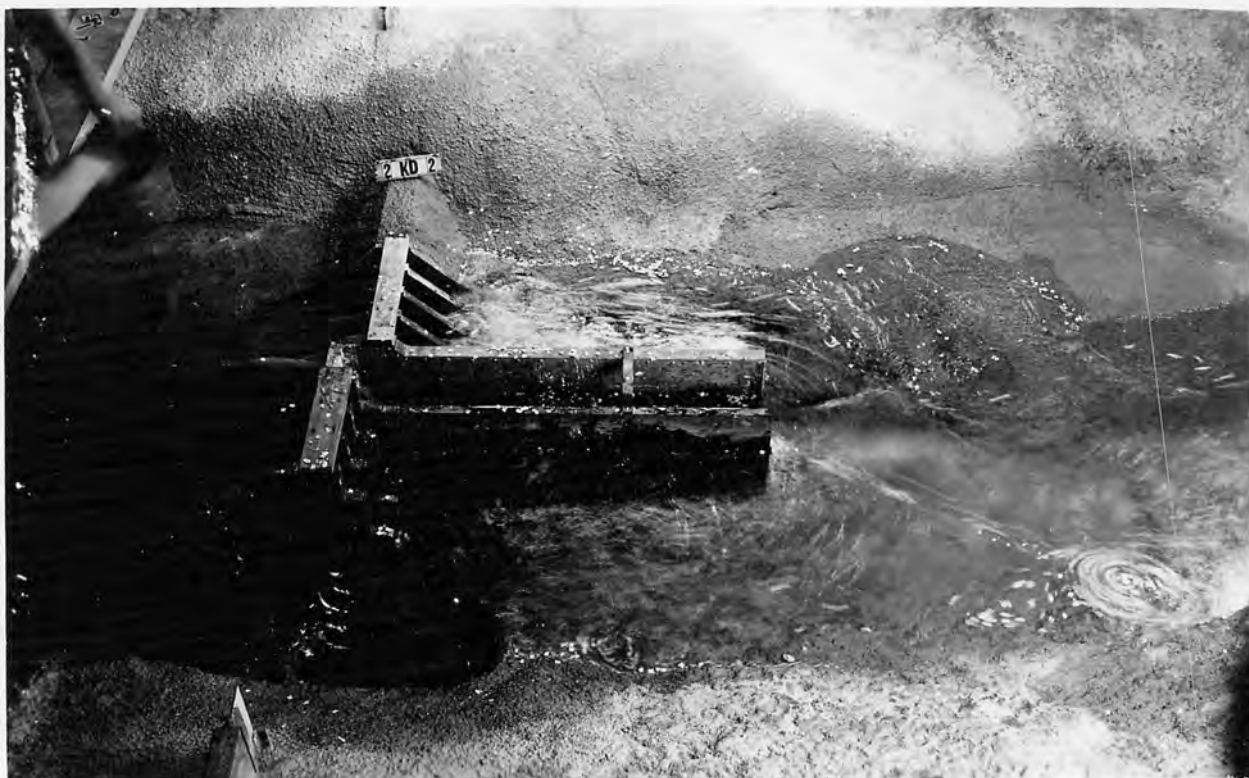
A. Original design - Spillway discharge, 25,000 second-feet; fishway discharge, 300 second-feet; and tailwater elevation 504.20.

FLOW CONDITIONS IN INITIAL DEVELOPMENT

10. Fishway studies on the 1 to 80 model. The flow conditions to be encountered in the stream adjacent to the fishway in the original design of the initial stage, were studied in the 1 to 80 model and found to be unsatisfactory. The concentration of flow from the spillway section produced eddies and undesirable currents at the fishway entrance (figure 7A). These conditions were eliminated by altering the design to resemble more closely the ultimate stage. In this design the flow of water over the bench produced conditions that should enable the fish to locate the fishway entrance without difficulty (figure 7B).

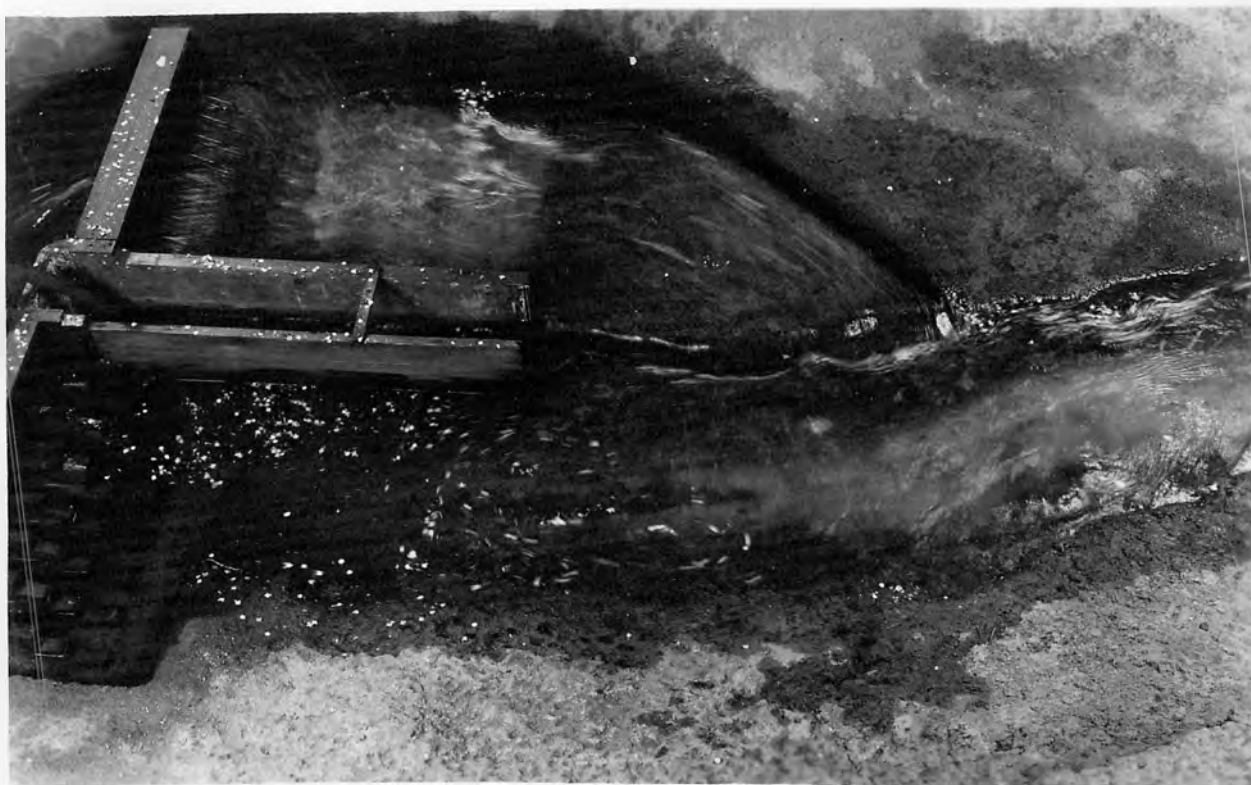
B. Modified design - Spillway discharge, 15,000 second-feet; fishway discharge, 300 second-feet; and tailwater elevation 498.75.

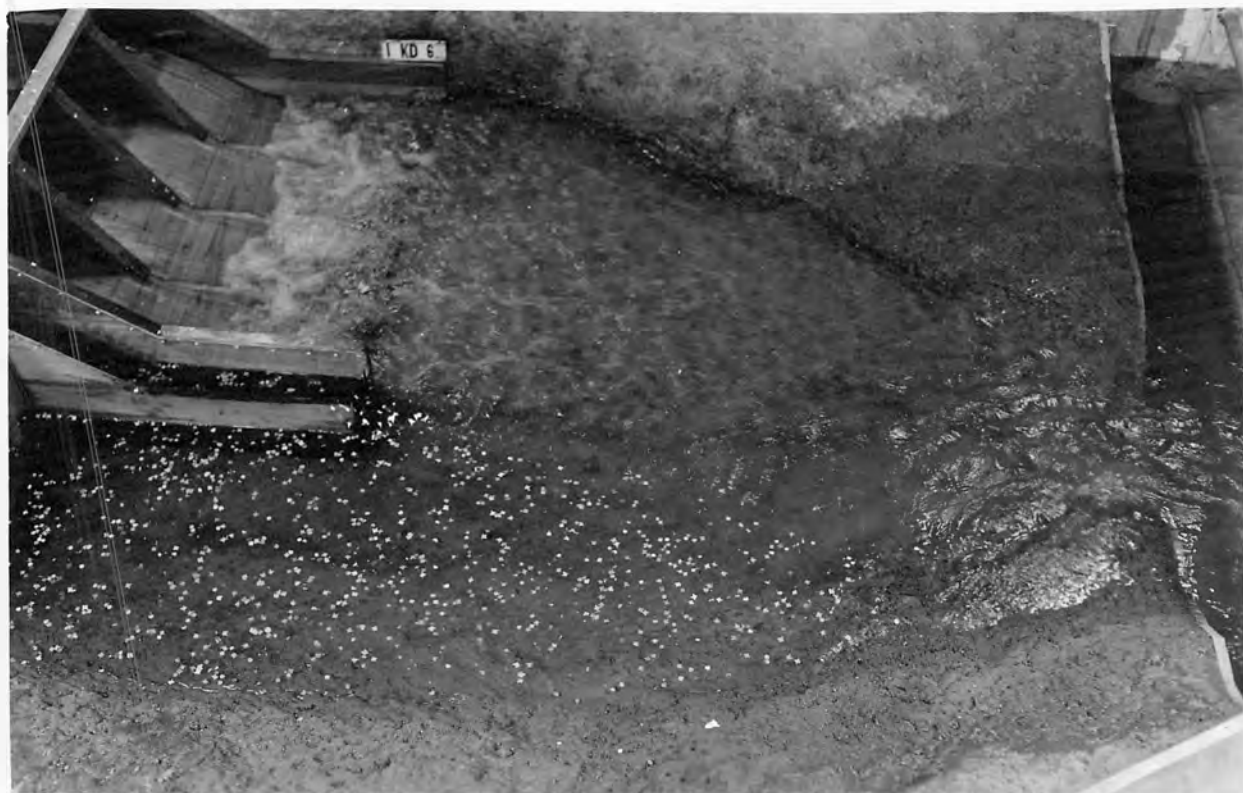
B. Spillway discharge, 50,000 second-feet; no fishway or powerhouse discharge; and tailwater elevation 513.75.

FLOW CONDITIONS IN ORIGINAL DESIGN OF ULTIMATE DEVELOPMENT
KESWICK DAM - 1:80 MODEL

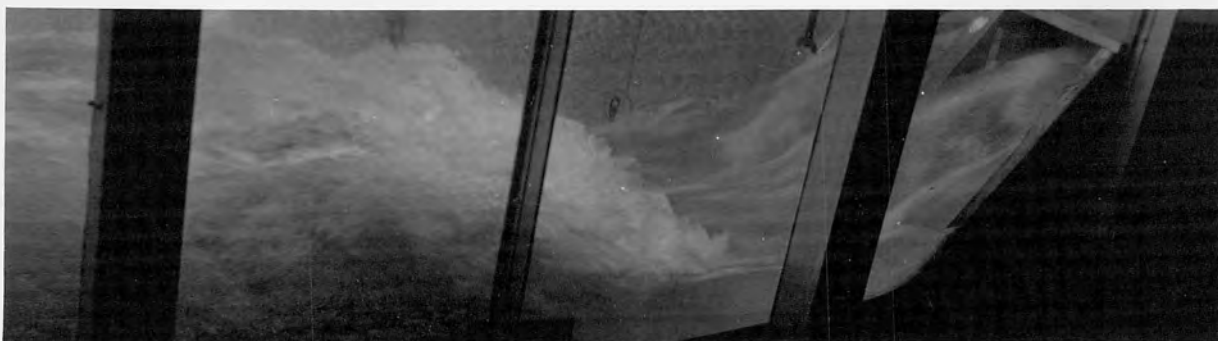
A. Discharge - 250,000 second-feet.

DESIGN 1 (ORIGINAL) - 5:1 SLOPING APRON WITH DENTATED SILL

The original spillway design was tested in the 1 to 48 model to demonstrate its inadequacy and to establish a basis for subsequent improvements (design 1, figures 11 and 12 A and B). The location of the jump at normal tailwater and the scour after the run were recorded by photographs and were compared with subsequent tests on the various proposed designs to establish the relative improvement accruing from the revisions. These tests definitely indicated that the original design of the spillway could be revised to improve the operating characteristics.

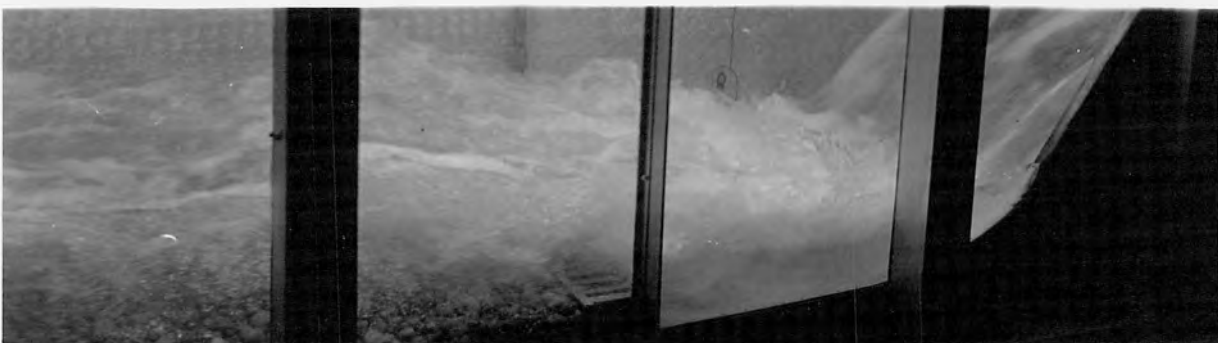
C. Discharge - 250,000 second-feet.

DESIGN 3 - 16:1 SLOPING APRON WITH DENTATED SILL

apron was increased from 60 feet to 120 feet (prototype). The apron slope was changed from 5 to 1 to 16 to 1, and the apron lengthened 23 feet (design 3, figure 11). A dentated sill 12 feet high was added, similar to the one used in tests on the original design. This arrangement proved satisfactory as the stilling pool had sufficient length to properly transform the kinetic energy of the jet to turbulent energy and dissipate the latter on the spillway apron (figure 12 C and D). The dentated sill was moved upstream to make the apron the same length as in the original design (design 4, figure 11), but the test demonstrated that the apron should be at least as long as in design 3. When this sill was replaced with one having a trapezoidal cross-section the dissipation of energy was incomplete, indicating the dentated sill to be the better design, (design 5, figure 11). By raising the sill to elevation 497.00, the flow conditions were improved and scour practically eliminated (design 6, figure 11). Flow conditions were not adverse when the dentated sill was replaced with a smooth sill, but the scour was excessive (design 7, figure 11). The crest was raised to elevation 540.00, and the rock bench downstream to elevation 500.00 (design 8, figure 11). Flow conditions were satisfactory and there was very little scour (figure 13 A and B).

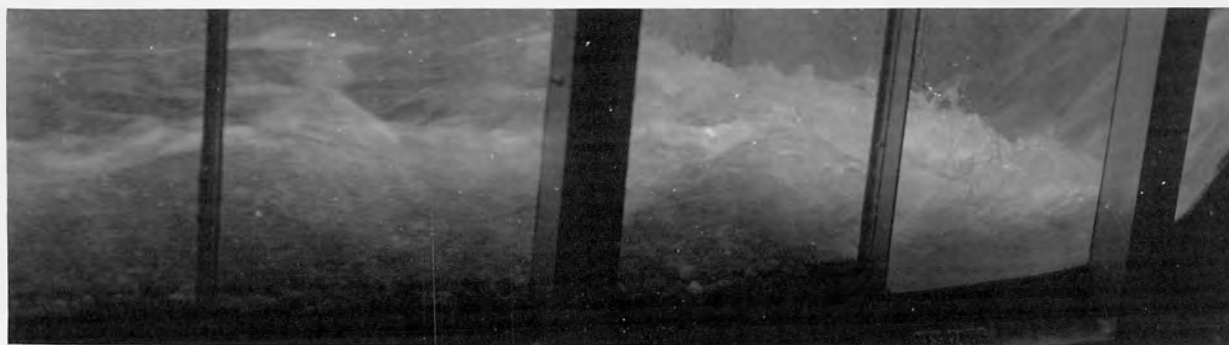
A. Discharge - 250,000 second-feet.

DESIGN 8 - DENTATED SILL AT END OF APRON

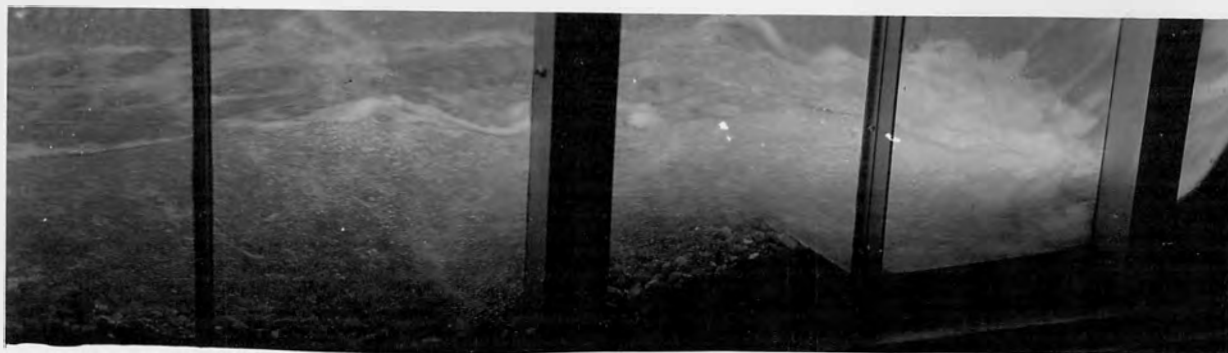
A. Discharge - 250,000 second-feet.

B. Erosion of sand-gravel bed.

DESIGN 10 - TRAPEZOIDAL SILL AND STEPS WITH 10-DEGREE UPWARD SLOPE
ON TOP SURFACES

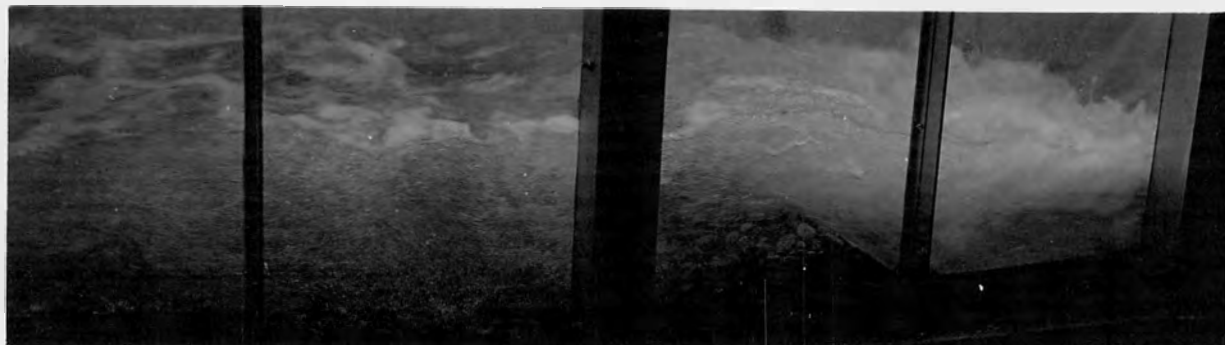
C. Discharge - 250,000 second-feet.

D. Erosion of sand-gravel bed.

DESIGN 11 - TRAPEZOIDAL SILL AND STEPS WITH 5-DEGREE UPWARD
SLOPE ON TOP SURFACES

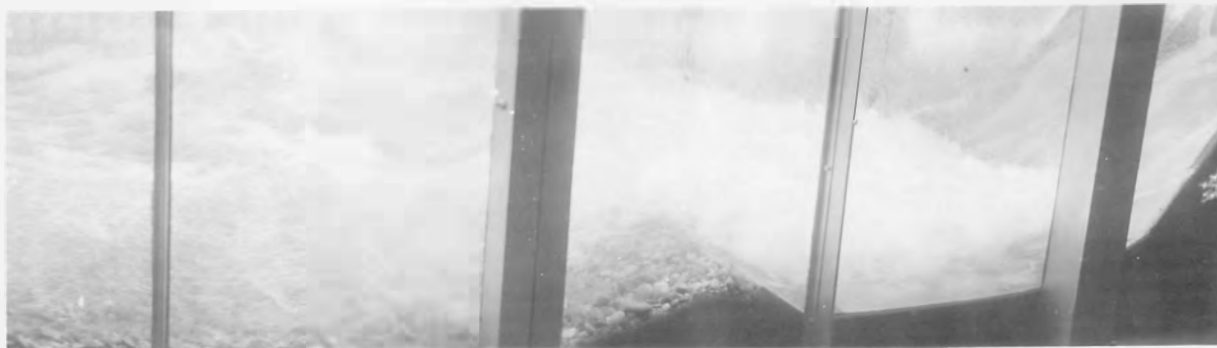
A. Discharge - 250,000 second-feet.

B. Erosion of sand-gravel bed.

DESIGN 12 - TRAPEZOIDAL SILL AND STEPS WITH 10-DEGREE DOWNWARD
SLOPE ON TOP SURFACES

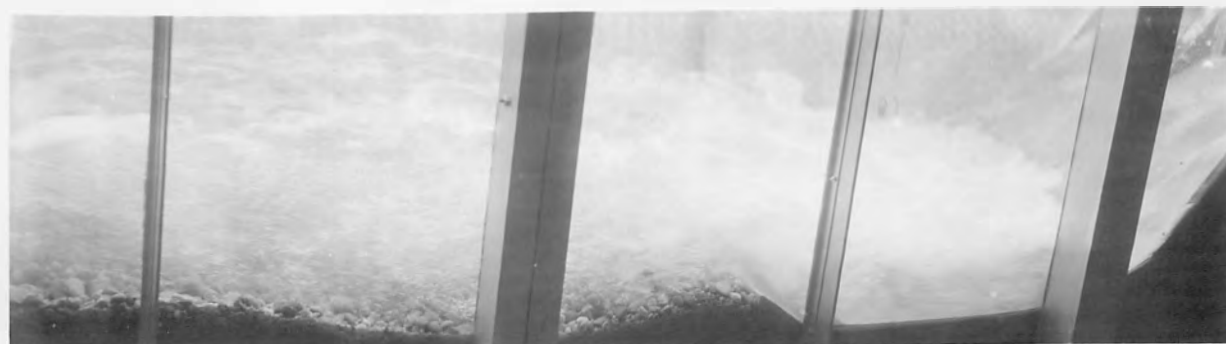
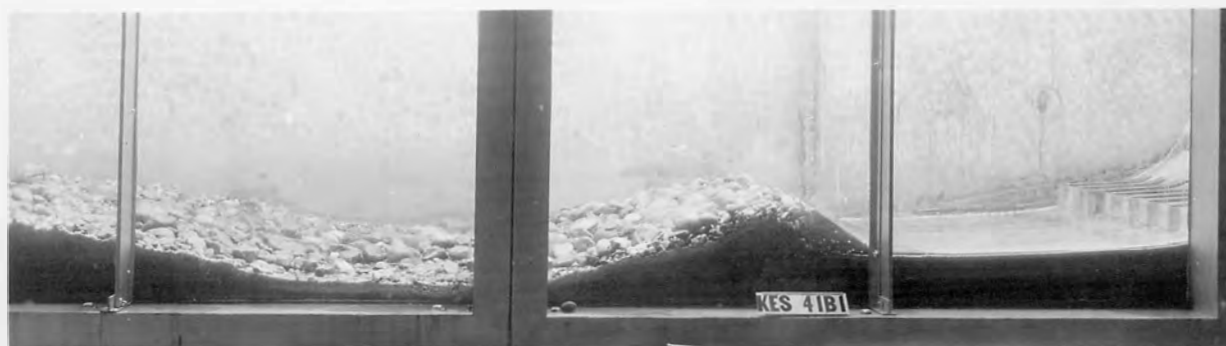
C. Discharge - 250,000 second-feet.

D. Erosion of sand-gravel bed.

DESIGN 13 - TRAPEZOIDAL SILL AND STEPS WITH 5-DEGREE DOWNWARD
SLOPE ON TOP SURFACES

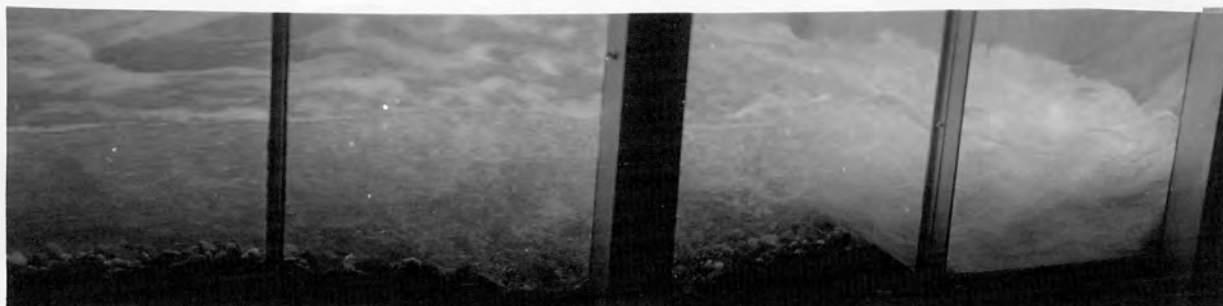
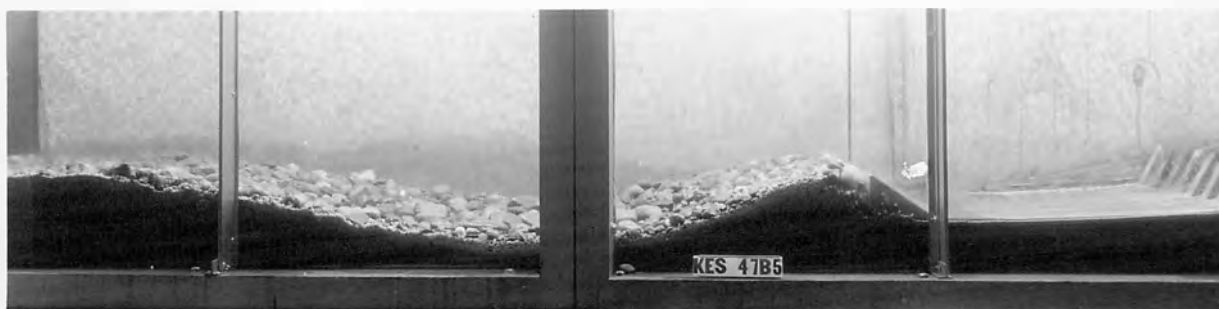
C. Discharge - 250,000 second-feet.

D. Erosion of sand-gravel bed.

DESIGN 15 - TRAPEZOIDAL SILL AND STEPS WITH $\frac{1}{2}$:1 SLOPE ON
DOWNSTREAM SIDE

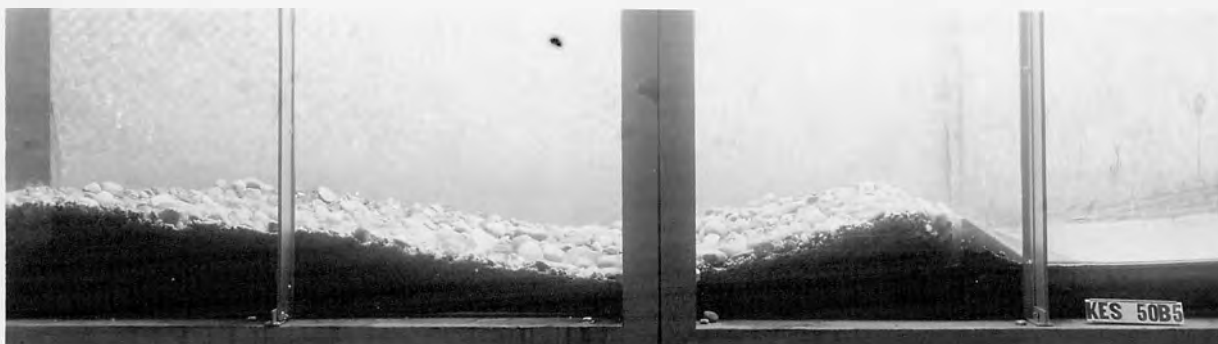
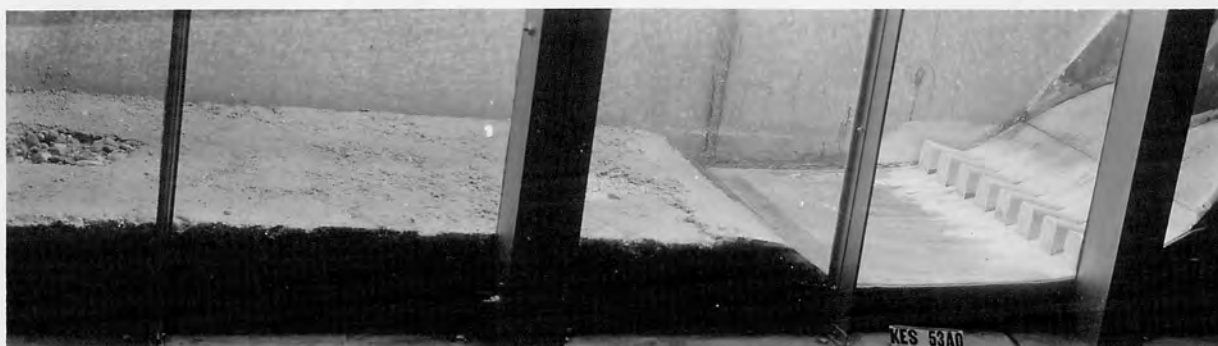
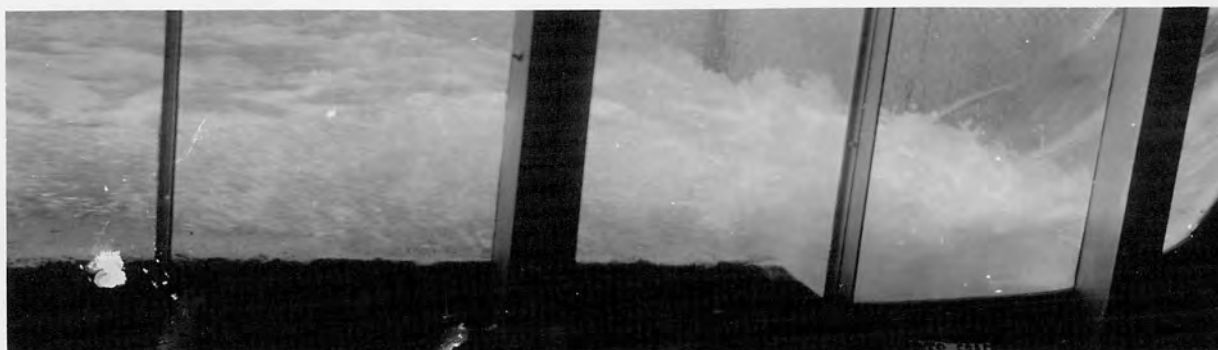
A. Discharge - 250,000 second-feet.

B. Erosion of sand-gravel bed.

C. Sand-gravel bed stabilized with concrete.

D. Discharge - 250,000 second-feet.

DESIGN 16 - TRAPEZOIDAL SILL AND STREAMLINED STEPS ON APRON

EFFECT OF STABLE RIVER BED ON STILLING POOL ACTION
KESWICK DAM - 1:48 MODEL OF ULTIMATE DEVELOPMENT

model was made. A layer of concrete was placed to elevation 500.00 to replace the movable bed. When the model was tested, the hydraulic jump was considerably worse than with the movable beds. It was necessary to raise the tailwater elevation from one to two feet (prototype) above the normal level before the jump became satisfactory. A reduction in the tailwater elevation of $3\frac{1}{2}$ feet below the normal level was necessary to sweep it from the apron at the maximum discharge of 250,000 second-feet. This test showed that the sand-gravel bench had considerable effect upon the jump characteristics. Its efficiency was improved by the increased friction and by the roller which was formed in the bucket-like pocket scoured downstream from the sill during high discharges.

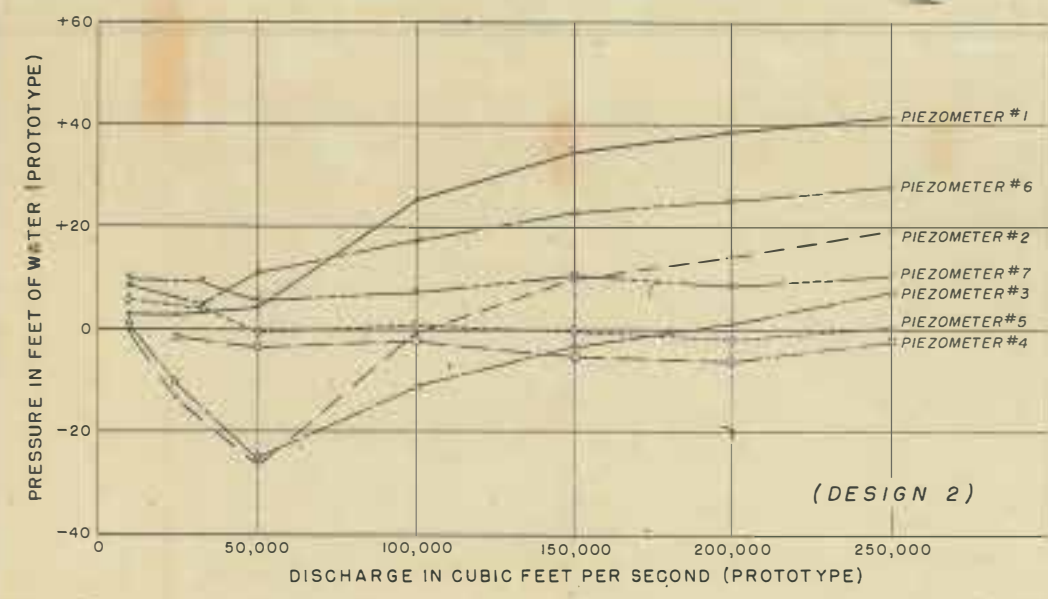
CENTRAL VALLEY PROJECT - CALIFORNIA
KESWICK DAM
HYDRAULIC MODEL STUDIES - SCALE 1:48
PRESSURES ON APRON STEPS

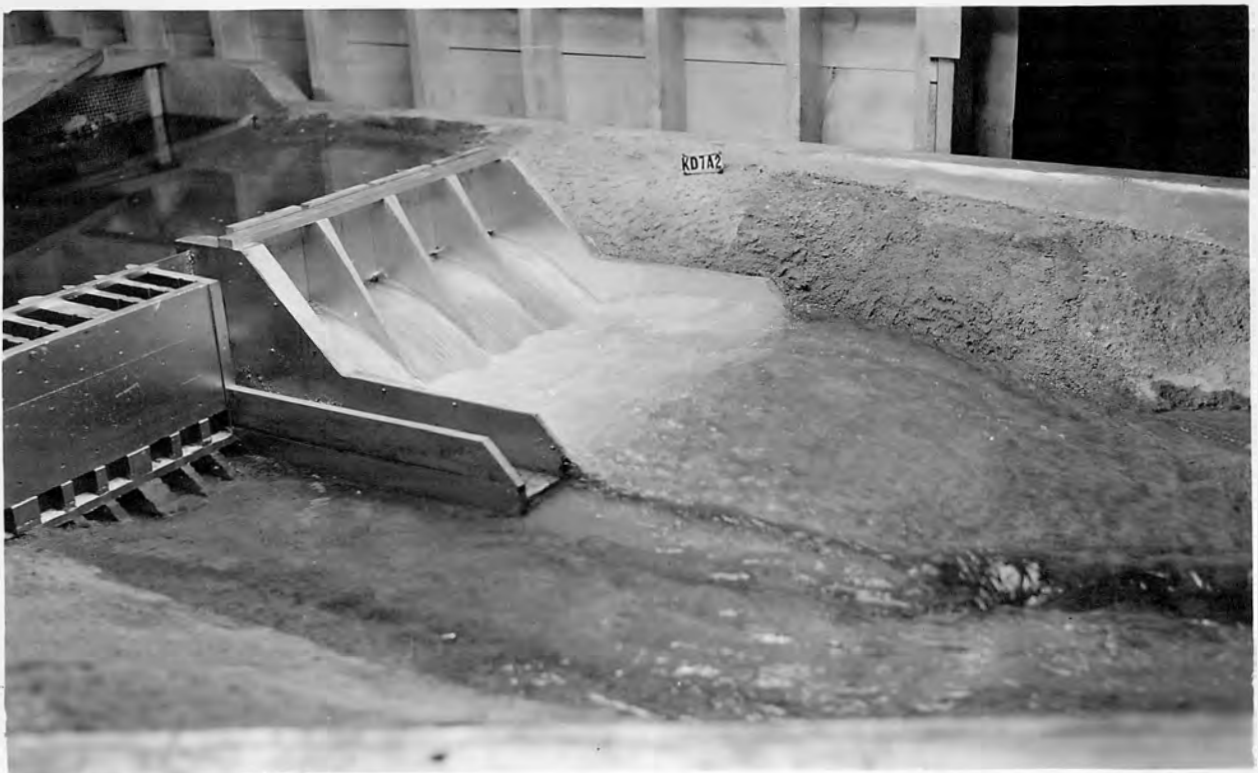
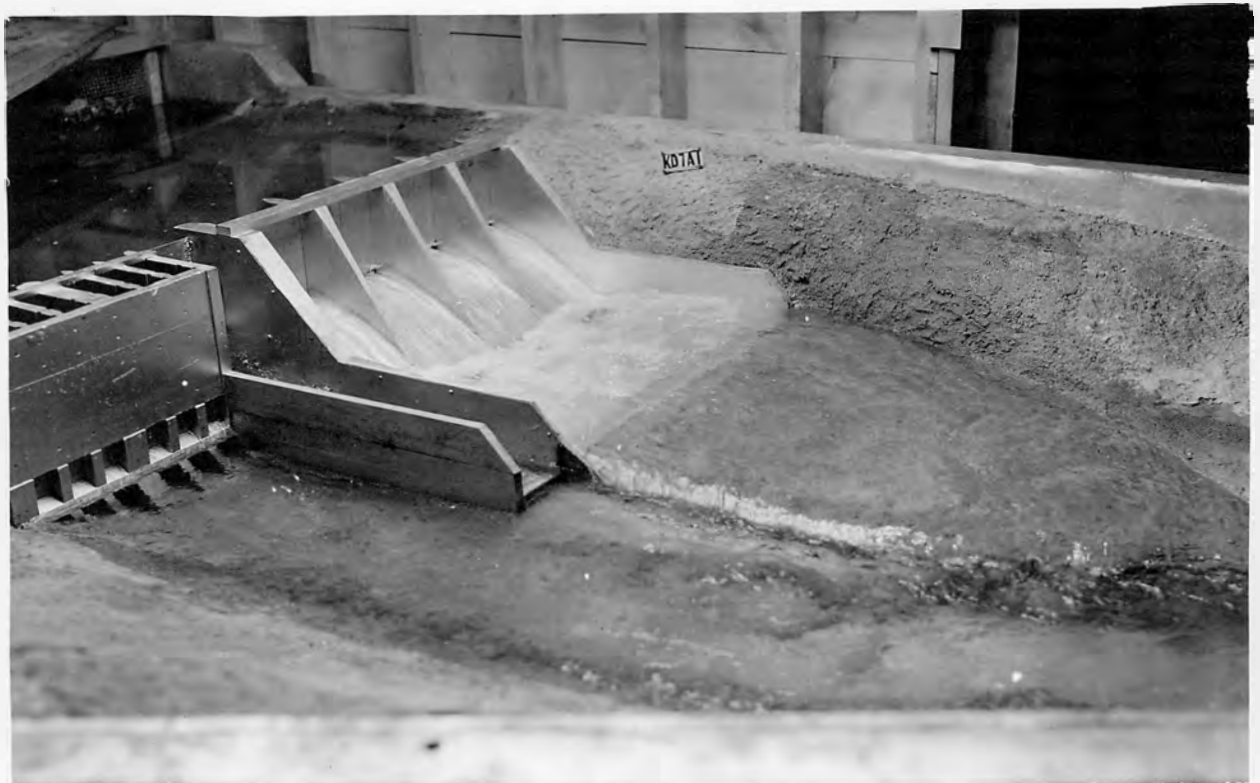
A. Spillway discharge, 25,000 second-feet; fishway discharge, 300 second-feet; no powerhouse discharge; and tailwater elevation 504.20.

B. Spillway discharge, 50,000 second-feet; fishway discharge, 300 second-feet; no powerhouse discharge; and tailwater elevation 513.60.

FLOW CONDITIONS IN RECOMMENDED DESIGN OF SPILLWAY
KESWICK DAM - 1:80 MODEL OF ULTIMATE DEVELOPMENT

9. Tests of the recommended design on the 1 to 80 model. After determining an acceptable spillway profile on the 1 to 48 sectional model, it was incorporated in the 1 to 80 model to study its action in conjunction with the other hydraulic features of the dam. The spillway operated satisfactorily under all conditions of flow expected on the prototype (figures 20 and 21). The hydraulic jump could not be swept from the apron at maximum discharge by lowering the tailwater elevation in the river channel. The rock bench was sufficiently high to prevent the tailwater falling below the sweep-out elevation. Pressure tests were made on the spillway section along the center of the second bay to the left of the powerhouse. The pressures were satisfactory, that is, greater than atmospheric, for all discharges (figure 22). The crest was calibrated by measuring the head over it for various discharges (figure 23). The prototype, however, should give slightly higher discharges for the same heads as the friction factor was not to scale, being relatively greater for the model.

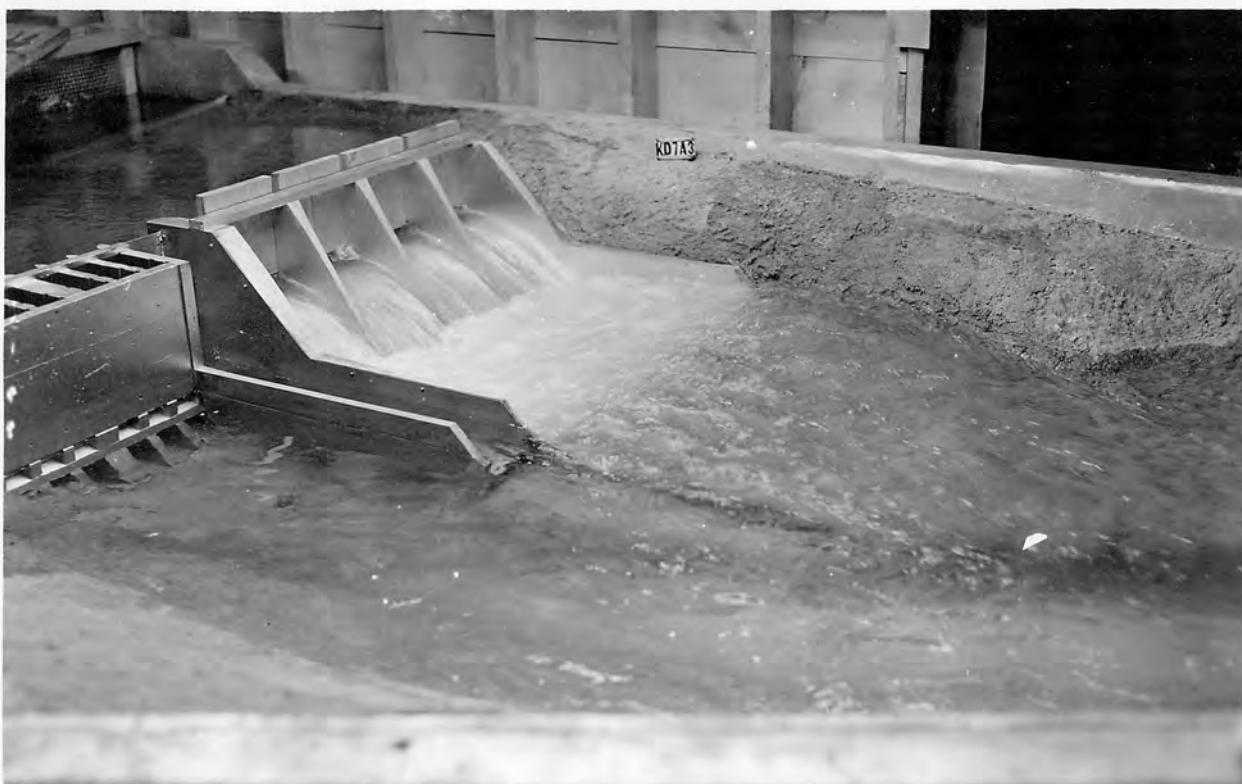
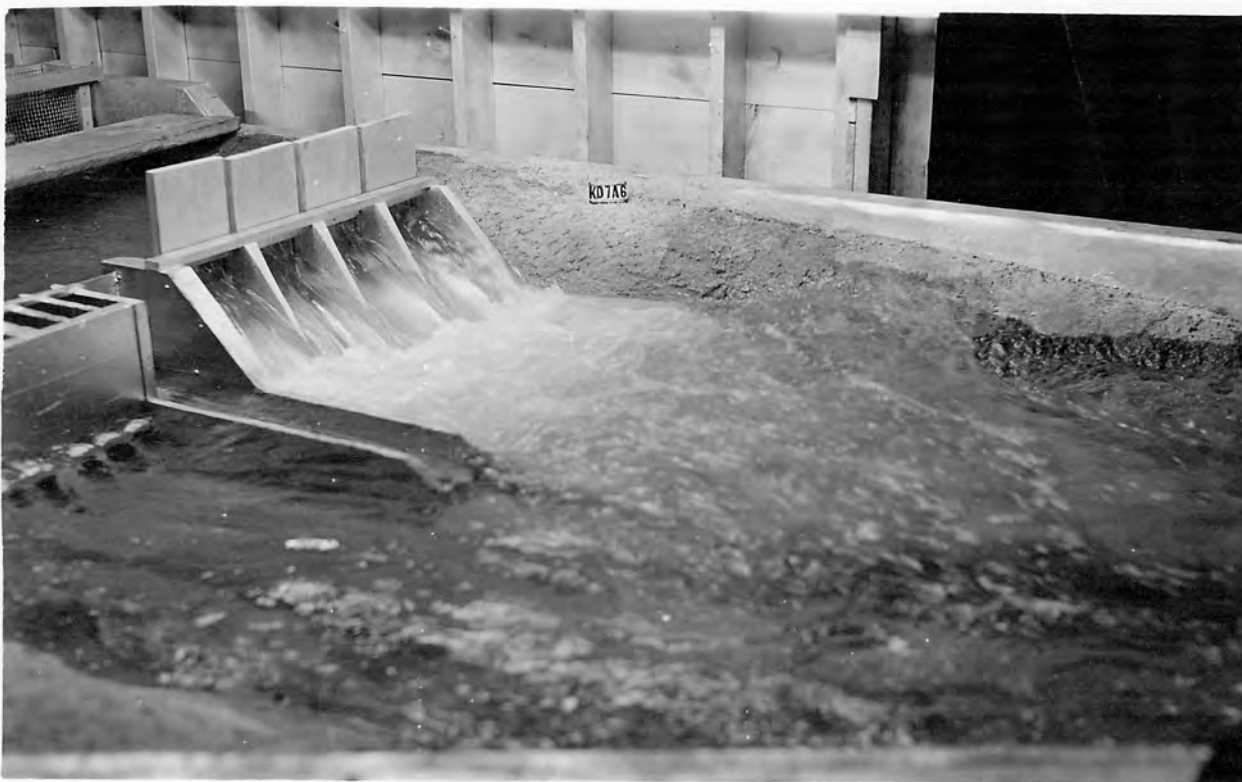
A. Spillway discharge, 100,000 second-feet; no fishway or powerhouse discharge; and tailwater elevation 524.20.

B. Spillway discharge, 250,000 second-feet; no fishway or powerhouse discharge; and tailwater elevation 541.00.

FLOW CONDITIONS IN RECOMMENDED DESIGN OF SPILLWAY

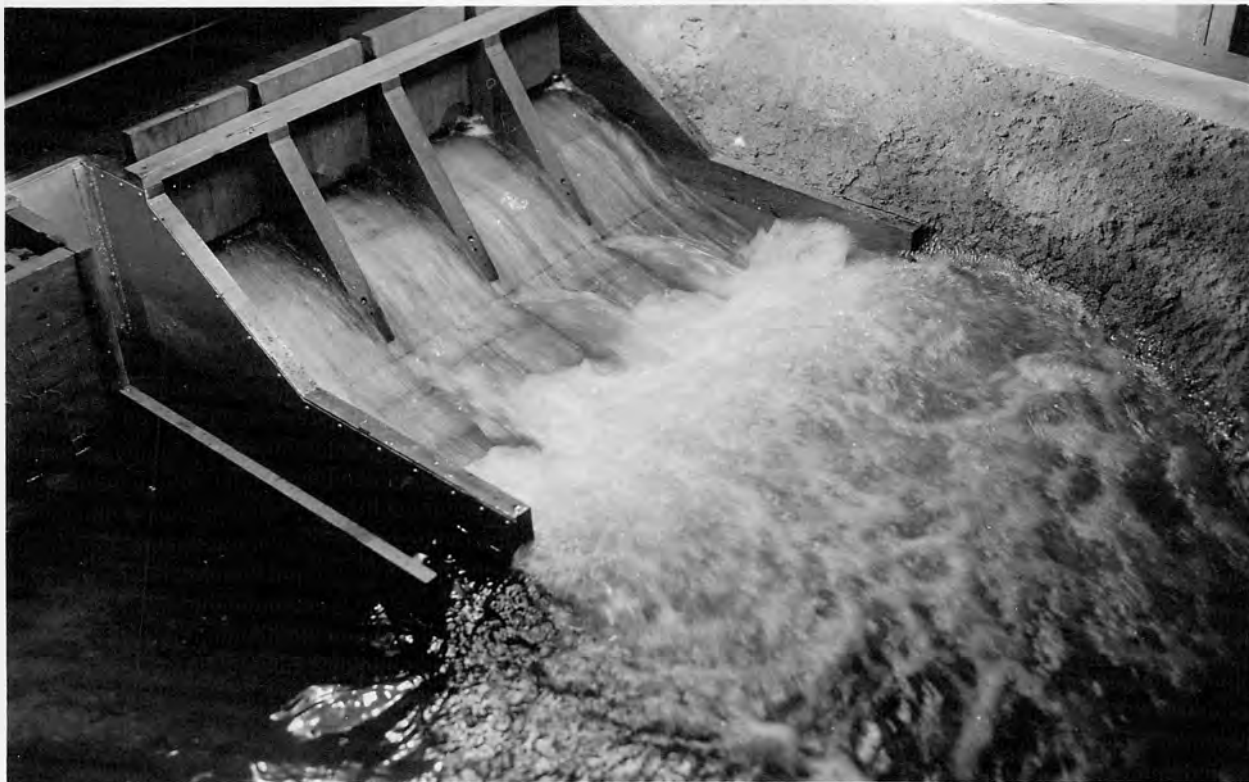
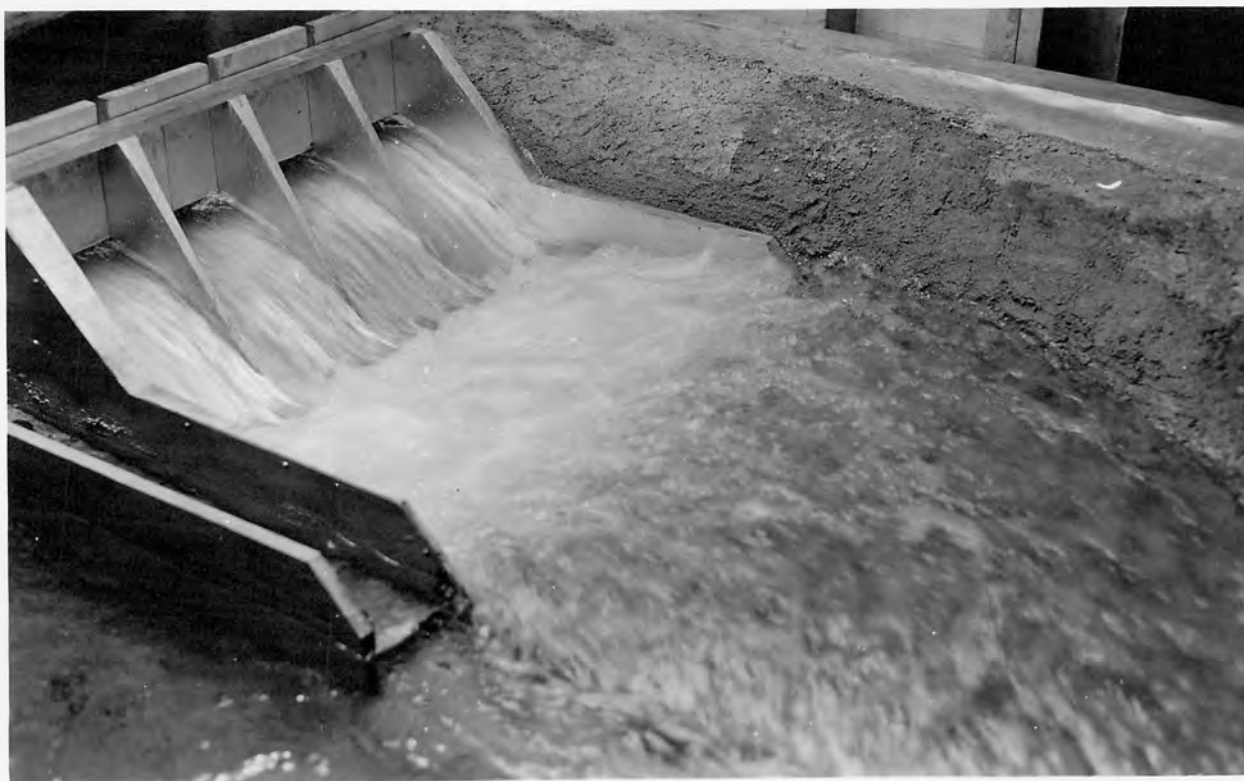
A. Fin downstream from original design of spillway piers.

B. Elimination of fin by streamlining of piers.

FLOW CONDITIONS IN STILLING POOL SHOWING EFFECT OF STREAMLINING SPILLWAY
PIERS

The downstream end of the piers were streamlined to eliminate fins forming downstream on the original design (figure 24). Other tests made will be described subsequently under fishway studies.

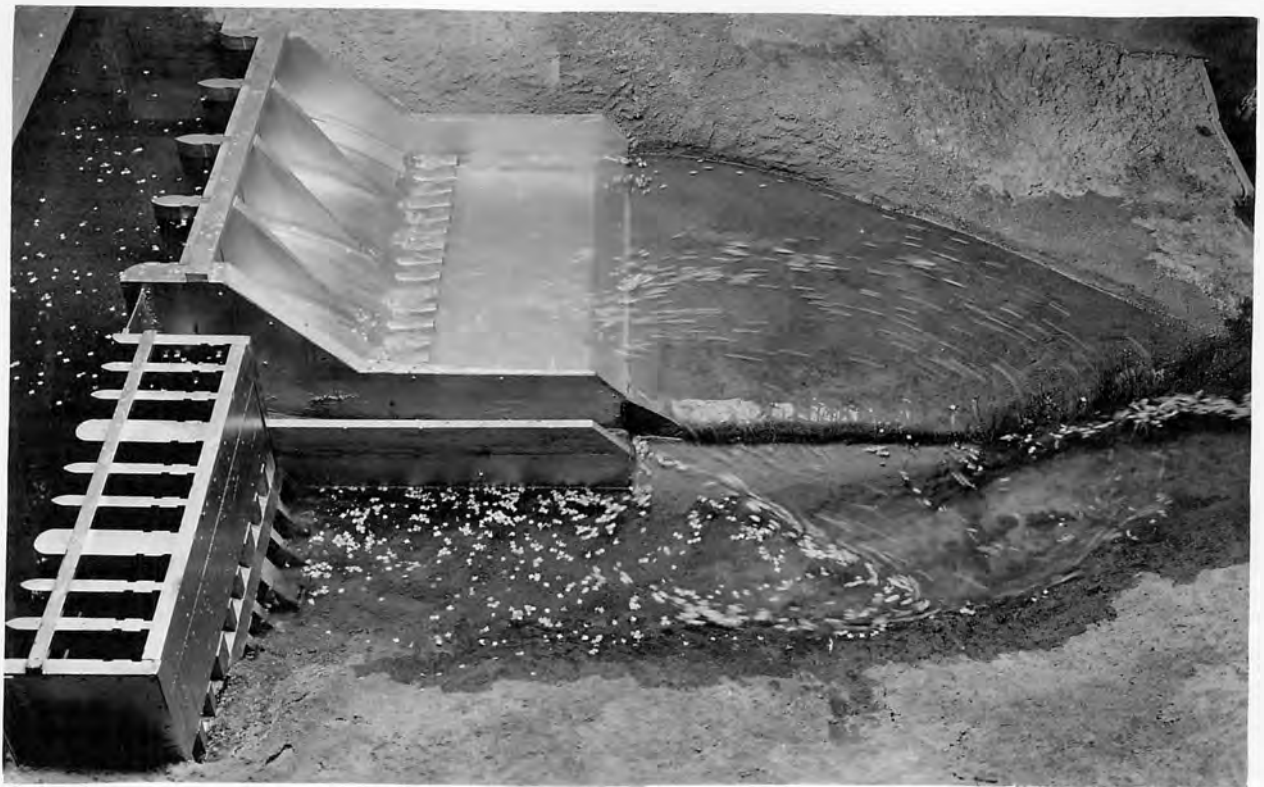
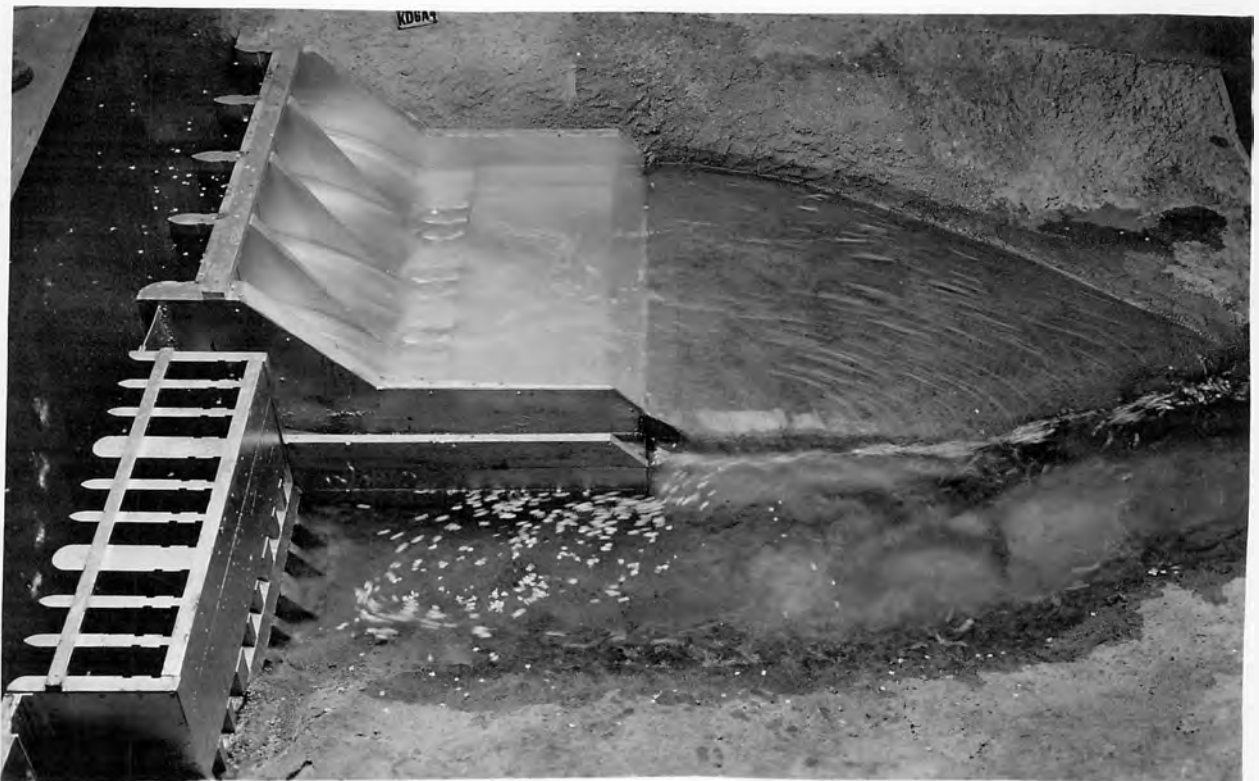
A. Spillway discharge, 3,000 second-feet; fishway discharge, 300 second-feet; no powerhouse discharge; and tailwater elevation 488.00.

B. Spillway discharge, 15,000 second-feet; fishway discharge, 300 second-feet; no powerhouse discharge; and tailwater elevation 498.75.

FLOW CONDITIONS IN RIVER CHANNEL WITH RECOMMENDED DESIGN OF SPILLWAY

Though the original design of the ultimate stage was reasonably satisfactory from the standpoint of fishway operation (figure 8A), hydraulic conditions dictated the changes in spillway design previously described. When the revised spillway design was included in the 1 to 80 scale model, flow conditions were satisfactory for the fishway (figure 25).

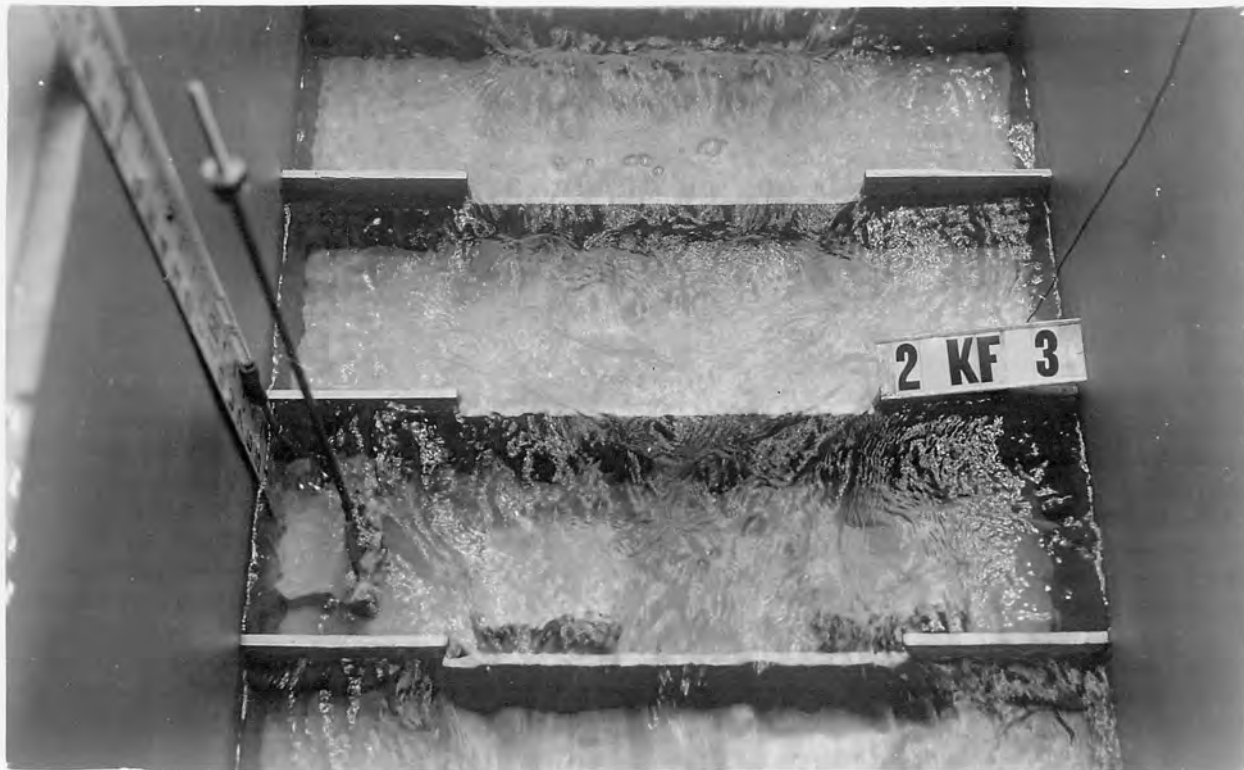
B. Action with flow of 120 second-feet through pools of ladder and 180 second-feet from auxiliary outlet in floor of pool in foreground.

FLOW CONDITIONS IN ORIGINAL DESIGN OF FISHWAY LADDER

13. Operating characteristics of the ladder. Flow characteristics from pool to pool down the ladder were considered satisfactory for the proper operation of the fishway (figure 28). The tests demonstrated that a ladder slope of 1 to 12 gave flow conditions which would induce the fish to climb the ladder. The velocities were also sufficiently low to obviate the danger of possible injury to the fish if forced against the side of the fishway by the currents. This factor was one of the most important design considerations to be checked by the model study, for all cuts, bruises, and similar injuries to salmon will not heal in fresh water. The plan of admitting additional water from below into every third pool by means of the auxiliary water supply system to maintain the proper velocity in the fishway entrance seemed quite satisfactory with the exception of minor modifications to be described subsequently. When the tailwater elevation rises, the upstream auxiliary conduits will be opened to introduce the auxiliary flow at the approximate tailwater surface. This may be done by closing the downstream outlets, or partially closing them when the upstream outlets are opened.

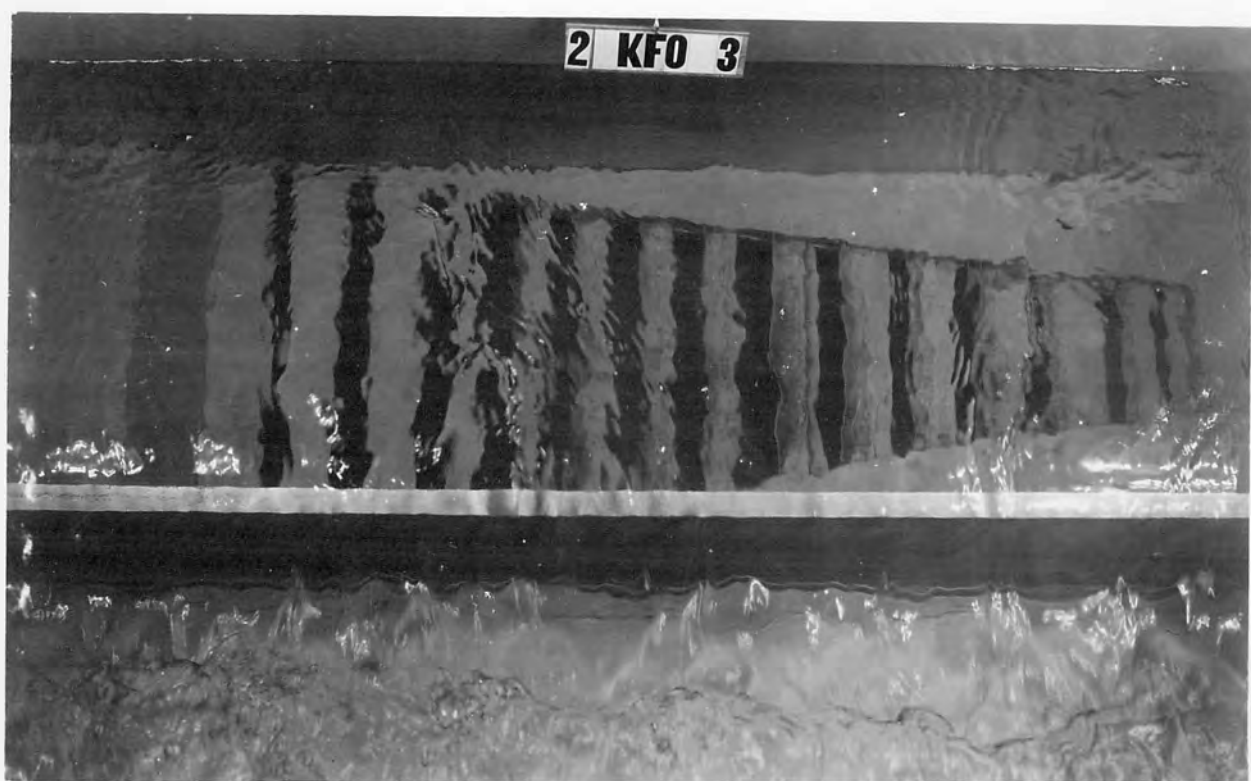
B. Design 3, figure 30.

FLOW CONDITIONS WITH DISCHARGE OF 220 SECOND-FEET THROUGH AUXILIARY
SUPPLY OUTLET
