MODEL TESTS OF GILA VALLEY CANAL
HEADWORKS AND BALL CHECK VALVES FOR
THE DESILTING BASINS--IMPERIAL DAM--
ALL AMERICAN CANAL PROJECT

Hydraulic Laboratory Report No. Hyd. 183

Subject: Model tests of Gila Valley Canal Headworks and Ball Check
Valves for the Desilting Basins - Imperial Dam - All-American
Canal Project.

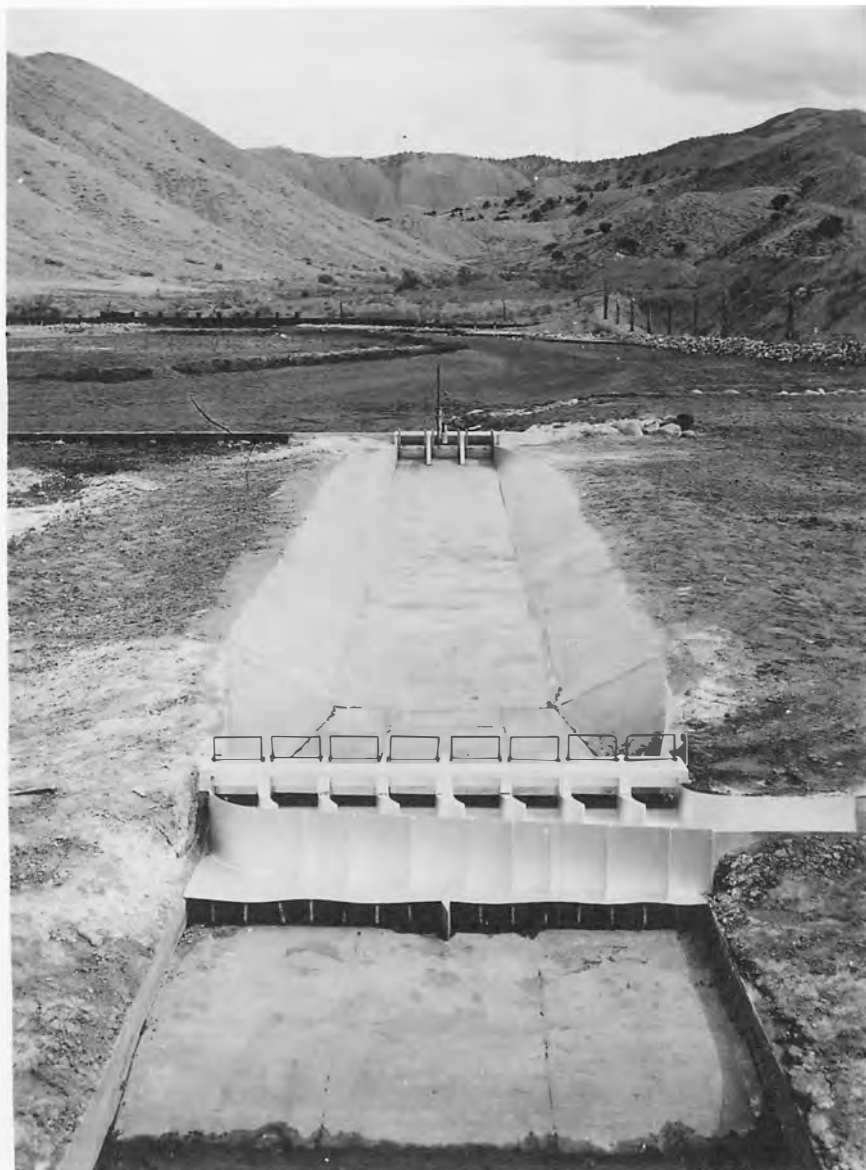
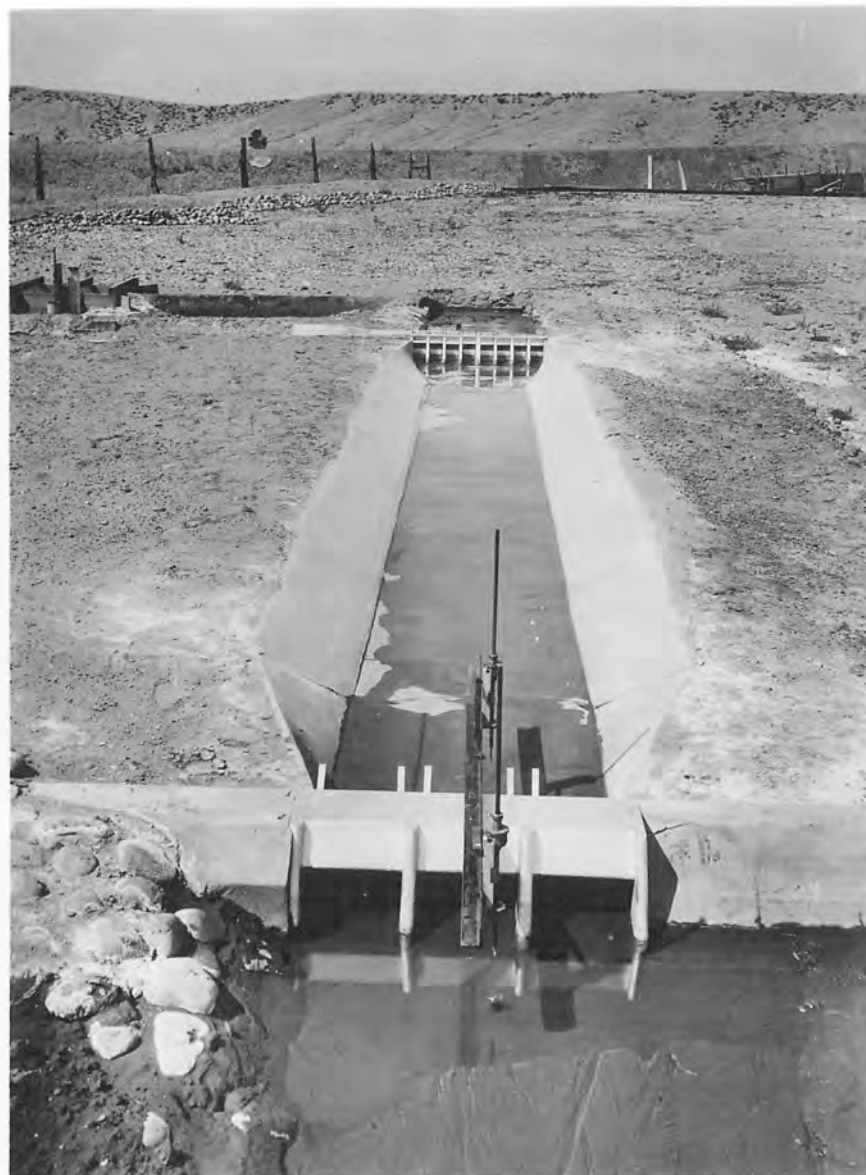
GILA VALLEY CANAL HEADWORKS

Looking Upstream

Looking Downstream

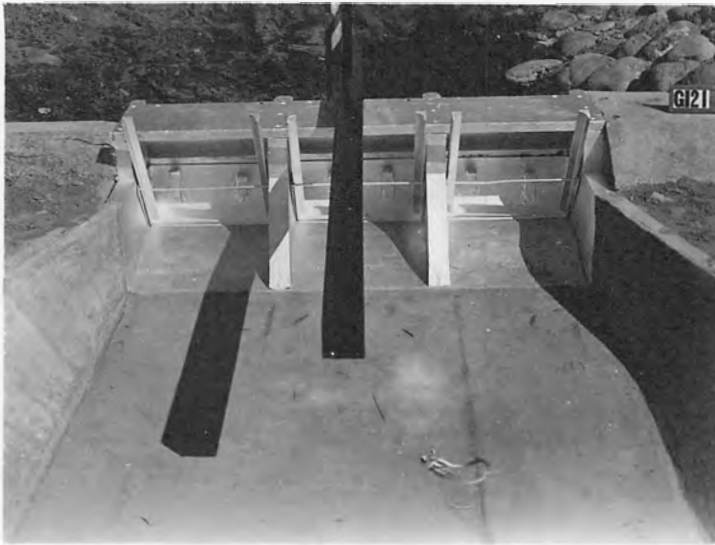
Inlet Structure

Looking Upstream

Looking Downstream

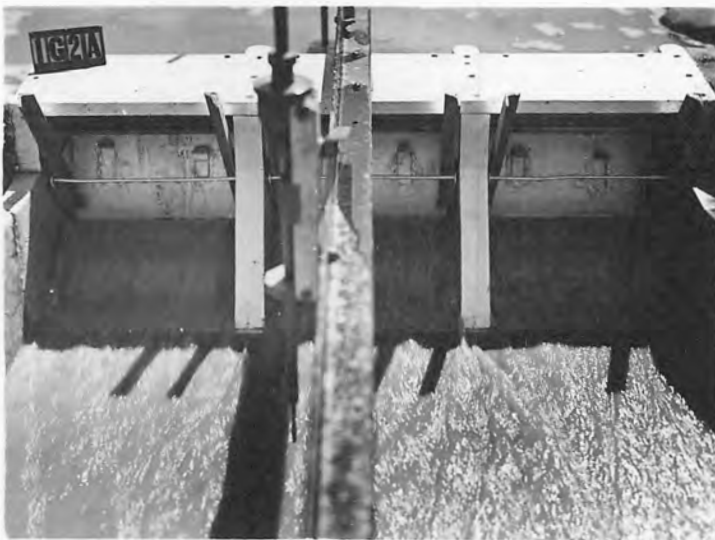
Flow Conditions - Plan 1

Low Tailwater

Medium Tailwater

2. Improvement of Inlet Gate Crest. Preliminary runs on the original design of the crest of the inlet structure plan 1, figure 4, had indicated that very bad entrance conditions existed under the lip of the gate when these gates were opened only a small amount and the water in the desilting basin was low, figure 5. Consequently, runs were made on this design and on the several proposed changes by raising the water surface in the desilting basin by one-foot steps beginning at elevation 161.0 and ranging to elevation 179.5. The adverse condition consisted of a shooting jet of water which broke

free of the crest at the lip of the gate and impinged on the crest at the extreme downstream end, figure 5. This condition existed until the water in the desilting basin gained an elevation of 171.0, at which point the jet became drowned and various forms of surges and rolls existed until the water surface reached an elevation of 179.5, figures 5 and 6. With the maximum water surface the flow was fairly smooth. In an effort to eliminate this jet condition the area above the inlet gates was paved for a distance of about 32 feet upstream, on a slope beginning at elevation 159.0 and rising to elevation 164.5 at the crest, plan 2, figure 4. This plan did not improve the flow conditions over the crest as is shown by the pictures on figure 6. A comparison of the pictures on figures 5 and 6, show that practically the same conditions exist with or without the paving in this area. In a further attempt to improve this flow condition the upstream paving was changed as shown on plan 3, figure 4. With a low water level in the desilting basin the water did not tend to leave the crest but flowed smoothly over it, figure 7. At medium water surface elevation the flow was very much improved, being smoother and quieter than in previous tests. With the maximum water surface elevation in the desilting basin the flow entered so evenly that scarcely a ripple was visible on the surface, figure 7. Unless construction or operation conditions warrant otherwise, it is recommended that this plan be considered as the solution to the problem.

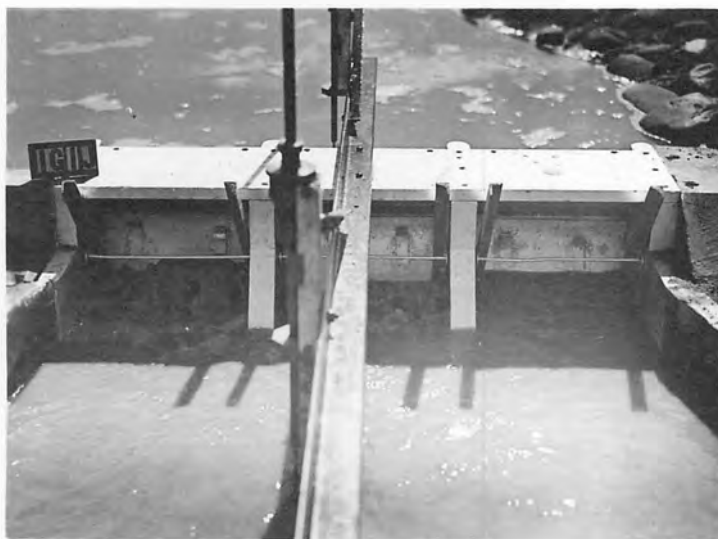
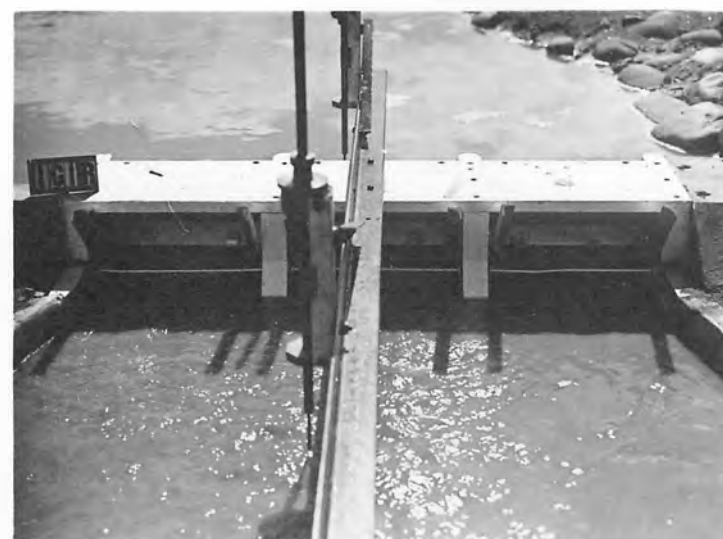
Flow Conditions - Plan 2

Medium Tailwater

High Tailwater

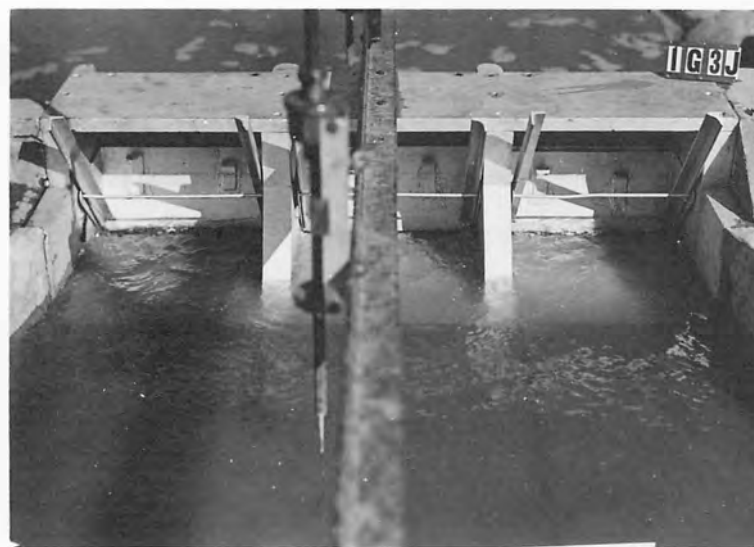
Low Tailwater

Medium Tailwater

High Tailwater
FLOW CONDITIONS - PLAN 3

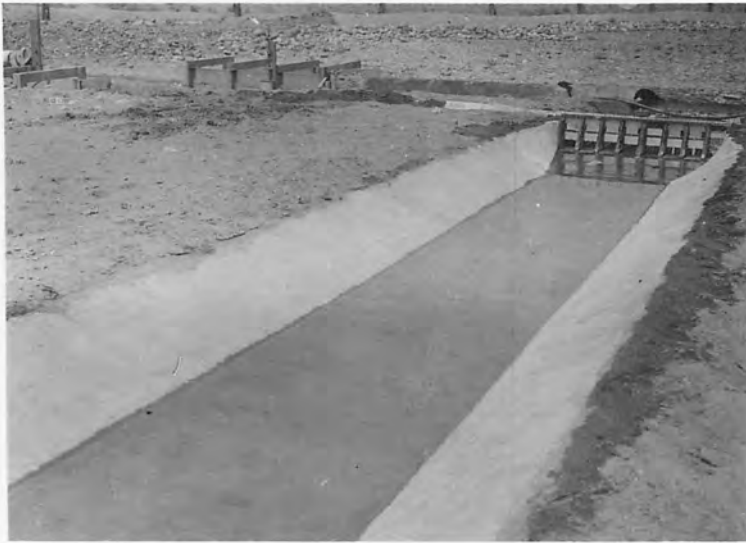
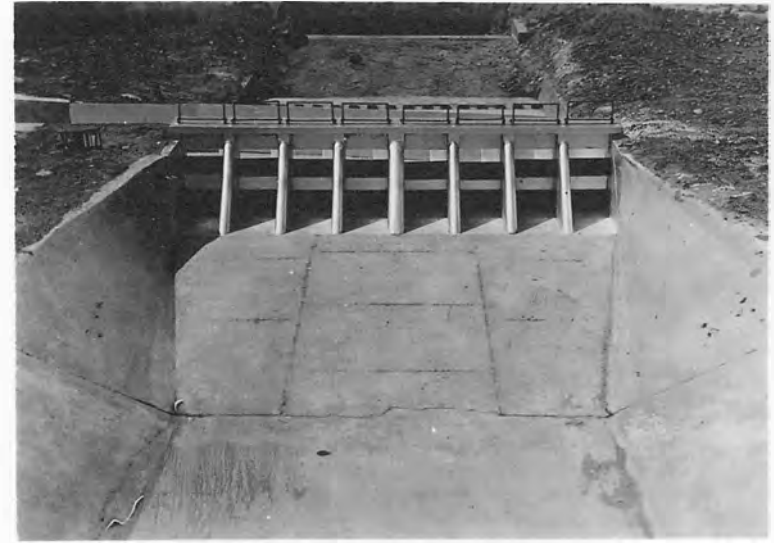
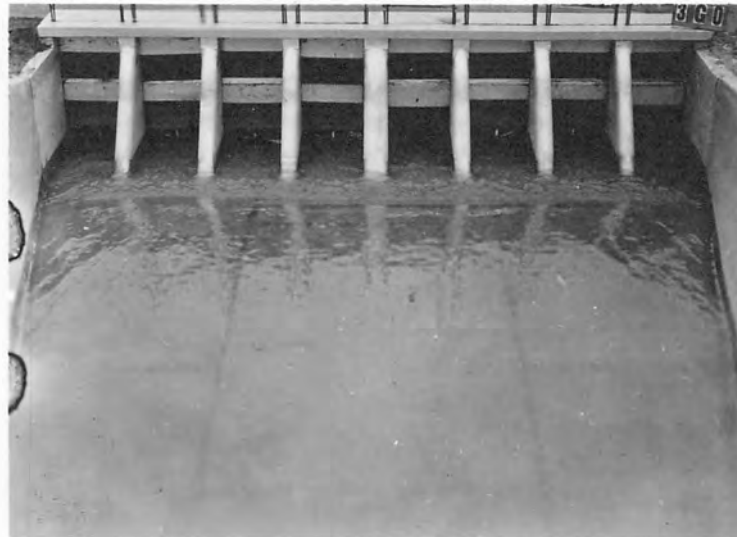
Structure & Desilting Basin

Looking Downstream

Flow Conditions - Looking Downstream
SLUICeway STRUCTURE - ORIGINAL DESIGN

Preliminary tests had indicated that with the original design undesirable hydraulic conditions existed downstream from the wide center pier of the sluiceway structure. A wide fin of water was spread over practically the entire paved area below the structure and caused undesirable rough waves on this surface due to flow from the other openings striking this larger fin of water. The worst condition existed with the water surface in the desilting basin at the top of the sluice gates and a discharge of 2,000 second-feet, figure 11. The first attempt to improve this condition consisted of extending this pier 20 feet downstream in the shape of a wedge, plan 1, figure 12. This pier addition improved the flow distribution and entirely eliminated any disturbance below the structure, figure 11, but due to the narrowness of the pier it was believed that the same results might be obtained with a short section which

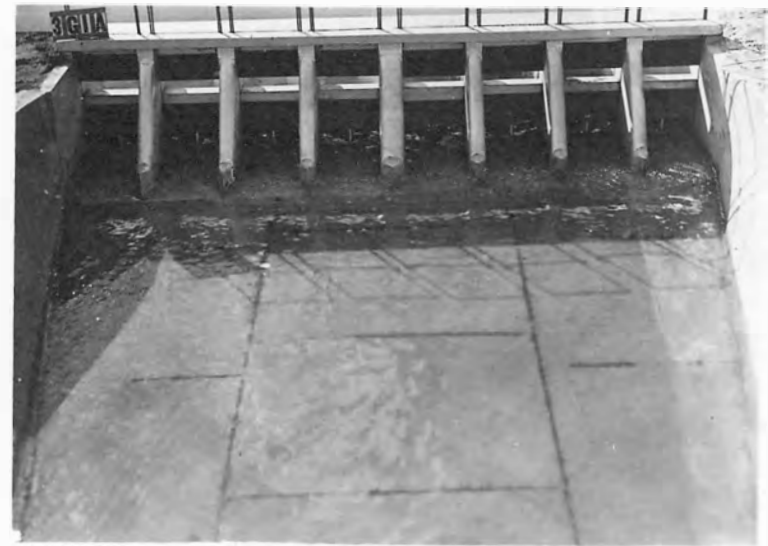
New pier shape - Looking Downstream

Flow conditions - Looking Downstream

Flow conditions around one pier
SLUICeway STRUCTURE - IMPROVED DESIGN

would conform better to the general shape of the structure. With this thought in mind the next section tested was of the same general shape but only 10 feet in length, plan 2, figure 12. This addition did not give quite as good results as the longer section but since it conforms more to the general shape of the structure it is considered satisfactory, figure 11.

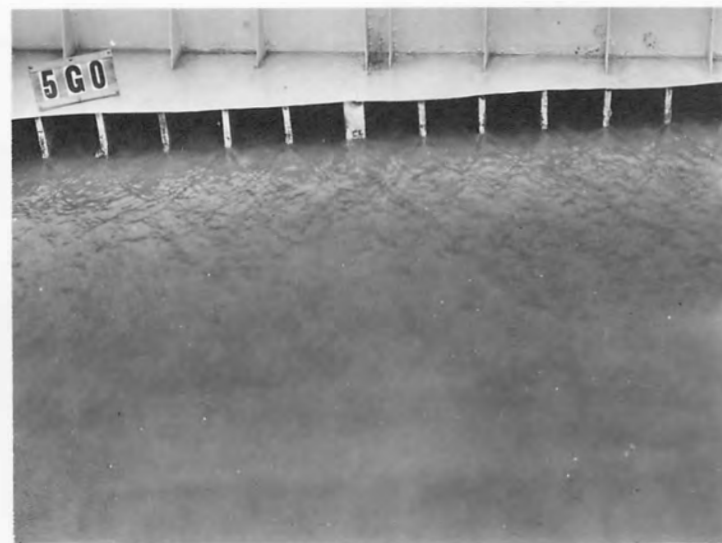
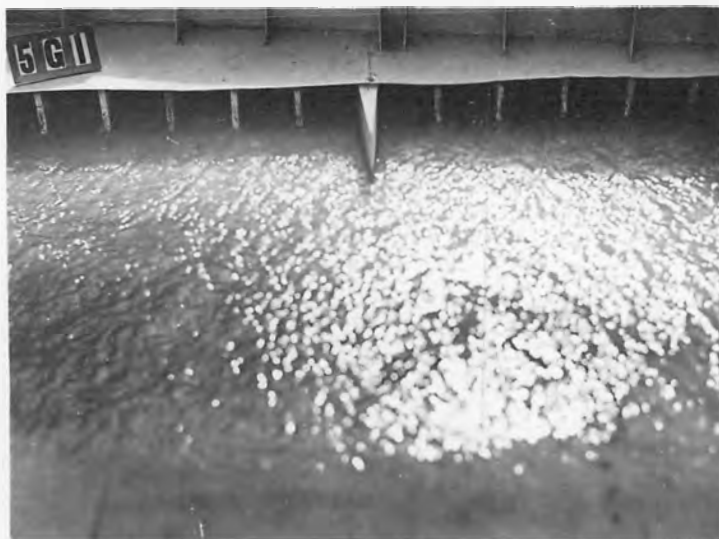
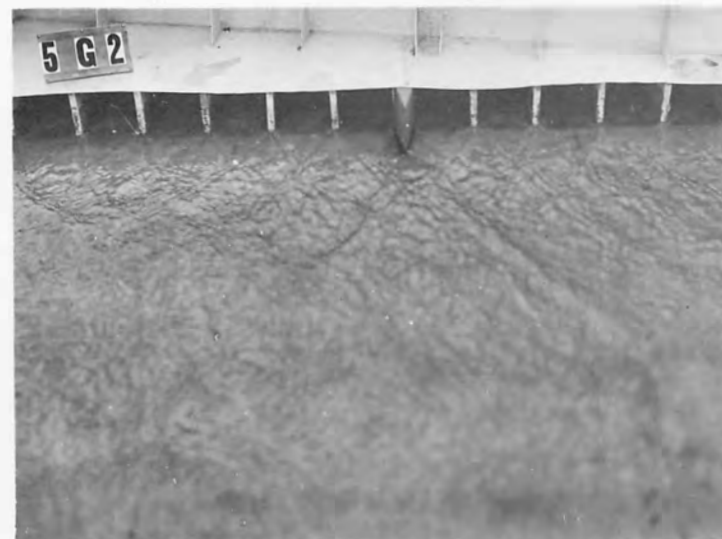
UPSTREAM VIEW OF SLUICWAY STRUCTURE

Original Design

Flow conditions - Original Design

Flow conditions - Plan 1

Flow conditions - Plan 2

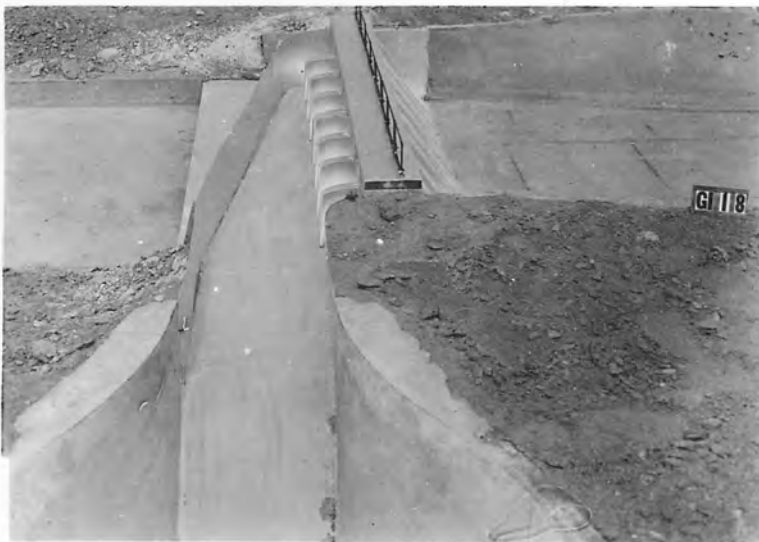
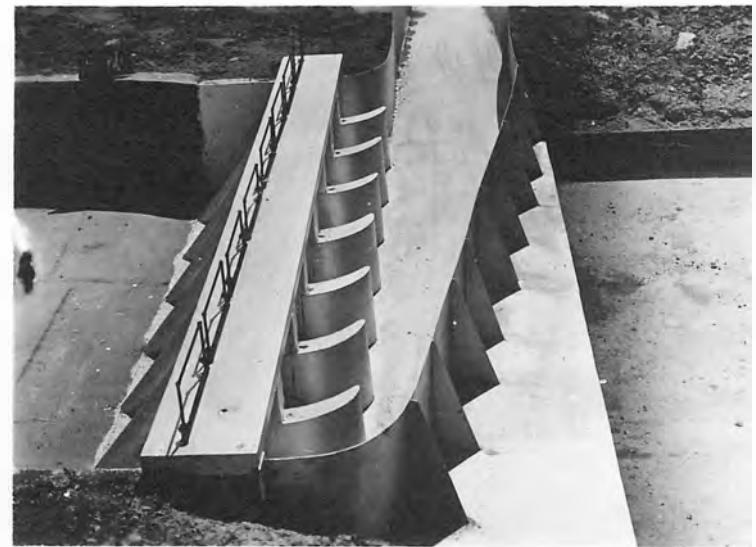
View from left

View from right

Flow Condition - Plan 1

Flow Condition - Plan 2

The water surface in the desilting basin was held at elevation 179.5. The first attempt to improve the conditions in the channel consisted of shortening the three pier tails on the right, plan 2, figure 13. Some improvement was noted in the flow, especially between the second and third gates from the right, figure 14, and some of the whirl was quieted in the canal channel. There was also an evident drop in head

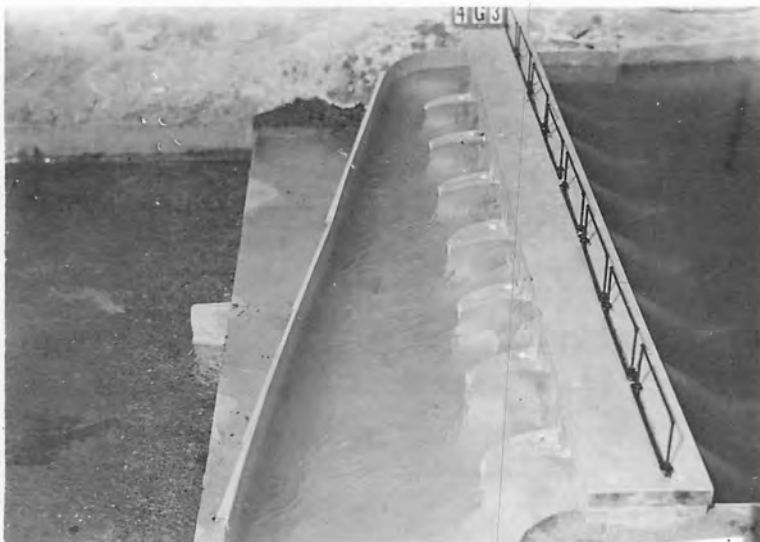
Flow Conditions - Plan 4

The formation of a slight roll below each gate was noted. The jet from each of the gates was visible to the center of the channel and then became evenly distributed in the canal. These three changes, namely, change in shape of pier tails, plan 3, figure 15, new position of canal wall, plan 4, figure 15, and raising the bottom of the beam above the gates, have combined to improve the distribution of flow and entrance conditions in the canal.

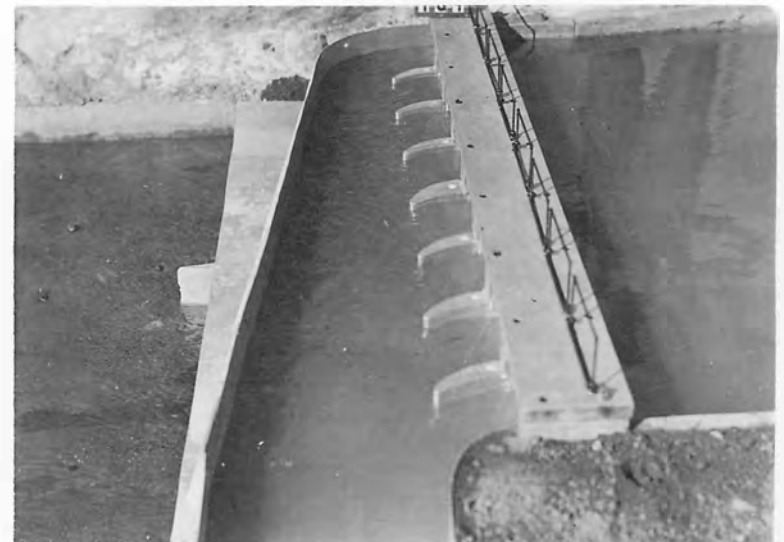
Flow Conditions - Bottom of Beam
above Gates at Elevation 180.0
