HYDRAULIC MODEL STUDIES OF GRASSY LAKE DAM OUTLET WORKS AND SPILLWAY

UPPER SNAKE RIVER PROJECT, WYOMING

Hydraulic Laboratory Report No. Hyd-226

Subject: Hydraulic model studies of Grassy Lake Dam Outlet Works and
Spillway--Upper Snake River Project, Wyoming.

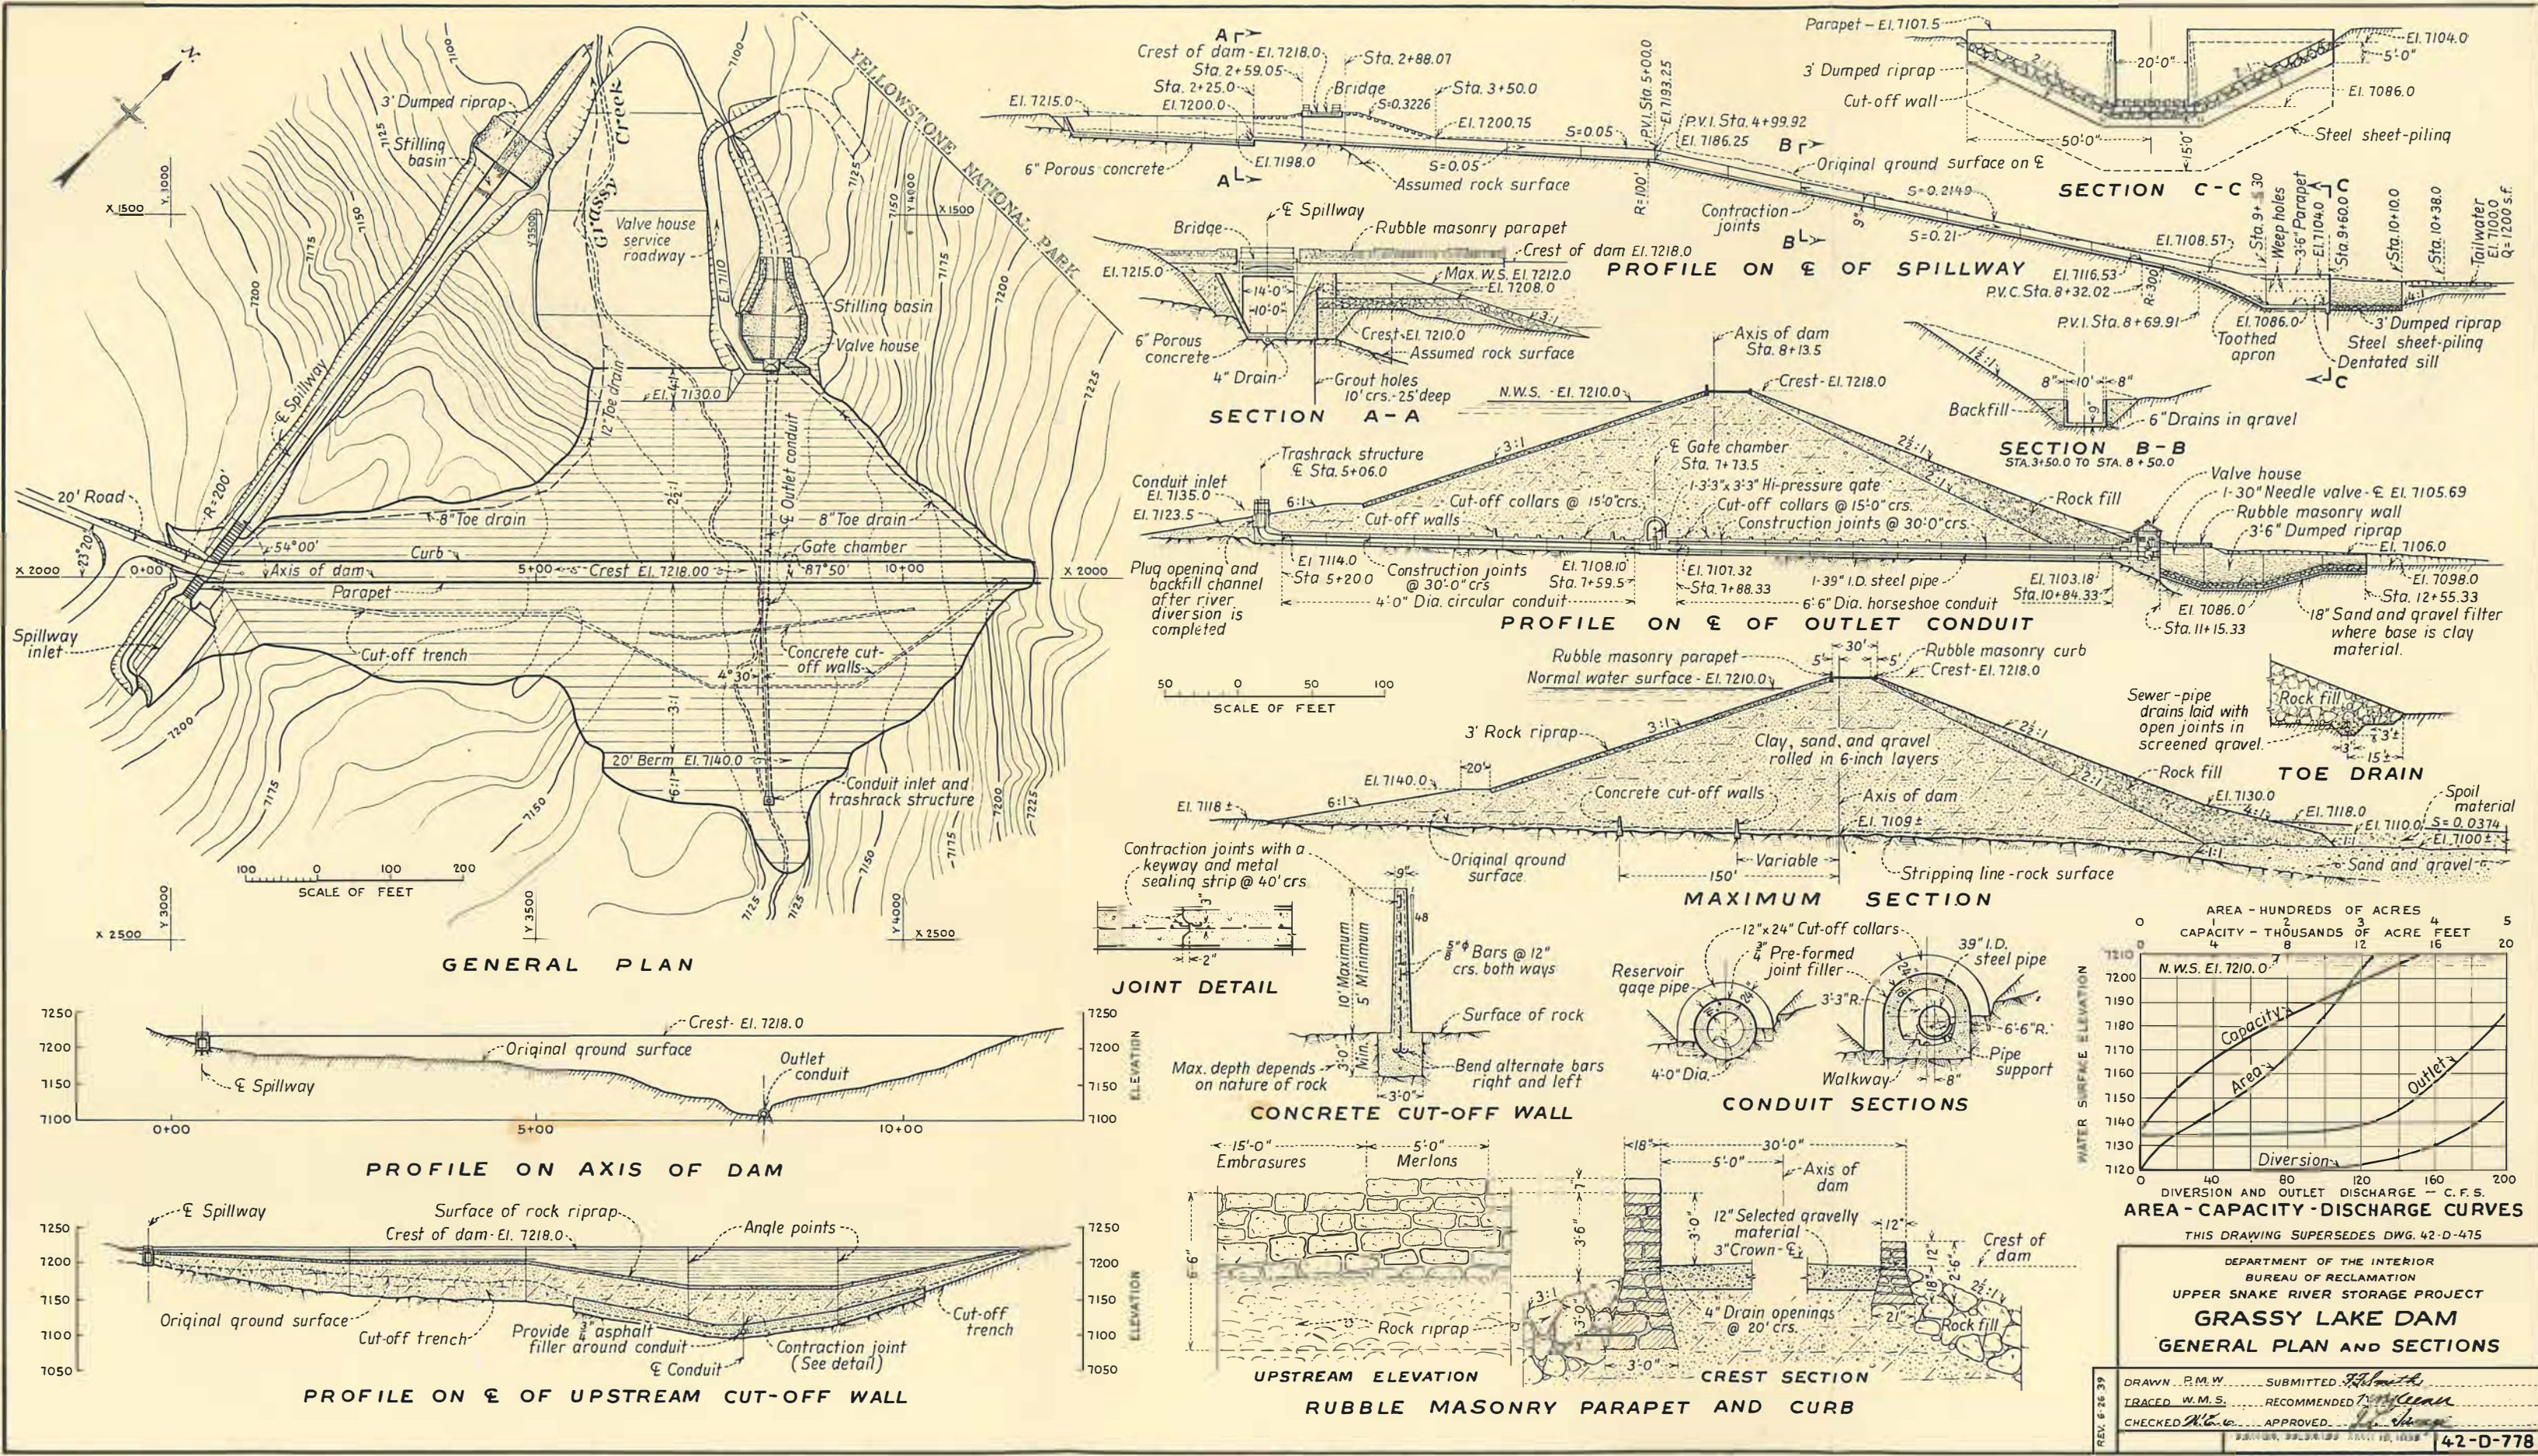
GRASSY LAKE DAM
GENERAL PLAN AND SECTIONS

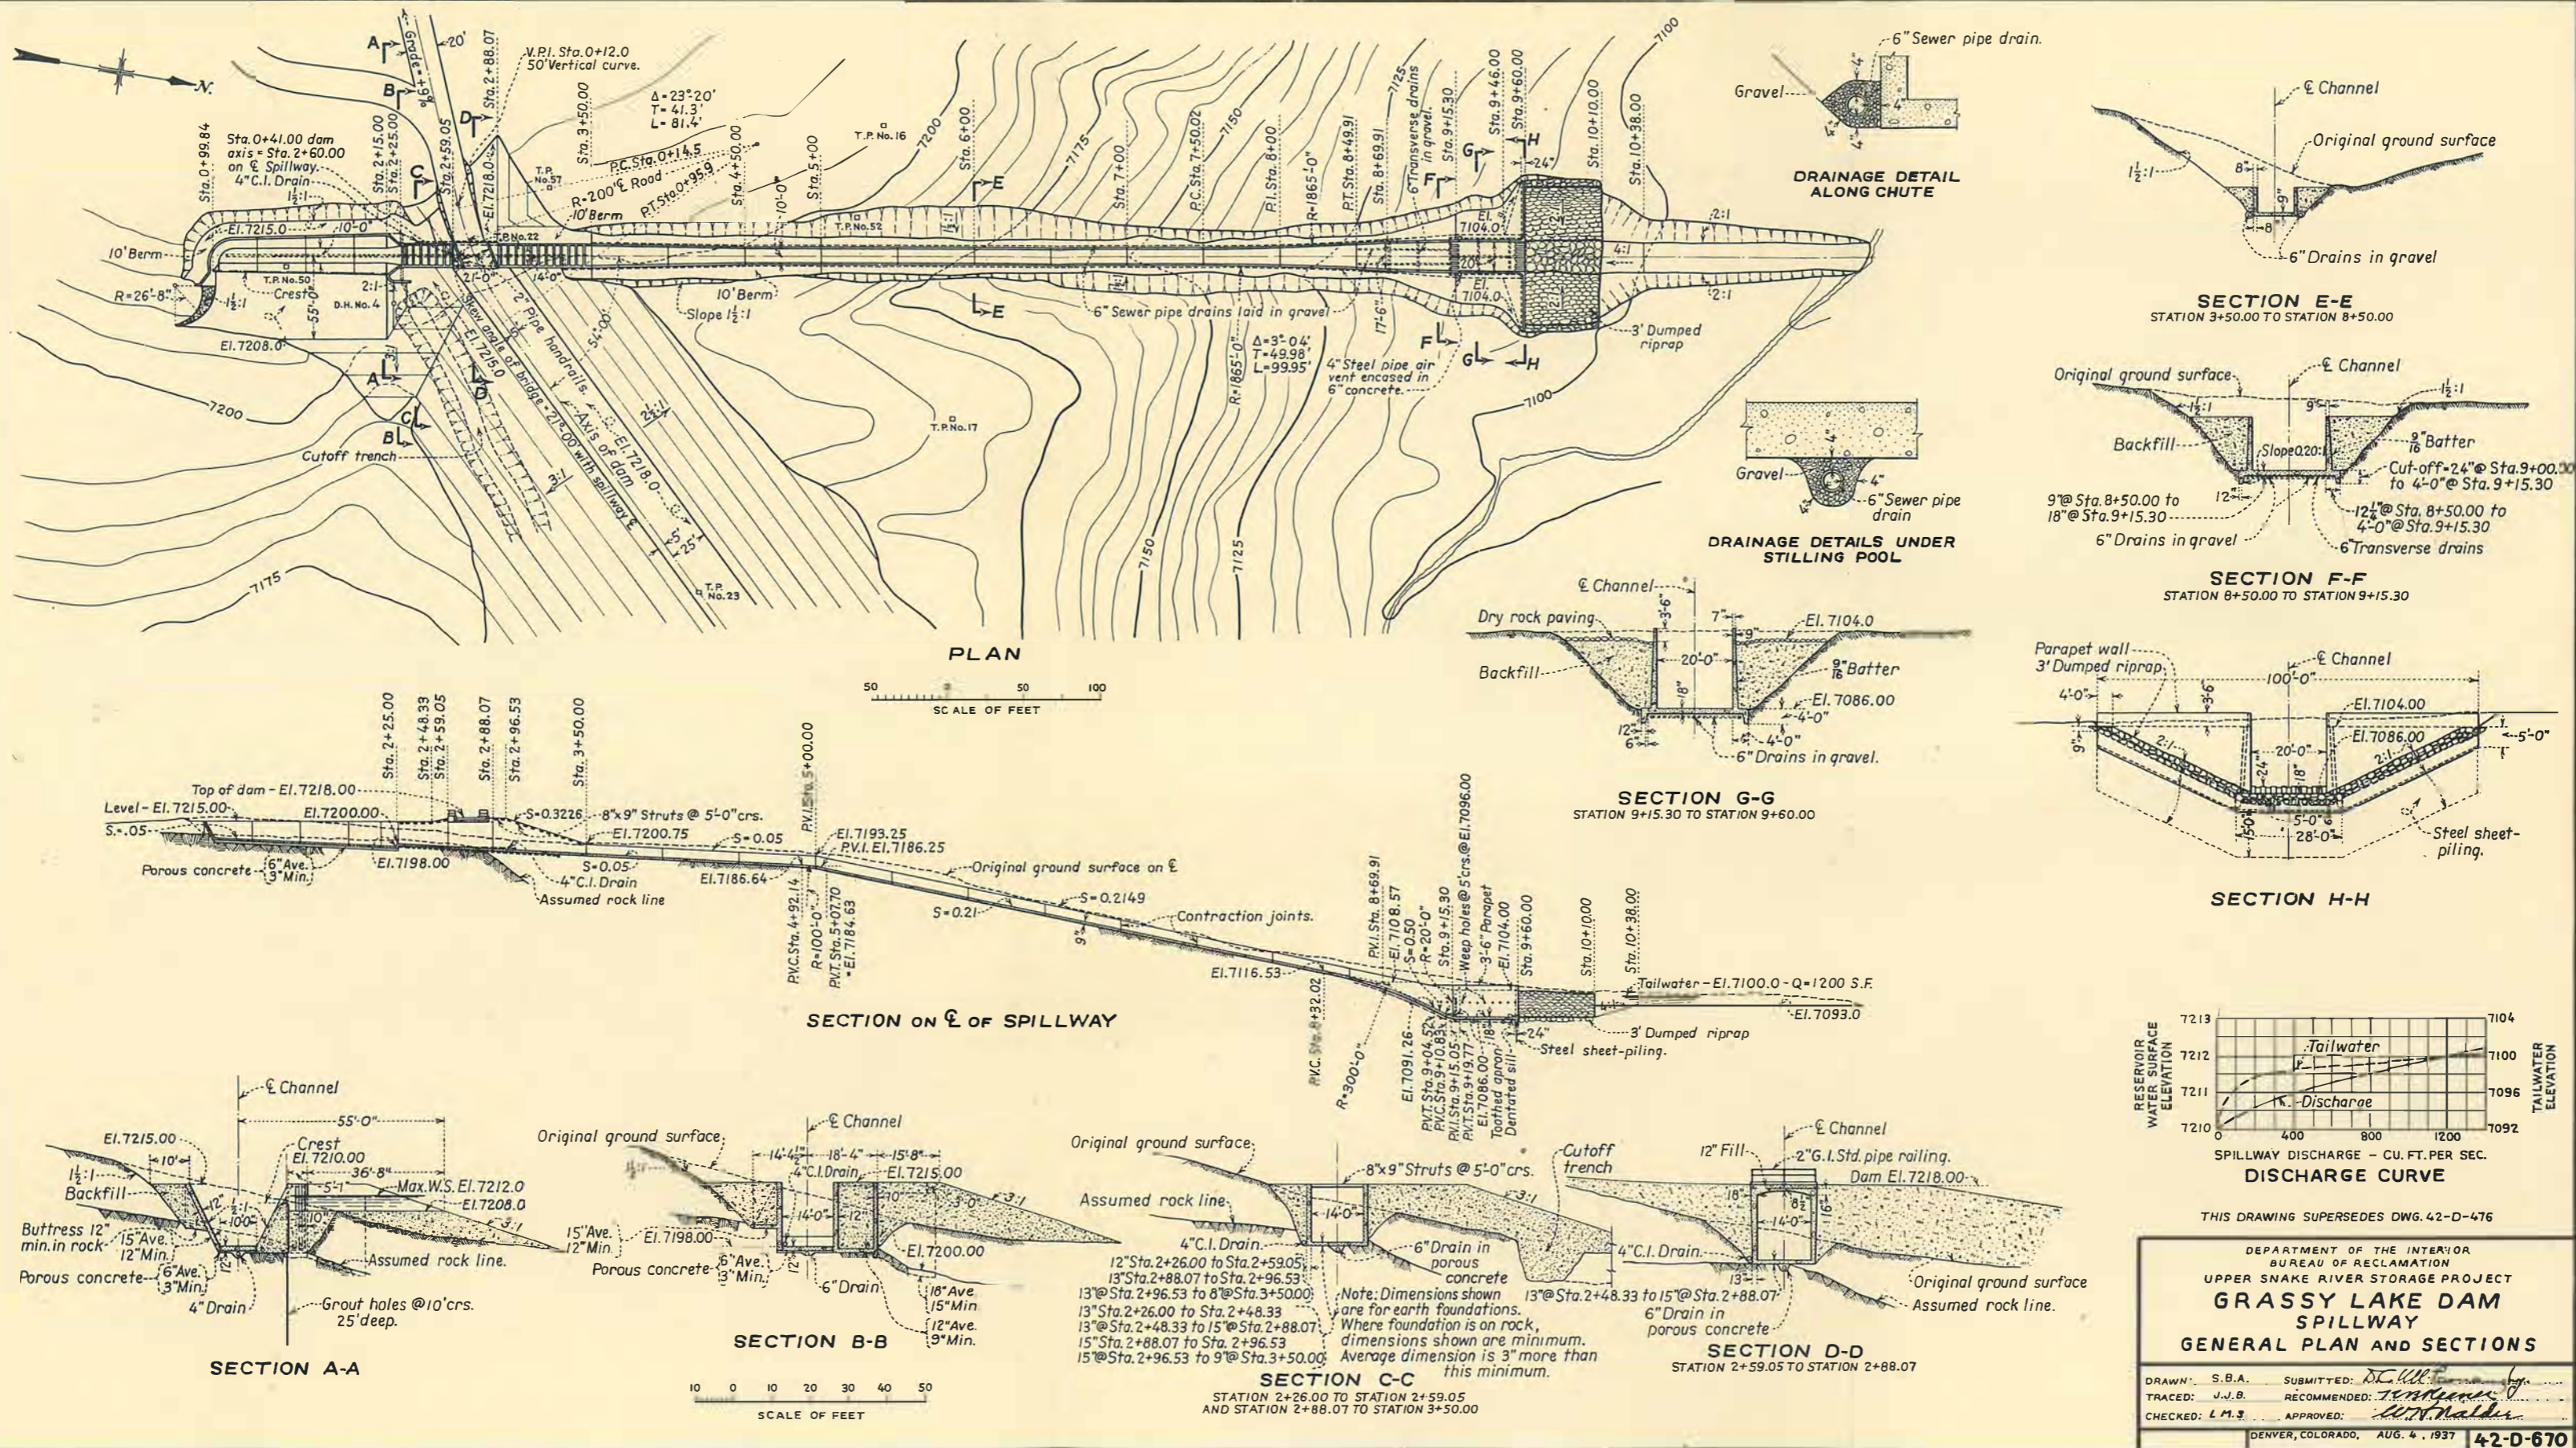
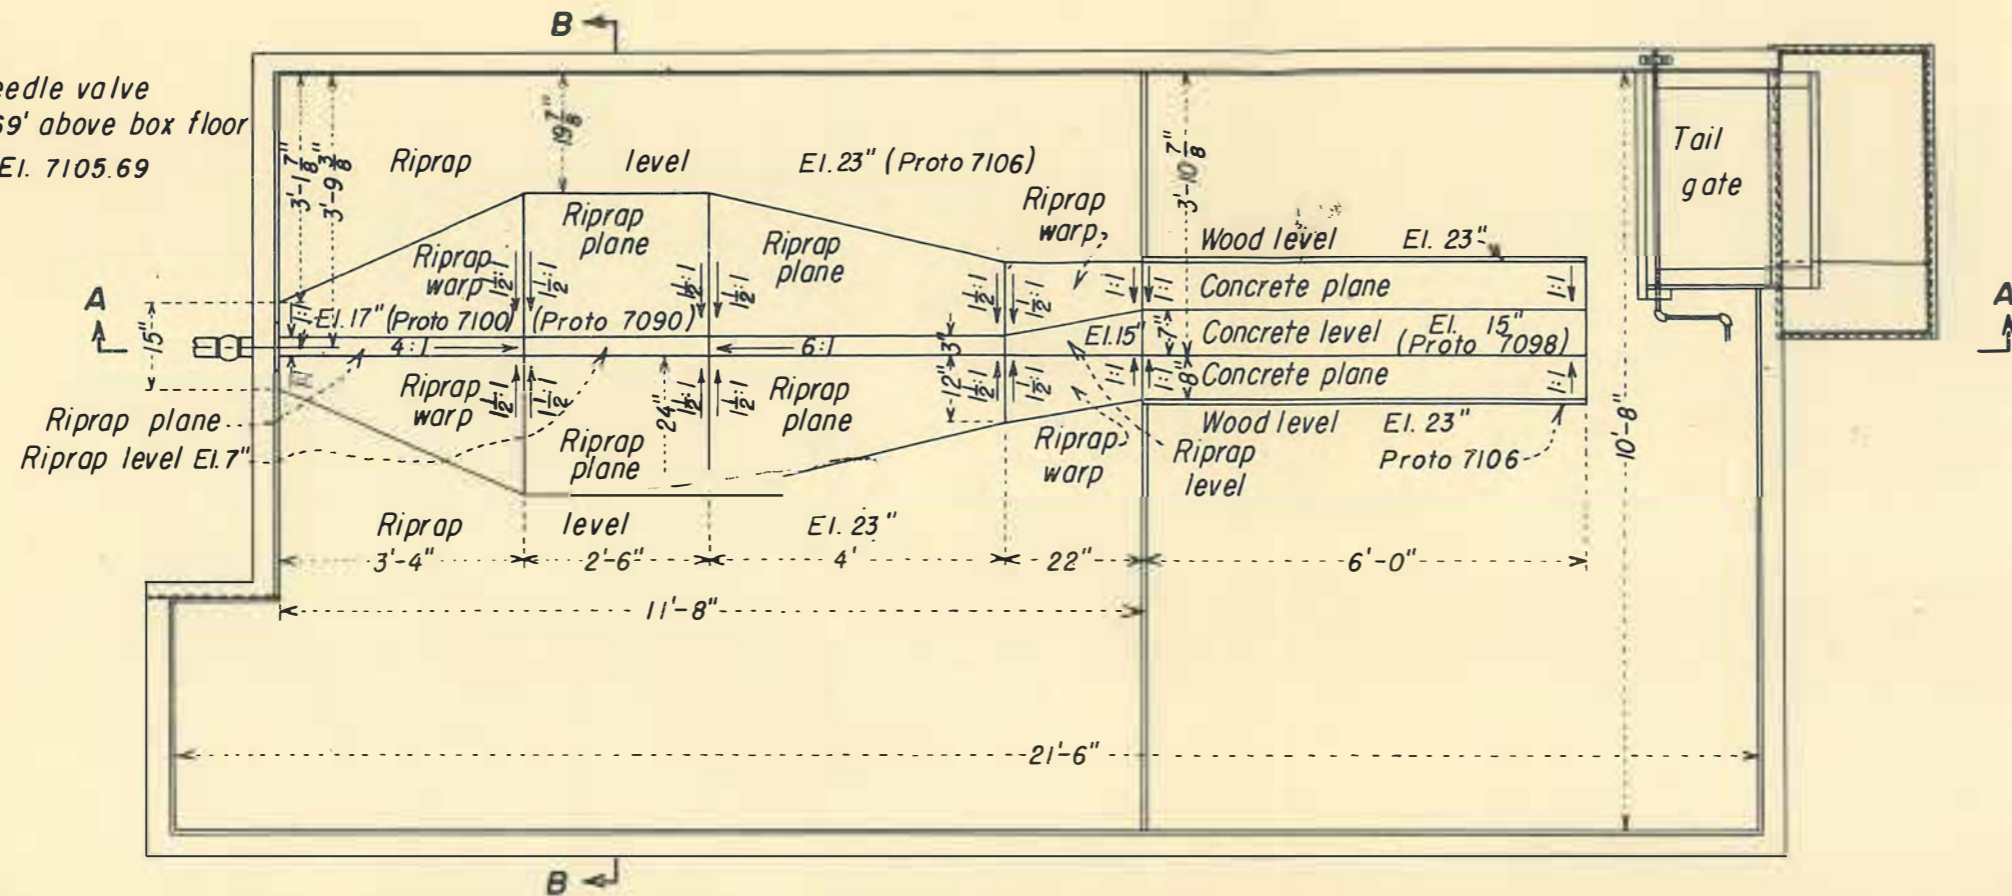
SECTION A-A

Elevations shown are above bottom of box (Proto 7083). Riprap to be evenly graded from $\frac{3}{4}$ " to 2" gravel and to have a vertical depth of at least 2".

UNITED STATES	
DEPARTMENT OF THE INTERIOR	
BUREAU OF RECLAMATION	
UPPER SNAKE RIVER - PROJECT	
GRASSY LAKE DAM	
HYDRAULIC MODEL STUDIES	
MODEL SCALE 1:12	
ORIGINAL OUTLET WORKS POOL	
DRAWN... R.C.B.	SUBMITTED.....
TRACED... J.H.W.	RECOMMENDED.....
CHECKED.....	APPROVED.....
DENVER, COLO.

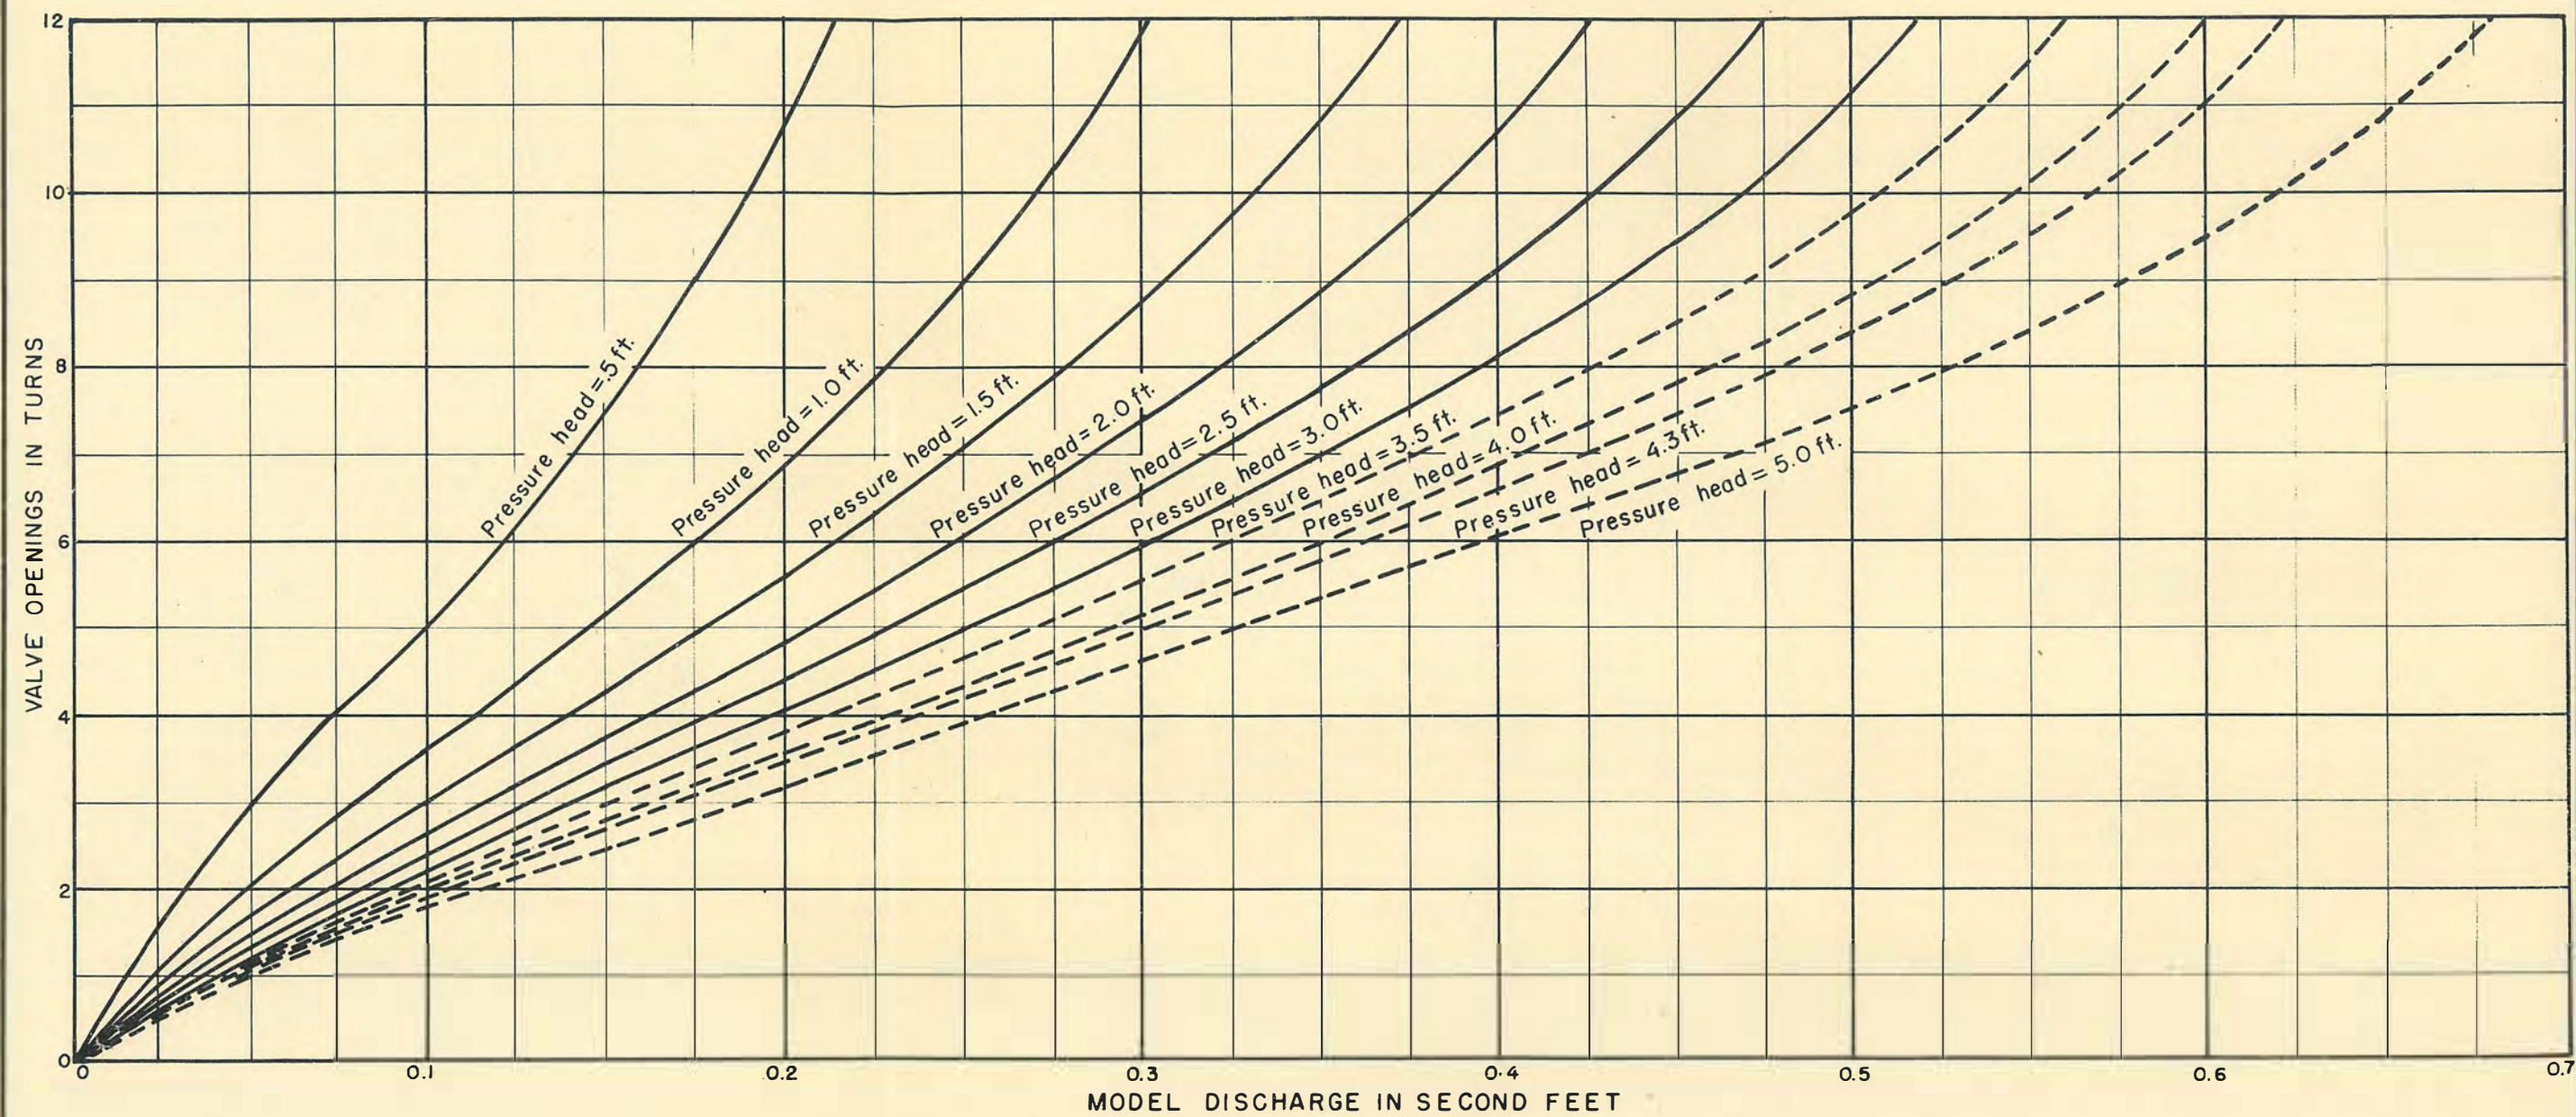
TAKEN FROM TESTS FOR KERN COUNTY CANAL OUTLET
WORKS - FRIANT DAM. TESTS SERIES 4-FD TO 9-FD
INCLUSIVE.

GRASSY LAKE DAM
DISCHARGE OF 2.8" NEEDLE VALVES WITH
VARIOUS OPENINGS AND UNDER
VARIOUS HEADS

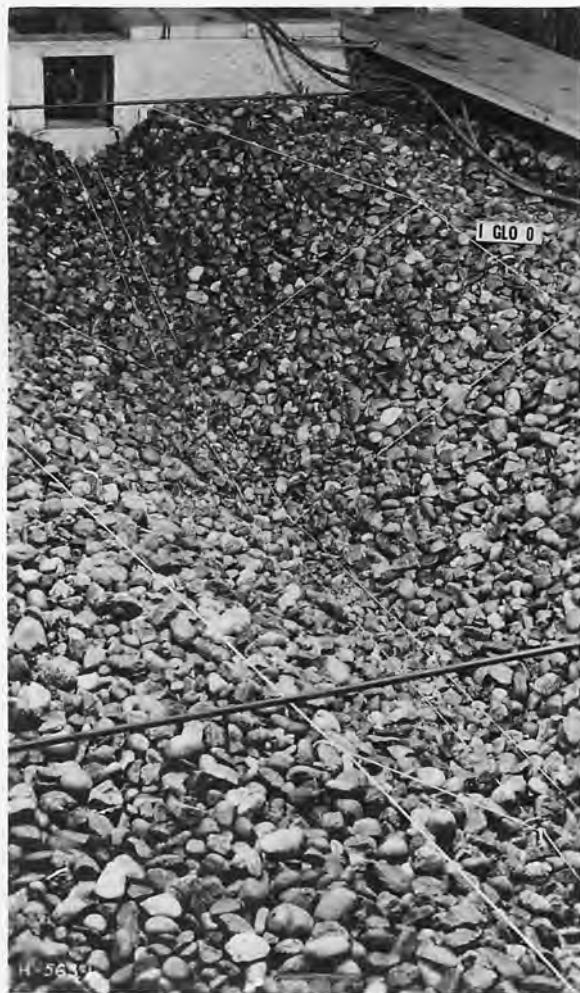
1

A. Stilling pool before run.

OUTLET STILLING POOL STUDIES 1:12 MODEL
ORIGINAL DESIGN

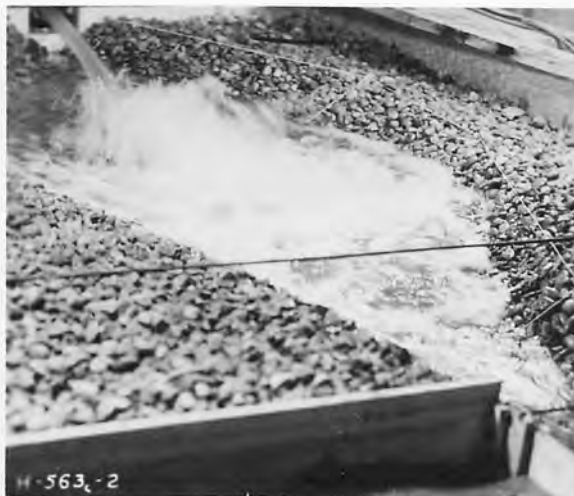
2

B. Flow of 243 second-feet.

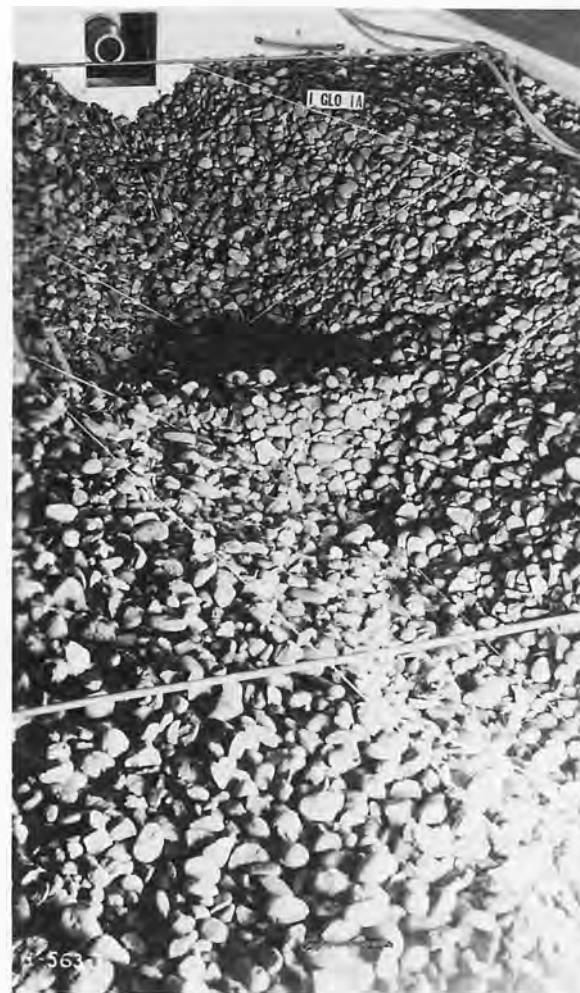
3

C. Riprap scour after 1 hour.
(model)

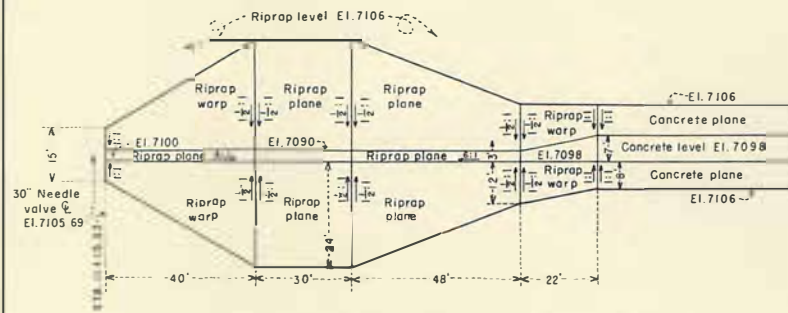
A. ORIGINAL DESIGN

GRASSY LAKE
HYDRAULIC MODEL STUDIES
OUTLET WORKS - REVISIONS
MODEL SCALE 1:12

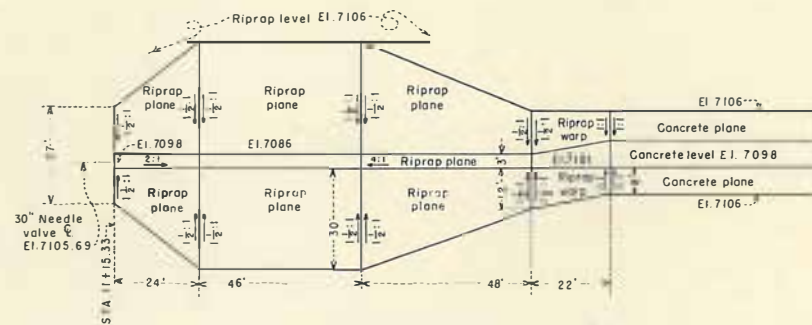
B. FIRST REVISION

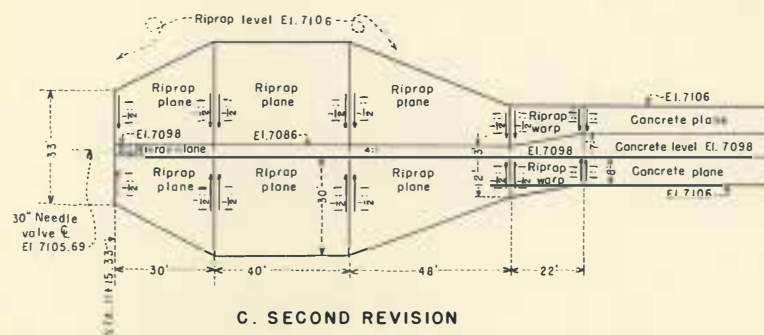
C. SECOND REVISION

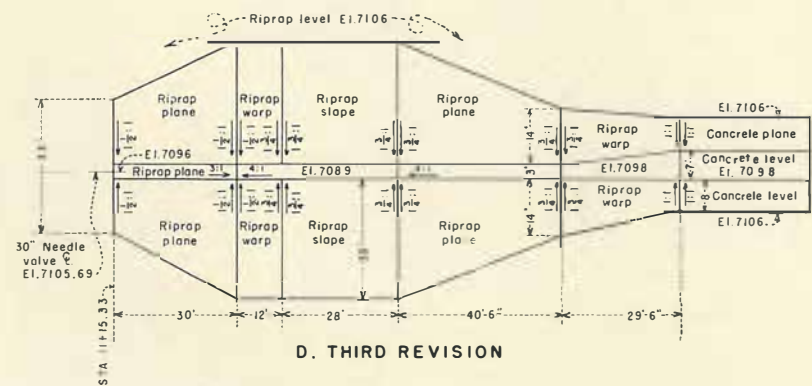
D. THIRD REVISION

In what proved to be the recommended design (Figure 10) the slope of the sides was maintained at 1-3/4:1, but the reverse slope used in the previous design was eliminated. When this pool was operated under conditions of maximum discharge and head, it was immediately apparent that the strong back currents along the sides had been reduced, both in velocity and area, to harmless proportions. This was also true of the waves. All currents were forwarded downstream from Station 13/25 (Figure 11B). These observations were verified by the scour pattern after a run of 1-hour duration. No erosion occurred on the right bank, but a small area on the left bank at Station 13/10 had been scoured to a maximum depth of 1 foot (prototype). This material had been deposited on the bottom, the amount being negligible. Figures 11A and C show the riprap in the pool before and after the run, respectively. For the intermediate discharge, corresponding to a prototype discharge of 180 second-feet at a total head of 50 feet, there was no disturbance of the riprap. The back currents and waves, referred to previously, were slight in magnitude. The surface appearance of the pool was quite satisfactory.

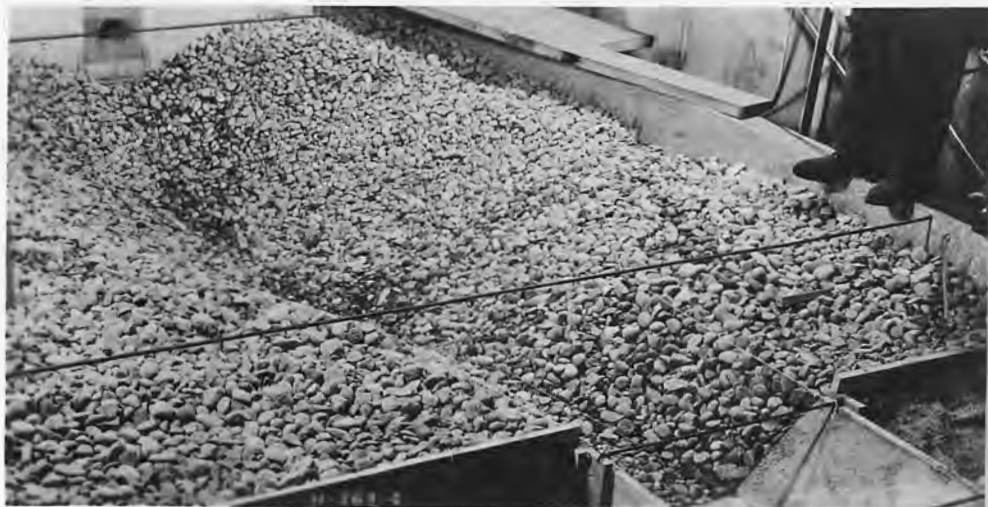
4

A. Stilling Pool before run.

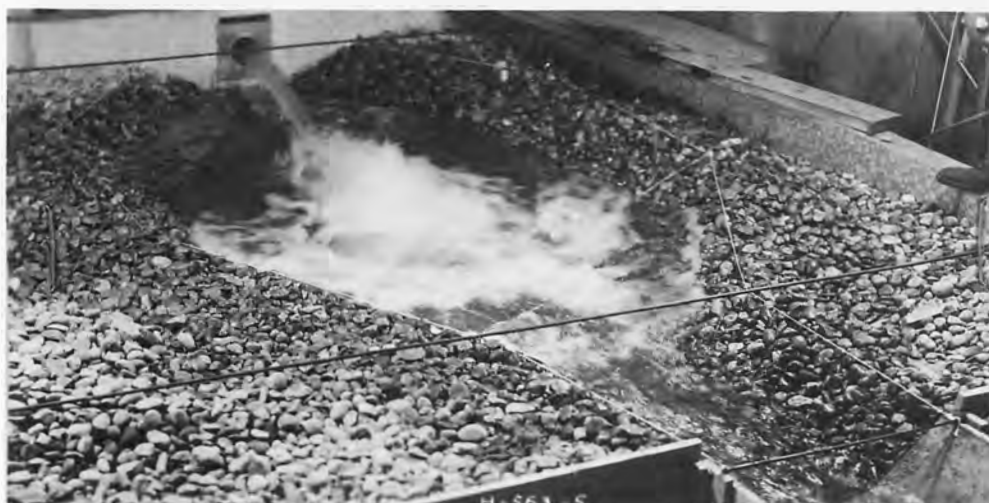
5

B. Flow of 243 second-feet.

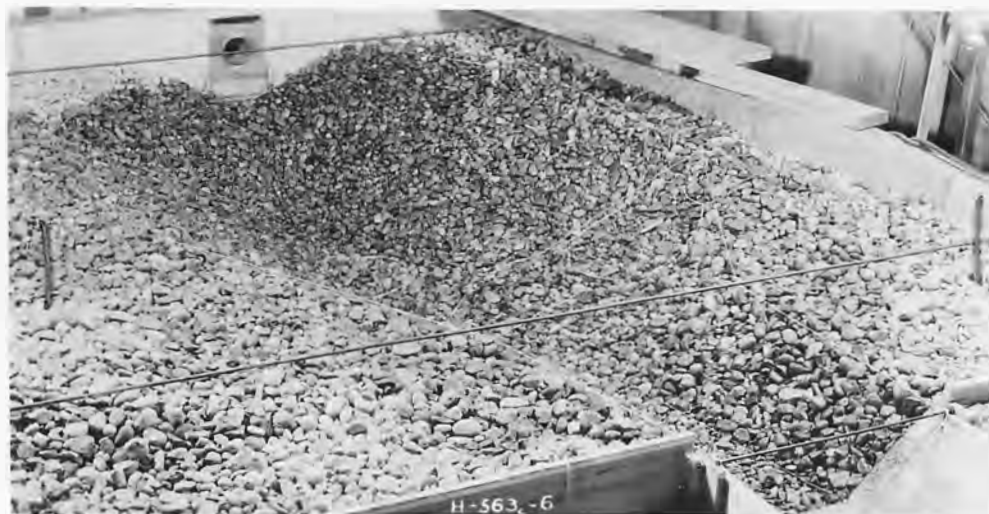
6

C. Riprap scour after 1 hour run.
(model)

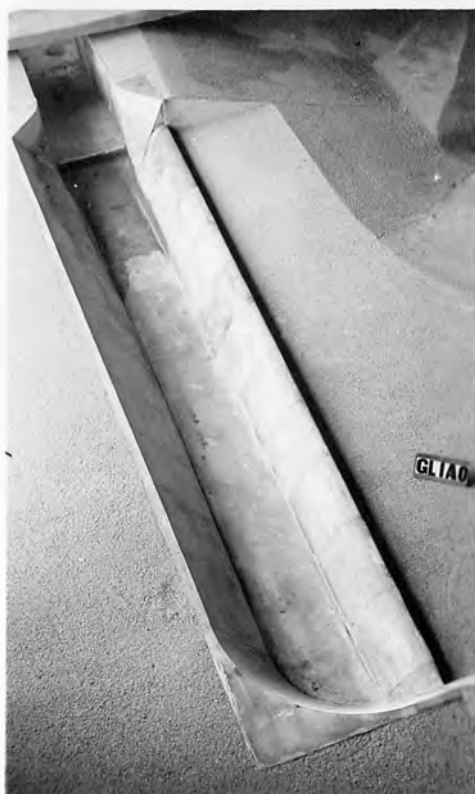
A. Original design.

APPROACH CONDITIONS ON 1:20
SCALE MODEL OF GRASSY LAKE SPILLWAY

Model tests on the initial spillway design (Figure 6) indicated that both wing-walls of the approach to the side-channel spillway could be improved. Eddies caused by abrupt changes in the direction of flow at these points resulted in scour at the base of both walls and contributed to rough flow in the region of the control sill. Figure 12A shows the original design of the wing-walls, Figure 12B shows the model in operation at 1,200 second-feet, and Figure 12E

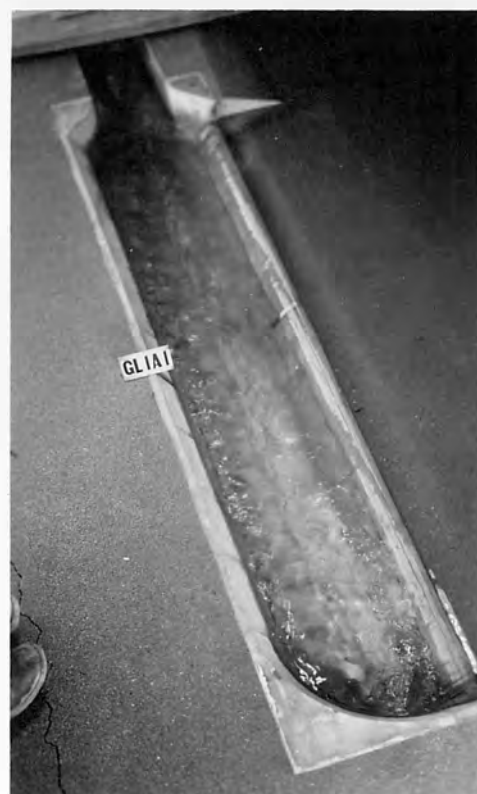
B. Flow of 12,000 second-feet.

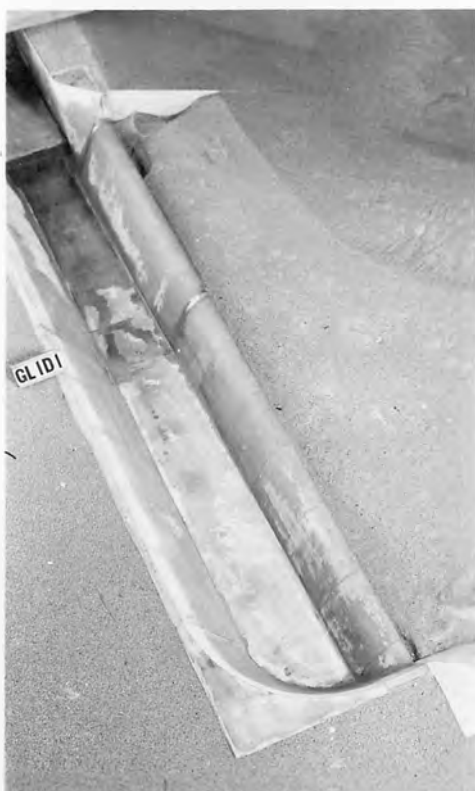
C. Erosion caused by flow of 12,000 second-feet.

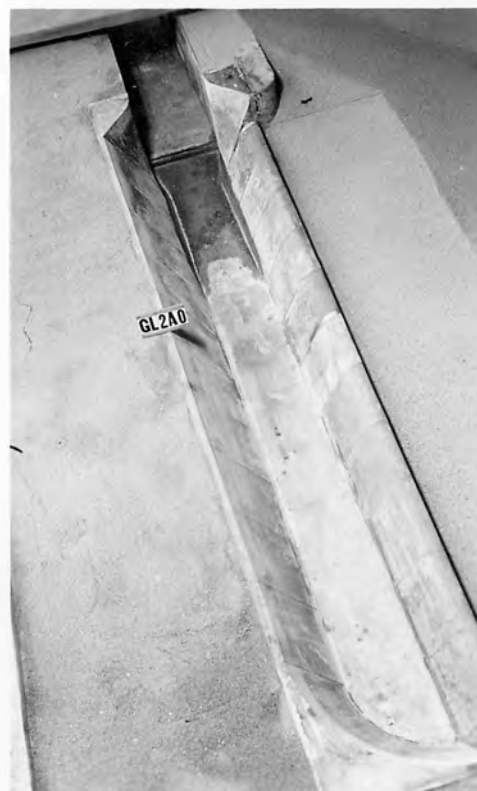
D. Recommended design.

The shape of the upstream approach wall was then altered to that shown on Figure 4, while that on the upstream side was given a circular flare (Figures 4 and 12D). When the maximum flow of 1,200 second-feet was run through the model for 70 minutes, it was found that this alteration had effectively prevented the erosion inherent in the initial design. Flow conditions in the side-channel unit had also improved, but there was reason to believe that they might be further improved by changing the downstream transitions of the unit and by increasing the height of the control sill.

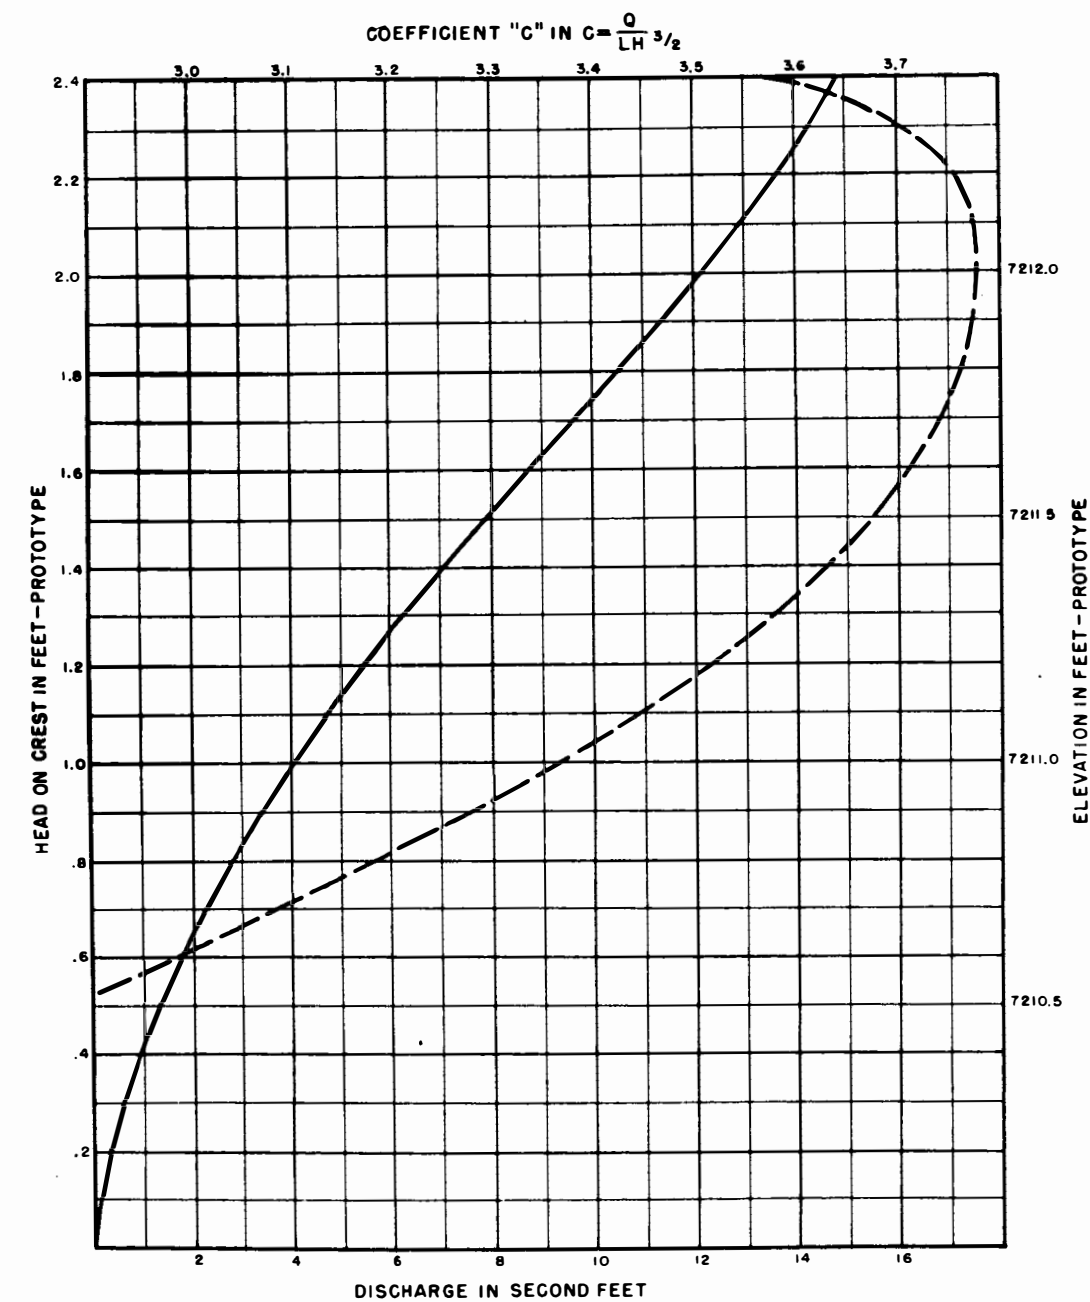
--- C vs H
 — Q vs H

DISCHARGE AND COEFFICIENT CURVES
 GRASSY LAKE SPILLWAY
 1:20 HYDRAULIC MODEL STUDIES

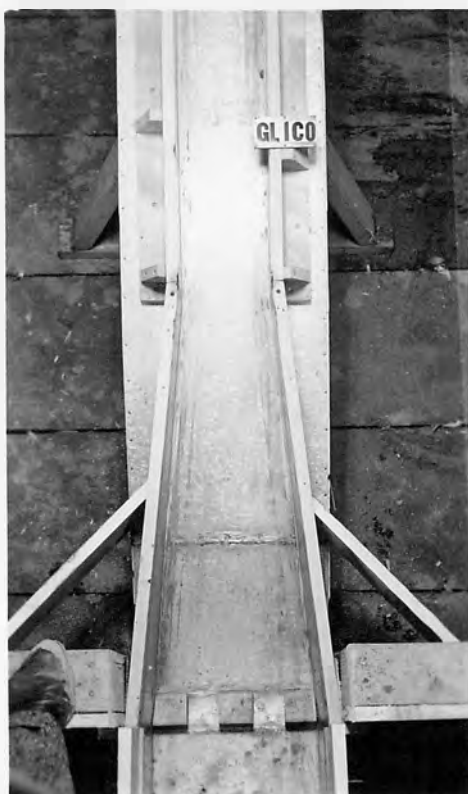
A. Original design.

CHUTE STUDIES ON 1:20 SCALE MODEL

It was noted during the first model tests that the flow in the chute could be improved. Flow down the structure was smooth except for a narrow friction fin along each wall, but the transition beginning at Station 8/69.91 was too abrupt for the velocities involved and the jet could not spread sufficiently to follow the walls (Figures 14A and B and Figure 15A).

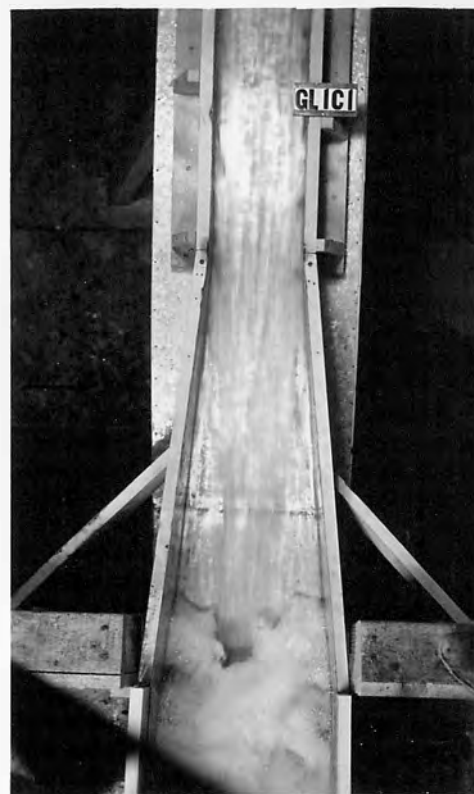
B. Flow of 12,000 second-feet.

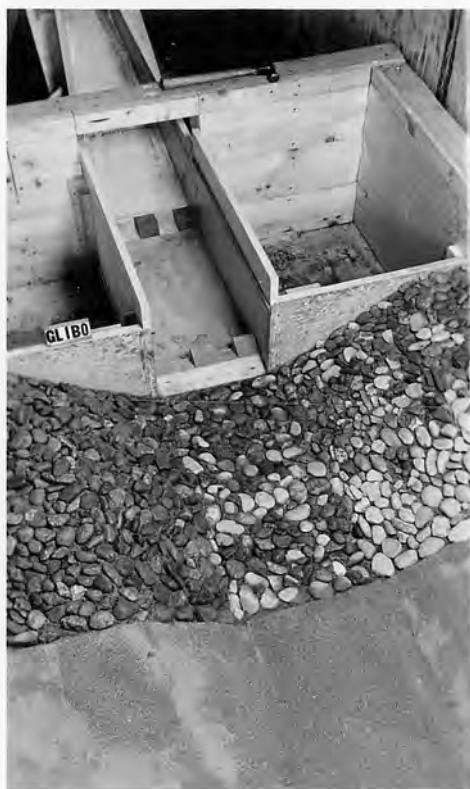
C. Original design.

STILLING POOL STUDIES ON 1:20 SCALE
MODEL OF GRASSY LAKE SPILLWAY

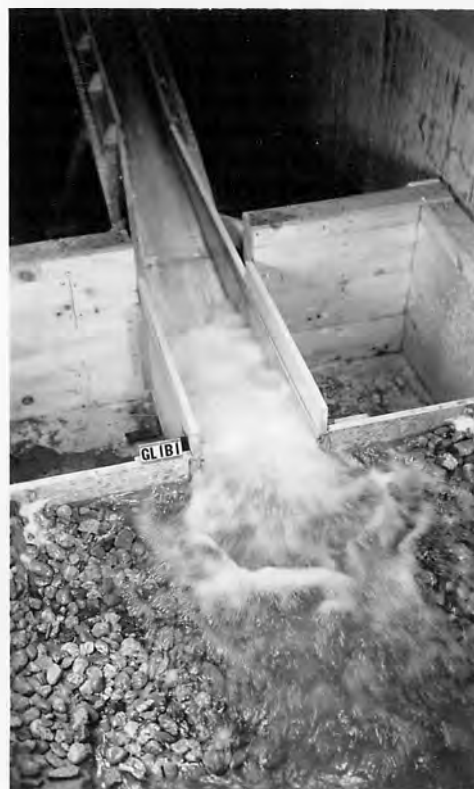
D. Flow of 12,000 second-feet.
