HYDRAULIC MODEL STUDIES OF GRASSY LAKE DAM OUTLET WORKS AND SPILLWAY

UPPER SNAKE RIVER PROJECT, WYOMING

Hydraulic Laboratory Report No. Hyd-226

Subject: Hydraulic model studies of Grassy Lake Dam Outlet Works and
Spillway--Upper Snake River Project, Wyoming.

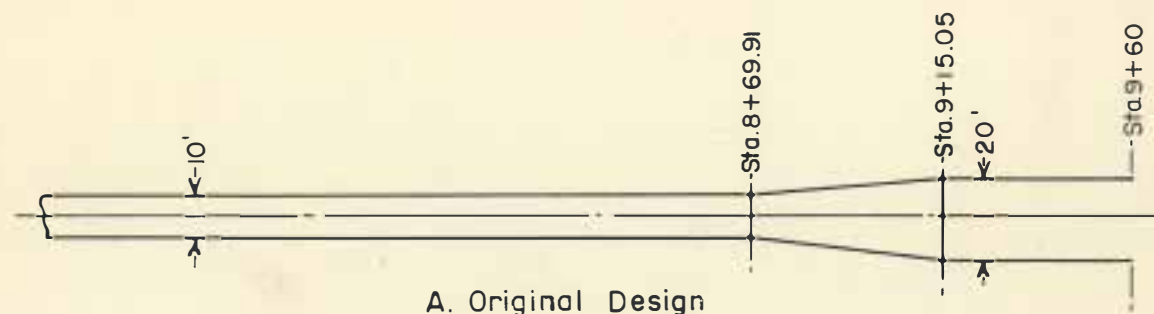
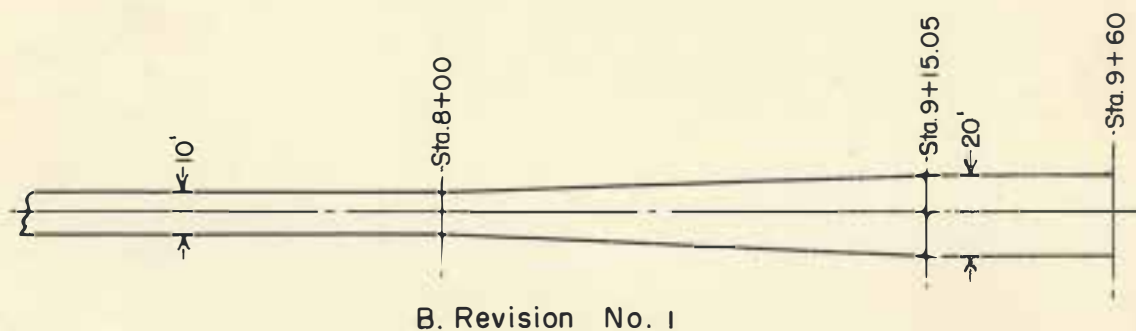
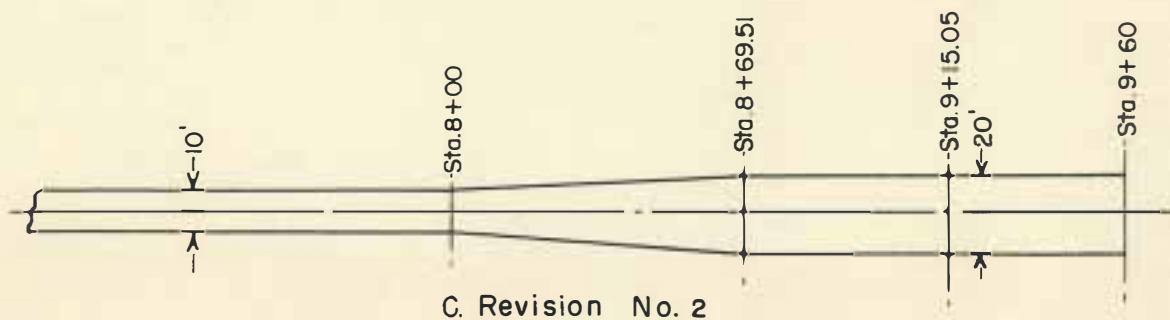
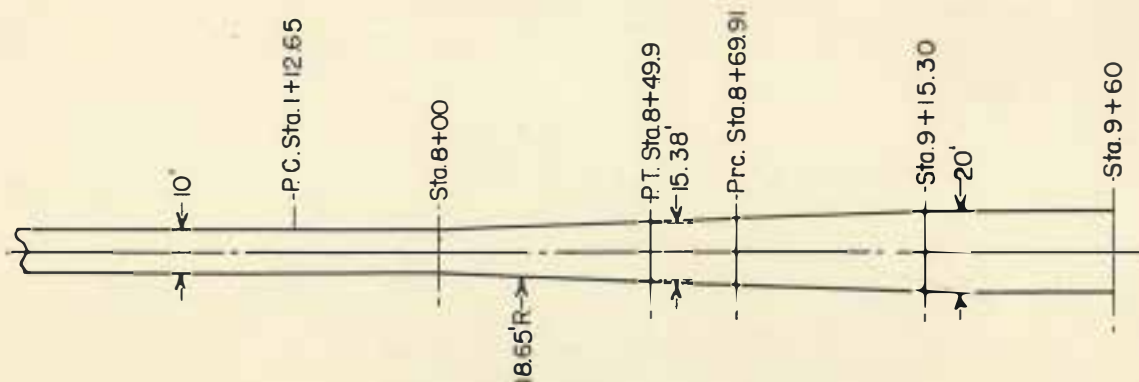
GRASSY LAKE DAM SPILLWAY REVISIONS TO SPILLWAY TRANSITION

It was noted during the first model tests that the flow in the chute could be improved. Flow down the structure was smooth except for a narrow friction fin along each wall, but the transition beginning at Station 8/69.91 was too abrupt for the velocities involved and the jet could not spread sufficiently to follow the walls (Figures 14A and B and Figure 15A).

To remedy this condition, the beginning of the transition was moved upstream to Station 8/00 (Figure 15B). This provided a distance of 115 feet for a 10-foot change in width, but proved inadequate.

As a second revision, the beginning of the transition remained at Station 8/00, but the length was shortened to 69.51 feet, ending approximately 45.5 feet from the stilling-pool (Figure 15C). This change caused a concentration of water along the sides of the chute for the last 20 feet before entering the pool. Considerable splash in the center of the chute was also present.

Revision No. 3 (which proved to be the recommended design) featured a curved transition originating at Station 7/50.02 and ending at Station 9/15.30 (Figures 15D and 16). In addition, it was decided to increase the radius of the vertical curve entering the stilling-pool from 150 to 300 feet to decrease the rate of drop and allow the jet to spread more uniformly. This design accomplished the purpose desired. The center fins and splash action were damped effectively and all other phases of the operation seemed satisfactory.

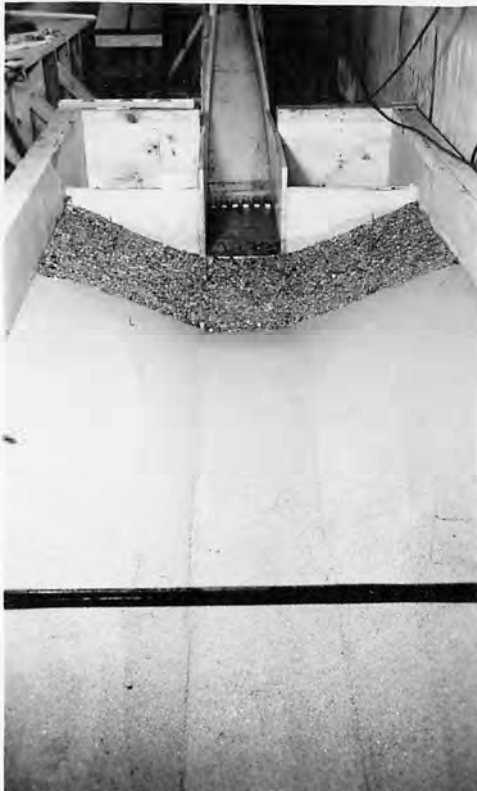
A. Recommended design setup.

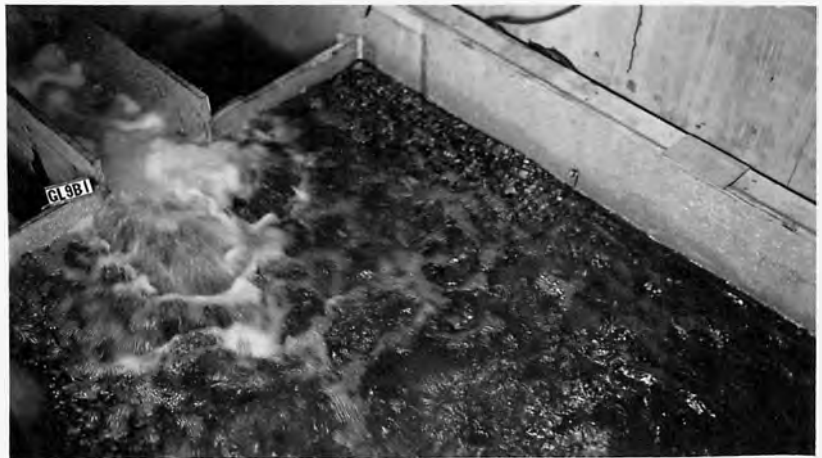
B. Flow of 1,200
second-feet.

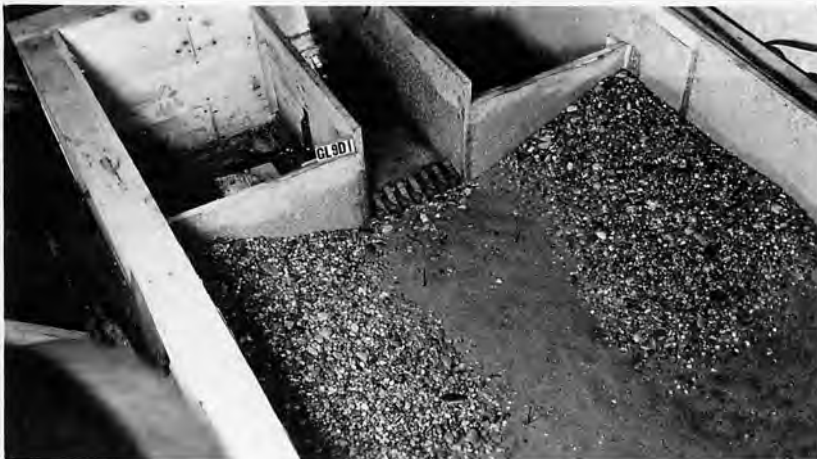
C. Erosion caused by
flow of 1,200
second-feet.
