HYDRAULIC MODEL STUDIES OF THE
CHERRY CREEK DAM OUTLET WORKS AND
THE PROPOSED IRRIGATION INLET
CHERRY CREEK PROJECT, COLORADO

Hydraulic Laboratory Report Hyd. 241

APRIL 29, 1948

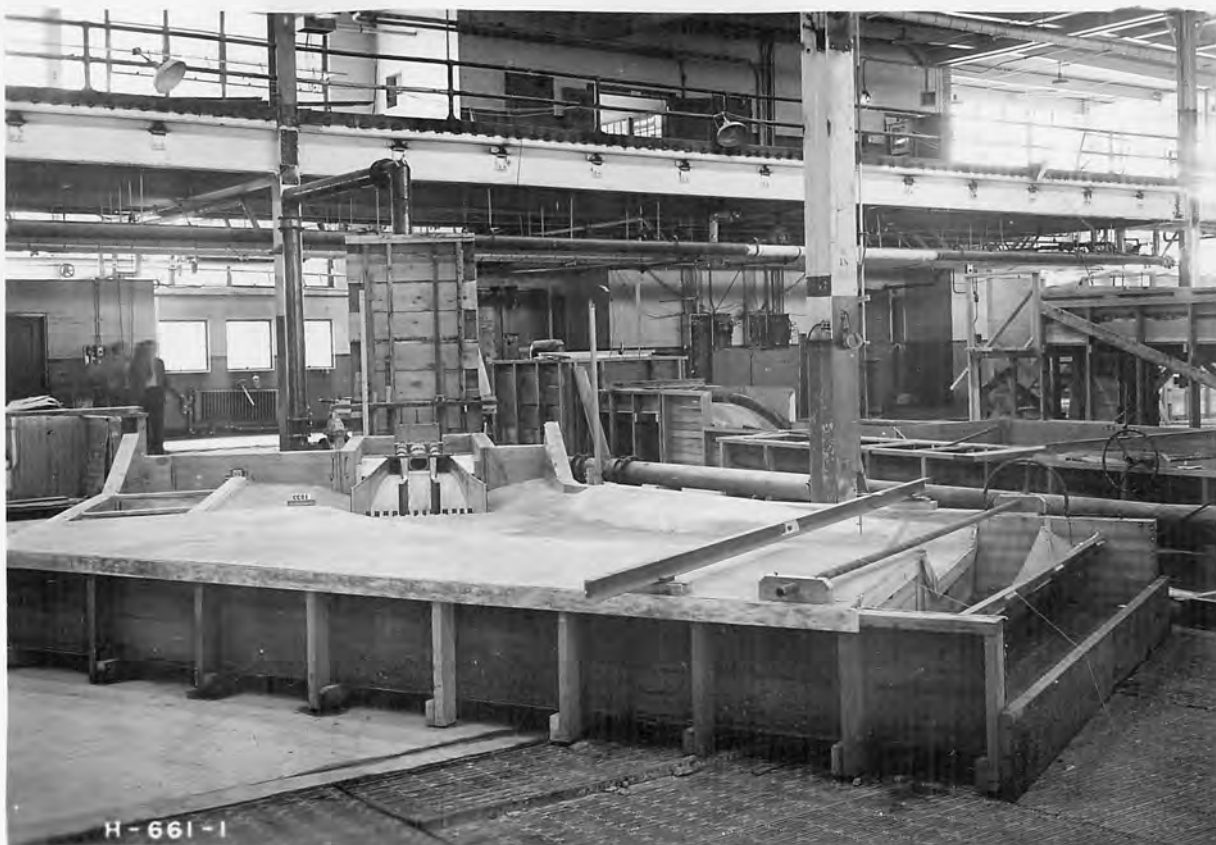
A. Completed model

1:28 MODEL, CHERRY CREEK OUTLET WORKS, ORIGINAL DESIGN, INITIAL PHASE

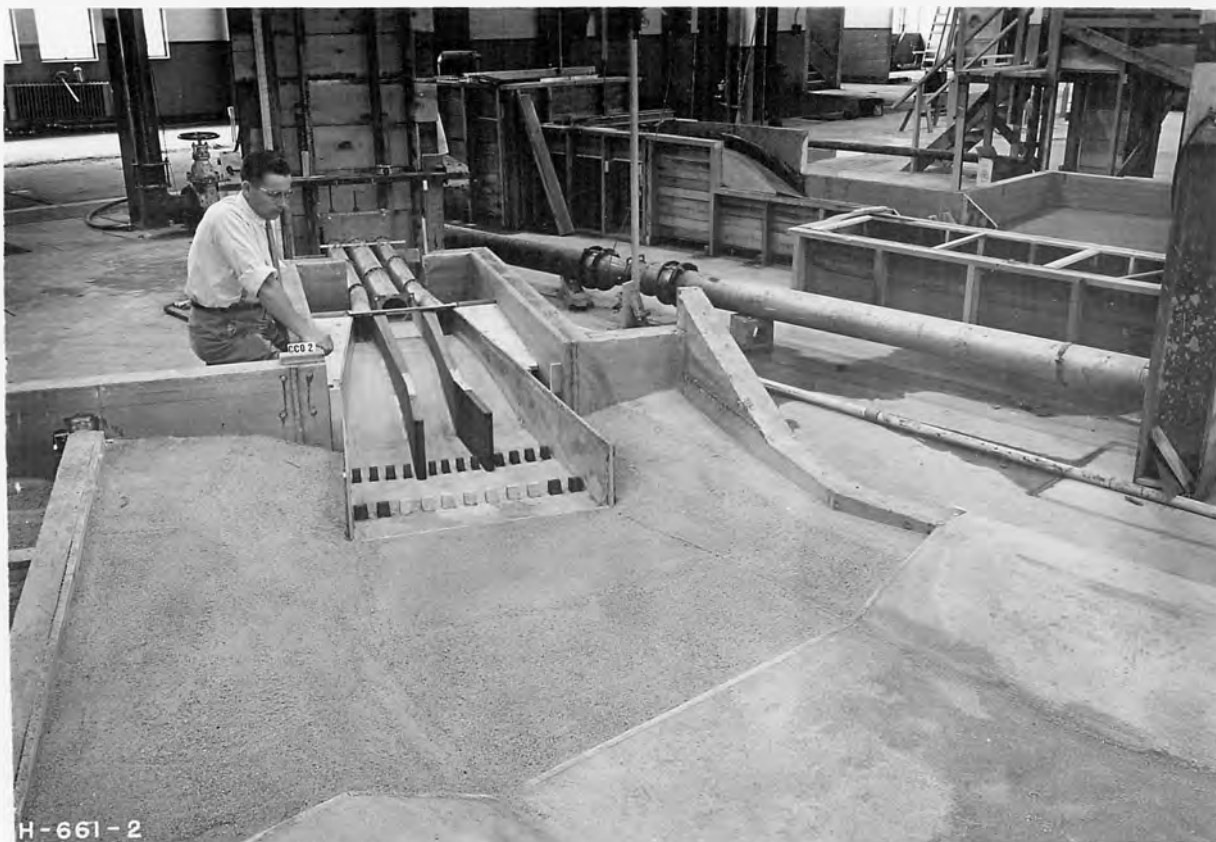
B. Stilling-basin

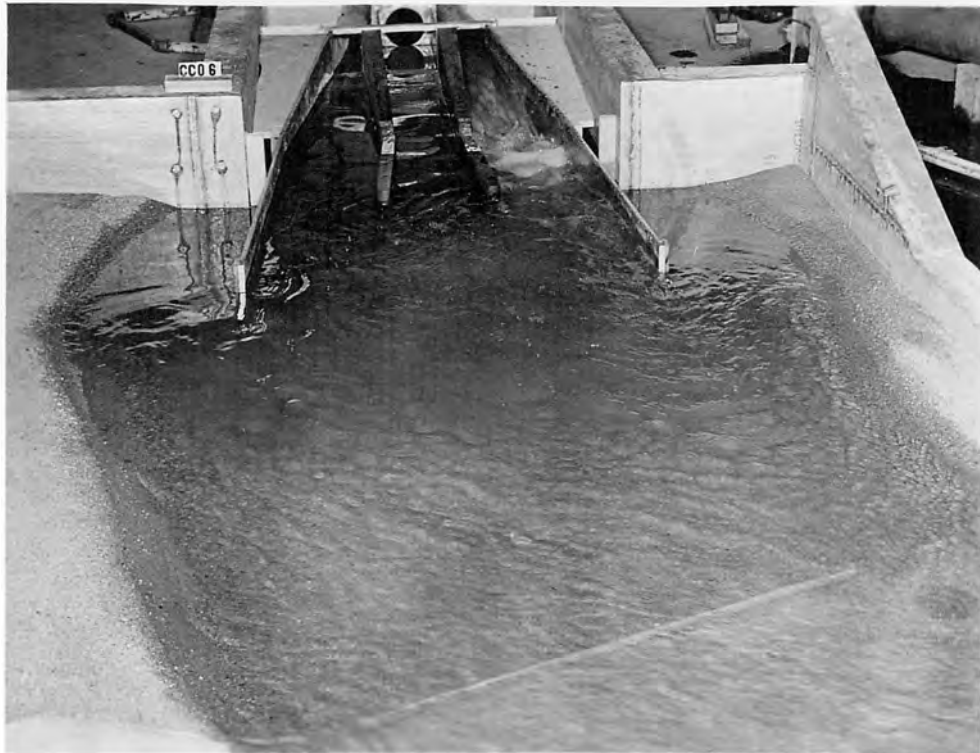
A. Left conduit discharging 2,275 second-feet

Initial phase. Operation of the stilling-basin for the initial phase, Figure 3, with one outside conduit discharging 2,275 second-feet is shown in Figure 7A and with both outside conduits discharging a total of 4,550 second-feet in Figure 7B. The center conduit discharging 1,450 second-feet is shown in Figure 8A and all three conduits discharging a total of 6,000 second-feet is shown in Figure 8B. For the flow conditions shown in Figures 7 and 8, operation of the stilling-basin was entirely satisfactory. Velocity distribution at the end of the apron was excellent for the flows tested and in no case were eddy currents objectionable, even with the unsymmetrical operation of one outside conduit, Figure 7A. Wave heights were measured in the channel about 125 feet from the end of the apron. For the 6,000 second-foot discharge they were approximately one foot high.

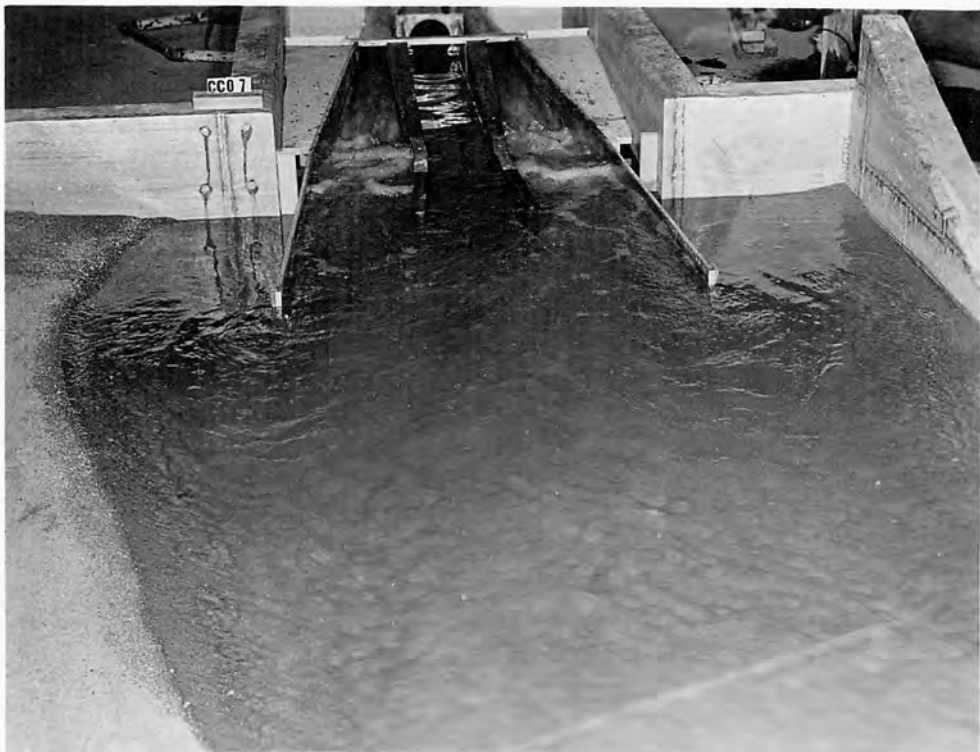
B. Both outside conduits operating - 4,550 second-feet

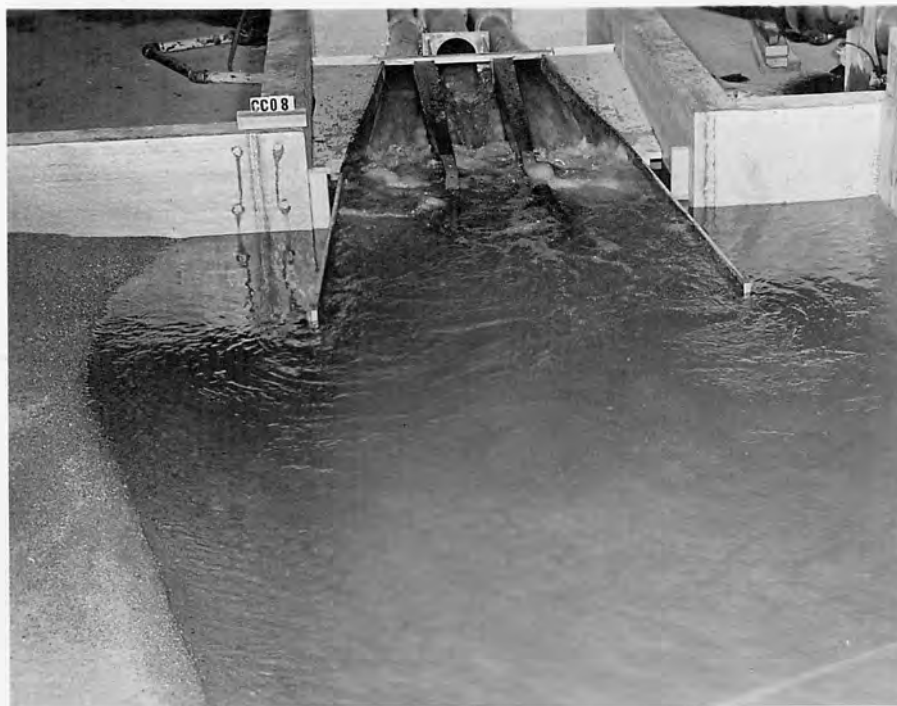
FIGURE 8

B. All conduits operating - 6,000 second-feet

1:28 MODEL, CHERRY CREEK STILLING-BASIN, ORIGINAL DESIGN, INITIAL PHASE

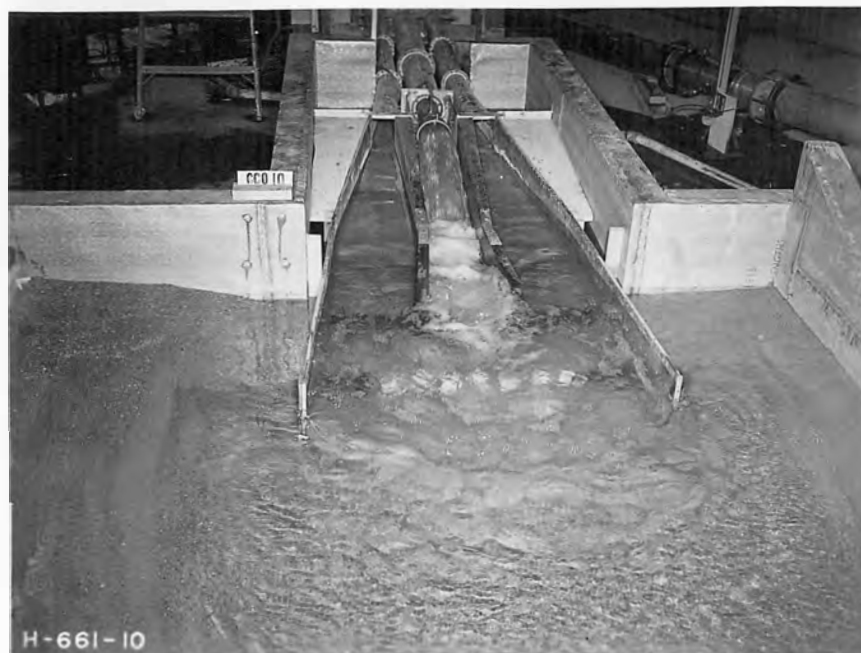
A. Hollow-jet valve discharging 1,500 second-feet

1:28 MODEL, CHERRY CREEK STILLING-BASIN, ORIGINAL DESIGN, FINAL PHASE

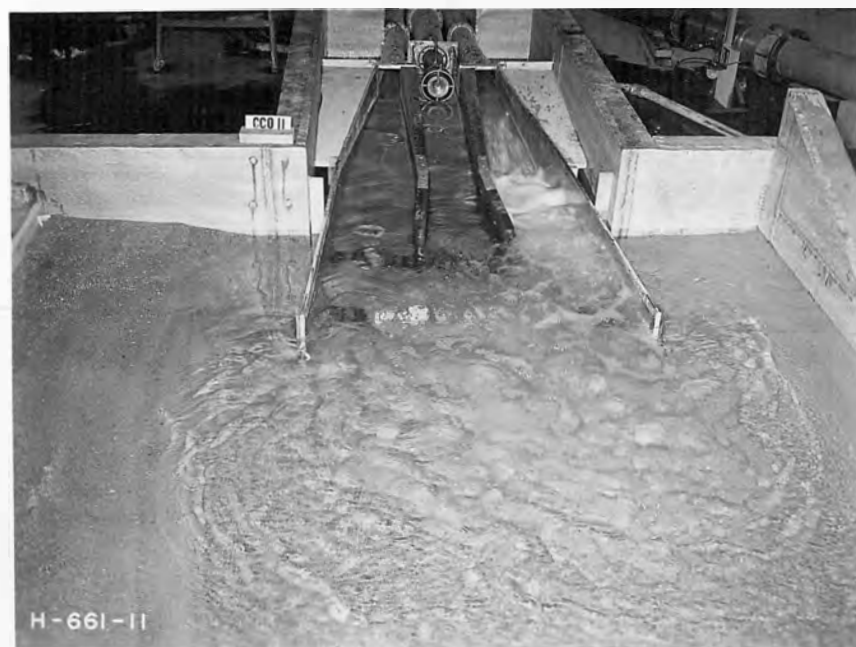
B. Left conduit discharging 2,275 second-feet

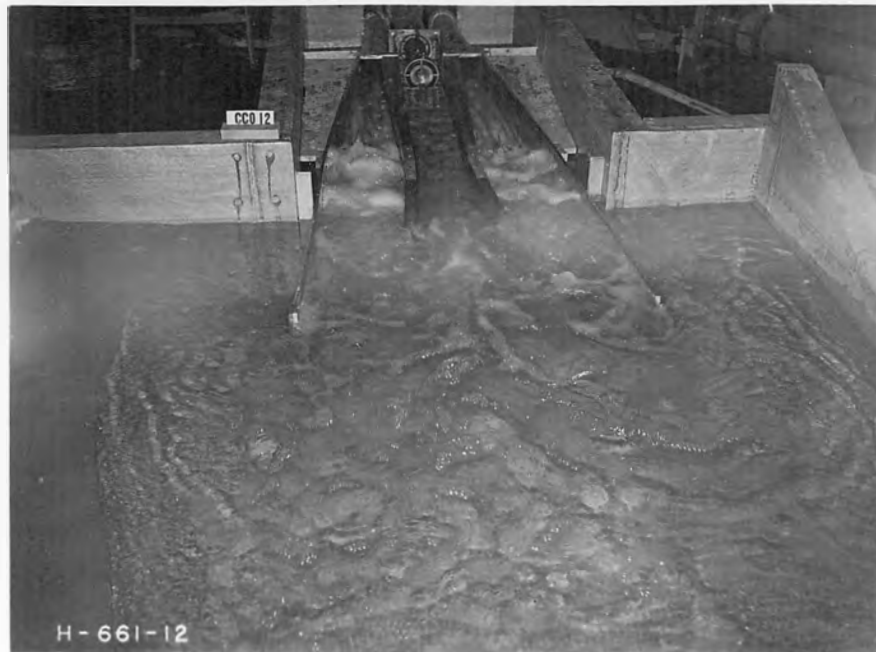
A. Both outside conduits operating - 6,000 second-feet

1:28 MODEL, CHERRY CREEK STILLING-BASIN, ORIGINAL DESIGN, FINAL PHASE

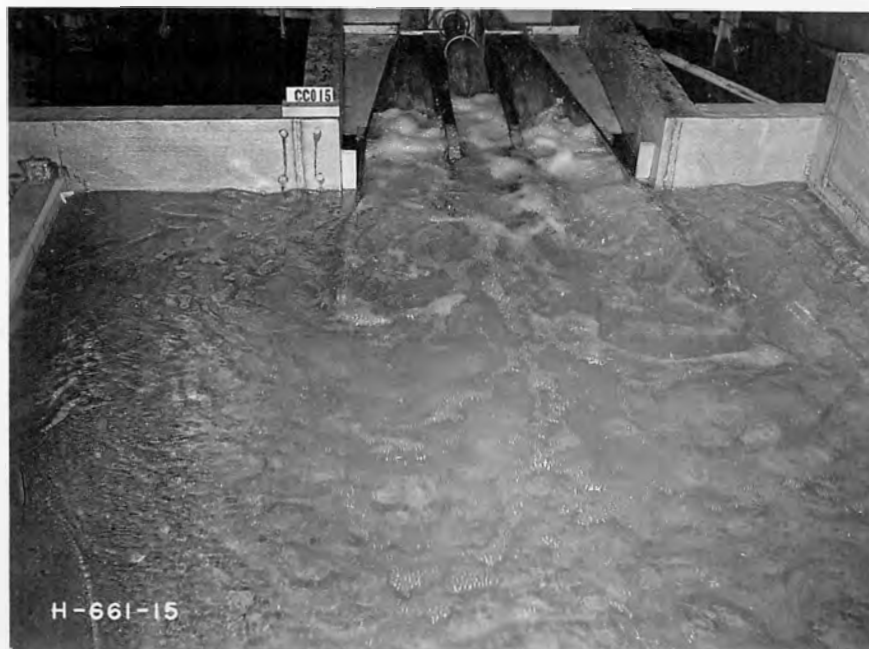
B. All conduits operating - 9,400 second-feet

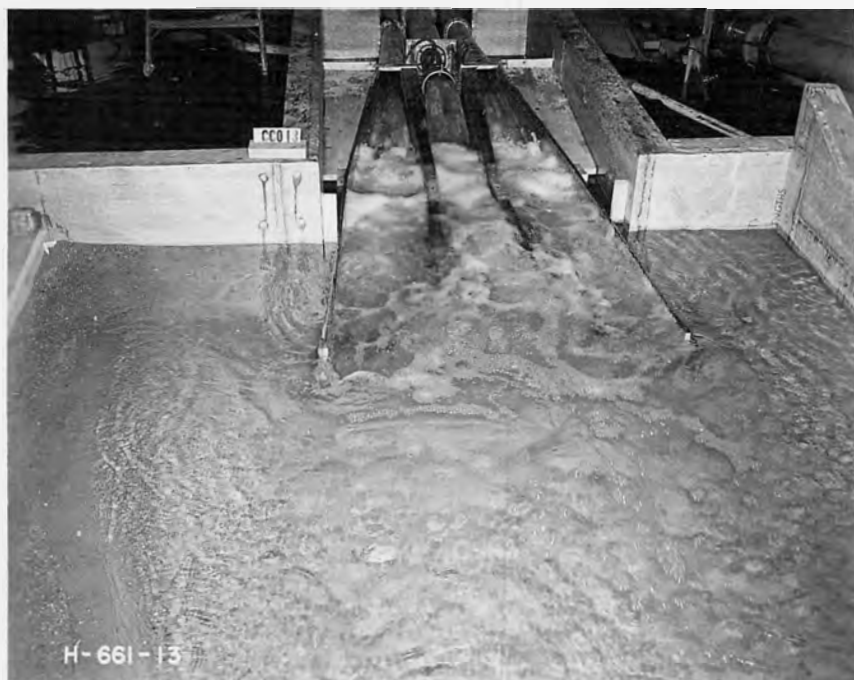
A. All conduits operating - 6,000 second-feet

1:28 MODEL, CHERRY CREEK STILLING-BASIN, ORIGINAL DESIGN, FINAL PHASE

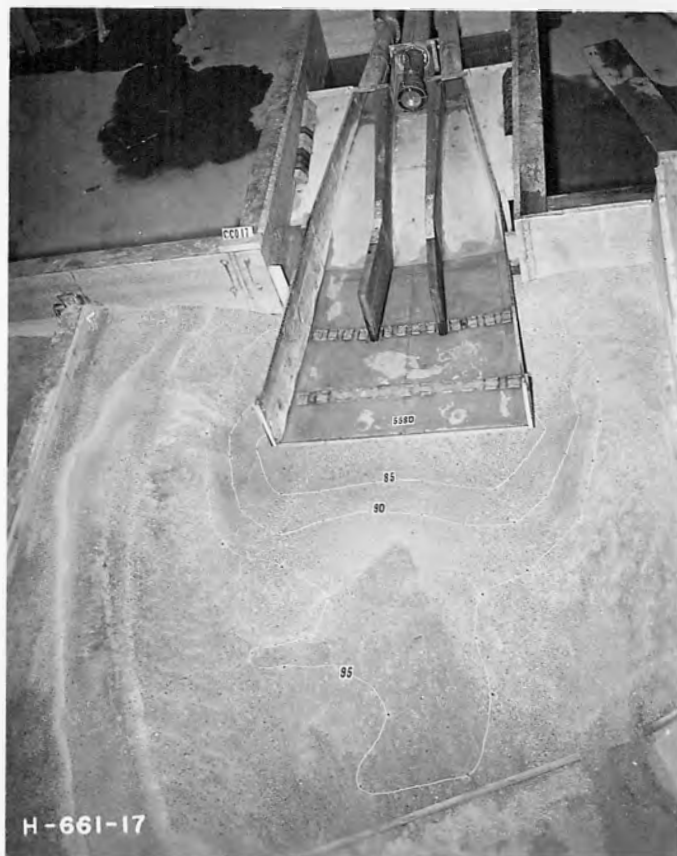
Scour after one hour operation, 3 conduits discharging 6,000 second-feet, tailwater elevation 5502.8.

1:28 MODEL, CHERRY CREEK STILLING-BASIN, ORIGINAL DESIGN, FINAL PHASE, BAFFLE PIERS REMOVED

Baffle piers. During the tests on the initial and final phases of the stilling-basin it was noted that the original baffle piers were not fully effective because they were located too far downstream, Figure 3. In order to evaluate the effectiveness of the piers in this original position, the model was operated with all baffles removed. Flow at the downstream end of the stilling-basin appeared the same whether or not the baffles were in place. Scour was slight after one hour of operation at 6,000 second-feet, Figure 13. The only discernible difference in the erosion pattern was the absence of the sand deposits on the downstream end of the apron with the baffles removed.

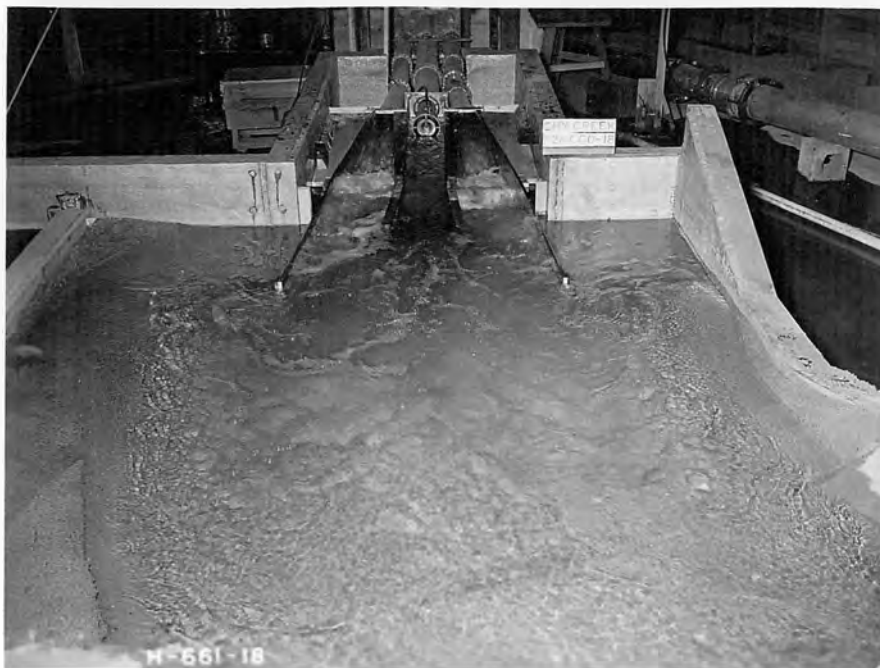
A. Both outside conduits operating - 6,000 second-feet

1:28 MODEL, CHERRY CREEK STILLING-BASIN,
SECOND BAFFLE PIER DESIGN, FINAL PHASE

As a result of the foregoing studies the second baffle pier design was installed in the model, Figure 14. As shown in the figure, two rows were used as before, but they were placed farther upstream between the dividing walls. Operation at 6,000 second-feet with the two outside conduits open is shown in Figure 15 A and with all three conduits flowing in Figure 15 B. In this position the baffles were definitely aiding in the dissipation of energy as evidenced by the increased turbulence at the upstream end of the stilling-basin. The location of the jump and the appearance of the stilling action was otherwise unchanged from the test with the first baffle pier design. Scour after one hour of operation at 6,000 second-feet and tailwater elevation 5502.8 is shown in Figure 16. Erosion was slight with small sand deposits occurring on the downstream end of the apron similar to those observed with the original baffle piers. This baffle pier design and position was considered satisfactory and it was retained in the model for the remainder of the studies.

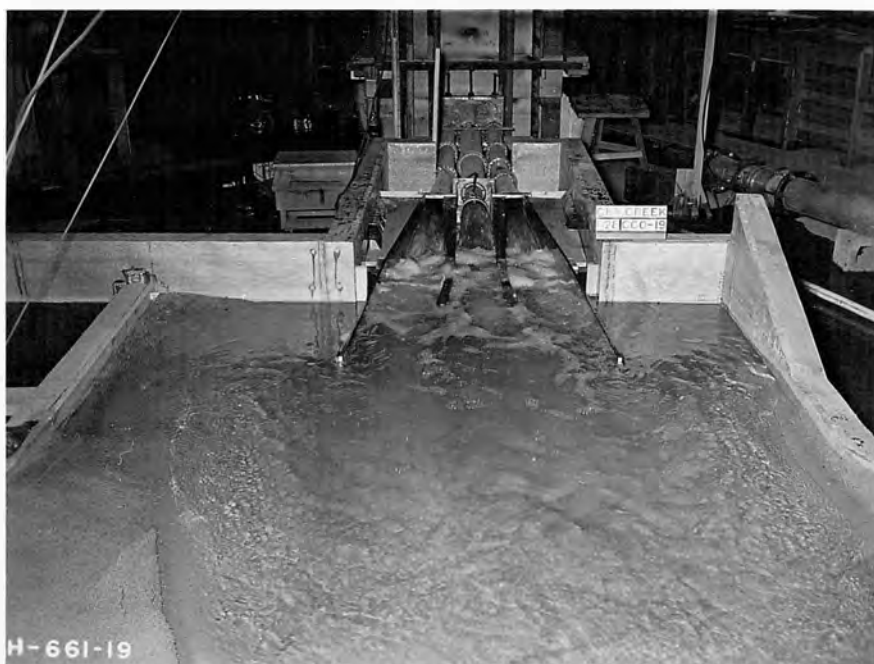
B. All conduits operating - 6,000 second-feet

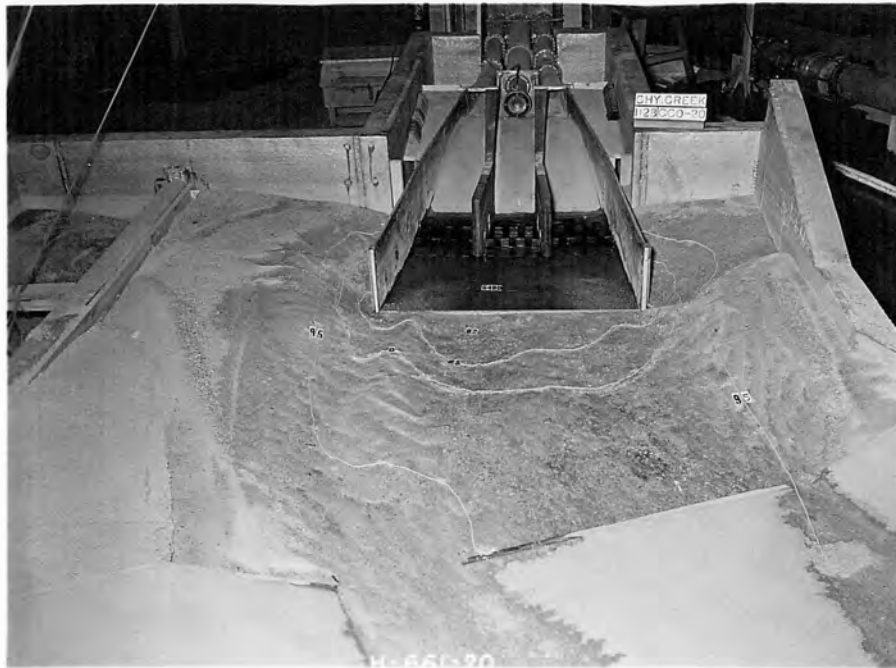
FIGURE 16

Scour after one hour operation, 3 conduits discharging
6,000 second-feet, tailwater elevation 5502.8

1:28 MODEL, CHERRY CREEK STILLING-BASIN,
SECOND BAFFLE PIER DESIGN, FINAL PHASE

Short walls were next installed consisting of the original walls, Figure 4, but extended only from the portals to the toe of the chute. Stable flow conditions were found in the stilling-basin with the operation of any one or two conduits and operation was satisfactory with all conduits discharging, Figure 18 A. Scour after a one hour test at 6,000 second-feet, Figure 18 B, was the same as found with the longer walls, Figure 16. A small sand deposit occurred on the apron near the left training wall.

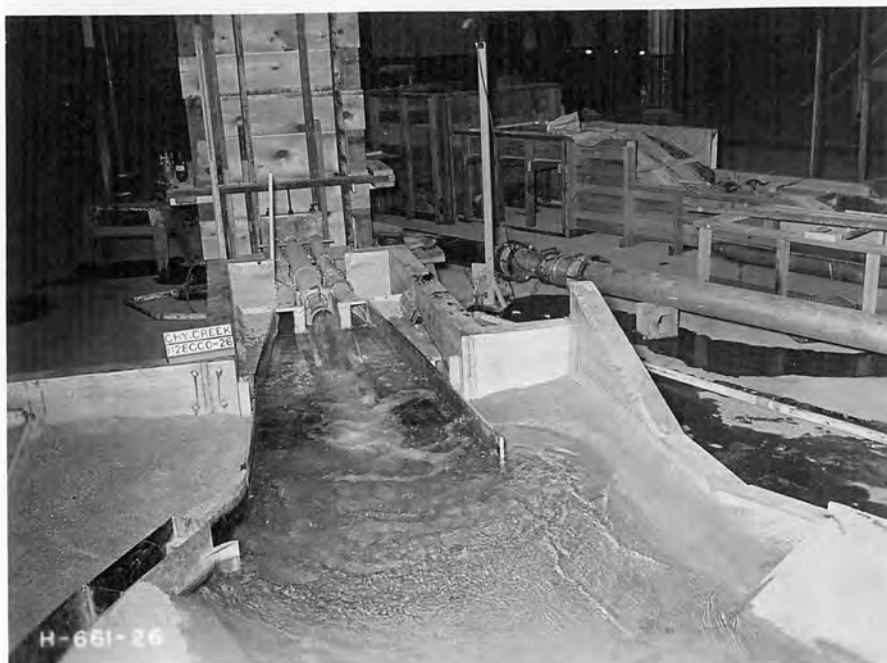
A. Hollow-jet valve discharging 1,500 second-feet.
Flow is along centerline of basin.

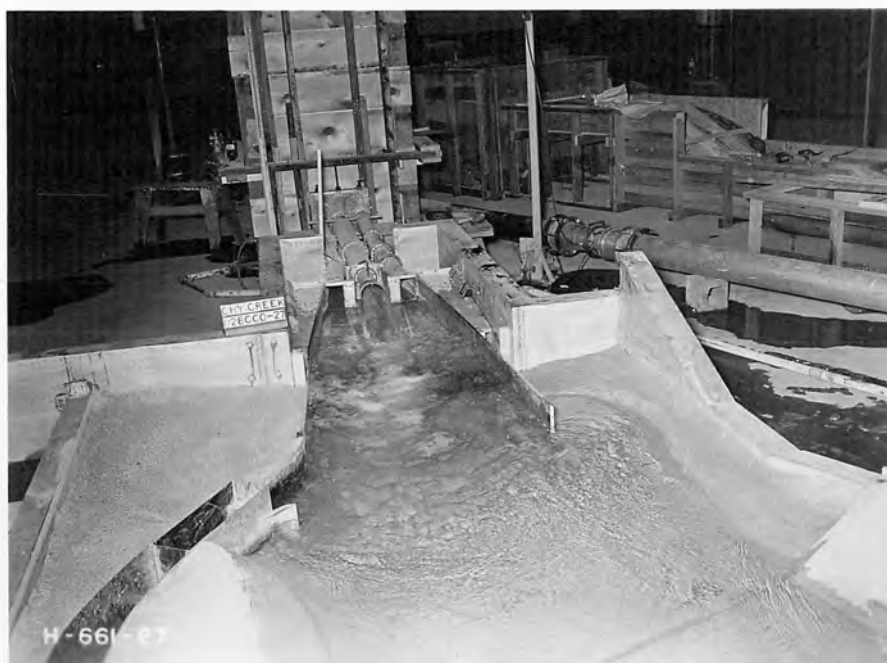
B. Hollow-jet valve operating - 1,500 second-feet.
Flow is to the right of basin centerline.

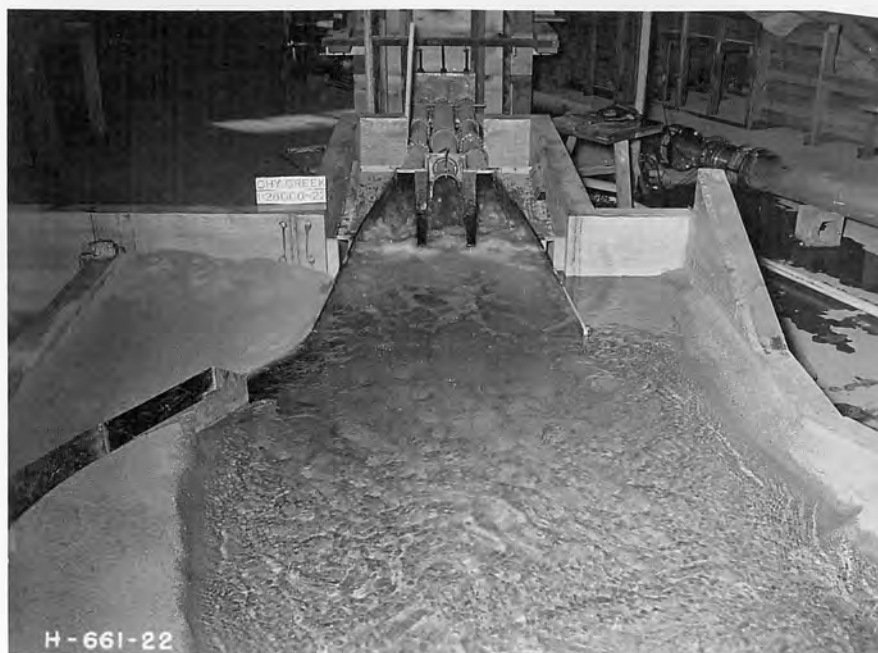
A. All conduits operating - 6,000 second-feet

1:28 MODEL, CHERRY CREEK STILLING-BASIN, SHORT DIVIDING WALLS, FINAL PHASE

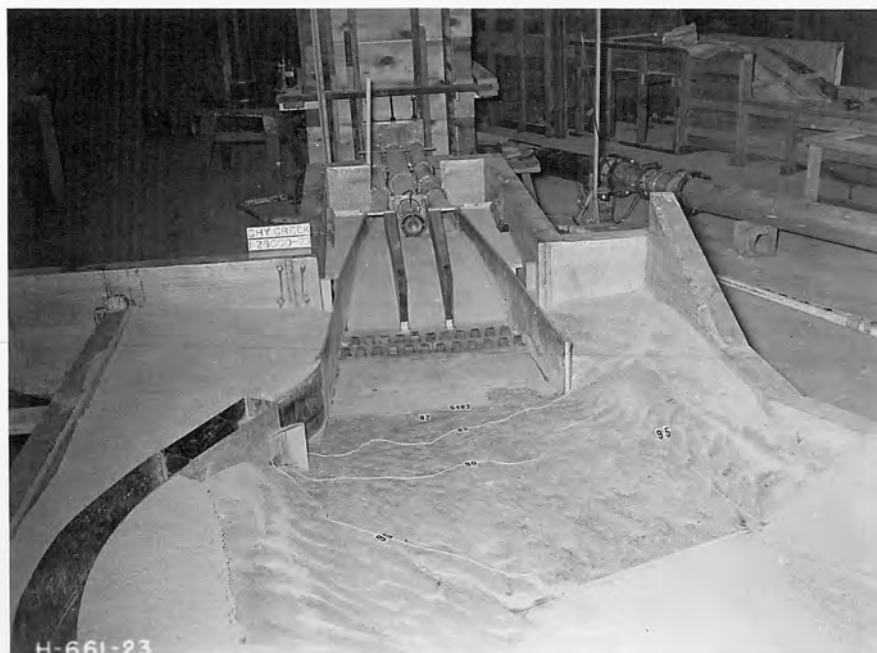
B. Scour after 1 hour operation, 3 conduits discharging 6,000 second-feet. Tailwater elevation 5502.8.

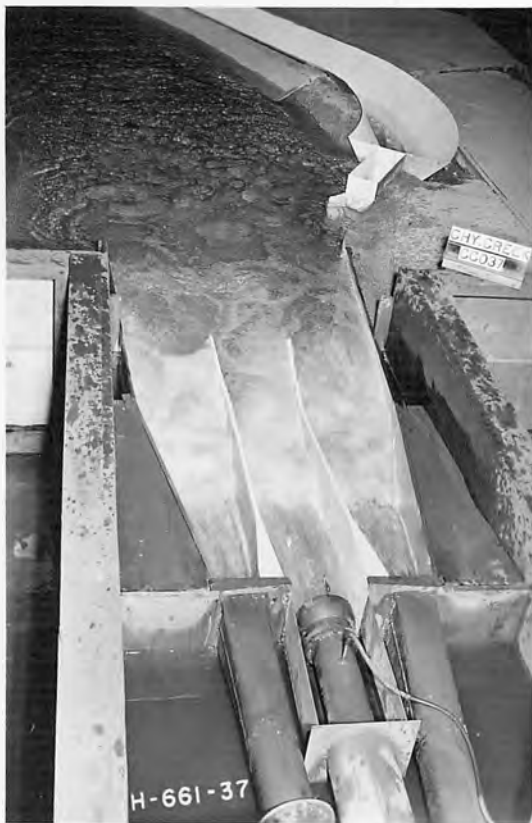
A. All conduits operating - 6,000 second-feet

1:28 MODEL, CHERRY CREEK STILLING-BASIN, SECOND
DIVIDING WALL DESIGN, FINAL PHASE

The second dividing wall design proposed by the United States Engineers, Figure 19, was installed in the model and tested. With three conduits discharging 6,000 second-feet, Figure 20 A, flow conditions, in general, were similar to the original wall design except that water climbed the sloping sides of the piers near the upstream end as shown in Figures 20 A and 20 B. Both outside conduits operating with a total flow of 6,000 second-feet is shown in Figure 20 B. With the center conduit closed, a cross-flow resulted as with the previous test with shorter walls; however, it was much less pronounced. Due to these conditions it was decided to retain the original dividing walls for the stilling-basin.

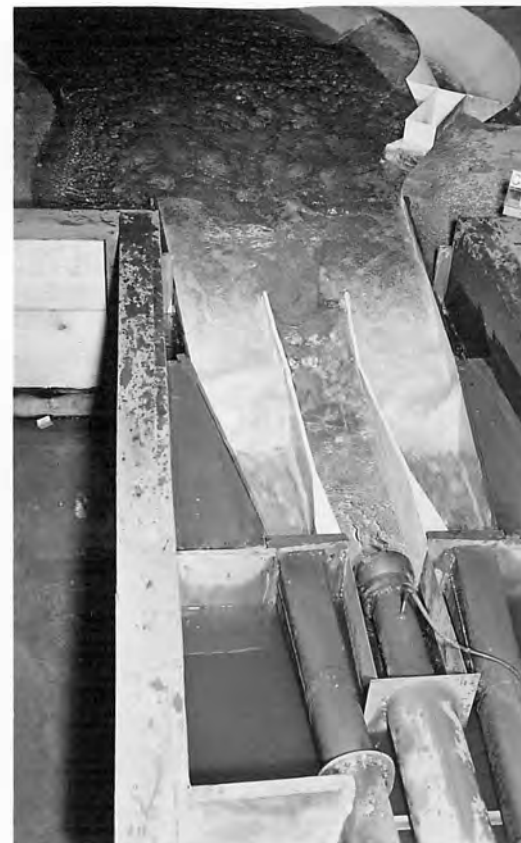
B. Both outside conduits operating - 6,000 second-feet

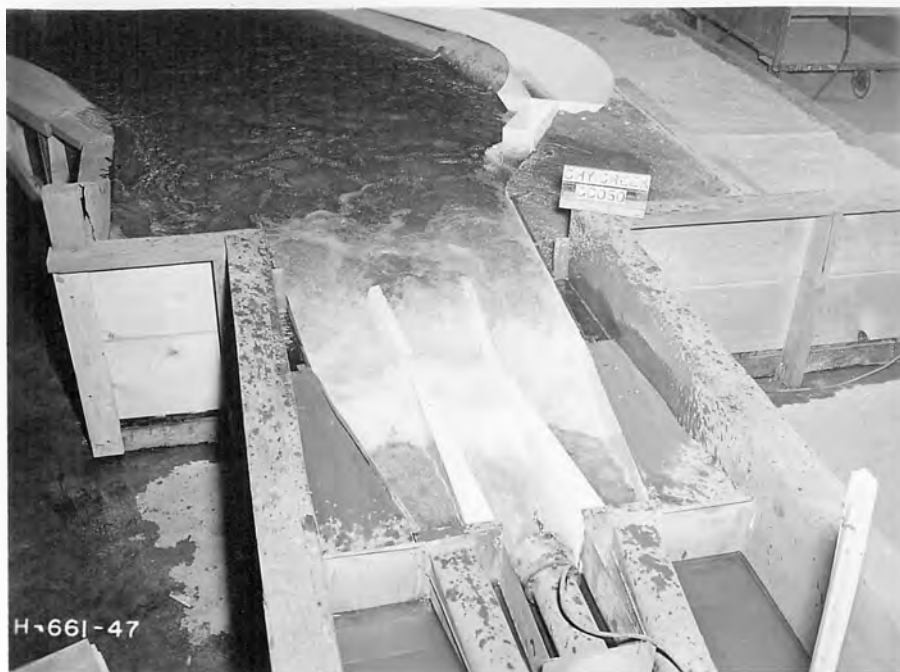
A. All conduits discharging - 9,400 second-feet

1:28 MODEL, CHERRY CREEK STILLING-BASIN, RECOMMENDED DESIGN

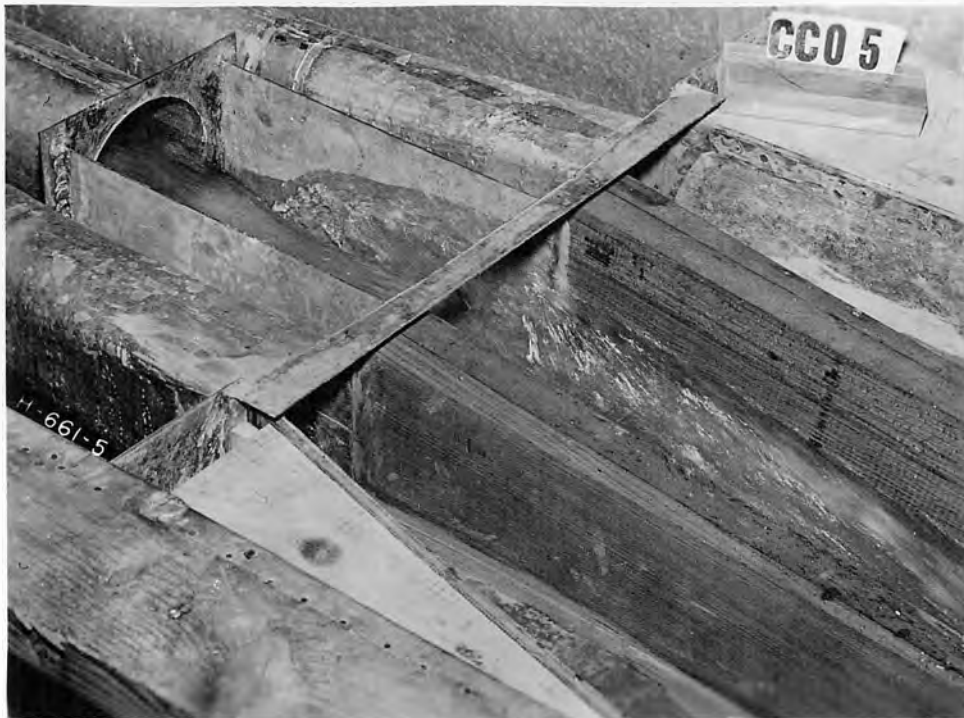
A. Flow near portal of center conduit -
Initial phase, discharge 1,500 second-feet

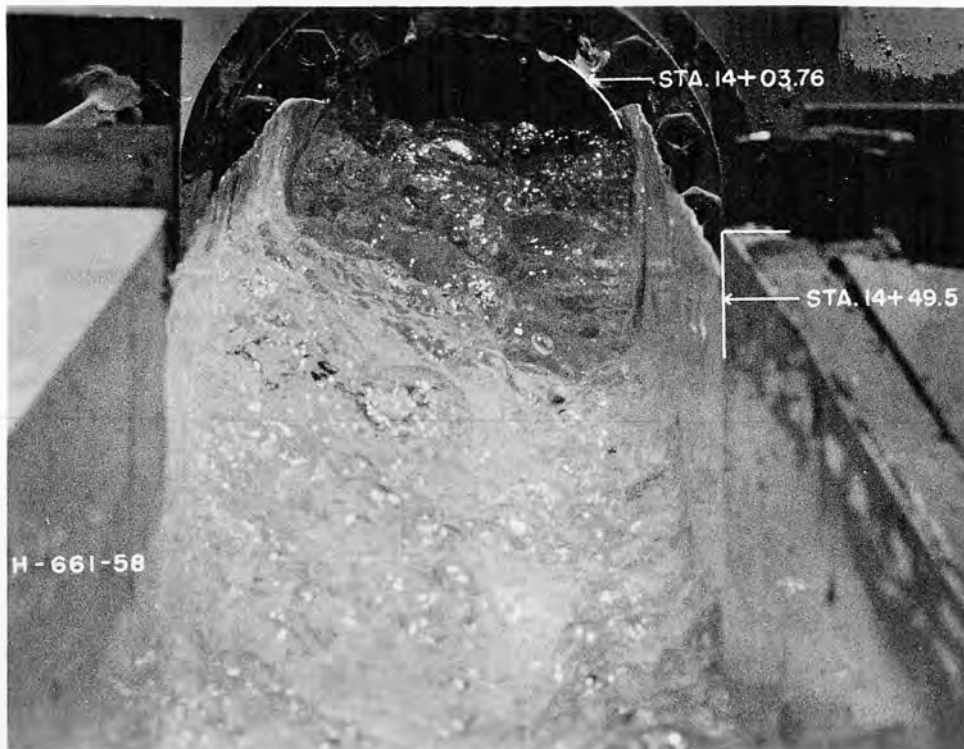
B. Flow in downstream section of left conduit with roof removed, discharge 2,275 second-feet. 1/20,000 sec. exposure.

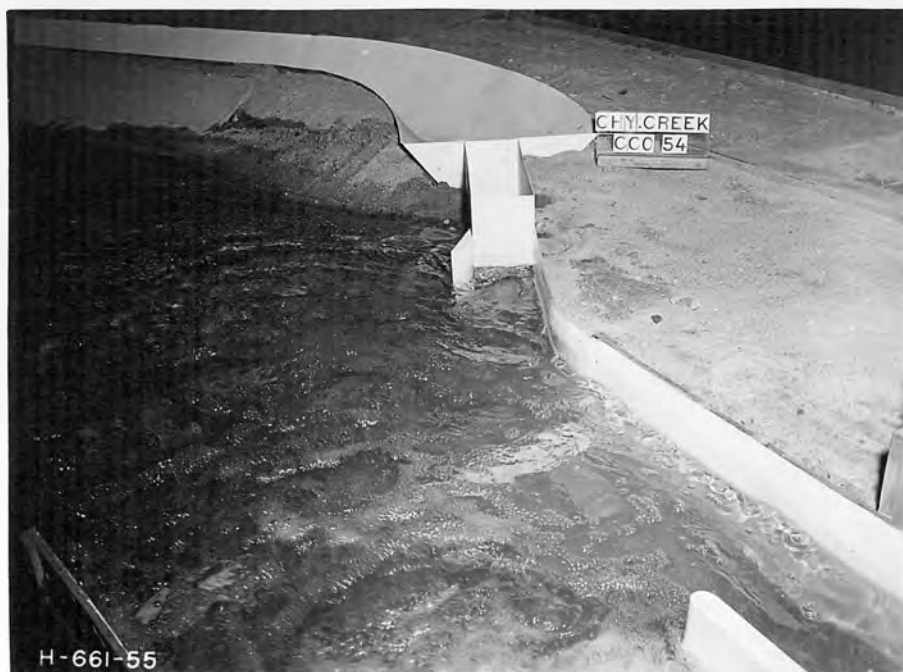
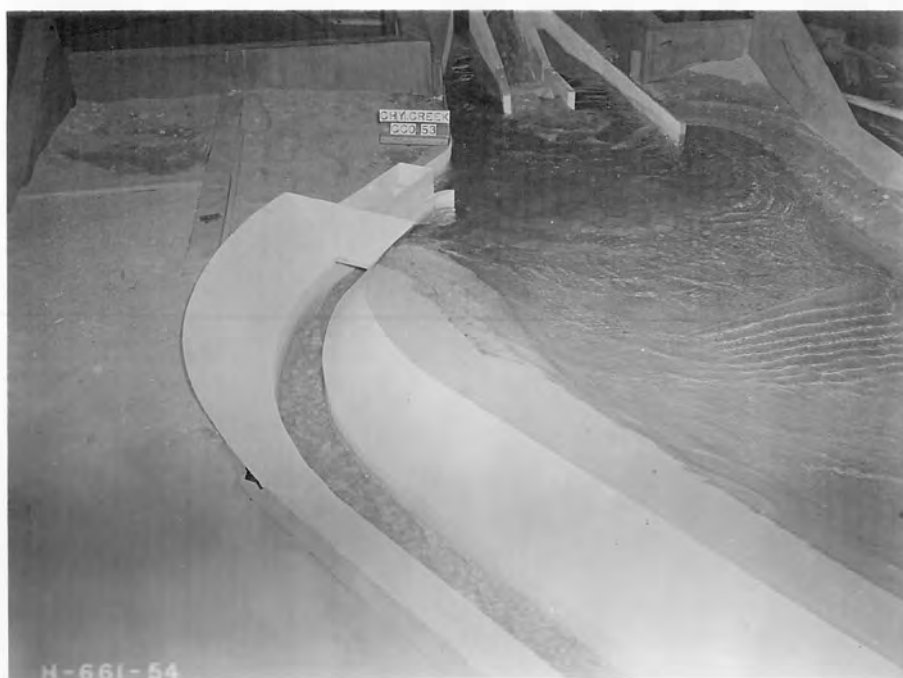
A. Flow conditions at entrance

B. Flow conditions in the canal

CANAL DISCHARGE 750 SECOND-FOOT - 4-FOOT GATE OPENING. HOLLOW-JET VALVE DISCHARGING 1,500 SECOND-FOOT, TAILWATER ELEVATION 5497.6

1:28 MODEL, CHERRY CREEK IRRIGATION INLET

The irrigation canal and inlet structure as installed in the model is shown in Figure 24 A & B. With the hollow-jet valve discharging 1,500 second-feet photographs were taken of flow in the irrigation outlet. In Figure 25 two views are shown with the radial gate of the inlet open 4 feet and in Figure 26 two views are shown with the gate fully open. Choppy waves were present on the water surface at the entrance to the inlet and a depressed water surface or drawdown existed around the upstream end of the left training wall, due to the contraction in the flow. This drawdown increased with high flows into the irrigation canal. Depth of

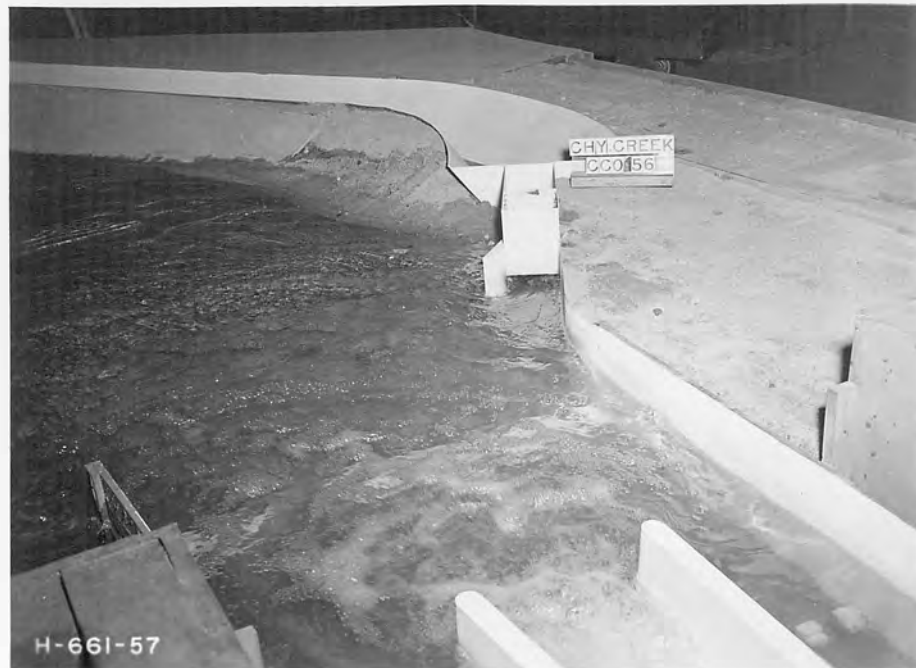
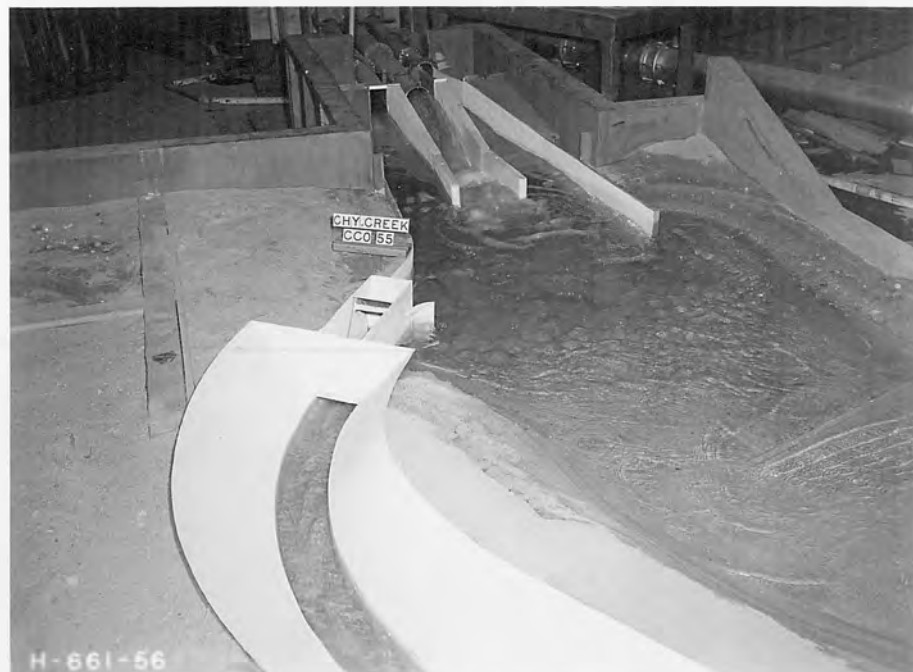
FIGURE 26

A. Flow at entrance is affected slightly by contraction

B. Flow in canal is concentrated along outside of bend

CANAL DISCHARGE 1,200 SECOND-FEET - GATE FULLY OPEN. HOLLOW-JET
VALVE DISCHARGING 1,500 SECOND-FEET, TAILWATER ELEVATION 5496.3

1:28 MODEL, CHERRY CREEK IRRIGATION INLET
