HYD-3.3

HYDRAULIC LABORATORY

Moon Lake Dam is to be constructed at the lower end of the present Moon Lake, which is located on the West Fork of the Lake Fork of the Duchesne River in northeastern Utah. The dam site is 32 miles north of the town of Duchesne and about 75 miles east and slightly south of Salt Lake City. The dam will be of the earth fill type having a height of approximately 120 feet above the river, and will increase the storage capacity of the present Moon Lake to 30,000 acre feet. The additional storage will create a supplementary supply of irrigation water for lands already under cultivation, and will open up additional crop acreage in the vicinity which has hitherto been restricted due to the shortage of water.

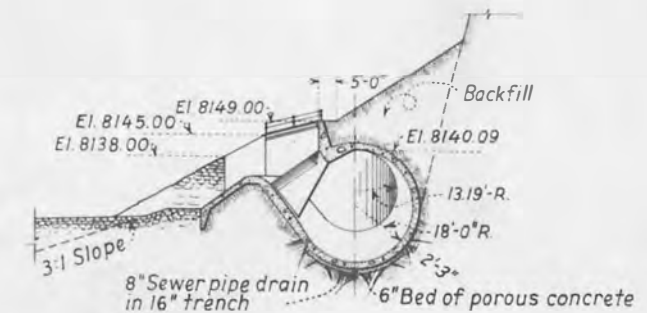
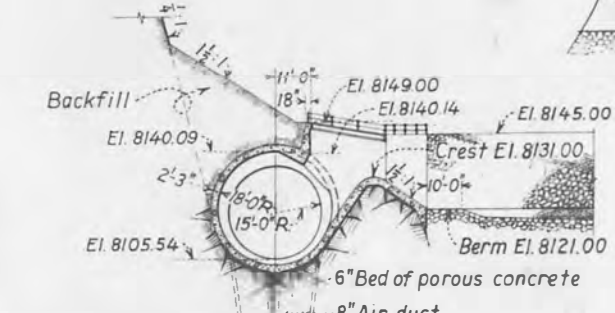
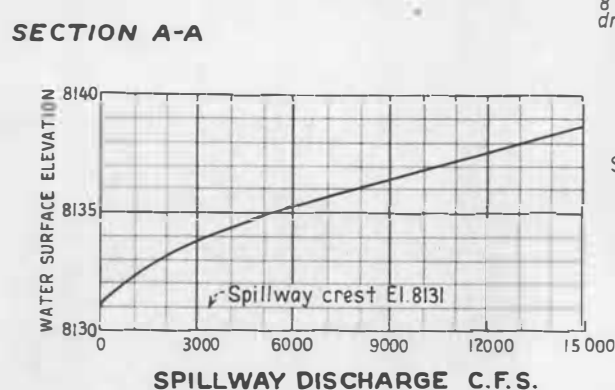
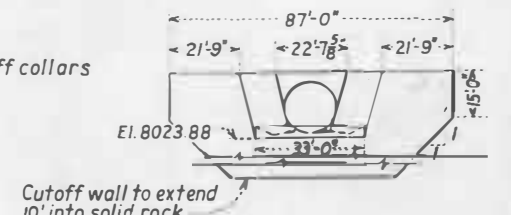
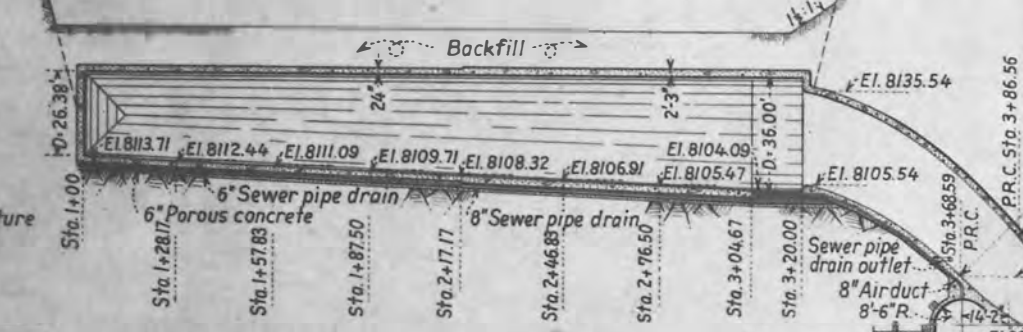
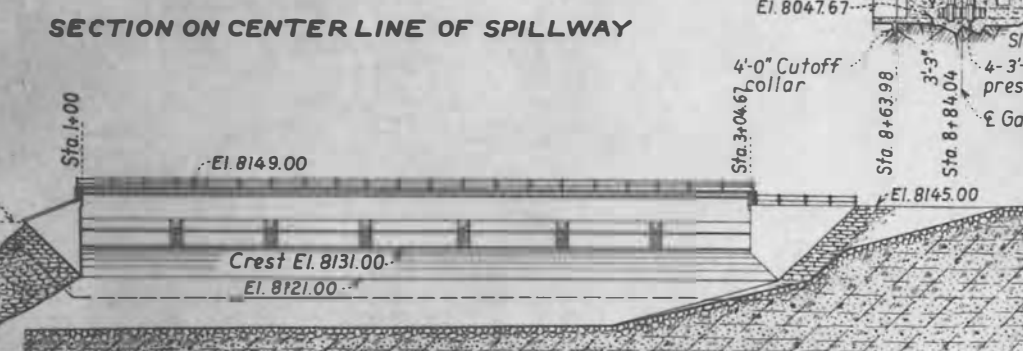
NOTE
Excavated surfaces in shale to be coated with a sealing solution for protection from weathering until concrete is placed.

In connection with the dam, the spillway which will carry off the excess flow during flood seasons is to be located in the east canyon wall somewhat upstream from the axis of the dam. (See figure 1). Due to the abruptness of the canyon walls and the stability of the rock of which they are formed, a side channel spillway, which proves to be a unique design in this particular case, was proposed. A detailed drawing of the spillway is shown in figure 2. The side channel proper which will be about 200 feet long, will consist of a conical tunnel having a diameter of 30 feet at the upper end and 36 feet at the downstream end, roofed completely by the canyon wall. Thus the canyon wall will be practically undisturbed and the

side channel will be protected from rock slips. The spillway will have a free overflow crest which will be in the open and visible from the reservoir. Water passing over the crest will enter the conical channel through a long horizontal slot-like opening in the canyon wall. Six concrete piers equally spaced and resting on the crest will serve as supports to strengthen the arch of the conical channel section. The piers serve only this one purpose as no gates or devices for controlling the spillway flow are provided. With 168.67 feet of free crest, it will be possible to obtain the maximum discharge of 10,000 c.f.s. through the spillway with a head of approximately 6 feet on the crest.

Beginning at the lower end of the conical channel, a transitional chute, circular in section but gradually decreasing in diameter, will conduct the water from the spillway through a drop of 60 feet in a distance of 122 feet, to a 16.5-foot constant diameter tunnel. The 16.5-foot tunnel, which will have a slope of 0.043, will convey the water to the outlet portal from which it will discharge directly into the river below the dam. The original diversion tunnel will be utilized to conduct water for irrigation purposes, when the spillway is not in operation, from the reservoir to the 16.5-foot spillway tunnel, which in turn will deliver it to the river below the dam. (See figure 2). The control works will be located just above the junction of the two tunnels.

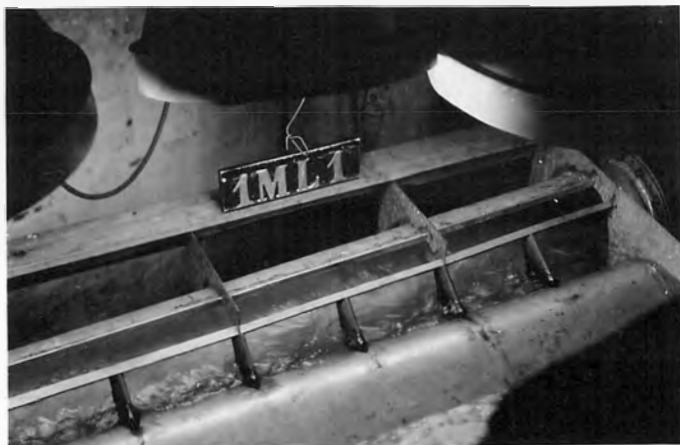
A. SIDE CHANNEL - DISCHARGE 10,000 C.F.S.

ORIGINAL DESIGN.

The model as originally designed indicated that a few changes should be made. A sketch of the original design is shown in figure 5 and photographs of the same are shown in plate 1. At the maximum discharge of 0.988 c.f.s. which corresponds to 10,000 c.f.s. in the prototype, the side channel was flowing nearly full at the downstream end and the crest was submerged at the upper end. The rolling motion, ever present in side channel spillways, was repeatedly broken up on the right side of the channel by the six piers, but it persisted on the left side and the water entered the chute with a pronounced whirl. The greater portion of the chute was flowing full at maximum discharge, and the 15-foot tunnel was flowing completely full. Photograph C (plate I) shows the water surface in the upper part of the chute, and photograph A shows the side channel in operation for the maximum discharge of 10,000 c.f.s. From all evidence, the 15-foot tunnel was too small and it backed the water up in the chute. This in turn raised the water surface in the side channel sufficiently to submerge the crest at the upper three pier spaces.

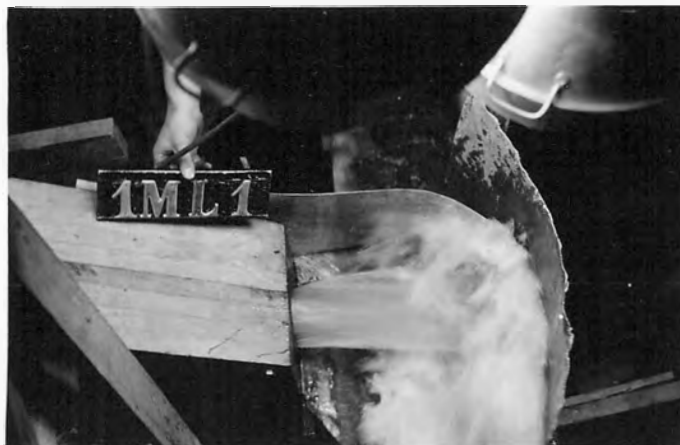
B. LOWER END OF CHUTE - DISCHARGE 10,000 C.F.S.

In order to prove definitely that the 15-foot tunnel was too small, a run was made with the tunnel disconnected from the chute. As the water flowed out of the chute, it was caught in a temporary sheet metal flume and returned to the system. With the tunnel removed, the choking effect was partially relieved in the chute; but it can be seen from photograph B (plate I) that the chute still flowed full at the lower end.

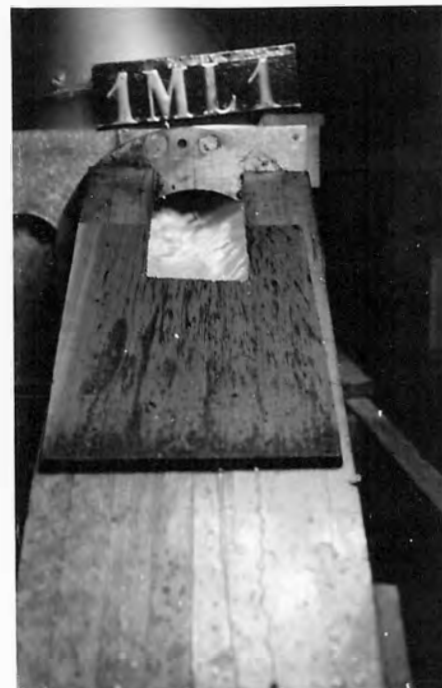
C. UPPER END OF CHUTE.
DISCHARGE 10,000 C. F. S.

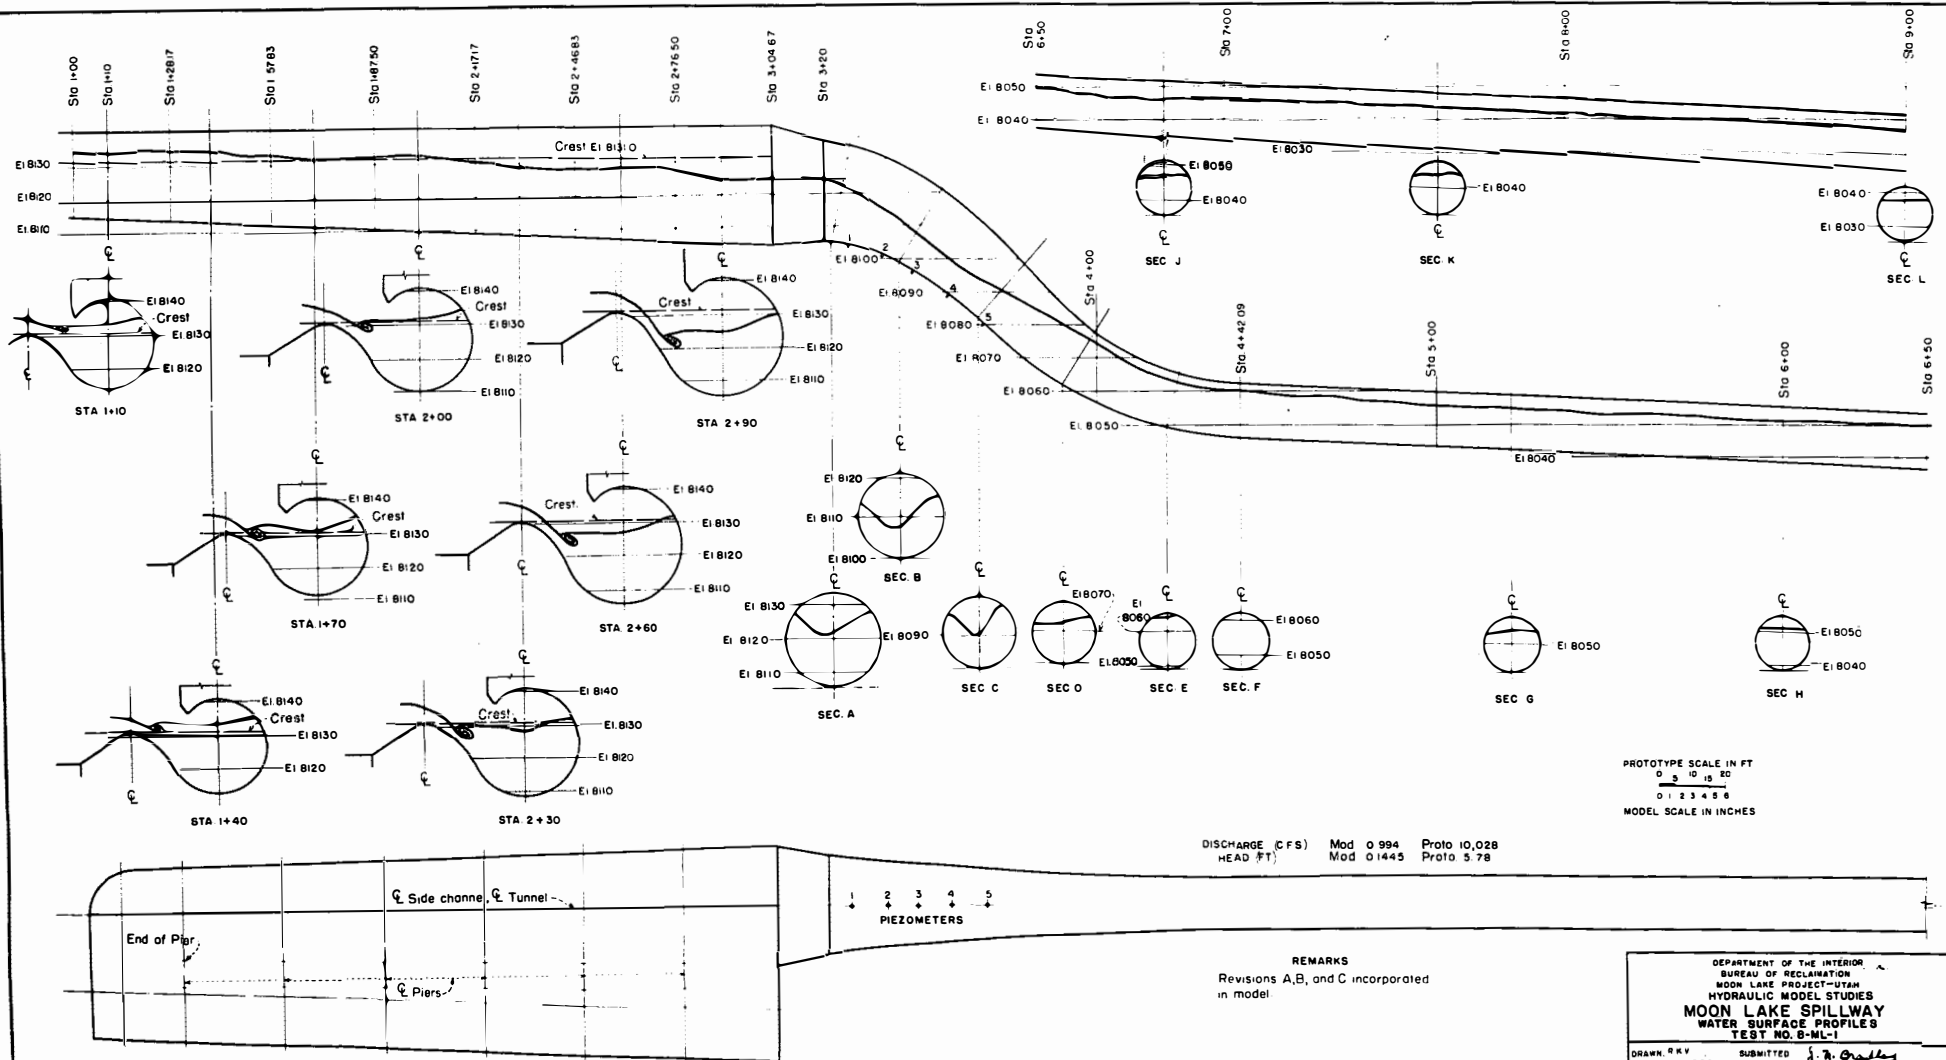
DEPARTMENT OF THE INTERIOR BUREAU OF RECLAMATION MOON LAKE PROJECT—UTAH HYDRAULIC MODEL STUDIES MOON LAKE SPILLWAY WATER SURFACE PROFILES TEST NO. 8-ML-1	
DRAWN R.K.V. TRACED H.W.E.B. CHECKED J.N.B.	SUBMITTED RECOMMENDED APPROVED
DENVER, COLO. DEC 18, 1934

able due to these changes. Test 8-1 shown in figure 6 shows the water surface at various sections taken along the channel, chute, and tunnel, and a profile of the water surface on the center line for a discharge of 10,000 c.f.s. In test 8-1, the above three revisions A, B, and C, were incorporated in the model. There was still considerable room for improvement in flow conditions. Note the irregularity of the water surface in sections A, B, C, and D shown in figure 6. Photograph A (plate II) is a view looking upstream at the conical side channel through the upper portion of the chute. Photograph B shows the spillway in operation for a discharge of 10,000 c.f.s.

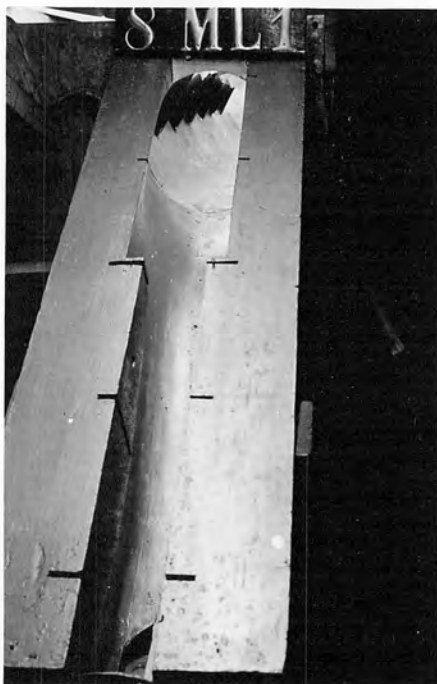
A. REVISIONS A, B, AND C.

REVISED DESIGNS.
LOOKING UPSTREAM THROUGH CHUTE.

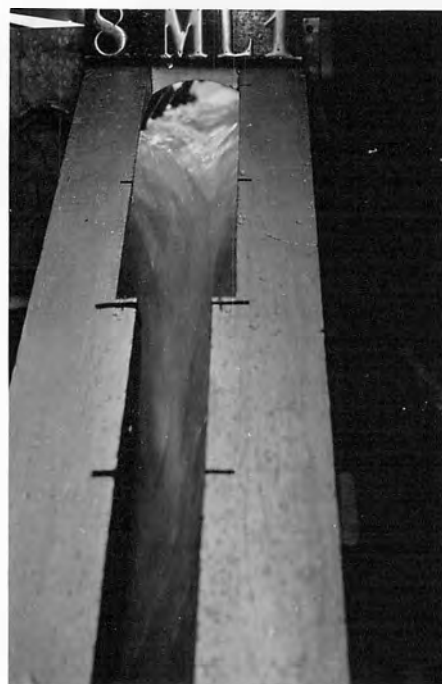
B. REVISIONS A, B, AND C.
DISCHARGE 10,000 C.F.S.

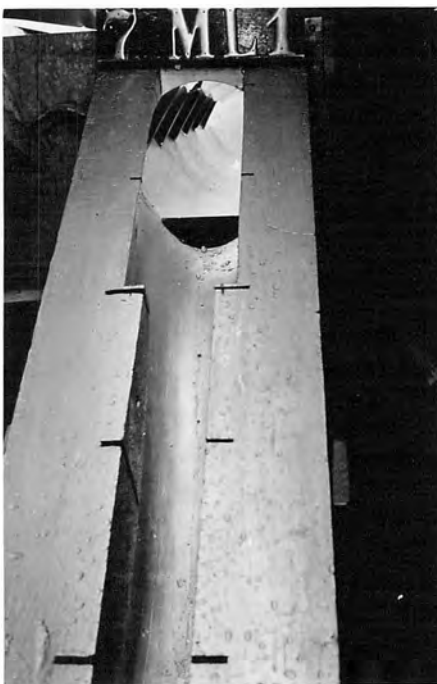
C. REVISIONS A, B, C, AND D.

Test 7-1 (figure 7) shows the plot of a run at maximum discharge with a flat topped check 4 feet high installed at station 3+20. Photograph C (plate II) shows a picture of the check, and photograph

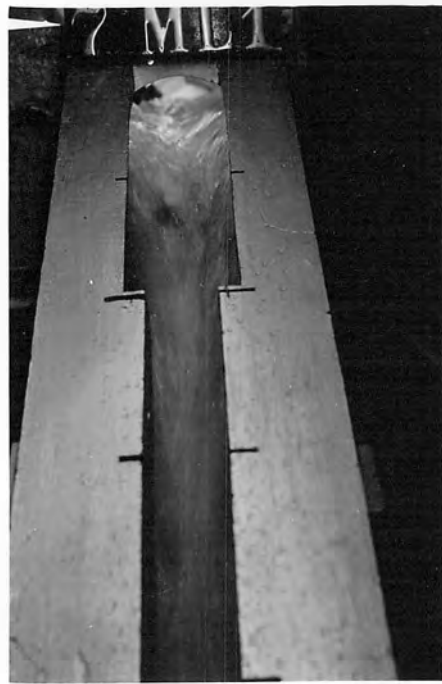
D. REVISIONS A, B, C, AND D.
DISCHARGE 10,000 C.F.S.

D shows the spillway discharging at a 10,000 c.f.s. with the check installed. The model as for test 7-1 involved a combination of all revisions so far made, namely A, B, C, and D. Flow conditions in the chute showed a slight but noticeable improvement over those encountered in previous tests.

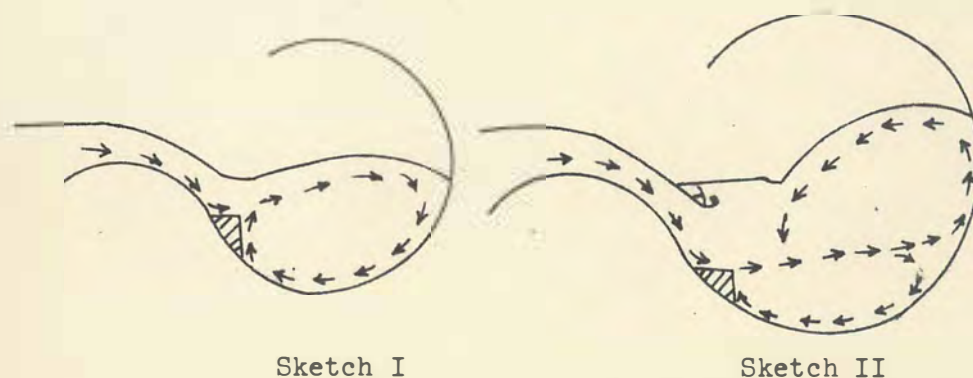
recommended design on figure 5. The upstream step reversed the customary roller in the upper portion of the side channel as shown below in sketch I. The downstream step split the jet so that a roller was formed in both directions as shown below in sketch II. In this case, the counter clockwise roller predominated.

This combination of rollers evidently counteracted one another to some extent as very good flow conditions were produced in the side channel, chute, and tunnel. For a more detailed account of the various step sills tried and their locations, see the appendix of this report.

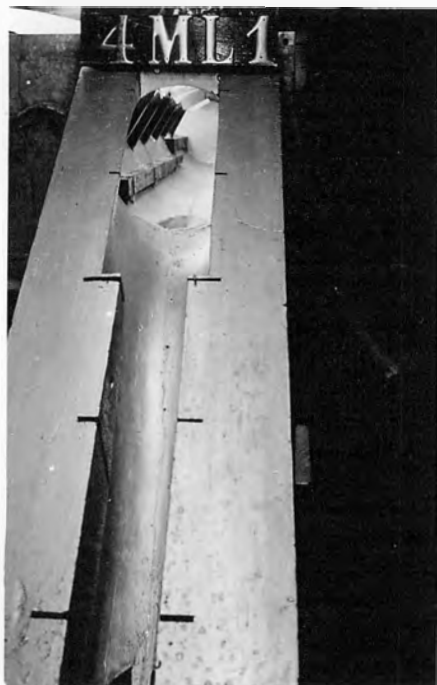
A. REVISIONS A, B, C, AND E.

REVISED DESIGNS.
LOOKING UPSTREAM THROUGH CHUTE.

Test 4-1 (figure 8) shows a profile on the center line and some sections for a run at maximum discharge using steps 4 feet wide installed as shown in figure 5. Photograph A (plate III) is a view of the layout, and photograph B shows the spillway operating at 10,000 c.f.s. The model during these tests had incorporated in it revisions A, B, C, and E (D being omitted).

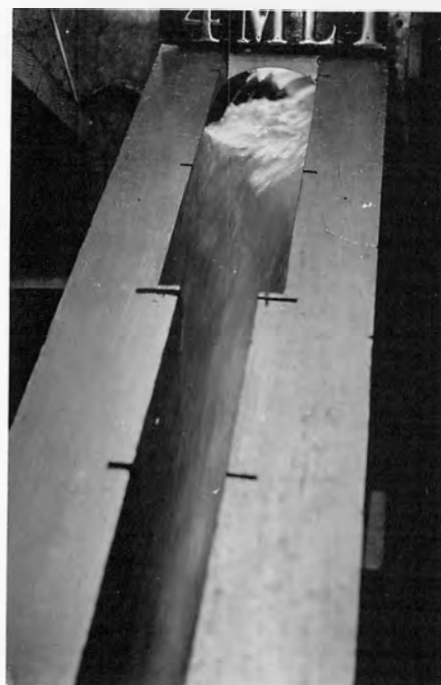
B. REVISIONS A, B, C, AND E.
DISCHARGE 10,000 C.F.S.

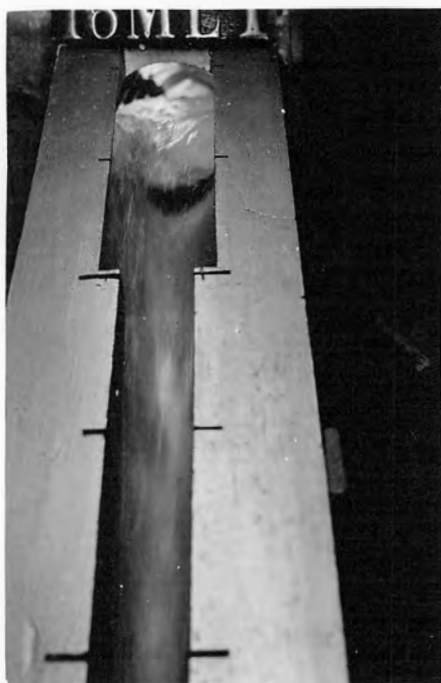
C. RECOMMENDED DESIGN.
DISCHARGE 10,000 C.F.S.

Tests 16-5 and 16-2 (figure 9) show the center line profiles and some sections taken along the channel, chute, and tunnel for runs of 10,000 c.f.s. and 6,000 c.f.s. respectively for the model as finally revised. Tests 16-1 and 16-3 (figure 10) are plotted for runs of 8,000 c.f.s. and 4,000 c.f.s. Photographs C and D (plate III) show the model of the recommended spillway discharging at 10,000 and 6,000 c.f.s. respectively.

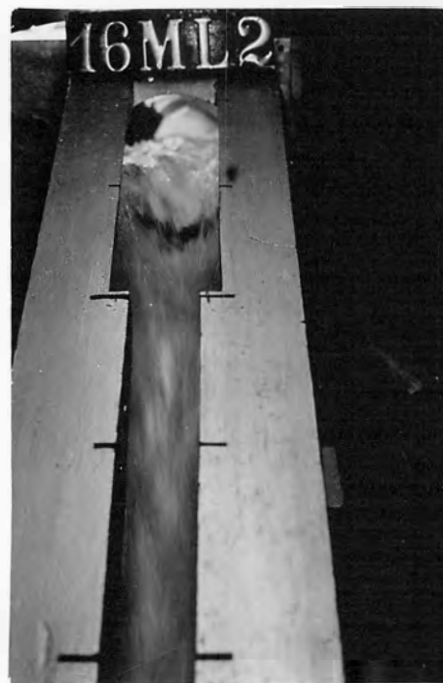
D. RECOMMENDED DESIGN.
DISCHARGE 6,000 C.F.S.

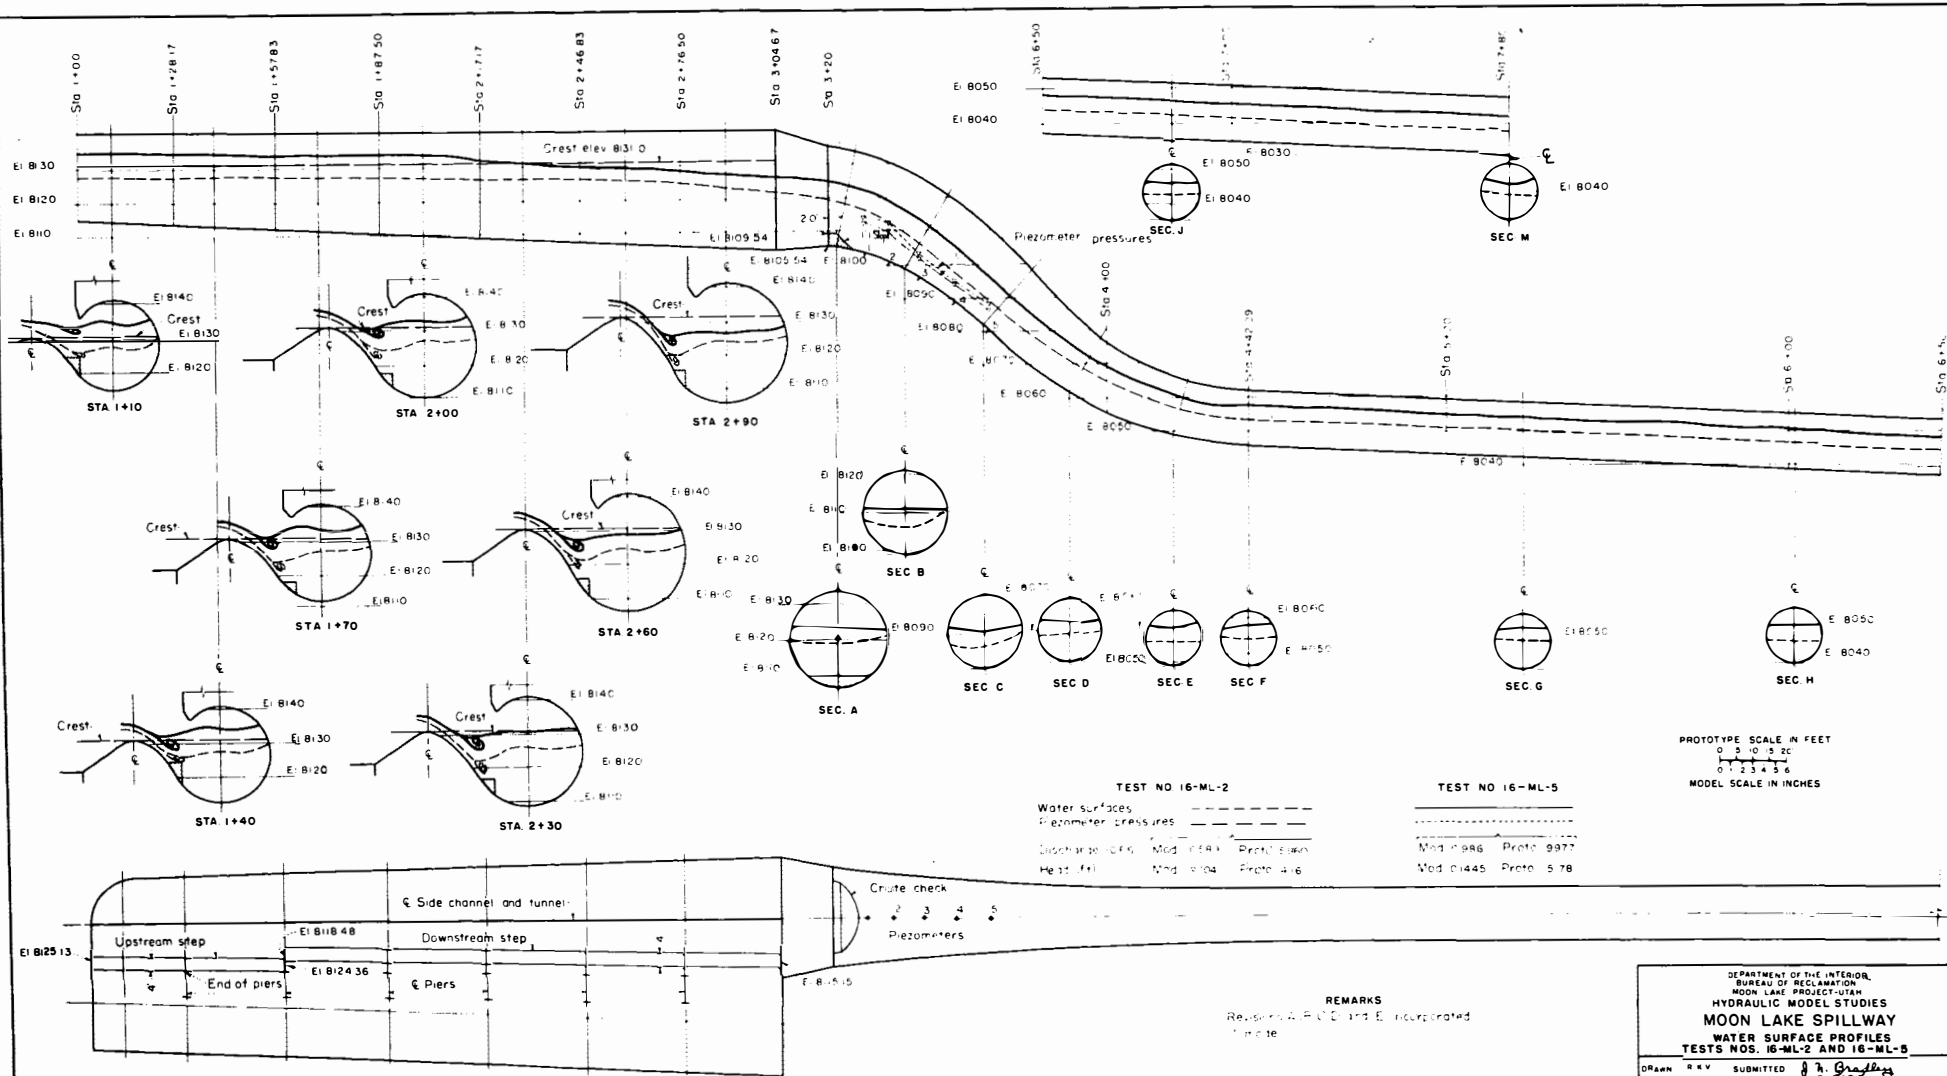
DEPARTMENT OF THE INTERIOR
BUREAU OF RECLAMATION
MOON LAKE PROJECT-UTAH
HYDRAULIC MODEL STUDIES
MOON LAKE SPILLWAY
WATER SURFACE PROFILES
TESTS NOS. 16-ML-2 AND 16-ML-5

The pressures recorded by the five piezometers which were located in the invert of the chute are shown plotted on figures 9 and 10 for the four runs made on the recommended design. In no case was a pressure recorded which was below atmospheric.

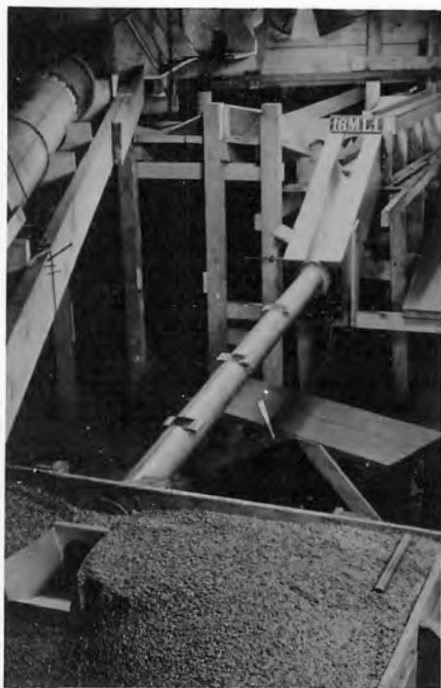
A. GENERAL VIEW OF MODEL.

RECOMMENDED DESIGN.
REVISIONS A, B, C, D, AND E.

on the same page for the purpose of comparison. Other photographs of the model representing the recommended design are shown on plate IV.

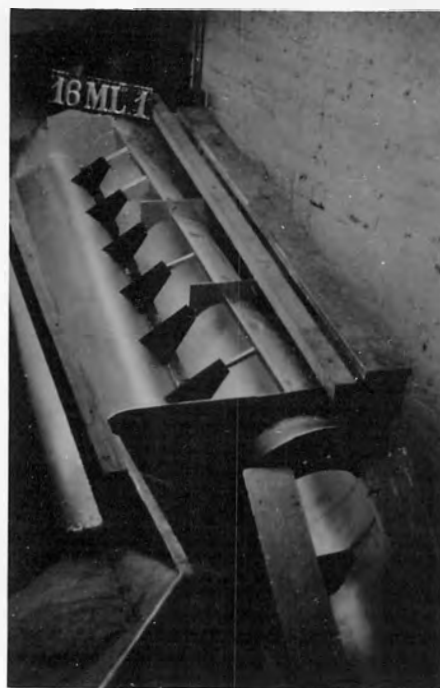
B. VIEW OF SIDE CHANNEL
AND OVERFLOW SECTION.

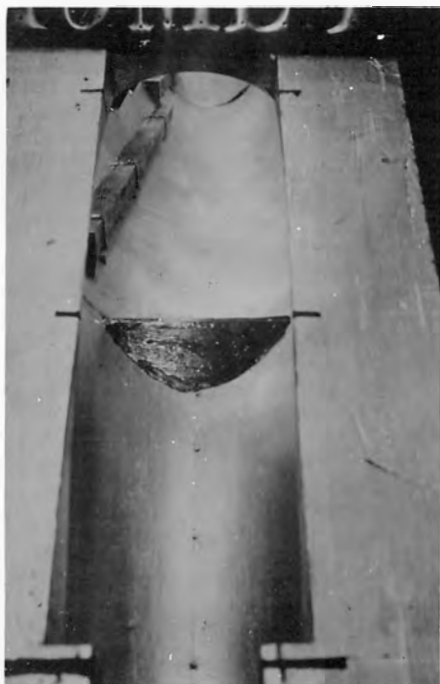
C. VIEW LOOKING UPSTREAM
THROUGH PORTAL OF CHUTE.

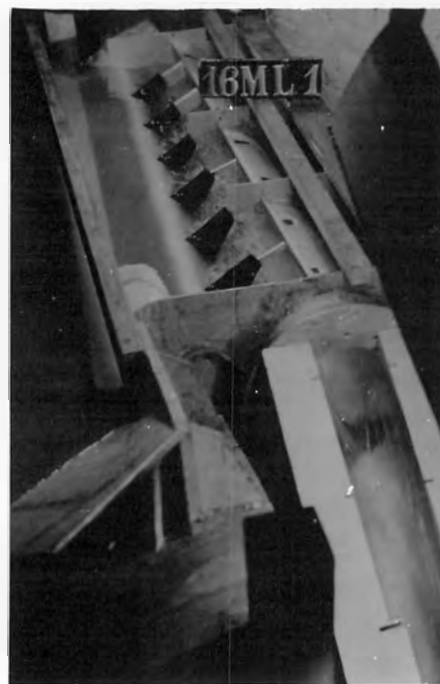
D. SPILLWAY -
DISCHARGE 10,000 C.F.S.

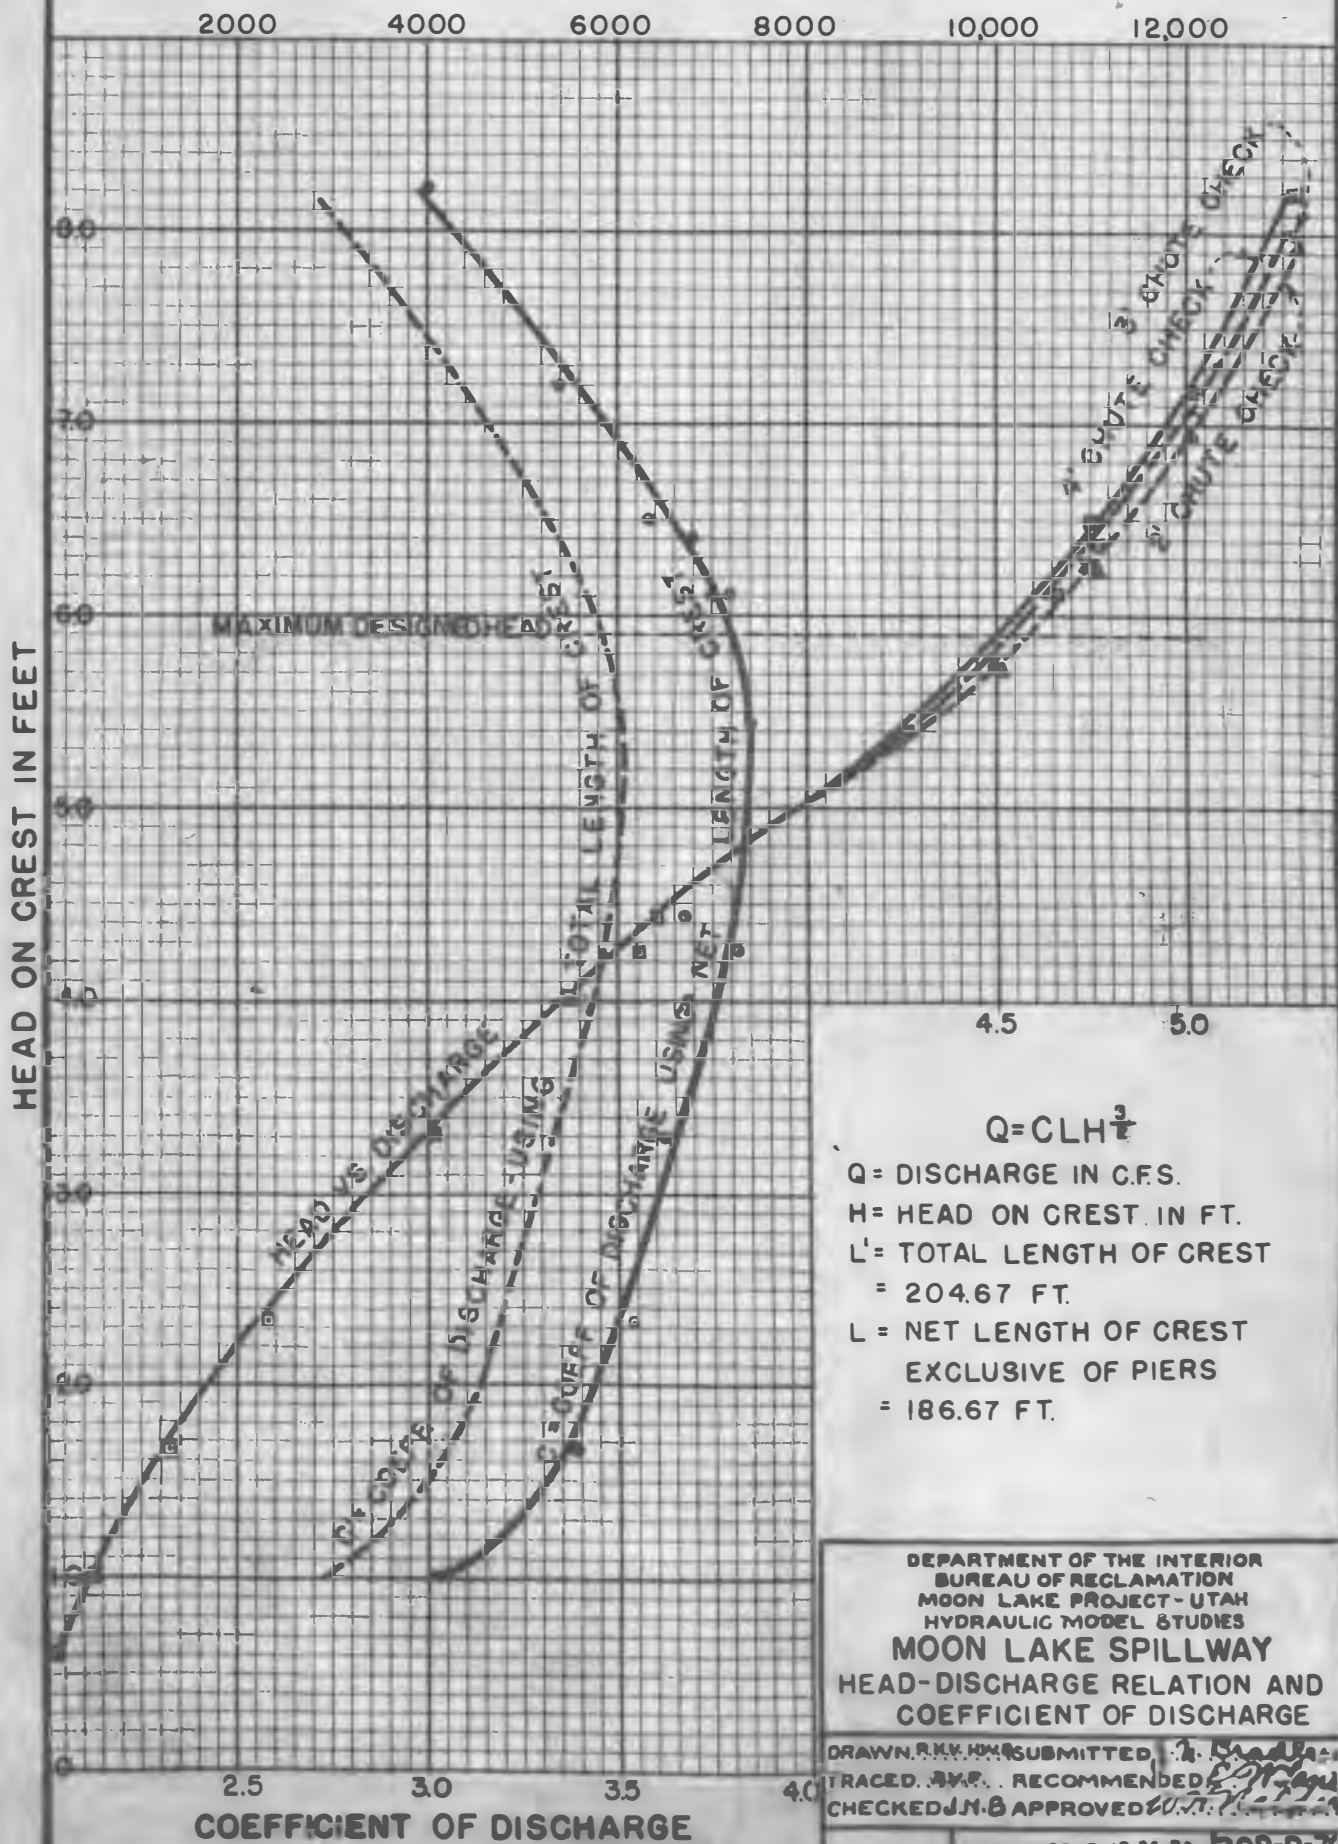
HEAD ON CREST IN FEET

$$Q = CLH^{\frac{3}{2}}$$

Q = DISCHARGE IN C.F.S.

H= HEAD ON CREST IN FT.

L' = TOTAL LENGTH OF CREST

$$= 204.67 \text{ FT.}$$

As it is difficult to estimate the coefficient of discharge for an overflow section such as that of the Moon Lake spillway, where part of the crest is submerged at maximum discharge, a series of runs were made on the model to determine the coefficient experimentally for various heads. Using the formula $Q = CLH^{3/2}$, the coefficients were computed using two crest lengths namely, the full length of crest or 204.67 feet, and the net length of crest (exclusive of the pier widths) or 186.67 feet. These coefficients are plotted as two separate curves on figure 11. Due to the piers being located on the downstream side of the overflow section rather than on top of the crest as is usually the case, doubt was expressed as to what extent the piers would affect the flow over the crest - hence the two curves. The piers did affect the discharge, but not as much as would have been the case had they been located on top of the crest. Also plotted on figure 11, indicated by a heavy full line, is a curve showing the relation head bears to discharge in the recommended design. Submergence commences when the head on the crest reaches about 5 feet, as both the head-discharge and coefficient curves indicate. Above 5 feet, the value of the coefficient falls off and likewise the rate at which the discharge is increasing, decreases. For the maximum designed discharge of 10,000 c.f.s., the head on the crest is 5.90 feet and the coefficient of discharge computed using the net crest length is 3.80.

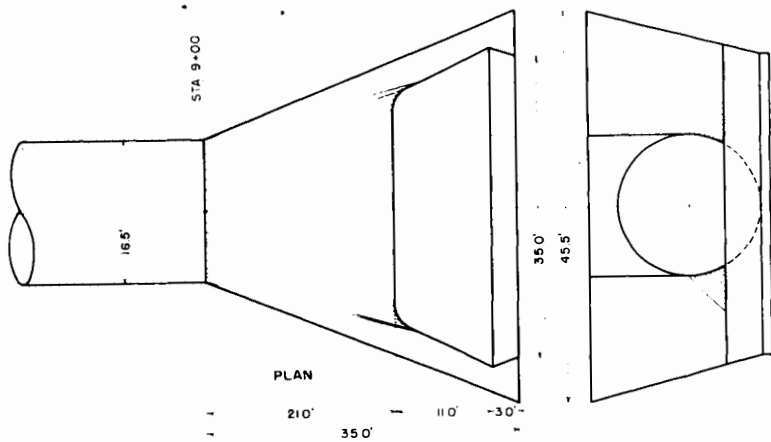
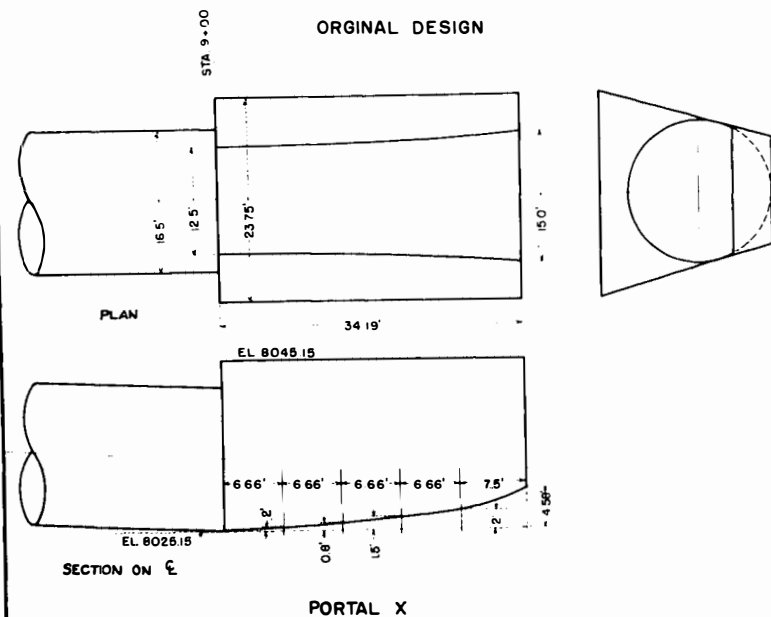
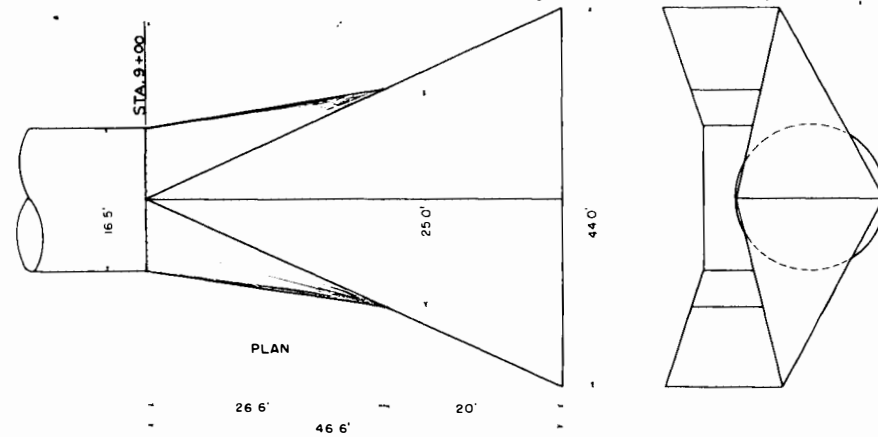
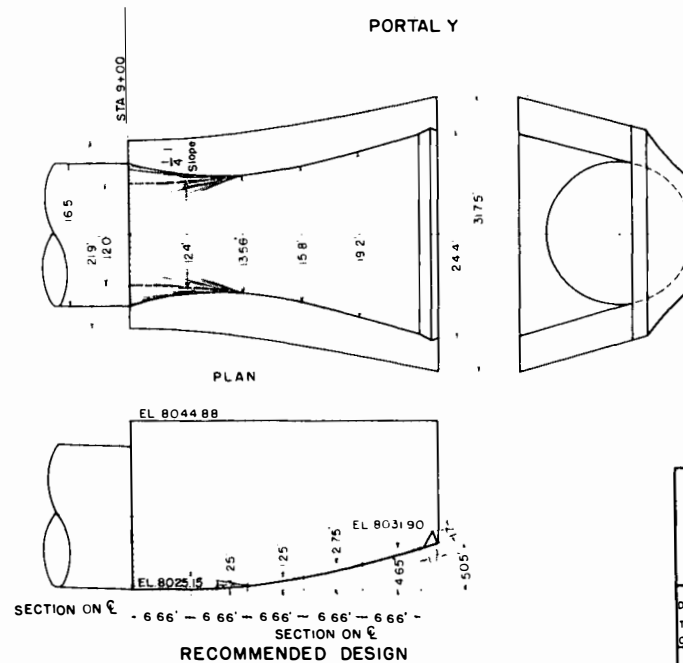
DEPARTMENT OF THE INTERIOR BUREAU OF RECLAMATION MOON LAKE PROJECT-UTAH HYDRAULIC MODEL STUDIES MOON LAKE SPILLWAY OUTLET PORTALS USED IN MODEL STUDIES			
DRAWN BY	TRACED	AWG	E.E.B.
CHECKED	J.N.B.	APPROVED	<i>W. H. Alder</i>
SUBMITTED: <i>J. A. Bradley</i> RECOMMENDED: <i>E. H. Alder</i>			DENVER, COLO. DEC 20, 1934
209-D-71

It was found that the outlet as originally designed (See original design, figure 12) would be endangered by undercutting. A large fin was present at each side of the fan-shaped jet which upon striking the river created a whirlpool on each side of the portal structure. The high velocity currents undercut the portal and also washed away most of the sand that was piled against the side walls when the tailwater elevation was normal or greater than normal. Photographs A and B (plate V) show two views of the jet issuing from the original portal. Notice the heavy fin on each side of the fan and the resulting whirlpools on each side of the structure. Photograph C (plate V) is a picture of the sand box after a 15-minute run at maximum discharge and normal tailwater. If it had not been for the board and the bricks shown in the photographs, practically all of the sand which is behind them would have been eroded. Unfortunately there were no pictures taken to verify the fact, but in previous tests made without the board and bricks, the

As a first attempt to improve conditions about the outlet portal, the structure was revised as shown for portal X in figure 12. The side walls were drawn in parallel, the sill was omitted, and the floor was changed to slope upward in a downstream direction. The resulting jet was more concentrated and did shoot farther out into the river than the one in the original design. Its concentrated shape, however, caused considerable disturbance in the form of waves and surges which gradually washed away a good part of the material around the portal. Erosion was less pronounced than in the former case, but was still sufficient to make it necessary to classify this structure as questionable. Photograph A (plate VI) shows this portal in operation, and photograph B shows the sand box after a run of 15 minutes duration.

A third but entirely different type of portal which was tried on the model is shown as portal Y, in figure 12. The floor on the center line, beginning at station 9+00, sloped upward in a downstream direction with a slope of 0.375. From the center line, the floor sloped downward on either side until it met the side walls. The lines of intersection on the floor with the side walls had slopes of 0.25. A cross section taken perpendicular to the center line would show the floor to be of triangular shape. The purpose in sloping the floor away from the center line was to spread the jet laterally giving an exceptionally wide fan of equal thickness. In addition, the upward slope in the downstream direction should throw the jet a considerable distance out into the river.

The flaring side walls resembled the original design and the parabolic slope on the floor was similar to that in portal X. In addition, a small triangular sill was constructed on the end of the floor to give the jet increased elevation. A sketch of this portal which is designated as the "Recommended Design" is shown in figure 12. Photographs of the portal discharging at 10,000 c.f.s. are shown in B (plate VII) and A (plate VIII). Photographs A and C (plate VII) show the river bed before and after a 15-minute run made at maximum discharge and normal tailwater. The tags shown in C represent elevations from 8013 to 8105. Photographs B and C (plate VIII) show the recommended portal discharging at 6,000 and 2,000 c.f.s. respectively.

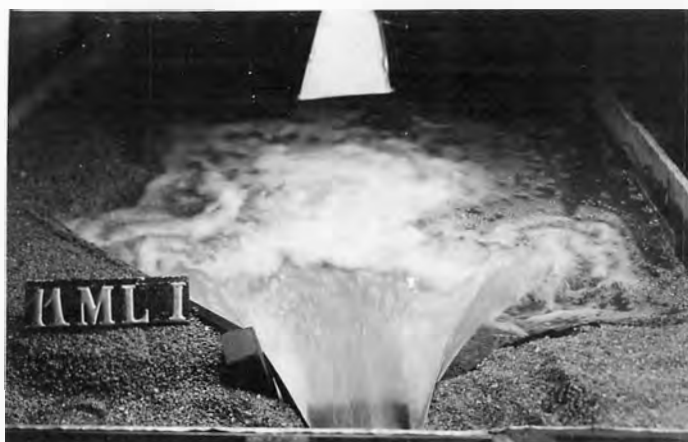
A. PLAN VIEW OF JET.

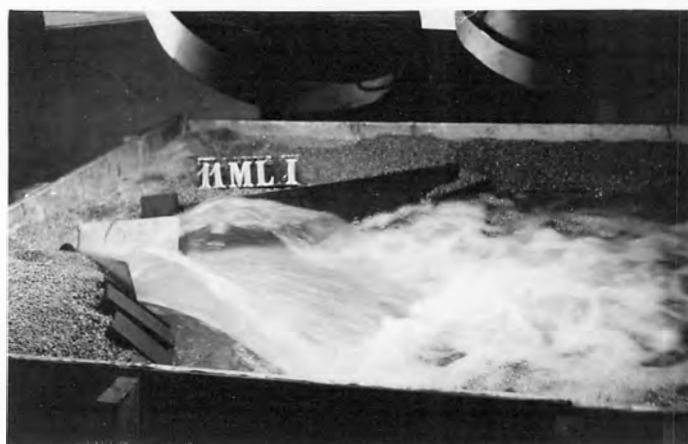
B. VIEW SHOWING TRAJECTORY OF JET.

ORIGINAL DESIGN OF OUTLET PORTAL.
DISCHARGE 10,000 C.F.S.

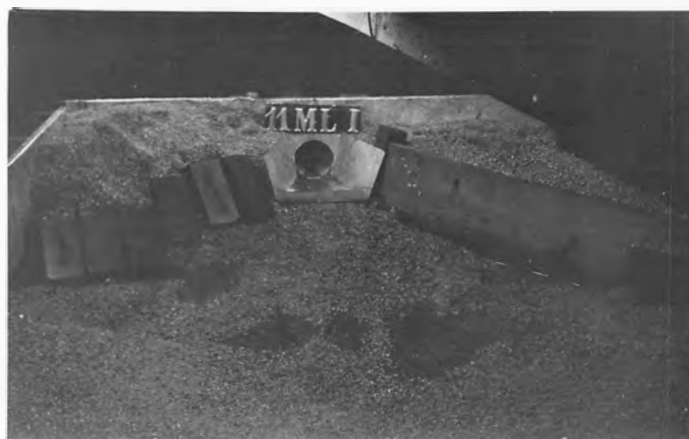
C. SAND BED AFTER 15 MINUTE RUN.

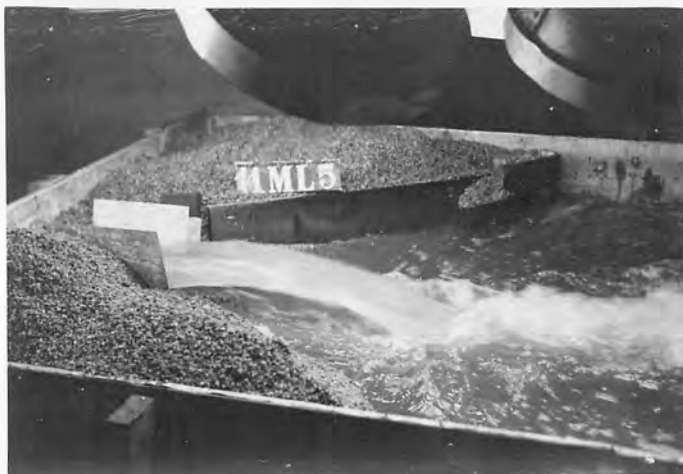
A. VIEW SHOWING TRAJECTORY OF JET.
DISCHARGE 10,000 C.F.S.

OUTLET PORTAL X.

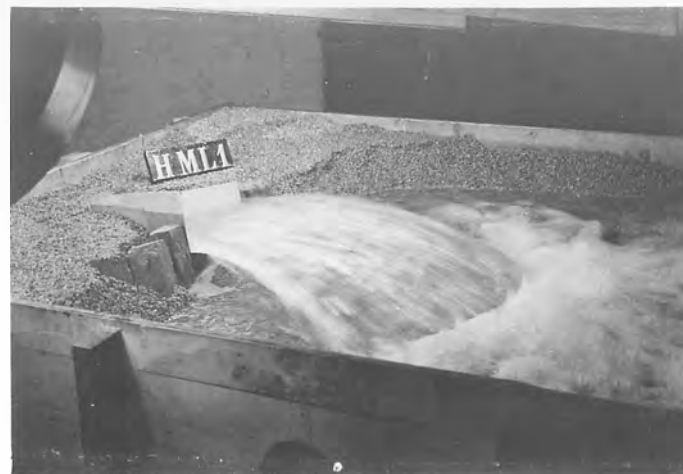
C. VIEW OF JET.
DISCHARGE 10,000 C.F.S.

OUTLET PORTAL Y.

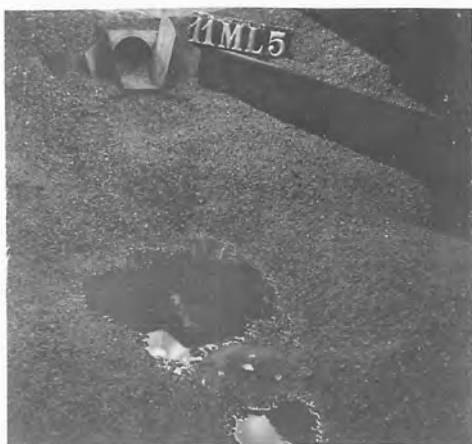
B. SAND BED AFTER 15 MINUTE RUN.

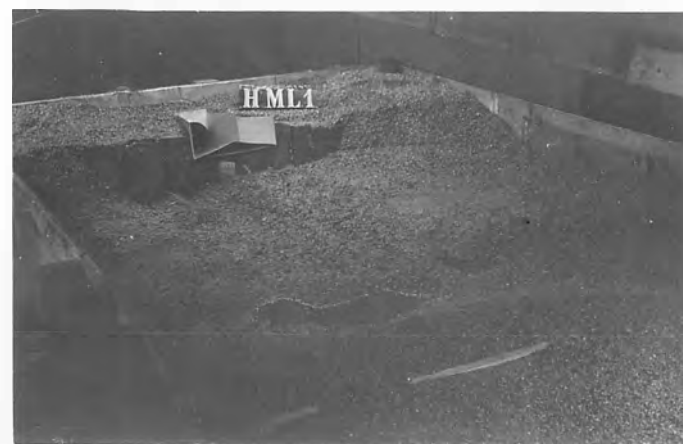
D. SAND BED AFTER 15 MINUTE RUN.

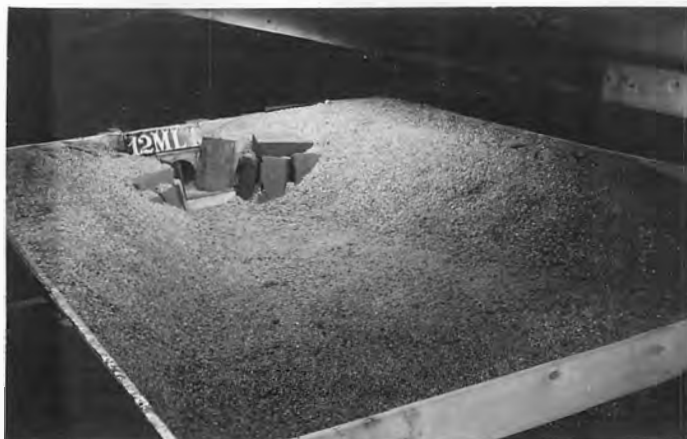
A. SAND BED BEFORE RUN.

RECOMMENDED OUTLET PORTAL DESIGN.

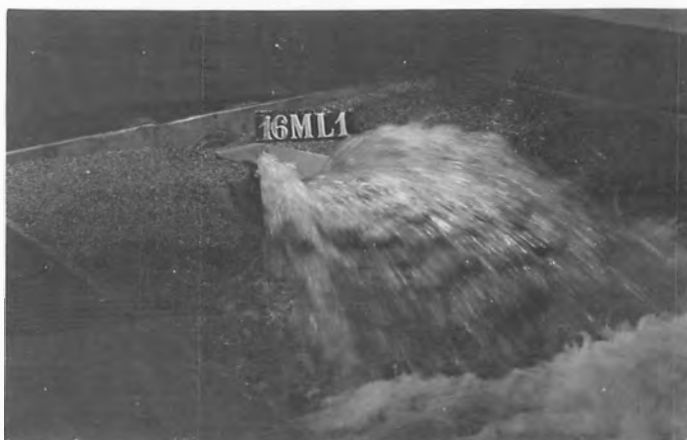
B. DISCHARGE 10,000 C.F.S.

It can be observed from the photographs that this portal worked very well. The jet did not spread as evenly as in the initial design of portal Y, but it did carry to a point farther down the river. Very little back wash was noticeable at any discharge and erosion was a minimum. Notice in the pictures showing the portal in operation, that with normal tailwater, the river bed under the

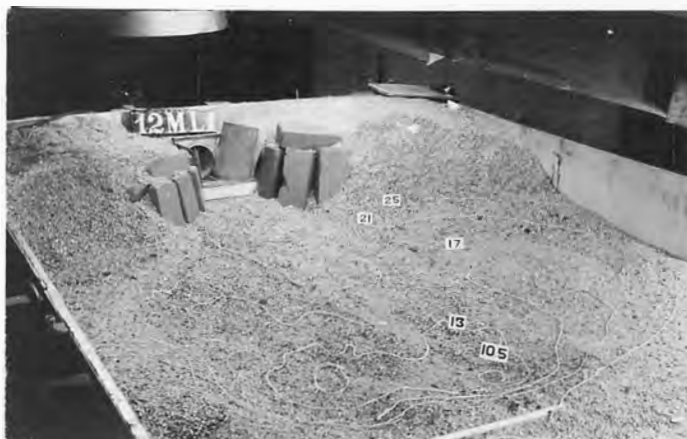
C. SAND BED AFTER 15 MINUTE RUN.

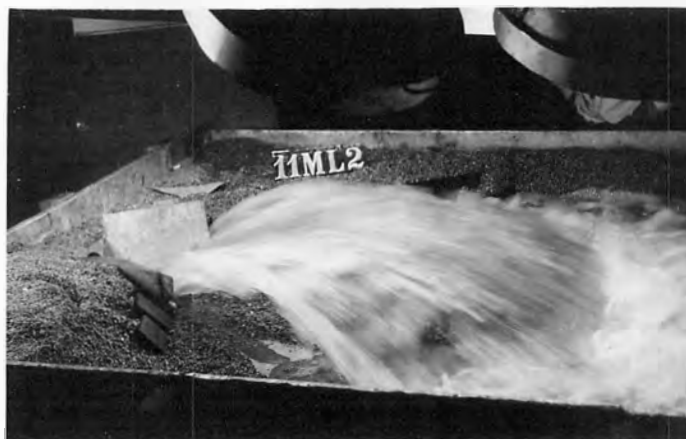
A. DISCHARGE 10,000 C.F.S.

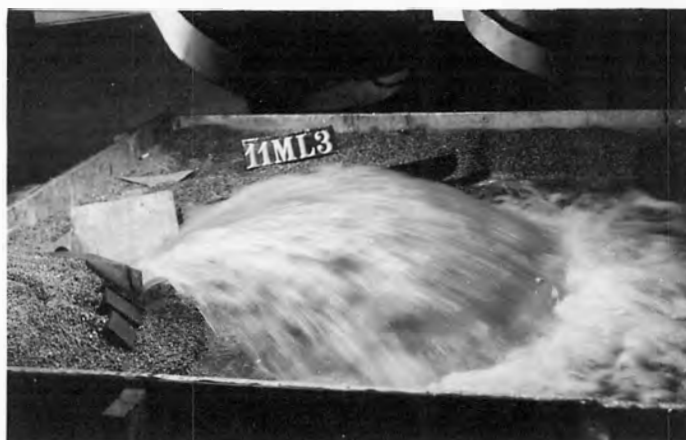
B. DISCHARGE 6,000 C.F.S.

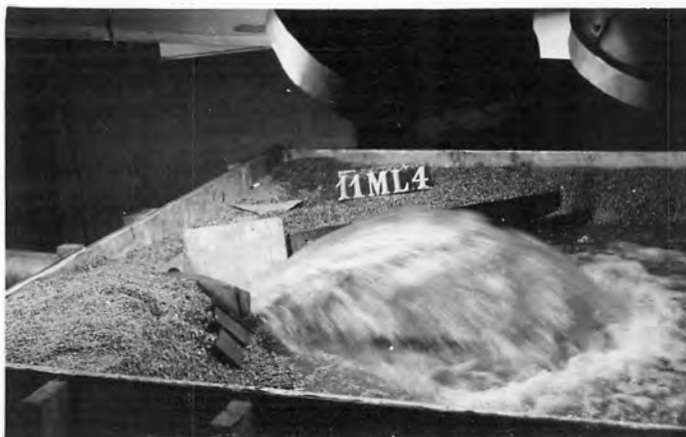
C. DISCHARGE 2,000 C.F.S.
