MEMORANDUM TO CHIEF DESIGNING ENGINEER  
SUBJECT: HYDRAULIC MODEL STUDIES FOR THE DESIGN  
OF  
THE ISLAND PARK DAM SPILLWAY

by J. N. BRADLEY, ASSISTANT ENGINEER  
and  
J. B. DRISKO, ASSISTANT ENGINEER

TECHNICAL MEMORANDUM NO. 478

DEPARTMENT OF THE INTERIOR  
BUREAU OF RECLAMATION  
UPPER SNAKE RIVER PROJECT-IDAHO  
HYDRAULIC MODEL STUDIES  
**MODEL OF ISLAND PARK DAM SPILLWAY**  
**MODEL SCALE 1:30**

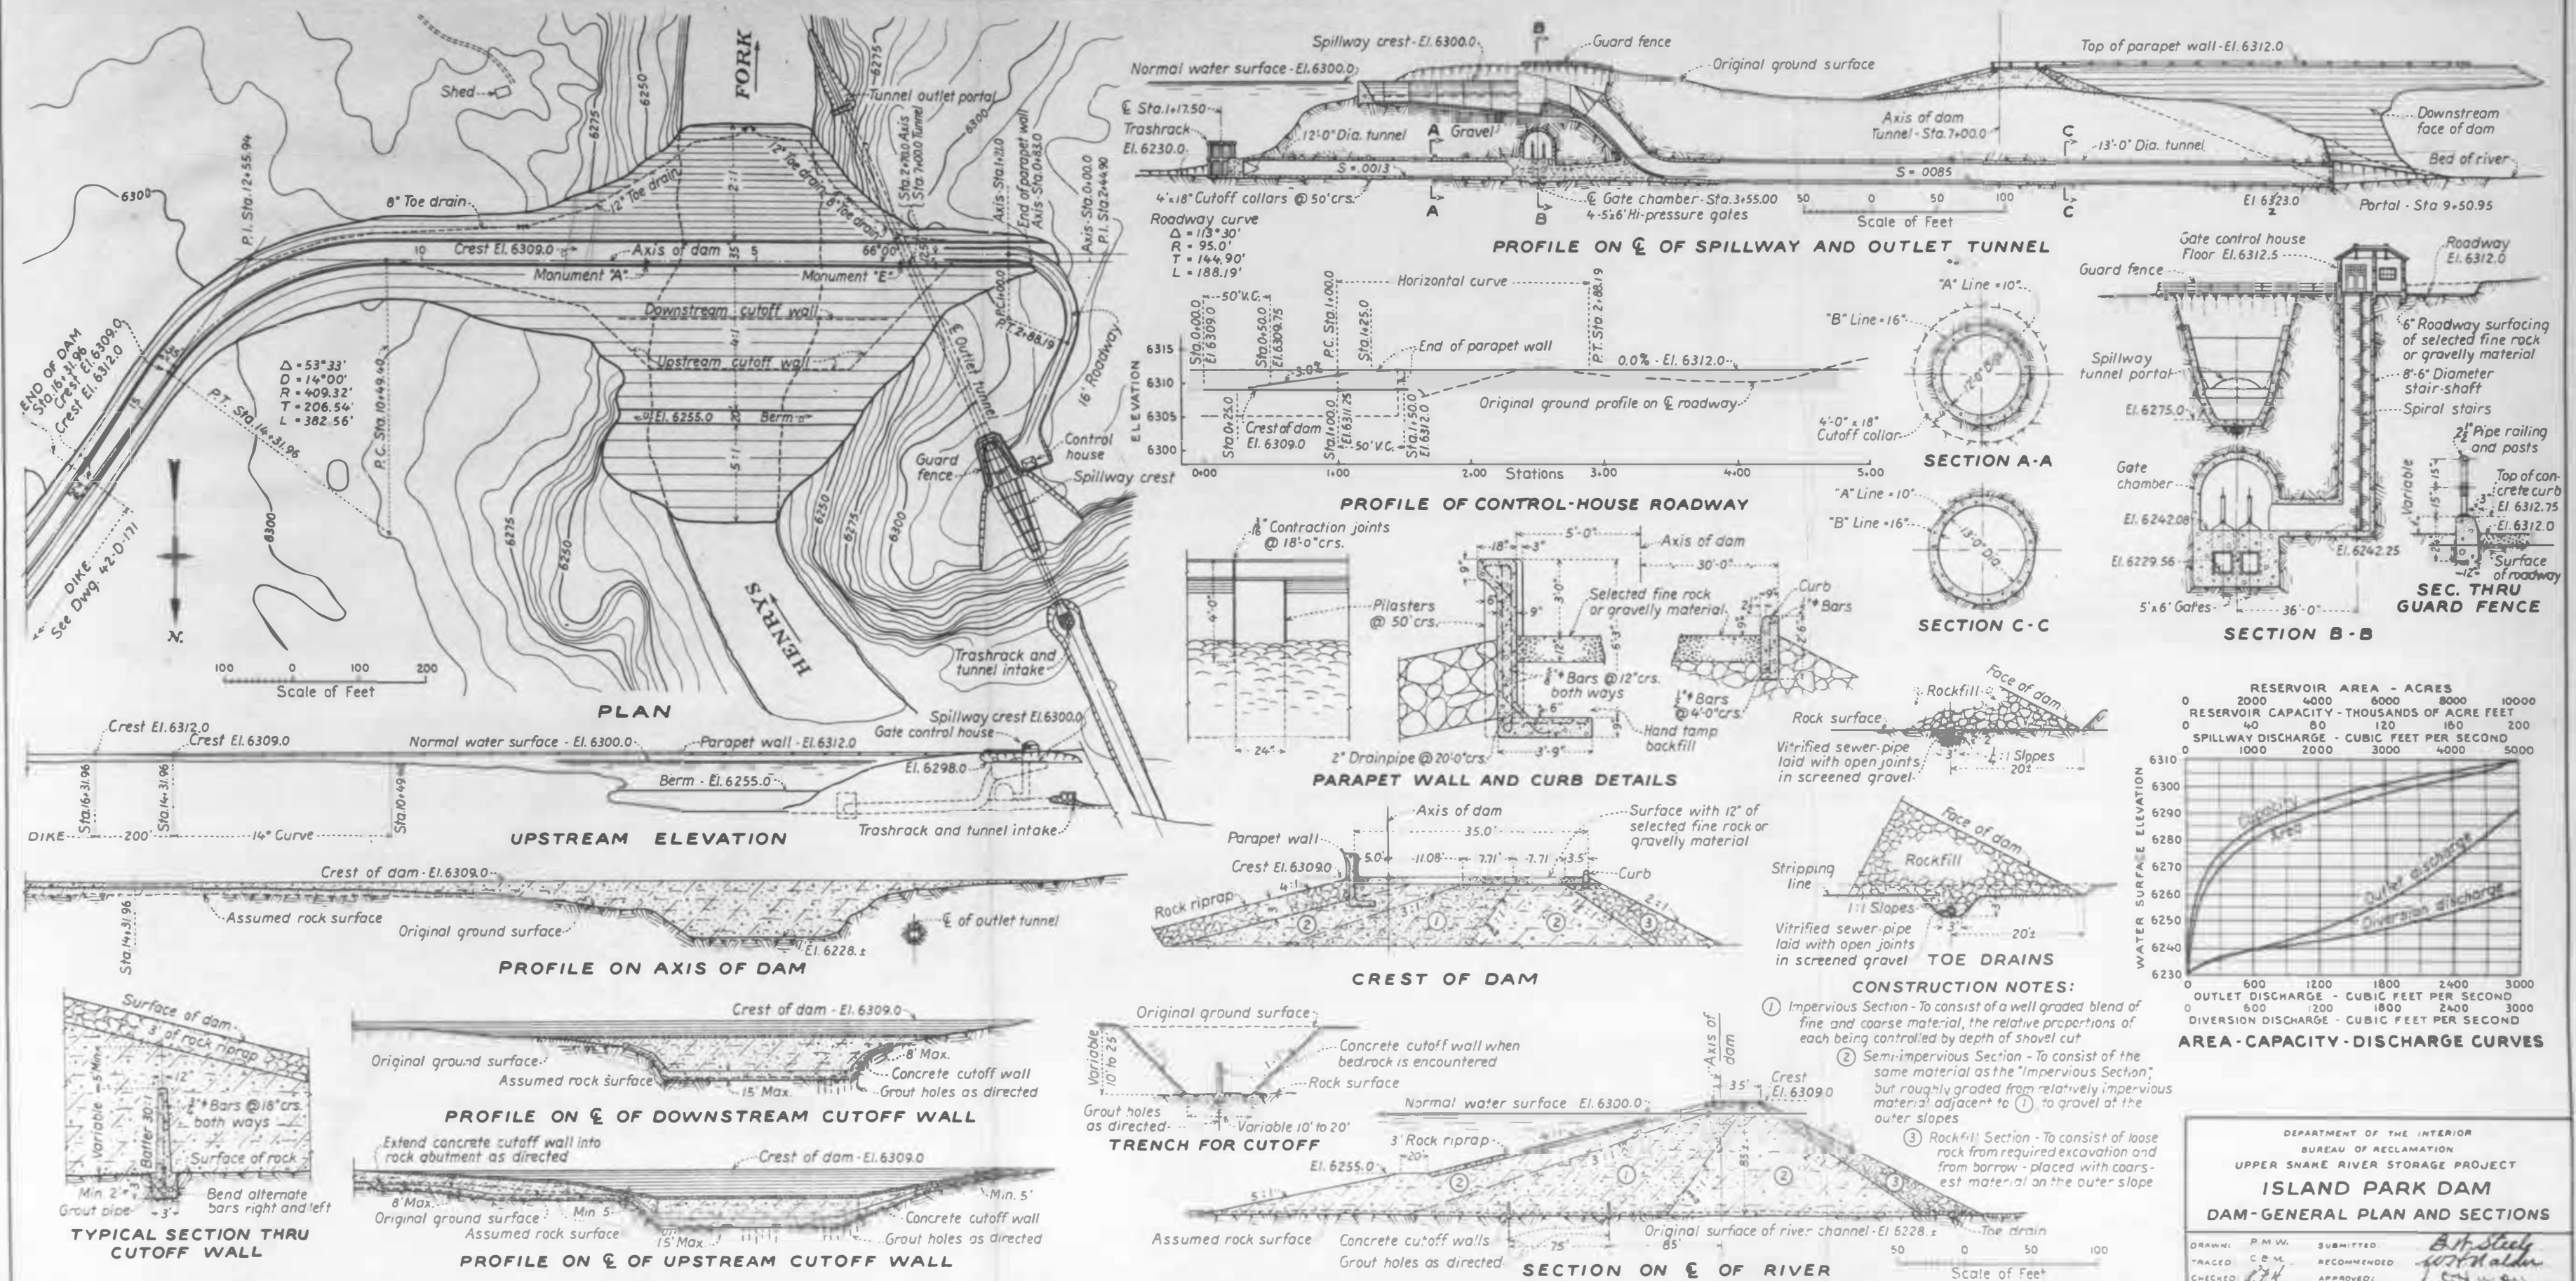
Island Park Dam will be located on Henry's Fork about 25 miles north of Ashton, Idaho. The dam will be of the earth fill type having a height of approximately 82 feet above the river bed and will create a reservoir having a capacity of 110,000 acre feet. This storage will provide a supplementary supply of water for the irrigated lands located in the Upper Snake River Valley between Idaho Falls and Ashton. A general plan of the dam is shown on figure 1.

The spillway in connection with the dam (see figures 1 and 2) will consist of a free overflow crest approximately 257 feet long, somewhat resembling a side channel spillway except that, in this case, the water will spill into the channel from both sides and also over the upstream end. The greater part of the channel floor is on a slope of 0.1097 which automatically increases its cross-sectional area in a downstream direction. Beginning at the downstream end of the channel, a converging horseshoe shaped chute will drop the water 57 feet into a 13-foot diameter circular tunnel 495 feet long having a slope of 0.0085. A transition at the upstream end of this tunnel will transform the horseshoe section into the circular section. The downstream end of the circular tunnel will lead to an open trapezoidal channel which in turn will discharge directly into the river below the dam. As the river bed and canyon walls consist of a stable rock formation, it will not be necessary to construct a stilling pool or structure to

In order to divert water from the reservoir to the river below the dam during the greater part of the year when the spillway will not be in operation, the original diversion tunnel will be utilized as shown in figures 1 and 2. It will intersect the spillway tunnel in the form of two rectangular conduits. These will have a maximum capacity of 2,500 c.f.s. which is equal to one-half of the spillway capacity.

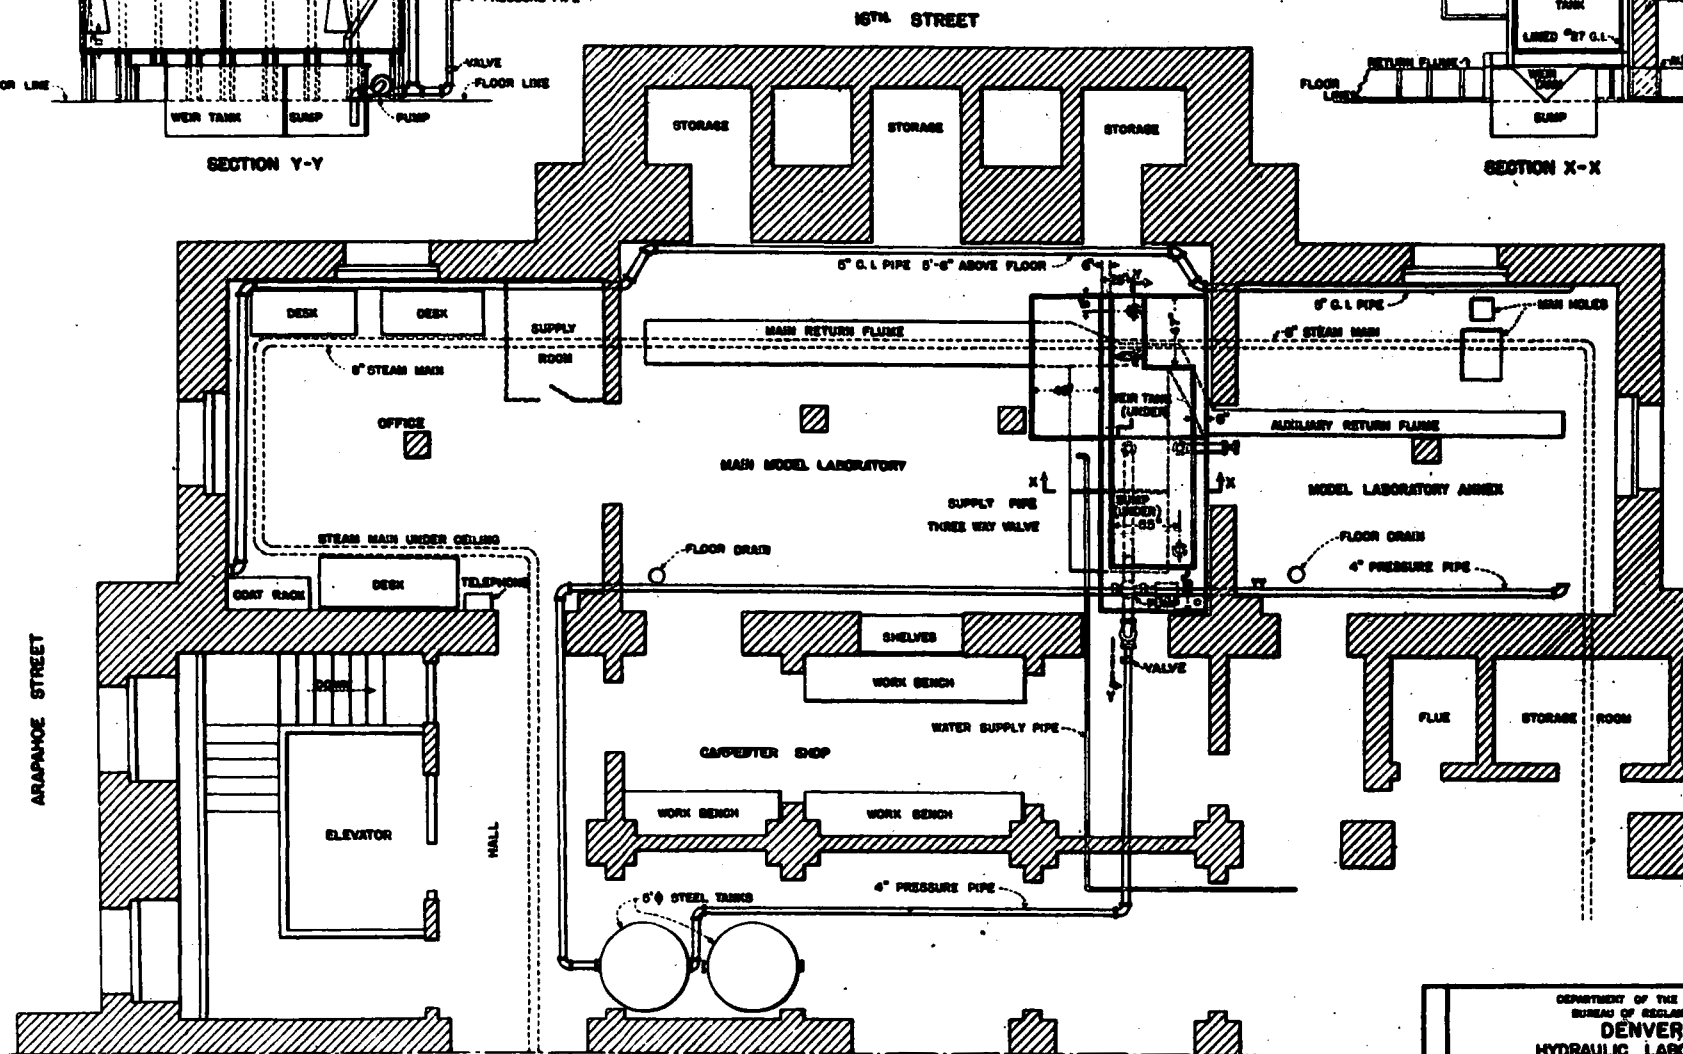
BASEMENT FLOOR PLAN

DEPARTMENT OF THE INTERIOR BUREAU OF RECLAMATION	
DENVER HYDRAULIC LABORATORY 15TH AND ARAPAHOE STREETS GENERAL LAYOUT	
DESIGN E. A. B.	SUBMITTED <i>[Signature]</i>
TRACED S. A. F. S. S.	RECOMMENDED <i>[Signature]</i>
CHECKED <i>[Signature]</i>	APPROVED <i>[Signature]</i>
DENVER, COLO., JAN. 17, 1934

Water for supplying the models is measured over a 90° V notch weir located in the end of a weir tank 6 by 12 by 4 feet deep, which is partially below the laboratory floor. From here a 6-inch centrifugal pump having a capacity of 3 c.f.s. raises the water up into a constant level tank located as high as the ceiling of the laboratory will permit. A stationary skimming weir makes it possible to maintain a constant head of water on this tank. The water flows from the constant level tank through calibrated gate valves, and large expanding cones into two head reservoirs, located directly below the constant level tank. Water is then supplied to the models directly from these head reservoirs. With this arrangement, two models can be operated simultaneously. The overflow section of the Island Park model was constructed in one of these head reservoirs. After passing through the model, the water collected in a sheet metal flume and flowed back to the weir tank. In this way, the water was continuously remeasured and recirculated. The head on the measuring weir was observed by two hook gages.

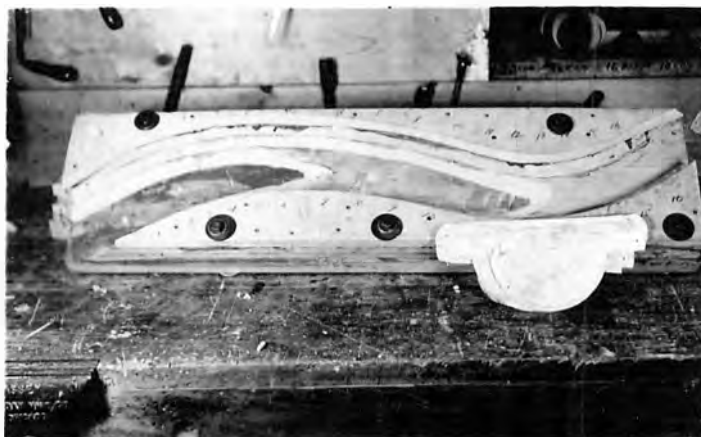
A. METHOD OF CONSTRUCTION  
OF CHUTE

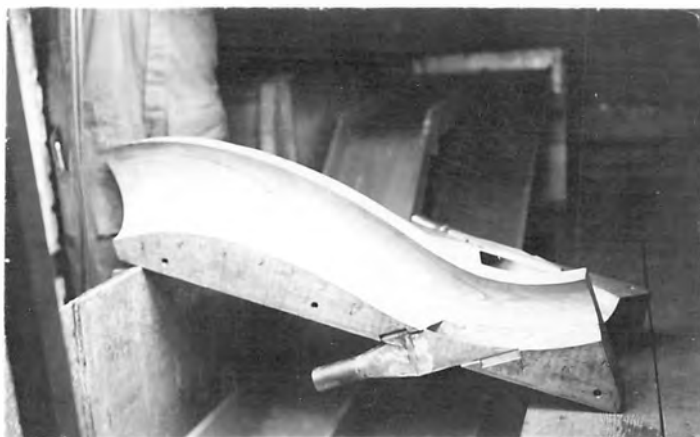
B. ONE-HALF OF CHUTE COMPLETED

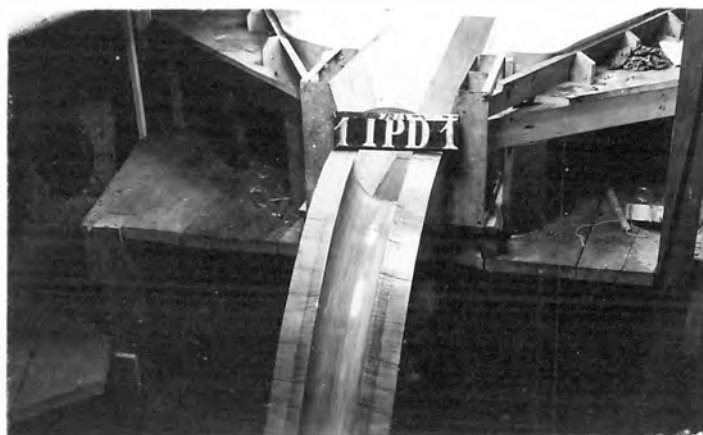
C. ORIGINAL CHUTE COMPLETED AND INSTALLED  
CHUTE COVER HAS BEEN REMOVED

A sketch of the original design of the overflow channel is shown in layout 1 (figure 7) and a drawing of the original chute is shown on figure 5. Photograph A (plate I) is a view of the complete model; photograph C (plate II) is a closer view of the overflow section showing a portion of the original circular chute; and photograph B (plate I) shows the original spillway in operation at the maximum discharge of 5,000 c.f.s. These pictures were taken with the chute cover removed. Note the splashing at the lower end of the chute in photograph B (plate I).

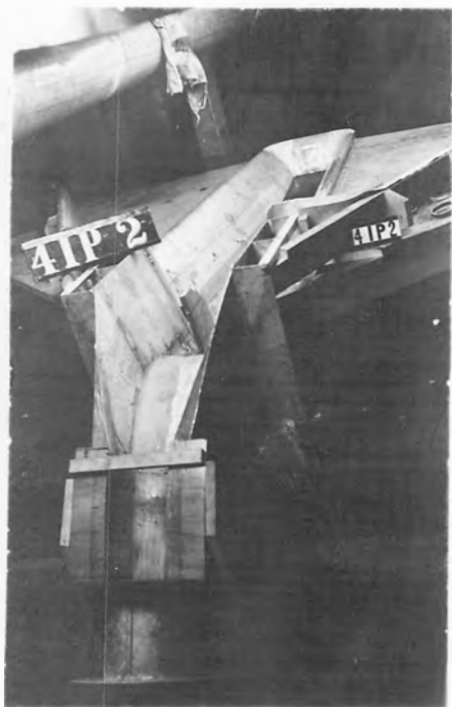
A. REVISED SPILLWAY WITH DIVIDING WALL  
AND STEPS ON OVERFLOW SECTION

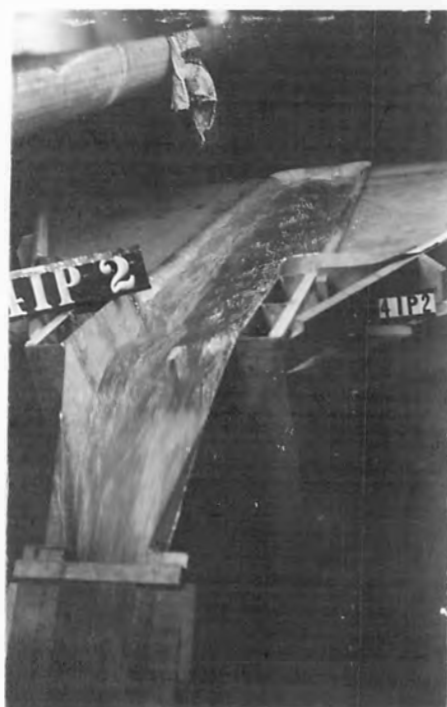
B. DISCHARGE 5,000 SECOND-FEET

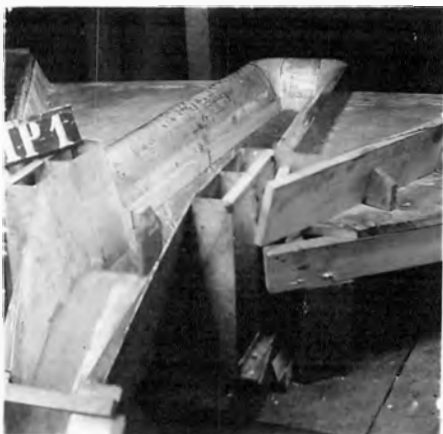
C. REVISED SPILLWAY WITH DIVIDING WALL  
AND STEPS ON OVERFLOW SECTION

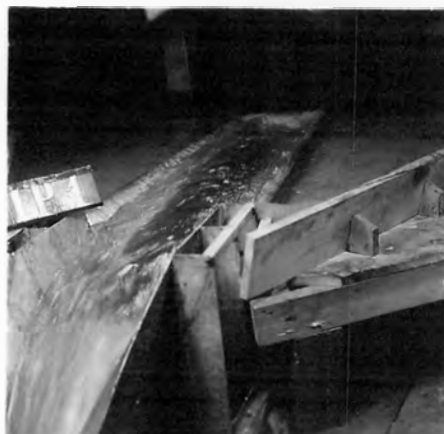
D. DISCHARGE 5,000 SECOND-FEET

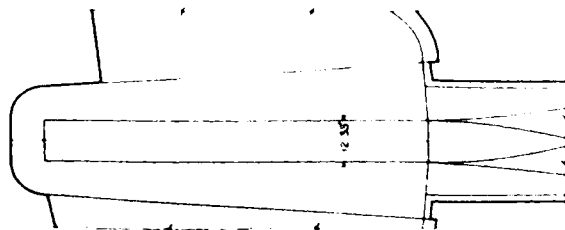
SECTION ON E  
LAYOUT NO. 1  
ORIGINAL DESIGN

taken during these tests as visual observations were sufficient in most cases. Some of the most representative of these layouts are shown in figures 7, 8, and 9 and a brief discussion of the results obtained with these follows. The channel as originally designed is shown as layout 1 on figure 7.

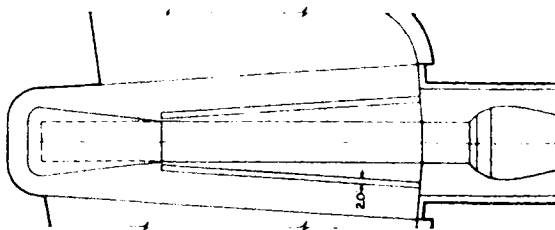
SECTION ON E  
LAYOUT NO. 2

It was anticipated that small steps on the downstream face of the overflow crest would tend to break up the rolling motion in the channel and possibly improve flow conditions farther downstream. Layouts 2 and 3 (figure 7) illustrate two arrangements tried using steps with the dividing wall removed. The sills did improve the flow through the spillway. In layout 2 a portion of the channel floor was raised for the purpose of reducing the boil at the upstream end of the channel but this arrangement made it more pronounced than ever.

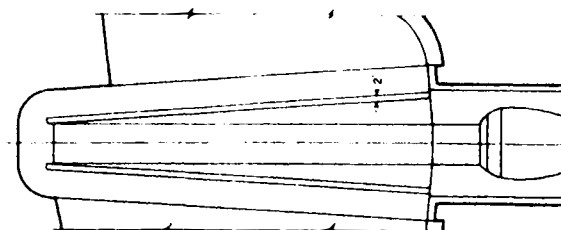
SECTION ON E  
LAYOUT NO. 3

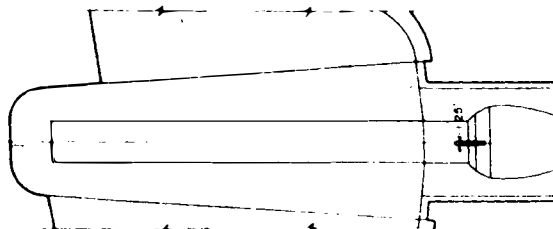
SECTION ON E  
LAYOUT NO. 4

In an attempt to iron out the surges and stabilize the flow at the chute portal, a dividing wall was installed on the center line of the spillway in the throat of the chute as shown in layout 4 (figure 7). A very noticeable improvement was evidenced in that the oscillatory surging was reduced.

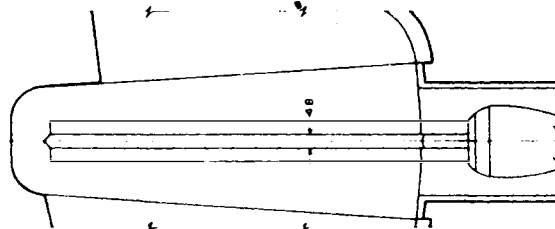
SECTION ON E  
LAYOUT NO. 5

In layout 5 (figure 7) the steps were removed from the overflow crest and a large triangular sill was installed on the center of the channel floor. The sill proved to be ineffective and no other variation of this was tried.

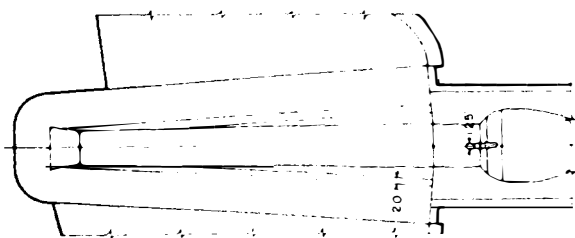
SECTION ON E  
LAYOUT NO. 7

In layouts 7 to 15, inclusive, on figure 8 and 9, various step arrangements were tried in combination with the dividing wall at the chute portal. Also, the slope and shape of the channel floor was varied throughout these tests. In general, the layouts in which the steps extended the full length of the crest produced the best flow conditions in the channel and down the chute. In other words, layouts 7, 8, and 14 were the best of the group with layout 14 the most satisfactory of the three. It should be noted that in some of the later layouts including number 14, the upstream 30 feet of channel floor was constructed level at elevation 6285.3. It was found that this revision reduced considerably the boil and splash caused by the water flowing over the upstream end of the crest.

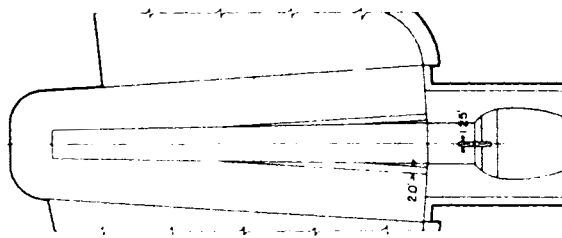
SECTION ON E  
LAYOUT NO. 8

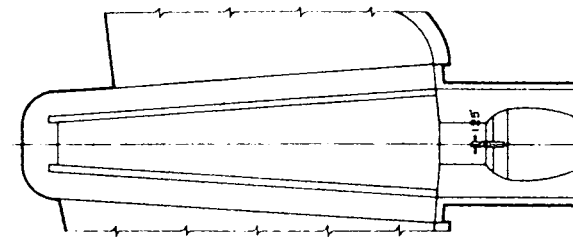
SECTION ON E  
LAYOUT NO. 9

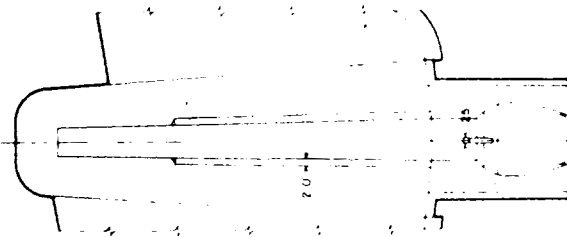
SECTION ON E  
LAYOUT NO. 10

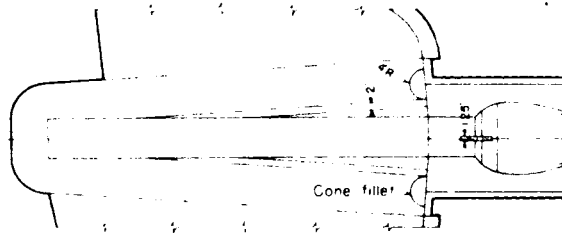
SECTION ON E  
LAYOUT NO. 11

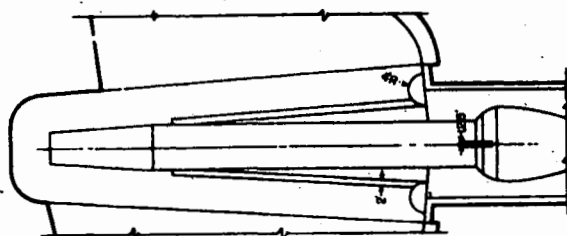
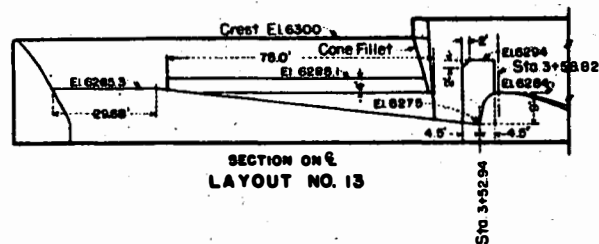
SECTION ON E  
LAYOUT NO. 13

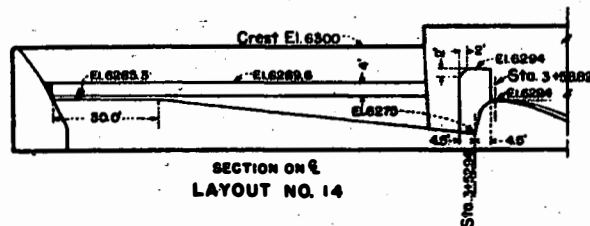
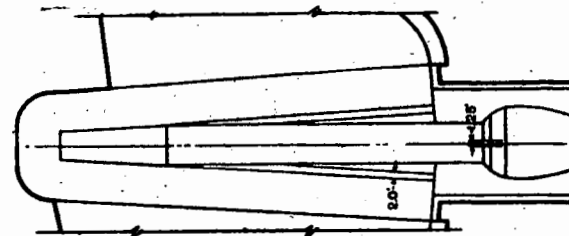
SECTION ON E  
LAYOUT NO. 14

PLAN

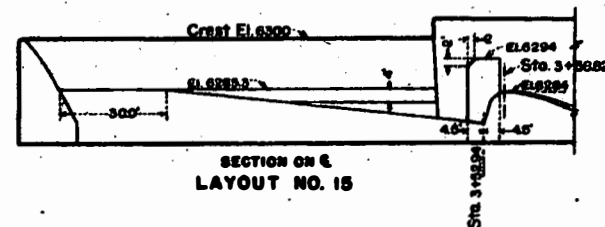
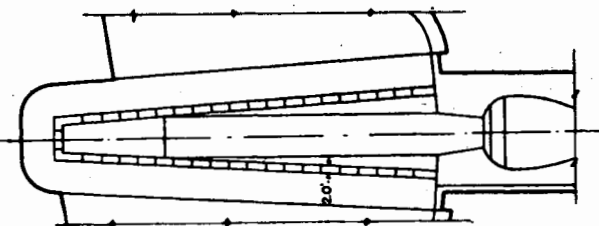
SECTION ON E  
LAYOUT NO. 15

PLAN

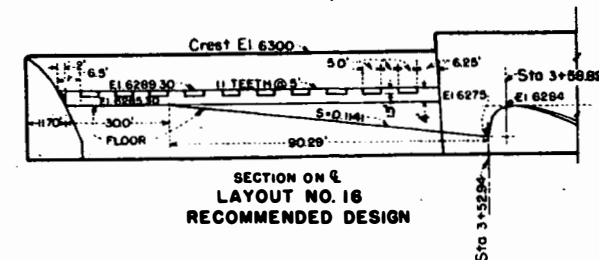
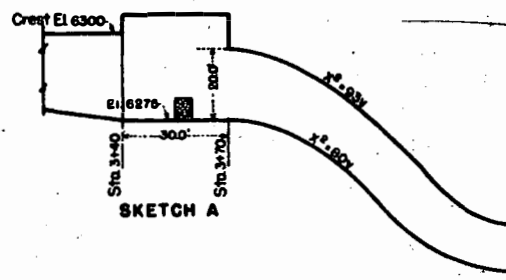
SECTION ON E  
LAYOUT NO. 16  
RECOMMENDED DESIGN

PLAN

In spite of the improvement in flow in the upper part of the spillway, a certain amount of splashing was still present at the lower end of the chute. In a further effort to correct this undesirable condition, the horseshoe section was continued down to the end of the chute or station 4+53.34. The transition from the horseshoe to the circular section in this case was incorporated in the upstream end of the 13-foot constant diameter tunnel. This revision remedied the splashing and very satisfactory flow existed throughout the spillway. A drawing of the recommended chute is shown in figure 6 and the corresponding channel layout is shown as no. 16 on figure 9.

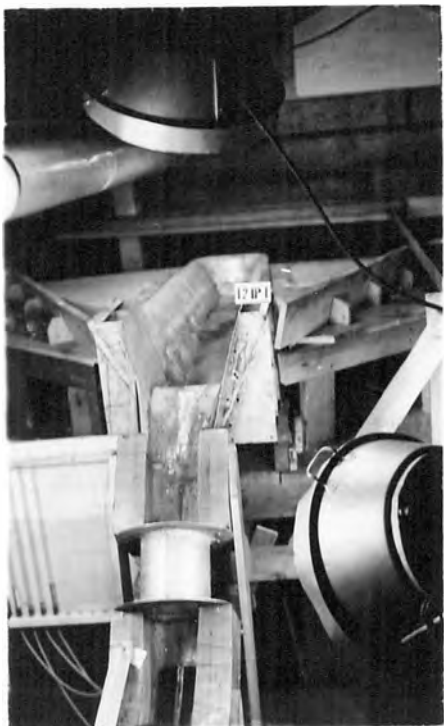
A. SPILLWAY

SAME AS RECOMMENDED DESIGN EXCEPT STEPS  
ON OVERFLOW SECTION OMITTED

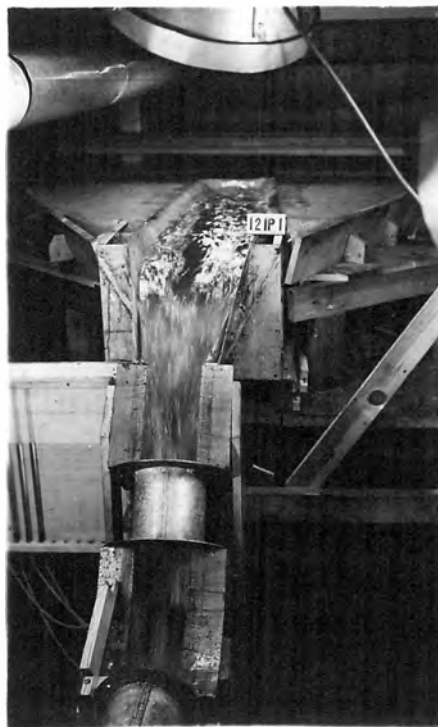
B. DISCHARGE 5,000 SECOND-FEET

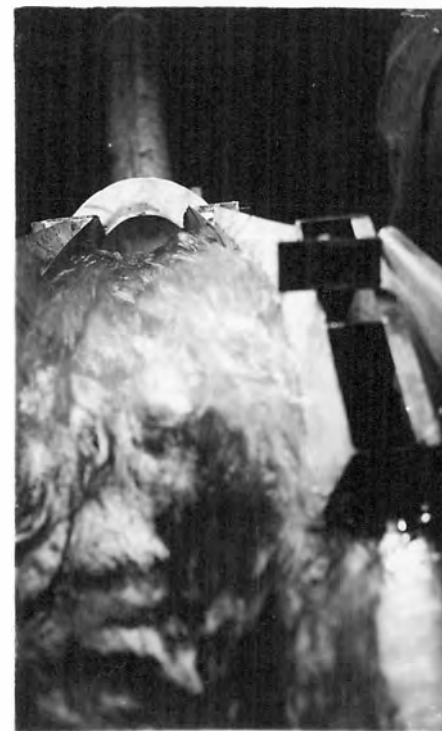
C. DISCHARGE 5,000 SECOND-FEET

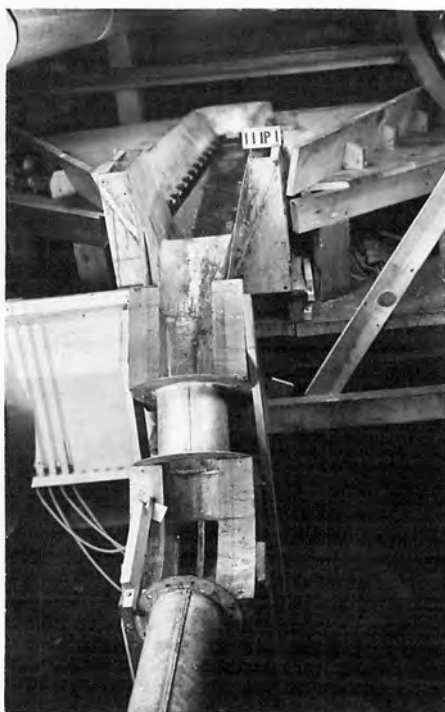
A. RECOMMENDED SPILLWAY

RECOMMENDED DESIGN

The photographs on plates V and VI show views of the recommended spillway. Photograph A (plate V) is a view of the spillway as recommended and photograph B shows it in operation at the maximum discharge. Photograph C on the same plate is a view looking down the chute and D shows the maximum discharge flowing through it. Photograph A (plate VI) is a closeup showing one of the dentated steps on the overflow crest; B shows the spillway in operation for a discharge of 600 c.f.s.; and C is a view showing this same discharge flowing down the chute.

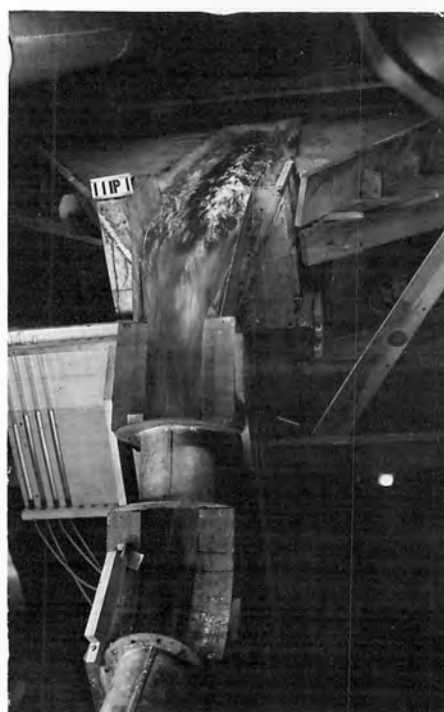
B. DISCHARGE 5,000 SECOND-FEET

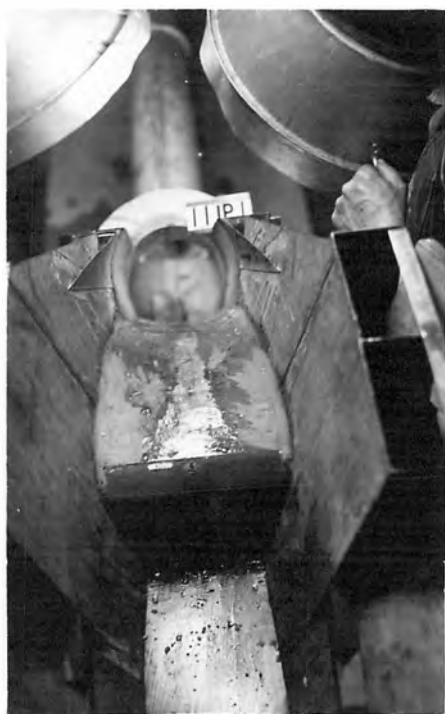
C. LOOKING DOWN CHUTE

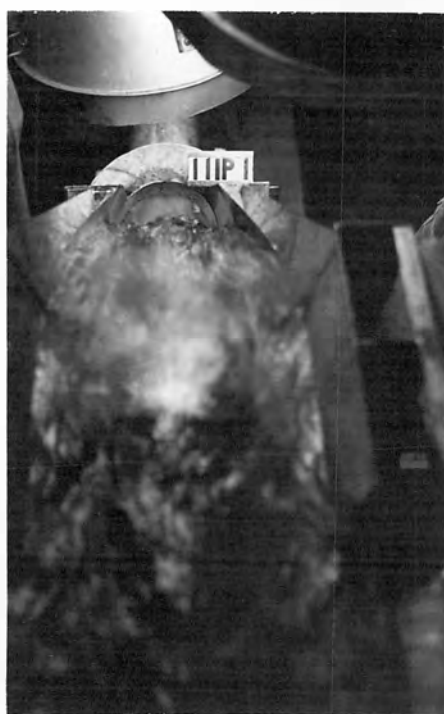
D. LOOKING DOWN CHUTE WITH  
DISCHARGE 5,000 SECOND-FEET

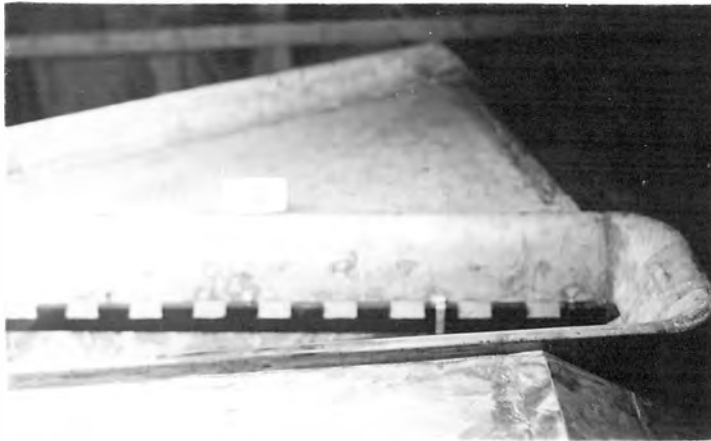
A. OVERFLOW CHANNEL SHOWING  
DENTATED STEP

RECOMMENDED DESIGN

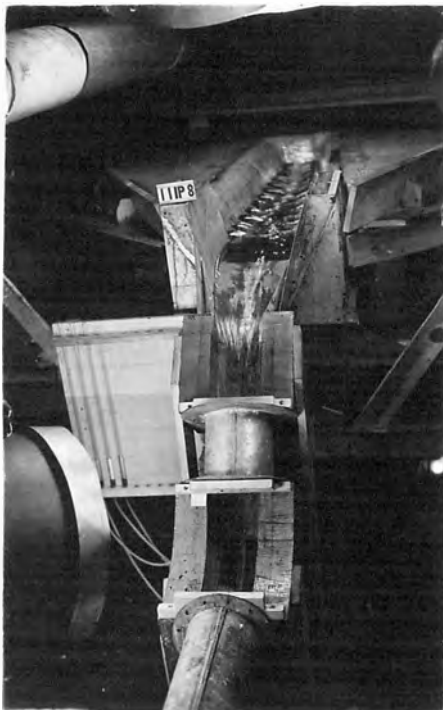
B DISCHARGE 600 SECOND-FEET

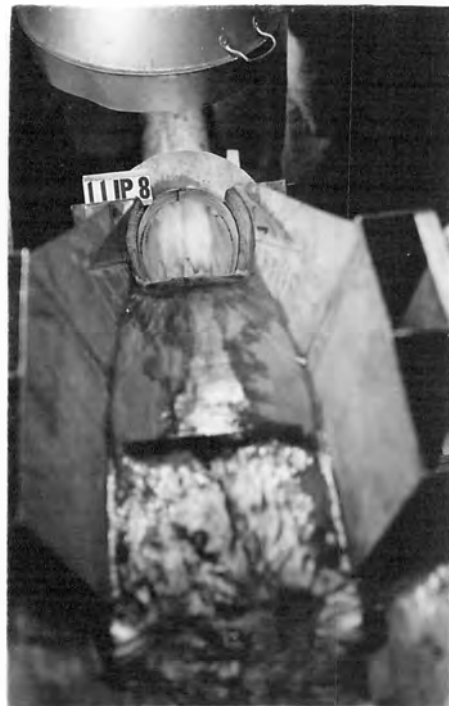
C. FLOW CONDITIONS IN CHUTE WITH  
DISCHARGE 600 SECOND-FEET

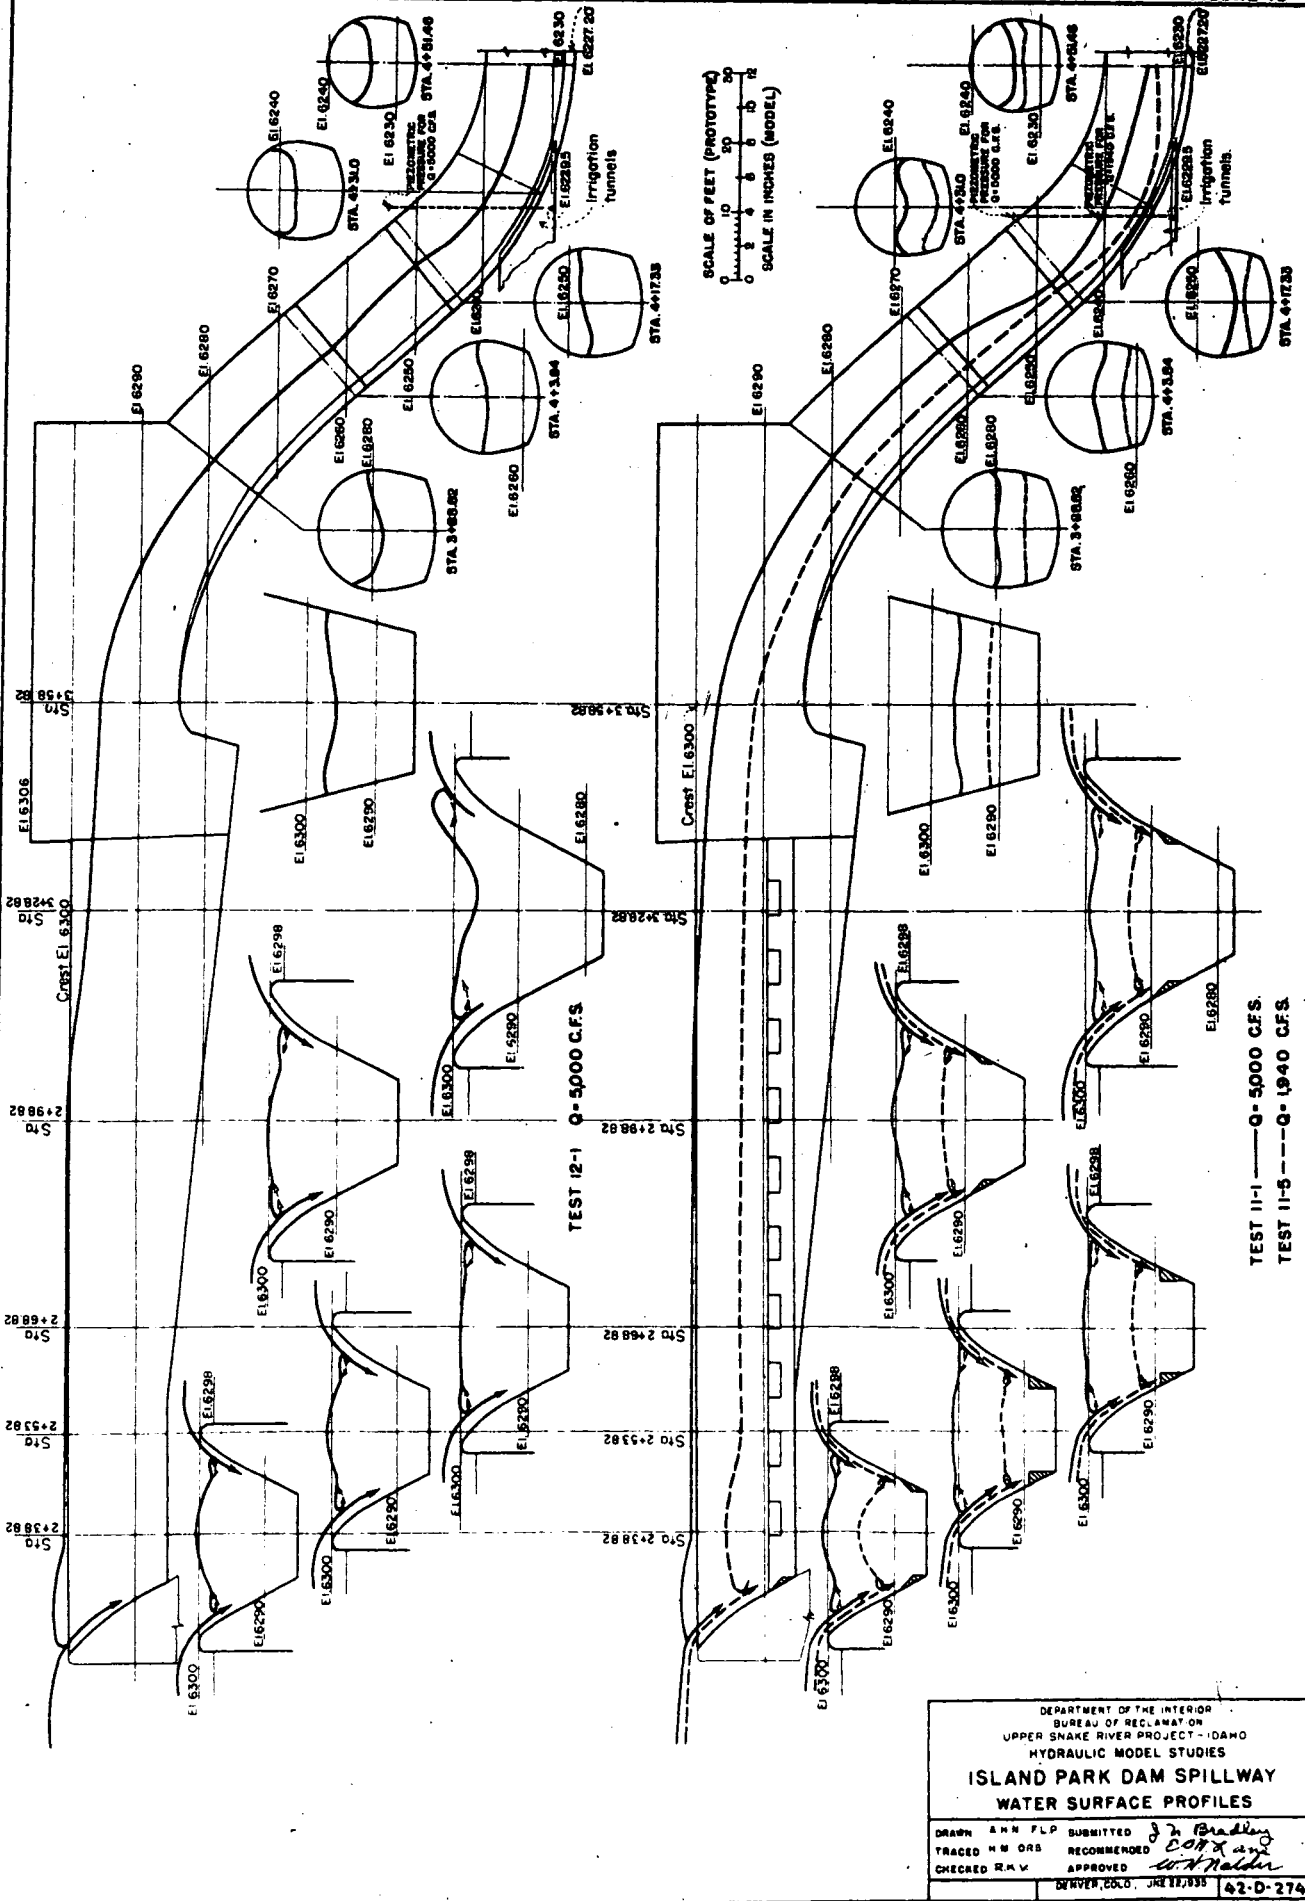
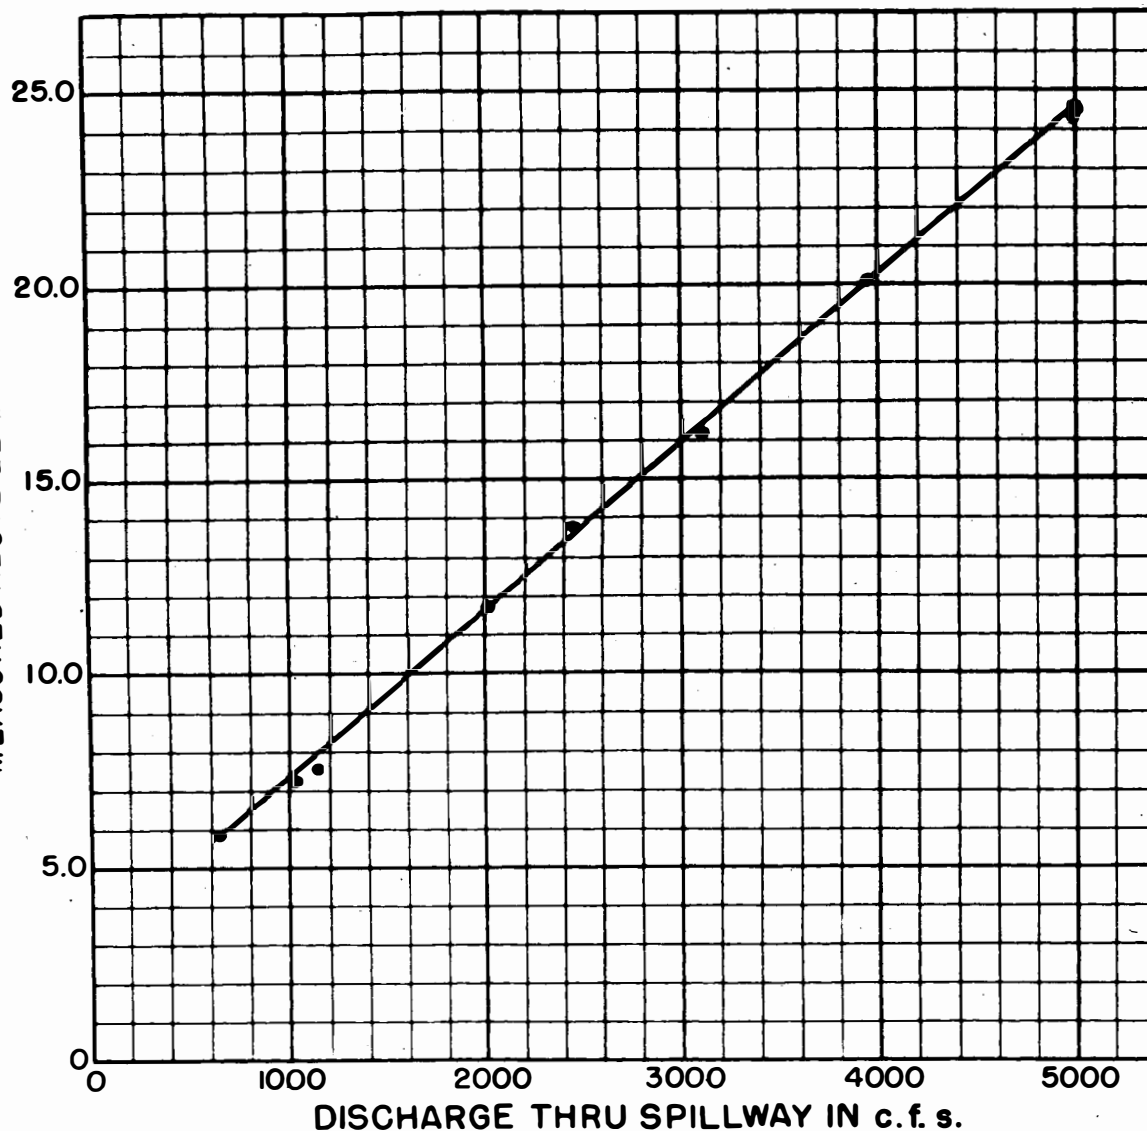
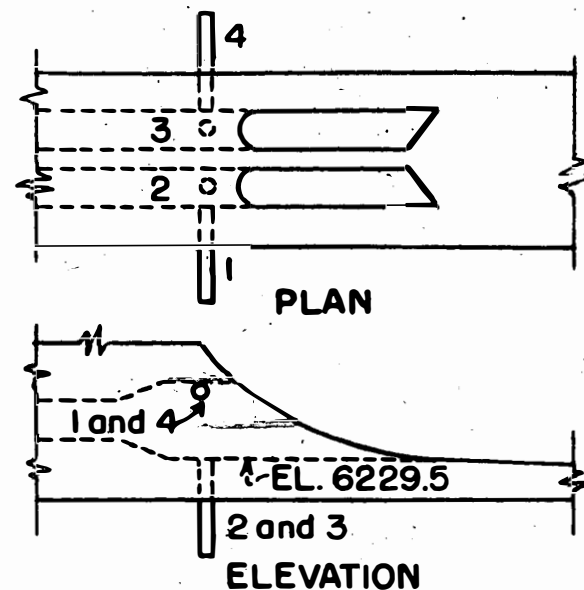
PRESSURE IN FT. OF WATER PROTOTYPE  
MEASURED ABOVE EL. 6229.5

IRRIGATION TUNNELS  
SHOWING LOCATION OF PIEZOMETERS

DEPARTMENT OF THE INTERIOR  
BUREAU OF RECLAMATION  
UPPER SNAKE RIVER PROJECT-IDAHO  
HYDRAULIC MODEL STUDIES  
ISLAND PARK DAM SPILLWAY  
PRESSURES IN IRRIGATION TUNNELS

Piezometers were installed in the walls of the outlets, as shown in the sketch on figure 11, for the purpose of studying the pressures in these tunnels. The curve on figure 11 shows the results of tests made for the condition existing in the tunnels when the spillway was operating at various discharges with the outlet tunnels shut down. The average pressures in feet of water measured above elevation 6229.5 (converted into prototype values) are plotted with respect to the discharge through the spillway. The pressures observed for tests 12-1, 11-1, and 11-5 are also indicated on the plotted profiles on figure 10. The results definitely indicate that a pressure above atmospheric will exist in the irrigation outlets for all stages of flow through the spillway.

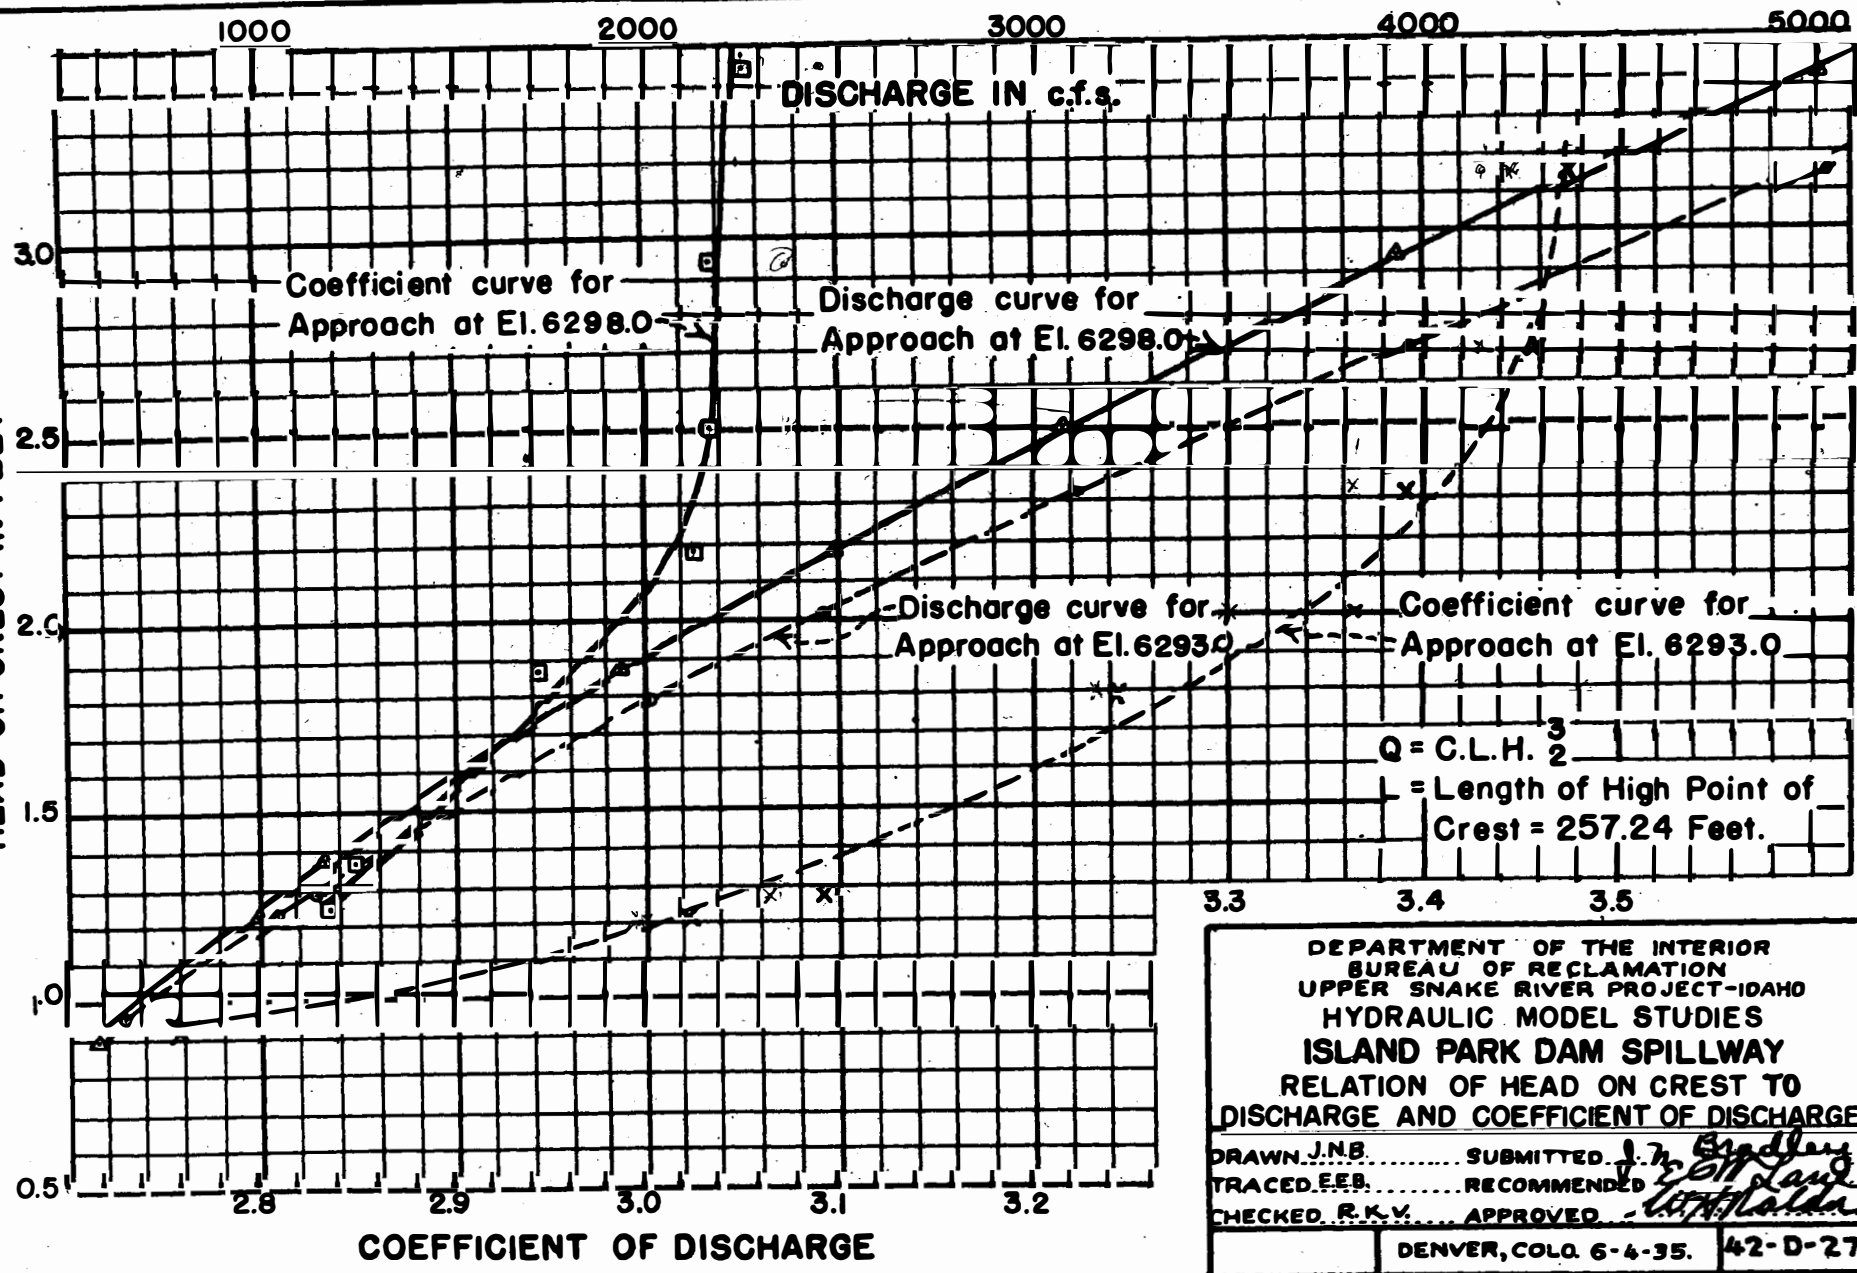
FIGURE 12

HEAD ON CREST IN FEET

DEPARTMENT OF THE INTERIOR  
BUREAU OF RECLAMATION  
UPPER SNAKE RIVER PROJECT-IDAHO  
HYDRAULIC MODEL STUDIES  
ISLAND PARK DAM SPILLWAY  
RELATION OF HEAD ON CREST TO  
DISCHARGE AND COEFFICIENT OF DISCHARGE

As originally designed, the approach to the overflow crest was to be excavated to 2 feet below the crest or elevation 6293.0 and the width of approach was to be as shown in figure 2. The head discharge relation obtained from runs made on this layout is plotted as a full line on figure 12. A head of 3.48 feet on the crest was required to get the maximum discharge of 5,000 c.f.s. over the spillway. The coefficients of discharge for the above runs were computed from the formula  $Q = CLH^{3/2}$  where L is the length of the high point on the crest or 257.24 feet (measured on the model and converted to prototype). The coefficient curve for this layout is also plotted as a full line on figure 12. For maximum discharge, the coefficient of discharge is about 3.045.

During a series of experiments on approach studies, the head discharge relation was again determined for various discharges with the approach floor dropped to 7 feet below the crest or elevation 6293.0. One of the dotted lines on figure 12 shows this relation and the other is the coefficient of discharge curve for this layout. For a head of 3.0 feet on the crest there is a difference of 500 c.f.s. in the discharge using the approach floor at the two elevations. With the approach floor at elevation 6293.0, a head of only 3.20 feet is required on the crest for a maximum discharge and this gives a coefficient of discharge of 3.470.
