MEMORANDUM TO CHIEF DESIGNING ENGINEER  
SUBJECT: HYDRAULIC MODEL STUDIES FOR THE DESIGN  
OF  
THE ISLAND PARK DAM SPILLWAY

by J. N. BRADLEY, ASSISTANT ENGINEER  
and  
J. B. DRISKO, ASSISTANT ENGINEER

TECHNICAL MEMORANDUM NO. 478

DEPARTMENT OF THE INTERIOR  
BUREAU OF RECLAMATION  
UPPER SNAKE RIVER PROJECT-IDAHO  
HYDRAULIC MODEL STUDIES  
**MODEL OF ISLAND PARK DAM SPILLWAY**  
**MODEL SCALE 1:30**

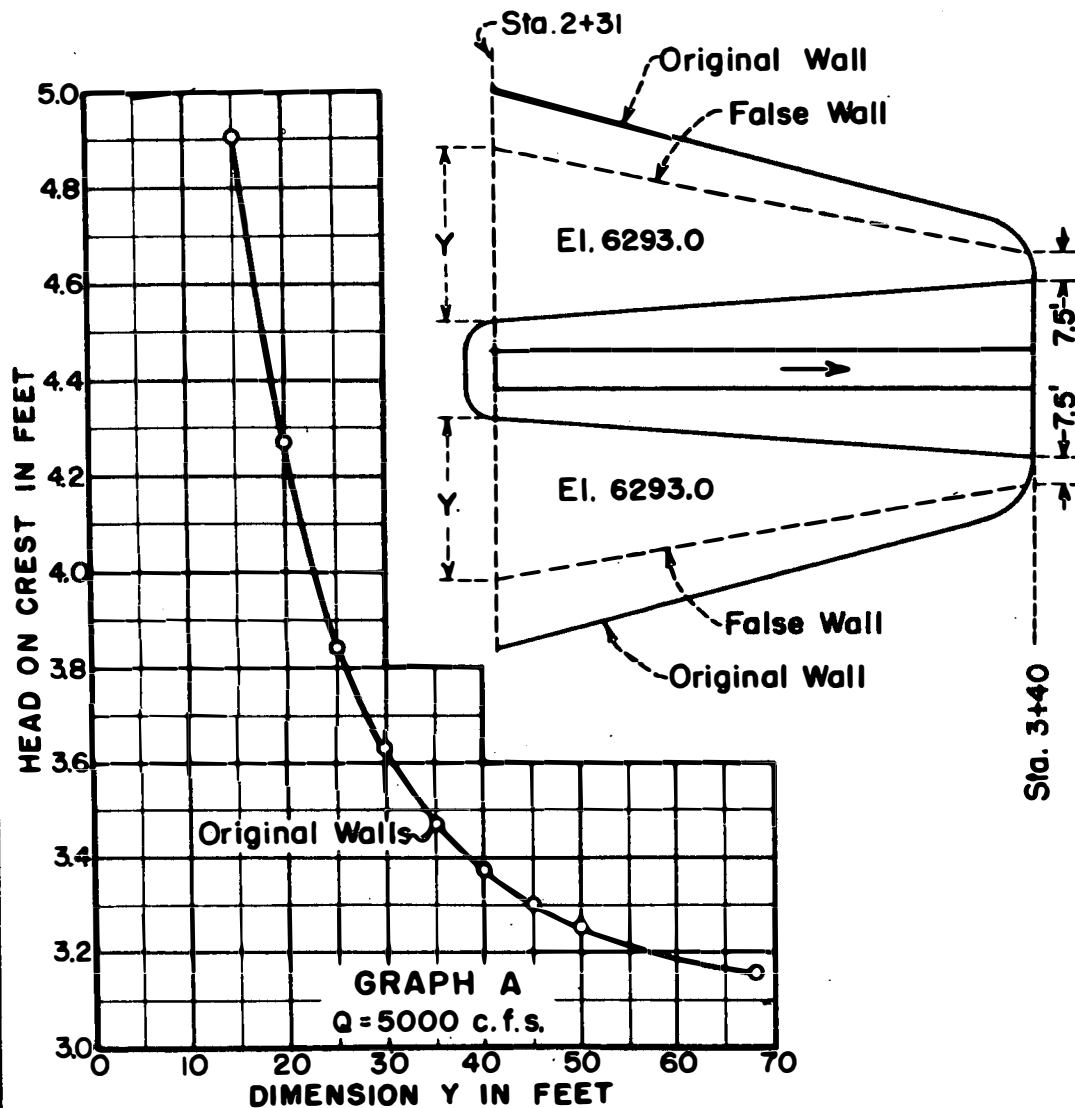
**CURVE SHOWING RELATION OF WIDTH OF APPROACH TO THE HEAD ON THE CREST.**  
 APPROACH FLOOR WAS AT ELEV. 6293.0

DEPARTMENT OF THE INTERIOR  
 BUREAU OF RECLAMATION  
 UPPER SNAKE RIVER PROJECT-IDAHO  
 HYDRAULIC MODEL STUDIES  
**ISLAND PARK DAM SPILLWAY**  
 RELATION OF WIDTH AND DEPTH OF  
 APPROACH TO HEAD ON THE CREST

In connection with the approach studies mentioned in the above paragraph, the head on the crest was observed for depths of approach varying from 2 to 7 feet below the crest using the original approach width. These runs were all made at the maximum discharge. The resulting curve is plotted as graph B on figure 13. The curve shows that the head on the crest decreases rapidly with an increase in the depth of approach.

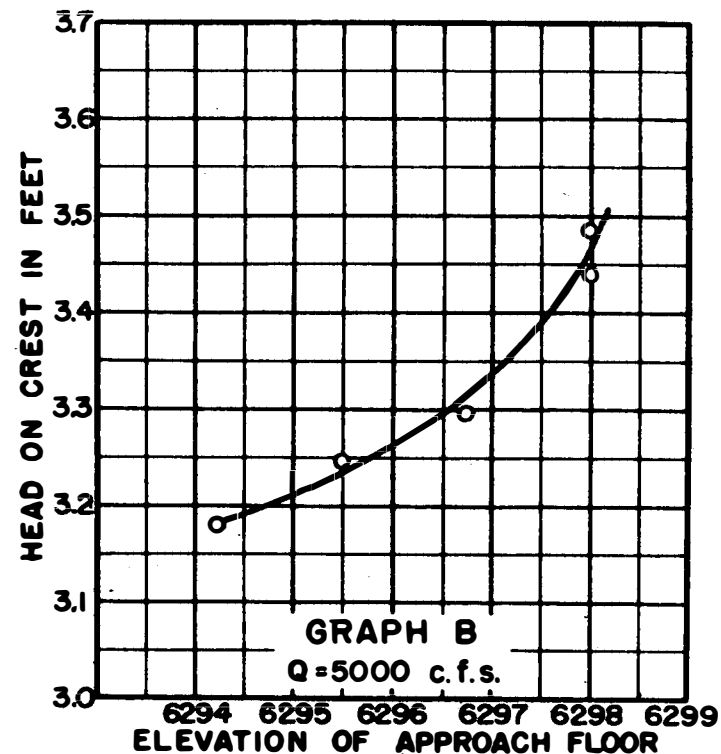
**CURVE SHOWING RELATION OF DEPTH OF APPROACH TO THE HEAD ON THE CREST.**  
 APPROACH WALLS AS ORIGINALLY DESIGNED
