HYD 329

Design and Construction Division  
Engineering Laboratories Branch  
Denver, Colorado  
January 16, 1952

Laboratory Report No. Hyd-329  
Hydraulic Laboratory  
Written by: E. J. Rusho  
Reviewed by: A. J. Peterka  
Checked by: J. N. Bradley

Subject: Hydraulic model studies of the service spillway—Shadehill  
Dam—Missouri River Basin Project

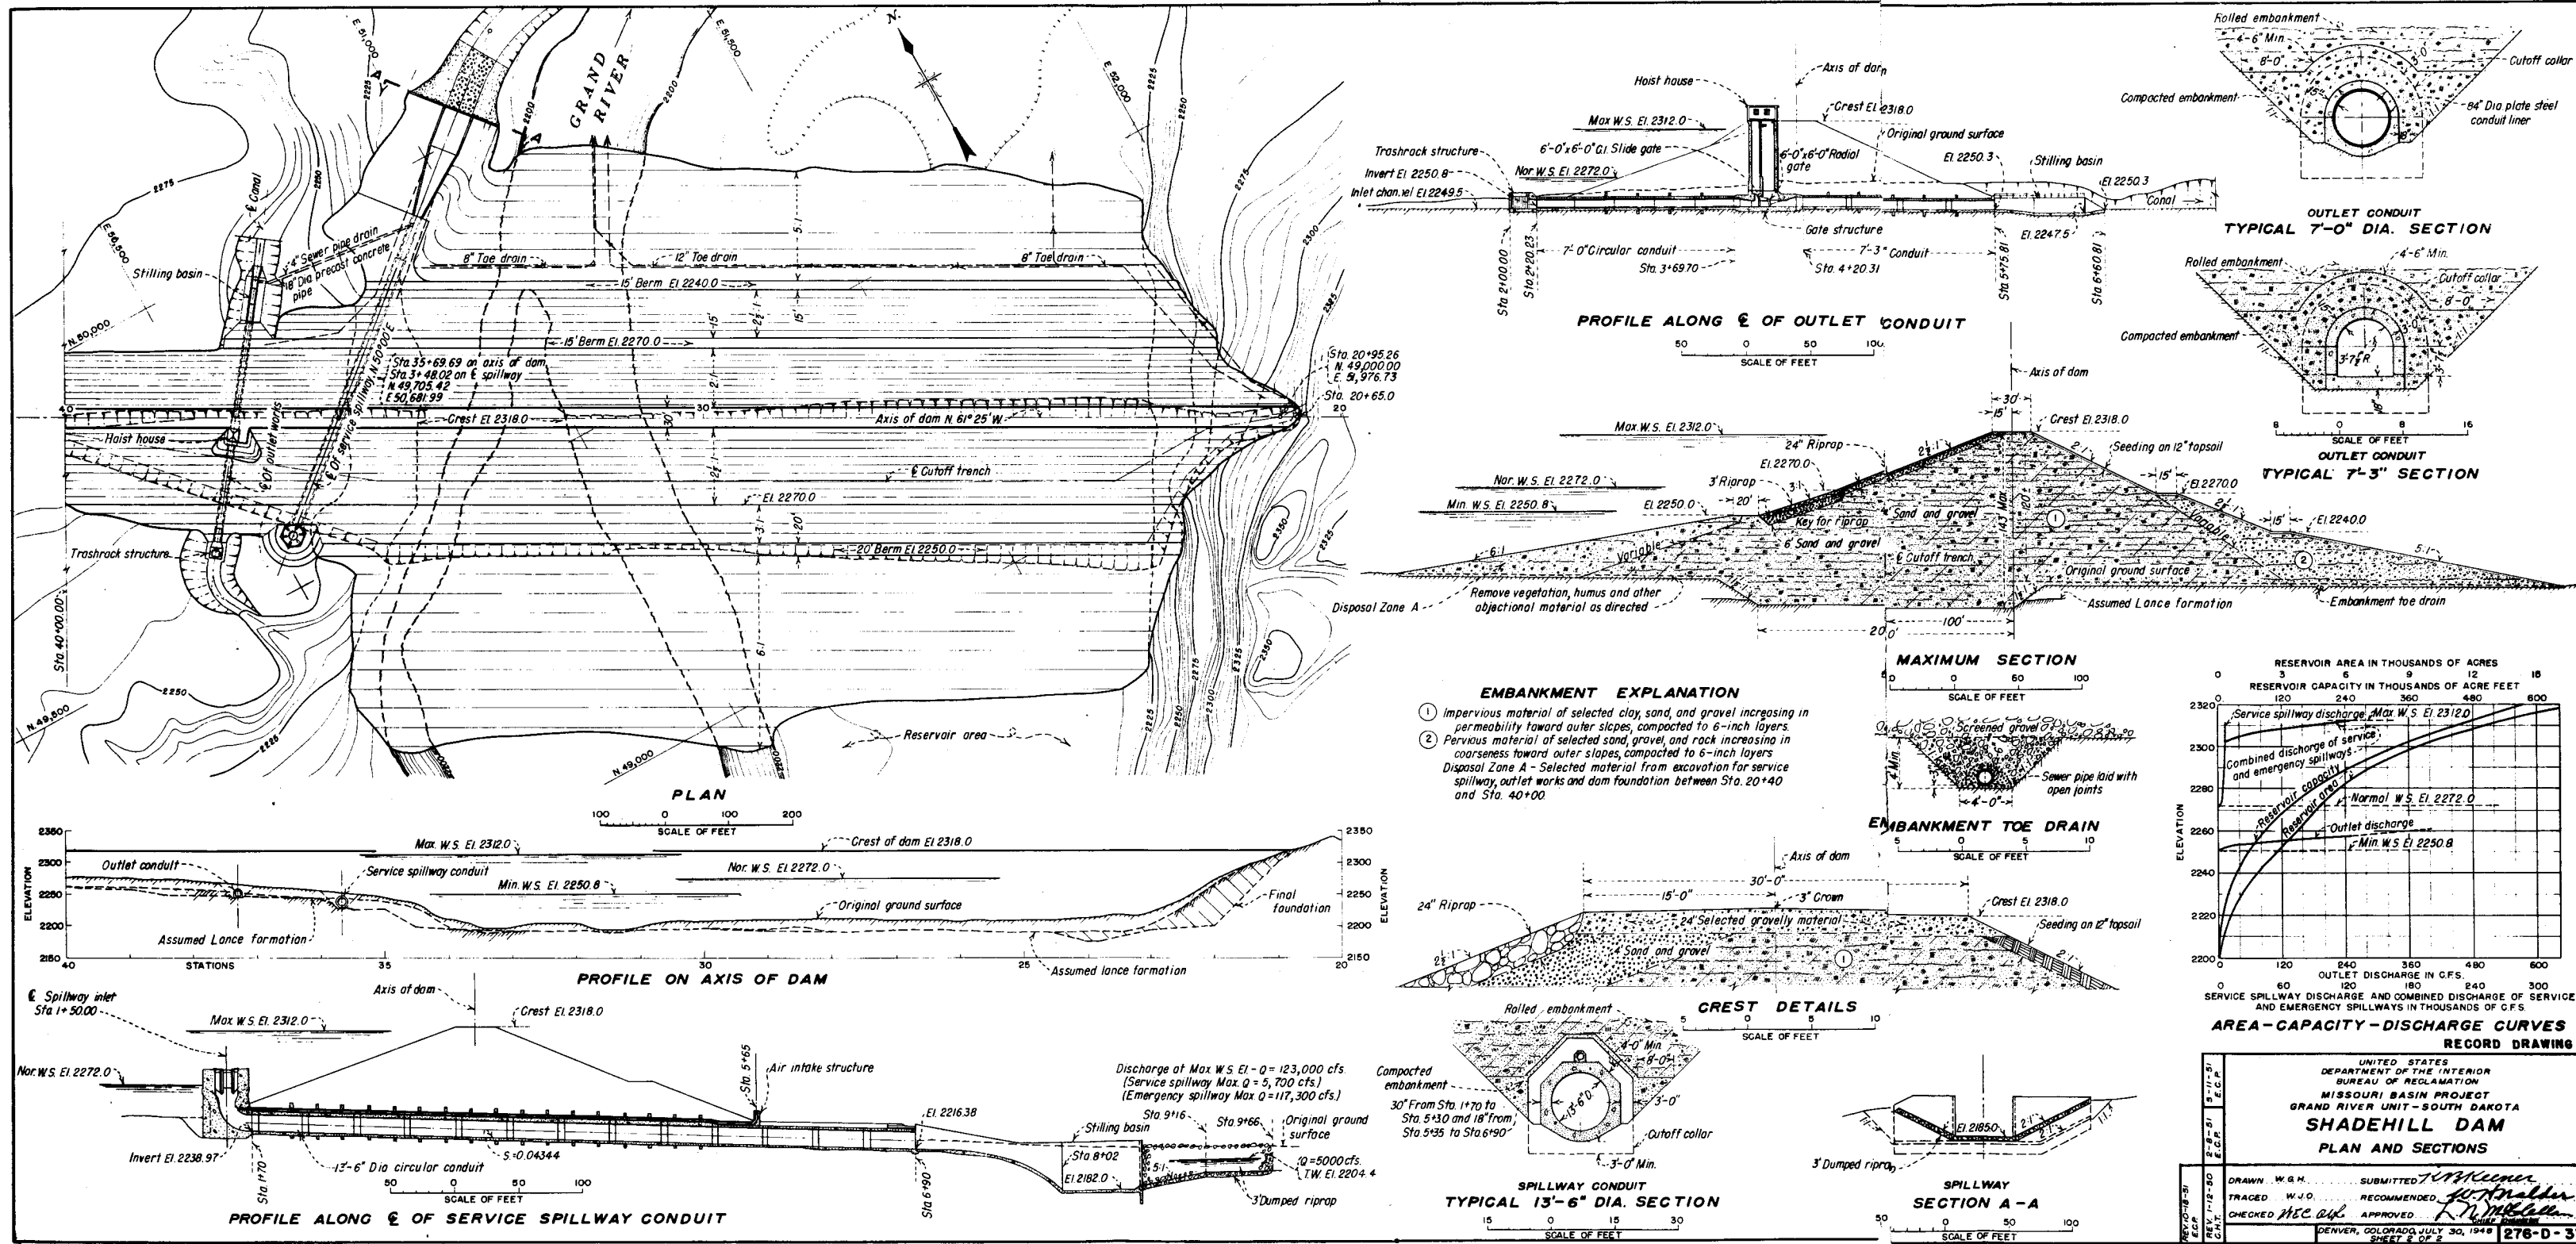
SHADEHILL DAM  
SERVICE SPILLWAY MODEL  
1:20,732 SCALE MODEL

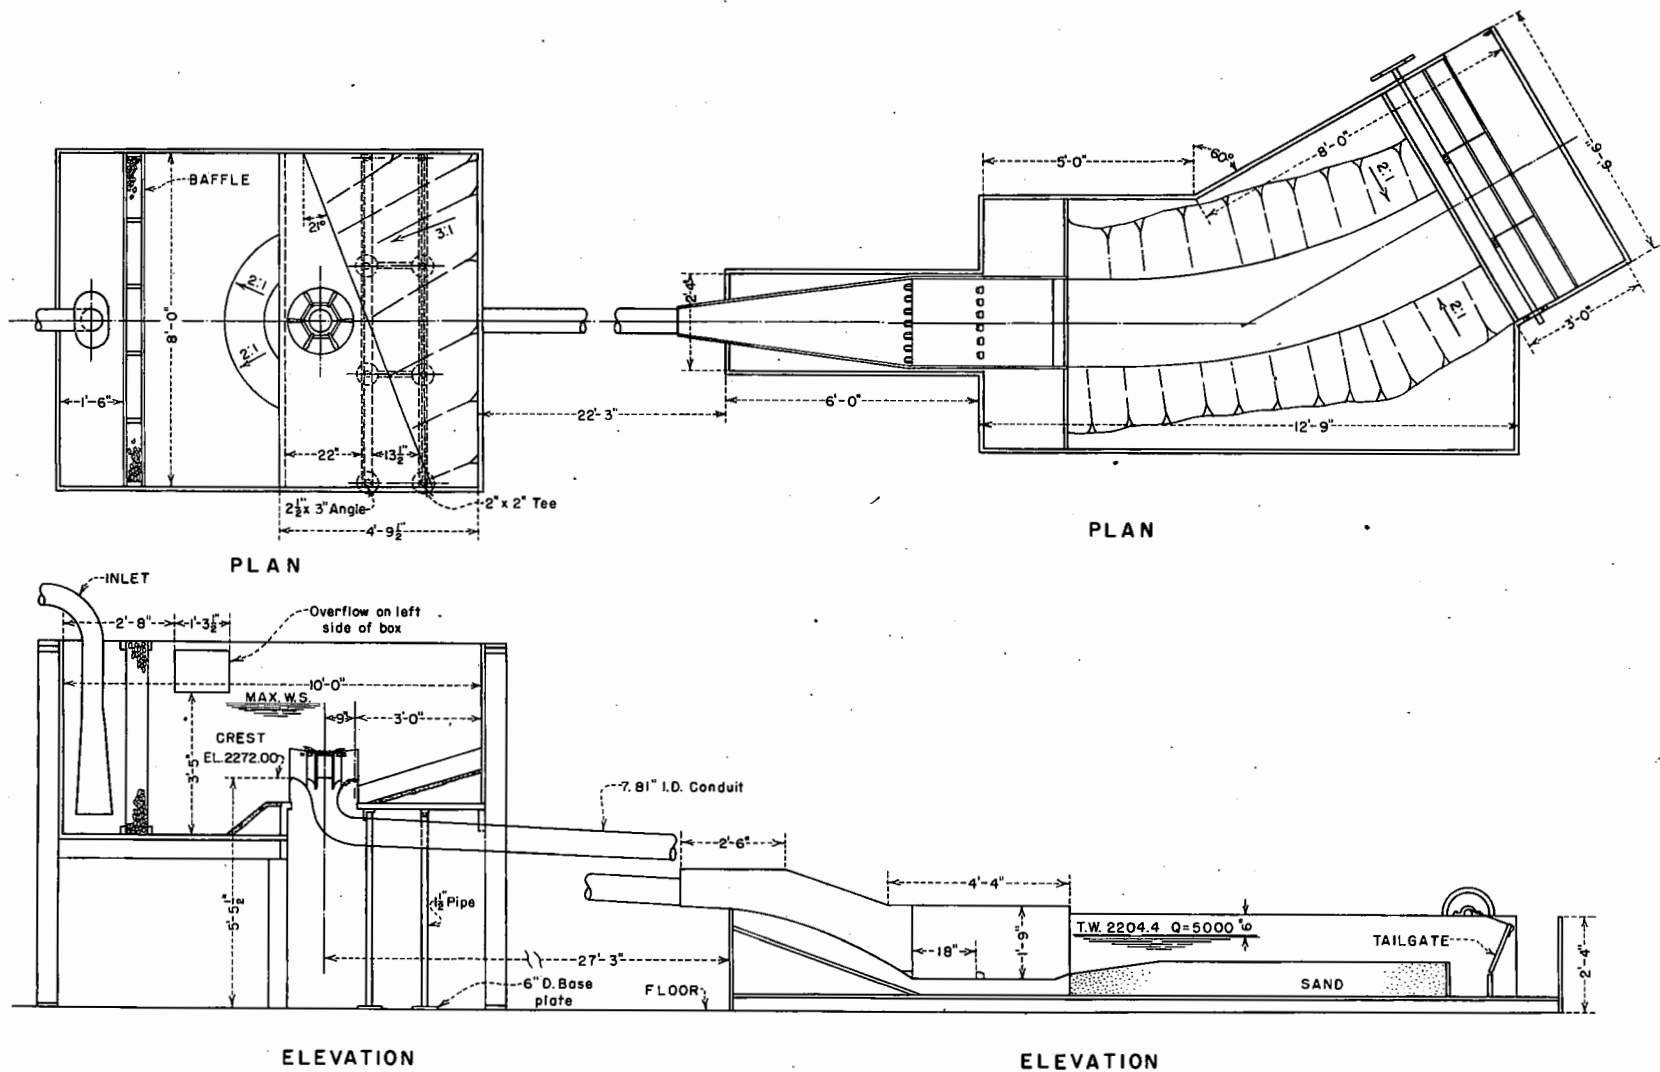
**SHADEHILL DAM  
SERVICE SPILLWAY ENTRANCE  
PRELIMINARY**

LINE	SYMBOL	RESERVOIR ELEVATION	DISCHARGE SEC.-FT.	REMARKS
(A)	—	2306.0	4980	
(B)	---	2280.0	3550	DEFLECTOR IN PLACE
(C)	- - -	2276.6	2950	
(D)	+++	2291.0	4980	DEFLECTOR REMOVED & TUNNEL RUNNING FULL
(E)	-++	2276.6	3550

Tests of the preliminary spillway entrance, Figure 5, showed that the design in general was satisfactory. Flow through the entrance and the bend was smooth and pressures on the face of the crest and bend indicated satisfactory flow conditions. Small vortices appeared over the entrance in the vicinity of the piers and they became larger when the piers were submerged, indicating that the pier heights should be increased. Calibration of the preliminary spillway, Figure 7, showed a discharge of 4,530 second feet at reservoir elevation 2297.0, indicating that the throat diameter should be increased to give the required 5,000 second feet discharge. The spillway was operated after removing the deflector on the downstream side of the throat. At discharges above 3,300 second feet, with the crest submerged, the tunnel ran full and pressures were below atmospheric in the spillway entrance. This unsatisfactory performance demonstrated the need for a deflector in the throat.

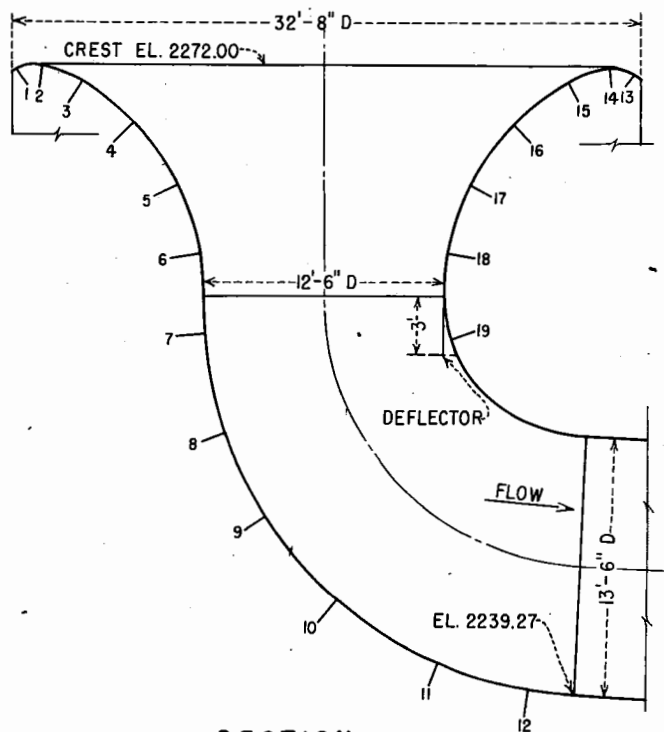
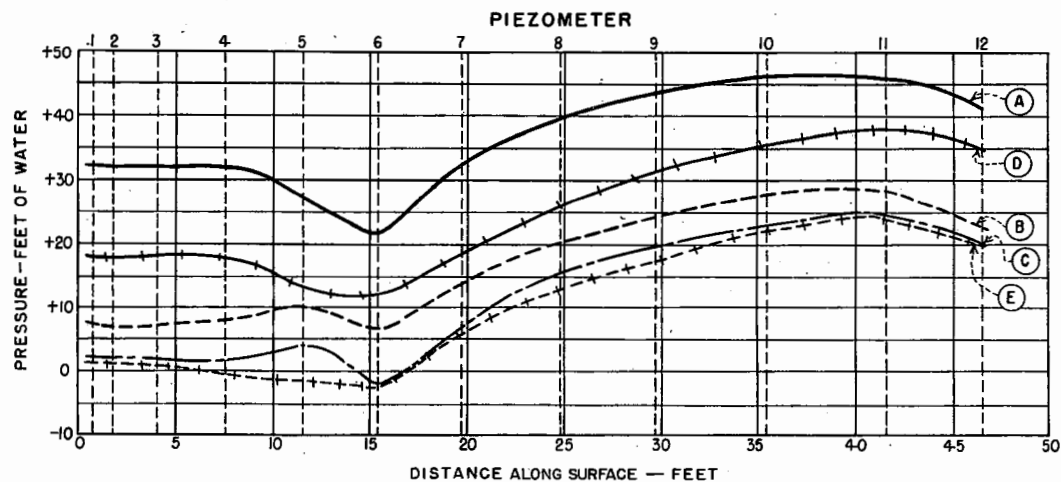
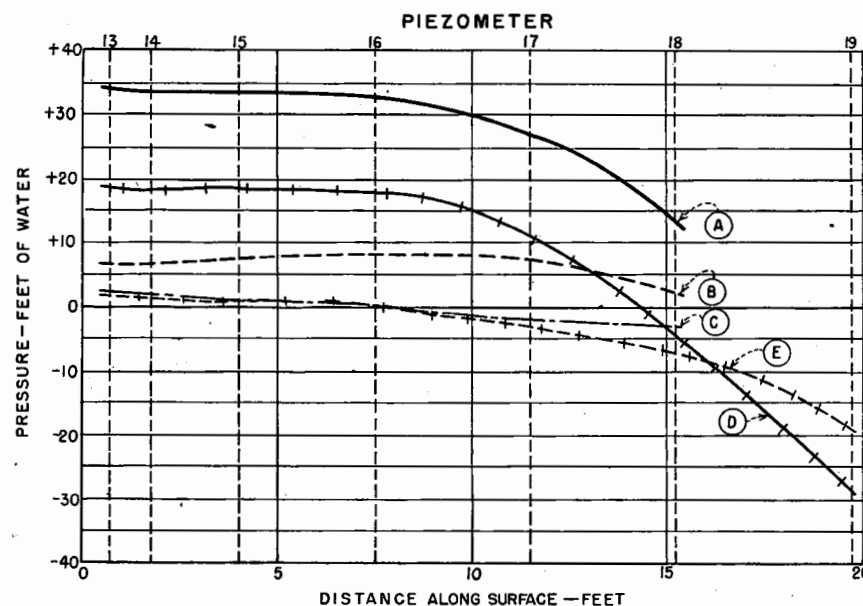
SECTION  
SHOWING PIEZOMETER LOCATION

SHADEHILL DAM  
SERVICE SPILLWAY  
PRESSURES IN ENTRANCE AND ELBOW  
PRELIMINARY

PRESSURES ALONG UPSTREAM CURVE

PRESSURES ALONG DOWNSTREAM CURVE

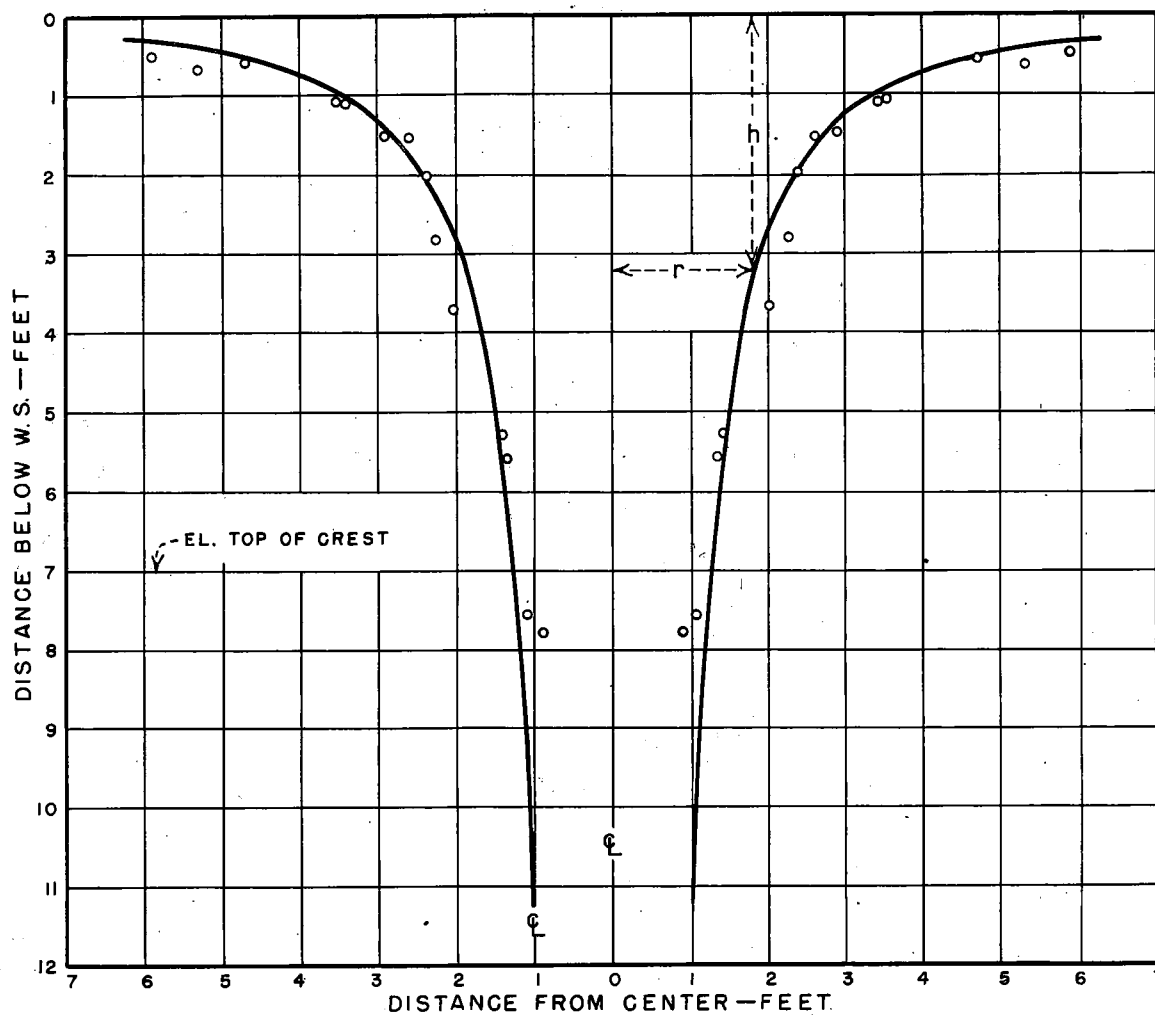
VORTEX CROSS SECTION  
 —○— MEASUREMENT IN MODEL WITH  
 RESERVOIR ELEVATION 2279 AND  
 PIERS REMOVED,  $hr^2 = 11.3$

SHADEHILL DAM  
 VORTEX OVER SPILLWAY  
 ENTRANCE

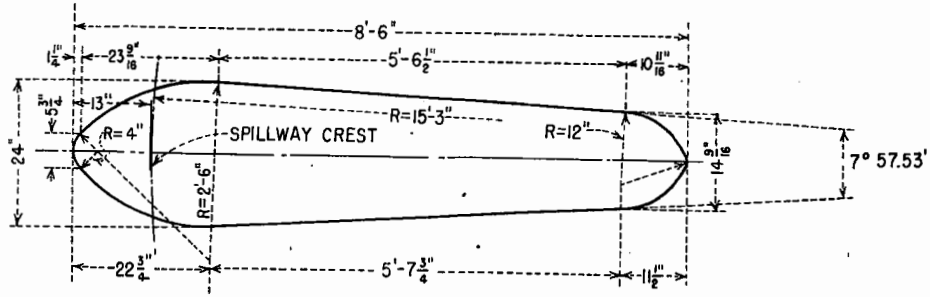
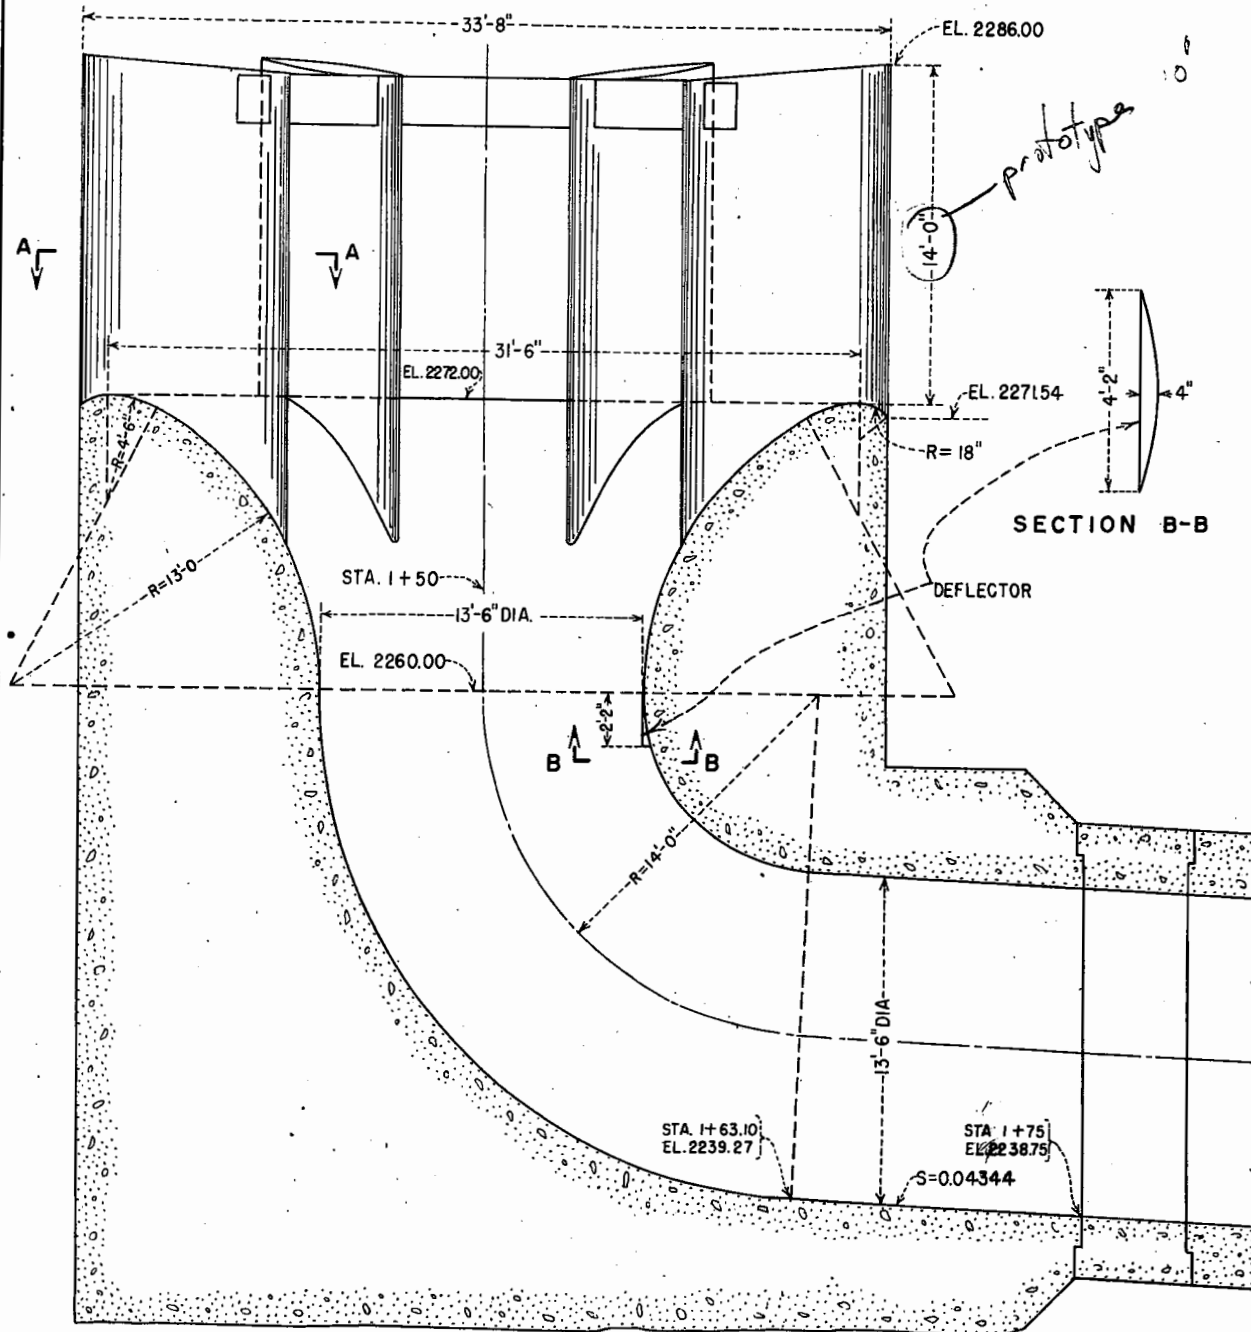
FIGURE 9

SECTION A-A

SHADEHILL DAM  
SERVICE SPILLWAY ENTRANCE  
RECOMMENDED

LINE	SYMBOL	RESERVOIR ELEVATION	DISCHARGE SEC.-FT.
(A)	—	2297.6	5010
(B)	- - -	2285.8	4305
(C)	- · - · -	2276.8	3610
(D)	- · - · -	2276.0	2915

The recommended entrance structure, Figure 9, has piers 14 feet high and a throat diameter of 13 feet 6 inches. Flow was satisfactory at all discharges. Vortex action occurred as before, but the higher piers reduced the size of the vortices. Pressures throughout the crest and bend were satisfactory. The discharge capacity curve for the recommended entrance, Figure 7, showed a discharge of 5,000 second feet at reservoir water-surface elevation 2297. The spillway capacity was influenced by the deflector width which was adjusted to give the required discharge.

Operation and pressures. The second entrance and bend tested is shown in Figure 9. The diameter of the spillway throat was equal to that of the tunnel or 13.5 feet, so that the vertical bend was of constant diameter. The maximum spillway entrance diameter was increased 1 foot to 33 feet 8 inches. The crest remained at elevation 2272.00 and the shape of the morning-glory crest section was the same as that of the preliminary entrance. The piers were 14 feet high, an increase of

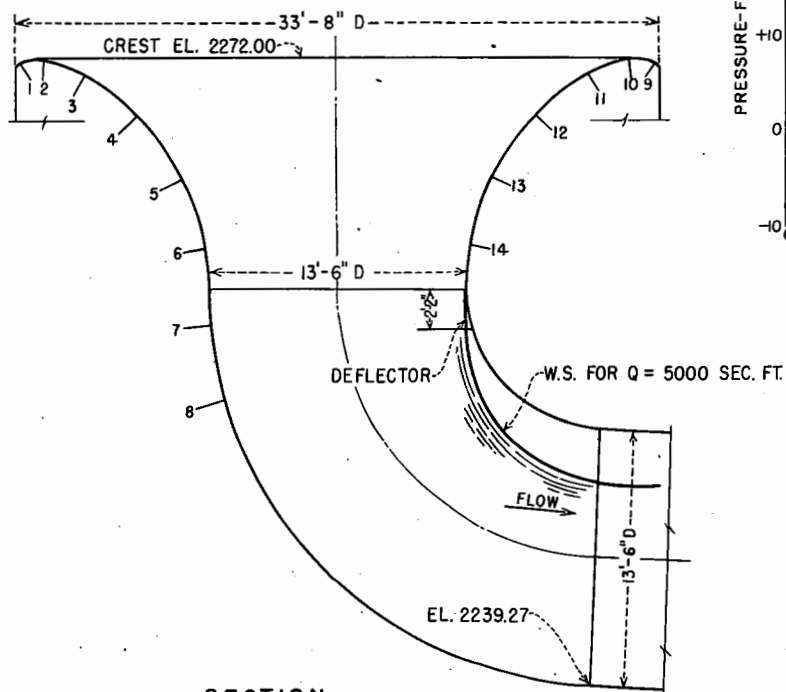
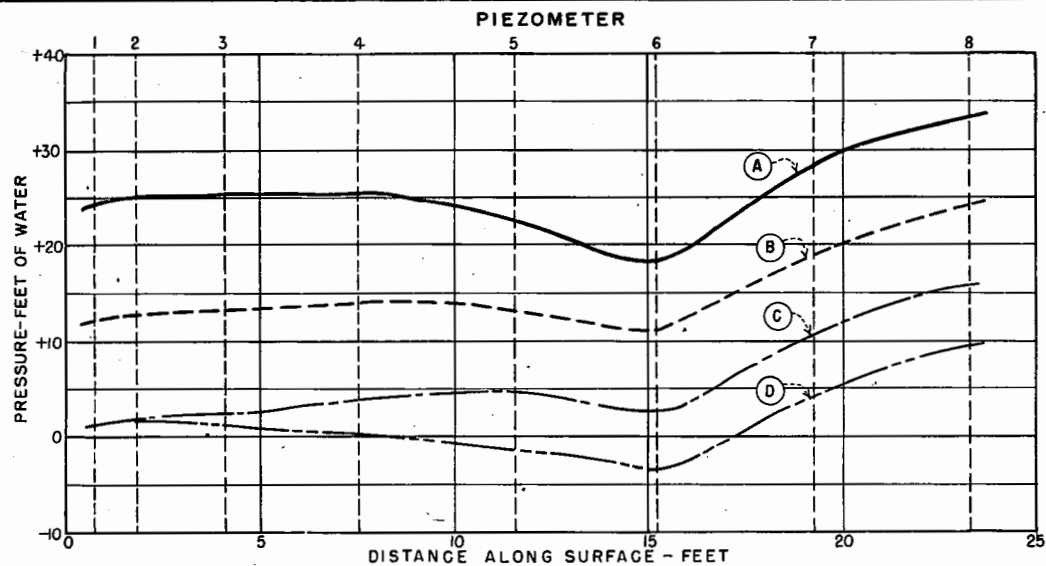
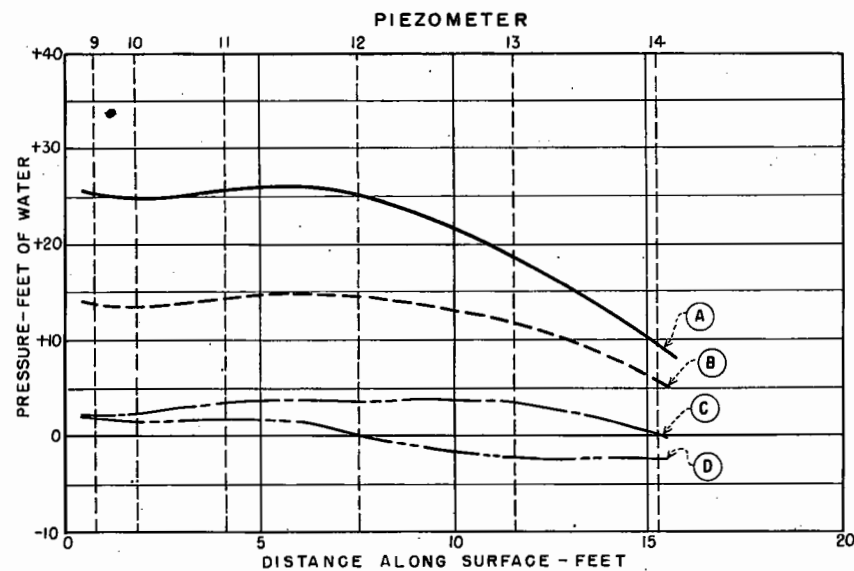
SECTION  
SHOWING PIEZOMETER LOCATION

SHADEHILL DAM  
SERVICE SPILLWAY  
PRESSURES IN ENTRANCE AND ELBOW  
RECOMMENDED

PRESSURES ALONG UPSTREAM CURVE

PRESSURES ALONG DOWNSTREAM CURVE

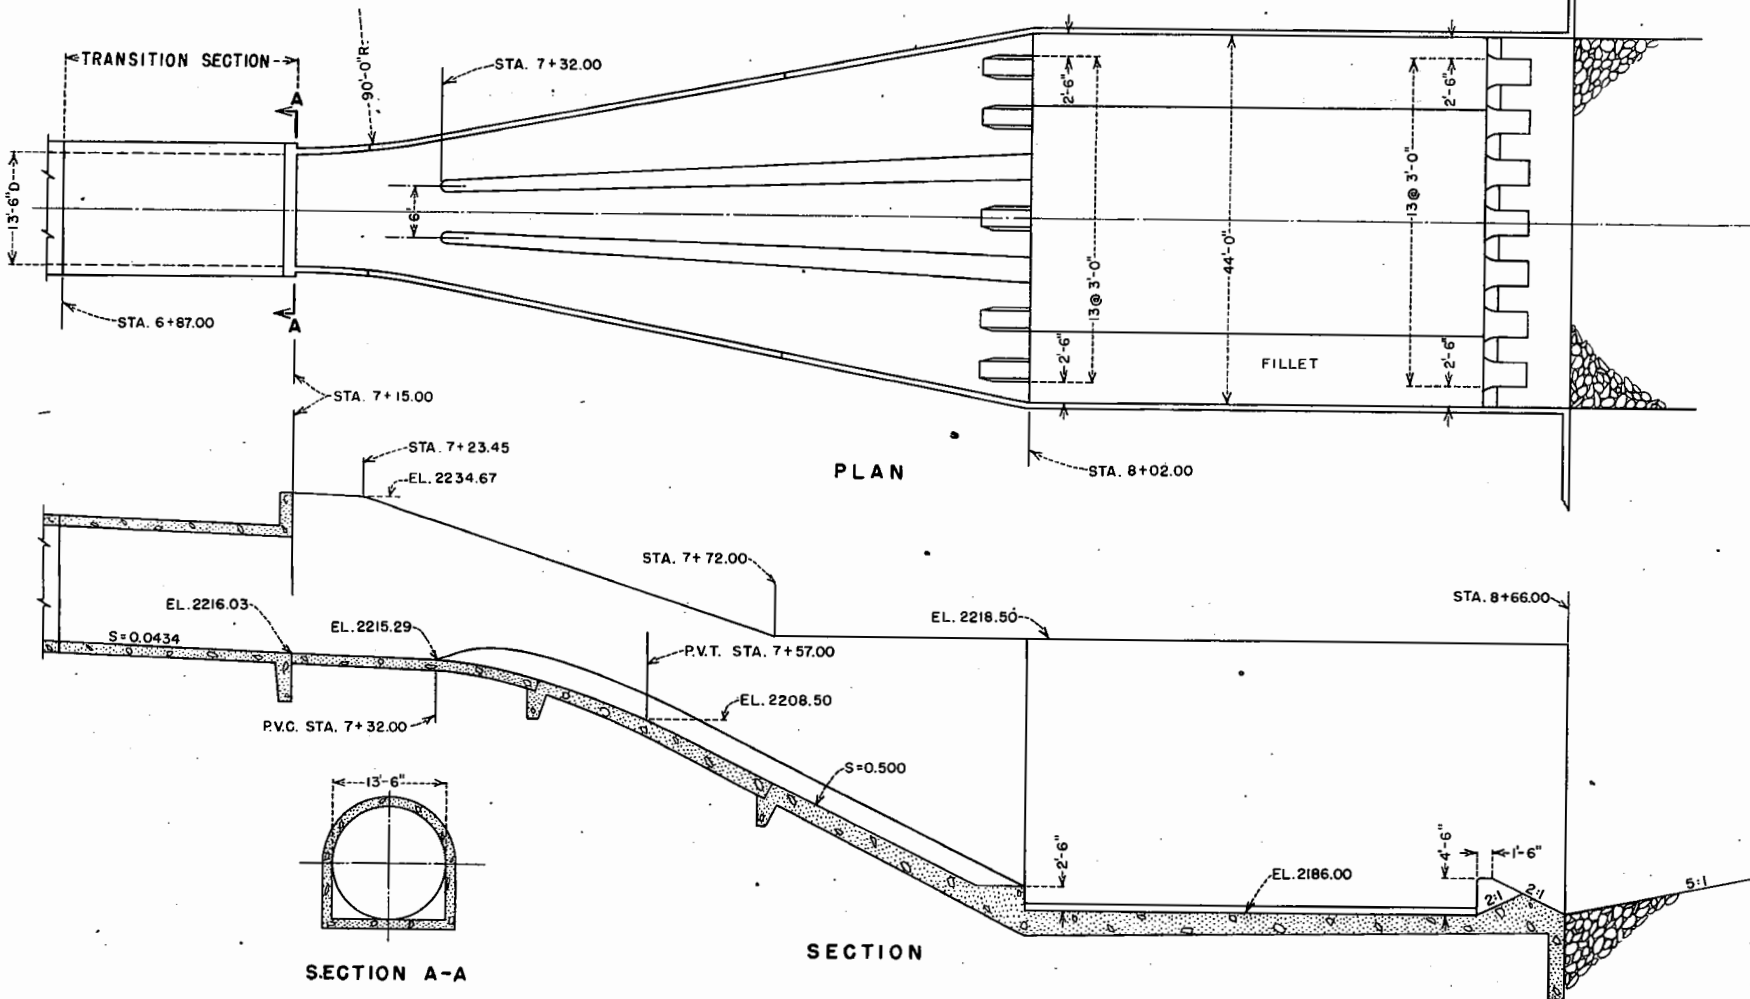
SHADEHILL DAM  
 SERVICE SPILLWAY SPILLING BASIN  
 PRELIMINARY

The preliminary stilling basin, Figure 11, gave unsatisfactory performance because the jet did not spread in passing down the chute, thus causing a flow concentration in the center of the stilling basin. Stilling Basin No. 2, Figure 13, had a longer and flatter parabolic chute section than Basin No. 1. The performance was improved, but the flow was still concentrated in the center of the basin, and the scour was practically unchanged. A longer chute with a more gradual parabolic slope was then used for Basin No. 3, Figure 15. The horizontal floor was lowered 4 feet and baffle piers and a solid end sill were used instead of the dentated end sill. Operation was satisfactory with the spreader walls installed, but their removal resulted in better spreading of the flow. Pressures on the chute and baffle piers were above atmospheric and scour in the river channel was moderate. Accordingly, this basin was recommended for construction.

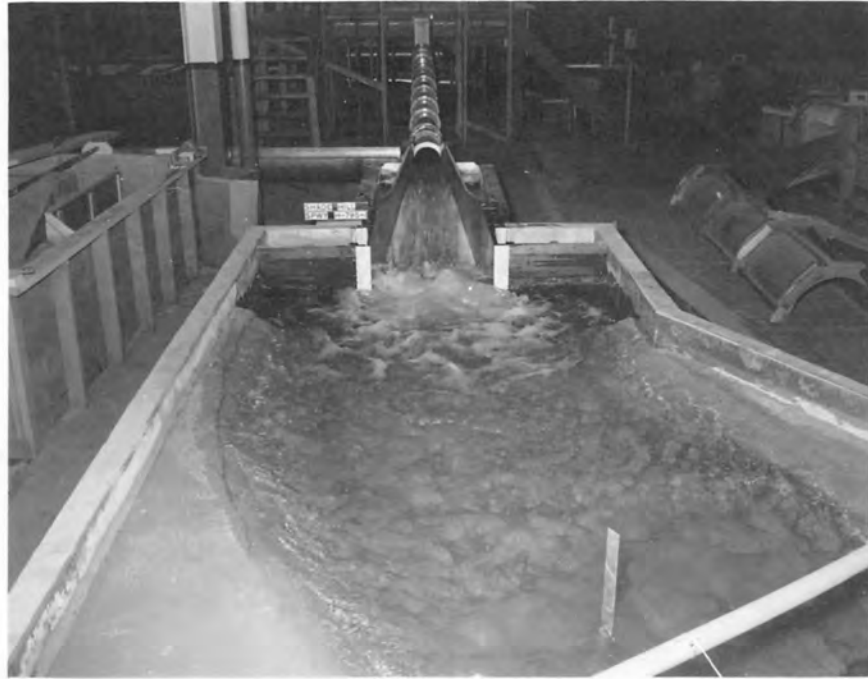
**A. Operation at 5,000 second-feet  
Tailwater elevation 2204.5**

**SHADEHILL DAM  
Service Spillway  
Preliminary Stilling Basin**

Operation of the stilling basin with the maximum discharge of 5,000 second feet is shown in Figure 12A. The jump formed too far downstream as the toe of the chute was exposed. The water surface in the channel was rough with 3-foot high waves. The profile of the chute did not conform to the trajectory of the water flowing over it. This caused low pressures on the chute, and very little spreading of the flow. The flow was concentrated in the center of the basin, thus the spreader walls were ineffective.

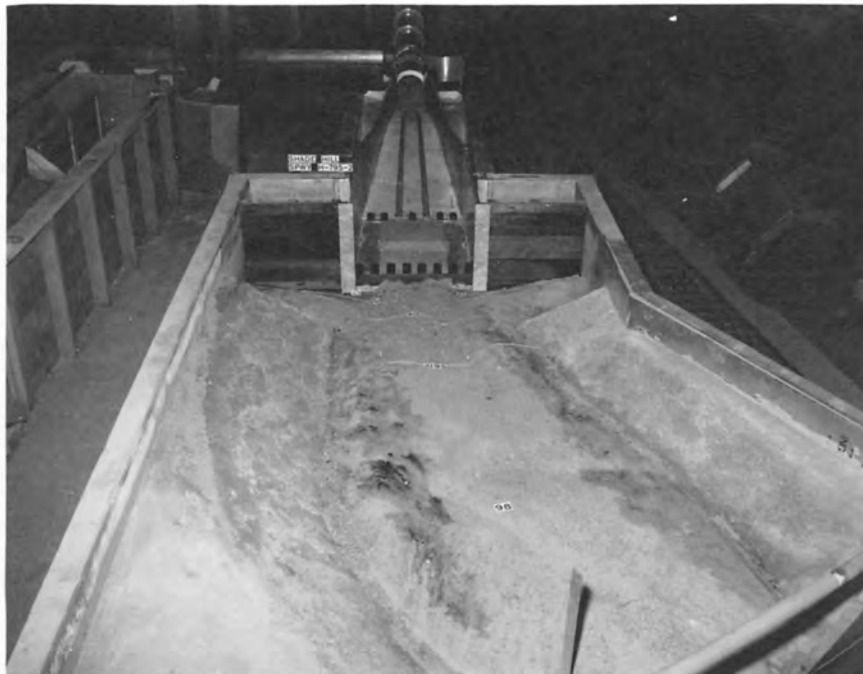
**B. Scour after 1 hour at 5,000 second-feet  
Tailwater elevation 2204.5**

An erosion test was run by operating the model for 1 hour at a discharge of 5,000 second feet with the tail water at elevation 2204.5. The scour that resulted is shown in Figure 12B. The lowest streambed elevation was 3 feet below the apron floor and occurred at the cut-off wall on each side of the basin. While the condition of the bed showed fair stilling action, the removal of all sand from the concrete side slopes indicated turbulent flow and high velocities near the water surface.

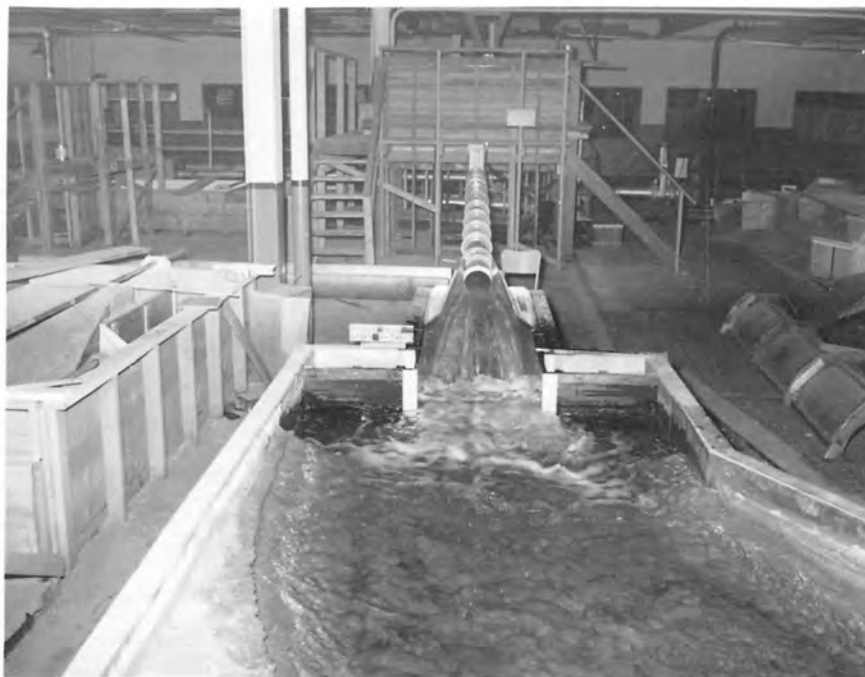
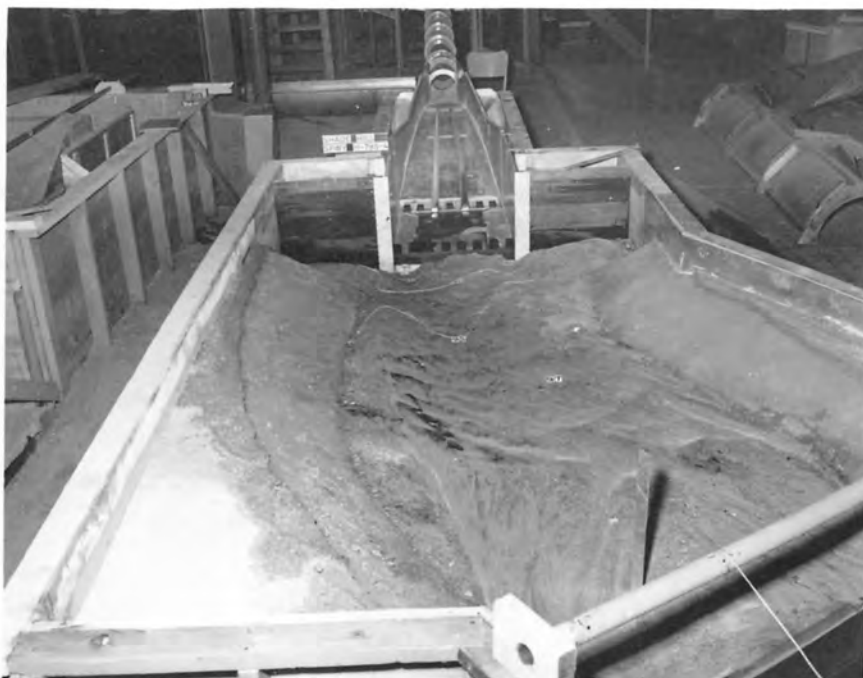
**FIGURE 13**

**A. Operation at 5,000 second-feet  
Tailwater elevation 2204.5**

**B. Scour after 1 hour at 5,000 second-feet  
Tailwater elevation 2204.5**

**SHADEHILL DAM  
Service Spillway Stilling Basin No. 2**

Operation and erosion. The concentration of flow in the center of the basin was the greatest objection to the performance of the preliminary stilling basin. This was caused by the shape of the chute section so this portion of the basin was modified for Stilling Basin No. 2. The training wall divergence was changed by eliminating the 90-foot radius at the tunnel portal to give straight walls, Figure 13. The vertical curve and steep slope of the chute floor were replaced by a parabolic-shaped floor as shown in the same figure. Remaining features of the basin were unchanged from the preliminary.

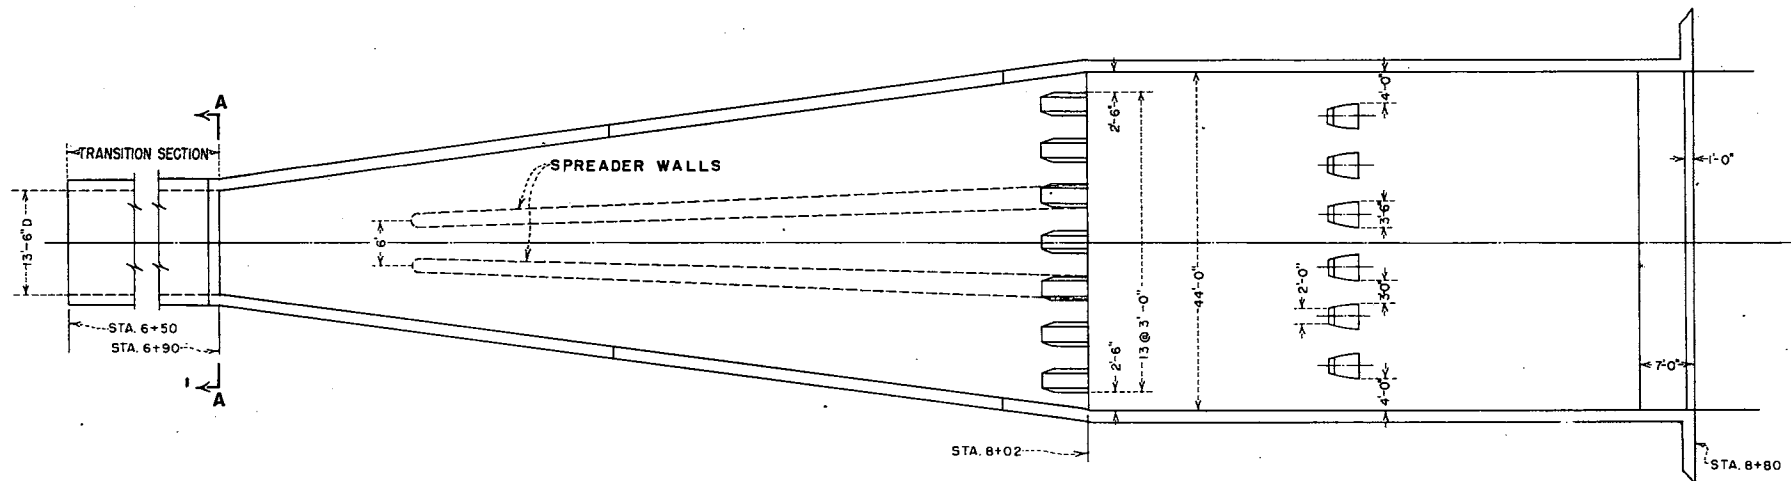
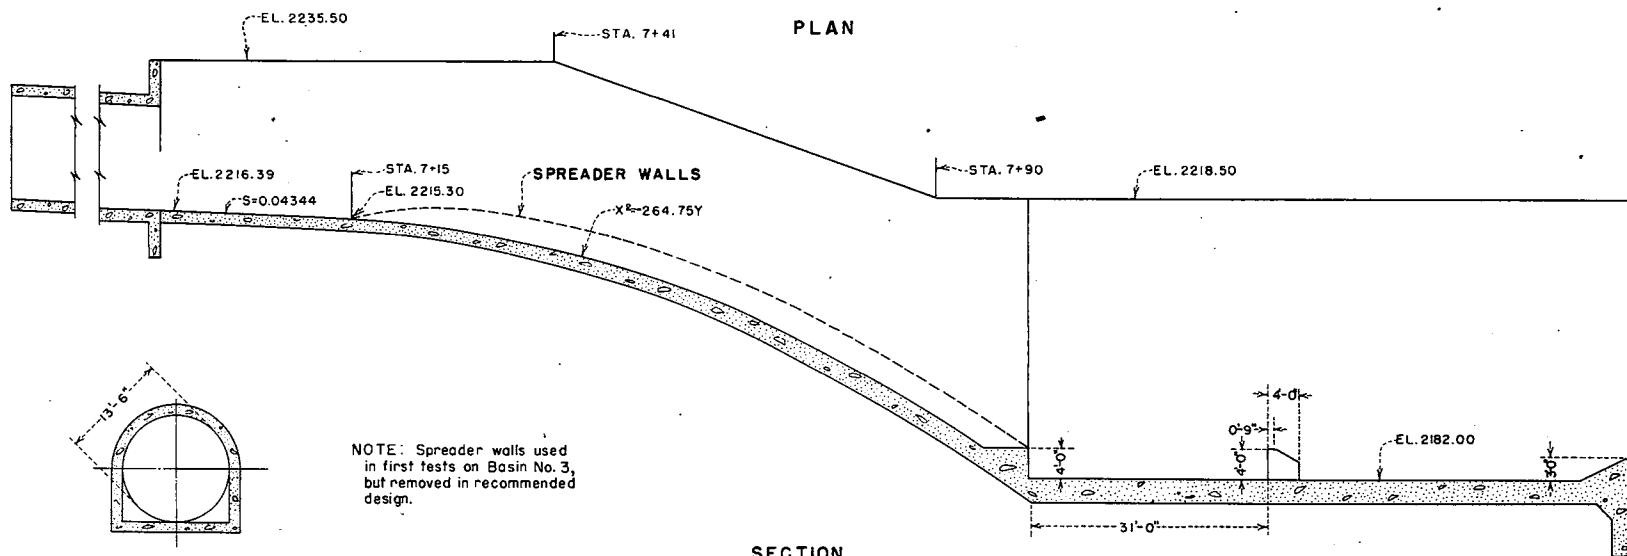
PLAN

SECTION

NOTE: Spreader walls used in first tests on Basin No. 3, but removed in recommended design.

SHADEHILL DAM  
SERVICE SPILLWAY STILLING BASIN  
No. 3-RECOMMENDED

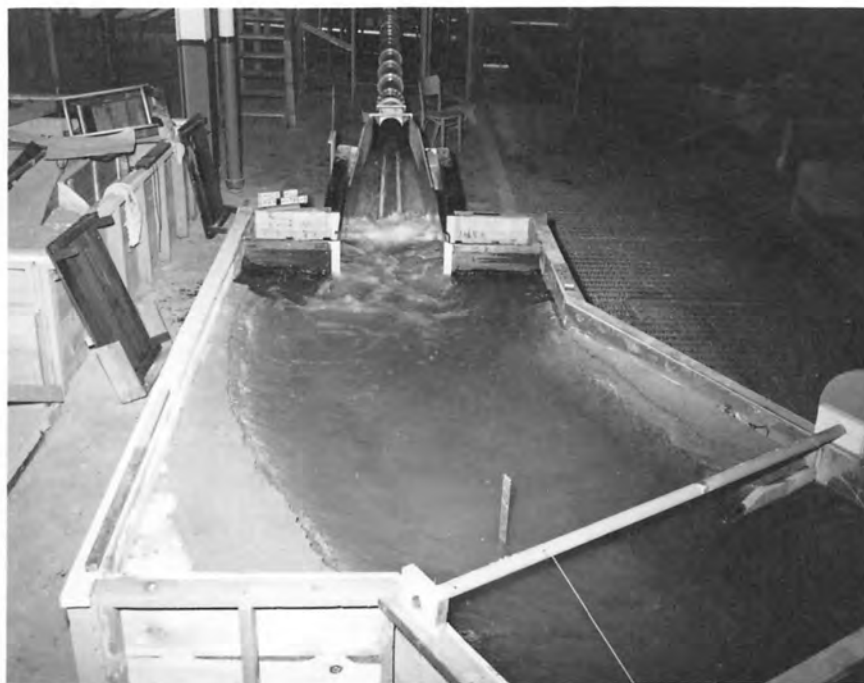
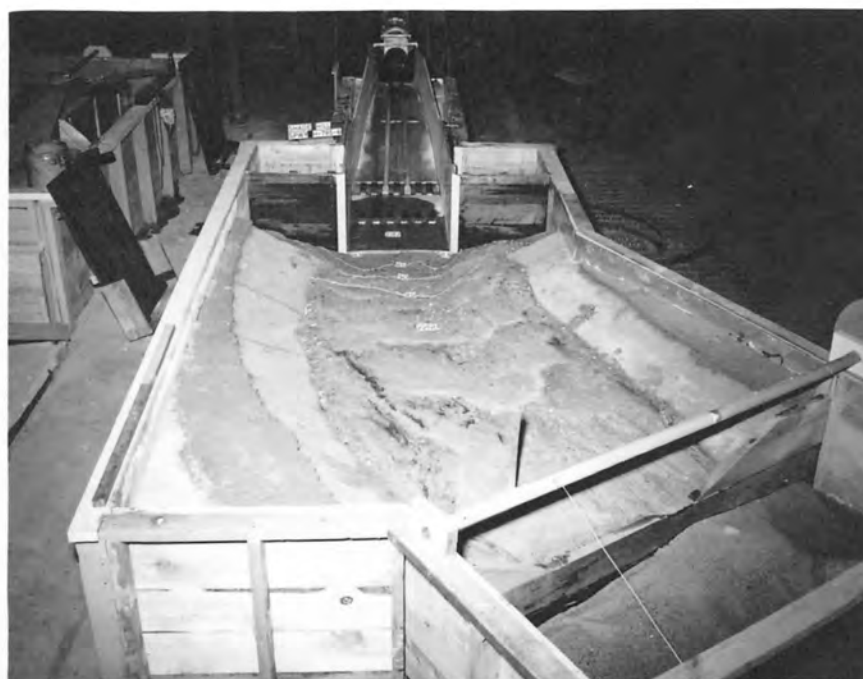
**A. Operation at 5,000 second-feet  
Tailwater elevation 2204.5**

**B. Scour after 1 hour at 5,000 second-feet  
Tailwater elevation 2204.5**

**SHADEHILL DAM  
Service Spillway Stilling Basin No. 3  
With Spreader Walls**

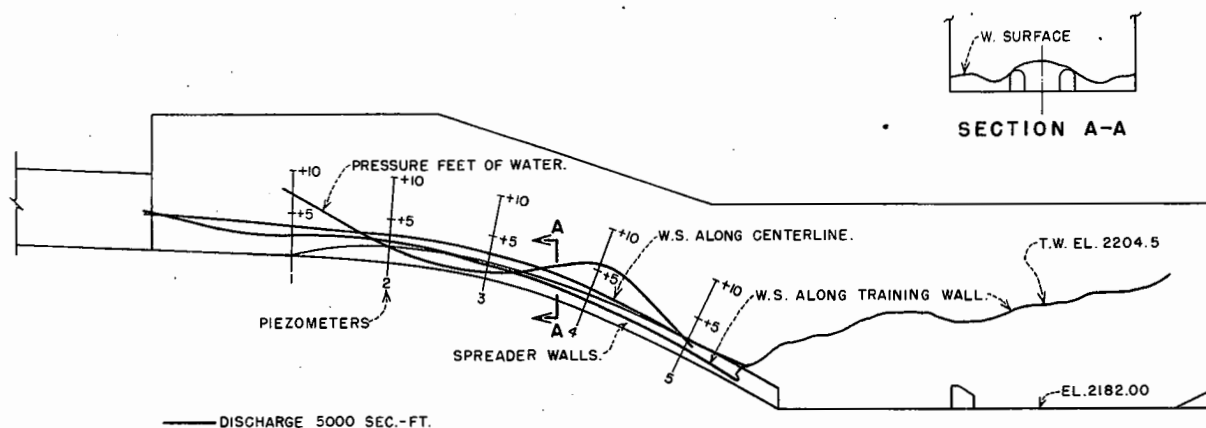
## ELEVATION

WATER SURFACE PROFILES AND PRESSURES  
SPREADER WALLS INSTALLED

PIEZOMETER	PRESSURE FEET OF WATER	DISCHARGE SEC.-FT.	TAILWATER ELEVATION
1	+7.2'	5000	2204.5
2	+6.5'	5000	2204.5
3	+7.8'	5000	2204.5
4	+7.0'	5000	2204.5
1	+11.5	3400	2202.0
2	+10.5	3400	2202.0
3	+10.5	3400	2202.0
4	+7.8	3400	2202.0

PRESSURES  
ON BAFFLE PIER

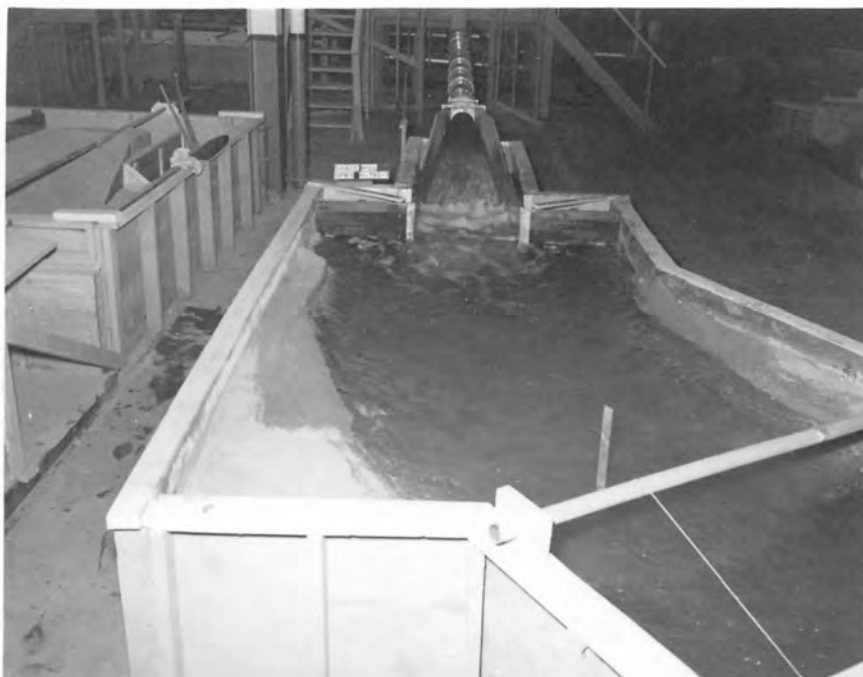
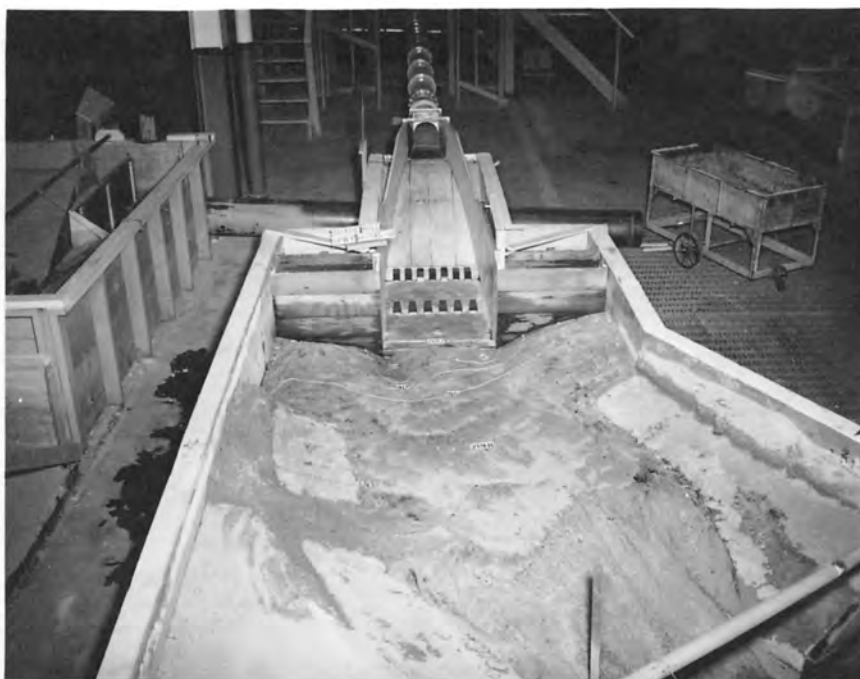
**A. Operation at 5,000 second-feet  
Tailwater elevation 2204.5**

**B. Scour after 1 hour at 5,000 second-feet  
Tailwater elevation 2204.5**

**SHADEHILL DAM  
Service Spillway Stilling Basin No. 3  
Without Spreader Walls--Recommended**

Basin without spreader walls---Recommended. The spreader walls on the chute were removed and the concrete side slopes in the tail box were cut off for a length of 50 feet at the end of the basin and replaced with sand. Performance of the basin with a discharge of 5,000 second feet, Figure 18A, showed improvement over that with the spreader walls in place. A more uniform flow distribution occurred across the basin with a resulting smoother water surface in the river channel.
