HYD 329

Design and Construction Division  
Engineering Laboratories Branch  
Denver, Colorado  
January 16, 1952

Laboratory Report No. Hyd-329  
Hydraulic Laboratory  
Written by: E. J. Rusho  
Reviewed by: A. J. Peterka  
Checked by: J. N. Bradley

Subject: Hydraulic model studies of the service spillway—Shadehill  
Dam—Missouri River Basin Project

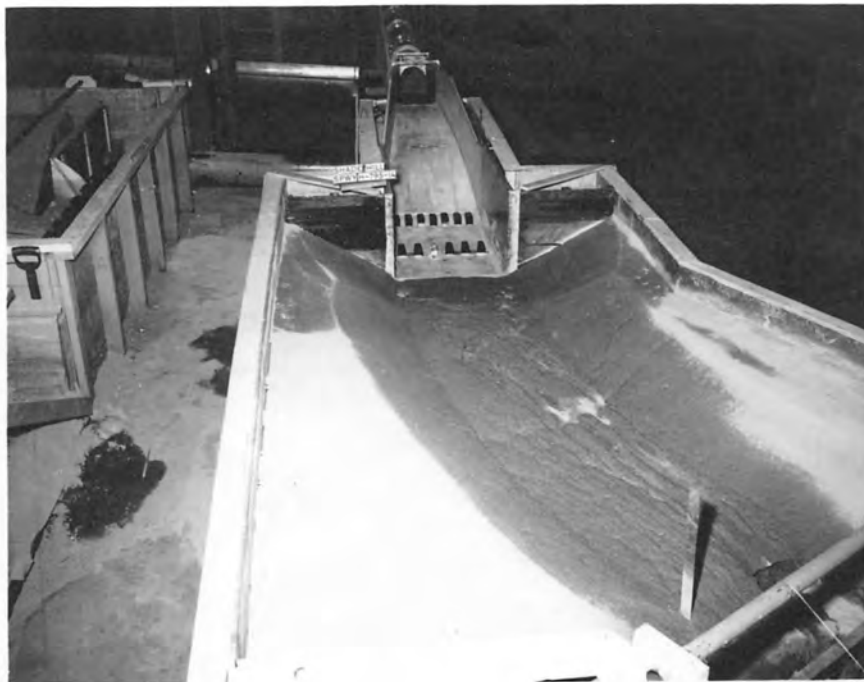
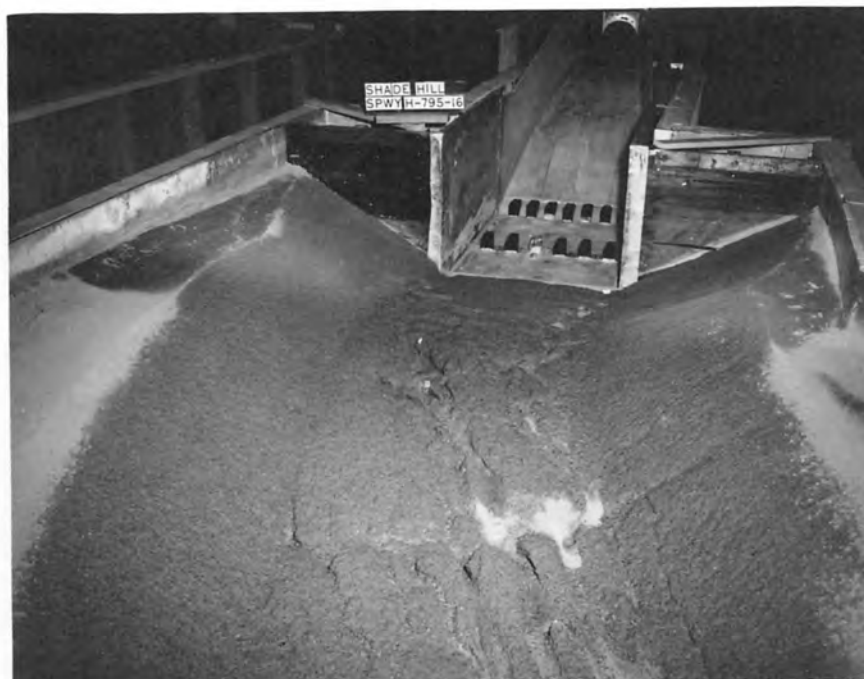
**A. Scour after 7 hours at 5,000 second-feet  
with stabilized sand--overall view  
Tailwater elevation 2204.5**

**B. Scour after 7 hours at 5,000 second-feet  
with stabilized sand--closeup view**

**SHADEHILL DAM  
Service Spillway Stilling Basin No. 3  
Without Spreader Walls--Recommended**

The second erosion test made use of a different bed material. The sand in the tail box was stabilized by mixing with cement in the ratio of 1 part of cement to 90 parts of sand by weight. The materials were formed to the shape of the river channel and after setting for 48 hours, the bed was firm and ready for the erosion test. The model was operated for 7 hours at the maximum discharge of 5,000 second feet and tail-water elevation 2204.5. The resulting erosion is shown in Figure 19A and B. Scour was not severe and was confined to the bed of the channel. The banks were smooth indicating minor erosion from wave action. With stabilized sand, holes eroded in the channel were not filled by loose sand so that areas subjected to the most scour could be located. This test indicated erosion to be greatest, not at the end of the stilling basin, but 100 feet downstream from this point. From these tests, together with the operating and pressure test, the stilling basin was considered satisfactory and was recommended for construction.
