UNITED STATES
DEPARTMENT OF THE INTERIOR
BUREAU OF RECLAMATION

HYDRAULIC MODEL STUDIES OF THE
OVERFLOW SPILLWAY AND THE HALE
DITCH IRRIGATION OUTLET--BONNY DAM
MISSOURI RIVER BASIN PROJECT

Hydraulic Laboratory Report No. Hyd-331

January 31, 1952

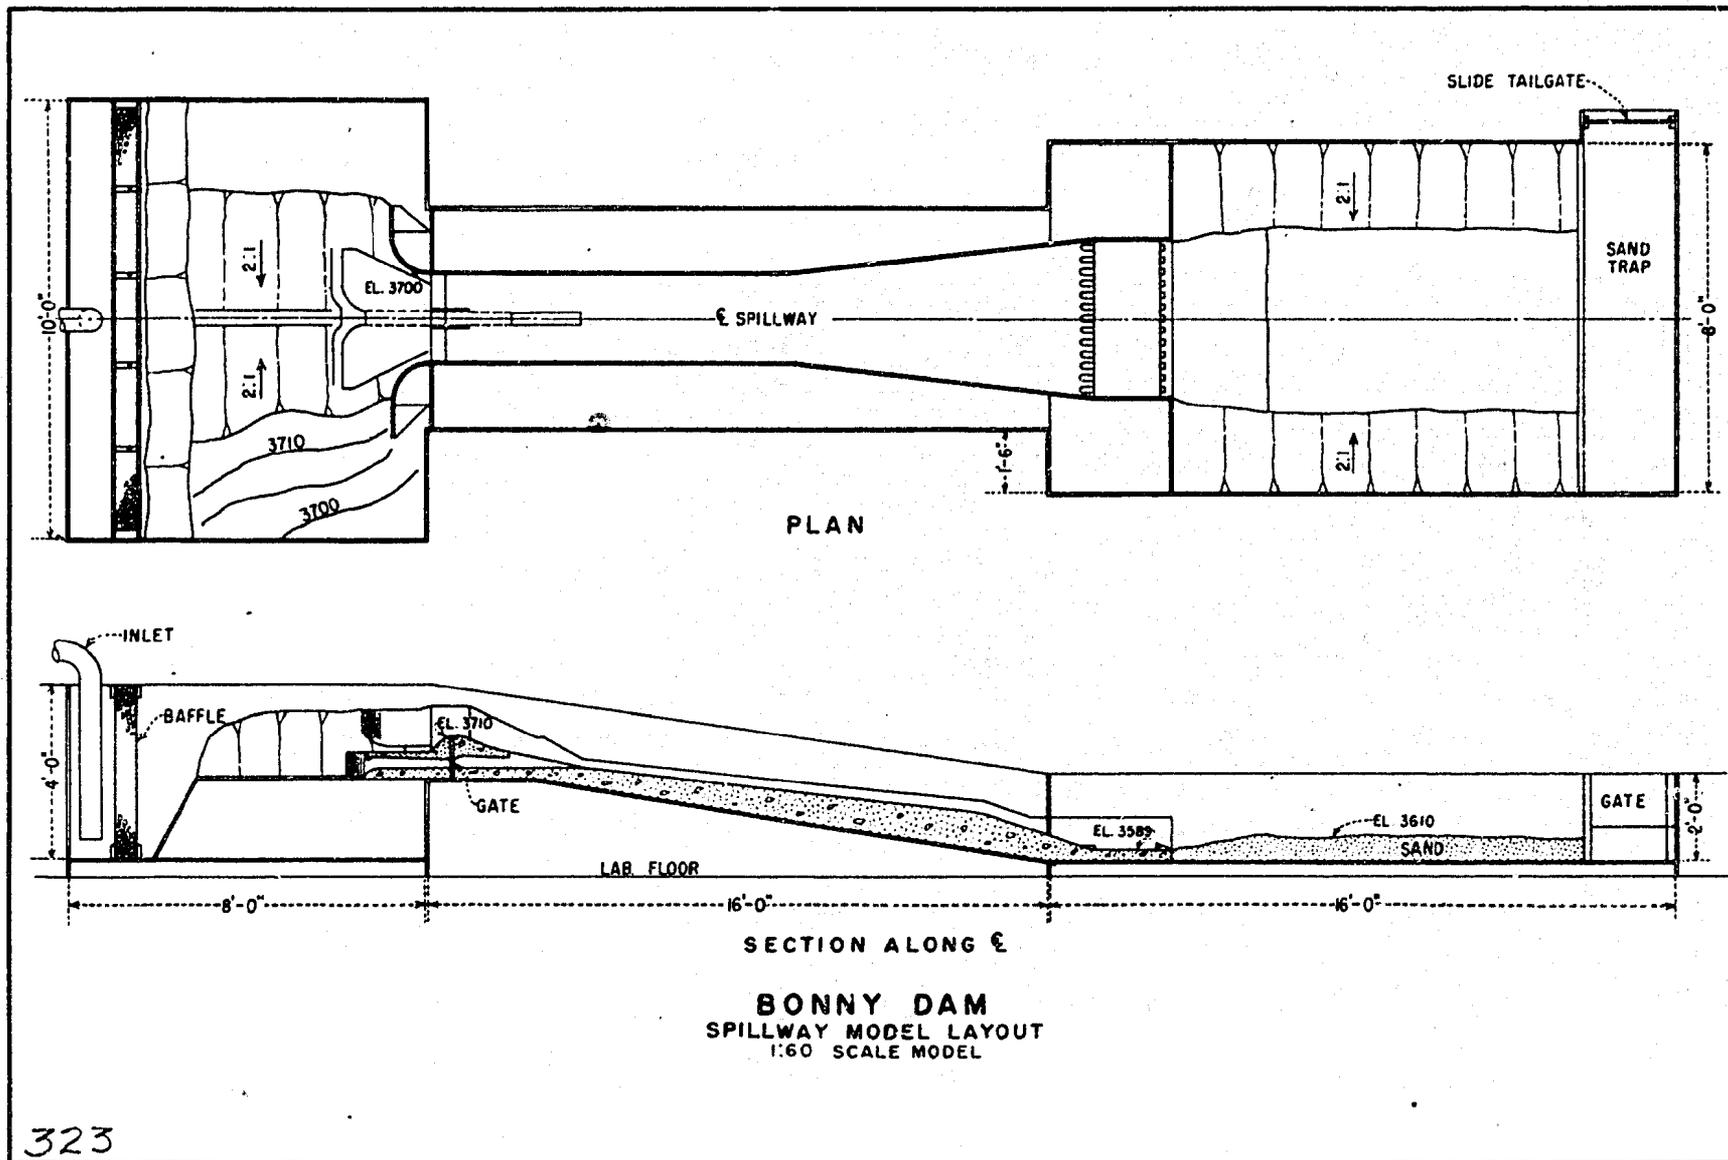
BONNY DAM
SPILLWAY MODEL LAYOUT
 1:60 SCALE MODEL

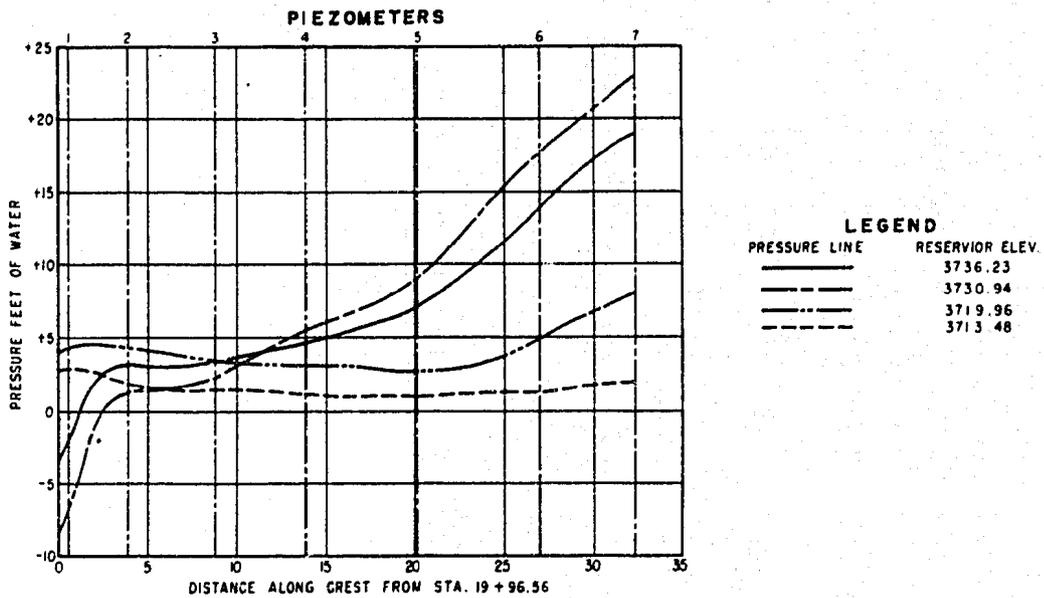
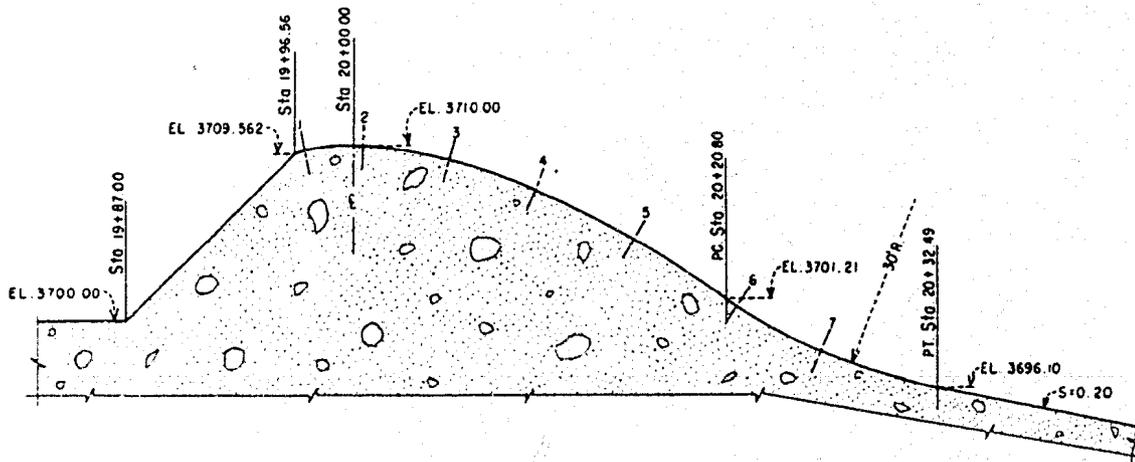
FIGURE 8

PRESSURES ON CREST

OVERFLOW SECTION

BONNY DAM
OVERFLOW SECTION NO. 1 — RECOMMENDED
 1:60 SCALE MODEL STUDY

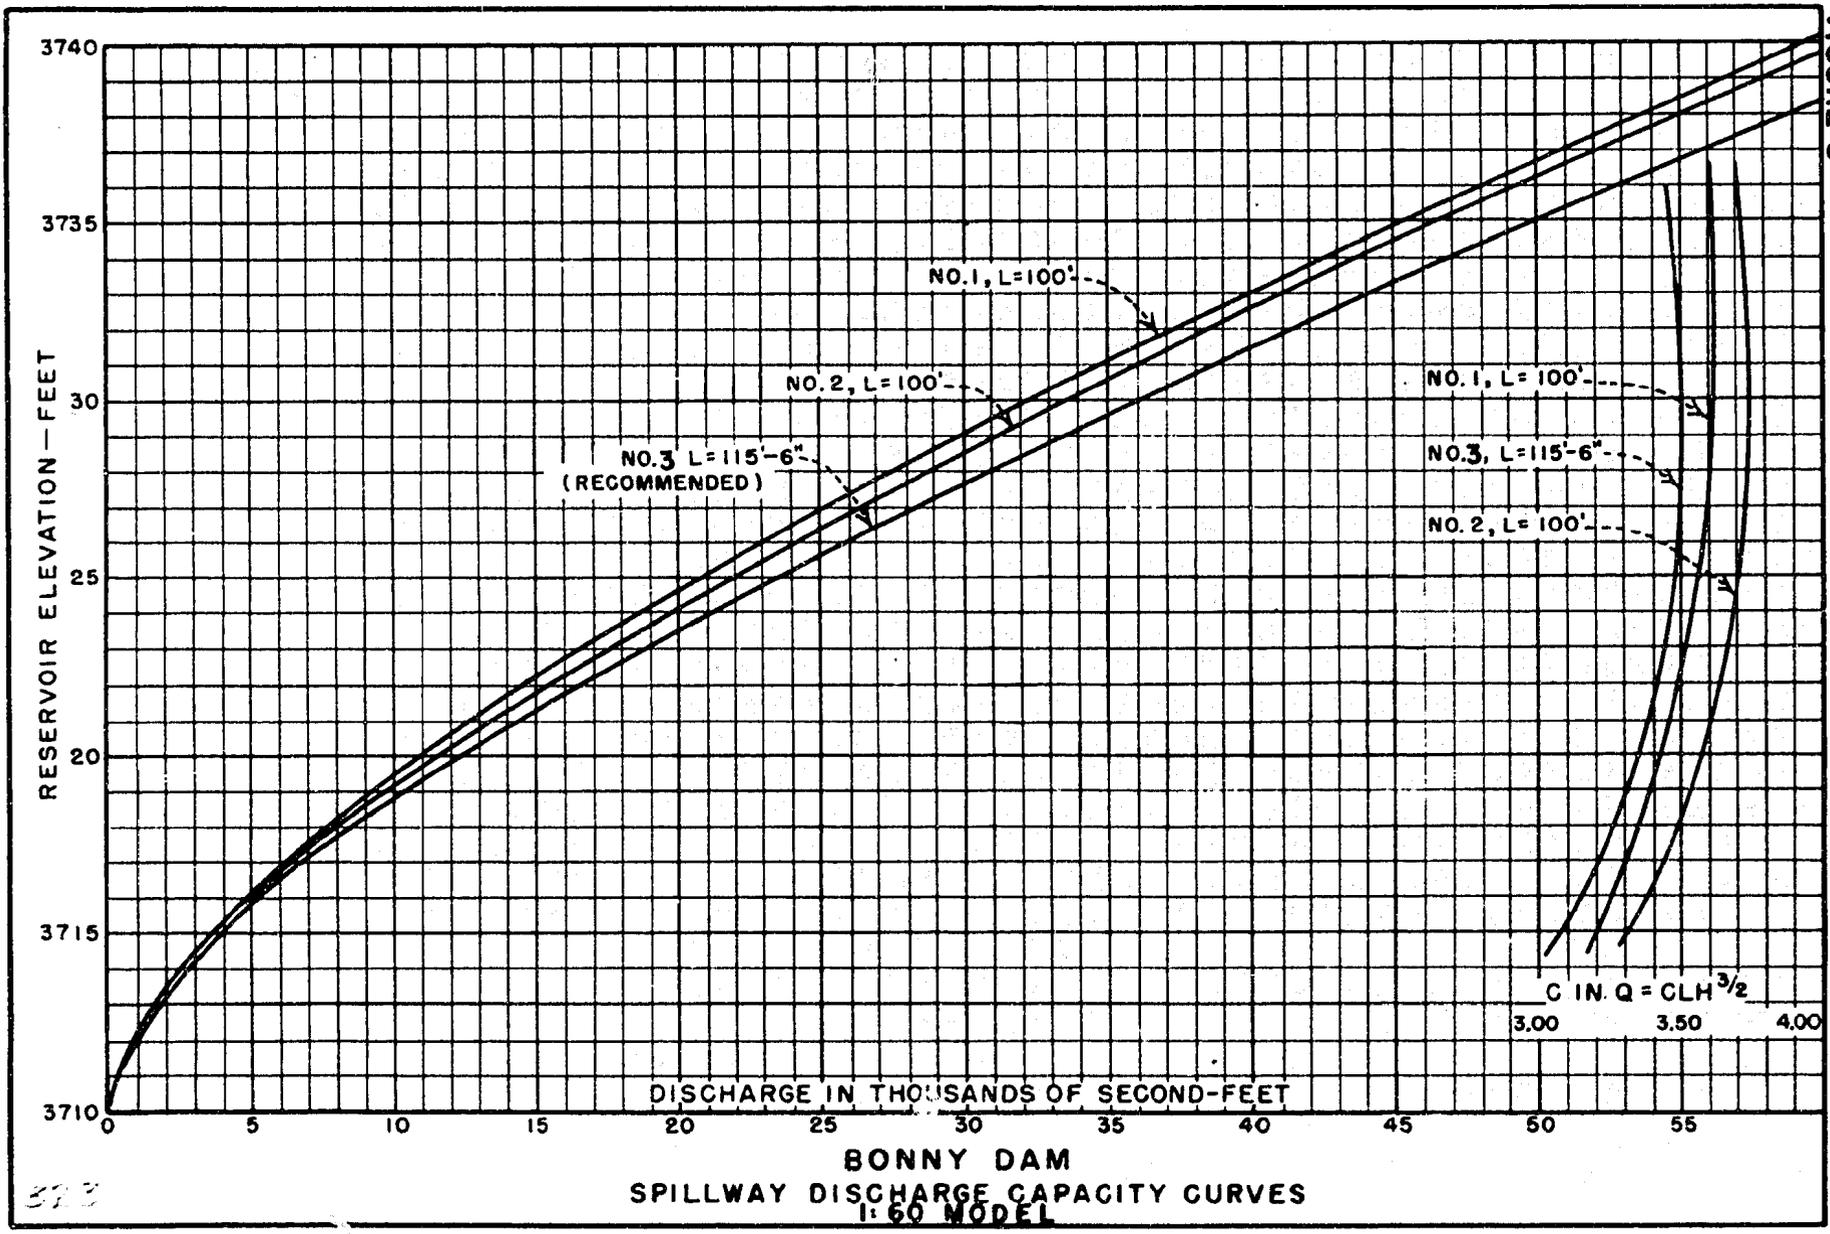
BONNY DAM
SPILLWAY DISCHARGE CAPACITY CURVES
1:60 MODEL

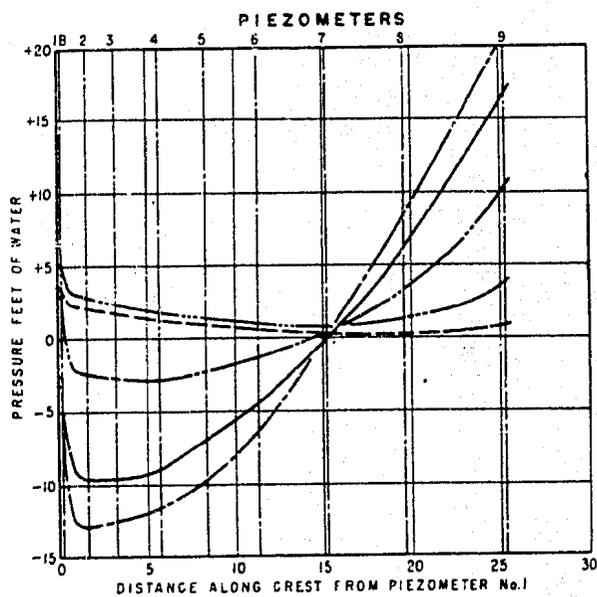
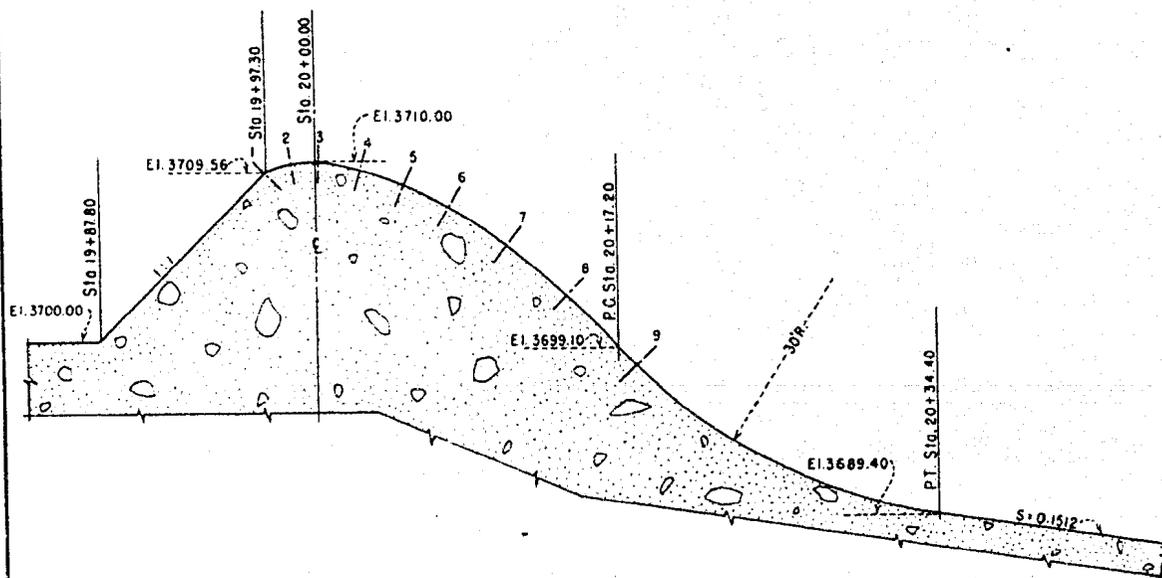
PRESSURES ON CREST

OVERFLOW SECTION

**BONNY DAM
OVERFLOW SECTION NO. 2
1:60 SCALE MODEL STUDY**

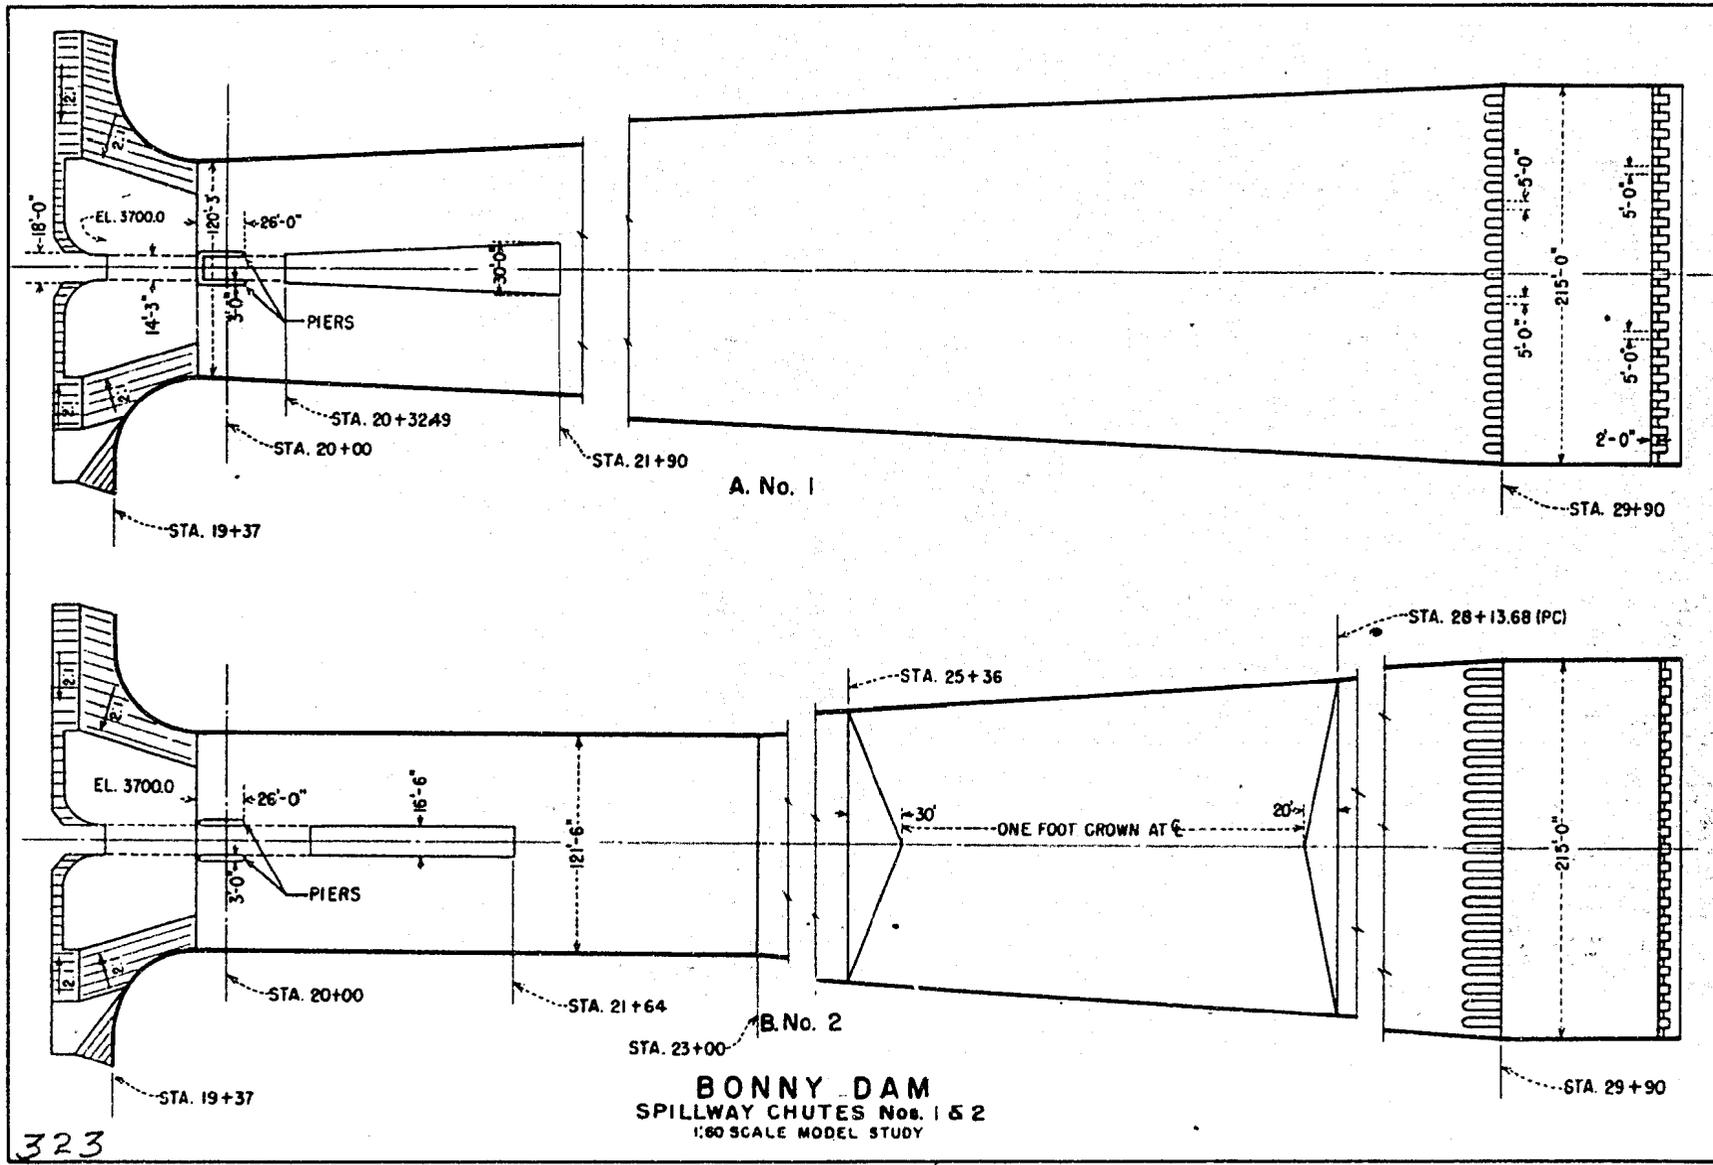
FIGURE II

BONNY DAM
 SPILLWAY CHUTES Nos. 1 & 2
 1:60 SCALE MODEL STUDY

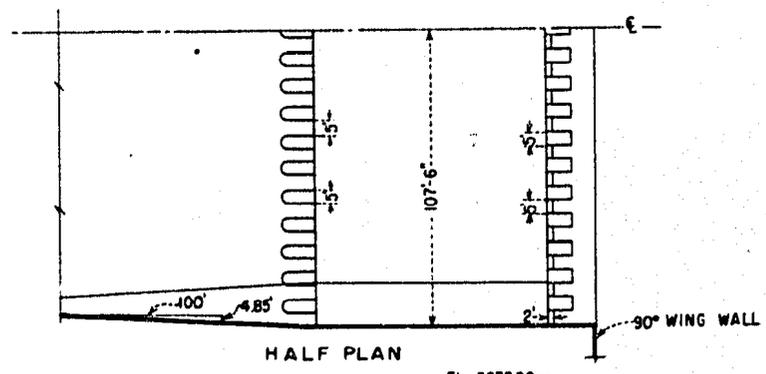
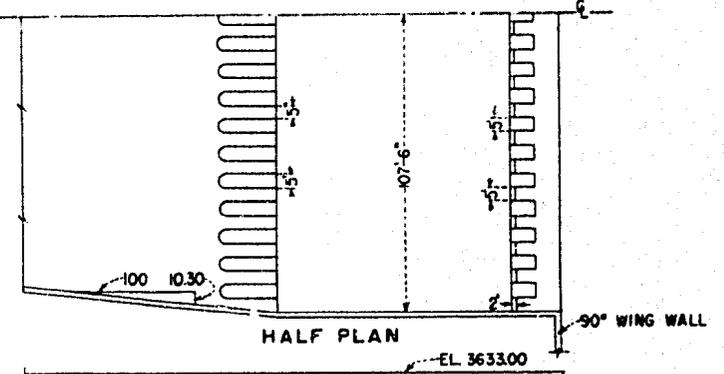
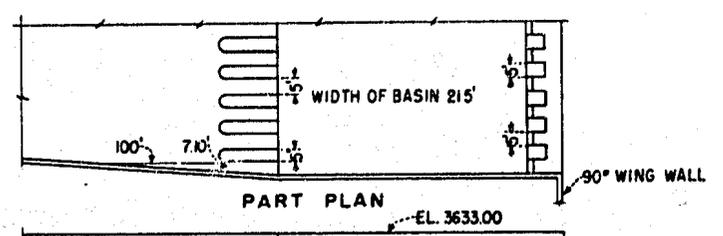
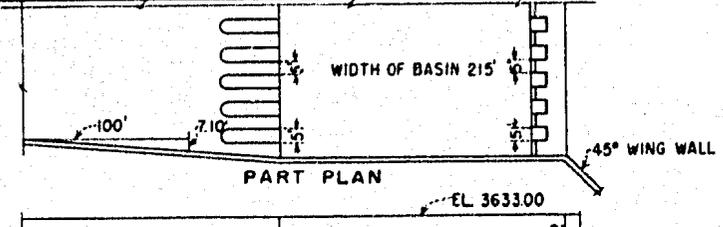
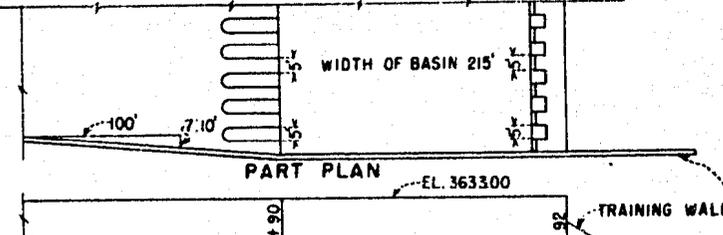
HALF PLAN
EL. 3633.00
ELEVATION
A. BASIN NO. 1 - PRELIMINARY

HALF PLAN
EL. 3633.00
ELEVATION
E. BASIN NO. 5 - RECOMMENDED

PART PLAN
EL. 3633.00
ELEVATION
B. BASIN No. 2

PART PLAN
EL. 3633.00
ELEVATION
C. BASIN No. 3

PART PLAN
EL. 3633.00
ELEVATION
D. BASIN No. 4

BONNY DAM
STILLING BASINS TESTED
1:60 SCALE MODEL STUDY

Stilling Basin No. 2. The chute blocks were increased in height to 7.5 feet to give more turbulence in the basin and an end sill 5 feet high was installed for Basin No. 2, Figure 16B. The operation of the basin for the maximum discharge of 71,400 second feet is shown in Figure 18A. The erosion resulting from operating 1 hour at the maximum discharge and the tail-water elevation at 3623.4 is shown in Figure 18B. The erosion was more severe than in the test with the preliminary basin, but the two tests are not comparable because of the higher discharge of the second test. The greatest depth of scour occurred downstream from each training wall.

Stilling Basin No. 5--recommended. The 90-degree wing walls were reinstalled for Basin No. 5, Figure 16E. An 8-foot high end sill was installed while the 7.5-foot high chute blocks were retained. Flow distribution was satisfactory with the major portion of the jump contained in the basin, Figure 20A. Erosion resulting from 1 hour of operation at 71,400 second feet was moderate, Figure 20B. Scour was downstream from the basin so that the cut-off wall at the downstream end of the basin was not endangered. As it was planned to use riprap in the river channel, the basin was considered satisfactory and was thus recommended for construction.

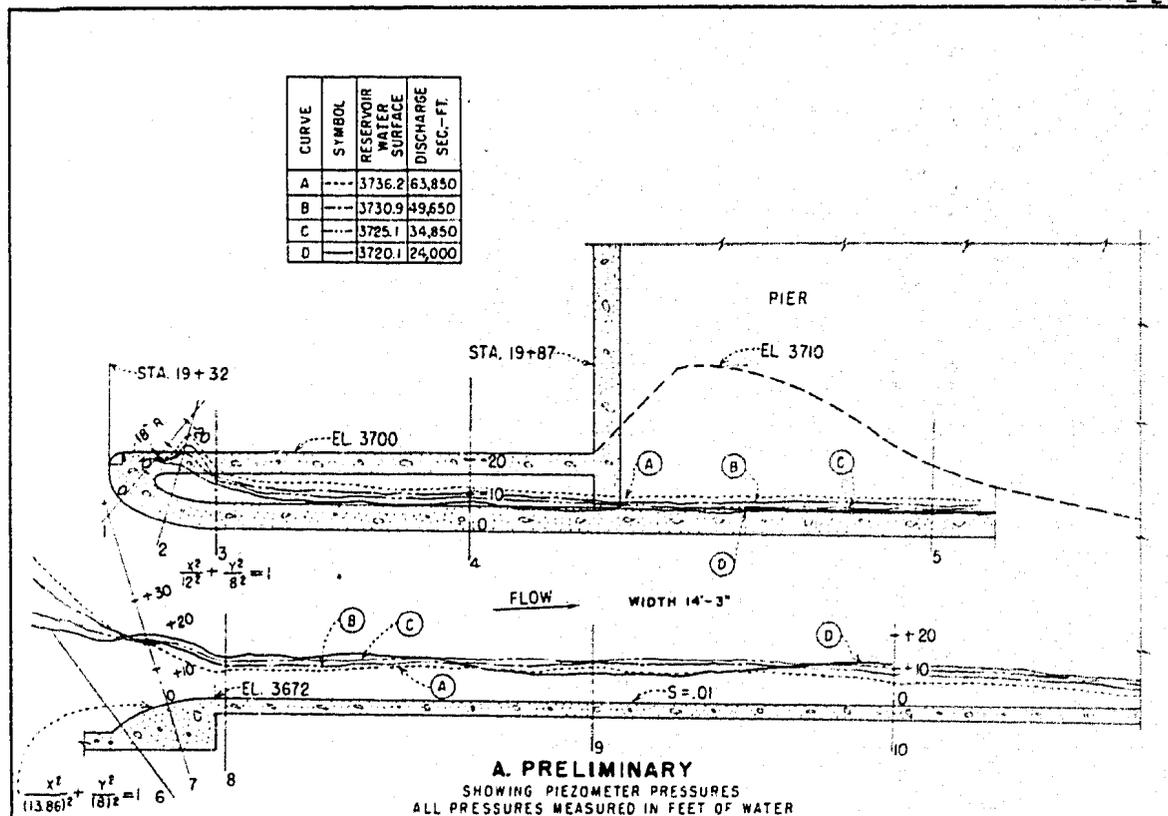
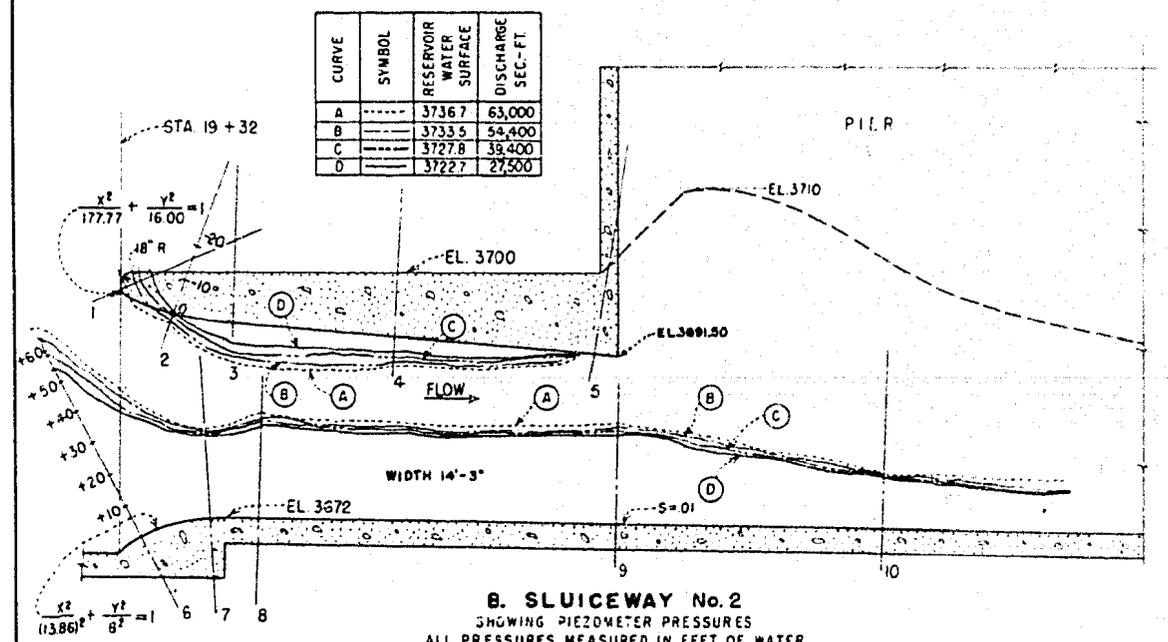
BONNY DAM
SLUICWAYS 1 & 2 & PRESSURES
1:60 SCALE MODEL

The preliminary sluiceway, No. 1, Figures 6 and 21A, had the invert entrance at elevation 3672.00 and the width was 14 feet 3 inches. The design discharge for the sluiceway was 10,000 second feet at reservoir elevation 3710.00. Appearance of the flow from the downstream portal, Figures 12A and B, was satisfactory, but a disturbance was caused by the intersection of this flow with the flow from the overflow section. Sluiceway pressures were measured along the roof near the left-side wall and along the floor for various reservoir elevations. Floor pressures were all above atmospheric, but roof pressures were subatmospheric, Figure 21A. The lowest pressure was 18 feet of water below atmospheric at Piezometer No. 2 with reservoir elevation 3736.2.

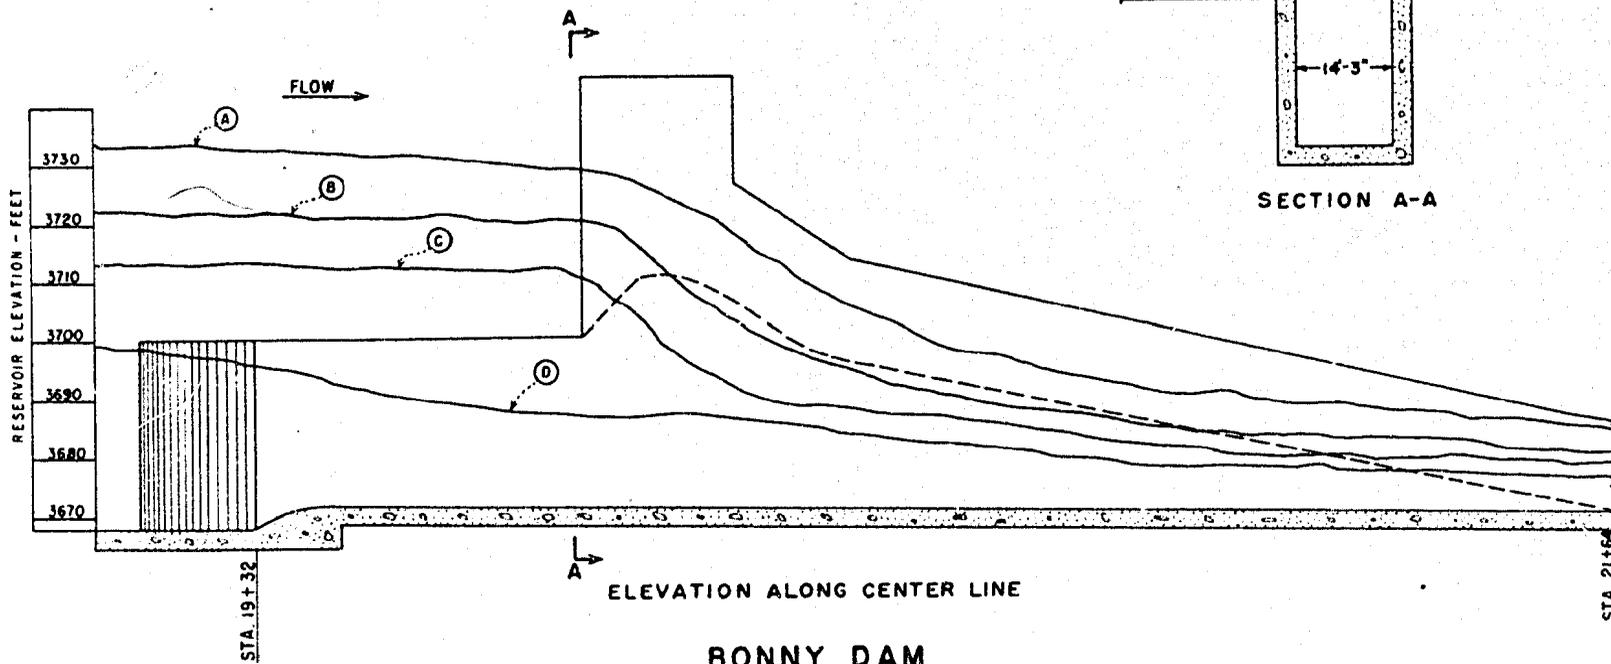
CURVE	DISCHARGE SEC.-FT.
A	64550
B	30230
C	11190
D	5940

BONNY DAM
 SLUICWAY NO. 1 - PRELIMINARY
 WATER SURFACE PROFILES WITH TOP REMOVED
 1:60 SCALE MODEL

To aid in determining the roof shape that would give satisfactory pressures, the roof section was removed and water-surface profiles were taken throughout the length of the sluiceway. The water-surface profile D of Figure 23 indicated a slope should be used on the roof.

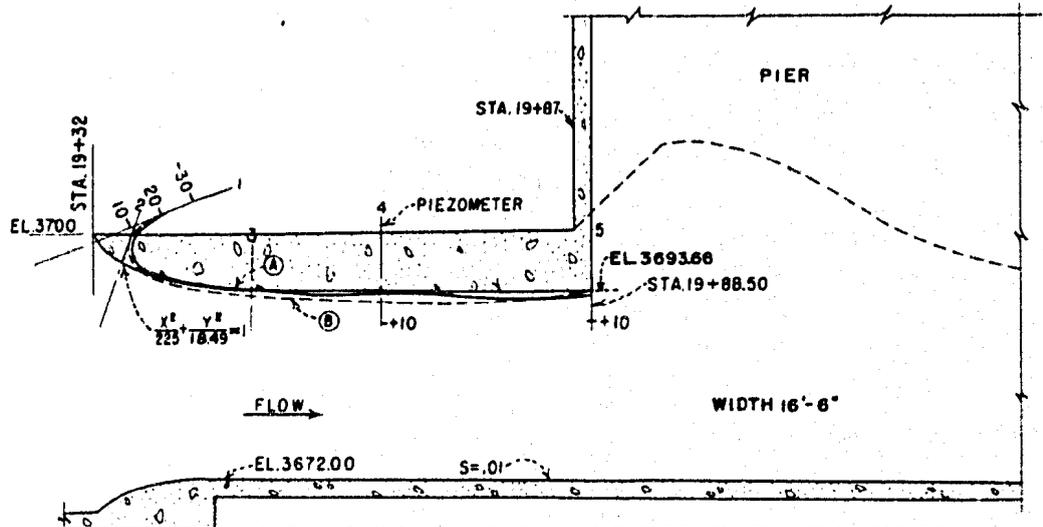
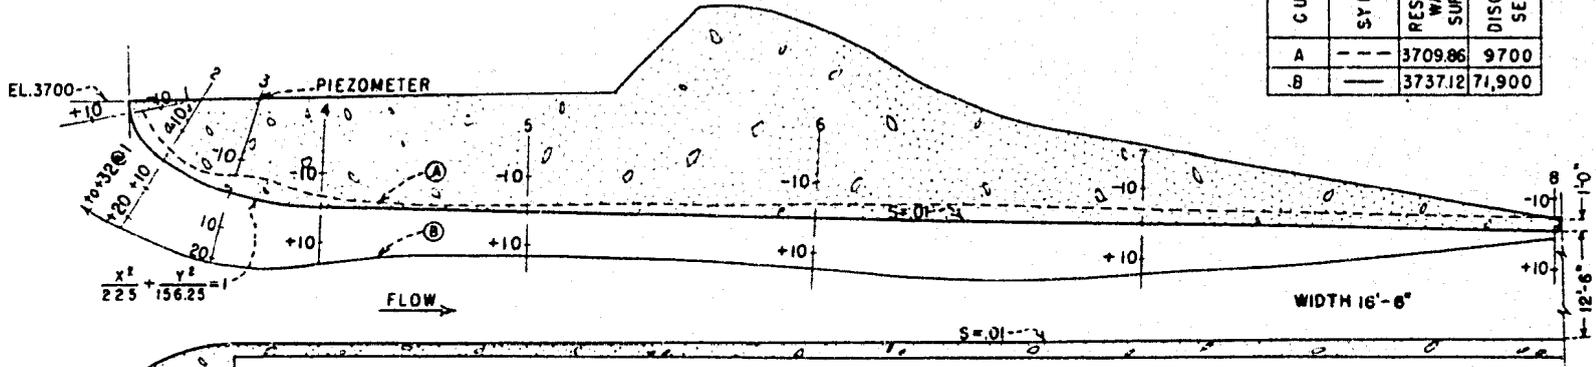
A. SLUICWAY No. 3, SHOWING PIEZOMETER PRESSURES
ALL PRESSURES MEASURED IN FEET OF WATER

CURVE	SYMBOL	RESERVOIR WATER SURFACE	DISCHARGE SEC. FT.
A	---	3711.80	10,300
B	---	3736.85	65,100

B. SLUICWAY No. 4, SHOWING PIEZOMETER PRESSURES
ALL PRESSURES MEASURED IN FEET OF WATER

CURVE	SYMBOL	RESERVOIR WATER SURFACE	DISCHARGE SEC. FT.
A	---	3709.86	9700
B	---	3737.12	71,900

BONNY DAM
SLUICWAYS 3 & 4 AND PRESSURES
1:60 SCALE MODEL

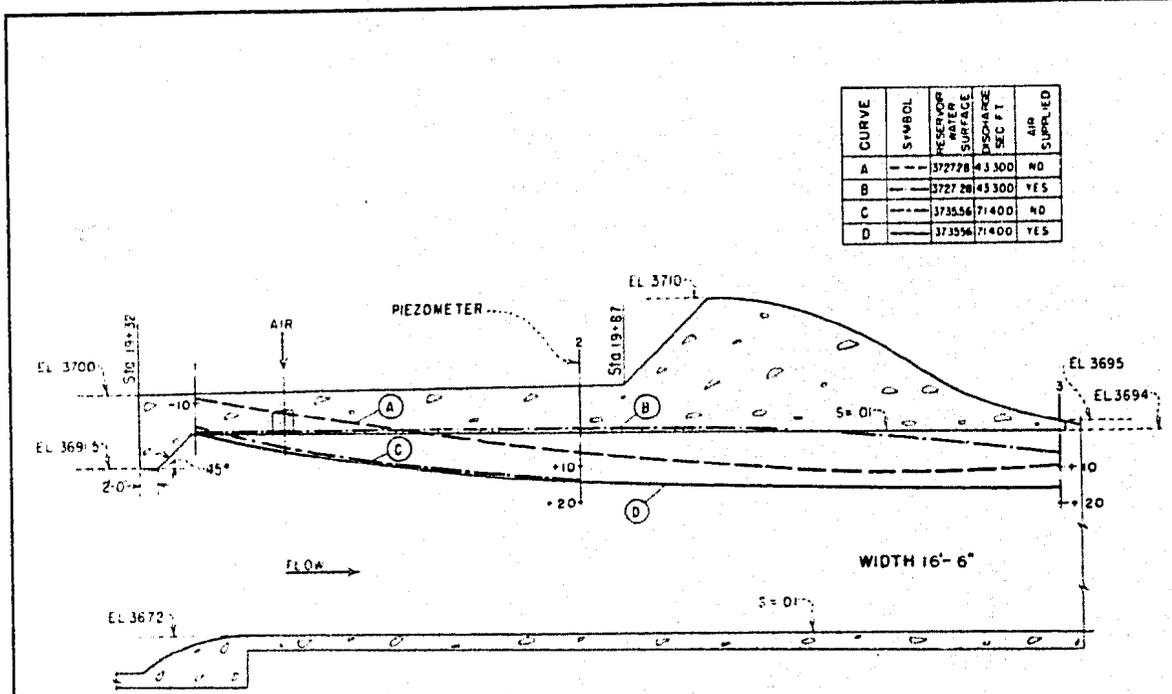
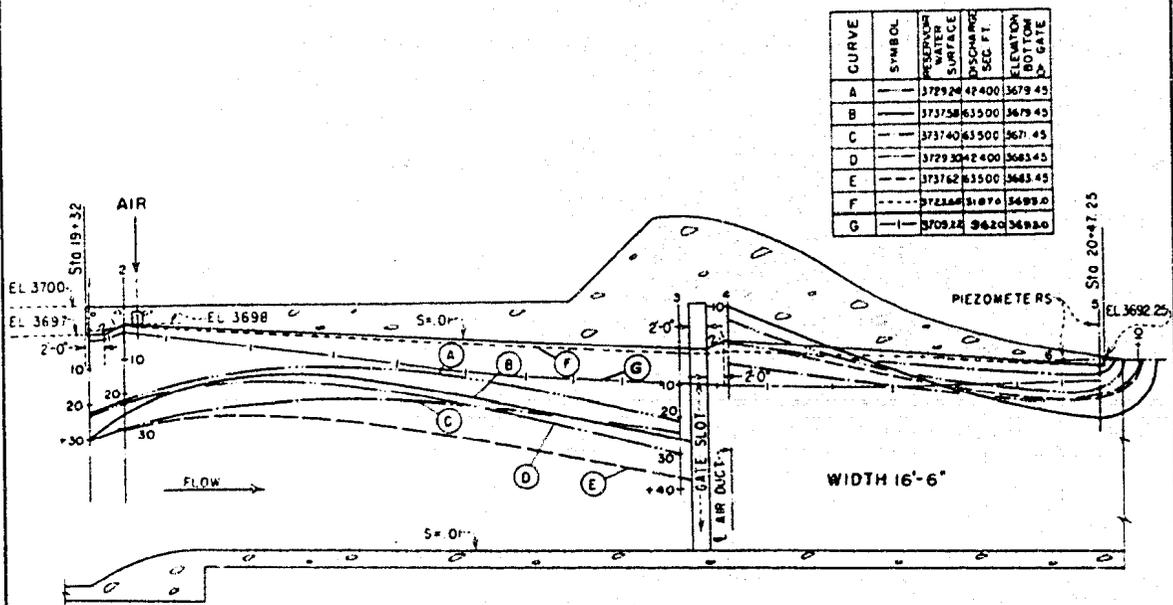
CURVE	SYMBOL	RESERVOIR WATER SURFACE ELEVATION (FEET)	DISCHARGE (SEC FT)	AIR SUPPLIED
A	---	3727.28	43.300	NO
B	---	3727.28	43.300	YES
C	---	3735.56	71.400	NO
D	---	3735.56	71.400	YES

A. SLUICWAY No. 5, SHOWING PIEZOMETRIC PRESSURES
ALL PRESSURES MEASURED IN FEET OF WATER

CURVE	SYMBOL	RESERVOIR WATER SURFACE ELEVATION (FEET)	DISCHARGE (SEC FT)	ELEVATION BOTTOM OF GATE (FEET)
A	---	3729.24	42.400	3679.45
B	---	3737.58	63.500	3679.45
C	---	3737.40	63.500	3679.45
D	---	3729.30	42.400	3683.45
E	---	3737.62	63.500	3683.45
F	---	3723.18	51.870	3689.0
G	---	3709.14	36.20	3689.0

B. SLUICWAY No. 6, SHOWING PIEZOMETRIC PRESSURES
ALL PRESSURES MEASURED IN FEET OF WATER

BONNY DAM
SLUICWAYS 5 & 6 AND PRESSURES
1:60 SCALE MODEL

The discharge-capacity curve for this sluiceway is Curve 5 in Figure 22. At reservoir elevation 3710.00 the discharge was 9,600 second feet, indicating that it would be necessary to increase the area at the entrance, Figure 25A, if the desired discharge of 10,000 second feet was to be obtained.

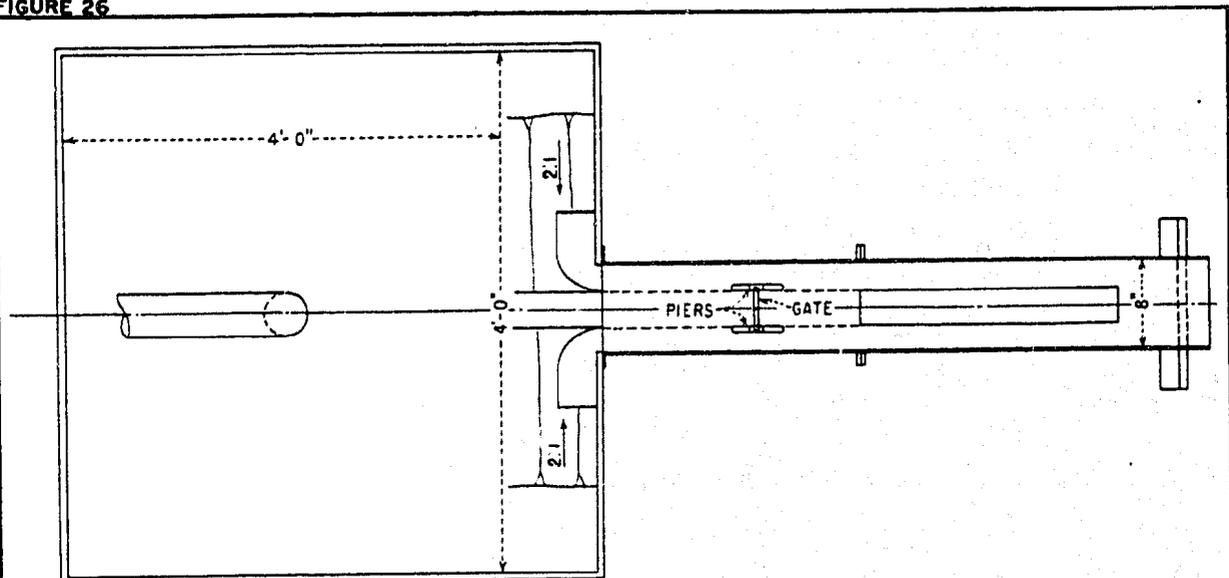
FIGURE 26

PLAN

The 1:60 plastic sluiceway model was attached to one side of a 4- by 4-foot sheet-metal-lined wooden head box, Figure 26. Transparent plastic was used for construction of the sluiceway which also included a portion of the overflow section 40 feet wide with plastic training walls. The two piers were made of wood and the gate was built of brass. Piezometers were installed in the sluiceway walls and roof in the region of the gate and also on the upstream and downstream faces of the gate. Air inlets were provided at the upstream roof entrance and downstream from the gate. A 4-inch pipe supplied water to the head box from the laboratory supply system which contained venturi meters for measuring the flow.

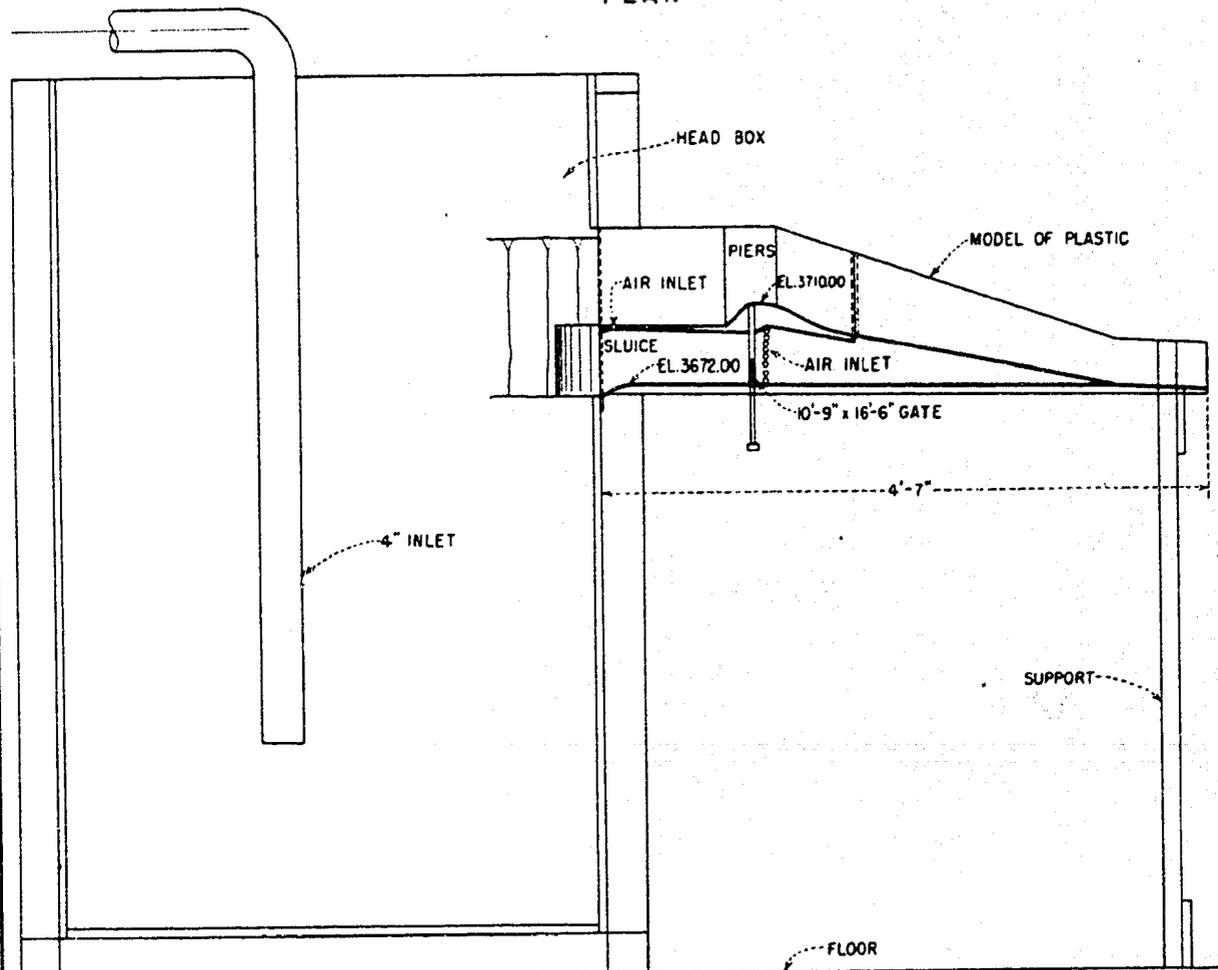
SECTION ON C

BONNY DAM
SPILLWAY SLUICE
1:60 MODEL LAYOUT

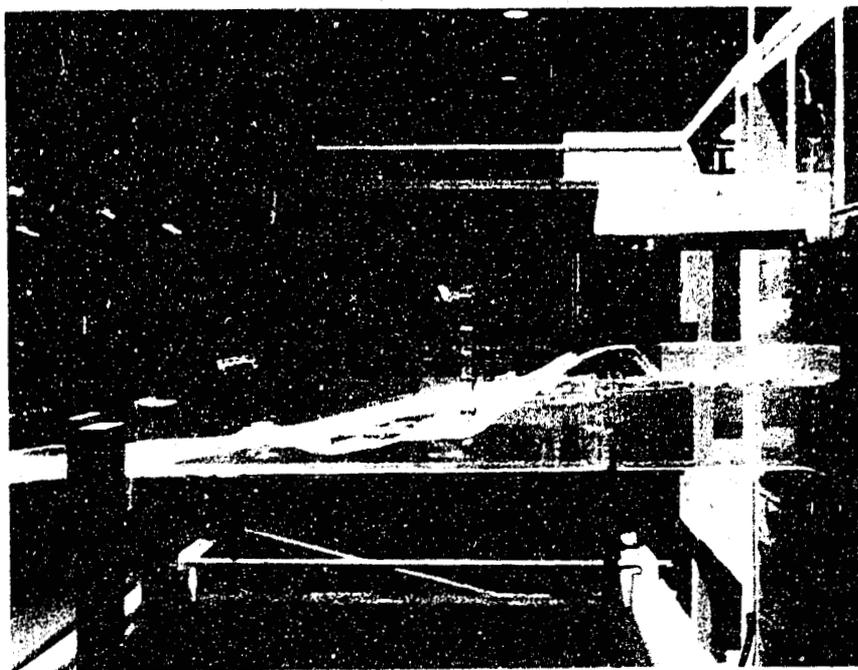
FIGURE 28

A. SLUICWAY NO. 6
DISCHARGE 5,000 SEC.-FT. - GATE DOWN

BONNY DAM
COMPARISON OF SLUICWAYS NOS. 6 AND 7
1:60 PLASTIC MODEL STUDY

free of the roof at a different point on one side than the other, producing a warped water surface with a resulting uneven wave pattern, Figure 28A.

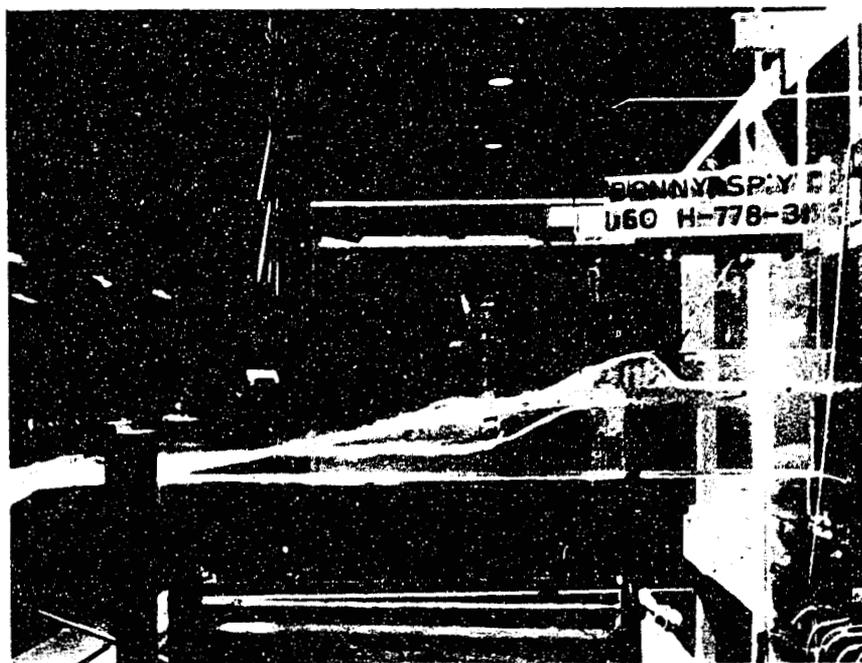
B. SLUICWAY NO. 7 - RECOMMENDED
DISCHARGE 5,000 SEC.-FT. - GATE DOWN

Sluiceway No. 7--recommended. The elevation of the roof of Sluiceway No. 7 immediately downstream from the gate was raised 1 foot to elevation 3695.00, Figure 29, but other dimensions of the sluiceway remained unchanged. Operation of the sluiceway with the gate in the down position and reservoir elevation 3710.00 is shown in Figure 28B. Closed conduit flow ceased after passing over the gate and smooth flow resulted downstream. The improvement is apparent by comparing the two photographs of Figure 28. Pressures were measured on the nine piezometers for various reservoir elevations with the gate lowered to the bottom and raised so that the top of the gate was at the top of the sluiceway. These pressures are shown in the table of Figure 29. All pressures were at or above atmospheric for all operating conditions. Curves were calculated for the total pressure in feet of water on the gate from the pressures observed on the upstream and downstream gate face. These curves are shown in Figure 29 for two gate positions. The highest pressures occurred when the gate was in the down position, but these were lower than would occur from a static head if there were no flow.

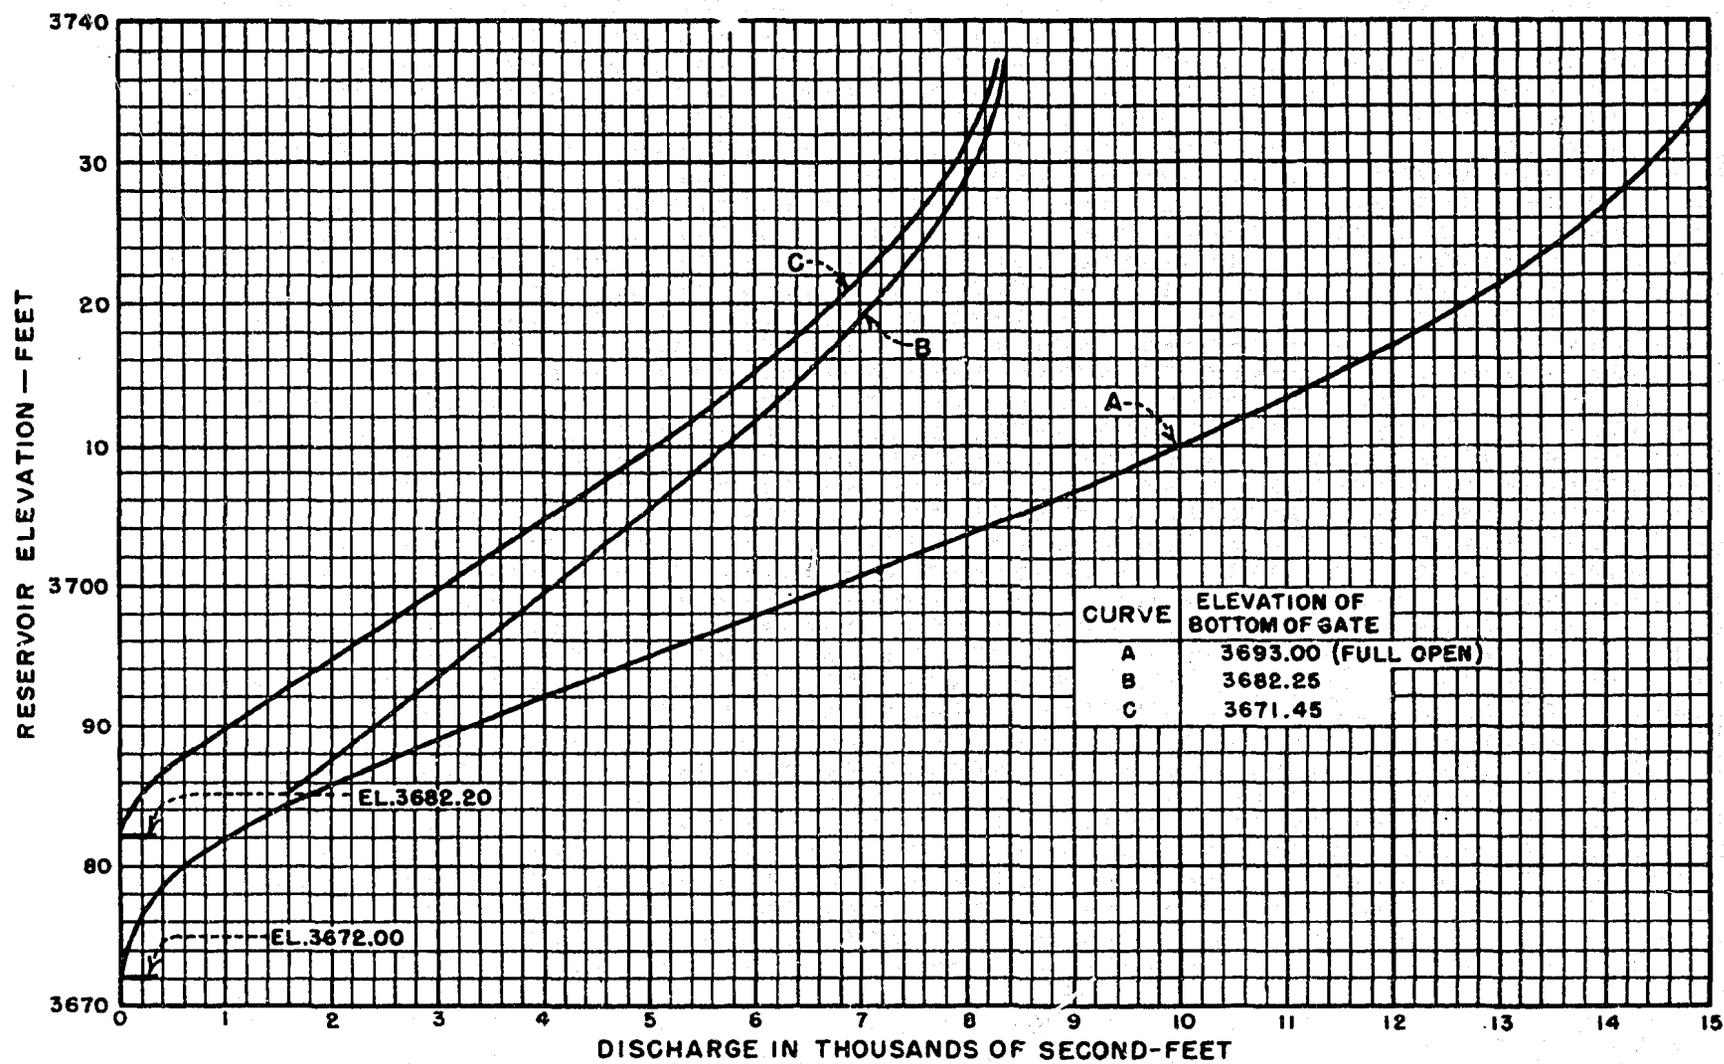
FIGURE 30

BONNY DAM
 SLUICeway DISCHARGE CAPACITY CURVES
 NO. 7-RECOMMENDED-1:60 MODEL

Discharge-capacity curves were obtained for three gate settings and these are shown in Figure 30. For reservoir elevation 3710.00, the discharge with gate fully open was 10,000 second feet and with the gate all the way down 5,000 second feet. These were the required discharges for the sluiceway. Results of the tests indicated this design was satisfactory and it was recommended for construction.

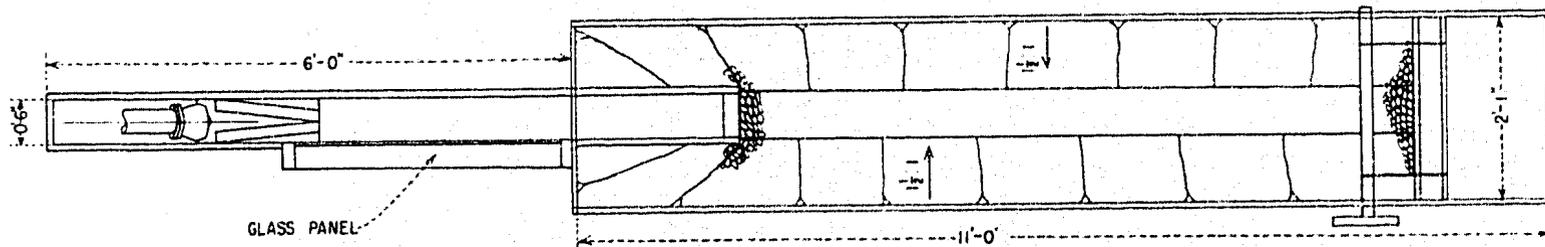
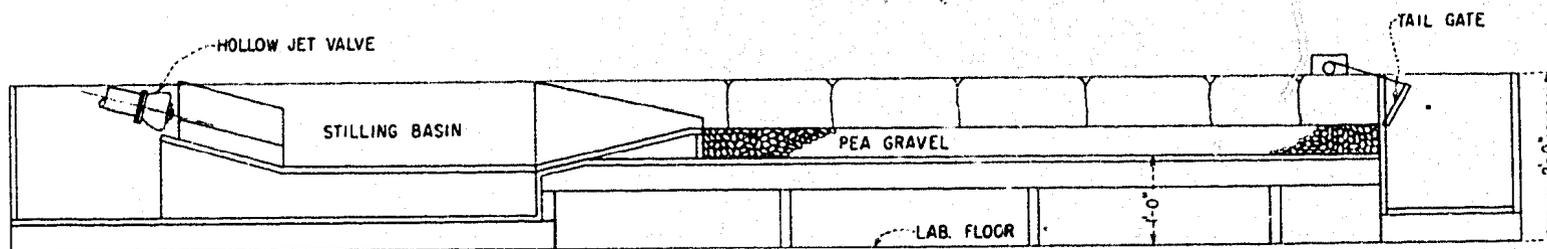
FIGURE 31

PLAN

SECTION ALONG CENTER LINE

BONNY DAM
HALE DITCH STILLING BASIN
1/6 SCALE MODEL LAYOUT

The model studies of Bonny Dam consisted of three main parts conducted on three hydraulic models: (1) the open-chute spillway, (2) a sluiceway in the overflow section of the spillway, and (3) an irrigation outlet, known as the Hale Ditch outlet, which discharges into a canal, the latter having no connection with the spillway. A 1:60 spillway model, Figure 5, was used to study the performance of the overflow section, the chute, the stilling basin, and the center sluiceway of the spillway. A second model of transparent plastic, on a 1:60 scale, Figure 26, was required for further study of the sluiceway. A third model on a scale of 1:6 was utilized, Figure 31, to study the stilling basin for the Hale Ditch irrigation outlet.

A model of the irrigation outlet for Hale Ditch, Figure 4, was built to a scale of 1:6 so that a 3-inch hollow-jet valve could be used to represent the 24-inch hollow-jet valve of the prototype. The stilling basin was placed in a wooden box lined with sheet metal with a glass panel in the right wall, Figure 31. The channel downstream from the basin was molded in pea gravel and was contained in a metal-lined wooden box. A tailgate at the end of this box was used to regulate the depth of water in the channel which was measured with a staff gage. A piezometer in the 3-inch pipe upstream from the valve was used to measure the pressure head. Water was supplied by a portable 6-inch pump and an orifice meter in the supply line was used to measure the flow.
