UNITED STATES
DEPARTMENT OF THE INTERIOR
BUREAU OF RECLAMATION

HYDRAULIC MODEL STUDIES OF THE
OVERFLOW SPILLWAY AND THE HALE
DITCH IRRIGATION OUTLET--BONNY DAM
MISSOURI RIVER BASIN PROJECT

Hydraulic Laboratory Report No. Hyd-331

January 31, 1952

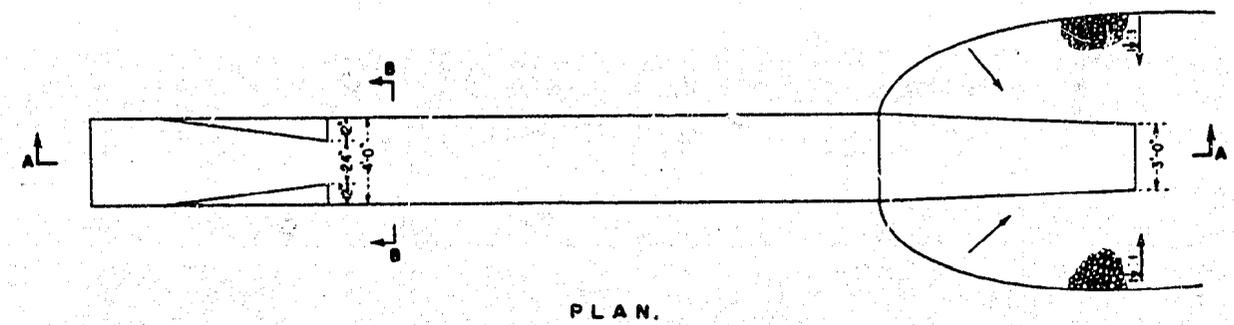
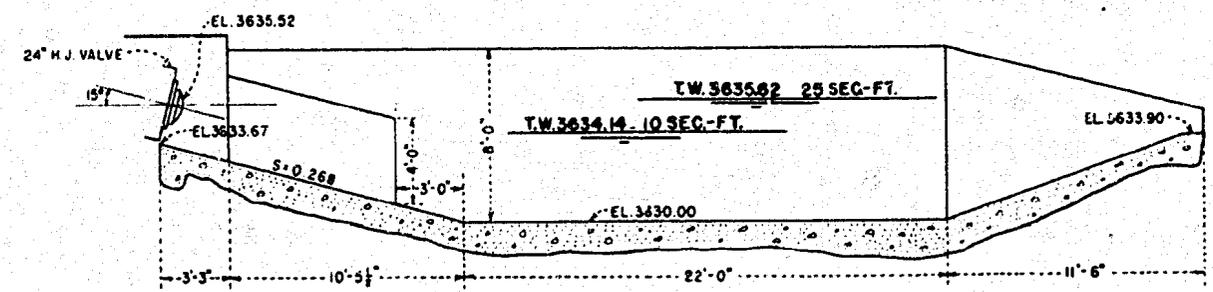
PLAN.

SECTION B-B

SECTION A-A

BONNY DAM
HALE DITCH STILLING BASIN
BASIN NO. 1 - PRELIMINARY

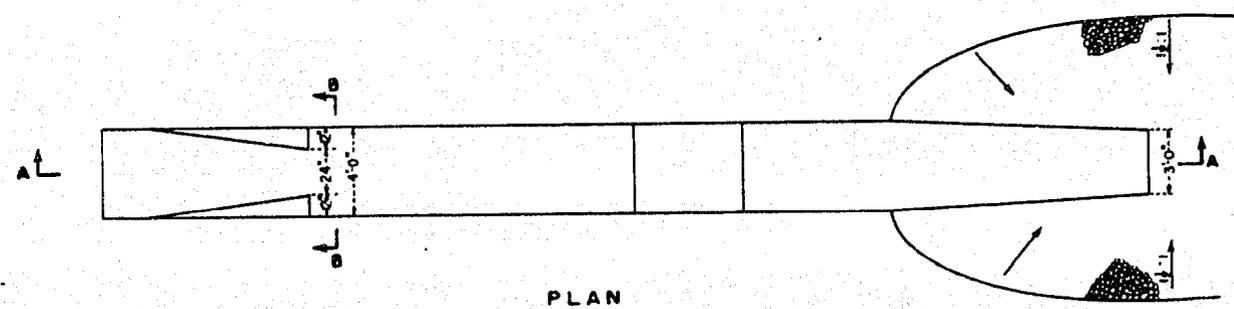
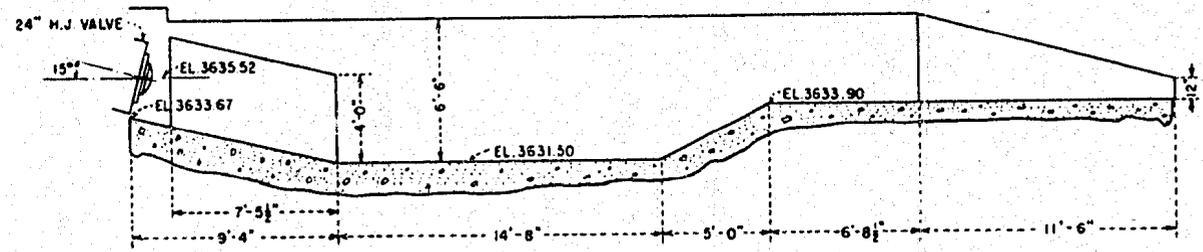
PLAN

SECTION B-B

SECTION A-A

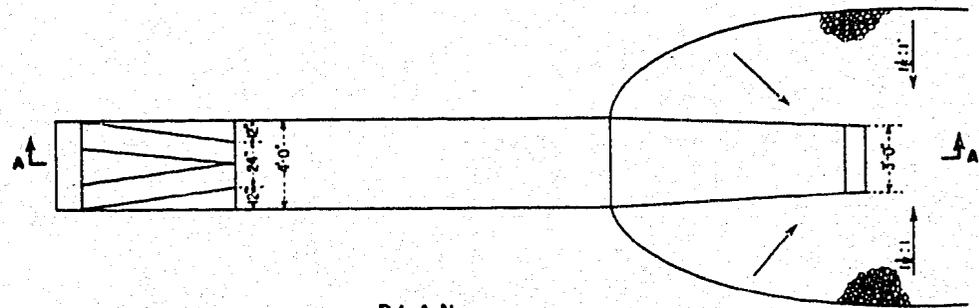
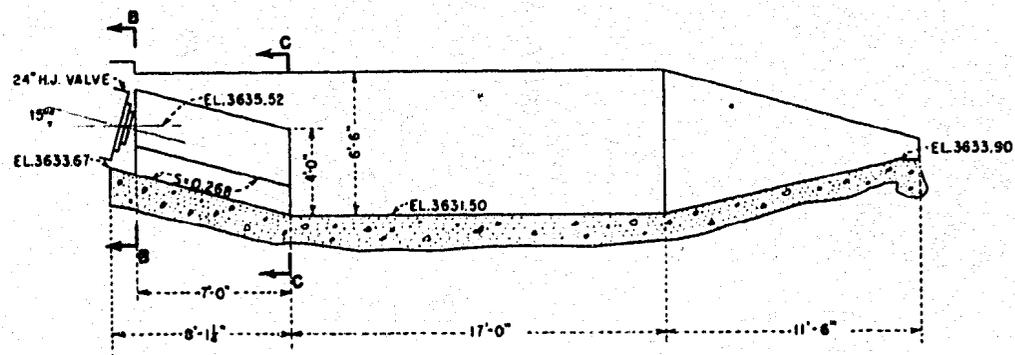
SECTION B-B

PLAN

SECTION C-C

SECTION A-A

BONNY DAM
 HALE DITCH STILLING BASIN
 BASIN NO. 3 - RECOMMENDED
