BLACK CANYON
REPORT

Subject: Model demonstration of bucket proposed for rehabilitation of Black Canyon Dam Spillway--Boise Project, Idaho

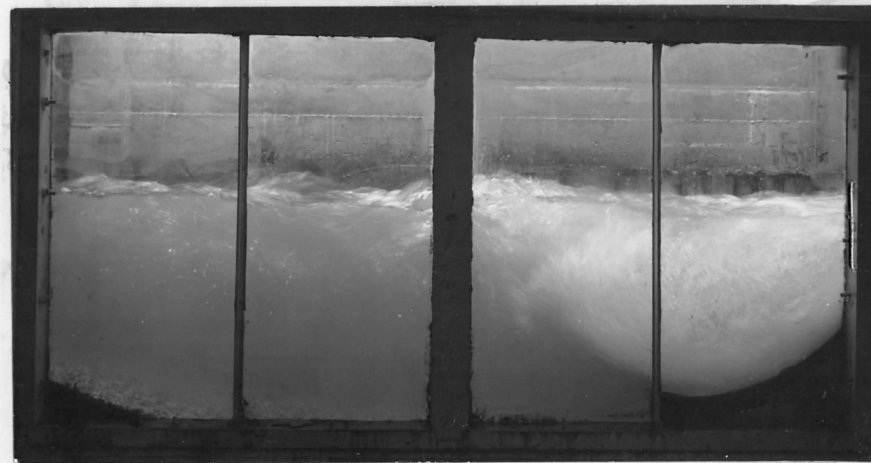
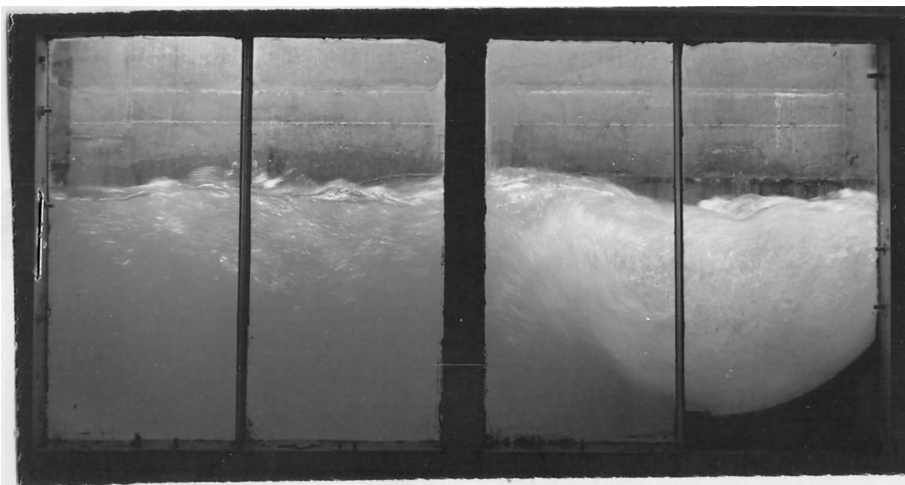
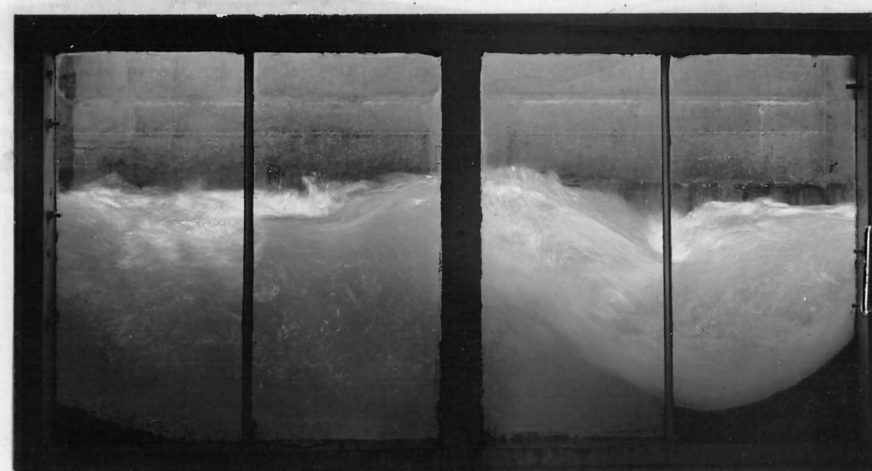
9,000 cfs

15,000 cfs

18,000 cfs

24,600 cfs

Spillway Bucket Operation
Black Canyon Dam

2. Operation of the model spillway was observed by Messrs. Nalder, Hammond, Puls, Schultz, Winter, and Krueger. All expressed the opinion that the operation was satisfactory over the entire range of discharges and tail-water depths. Photographs of the bucket operating at discharges of 9,000, 15,000, 18,000, 24,600, 27,000, 29,300, 33,100, and 36,000 second feet are included as Figures 2 and 3. The estimated tail-water curve used in connection with these tests is included in Figure 4.

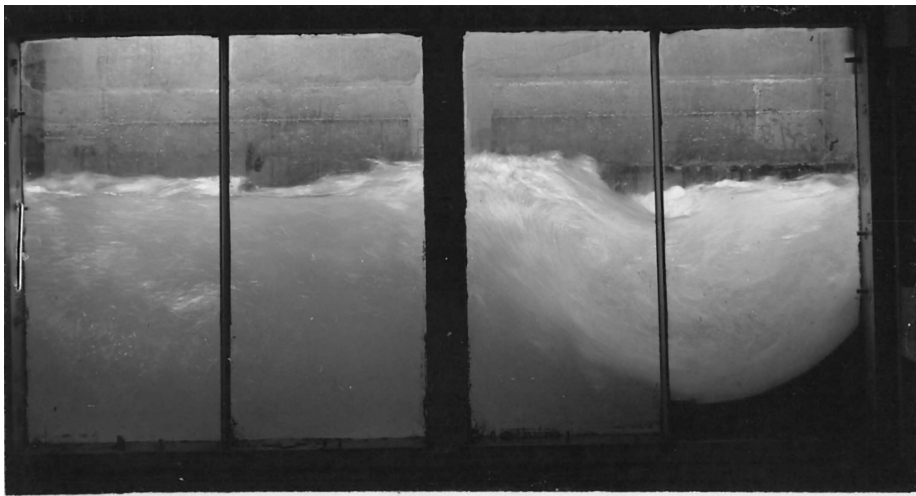
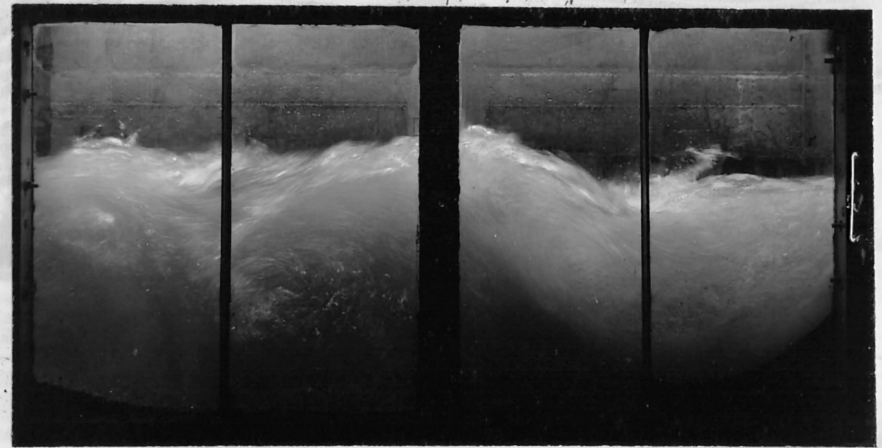
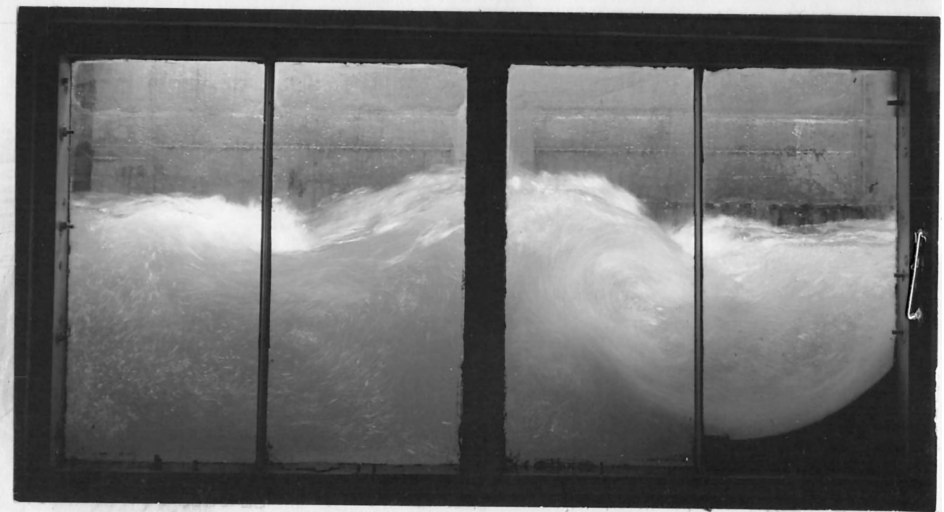
27,000 cfs

29,300 cfs

33,100 cfs

36,000 cfs

Spillway Bucket Operation
Black Canyon Dam
