ABRASION AND PERCUSSION TESTS  
ON A VITREOUS-COATED GATE LEAF  
WITH CATHODIC PROTECTION

Hydraulic Laboratory Report No. HYD-349

Subject: Abrasion and percussion tests on a vitreous-coated gate leaf with cathodic protection

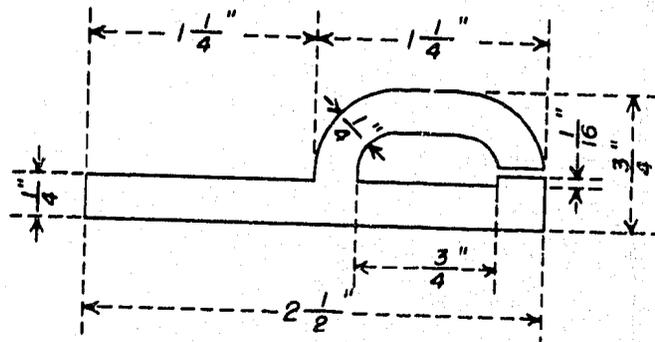
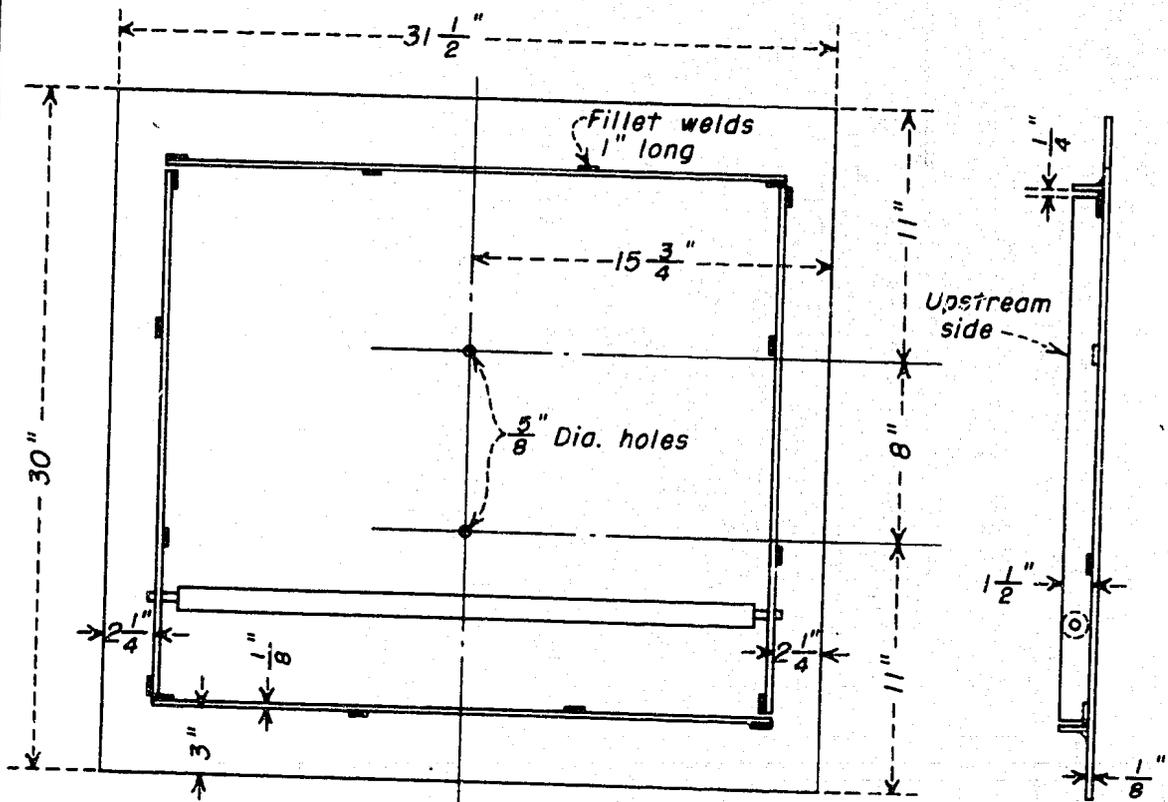
RUBBER GUIDE AND SEAL

GLASS COATED GATE LEAF

Note: All dimensions and notes taken from drawing by A.O. Smith Co.

DETAILS OF  
VITREOUS COATED TURNOUT GATE LEAF

The gate leaf supplied for test purposes was 30 by 31-1/2 by 1/8 inches in size as shown in Figure 1. The entire gate with the exception of the 1/8-inch edges of the leaf itself and the edges of the two 5/8-inch diameter holes located on the centerline of the leaf was covered with a vitreous protective coating. The vitreous protective coating was measured with a micrometer and found to be approximately 0.015 inches thick.

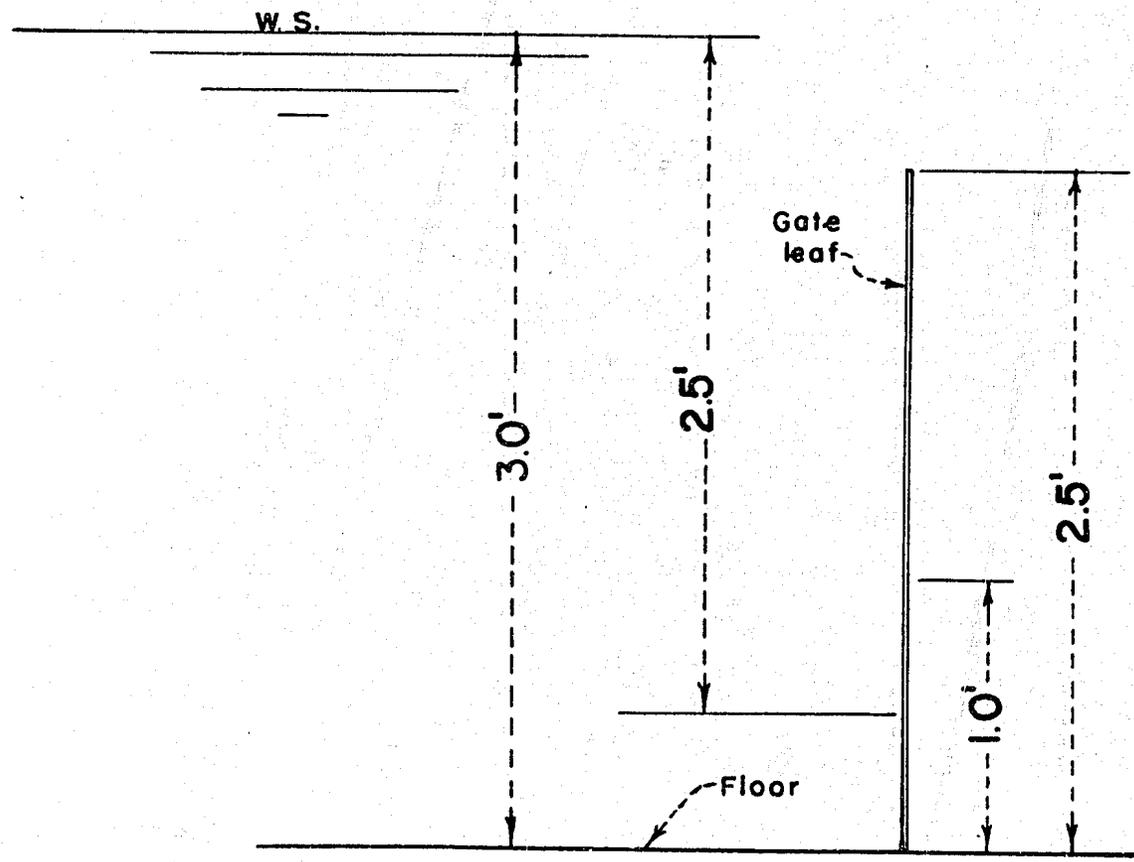
Force on lower 1.0' section of gate leaf  
 $F = WA\Delta H$   
 $F = 2.5 \times 2.5 \times 1 \times 62.45$   
 $F = 390^{\#}$

LOAD PLAN  
VITREOUS COATED  
TURNOUT GATE LEAF
