COMBINATION ROAD CROSSING,
CHECK DROP, AND OUTLET STRUCTURE
MADERA DISTRIBUTION SYSTEM
CENTRAL VALLEY PROJECT, CALIFORNIA

Hydraulic Laboratory Report No. Hyd. 361

November 12, 1952

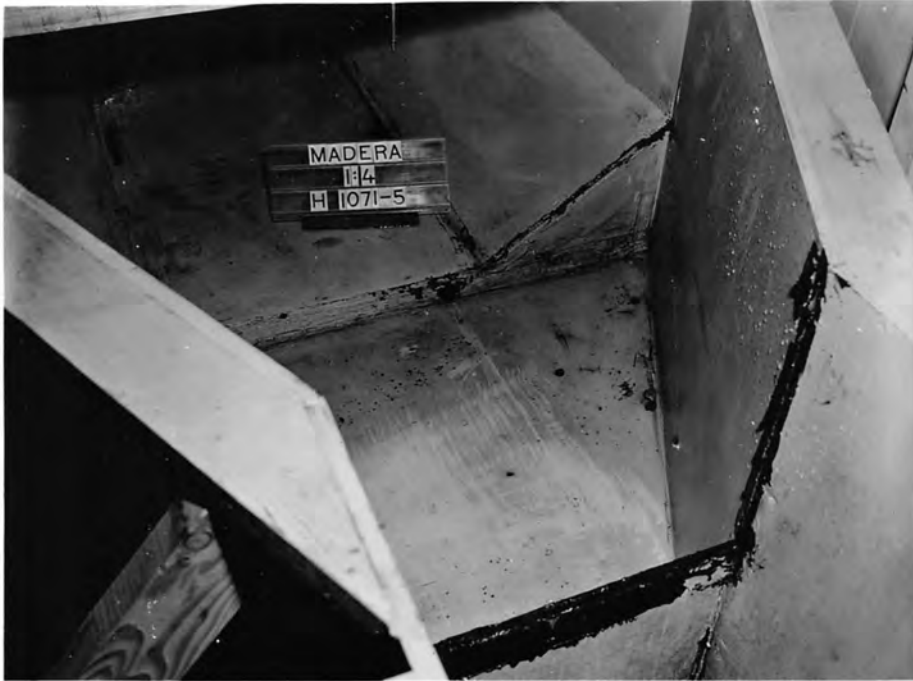
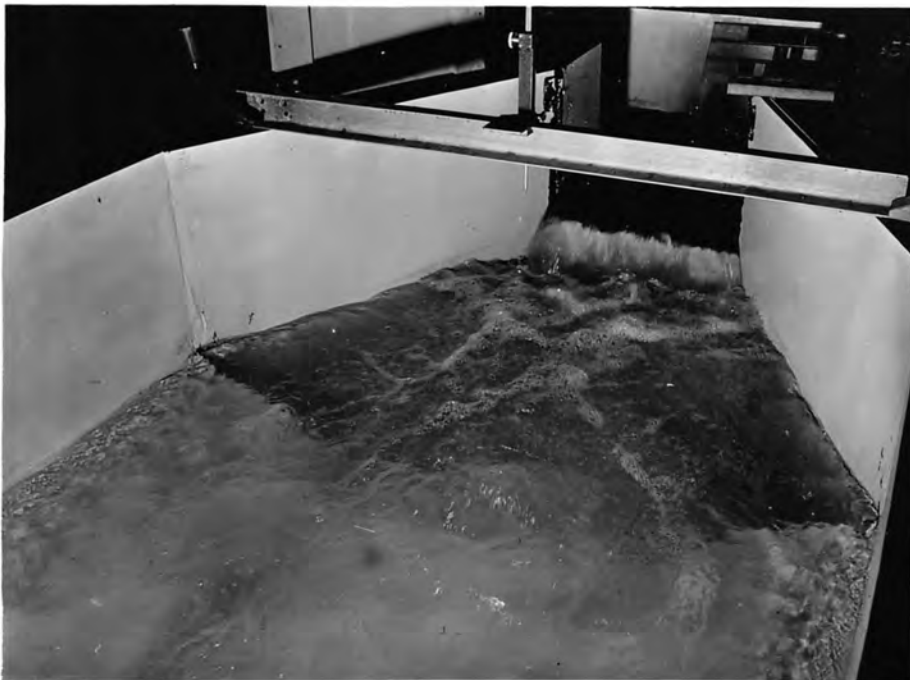
Figure 3
Report Hyd. 361

(A) No Discharge

(B) Normal Maximum Tailwater--Discharging 60 cfs

RECOMMENDED STILLING BASIN

Stilling basin. Three variations of stilling pools were investigated. The first was the recommended design (Figures 2 and 3). The total discharge representing 60 cfs was passed over the vertical check wall without the turnouts operating, to study the effect of the maximum discharge in the stilling pool. Operation at normal tail water or less was satisfactory, although a boil formed in the water surface at the intersection of the stilling basin and the canal. Sand was placed in the model where the boil formed. The sand was displaced on the canal slope at the top corners only, and was not disturbed on the bottom of the canal.

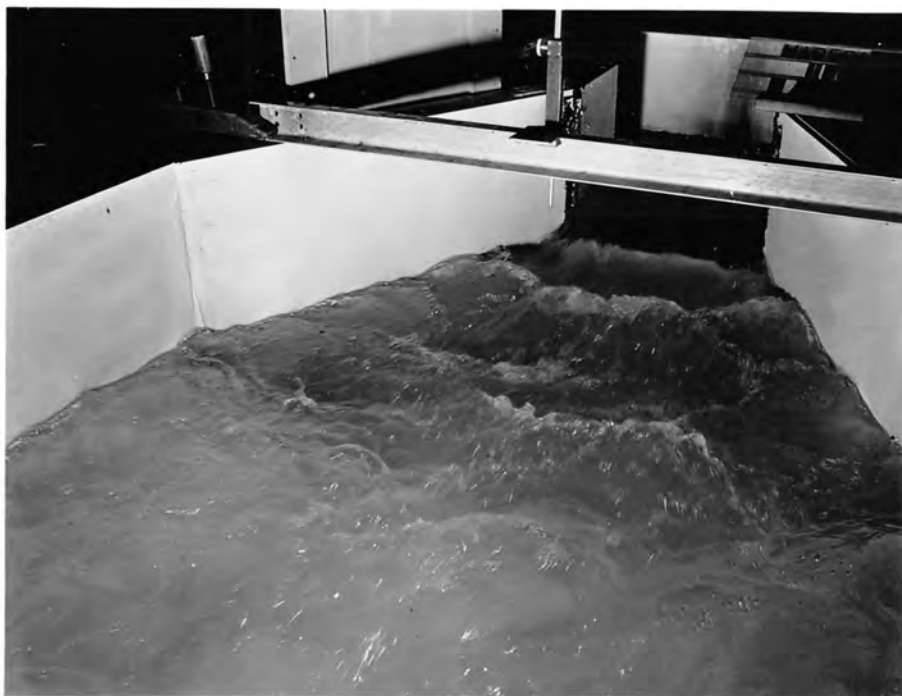
Figure 4
Report Hyd. 361

(A) Recommended Stilling Basin--Discharging 60 cfs

**(B) Recommended Stilling Basin--With Baffle--
Discharging 60 cfs**

RECOMMENDED STILLING BASIN WITH HIGH TAILWATER

6. The energy is not dissipated in the stilling basin when the tail water is above the crest of the check wall. High surface velocities with considerable turbulence are present (Figure 4A). The beam baffle shown in Figures 2 and 4B will give satisfactory conditions when the tail water is at or above the top of the check wall.

A high-velocity surface stream was created when the tail water was raised above the top elevation of the vertical check wall. This condition was readily alleviated by using a vertical beam baffle downstream from the check (Figure 4).

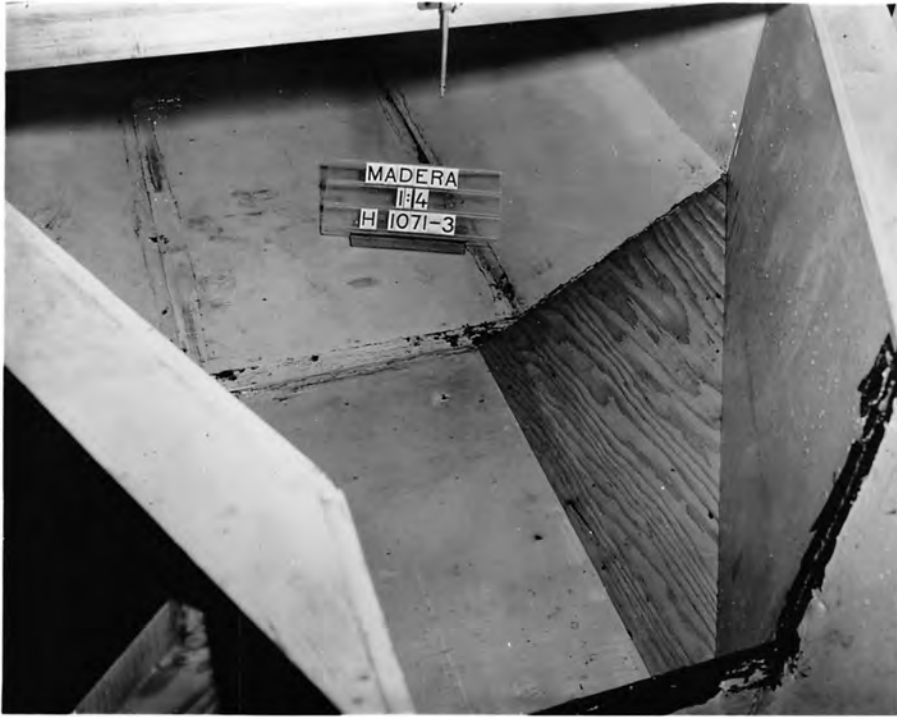
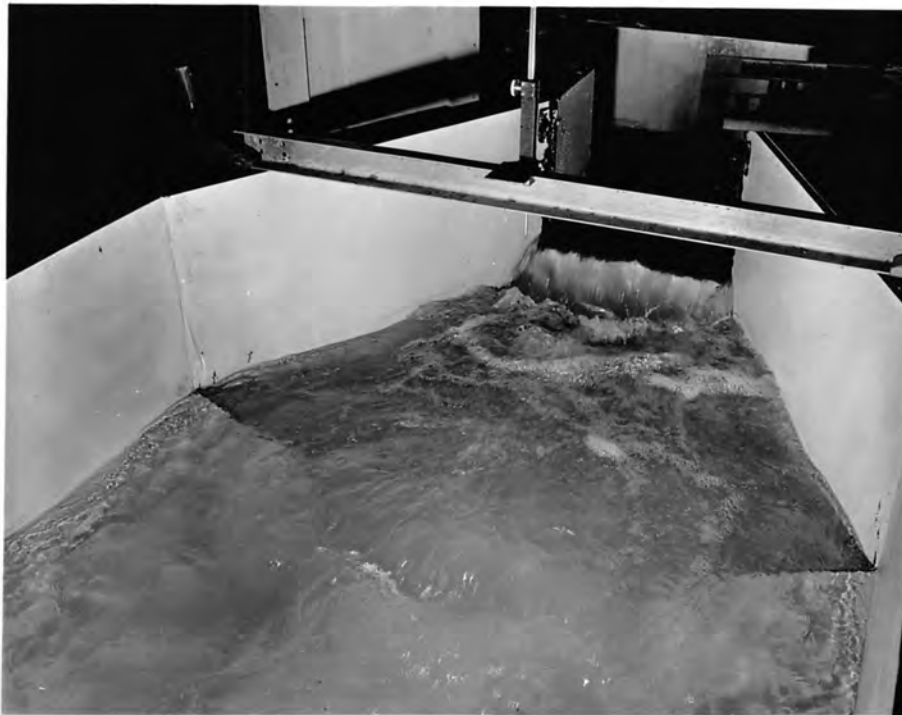
Figure 5
Report Hyd. 361

(A) No Discharge

(B) Discharging 60 cfs

STILLING BASIN WITH "BROKEN BACK" TRANSITION

The stilling basin was modified to the preliminary design by sloping the side walls to intersect the canal side slope, forming a "broken back" transition. This eliminated the corner disturbance of the recommended design but concentrated the water in the center of the canal. Studies with sand showed that the bottom of the canal was being considerably disturbed for some distance downstream. Figure 5 shows the set-up and the pool in action.

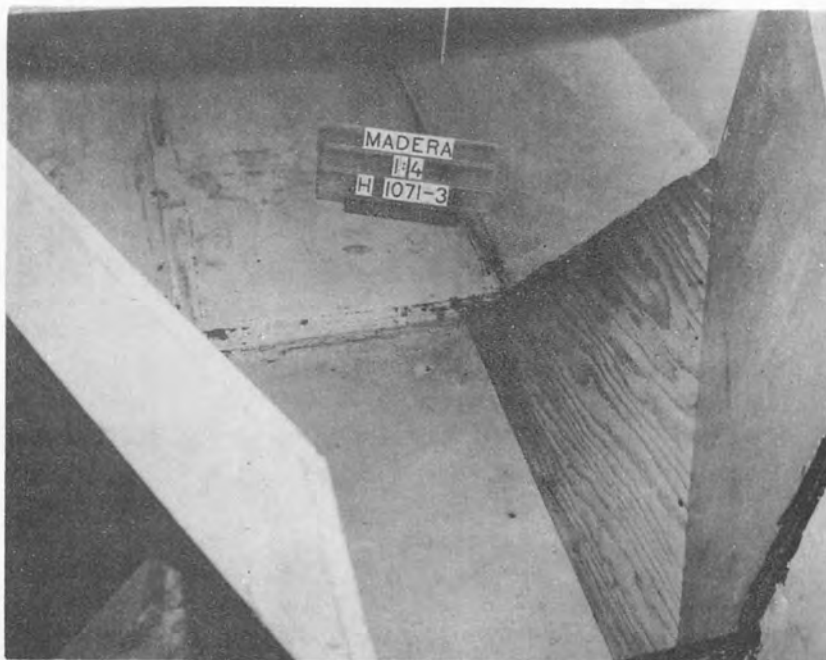
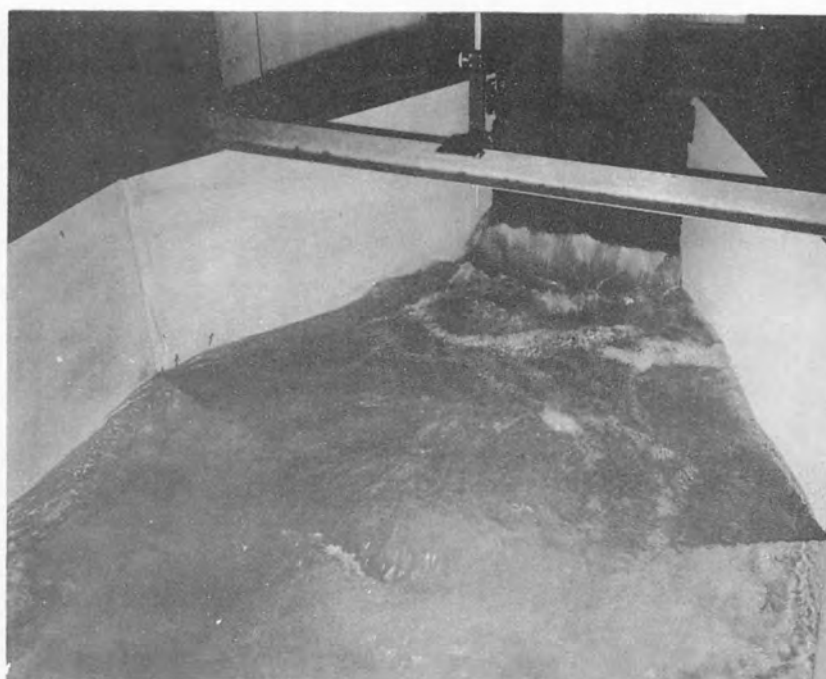
Figure 6
Report Hyd. 361

(A) No Discharge

(B) Discharging 60 cfs

STILLING BASIN WITH "BROKEN BACK" TRANSITION

The model was again modified by sloping the bottom of the basin upward to the floor of the canal. This modification gave the best surface condition (Figure 6) but gave the worst scouring effect on the canal sides and bottom. Large whirls were also formed in the downstream corners of the pool.

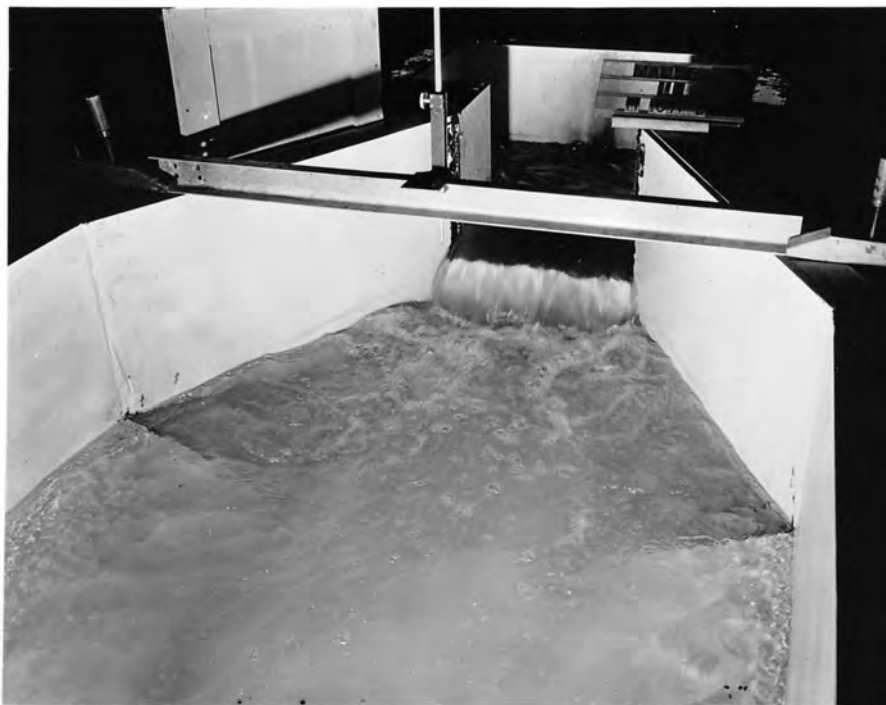
(A) "Broken-Back" Stilling Basin with Sloping Floor

**"Broken-Back" Stilling Basin with Sloping Floor and
Discharging 60 cfs**
**STILLING BASIN WITH "BROKEN BACK" TRANSITION AND
SLOPING FLOOR**

"Broken-Back" Stilling Basin with Sloping Floor and
Discharging 60 cfs
STILLING BASIN WITH "BROKEN BACK" TRANSITION AND
SLOPING FLOOR

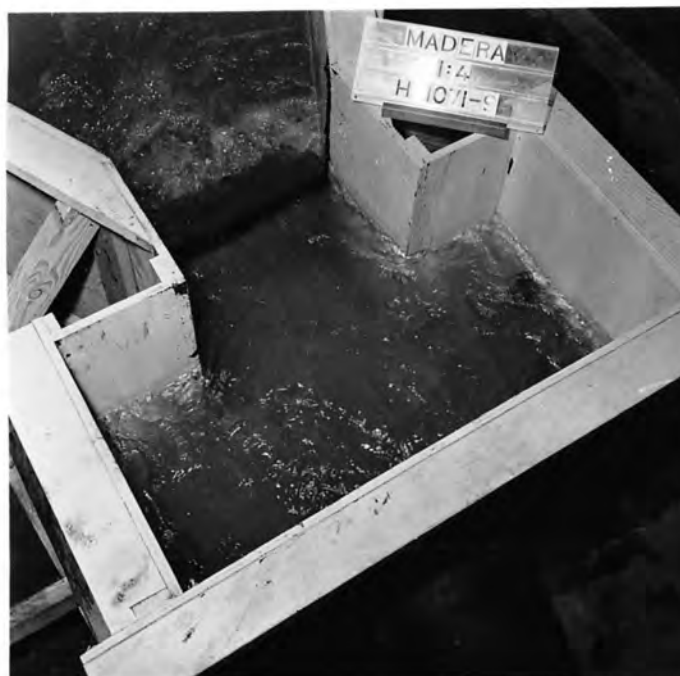
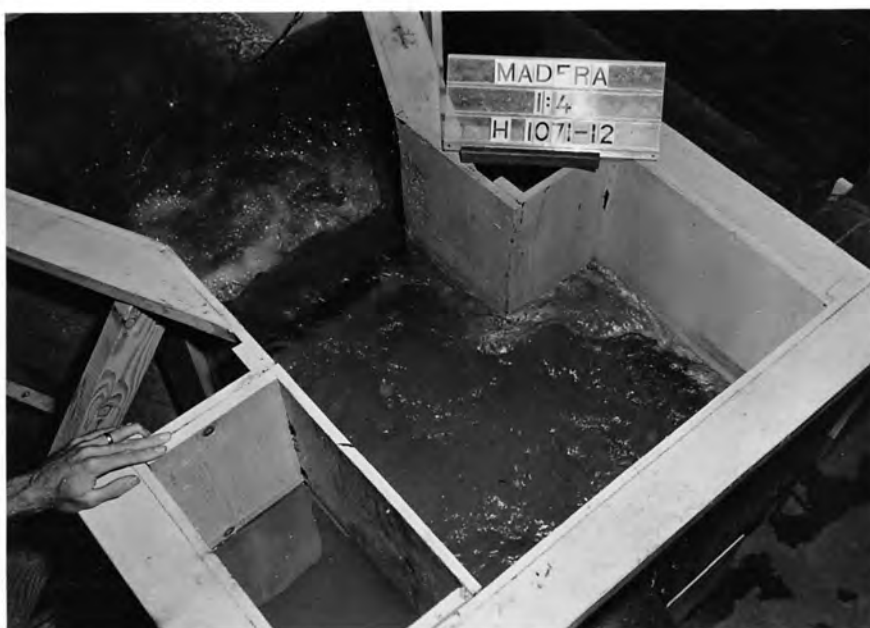
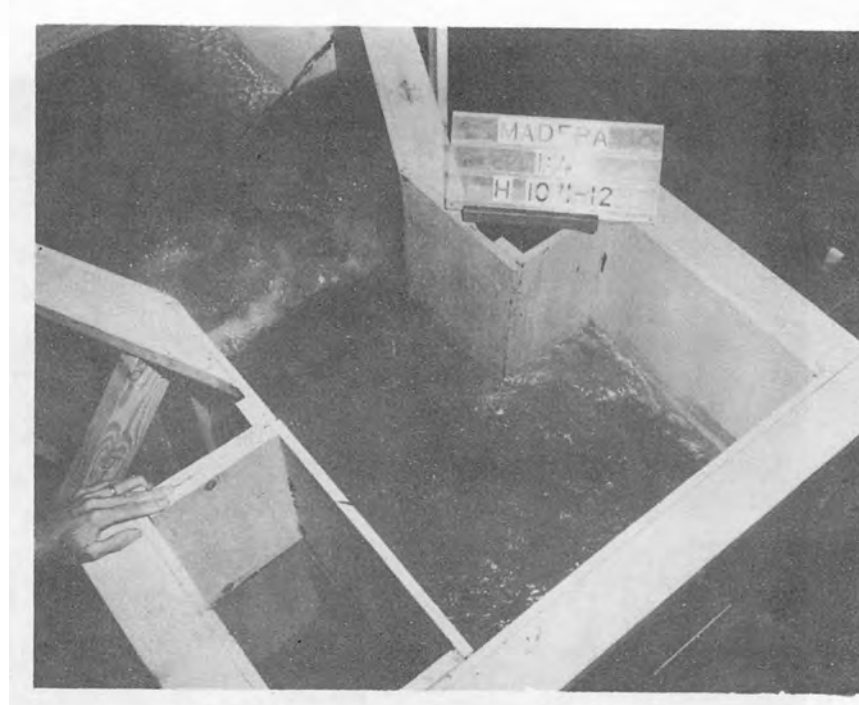
Figure 7
Report Hyd. 361

(A) Tee-Shaped Forebay--60 cfs Total Discharge with
Right Turnout Operating

(B) Ell-shaped Forebay--60 cfs Total Discharge with
Turnout at Right Operating

RECOMMENDED FOREBAY DESIGNS

The majority of the turnouts in these structures will be single instead of double so the left turnout was closed. Figure 7A shows the single turnout in operation in the "tee" forebay and Figure 8B shows the over-all model. Conditions were good except for a vortex that formed in the upstream corner near the turnout entrance. The vortex became more pronounced as the head on the turnout was reduced and eventually separated into several vortices.

The "ell-shaped" forebay was evolved to save space and material where only one turnout was included. The operation of this forebay is shown in Figure 7B. Operation was satisfactory but a vortex formed as in the "tee" shape.

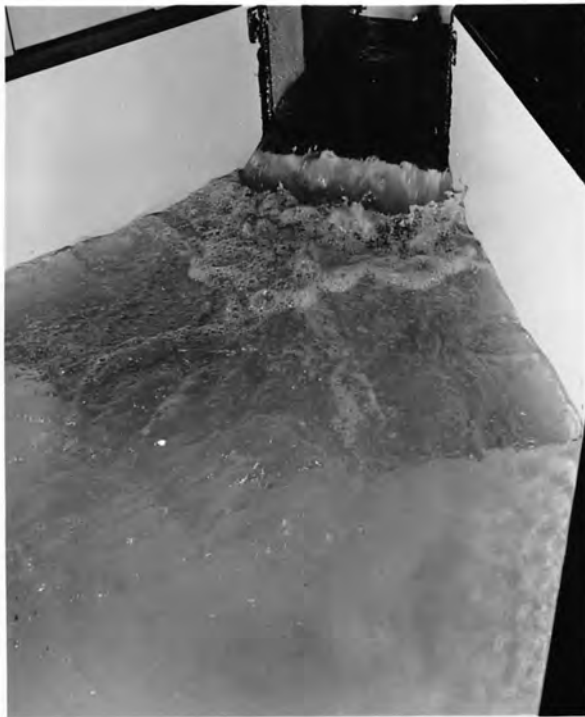
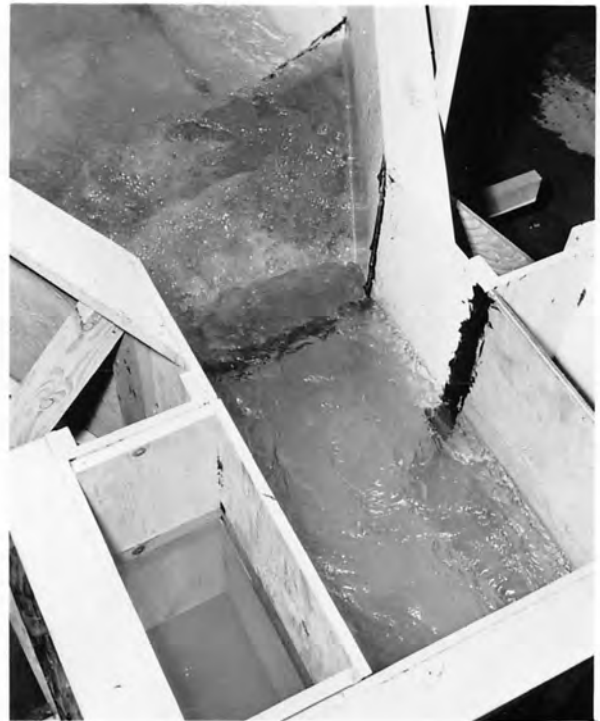
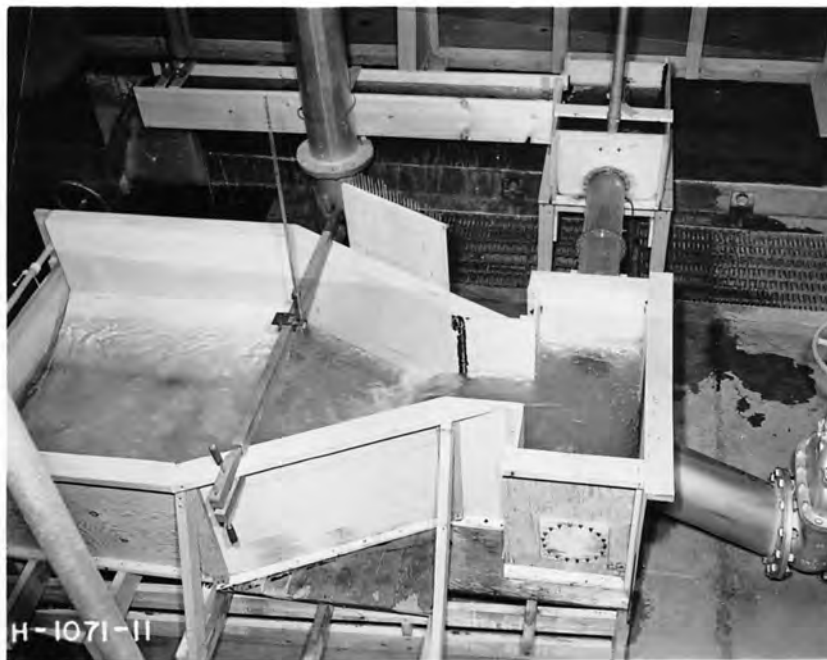
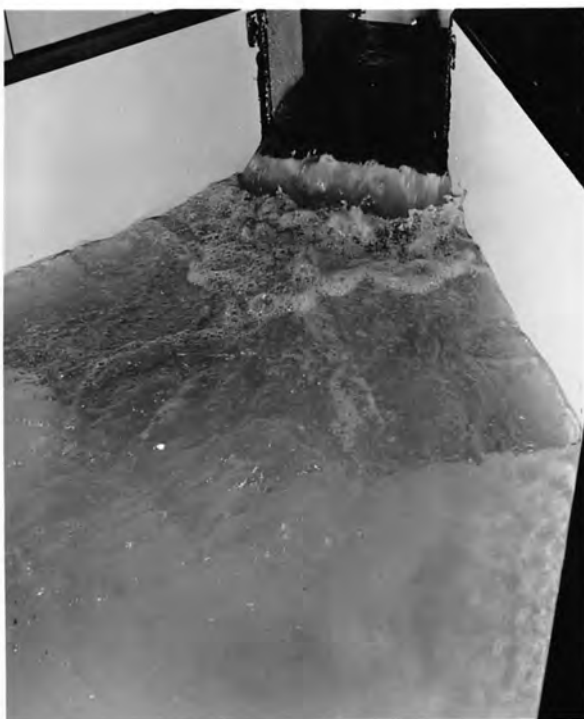
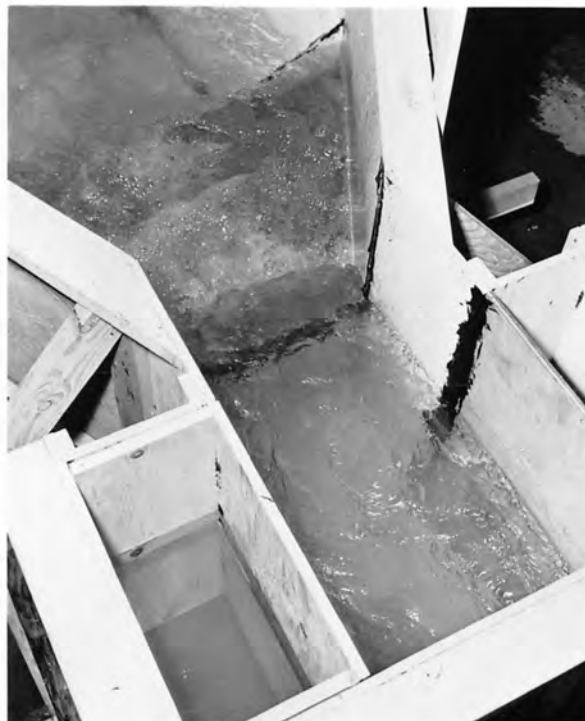
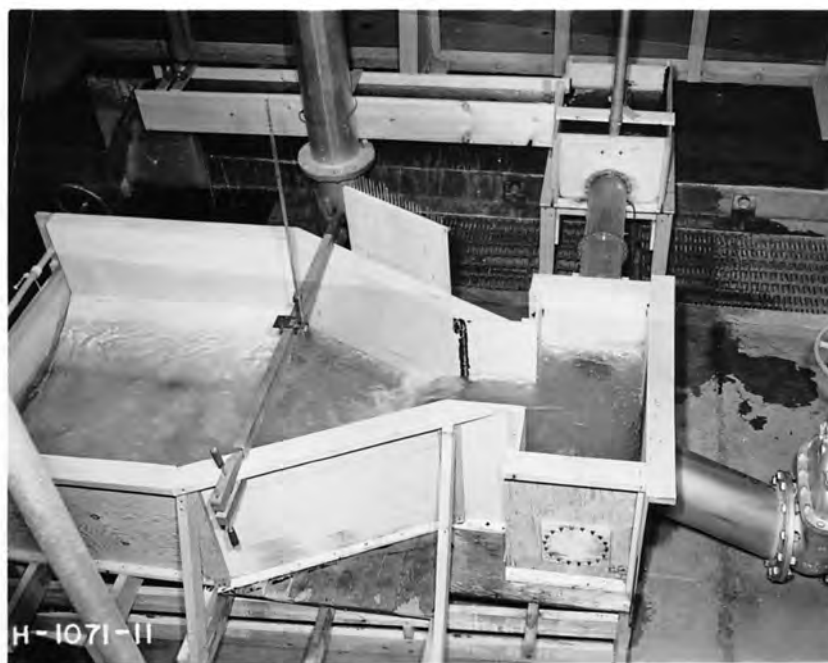
Figure 8
Report Hyd. 361

(A) In-Line Forebay--60 cfs Total Discharge with Right Outlet Operating

(B) Over-all View with Tee-shaped Forebay--60 cfs Total Discharge with Right Outlet Operating

"TEE-SHAPED" AND IN-LINE FOREBAYS

The "in line" shape was tried during head loss studies. The forebay was made the equivalent of 6 feet wide from the head wall to the vertical check. It is shown in operation in Figure 8A. Action in the forebay was good, contrary to the same shape in the preliminary model. No pile-up of water along the sides or reverse flow occurred. The improved performance was probably due to the upward velocity in the 2:1 slope of the road crossing pipe which was not incorporated into the preliminary model.
