SLY PARK DAM SPILLWAY HYDRAULIC
MODEL STUDIES--SLY PARK UNIT
AMERICAN RIVER DIVISION
CENTRAL VALLEY PROJECT, CALIFORNIA

Hydraulic Laboratory Report No. Hyd-370

May 27, 1953

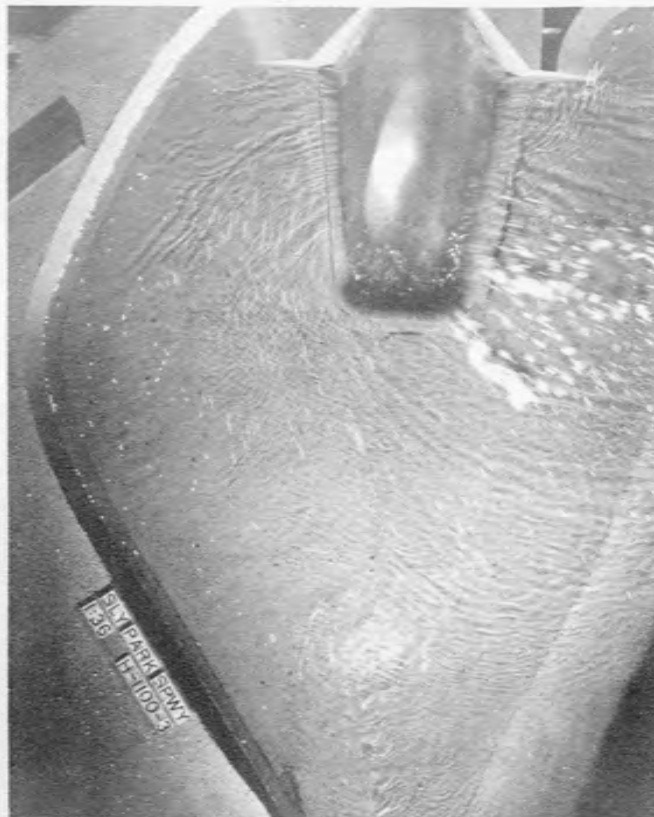
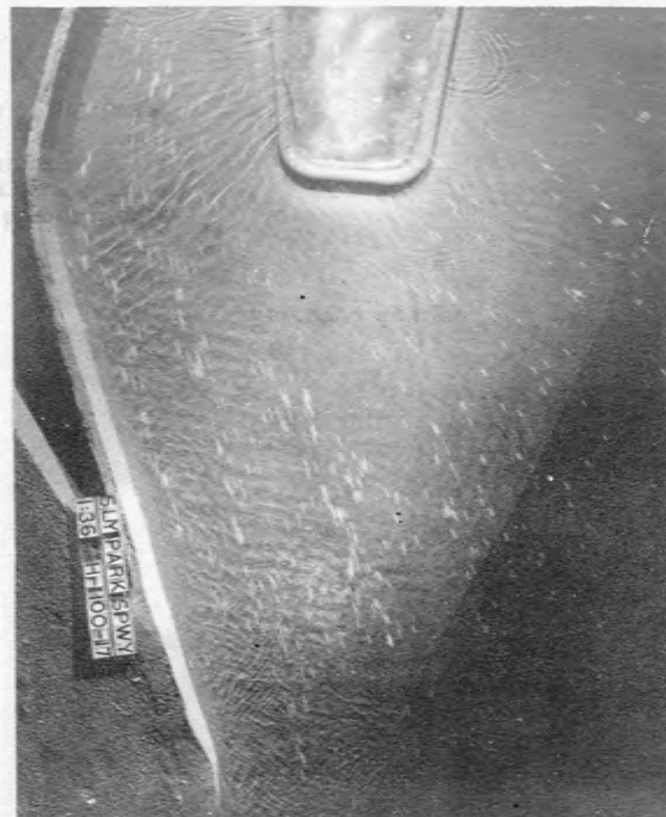
A. Preliminary design

B. Recommended design

**Flow pattern in Approach Channel
Discharge 6,700 cfs**

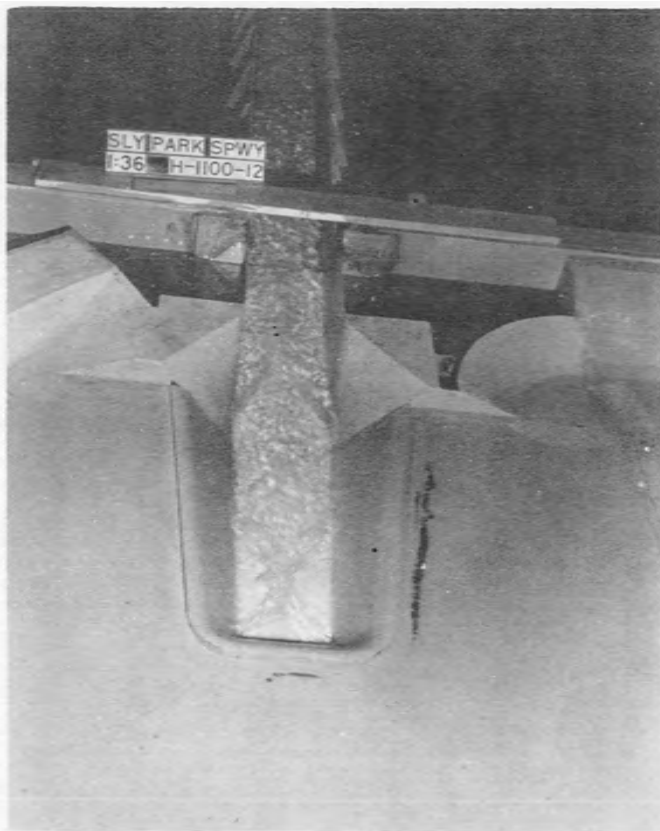
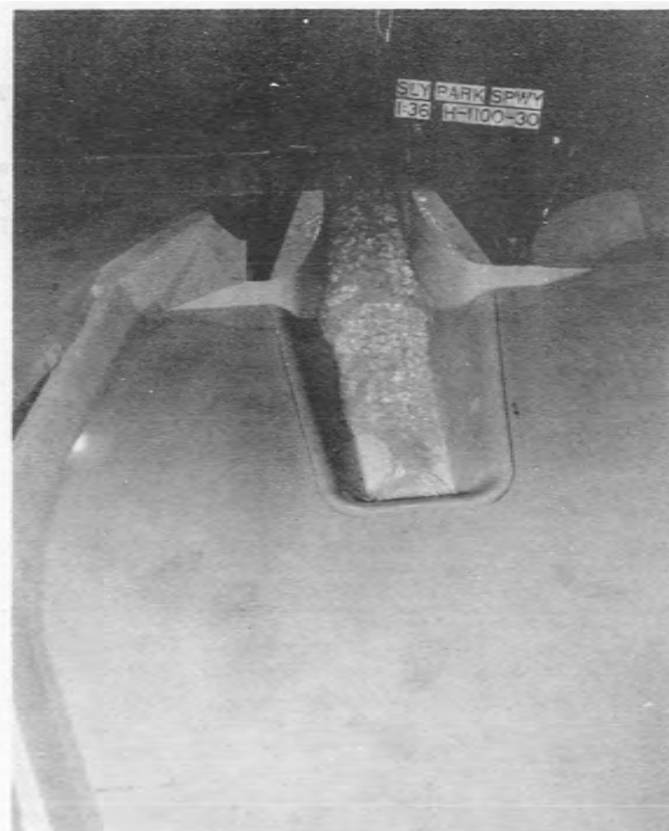
A. Preliminary design

B. Recommended design

Flow conditions in upstream end of spillway
Discharge 1,000 cfs

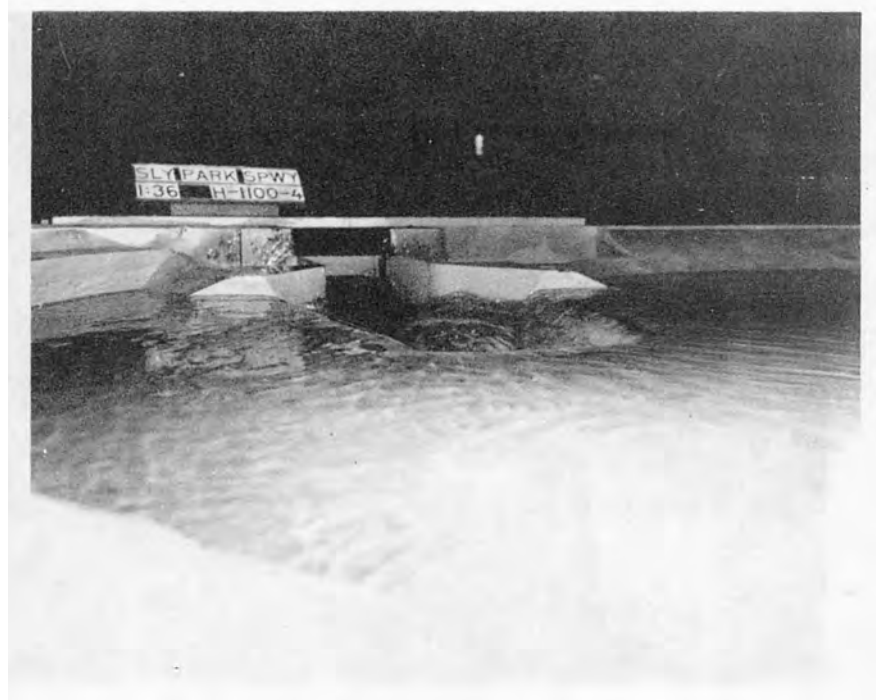
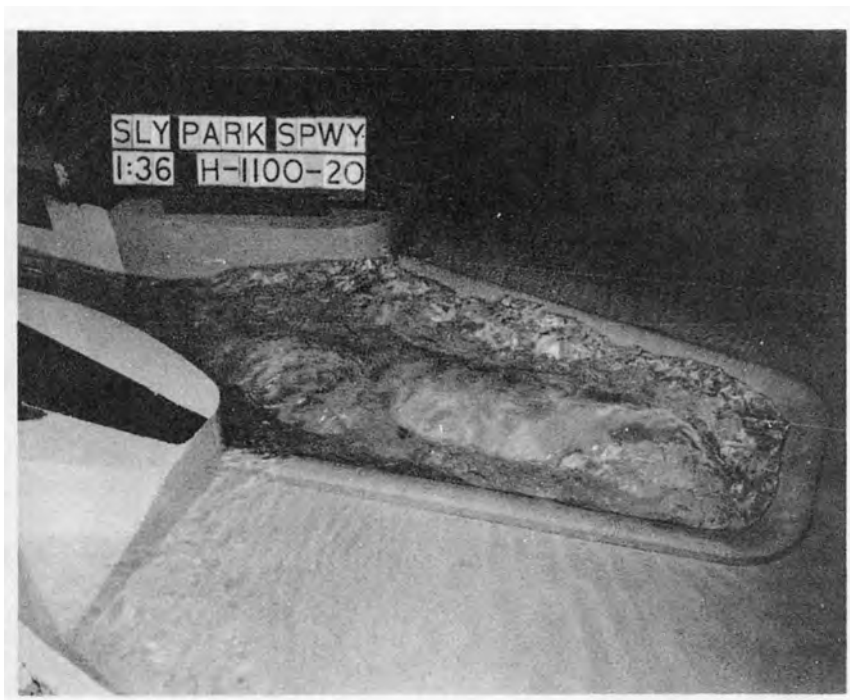
FIGURE 11
REPORT Hyd-370

A. Preliminary design

B. Recommended design

Flow conditions along right side of spillway
Discharge 6,700 cfs

Both designs were capable of passing the maximum discharge of 6,700 cfs without submergence. Irregular wave action momentarily submerged small sections of the crest, but had no over-all effect on the discharge. These waves can be seen in Figures 7B, 8B, and 11. The discharge and coefficient curves for the recommended design are shown on Figure 4.

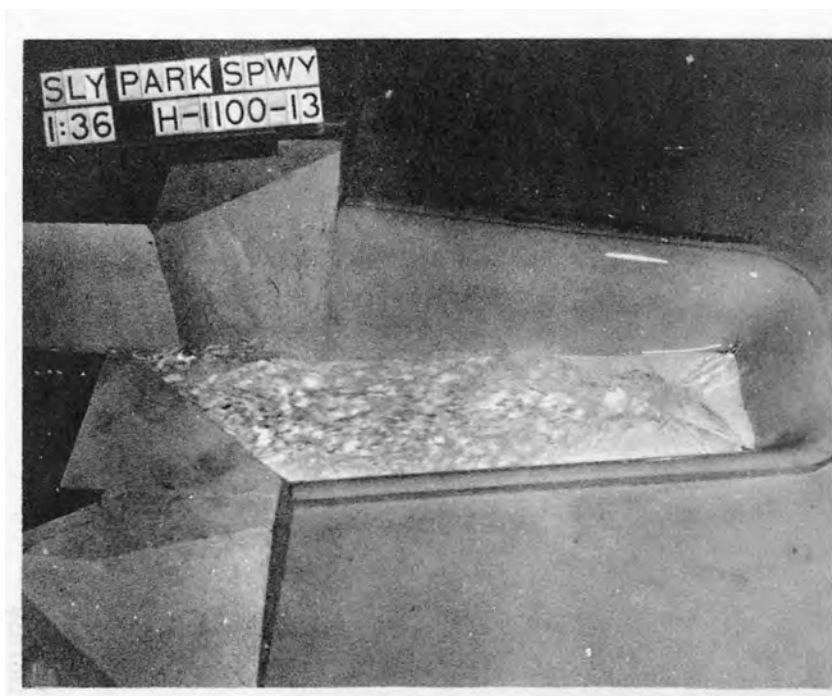
FIGURE 13
REPORT Hyd-370

A. Preliminary design

B. Recommended design

Flow conditions along right side of spillway
Discharge 1,000 cfs

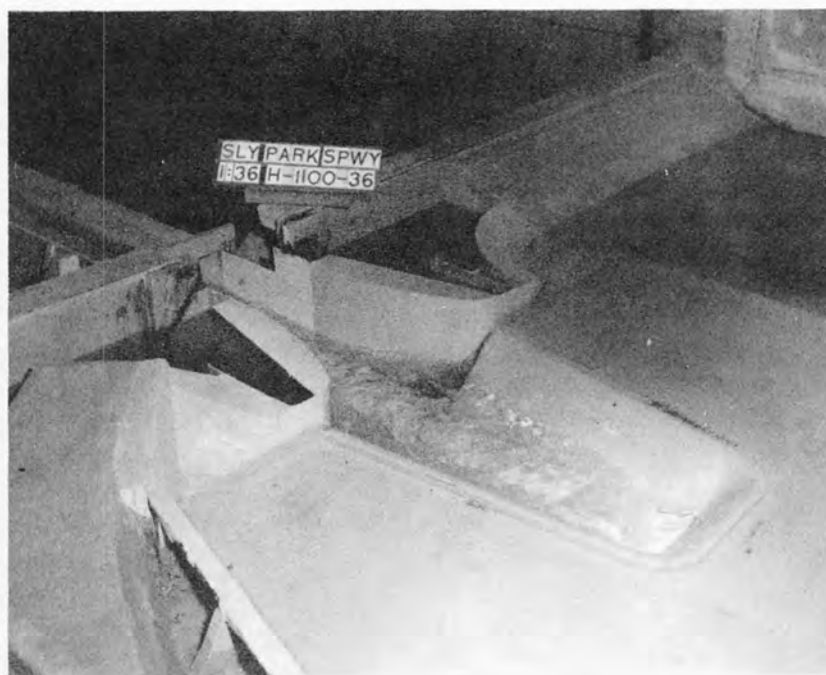
A. Discharge 6,700 cfs

B. Discharge 3,000 cfs

Flow conditions in recommended design spillway without
downstream crest slopes extended to transition walls

The extensions of the spillway downstream crest slopes to the vertical walls were removed to ascertain the effect on flow conditions. The performance was satisfactory, Figures 14 and 15. This change was made after the specifications were issued and was not included in the final design.
