UNITED STATES
DEPARTMENT OF THE INTERIOR
BUREAU OF RECLAMATION

HYDRAULIC MODEL STUDIES TO
DETERMINE THE REQUIRED COVER
BLANKET TO PREVENT FINE BASE
MATERIAL FROM LEACHING DUE TO
WAVE ACTION--KENNEWICK MAIN CANAL
YAKIMA PROJECT, WASHINGTON

Hydraulic Laboratory Report No. Hyd-381

June 4, 1954

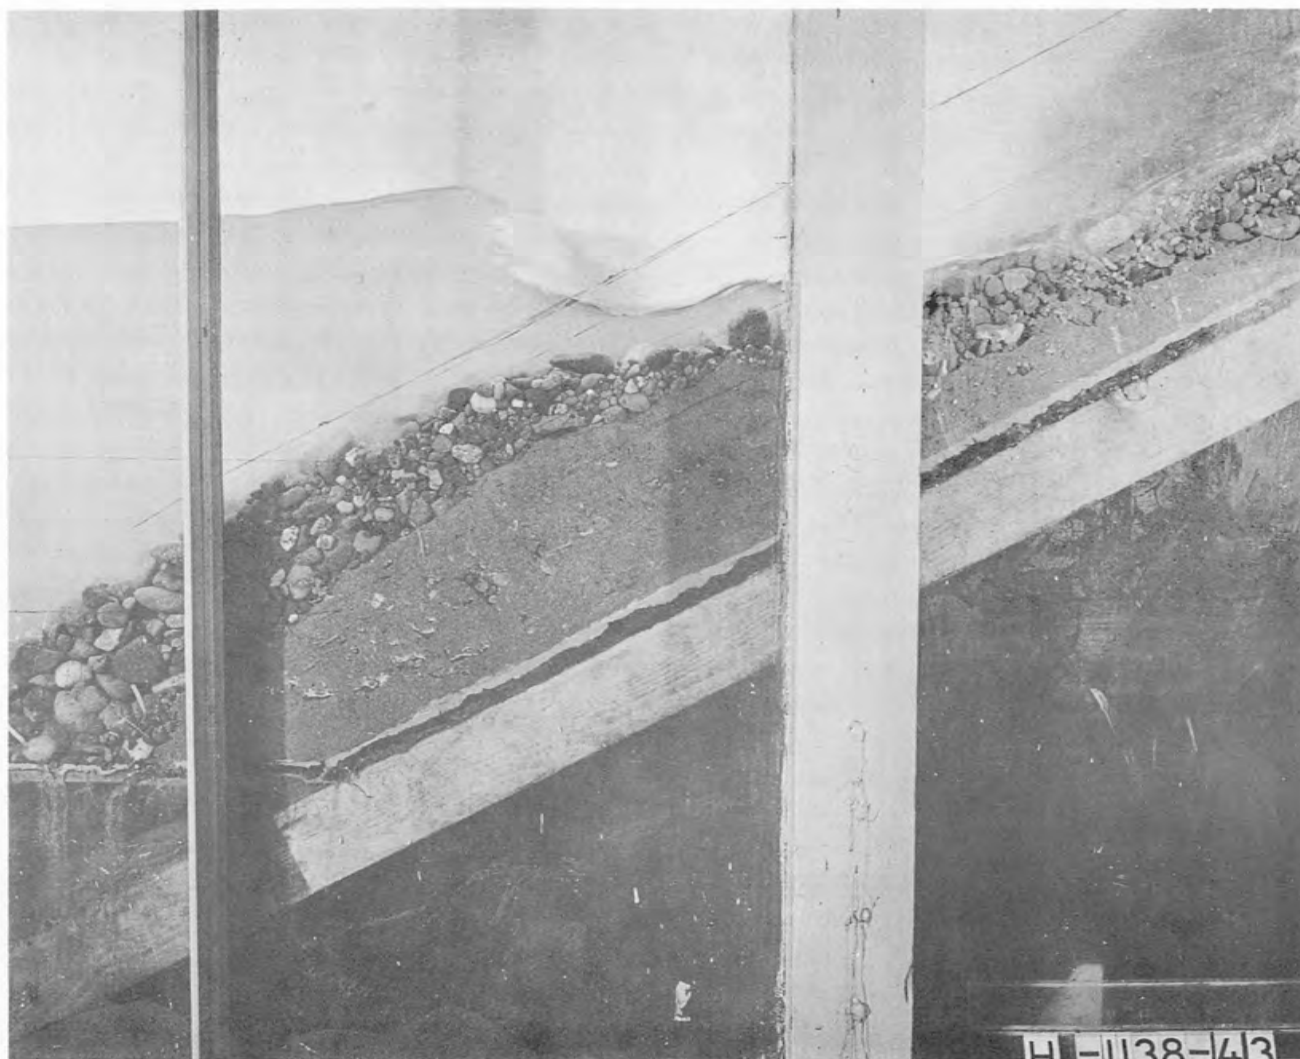
(FRONTISPIECE)
Yakima Project - Washington
KENNEWICK MAIN CANAL
TEST 8 - AFTER 5 HOURS OF OPERATION
Model study

In the model operation, the recommended cover resulted in a stable protective blanket. The fine material was prevented from leaching through or into the cover blanket. The surface of the cover blanket was relatively stable with beaching resulting from only large waves. A photograph of the recommended cover blanket after 128 hours of operation at various wave heights and frequencies may be seen in Figure 26.

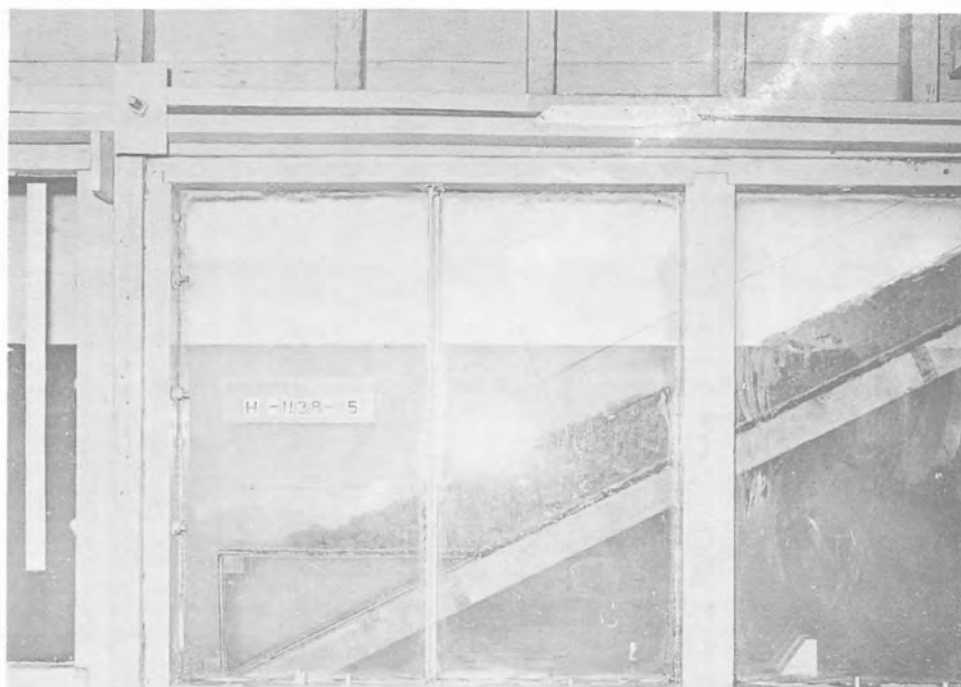
Figure 8

(a) Model prepared for Test 1

(b) Slope failure after 45 minutes
of operation at 32 waves per
minute - wave height 0.32 ft.

Yakima Project - Washington
KENNEWICK MAIN CANAL
TEST 1 (GRAVEL MOISTENED AND WELL MIXED)
Model study

2:1 slope. No effort to compact the material was made. The moist sand particles adhered to the gravel and were well distributed throughout the 6-inch layer. As shown in Figure 8a, the water was raised to a depth of 2.7 feet. The wave machine was operated at 32 waves per minute which created a wave with a height from trough to crest of approximately 0.32 foot.

Immediately after the wave machine was turned on, the Kennewick gravel material began to slip and roll down the slope. As sand had adhered to the gravel particles, it is believed the sand, washing from between the gravel particles, reduced friction throughout the layer, and the force of the water flowing out of the blanket was enough to start the particles to slide and roll down the slope. Approximately 20 minutes after the beginning of the test the board slope was exposed. The photograph of Figure 8b shows Test 1, after the test had been in operation for 45 minutes. Complete failure near the water surface had occurred. The model was turned off after 1 hour.

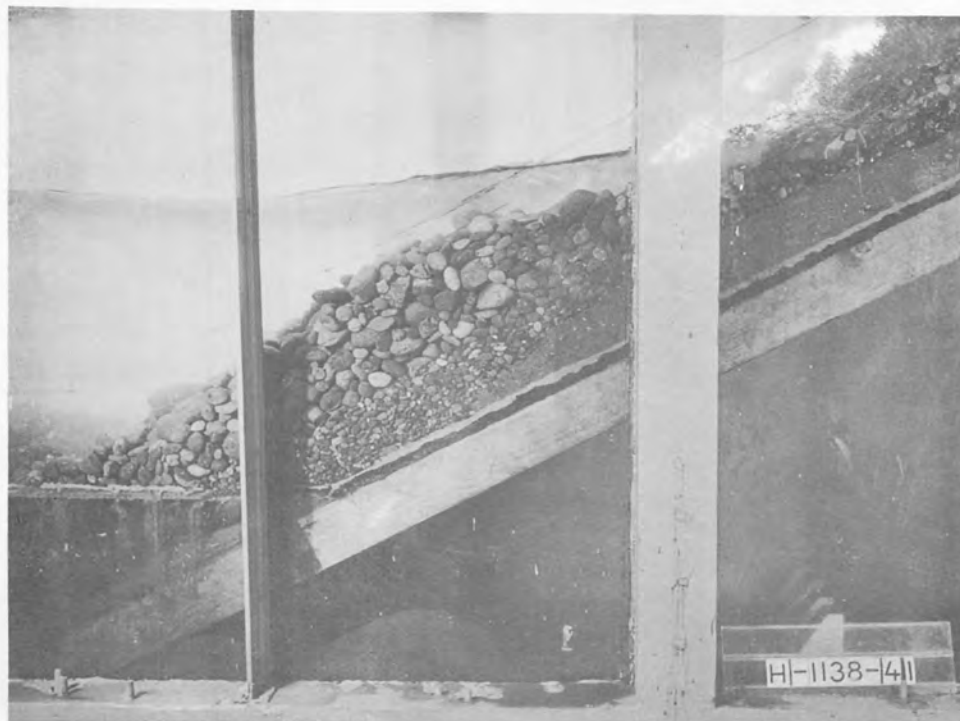
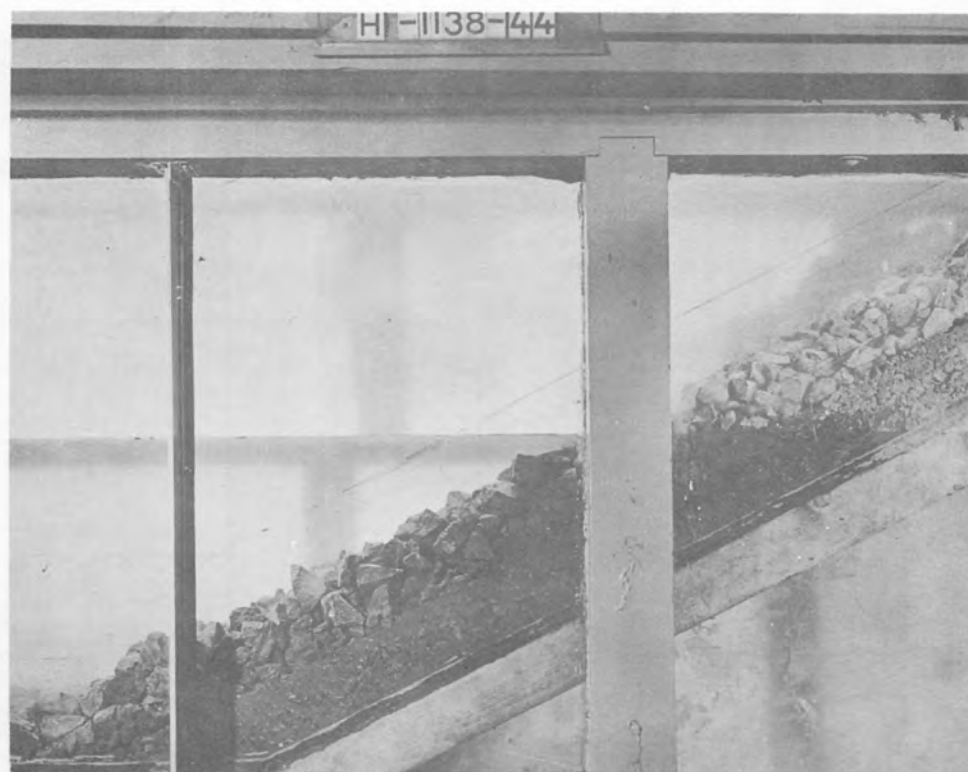
Figure 16

(a) Test 6--After 23 hours of operation
2.7 ft. depth--42 waves per minute--
wave height 0.43 ft.

(b) Test 9--Prepared for operation--
Recommended cover - talus
separated on 3/4-inch screen

Yakima Project - Washington
KENNEWICK MAIN CANAL
TESTS 6 and 9
Model study

As the mechanical analyses and the specific gravity of the two talus samples were quite similar (see Figure 5), the two samples were mixed before being tested. The mixed talus material was screened on the 3/4-inch screen, resulting in the analyses curves shown in Figure 17 together with the base material analysis curve and Bureau of Reclamation filter criteria. Before placing the material, 3.6 percent moisture (by dry weight) was added to the material smaller than 3/4 inch in size to simulate field conditions. Four inches of material smaller than 3/4 inch in size was placed on the 2:1 slope and protected by 4 inches

of material larger than 3/4 inch in size (Figure 16b). The model was filled to a depth of 2.7 feet and the wave machine started.

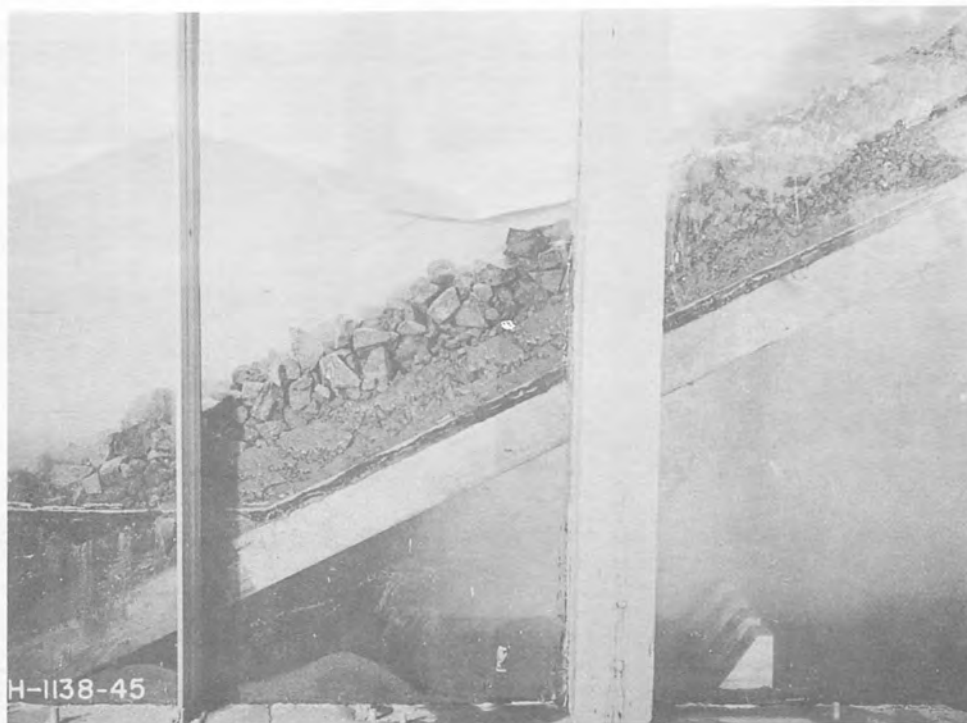
Figure 18

(a) A 0.5 ft. wave approaching the 2:1 slope

(b) Slope after 5 hours of operation at
varying wave heights and frequencies

Yakima Project - Washington
KENNEWICK MAIN CANAL
TEST 9 (RECOMMENDED COVER -
TALUS SEPARATED ON 3/4-INCH SCREEN)
Model study

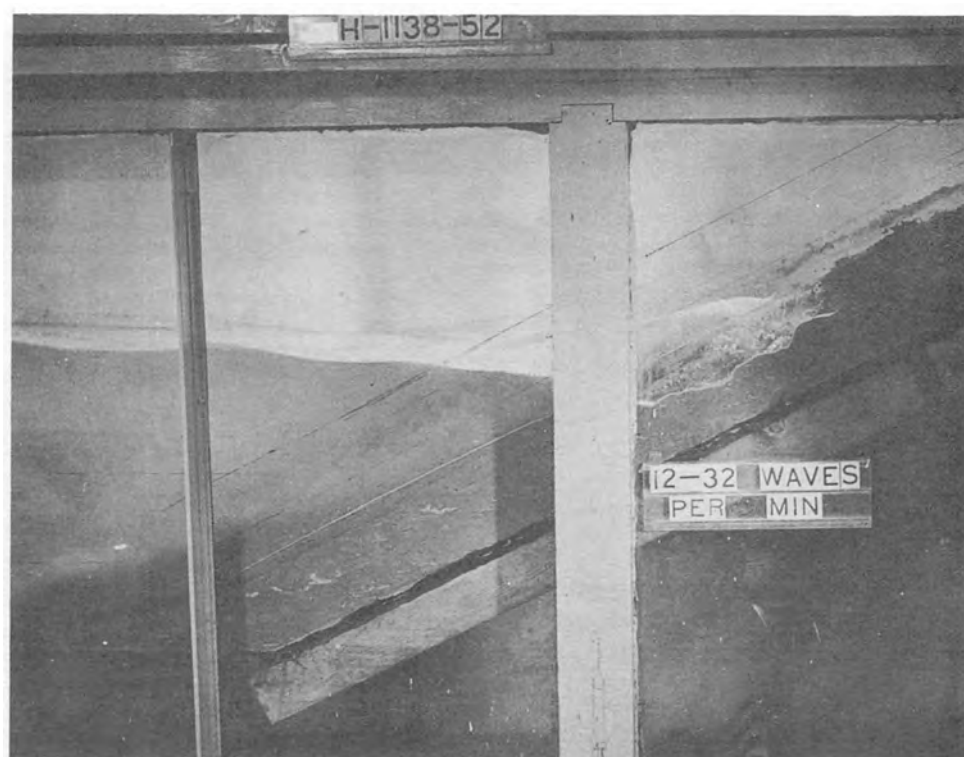
Figure 21

(a) Ready for operation

(b) Two minutes after operation started
at 2.7 ft. depth and 32 waves per
minute--wave height 0.26 ft.

Yakima Project - Washington
KENNEWICK MAIN CANAL
TEST 12 (FINE BASE MATERIAL)
Model study

A 6-inch layer of the fine base material (analysis curve shown in Figure 3) was subjected to wave action. In preparing the material enough water was added to bring the moisture content to 18 percent of the dry weight of the material. The 18 percent moisture is the optimum moisture content for maximum compaction. The material was placed on the 2:1 slope in layers of approximately 2 inches, and each layer was tamped to near maximum compaction with a wooden tamper. Before compacting the base material, the 2:1 board slope was roughened with a layer of metal lath. The slope was roughened as an aid in preventing the base material from sliding on the board slope. The model ready for operation may be seen in Figure 21a.

During the operation complete failure of the slope occurred. Immediately on starting the wave machine, the earth material began to fail. A photograph taken 2 minutes after operation started may be seen in Figure 21b. A density current of fine material flowed down the slope and to the bottom of the flume. After 12 minutes of operation, the 2:1 slope was completely exposed. The model was operated for 1 hour after which it was turned off and slowly drained. The fine material assumed an approximate level position as shown in Figure 22a.

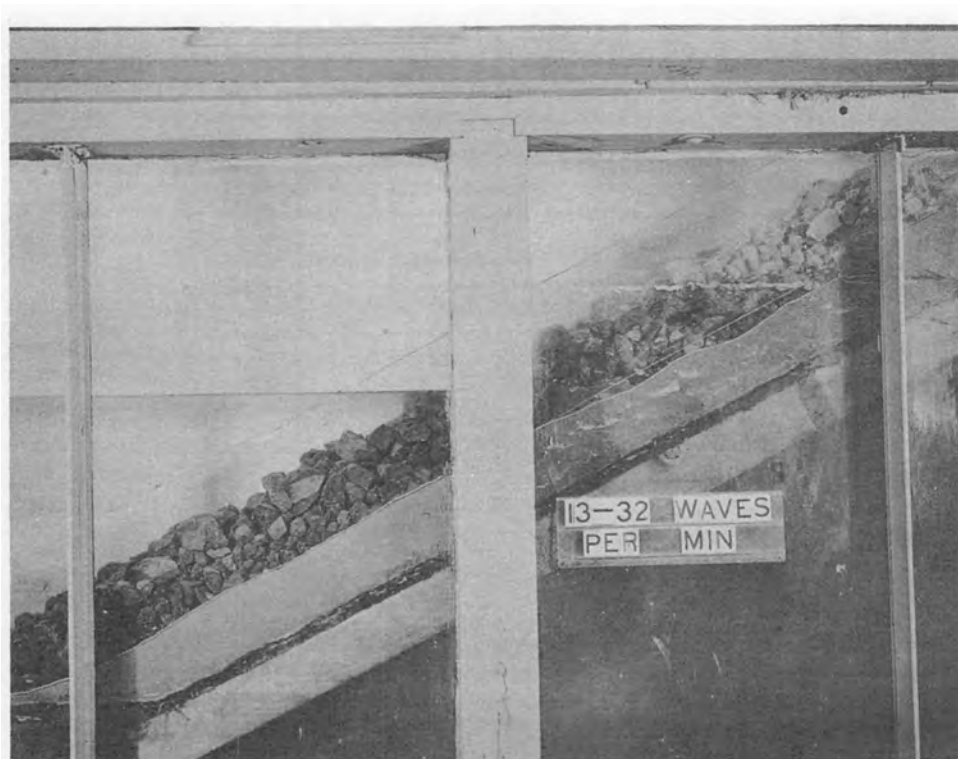
Figure 22

(a) Test 12--after 1 hour of operation
at 2.7 ft. depth--32 waves per
minute--wave height 0.26 ft.

(b) Test 13--ready for operation.
Base material covered with
plus 1/2-inch talus

Yakima Project - Washington
KENNEWICK MAIN CANAL
TESTS 12 and 13
Model study

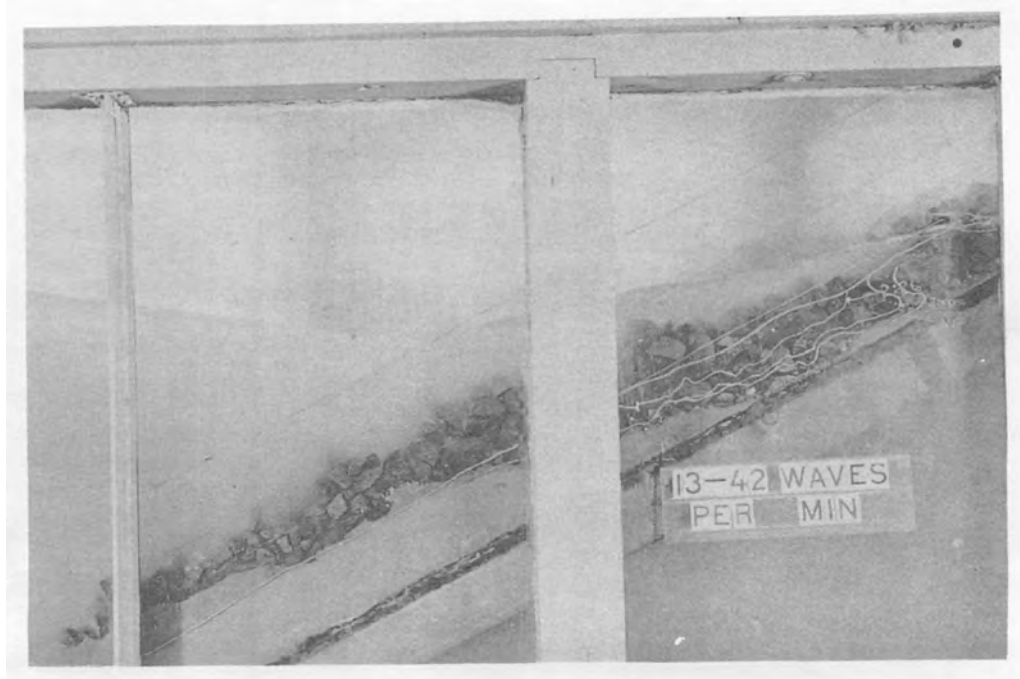
Figure 24

- (a) Test 13--after the model was left running all night at 42 waves per minute. Base material completely leached out in area near water surface

Yakima Project - Washington
KENNEWICK MAIN CANAL
TESTS 13 and 14
Model study

The model was operated an additional 17.5 hours at 42 waves per minute. During this time the upper part of the slope failed completely. The fine material was completely washed from beneath the talus cover. A photograph showing the failure may be seen in Figure 24a.

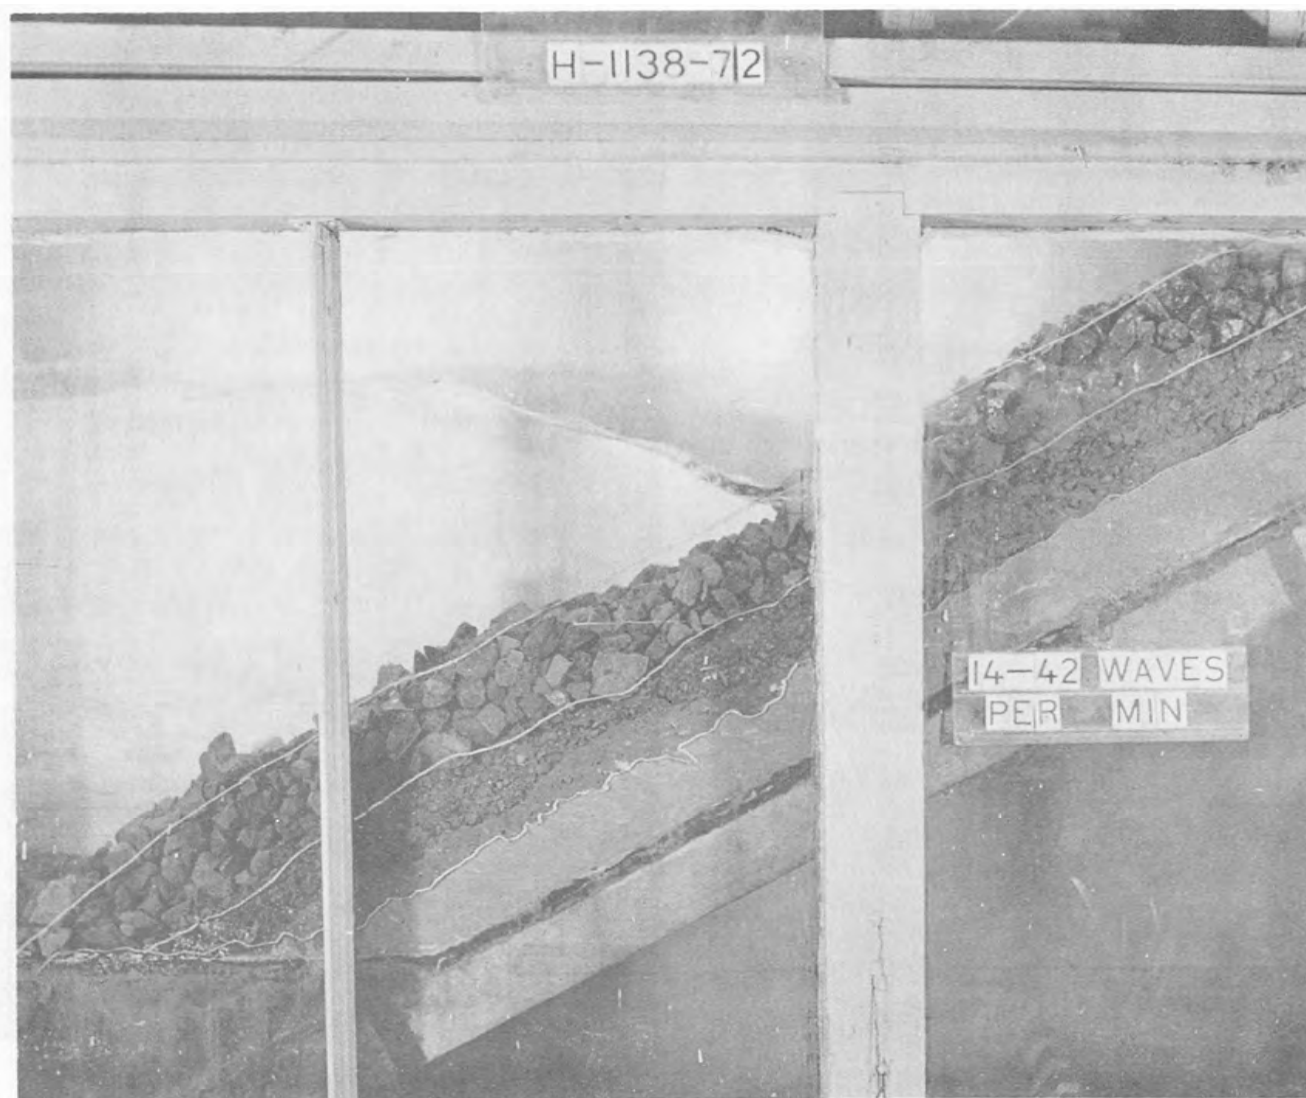
Yakima Project - Washington
KENNEWICK MAIN CANAL
TEST 14 (RECOMMENDED COVER) AFTER 28 HOURS OF OPERATION
AT 42 WAVES PER MINUTE--2.7 FT. DEPTH--WAVE HEIGHT 0.43 FT.
Model study
