UNITED STATES  
DEPARTMENT OF THE INTERIOR  
BUREAU OF RECLAMATION

HYDRAULIC MODEL STUDIES OF  
PALO VERDE DIVERSION DAM

Hydraulic Laboratory Report No. Hyd-408

June 4, 1956

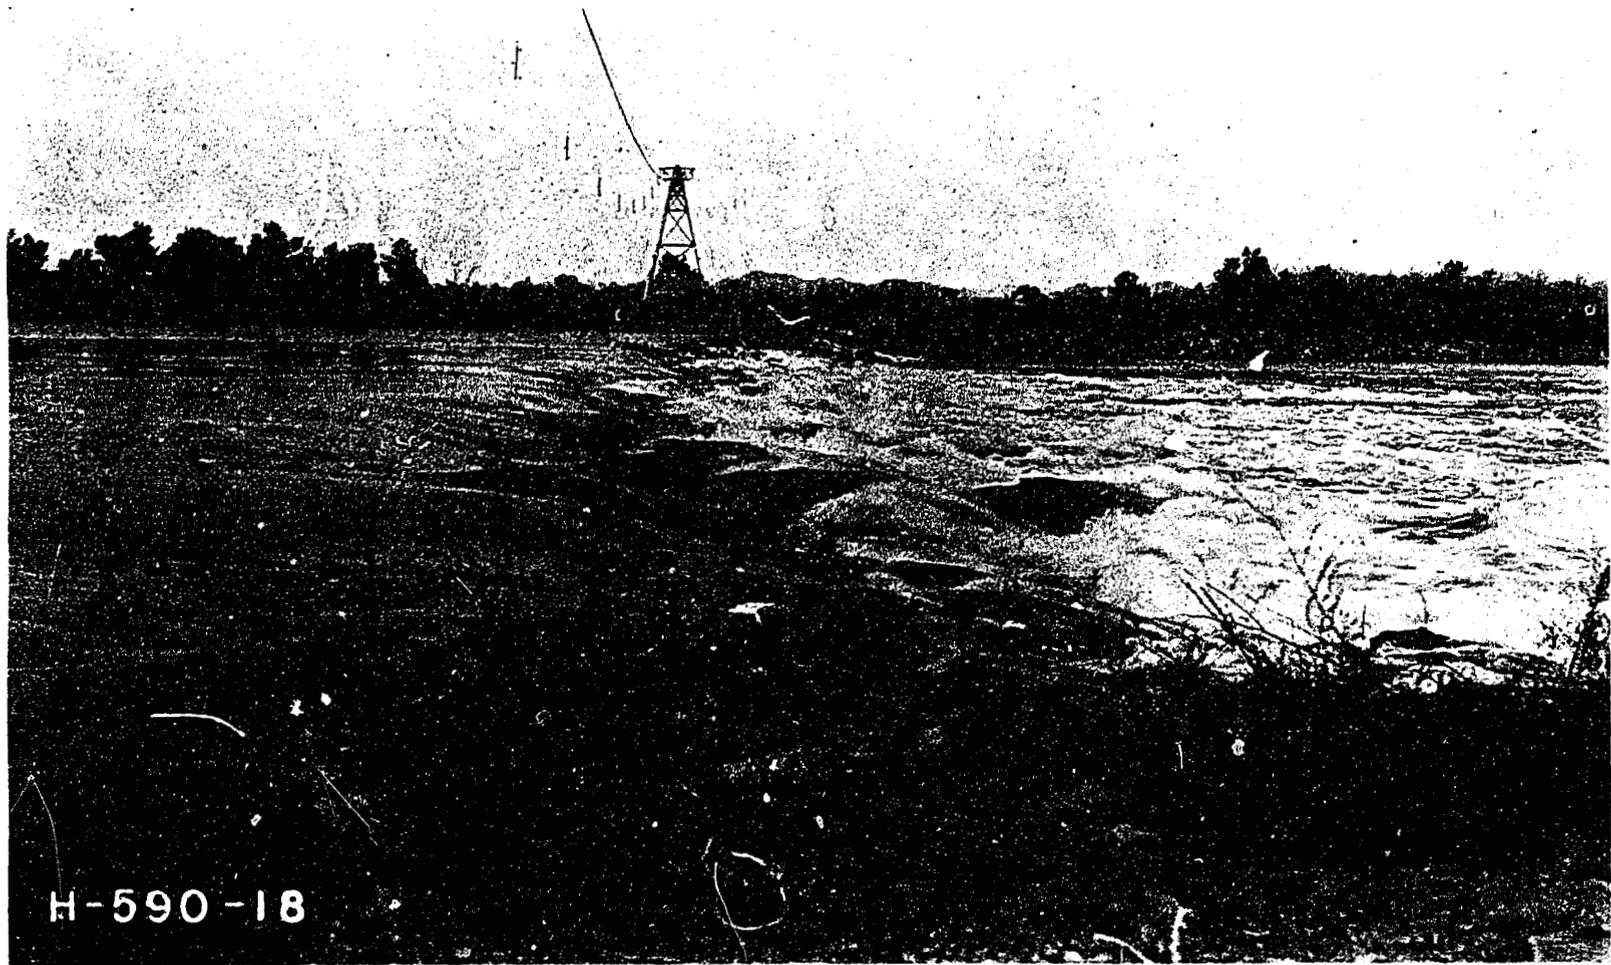
H-590-18

PALO VERDE DIVERSION DAM  
TEMPORARY ROCK WEIR DISCHARGING 16,000 SECOND FEET

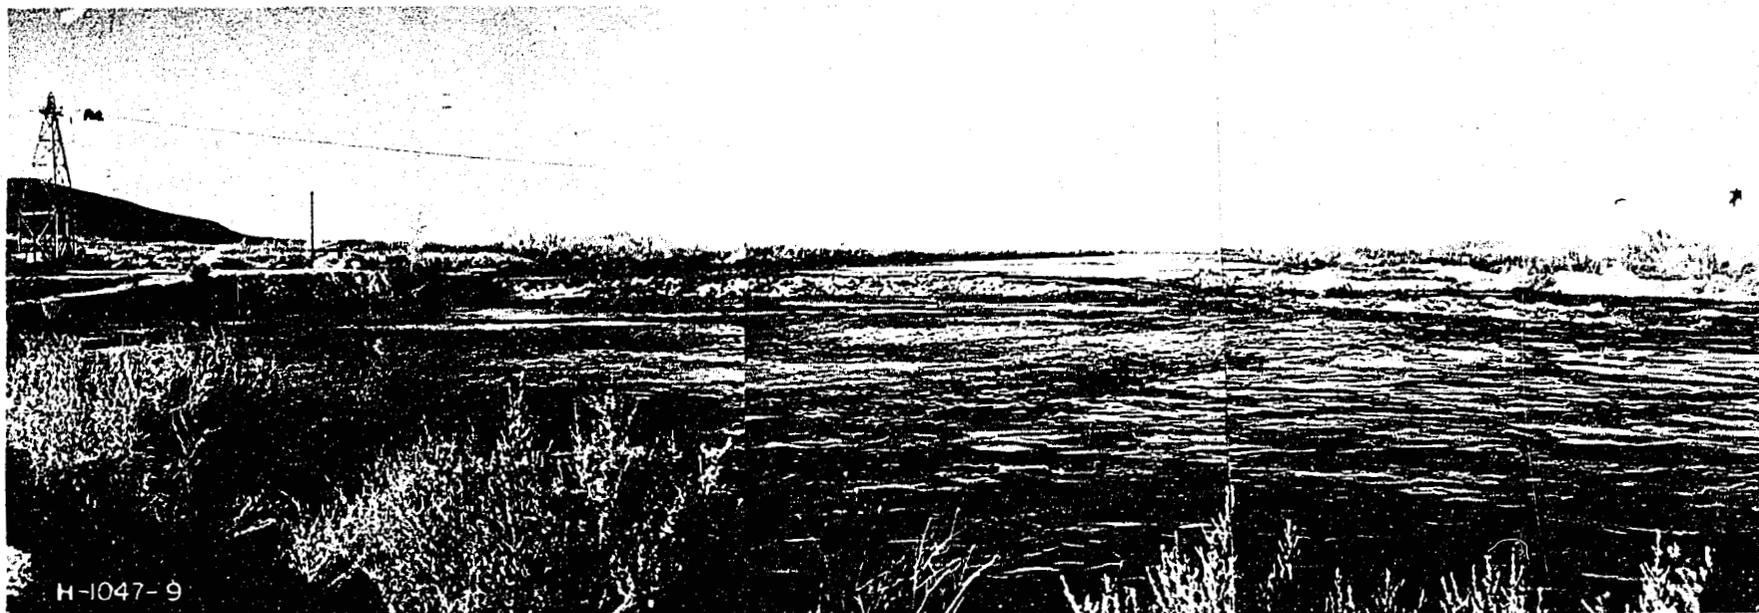
PALO VERDE DIVERSION DAM  
FLOOD DAMAGE TO TEMPORARY ROCK WEIR LOOKING UPSTREAM

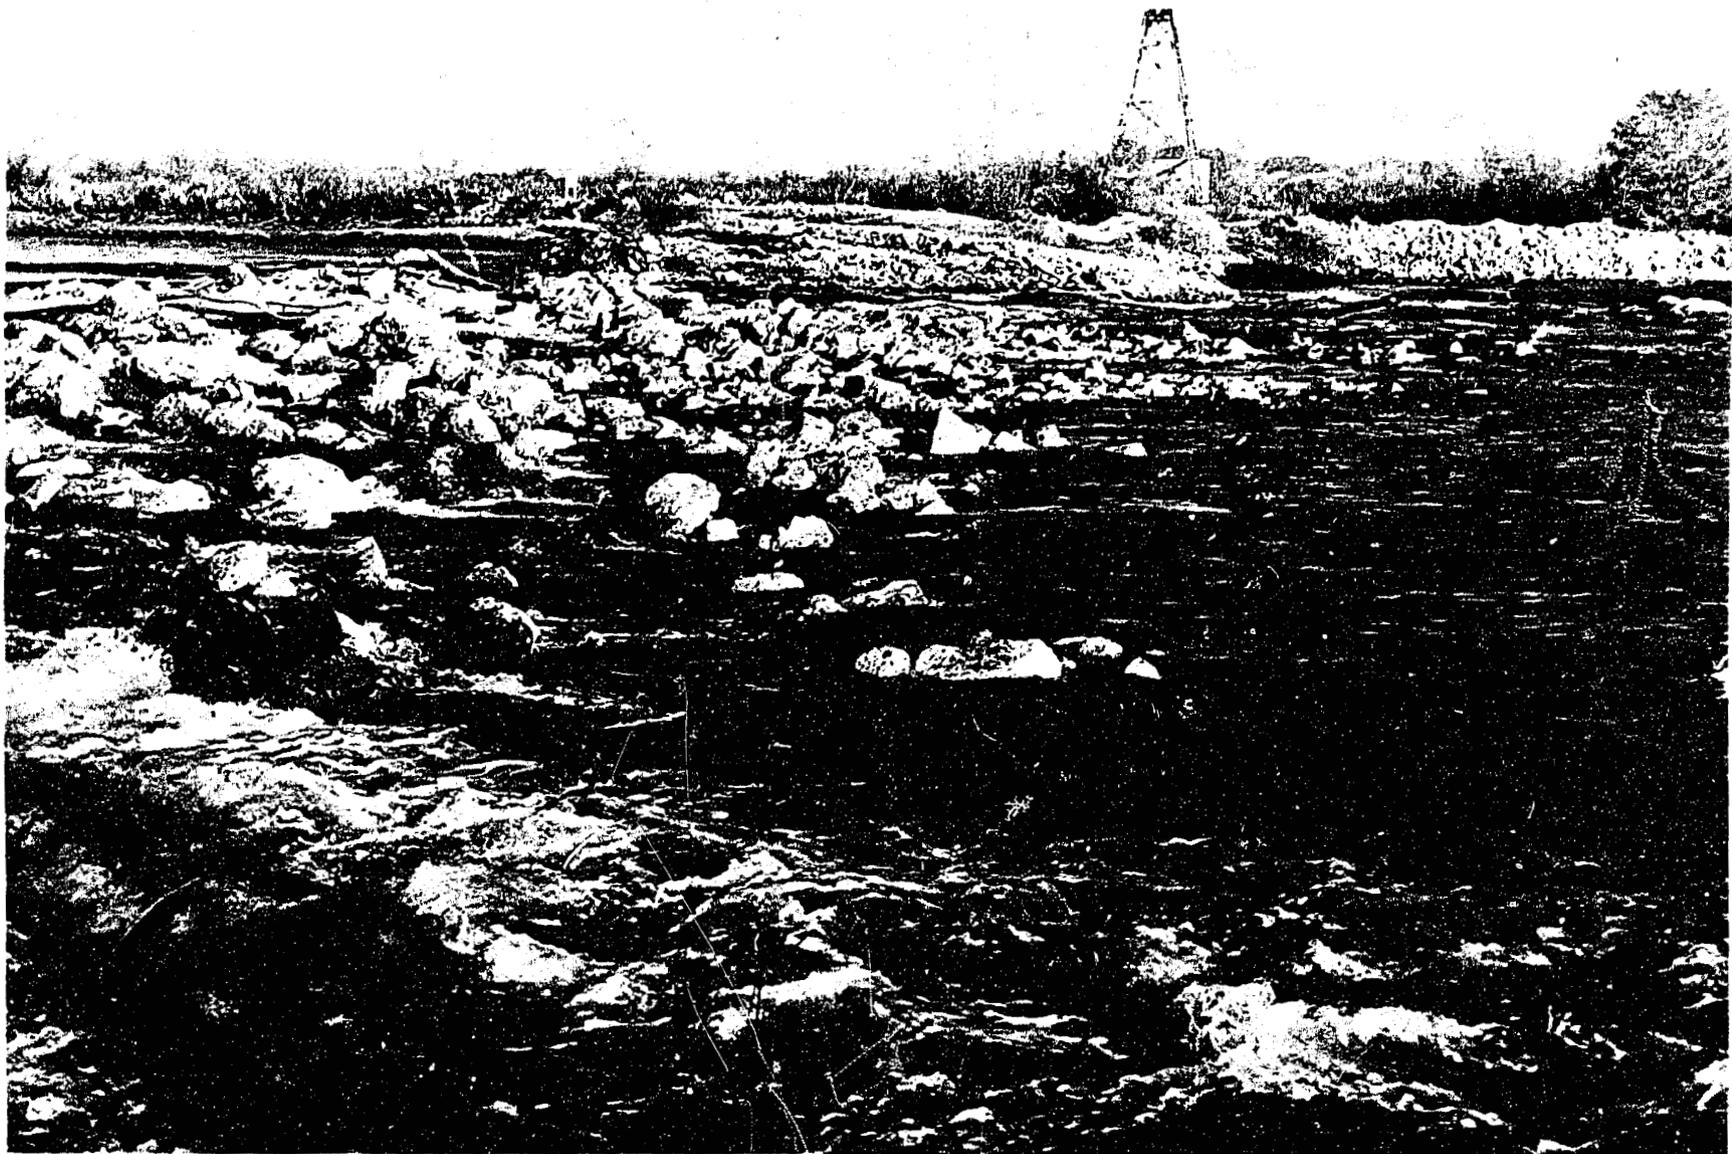
PALO VERDE DIVERSION DAM  
FLOOD DAMAGE TO TEMPORARY ROCK WEIR - LOOKING TOWARD LEFT BANK

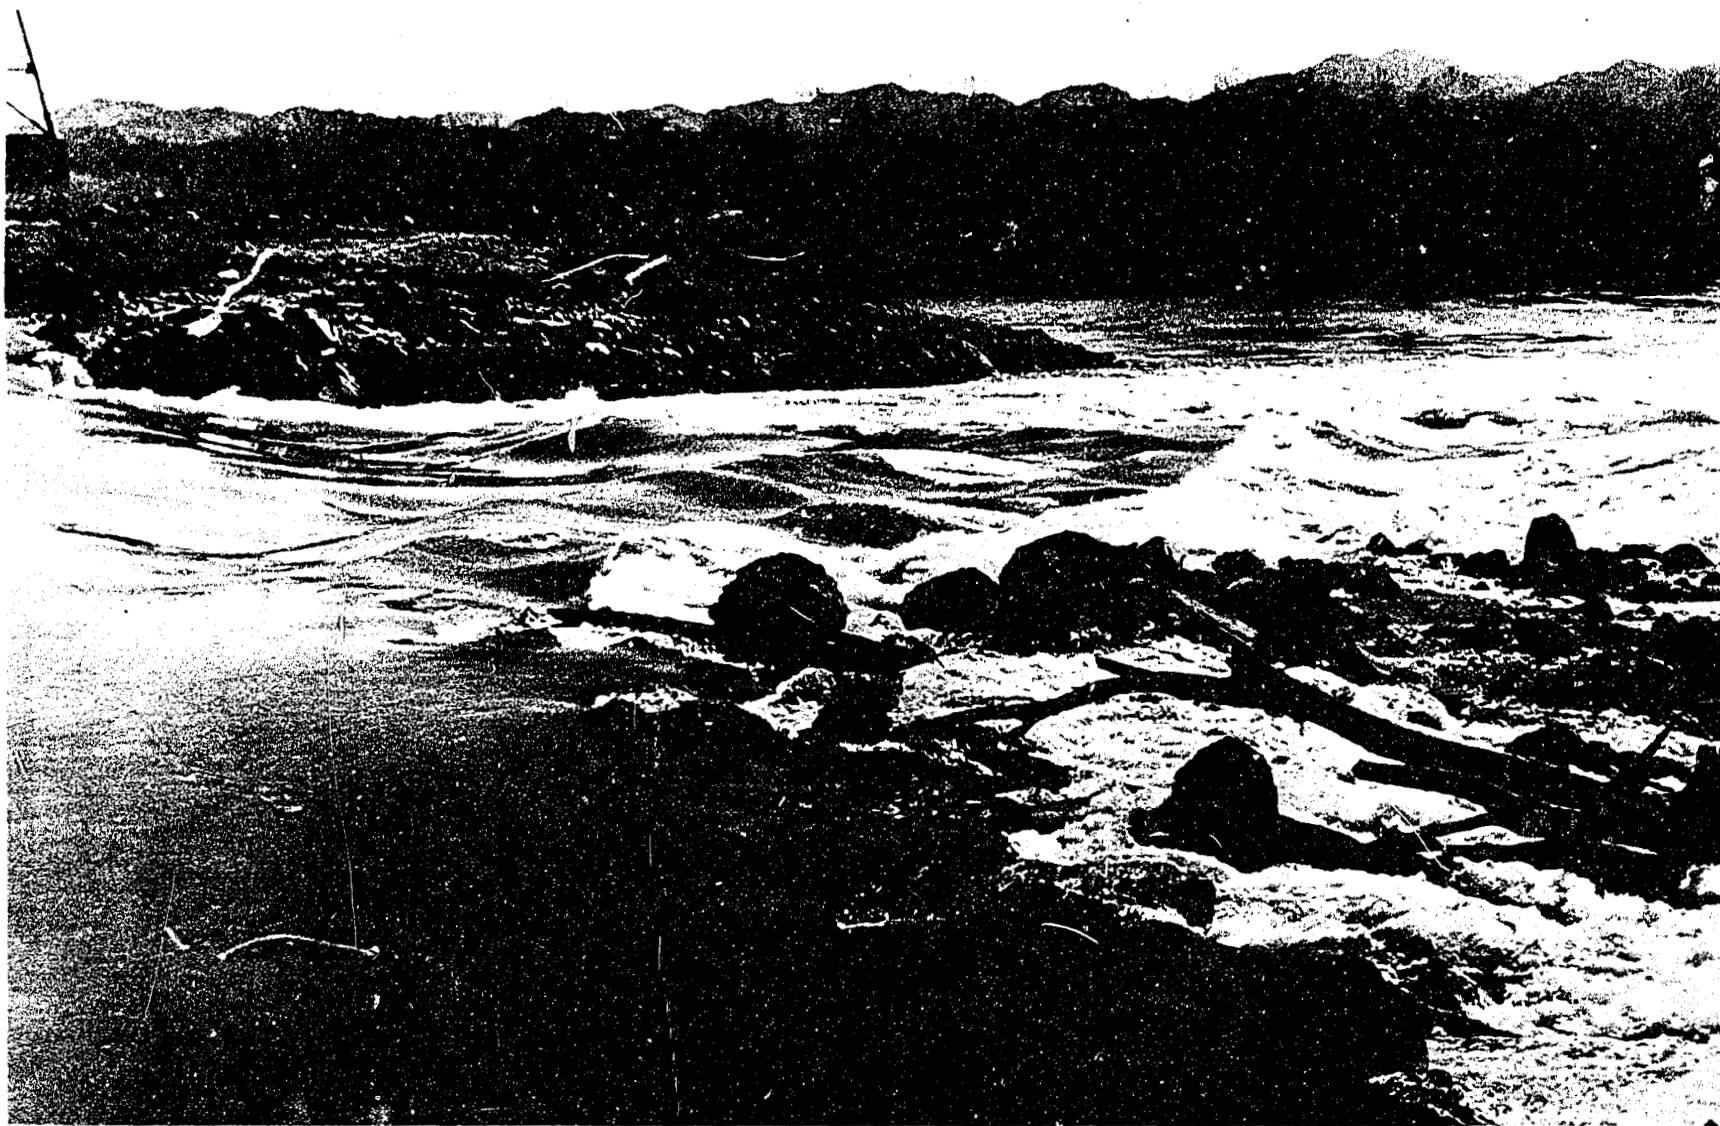
PALO VERDE DIVERSION DAM  
FLOOD DAMAGE TO TEMPORARY ROCK WEIR - LOOKING TOWARD LEFT BANK

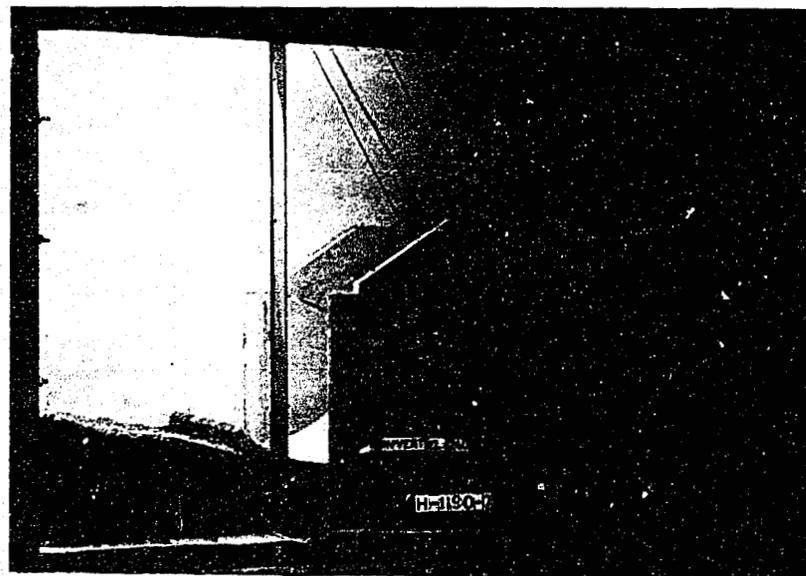
Single bay sectional model with  
preliminary bucket type energy  
dissipator in place

PALO VERDE DIVERSION DAM  
SECTIONAL SPILLWAY MODEL  
1:28.3 SCALE MODEL

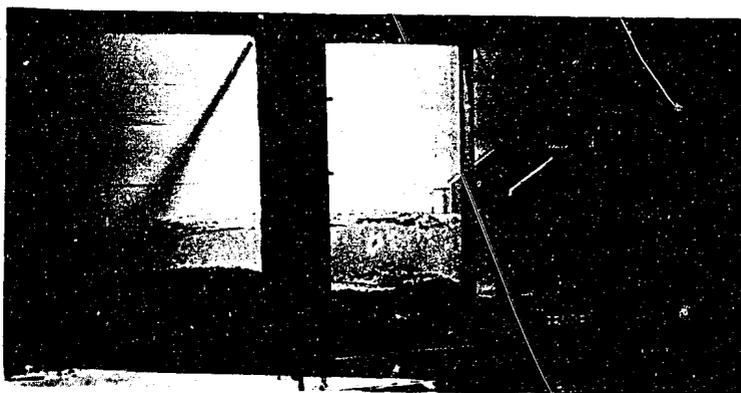
A. Preliminary Bucket -  
(slotted-baffle type -  
see Figure 18).

B. Baffles removed

C. Solid sill in place  
of baffles.

Note: The conditions shown are at the conclusion of a 30-minute model erosion test in which the discharge is 8,000 second feet, the reservoir at elevation 283.5, and the tailwater at elevation 271.

PALO VERDE DIVERSION DAM  
PRELIMINARY SPILLWAY BUCKET DISCHARGING  
WITH & WITHOUT MODIFICATIONS  
1:28.3 SCALE MODEL

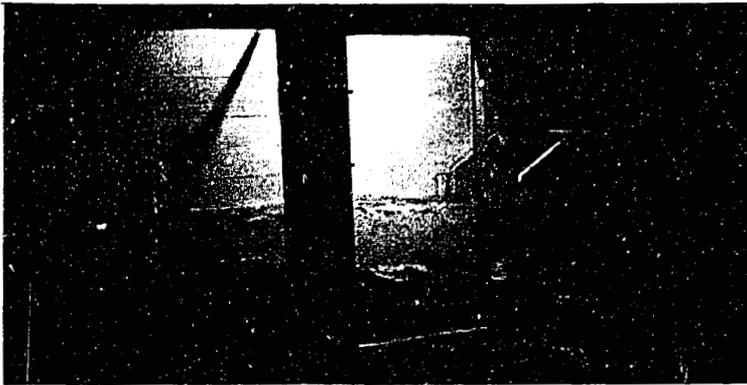
A. Baffles 14-foot wide,  
slots 25-inches

Note: The conditions shown are at the conclusion of a 30 minute model erosion test in which the discharge is 8,000 second feet, the reservoir at elevation 283.5, and the tailwater at elevation 271.

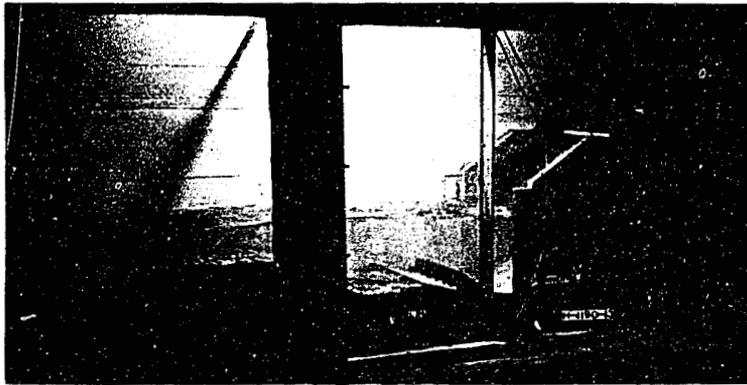
B. Baffles 7-foot wide,  
slots 18-inches.

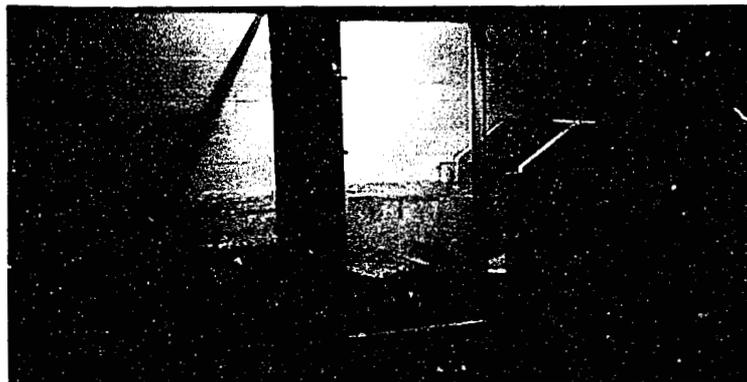
C. Baffles taper from  
7-feet upstream to  
6-feet 9 inches down-  
stream, slots from  
24 inches to 27 inches.

**FIGURE 24  
REPORT HYD 408**

For the next test, the slot width was increased to 24 inches at the upstream end and 27 inches at the downstream end, Figure 24A, which is the same as recommended with the preliminary

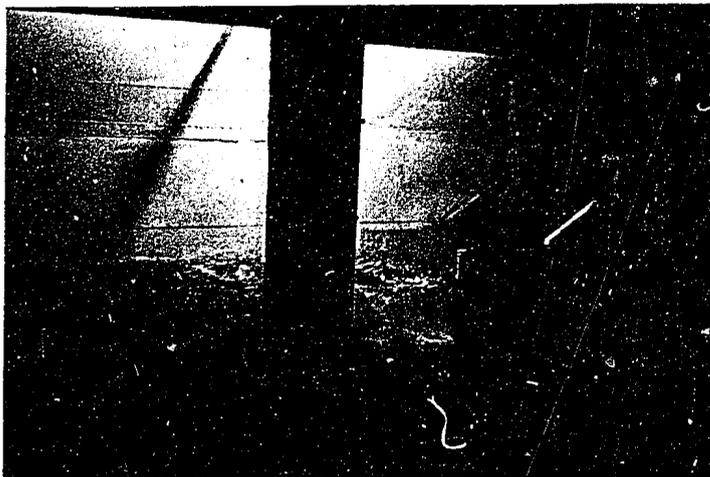
- B. Solid bucket with horizontal top on end sill. See Figure 25.**

**Note: The conditions shown are at the conclusion of a 30-minute model erosion test in which the discharge is 8,000 second feet, the reservoir at elevation 283.5, and the tailwater at elevation 271.**

A solid end sill, shown in Figure 25, was placed in the 25-foot-radius bucket for the next tests. With the horizontal top, Figure 25, very little erosion occurred, Figure 24B, and there was no general movement of material along the apron. However, a considerable amount of bed material did swirl on and off the apron which was objectionable. Also, the water surface was rougher than when baffles were used.

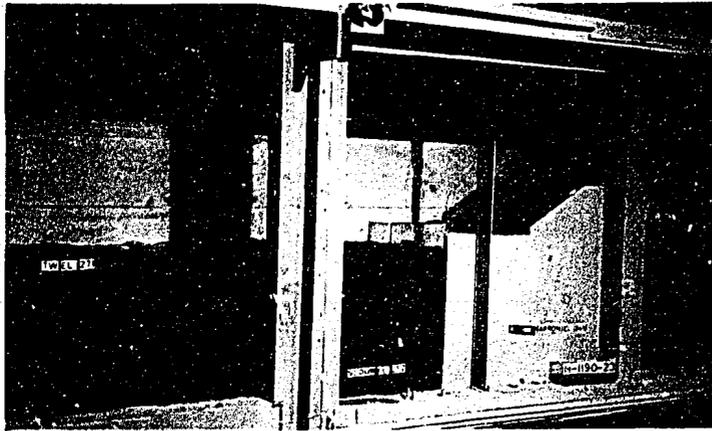
A. 2:1 sloping end sill.  
See Figure 26A

PALO VERDE DIVERSION DAM  
HORIZONTAL APRON AT ELEVATION 245  
WITH VARIOUS END SILL ARRANGEMENTS  
1:28.3 SCALE MODEL

The first sill tested had a 2:1 upstream slope, as shown in Figure 26A. Erosion of the bed material was very minor, Figure 27A, and very little movement of material occurred along the lip of the apron. The water surface was a little rough, with wave heights from crest to trough reaching 3 to 4 feet. Although the design appeared adequate, it was felt that improvements could be made.

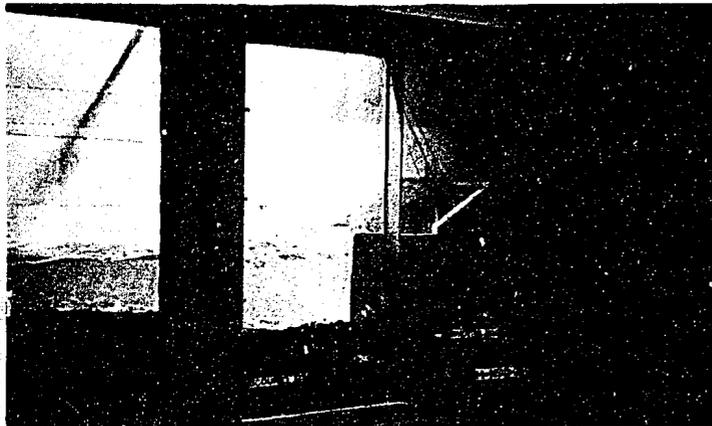
B. Double slope end sill.  
See Figure 26B.

A sill with a double slope, shown in Figure 26B, similar to the one tested with the 25-foot-radius bucket was investigated. Results were practically identical to those for the 2:1 sloping sill, Figure 27B.

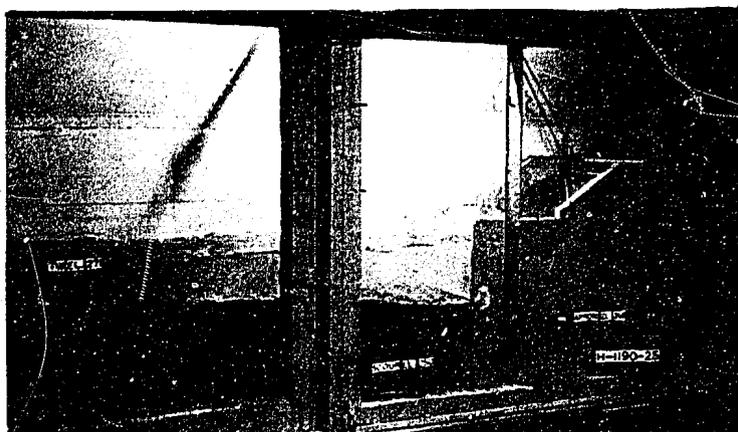
A. 6 baffles on 4:1 sloping end sill. See Figure 26D.

PALO VERDE DIVERSION DAM  
HORIZONTAL APRON AT ELEVATION 245  
WITH VARIOUS END SILL AND BAFFLE ARRANGEMENTS  
1:28.3 SCALE MODEL

Six baffles 5 feet 6 inches wide and spaced 27 inches apart, previously used in the 25-foot-radius bucket, were placed on the 4:1 sloping sill as shown in Figure 26D. Erosion was reduced and water surface roughness was improved as shown in Figure 28A. When the baffles were moved upstream onto the apron, as shown in Figure 26E, some of the water surface roughness was moved upstream into the basin between the spillway piers. Erosion was the same as with the piers on the slope, Figure 28B.

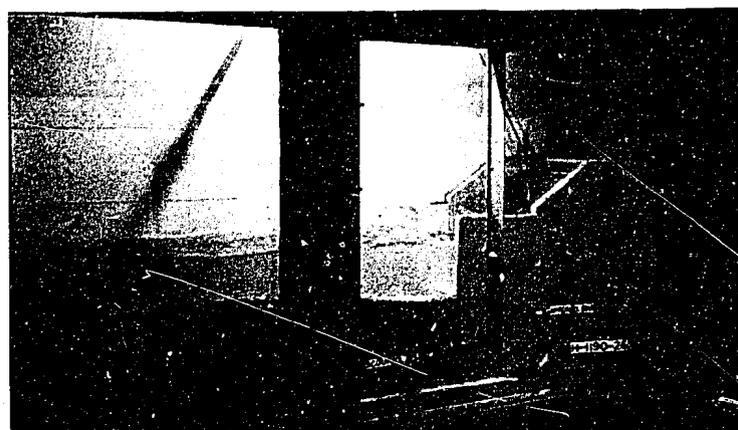
B. 6 baffles on apron upstream from 4:1 sill. See Figure 26E.

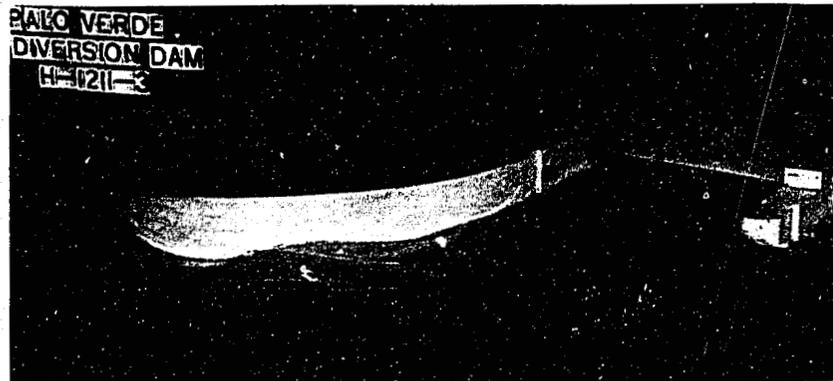
A. Preliminary left wall.

PALO VERDE DIVERSION DAM  
LEFT SPILLWAY APPROACH TRAINING  
WALL 75,000 SECOND FEET  
1:50 SCALE MODEL

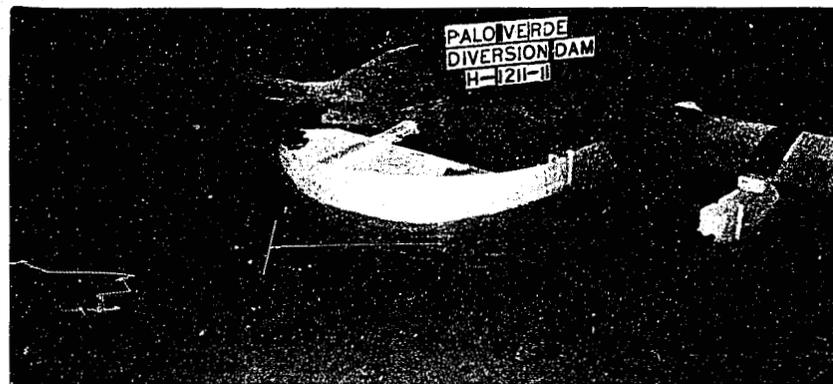
C. 51 foot radius wall - Recommended

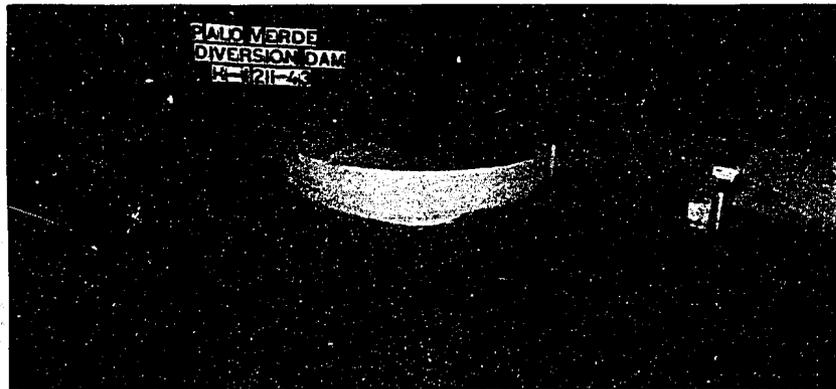
C. Flow around left training wall.

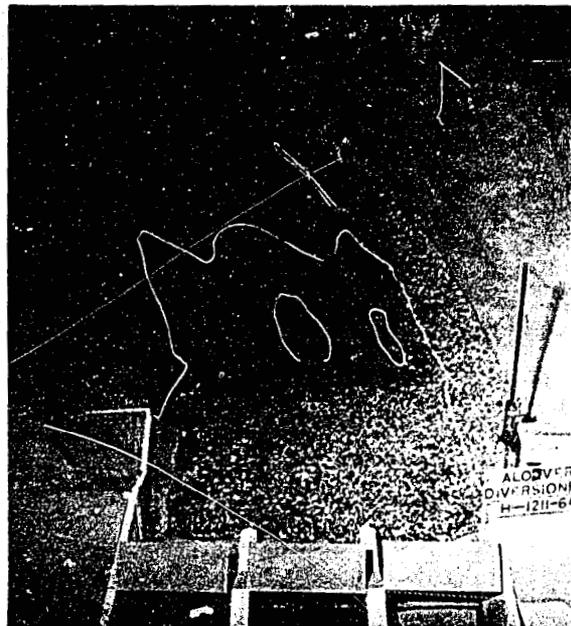
B. Erosion after 45,000 second feet for 30 minutes with tailwater at elevation 281 expected in year 1967. Reservoir at elevation 283.5 near headworks.

PALO VERDE DIVERSION DAM  
DISCHARGE CHANNEL EROSION TRENDS  
RECOMMENDED SPILLWAY  
1:50 SCALE MODEL

Using an erodible sand bed downstream from the riprap in the discharge channel that eroded as shown in Figure 42A, the spillway was calibrated for gate controlled flow with reservoir at elevation 283.5 and for uncontrolled flow with higher reservoir elevations. These discharge curves are shown in Figure 48 and may be used for prototype operation of the spillway. All three gates are to be opened the same amount.

channel bed. Discharge calibration tests were then made to determine whether the curves in Figure 48, which were obtained with an erodible sand bed downstream from the riprap that did erode as shown in Figure 42, were still reliable. No measurable differences in the discharge curves could be detected. It was therefore concluded that the curves of Figure 48 were reliable for any anticipated condition of the discharge channel bed.

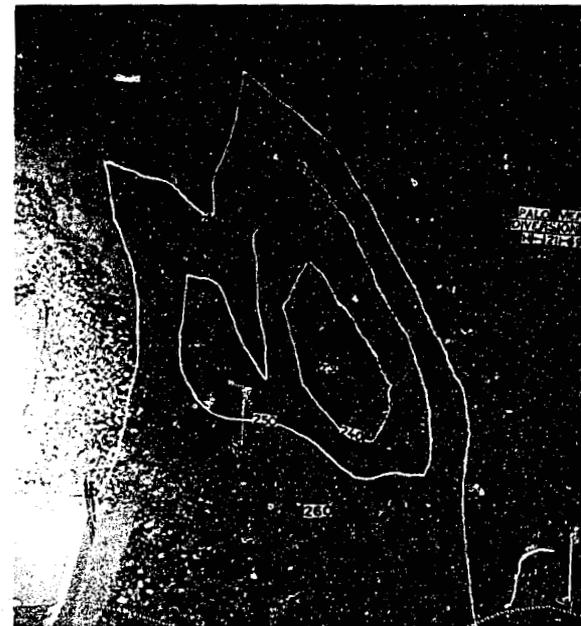
C. Erosion after 75,000 second feet for 30 minutes with tailwater at elevation 283 expected in year 1970. Reservoir at elevation 288 near headworks.
