EROSION STUDIES ON SANDSTONE THROUGH
WHICH THE GLEN CANYON DAM DIVERSION
TUNNELS WILL PASS--GLEN CANYON DAM--
COLORADO RIVER STORAGE PROJECT

Hydraulic Laboratory Report No. Hyd-423

Subject: Erosion studies on sandstone through which the Glen
Canyon Dam diversion tunnels will pass--Glen Canyon Dam--
Colorado River Storage Project

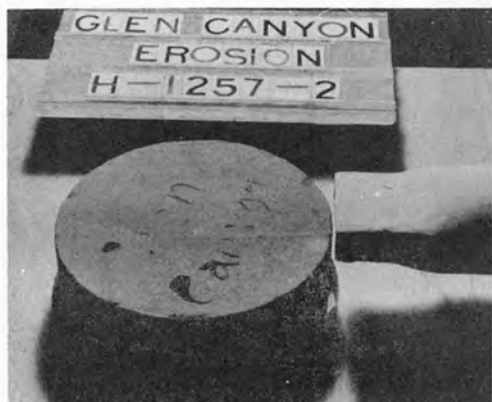
A. Surface before tests

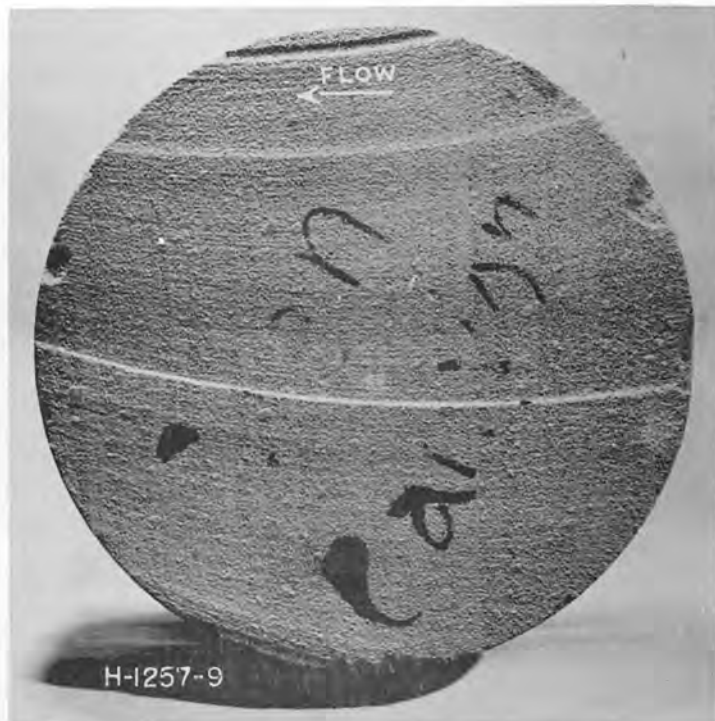
B. Erosion after 4 hrs. at 20 fps, 25½ hrs. at 40 fps, 16 hrs. at 58 fps, and 7½ hrs. at 72 fps with flow parallel to surface.

Very little material was removed from Sample 33-7-126 during the tests with clear water and with the flow parallel to the core surface. A 4-hour test at 20 feet per second, followed by a 25-1/2-hour test at 40 feet per second, produced negligible erosion. An additional 16-hour test at 58 feet per second, and a 7-1/2-hour test at 72 feet per second produced barely detectable erosion (Figure 2B). Similarly, only negligible erosion was detected on Sample 29-8-8 after a 13-hour test at 40 feet per second (Figure 3B).

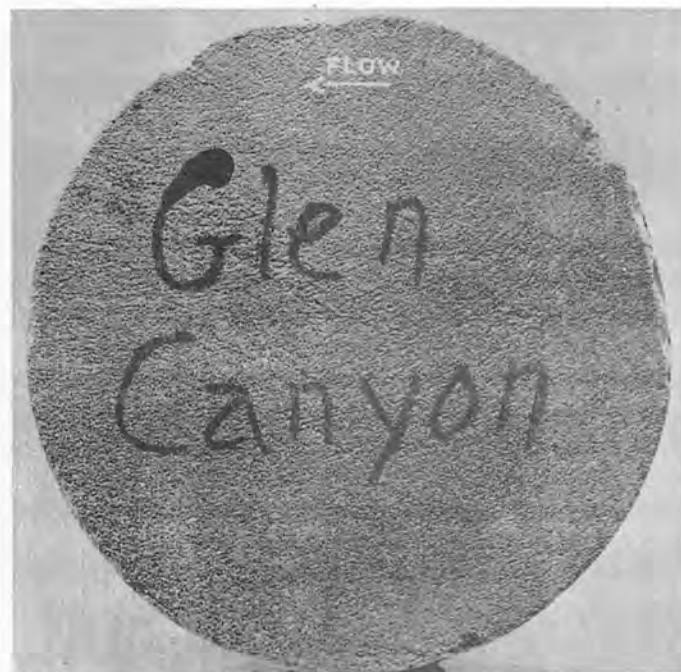
C. Erosion after above test plus 24 hours at 72 fps with flow impinging at 25° .

increased to 110 feet per second, noticeable erosion occurred in 10 hours of operation (Figure 2C). Sample 29-8-8 showed practically no erosion following the impinging test with a velocity of 72 feet per second for 24 hours (Figure 3C).

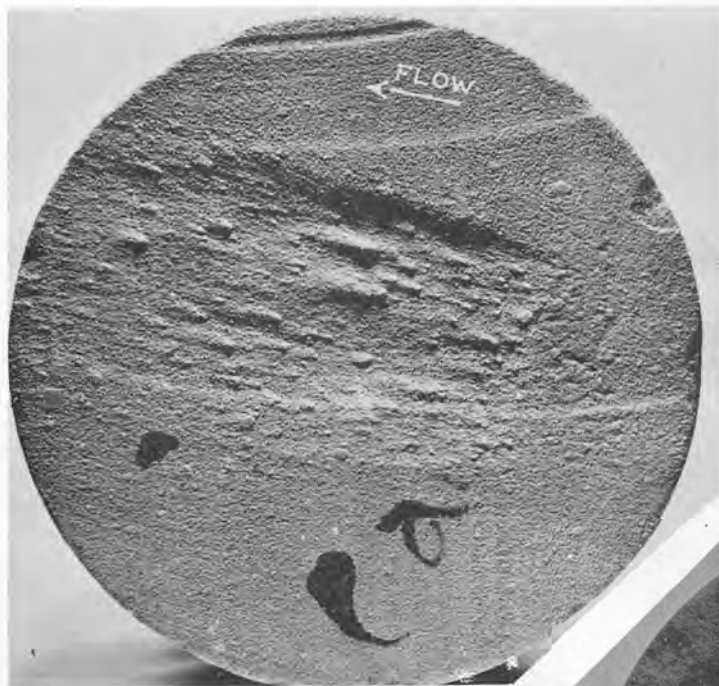
A. 4 hour test at 20 fps
removed 5.2cc of sandstone.
Sediment concentration - 214 ppm.

In the first tests with sediment-laden water, the sediment consisted of ordinary commercial sand having a mean diameter of 0.40 mm (Figure 6A). In a 4-hour test with a stream velocity of 20 feet per second, 5.2 cc of sandstone material were worn from the surface of Sample 33-7-126 (Figure 4A). The eroded portion of the sample was then trimmed to a fresh surface. A test was made with a velocity of 30 feet per second and 38.1 cc of sandstone were removed in 4 hours (Figure 4B). In a similar 4-hour test with a velocity of 40 feet per second, 52.5 cc of sandstone were removed (Figure 4C). The sediment loads were 214, 911 and 632 ppm, respectively, and the sediment sizes are shown in Figure 6A.

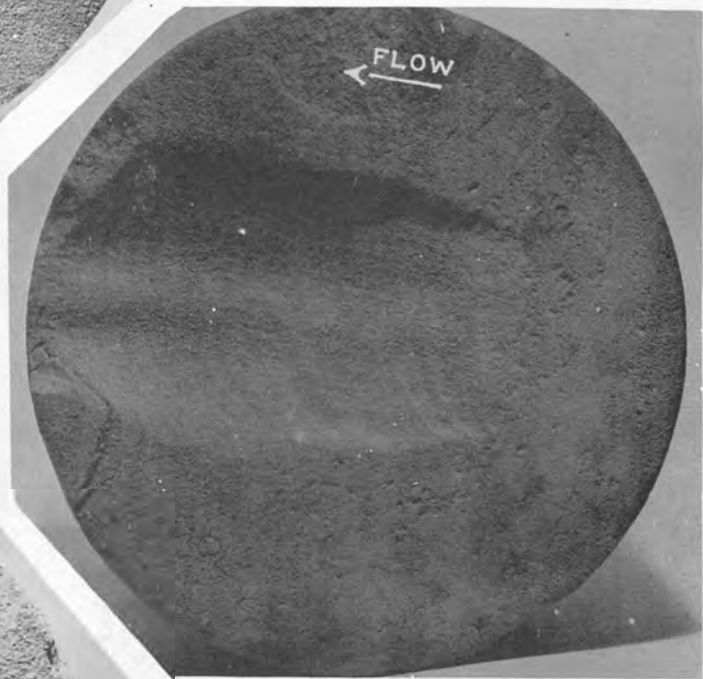
B. 4 hour test at 30 fps
removed 38.1cc of sandstone
Sediment concentration - 911 ppm.

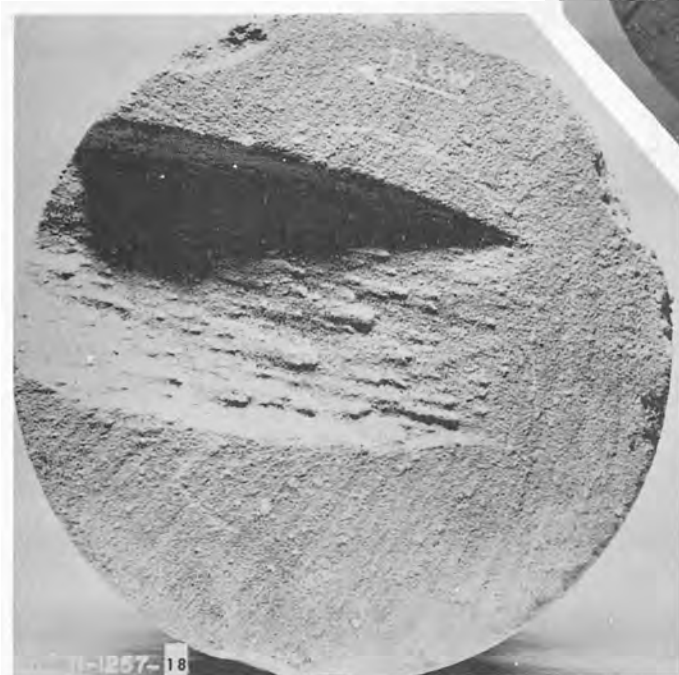
C. 4 hour test at 40 fps removed 52.5 cc of sandstone
Sediment concentration - 632 ppm.
GLEN CANYON SANDSTONE EROSION STUDIES

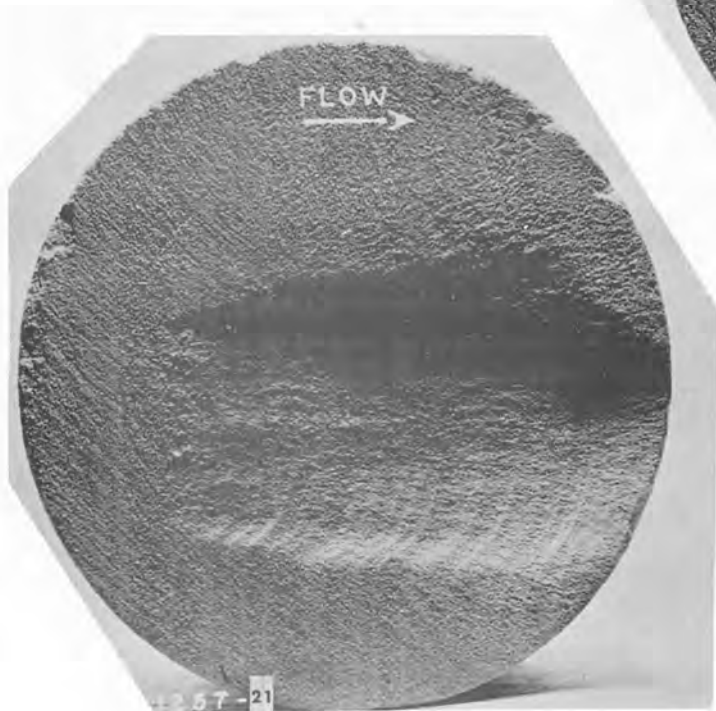
C. 4 hour test at 40 fps removed 25.5cc of sandstone
Sediment concentration-2,370 ppm.

Erosion With Sediment-Laden Water - Fine Grain Sand
Similar to that at Glen Canyon Damsite Sample 33-7-126

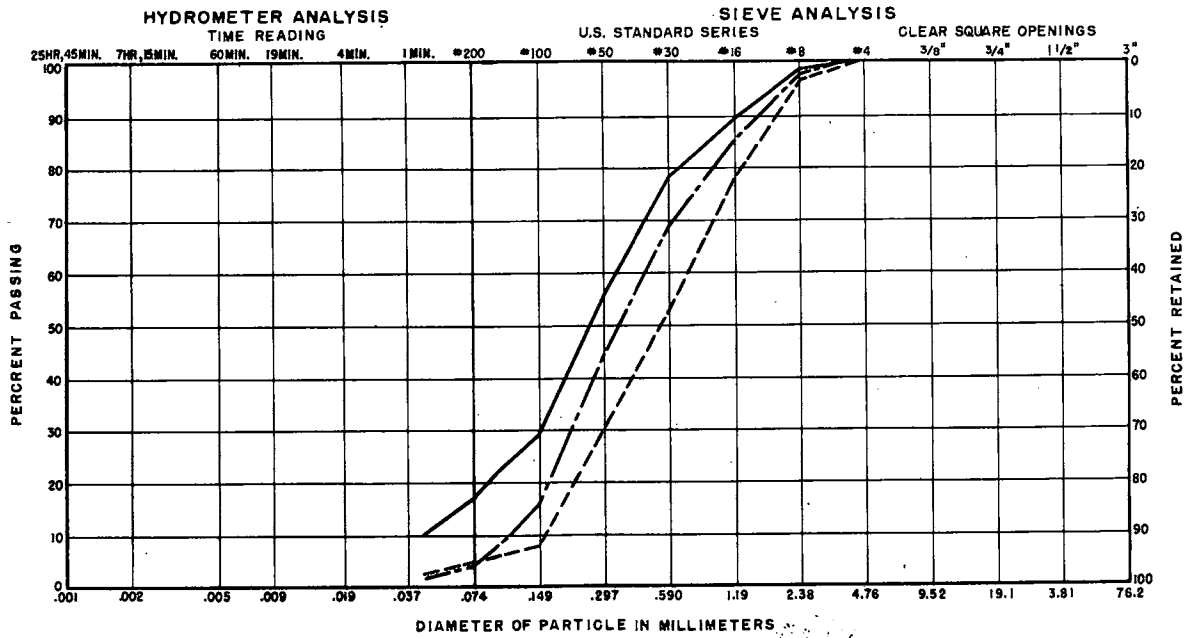
A - TESTS WITH COMMERCIAL SAND
