UNITED STATES
DEPARTMENT OF THE INTERIOR
BUREAU OF RECLAMATION

HYDRAULIC MODEL STUDIES OF THE
TRINITY DAM MORNING-GLORY SPILLWAY
TRINITY RIVER DIVISION
CENTRAL VALLEY PROJECT--CALIFORNIA

Hydraulic Laboratory Report No. Hyd-447

April 22, 1960

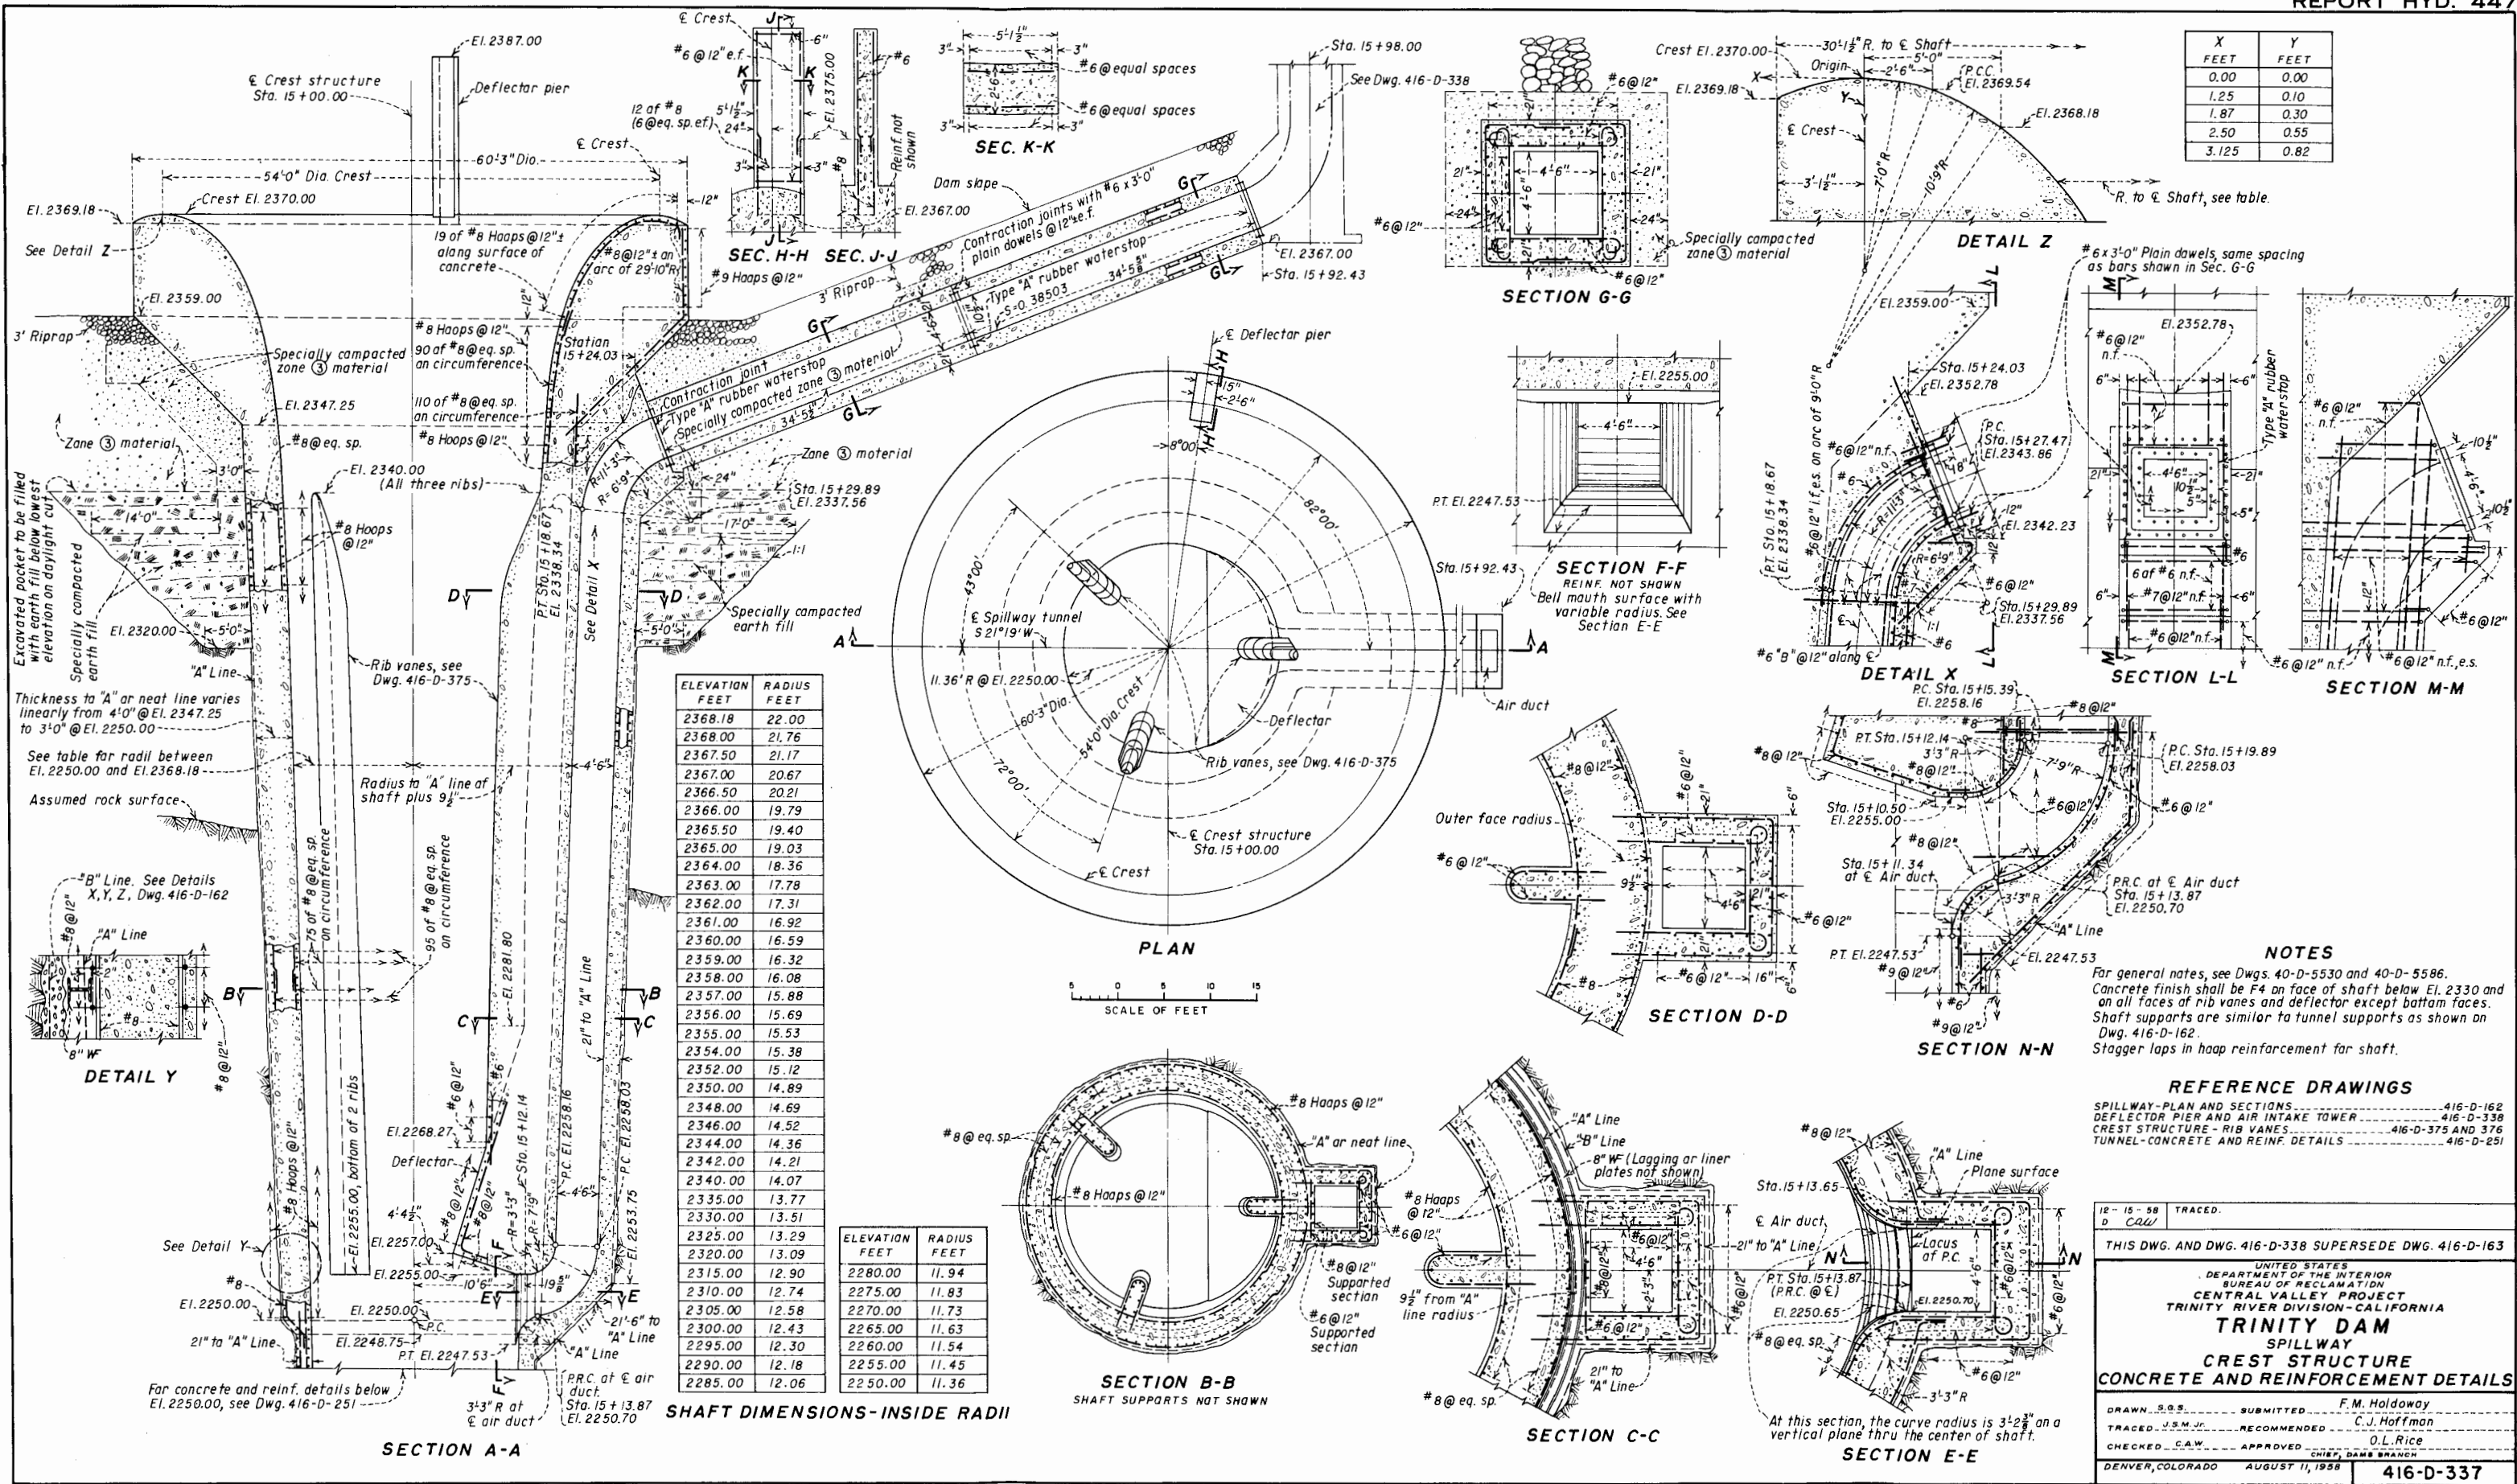
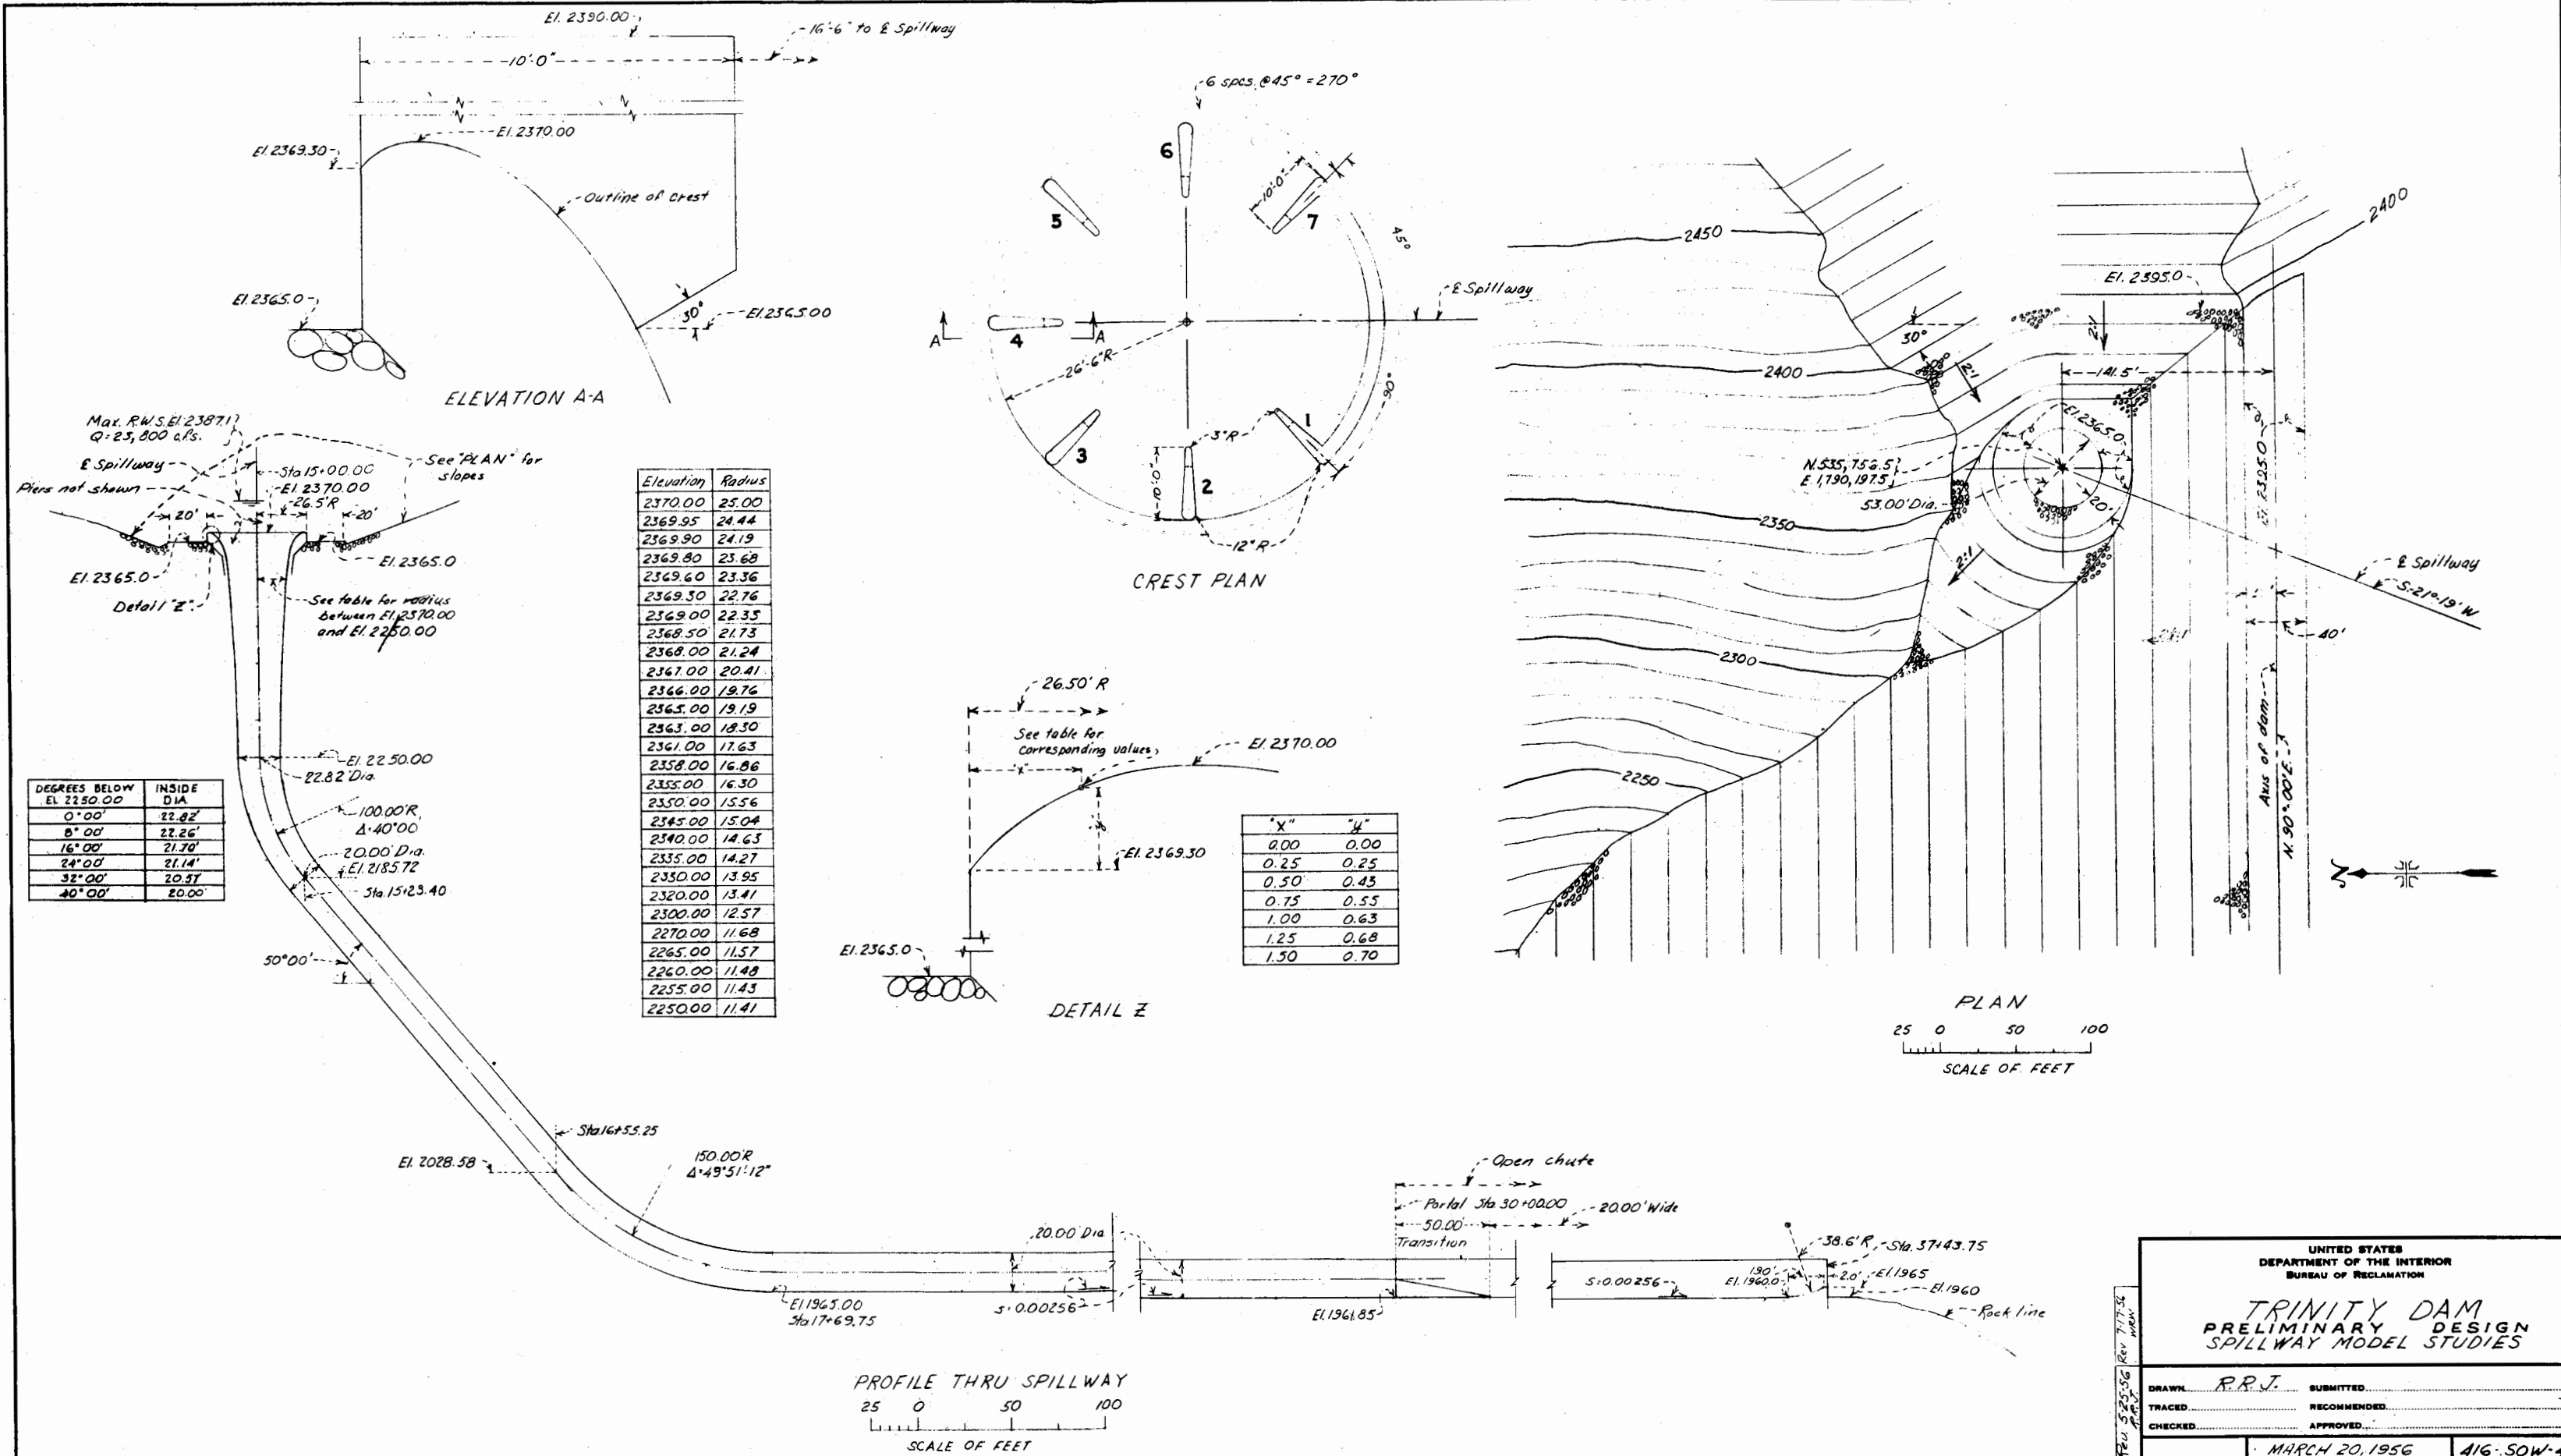
**TRINITY DAM
PRELIMINARY DESIGN
SPILLWAY MODEL STUDIES**

The preliminary design of the crest profile, Figure 4, was based on the results of investigations of the undernappe shape of water flowing over a sharp-crested circular weir. The recommended design procedures are reported in the Transactions of the American Society of Civil Engineers, Volume 121, 1959. ^{1/} Profiles obtained from these studies are correct when (1) the approaching flow is radial, and (2) the undernappe is at atmospheric pressure. For Trinity spillway, the first assumption is only partly true, and since the undernappe surface is in contact with a concrete surface, the second assumption may not be true. Therefore, the preliminary design must be regarded only as a starting point from which development tests may proceed.

Description. --The preliminary design is shown in Figure 4. On the crown side of the spillway, one-quarter of the crest circumference was blocked to prevent flow of water. This was done to allow an unimpeded flow of air into the shaft. The outside diameter of the spillway was 53 feet, and the crest diameter was 50 feet.

Following the trial runs made without reservoir topography, the land features in Figure 4 were installed. Flow characteristics described above were found in general to apply with the topography in place. Topography in some form was used in all tests which followed.

In the original design, Figure 4, the berm surrounding the morning-glory was at elevation 2364, 5 feet below the spillway crest. Minimum width was 20 feet on the east, southeast, and south and the maximum width was 25 feet on the northwest. Since the operating head for maximum discharge is 17.1 feet, and the total depth of flow over the berm is 23.1 feet, the depth from berm to crest amounts to 26 percent of the total.

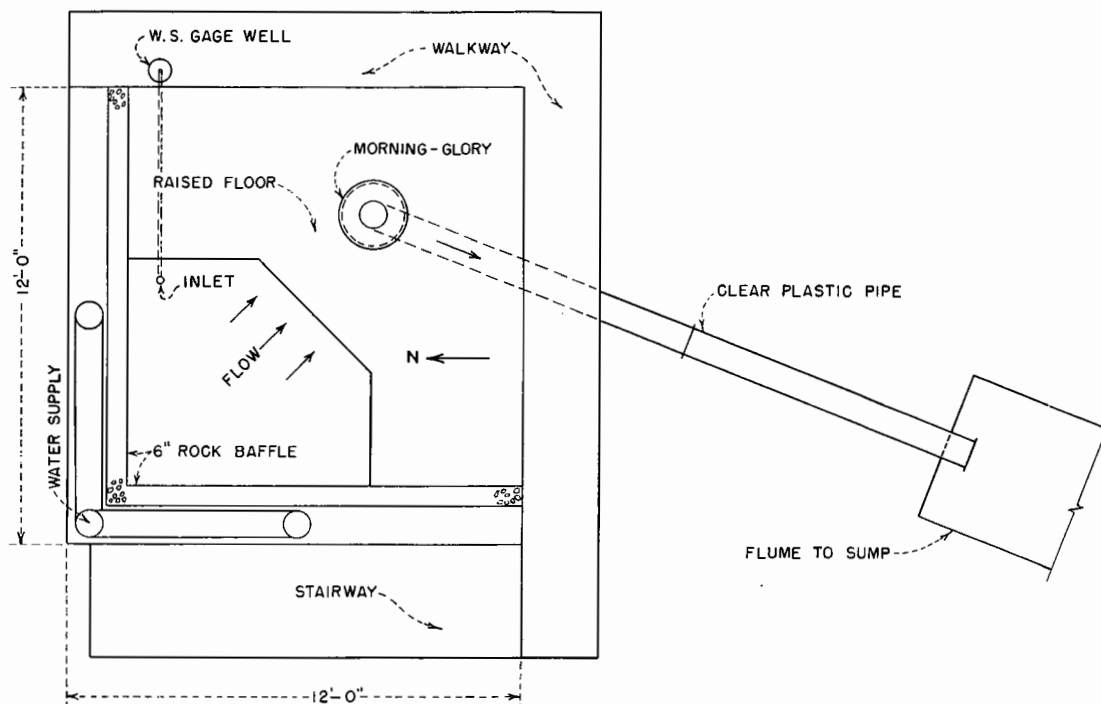
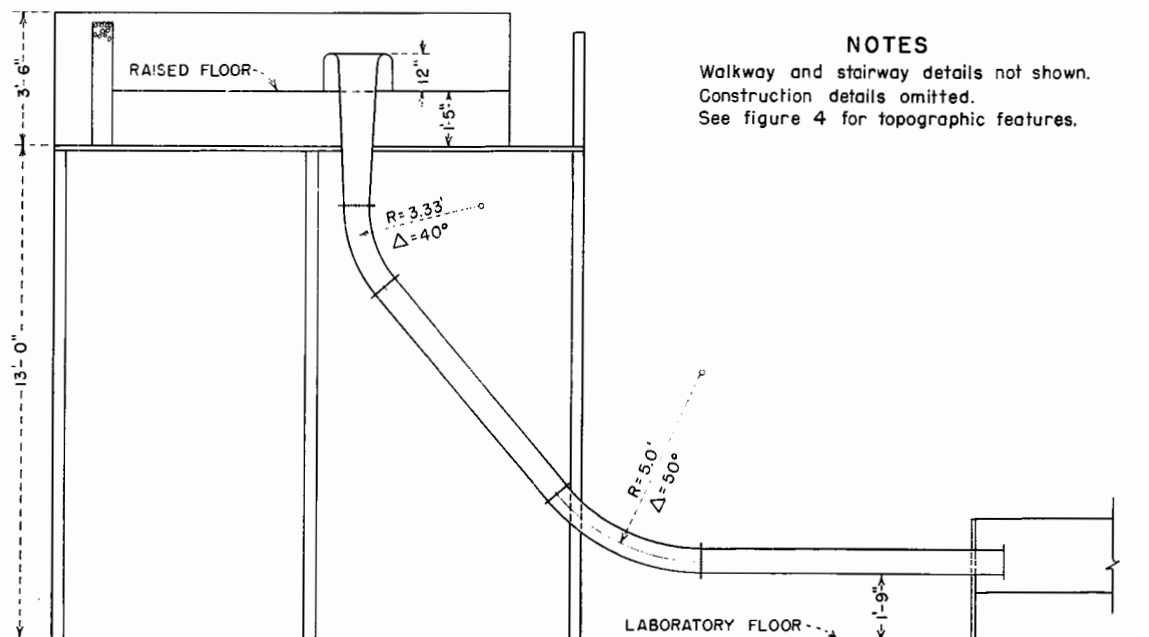
PLAN

SECTION THROUGH MORNING-GLORY AND PLASTIC PIPE

TRINITY MORNING-GLORY SPILLWAY
MODEL LAYOUT
1:30 MODEL

was built initially, as shown in Figure 4. A rock baffle along two sides of the head box served to minimize the turbulence in the inflowing water and to introduce water to the model reservoir in as uniform a manner as possible. The water supply pipe was divided into two branches to help equalize the distribution of flow through the baffle. The morning-glory spillway was formed in mortar and screeded to the shape of galvanized iron templates. The vertical shaft and tunnel were made of transparent plastic pipe to facilitate viewing of the flow throughout the structure.

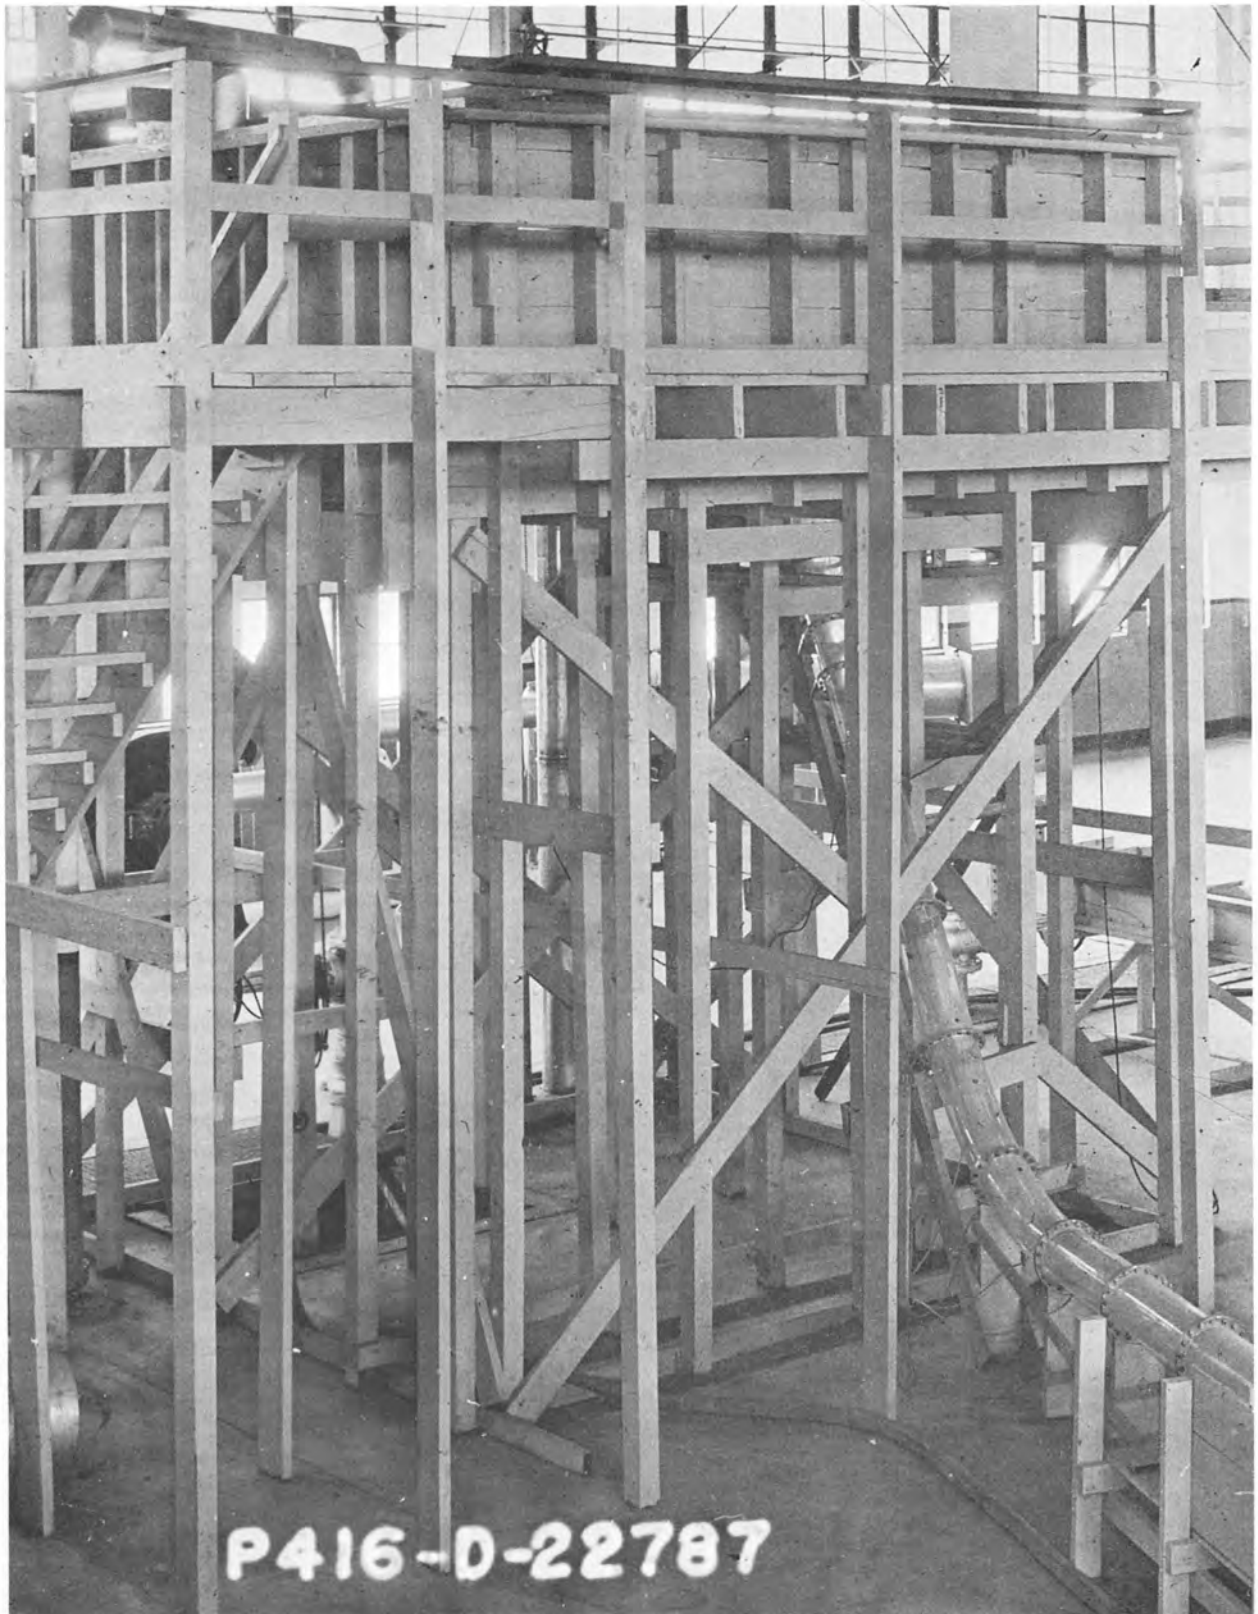
TRINITY MORNING-GLORY SPILLWAY
1:30 MODEL HEADBOX AND TUNNEL

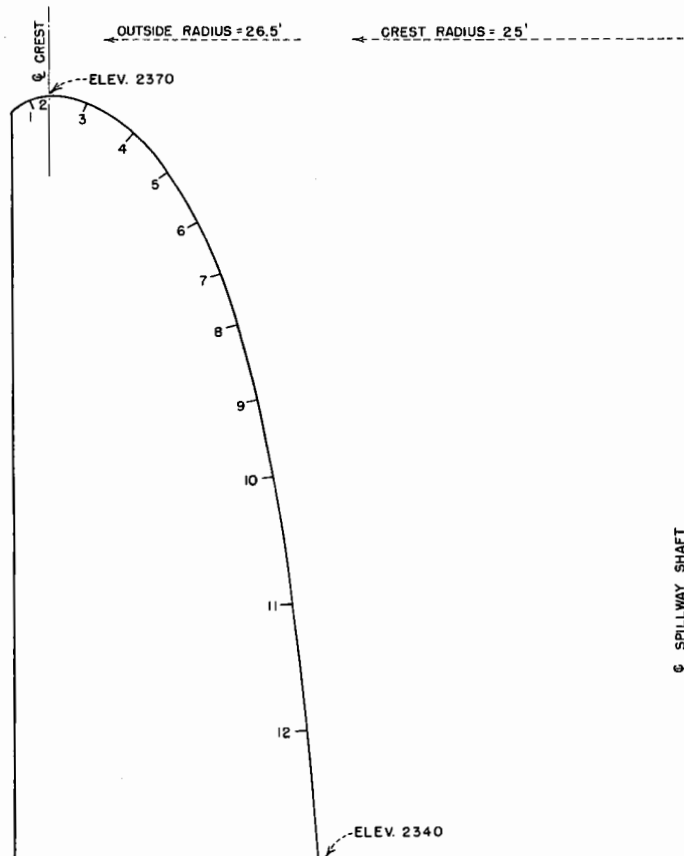
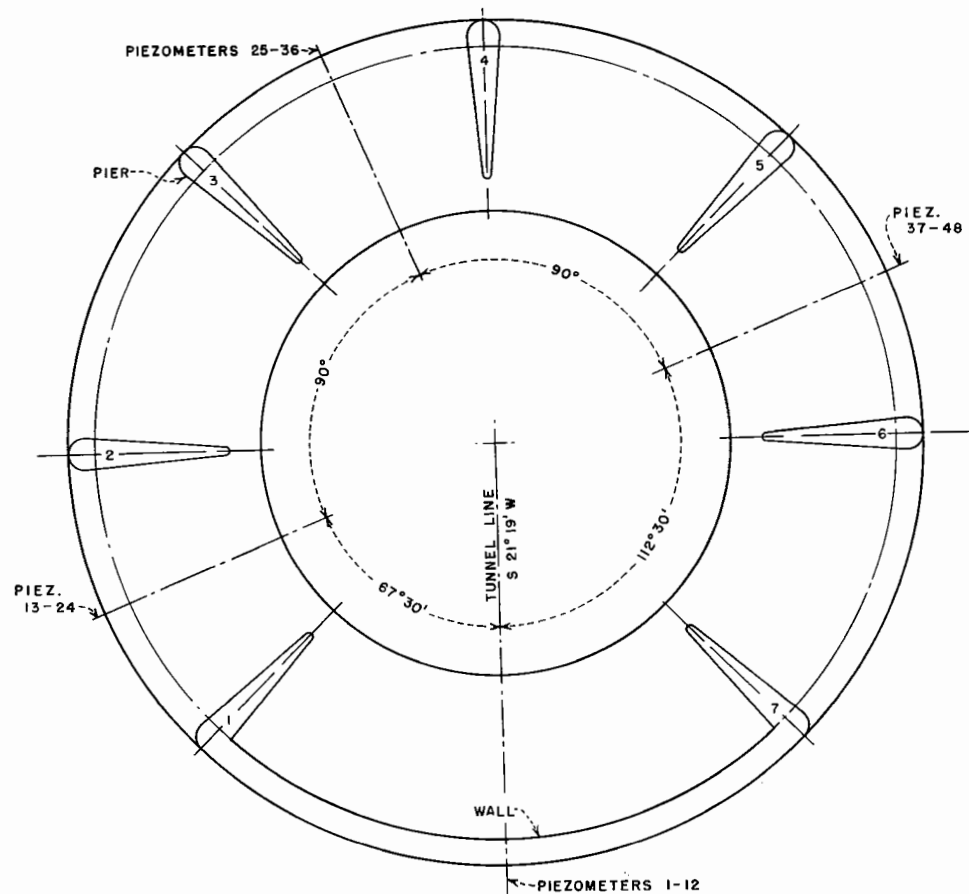
SECTION
SHOWING PIEZOMETER LOCATIONS

PLAN
SHOWING PIEZOMETER SETS

TRINITY MORNING-GLORY SPILLWAY
PRELIMINARY CREST DESIGN
1:30 MODEL

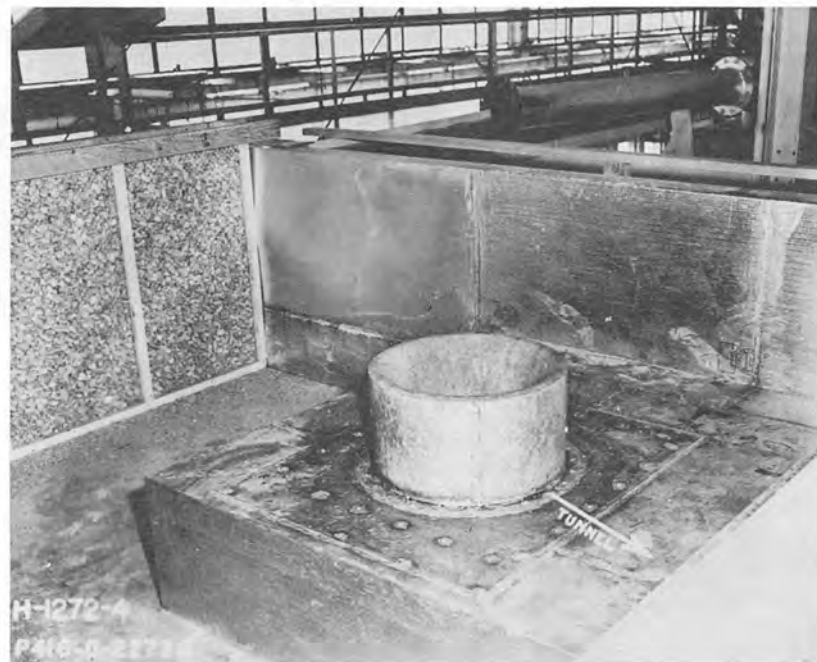
TRINITY MORNING-GLORY SPILLWAY
MORNING-GLORY STRUCTURE BEFORE
INSTALLATION OF TOPOGRAPHY
1:30 MODEL

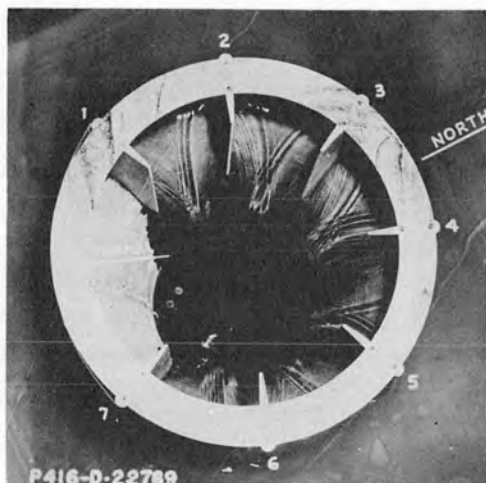
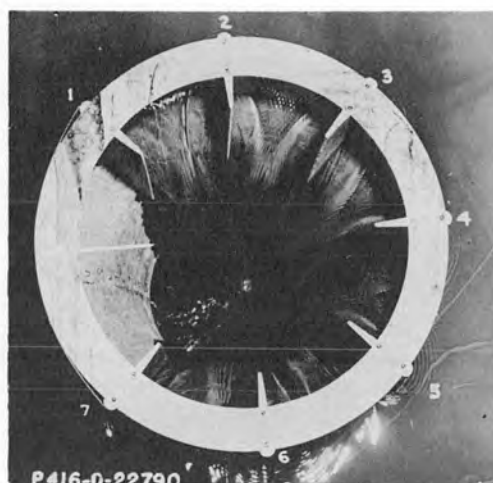
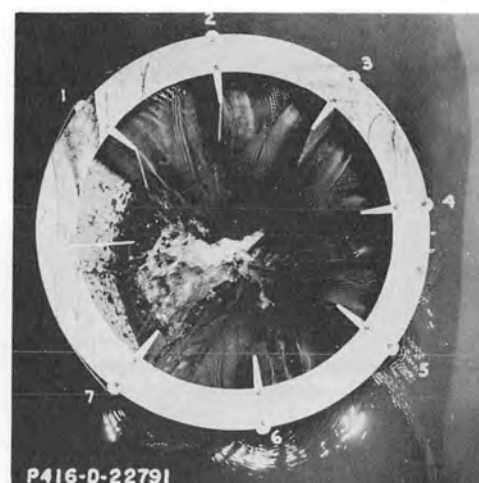
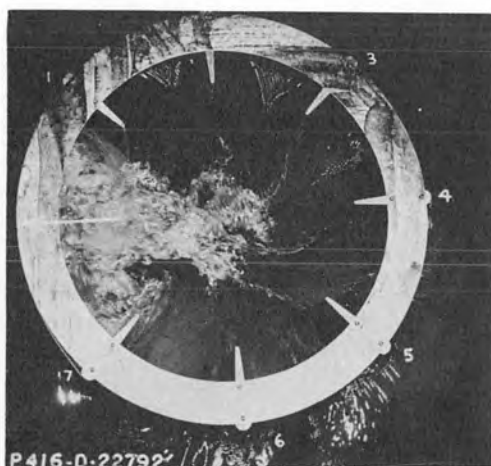
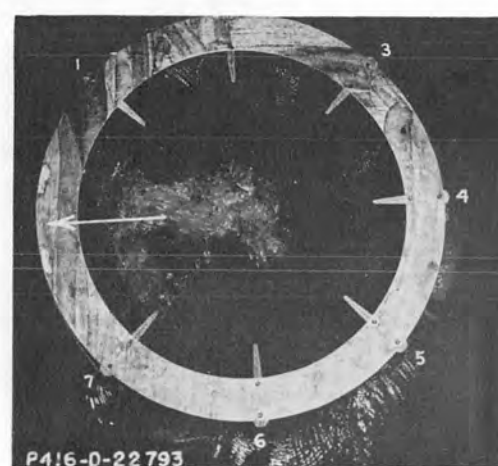
A. Discharge 5,600 cfs

B. Discharge 11,200 cfs

C. Discharge 16,800 cfs

D. Discharge 22,400 cfs

E. Discharge 26,700 cfs

TRINITY MORNING-GLORY SPILLWAY
CREST FLOWS, PRELIMINARY DESIGN, 1:30 MODEL

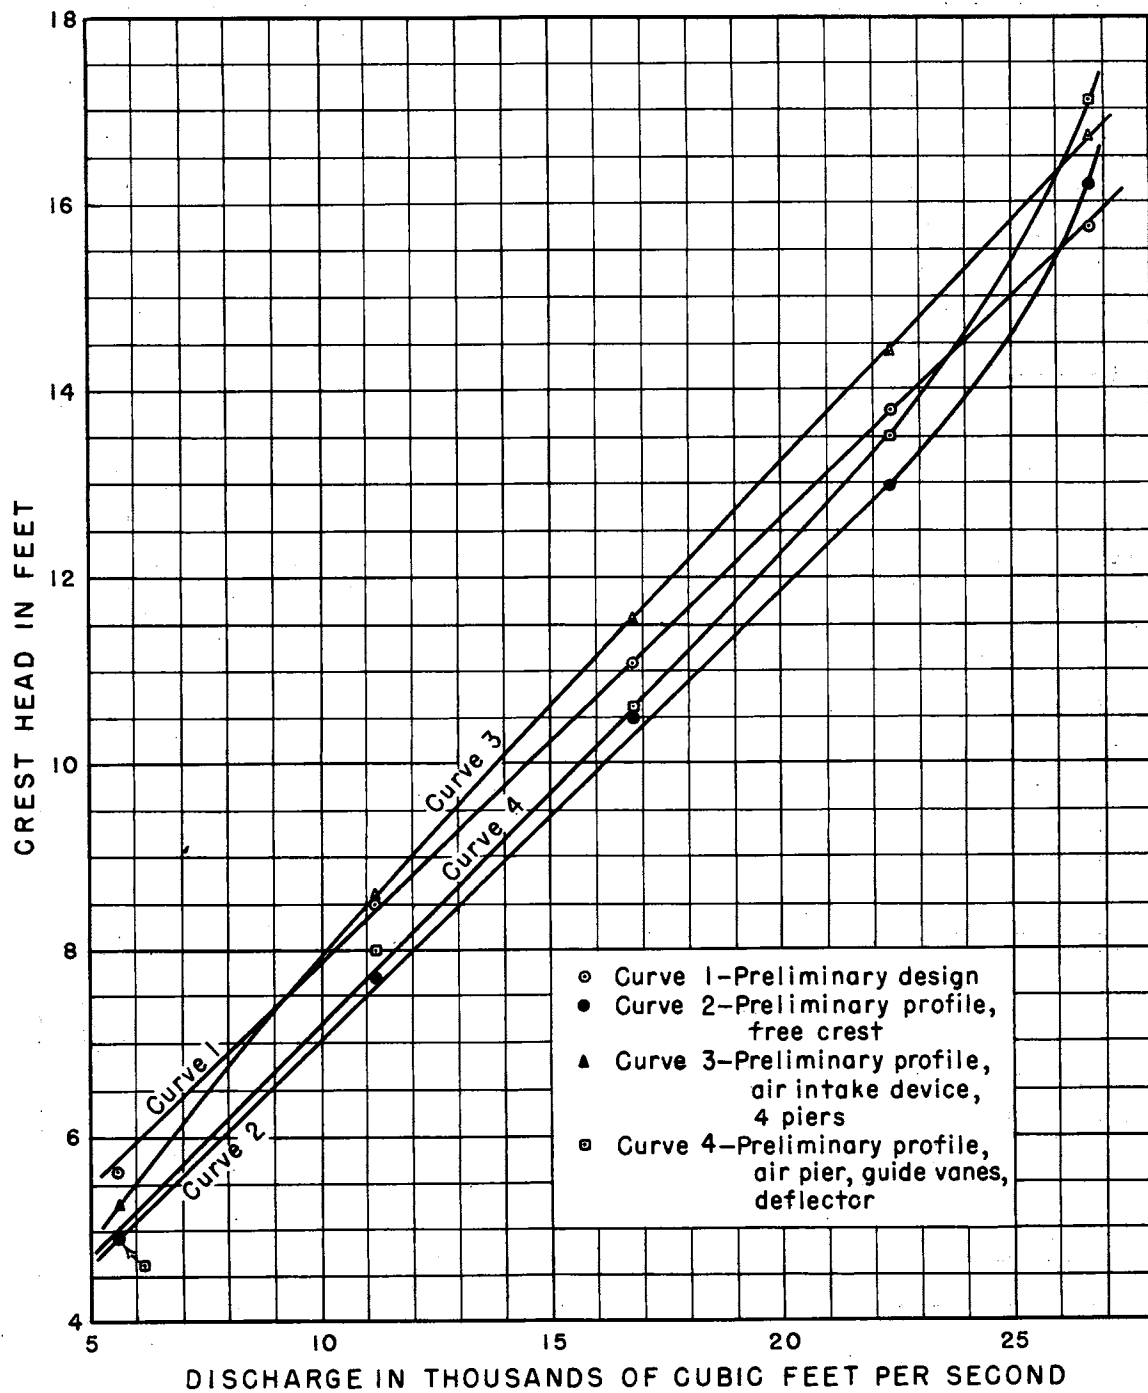
TRINITY MORNING - GLORY SPILLWAY

HEAD - DISCHARGE CURVES
PRELIMINARY PROFILE

1:30 MODEL

Head-discharge relationship. --For comparative purposes, head-discharge relationships for all preliminary spillway profiles have been plotted in groups on Figure 10, 11, and 12. Figure 13 shows the relationship for the recommended design.

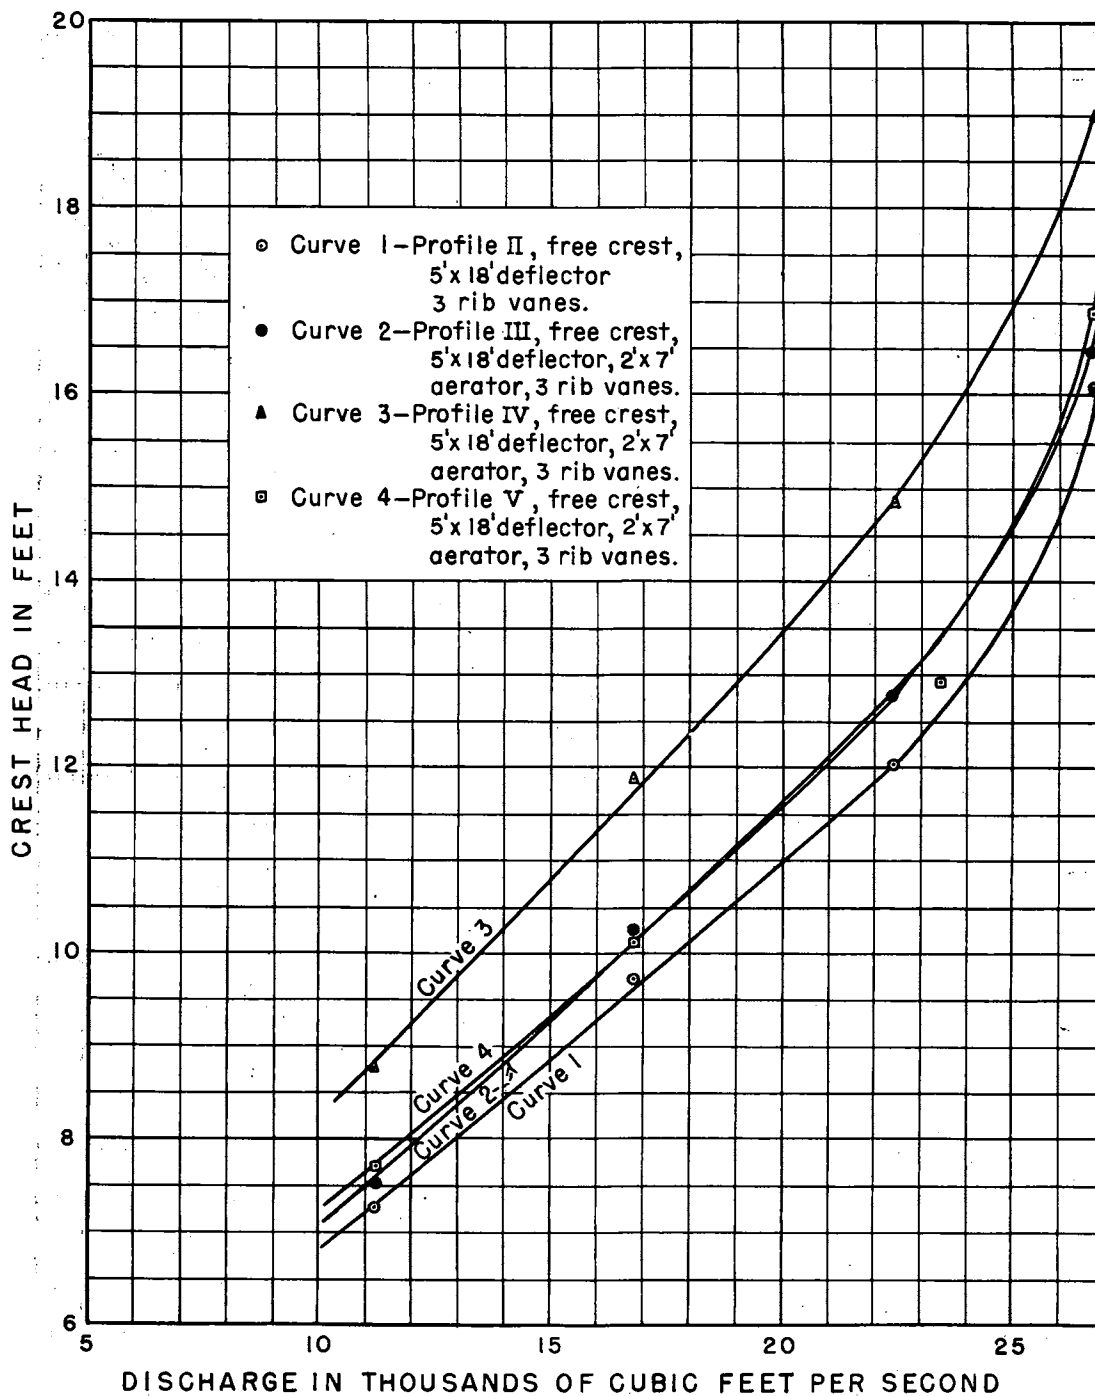
FIGURE 11
REPORT HYD. 447

TRINITY MORNING - GLORY SPILLWAY

HEAD - DISCHARGE CURVES
 VARIOUS CREST PROFILES
 1:30 MODEL

Head-discharge relationship.--Curve 1 of Figure 11 shows the variation of crest head with discharge for Profile II. Less head was required to pass a given discharge with Profile II than with any scheme using Profile I. The upturn in the rating curve for Profile II showed that the deflector began to decrease the discharge and raise the head on the crest at a point near 24,000 second-feet, but the head at this discharge was over 4 feet lower than desired. The increase in deflector size from 2 by 10 feet to 5 by 18 feet was therefore inadequate to produce the design reservoir head.

Head-discharge relationship. --Curve 2 of Figure 11 shows that more head was required to pass a given discharge than was required with Profile II. Curves 1 and 2 are separated by about 0.5 foot. Though the crest diameter was not changed, flattening the profile in the crest region apparently made the spillway less efficient and produced a rise in operating head. Curve 2 also shows a gradual shift in hydraulic control from crest to the deflector. At 24,000 second-feet, the crest head was 13.5 feet, still about 3.5 feet short of the design head.

Head-discharge relationship. --The head-discharge curve obtained for Profile IV, Curve 3 of Figure 11, was not appreciably different in shape from that derived from tests of Profile III; however, approximately 1-3/4 feet of additional head was required for all discharges. The characteristic upturn of the curve again occurred at 23,000 second-feet. This fact supported the contention that no boil existed at 15,000 second-feet. The operating head was about 1.2 feet below the design value.

Head-discharge relationship. --Curve 4 of Figure 11 shows the variation of crest head with discharge. In comparison with Curve 3 for Profile IV, less head was required to pass a given discharge, and the discharge curve was not appreciably different than the one for Profile III.

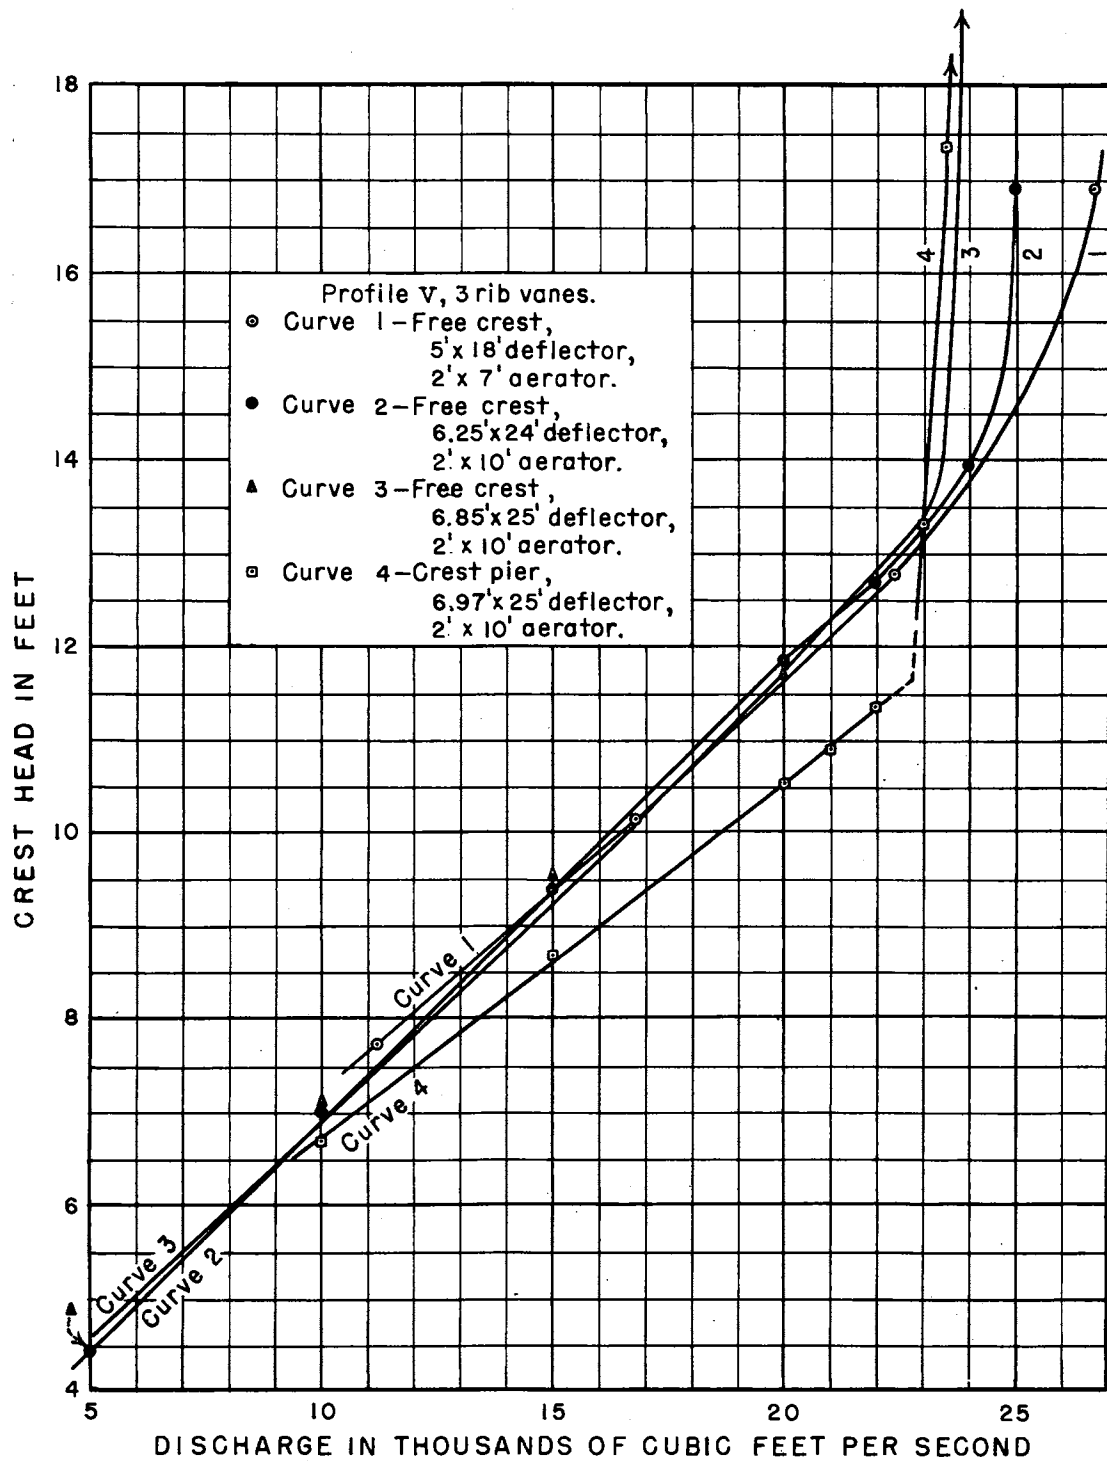
TRINITY MORNING - GLORY SPILLWAY

HEAD - DISCHARGE CURVES
CREST PROFILE V
1:30 MODEL

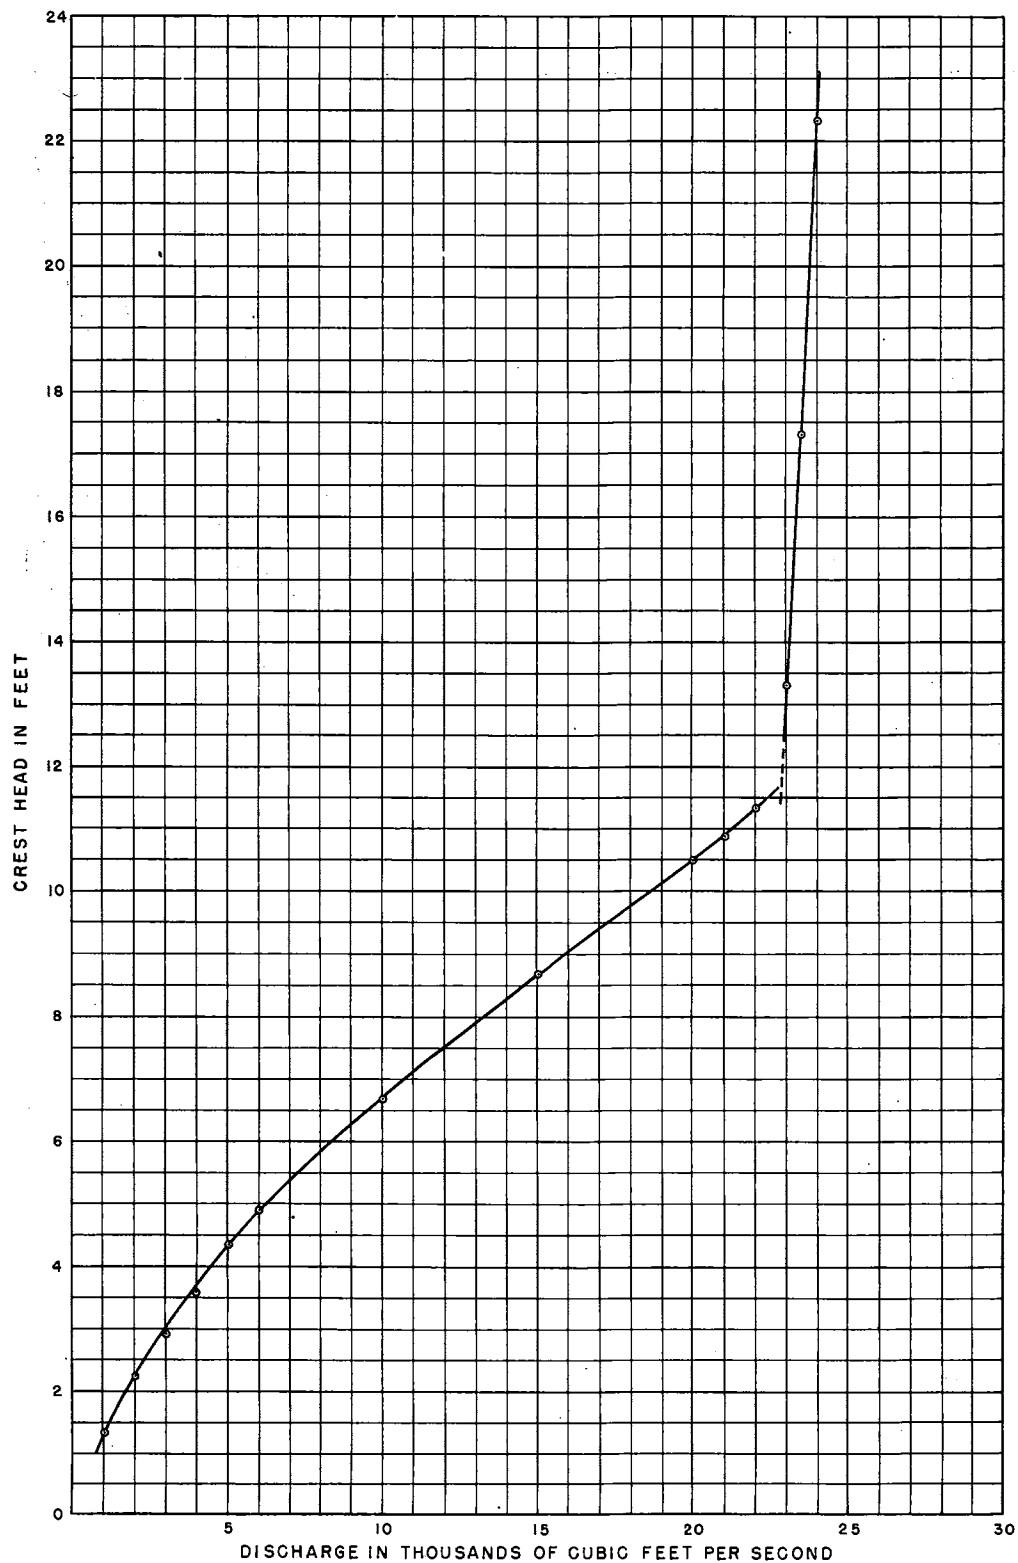
FIGURE 13
REPORT HYD. 447

TRINITY MORNING-GLORY SPILLWAY
HEAD - DISCHARGE CURVE FOR RECOMMENDED DESIGN

1:30 MODEL

The water discharge for which air demand is a maximum does not correspond to that which indicates an impending shift of hydraulic control from crest to deflector, Figure 13. From visual observation of flows above 21,000 second-feet, it did not appear that there was an increase in the intake of air through the water down

Figure 13 shows the head-discharge curve for the recommended profile, deflector pier, rib vanes, shaft deflector, and modified topography.
