UNITED STATES
DEPARTMENT OF THE INTERIOR
BUREAU OF RECLAMATION

HYDRAULIC MODEL STUDIES OF THE
TRINITY DAM MORNING-GLORY SPILLWAY
TRINITY RIVER DIVISION
CENTRAL VALLEY PROJECT--CALIFORNIA

Hydraulic Laboratory Report No. Hyd-447

April 22, 1960

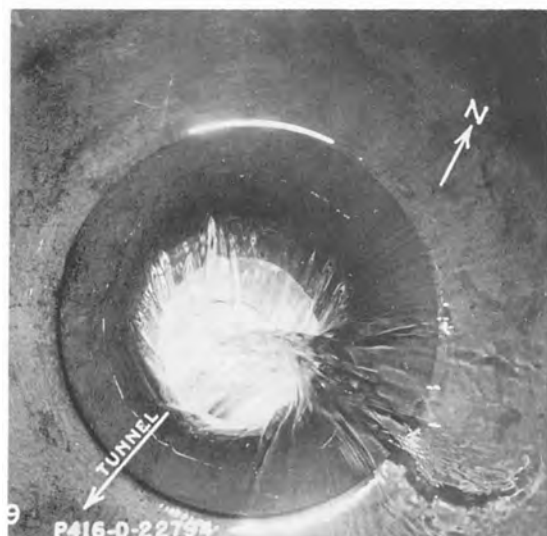
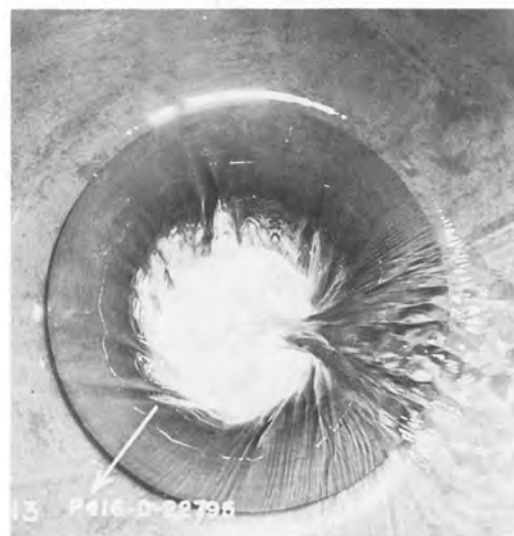
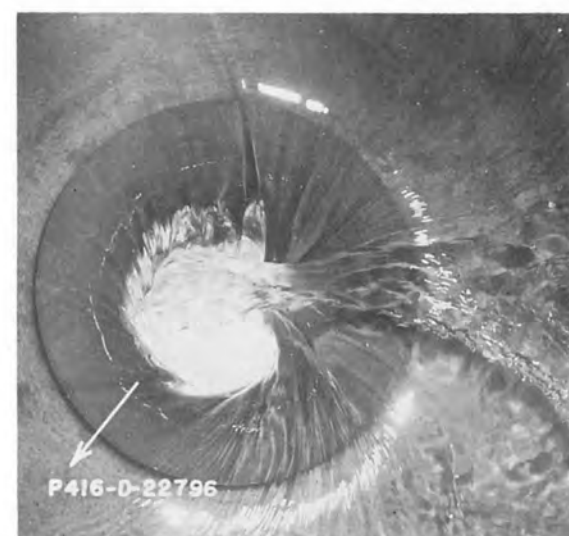
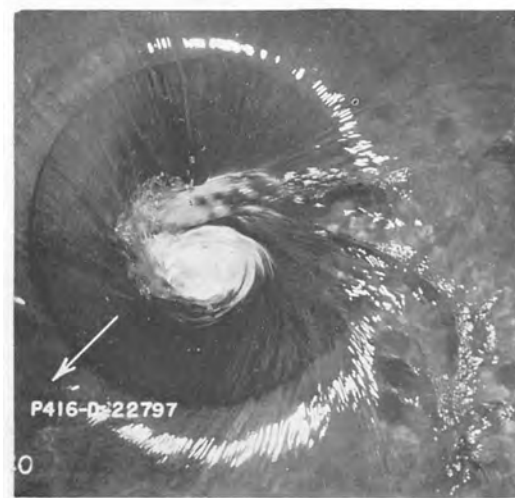
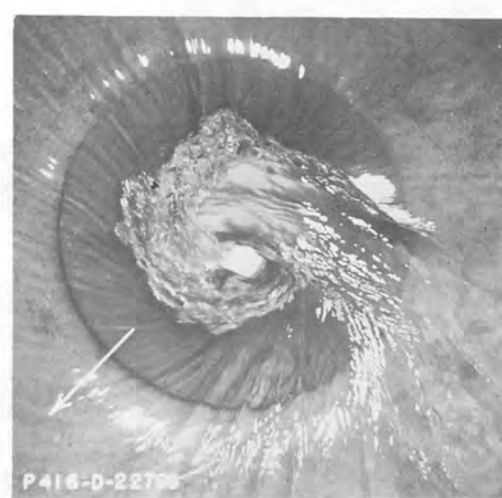
A. Discharge 5,600 cfs

B. Discharge 11,200 cfs

C. Discharge 16,800 cfs

D. Discharge 22,400 cfs

E. Discharge 26,700 cfs

TRINITY MORNING-GLORY SPILLWAY
CREST FLOWS, FREE CREST, PRELIMINARY PROFILE
1:30 MODEL

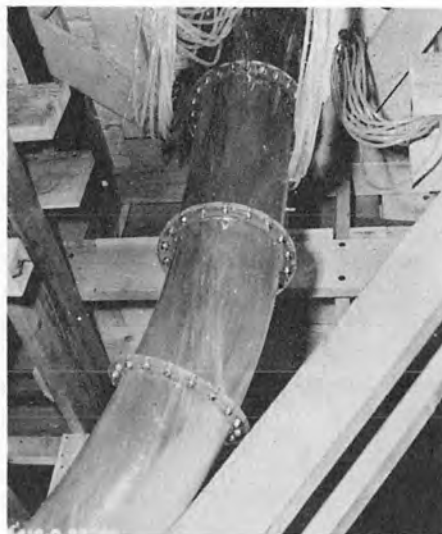
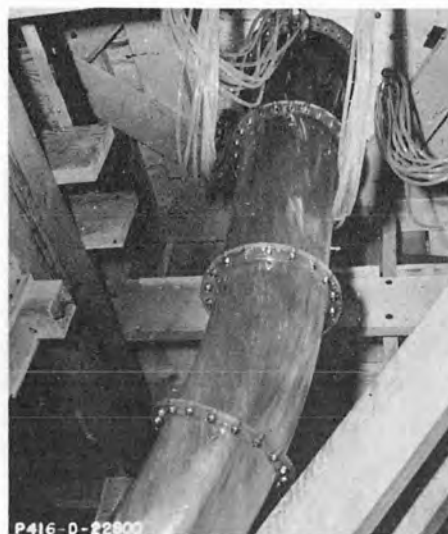
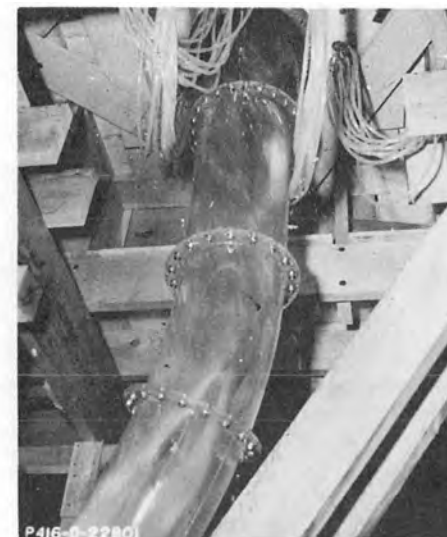
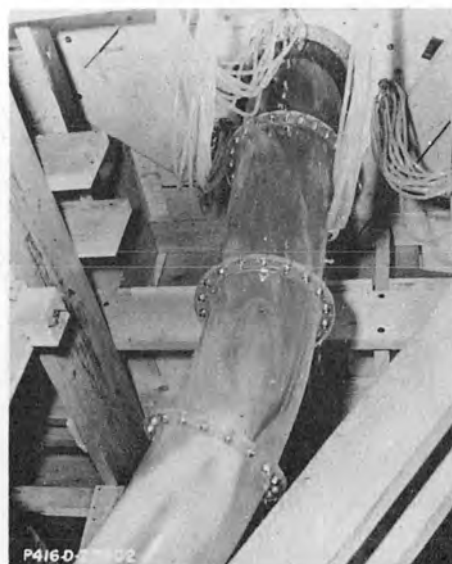
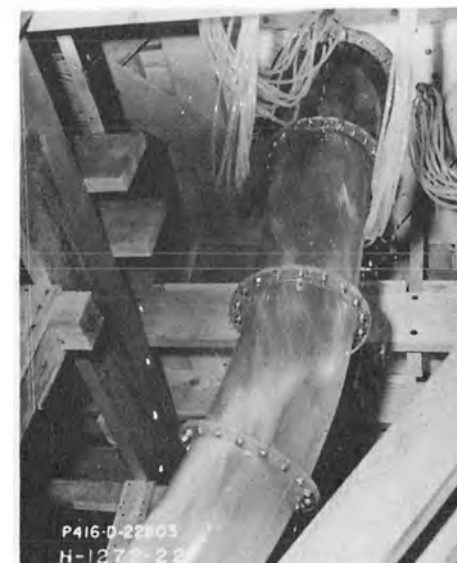
A. Discharge 5,600 cfs

B. Discharge 11,200 cfs

C. Discharge 16,800 cfs

D. Discharge 22,400 cfs

TRINITY MORNING-GLORY SPILLWAY
FLOW IN UPPER BEND
PRELIMINARY SPILLWAY PROFILE
1:30 MODEL

E. Discharge 26,700 cfs

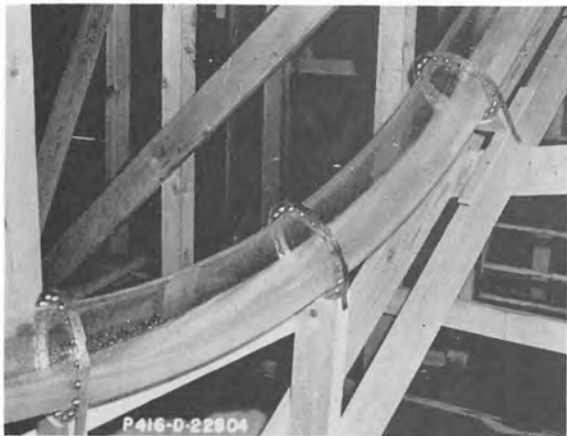
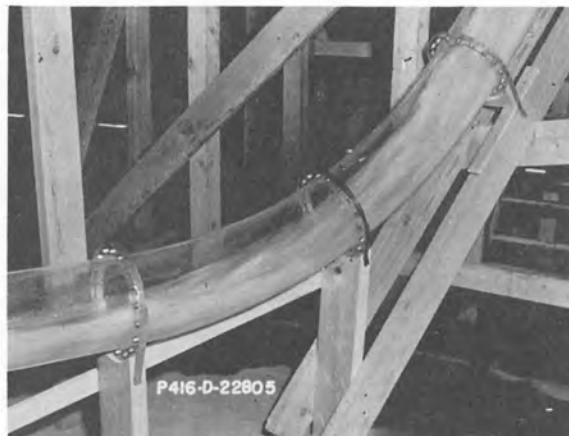
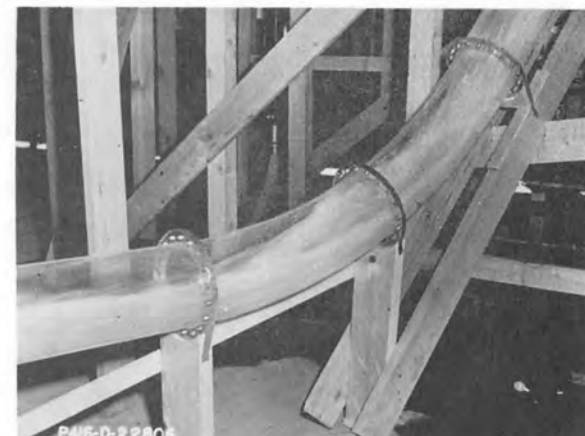
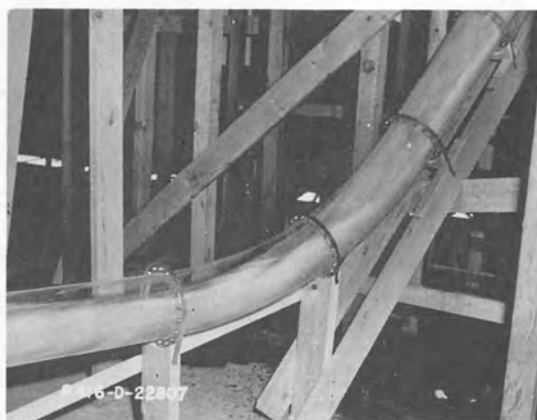
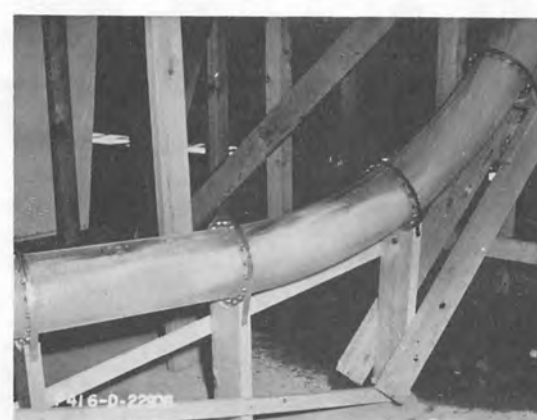
A. Discharge 5,600 cfs

B. Discharge 11,200 cfs

C. Discharge 16,800 cfs

D. Discharge 22,400 cfs

E. Discharge 26,700 cfs

TRINITY MORNING-GLORY SPILLWAY
FLOW IN LOWER BEND
PRELIMINARY SPILLWAY PROFILE
1:30 MODEL

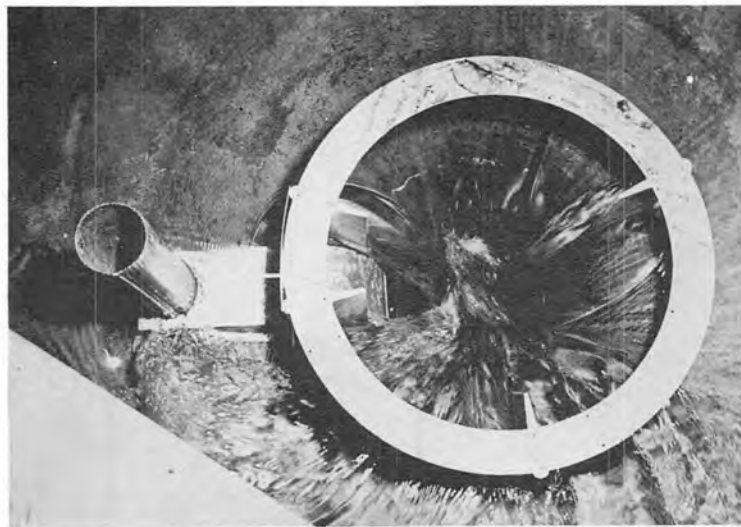
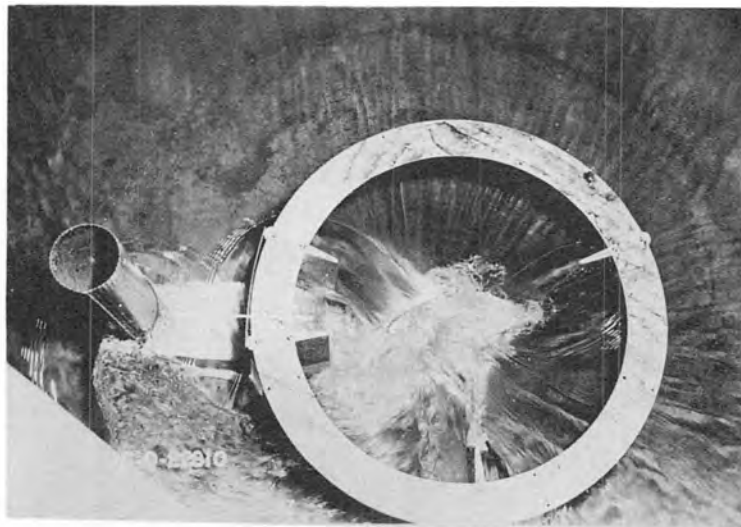
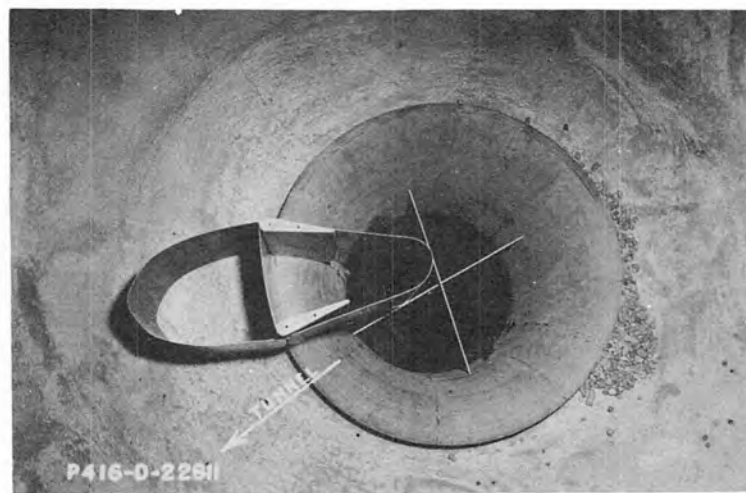
A. Air Intake Device, 4 piers, Discharge 16,800 cfs

B. Air Intake Device, 4 piers, Discharge 26,700 cfs

C. Air Intake Pier, Metal Guide Vanes, No Flow

TRINITY MORNING-GLORY SPILLWAY
PRELIMINARY PROFILE, AIR INTAKE DEVICES
1:30 MODEL

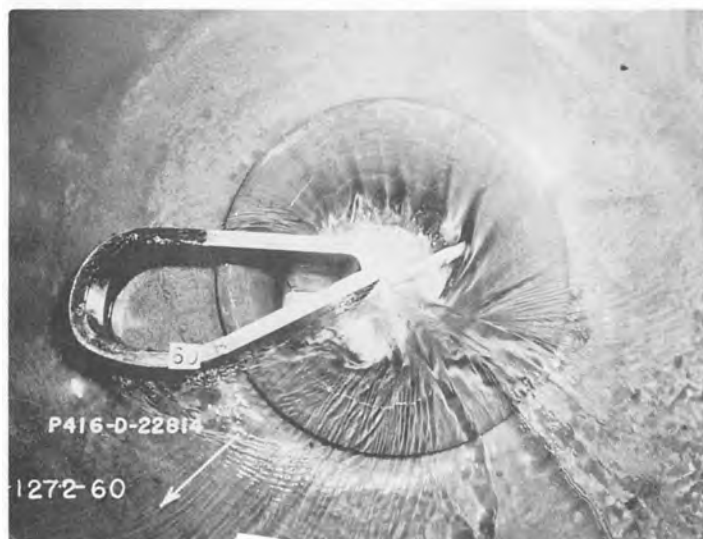
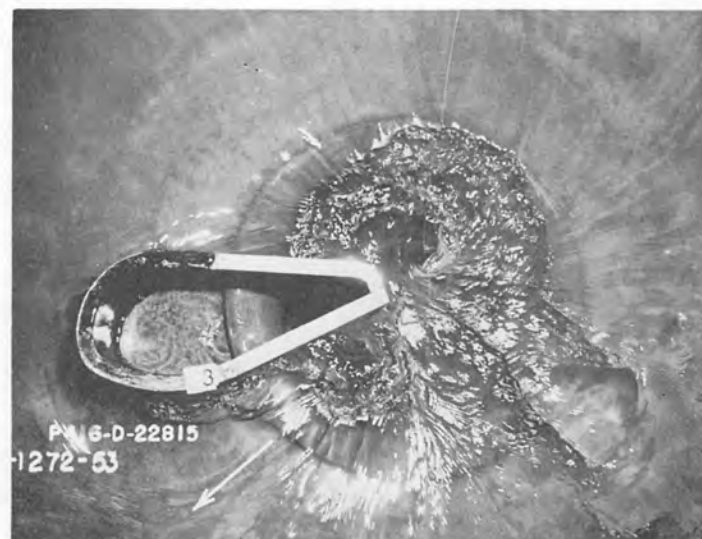
B. Discharge 16,800 cfs

C. Discharge 22,400 cfs

D. Discharge 26,700 cfs

TRINITY MORNING-GLORY SPILLWAY
 PRELIMINARY PROFILE, SCALED AIR INTAKE PIER AND GUIDE VANES
 1:30 MODEL

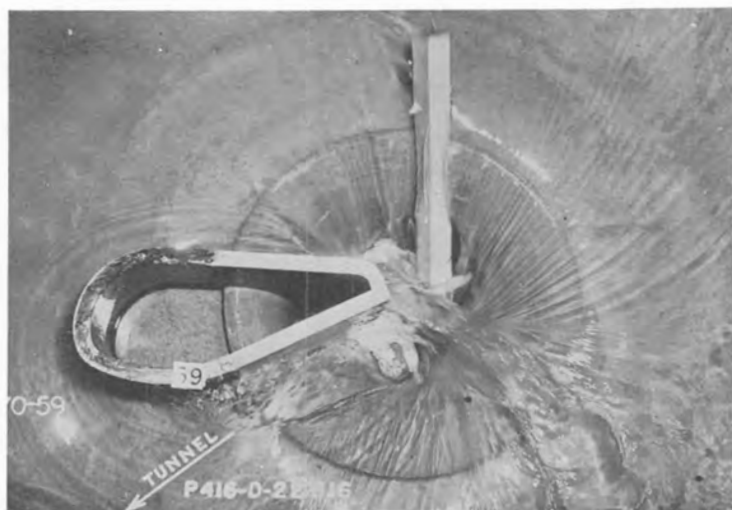
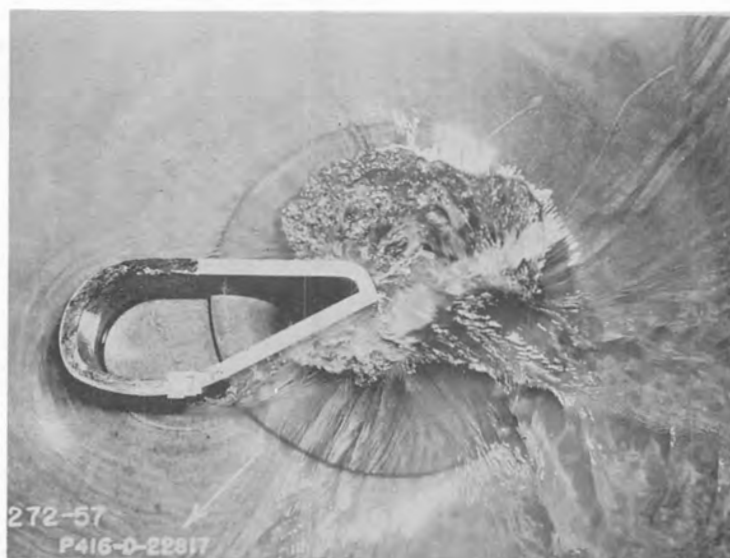
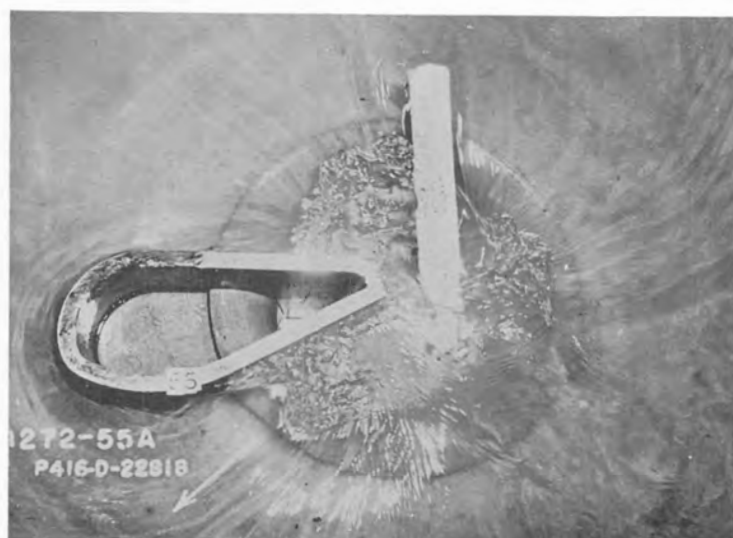
A. Discharge 16,800 cfs

B. Discharge 22,400 cfs

C. Discharge 26,700 cfs

TRINITY MORNING-GLORY SPILLWAY
PRELIMINARY PROFILE, SCALED AIR INTAKE PIER AND GUIDE VANES
LOGS JAMMED IN THROAT OF STRUCTURE
1:30 MODEL

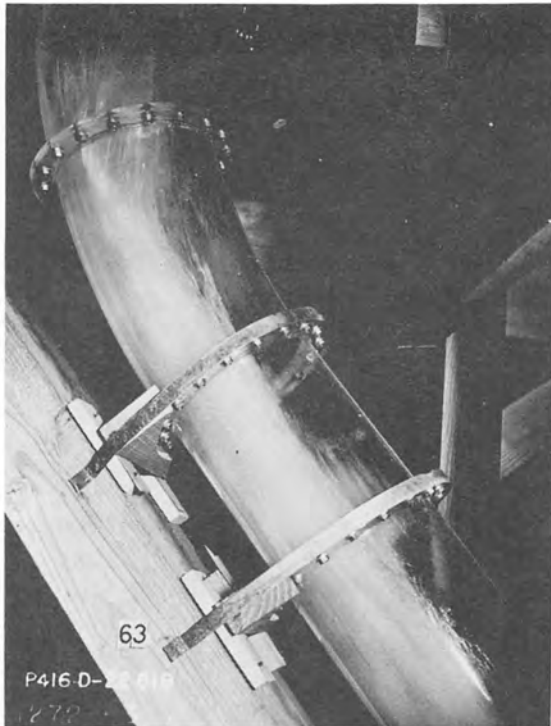
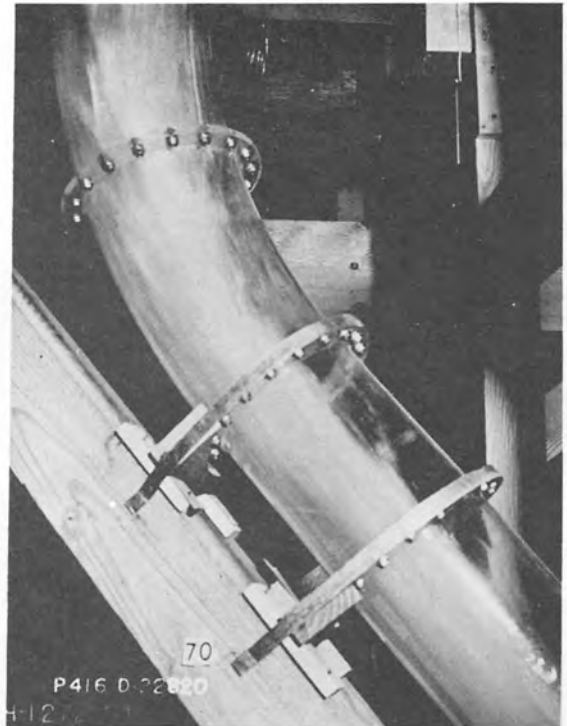
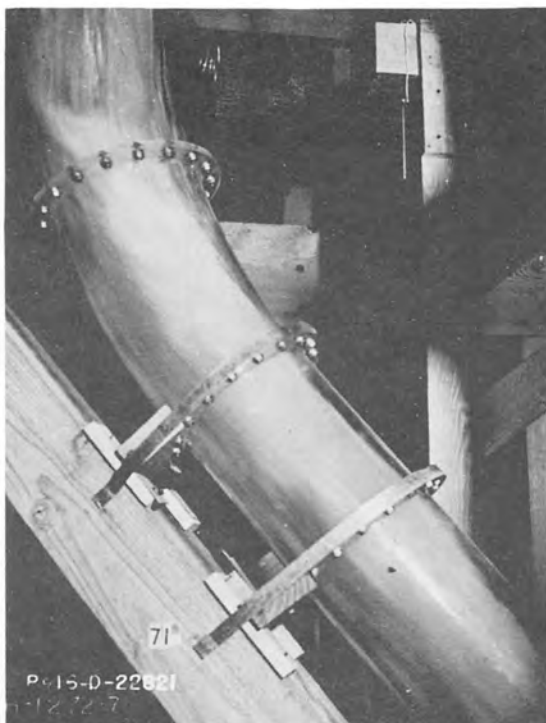
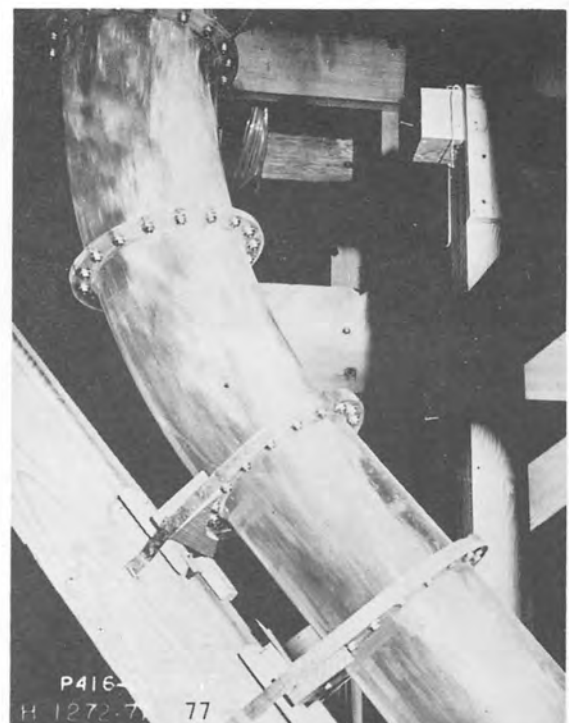
A. Discharge 11,200 cfs

B. Discharge 16,800 cfs

C. Discharge 22,400 cfs

D. Discharge 26,700 cfs

TRINITY MORNING-GLORY SPILLWAY
FLOWS IN UPPER BEND
PRELIMINARY PROFILE, SCALED AIR INTAKE PIER AND GUIDE VANES
1:30 MODEL

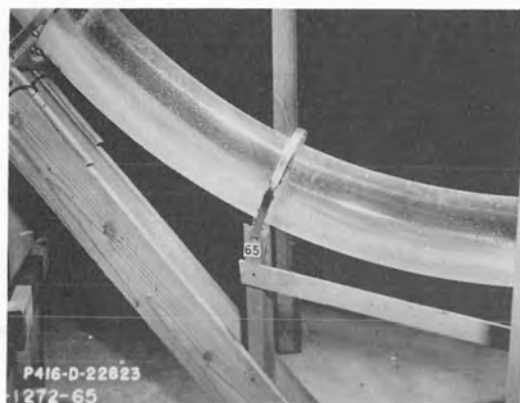
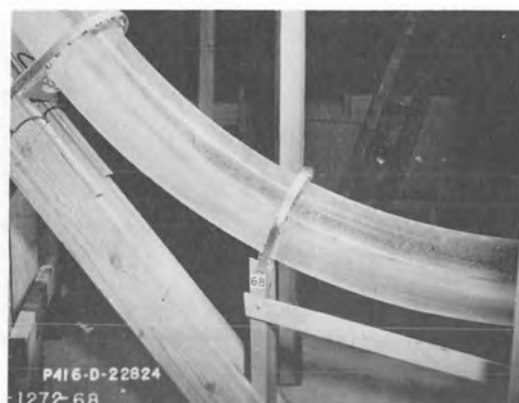
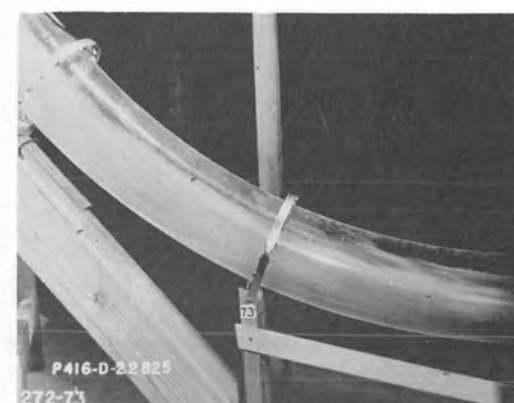
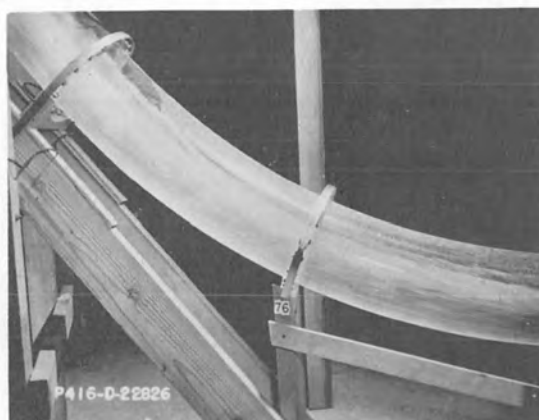
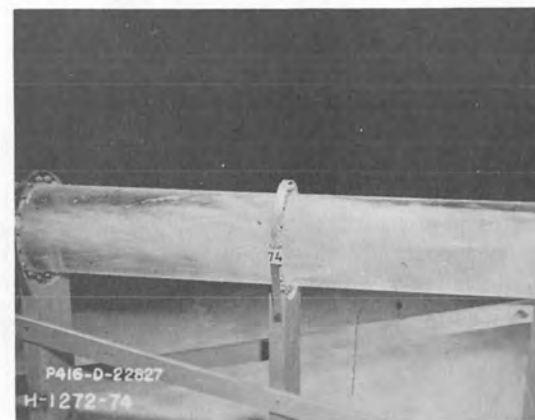
A. Discharge 11,200 cfs

B. Discharge 16,800 cfs

C. Discharge 22,400 cfs

D. Discharge 26,700 cfs

E. Discharge 22,400 cfs

TRINITY MORNING-GLORY SPILLWAY
FLOW IN LOWER BEND AND TUNNEL
PRELIMINARY PROFILE, SCALED AIR INTAKE PIER AND GUIDE VANES
1:30 MODEL

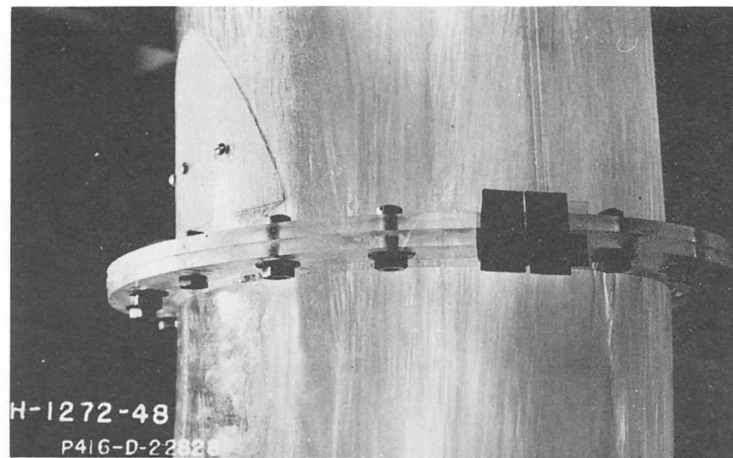
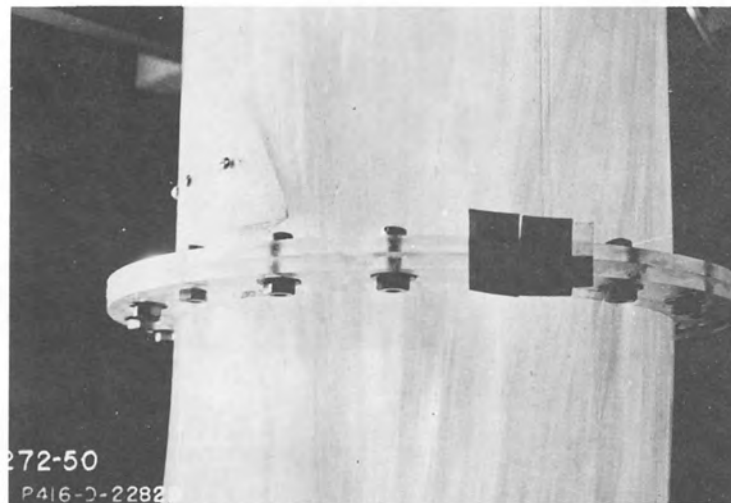
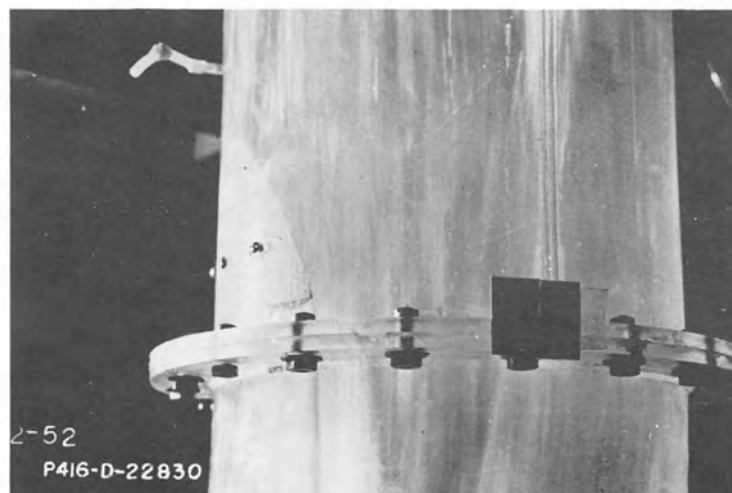
A. Discharge 5,600 cfs

B. Discharge 16,800 cfs

C. Discharge 26,700 cfs

TRINITY MORNING-GLORY SPILLWAY
PRELIMINARY PROFILE, FLOWS AT PRELIMINARY DEFLECTOR
1:30 MODEL

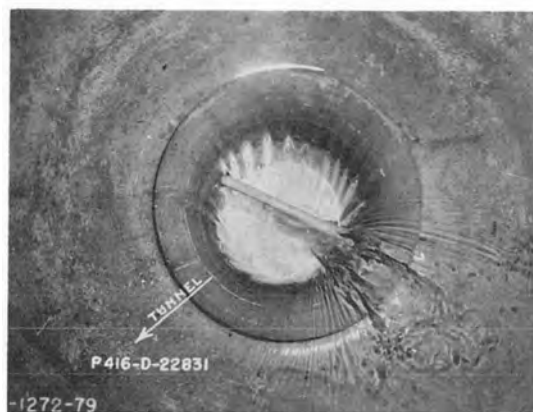
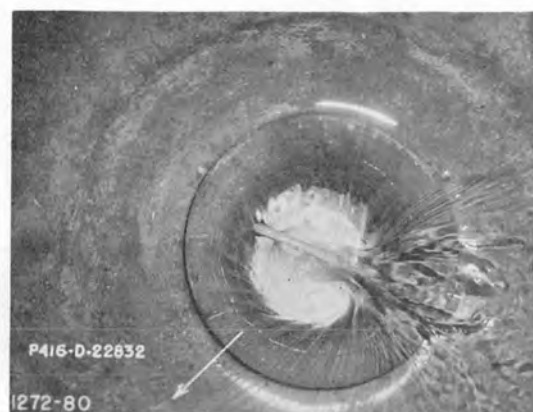
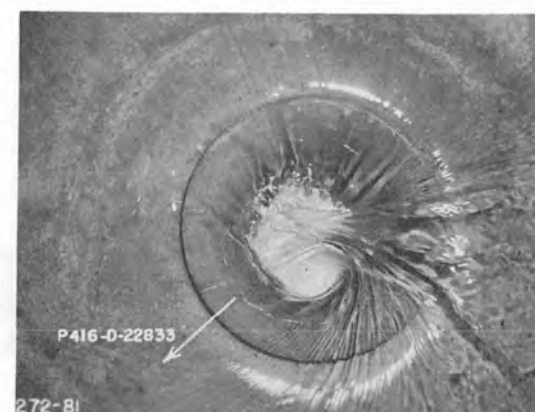
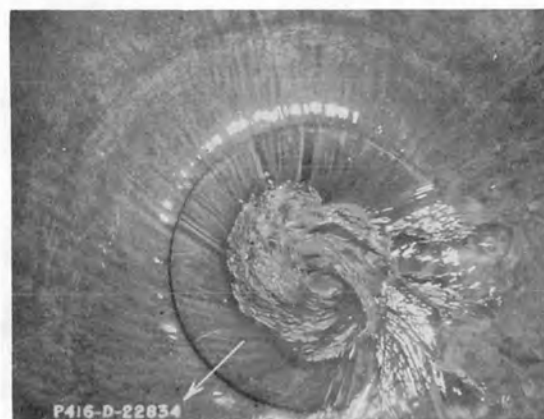
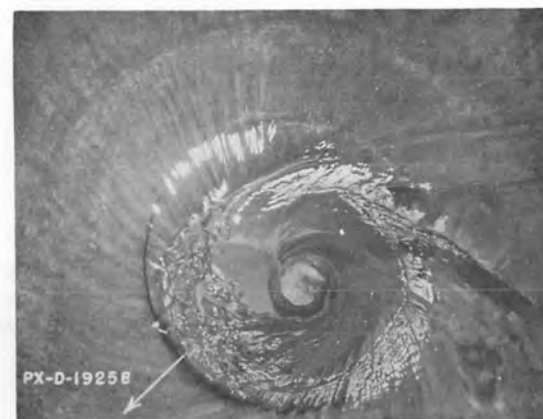
A. Discharge 5,600 cfs

B. Discharge 11,200 cfs

C. Discharge 16,800 cfs

D. Discharge 22,400 cfs

E. Discharge 26,700 cfs

TRINITY MORNING-GLORY SPILLWAY
FLOW WITH SINGLE DIAMMETRICAL GUIDE VANE, PRELIMINARY PROFILE
1:30 MODEL

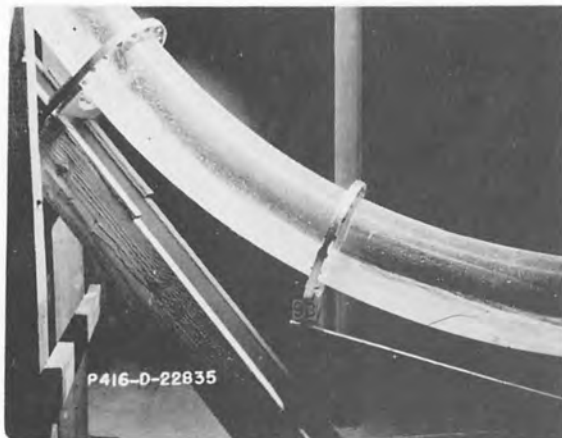
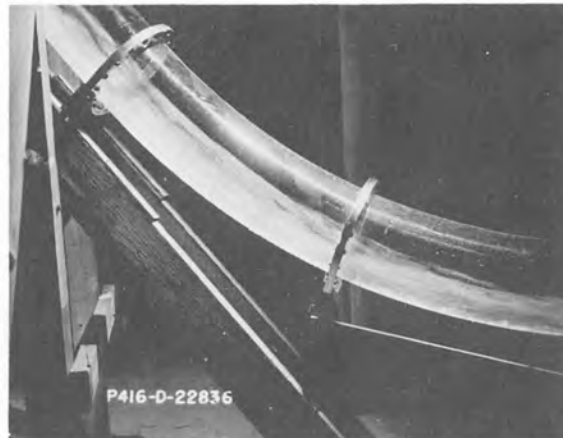
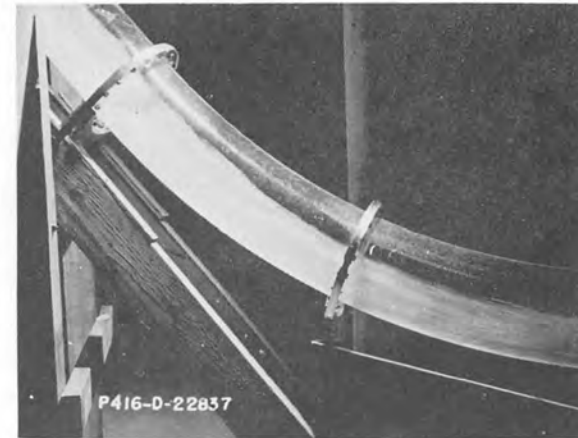
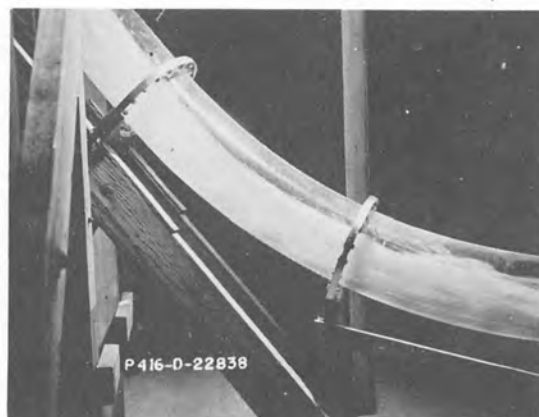
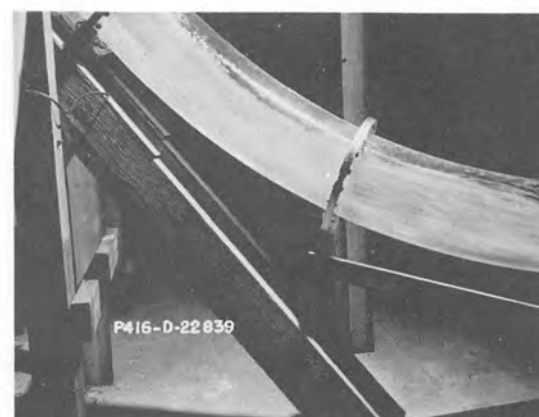
A. Discharge 5,600 cfs

B. Discharge 11,700 cfs

C. Discharge 16,800 cfs

D. Discharge 22,400 cfs

E. Discharge 26,700 cfs

TRINITY MORNING-GLORY SPILLWAY
 FLOWS IN LOWER BEND
 PRELIMINARY PROFILE, SINGLE DIAMMETRICAL GUIDE VANE
 1:30 MODEL

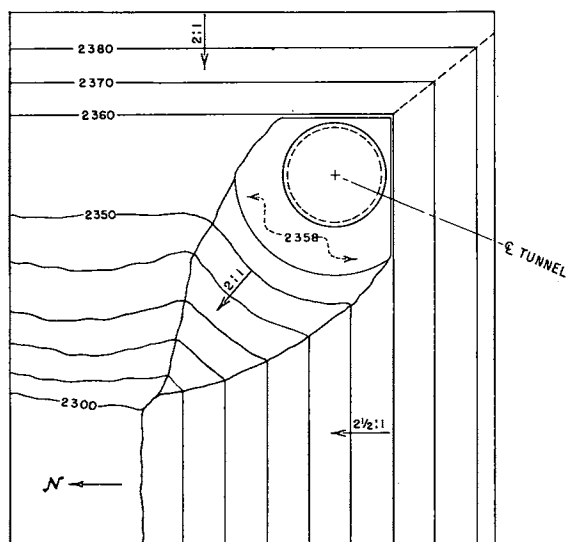
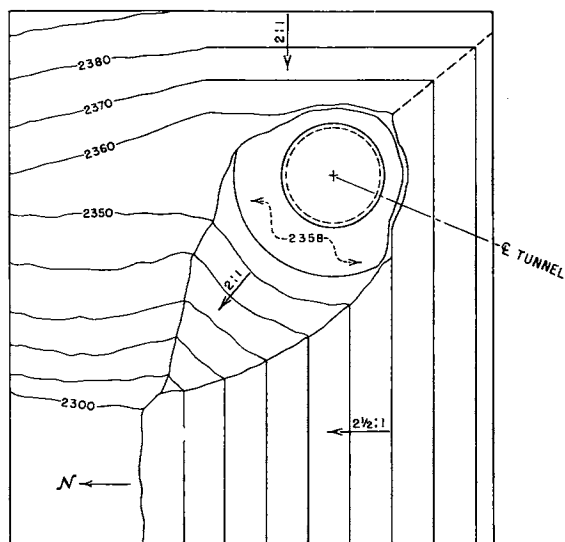
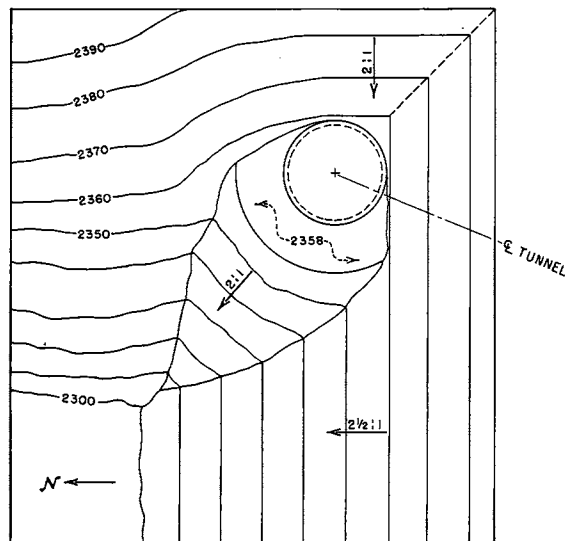
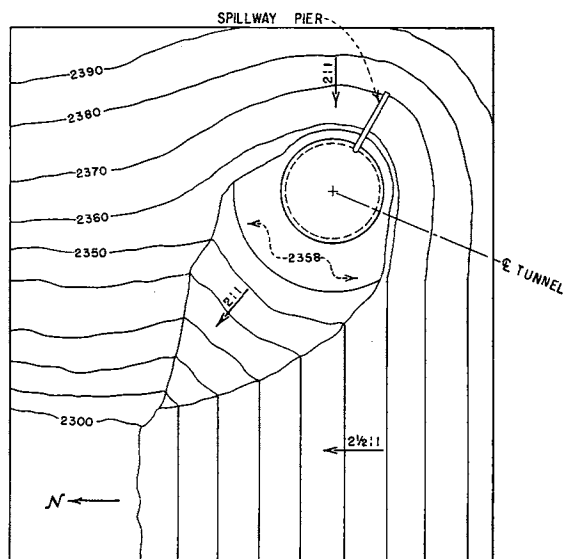
A.— FIRST MODIFICATION

B.— SECOND MODIFICATION

C.— THIRD MODIFICATION

D.— RECOMMENDED CONFIGURATION

TRINITY MORNING - GLORY SPILLWAY
MODIFICATIONS OF TOPOGRAPHIC FEATURES

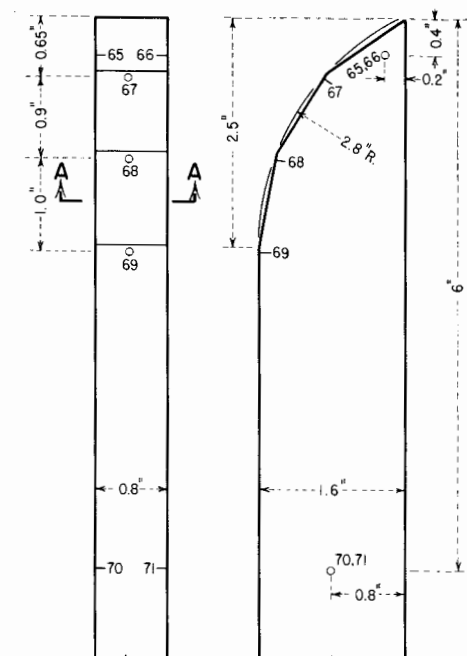
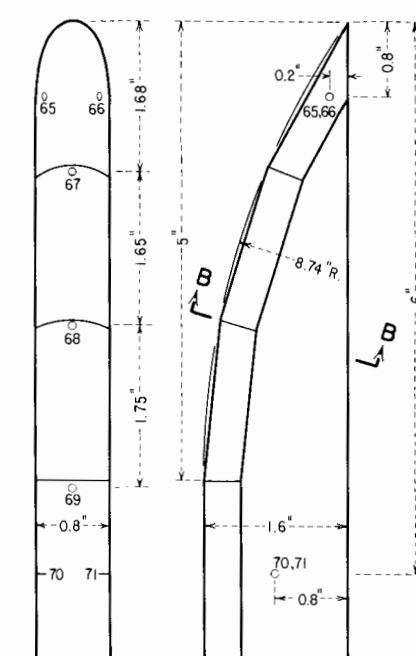
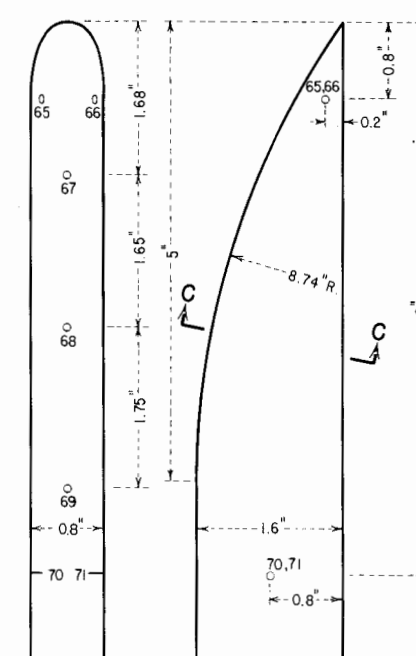
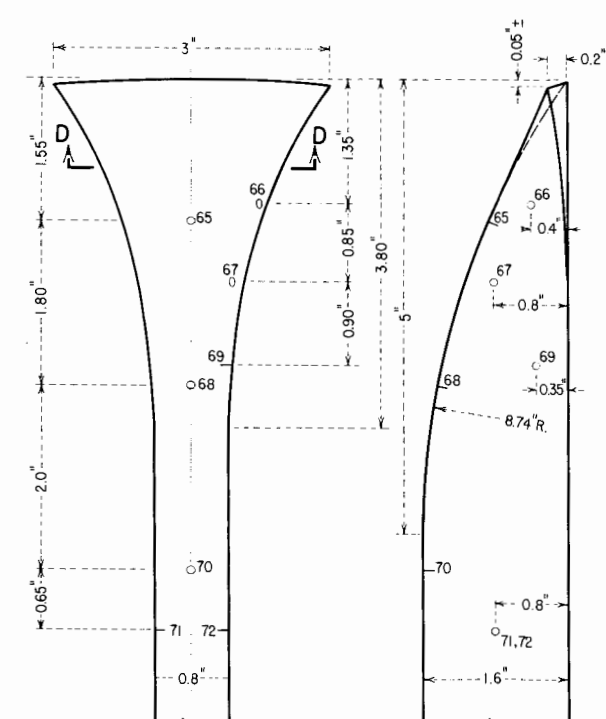
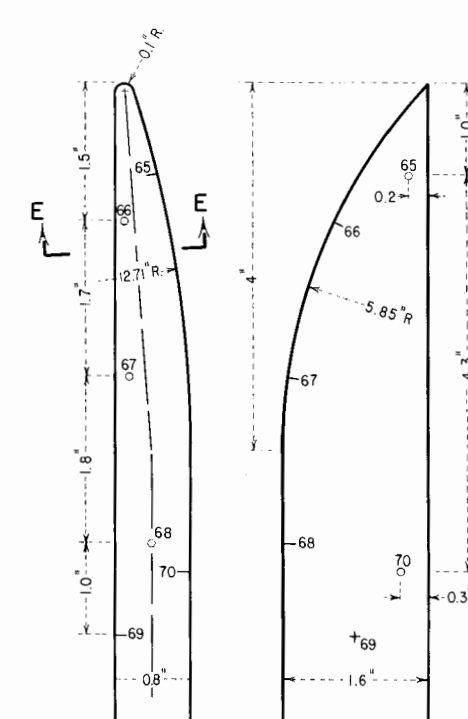
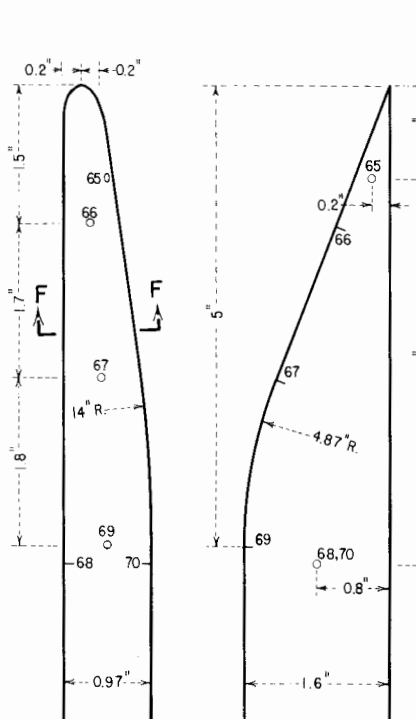
SECTION A-A

SECTION B-B

SECTION C-C

SECTION D-D

SECTION E-E

SECTION F-F

TRINITY MORNING-GLORY SPILLWAY
RIB VANE DESIGNS-TOP DETAILS
1:30 MODEL

The recommended location of the rib vanes is shown in Figure 28. The recommended design for the rib vane top is also shown in Figures 28 and 29.

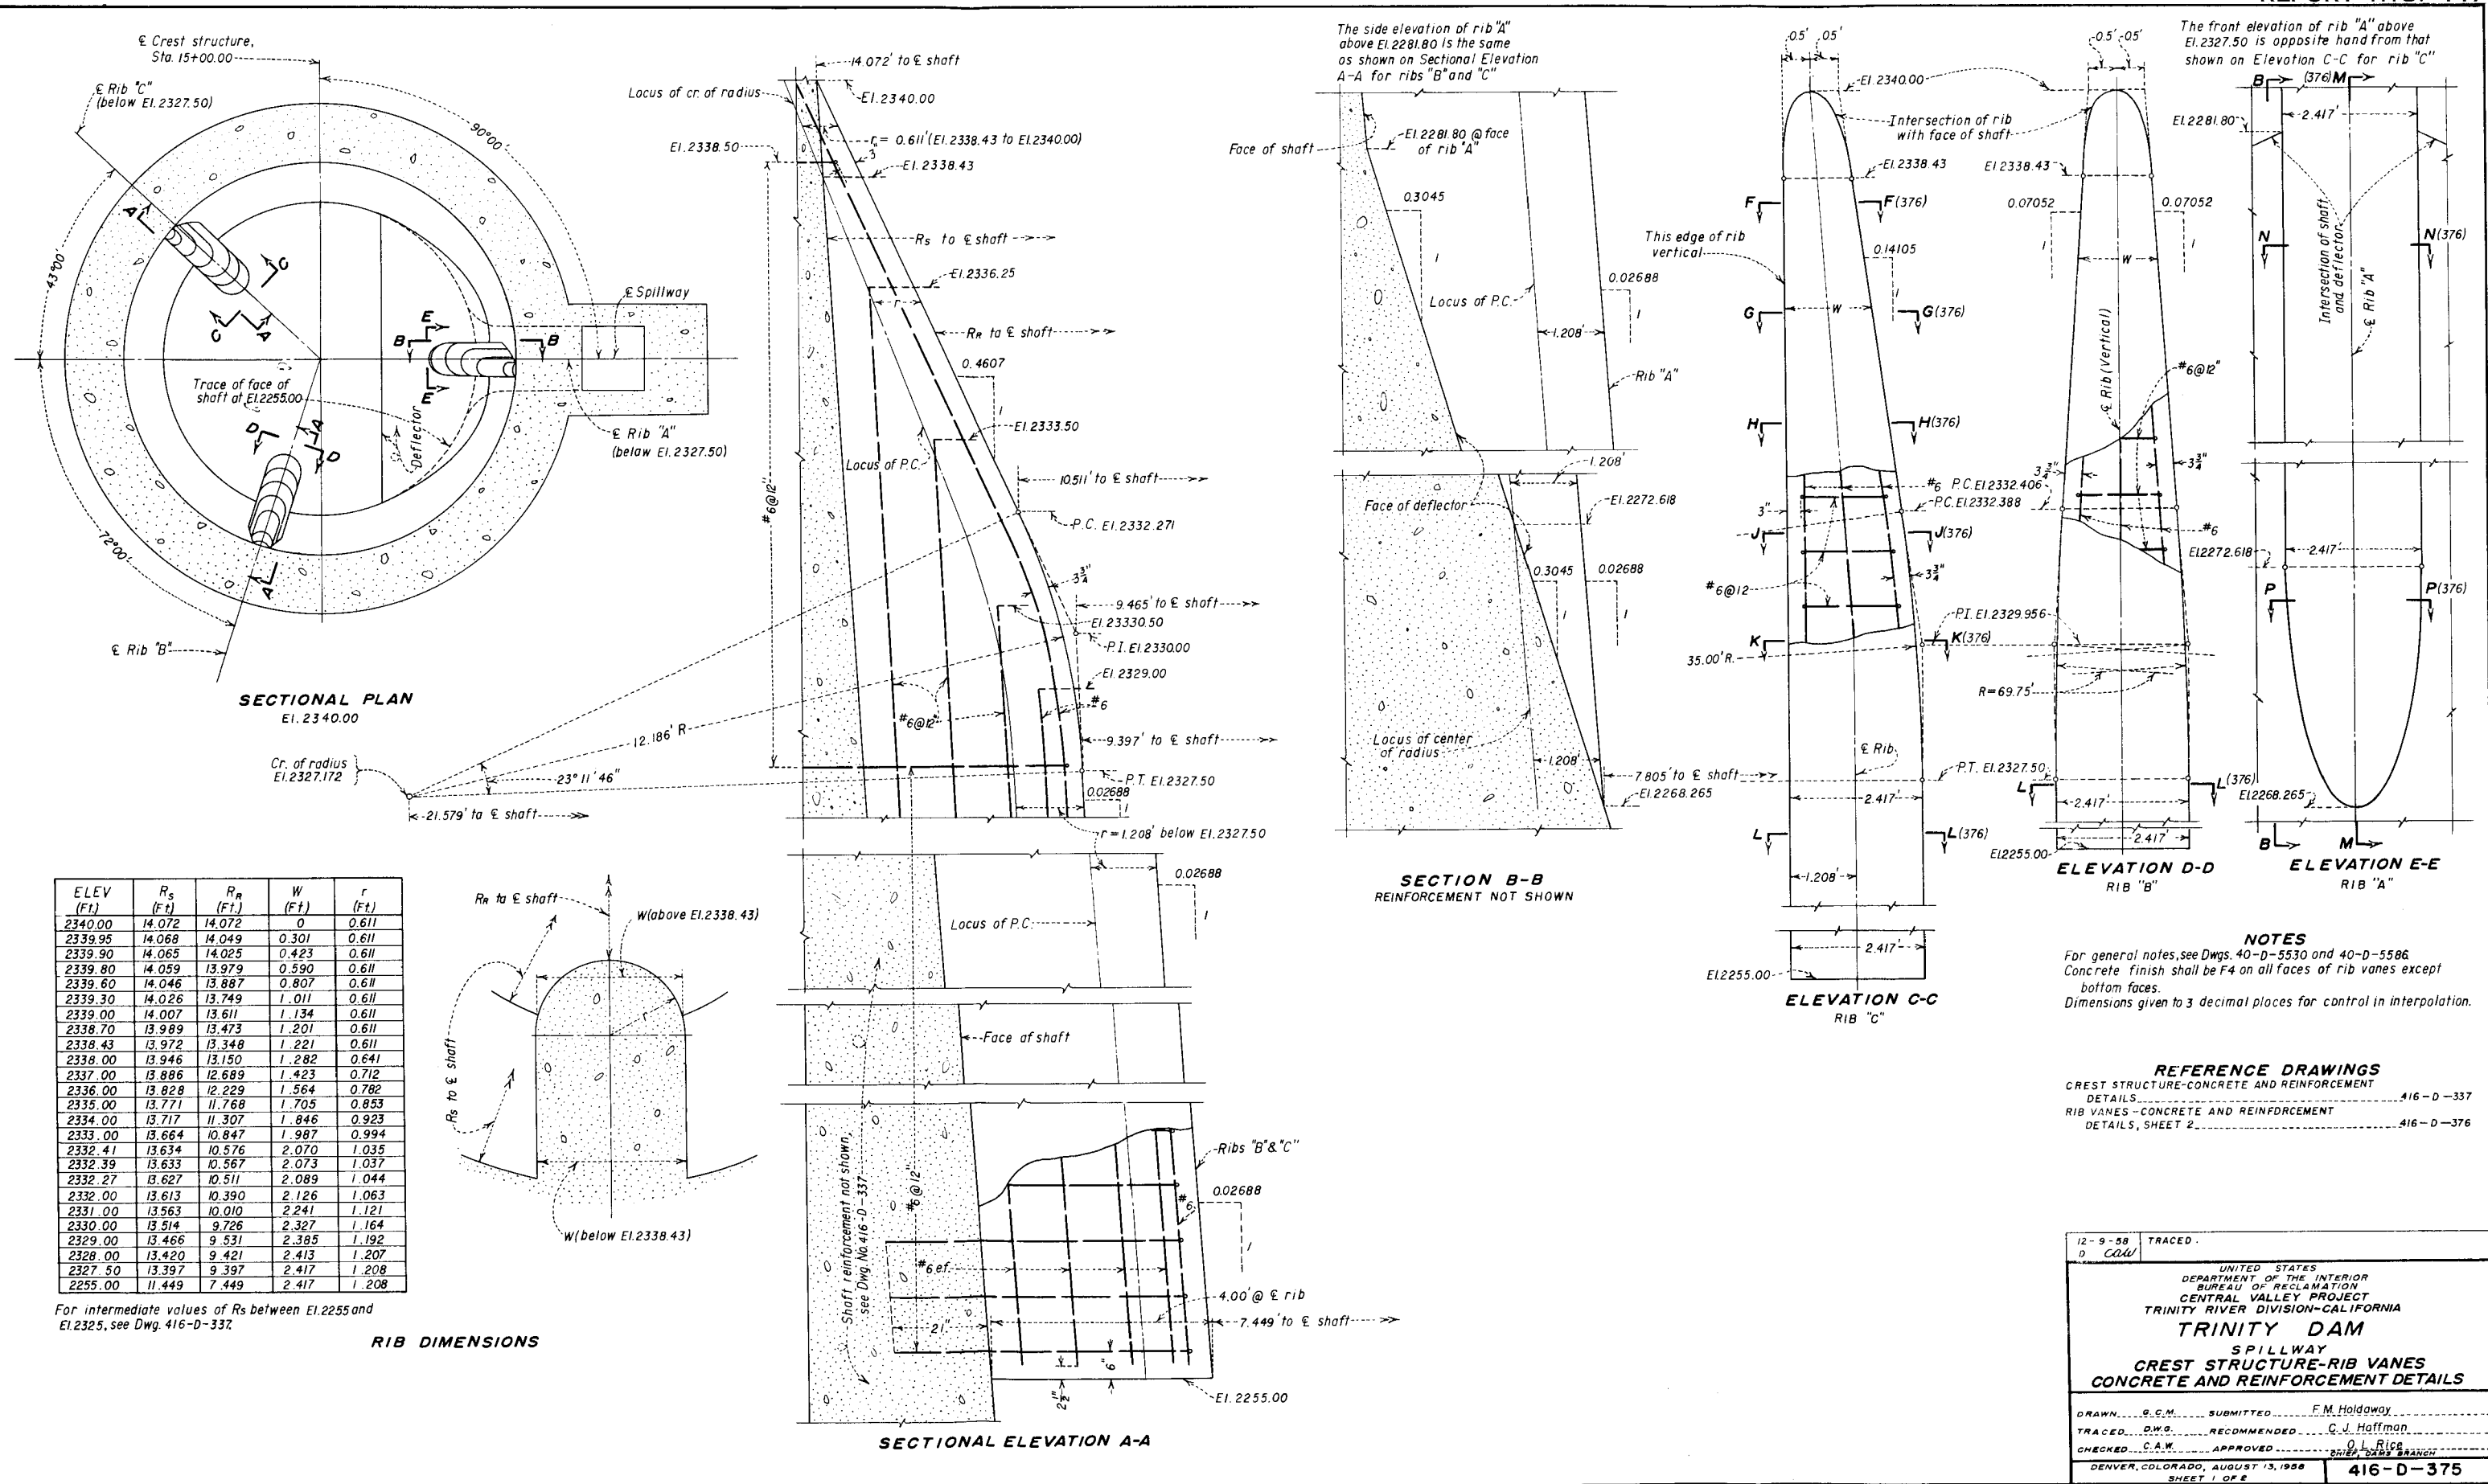
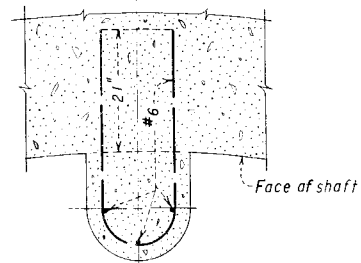
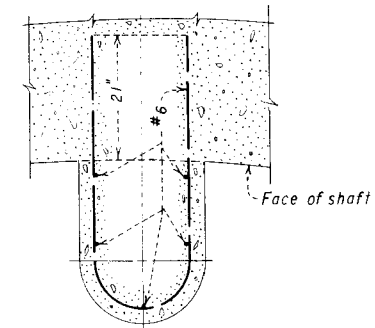
SECTION F-F (375)
TYPICAL, ALL RIBS
ABOVE EL. 2336.25

SECTION G-G (375)
TYPICAL, ALL RIBS
EL. 2333.50 TO EL. 2336.25

SECTION H-H (375)
TYPICAL, ALL RIBS
EL. 2330.50 TO EL. 2333.50

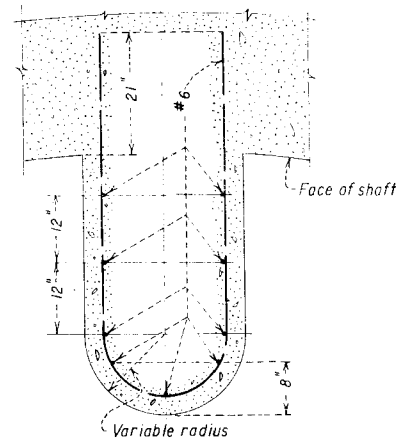
SECTION J-J (375)

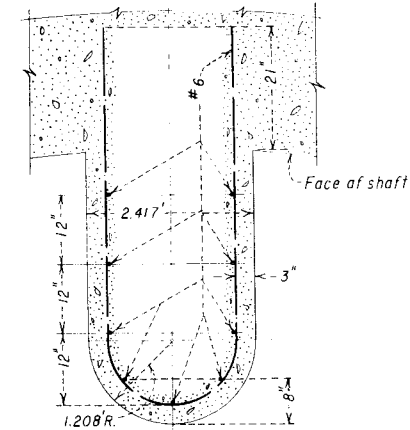
SECTION K-K (375)
TYPICAL, ALL RIBS
EL. 2327.50 TO EL. 2329.00

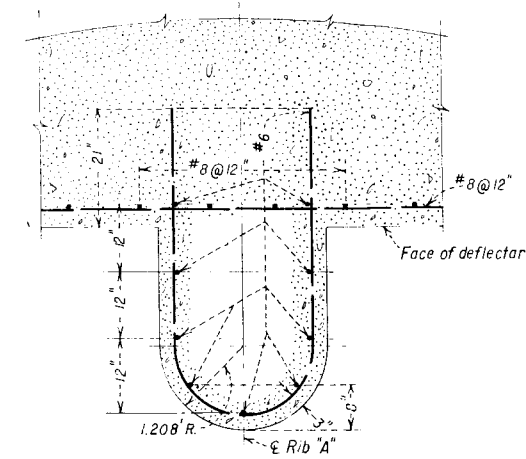
SECTION M-M (375)

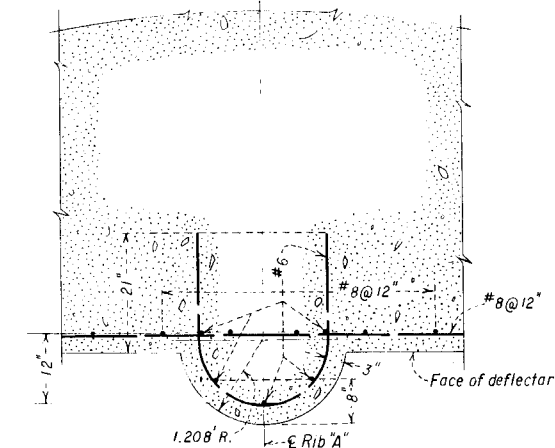
SECTION N-N (375)

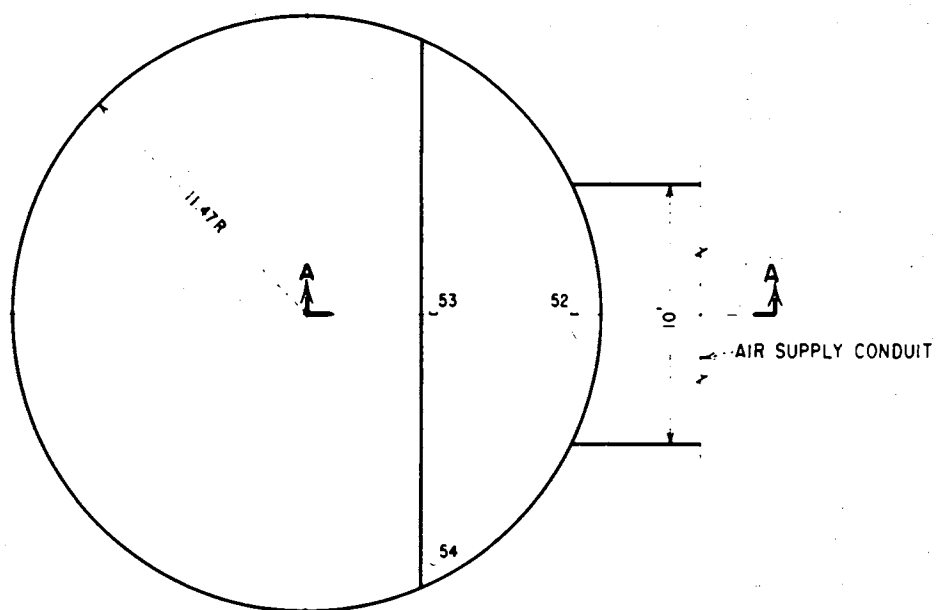
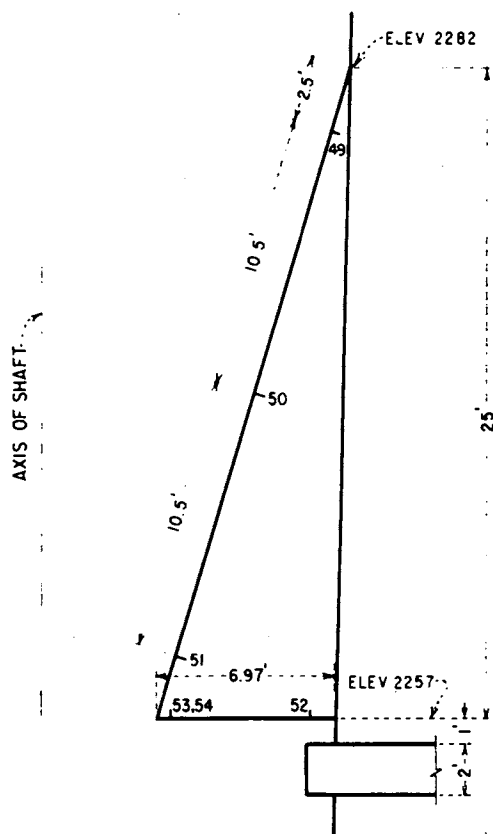
FIGURE 31
REPORT HYD. 447

PLAN
VIEW FROM UNDERSIDE

NOTE
Numbers refer to piezometers.

SECTION A-A

TRINITY MORNING-GLORY SPILLWAY
FLOW DEFLECTOR
1:30 MODEL

4. A flow deflector in the shaft is required to divert the water from the crown side of the shaft to the invert side in the vicinity of the upper bend. A wedged-shaped deflector on the crown side between elevations 2257 and 2282, projecting radially 6.97 feet from the shaft boundary at the lower elevation, is recommended, Figures 3 and 30. The deflector should be placed so that it is symmetrical about a line defining the tunnel bearing.
