UNITED STATES
DEPARTMENT OF THE INTERIOR
BUREAU OF RECLAMATION

HYDRAULIC MODEL STUDIES OF THE
TRINITY DAM MORNING-GLORY SPILLWAY
TRINITY RIVER DIVISION
CENTRAL VALLEY PROJECT--CALIFORNIA

Hydraulic Laboratory Report No. Hyd-447

April 22, 1960

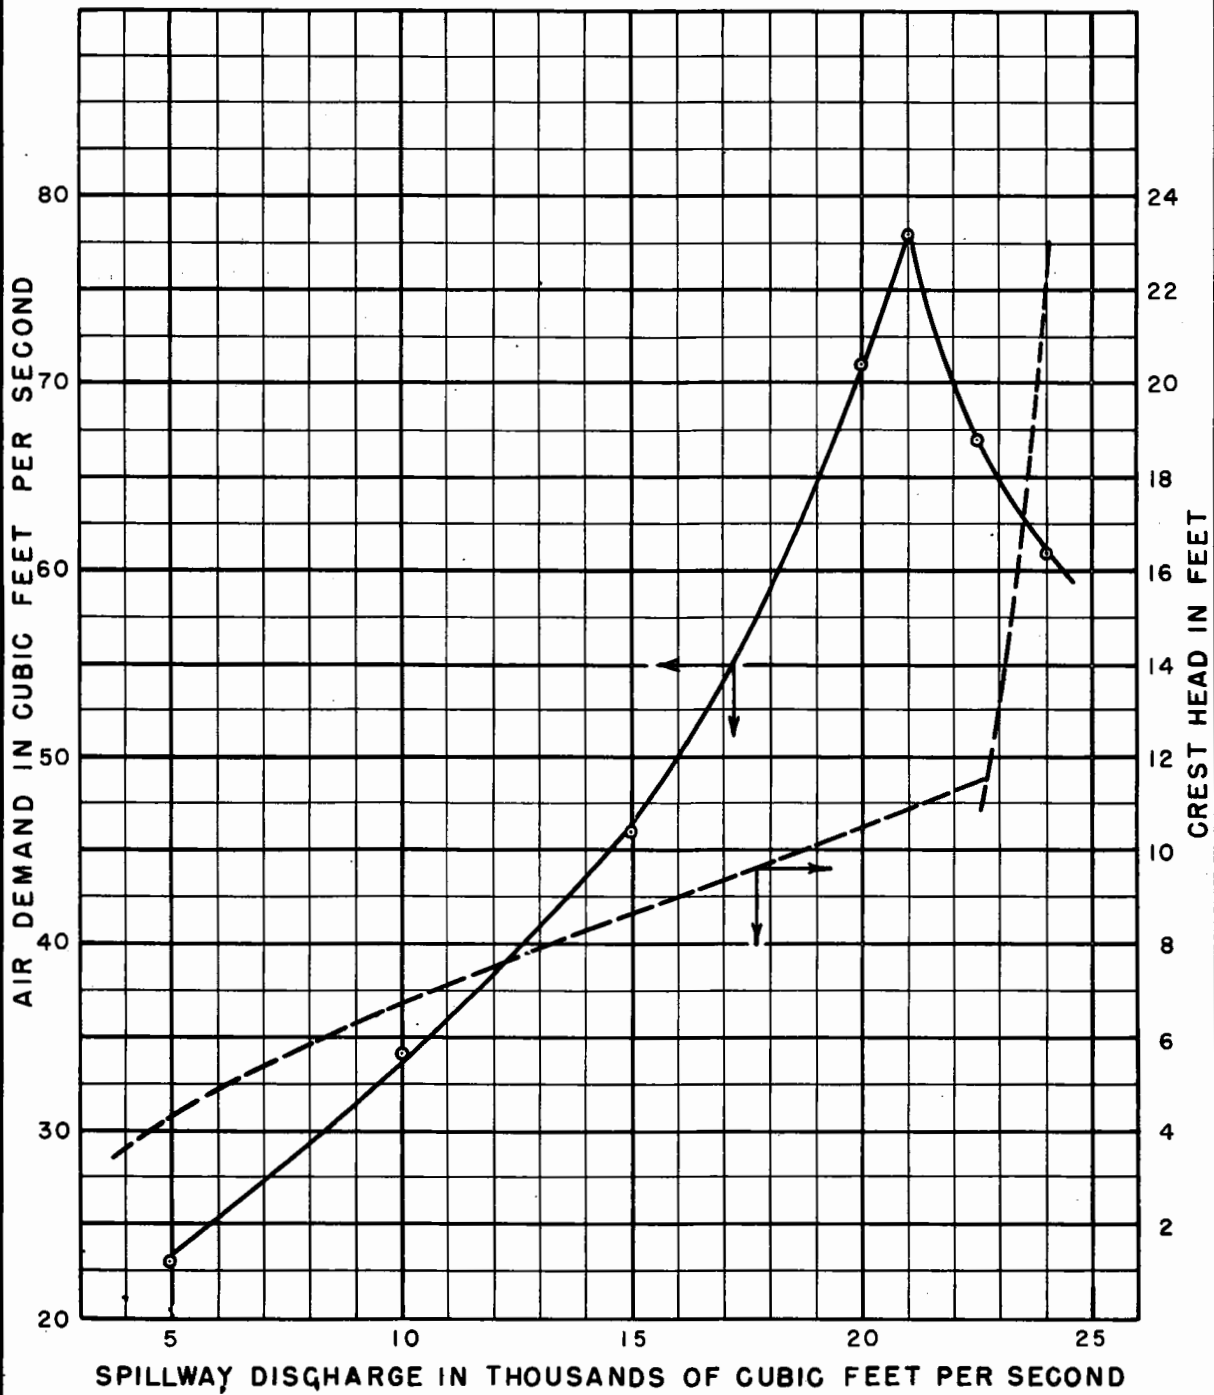
TRINITY MORNING - GLORY SPILLWAY

DEFLECTOR AIR DEMAND VS. SPILLWAY DISCHARGE
RECOMMENDED DEFLECTOR 6.97' x 25'

1:30 MODEL

The air demand of the recommended deflector 6.97 by 25 feet was measured so that comparisons could be made with future prototype measurements. A circular sharp-edged orifice was used to determine the quantity of air required for 7 spillway discharge rates. The coefficient of discharge of the orifice was assumed to be 0.60. Table 5 gives the air quantities in the model. Figure 31 was plotted from Table 5 to show the variation of air demand with spillway discharge. The maximum prototype demand of 78 second-feet is reached at 21,000 second-feet. At 24,000 second-feet, with the spillway submerged, the air demand shows a marked decrease to 60 second-feet. The general shape of the curve conforms well to a similar curve based on air demand measurements made at Shadehill Dam, shown in Figure 52 of Engineering Monograph No. 16.

the shaft to compensate for the decrease measured in the air conduit; to the contrary, this quantity seemed to decrease as the crest began to submerge. One plausible explanation is that a shift in control had begun near 21,000 second-feet, but the height of the boil in the shaft was not sufficient to affect the crest head until the discharge was 23,000 second-feet. Between 21,000 and 23,000 second-feet, there could be two controls; (1) the crest, and (2) an orifice in a horizontal plane of unstable elevation. Both controls adjust to discharge the same quantity of water at the same time. The point of reversal in the curve of Figure 31, therefore, may be an accurate indicator of the beginning of a shift in hydraulic control, to the spillway throat.

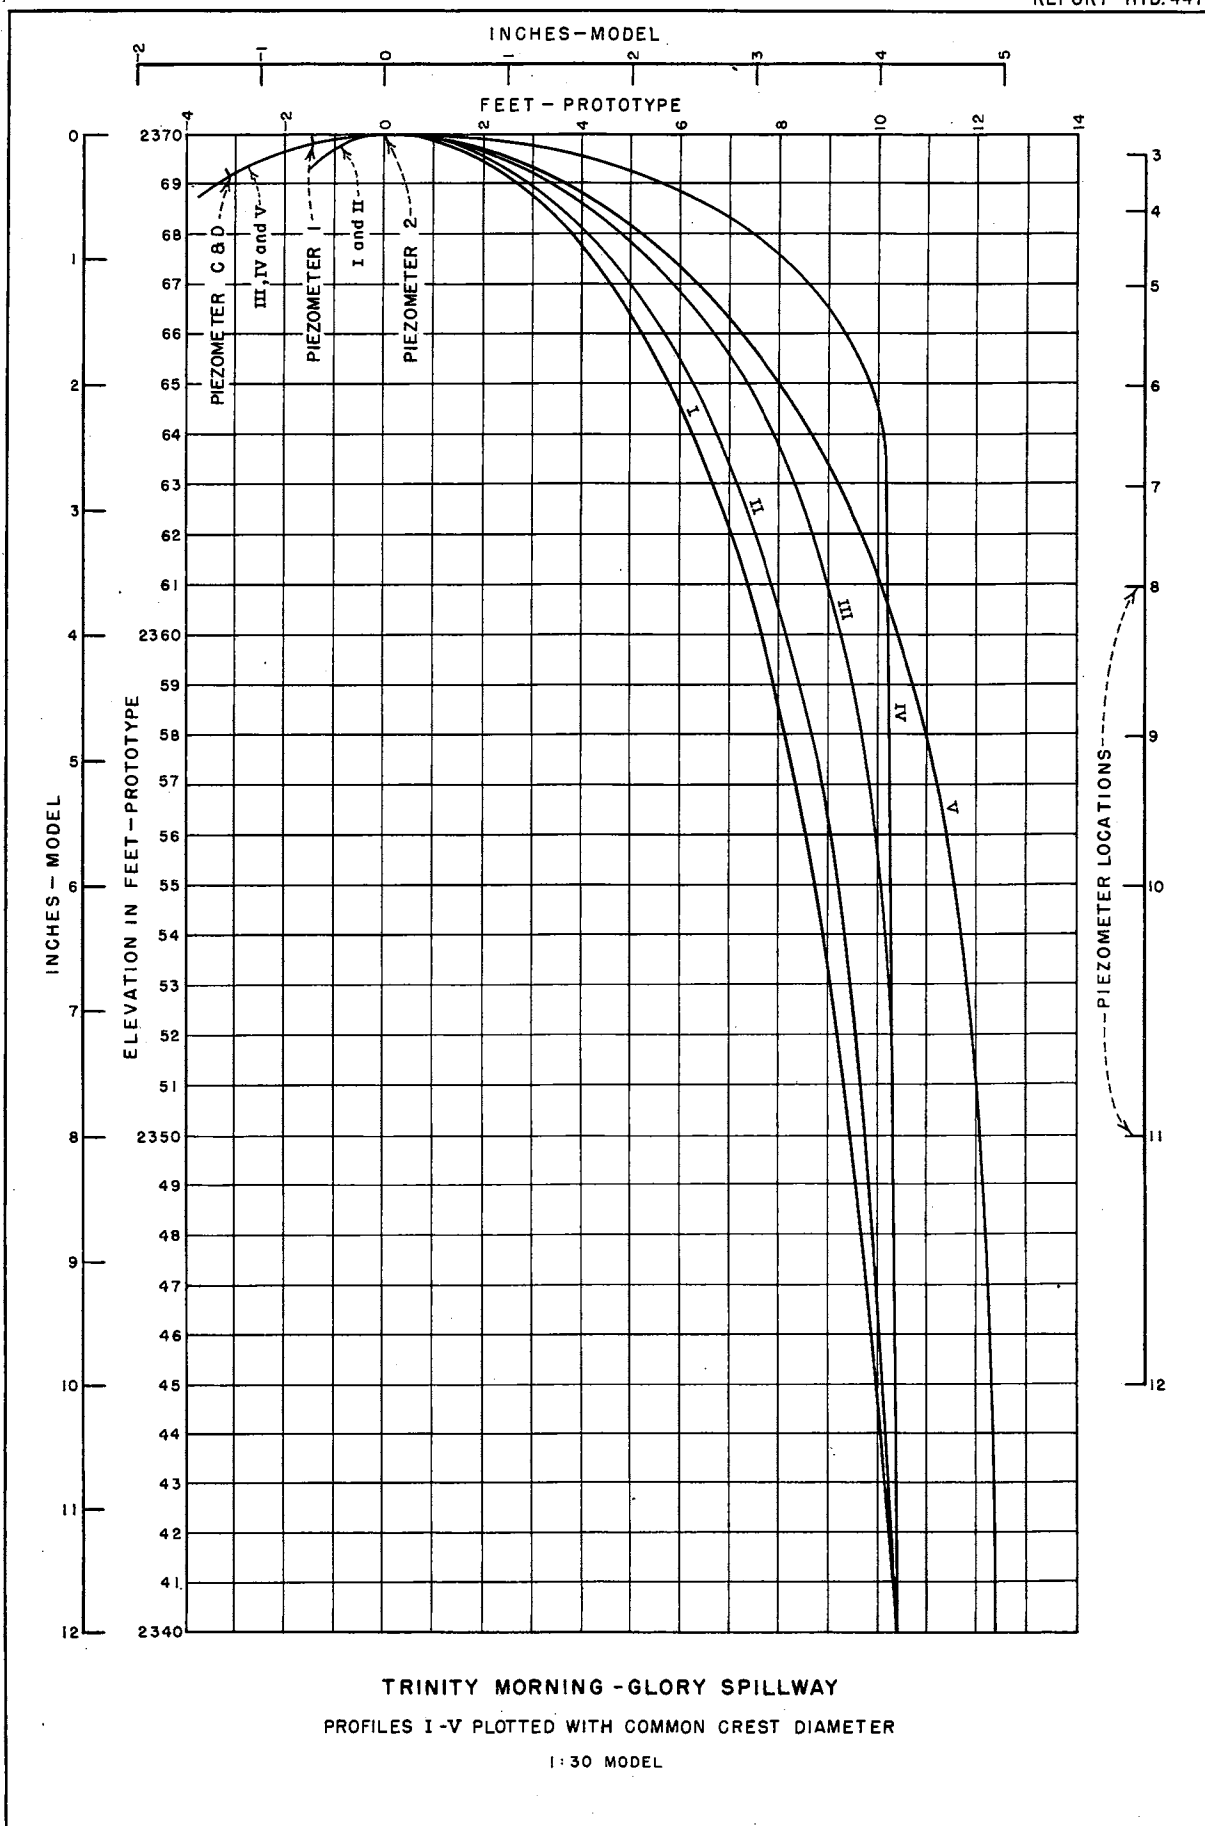
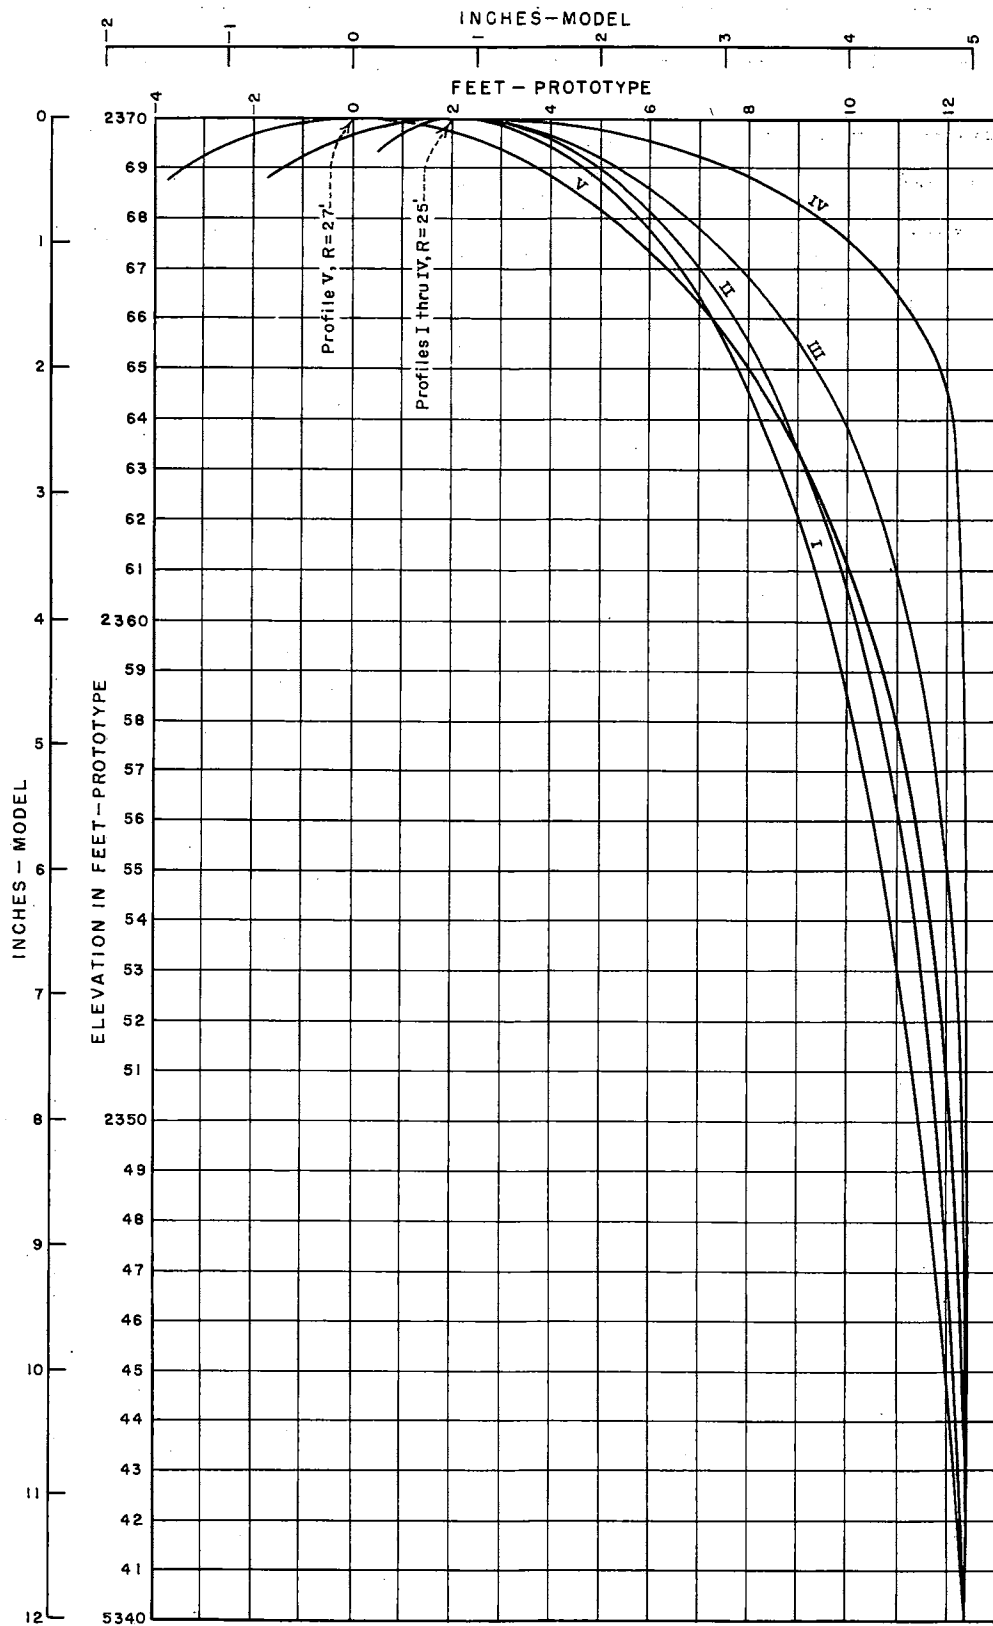
FIGURE 34
REPORT HYD. 447

TRINITY MORNING-GLORY SPILLWAY
PROFILES I-V PLOTTED IN TRUE RELATIVE POSITIONS

1:30 MODEL

The coordinates for all spillway profiles tested are contained in Table 1. To facilitate comparisons of them two plots were prepared: (1) profiles plotted from a common crest point without regard to crest diameter, Figure 33, and (2) profiles plotted in proper vertical and horizontal positions, Figure 34.

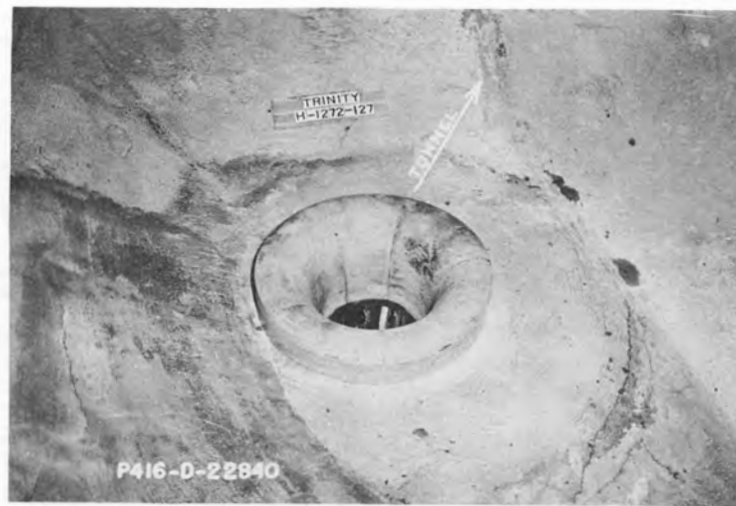
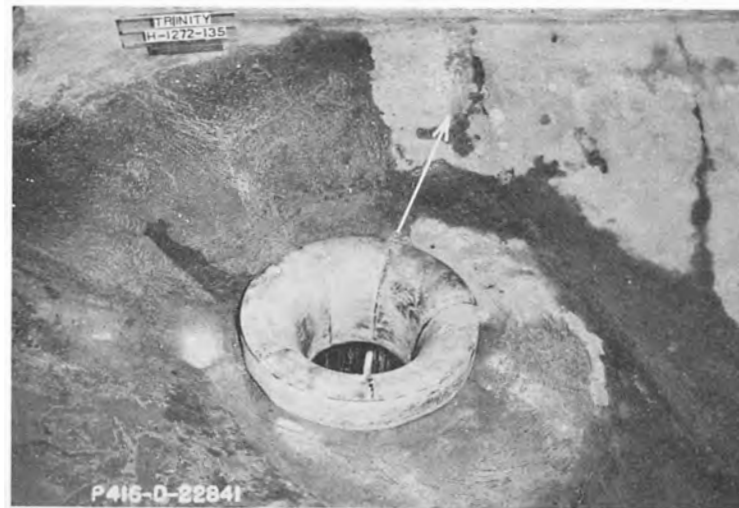
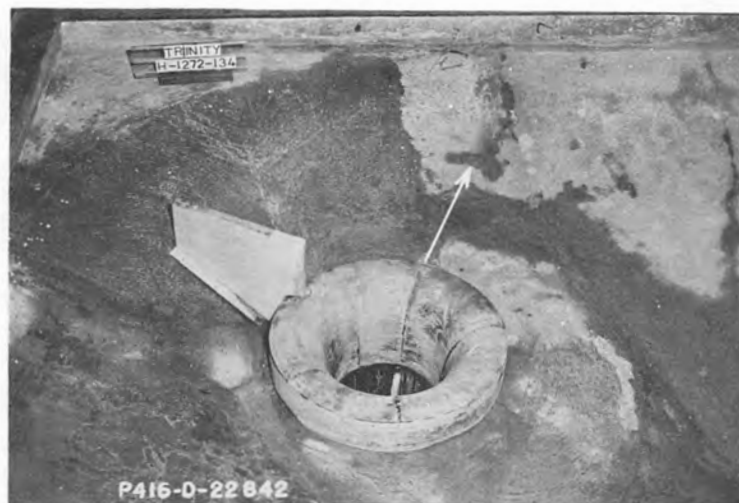
Figure 35
Report HYD - 447

A. Preliminary Topography

B. Final Topography

C. Final Topography with Spillway Pier

**TRINITY MORNING-GLORY SPILLWAY
TOPOGRAPHY CHANGES WITH RECOMMENDED PROFILE
1:30 MODEL**

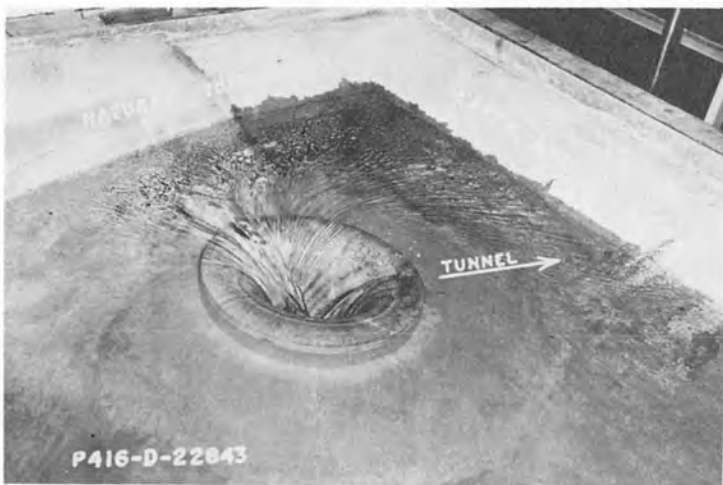
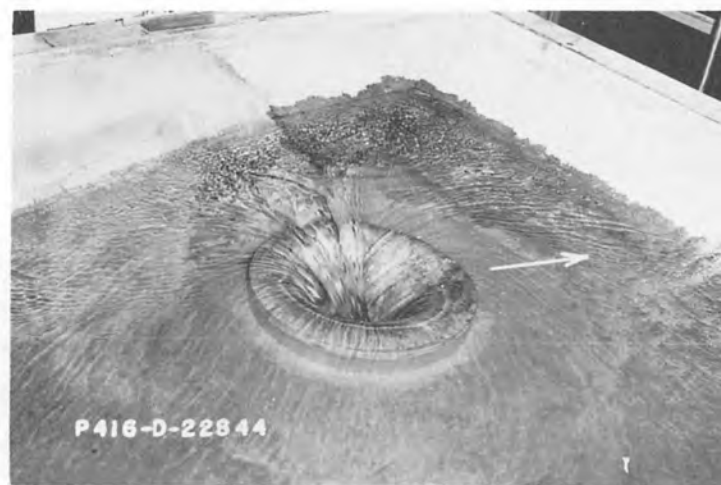
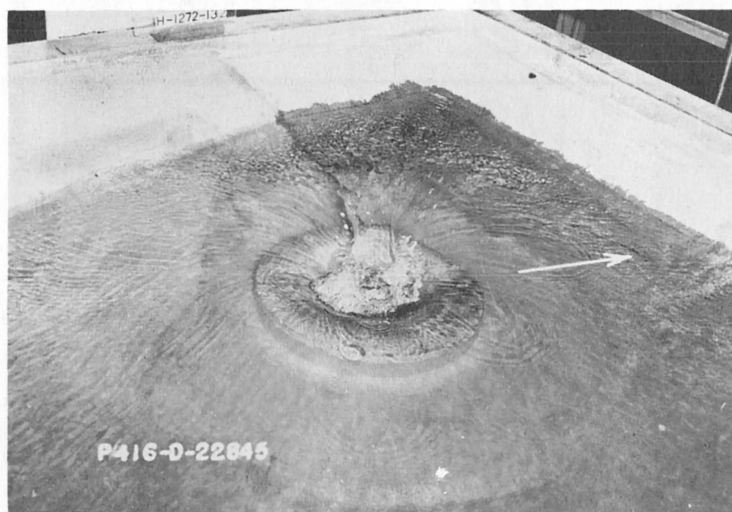
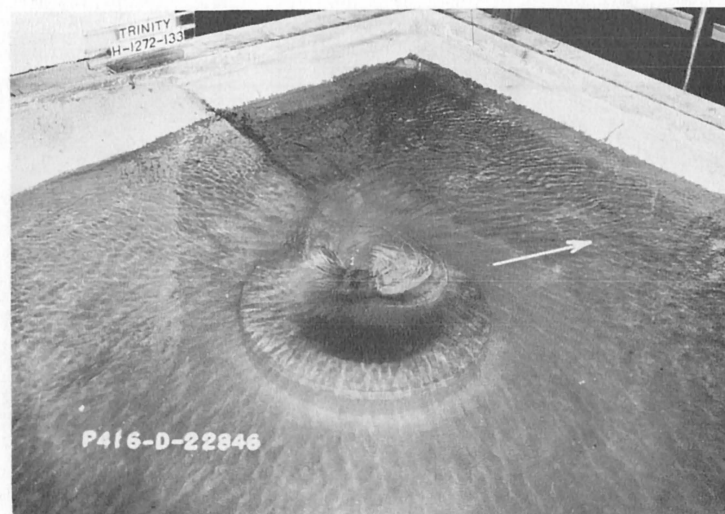
A. Discharge 15,000 cfs

B. Discharge 20,000 cfs

C. Discharge 22,500 cfs

D. Discharge 24,000 cfs

TRINITY MORNING-GLORY SPILLWAY
PERFORMANCE OF RECOMMENDED PROFILE WITH PRELIMINARY TOPOGRAPHY
1:30 MODEL

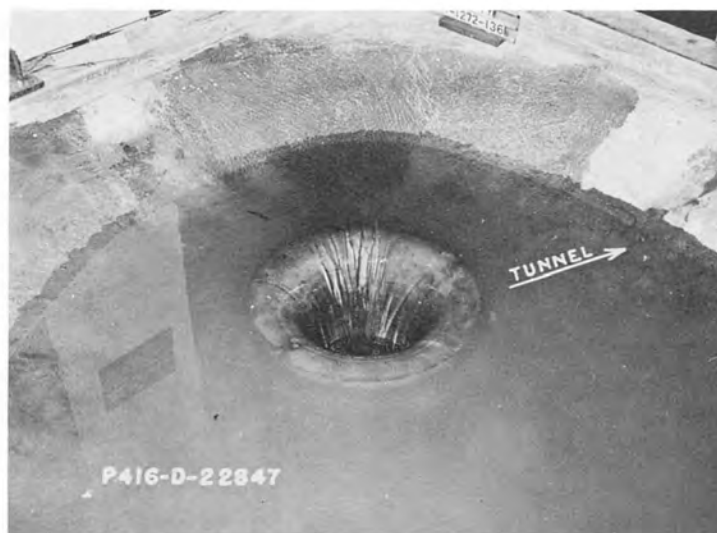
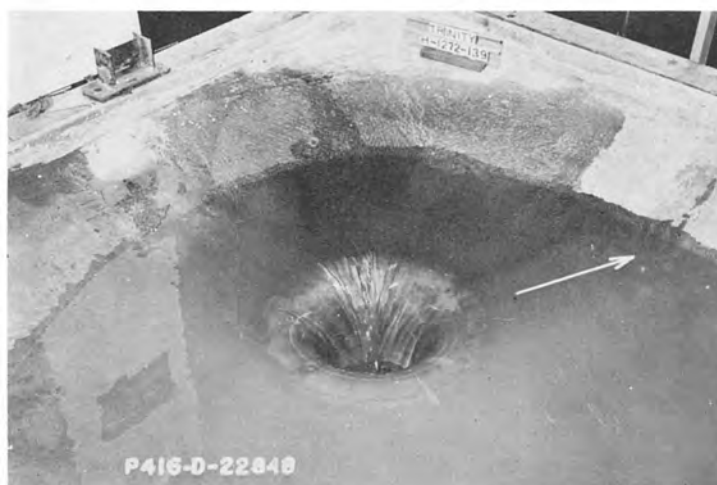
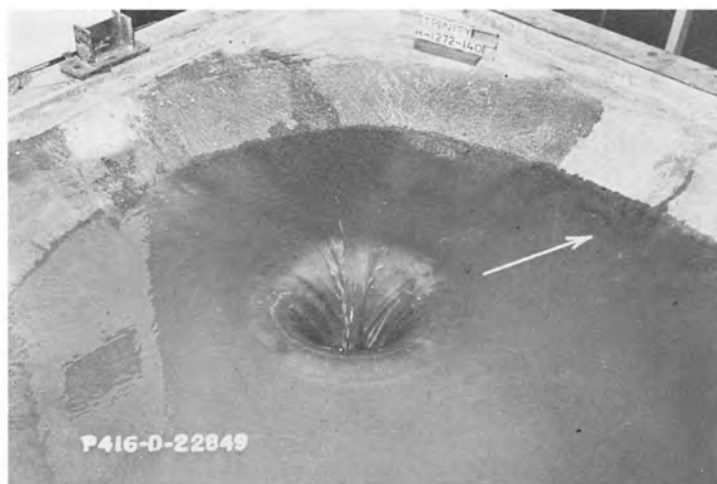
A. Discharge 5,000 cfs

B. Discharge 10,000 cfs

C. Discharge 15,000 cfs

TRINITY MORNING-GLORY SPILLWAY
PERFORMANCE OF RECOMMENDED PROFILE WITH FINAL TOPOGRAPHY
1:30 MODEL

Flow patterns for six discharges are shown in Figure 37A, B, C and Figure 38 A, B, and C. These views may be compared with those in Figure 14. Filling the draw produced a beneficial effect over

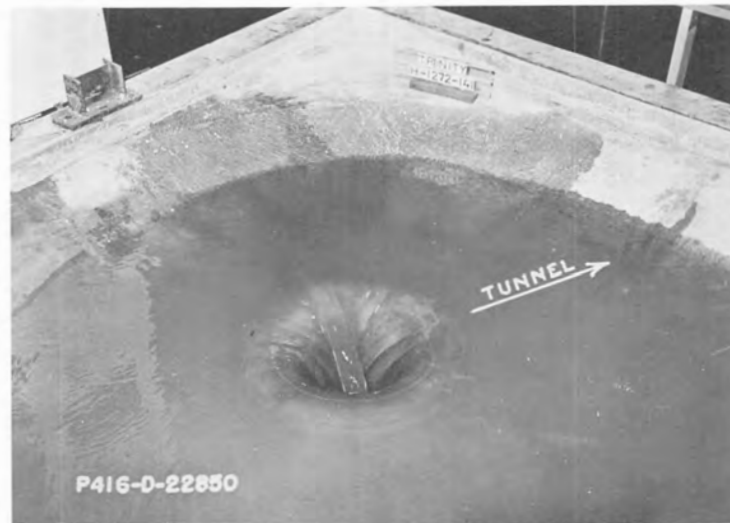
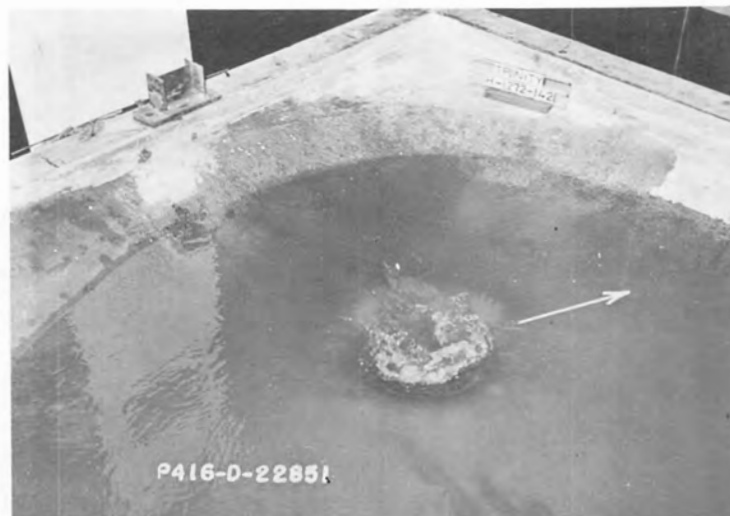
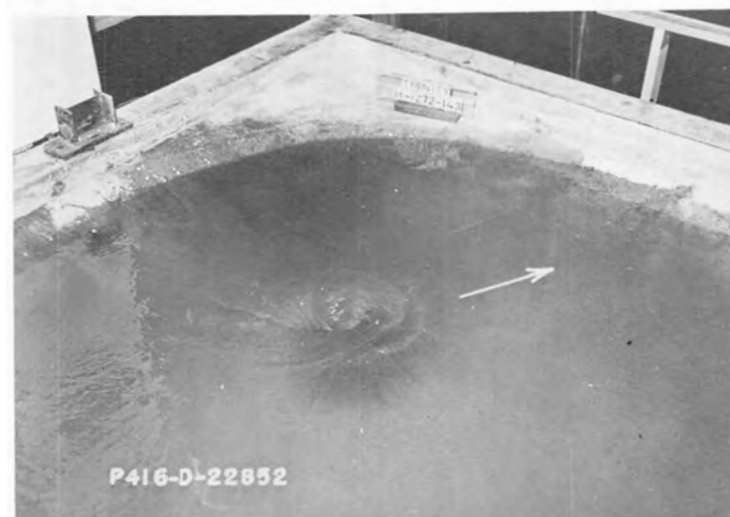
Figure 38
Report HYD - 447

A. Discharge 20,000 cfs

B. Discharge 23,000 cfs

C. Discharge 24,000 cfs

TRINITY MORNING-GLORY SPILLWAY
PERFORMANCE OF RECOMMENDED PROFILE WITH FINAL TOPOGRAPHY
1:30 MODEL

The spillway submerges to the degree shown in Figure 38B for 23,000 second-feet. There was about a 400 second-foot range near 23,000 second-feet over which water coming from the southeast on the bearing of the fin appeared to override radial flow from the north-east. As the hydraulic control shifted from the crest to the shaft deflector and back, the period of submergence was about 4 seconds prototype. The reservoir surface was set into motion by this action.

For the maximum discharge of 24,000 second-feet, Figure 38C, a small vortex formed. The direction of rotation was always counter-clockwise, and the center moved but slightly over the shaft.

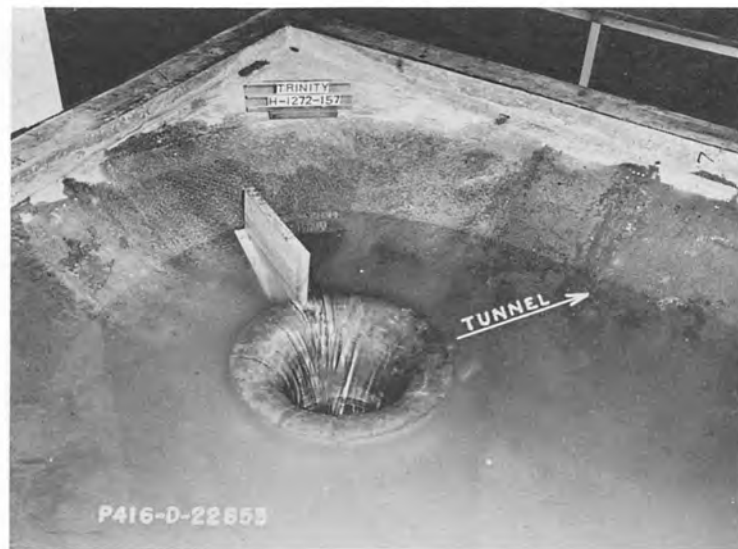
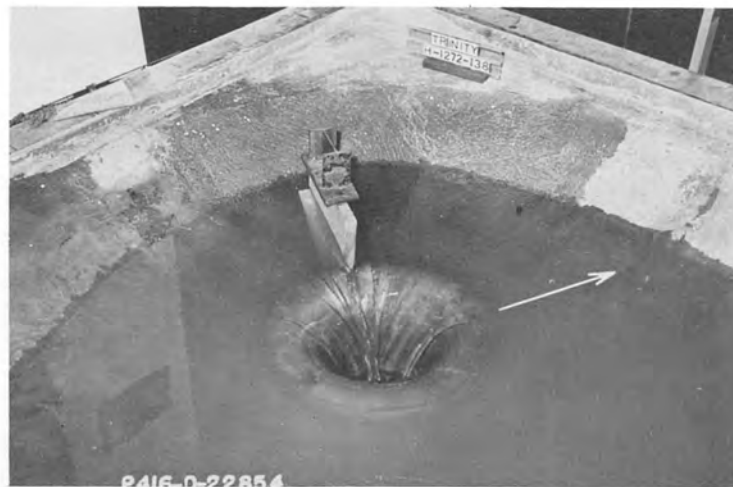
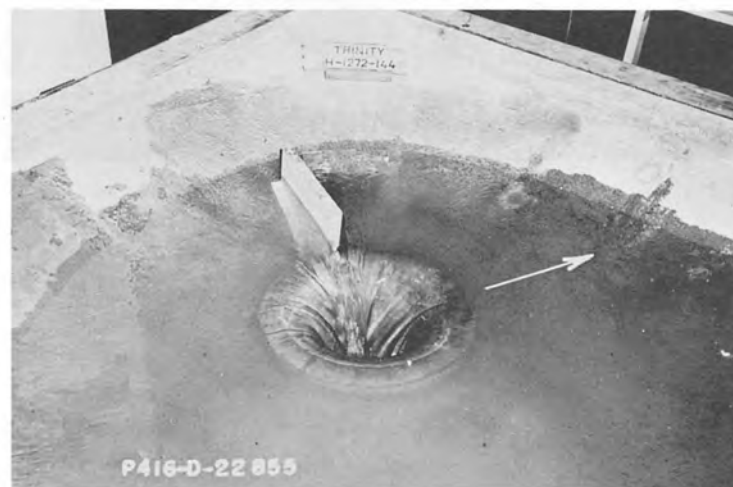
A. Discharge 5,000 cfs

B. Discharge 10,000 cfs

C. Discharge 15,000 cfs

TRINITY MORNING-GLORY SPILLWAY
OPERATION OF RECOMMENDED DESIGN
1:30 MODEL

Flow patterns for five discharges with the spillway pier in place are shown in Figures 39 and 40. These views may be compared with those in which no pier was used. For discharges below that required for submergence of the crest, the advantage of the pier is found in stabilization of the fin. At maximum discharge, Figure 40B, the pier provided a control over vortex formation which had not been possible in any other scheme tried. As shown in the photograph, the water surface was more tranquil than ever before, and no sudden deviation in flow regimen occurred. Small vortices formed and disappeared, singly and in pairs. The directions of rotation were alternately clockwise and counterclockwise.

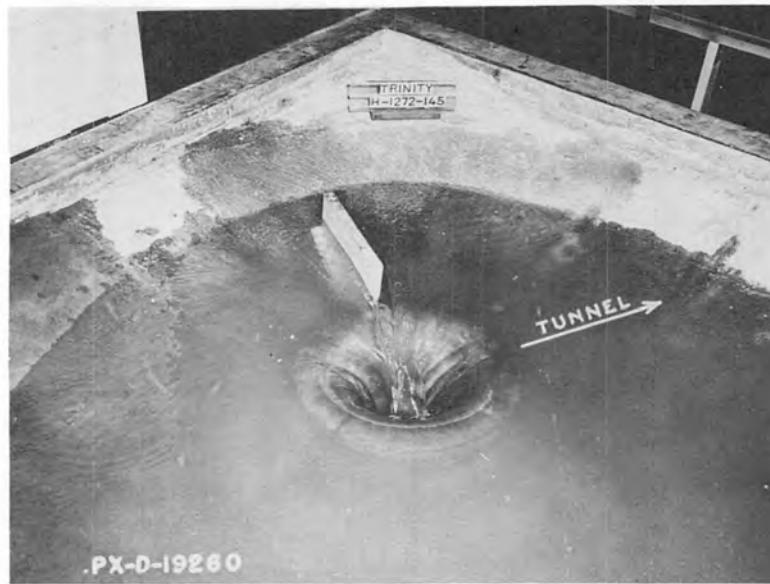
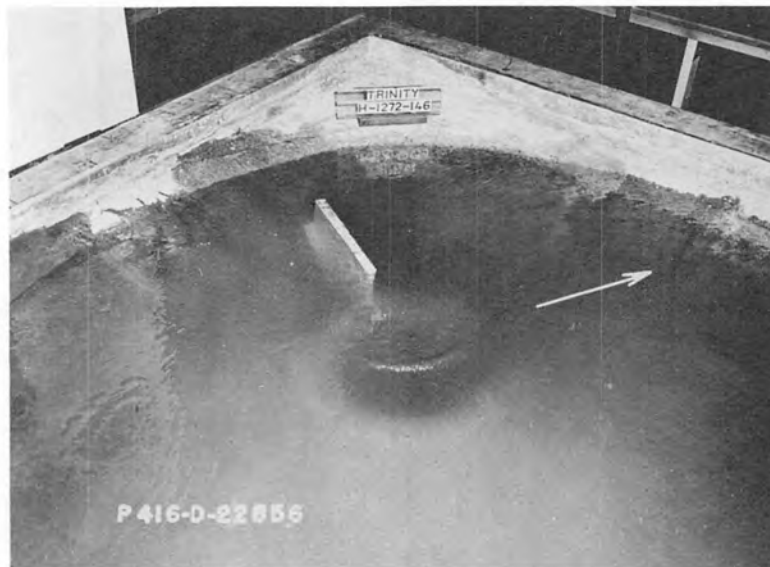
Figure 40
Report HYD - 447

A. Discharge 20,000 cfs

B. Discharge 24,000 cfs

TRINITY MORNING-GLORY SPILLWAY
OPERATION OF RECOMMENDED DESIGN
1:30 MODEL

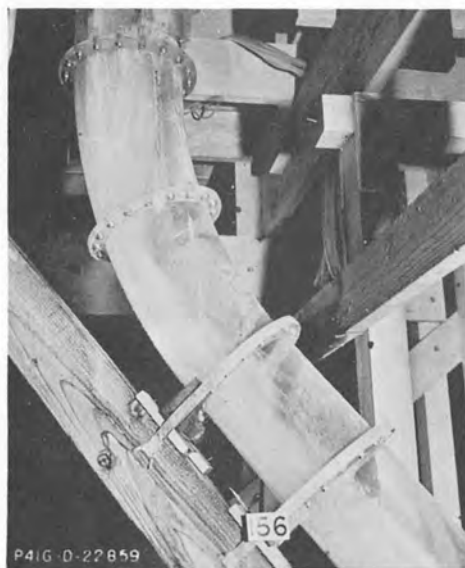
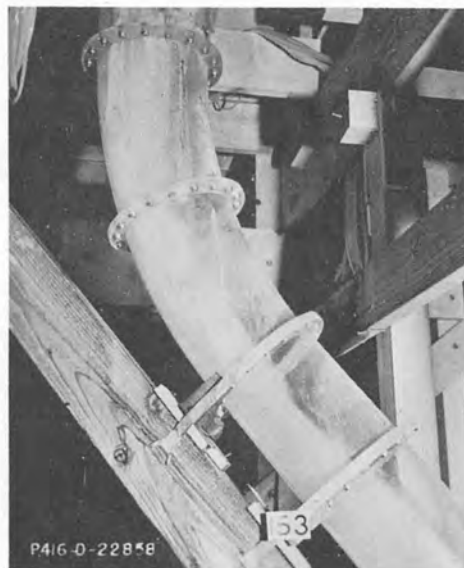
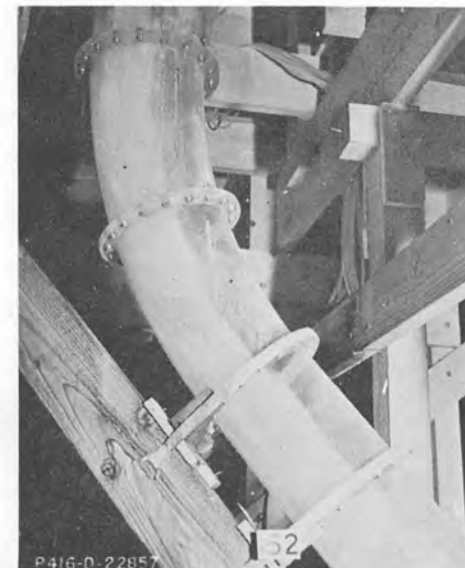
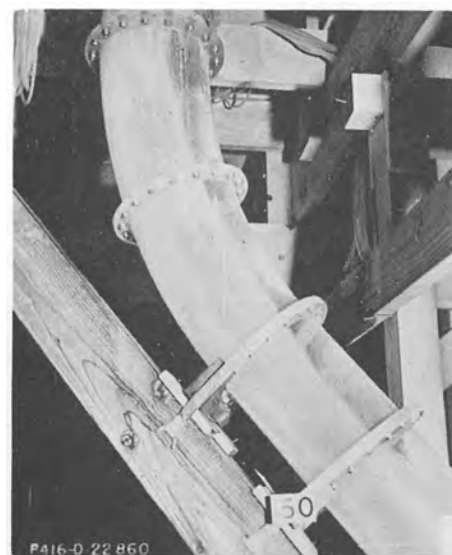
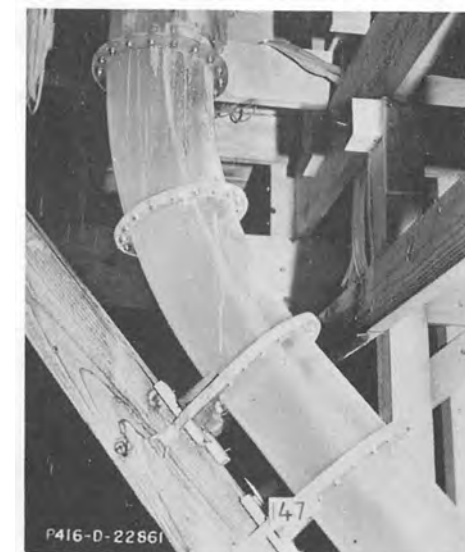
A. Discharge 5,000 cfs

B. Discharge 10,000 cfs

C. Discharge 15,000 cfs

D. Discharge 20,000 cfs

TRINITY MORNING-GLORY SPILLWAY,
RECOMMENDED DESIGN
FLOW IN UPPER BEND
1:30 MODEL

E. Discharge 24,000 cfs

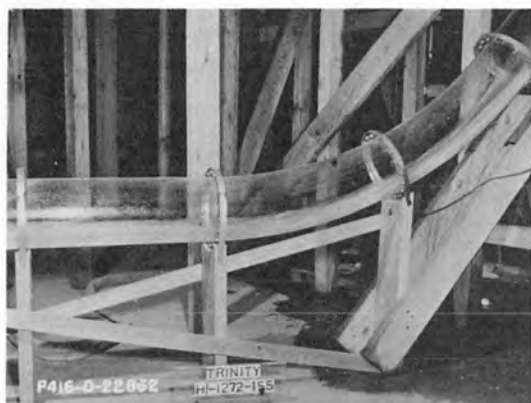
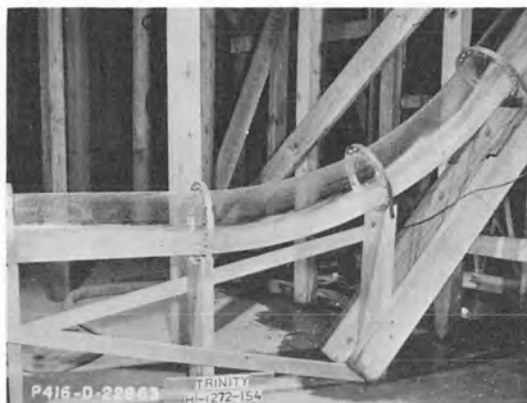
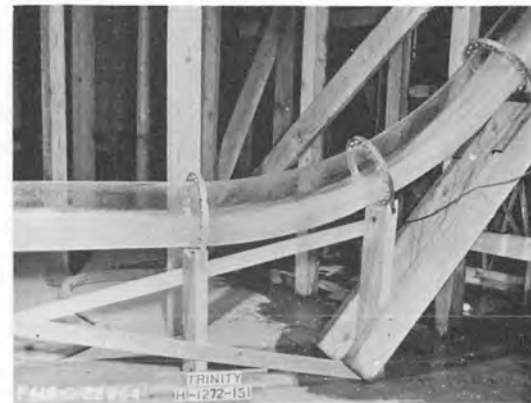
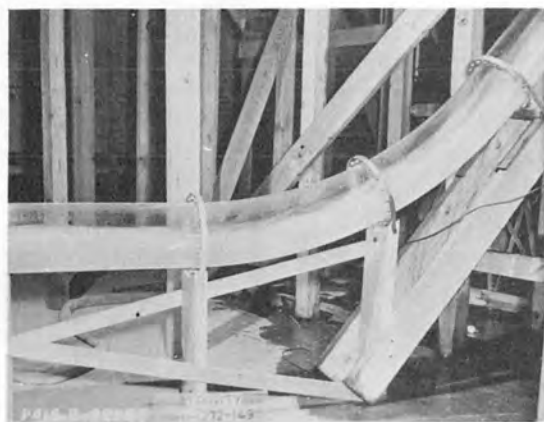
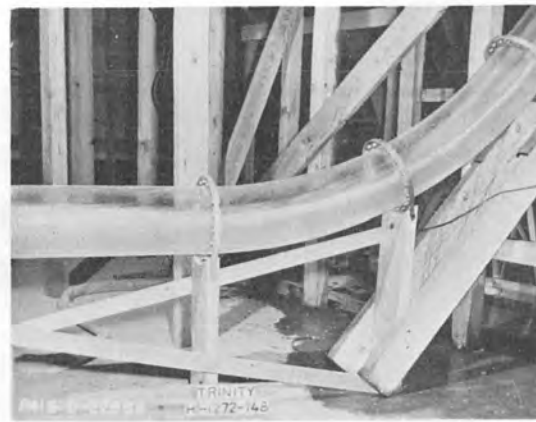
A. Discharge 5,000 cfs

B. Discharge 10,000 cfs

C. Discharge 15,000 cfs

D. Discharge 20,000 cfs

E. Discharge 24,000 cfs

TRINITY MORNING-GLORY SPILLWAY
RECOMMENDED DESIGN
FLOW IN LOWER BEND
1:30 MODEL
