HYDRAULIC MODEL STUDIES OF THE
TRINITY DAM SPILLWAY FLIP BUCKET
CENTRAL VALLEY PROJECT--CALIFORNIA

Hydraulic Laboratory Report No. Hyd-467

August 10, 1960

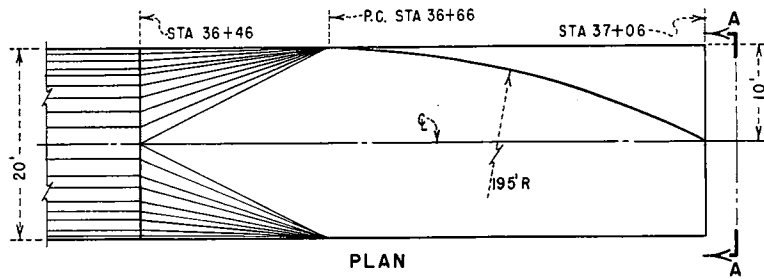
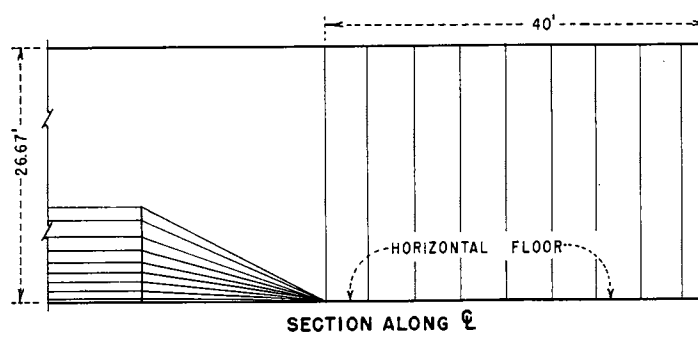
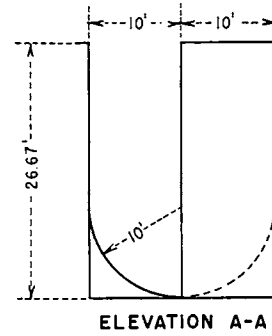
A. BUCKET NO.3

TRINITY DAM SPILLWAY
BUCKET STUDIES
FLIP BUCKETS 3 AND 4

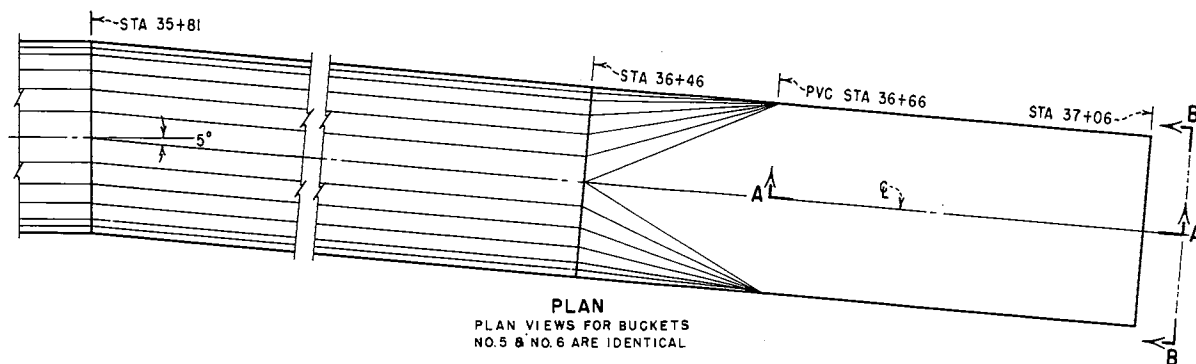
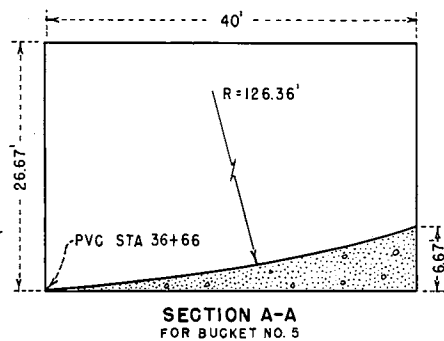
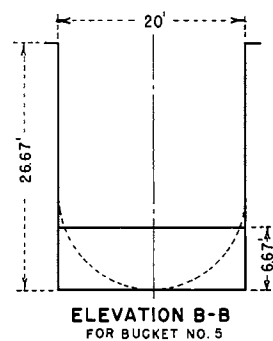
A. BUCKET No. 5

**TRINITY DAM SPILLWAY
BUCKET STUDIES
FLIP BUCKETS 5 AND 6**

For Bucket No. 5, the 5-degree turn in the channel alinement was maintained, the right wall was replaced, and a 40-foot-long curved deflector was placed in the floor of the bucket section, Figure 7A. The deflector was a segment of a 123.36-foot-radius circle with the point of curvature at Station 36+66. The lip at the end of the deflector was 6.67 feet above the floor. At the point of impact, the jet covered an area of about 80 feet square. However, the vertical angle of the jet as it struck the tail-water surface was such that it caused a clockwise eddy to form in the dead-water area to the right of the bucket. The eddy moved material eroded by the jet into a sandbar in front of the powerplant and outlet-works stilling basin. It was apparent that this obstruction would interfere with the discharge from these structures.

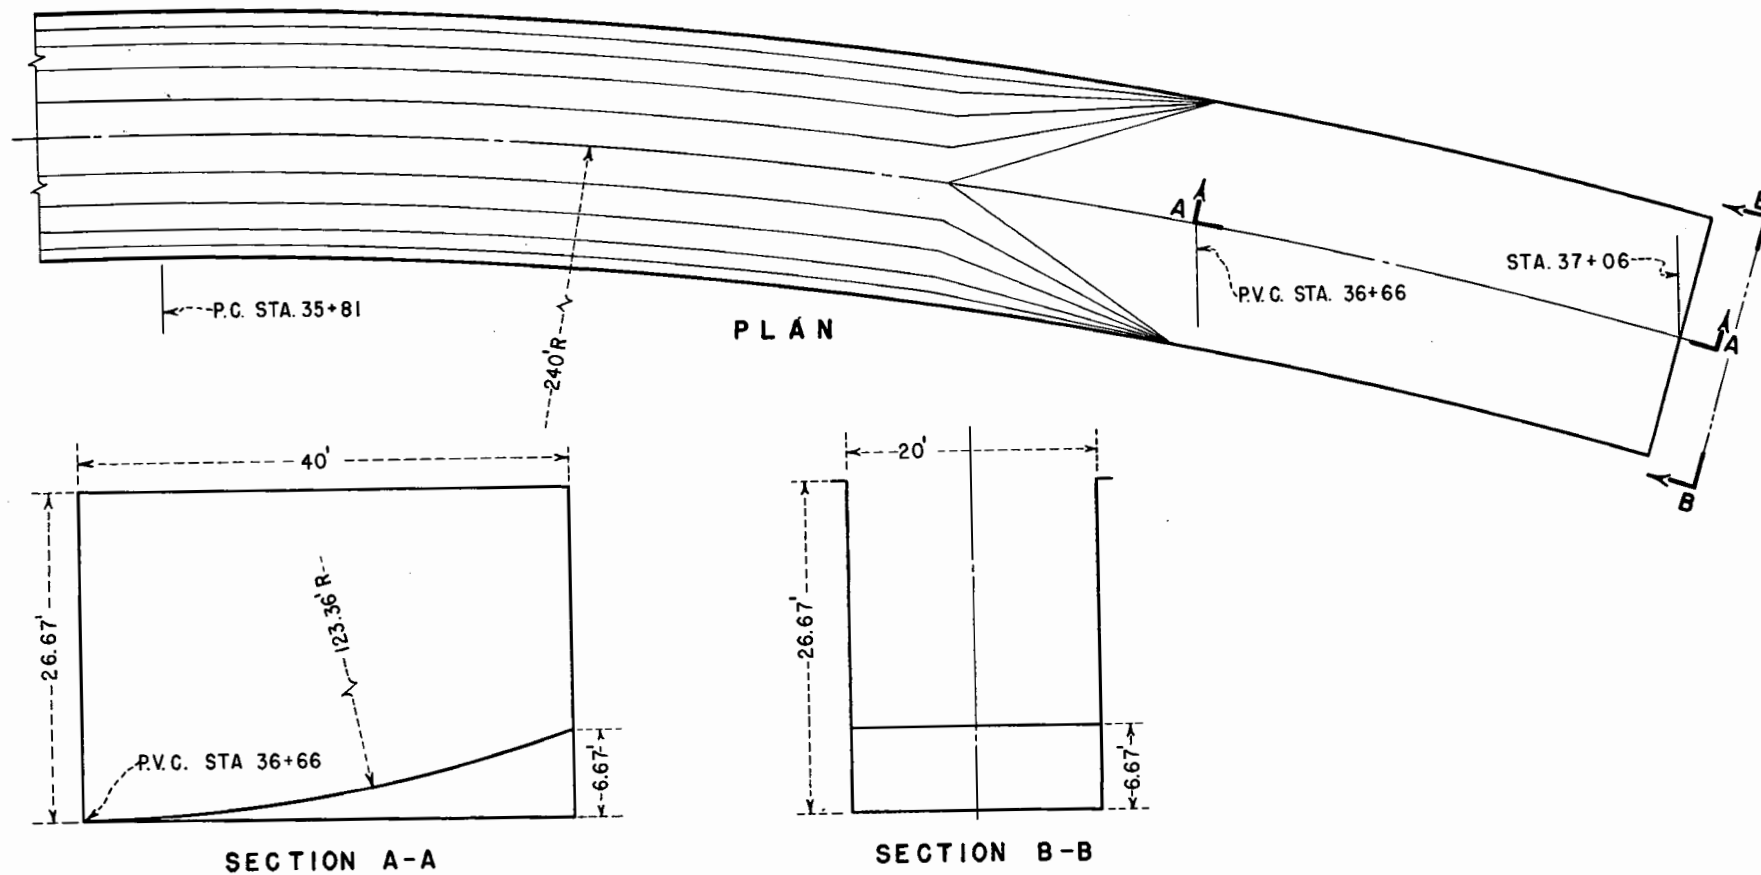
TRINITY DAM SPILLWAY
 BUCKET STUDIES
 FLIP BUCKET NO. 7

the downstream end, the channel was extended on a 3:1 slope to elevation 1912.0, 22.21 feet lower than for the previous bucket. Low Level Flip Bucket No. 7 was placed at the end of the conduit, but the drip apron was eliminated. The rock on the right side of the bucket was removed to form an excavated channel leading down to river level. At the end of the bucket, the rock was removed to provide a smooth slope into the river channel. The recommended bucket and the surrounding topography are shown in Figure 33.

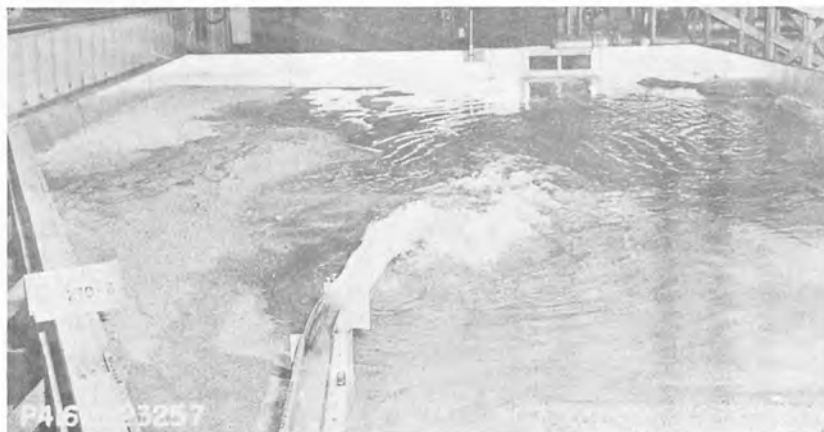
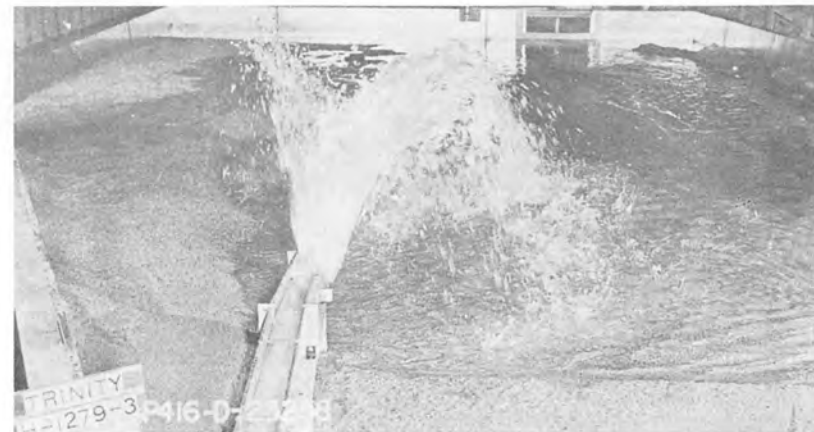
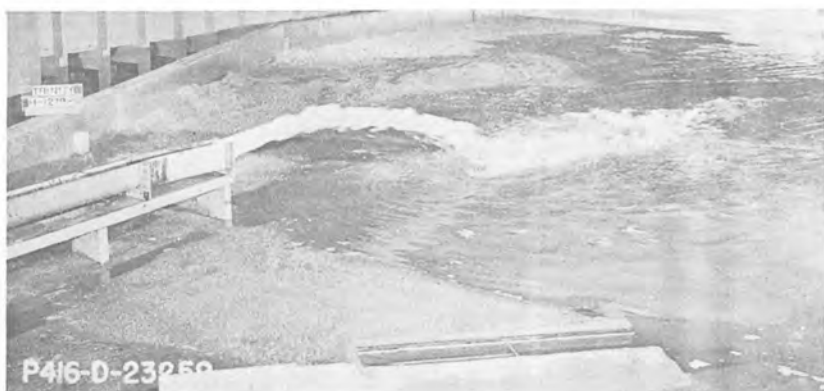
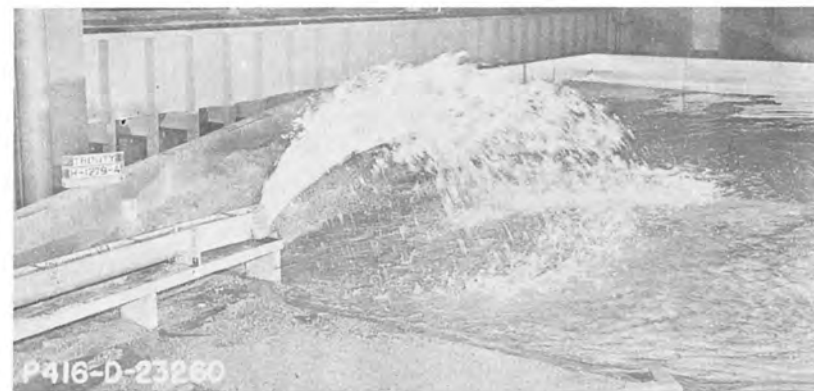
A. Flip Bucket No. 7

B. Dispersion Bucket No. 1

Discharge = 24,000 cfs

TRINITY DAM SPILLWAY
Bucket Studies
Flow conditions for Flip Bucket No. 7 and Dispersion Bucket No. 1

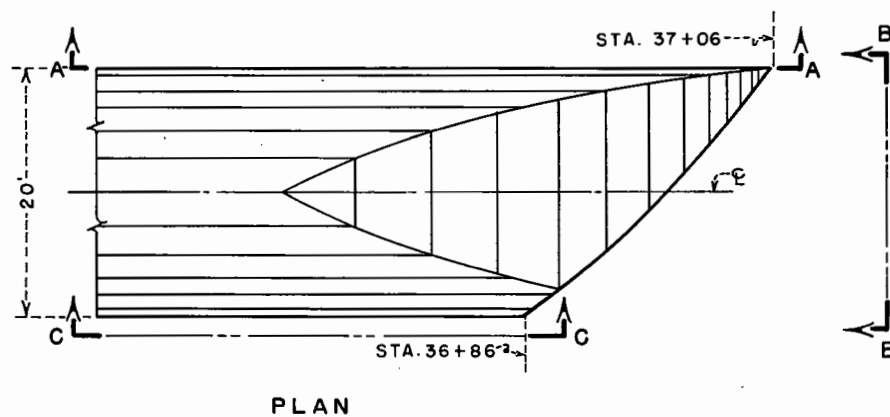
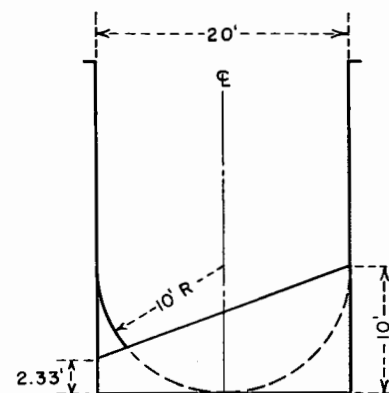
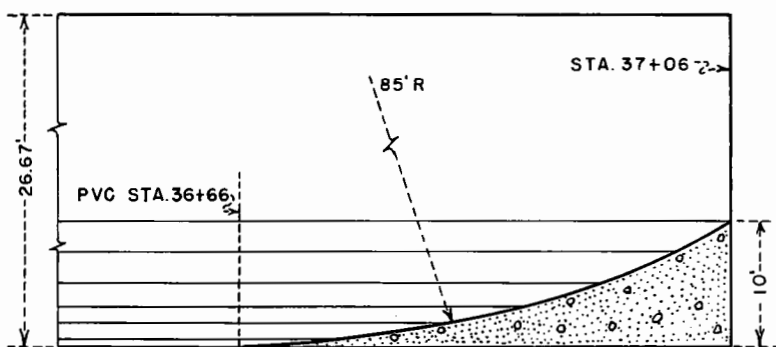
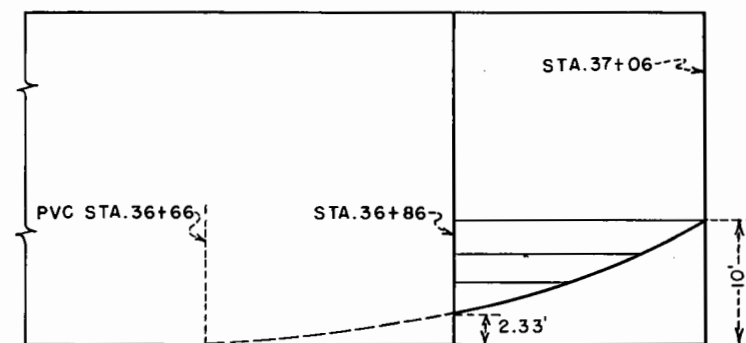
TRINITY DAM SPILLWAY
BUCKET STUDIES
DISPERSION BUCKET NO. 1

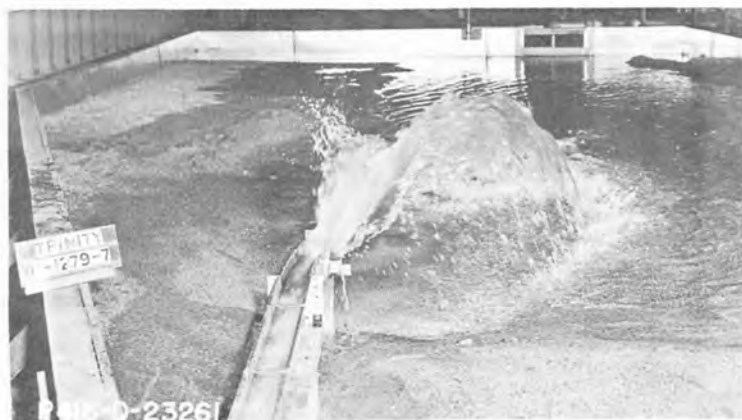
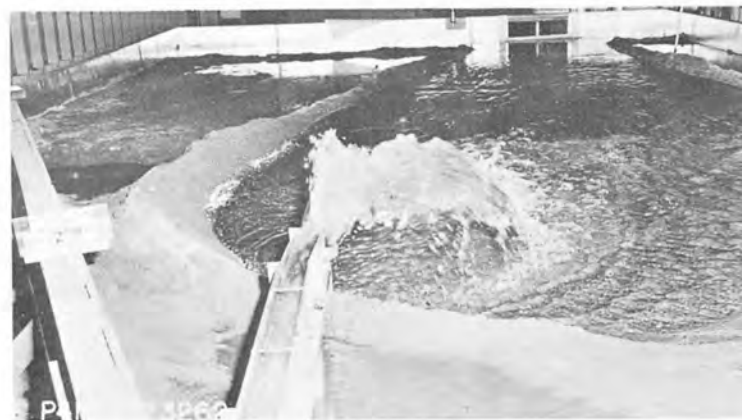
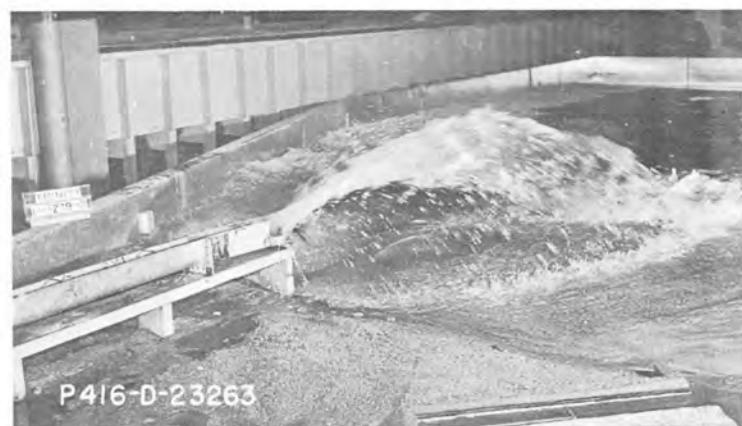
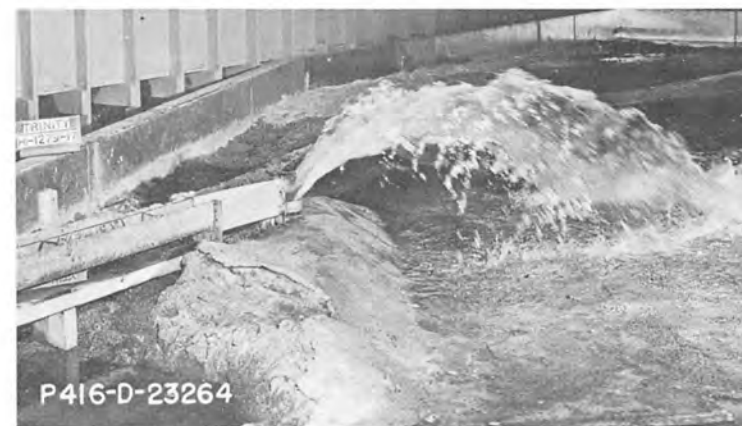
A. Dispersion Bucket No. 2

B. Dispersion Bucket No. 3

Discharge = 24,000 cfs

TRINITY DAM SPILLWAY
 Bucket Studies
 Flow Conditions - Dispersion Buckets 2 and 3

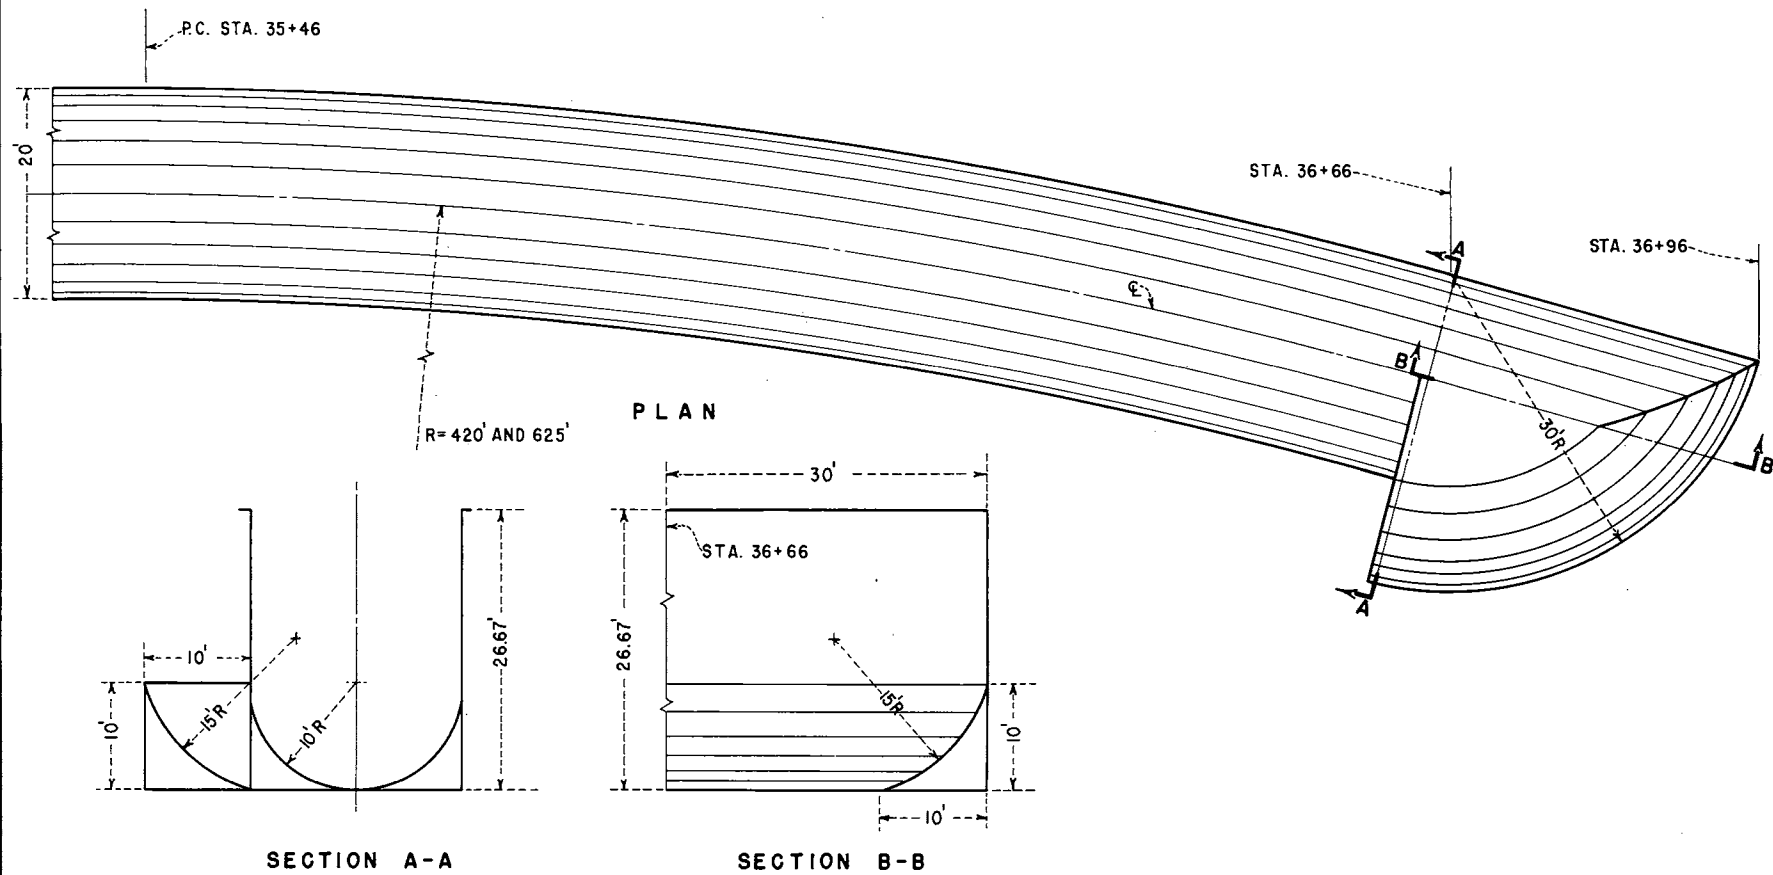
TRINITY DAM SPILLWAY
 BUCKET STUDIES
 DISPERSION BUCKET NO. 3

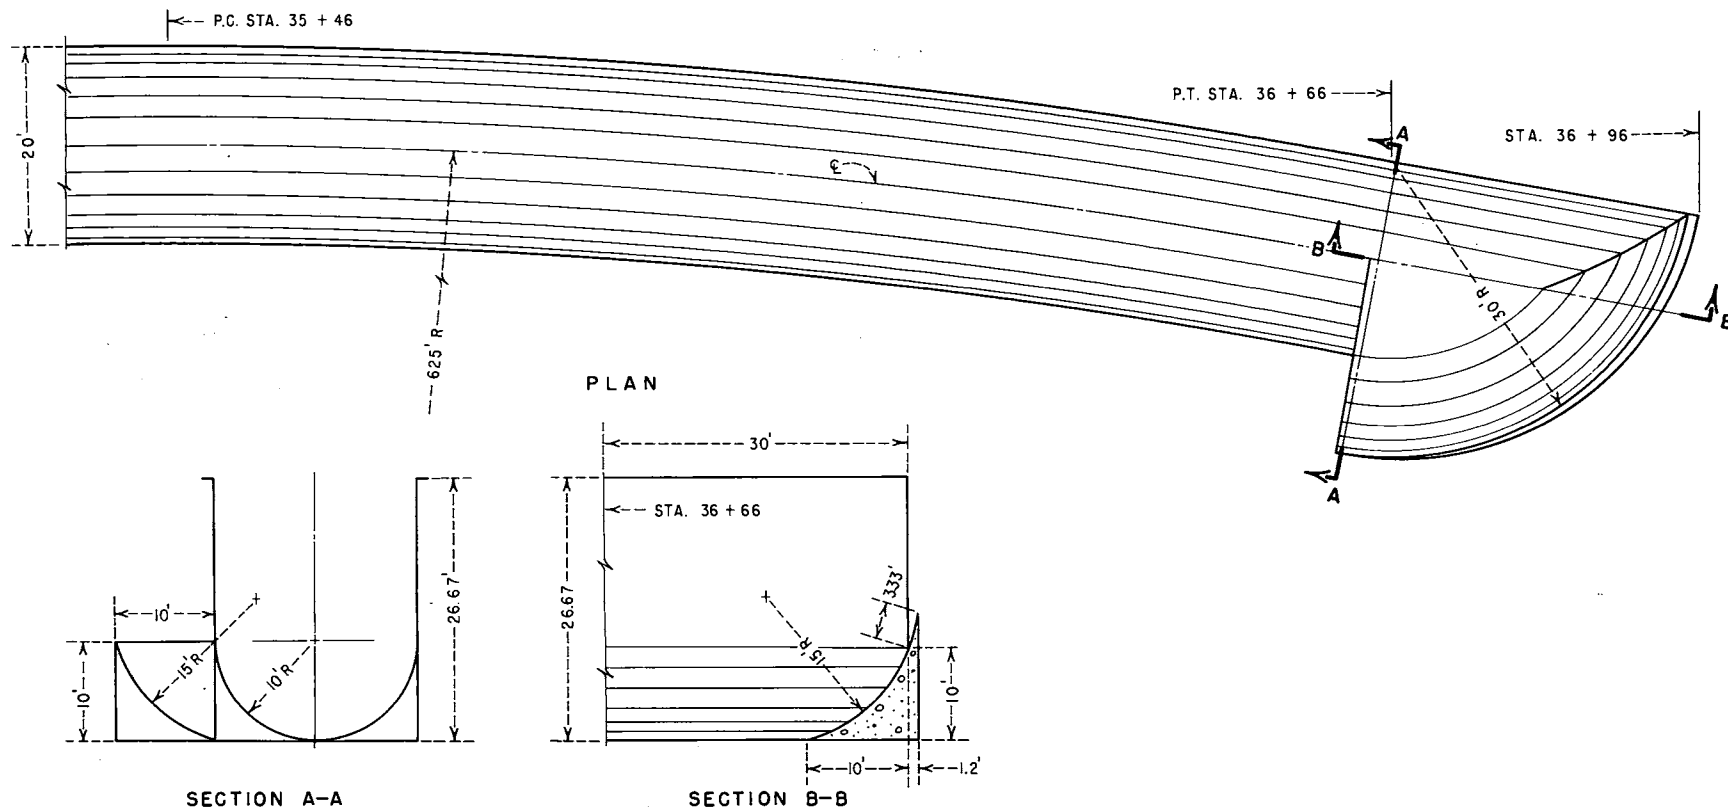
TRINITY DAM SPILLWAY
BUCKET STUDIES
DISPERSION BUCKET NO. 4

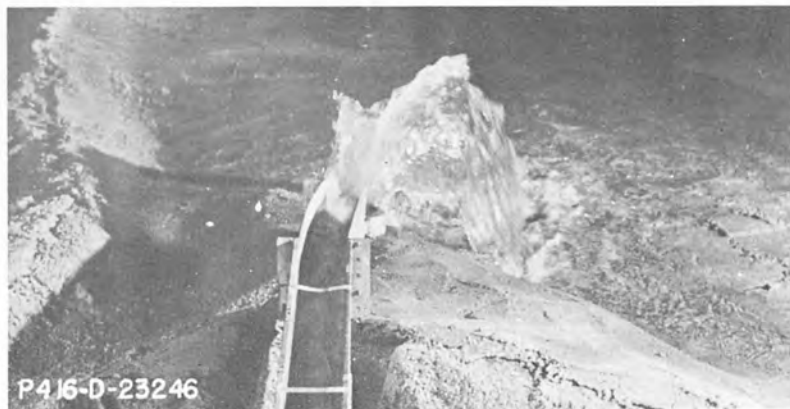
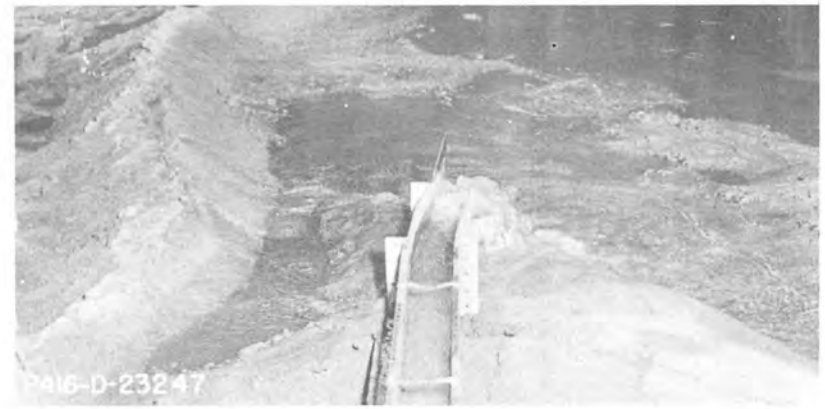
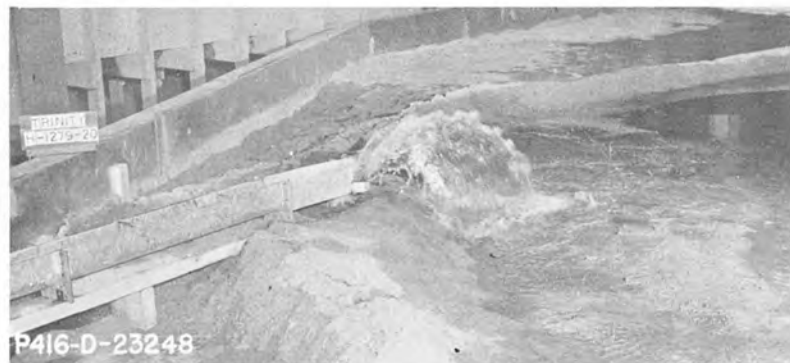
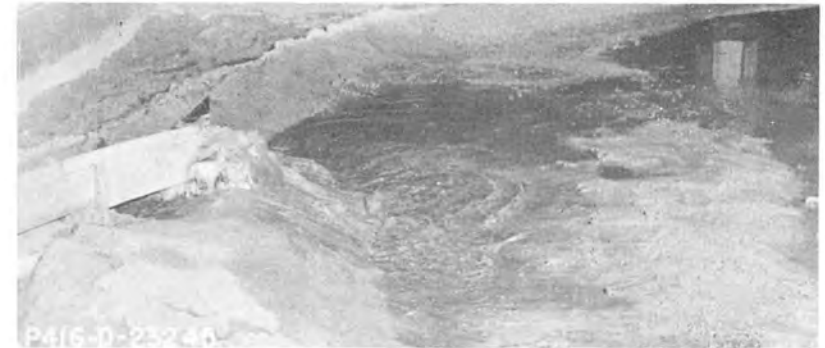
Discharge = 5,000 cfs

Discharge = 2,000 cfs

TRINITY DAM SPILLWAY
Bucket Studies
Flow Conditions - Dispersion Bucket 4

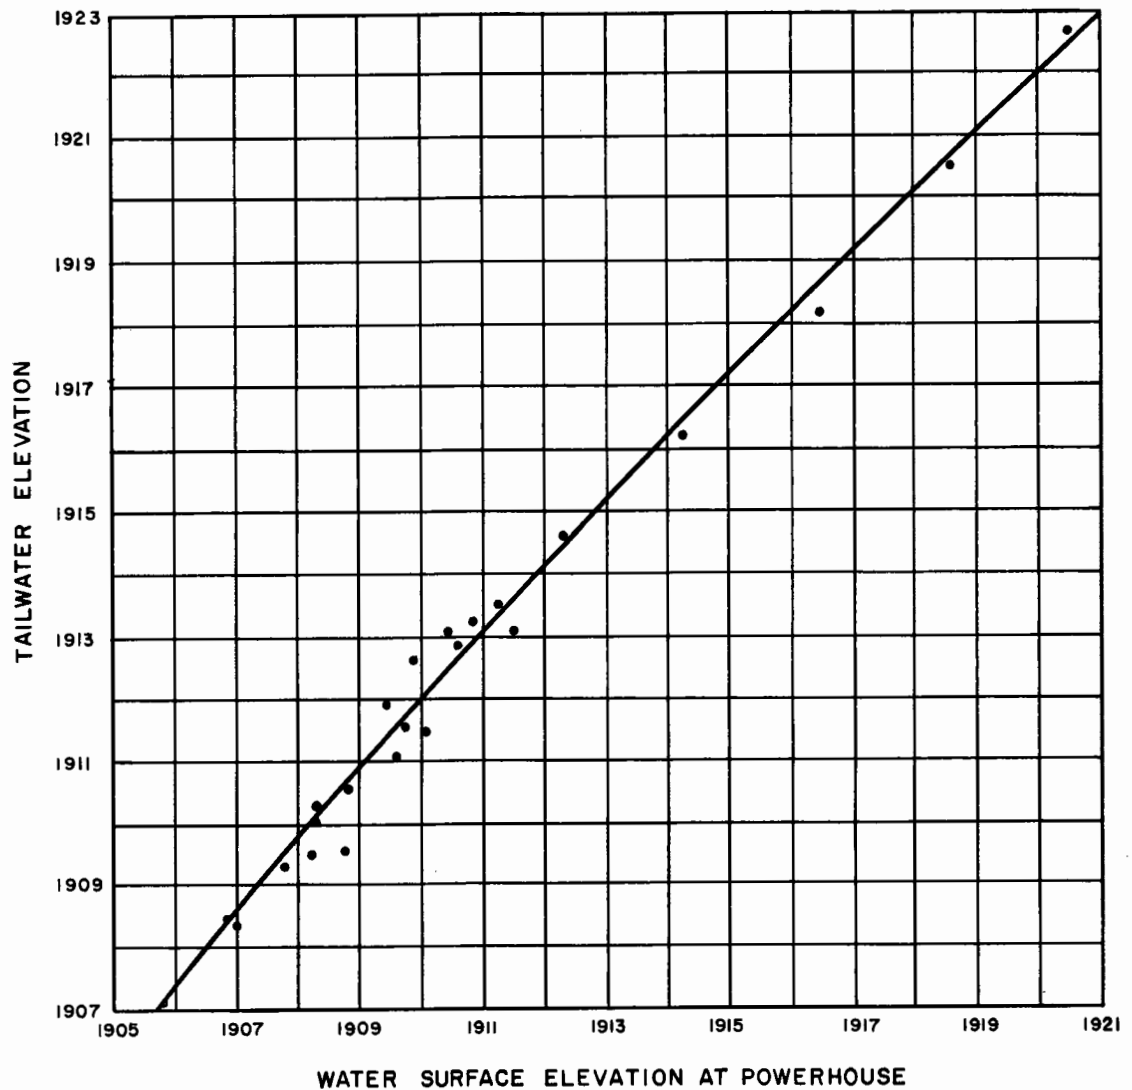
TRINITY DAM SPILLWAY
BUCKET STUDIES
WATER SURFACE DRAWDOWN FOR MAXIMUM DISCHARGE
DISPERSION BUCKET NO. 4

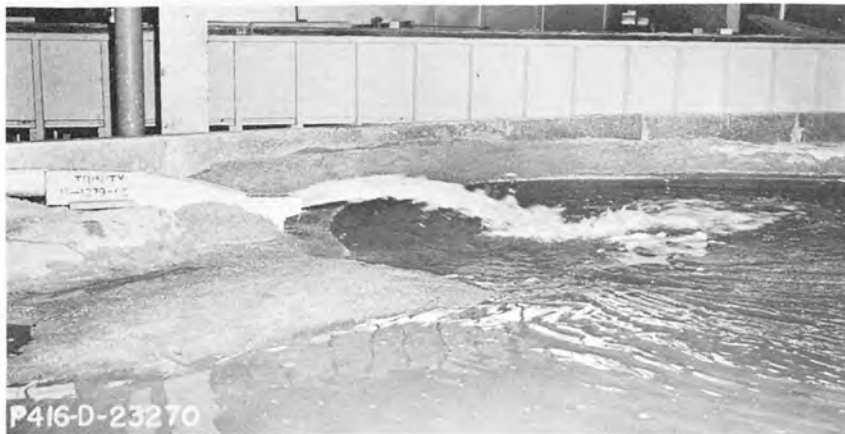
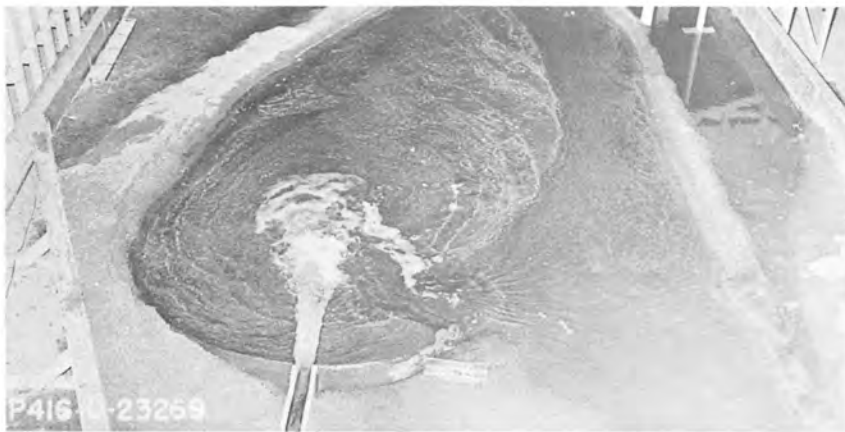
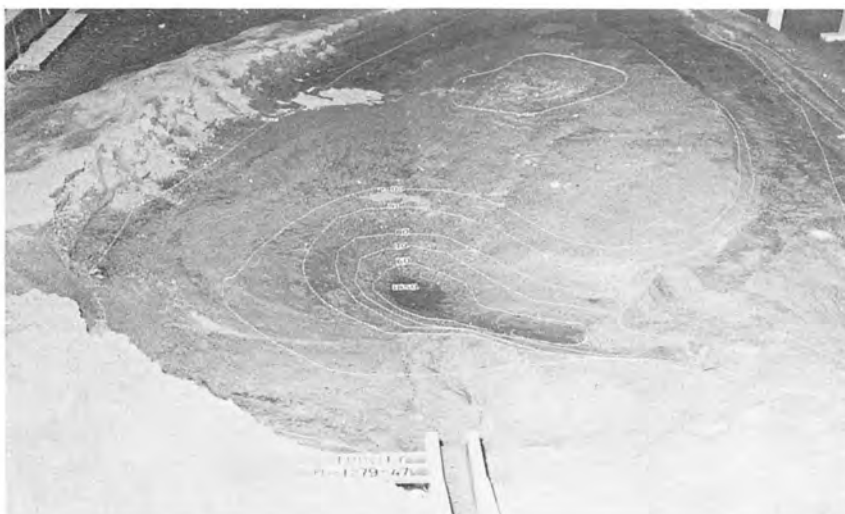
Figure 18
Report Hyd 467

Discharge = 24,000 cfs

Erosion after 1-hour operation

TRINITY DAM SPILLWAY
Bucket Studies
Flow and Erosion - Low Level Bucket No. 1

Prior to this test, the concrete river channel had been replaced with an erodible sandbed to measure bed scour and to determine bank erosion caused by eddies. To the left of the jet a bank area, about 120 feet wide by 300 to 400 feet long, was removed by the left eddy, Figure 18, and the jet eroded a large hole about 40 feet deep at the point of impact.

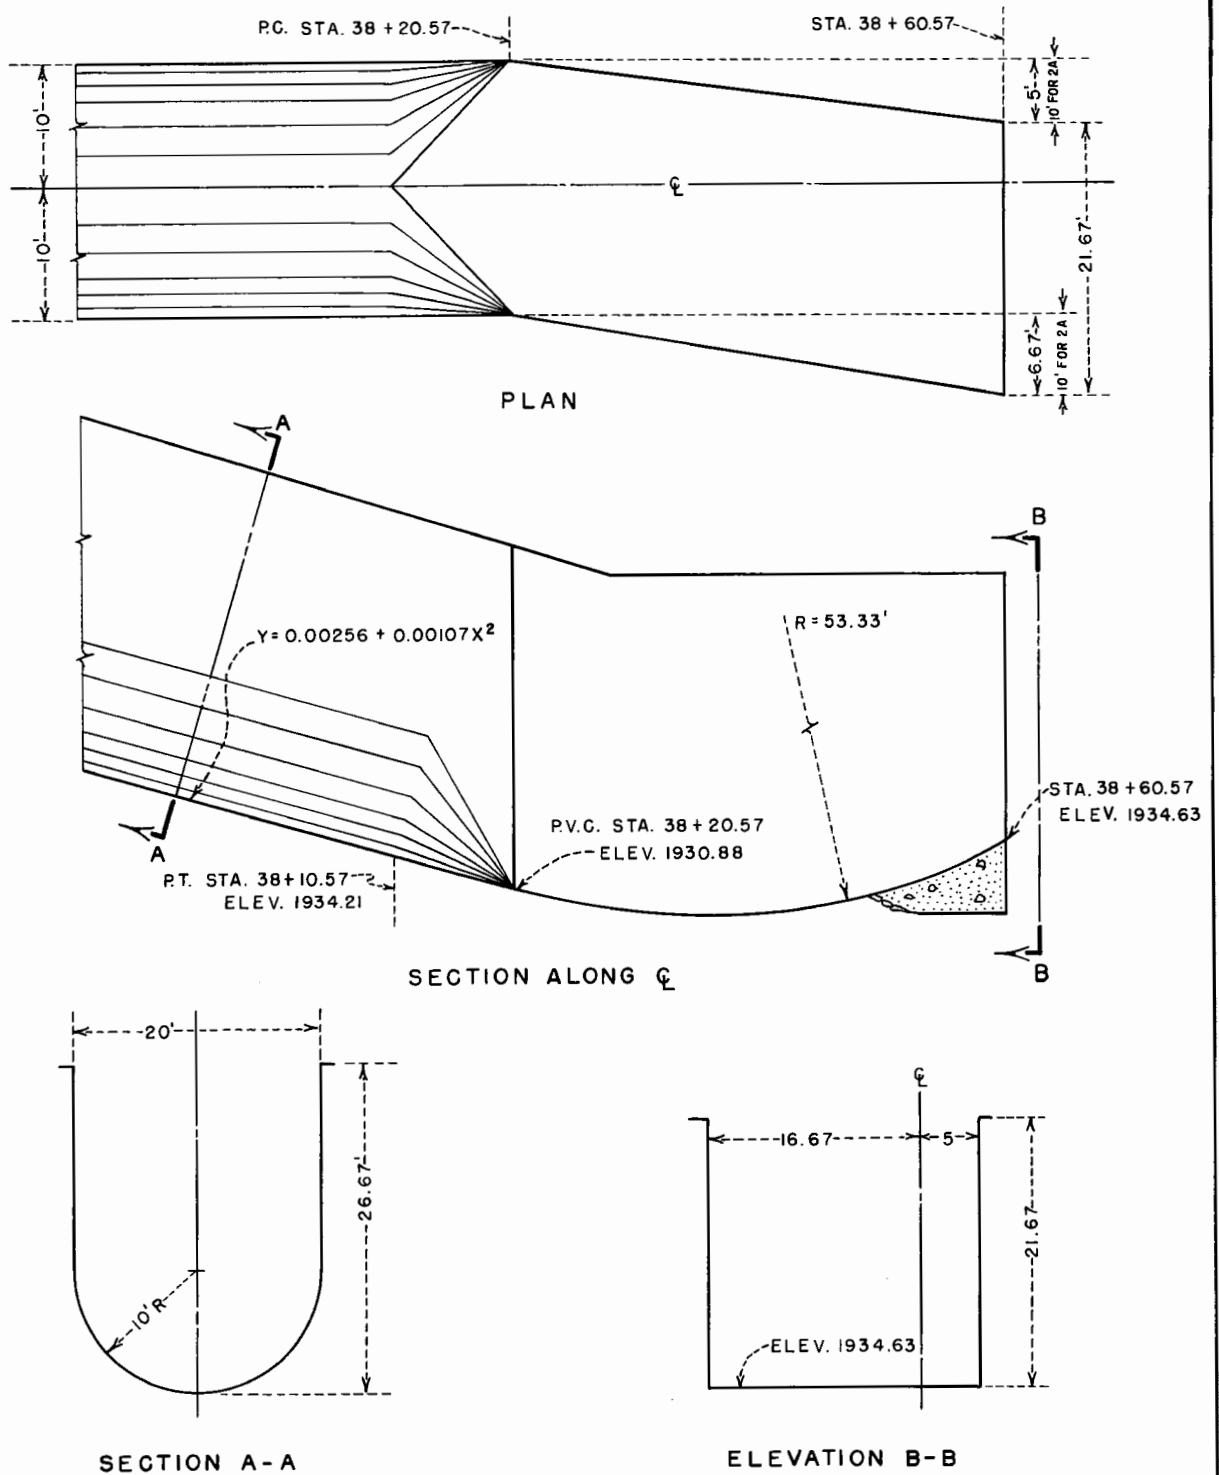
TRINITY DAM SPILLWAY
BUCKET STUDIES
LOW LEVEL BUCKETS 2 AND 2A

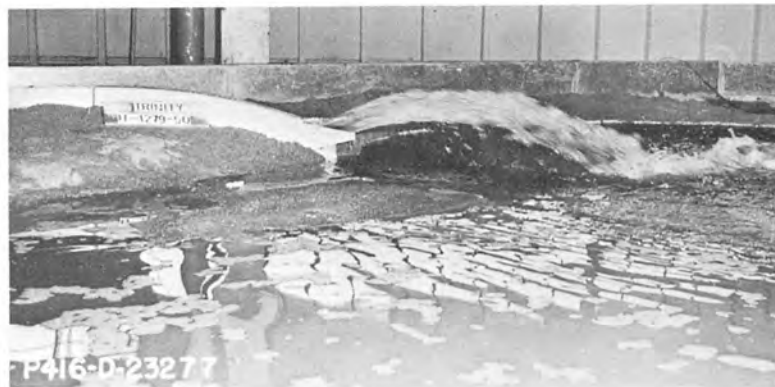
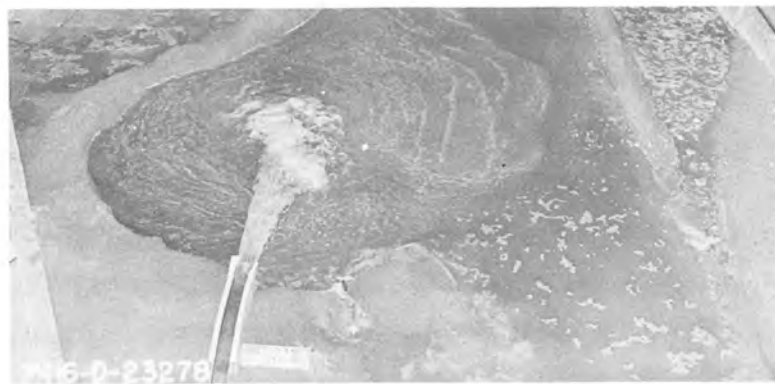
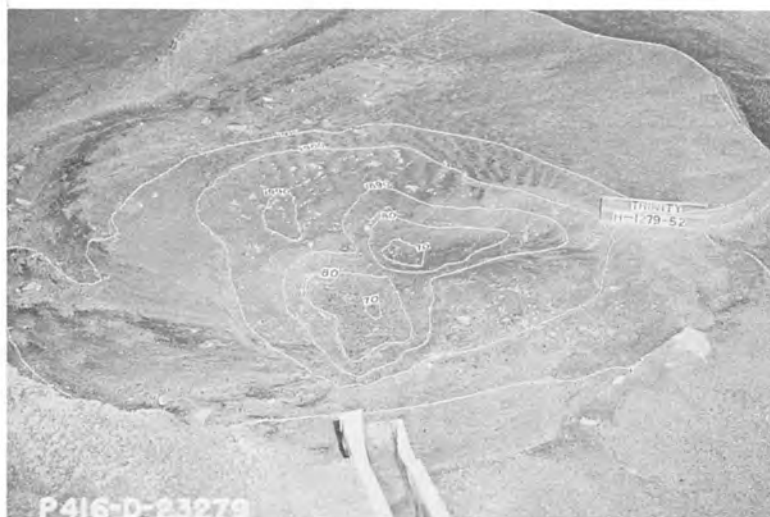
Figure 20
Report Hyd 467

Discharge = 24,000 cfs

Erosion after 1-hour operation

TRINITY DAM SPILLWAY
Bucket Studies
Flow and Erosion - Low Level Bucket No. 2

In operation, the jet was turned to the right and the diverging right wall allowed the jet to spread more than had occurred with the previous bucket. There also was more longitudinal dispersion in the jet, Figure 20. The greater dispersion reduced the depth of erosion from 40 feet to 20 feet; however, there was considerably more bank erosion. The bank on the left side was eroded back almost 300 feet from its original line. The material eroded from the left bank was moved to the right where it formed a large bar near the center of the channel. However, a sufficient width of channel remained between the sandbar and the right riverbank to pass normal powerplant and outlet works discharges.

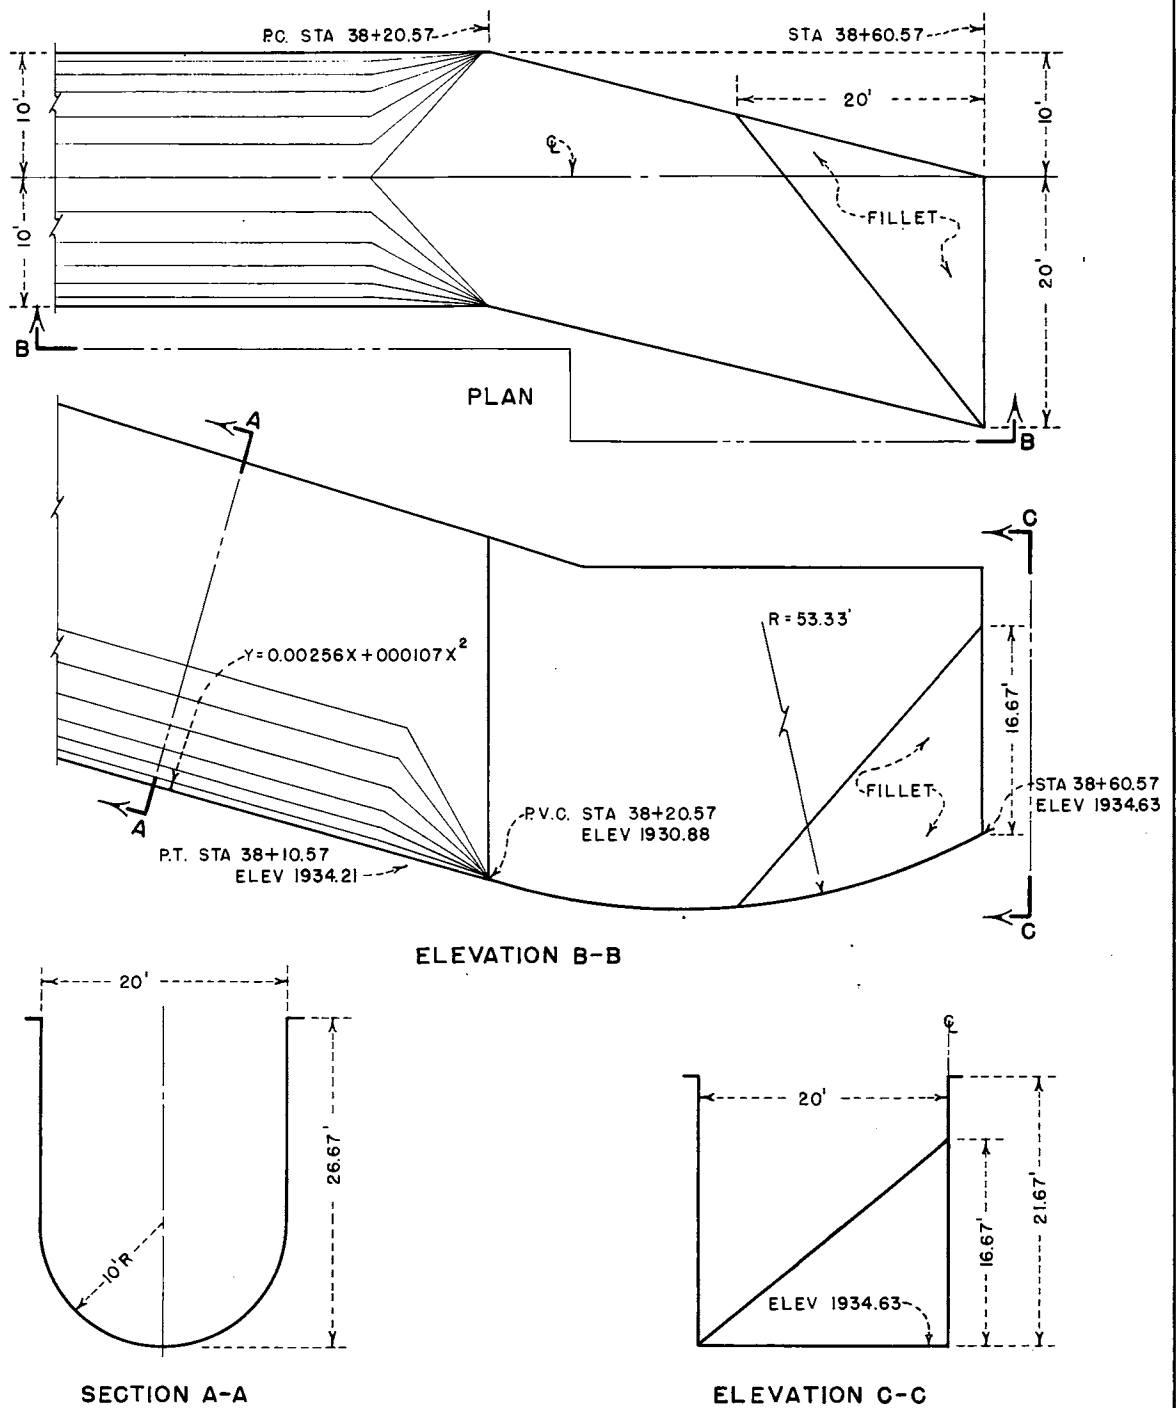
TRINITY DAM SPILLWAY
BUCKET STUDIES
LOW LEVEL BUCKET NO. 3

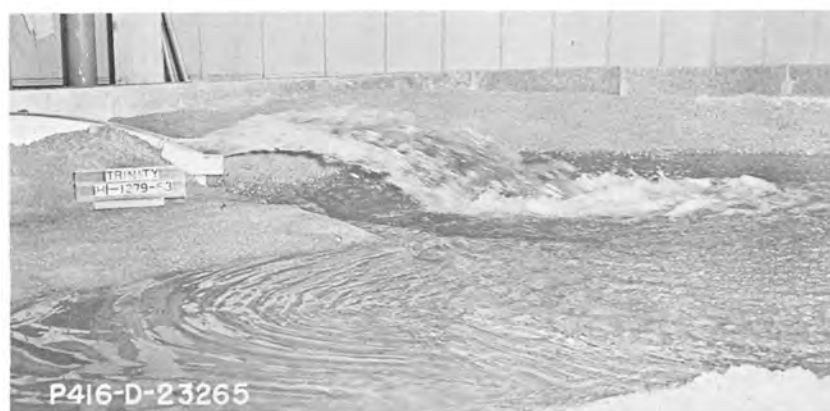
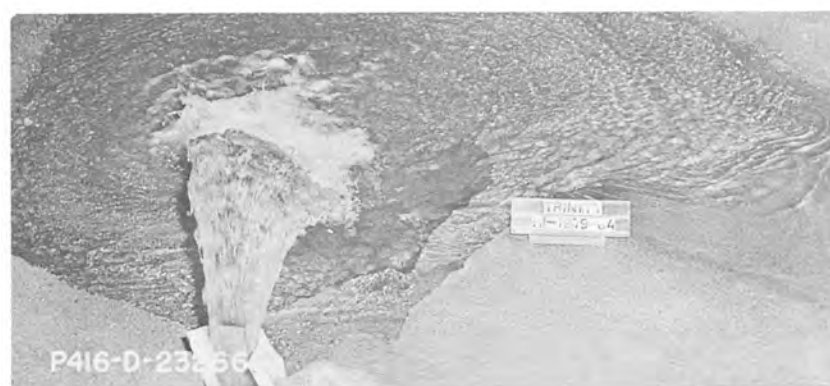
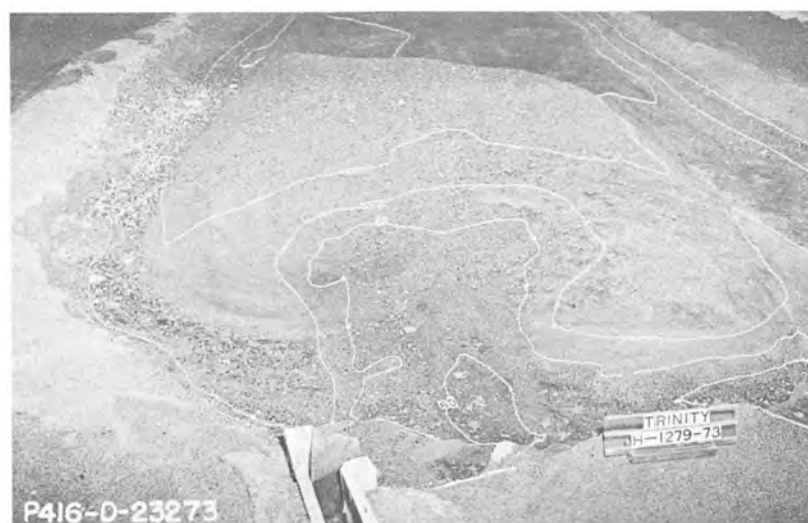
Discharge = 24,000 cfs

Erosion after 1-hour operation

TRINITY DAM SPILLWAY
Bucket Studies
Flow and Erosion - Low Level Bucket No. 3

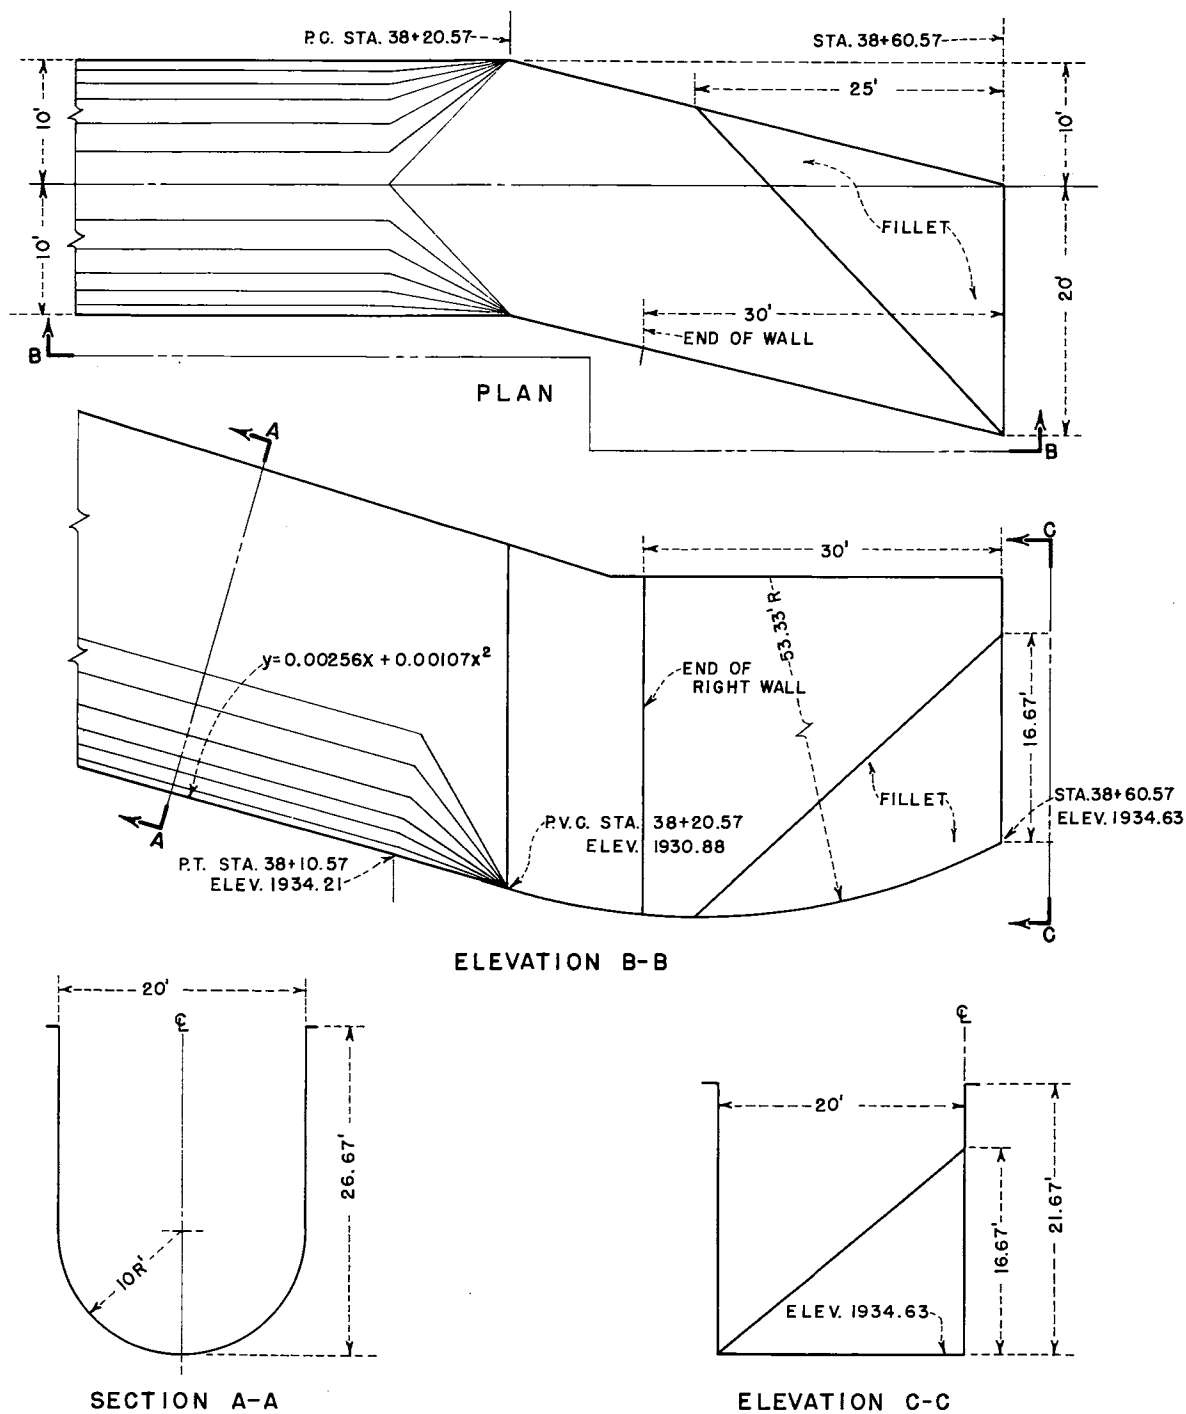
TRINITY DAM SPILLWAY
BUCKET STUDIES
LOW LEVEL BUCKET NO. 4

For Low Level Bucket No. 4, the right wall of the bucket was shortened 30 feet and the leading edge of the triangular fillet was moved upstream about 5 feet, giving less superelevation in the bucket, Figure 23. Jet dispersion was increased by this bucket because the right side of the jet was deflected out of the open side of the bucket. However, water leaving the right side struck the river channel near the end of the bucket. This flow neutralized the damaging eddy previously in evidence along the right side of the jet. The main portion of the flow from the spillway moved downstream in a direct line, Figure 24. The contact line of the jet with the tail water was continuous from a point to the right of the bucket to a point about 300 feet downstream. Bank erosion on the left side was negligible. Bed scour was about 20 feet deep but a small area was eroded an additional 10 feet deep, Figure 24.

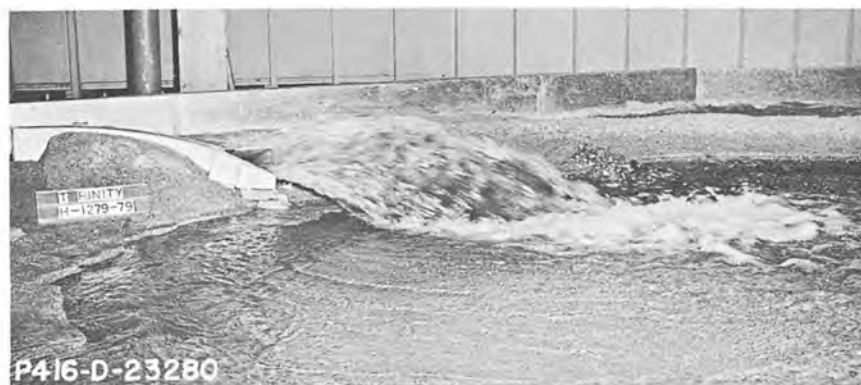
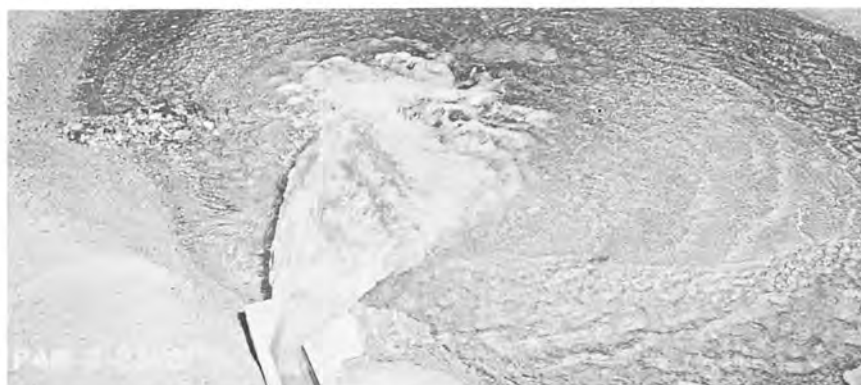
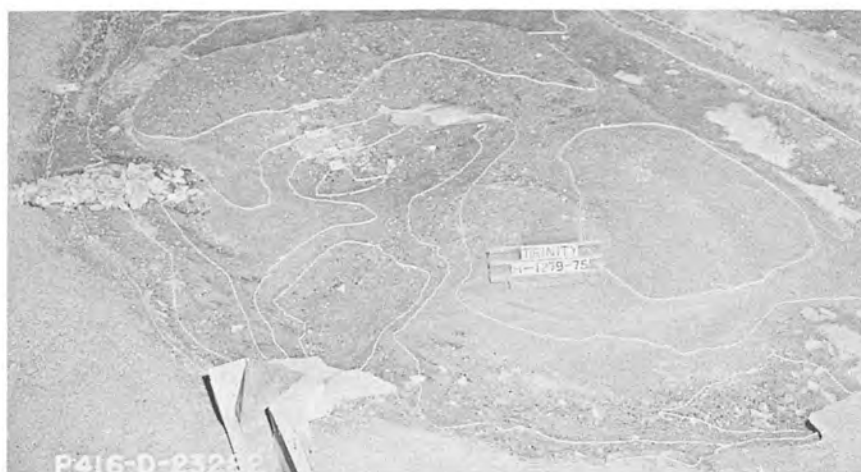
Figure 24
Report Hyd 467

Discharge = 24,000 cfs

Erosion after 1-hour operation

TRINITY DAM SPILLWAY
Bucket Studies
Flow and Erosion - Low Level Bucket No. 4
