HYDRAULIC MODEL STUDIES OF THE
TRINITY DAM SPILLWAY FLIP BUCKET
CENTRAL VALLEY PROJECT--CALIFORNIA

Hydraulic Laboratory Report No. Hyd-467

August 10, 1960

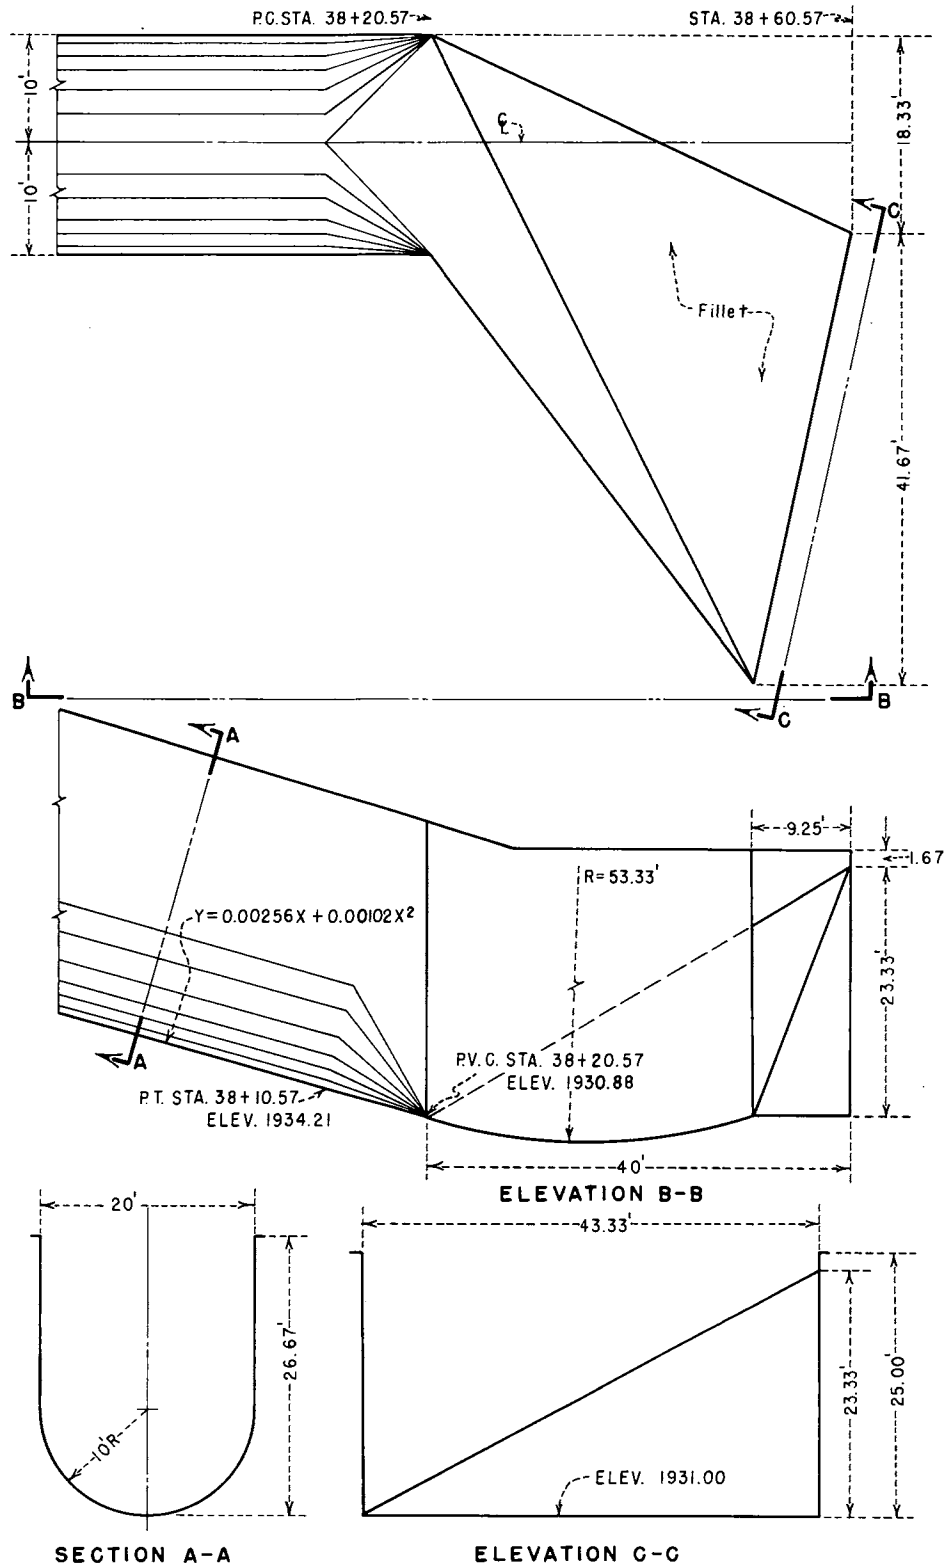
TRINITY DAM SPILLWAY
BUCKET STUDIES
LOW LEVEL BUCKET NO. 5

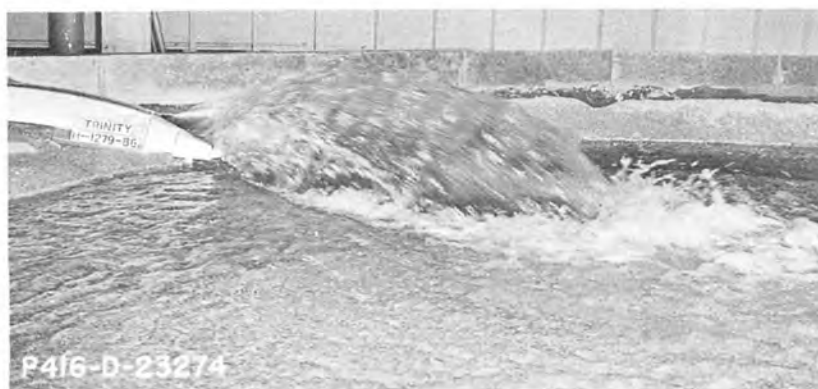
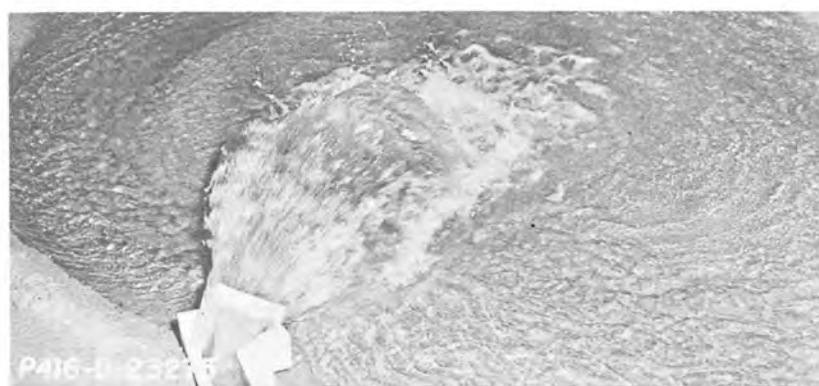
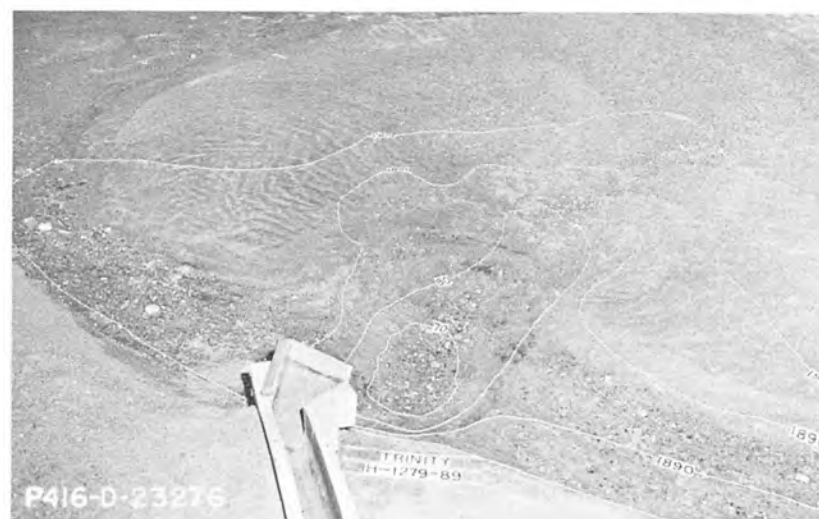
Discharge = 24,000 cfs

Erosion after 1-hour operation

TRINITY DAM SPILLWAY
Bucket Studies
Flow and Erosion - Low Level Bucket No. 5

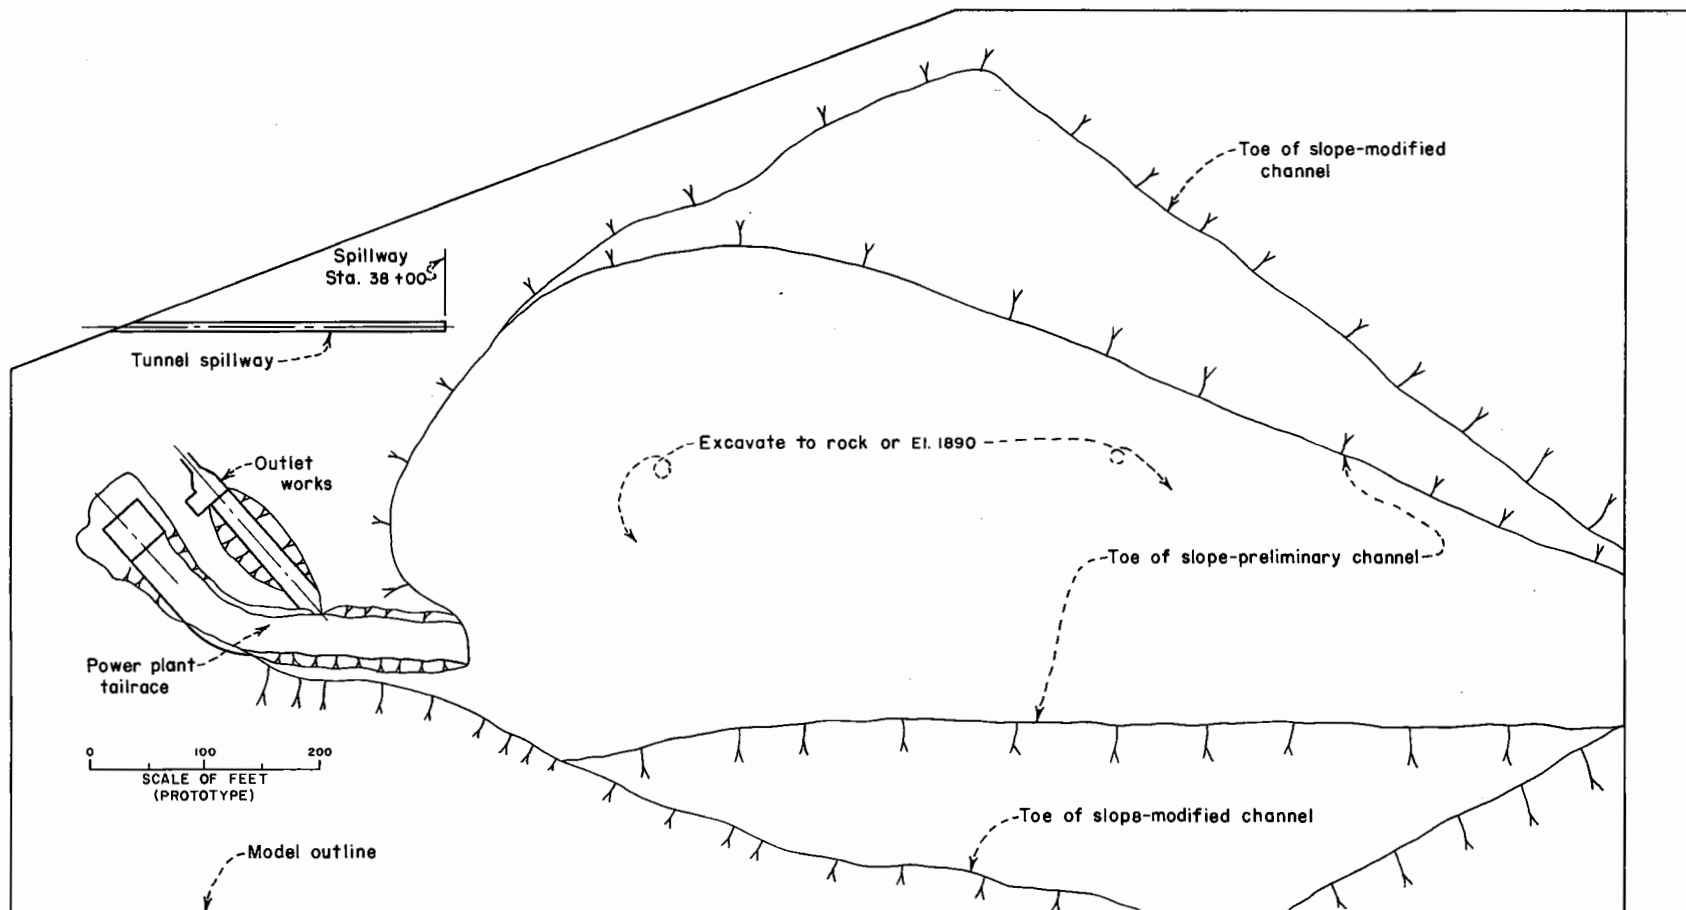
TRINITY DAM SPILLWAY
BUCKET STUDIES
RIVER CHANNEL MODIFICATION

28, the left riverbank was moved to the left almost 500 feet and the right was moved about 200 feet to the right. The modification to the bucket greatly improved the dispersion of the jet and practically eliminated the eddy action on both sides, Figure 29. Because of the increase in channel width, the eddy currents were reduced and bank erosion was negligible. Bottom scour was about 20 feet deep. The bed material removed by the jet formed a bar downstream, but it appeared that the bar would not interfere with normal flows from the powerplant.

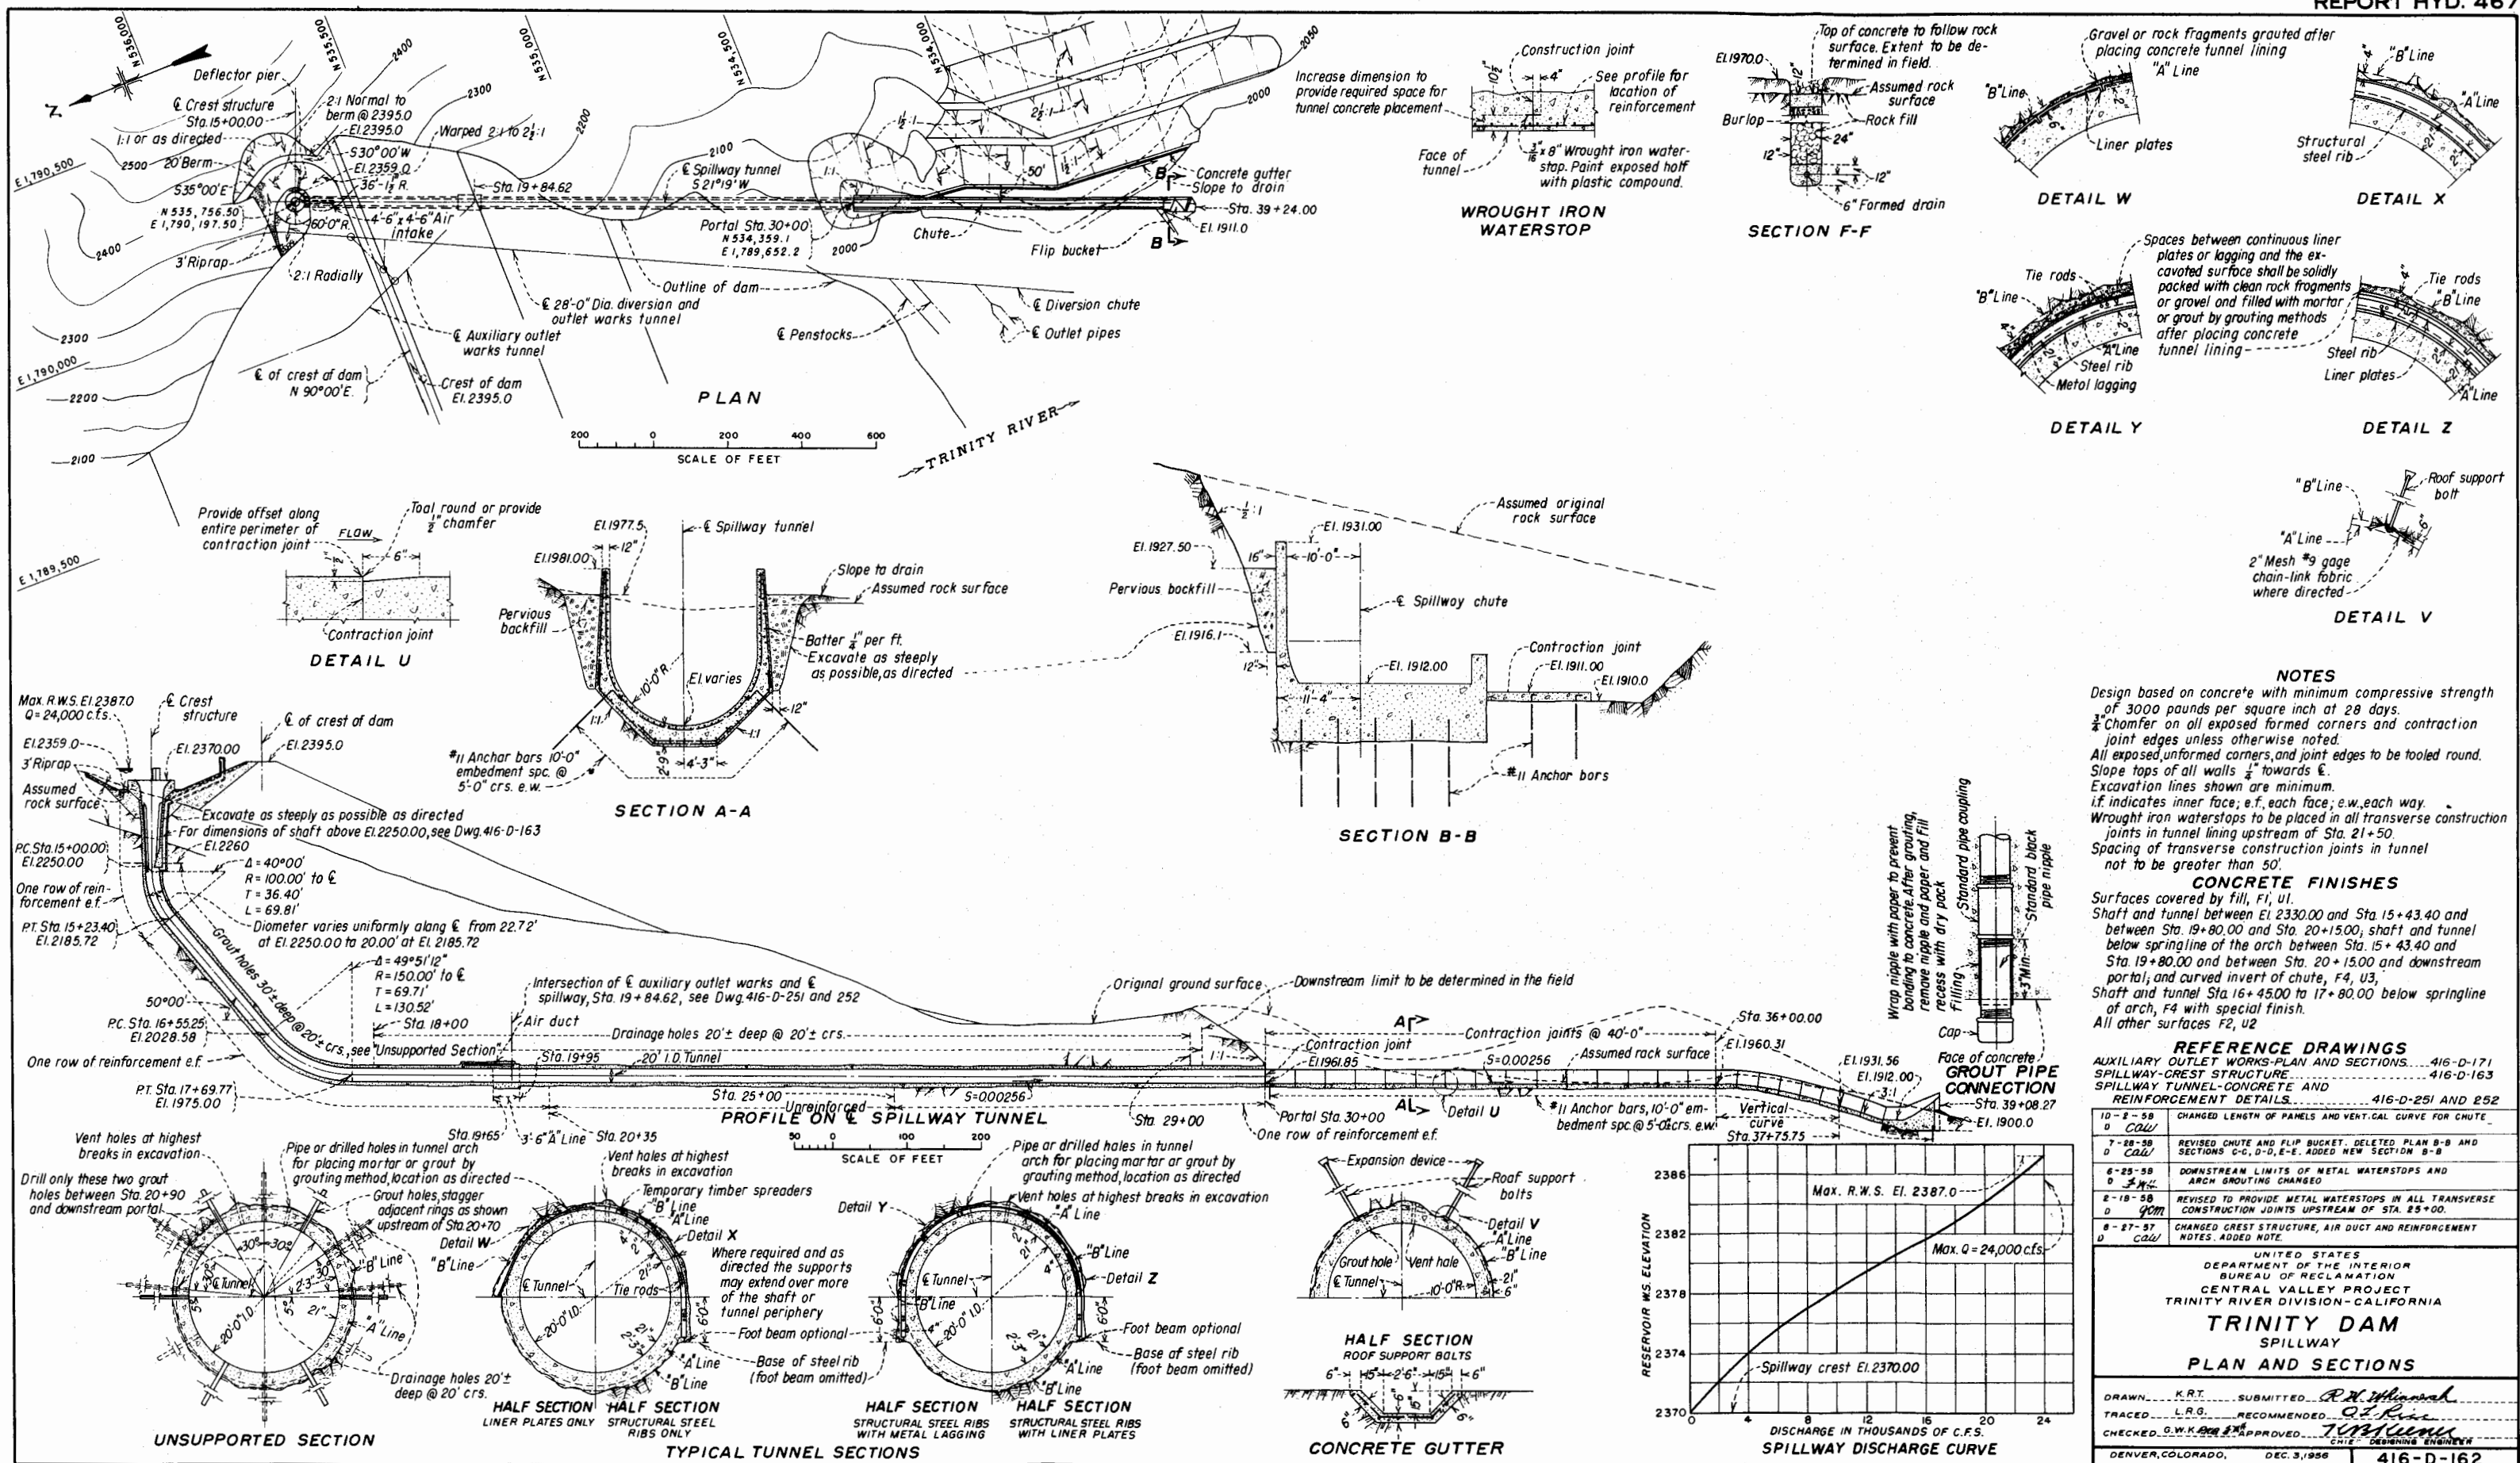
FIGURE 3
REPORT HYD. 467

UNITED STATES DEPARTMENT OF THE INTERIOR BUREAU OF RECLAMATION CENTRAL VALLEY PROJECT TRINITY RIVER DIVISION - CALIFORNIA	
TRINITY DAM SPILLWAY	
PLAN AND SECTIONS	
DRAWN - K.R.T.	SUBMITTED - <i>R.H. McNeal</i>
TRACED - L.R.G.	RECOMMENDED - <i>O.L. Rice</i>
CHECKED - G.W.K. <i>W.K.</i>	APPROVED - <i>T. H. ...</i>
	CHIEF DESIGNING ENGINEER
DENVER, COLORADO,	DEC. 3, 1966
	416-D-162

Where the horizontal tunnel emerges from the left abutment, it becomes a 20-foot-diameter semicircular open-top conduit 660 feet long which connects to the flip bucket used to direct spillway flows into the river channel, Figure 3. The outlet works and powerplant are also located at the left abutment about 550 feet to the right of the spillway tunnel. Flows from the powerplant and outlet works discharge into the river channel upstream from the spillway. The flip-bucket structure and the effect of spillway flows being discharged into the river channel were the subject of this investigation. Hydraulic model studies were also made on the morning-glory spillway and tunnel. The results of these studies are contained in Hydraulic Laboratory report Hyd-447, "Hydraulic Model Studies of the Trinity Dam Morning-Glory Spillway--Trinity River Division--Central Valley Project, California."

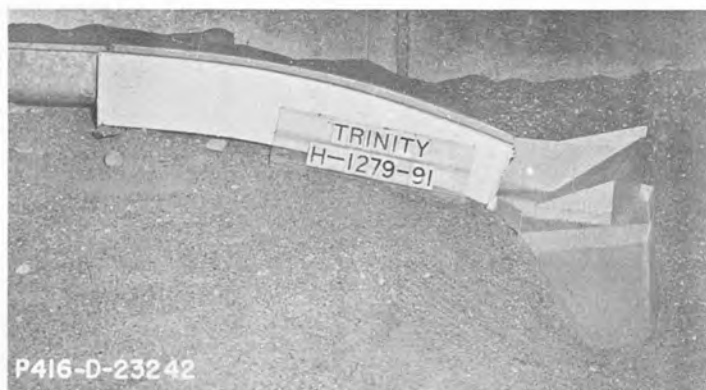
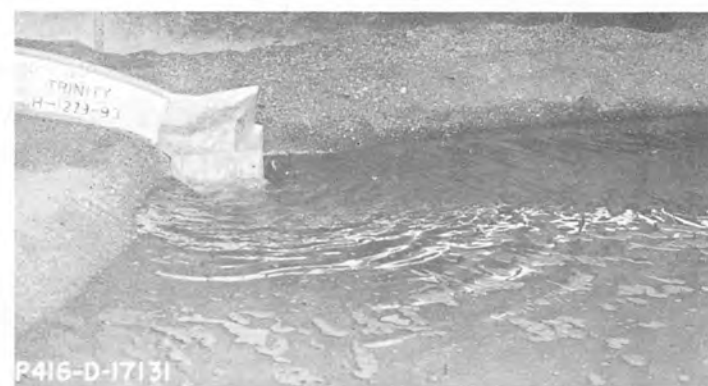
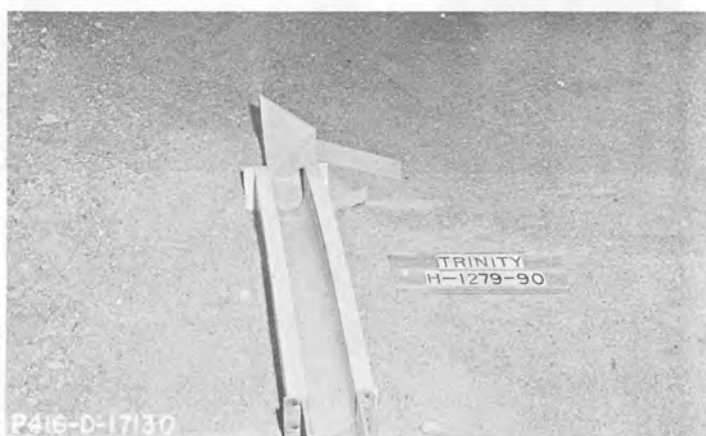
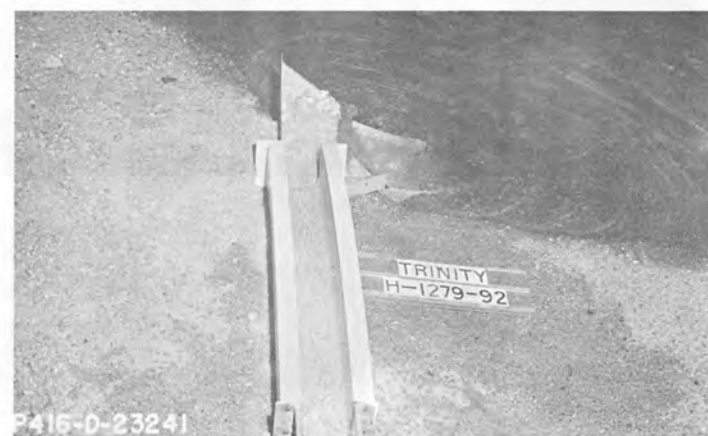
No Flow

Discharge = 1,000 cfs
Jump in Bucket

TRINITY DAM SPILLWAY
Bucket Studies
Low Level Bucket No. 7

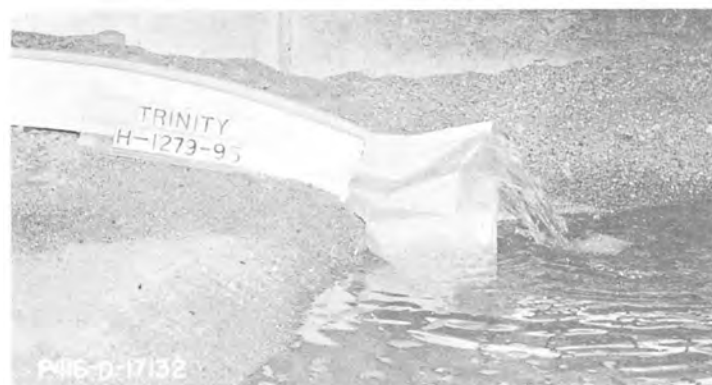
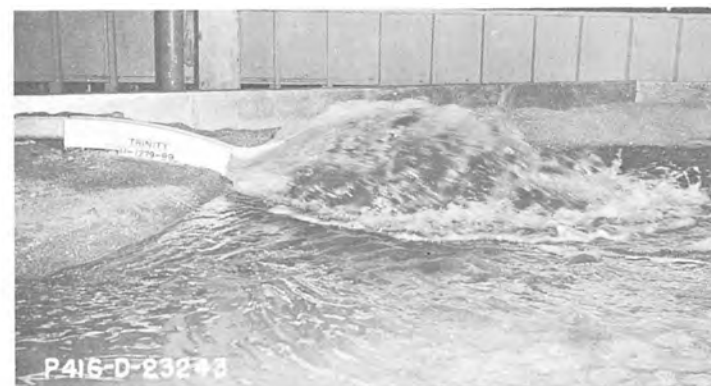
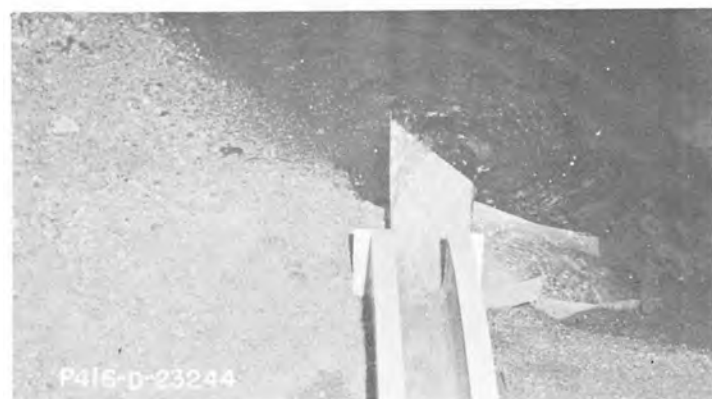
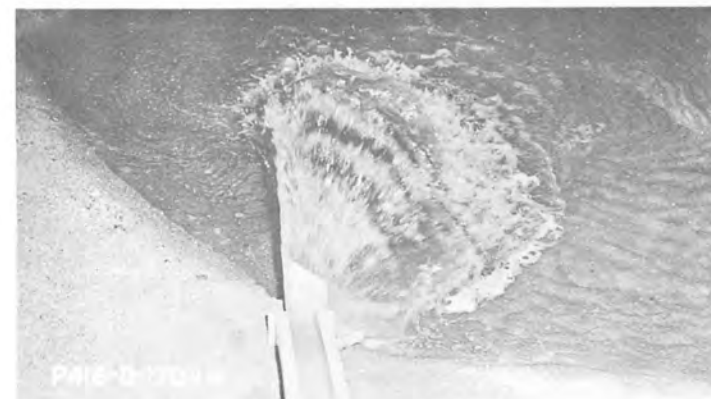
Discharge = 1,000 cfs
Jump swept out of bucket

Discharge = 24,000 cfs

TRINITY DAM SPILLWAY
Bucket Studies
Flow Conditions - Low Level Bucket No. 7

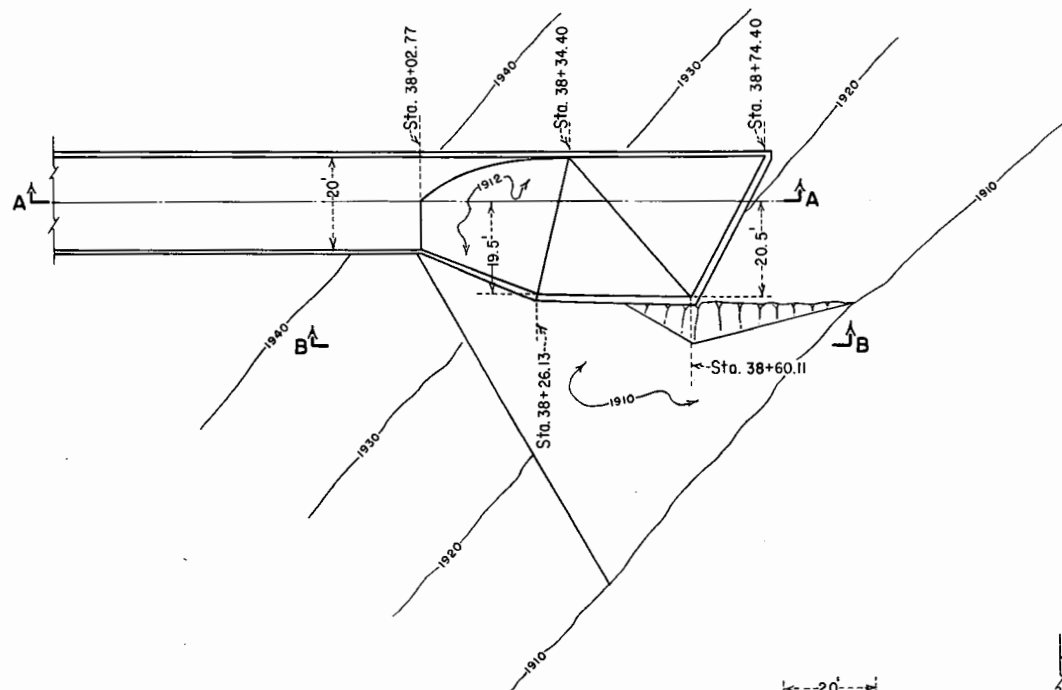
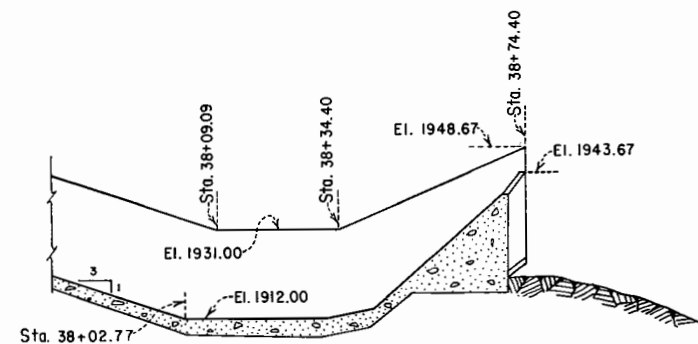
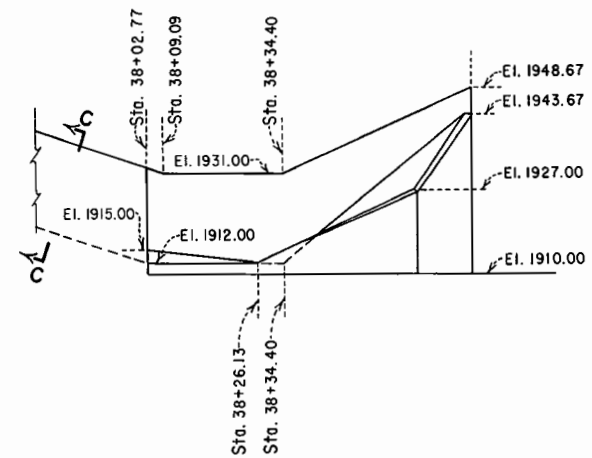
TRINITY DAM SPILLWAY
BUCKET STUDIES
RECOMMENDED LOW LEVEL BUCKET

the downstream end, the channel was extended on a 3:1 slope to elevation 1912.0, 22.21 feet lower than for the previous bucket. Low Level Flip Bucket No. 7 was placed at the end of the conduit, but the drip apron was eliminated. The rock on the right side of the bucket was removed to form an excavated channel leading down to river level. At the end of the bucket, the rock was removed to provide a smooth slope into the river channel. The recommended bucket and the surrounding topography are shown in Figure 33.

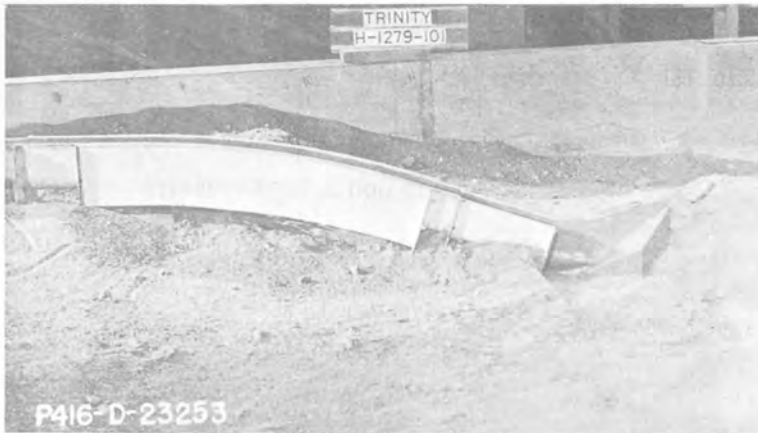
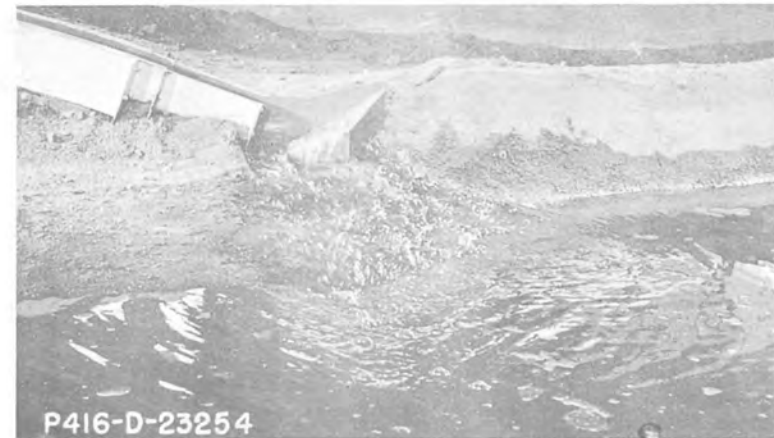
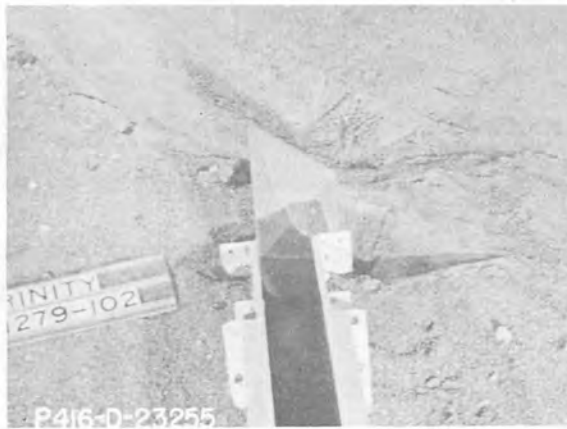
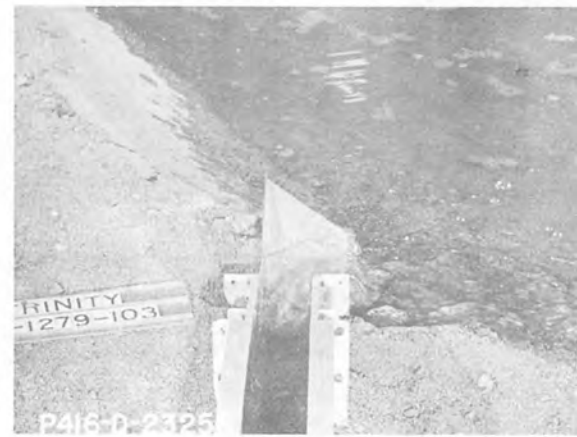
No Flow

Discharge = 1,000 cfs

TRINITY DAM SPILLWAY
Bucket Studies
Recommended Low Level Bucket

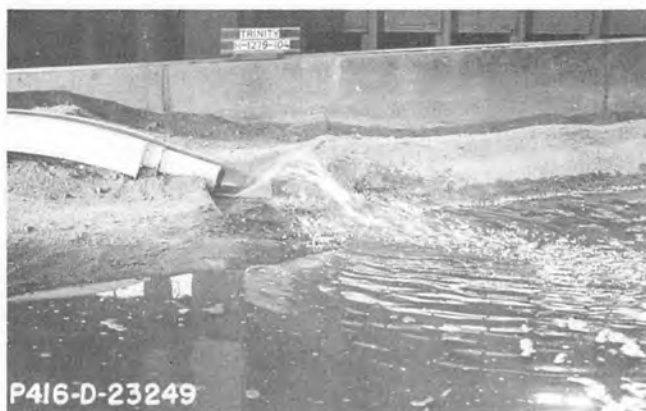
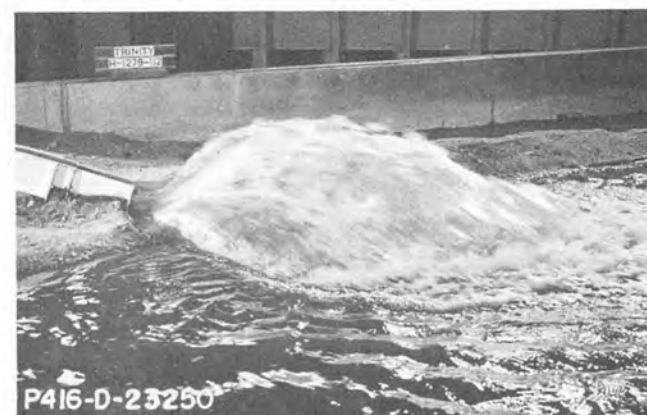
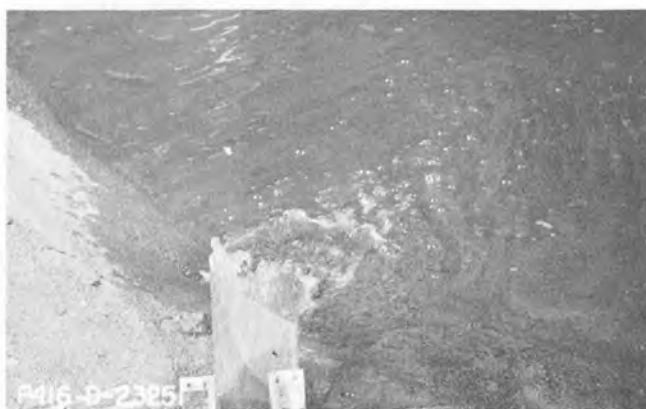
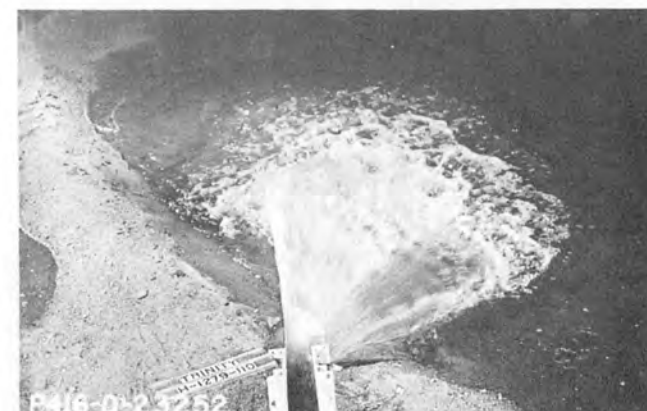
Discharge = 2,000 cfs

Discharge = 24,000 cfs

TRINITY DAM SPILLWAY
Bucket Studies
Flow Conditions - Recommended Low Level Bucket

The river bottom had been formed in nonerodible mortar so no scour tests were made. However, the channel banks were formed from erodible sand and tests performed at the maximum discharge did not cause extensive damage to the channel banks.
