HYDRAULIC MODEL STUDIES OF THE SPILLWAYS
AND OUTLET WORKS--GLEN CANYON DAM
COLORADO RIVER STORAGE PROJECT, ARIZONA

Report No. Hyd-469

Hydraulics Branch
DIVISION OF RESEARCH

February 18, 1964

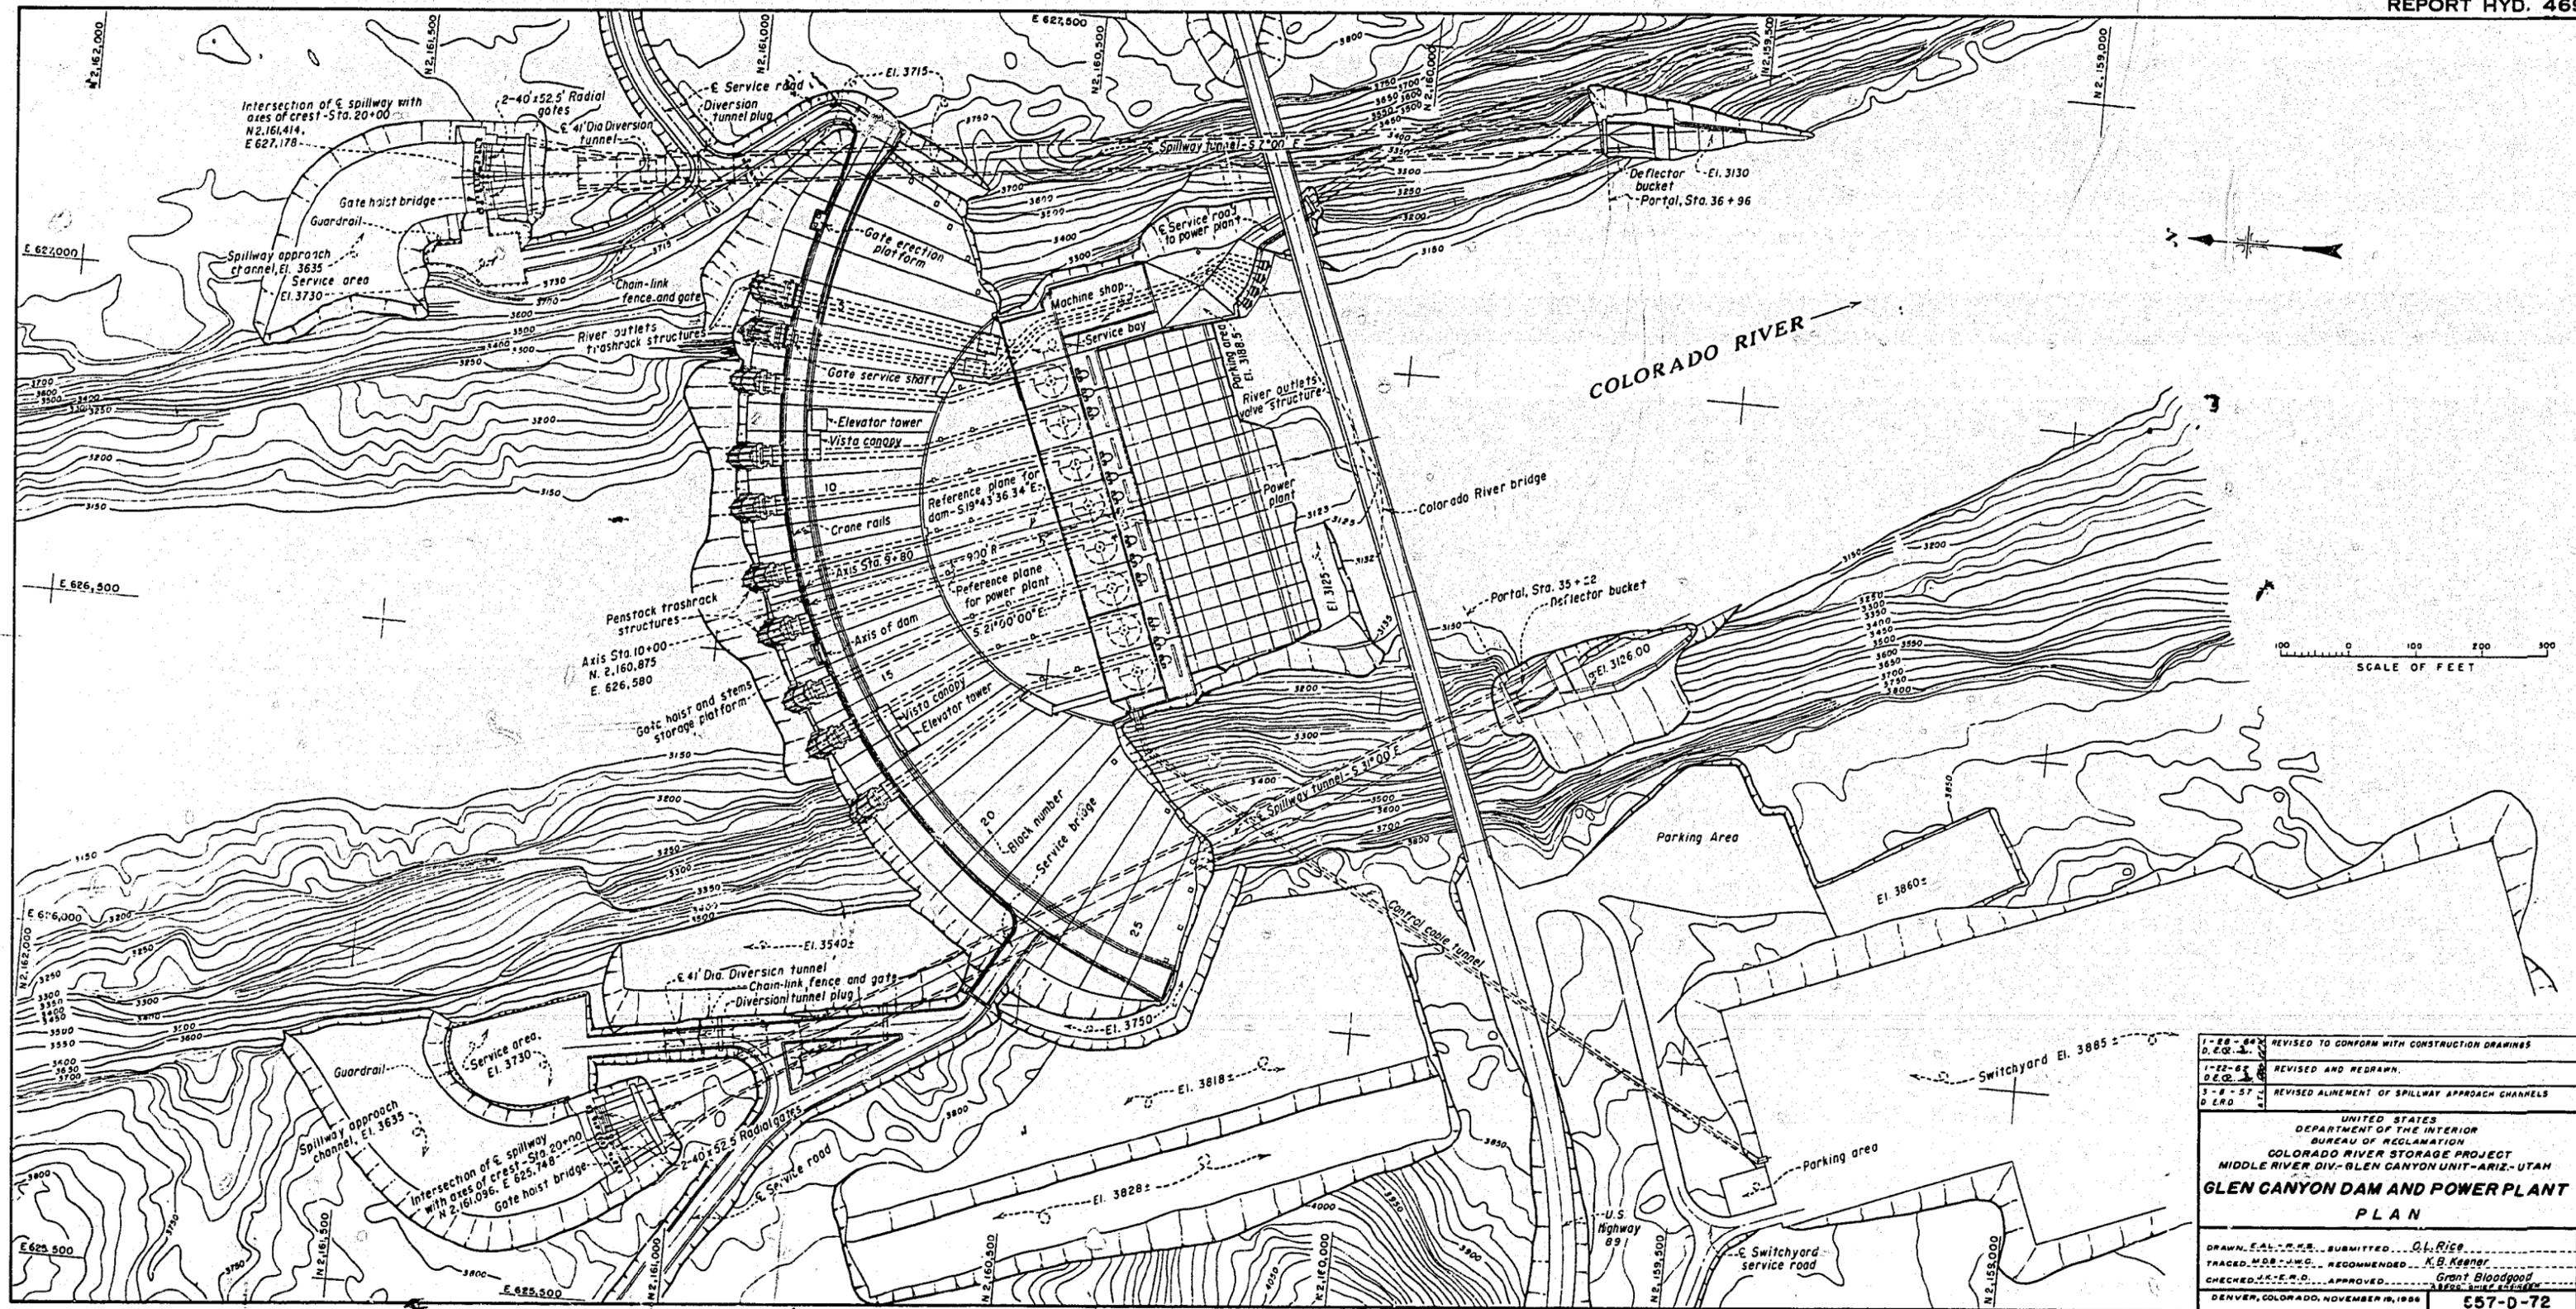
FIGURE 2
REPORT HYD. 469

1-28-64 D. G. R.	REVISED TO CONFORM WITH CONSTRUCTION DRAWINGS
1-22-64 D. G. R.	REVISED AND REDRAWN.
1-8-57 D. G. R.	REVISED ALIGNMENT OF SPILLWAY APPROACH CHANNELS
UNITED STATES DEPARTMENT OF THE INTERIOR BUREAU OF RECLAMATION COLORADO RIVER STORAGE PROJECT MIDDLE RIVER DIV. GLEN CANYON UNIT-ARIZ-UTAH GLEN CANYON DAM AND POWER PLANT PLAN	
DRAWN: E. A. L. - R. E. SUBMITTED: G. L. Rice	
TRACED: M. B. J. W. C. RECOMMENDED: K. B. Keener	
CHECKED: C. E. R. D. APPROVED: Grant Bloodgood	
DENVER, COLORADO, NOVEMBER 19, 1956 557-D-72

1. The alinement of the tunnels, Figure 2, is satisfactory for diversion flows and spillway flows.
2. Preliminary tests on a 1:88 scale model indicated that the most satisfactory invert angle for the flip buckets was 35°. Subsequent tests on the 1:63.48 spillway model confirmed this.

The principal hydraulic features of the dam are two tunnel spillways and the river outlet works. The tunnel spillways are located in each abutment. The spillway entrances are located about 600 feet upstream from the dam and consist of unlined approach channels and reinforced-concrete crest structures, Figures 2 and 3. Flow in each spillway is controlled by two 40- by 52.5-foot radial gates. Downstream from each intake structure is a transition from a flat-arch roof section, 89 feet wide by 52 feet high, to a circular section 482.5 feet in diameter, Figure 4. A tapered circular transition reduces the tunnel diameter to 41 feet in 180 feet. The remainder of each tunnel is 41 feet in diameter, terminating in flip buckets at river level. The capacity of each spillway is 138,000 second-feet.

The river outlets are located downstream of the dam near the left abutment, Figure 2. Flow through the outlets is controlled by four 96-inch hollow-jet valves placed above the maximum tailwater to discharge horizontally into the atmosphere. Investigations of the river outlets were limited to alinement of valves and flow characteristics in the river when operating singly, jointly with the spillways, or with flow through the powerplant.

River outlets. -- The river outlets are four 96-inch hollow-jet valves located on the left side of the river 150 feet downstream from the machine shop, Figures 2 and 69. The outlets will be used principally to maintain the minimum downstream riverflow before the powerplant is in operation and to control storage in the reservoir during the flood seasons after the right diversion tunnel is closed. In the latter instance, the valves will be used in conjunction with the tunnel plug outlet works. The valves will also be used to supply sufficient releases during floods which approach the magnitude of the ultimate design flood. The maximum discharge capacity of the four valves is only 15,000 cfs due to the velocity limitations in the conduit. The

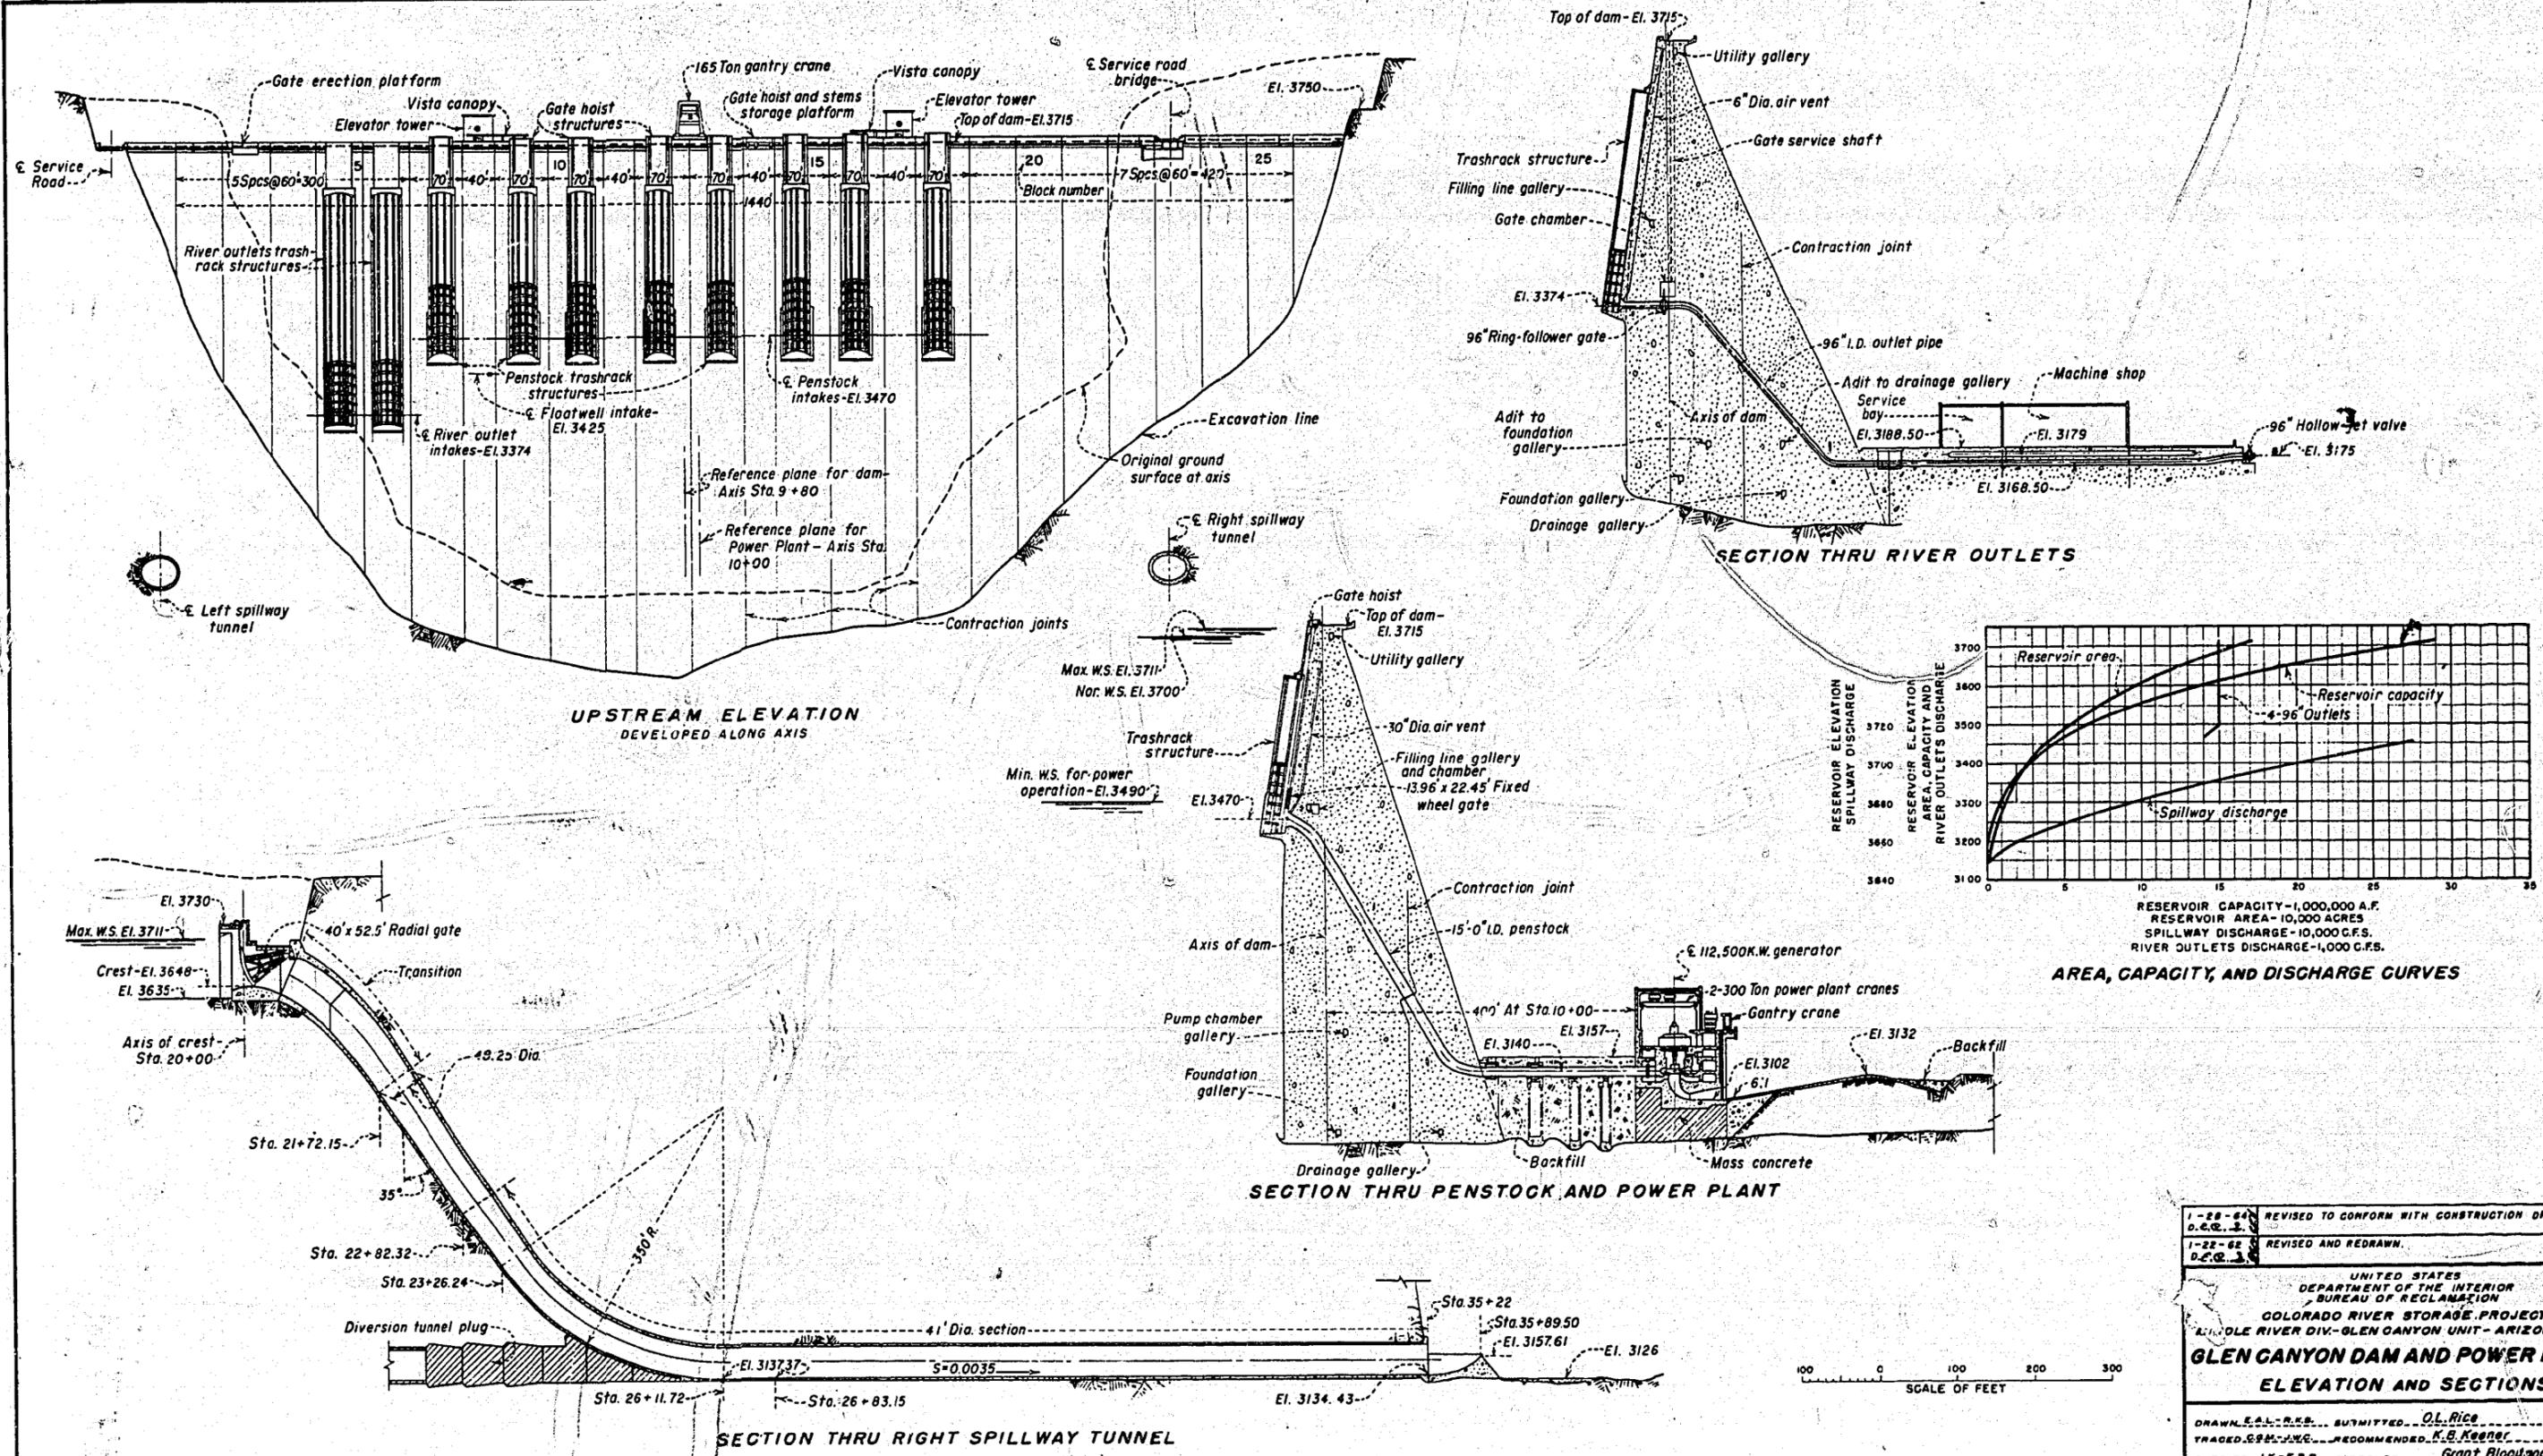
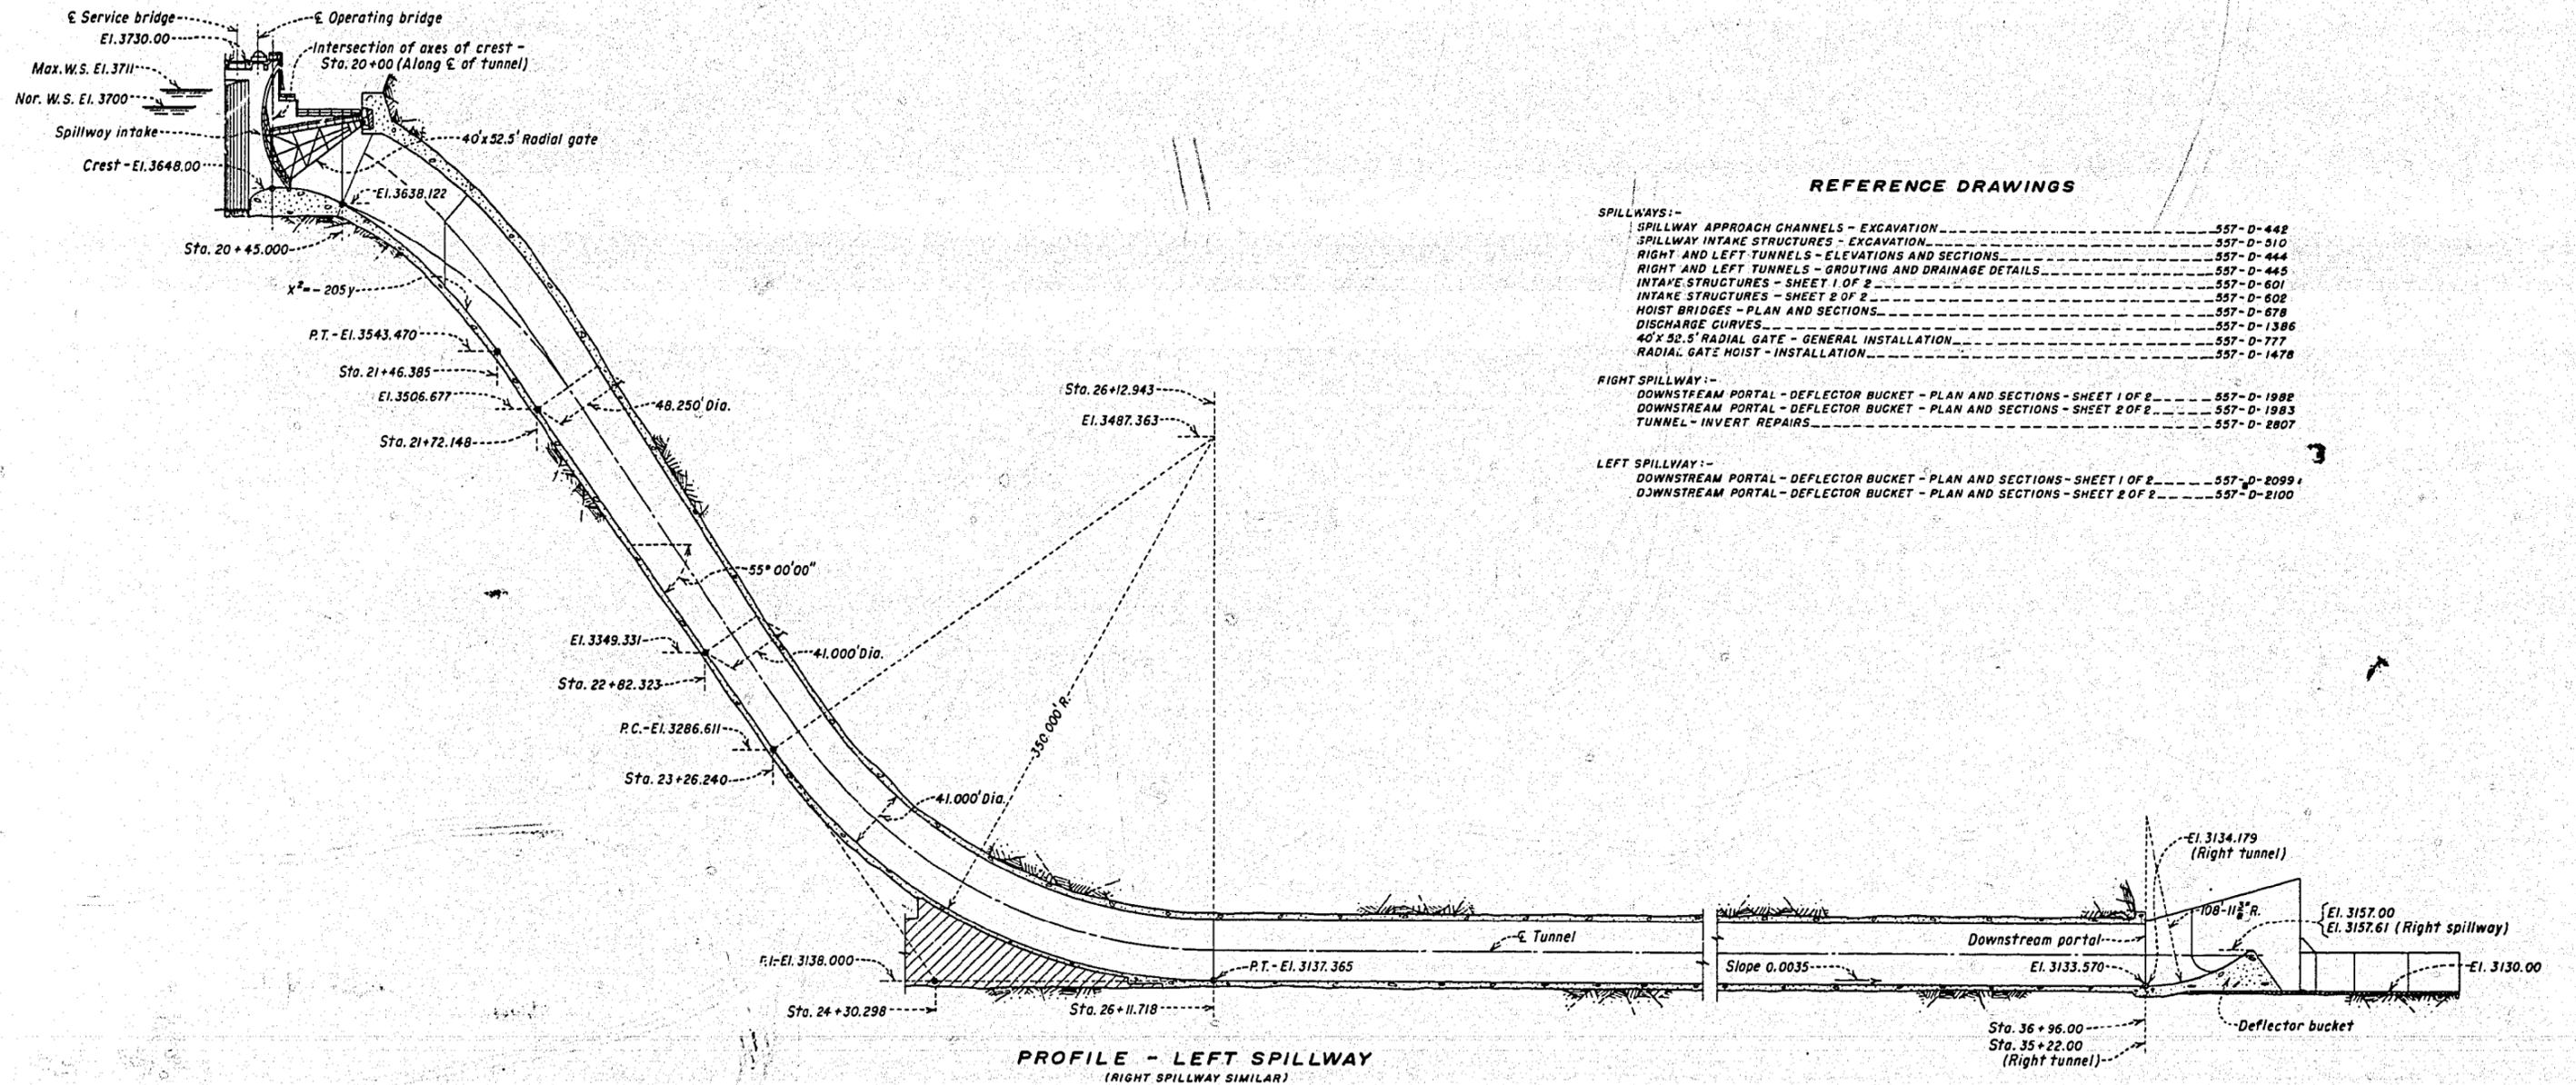
1-28-64	REVISED TO CONFORM WITH CONSTRUCTION DRAWINGS
D.C.C.	
1-22-62	REVISED AND REDRAWN
D.C.C.	
UNITED STATES DEPARTMENT OF THE INTERIOR BUREAU OF RECLAMATION COLORADO RIVER STORAGE PROJECT GLEN CANYON DAM AND POWER PLANT	
ELEVATION AND SECTIONS	
DRAWN: E.C.L., R.E.B. TRACED: C.F.M., J.W.C. CHECKED: J.K., E.R.P.	SUBMITTED: O.L. Rice RECOMMENDED: K.B. Keener APPROVED: Grant Bloodgood ASST. CHIEF ENGINEER
DENVER, COLORADO, NOV. 19, 1966	
567-D-73

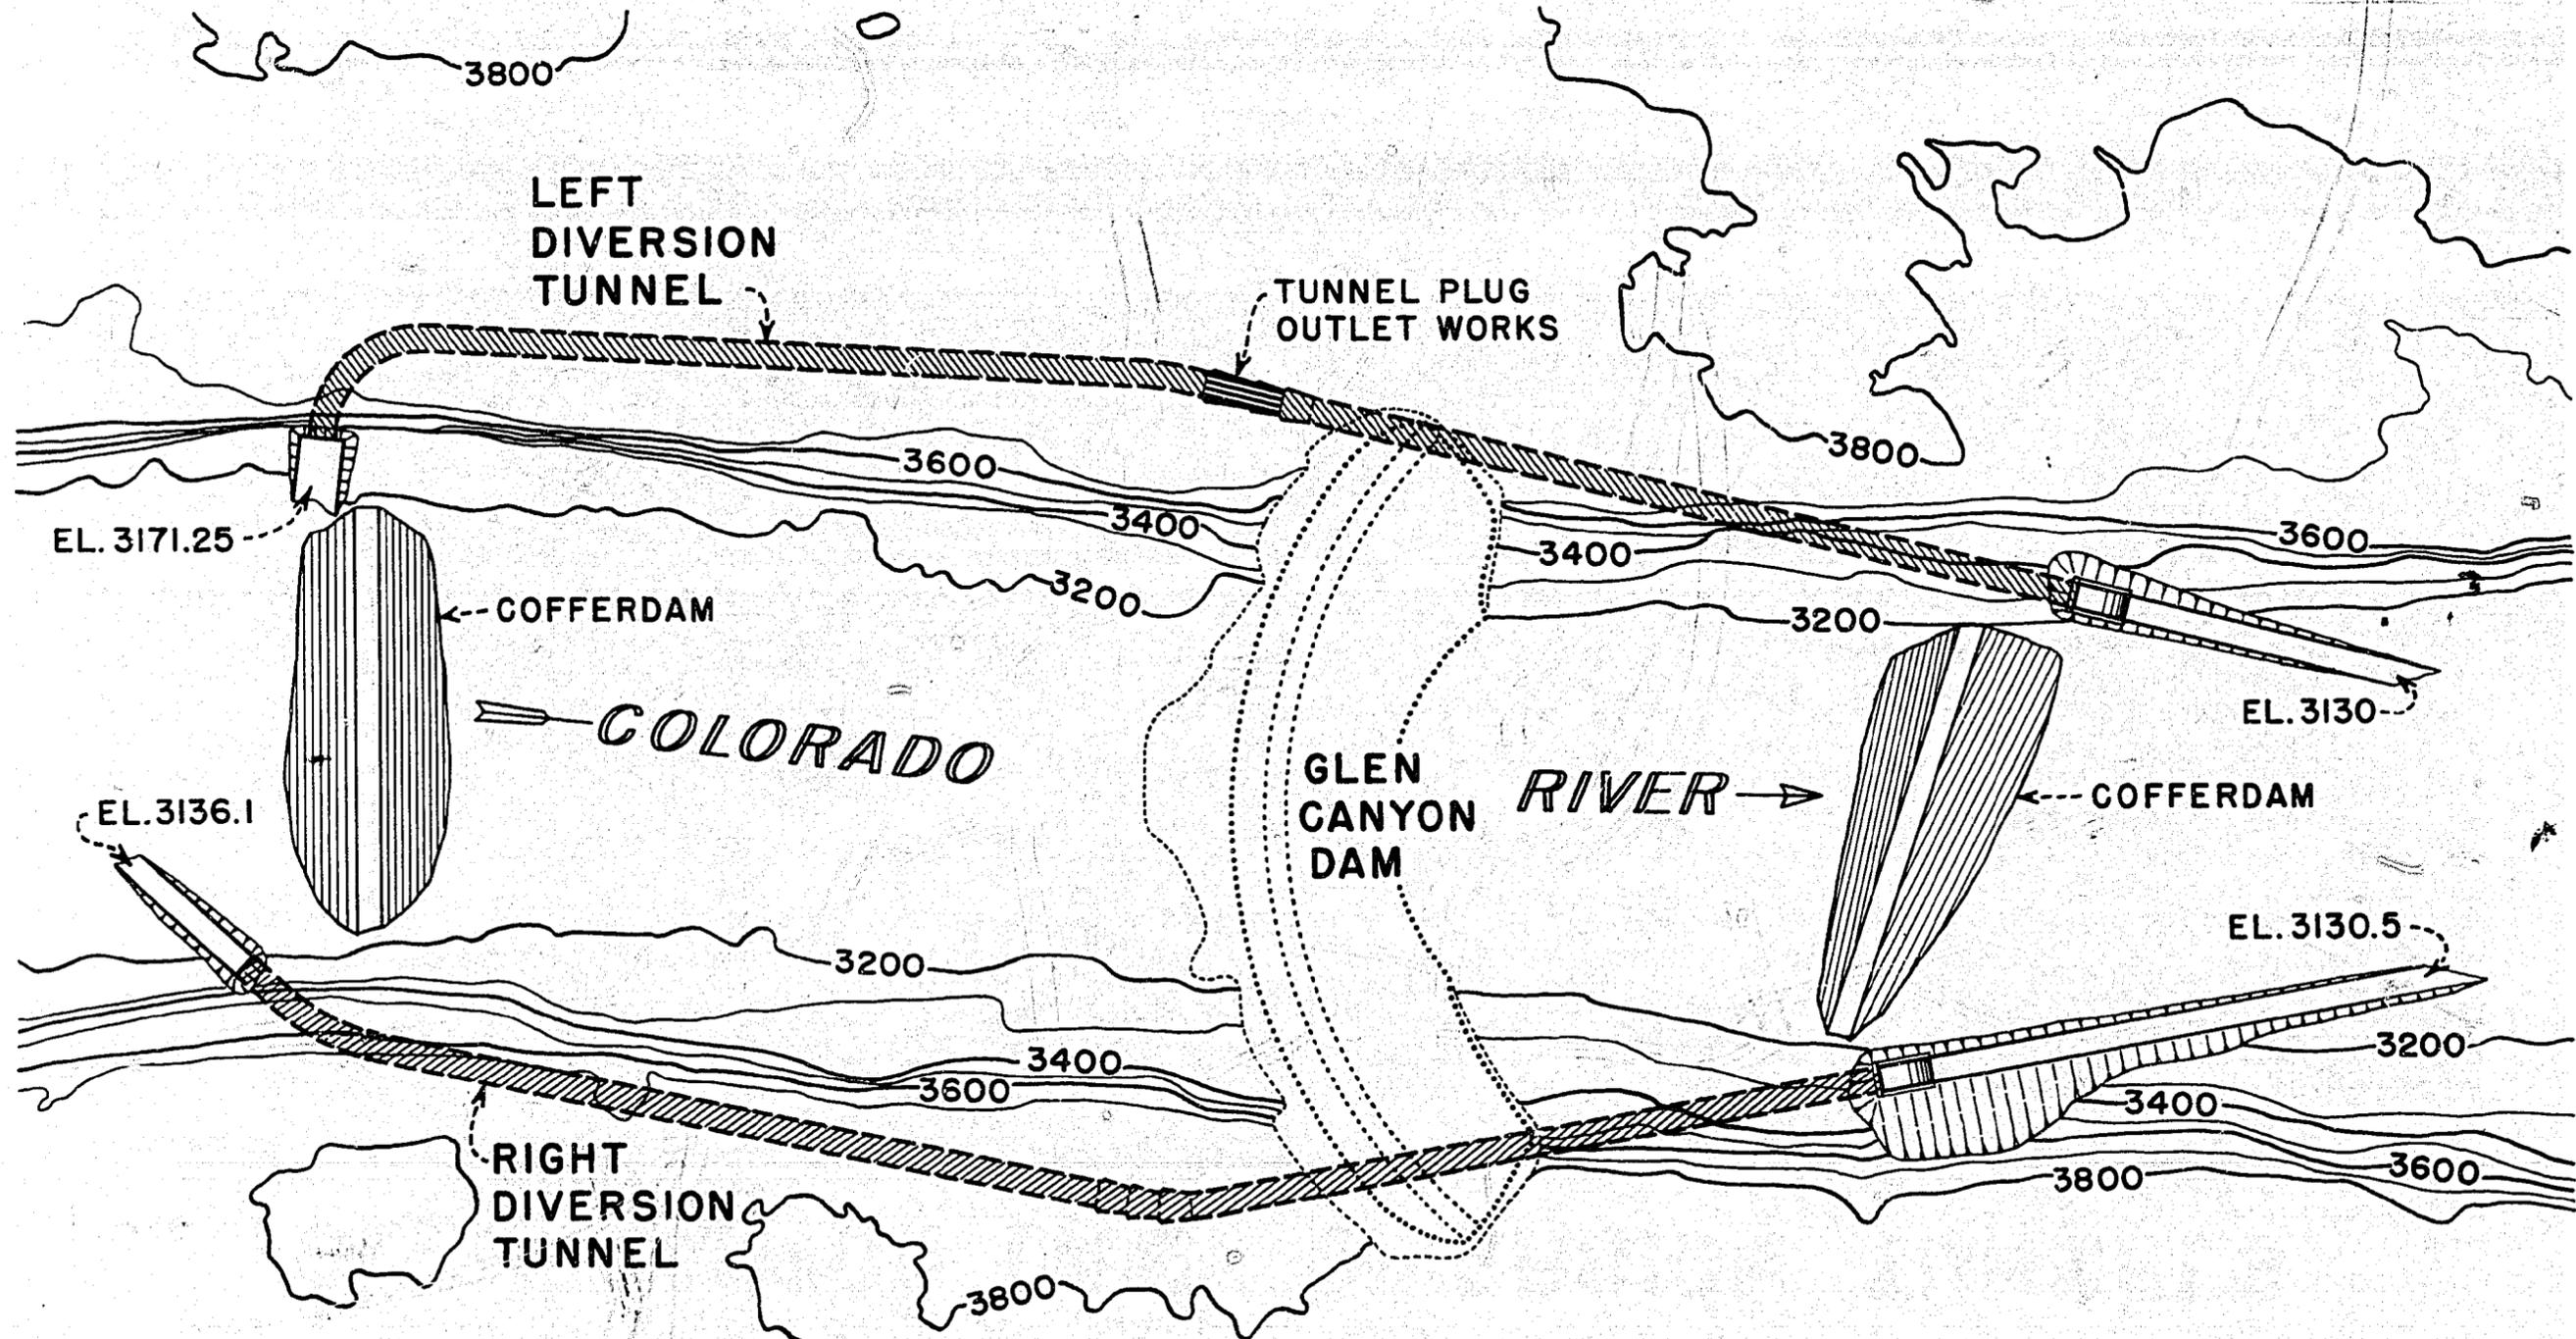
GLEN CANYON DAM DIVERSION TUNNELS

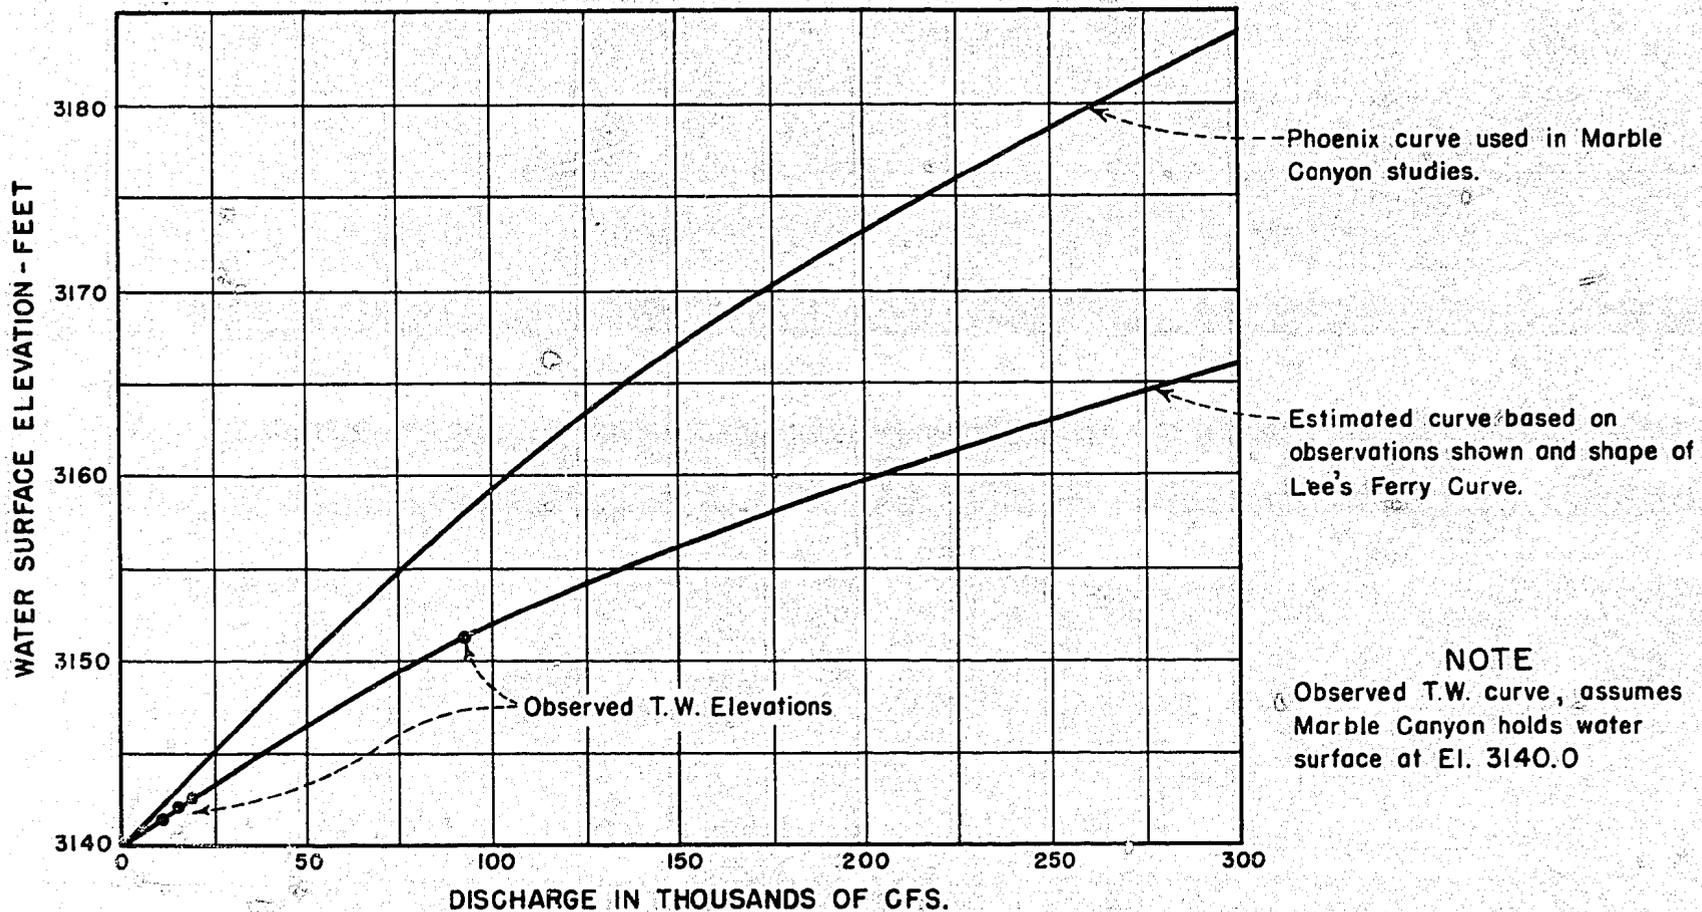
Phoenix curve used in Marble Canyon studies.

Estimated curve based on observations shown and shape of Lee's Ferry Curve.

GLEN CANYON DAM SPILLWAYS
 1:88 SCALE MODEL
 PRELIMINARY TAILWATER CURVES

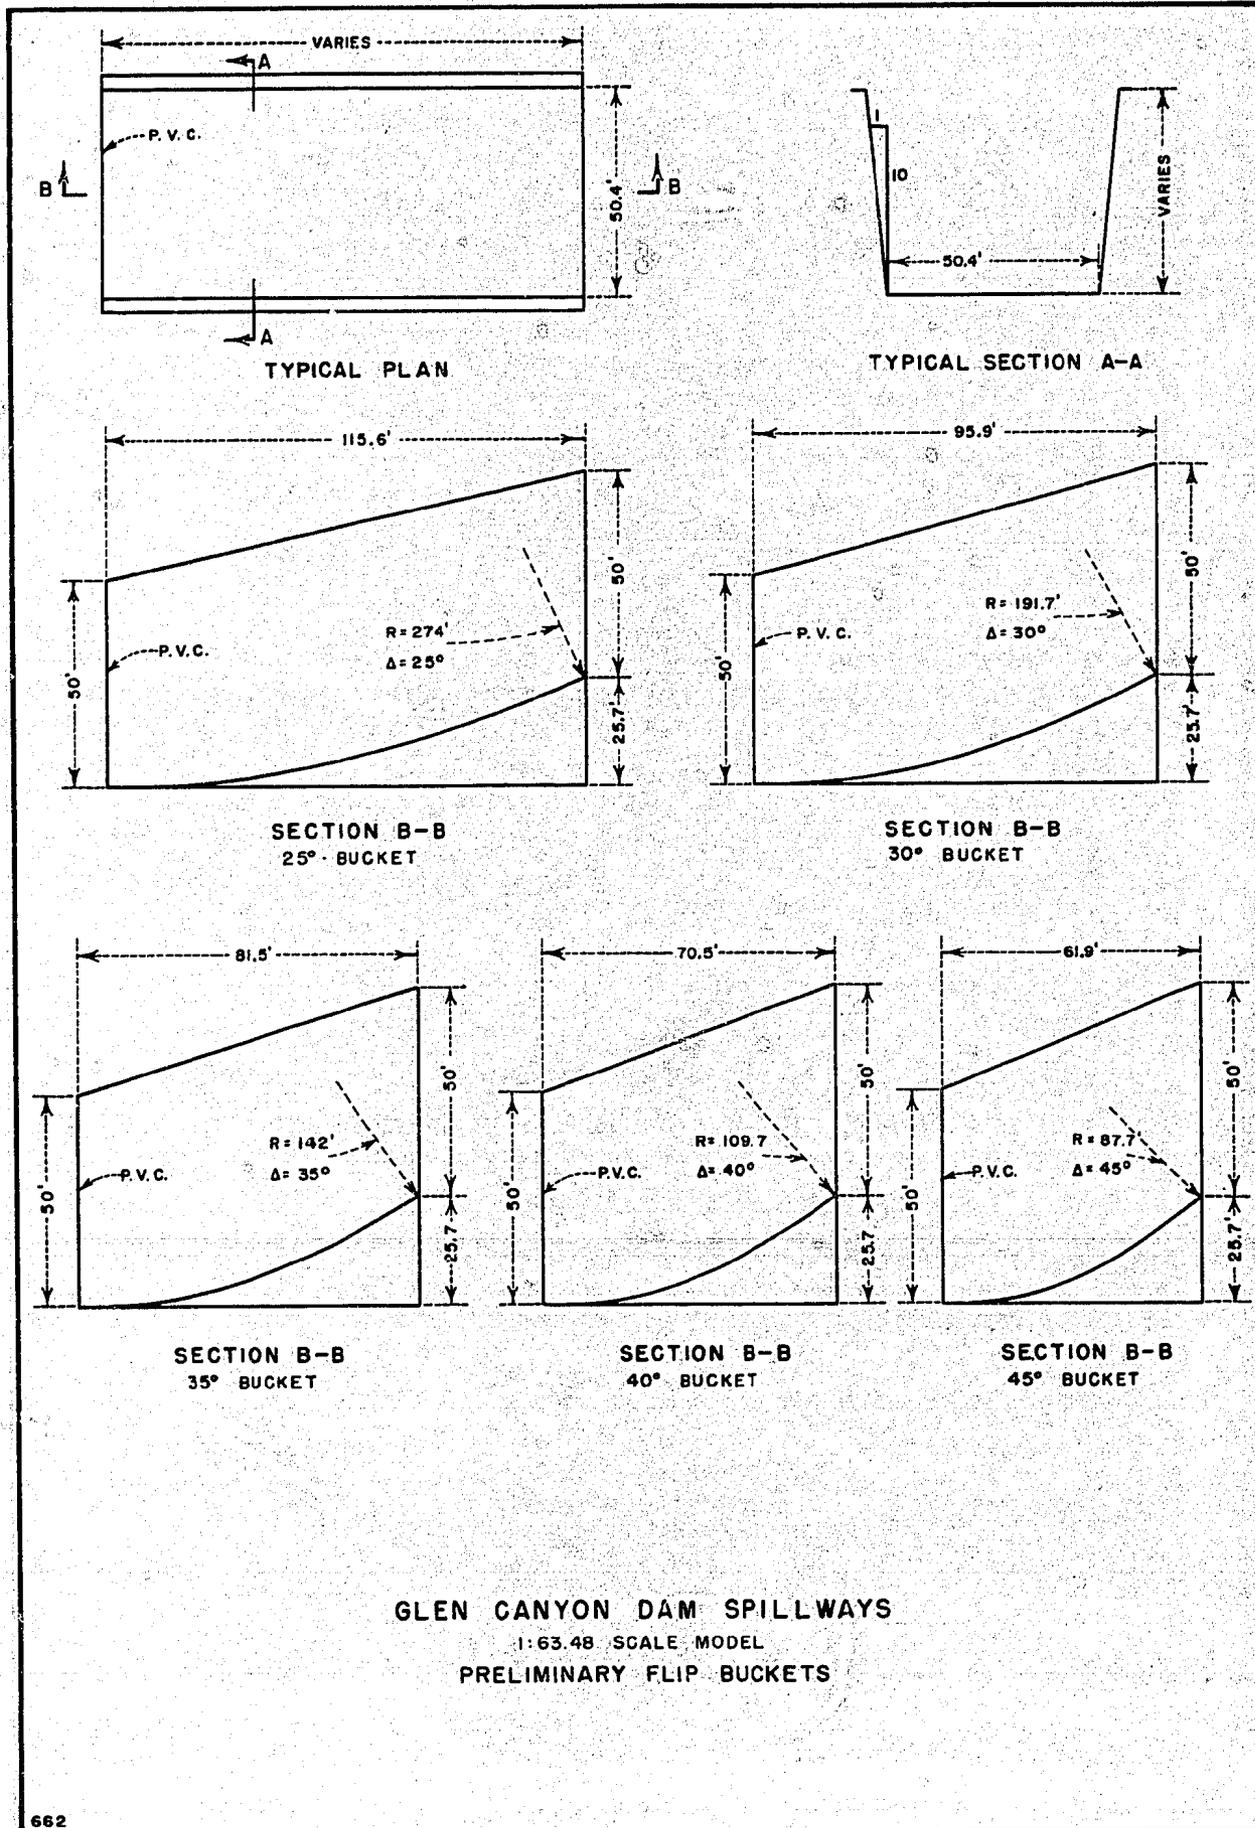
GLEN CANYON DAM SPILLWAYS
1:63.48 SCALE MODEL
PRELIMINARY FLIP BUCKETS

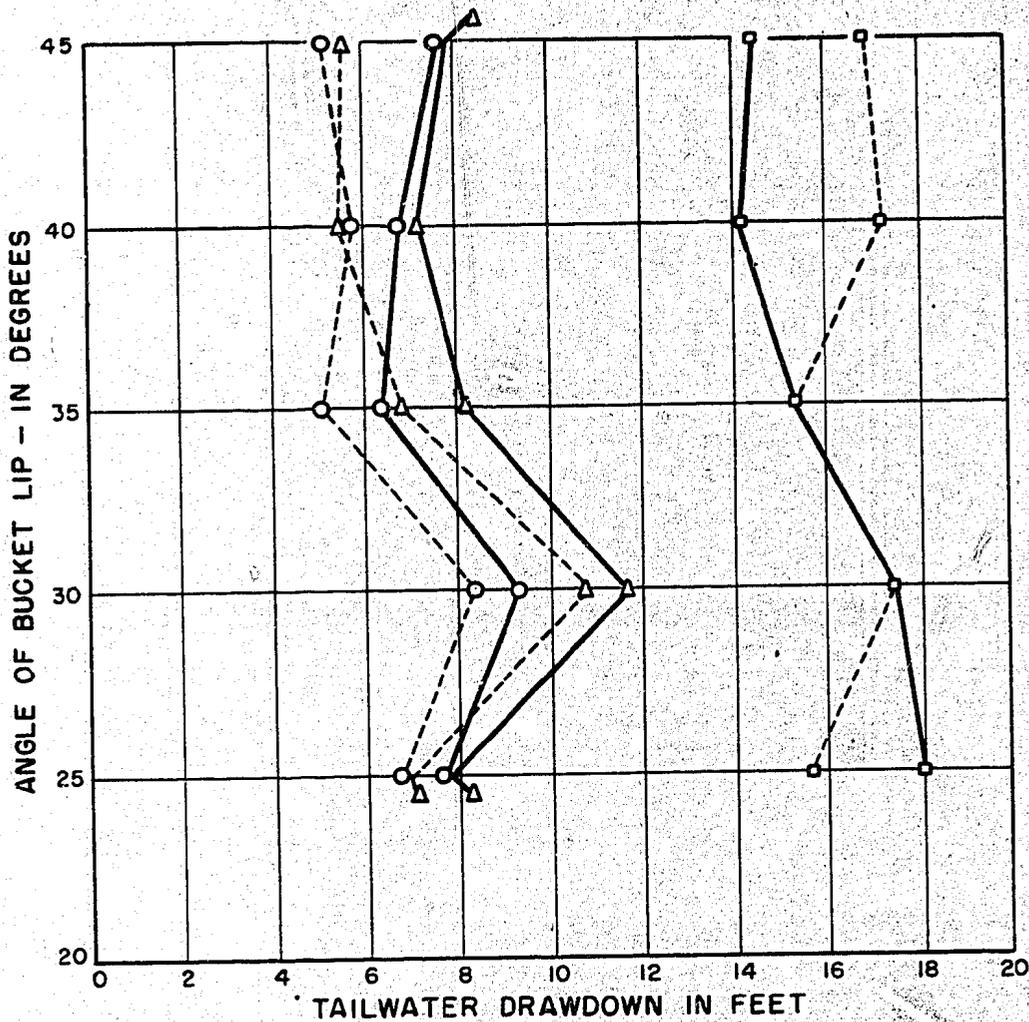
FIGURE 12
REPORT HYD. 469

MARBLE CANYON T.W.		LEE'S FERRY T.W.	
RIGHT BUCKET	○	—	○	- - -
LEFT BUCKET	△	—	△	- - -
BOTH BUCKETS	□	—	□	- - -

Drawdown is the difference in T.W. elevation measured at the powerhouse tailrace and 1800' ± downstream in the center of the channel.

GLEN CANYON DAM SPILLWAYS
1:88 SCALE MODEL
TAILWATER DRAWDOWN FOR VARIOUS LIP ANGLES

The curves on Figure 12 show the water surface drawdown for the different flip buckets. The curves indicate that for single-tunnel operation, the greatest drawdown occurred with the 30° flip bucket and the least drawdown with the 35° bucket. Due to the relative position of the buckets and their alinement with the river channel, the drawdown for the 30° and 35° buckets was greater when the left tunnel was operating than when the right tunnel was operating. For the 25°, 40°, and 45° buckets, the drawdown was about the same when either tunnel was operating. During single-tunnel operation, there was greater water surface drawdown with the higher tailwater elevation.

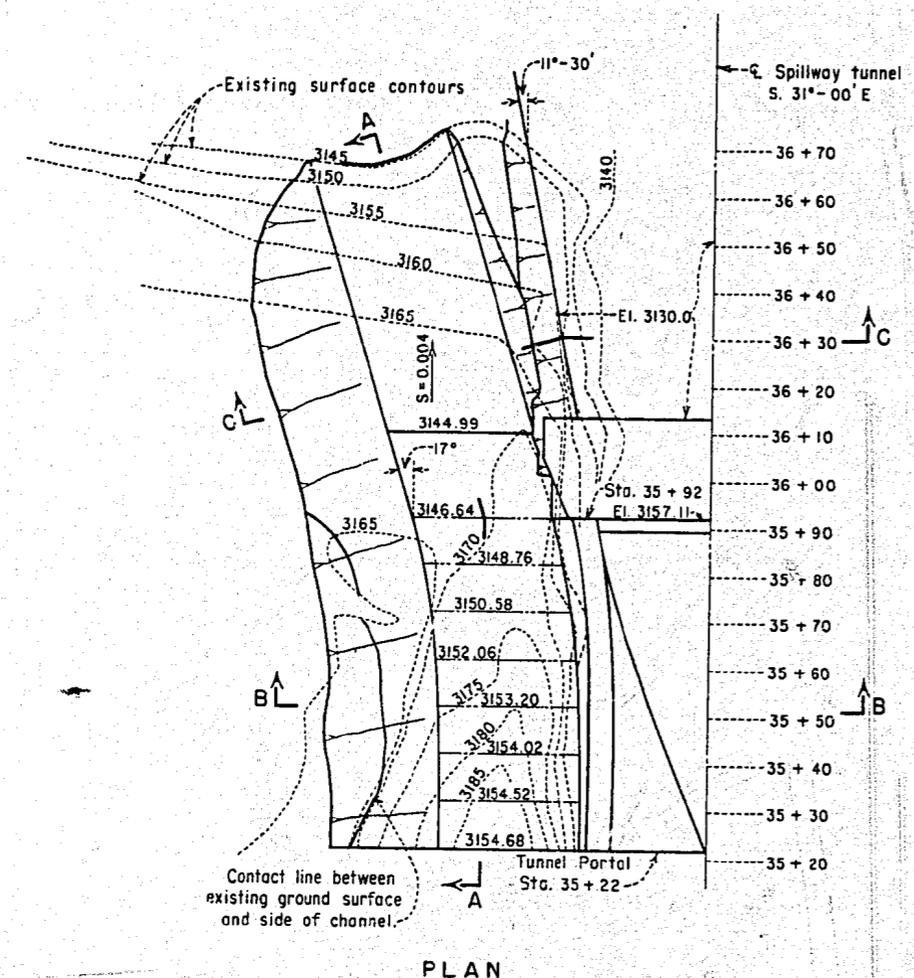
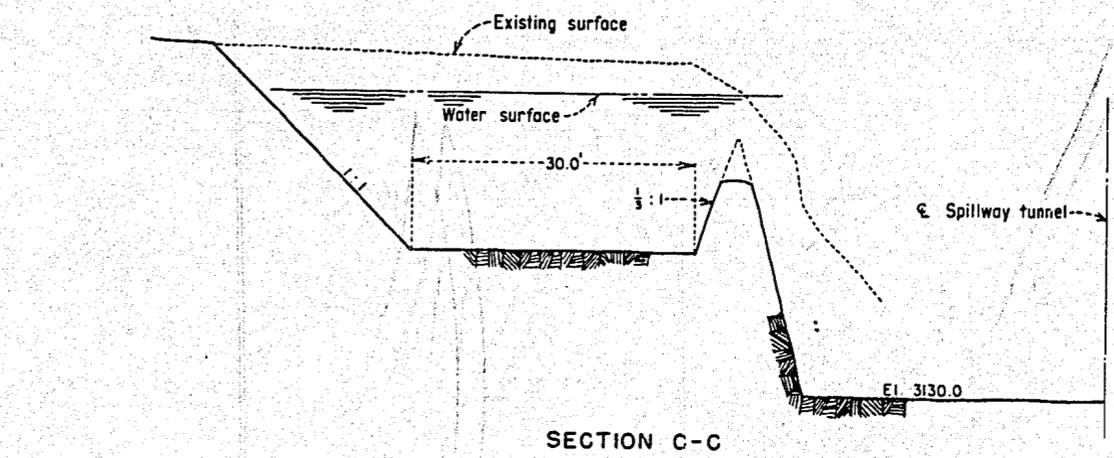
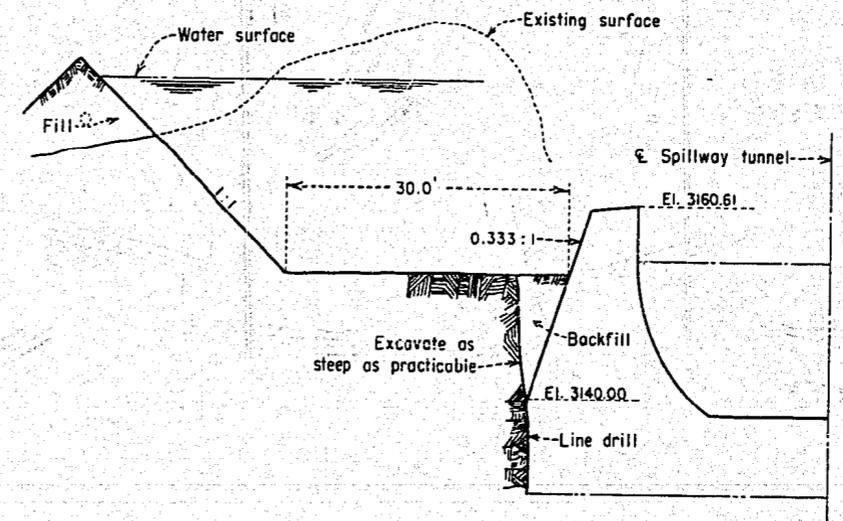
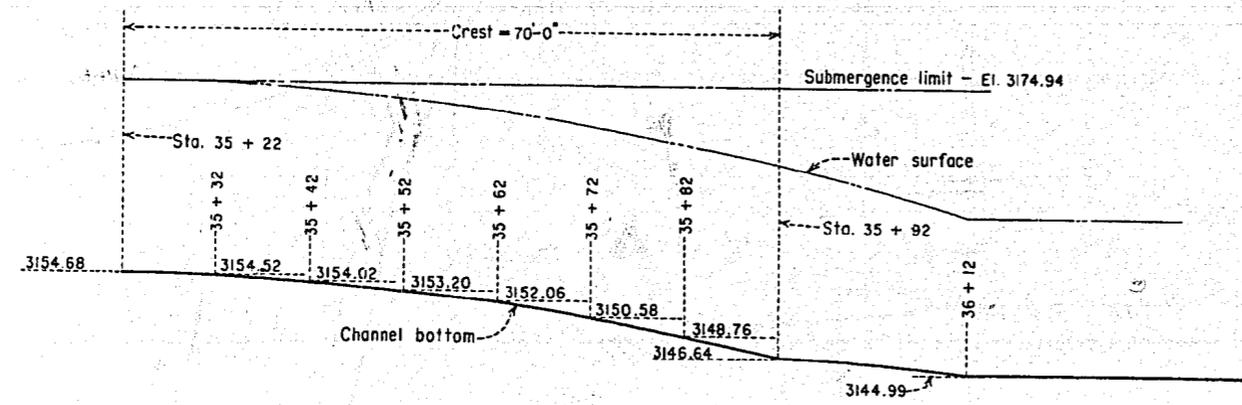
PLAN

SECTION C-C

SECTION B-B

SECTION A-A

NOTES
 Q in side channel = 14210 c.f.s.
 n = 1.00
 a = 0.23

GLEN CANYON DAM SPILLWAYS
 1:63.48 SCALE MODEL
 RIGHT DIVERSION TUNNEL-SIDE CHANNEL STUDIES

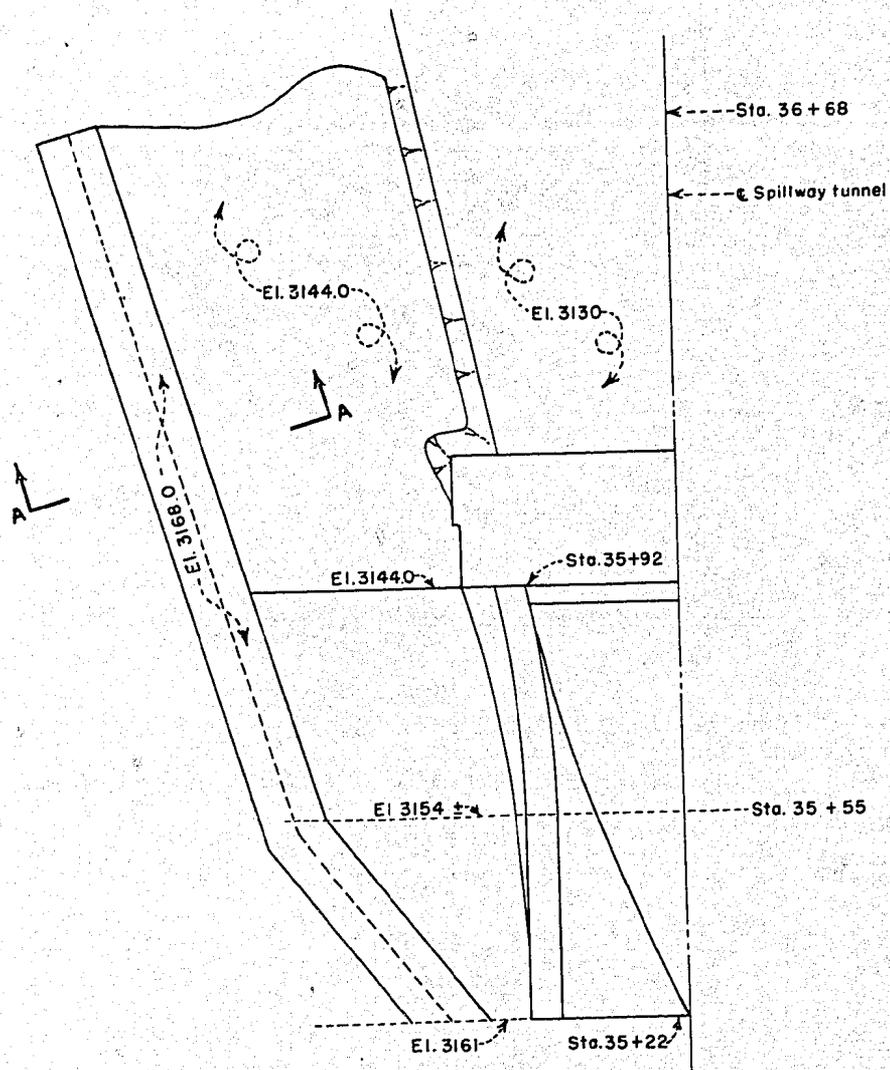
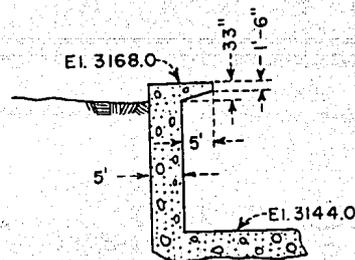
PLAN

SECTION A-A

GLEN CANYON DAM SPILLWAYS
1:63.48 SCALE MODEL
RIGHT DIVERSION TUNNEL - SIDE CHANNEL STUDY
FIRST MODIFICATION
