HYDRAULIC MODEL STUDIES OF THE SPILLWAYS
AND OUTLET WORKS--GLEN CANYON DAM
COLORADO RIVER STORAGE PROJECT, ARIZONA

Report No. Hyd-469

Hydraulics Branch
DIVISION OF RESEARCH

February 18, 1964

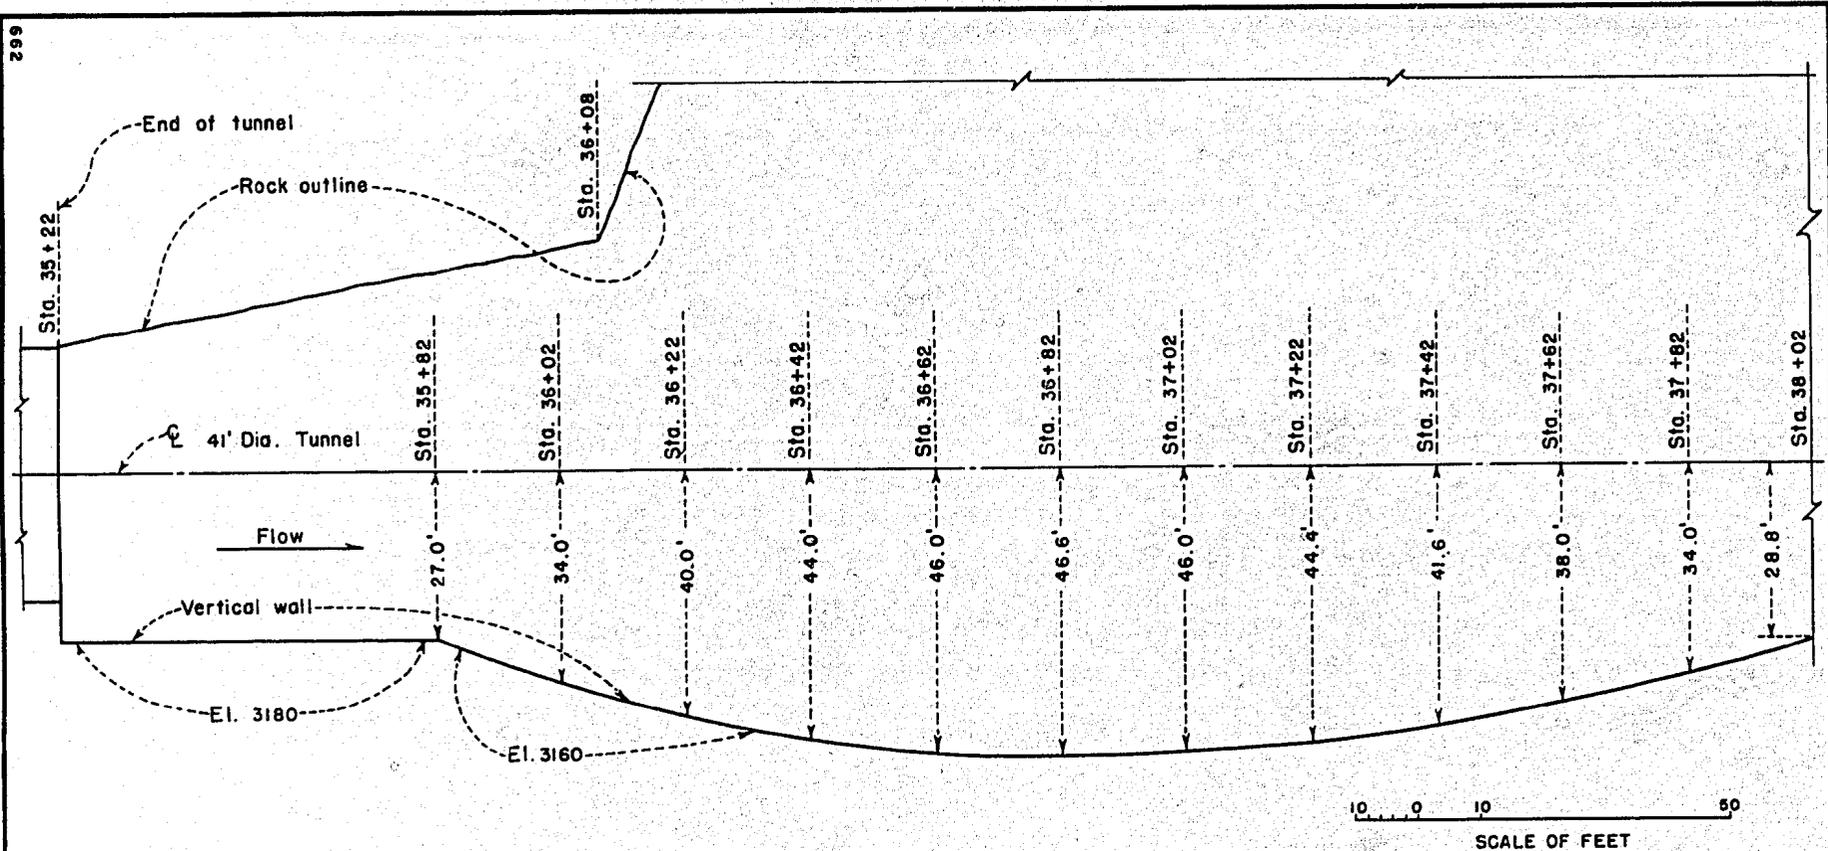
GLEN CANYON DAM SPILLWAYS
 1:63.48 SCALE MODEL
 LOW CURVED WALL ON RIGHT SIDE
 PORTAL OF RIGHT DIVERSION TUNNEL

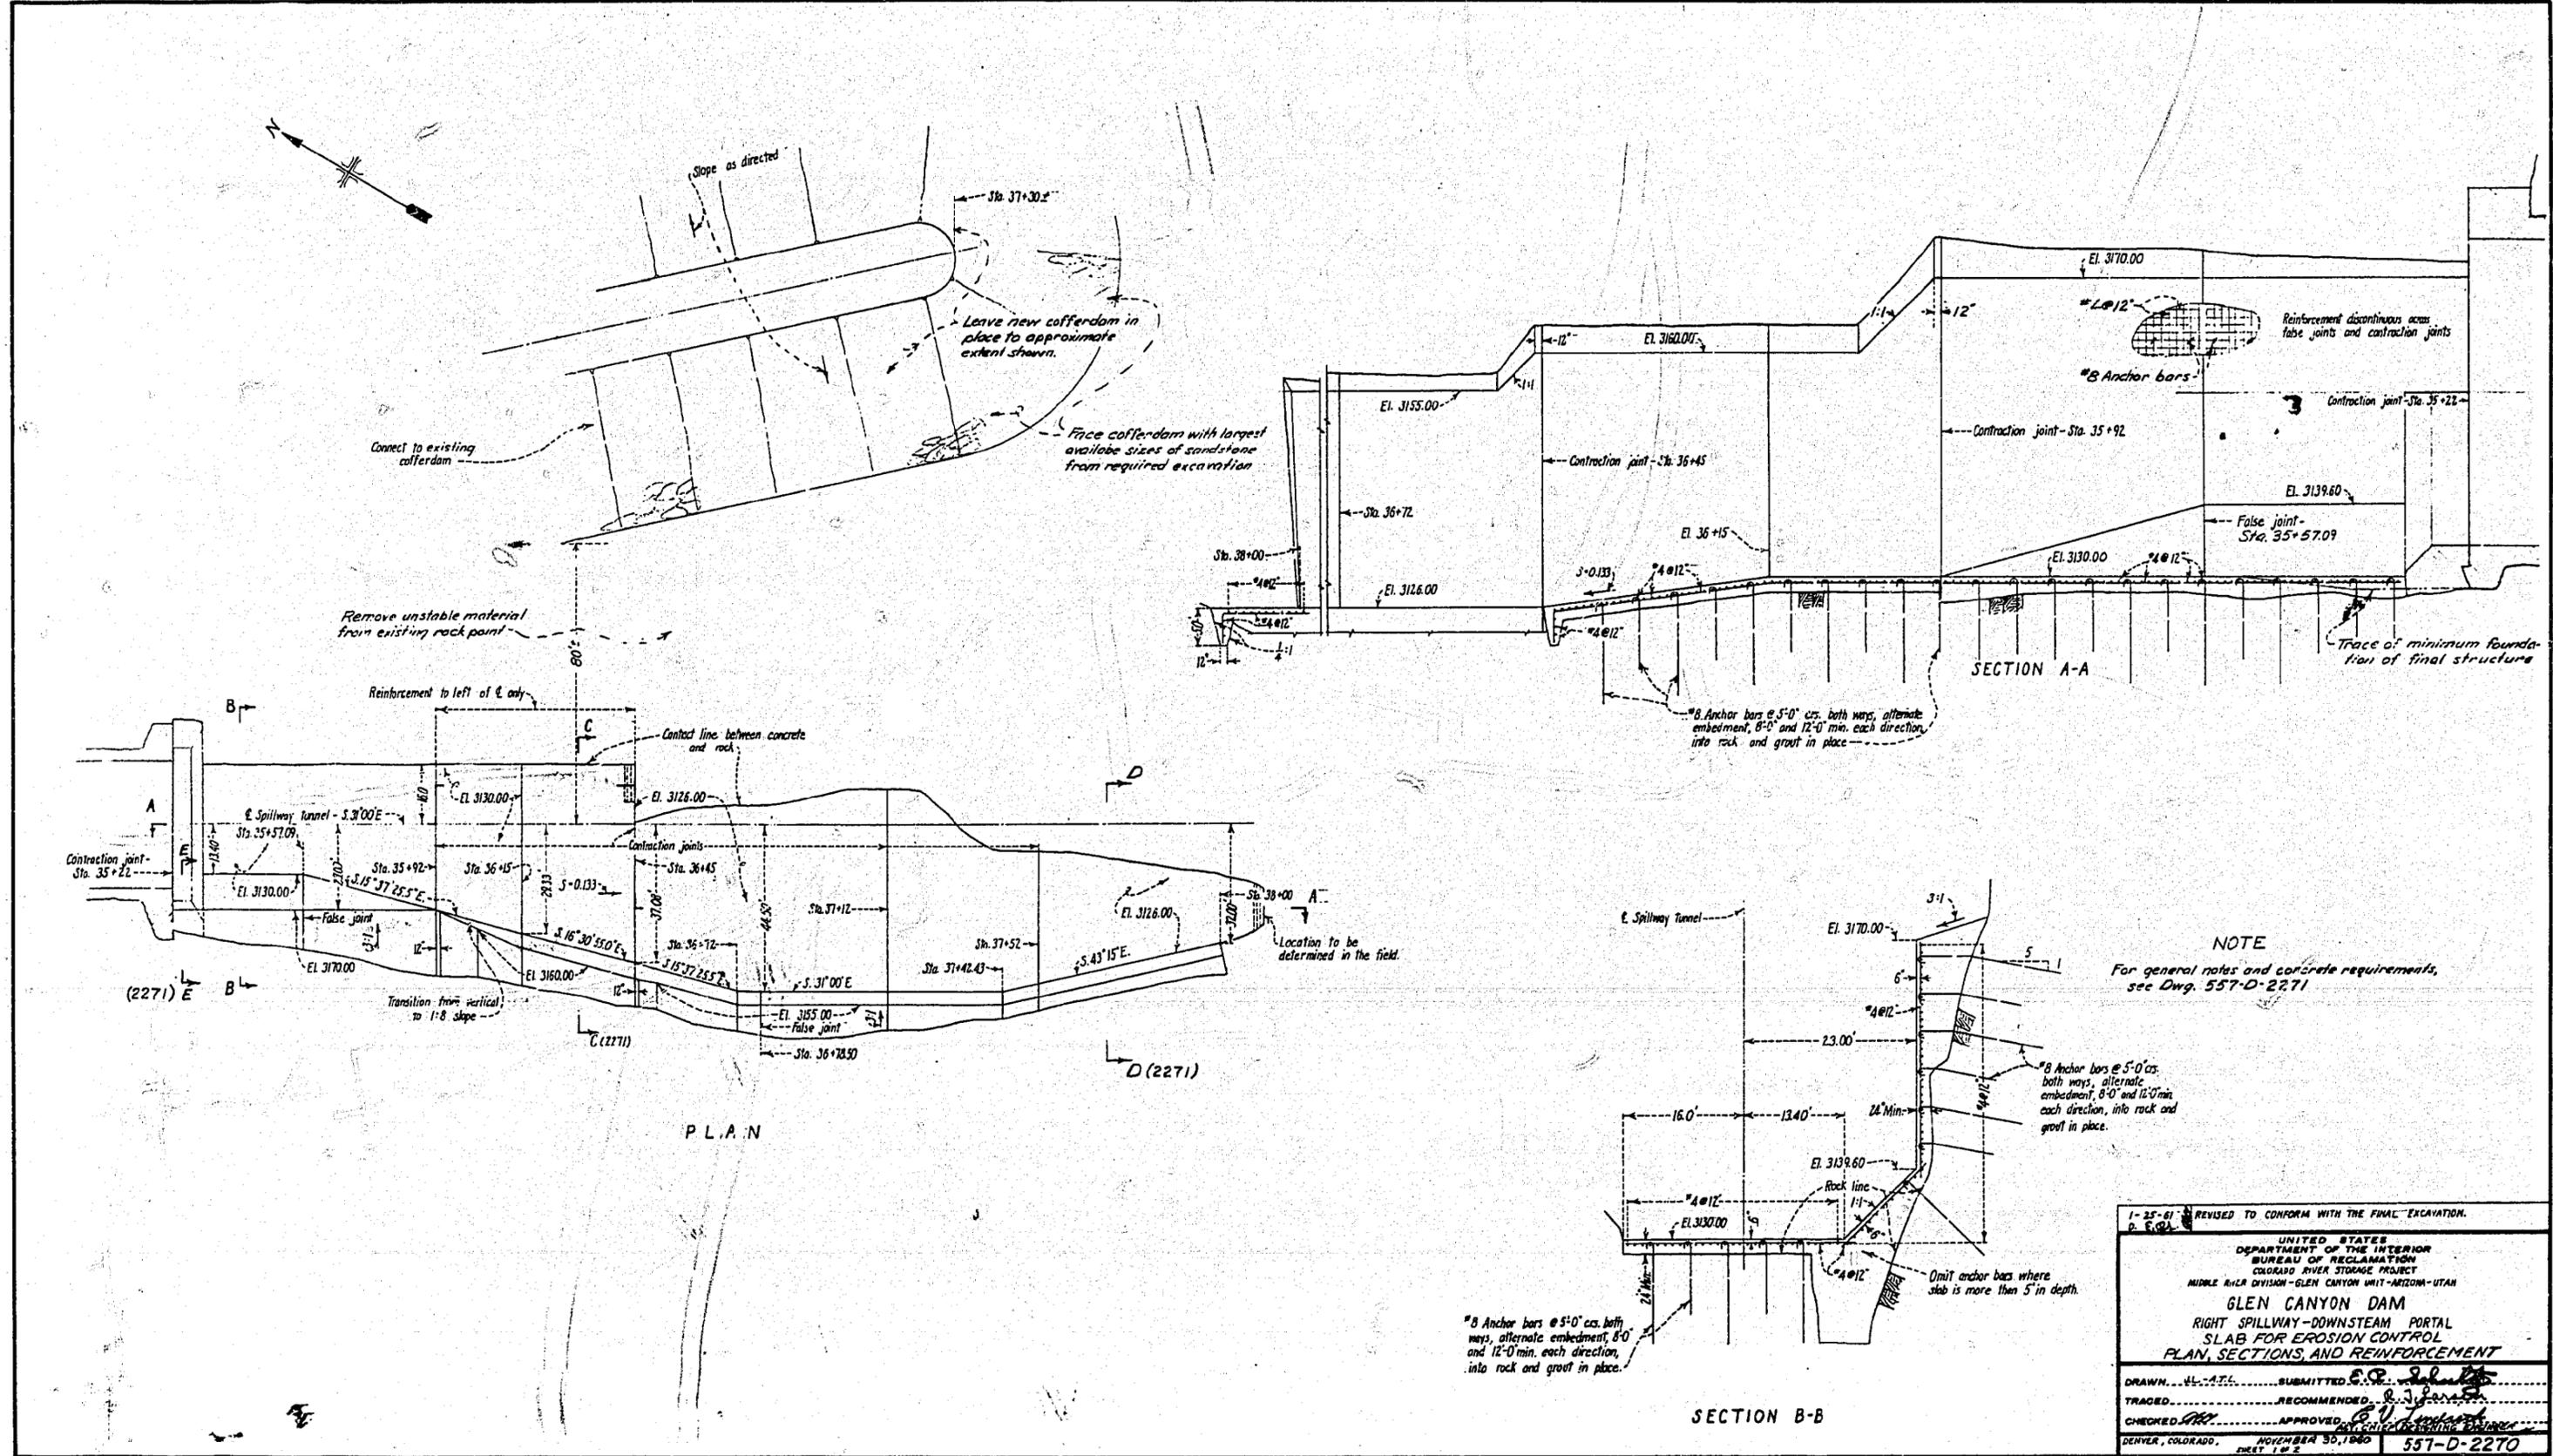
1-25-61 REVISED TO CONFORM WITH THE FINAL EXCAVATION. P. 5.92	
UNITED STATES DEPARTMENT OF THE INTERIOR BUREAU OF RECLAMATION COLORADO RIVER STORAGE PROJECT MIDDLE RIVER DIVISION - GLEN CANYON UNIT - ARIZONA-UTAH	
GLEN CANYON DAM RIGHT SPILLWAY - DOWNSTREAM PORTAL SLAB FOR EROSION CONTROL PLAN, SECTIONS, AND REINFORCEMENT	
DRAWN: H.L.A.T.L.	SUBMITTED: E.P. Roberts
TRACED: [initials]	RECOMMENDED: E.J. [initials]
CHECKED: [initials]	APPROVED: [initials]
DENVER, COLORADO, NOVEMBER 30, 1960	SHEET 1 OF 2

SECTION B-B

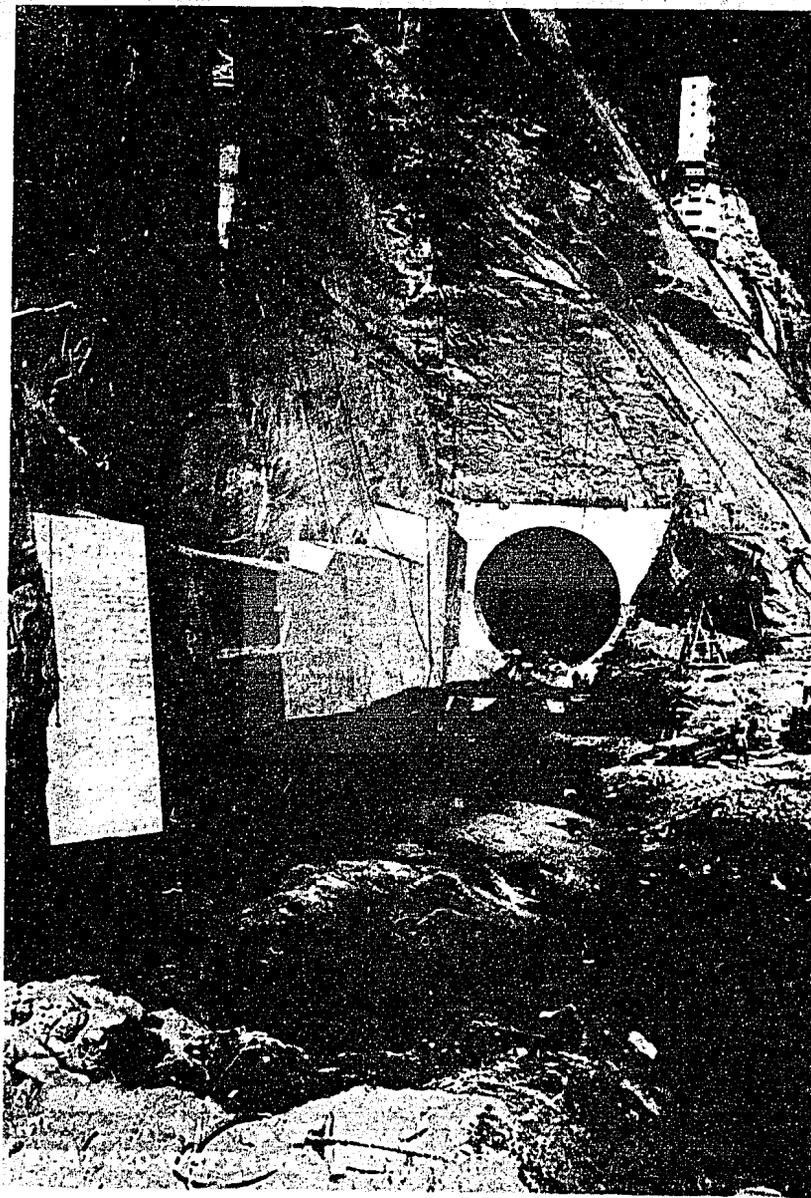
GLEN CANYON DAM SPILLWAYS
Protective Wall at Right Diversion Tunnel

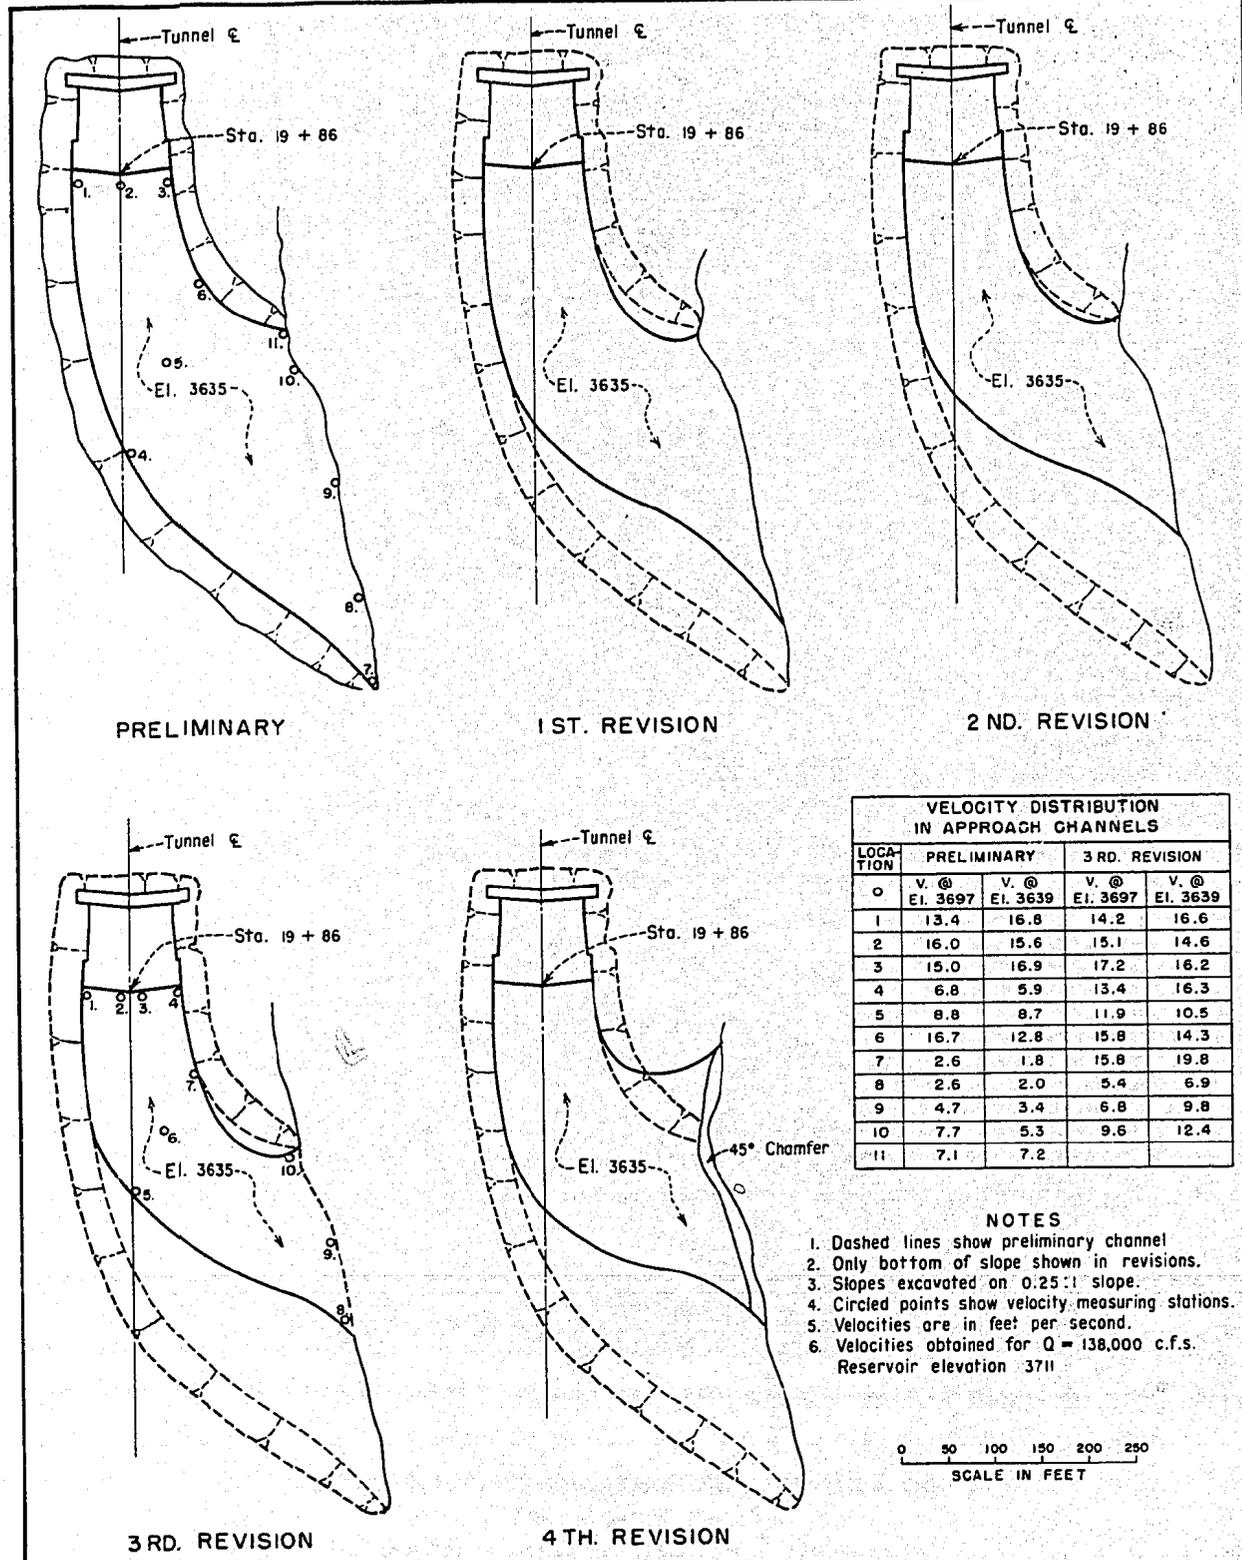
VELOCITY DISTRIBUTION IN APPROACH CHANNELS				
LOCATION	PRELIMINARY		3 RD. REVISION	
	V. @ El. 3697	V. @ El. 3639	V. @ El. 3697	V. @ El. 3639
1	13.4	16.8	14.2	16.6
2	16.0	15.6	15.1	14.6
3	15.0	16.9	17.2	16.2
4	6.8	5.9	13.4	16.3
5	8.8	8.7	11.9	10.5
6	16.7	12.8	15.8	14.3
7	2.6	1.8	15.8	19.8
8	2.6	2.0	5.4	6.9
9	4.7	3.4	6.8	9.8
10	7.7	5.3	9.6	12.4
11	7.1	7.2

- NOTES
1. Dashed lines show preliminary channel
 2. Only bottom of slope shown in revisions.
 3. Slopes excavated on 0.25:1 slope.
 4. Circled points show velocity measuring stations.
 5. Velocities are in feet per second.
 6. Velocities obtained for $Q = 138,000$ c.f.s. Reservoir elevation 3711

GLEN CANYON DAM SPILLWAYS
1:63.48 SCALE MODEL
LEFT SPILLWAY APPROACH CHANNEL REVISIONS

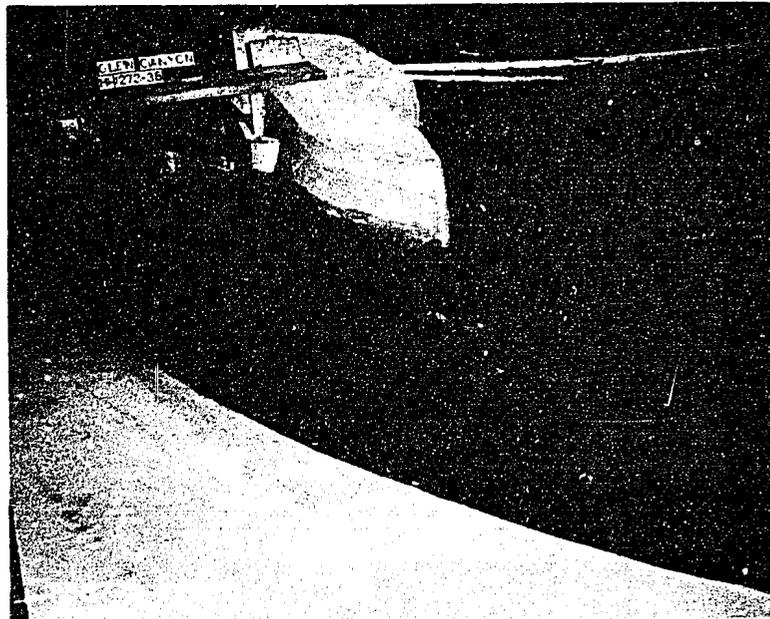
Discharge = 138,000 cfs
Reservoir Elev. 3711.0

GLEN CANYON DAM SPILLWAYS
1:63.48 Scale Model
Preliminary Left Spillway Approach Channel

Preliminary channel. --The arrangements of the preliminary right and left approach channels were similar. The gate section and tunnel portal of the right spillway were set a greater distance back from the canyon edge than the left spillway gate section. This difference permitted a more gradual or longer radius curve for the left wall of the right approach channel. The outside or right boundary of the right approach channel was in the form of a moderate "s" or reverse curve between the canyon edge and the gate section. The bottom width of the right channel was 460 feet at the canyon rim and reduced to about 110 feet wide at the gate section, Figure 32.

face, Figure 33. Velocities at the channel entrance were about 3.9 fps near the right side, 3.7 fps in the center, and 4.5 fps near the left side. In front of the spillway entrance, the velocities were about 14.6 fps on the right side, 15.1 fps in the center, and 15.8 fps on the left side. The velocity distribution for the maximum discharge in the preliminary channel is shown on Figure 32.

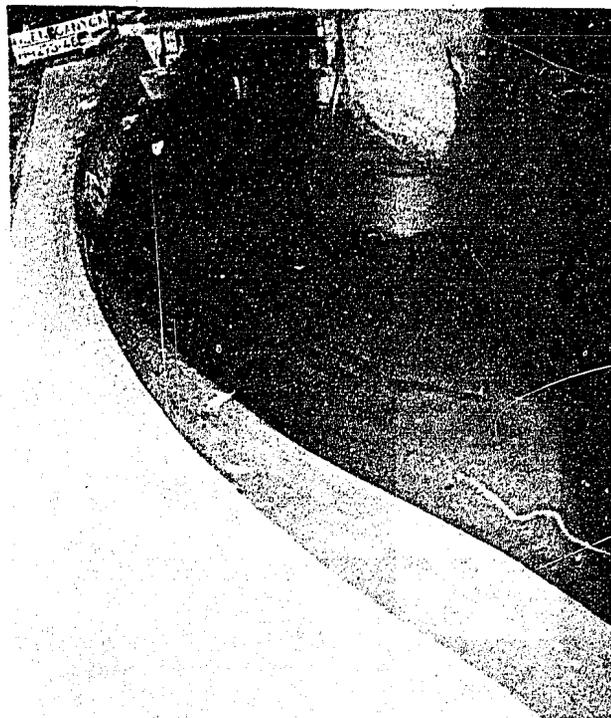
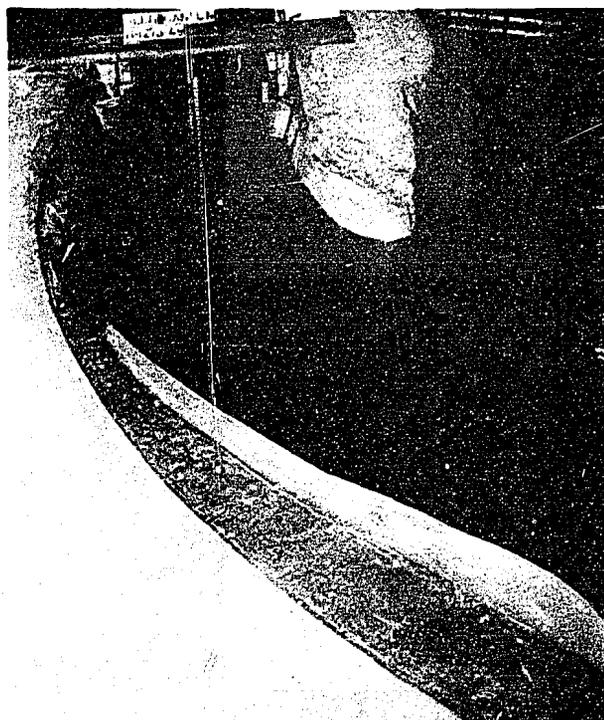
A. First Revision

Discharge = 138,000 cfs
Reservoir Elev. 3711.0

B. Second Revision

1:63.48 Scale Model
Revised Left Spillway Approach Channel

First revision. --The preliminary channel was modified by moving the right boundary downstream about 100 feet at the canyon rim and fairing it into the preliminary boundary about 100 feet upstream from the gate section, Figure 32. The left side of the channel was not modified.

Second revision. --The right wall was moved 75 feet farther downstream at the entrance and faired into the preliminary wall similar to the first revision, Figure 32. No changes were made to the left side.

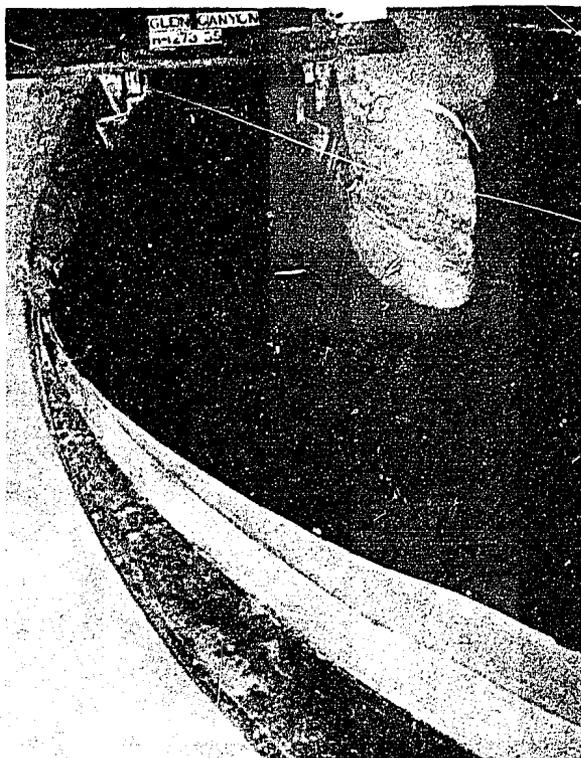
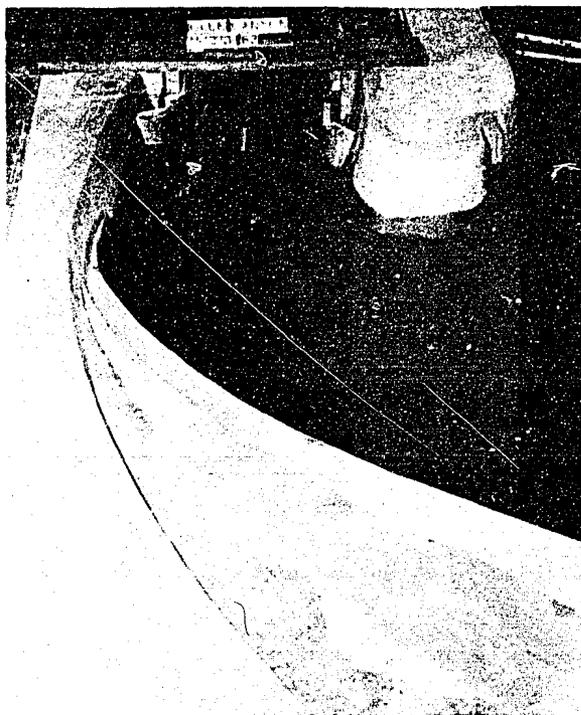
A. Third Revision

B. Recommended

Discharge = 138,000 cfs
Reservoir Elev. = 3711.0

1:63.48 Scale Model
Revised Left Spillway Approach Channel

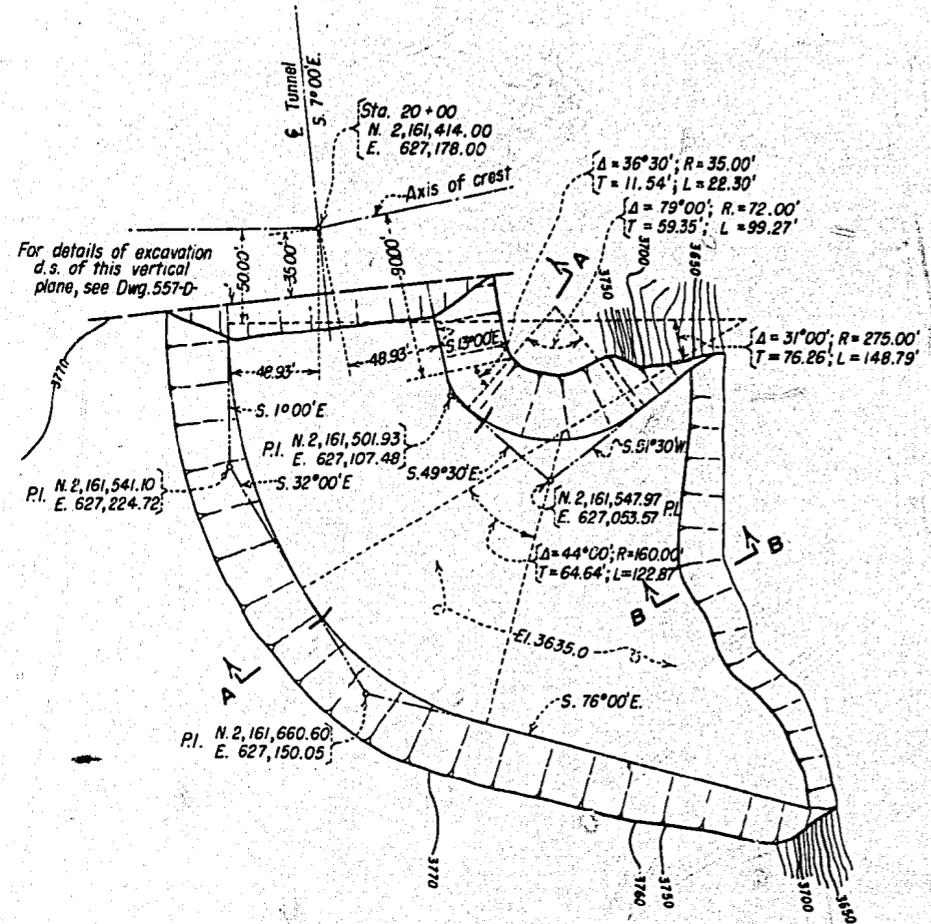
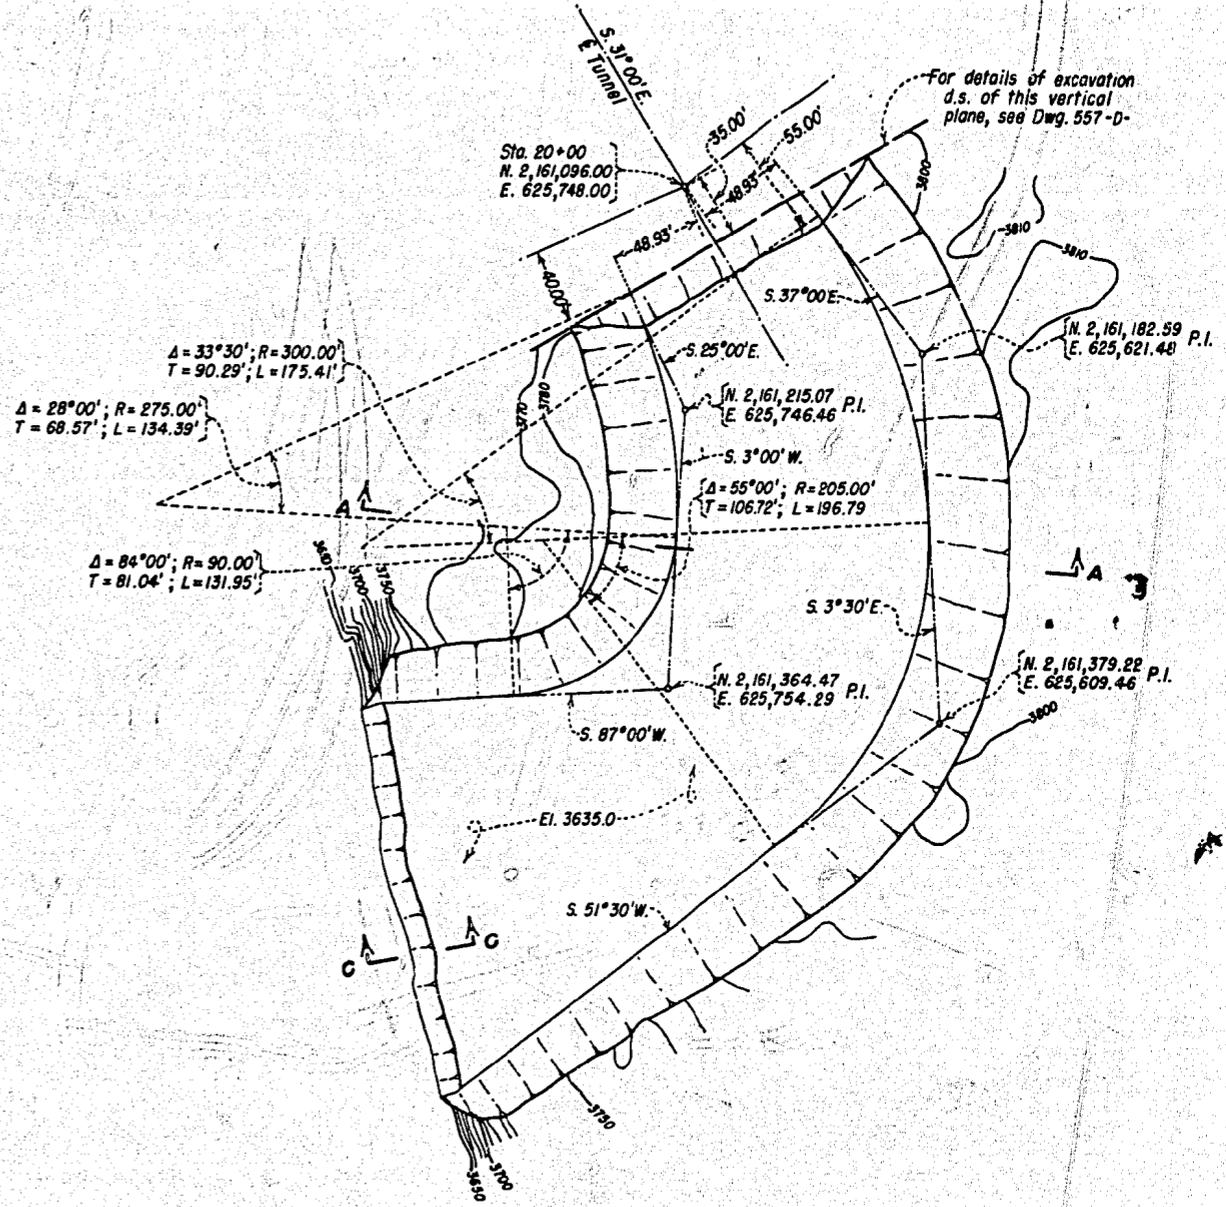
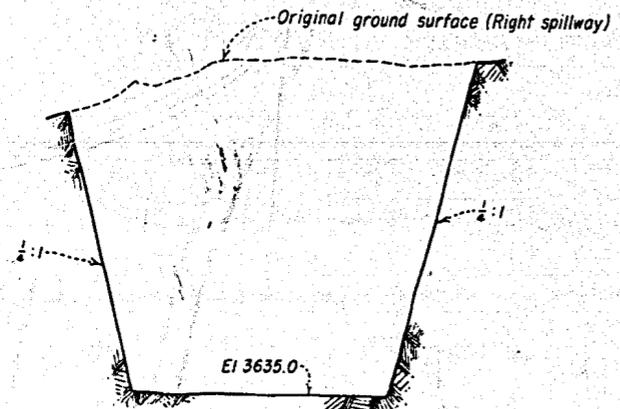
LEFT SPILLWAY APPROACH CHANNEL

RIGHT SPILLWAY APPROACH CHANNEL

8-1-67 S. J. R. TRACED	
UNITED STATES DEPARTMENT OF THE INTERIOR BUREAU OF RECLAMATION COLORADO RIVER STORAGE PROJECT MIDDLE RIVER DIV.-GLEN CANYON UNIT-ARIZONA-UTAH	
GLEN CANYON DAM SPILLWAY APPROACH CHANNELS EXCAVATION	
DRAWN.....J.H.	SUBMITTED.....E.R. Dexter
TRACED.....S.T.R.	RECOMMENDED.....O.L. Rice
CHECKED.....L.S.S.	APPROVED.....L.S. Puls
DENVER, COLORADO, JUNE 28, 1967	
857-D-442

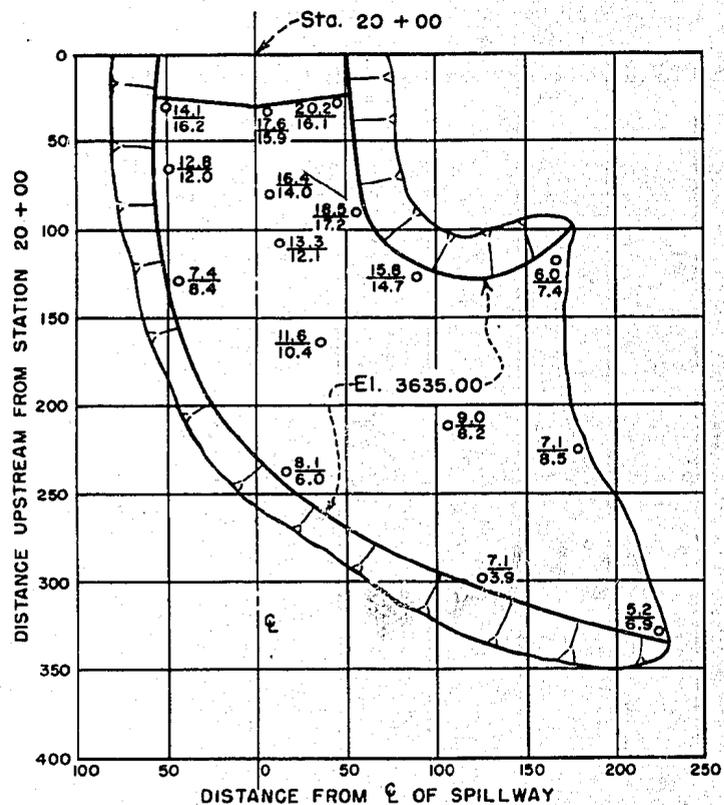
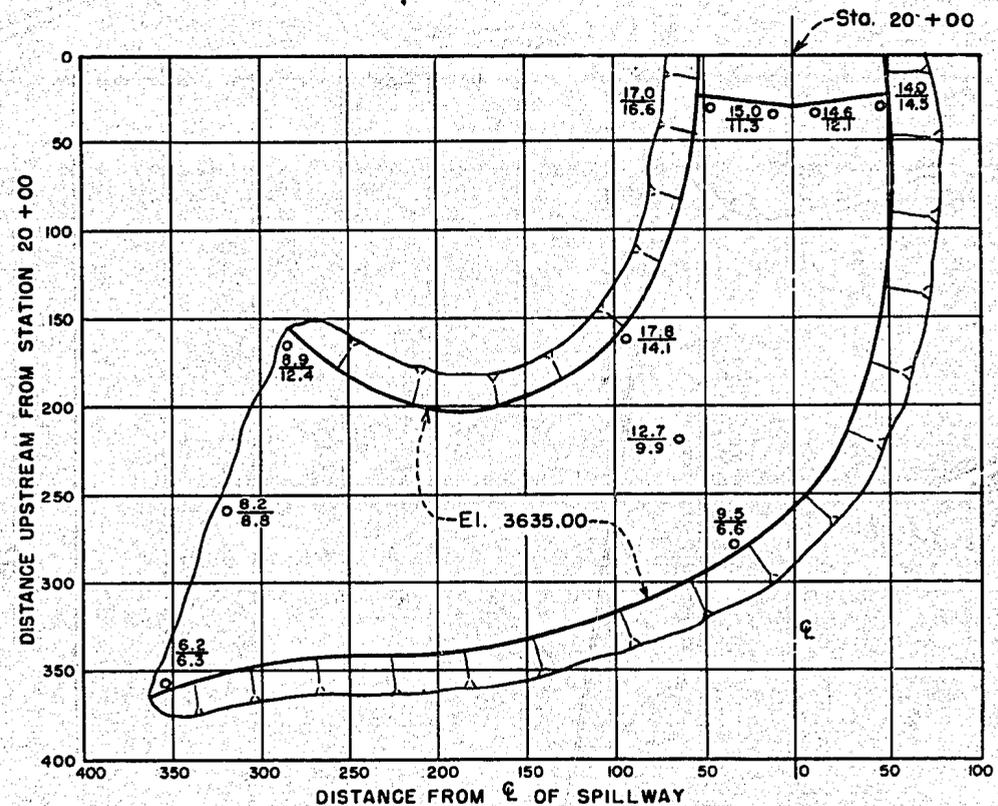
FIGURE 32
REPORT HYD. 469

LEFT APPROACH CHANNEL

RIGHT APPROACH CHANNEL

VELOCITY DISTRIBUTION IN RECOMMENDED APPROACH CHANNELS

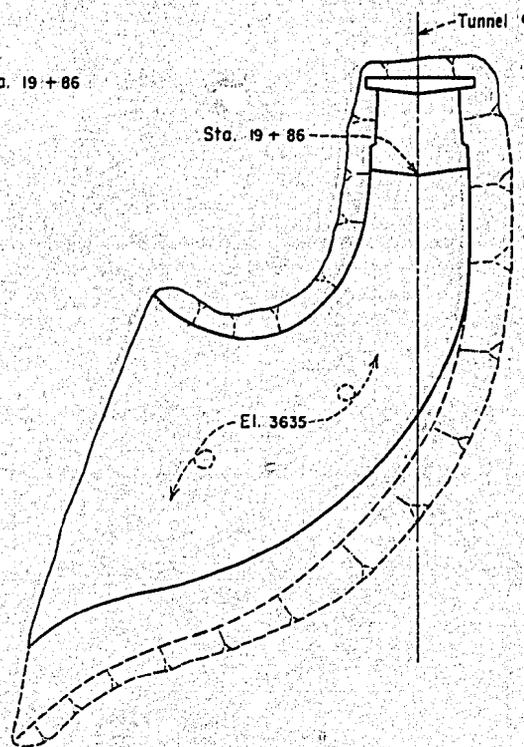
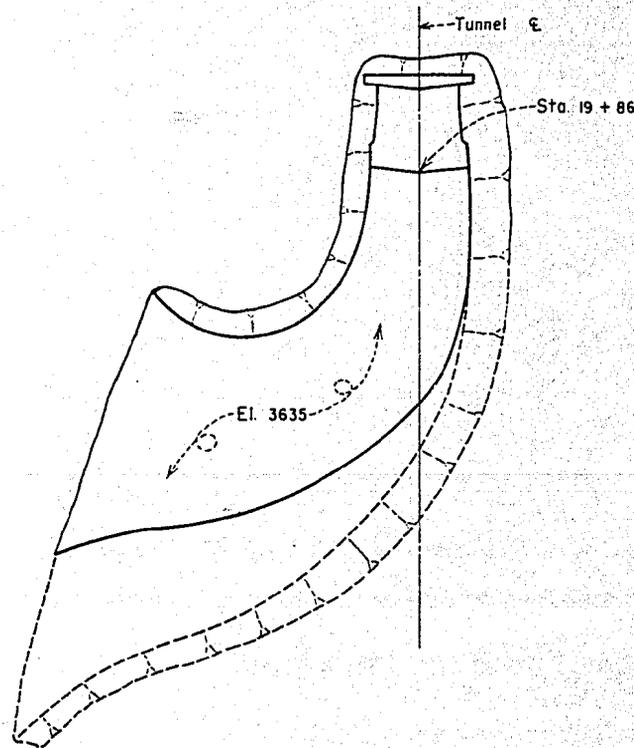
PRELIMINARY

1ST. REVISION

2 ND. REVISION

VELOCITY DISTRIBUTION IN PRELIMINARY APPROACH		
LOCATION	V @ EL. 3697	V @ EL. 3639
○ 1	16.0	15.6
○ 2	15.4	14.8
○ 3	13.9	15.4
○ 4	14.1	11.4
○ 5	10.0	8.0
○ 6	7.0	6.5
○ 7	4.9	4.0
○ 8	4.4	3.6
○ 9	4.2	3.2
○ 10	3.8	3.1
○ 11	4.2	3.6

GLEN CANYON DAM SPILLWAYS
1:63.48 SCALE MODEL
RIGHT SPILLWAY APPROACH CHANNEL REVISIONS

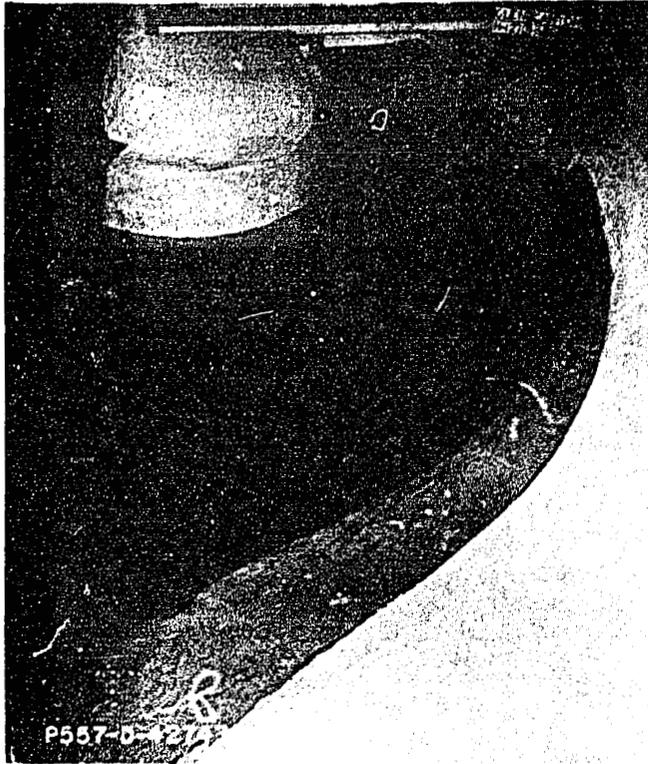
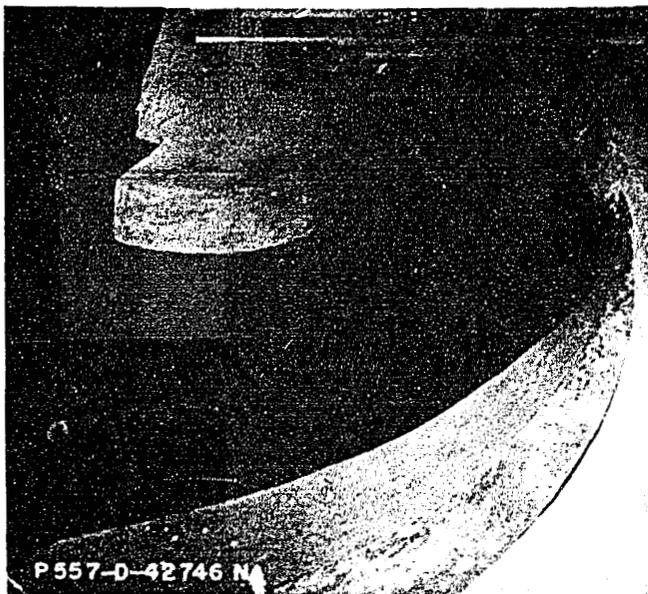
Figure 35
Report Hyd-469

Discharge = 138,000 cfs
Reservoir Elev. = 3711.0

A. First Revision

B. Second Revision

1:63.48 Scale Model
Revisions to Right Spillway Approach Channel

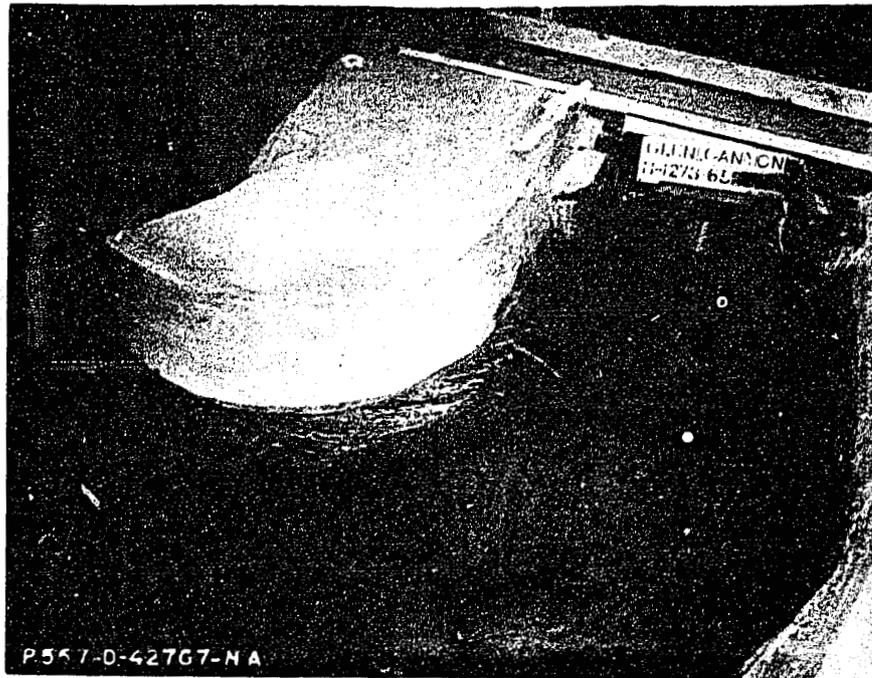
Discharge = 138,000 cfs
Reservoir Elev. = 3711.0

GLEN CANYON DAM SPILLWAYS

1:63.48 Scale Model
Flow with superelevated floor in
recommended approach channel

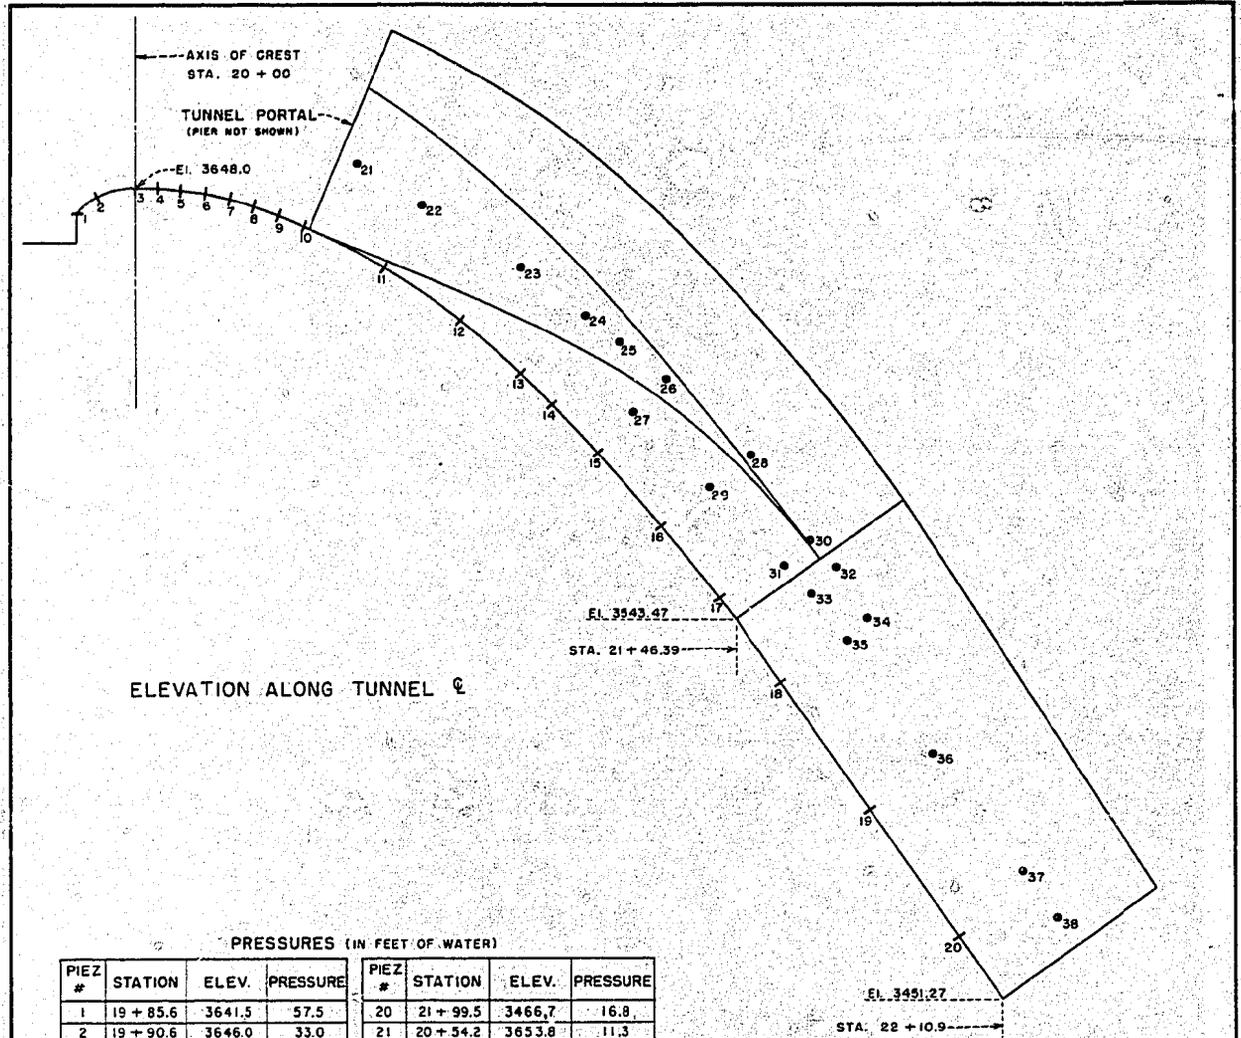
PRESSURES (IN FEET OF WATER)

PIEZ #	STATION	ELEV.	PRESSURE	PIEZ #	STATION	ELEV.	PRESSURE
1	19 + 85.6	3641.5	57.5	20	21 + 99.5	3466.7	16.8
2	19 + 90.6	3646.0	33.0	21	20 + 54.2	3653.8	11.3
3	20 + 00.0	3648.0	22.5	22	20 + 70.0	3643.4	6.0
4	20 + 05.5	3647.7	23.1	23	20 + 94.1	3628.6	6.7
5	20 + 11.0	3647.4	20.2	24	21 + 09.8	3616.9	4.9
6	20 + 17.0	3646.5	16.8	25	21 + 17.7	3609.0	5.5
7	20 + 23.0	3645.1	15.4	26	21 + 29.0	3601.0	5.0
8	20 + 29.0	3643.3	14.6	27	21 + 21.1	3590.0	7.3
9	20 + 35.0	3641.1	13.8	28	21 + 49.5	3583.1	2.3
10	20 + 41.0	3638.6	11.2	29	21 + 39.6	3575.1	-0.7
11	20 + 61.0	3628.4	9.3	30	21 + 64.0	3561.4	0.3
12	20 + 79.0	3615.5	7.1	31	21 + 57.5	3556.1	-12.9
13	20 + 93.6	3603.0	-1.7	32	21 + 70.3	3556.7	-9.3
14	21 + 01.5	3599.2	-1.5	33	21 + 64.2	3549.0	-13.7
15	21 + 12.3	3583.4	-12.9	34	21 + 77.6	3543.4	-1.4
16	21 + 27.5	3565.6	4.2	35	21 + 72.7	3538.4	-1.7
17	21 + 42.0	3547.3	1.8	36	21 + 93.6	3510.6	6.2
18	21 + 56.5	3528.1	6.3	37	22 + 15.2	3481.9	-14.0

- NOTES:
1. For details of transition see figure 42.
 2. For details of crest see figure 37.
 3. Piezometers located in left bay of left spillway nos. 1-20 on invert \bar{c} , nos. 21-38 on left wall.
 4. Pressures obtained for discharge of 138,000 c.f.s.

GLEN CANYON DAM SPILLWAYS
1:63.48 SCALE MODEL
PRESSURES ON CREST AND PRELIMINARY TRANSITION

7. The longer recommended transition, Figure 42, is adequately streamlined and provides smooth flow conditions with no adverse pressures on the sidewalls, Figures 43 and 44.
