HYDRAULIC MODEL STUDIES OF THE SPILLWAYS
AND OUTLET WORKS--GLEN CANYON DAM
COLORADO RIVER STORAGE PROJECT, ARIZONA

Report No. Hyd-469

Hydraulics Branch
DIVISION OF RESEARCH

February 18, 1964

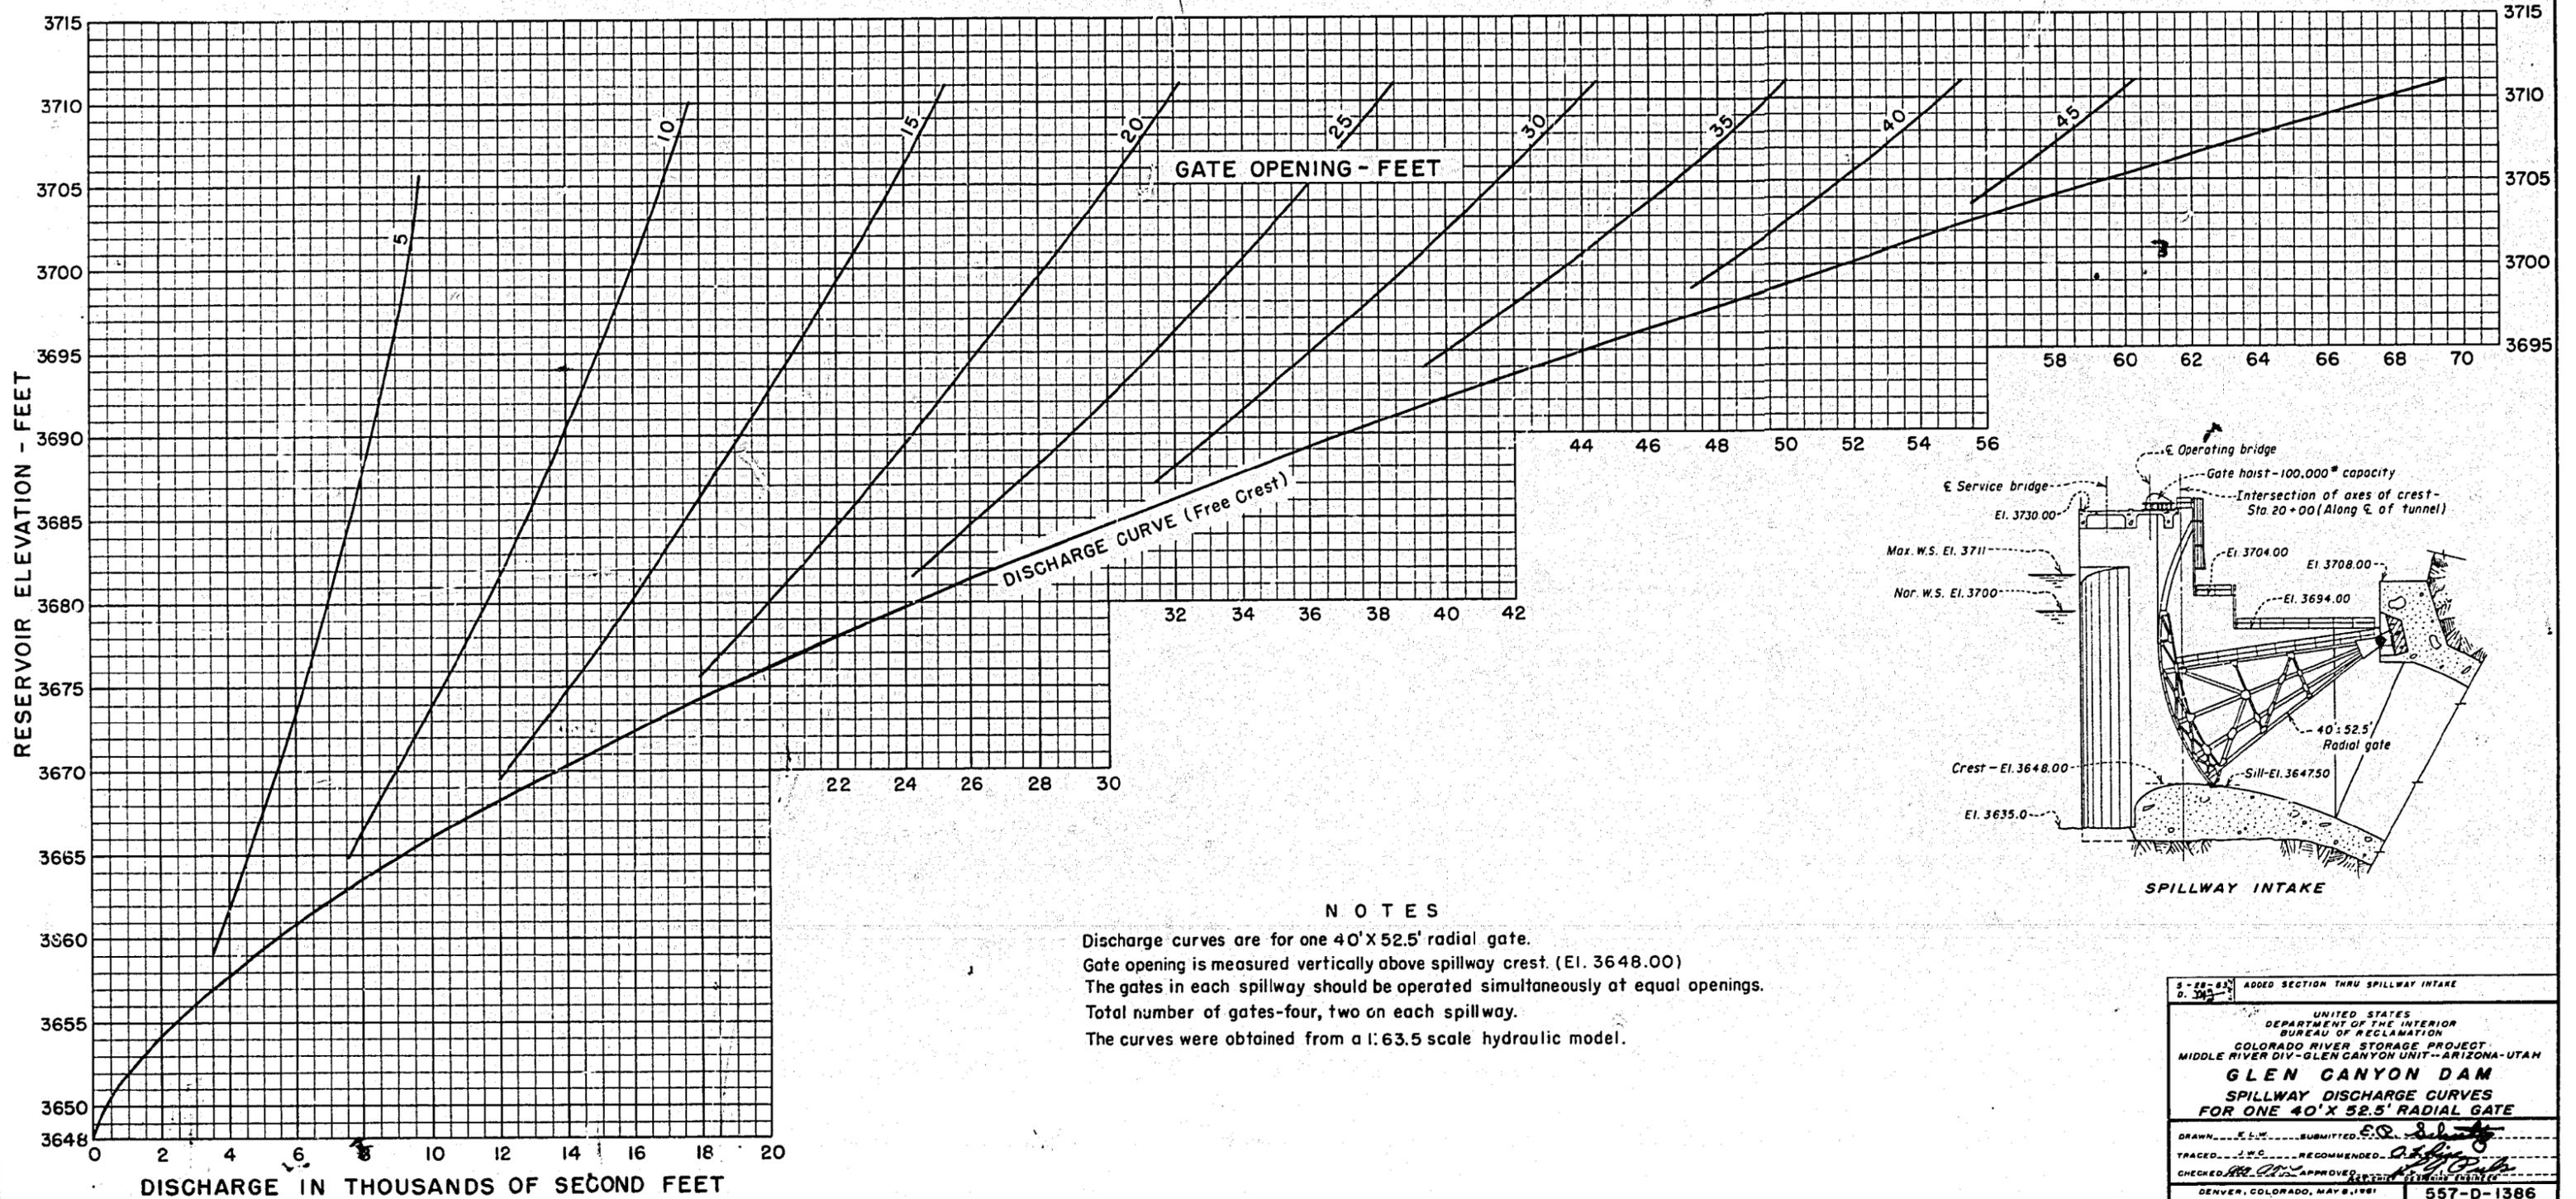
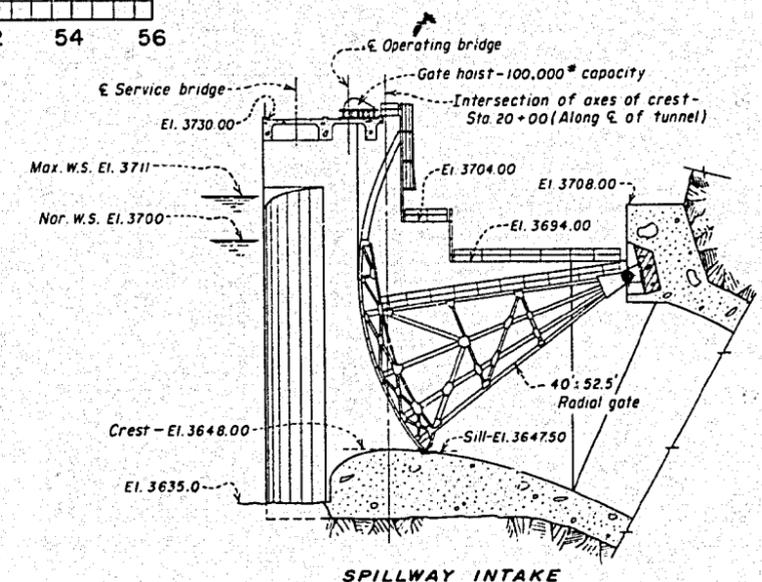
Discharge curves are for one 40' X 52.5' radial gate.
 Gate opening is measured vertically above spillway crest. (El. 3648.00)
 The gates in each spillway should be operated simultaneously at equal openings.
 Total number of gates-four, two on each spillway.
 The curves were obtained from a 1:63.5 scale hydraulic model.

5-28-83 D. 343		ADDED SECTION THRU SPILLWAY INTAKE	
UNITED STATES DEPARTMENT OF THE INTERIOR BUREAU OF RECLAMATION COLORADO RIVER STORAGE PROJECT MIDDLE RIVER DIV-GLEN CANYON UNIT--ARIZONA-UTAH GLEN CANYON DAM SPILLWAY DISCHARGE CURVES FOR ONE 40' X 52.5' RADIAL GATE			
DRAWN	E. L. V.	SUBMITTED	E. P. [Signature]
TRACED	[Signature]	RECOMMENDED	[Signature]
CHECKED	[Signature]	APPROVED	[Signature]
DENVER, COLORADO, MAY 8, 1961		557-D-1386

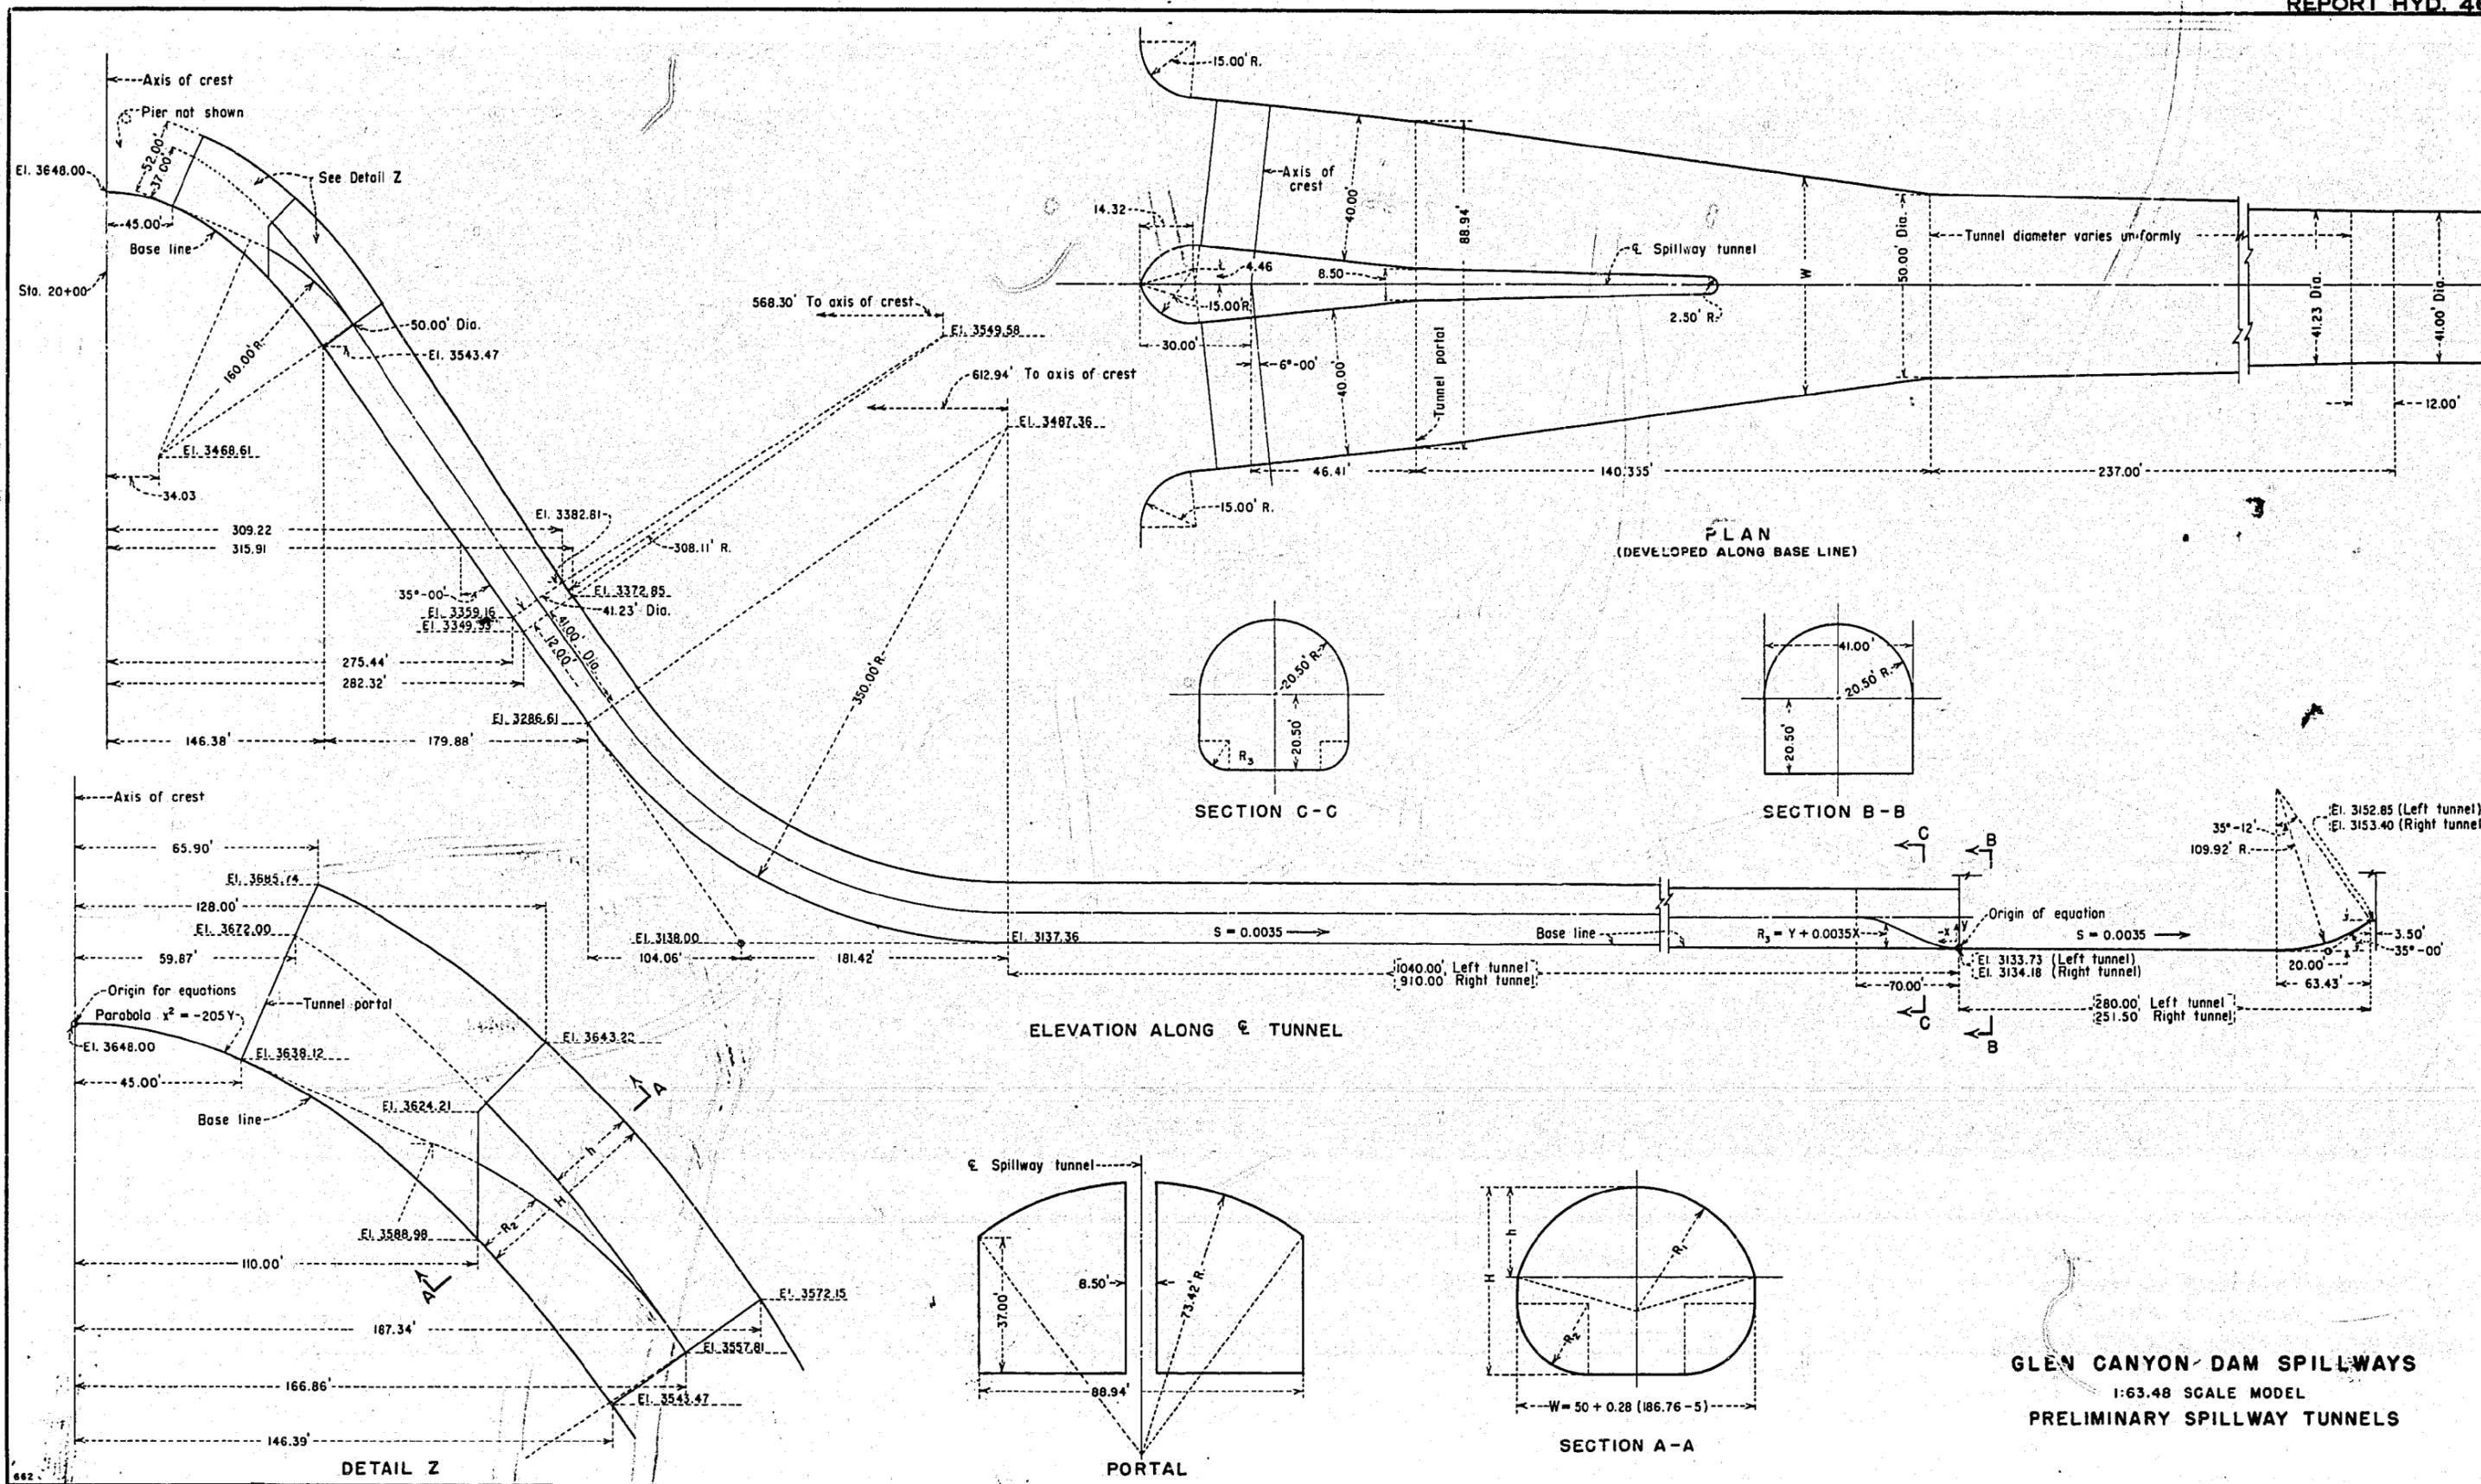
GLEN CANYON DAM SPILLWAYS
1:63.48 SCALE MODEL
PRELIMINARY SPILLWAY TUNNELS

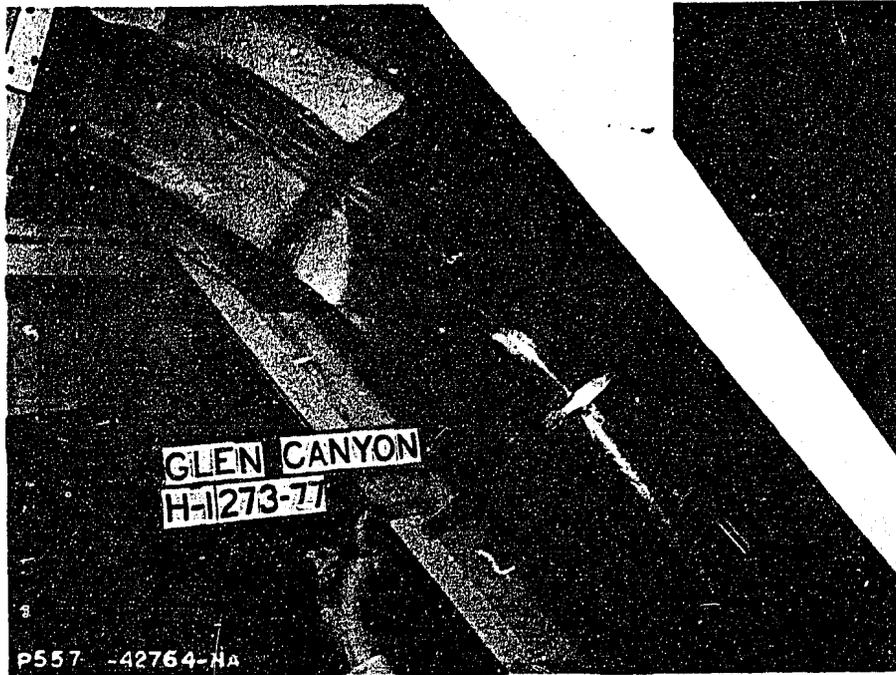
Flow appearance in transition

No separation

Flow separated from wall

Flow appearance downstream from transition

**1:63.48 Scale Model
Flow Conditions in Preliminary Transition**

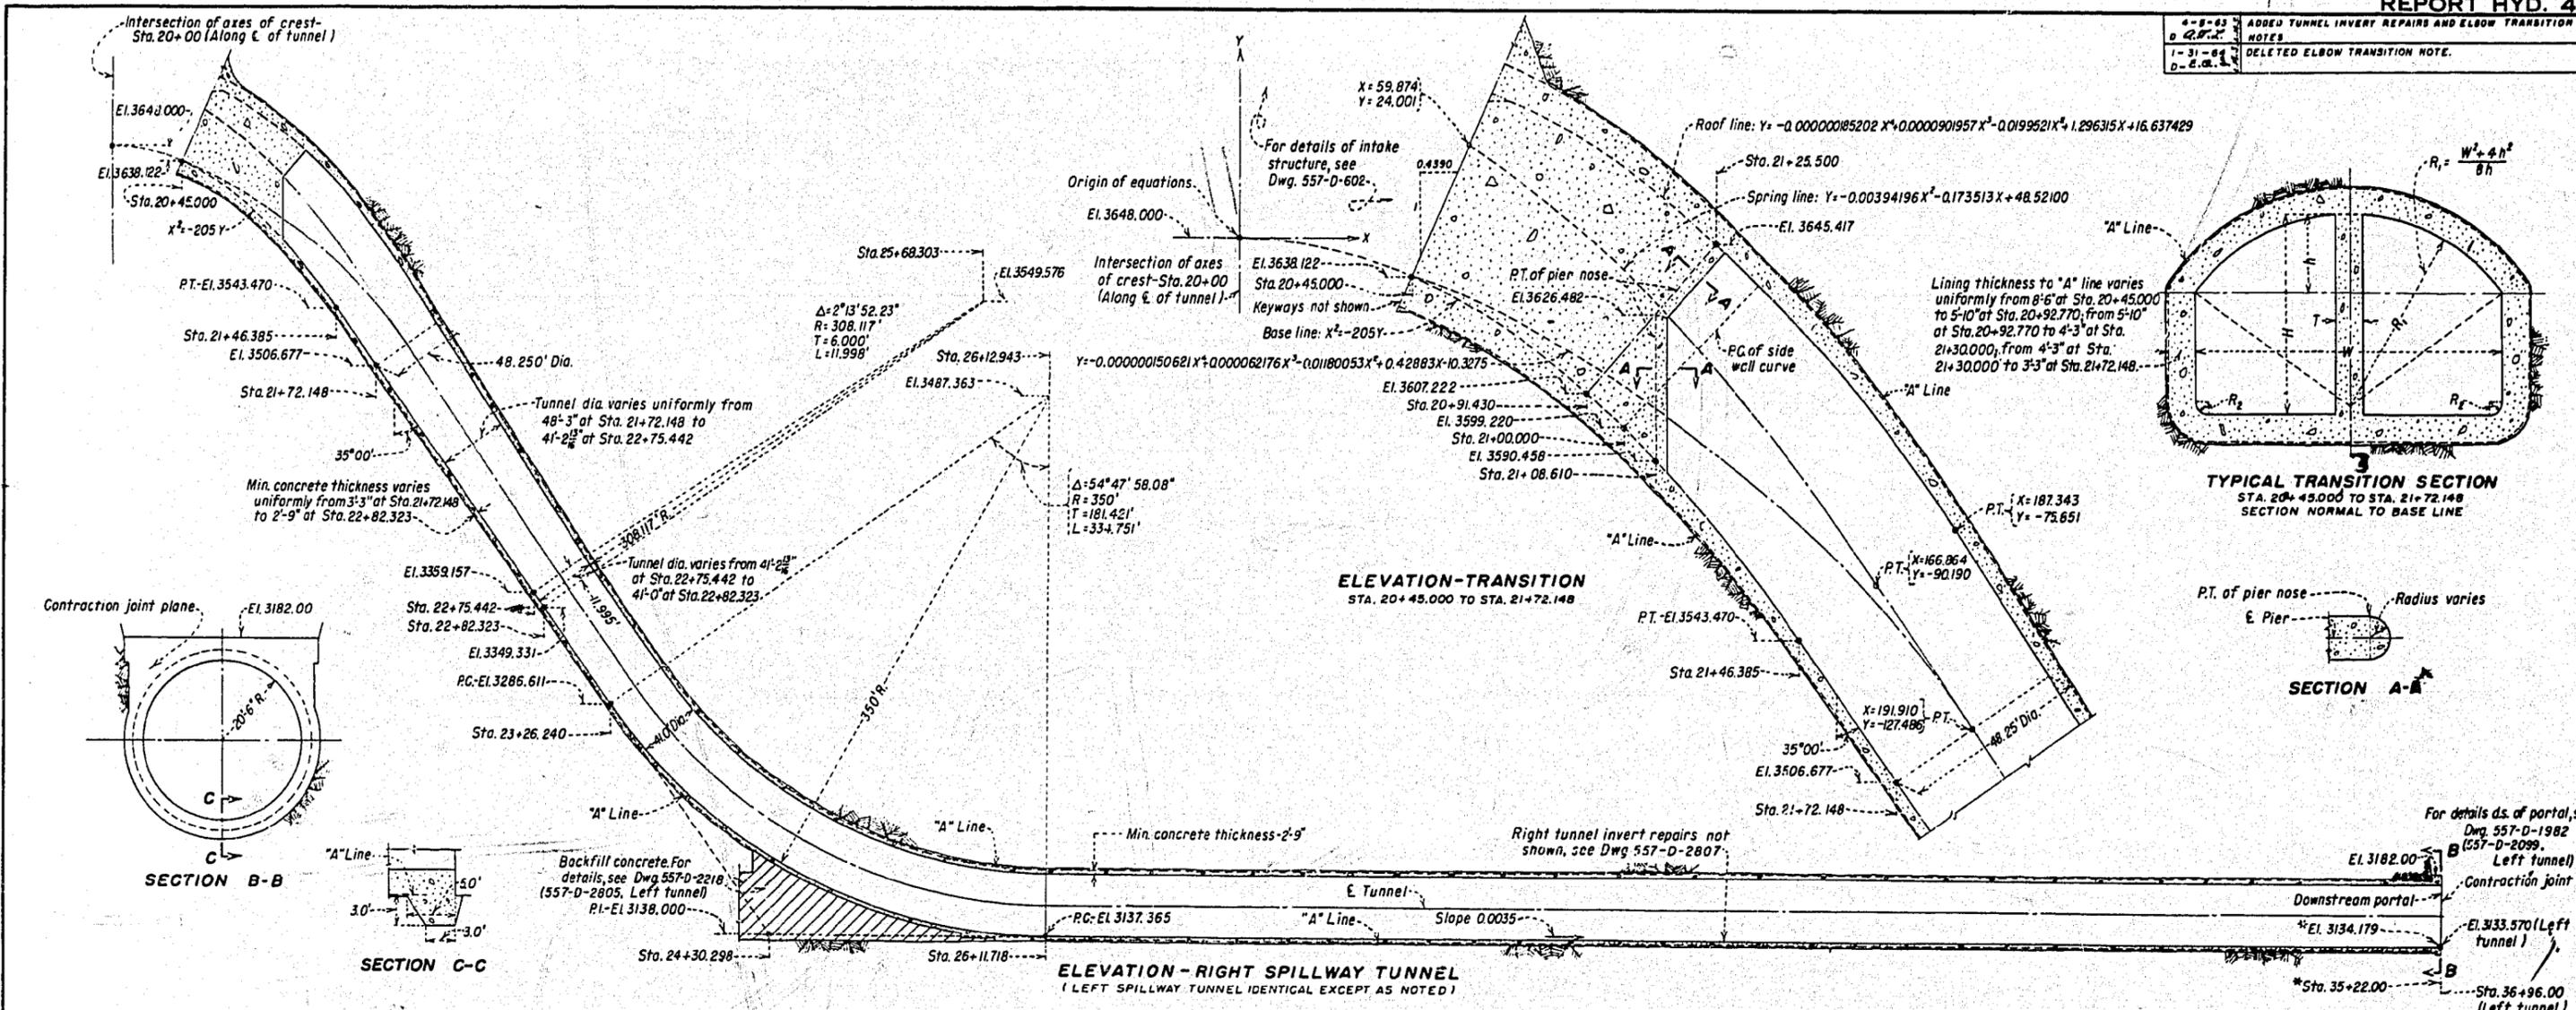
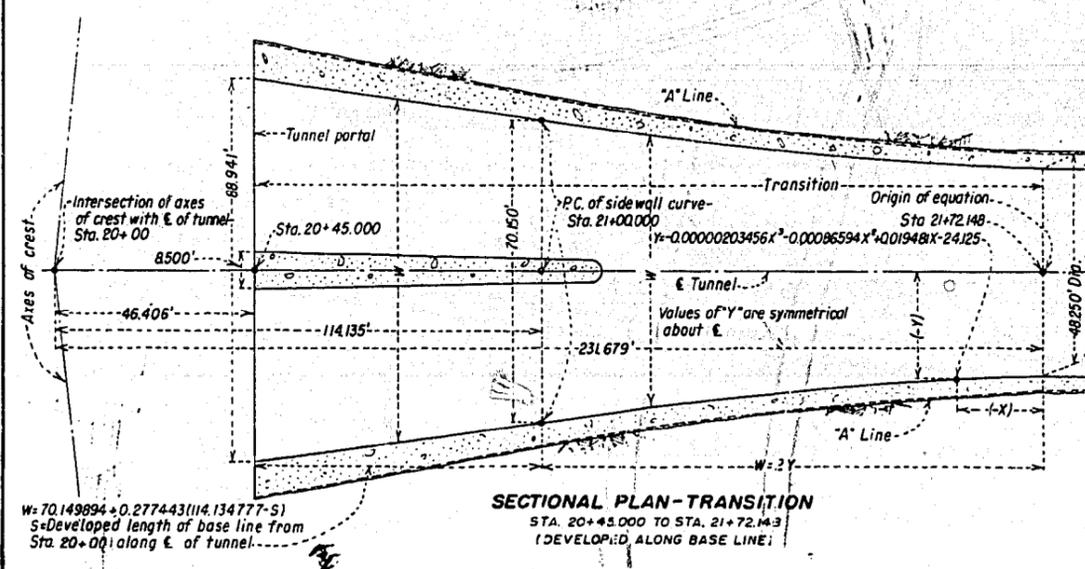
BASE LINE		ROOF LINE		ELEMENTS OF TRANSITION SECTIONS					
Station	Elevation	Station	Elevation	H	h	W	R ₁	R ₂	T
20+45.000	3638.122	20+65.903	3685.735	52'-0"	15'-0"	88'-11"	73'-5"	0	8'-6"
20+48.650	3636.455	20+71.051	3683.651	52'-2"	16'-0"	87'-9"	68'-1"	5"	8'-3"
20+52.230	3634.693	20+75.995	3681.331	52'-4"	16'-10"	86'-8"	64'-0"	10"	8'-11"
20+55.750	3632.839	20+80.763	3678.826	52'-4"	17'-7"	85'-7"	60'-9"	15"	7'-11"
20+59.250	3630.875	20+85.419	3676.144	52'-3"	18'-3"	84'-6"	58'-0"	20"	7'-9"
20+62.680	3628.835	20+89.905	3673.356	52'-2"	18'-9"	83'-4"	55'-8"	2'-1"	7'-7"
20+66.080	3626.700	20+94.288	3670.454	52'-0"	19'-3"	82'-3"	53'-3"	3'-6"	7'-5"
20+69.440	3624.478	20+98.561	3667.464	51'-11"	19'-8"	81'-2"	51'-7"	3'-0"	7'-3"
20+72.710	3622.211	21+02.671	3664.448	51'-9"	20'-1"	80'-0"	49'-10"	3'-6"	7'-0"
20+75.940	3619.889	21+06.689	3661.372	51'-7"	20'-5"	78'-11"	48'-3"	3'-11"	6'-10"
20+79.140	3617.448	21+10.632	3658.236	51'-6"	20'-9"	77'-10"	46'-9"	4'-6"	6'-8"

UNITED STATES
DEPARTMENT OF THE INTERIOR
BUREAU OF RECLAMATION
COLORADO RIVER STORAGE PROJECT
MIDDLE RIVER DIV. GLEN CANYON UNIT-ARIZONA-UTAH
**GLEN CANYON DAM
SPILLWAYS
RIGHT AND LEFT TUNNELS
ELEVATIONS AND SECTIONS**

7. The longer recommended transition, Figure 42, is adequately streamlined and provides smooth flow conditions with no adverse pressures on the sidewalls, Figures 43 and 44.

The recommended transition, Figure 42, had the same general appearance as the preliminary except that the side convergence was accomplished in a curve and the horizontal length was increased about 26 feet.

Downstream from the tapered section, the tunnel is 41 feet in diameter and follows the 55° slope for about 75 feet and then changes direction to the near horizontal tunnel with a 350-foot radius bend. The near horizontal tunnels continue for approximately 1,080 feet for the left tunnel and 910 feet for the right tunnel, before emerging from the canyon wall, Figure 42.

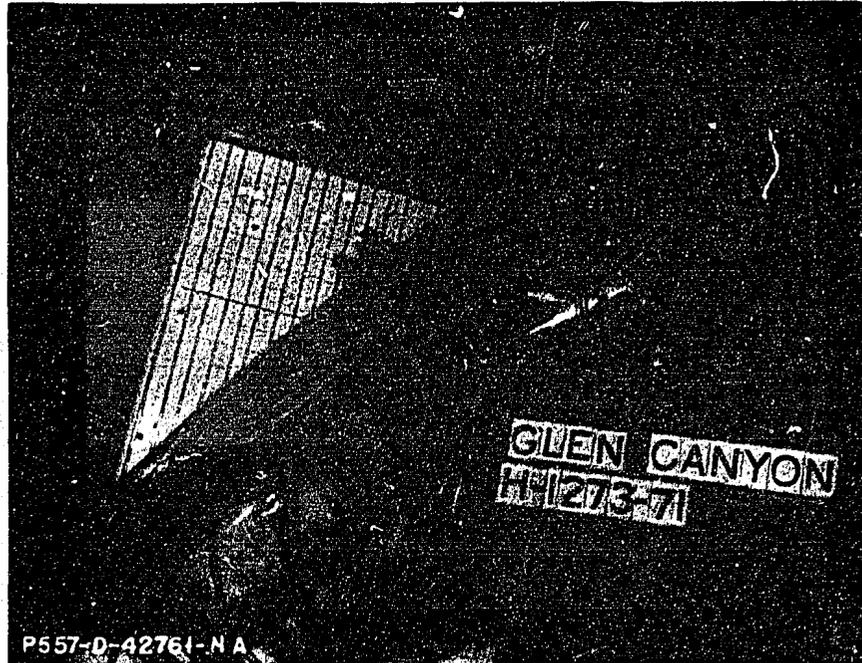
Flow in transition. Note small surface fin.

No separation.

Occasional separation from wall.

Flow Downstream from Transition
GLEN CANYON DAM SPILLWAYS

1:63.48 Scale Model
Flow in Recommended Transition

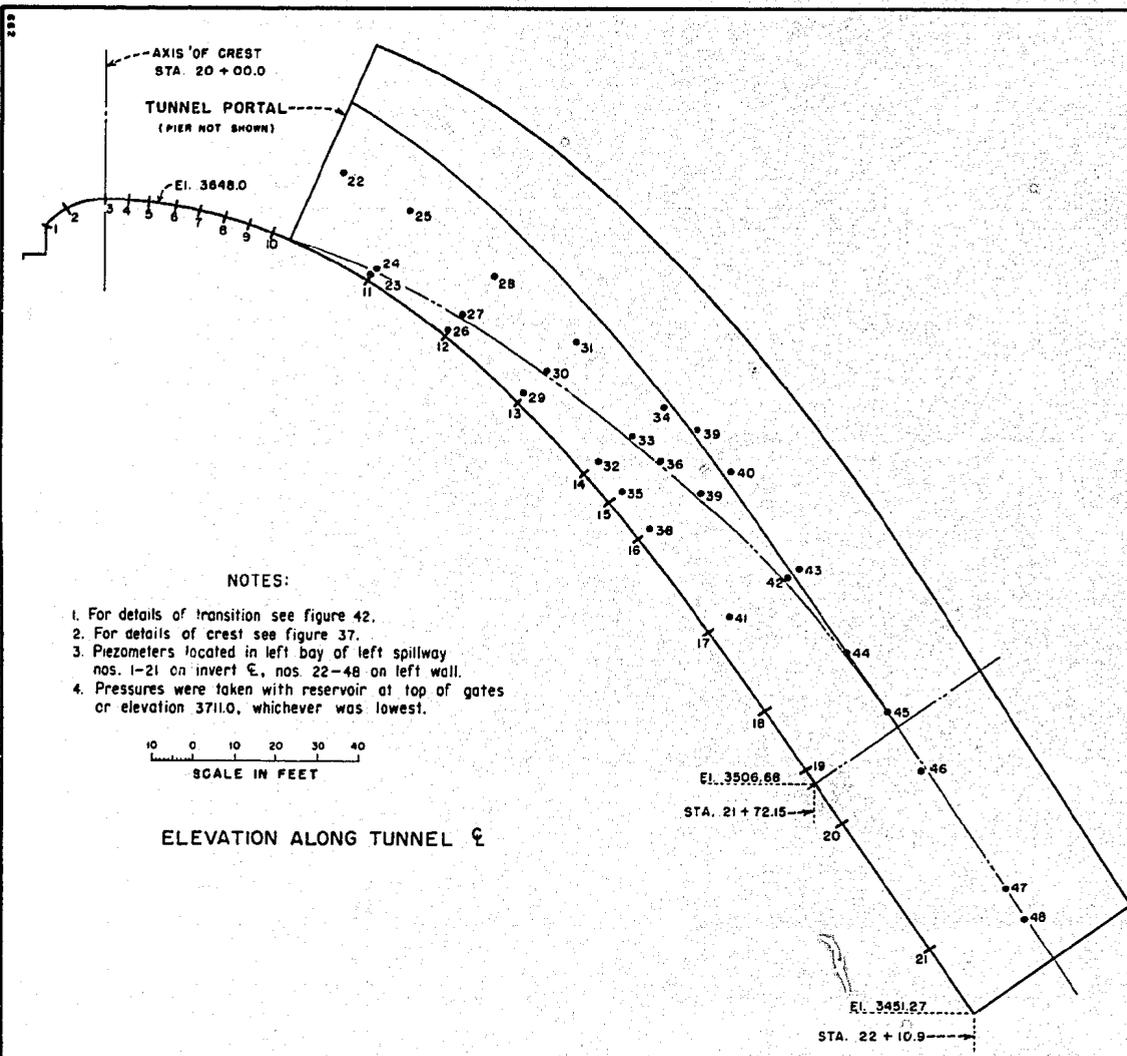
1. For details of transition see figure 42.
2. For details of crest see figure 37.
3. Piezometers located in left bay of left spillway nos. 1-21 on invert \bar{C} , nos. 22-48 on left wall.
4. Pressures were taken with reservoir at top of gates or elevation 3711.0, whichever was lowest.

PRESSURES ON CREST AND RECOMMENDED TRANSITION

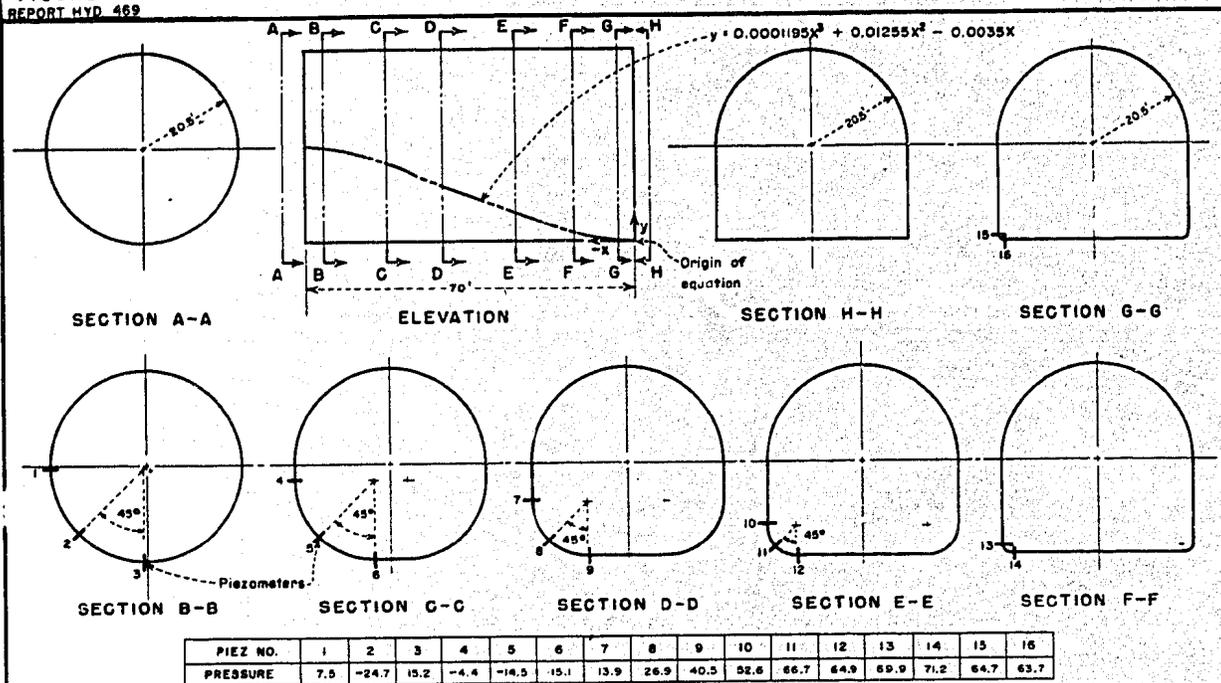
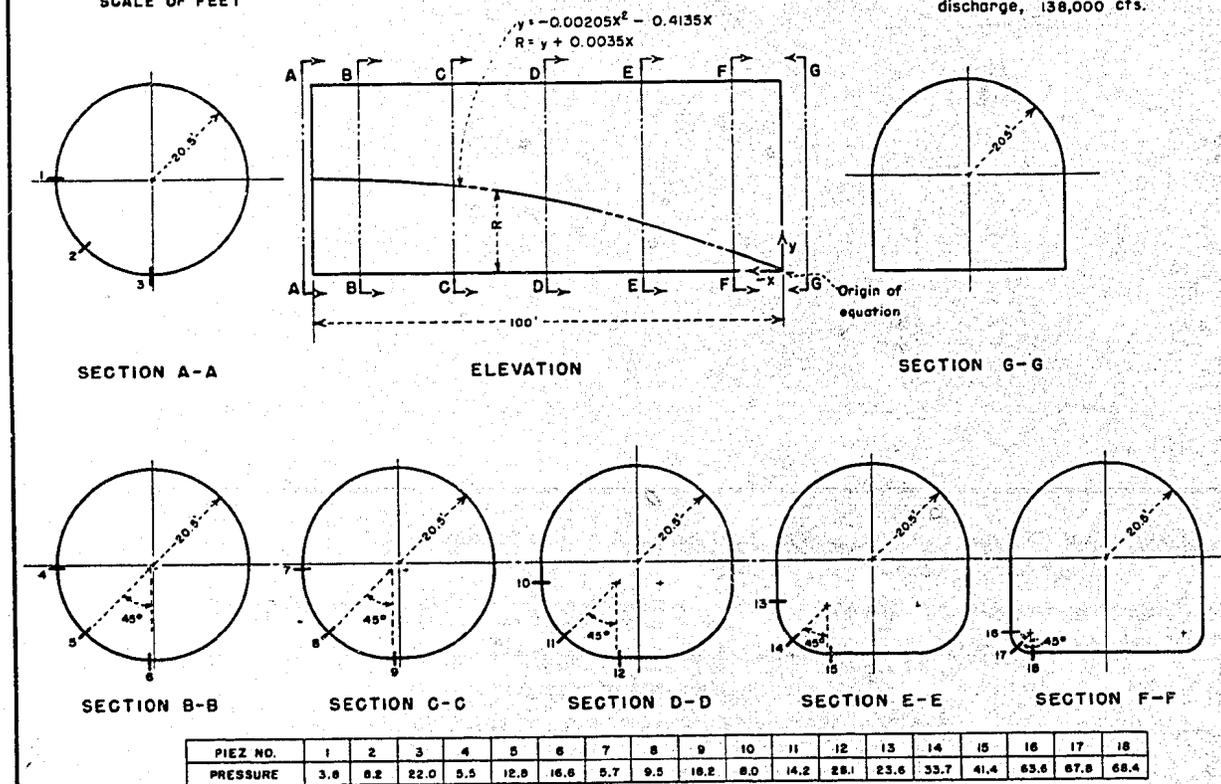
FIGURE 45
REPORT HYD 489

A. PRELIMINARY

NOTE
Pressure taken at maximum discharge, 138,000 cfs.

B. REVISED

GLEN CANYON DAM SPILLWAYS
1:63.48 SCALE MODEL
TRANSITION AT DOWNSTREAM TUNNEL PORTAL

8. Flow in the 41-foot-diameter tunnels was excellent at all discharges.
9. The preliminary downstream circular-to-rectangular tunnel transition was too short, as indicated by severely subatmospheric pressures in the lower corners, Figure 45. Increasing the transition length from 70 to 100 feet increased the pressures to a satisfactory degree. This transition was eliminated in the recommended design.

A transition was planned for the downstream end of each tunnel to guide the flow from the circular conduit to the rectangular channel between the tunnel portal and the flip bucket. Details of the preliminary transition, which was 70 feet long, are shown in Figure 45A.

The flow appearance in the transition was very good. However, piezometers along the lower corner of the transition indicated subatmospheric pressures in the cavitation range. Piezometers were installed as shown in Figure 45A. The piezometers along the bottom tangent line indicated above atmospheric pressures for the full length. The piezometers along the side tangent line showed above atmospheric pressures at the upstream end of the transition, 4 feet of water below atmospheric about 17 feet downstream from the start, and a steep increase to 13 feet of water above atmospheric at the third piezometer 11 feet farther downstream. The center row of piezometers indicated severe subatmospheric for the first 17 feet, the lowest pressure being 23 feet of water below atmospheric 3.5 feet downstream from the start of the transition. The pressure 29 feet downstream from the start of the transition increased to about 26 feet above atmospheric; pressures remained above atmospheric through the remainder of the transition, Figure 45A.

The subatmospheric pressures indicated that the change in cross section in the transition was too abrupt. Accordingly, the transition was modified so that it was 100 feet long with the centers of the radii on each side tracing a parabola, Figure 45B.

The appearance of the flow in the modified transition was excellent. Pressure readings from piezometers in locations similar to those in the preliminary transition were above atmospheric along the full length, Figure 45B. On the basis of these tests, the second transition was considered satisfactory for the field installation. However, during subsequent model investigations of the flip buckets downstream from the transition, it was determined that better bucket performance could be obtained if the semicircular invert of the tunnel was continued downstream and allowed to intercept the upward curve of the flip bucket. This not only provided good

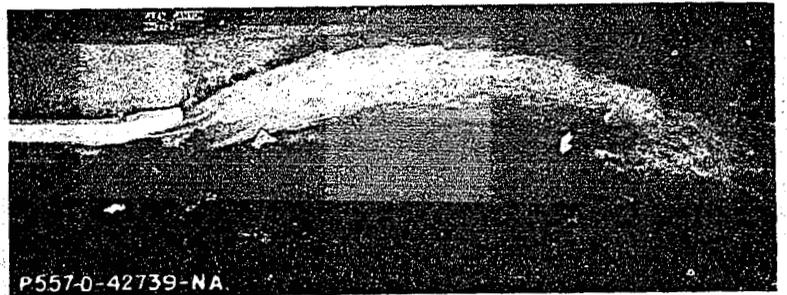
Discharge = 25,000 cfs

Discharge = 138,000 cfs

1:63.48 Scale Model
Flow Conditions with Both Preliminary Flip Buckets

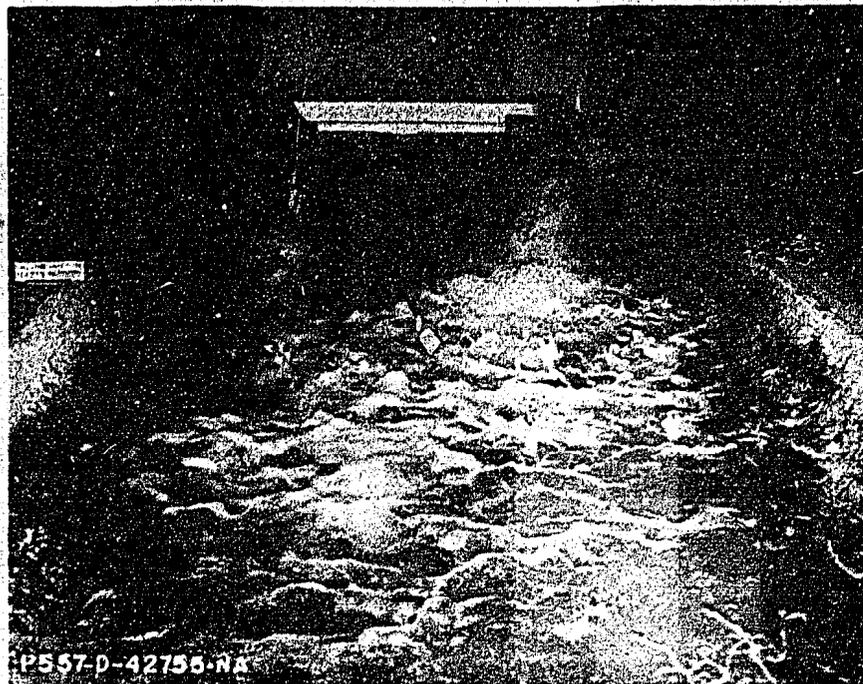
Discharge = 25,000 cfs

Discharge = 138,000 cfs

GLEN CANYON DAM SPILLWAYS
1:63.48 Scale Model
Flow in Preliminary Right Flip Bucket

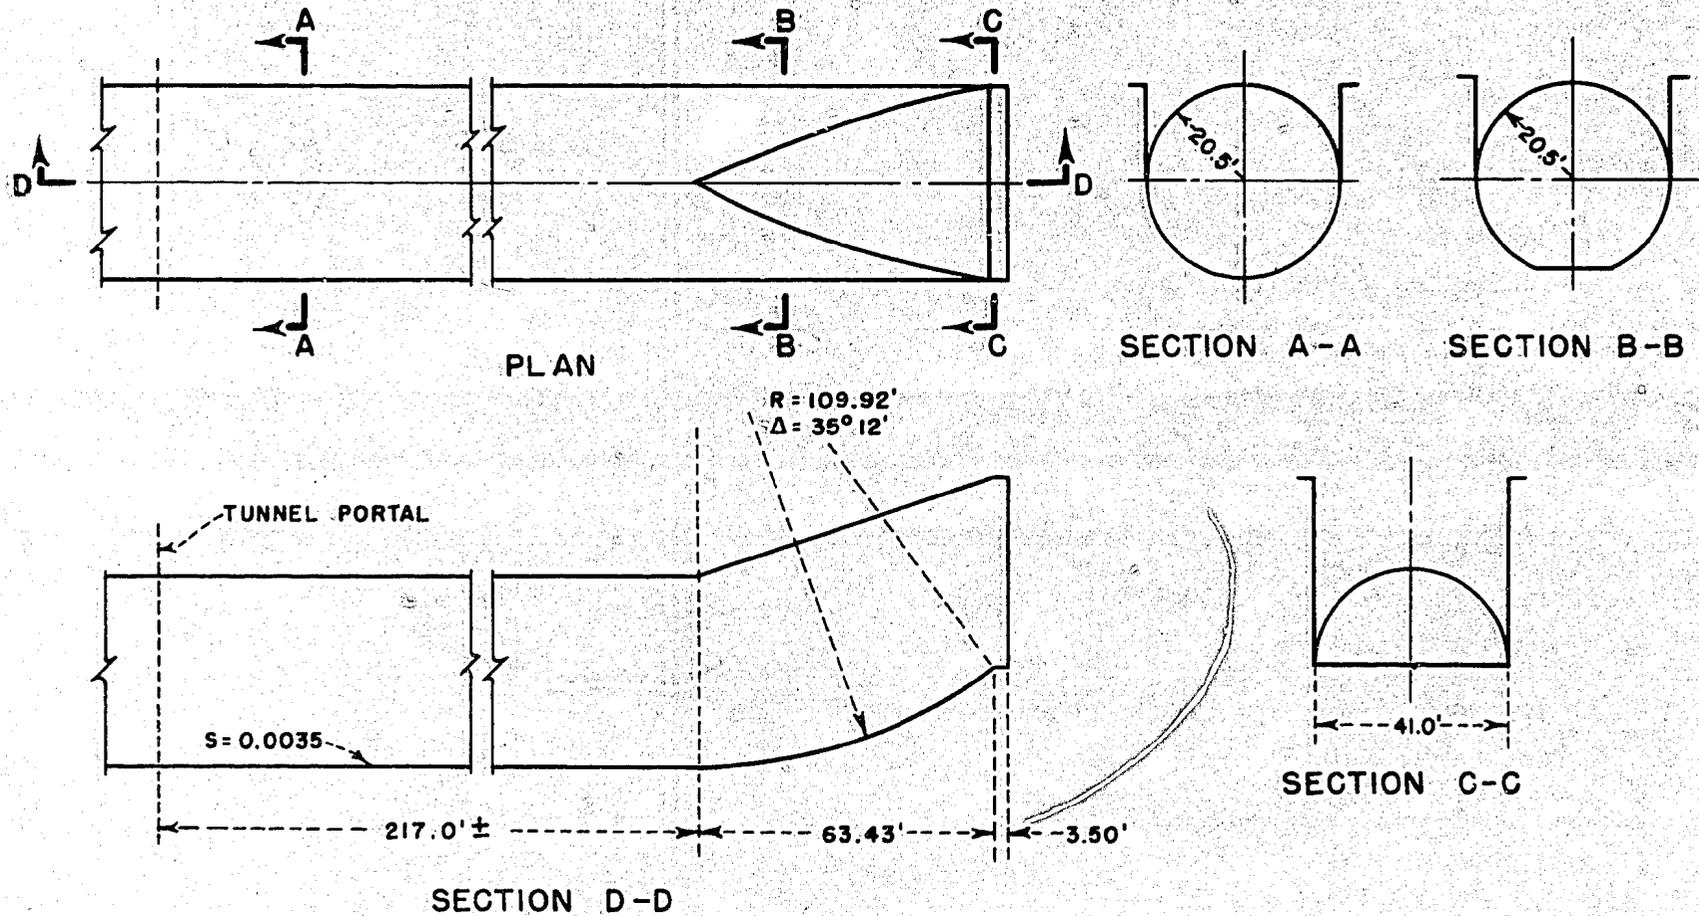
Discharge = 276,000 cfs
T. W. Elev. = 3180.0

GLEN CANYON DAM SPILLWAYS

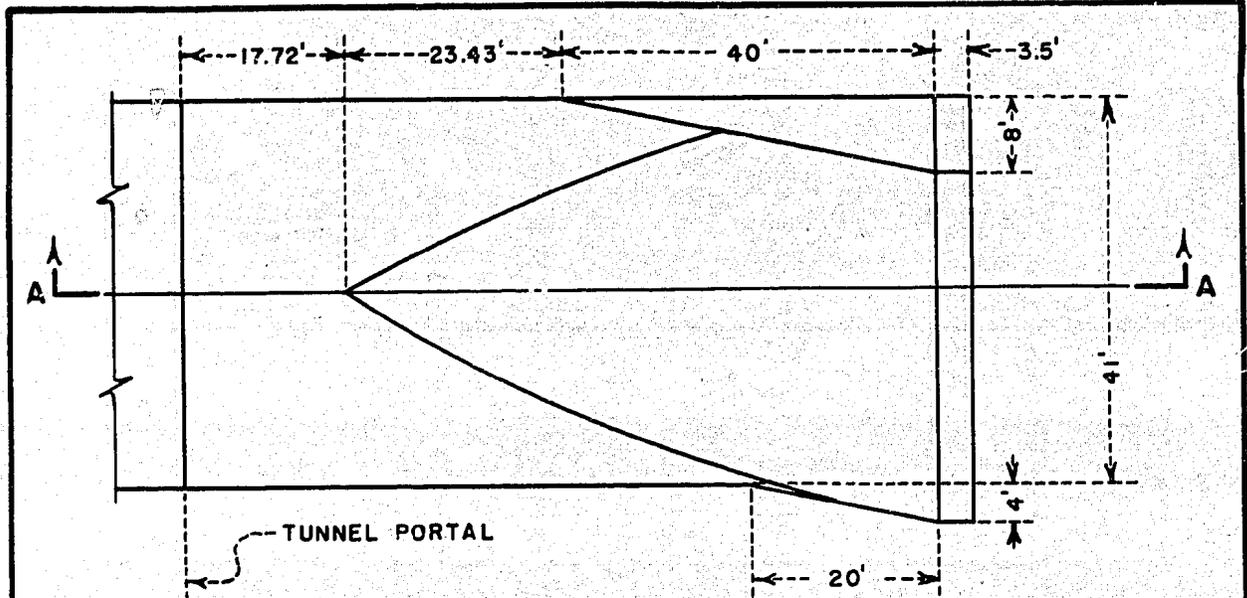
PLAN

Left Bucket shown, Right Bucket similar only on opposite hand.

$R = 109.92'$
 $\Delta = 35^\circ - 12'$

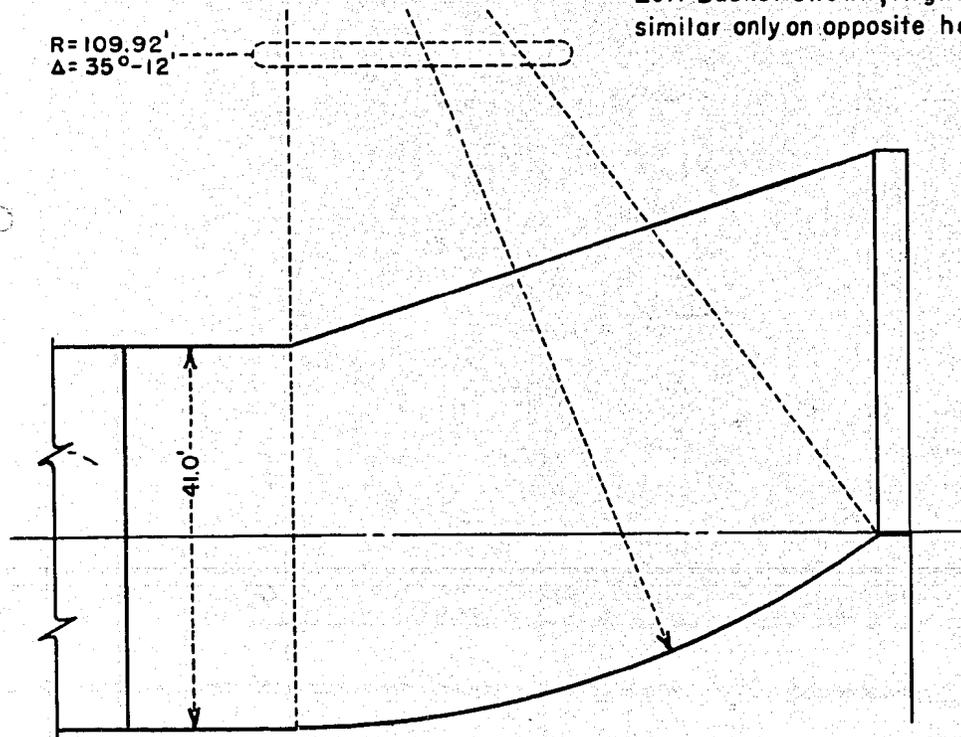
SECTION A-A

GLEN CANYON DAM SPILLWAYS

1:63.48 SCALE MODEL

FLIP BUCKETS - THIRD REVISION

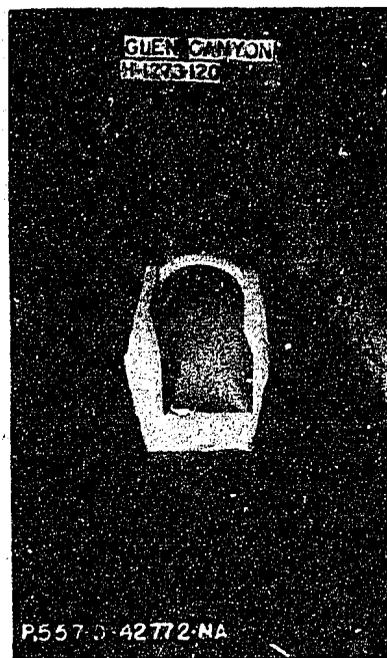
Discharge = 25,000 cfs

Discharge = 138,000 cfs

GLEN CANYON DAM SPILLWAYS
1:63.48 Scale Model
Flow in Left Flip Bucket - Third Revision

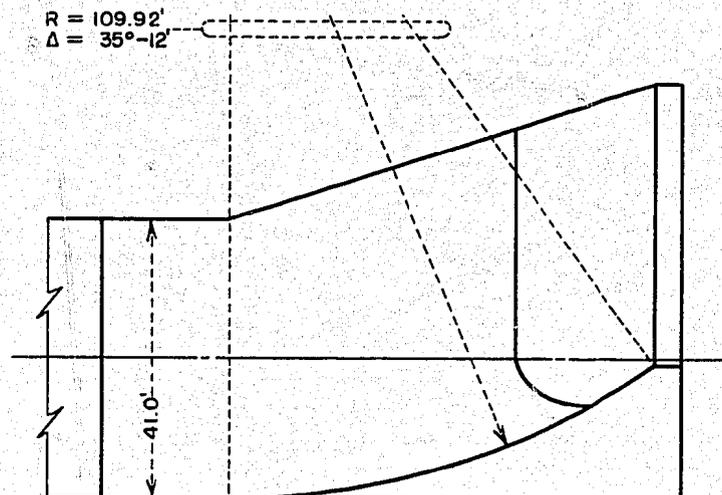
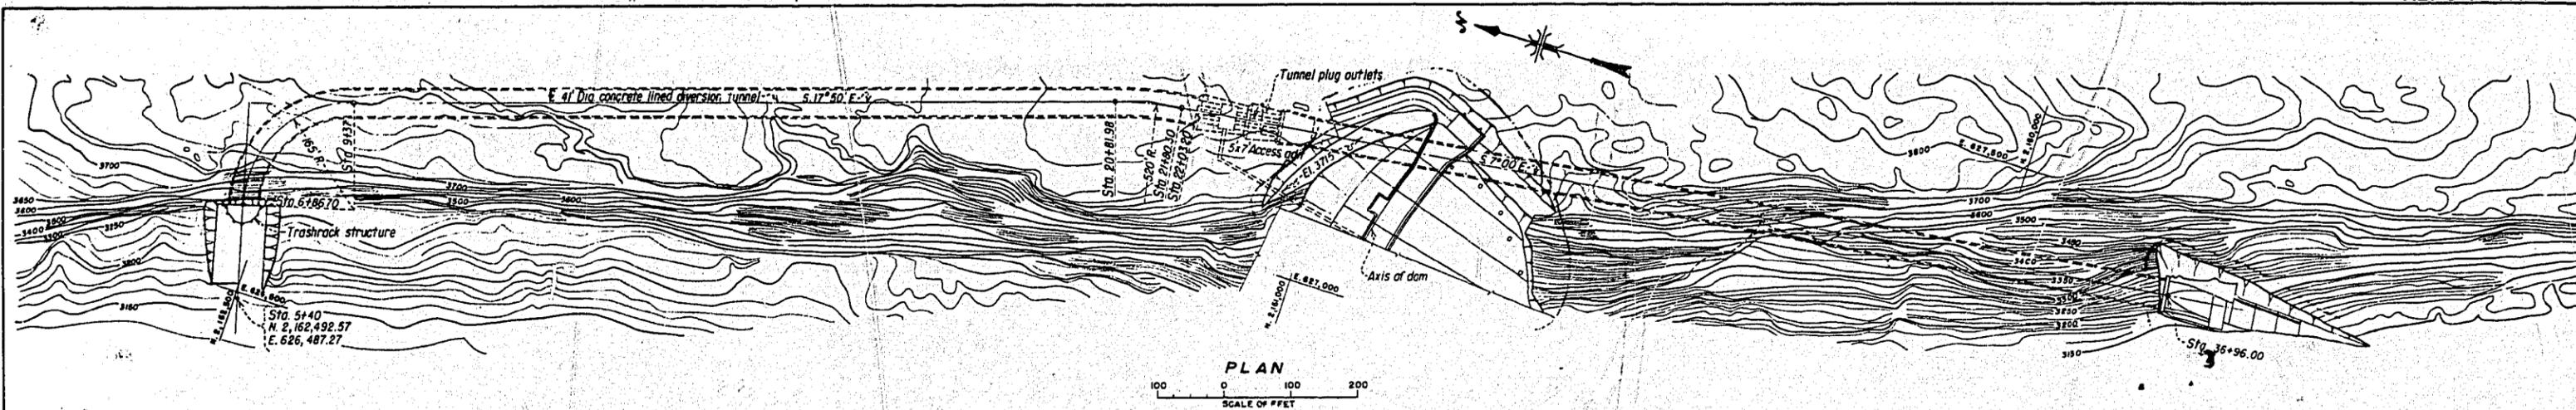
GLEN CANYON DAM SPILLWAYS
1:63.48 SCALE MODEL
FLIP BUCKETS - FOURTH REVISION

SECTION A-A
LEFT HAND BUCKET

SECTION B-B
RIGHT HAND BUCKET

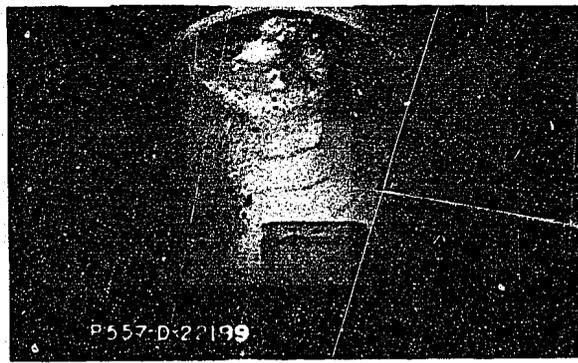
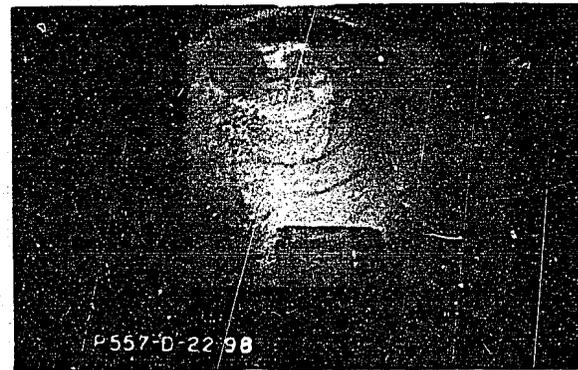
Tunnel Flow Conditions With Parallel Conduits - Left Gate Only
1:24 Model

Left gate full open, $Q = 5,760$

Left gate 75% open, $Q = 3,630$

Left gate 50% open, $Q = 2,290$

Left gate 25% open, $Q = 1,150$

Left gate full open, $Q = 10,770$

Left gate 75% open, $Q = 6,780$

Left gate 50% open, $Q = 4,290$

Left gate 25% open, $Q = 2,150$

A. 100 Foot Head

GLEN CANYON
LEFT DIVERSION TUNNEL OUTLET WORKS
