HYDRAULIC MODEL STUDIES OF THE SPILLWAYS
AND OUTLET WORKS--GLEN CANYON DAM
COLORADO RIVER STORAGE PROJECT, ARIZONA

Report No. Hyd-469

Hydraulics Branch
DIVISION OF RESEARCH

February 18, 1964

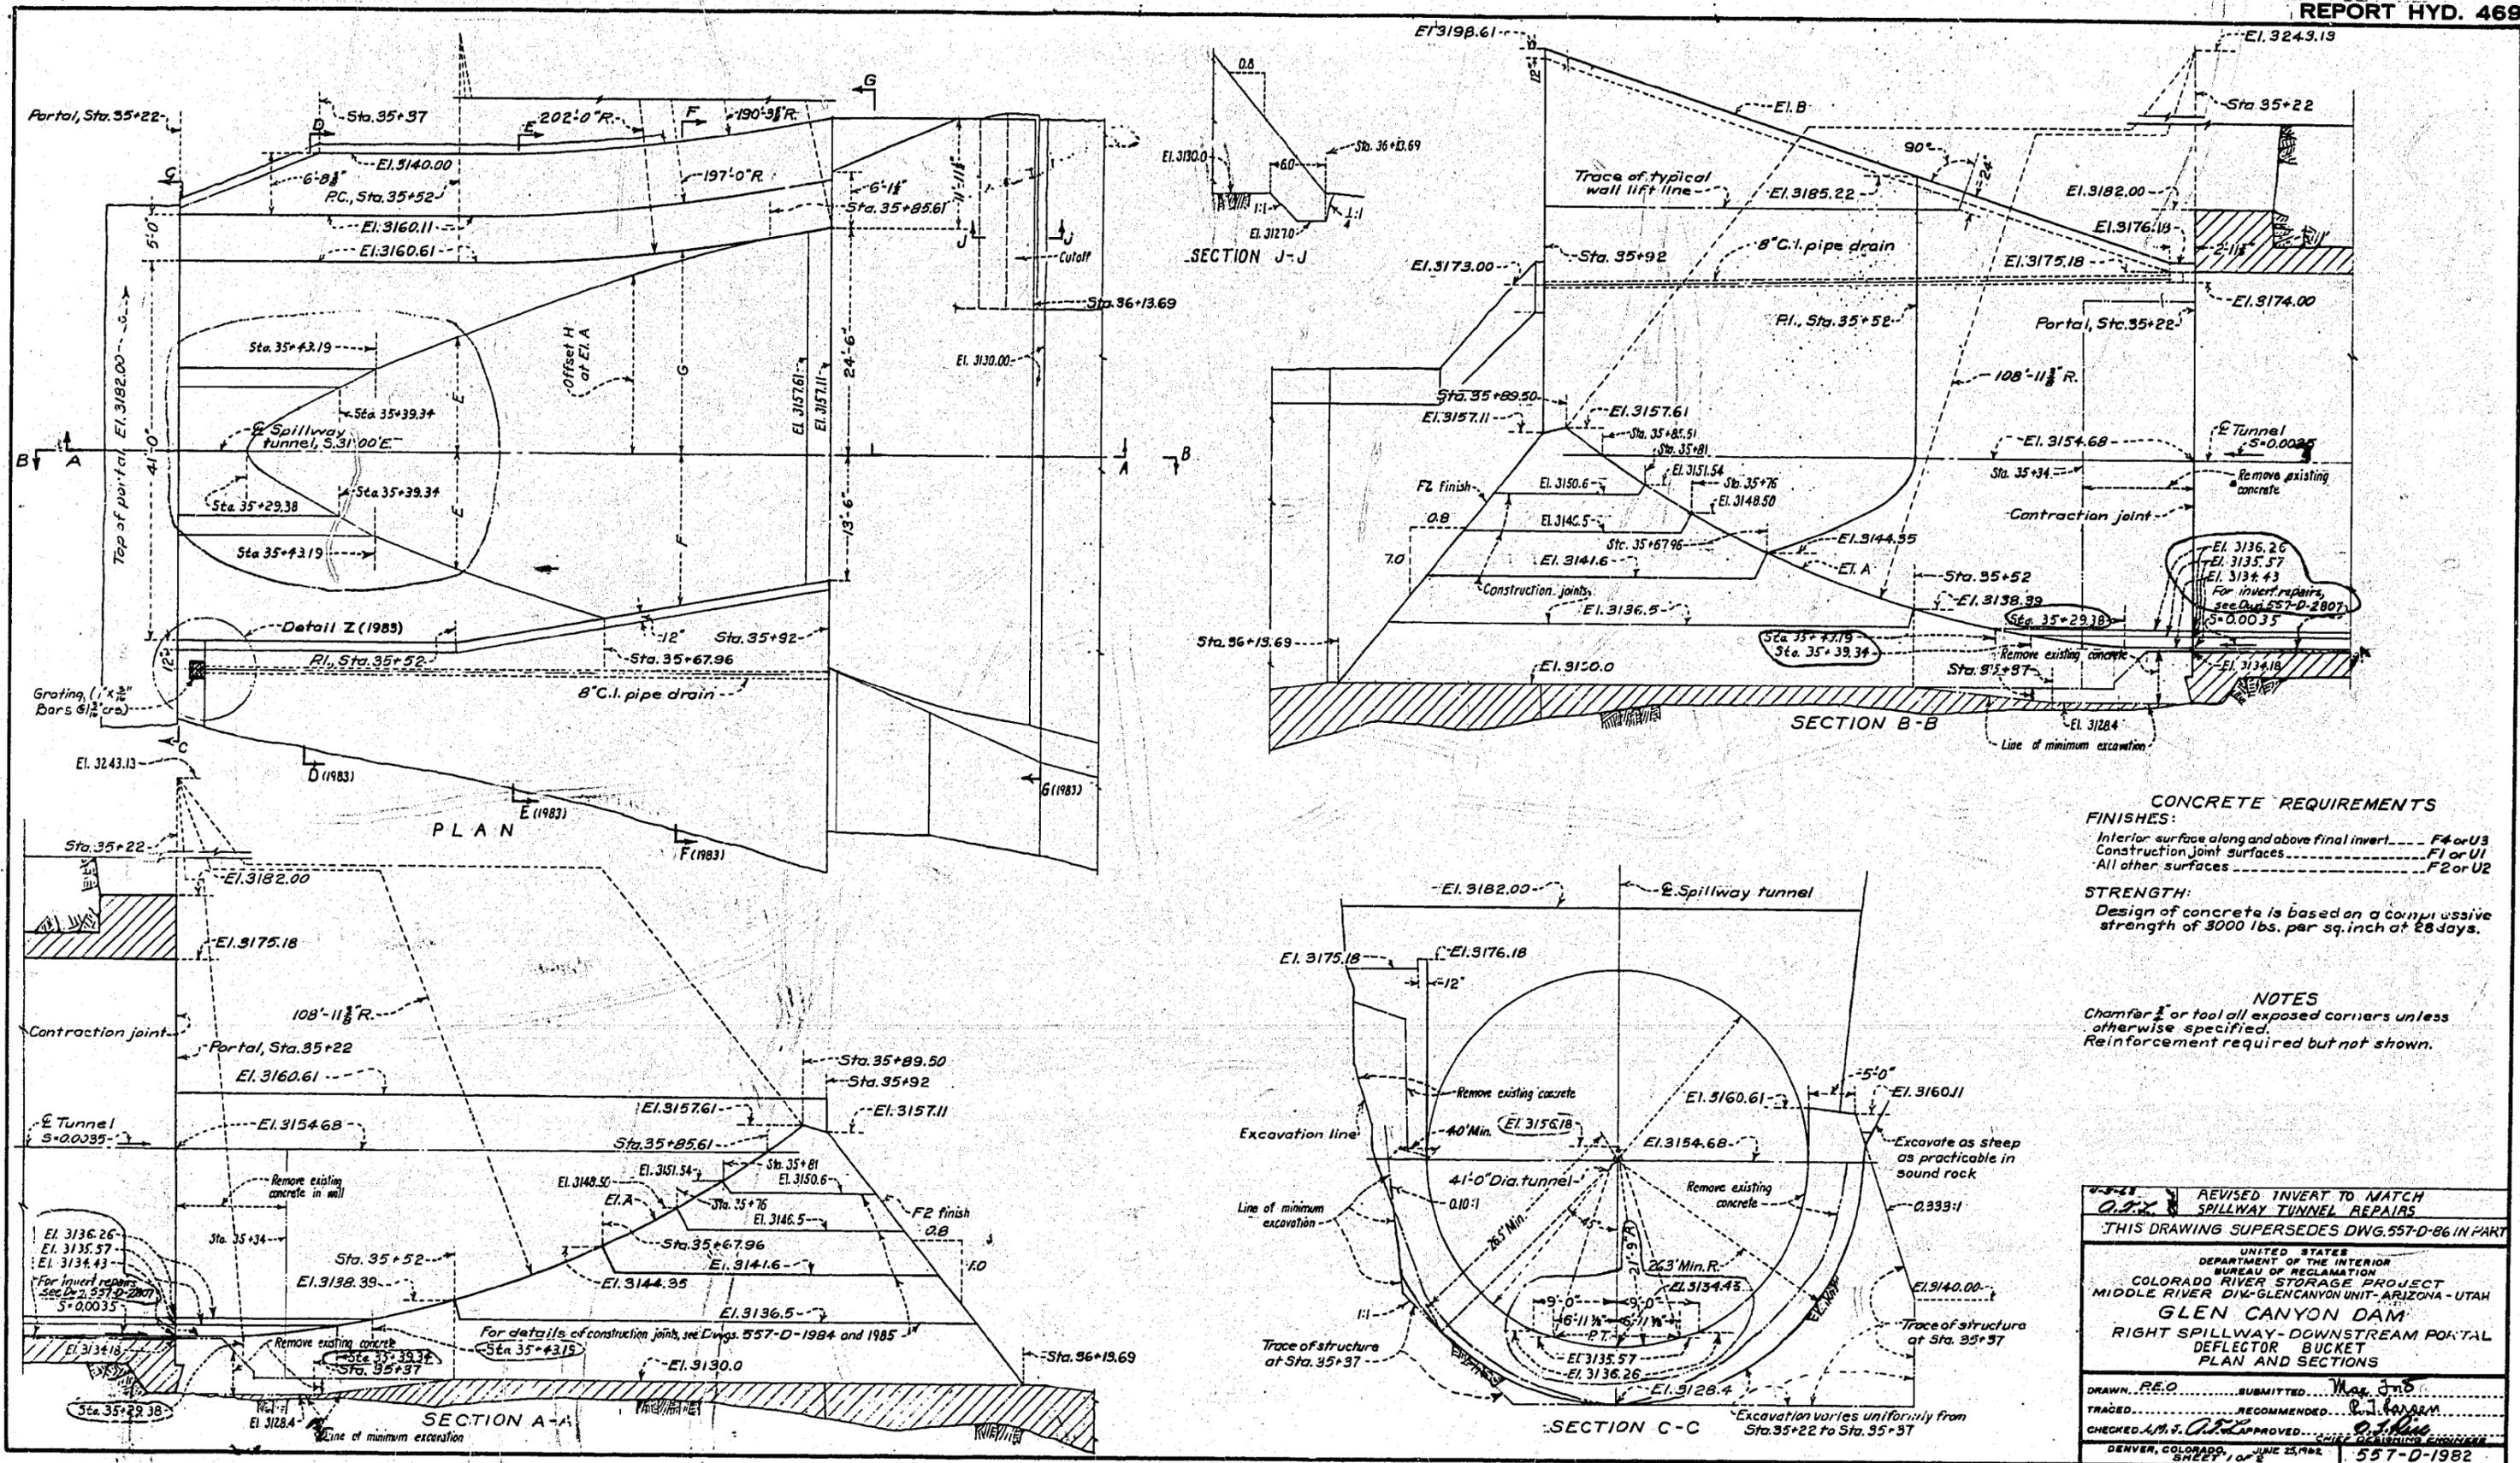
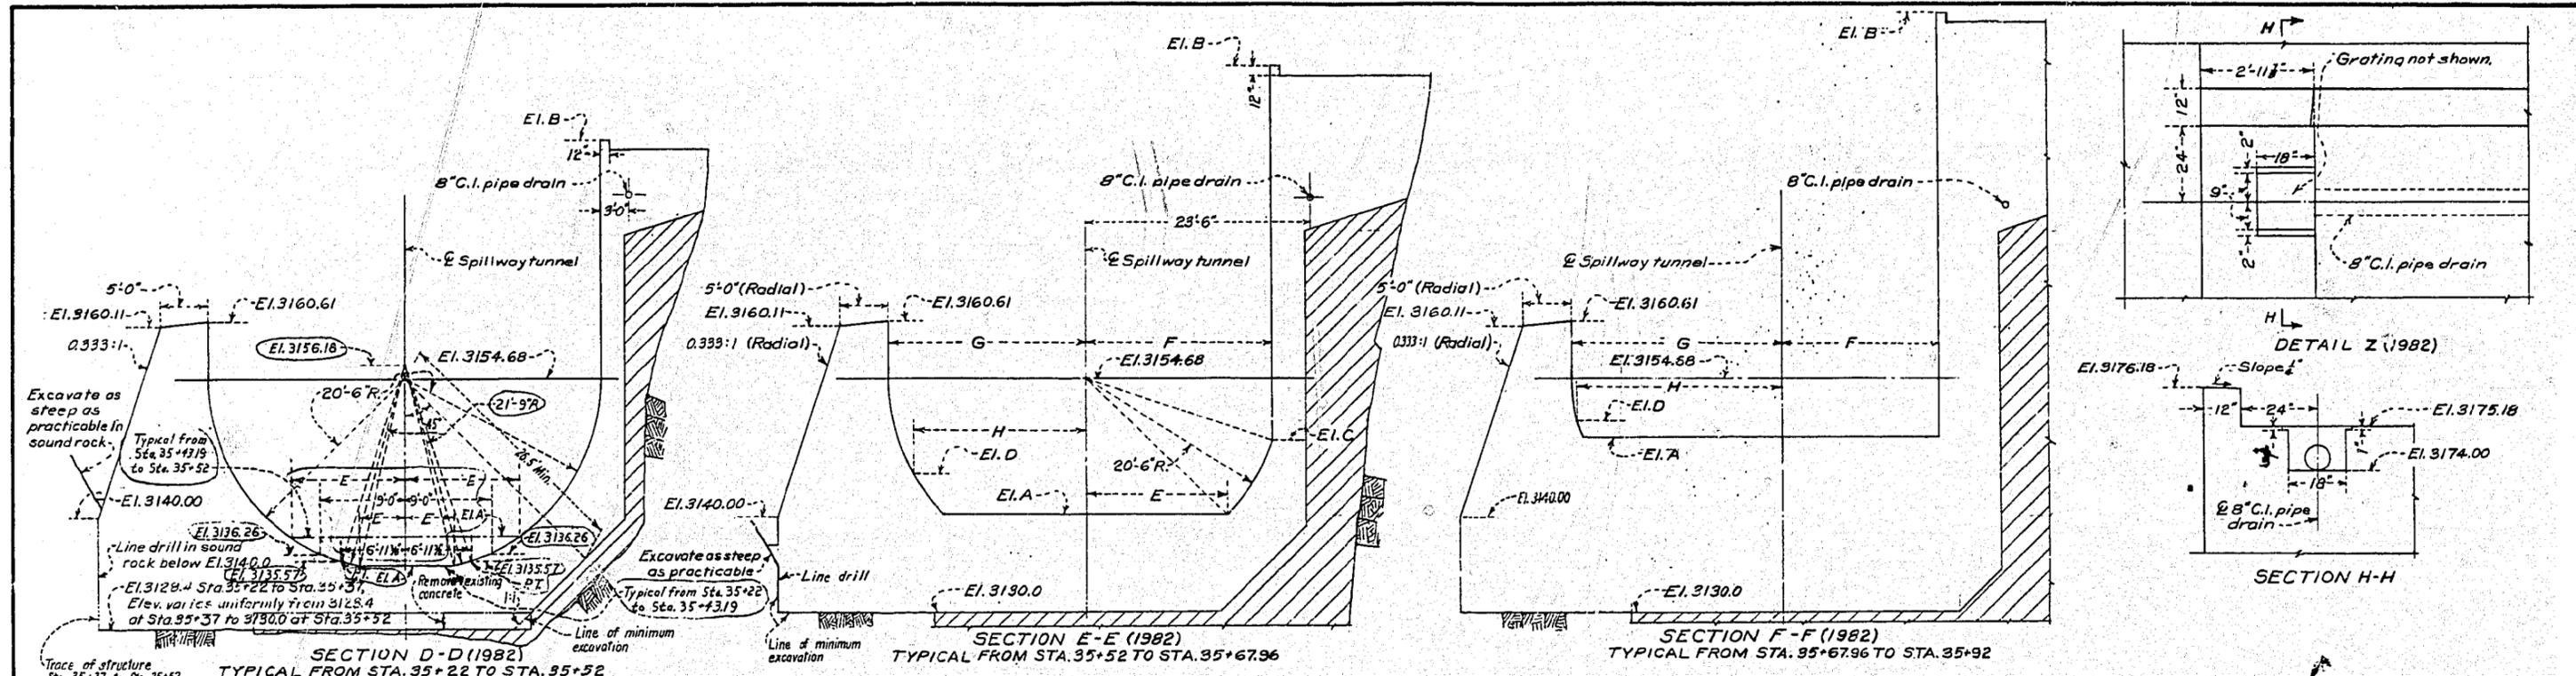
REVISED INVERT TO MATCH SPILLWAY TUNNEL REPAIRS	
THIS DRAWING SUPERSEDES DWG. 557-D-86 IN PART	
UNITED STATES DEPARTMENT OF THE INTERIOR BUREAU OF RECLAMATION COLORADO RIVER STORAGE PROJECT MIDDLE RIVER DIV. GLENCANYON UNIT - ARIZONA - UTAH GLENCANYON DAM RIGHT SPILLWAY - DOWNSTREAM PORTAL DEFLECTOR BUCKET PLAN AND SECTIONS	
DRAWN: P.E.O.	SUBMITTED: May 3, 1982
TRACED: [Signature]	RECOMMENDED: [Signature]
CHECKED: [Signature]	APPROVED: [Signature]
DENVER, COLORADO	JUNE 23, 1982
SHEET 1 OF 2	557-D-1982

10. The preliminary flip buckets, which were rectangular in cross section, were replaced by a bucket in which the circular invert of the tunnel intersected the vertical curve of the bucket, Figures 60 to 63. This type of bucket also eliminated the need for the circular-to-rectangular transition.

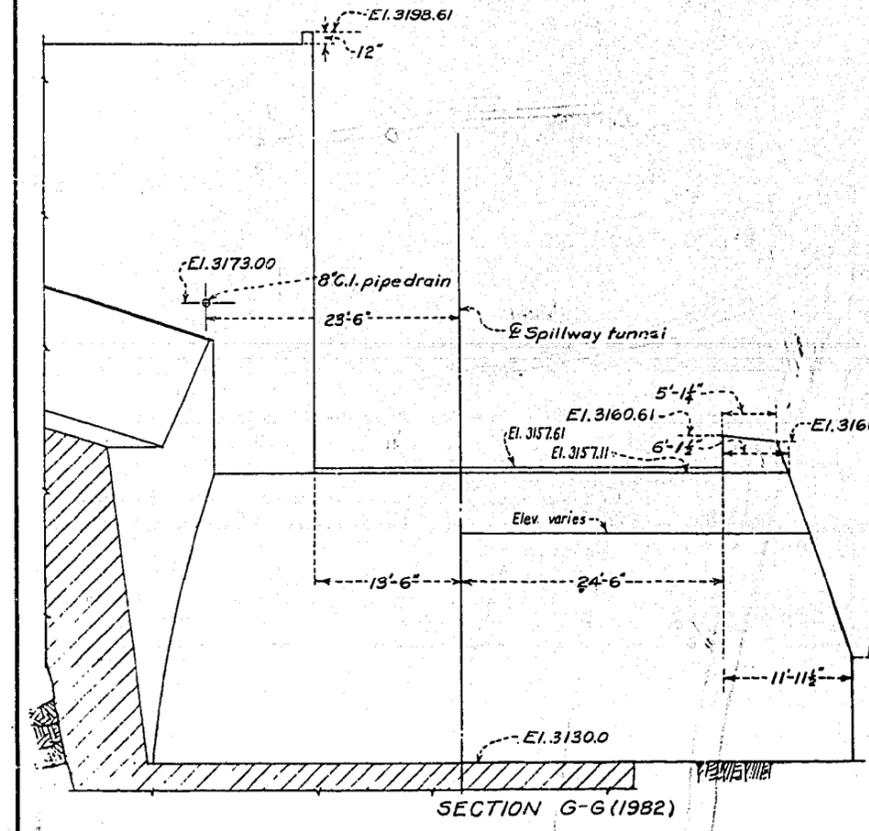
UNITED STATES
DEPARTMENT OF THE INTERIOR
BUREAU OF RECLAMATION
COLORADO RIVER STORAGE PROJECT
MIDDLE RIVER DIV.-GLEN CANYON UNIT-ARIZONA-UTAH
GLEN CANYON DAM
RIGHT SPILLWAY-DOWNSTREAM PORTAL
DEFLECTOR BUCKET
PLAN AND SECTIONS

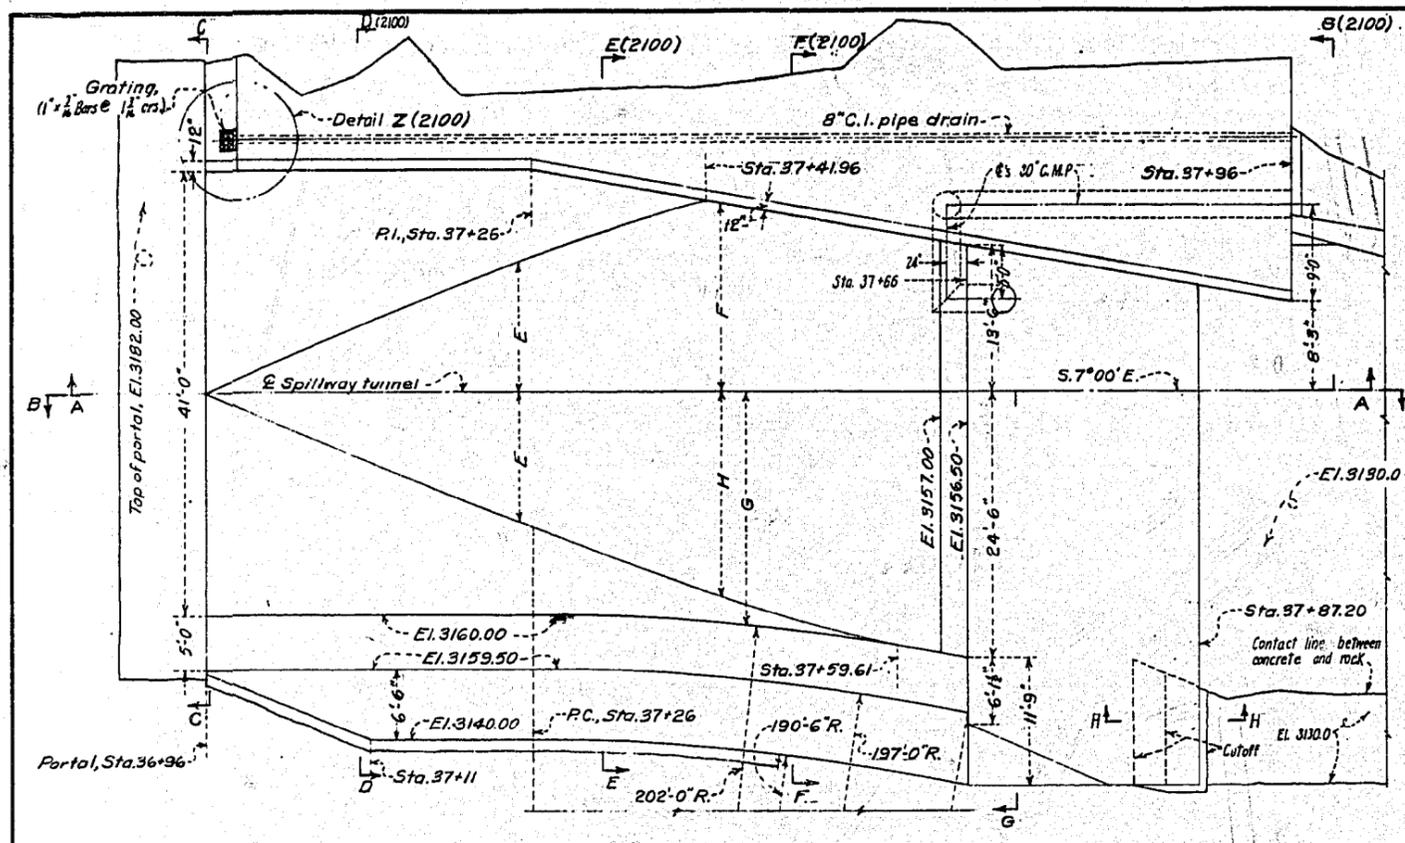
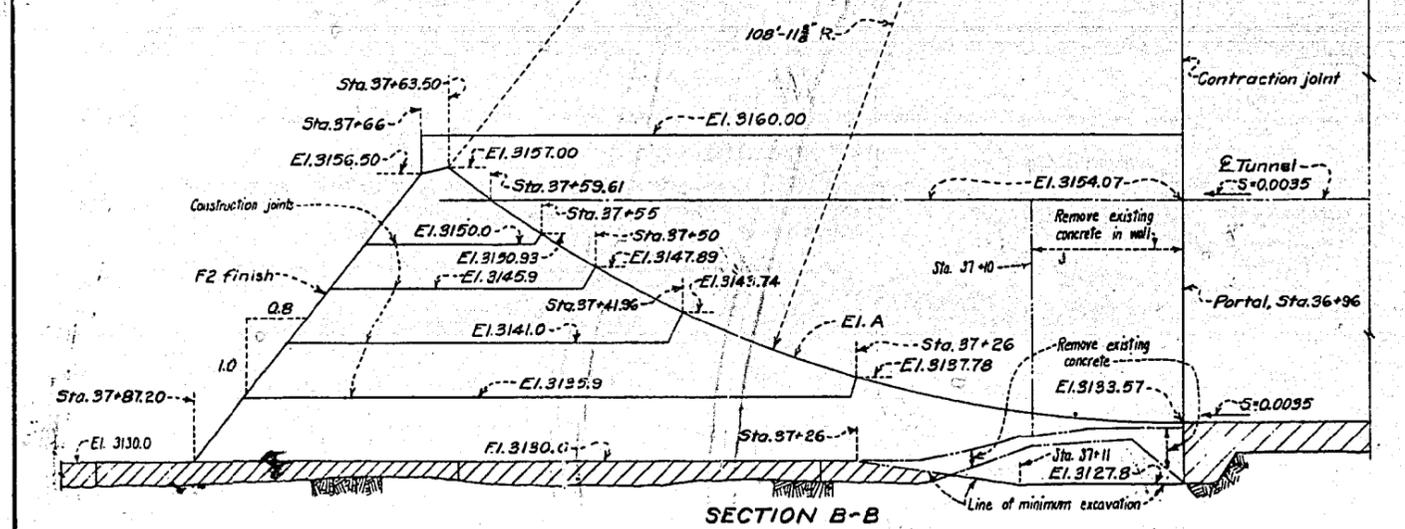
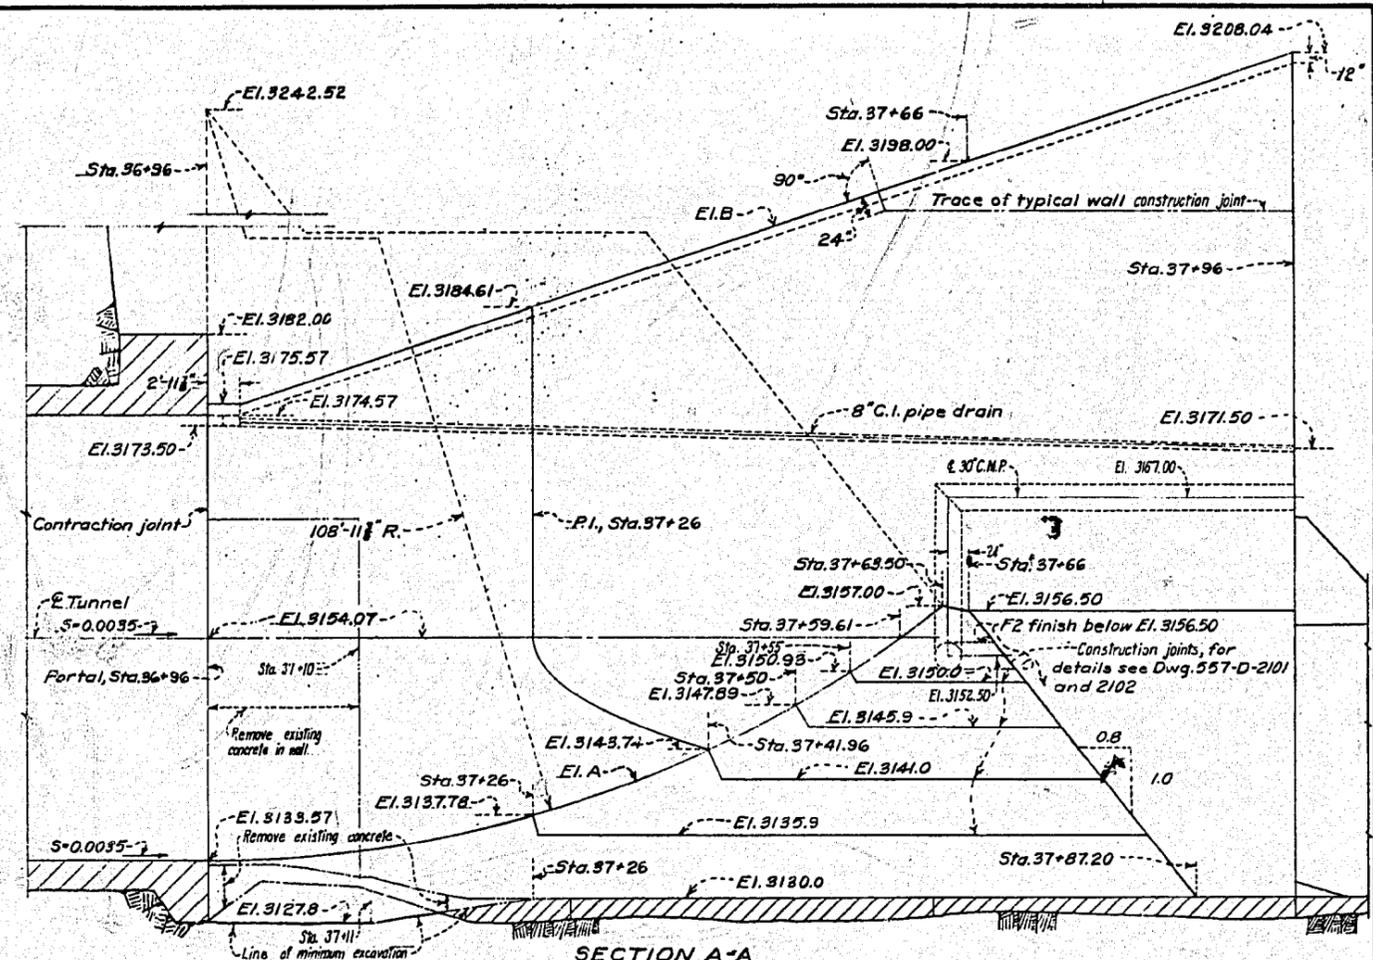
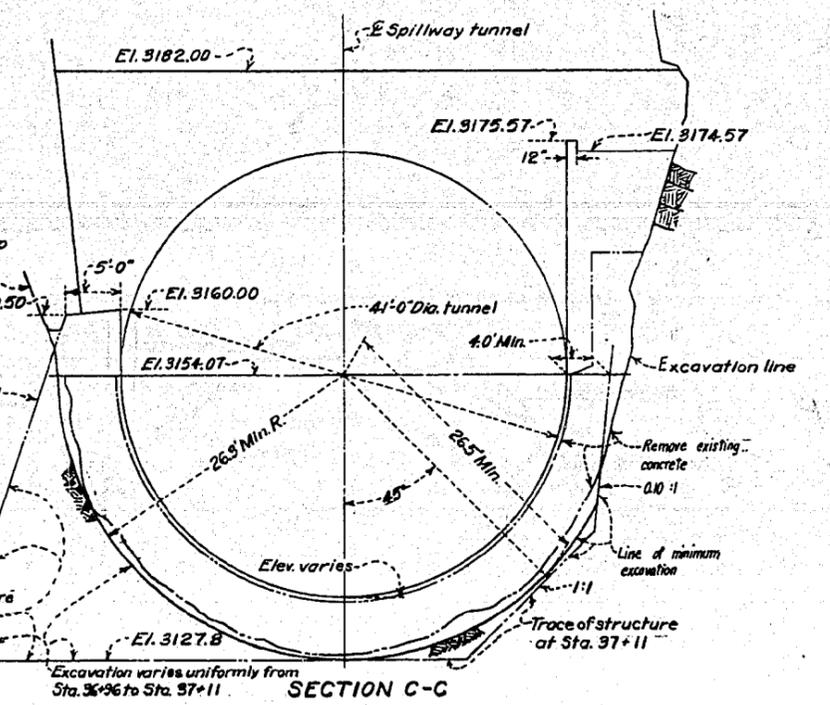
THIS DRAWING SUPERSEDES DWG. 557-D-87 IN PART
 UNITED STATES
 DEPARTMENT OF THE INTERIOR
 BUREAU OF RECLAMATION
 COLORADO RIVER STORAGE PROJECT
 MIDDLE RIVER DIV. GLEN CANYON UNIT- ARIZONA-UTAH
GLEN CANYON DAM
 LEFT SPILLWAY - DOWNSTREAM PORTAL
 DEFLECTOR BUCKET
 PLAN AND SECTIONS
 DRAWN: P.E.D. SUBMITTED: E.P. [Signature]
 TRACED: [Signature] RECOMMENDED: E.P. [Signature]
 CHECKED: [Signature] APPROVED: [Signature]
 DENVER, COLORADO, JUNE 30, 1968 SHEET 1 OF 2 557-D-2099

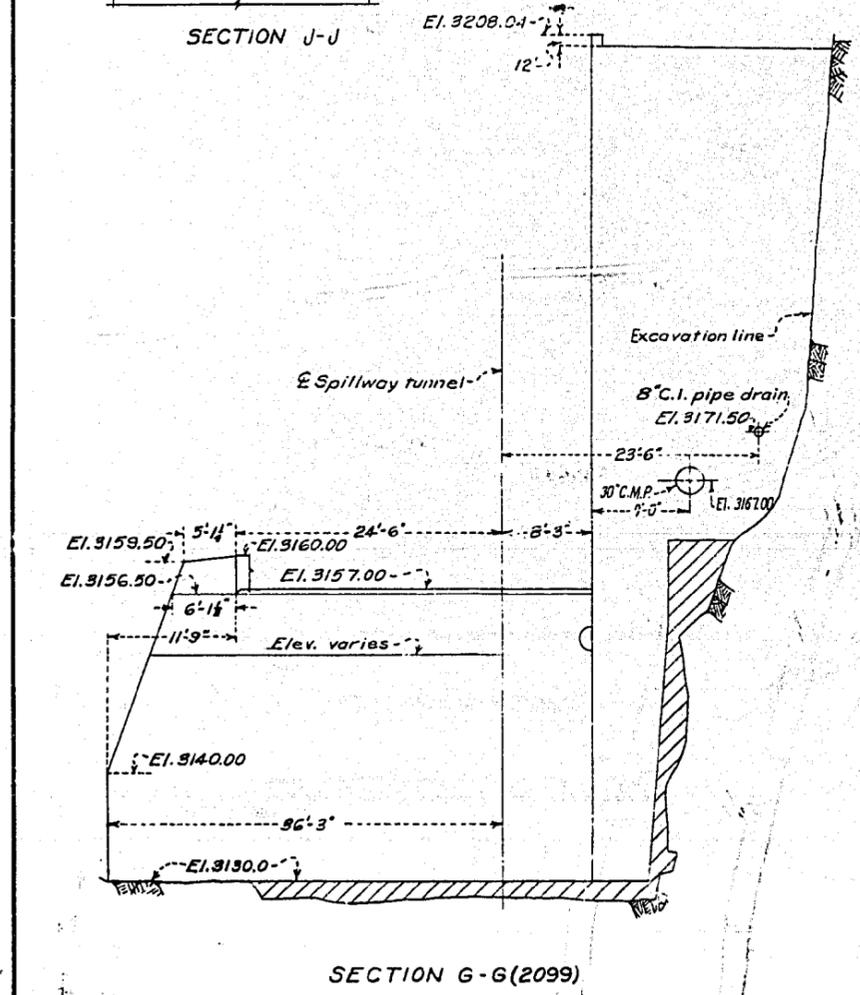
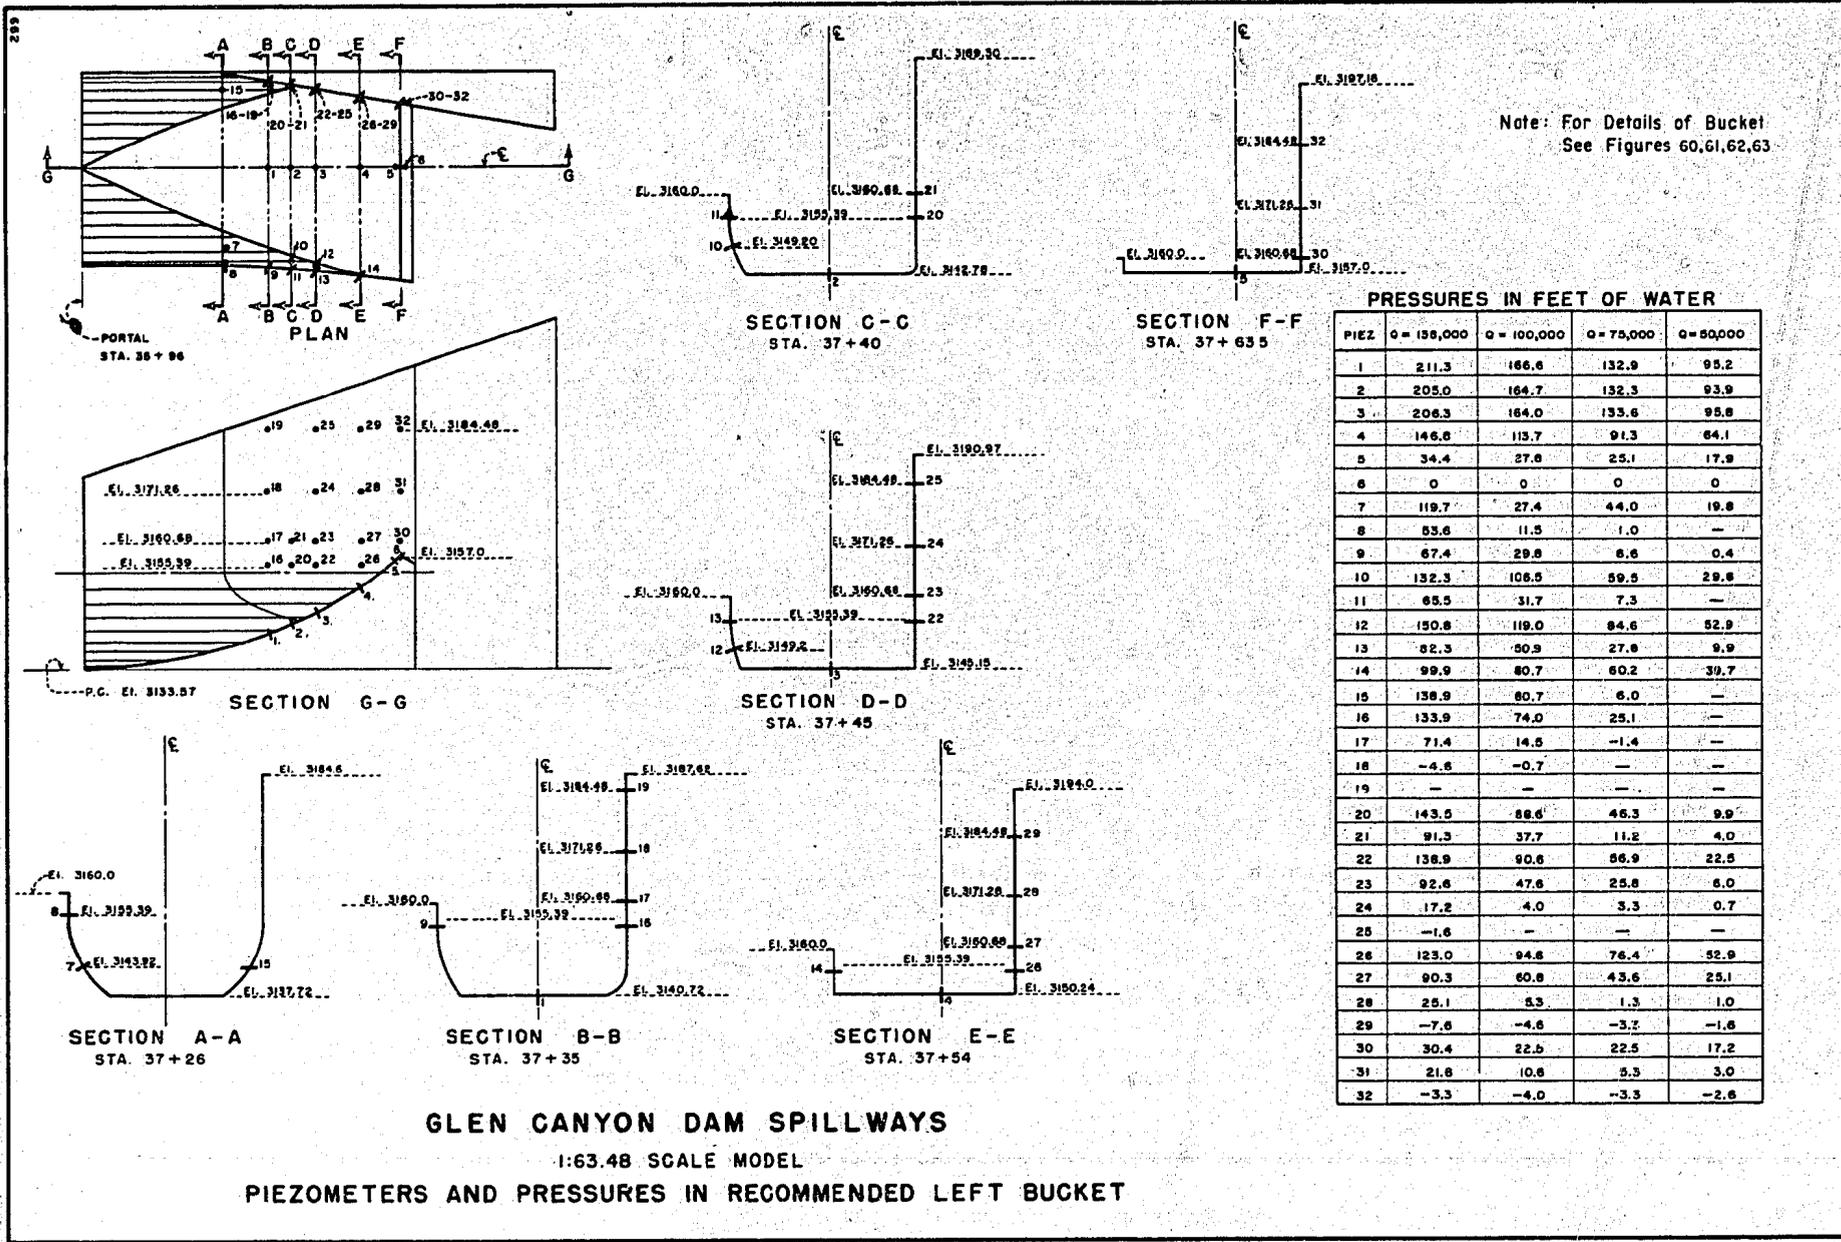
FIGURE 64
REPORT HD-489

Note: For Details of Bucket
See Figures 60, 61, 62, 63

PRESSURES IN FEET OF WATER

PIEZ.	Q = 136,000	Q = 100,000	Q = 75,000	Q = 50,000
1	211.3	166.6	132.9	95.2
2	205.0	164.7	132.3	93.9
3	206.3	164.0	133.6	95.8
4	146.8	113.7	91.3	64.1
5	34.4	27.8	25.1	17.9
6	0	0	0	0
7	119.7	27.4	44.0	19.8
8	53.6	11.5	1.0	—
9	67.4	29.8	6.6	0.4
10	132.3	106.5	59.5	29.8
11	65.5	31.7	7.3	—
12	150.8	119.0	84.6	52.9
13	62.3	50.9	27.8	9.9
14	99.9	80.7	60.2	39.7
15	138.9	80.7	6.0	—
16	133.9	74.0	25.1	—
17	71.4	14.5	-1.4	—
18	-4.6	-0.7	—	—
19	—	—	—	—
20	143.5	88.6	46.3	9.9
21	91.3	37.7	11.2	4.0
22	138.9	90.6	66.9	22.5
23	92.6	47.6	25.8	6.0
24	17.2	4.0	3.3	0.7
25	-1.6	—	—	—
26	123.0	94.8	76.4	52.9
27	90.3	60.8	43.6	25.1
28	25.1	8.3	1.3	1.0
29	-7.6	-4.6	-3.2	-1.6
30	30.4	22.5	22.5	17.2
31	21.8	10.8	5.3	3.0
32	-3.3	-4.0	-3.3	-2.6

A total of 32 piezometers were installed in the left bucket--6 in the invert, 17 in the left wall, and 9 in the right wall, Figure 64.

Pressure measurements were obtained at the maximum discharge and three smaller discharges as an aid in the structural design of the buckets and to determine whether any cavitation pressures were present. These measurements indicated that the highest pressures would occur along the inlet at Piezometer 1 at maximum discharge and would be equivalent to about 211 feet of water. The lowest observed pressure occurred at Piezometer 26, and was equivalent to 7.6 feet of water below atmospheric. The pressure readings are tabulated in Figure 64.

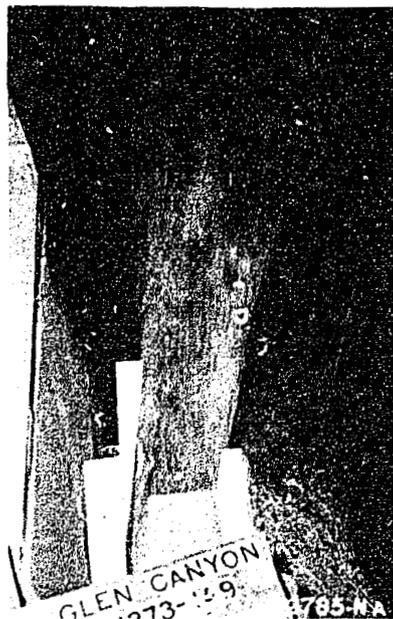
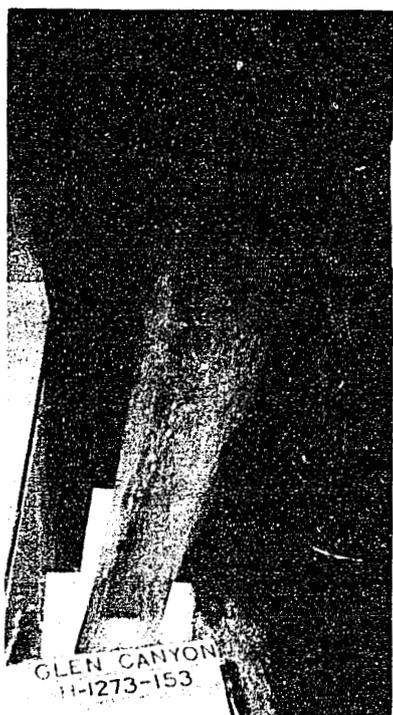
GLEN CANYON DAM SPILLWAYS

Discharge = 25,000 cfs

Discharge = 75,000 cfs

1:63.48 Scale Model
Flow in Recommended Left Flip Bucket

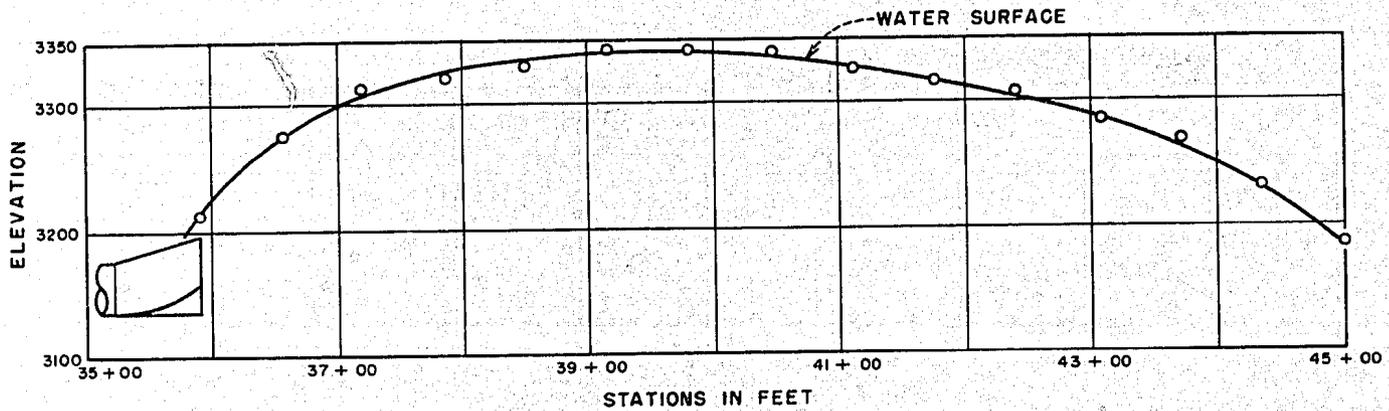
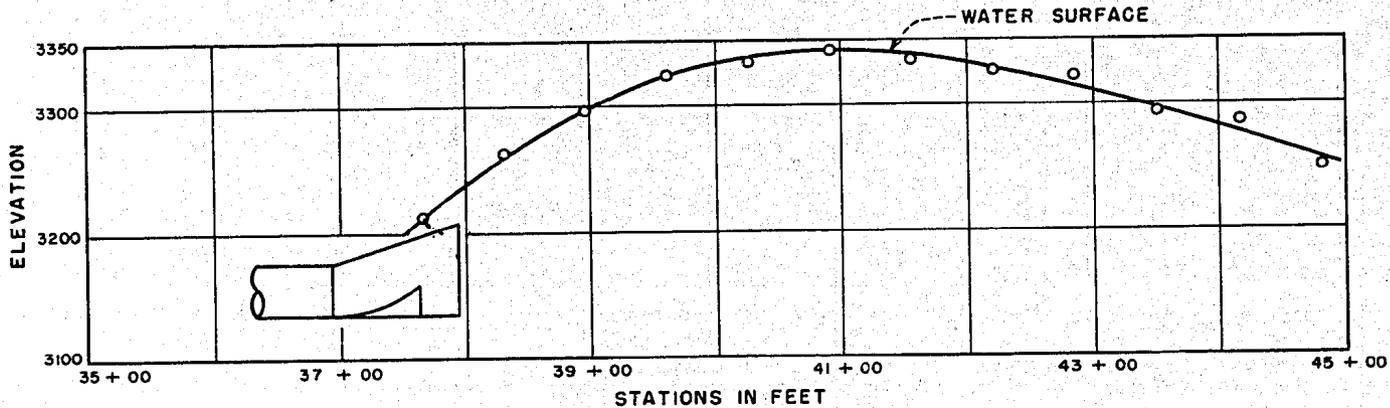
GLEN CANYON DAM SPILLWAYS

RIGHT SPILLWAY

Note: Profiles taken at maximum discharge, 138,000 c.f.s. each spillway, T.W. elev. 3180.0.

LEFT SPILLWAY

WATER SURFACE PROFILES FROM RECOMMENDED FLIP BUCKETS

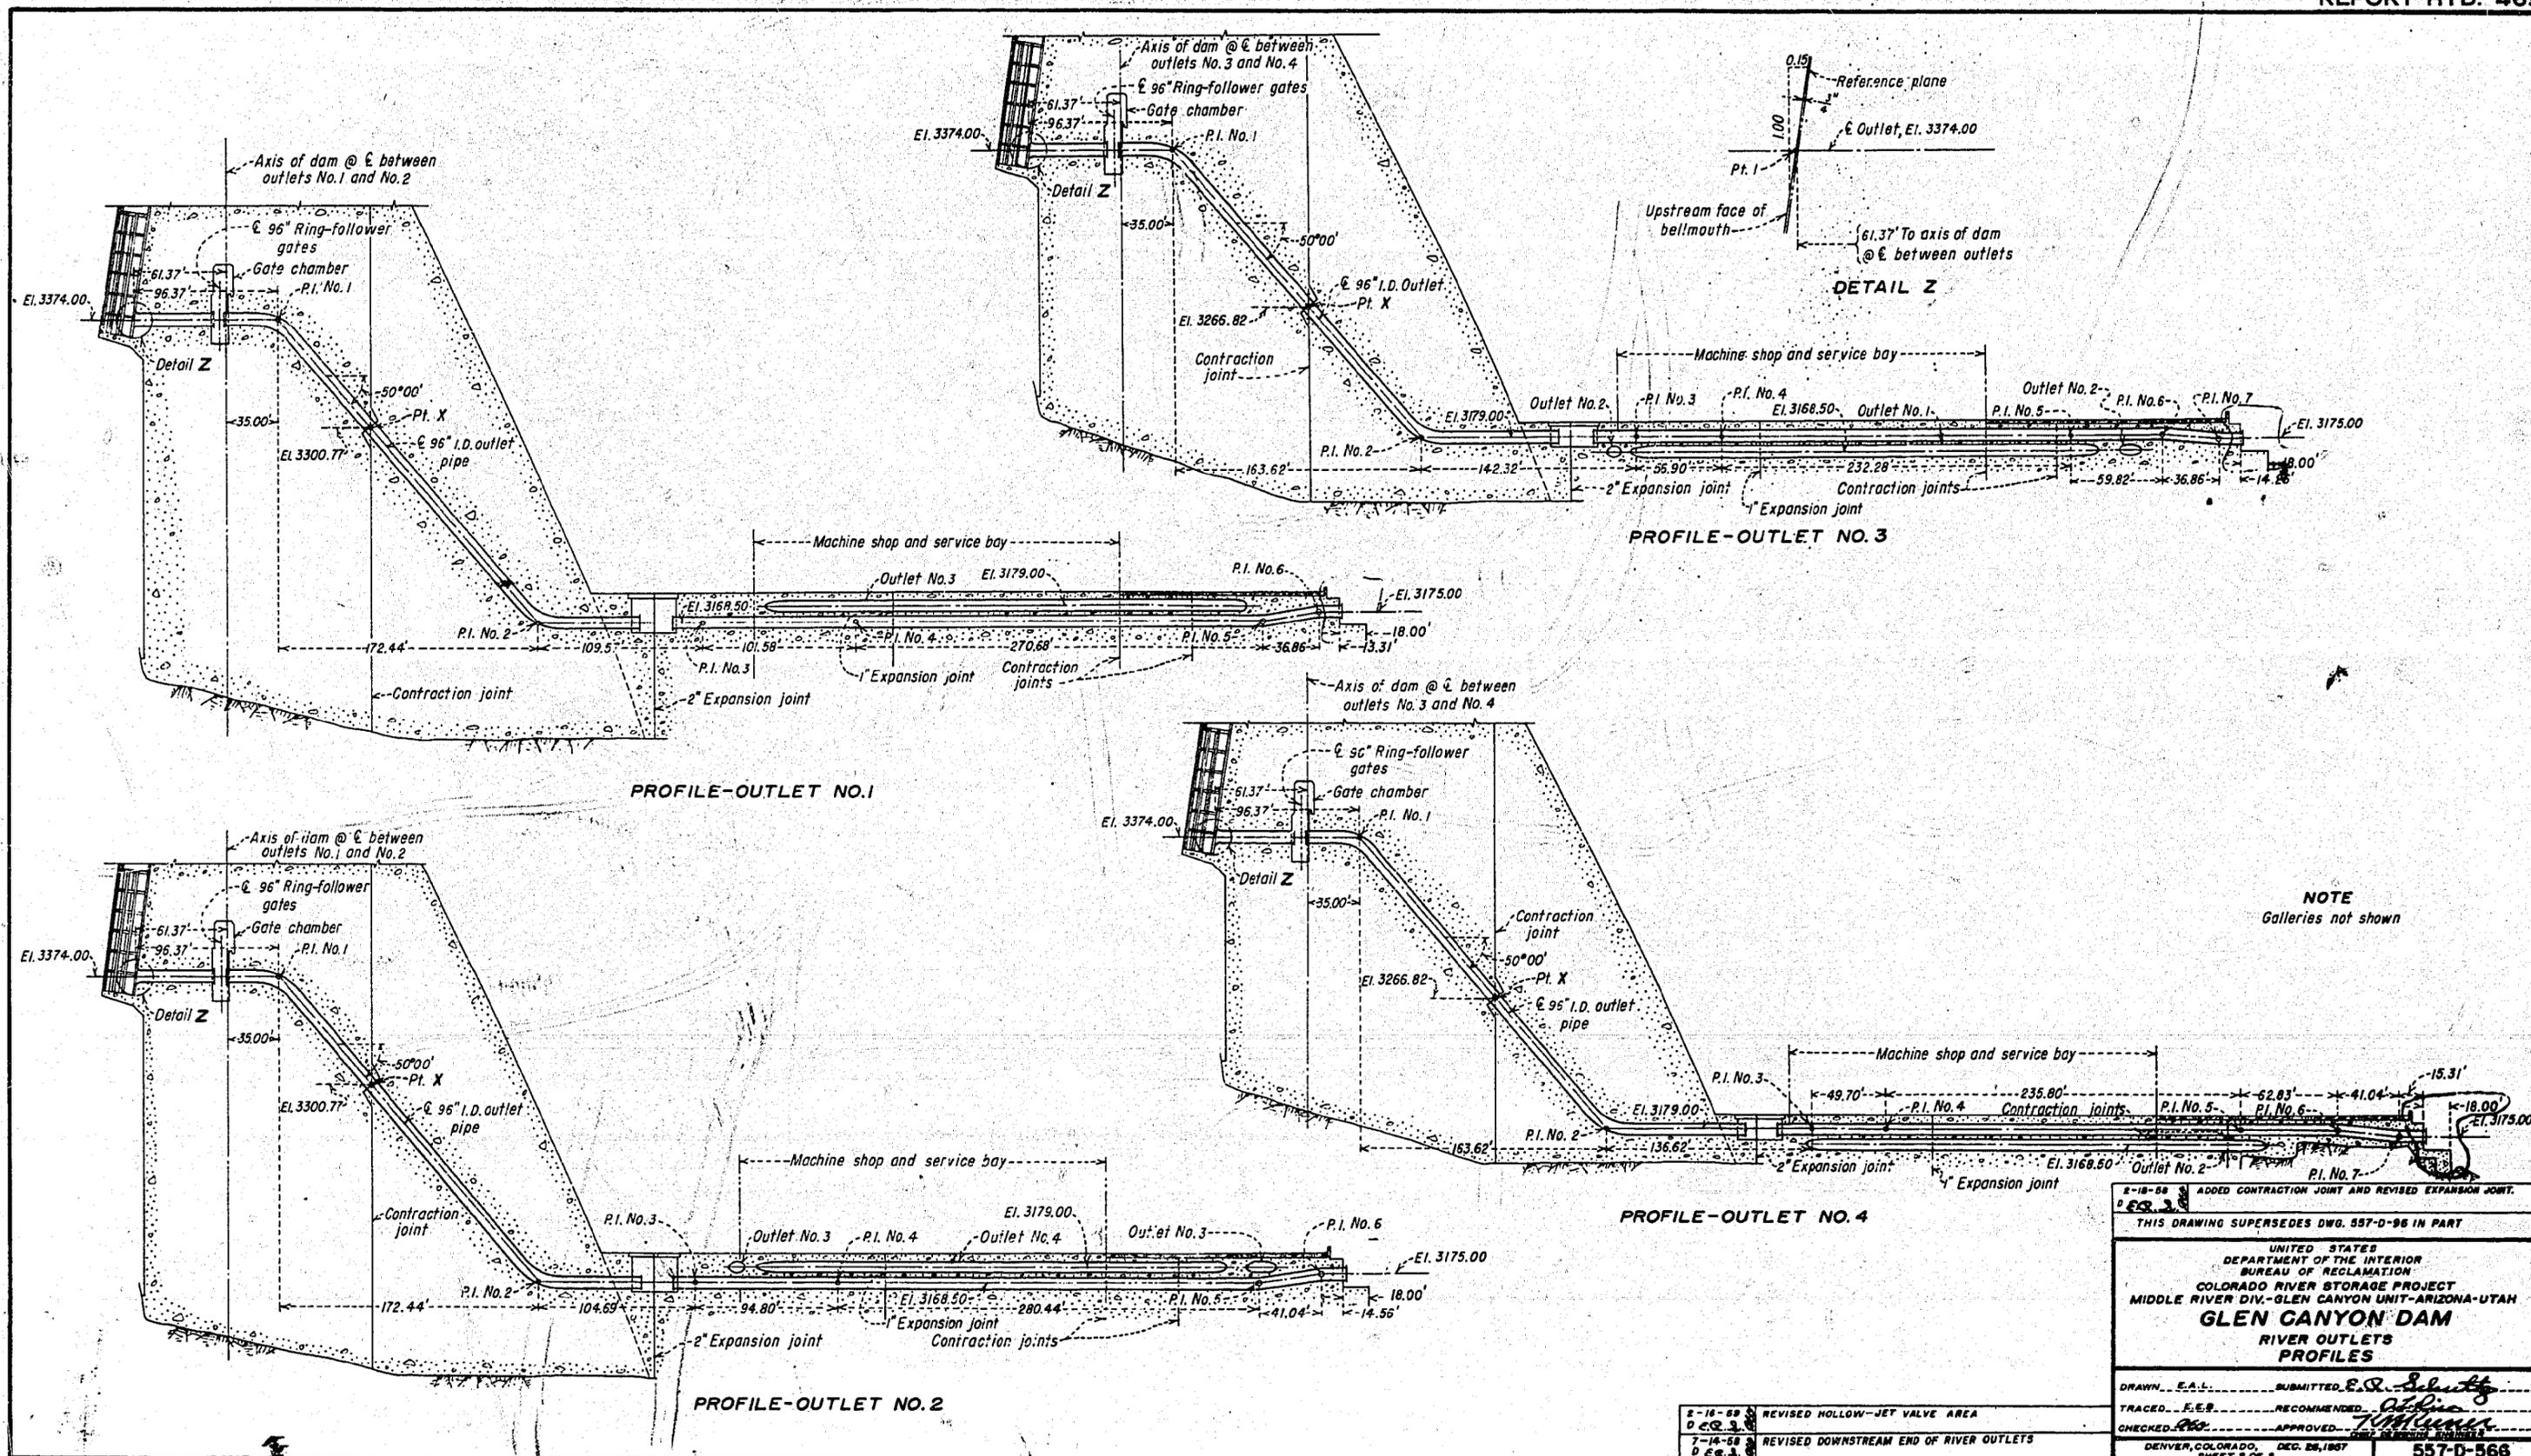
2-18-58 ADDED CONTRACTION JOINT AND REVISED EXPANSION JOINT.	
THIS DRAWING SUPERSEDES DWG. 557-D-96 IN PART	
UNITED STATES DEPARTMENT OF THE INTERIOR BUREAU OF RECLAMATION COLORADO RIVER STORAGE PROJECT MIDDLE RIVER DIV.-GLEN CANYON UNIT-ARIZONA-UTAH GLEN CANYON DAM RIVER OUTLETS PROFILES	
DRAWN... E.A.L.	SUBMITTED... E.R. Schutt
TRACED... F.E.B.	RECOMMENDED... [Signature]
CHECKED... [Signature]	APPROVED... [Signature]
DENVER, COLORADO, DEC. 28, 1957	
557-D-566

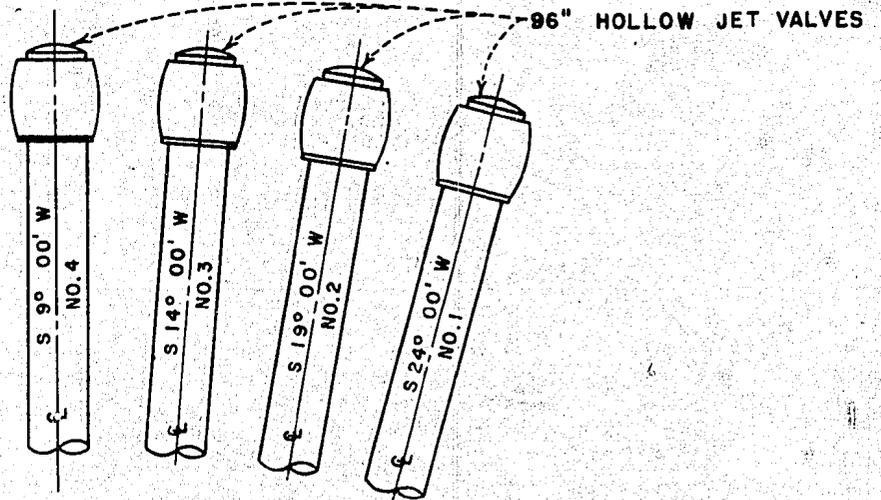
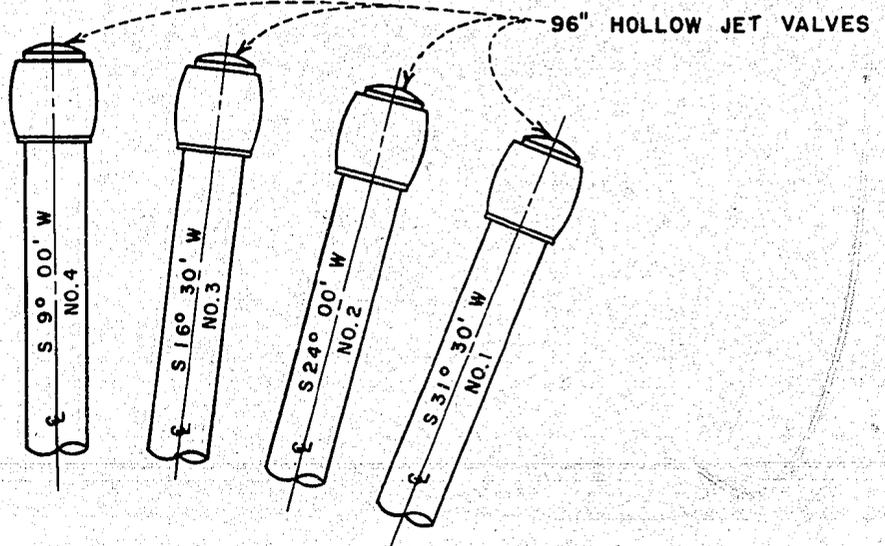
A. FIRST REVISION

B. RECOMMENDED

RIVER OUTLETS - VALVE ALINEMENT

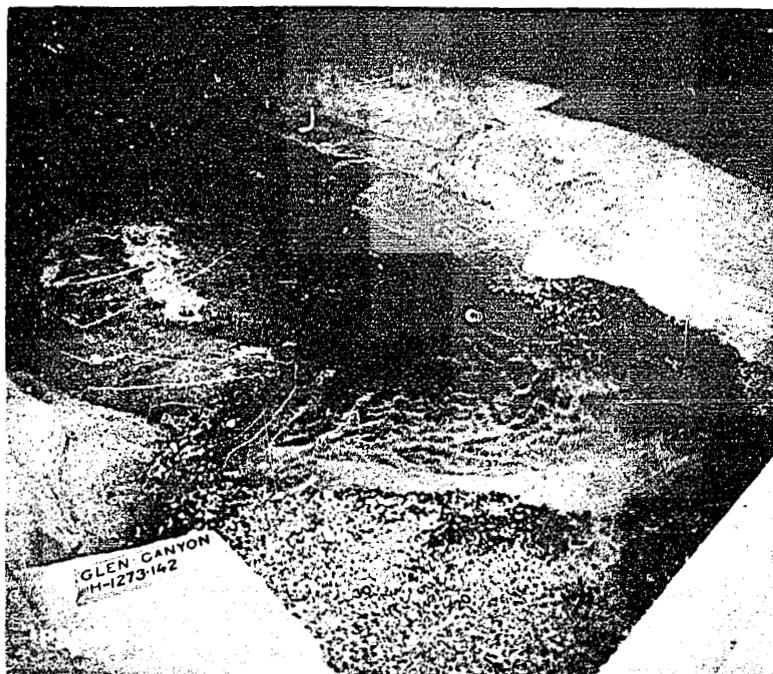
Discharge = 15,000 cfs from River Outlets;
32,000 cfs from T. P. O. W. , 24,000 cfs
through powerhouse.

Erosion after 10 hours operation under
above flow conditions.

1:63.48 Scale Model
Operation with Recommended Valve Alinement

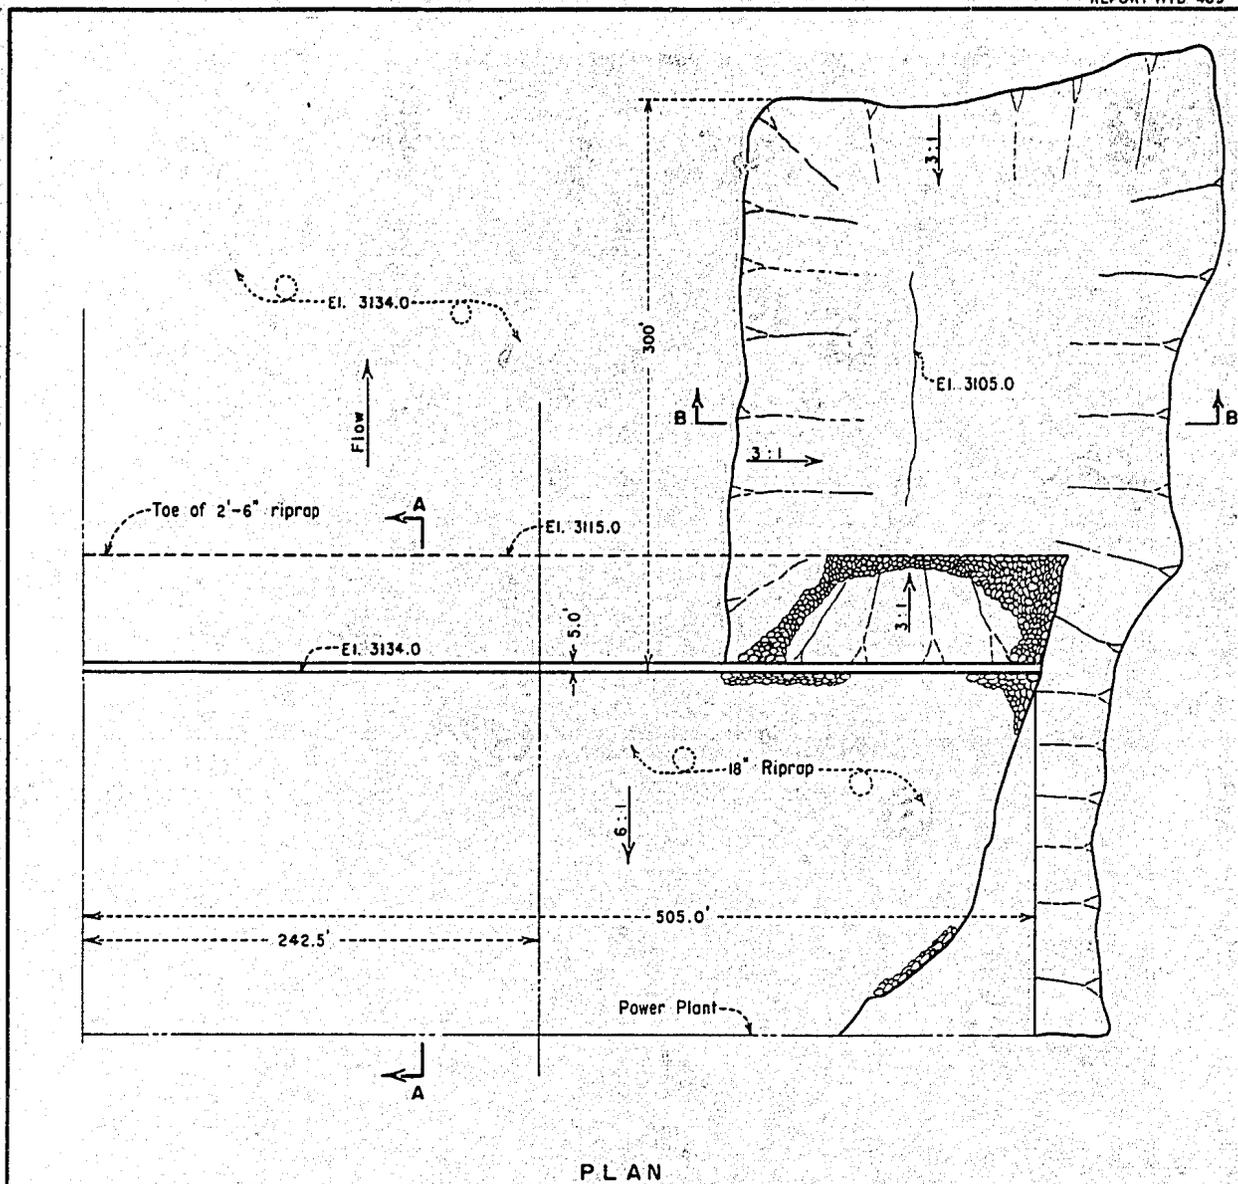
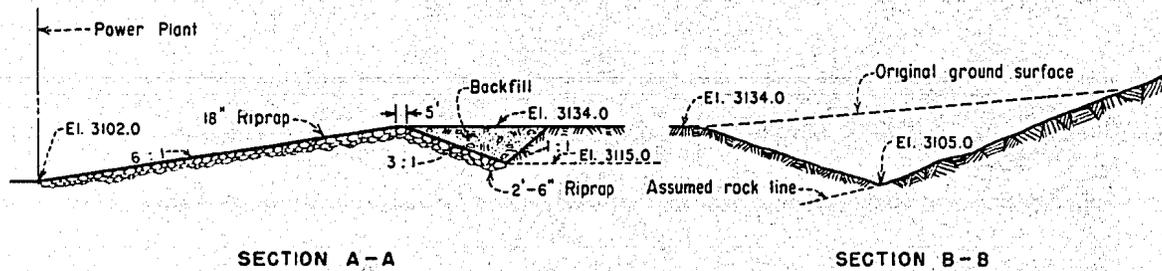
PLAN

SECTION A-A

SECTION B-B

GLEN CANYON DAM SPILLWAYS
1:63.48 SCALE MODEL
PRE-EXCAVATED AREA IN AFTERBAY
