HYDRAULIC MODEL STUDIES OF THE SPILLWAYS
AND OUTLET WORKS--GLEN CANYON DAM
COLORADO RIVER STORAGE PROJECT, ARIZONA

Report No. Hyd-469

Hydraulics Branch
DIVISION OF RESEARCH

February 18, 1964

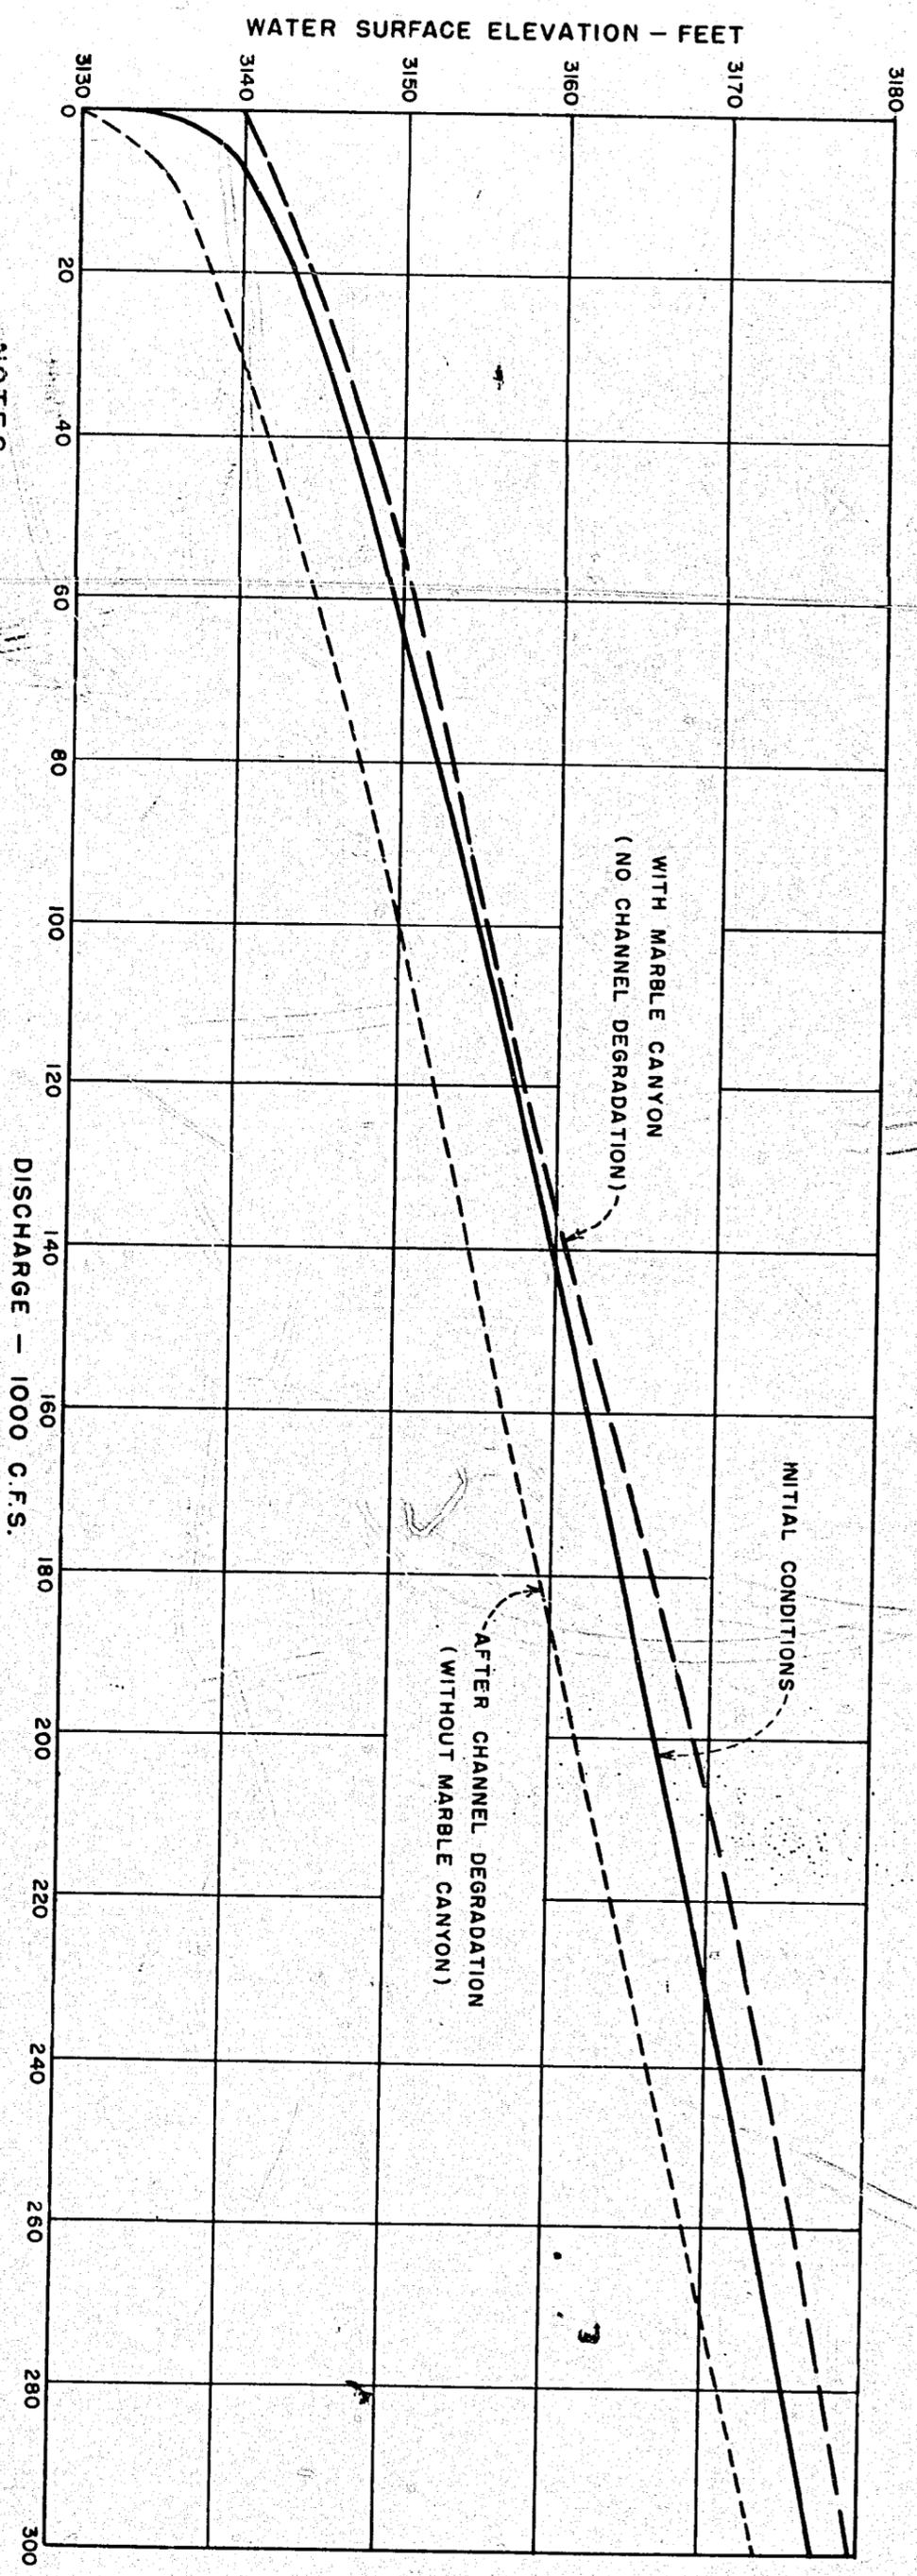
TAILWATER CURVES
COLORADO RIVER
R-20

(APPROX. 3400 FT. BELOW DAM AXIS)
Prepared in Hydrology Branch, Denver

Three theoretical tailwater elevation curves were available, Figure 75. These curves were contained in the report, "Tailwater and Degradation Studies--Colorado River Below Glen Canyon Dam,"

A water surface drawdown curve was also obtained without the sand placed on the concreted solid rock outline of the riverbed. This curve was almost identical with the drawdown curve after degradation. One run was made at maximum discharge with the downstream tailwater elevation corresponding to Curve 2 on Figure 75 (after channel degradation, without Marble Canyon). The controlled downstream and observed upstream tailwater elevations were 5 feet lower than for the previous tests, suggesting that the amount of water surface drawdown would be the same for any of the three tailwater conditions.

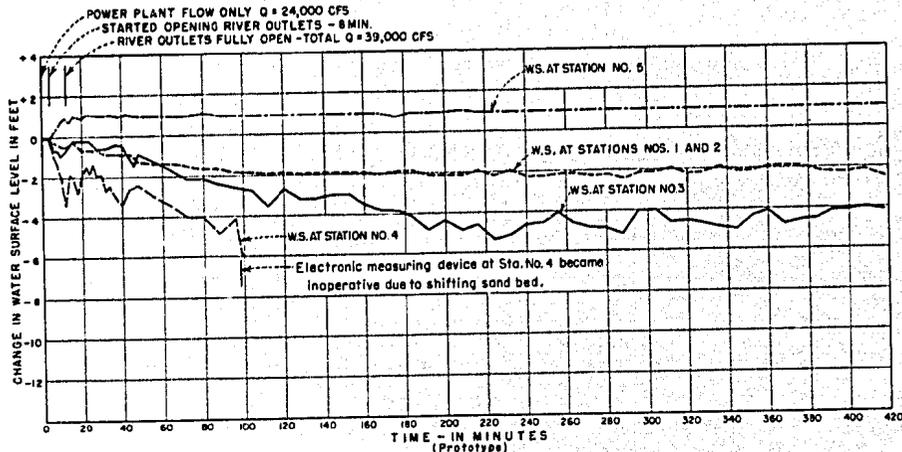
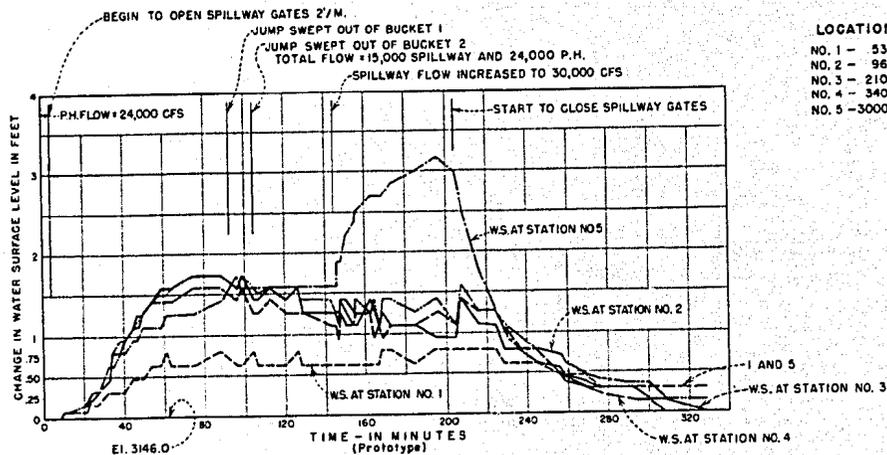
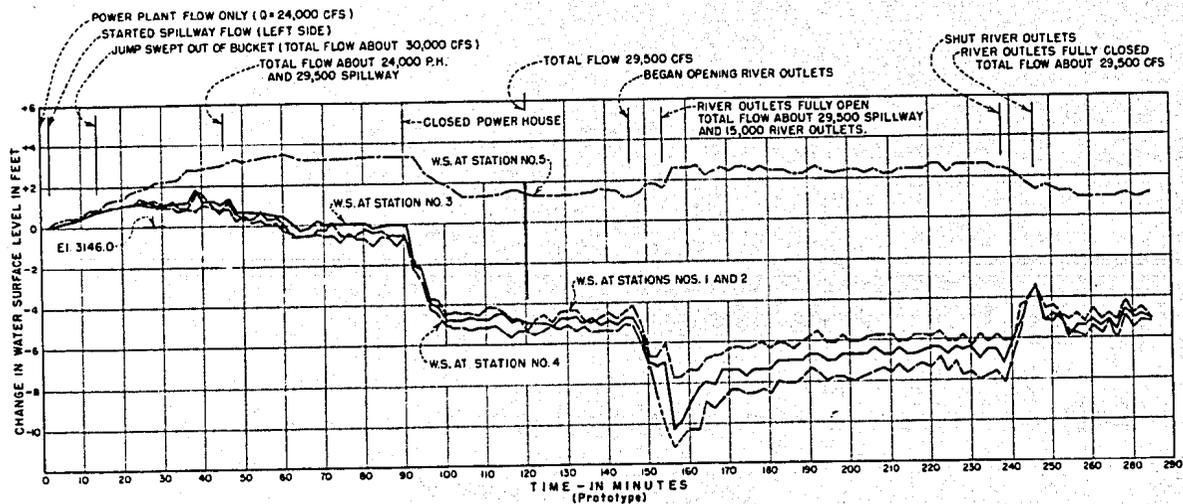
TEST NO. 1

LOCATION OF MEASURING STATIONS

- NO. 1 - 53 FT. DOWNSTREAM FROM POWER HOUSE
- NO. 2 - 96 FT. DOWNSTREAM FROM POWER HOUSE
- NO. 3 - 210 FT. DOWNSTREAM FROM POWER HOUSE
- NO. 4 - 340 FT. DOWNSTREAM FROM POWER HOUSE
- NO. 5 - 3000 FT. DOWNSTREAM FROM POWER HOUSE

TEST NO. 2

TEST NO. 3
