HYDRAULIC MODEL STUDIES FOR
DESIGN OF HEADGATE ROCK DAM
COLORADO RIVER INDIAN IRRIGATION PROJECT - ARIZONA

R. A. GOODPASTURE, JUNIOR ENGINEER

Denver, Colorado January 20, 1939

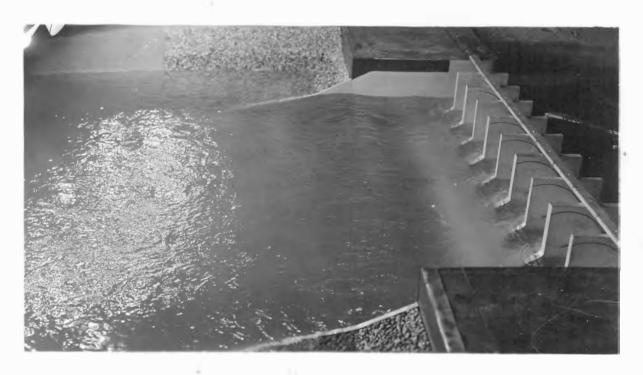
DISCHARGE 40,000 SECOND-FEET - POND ELEVATION 362 TAILWATER ELEVATION 350.8

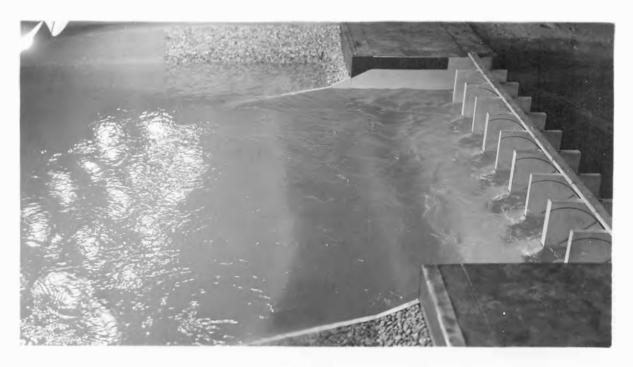
DISCHARGE 80,000 SECOND-FEET - POND ELEVATION 362 TAILWATER ELEVATION 355.7

MAXIMUM TAILWATER ELEVATIONS

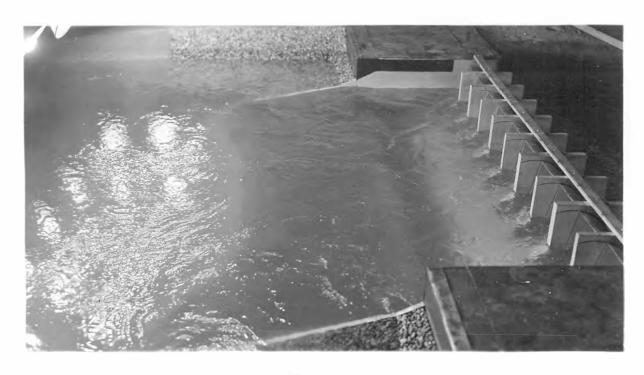
DISCHARGE 120,000 SECOND-FEET TAILWATER ELEVATION 359.2

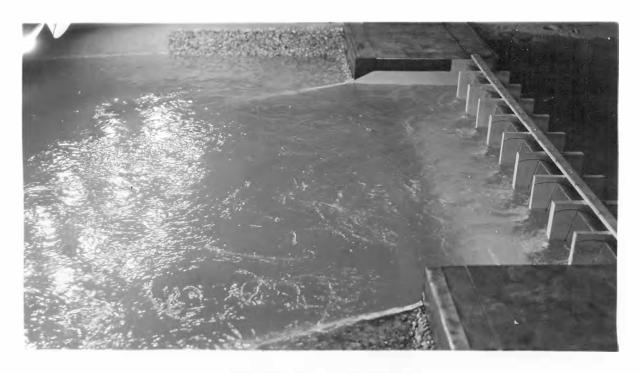
DISCHARGE 180,000 SECOND-FEET TAILWATER ELEVATION 362.9

MAXIMUM TAILWATER ELEVATIONS

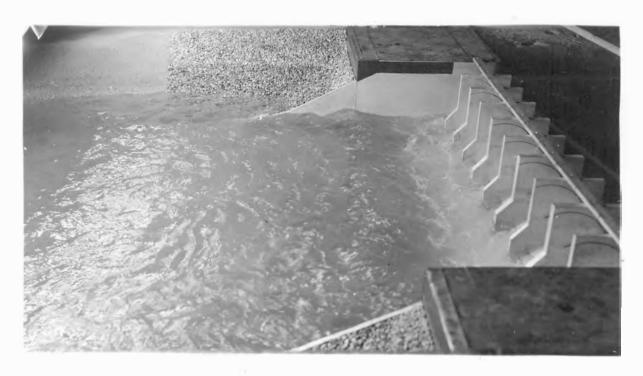
DISCHARGE 40,000 SECOND-FEET - POND ELEVATION 362
TAILWATER ELEVATION 338.2

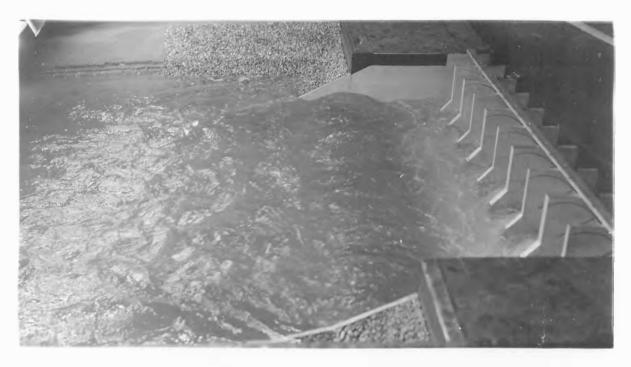
DISCHARGE 80,000 SECOND-FEET - POND ELEVATION 362 TAILWATER ELEVATION 342.5

AVERAGE TAILWATER ELEVATIONS

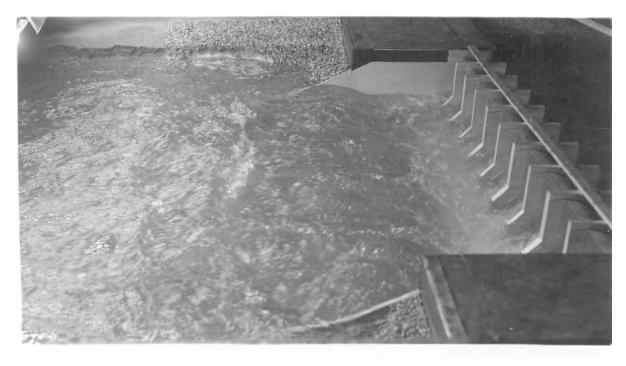
DISCHARGE 180,000 SECOND-FEET TAILWATER ELEVATION 348.9

AVERAGE TAILWATER ELEVATIONS

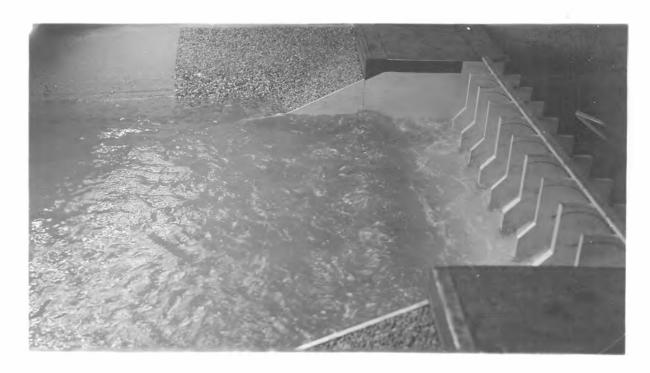
DISCHARGE 40.000 SECOND-FEET - POND ELEVATION 362 TAILWATER ELEVATION 325.6

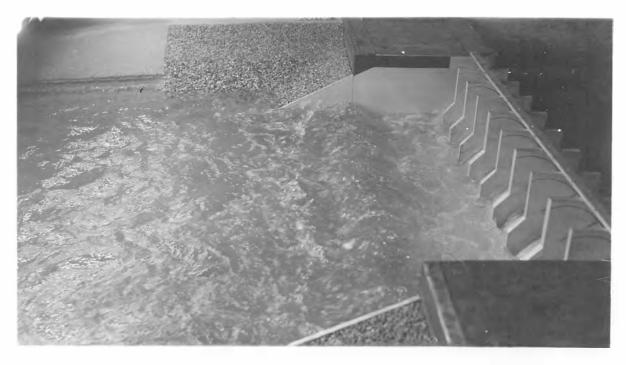
DISCHARGE 80,000 SECOND-FEET - POND ELEVATION 362 TAILWATER ELEVATION 329.2

MINIMUM TAILWATER ELEVATIONS

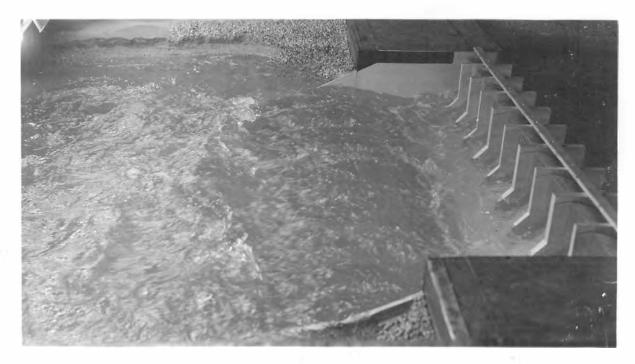
DISCHARGE 200,000 SECOND-FEET TAILWATER ELEVATION 349.3

AVERAGE TAILWATER ELEVATION

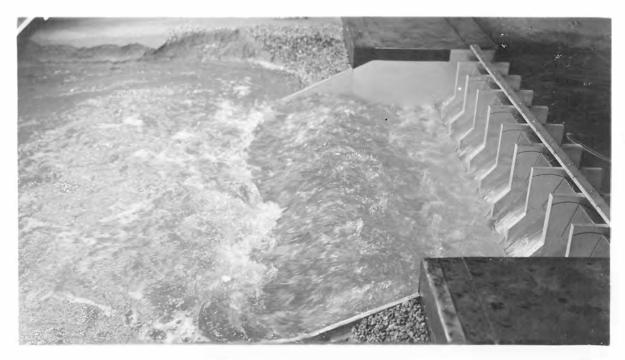
DISCHARGE 200,000 SECOND-FEET TAILWATER ELEVATION 335.0

MINIMUM TAILWATER ELEVATION
