HYDRAULIC MODEL STUDIES OF
FONTENELLE DAM SPILLWAY
SEEDSKADEE PROJECT, WYOMING

Hydraulic Laboratory Report No. Hyd-486

Subject: Hydraulic model studies of Fontenelle Dam spillway--
Seedskaadee Project, Wyoming

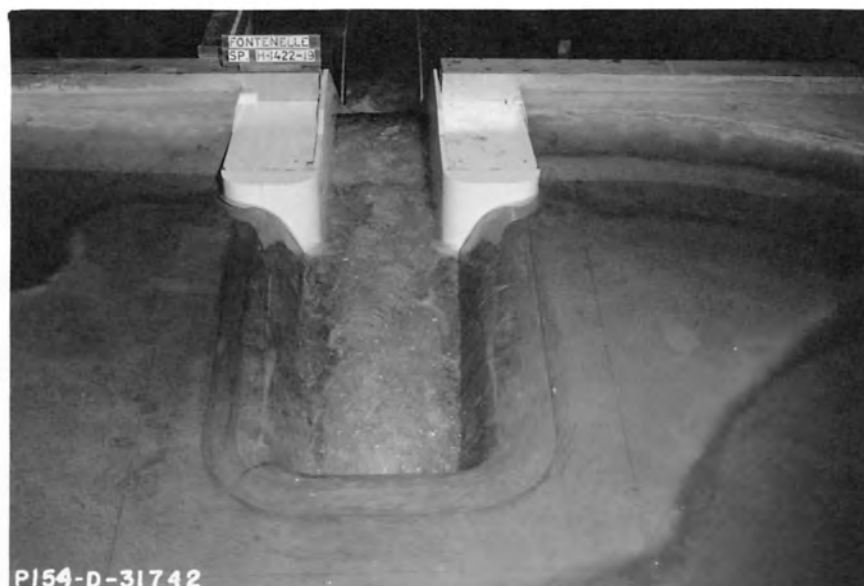
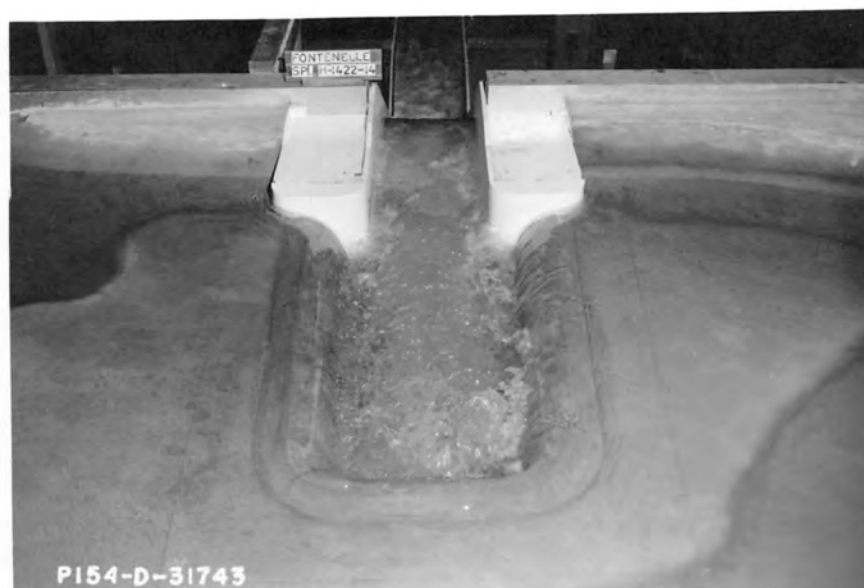
Figure 7
Hyd 486

$Q = 5,000$ cfs

$Q = 10,000$ cfs

FONTENELLE DAM SPILLWAY
HYDRAULIC MODEL STUDIES
1:30 Scale Model
Low Flows in Spillway Basin
Preliminary Design

Preliminary Design. --The model was operated with the original layout to determine the flow conditions over a complete range of discharges. For 5,000 second-feet the flow appearance was excellent. The flow from the reservoir approached the spillway in a smooth, well-distributed pattern. The flow from both sides of the crest came together in the center of the spillway basin and formed a small standing wave. There was only a slight drawdown of the flow around the piers. By the time the flow passed through the rectangular passage downstream from the piers, the standing wave had smoothed out and the flow was symmetrical, Figure 7.

When the discharge was increased to 10,000 second-feet, the appearance of the flow approaching and passing over the crest was still excellent. However, the standing wave formed by the intersection of the flows from opposite sides of the spillway was slightly to the right of center, indicating that more flow was passing over the left side of the spillway than over the right side, Figure 7. There was still only a slight drawdown in the water surface adjacent to the piers. The slight drawdown smoothed out as the flow passed through the rectangular section.

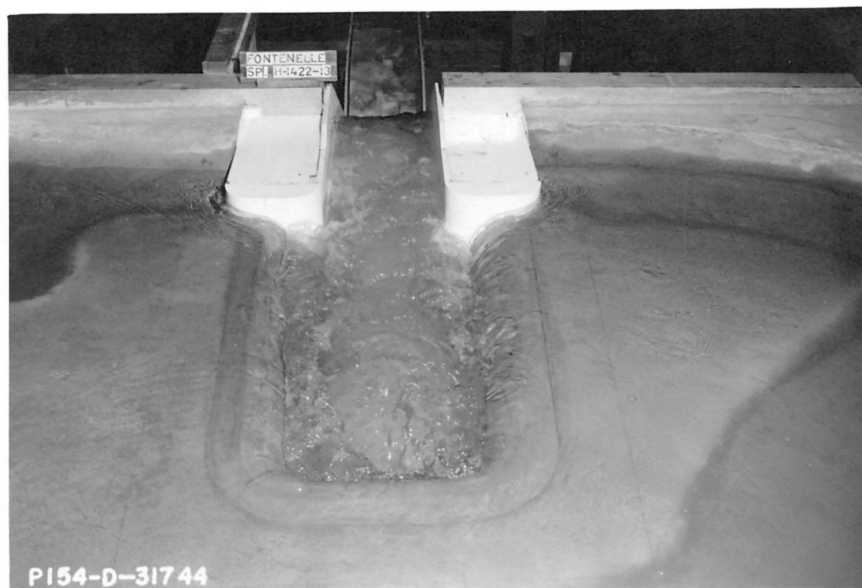
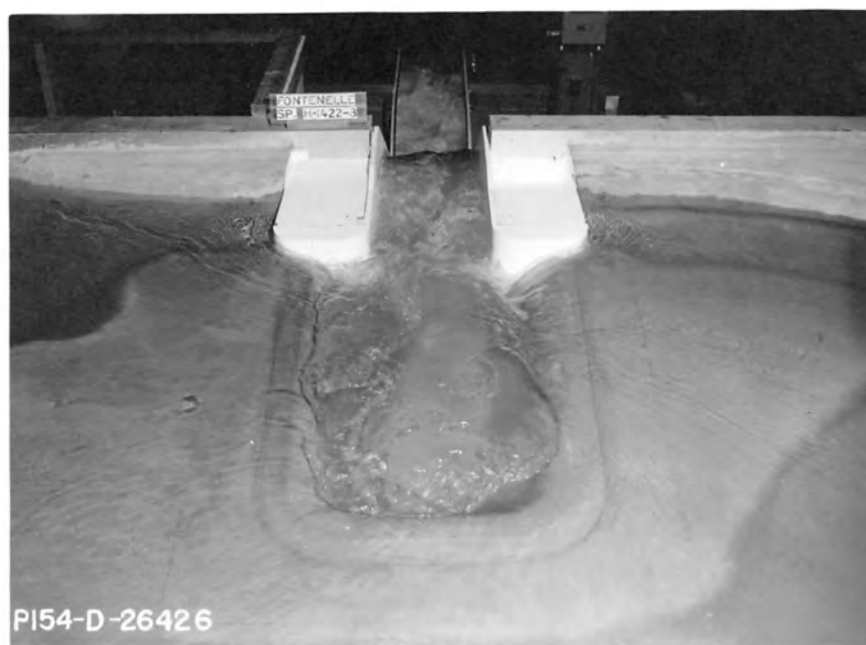
Figure 8
Hyd 486

$Q = 15,000 \text{ cfs}$

$Q = 20,000 \text{ cfs}$

FONTENELLE DAM SPILLWAY
HYDRAULIC MODEL STUDIES
1:30 Scale Model
Large Flows in Spillway Basin
Preliminary Design

For 15,000 second-feet, the flow in the approach was excellent. The standing wave in the spillway basin, caused by the intersection of the flows from the opposite sides of the spillway, had become even more off center toward the right, Figure 8. The standing wave was higher at the upstream end of the basin; however, it did not completely submerge the crest. With the 15,000-second-foot discharge, there was some impingement of the flow against the face of the piers at the downstream end of the spillway basin. The water surface was consistently within 2 to 3 feet of the top of the piers with considerable splash overtopping the piers. However, the drawdown around the piers

With the maximum discharge 20,000 second-feet, the flow conditions in the spillway approach still had an excellent appearance. In the spillway basin, the boil, or standing wave, was still off center to the right and it submerged the crest at the upstream end, Figure 8. The impingement of the flow against the pier faces was more pronounced and the tops of the piers were saturated from the frequent overtopping. The flow around the piers had a noticeable drawdown at this discharge.

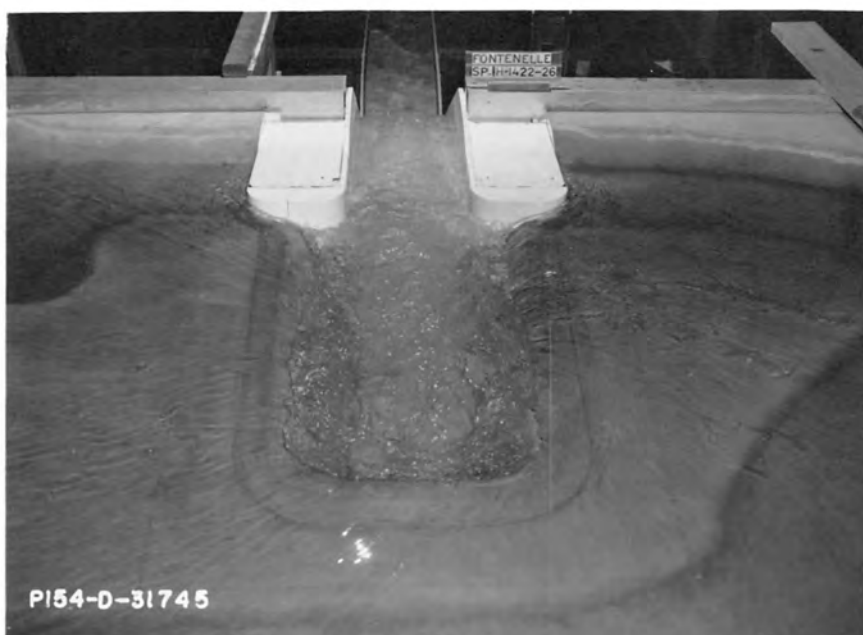
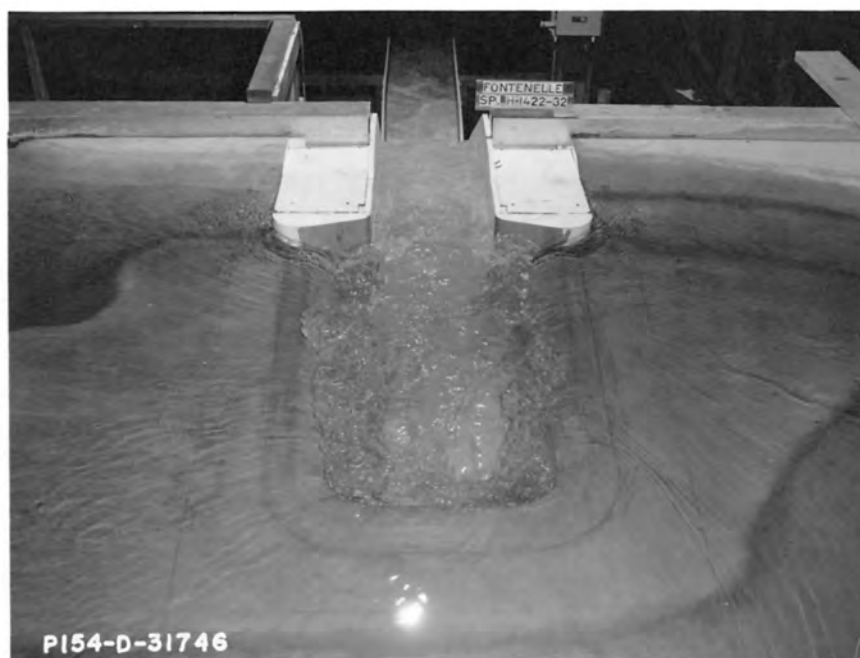
A. 4- by 4-foot Deflector Wall on Basin Floor
First Modification

B. Stepped Deflector Wall on Basin Floor
15-foot Radius on Side Piers
Second Modification

FONTENELLE DAM SPILLWAY
HYDRAULIC MODEL STUDIES
1:30 Scale Model
20,000 cfs Flow in Modified Spillway Basin

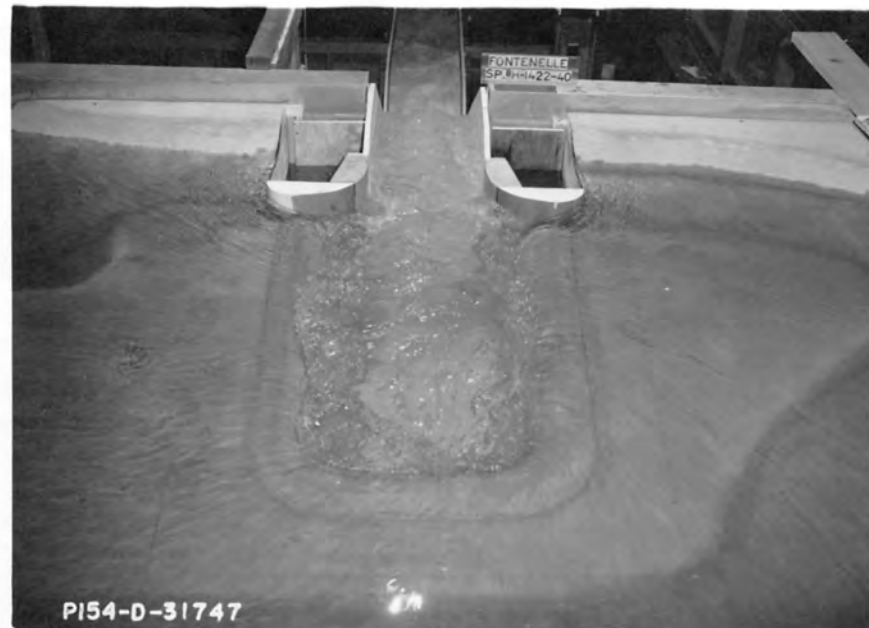
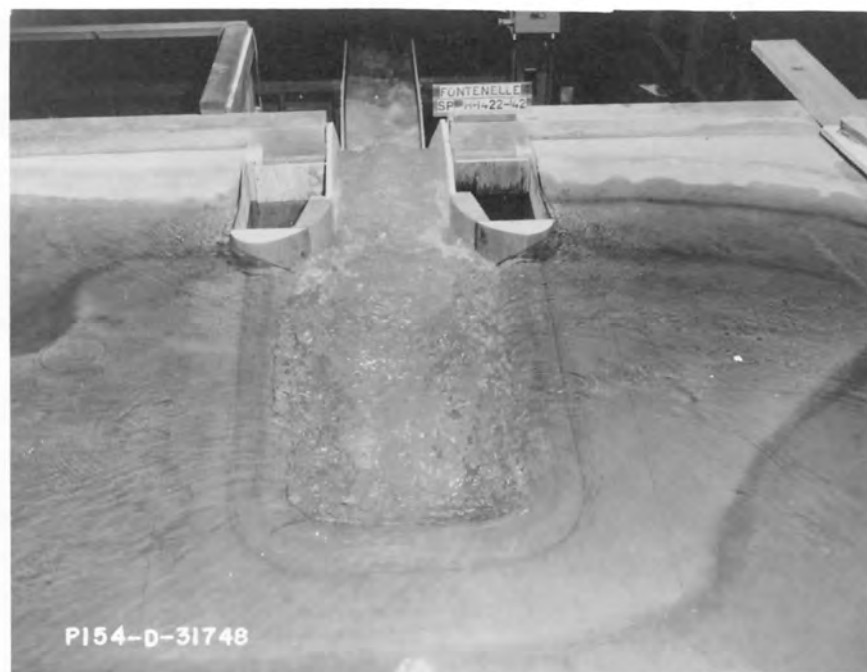
Figure 14
Hyd 486

A. 21-foot Radius on Side Piers

B. 31-foot Radius on Side Piers

Q = 20,000 cfs

**FONTENELLE DAM SPILLWAY
HYDRAULIC MODEL STUDIES
1:30 Model
Flow in Spillway Basin, Pier Modifications 2 and 3**

Neither of the two extreme streamlinings of the piers improved the flow conditions, Figure 14, so it was decided to use the original pier design. In addition, it was decided that, due to the infrequent operation of the spillway at or near the maximum discharge, the expense of the deflector wall in the spillway basin could not be justified and the wall was not included in the final design.

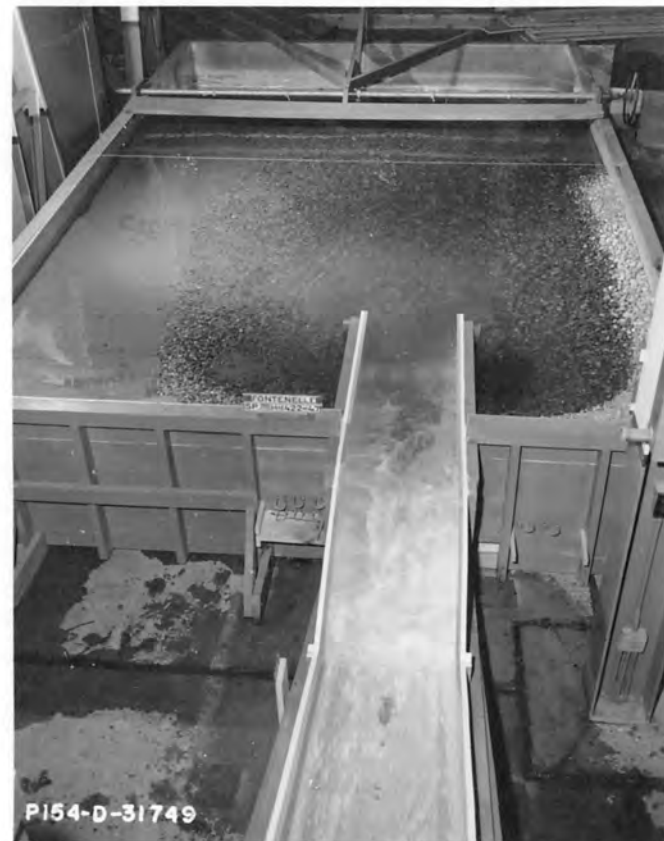
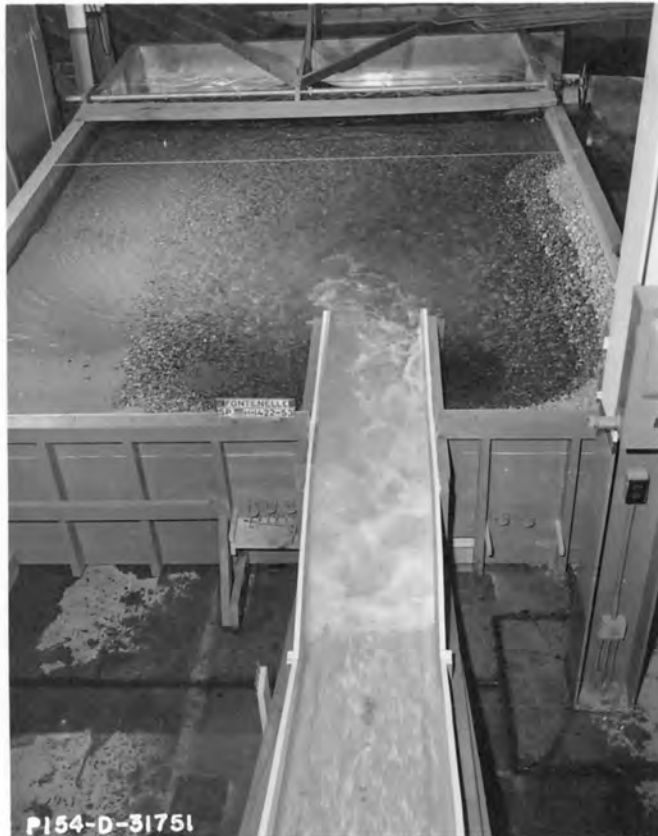
$Q = 5,000 \text{ cfs}$, T.W. = el. 6395.20

$Q = 5,000 \text{ cfs}$, T.W. = el. 6402.30

FONTENELLE DAM SPILLWAY
HYDRAULIC MODEL STUDIES
1:30 Model
5,000 cfs Flow in Final Stilling Basin

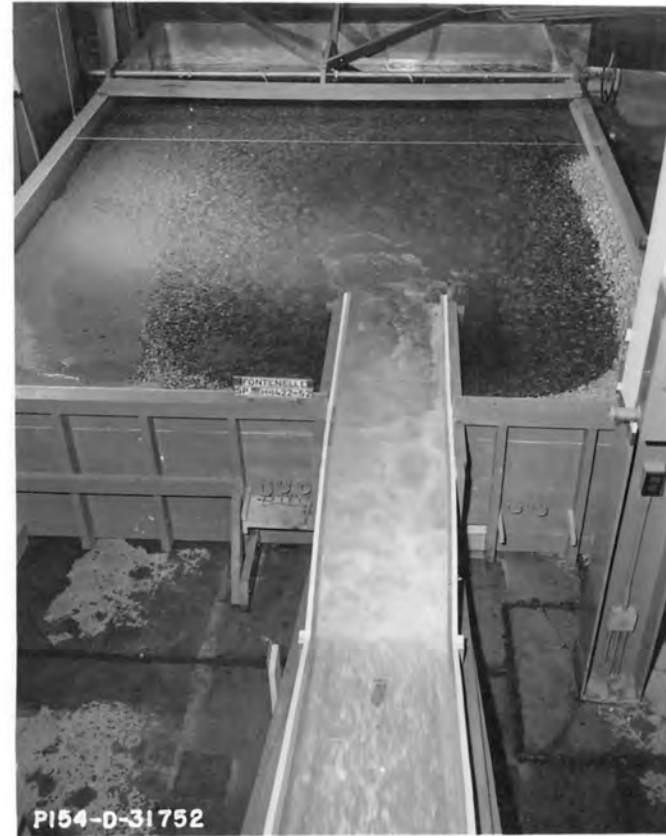
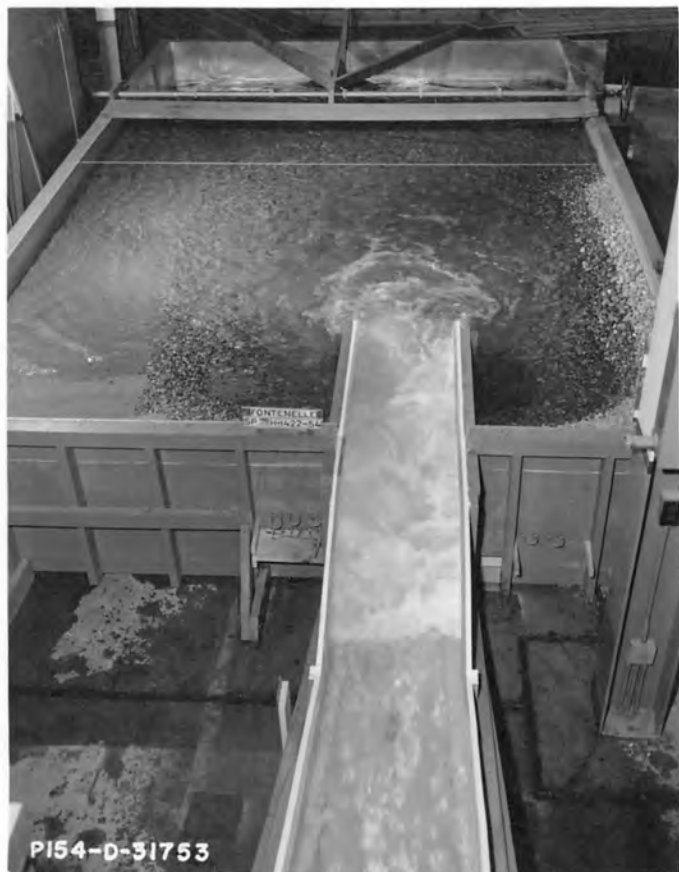
$Q = 10,000 \text{ cfs}$, T.W. = el. 6397.60

$Q = 10,000 \text{ cfs}$, T.W. = el. 6403.10

FONTENELLE DAM SPILLWAY
HYDRAULIC MODEL STUDIES
1:30 Scale Model
10,000 cfs Flow in Final Stilling Basin

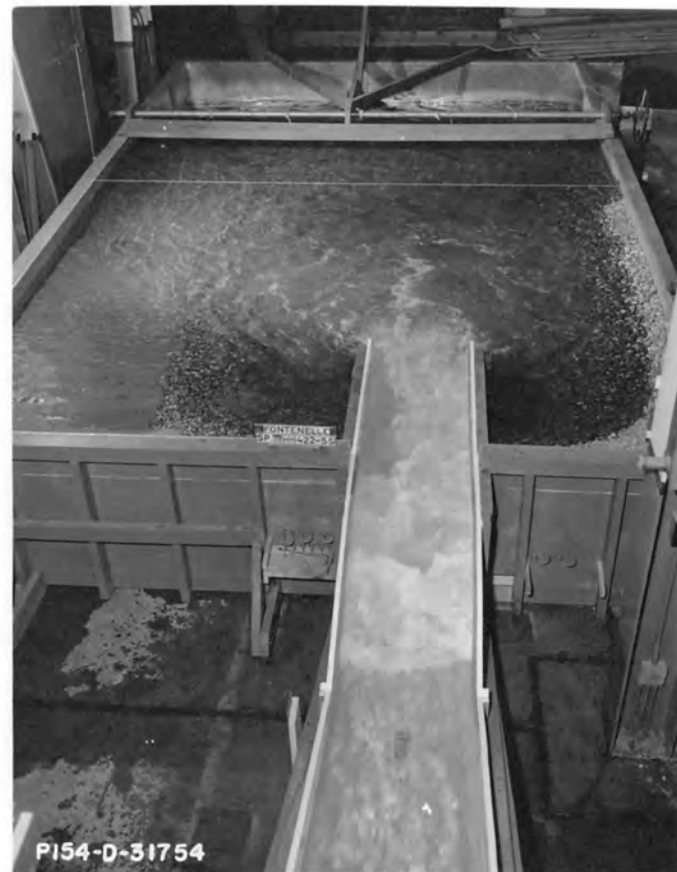
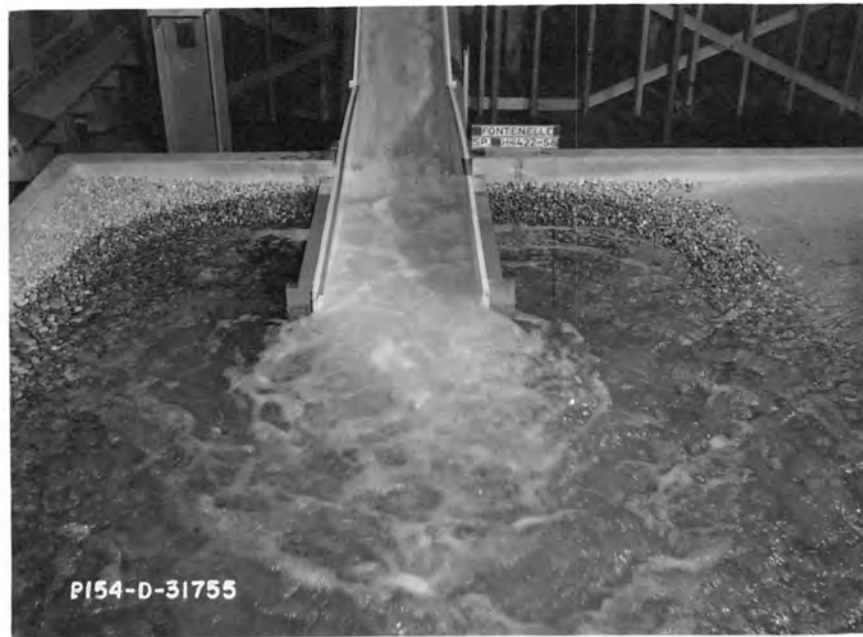
Figure 24
Hyd 486

$Q = 15,000 \text{ cfs}$, T.W. = el. 6399.70

$Q = 15,000 \text{ cfs}$, T.W. = 6403.80

FONTENELLE DAM SPILLWAY
HYDRAULIC MODEL STUDIES
1:30 Scale Model
15,000 cfs Flow in Final Stilling Basin

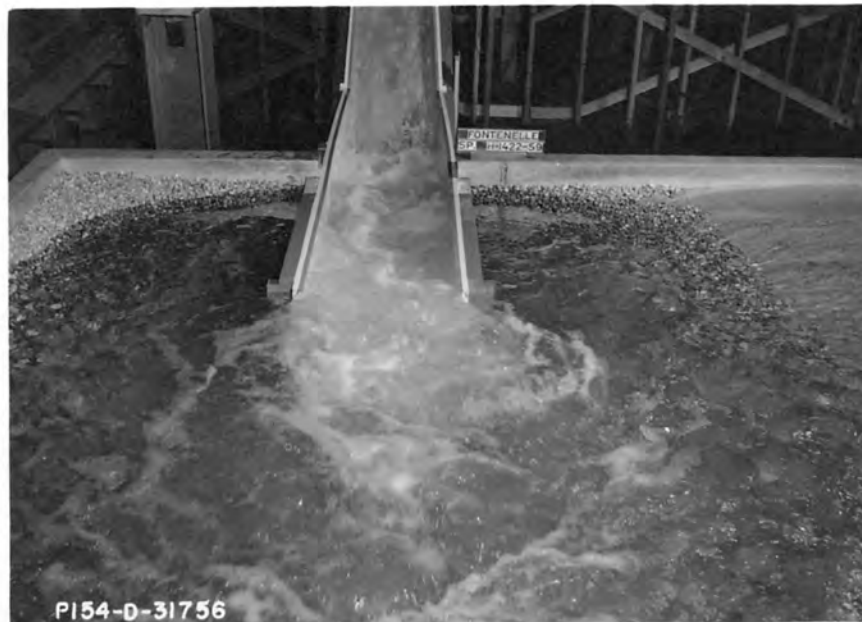
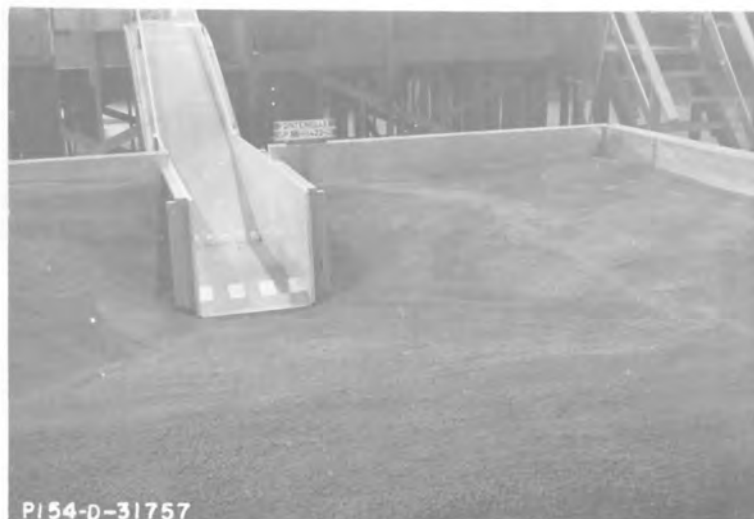
$Q = 20,000 \text{ cfs}$, T.W. = 6400.55

$Q = 20,000 \text{ cfs}$, T.W. = 6404.40

FONTENELLE DAM SPILLWAY
HYDRAULIC MODEL STUDIES
1:30 Scale Model
20,000 cfs Flow in Final Stilling Basin

At the maximum discharge, 20,000 second-feet, the flow entering the basin was extremely rough but was well distributed across the basin. The jump in the basin was very rough, with considerable splashing and surging that frequently overtopped the training walls along the full length of the basin, Figure 24. The boil at the end of the jump extended about 15 to 30 feet beyond the end of the basin. About 100 feet downstream from the end of the basin, the waves had a maximum height of about 4.5 feet and occurred frequently. The choppy water surface in the downstream channel rapidly destroyed the sand side slopes.

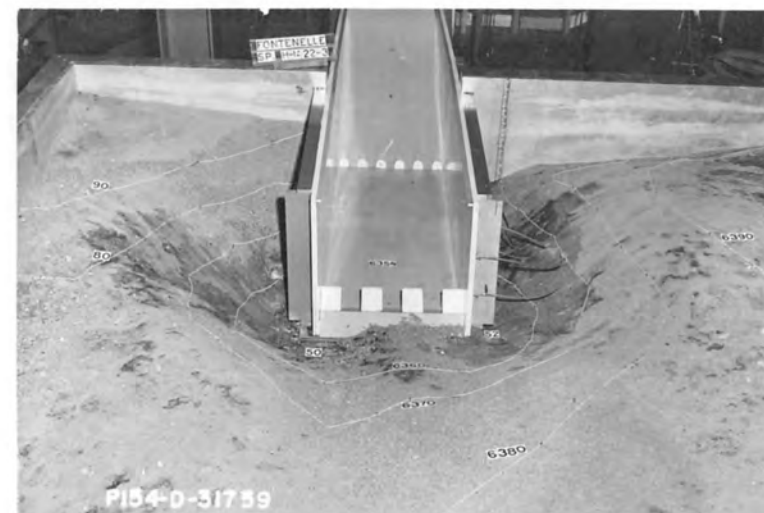
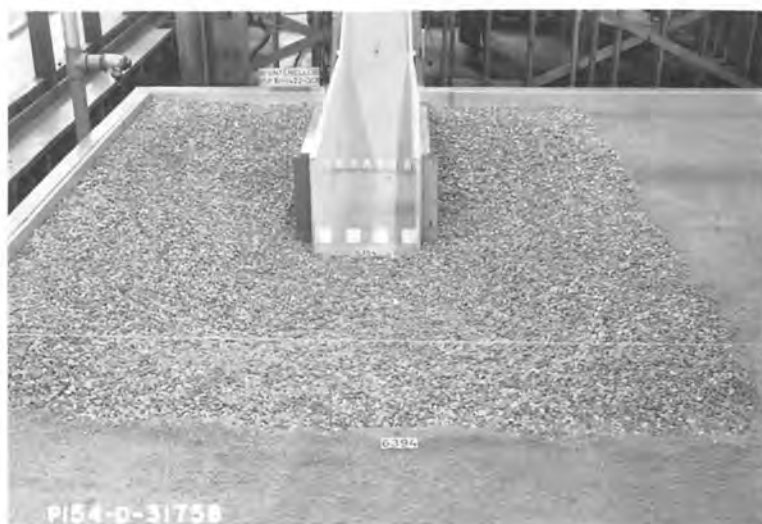
Channel before erosion test

Erosion after 8 hours

Riprap in downstream channel

FONTENELLE DAM SPILLWAY
HYDRAULIC MODEL STUDIES
1:30 Model
Channel Bed Scour and Protection
