HYDRAULIC MODEL STUDIES OF SANFORD DAM
SPILLWAY AND FLOOD CONTROL OUTLET WORKS
CANADIAN RIVER PROJECT, TEXAS

Hydraulics Branch Laboratory Report No. Hyd. 491

December 5, 1962

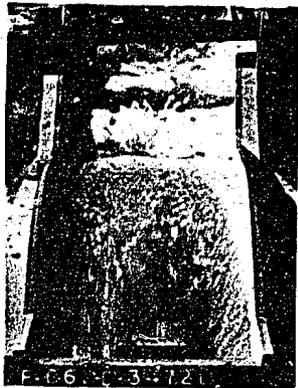
A. Unsymmetrical gate operation with recommended 40-foot-long walls

B. Unsymmetrical gate operation with preliminary 20-foot-long walls

SANFORD DAM FLOOD CONTROL OUTLET WORKS
FLOW DISTRIBUTION FOR UNSYMMETRICAL GATE OPERATION
1:46.42 MODEL

3. The tapered piers between adjacent tunnels at the outlet portal of the flood control outlet works were increased in length to 40 feet to ensure good chute flow conditions for one gate or two gate operation.

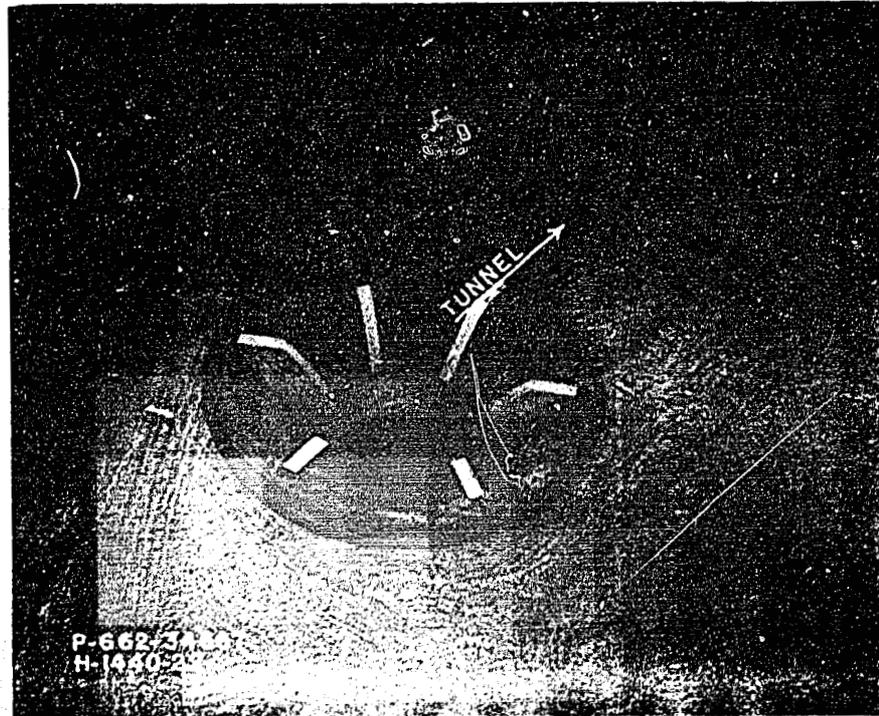
SANFORD DAM SPILLWAY
RIB VANES TO EL. 2950
(FLOW CONDITIONS WERE SIMILAR TO THOSE OBSERVED
WITH NO VANES ON THE CREST)
1:46.42 MODEL

Trial 3. --Since it was necessary to reduce the size of the vortex for submerged discharges and also to further improve tunnel flow conditions for unsubmerged discharges, it was decided to install rib vanes similar to those used on the Whiskeytown Dam Spillway.^{2/} Six rib vanes, approximately 2-1/2 feet wide and 4 feet high were installed. These rib vanes extended from the crest to elevation 2950, about halfway down the spillway profile, Figure 17. It was found that the rib vanes had some effect in stabilizing the vortex but had no apparent effect in reducing the size of the vortex. The tests also indicated that the vanes were too short in length to provide any improvement in the tunnel flow. The maximum spillway discharge was found to be approximately 19,100 cfs, Figure 14, which indicated that the rib vanes had little effect on the spillway capacity.

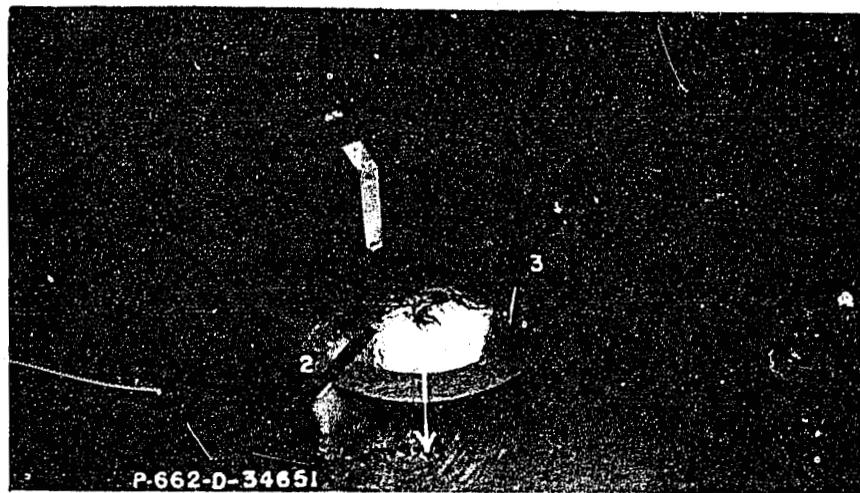
A. $Q = 6,000$ CFS, Reservoir El. = 2970

B. $Q = 15,000$ CFS, Reservoir El. = 2974

C. $Q = 19,250$ CFS, Reservoir El. = 3006

SANFORD DAM SPILLWAY
FLOW CONDITIONS AT ENTRANCE WITH THREE PIERS ON CREST
1:46.42 MODEL

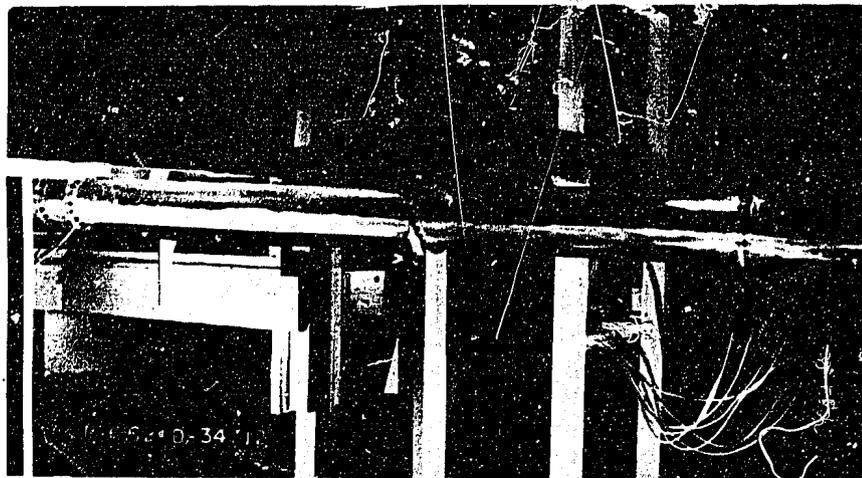
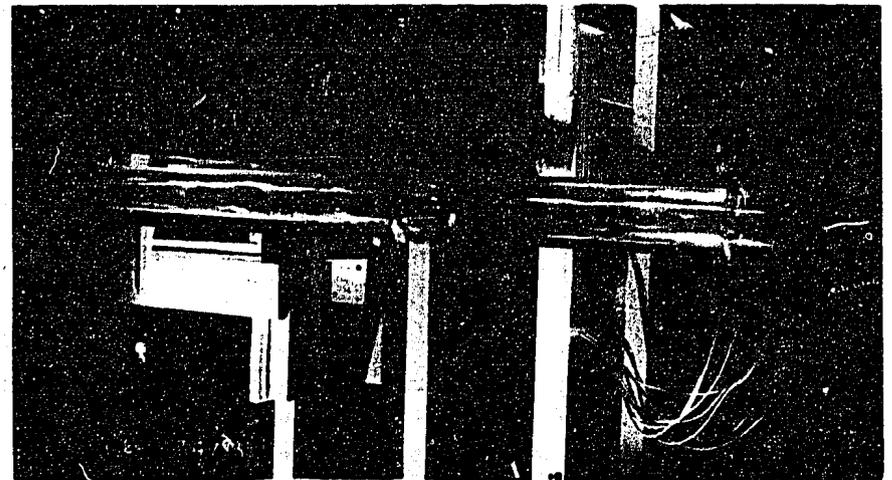
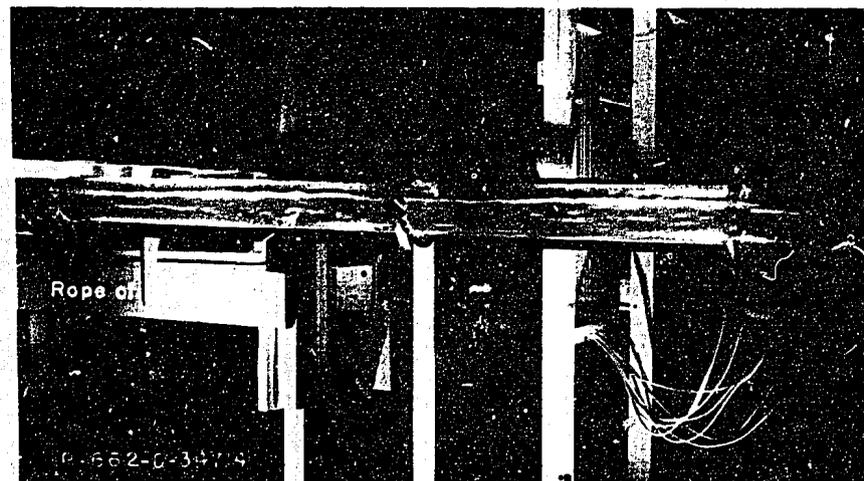
A. $Q = 6,000$ CFS

B. $Q = 15,000$ CFS

C. $Q = 19,250$ CFS

SANFORD DAM SPILLWAY
TUNNEL FLOW CONDITIONS WITH THREE PIERS ON CREST
1:46.42 MODEL
