HYDRAULIC MODEL STUDIES OF NORTON DAM
OUTLET WORKS--MISSOURI RIVER
BASIN PROJECT, KANSAS

Hydraulics Branch Report No. Hyd-497

October 21, 1963

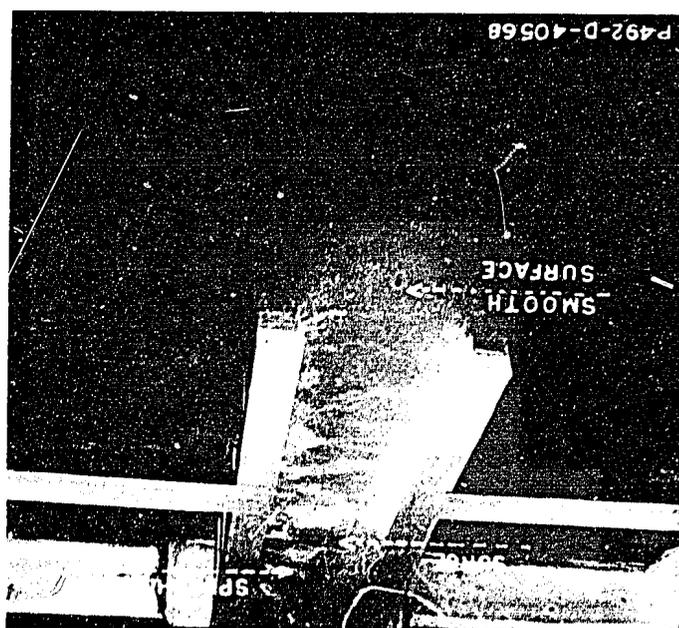
Stilling basin operation for $Q = 385$ cubic feet per second, minimum losses in system, 100 percent gate opening, reservoir at top of flood control pool.

B. Tailwater elevation 2244.3

A. Tailwater elevation 2250.7

Figure 8 shows the basin operation for the maximum discharge of 385 cubic feet per second which would occur with the reservoir at the top of the flood control pool. For the initial tailwater elevation 2250.7 the basin efficiency was very good, as exhibited by the smooth water surface in the downstream portion of the basin. A large amount of splashing occurred at the toe of the jump but was confined within the basin walls. The traveling surge noted in the photograph was dissipated before entering the river channel. Operation for the degraded tailwater, elevation 2244.3, was not as good as for the higher tailwater, but was still entirely satisfactory. The velocity of the water leaving the basin was higher because of the reduced depth at the end of the sloping apron and some turbulence existed on the surface. Splashing at the toe of the jump was reduced due to the steeper angle of entry of the chute flow into the basin pool.

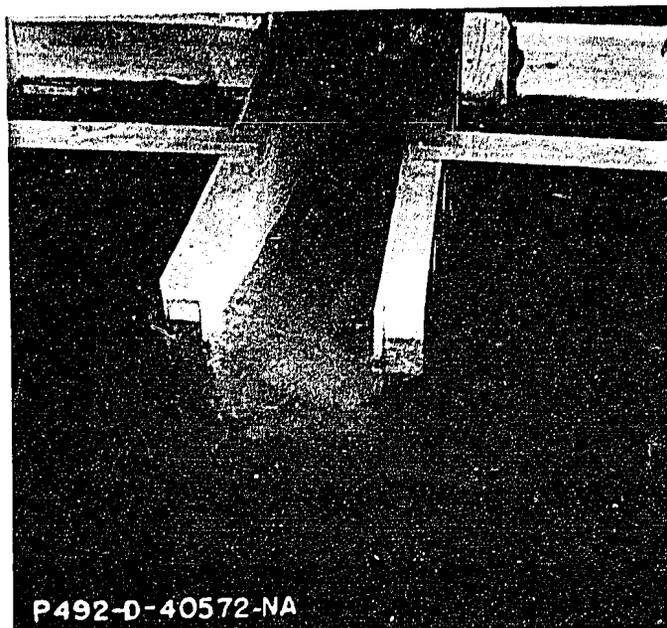
A. Tailwater elevation 2249.9

B. Tailwater elevation 2242.9

Stilling basin operation for $Q = 260$ cubic feet per second, maximum losses in system, 100 percent gate opening, reservoir at top of active conservation storage.

Flow conditions for a maximum discharge of 260 cubic feet per second which would occur with the reservoir at the top of the active conservation pool with maximum losses in the system are shown in Figure 10. It is evident that the basin operation at this flow was very satisfactory for both initial and degraded tailwater conditions.

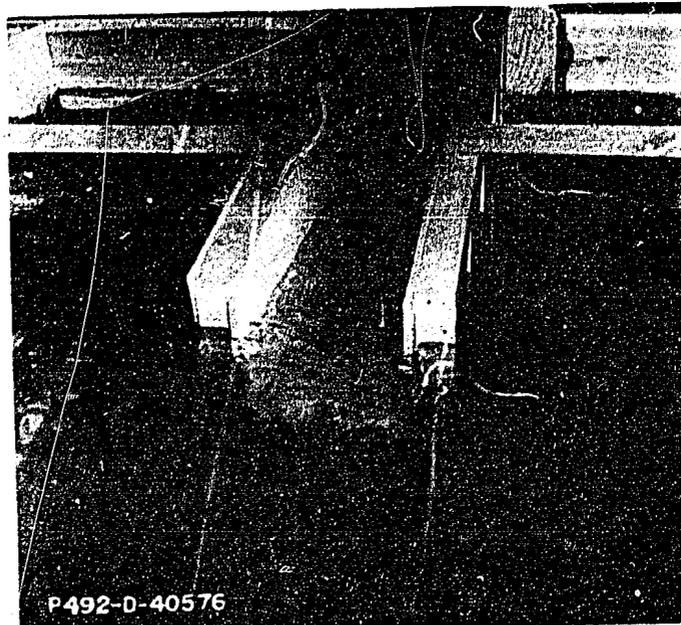
A. Tailwater elevation 2249.3

B. Tailwater elevation 2241.7

Stilling basin operation for $Q = 175$ cubic feet per second, minimum losses in system, 52 percent gate opening, reservoir at top of active conservation storage.

The normal discharge of 175 cubic feet per second was represented by gate openings of 43 and 52 percent with the reservoir at the top of the flood control pool and the top of the conservation pool, respectively. Figures 11 and 12 show that the basin operation with the initial tailwater elevation 2249.3 was apparently the same for either gate opening. For the degraded tailwater elevation 2241.7 more turbulence occurred in the basin for the 43 percent gate opening because of the higher jet velocity. The water surface at the end of the basin also appeared to be slightly rougher for the 43 percent opening.

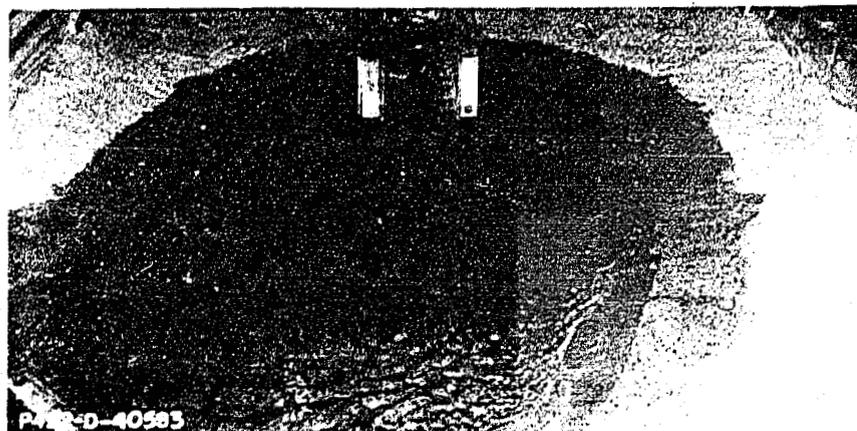
A. $Q = 315$ cubic feet per second, tailwater elevation 2243.6

B. Sand bed after 12 equivalent prototype hours at discharge in A.

Erosion test for maximum discharge with minimum losses in system, reservoir at top of active conservation storage.

After reshaping the channel the model was again operated for 12 prototype hours at a discharge of 316 cubic feet per second with degraded tailwater conditions. Erosion approximately 2.0 feet deep occurred at the end of the basin. The eroded material was deposited closer to the basin, as shown in Figure 16.
