MEMORANDUM TO CHIEF DESIGNING ENGINEER
SUBJECT: HYDRAULIC MODEL EXPERIMENTS FOR THE DESIGN OF
THE ALCOVA SPILLWAY

By JOHN B. DRISKO, ASSISTANT ENGINEER

TECHNICAL MEMORANDUM NO. 513

Feb. 26, 1936

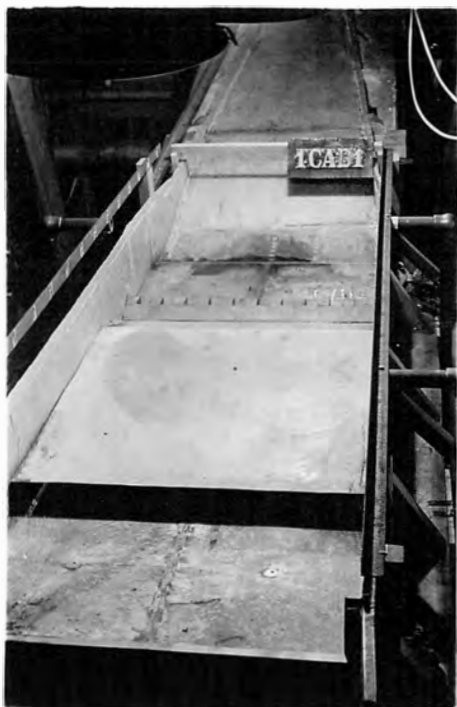
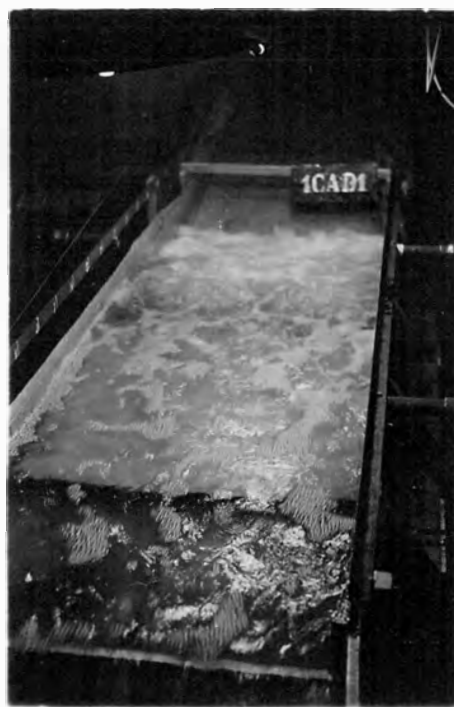
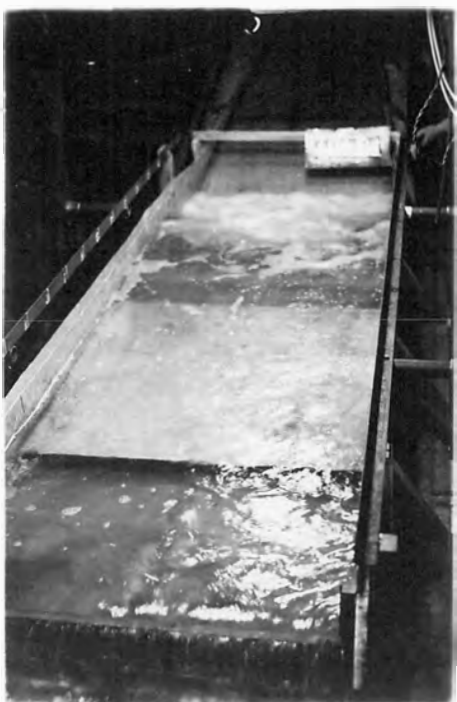
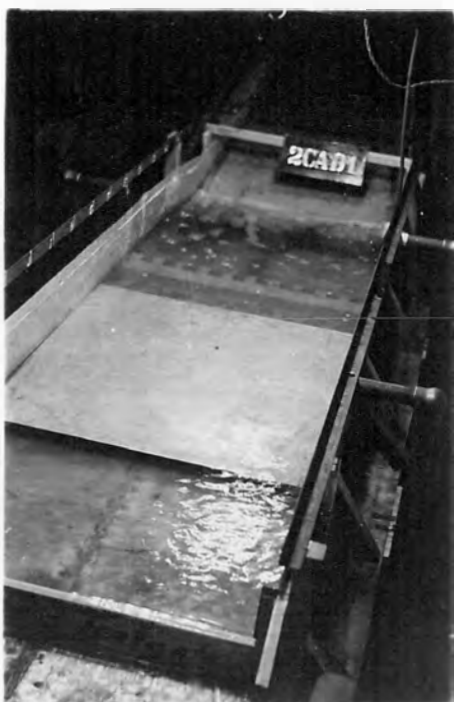
A. POOL WITH NO FLOW.

B. DISCHARGE 55,000 SECOND-FEET.

C. DISCHARGE 25,000 SECOND-FEET.

D. DISCHARGE 5,000 SECOND-FEET.

ORIGINAL DESIGN OF STILLING POOL - 200 FEET WIDE.

The original spillway flared to a pool width of 200 feet. The hydraulic jump forming was very shallow in comparison with the width of the pool, and at small discharges a large whirl formed (plate I). Due to the unsymmetrical approach to the gates, the flow through them and down the spillway was also slightly unsymmetrical, and the whirl in the pool rotated invariably in the same direction.

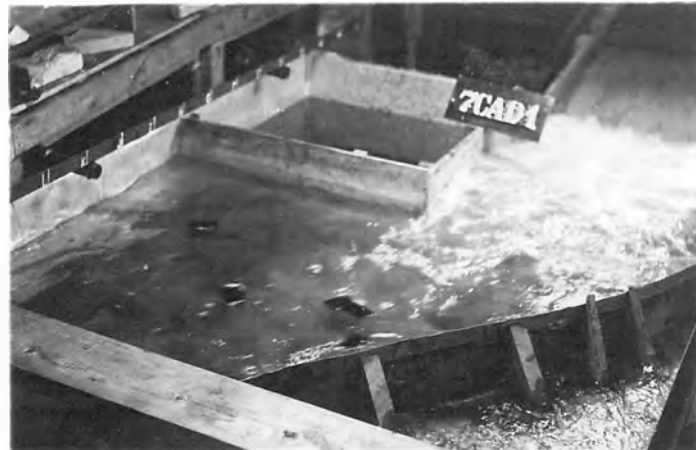
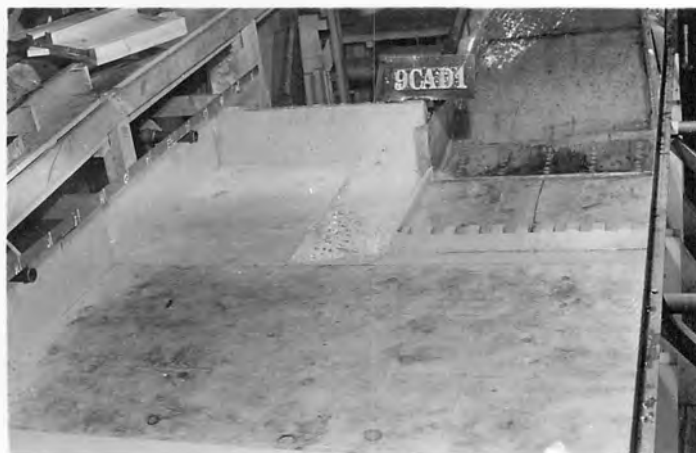
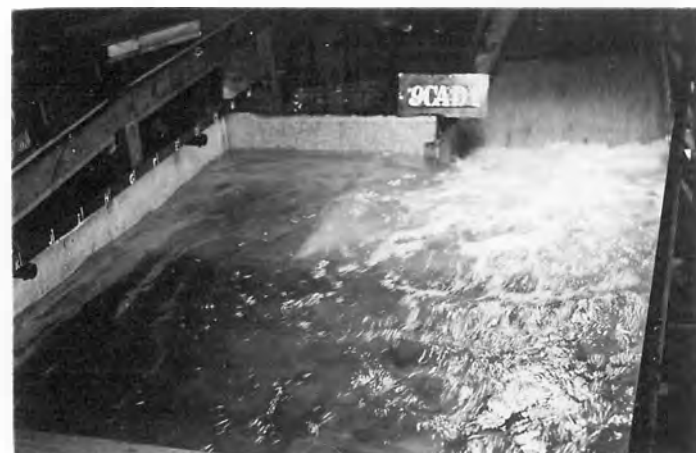
A. FALSE WALL SIMULATES HILLSIDE.

B. DISCHARGE 55,000 SECOND-FEET

C. RIGHT WALL OF POOL REMOVED.

D. DISCHARGE 55,000 SECOND-FEET.

VARIATIONS OF ORIGINAL POOL - 200 FEET WIDE.

Tests were made with different conditions downstream of the pool to see what influence they might have (plate II). In test 7 a metal wall simulated the hillside on the left of the tailway, and in test 9 the right wall of the pool was shortened. The former test revealed little, and the latter demonstrated the necessity of thorough lateral confinement of the jump.

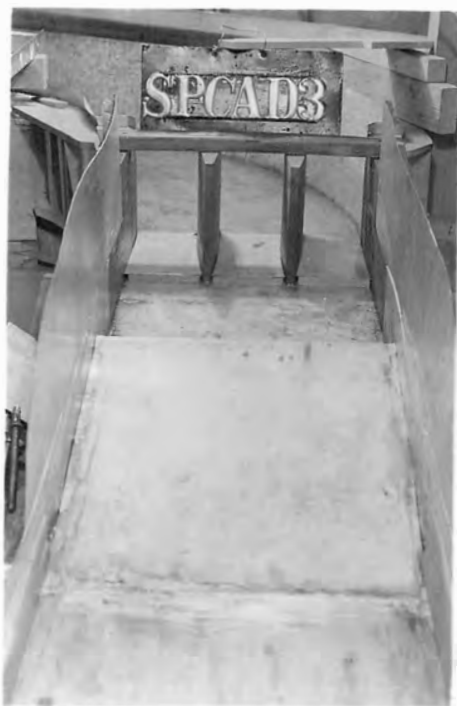
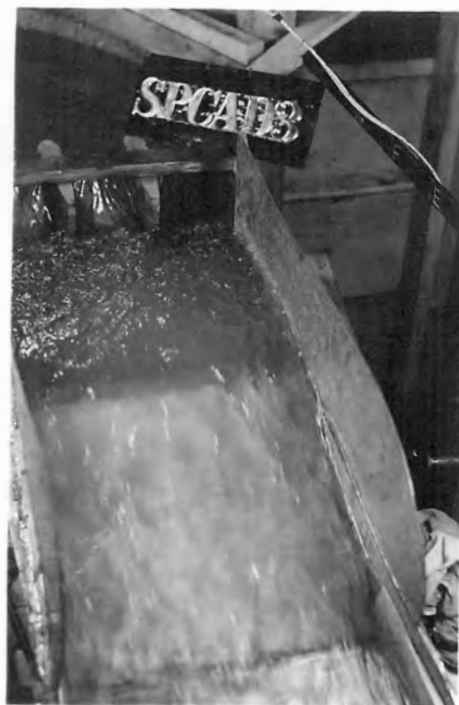
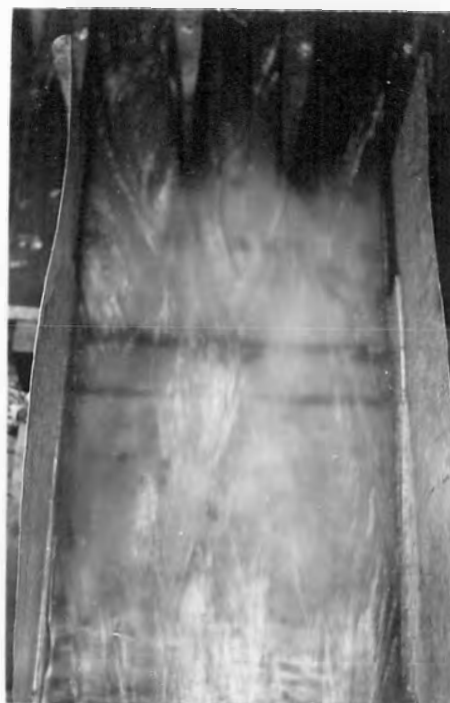
A. ALTERATION TO PRODUCE
HYDRAULIC JUMP.

B. DISCHARGE 55,000 SECOND-FOOT
HYDRAULIC JUMP FORMS BELOW PIERS.

C. REVISED GATE SECTION
PIERS 9 FEET THICK.

D. DISCHARGE 55,000 SECOND-FOOT.

In an effort to make the flow in the spillway symmetrical and also to smooth out the disturbance generated by the piers, temporary alterations were made in the model to form an hydraulic jump just below the piers (plate III). The pier disturbance disappeared but the flow in the spillway remained slightly unsymmetrical. Because of cost considerations, the use of an hydraulic jump immediately below the piers was abandoned. Figure 7, test SP-CAD-3, gives a profile of the jump just below the piers.

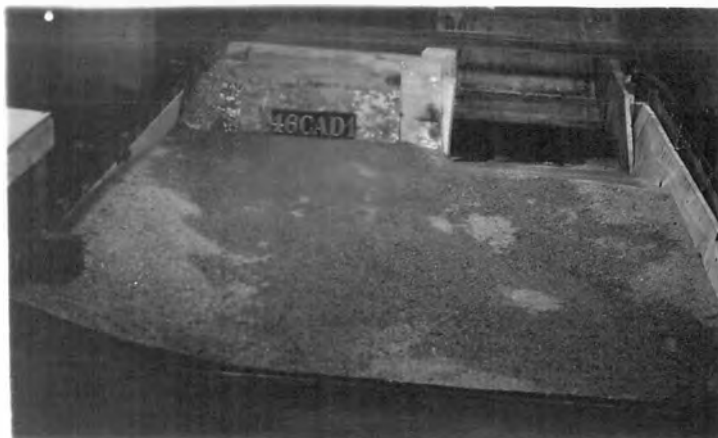
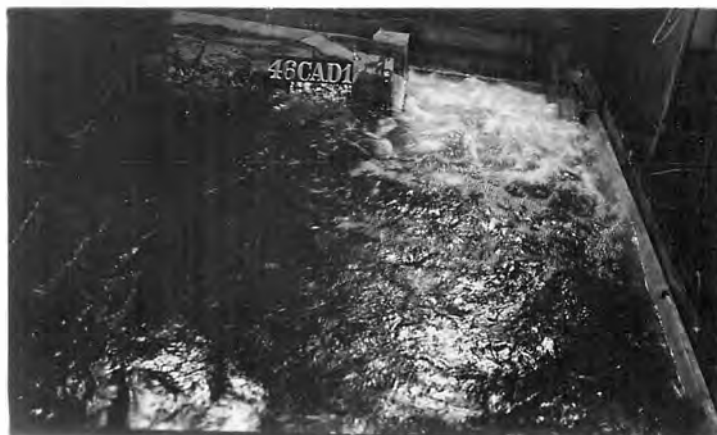
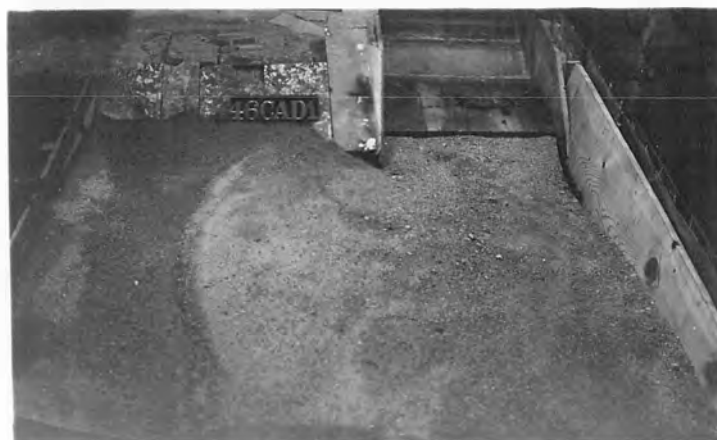
A. BED BEFORE RUN.

B. DISCHARGE 55,000 SECOND-FEET.

C. BED AFTER ONE HOUR RUN.

POOL WITH NO SILL.

After trying the dentated sill in various positions, it was decided to locate it 113 feet downstream from the beginning of the horizontal pool floor. With the sill at this position, the hydraulic jump formed well, and scour was not at all excessive. Test 46 (plate V and figs. 10 and 11) illustrates the excessive erosion which may be expected with a stilling pool having no sill or apron, and test 40 (plate VI and figs. 8 and 9) shows the results obtained with the same pool plus a dentated sill.

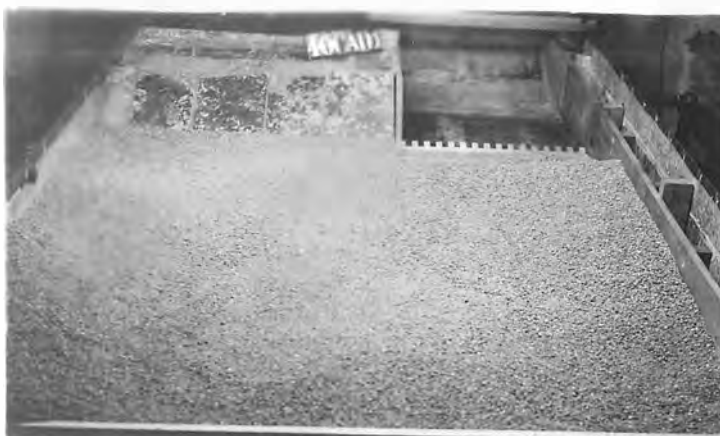
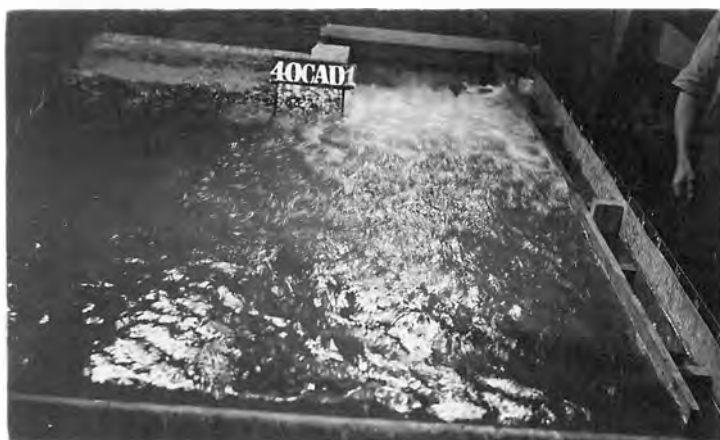
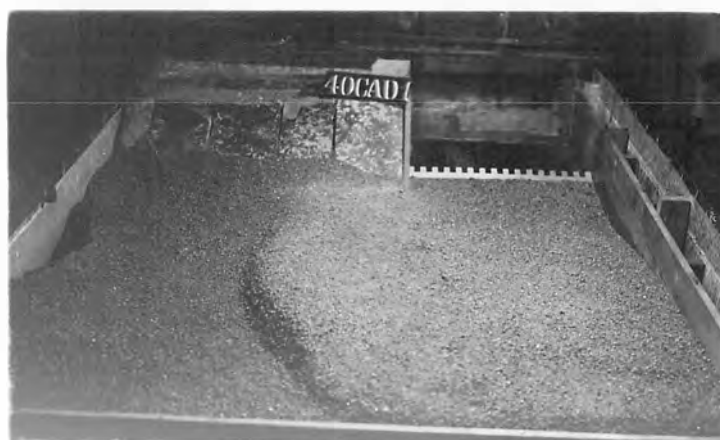
A. BED BEFORE RUN.

B. DISCHARGE 55,000 SECOND-FOOT.

C. BED AFTER ONE HOUR RUN.

POOL WITH DENTATED SILL

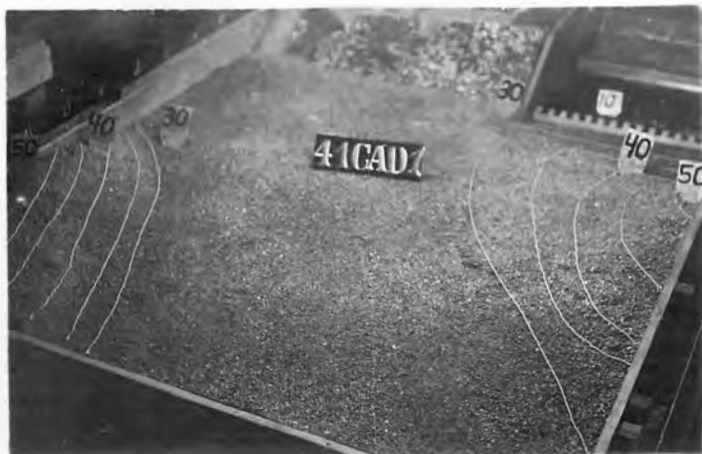
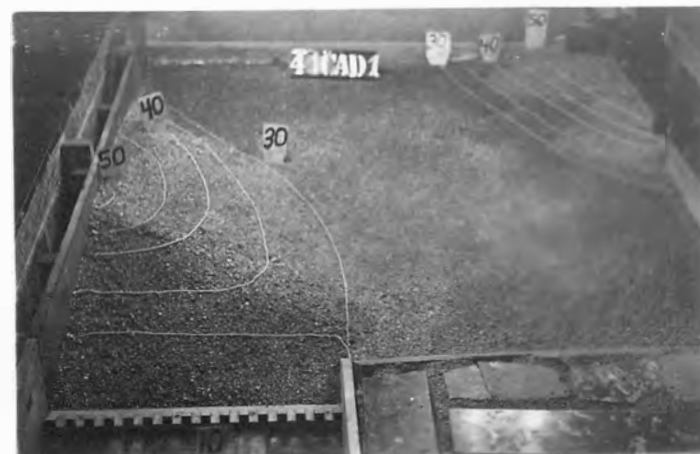
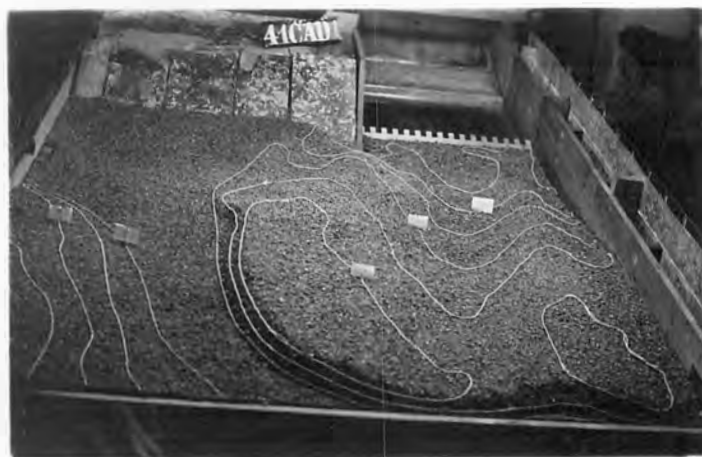
A. BED BEFORE RUN, LOOKING UPSTREAM.

B. BED BEFORE RUN, LOOKING DOWNSTREAM.

C. BED AFTER RUN, STEPPED APRON
7.9 FEET HIGH.

D. BED AFTER RUN, STEPPED APRON
4.3 FEET HIGH.

POOL WITH SILL AND STEPPED APRON.

Runs were made both with and without stepped aprons, or "step-offs" at the beginning of the pool. Various heights of stepped apron were investigated. It was noticed that a high apron produced a less foamy jump than a low apron. A low apron, on the other hand, seemed to induce a better looking jump than a smooth pool (no apron). There was little difference in the scour produced, either with or without an apron. A low apron, 4 feet high, was incorporated in the final design.

Tests 41 and 42 (plate VIII) compare the results obtained with high and low aprons, and tests 40 and 42 (figs. 8 and 9) show similar pools with and without an apron.

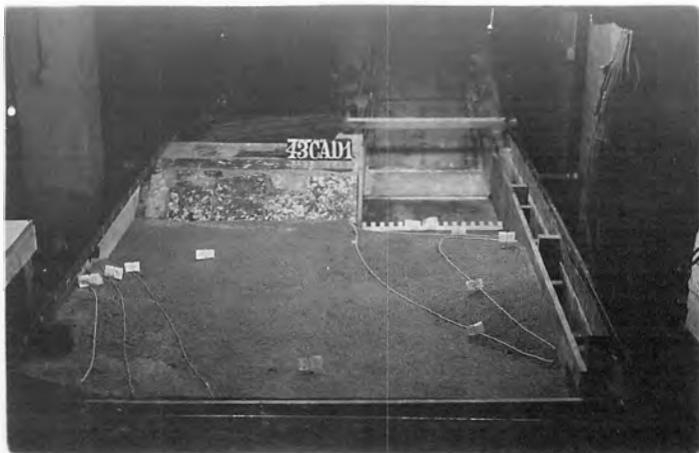
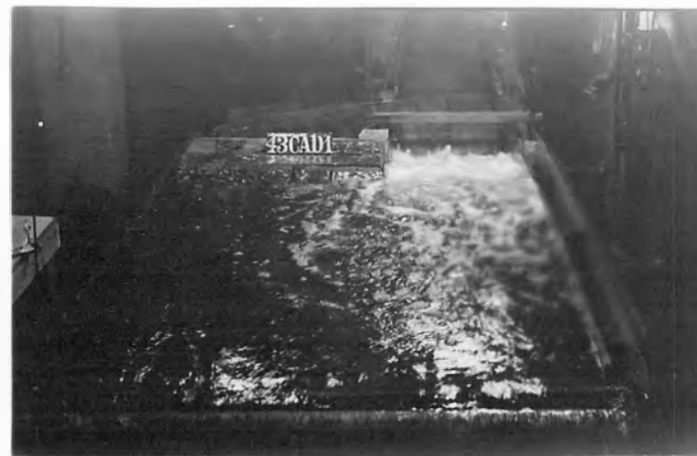
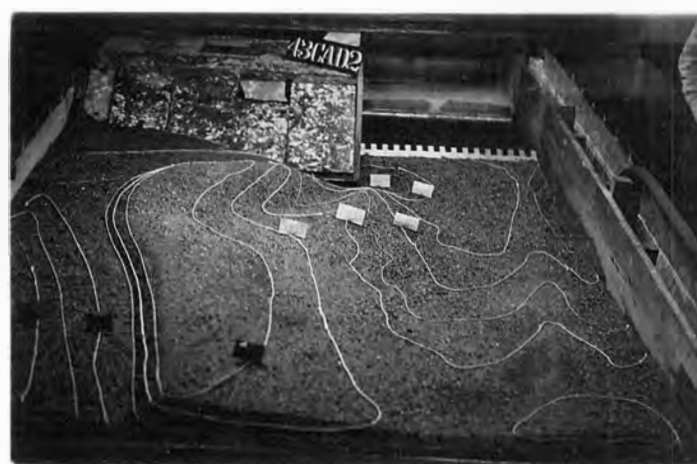
A. BED BEFORE RUN

B. DISCHARGE 55,000 GALLONS PER SECOND.

C. BED AFTER ONE HOUR RUN.

D. BED AFTER ONE HOUR RUN, SAND HAS
HAD COARSE GRAINS SIEVED OUT.

SCOUR WITH SAND IN TAILWAY (COMPARE PLATE VII. C).

Scour tests in the model were made with coarse sand at first. The question arose whether or not the use of finer sand in the model would show a different scour pattern, and so the coarse sand was replaced with building sand. Further tests showed that, although the absolute scour was not exactly the same, with the fine material, the pattern was very similar. Inasmuch as it is not safe, as yet, to predict the amount of scour to be expected in a prototype from model tests but only the general location or pattern of scour, either the coarse or the fine sand gave a proper indication. Psychologically, perhaps, the fine sand is to be preferred, for it makes the absolute scour slightly greater, and accentuates the need for proper precaution.

Test 43 (plate VIII and figs. 8 and 9) shows the scour obtained with fine sand in contrast to that given by coarse sand shown in test 42 (plate VII and figs. 8 and 9).

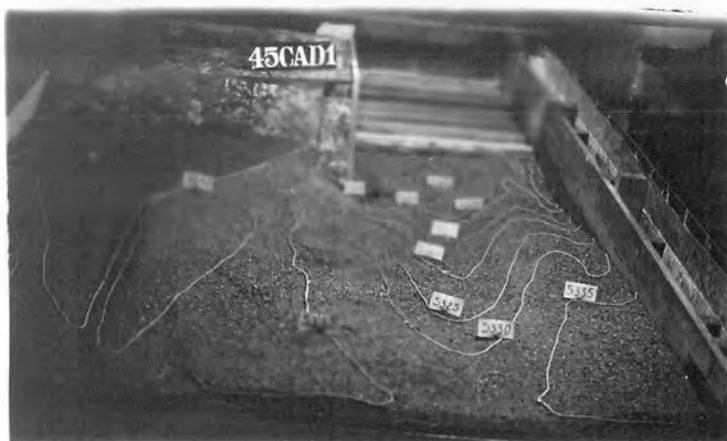
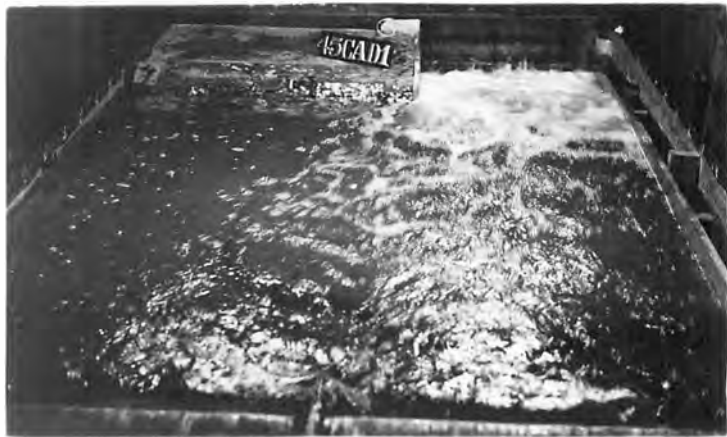
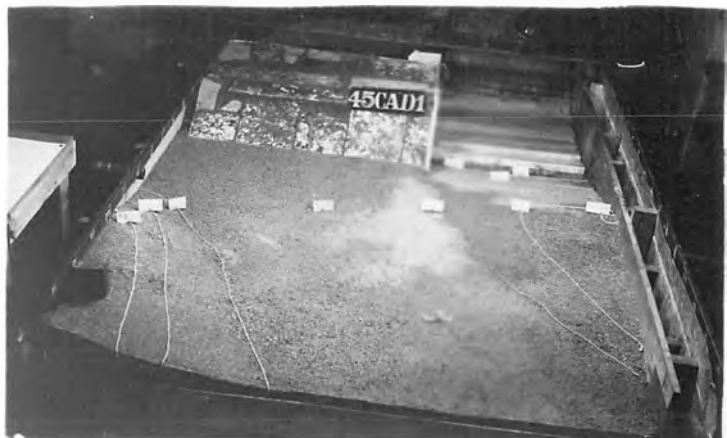
A. BED BEFORE RUN.

B. DISCHARGE 55,000 SECOND-FEET.

C. BED AFTER ONE HOUR RUN.

POOL WITH SAW-TOOTH FLOOR.

One test was made with a pool having a floor similar to a saw-tooth roof, with the sloping faces upstream and the steep vertical drops on the downstream side. It was suggested that the roller which would form in each of the pockets would contribute to the energy dissipation and would greatly reduce the bottom velocity which produces the harmful scouring. The resultant scour was about the same as that given by the conventional pool, and the jump action looked much poorer. Plate IX and test 45 (fig. 10) illustrate this pool and its behavior.

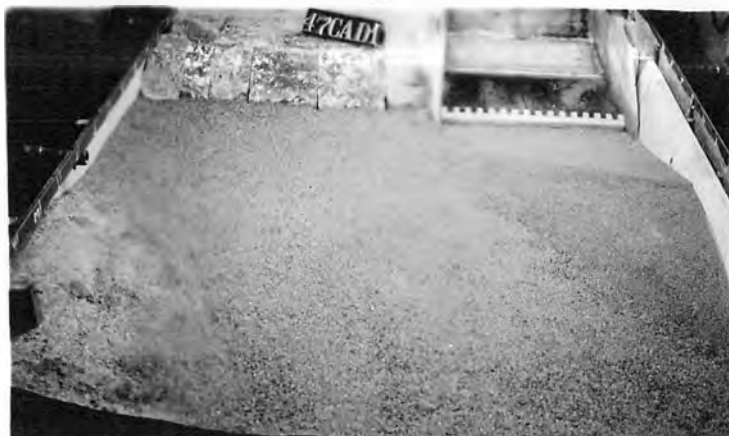
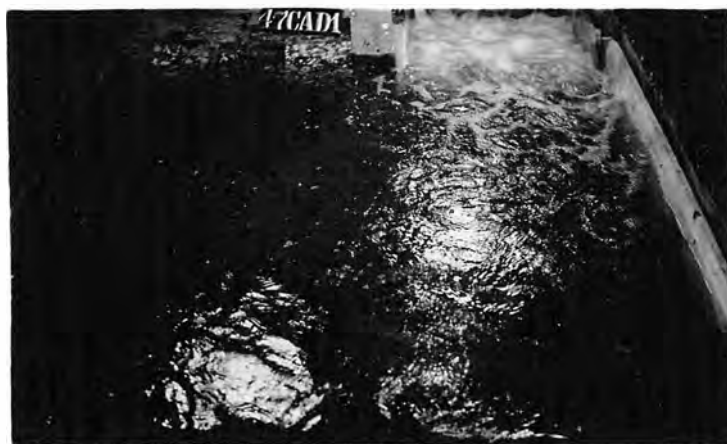
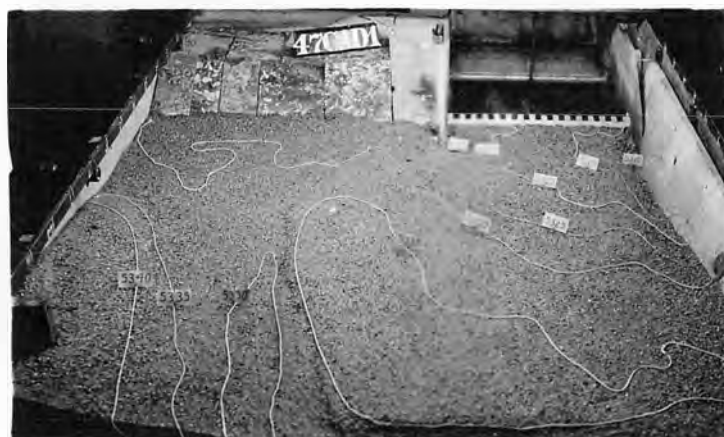
A. BED BEFORE RUN.

B. DISCHARGE 40,000 SECOND-FOOT.

C. BED AFTER ONE HOUR RUN.

FINAL DESIGN.

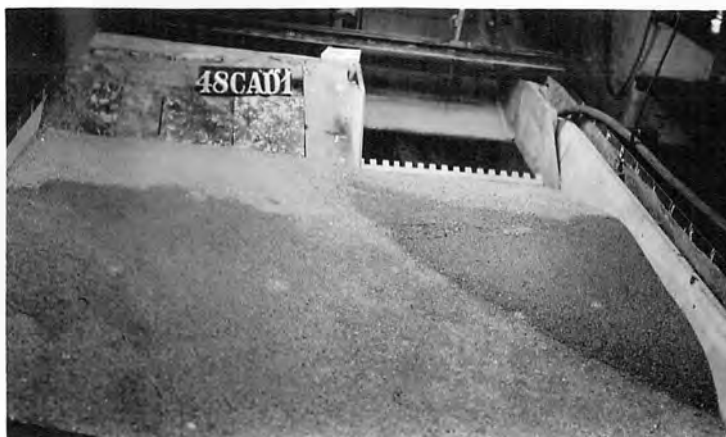
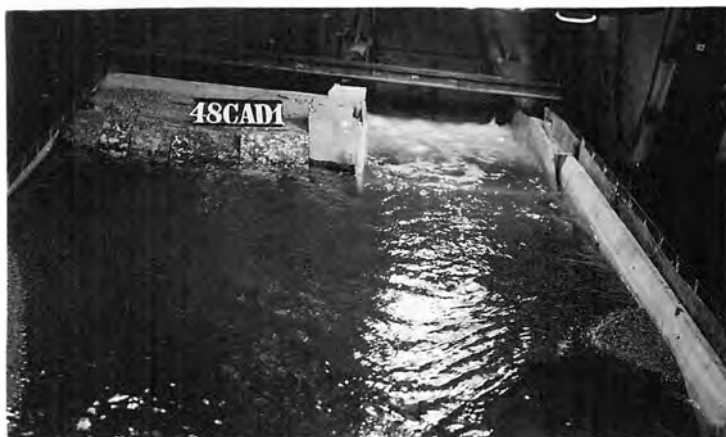
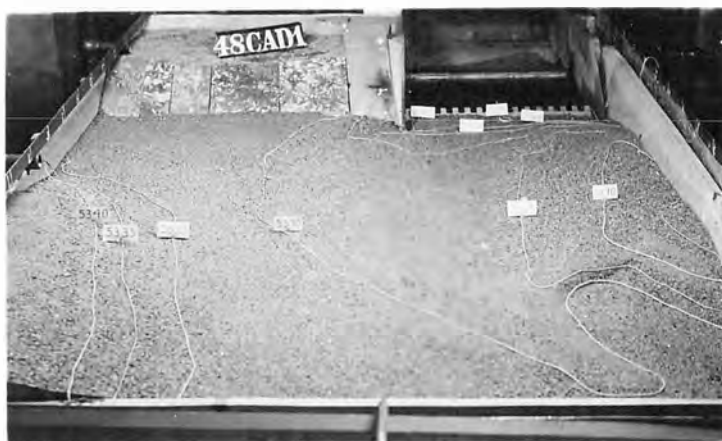
A. BED BEFORE RUN.

B. DISCHARGE 20,000 SECOND-FeET.

C. BED AFTER RUN.

FINAL DESIGN.

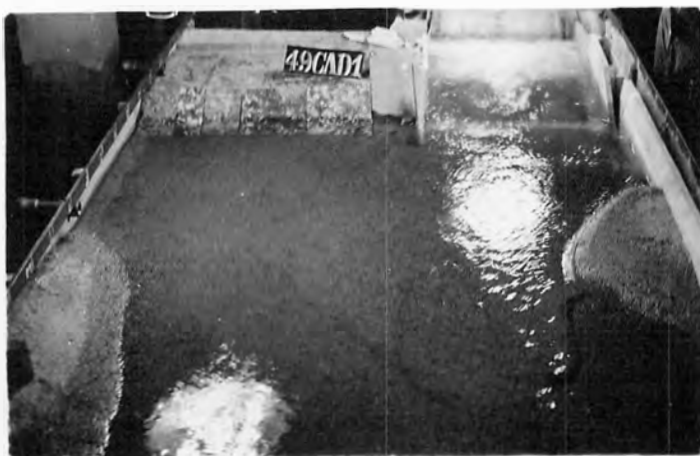
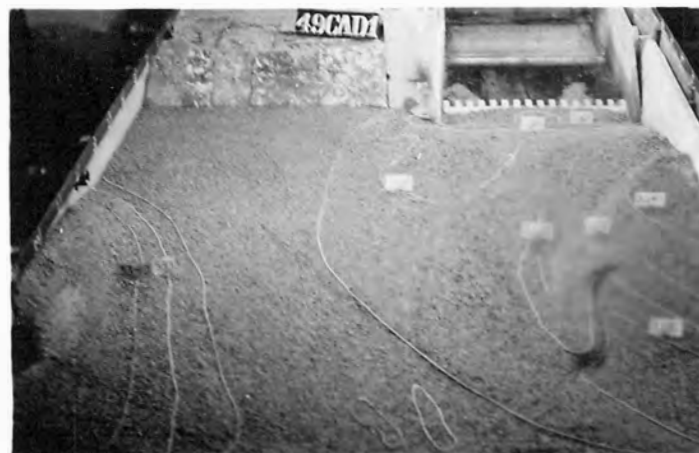
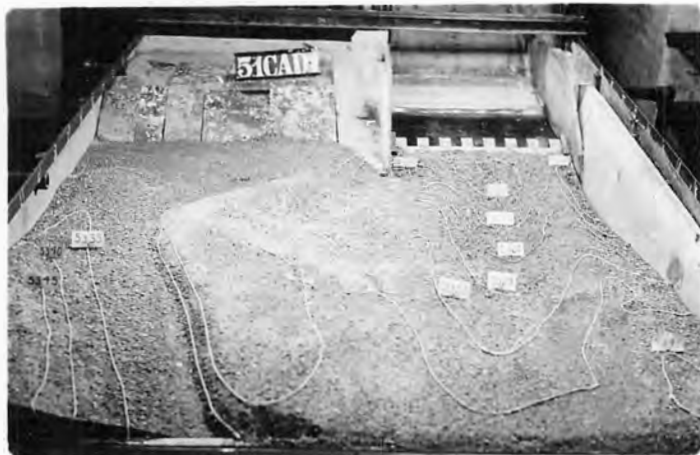
A. DISCHARGE 10,000 SECOND-FEET.

B. BED AFTER ONE HOUR RUN.

C. BED AFTER ONE HOUR RUN AT 55,000 SECOND-FEET; SILL WITH END BLOCKS.

D. BED AFTER ONE HOUR RUN AT 55,000 SECOND-FEET; SILL WITHOUT END BLOCKS.

FINAL DESIGN - EFFECT OF END BLOCKS ON SILL.
