UNITED STATES
DEPARTMENT OF THE INTERIOR
BUREAU OF RECLAMATION

HYDRAULIC MODEL STUDIES OF BLUE MESA DAM
SPILLWAY, COLORADO RIVER STORAGE
PROJECT, COLORADO

Report No. Hyd-515

July 8, 1964

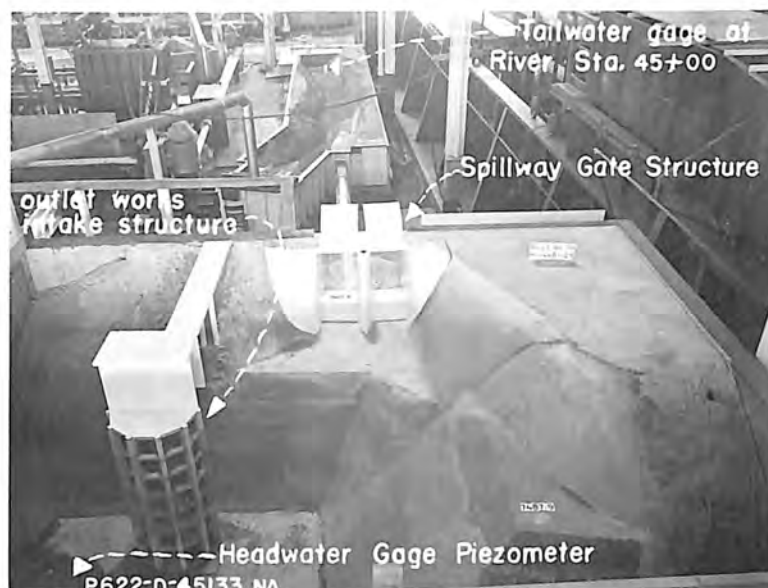
Figure 8
Report Hyd-515

A. Looking downstream from reservoir
(Recommended Approach Channel)

B. Looking upstream
Spillway, 33,700 cfs
Powerplant, 5,100 cfs
Outlet works, 3,080 cfs

C. Slide gate control in spillway
tunnel, prior to construction
of the model reservoir and
inclined tunnel

BLUE MESA DAM SPILLWAY

The 1:32.78 Scale Model

The reservoir area was contained in an 11- by 14-foot head box which allowed reproduction of the topography along the right bank of the reservoir for approximately 300 feet upstream from the spillway crest and about 200 feet to the right and left of the spillway centerline, Figure 7. The topography was reproduced from elevation 7397 up to the dam crest at elevation 7528. Topography in the reservoir area was molded of concrete mortar placed on expanded metal lath which had been nailed over wooden templates shaped to the ground surface contours. The surface was given a rough finish to simulate the natural topography of the prototype. Excavated surfaces were given a smoother finish. A 6-inch-wide rock baffle was installed along the left and upstream sides of the box to quiet the flow as it entered the reservoir area.

The spillway tunnel between the intake structure and the flip bucket, Figure 7, was constructed of transparent plastic. The portion of the center pier that extended into the tunnel transition section was fabricated in sugar pine. Plastic piezometers having a 1/16-inch-inside-diameter were installed in the transition section and along the invert of the tunnel. The constant diameter tunnel downstream from the vertical bend was made from 7-11/16-inch-inside-diameter extruded plastic pipe. The inside diameter of this pipe represented the 21-foot diameter prototype tunnel.

The flip bucket at the downstream end of the tunnel, Figure 7, was molded in concrete. Piezometers made from 1/16-inch-inside-diameter brass tubing were installed along the bucket invert, end sill, and in the right wall.

The exterior walls and floor of the powerplant tailrace and outlet works stilling basin were represented in the model and were constructed of wood, Figure 7. The quantity and velocity of the flow from the powerplant and outlet works were represented. The tailwater control weirs downstream from the powerplant and outlet works were constructed of concrete and accurately represented in the model.

The river channel was molded of concrete in the same manner as the reservoir area. Tailwater staff gages were installed in the powerplant tailrace and outlet works stilling basin upstream and downstream of the tailwater control structure, and at river Station 45+00, about 1,300 feet downstream from the powerplant, near the model tailwater control gate, Figure 7.

Water was supplied to the model spillway from the laboratory permanent supply system. For preliminary studies of the flip bucket, the water supply was pumped directly to the nearly horizontal tunnel downstream from the vertical bend. The depth and velocity of flow at the exit portal of the tunnel were controlled by means of a slide gate installed 12 feet 1-1/4 inches upstream from the portal, Figure 7.

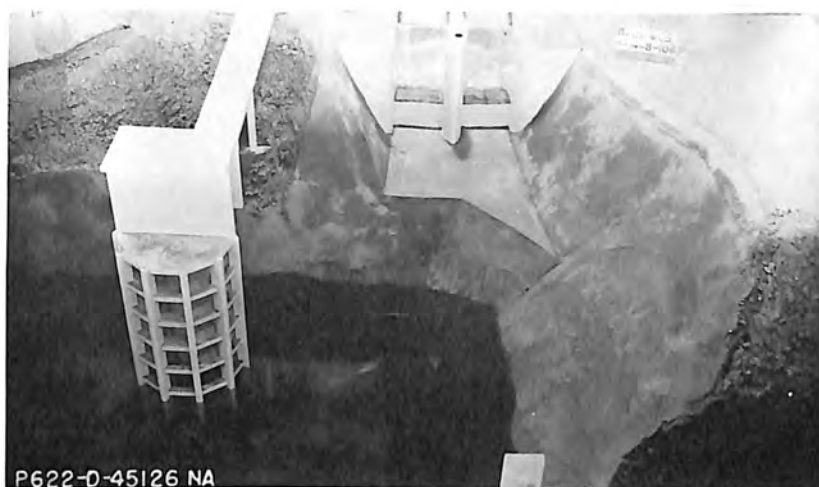
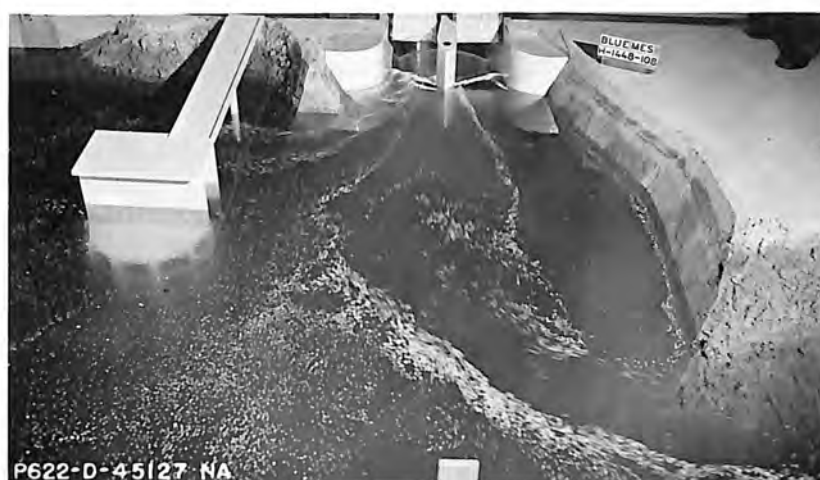
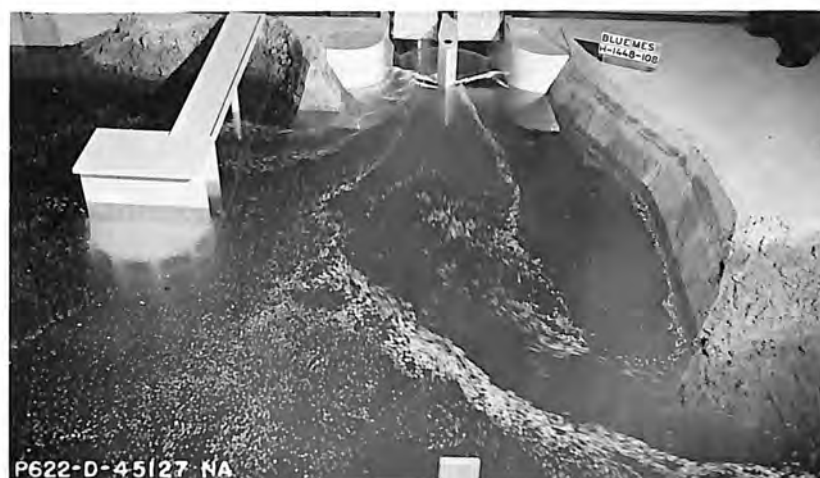
Figure 9
Report Hyd-515

A. Preliminary approach channel

B. 16,800 cfs

C. 33,700 cfs

BLUE MESA DAM SPILLWAY

Flow in preliminary approach channel
1:32.78 scale model

3. The approach channel was reshaped to improve the flow pattern through the spillway approach, gate structure, tunnel transition, and steeply inclined tunnel. Compare Figures 8 and 9 with 11 and 12.

Flow characteristics in the approach channel. --Flow in the preliminary spillway approach channel was satisfactory; however, some water surface disturbances occurred at both right and left banks, Figures 8 and 9. Flow around the upstream end of the cut in the right bank caused a large slow eddy and some water surface roughness along the bank. Flow from along the left bank moved toward the center pier while flow currents from deep in the reservoir boiled to the surface along the left bank line and approach wingwall, Figure 9.

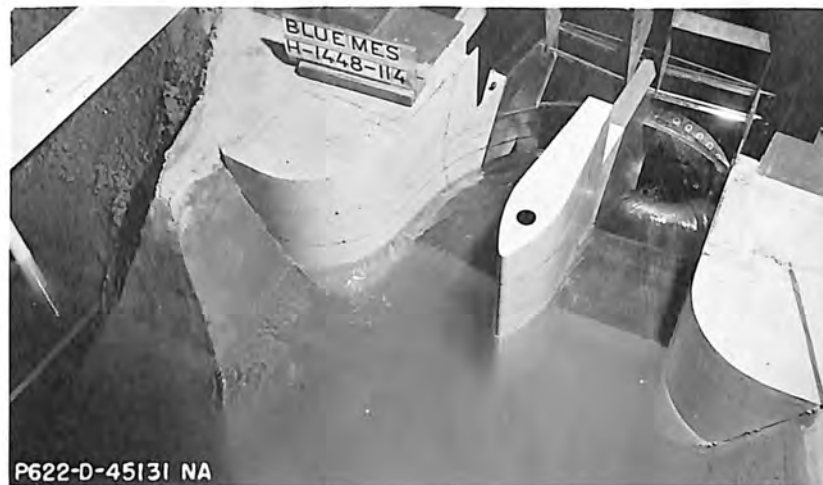
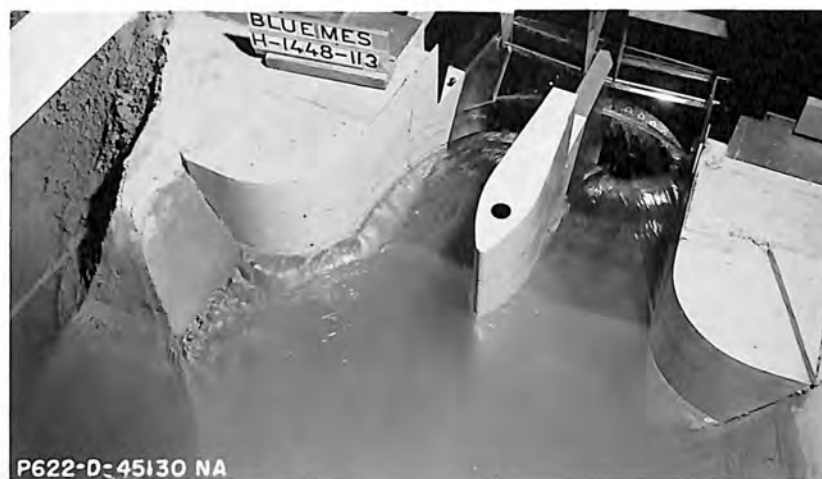
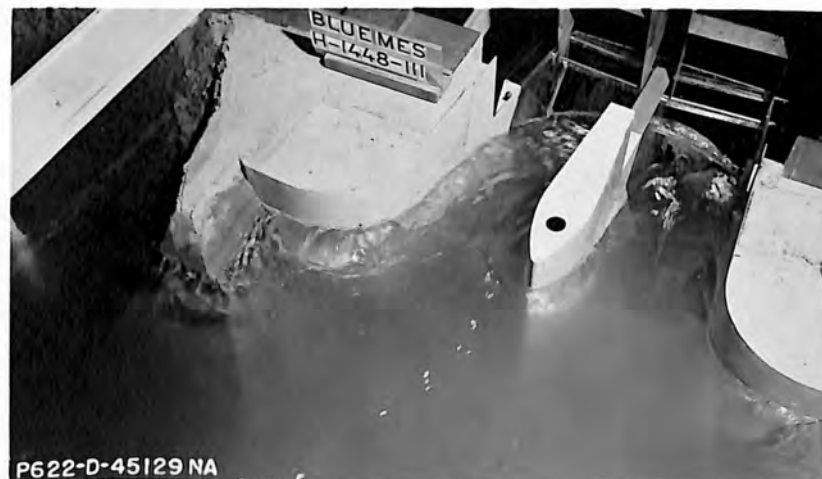
A. 8,400 cfs

B. 16,850 cfs

C. 33,700 cfs

BLUE MESA DAM SPILLWAY

Flow entering preliminary gate structure
1:32.78 scale model

Flow characteristics in the gate structure. --Flow entering and passing through the gate structure, Figure 9, was satisfactory. However, for the design flow of 33,700 cfs, a ridge of water formed along the left wall, Figure 9C, and intermittently struck the roof corner at the tunnel portal.

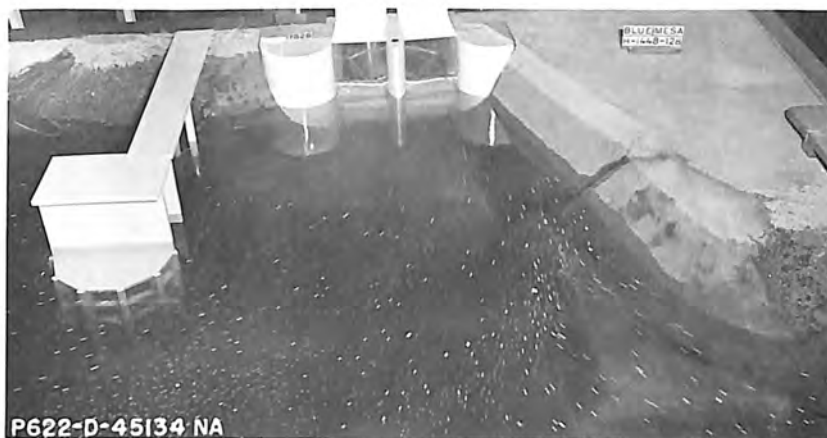
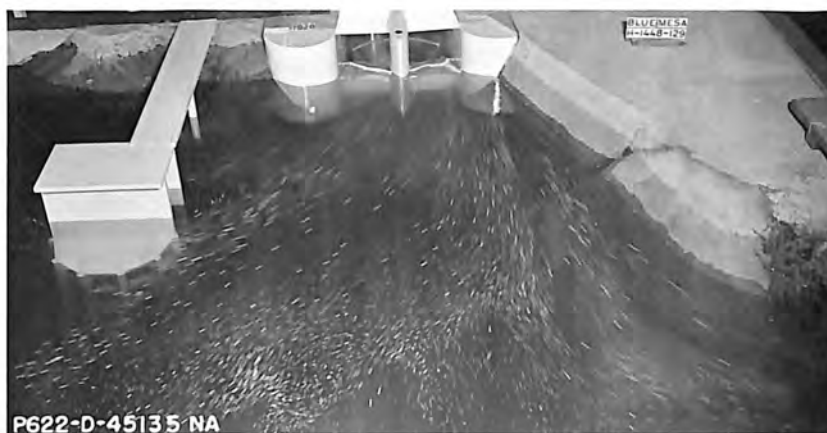
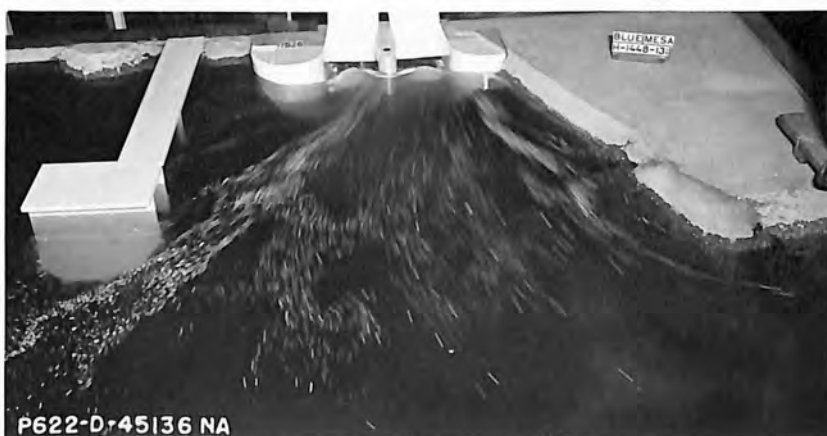
Figure 12
Report Hyd-515

A. 8,400 cfs

B. 16,850 cfs

C. 33,700 cfs

BLUE MESA DAM SPILLWAY

Flow in recommended approach channel
1:32.78 scale model

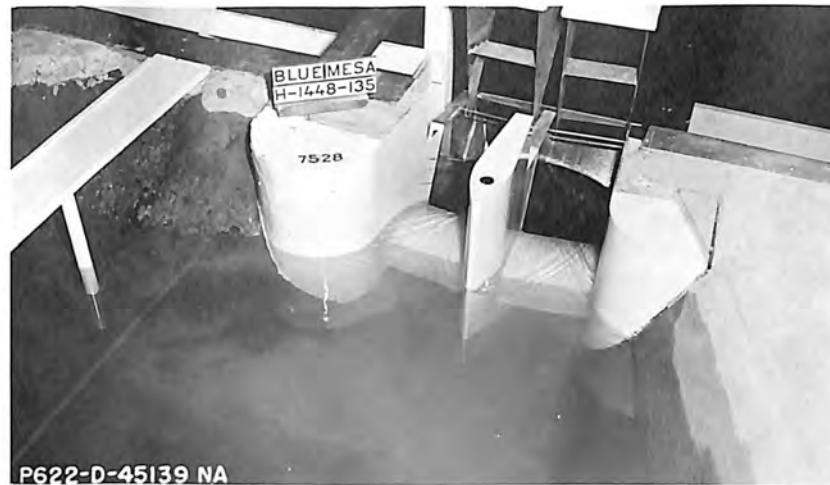
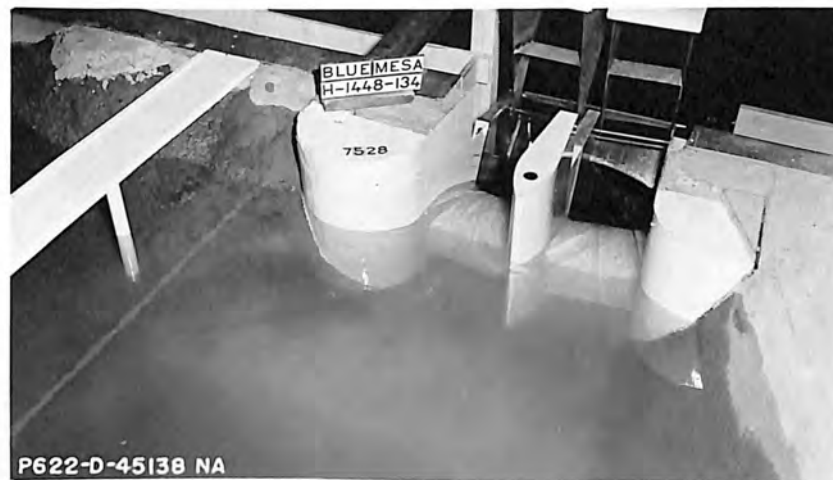
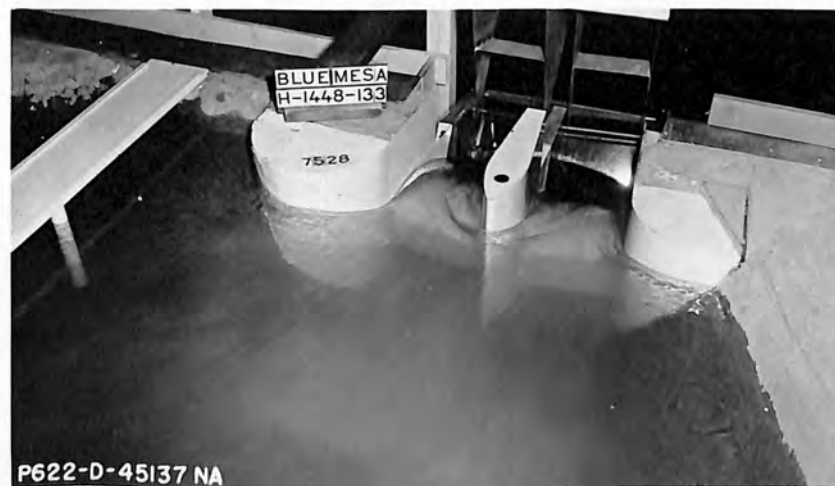
A. 8,400 cfs

B. 16,850 cfs

C. 33,700 cfs

BLUE MESA DAM SPILLWAY

Flow entering recommended gate structure
1:32.78 scale model

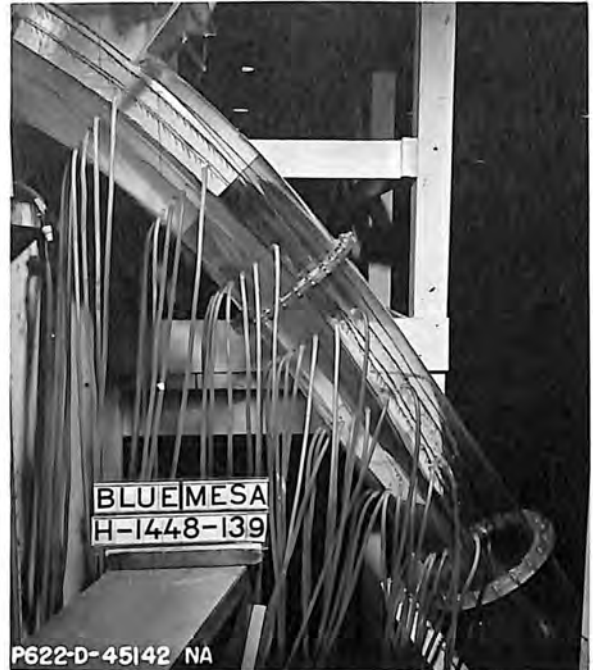
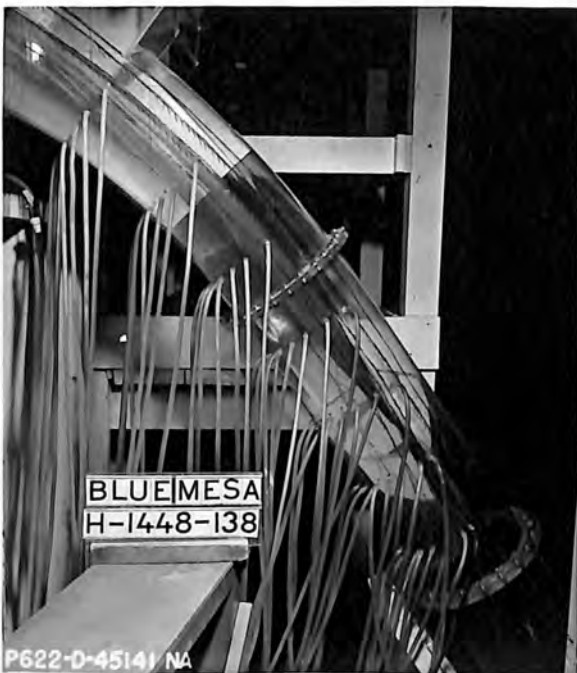
A. 8,400 cfs

B. 16,850 cfs

C. 25,250 cfs

D. 33,700 cfs

Note: The recommended pier is installed in transition section.
The water surface on tunnel walls for recommended design
is marked by the hatched lines. The line above each hatched
line is water surface for the preliminary design.

BLUE MESA DAM SPILLWAY

Flow in transition
1:32.78 scale model

Flow characteristics in the transition and inclined tunnel. --The recommended approach provided some improvement in flow conditions through the transition and steeply inclined tunnel; however, additional improvement was made by tapering the pier to a thickness of 18 inches rather than 24 inches at the downstream end, and by reducing the length along the invert from 53 to 41 feet, Figure 13. The extent of shortening and thinning of the center pier was limited since the pier was needed for structural support of the tunnel roof near the tunnel entrance portal.

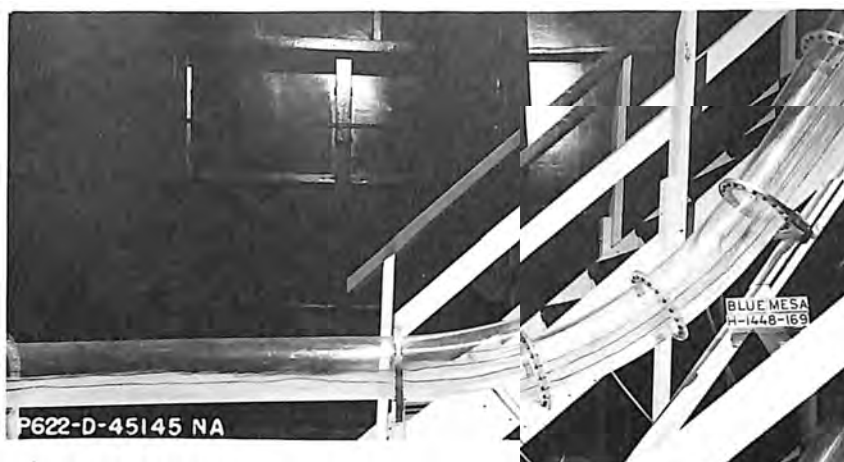
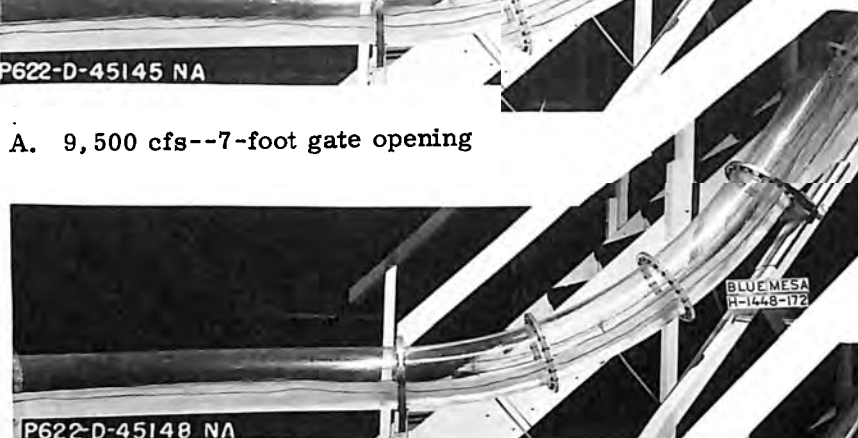
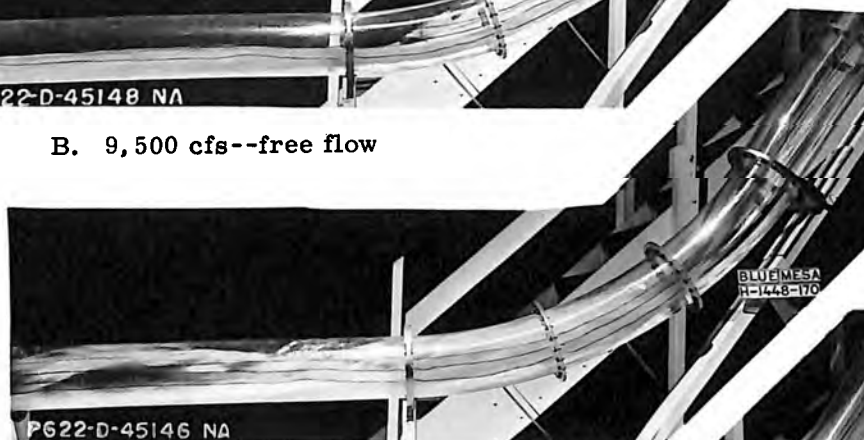
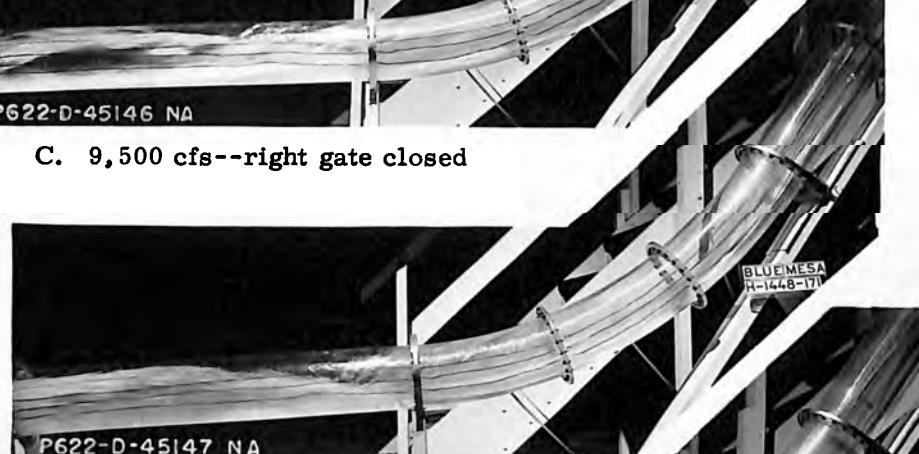
A. 9,500 cfs--7-foot gate opening

B. 9,500 cfs--free flow

C. 9,500 cfs--right gate closed

D. 9,500 cfs--left gate closed

BLUE MESA DAM SPILLWAY

Flow in vertical bend
1:32.78 scale model

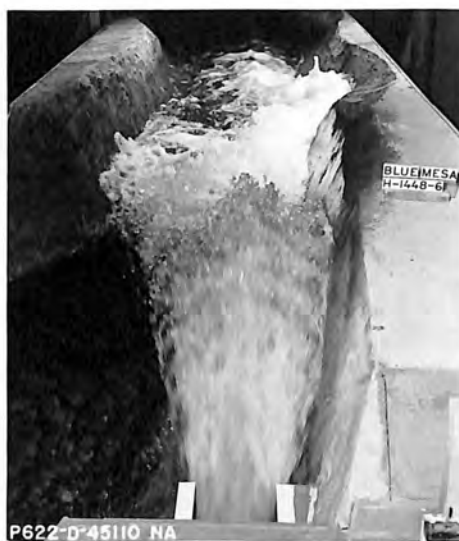
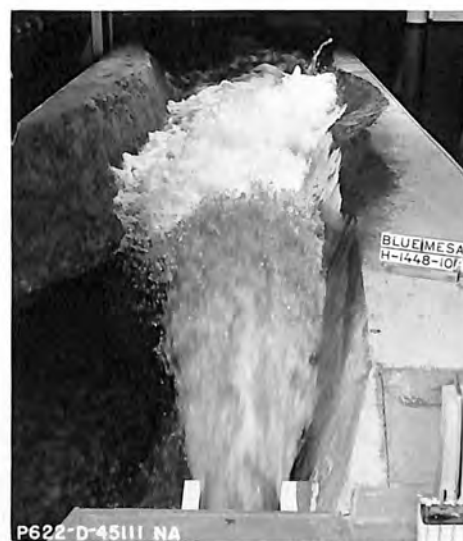
B. 8,400 cfs

C. 16,850 cfs

D. 33,700 cfs

Flow from preliminary flip bucket--
powerplant and outlet works operating
1:32.78 scale model

Flow characteristics in the flip bucket and stream channel. -- Preliminary tests showed that the flip bucket jet spread and impinged upon the excavated right bank of the stream channel, Figure 24. At the smaller discharges, a large eddy formed along the left bank when the spillway only was operating. Flow from the powerplant and outlet works eliminated the eddy. The spillway flows were concentrated near the right bank for all flow conditions.

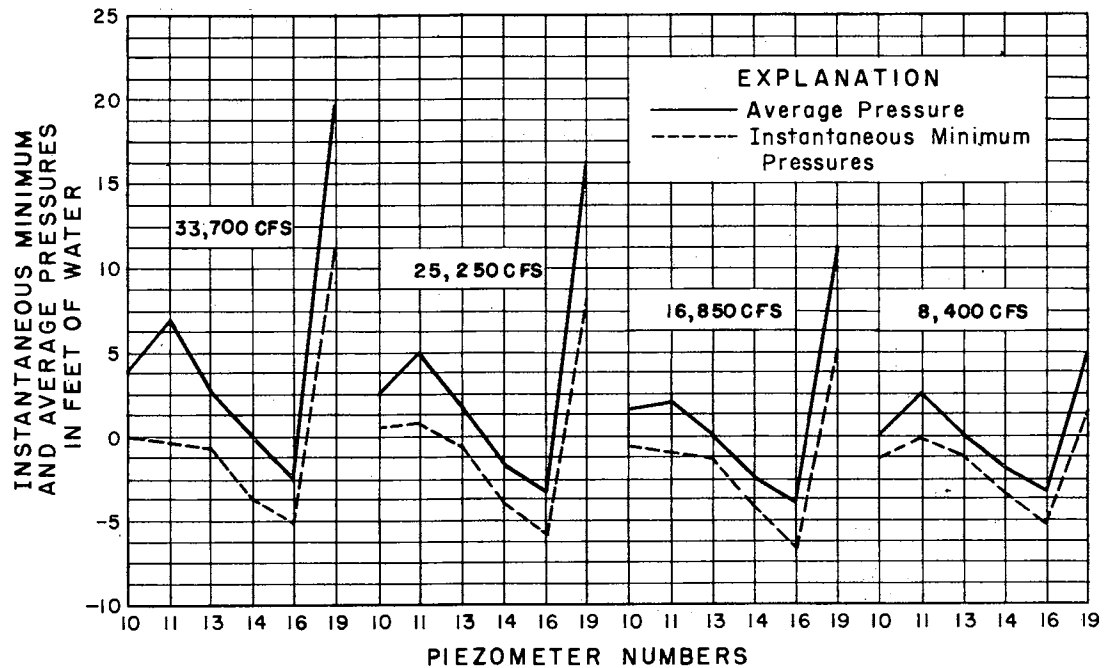
FIGURE 29
REPORT HYD-515

Pressure transducers were used to measure the average and minimum pressures in the diagram above. Water manometers were used to measure the minimum pressures in the diagram on the left. Zero pressure is atmospheric pressure. The flow was slide gate controlled from the spillway. An additional 8,180 cfs. was being discharged from the powerplant and outlet works. The tailwater elevation was normal for the improved channel. See Figure 26 for piezometer location.

BLUE MESA DAM SPILLWAY
PRESSURES IN THE RECOMMENDED FLIP - BUCKET
 1:32.78 SCALE MODEL

All pressures shown in Figures 27 and 28 were recorded when the flow velocity in the tunnel was controlled by the slide gate. For comparison the flip bucket pressures were again recorded for 33,700 cfs with the tunnel connected to the model reservoir. The agreement was very good, Figure 29. At Piezometer 1 in the invert of the tunnel the pressure obtained by free flow from the reservoir was higher indicating that the free-flow velocity was less than the gate-controlled velocity. In the bucket the impact pressures for free flow were lower than those obtained by gate-control flow. The slide gate-controlled flows provide the more representative results.

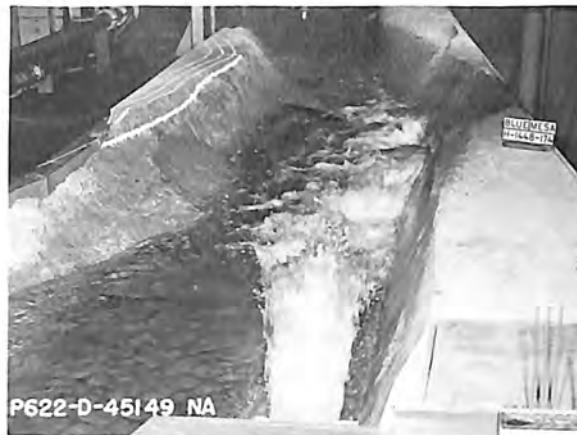
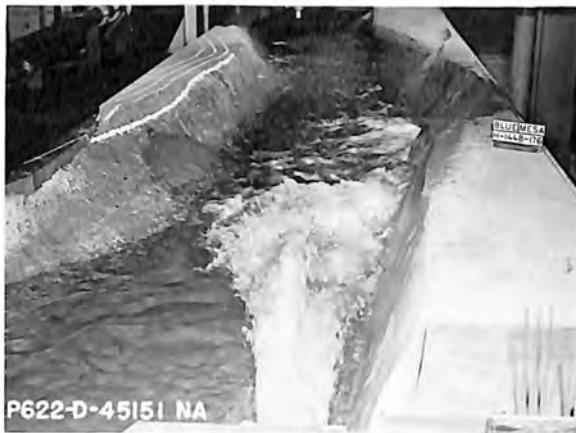
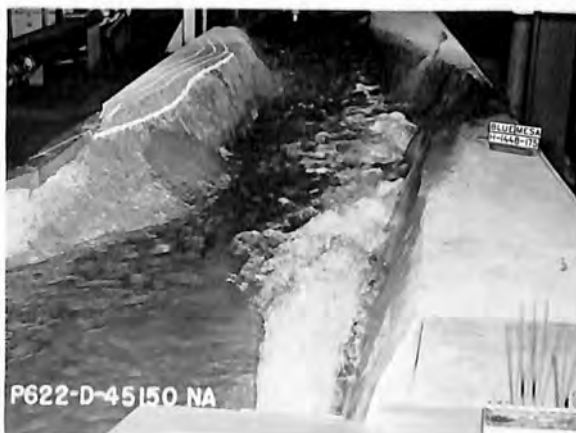
A. Both spillway gates open 5 feet

B. Left gate closed, right gate full open

C. Right gate closed, left gate full open

Discharge = 9,500 cfs

Spillway gate controlled flow from flip bucket
1:32.78 scale model

Flow characteristics in the flip bucket. --After completion of the reservoir portion of the model, the water to the flip bucket was supplied from the reservoir through the spillway intake. It was noted that the flow distribution in the stream channel could be changed by manipulation of the spillway gates. Operation at unequal gate openings at small discharges produced an unsymmetrical flow through the tunnel that was reflected in the flip bucket jet, Figure 30. The jets for the larger flows were not affected since both gates were fully open or nearly fully open to pass the discharge. For best flow distribution at all discharges, both gates should be opened approximately the same amount.

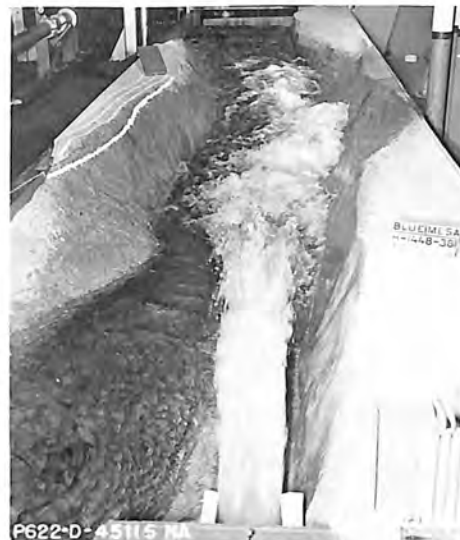
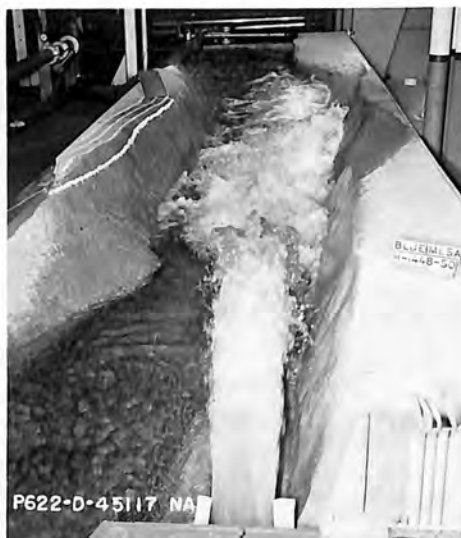
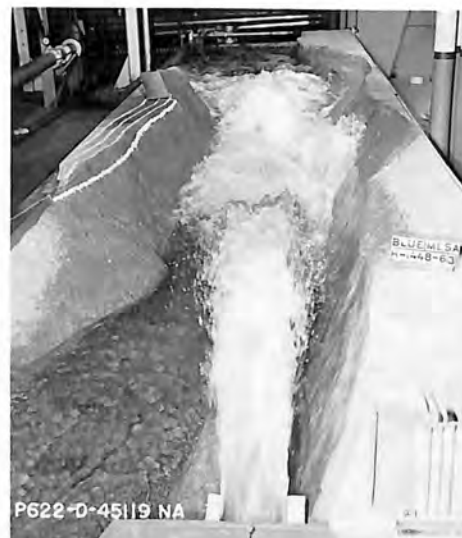
A. Spillway 8,400 cfs
Outlet works 5,100 cfs
Powerplant 3,080 cfs

B. Spillway 16,850 cfs
Outlet works 5,100 cfs

C. Spillway 25,250 cfs
Outlet works 5,100 cfs

D. Spillway 33,700 cfs
Outlet works 5,100 cfs

Flow from recommended flip bucket--
outlet works operating
1:32.78 scale model

The recommended bucket, with the right wall converged inward 3°, deflected the jet away from the excavated right bank. This was an improvement over the preliminary design. (Compare Figures 31 and 32 with Figure 24.) Dimensions of the jet are recorded in Figure 33. These dimensions were obtained when the flow was controlled by the slide gate.

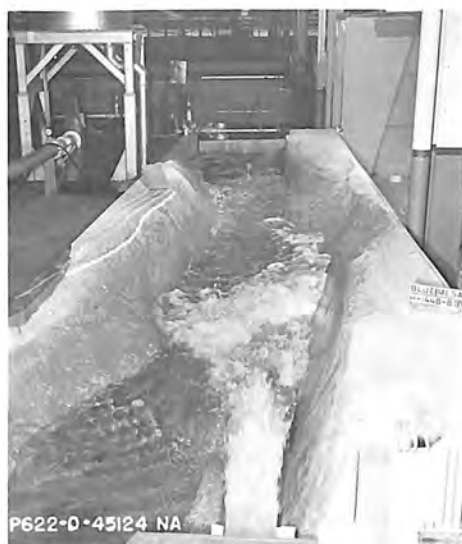
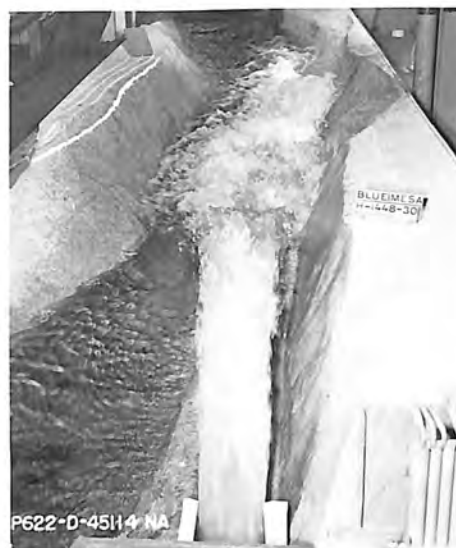
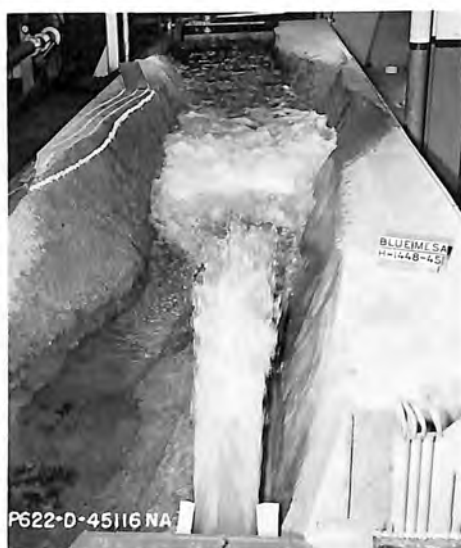
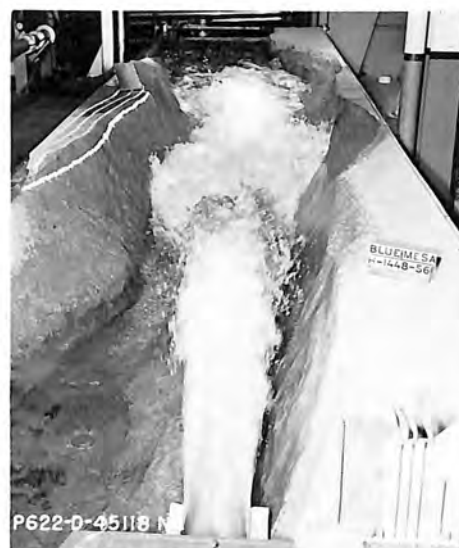
A. 8,400 cfs

B. 16,850 cfs

C. 25,250 cfs

D. 33,700 cfs

Flow from recommended flip-bucket--no flow
from outlet works or powerplant
1:32.78 scale model

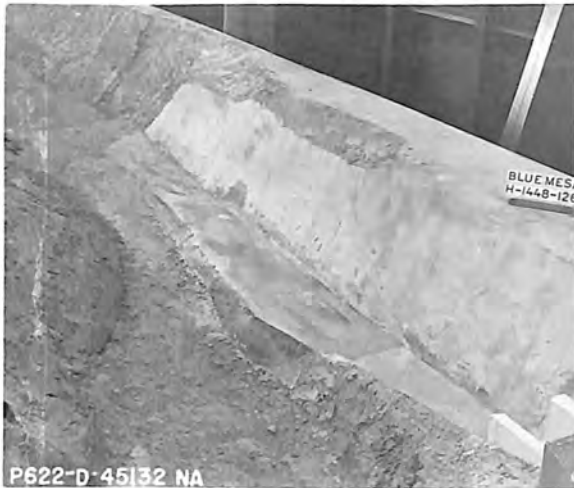
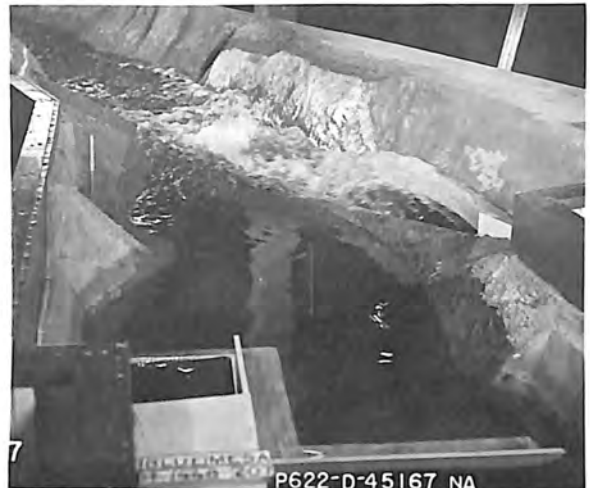
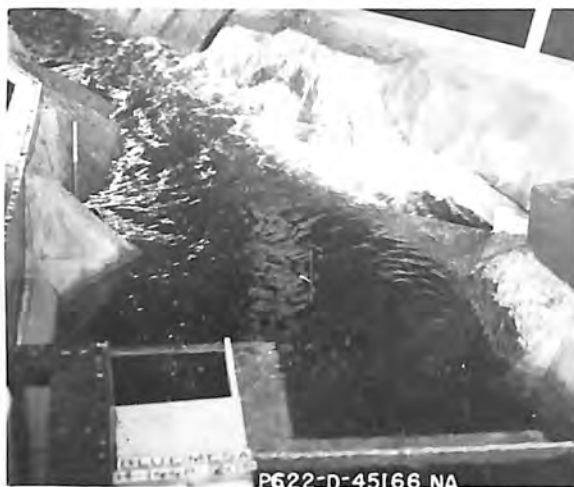
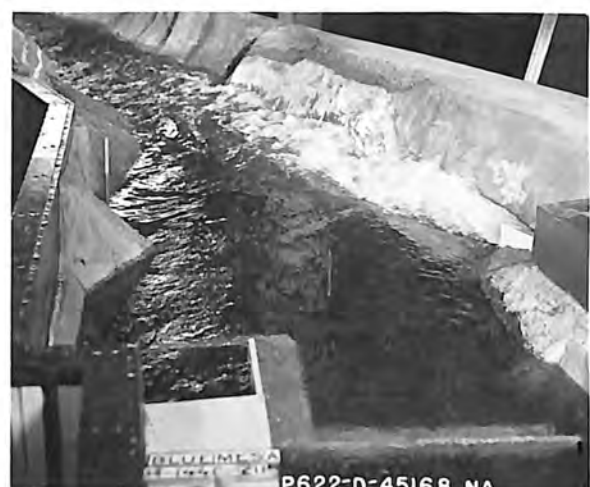
A. Revised streambed and
left bank topography

B. 5,500 cfs spillway

C. 5,500 cfs spillway
3,080 cfs powerplant

D. 5,500 cfs spillway
5,100 cfs outlet works
3,080 cfs powerplant

Flow from powerplant, outlet works,
and recommended flip bucket
1:32.78 scale model

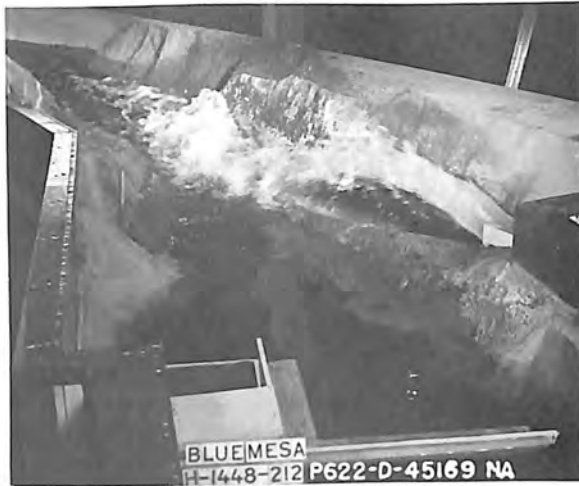
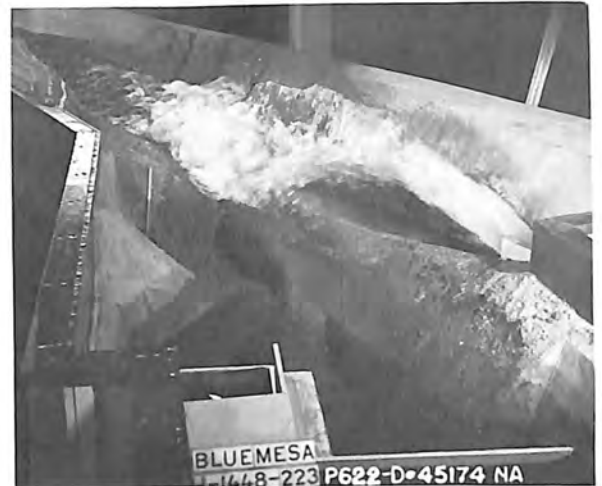
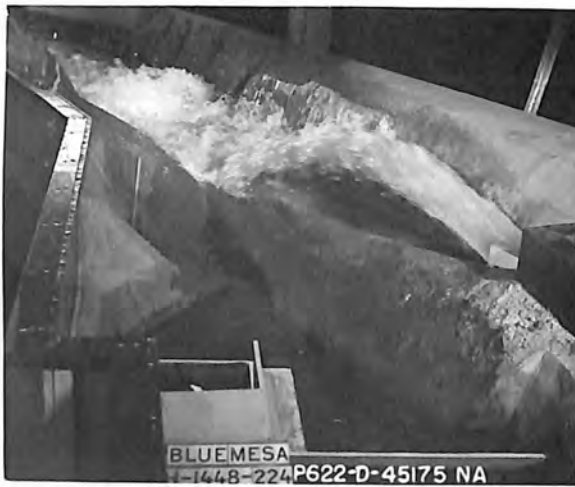
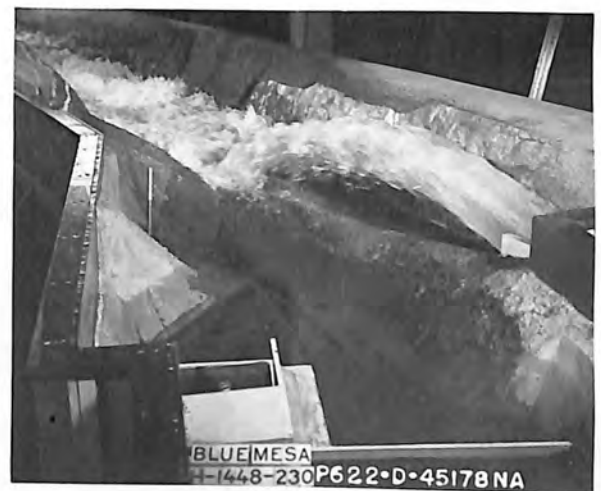
A. 9,500 cfs

B. 15,500 cfs

C. 21,500 cfs

D. 33,700 cfs

Flow from recommended flip bucket
1:32.78 scale model

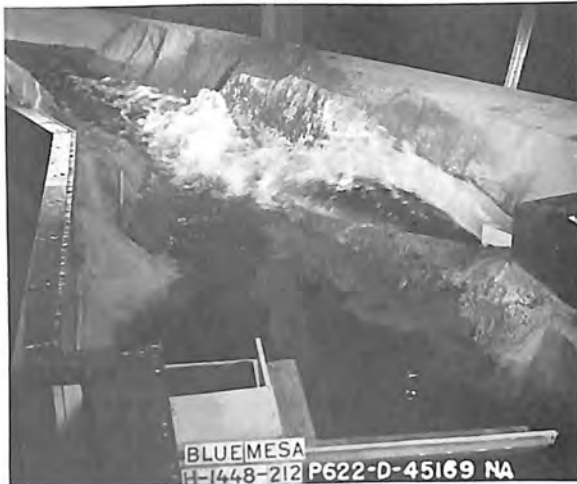
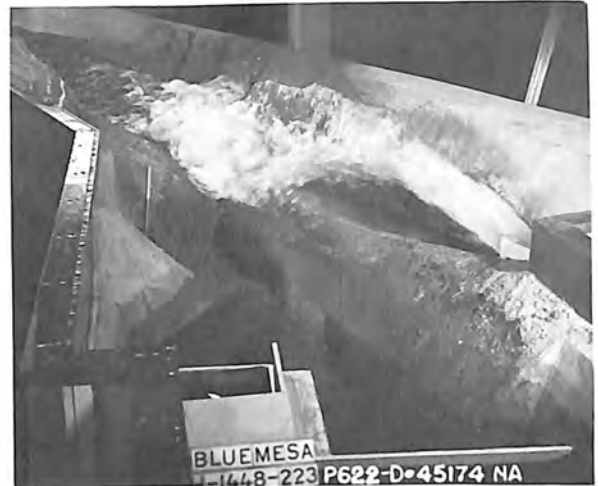
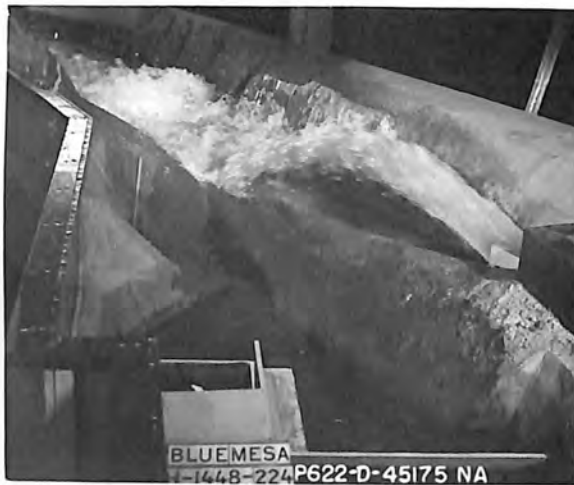
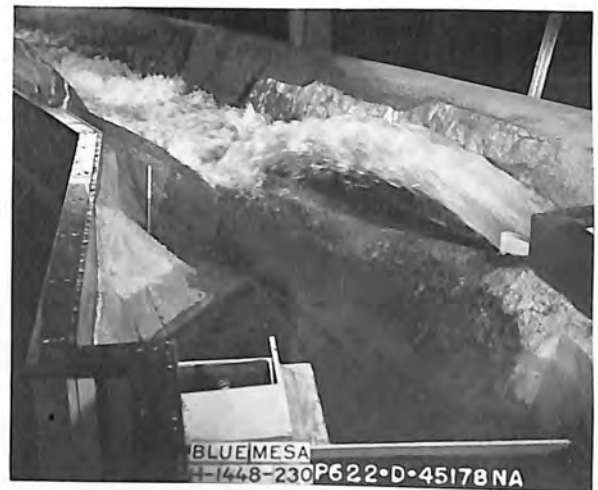
A. 9,500 cfs spillway
5,100 cfs outlet works
3,080 cfs powerplant

B. 15,500 cfs spillway
5,100 cfs outlet works
3,080 cfs powerplant

C. 21,500 cfs spillway
5,100 cfs outlet works

D. 28,000 cfs spillway
5,100 cfs outlet works

Flow from powerplant, outlet works, and
recommended flip bucket
1:32.78 scale model

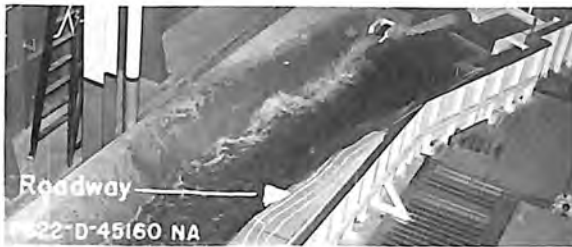
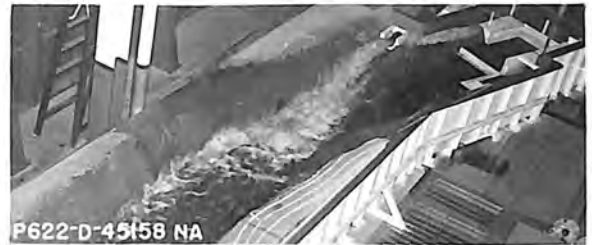
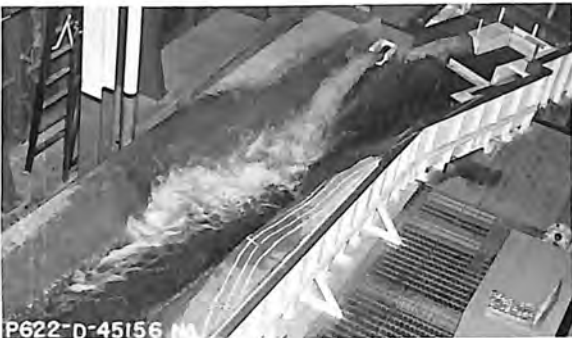
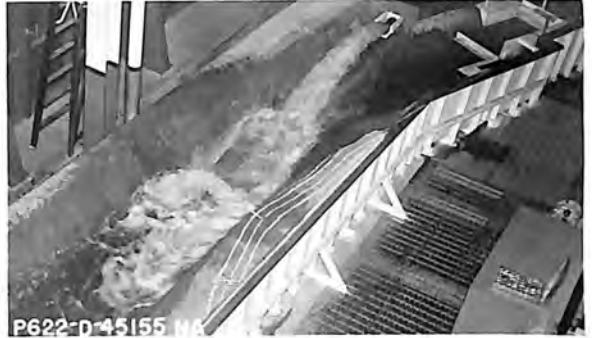
A. Spillway--5,500 cfs

B. Spillway--9,500 cfs

C. Spillway--15,500 cfs

D. Spillway--21,500 cfs

Flow in stream channel--recommended flip bucket
1:32.78 scale model

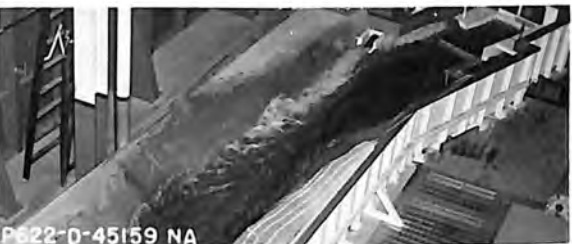
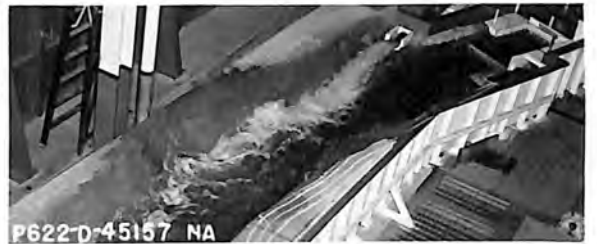
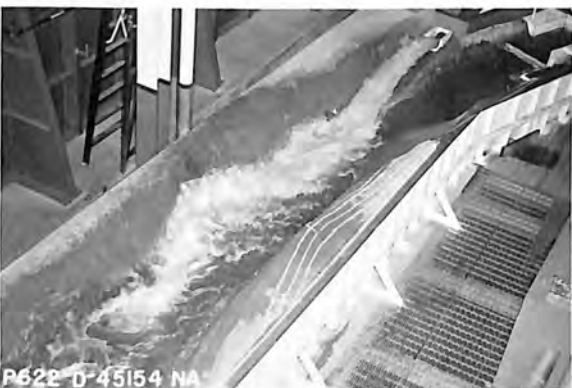
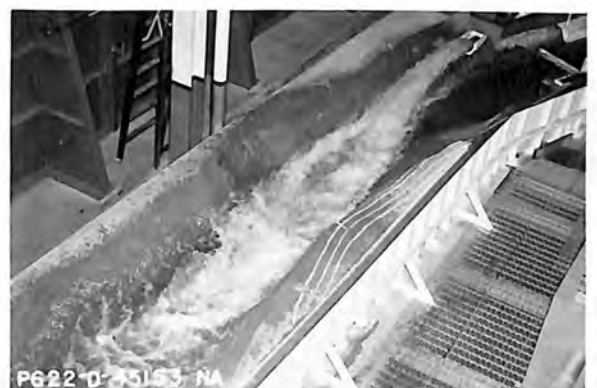
Figure 38
Report Hyd-515

E. Spillway--5,500 cfs
Outlet works--5,100 cfs
Powerplant--3,080 cfs

F. Spillway--9,500 cfs
Outlet works--5,100 cfs
Powerplant--3,080 cfs

G. Spillway--21,500 cfs
Outlet works--5,100 cfs

H. Spillway--28,000 cfs
Outlet works--5,100 cfs

Note: Dark areas on roadway in C, D, F, G, and H is
result of spray from jet.

Flow characteristics in the powerplant and outlet works area were satisfactory with or without the spillway operating, Figures 38 and 39. It was clearly demonstrated that the tailwater control structure was needed to maintain the minimum tailwater elevation for the powerplant tailrace and outlet works stilling basin for spillway discharges exceeding about 15,000 cfs. Should the tailwater elevation be less than anticipated, the control structure will be needed for even smaller spillway flows. Tailwater elevations upstream and downstream of the structure were recorded for various combinations of flows and are tabulated in Table 2.

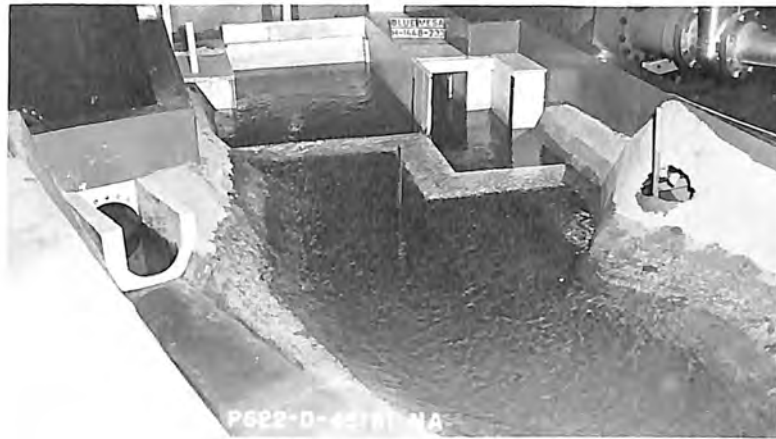
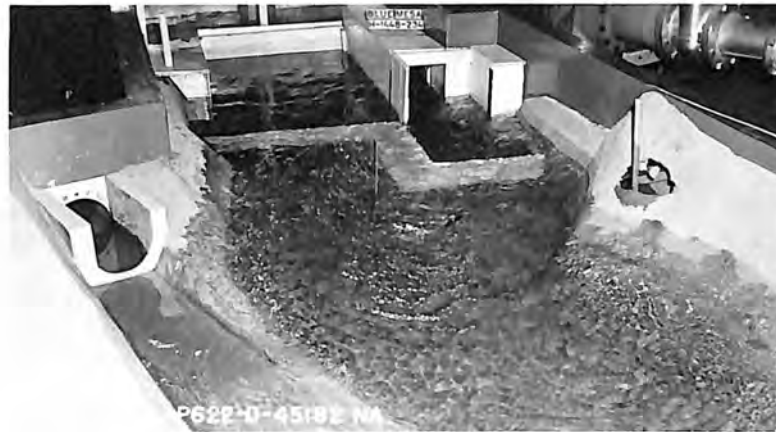
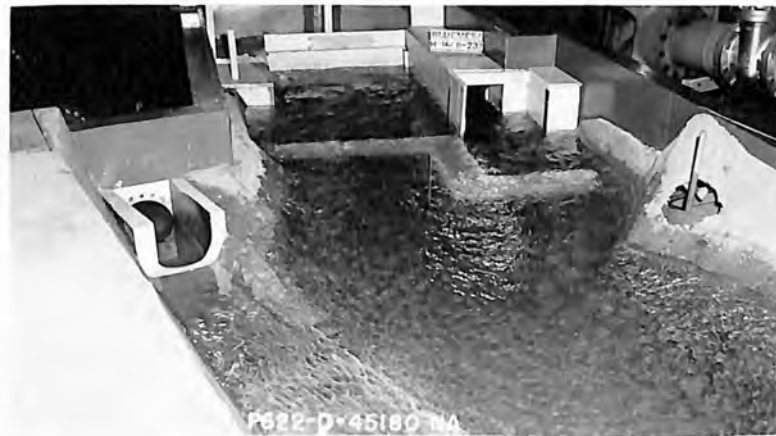
Figure 39
Report Hyd-515

A. 3,080 cfs powerplant

B. 5,100 cfs outlet works

C. 5,100 cfs outlet works
3,080 cfs powerplant

Flow over tailwater control structure--
no flow in spillway
1:32.78 scale model

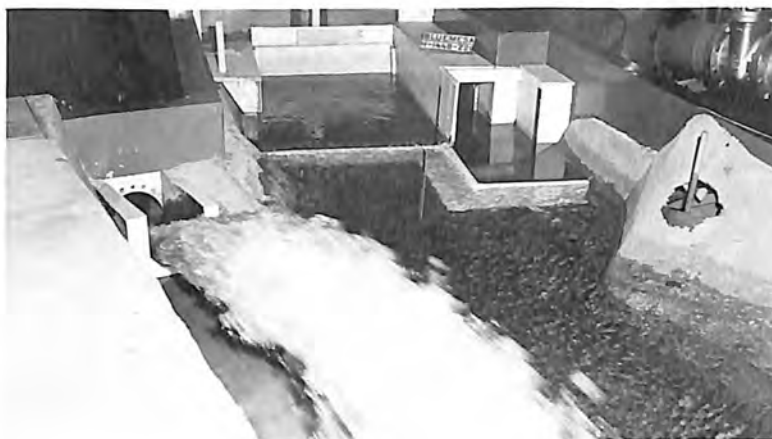
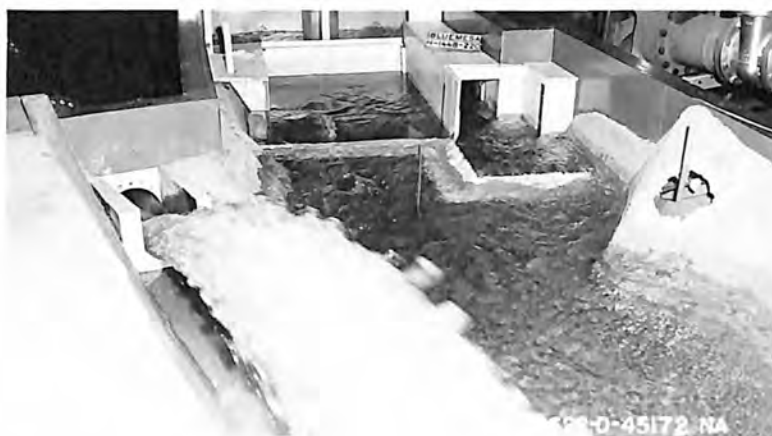
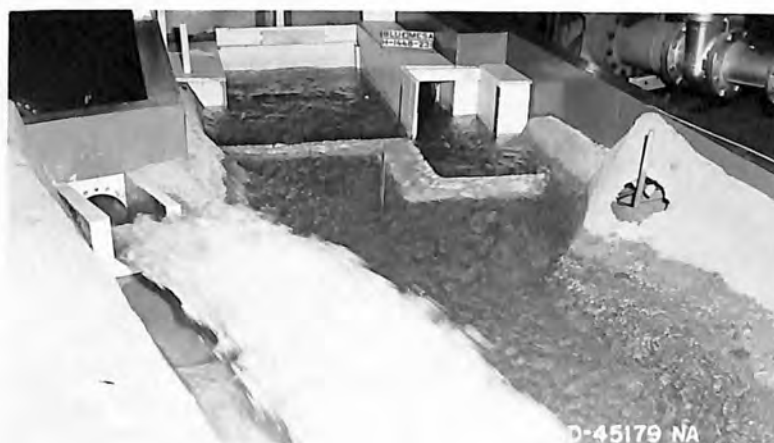
**A. 15,500 cfs spillway
3,080 cfs powerplant**

**B. 15,500 cfs spillway
5,100 cfs outlet works**

**C. 15,500 cfs spillway
5,100 cfs outlet works
3,080 cfs powerplant**

**Flow over tailwater control structure--
spillway operating
1:32.78 scale model**

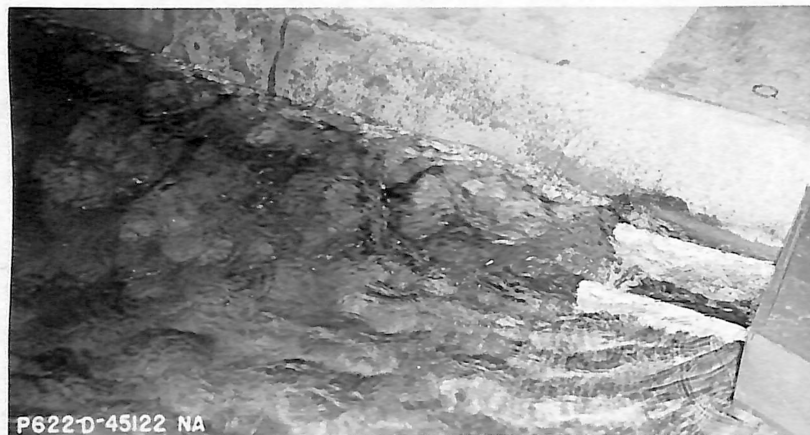
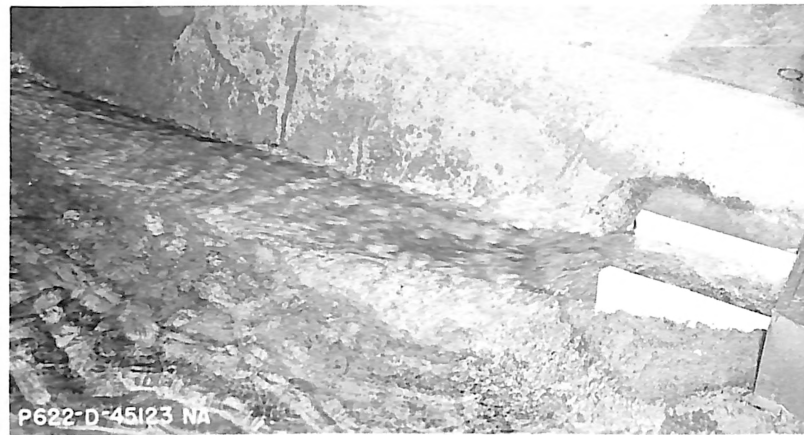
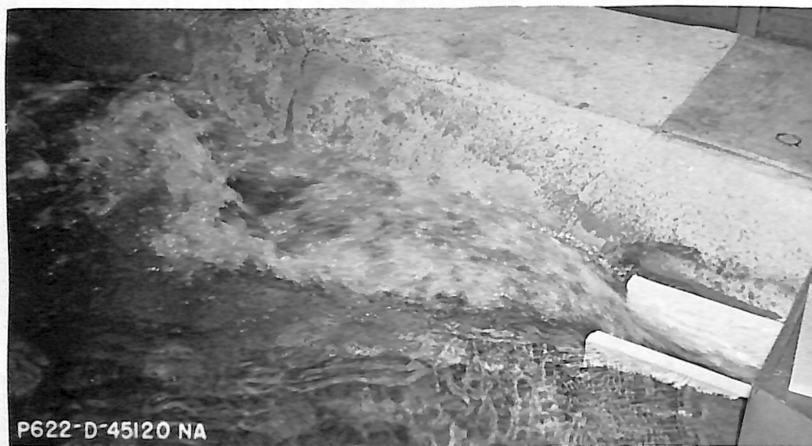
A. 6,400 cfs, unimproved channel

B. 6,400 cfs, improved channel

C. 14,100 cfs, unimproved channel

D. 14,100 cfs, improved channel

A model diversion flow of approximately 100 cfs was also observed by representatives of the contractor to aid in planning the channel improvement work.
