HYDRAULIC MODEL STUDIES OF FLAMING GORGE DAM
SPILLWAY AND OUTLET WORKS
COLORADO RIVER STORAGE PROJECT, UTAH

Report No. Hyd-531

May 28, 1964

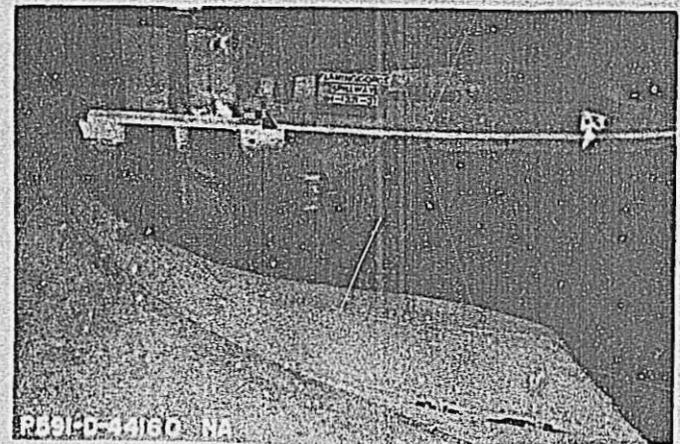
18-foot-radius pier on right side

27-foot-radius pier on right side

A. Fourth modification

B. Fifth modification

Spillway Approach Channel
Modifications

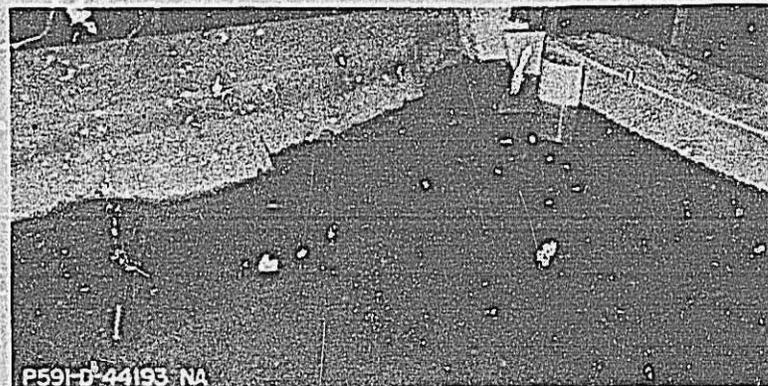
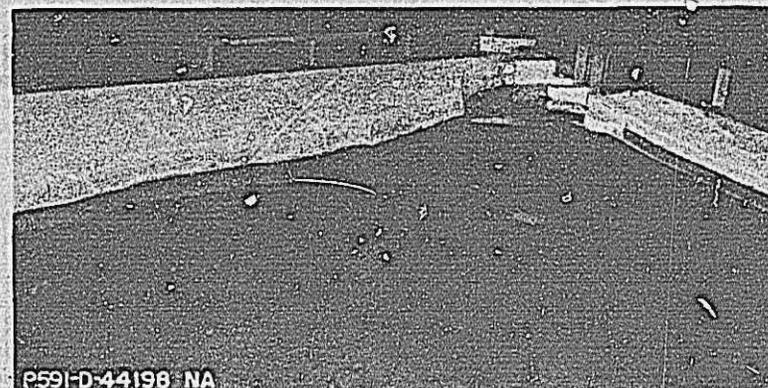
No flow

$Q = 7,200$ cfs

$Q = 28,800$ cfs

Flow in Spillway Approach
with Contractors Excavation

1. The preliminary approach channel was modified to improve flow conditions in the spillway entrance, Figure 6.
2. The excessive amount of excavation in the spillway approach area to accommodate the contractor's mix plant greatly improved the flow conditions in the approach channel, Figure 19.

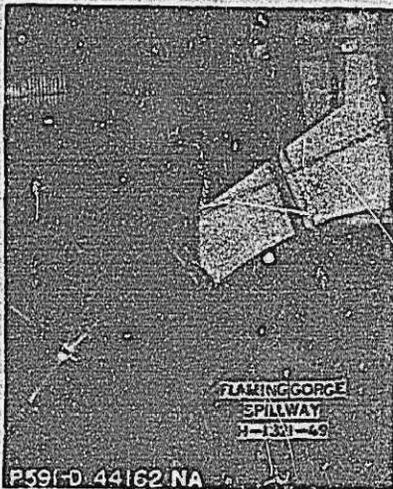
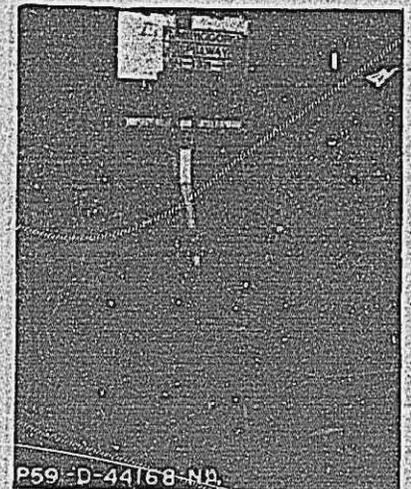
Flow with Preliminary Modified and Recommended Center Pier.

Preliminary pier and first modification to approach channel

Modified pier with first modification to approach channel

A. Maximum discharge in transition with preliminary and modified pier

Note "rope" of air at end of pier.

B. Maximum discharge in transition with recommended pier and recommended approach channel.

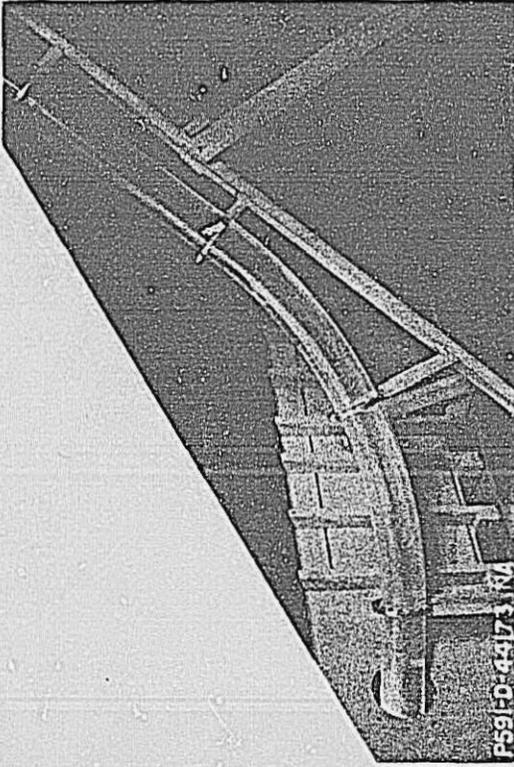
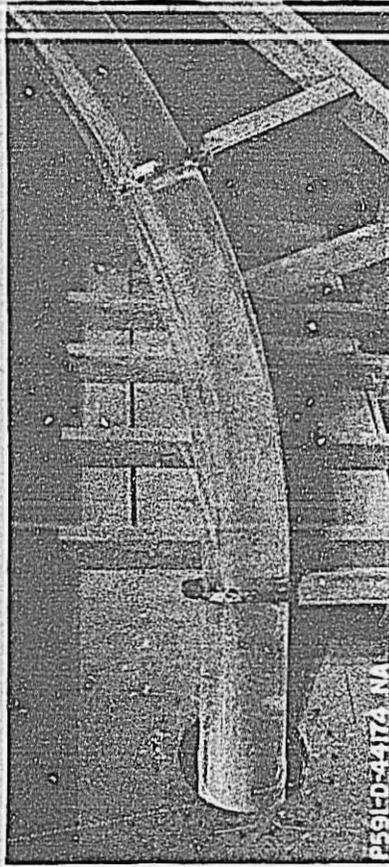
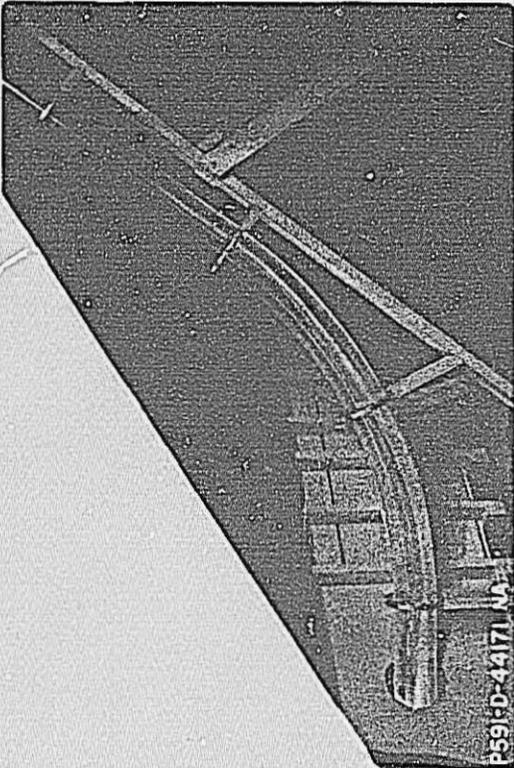
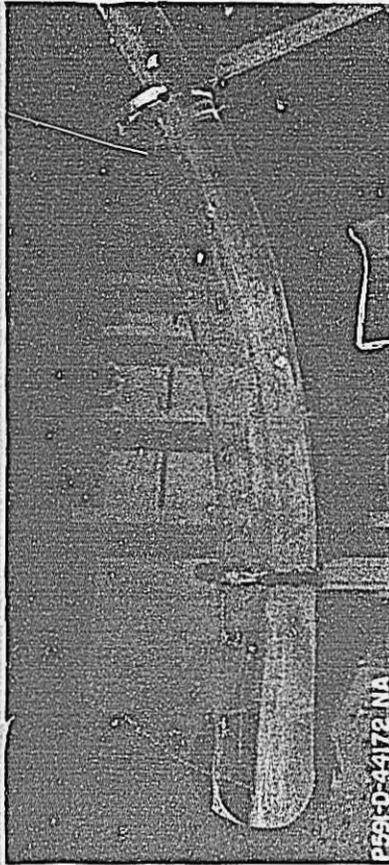
Flow in Sloping Tunnel, Vertical Bend
and Horizontal Tunnel

Discharge = 28,800 cfs

Discharge = 15,000 cfs

Unequal gate openings. --Flow conditions with unequal gate openings were very poor. The flow switched from side to side in the tunnel and on occasion would swirl over the crown. Unsymmetrical gate operation should be avoided.

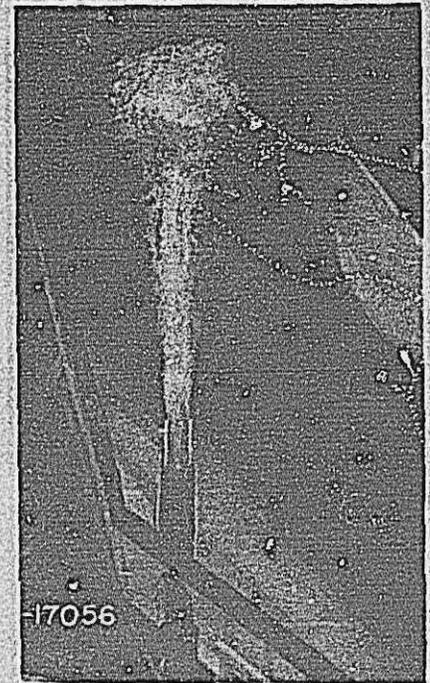
Flow in Preliminary Flip Bucket
35° Flip Angle

Discharge = 7,200 cfs

Discharge = 28,800 cfs

Pressures measured on the sidewalls of the 35° bucket indicated that the maximum pressure was approximately 11 times hydrostatic pressure and occurred near the base of the wall at about three-quarters of the bucket length downstream from the PC. At the end of the bucket, the maximum pressure was 4 times greater than hydrostatic. For the 15° bucket, the maximum pressure was 4 times greater than hydrostatic and occurred from about one-quarter to three-quarters of the bucket length. At the end of the bucket, the maximum sidewall pressure was about twice the hydrostatic pressure.

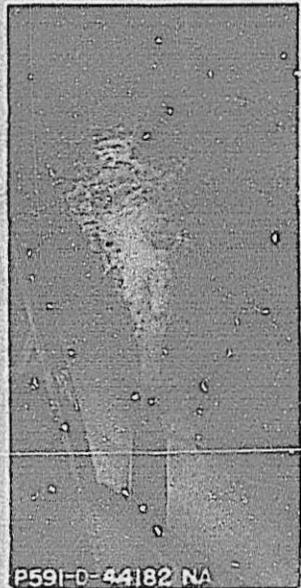
**Flow from Tunnel
with no Flip Bucket**

Q = 7,200 cfs

Q = 28,800 cfs

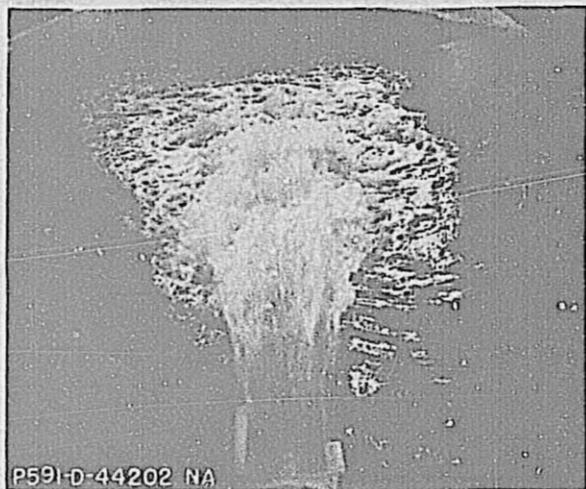
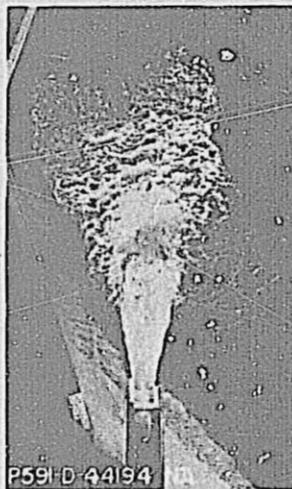
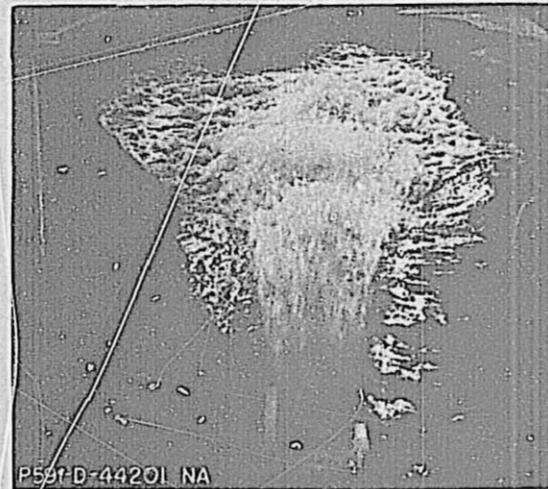
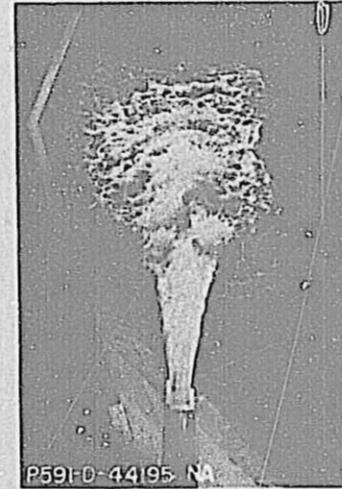
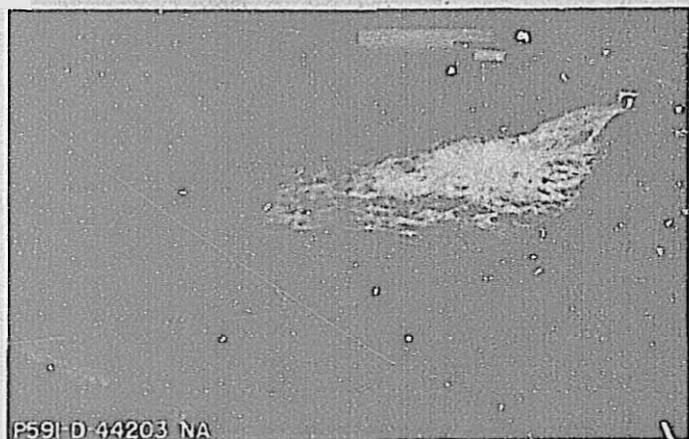
Flow in Recommended Flip Bucket

Discharge = 7,200 cfs
T. W. elevation = 5607.0

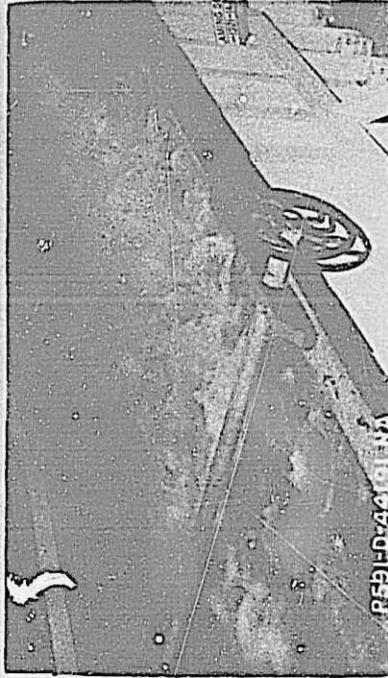
Discharge = 28,800 cfs
T. W. elevation = 5617.0

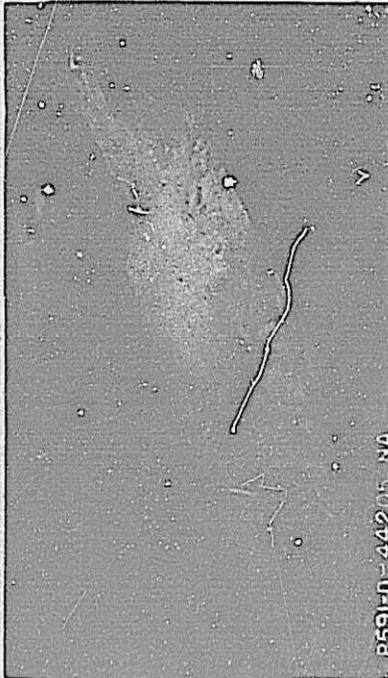
Discharge = 21,600 cfs
T. W. elevation = 5614.5

FLAMING GORGE DAM
1:36 Scale Model

Flow in Recommended Flip Bucket
Powerplant Q = 3,000 cfs

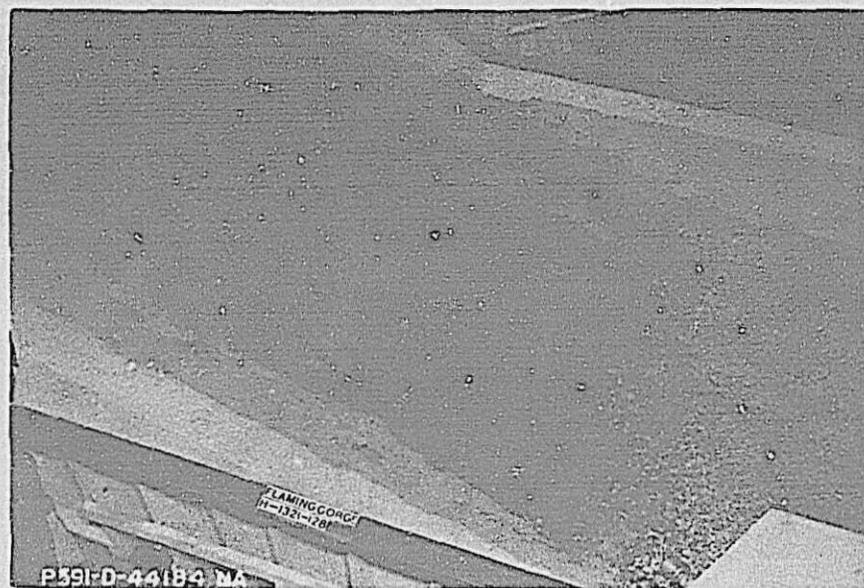
Preliminary alinement

Both valves turned 5° to right

Erosion pattern after 2 hours model operation
at a discharge of 1,000 cfs per valve. Preliminary
valve alinement.

Valve alinement and Scheme No. 1 Riprap Protection

An eddy formed to the right of the jet impact area at all discharges, Figure 41. The eddy moved upstream along the right bank, across the channel in front of the afterbay, then under the jets and downstream into the impact area. At maximum discharge the eddy eroded large quantities of the riverbed material which was carried downstream to form a bar across the full width of the river. The force of the eddy moving in front of the afterbay was sufficient to undercut the riprap and cause extensive damage to the sloped floor.

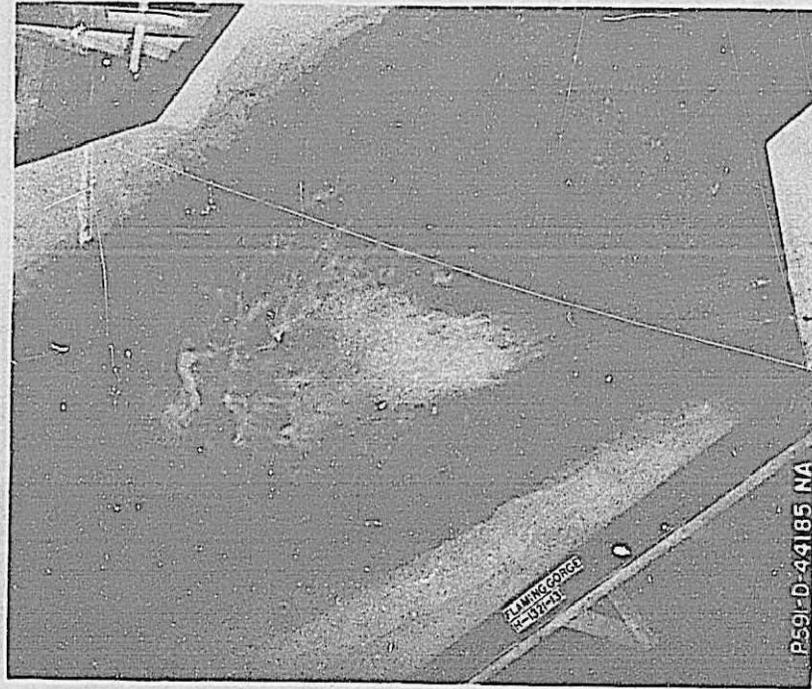
Figure 44
Report Hyd-531

River outlets discharging 2,000 cfs per valve. * Reservoir elevation 6045.

Riverbed erosion after 2-1/2 hours operation (model time). Discharge of 1,000 cfs per valve. Reservoir elevation 6045.

Riprap Evaluation for 1,000 cfs Discharge
Scheme No. 2

The riprap proposed in Scheme No. 2 was installed in the model and tested at varying discharges. The initial tests were with 1,000 cubic feet per second through each valve and no flow through the powerhouse. After 2-1/2 hours operation (model time) there was extensive erosion downstream from the riprap, but no movement of the riprap was observed, Figure 43. The discharge was increased to 2,000-cubic-feet-per-second per valve, Figure 43, and the test continued for 1-1/2 hours. After this period of operation, the extent of the erosion had not materially increased, Figure 44. The test was continued for an additional 4 hours at the same discharge, during which the erosion in the jet impact area was very extensive but the riprap had not moved, Figure 44.

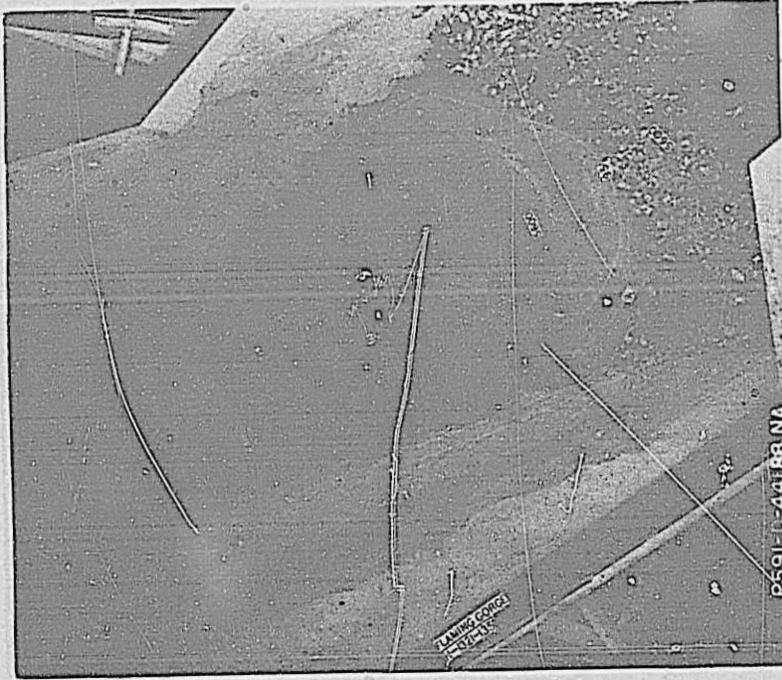
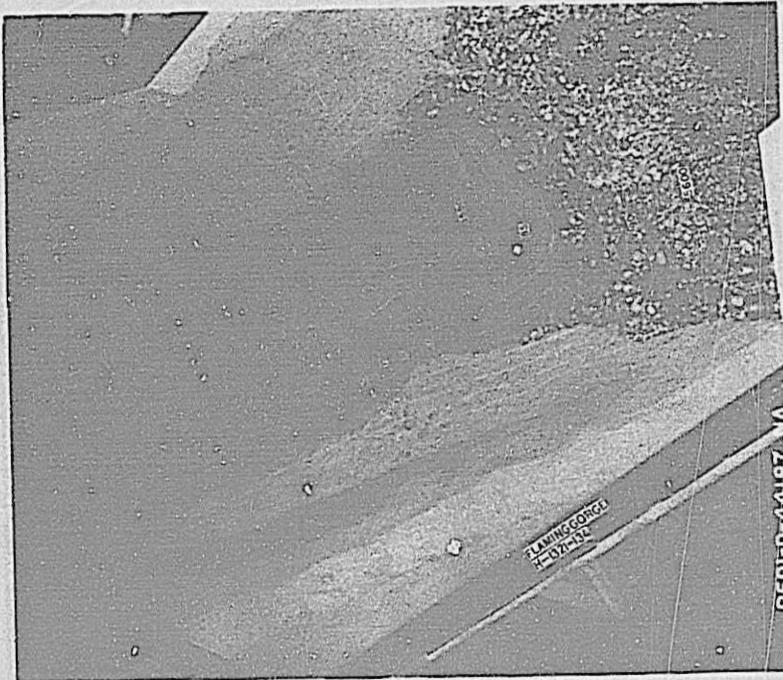
Erosion after 2-1/2 hours at
1,000 cfs per valve and 5-1/2 hours
at 2,000 cfs per valve. Reservoir
elevation 6045

Erosion after 2-1/2 hours at
1,000 cfs per valve and 1-1/2 hours
at 2,000 cfs per valve. Reservoir
elevation 6045

FLAMING GORGE DAM
1:36 Scale Model
Riprap Evaluation for 2,000 cfs Discharge
Scheme No. 2
