UNITED STATES
DEPARTMENT OF THE INTERIOR
BUREAU OF RECLAMATION

HYDRAULIC MODEL STUDIES OF SWIFT DAM
SPILLWAYS--PONDERA COUNTY CANAL
AND RESERVOIR COMPANY, MONTANA

Report No. Hyd-548

Hydraulics Branch
DIVISION OF RESEARCH

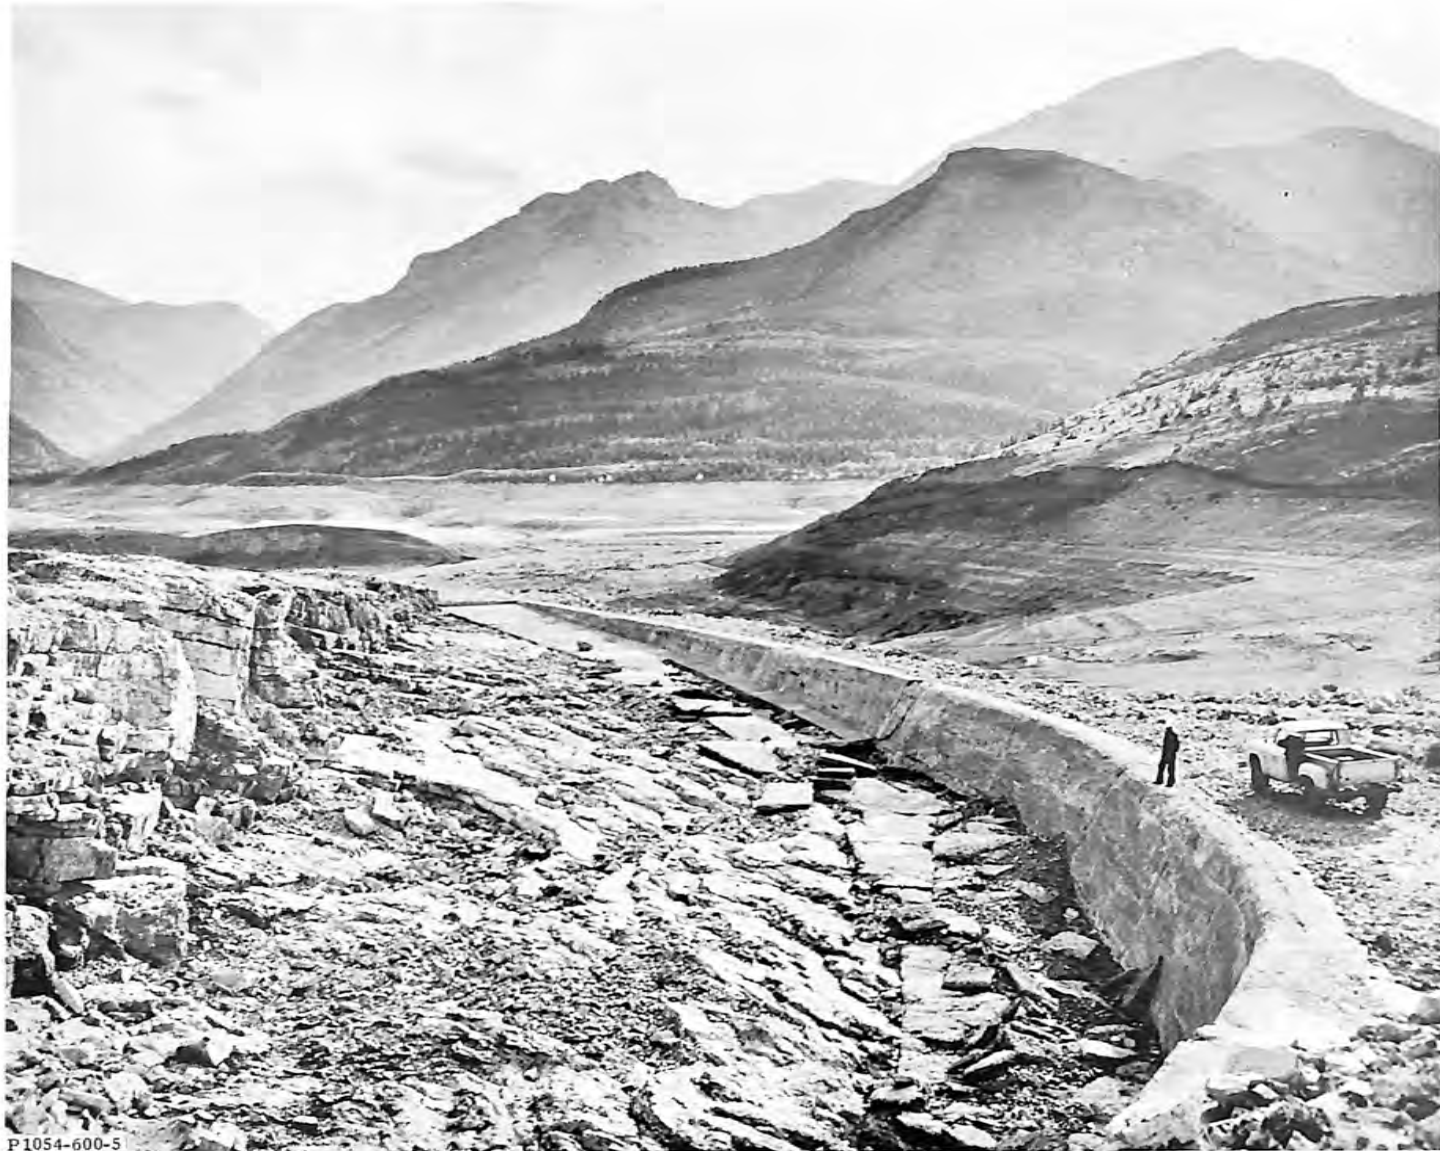
Figure 6
Report Hyd-548

SWIFT DAM
Existing Channel Spillway

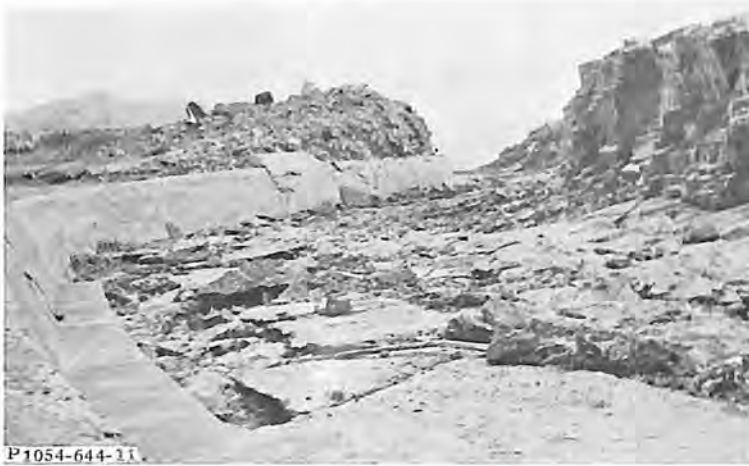
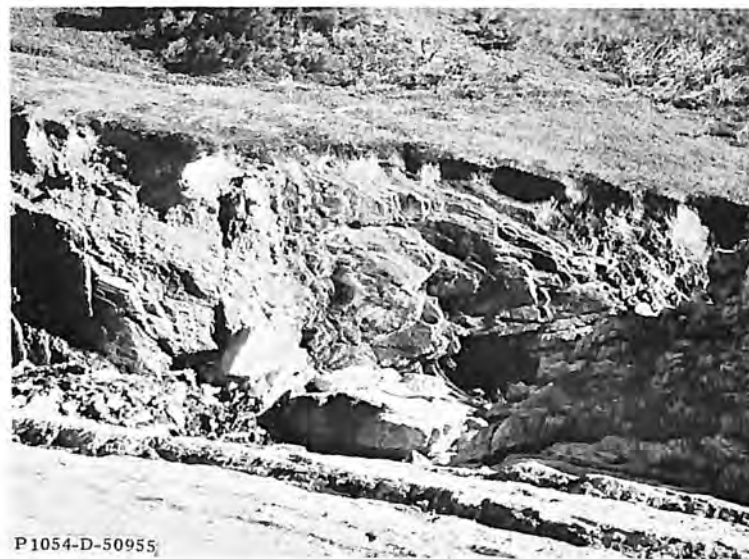
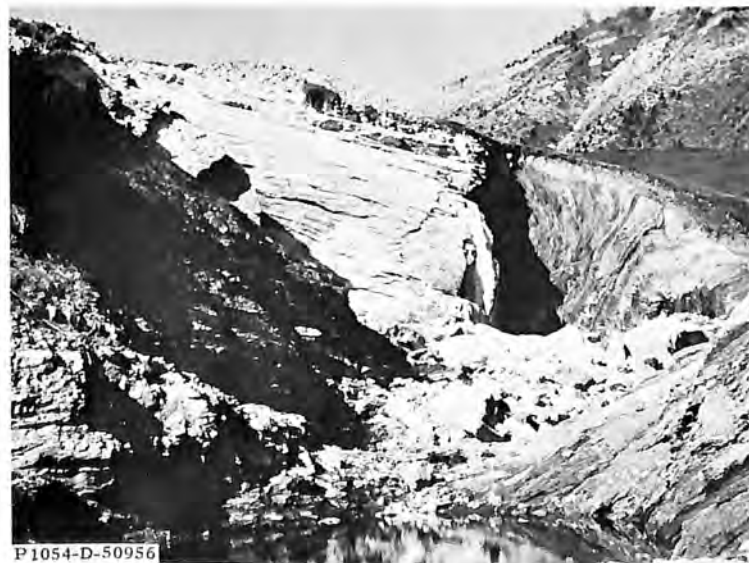
A. Looking downstream.
Side channel spillway.

B. Looking downstream
from end of spillway
into eroded gully.

C. Looking upstream.
Spillway flow is from
the left.

SWIFT DAM

Existing Channel Spillway and Gully

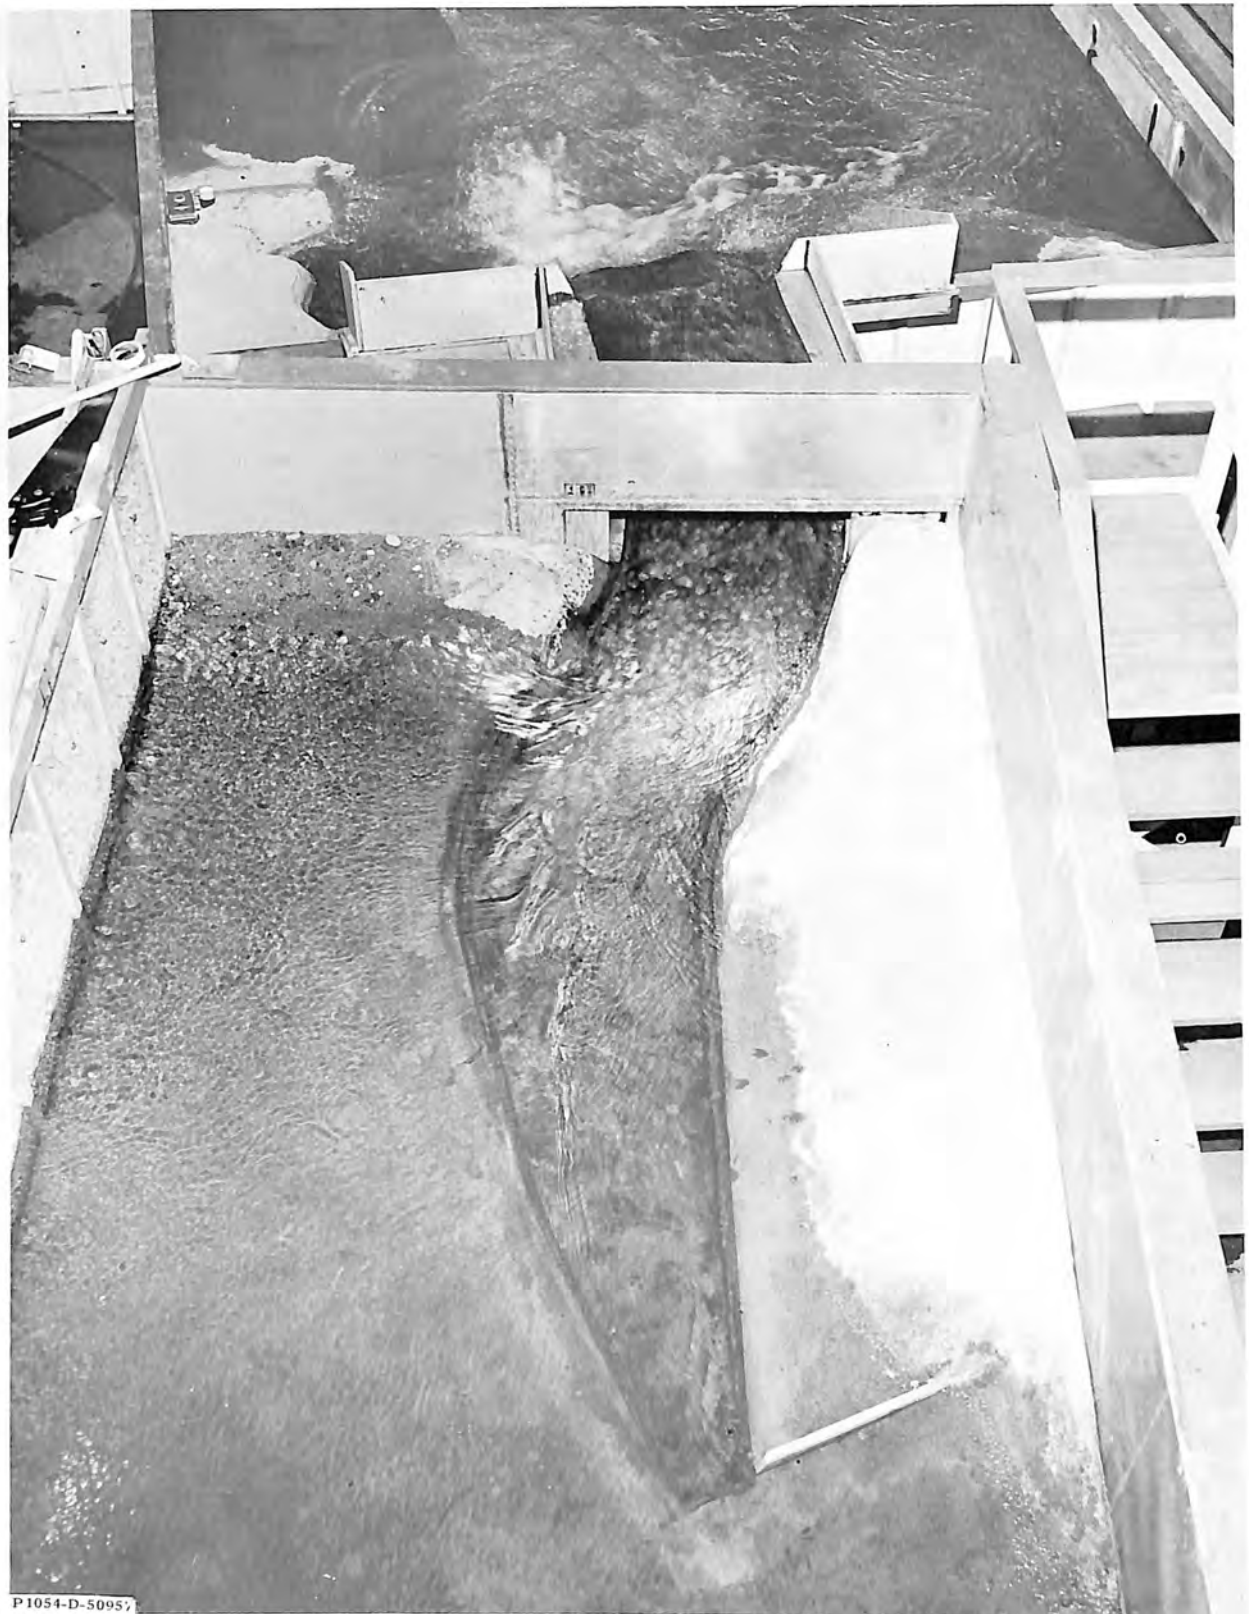
SWIFT DAM SPILLWAYS

1:42 Scale Model
Channel Spillway Model

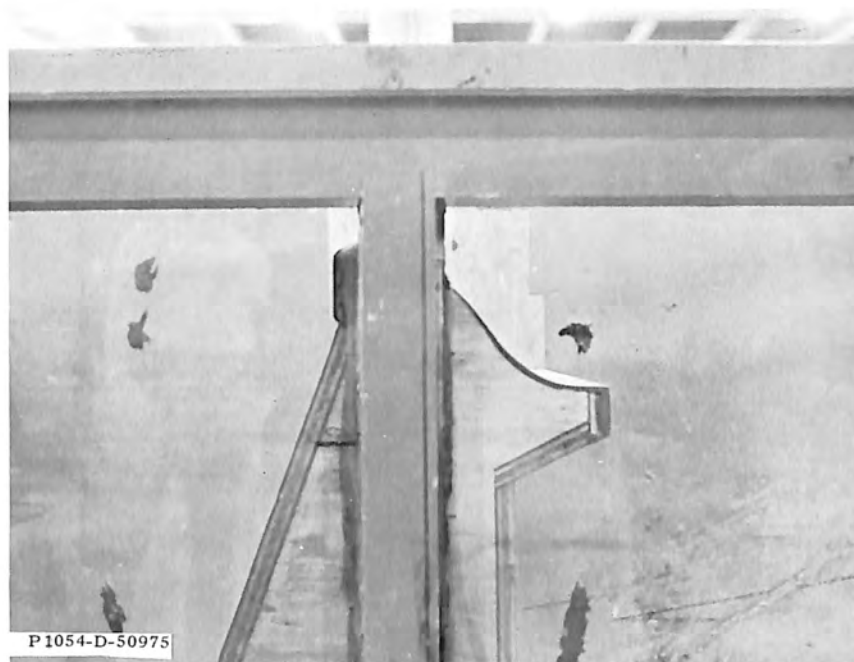
A. Looking upstream.

B. Side view, showing flip bucket.

SWIFT DAM SPILLWAYS

1:18 Scale Model
Sectional Model of the Arch Dam Emergency Spillway

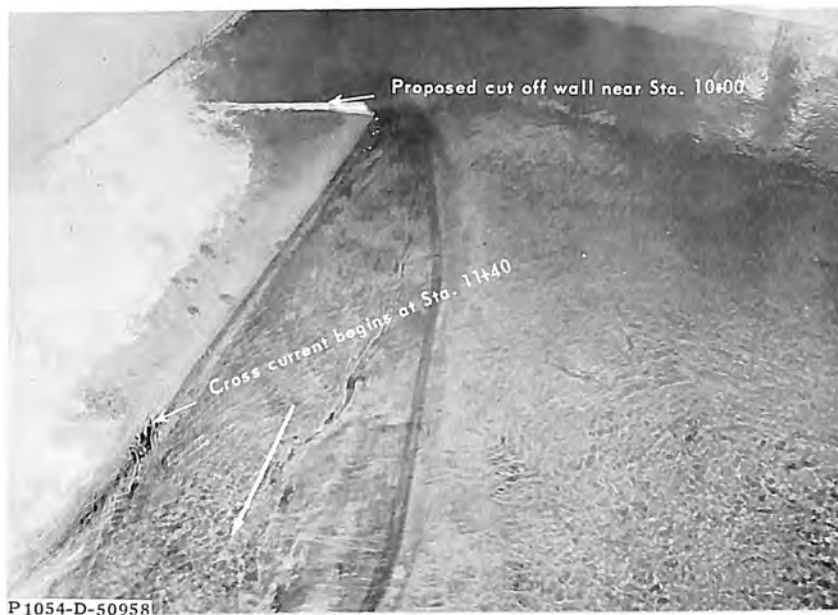
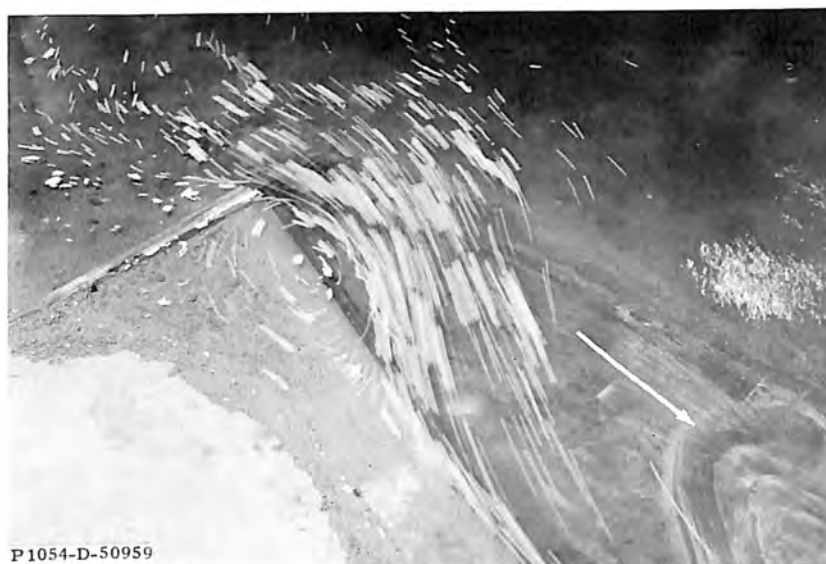
Figure 12
Report Hyd-548

A. Upstream end of spillway.

B. Flow at the cutoff wall.

1:42 Scale Model
Flow in Preliminary Channel Spillway--25,000 cfs

Flow characteristics in the channel. --In general, the flow conditions were satisfactory especially for flows of less than 14,000 cfs above which the crest submerged. For a discharge of 25,000 cfs the flow was fairly smooth and well distributed in the upstream part of the channel. However, disturbances formed along the right wall at a proposed cutoff or deflector wall near Station 10+00 and at about Station 11+40, where a typical cross wave pattern developed as a result of the curved wall alignment, Figure 11. On the left side of the spillway near the earth dike, at approximately Station 13+00, the ground surface was slightly higher than the crest. The flow velocity in this region increased and created a drawdown in the water surface, Figure 12A. At maximum discharge the resulting turbulence and cross waves caused overtopping of the channel walls downstream from the dike.

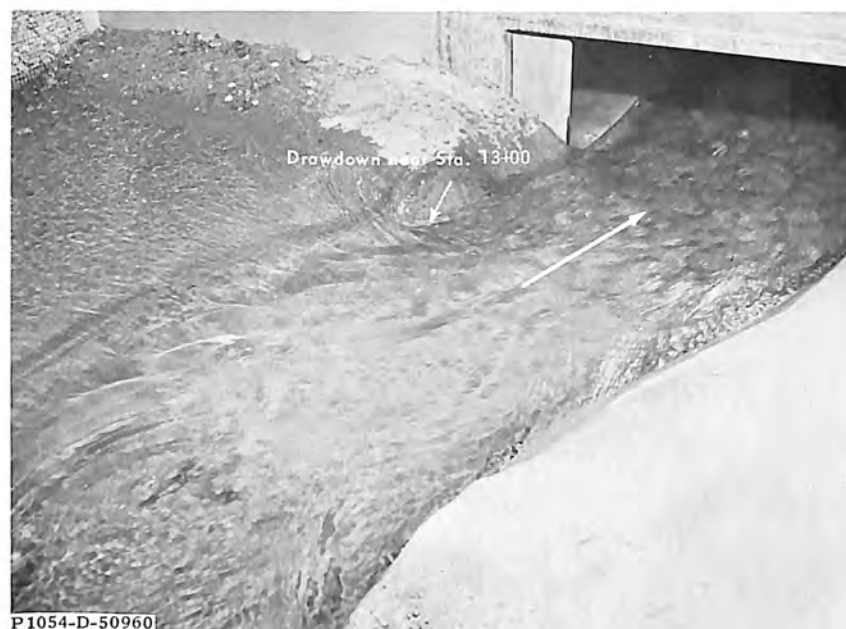
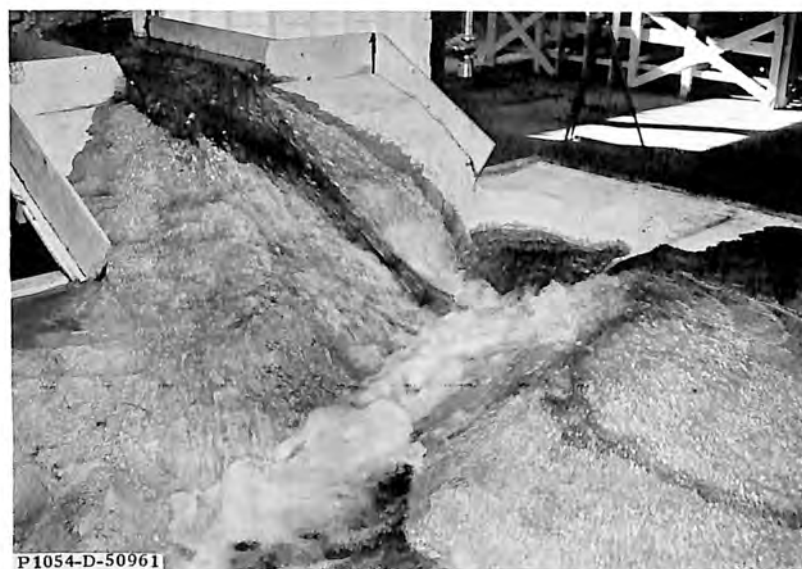
A. Drawdown at left side near
dike abutment.

B. Flow down hillside into gully.

Flow in Preliminary Channel Spillway--25,000 cfs

Flow characteristics downstream from the spillway channel. --The flow discharged from the spillway chute at elevation 4867 onto the hillside leading to an existing gully, Figure 12B. The flow on the hillside was partially deflected by an existing hump in the ground surface at the right of the chute centerline. The main part of the discharge followed the natural slope of the hillside to the eroded gully leading to the river channel. The portion of the flow that was deflected to the right of the hump followed a milder slope to the river channel and joined the main flow at the downstream end of the gully.

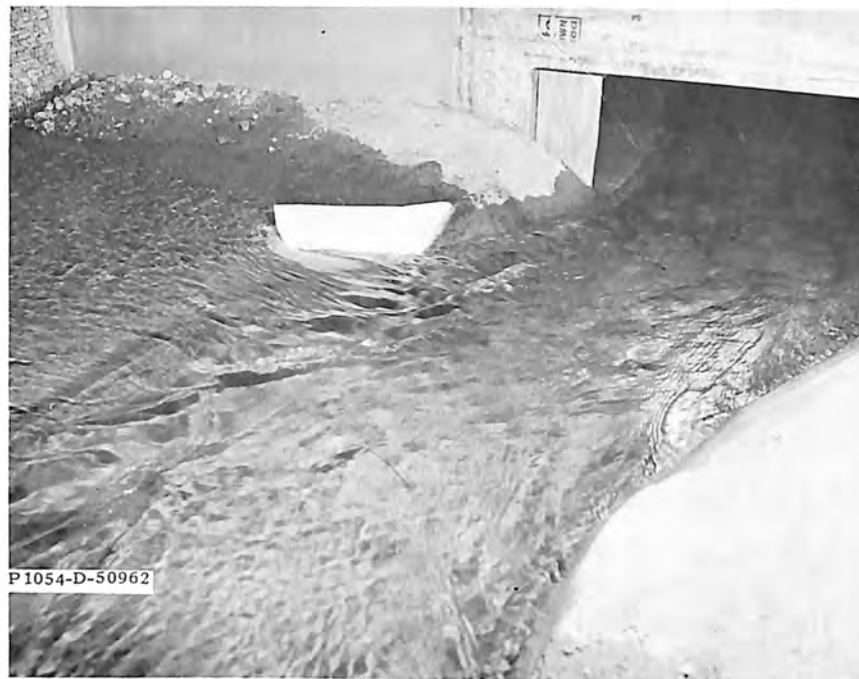
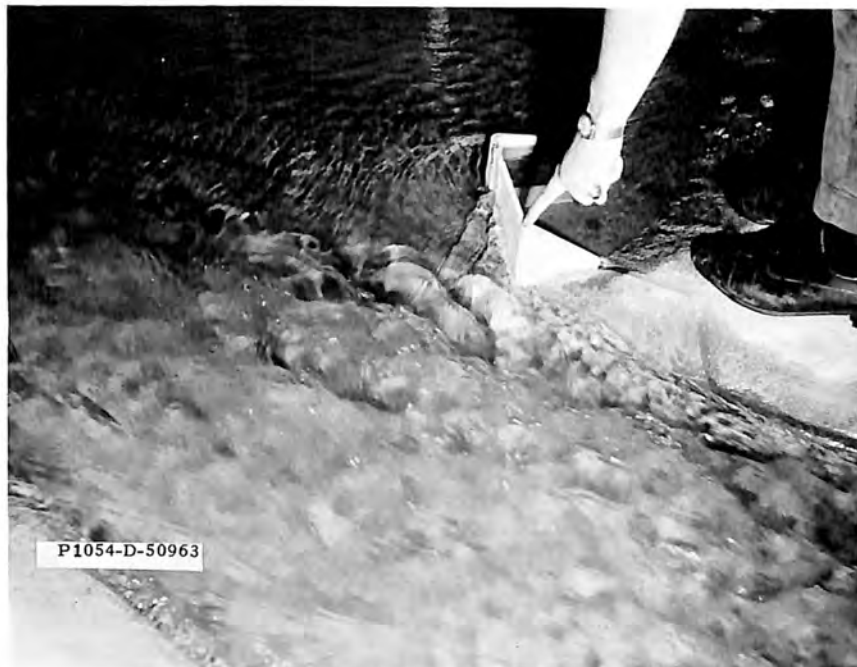
A. Straight guide wall to reduce scour.

B. Straight guide wall with curved approach
to reduce scour and drawdown.

1:42 Scale Model
Discharge Capacity of the Channel Spillway

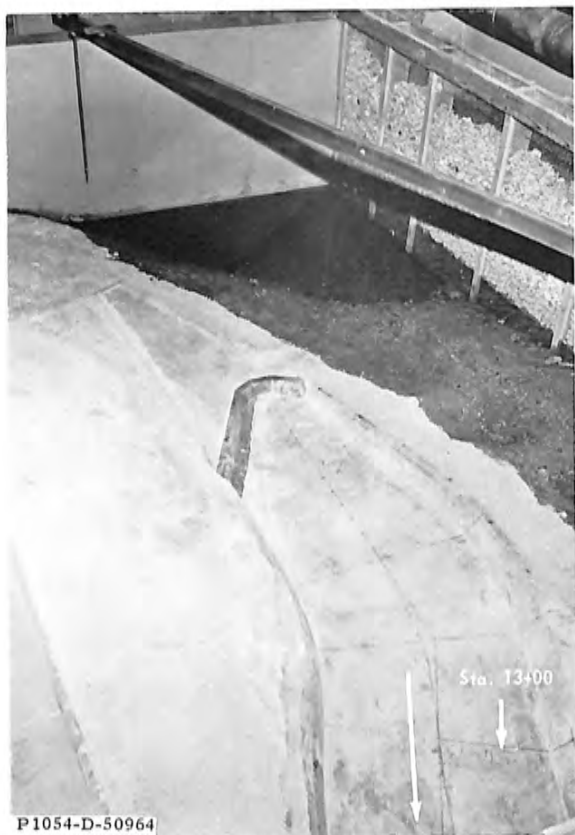
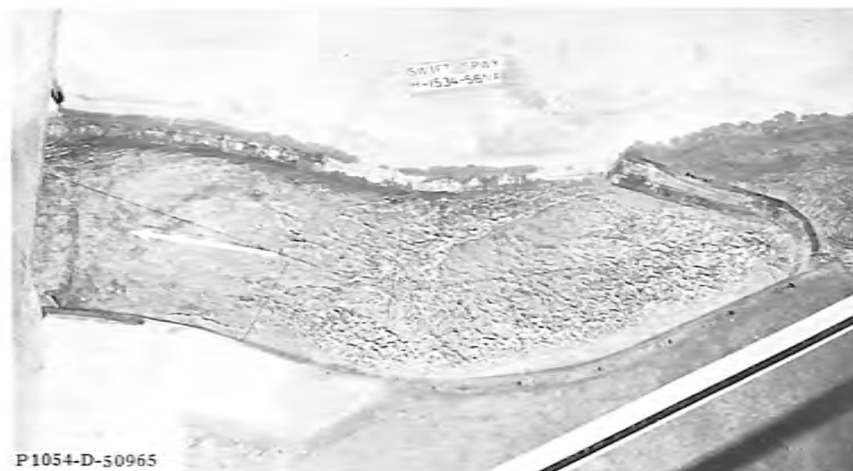
A. Channel spillway.

B. Channel spillway discharging 3,500 cfs.
Reservoir elevation 4886.0.

C. Flow down hillside into gully.
 $Q = 3,500$ cfs.

1:42 Scale Model
Recommended Channel Spillways

Flow characteristics and description. --The recommended channel spillway was similar to the second modification in which the channel length was reduced approximately 125 feet by installation of a new crest section across the upstream end of the channel. The upstream portion of the new crest section was divided into three short chords of a circular arc having a center angle of 90° and a radius of 23 feet measured from the crestline, and a straight section that angled downstream to the right, Figure 7. The right wall of the channel will be lined with concrete throughout its length, and the upstream slope of the dike abutment near the channel will be paved to protect the dike from erosion, Figures 7 and 8.

The appearance of the flow on the hillside (Figures 15, 16 and 17) was improved when the large hump in the right side of the flow path was removed. However, removal of the hump is not necessary for satisfactory flow conditions and was not recommended for the prototype.

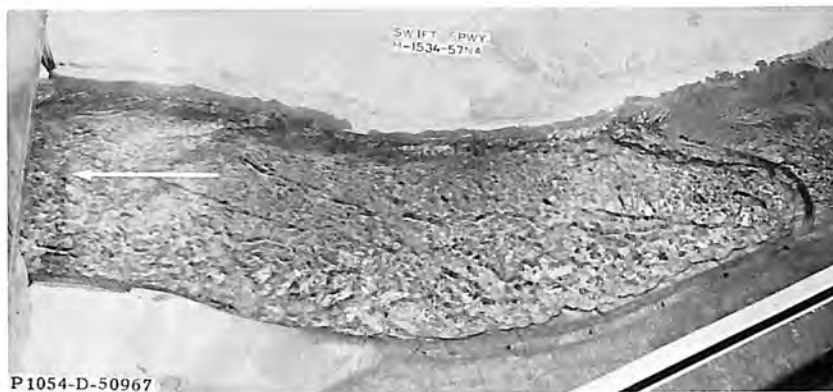
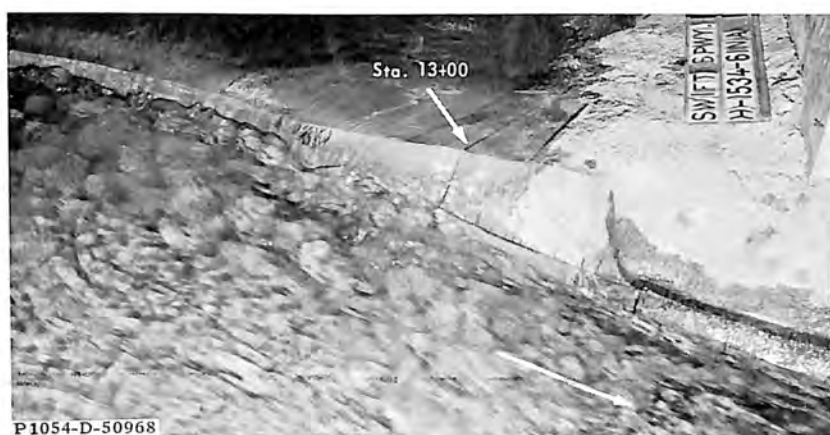
A. Side channel crest section.

B. Flow at dike abutment.

C. Flow down hillside into gully.

Flow in Recommended Channel Spillway--14,500 cfs

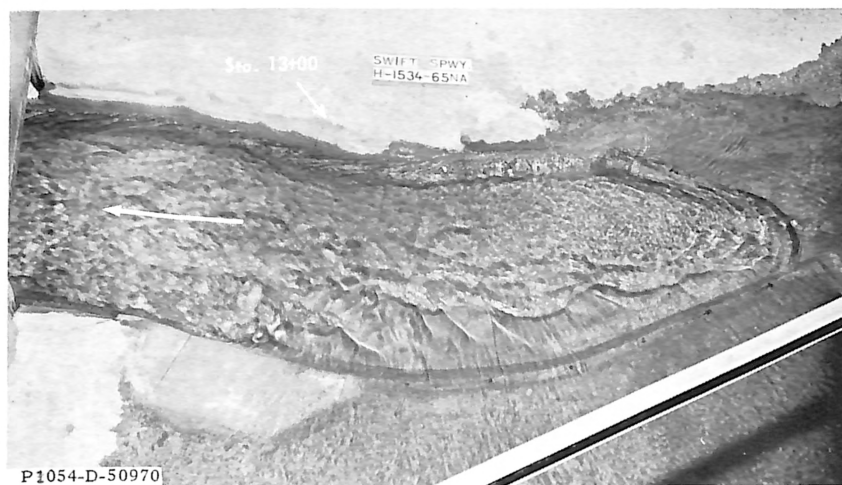
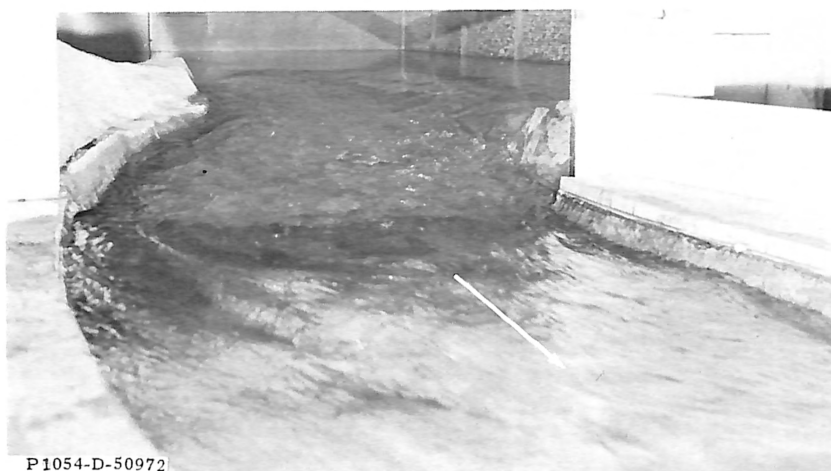
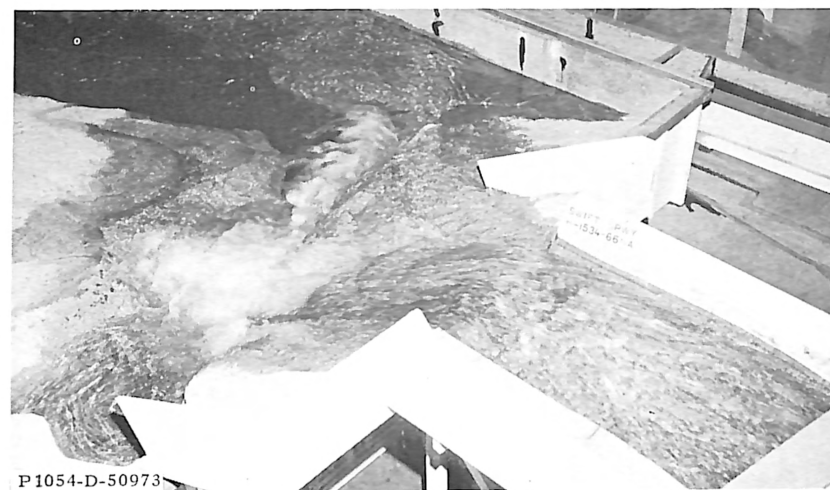
A. Flow over crest into channel.

B. Flow at dike abutment.

C. Flow in channel facing upstream.

D. Flow down hillside into gully.

Flow in Recommended Channel Spillway, 11,000 CFS

With the new crest section installed across the spillway channel, the adverse flow condition caused by the channel curvature at Station 11+40 was eliminated, Figure 17A. For low flows, a turbulent boil formed at the toe of the new crest section close to the left wall, creating an asymmetrical flow pattern, Figure 16A; when the crest started to submerge, this adverse flow condition ceased. Tests showed that the crest started to submerge when the reservoir elevation reached 4889.5 feet ($H = 6$ feet); the crest was fully submerged at reservoir elevation 4891.5.

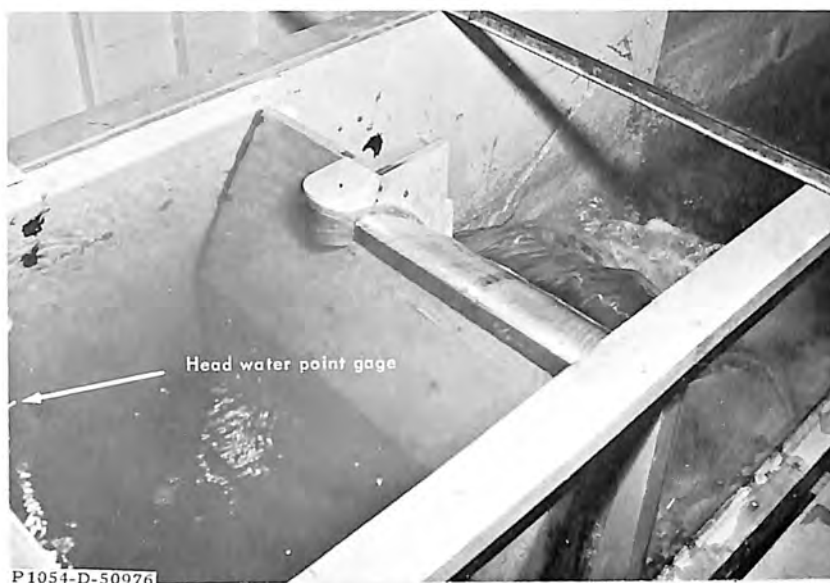
A. Spillway approach and left pier.

B. Flow from flip bucket.

1:18 Scale Sectional Model
Flow in Arch Dam Emergency Spillway--13,800 cfs

Since the spillway was located near the center of the arch dam, the flow approaching the spillway was assumed to be satisfactory. Only minor disturbances in the flow was observed, at the left approach wall, Figure 19, so no changes in the approach walls were recommended.

The jet leaving the flip bucket was very compact, and the trajectory indicated that the jet would impinge well downstream from the base of the dam, Figure 19B. No changes in the preliminary design of the flip bucket were recommended.
