HYDRAULIC MODEL STUDIES OF THE SPILLWAY AND  
OUTLET WORKS FOR LOWER TWO MEDICINE DAM  
BLACKFEET INDIAN IRRIGATION PROJECT  
MONTANA

Report No. Hyd-554

January 3, 1966

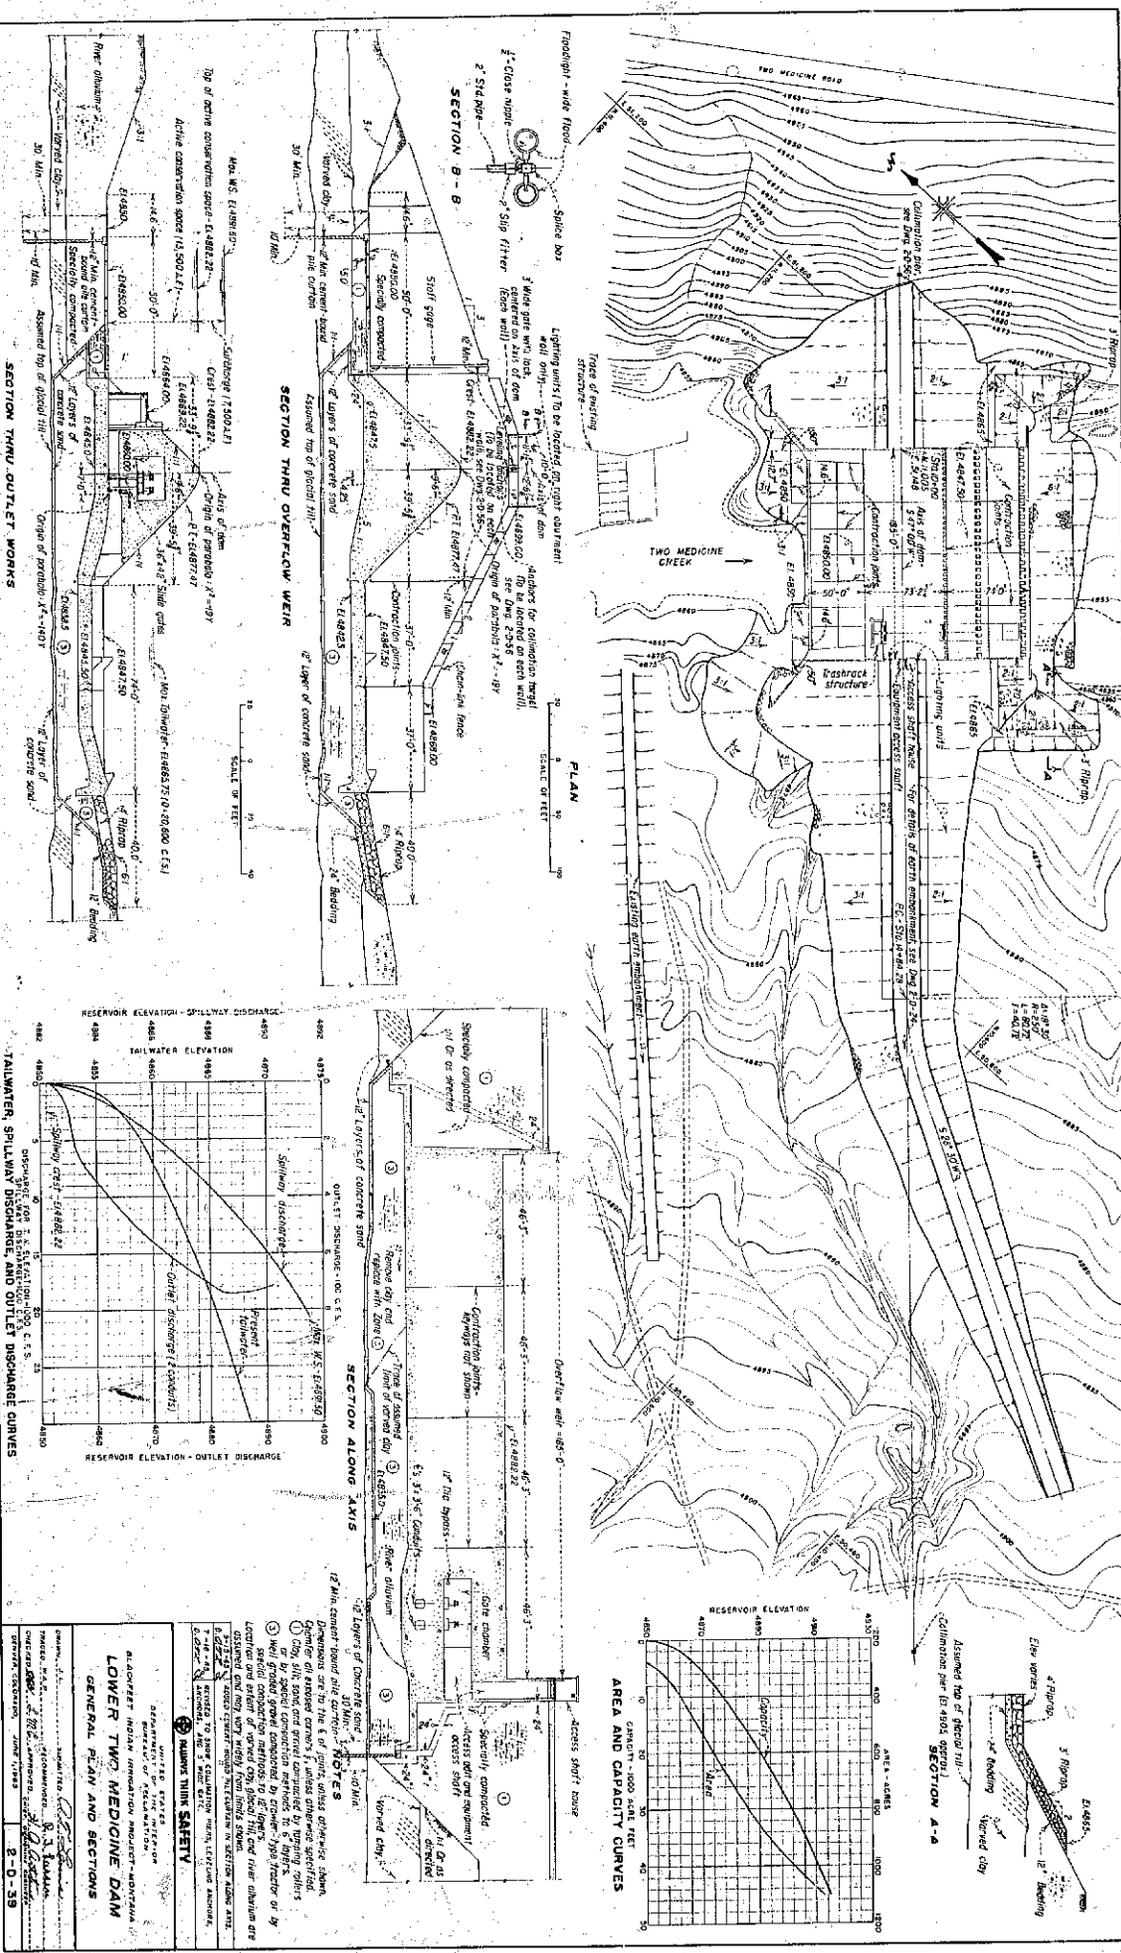
FIGURE 2  
REPORT HYD-554

**LOWER TWO MEDICINE DAM**  
GENERAL PLAN AND SECTIONS

Lower Two Medicine Dam is located on Two Medicine Creek about 40 miles west of Cut Bank in northwestern Montana, Figure 1. The dam is an earthfill structure with a height of approximately 56 feet and a crest length of about 1,100 feet, Figure 2.

The spillway, Figures 2 and 3, is an overflow crest with a width of 185 feet, located 16.78 feet below the crest of the dam. The outlet works, Figure 4, consists of two 3-foot-wide by 3-1/2-foot-high rectangular conduits, controlled by slide gates. The outlet works passes under the spillway section and discharges into a depressed section of the spillway stilling basin. The stilling basin discharges into the river channel, which is protected by riprap for a distance of 40 feet downstream from the end of the basin. The use of a common stilling basin for both the spillway and outlet works indicated that problems might be encountered during simultaneous operation of these features, therefore hydraulic model studies were requested.

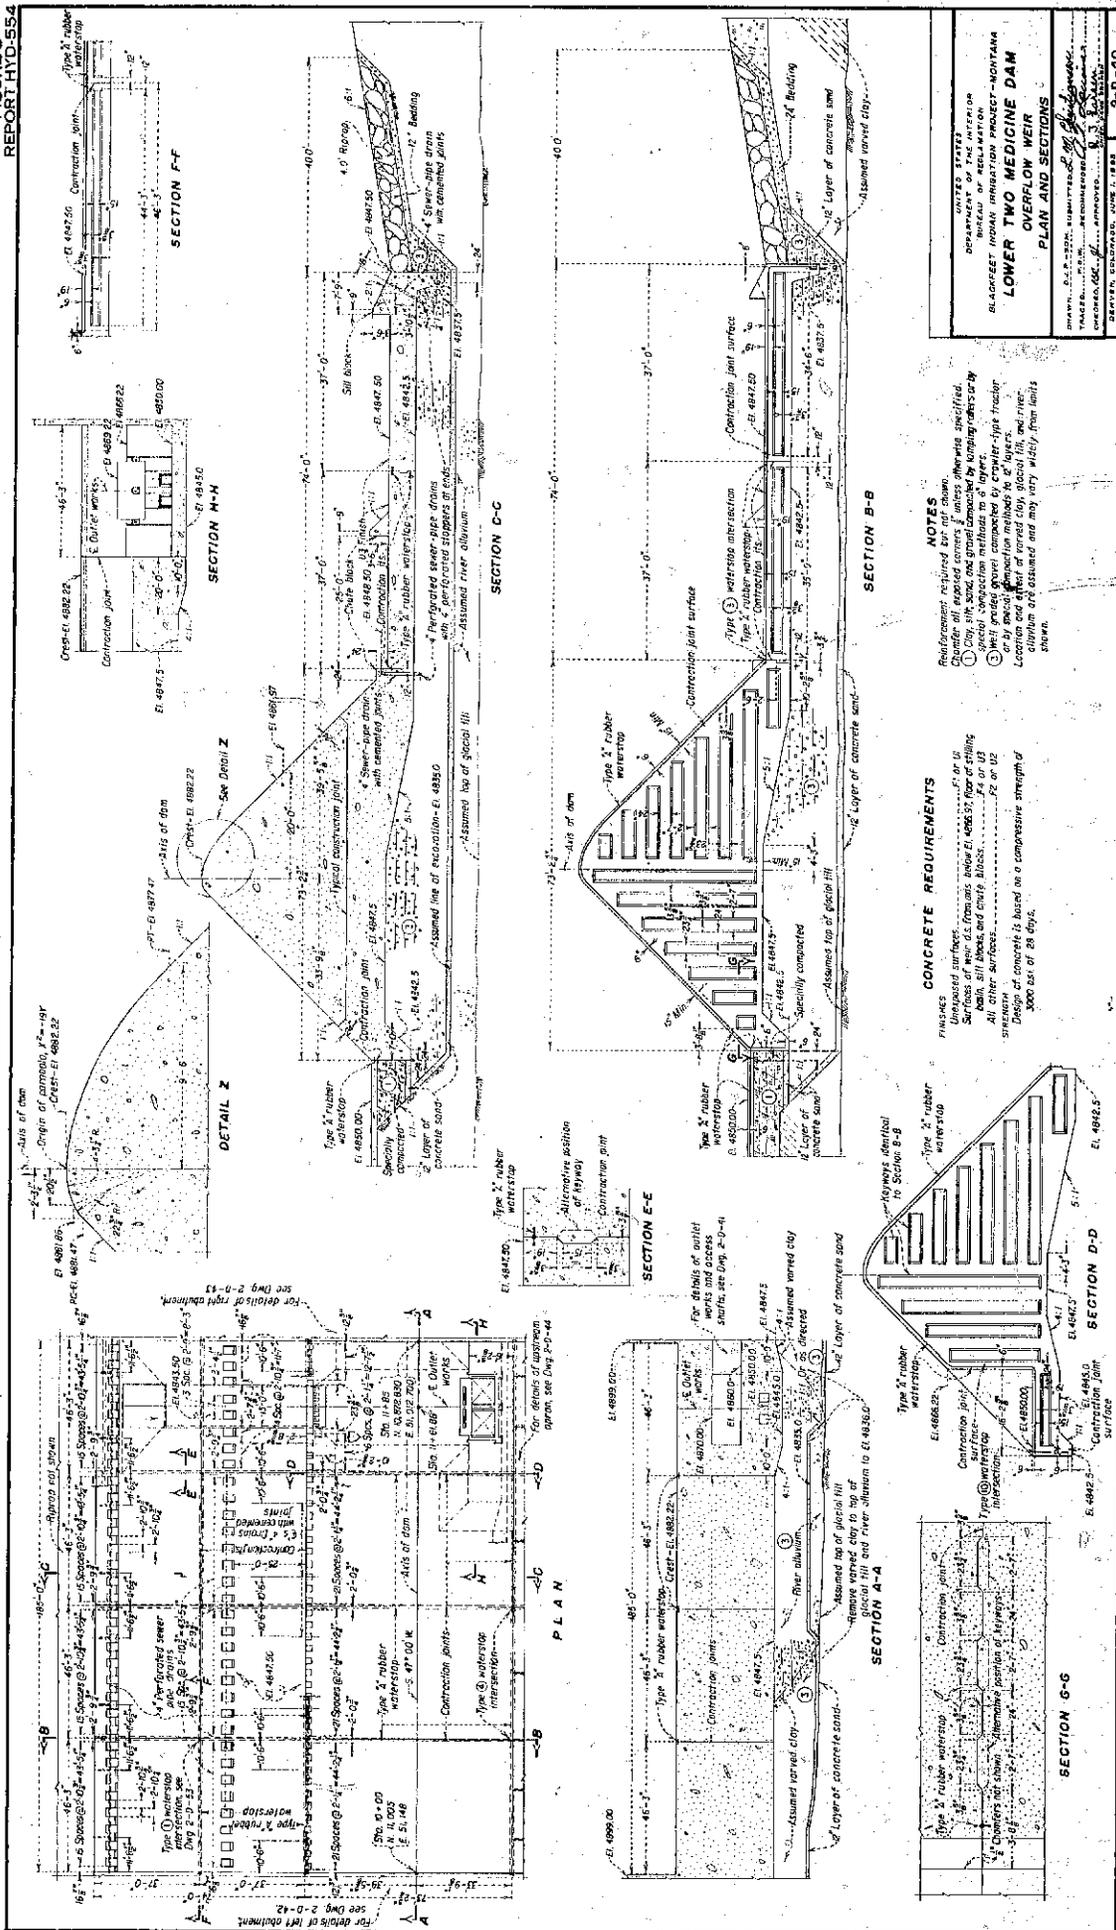
**LOWER TWO MEDICINE DAM  
 OVERFLOW WEIR  
 PLAN AND SECTIONS**

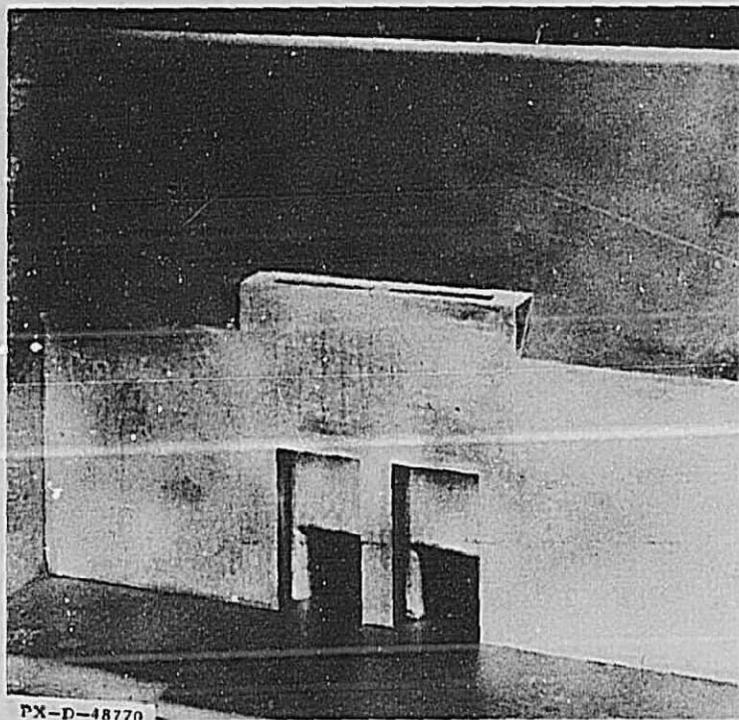
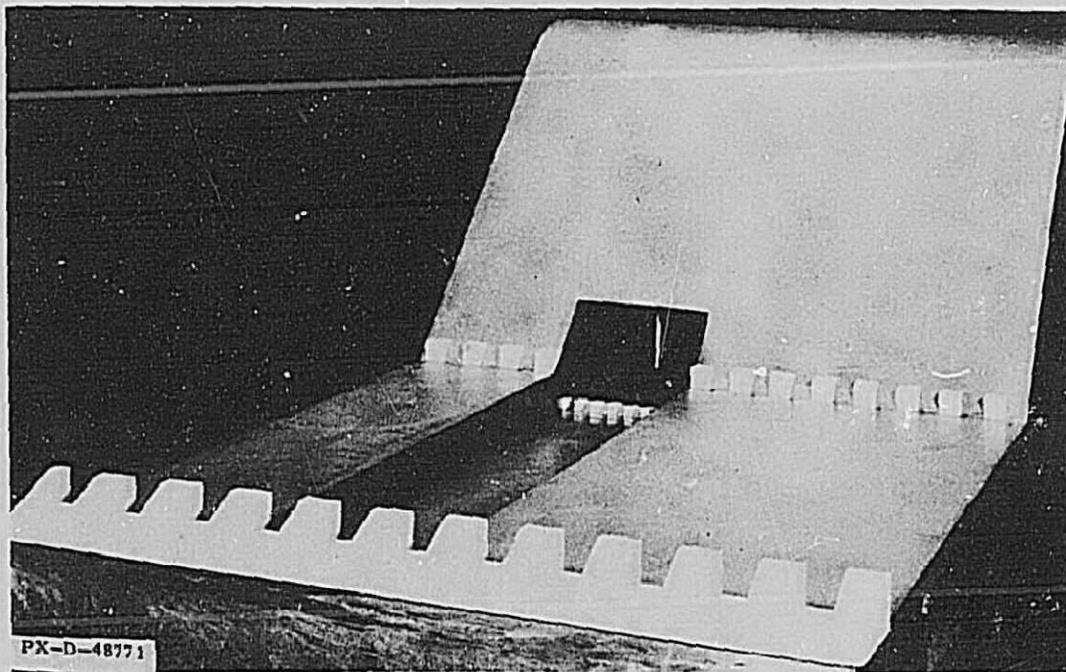
A. Outlet works entrances and upstream face of spillway

B. Outlet works exit, downstream face of spillway, and stilling basin

SECTIONAL MODEL OF SPILLWAY AND OUTLET WORKS

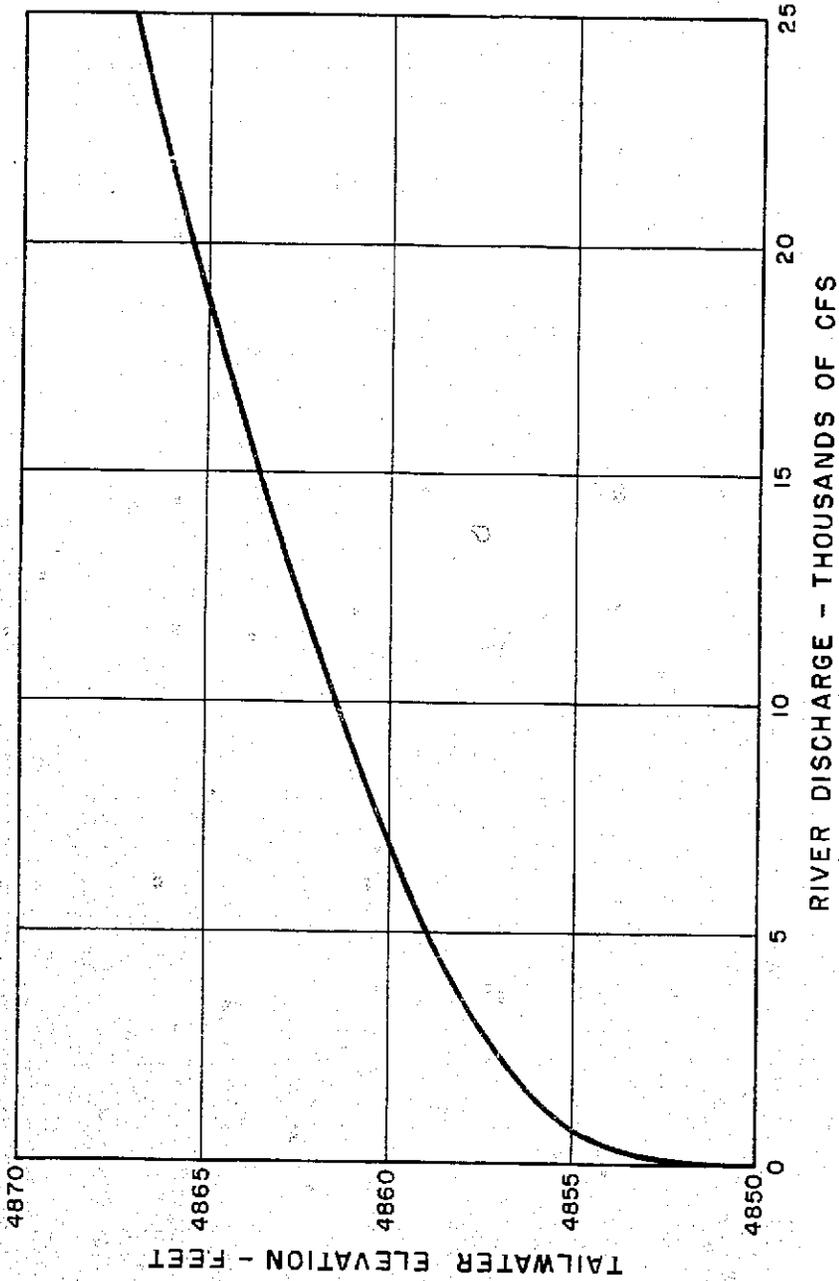
LOWER TWO MEDICINE DAM  
SPILLWAY AND OUTLET WORKS  
1:24 SCALE MODEL  
TAILWATER RATING CURVE  
(EXTRACTED FROM COMPUTED RATING CURVES)

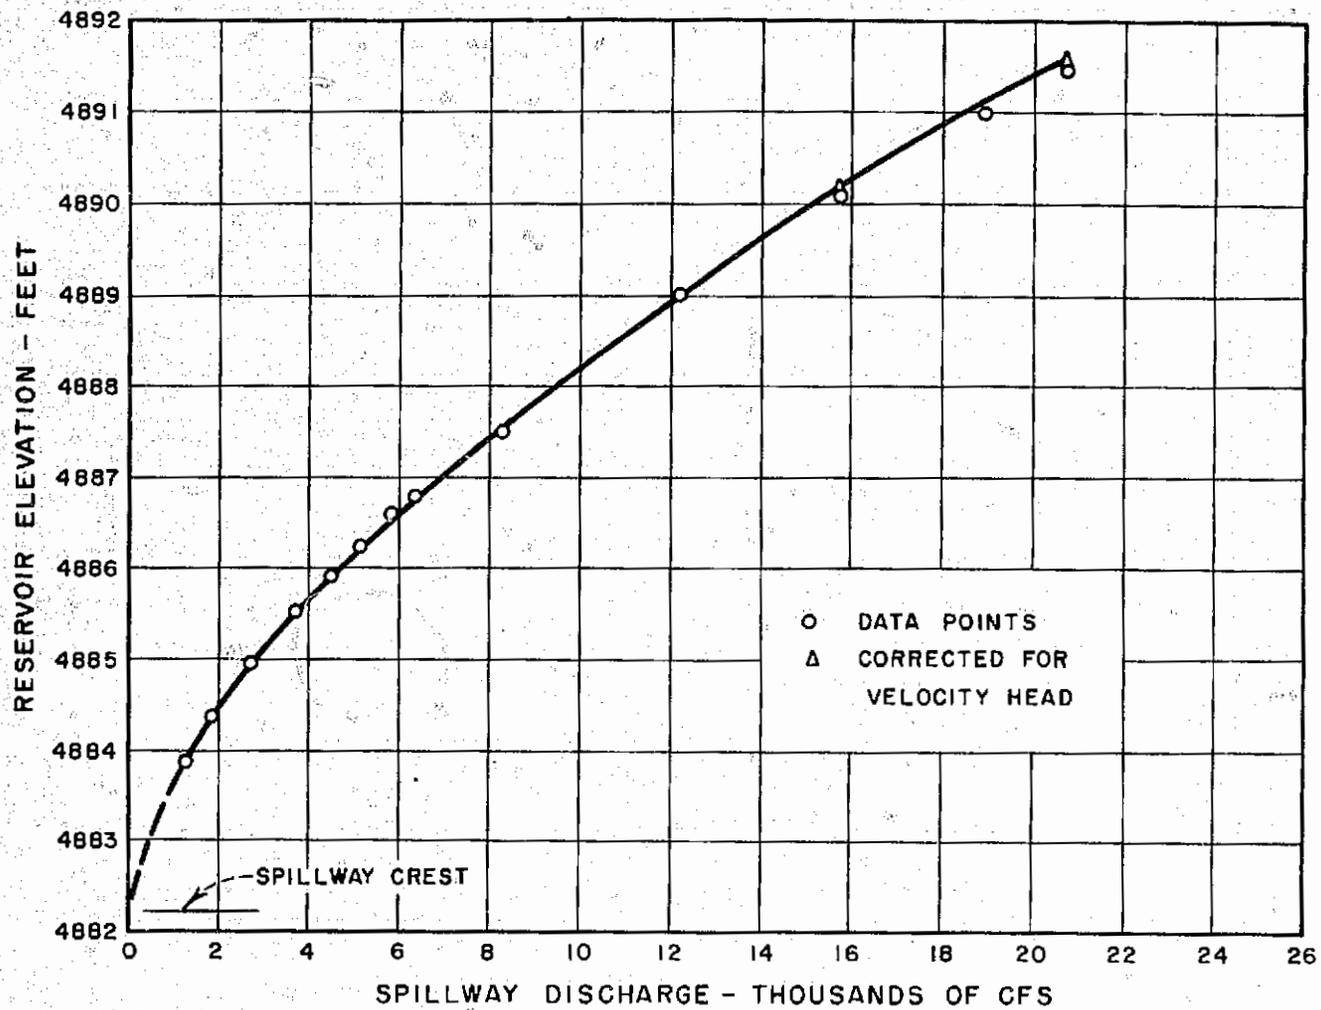
FIGURE 7  
 REPORT HYD-554

LOWER TWO MEDICINE DAM  
 SPILLWAY AND OUTLET WORKS  
 1:24 SCALE MODEL  
 SPILLWAY DISCHARGE CAPACITY

1. The preliminary designs of the spillway crest and the outlet works were satisfactory. Discharge capacities were adequate to pass the required maximum flows, Figures 7 and 9.

The discharge capacity of the spillway was determined to check the capacity assumed for design purposes. The reservoir elevation versus discharge curve is shown on Figure 7, which includes a correction for velocity head. This correction was necessary because the model configuration did not allow water surface elevation measurement at a sufficient distance from the crest to ensure low velocity and negligible velocity head. The section at which the model water surface elevation was measured was about 50 feet (prototype) upstream from the spillway crest. The water surface drawdown as the flow passed over the spillway caused a sufficient lowering of the water surface elevation at the measuring section to require a correction. The drawdown at any point is equal to the velocity head at that point. Velocity head corrections were negligible below a reservoir elevation of about 4890 (discharge = 15,000 cfs).

The spillway capacity was 20,500 cfs at maximum reservoir elevation 4891.5 or approximately 0.5 percent less than the assumed design capacity of 20,600 cfs. Velocity distribution 50 feet (prototype) upstream from the spillway crest for the maximum discharge is shown in Figure 8.

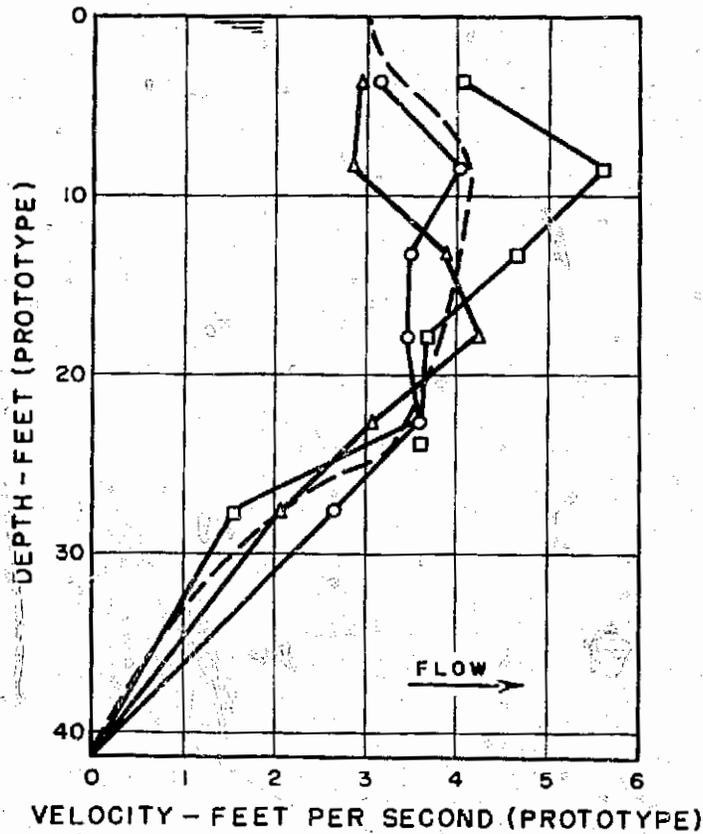
FIGURE 8  
REPORT HYD-554

- 24' (prototype) left of model  $\mathcal{C}$
  - △ Model  $\mathcal{C}$
  - 24' right of model  $\mathcal{C}$
  - Average of 3 sections
- Velocities measured 50' (prototype) upstream from spillway crest.

LOWER TWO MEDICINE DAM  
SPILLWAY AND OUTLET WORKS  
1:24 SCALE MODEL  
VELOCITY IN THE SPILLWAY APPROACH  
 $Q = 20,500$  CFS

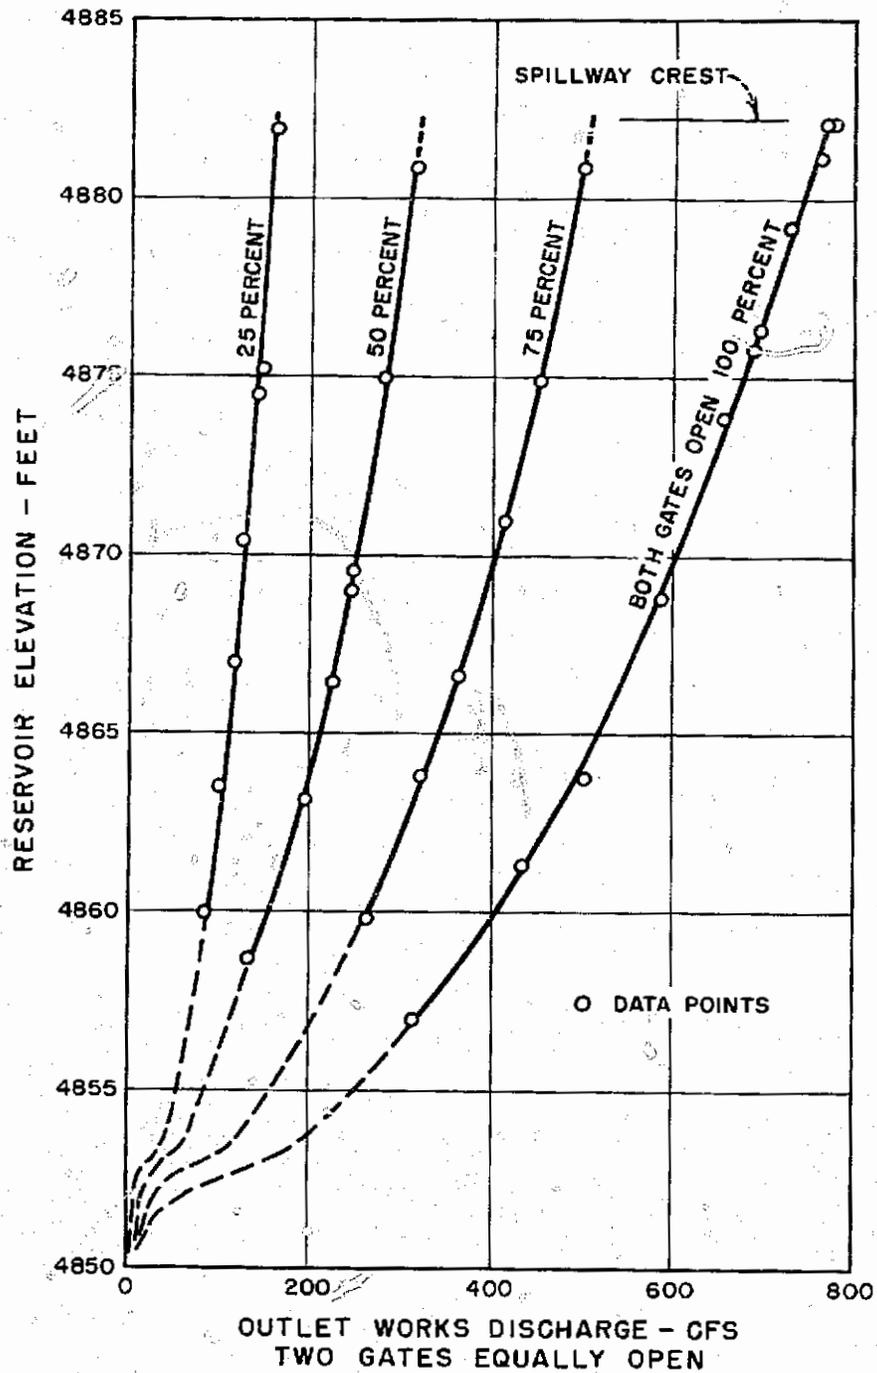
FIGURE 9  
REPORT HYD - 554

LOWER TWO MEDICINE DAM  
SPILLWAY AND OUTLET WORKS  
1:24 SCALE MODEL  
OUTLET WORKS DISCHARGE CAPACITY

The two-conduit outlet works was calibrated with the gates equally opened to 100, 75, 50, and 25 percent, and a curve showing discharge versus reservoir elevation was derived for each gate opening, Figure 9. Because the slide gates were not accurately represented in the model, the curves of Figure 9 for partial gate openings should be considered only an approximation of the discharge capacity of the outlet works. The model indicated that the outlet works discharge would be 770 cfs with the reservoir water surface at the spillway crest (elevation 4882.22) and with both gates 100 percent open. This is about 4 percent higher than the assumed design discharge of 740 cfs.

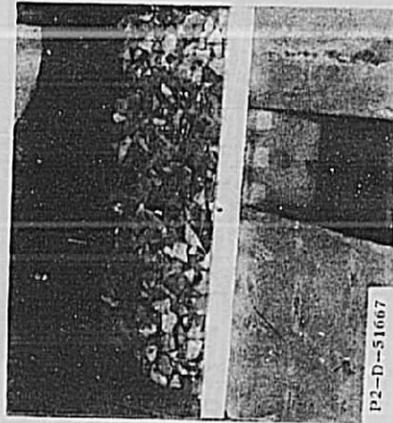
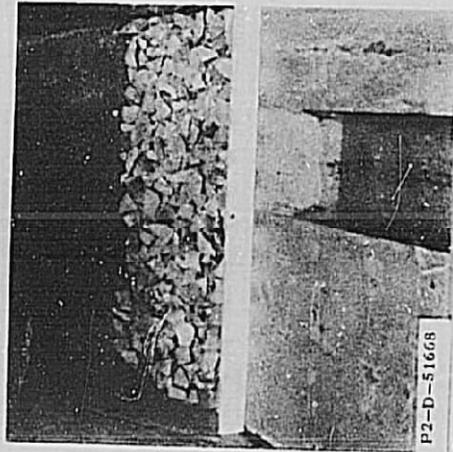
B. Spillway discharge = 20,500 cfs  
Outlet works discharge = 716 cfs

C. After test

A. Riprap bed before test

Lower Two Medicine Dam  
Spillway and Outlet Works  
1:24 Scale Model  
RIPRAP TEST, PRELIMINARY DESIGN

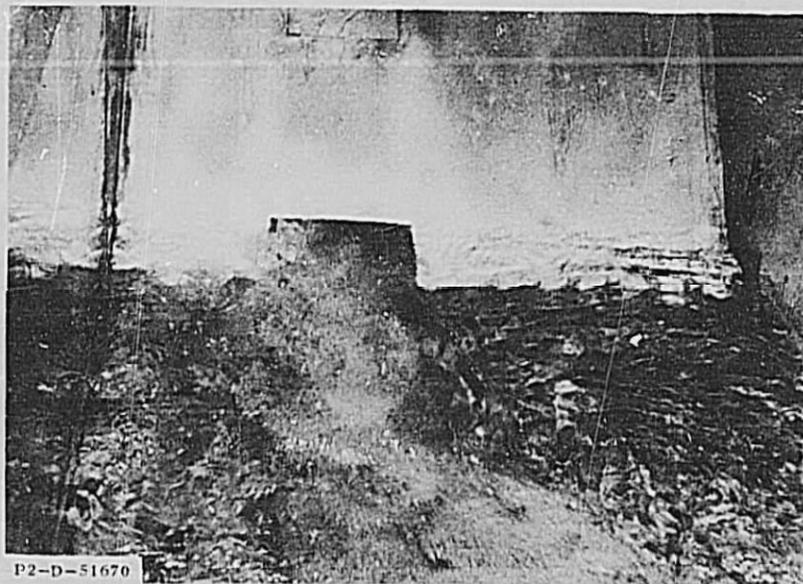
Figure 12  
Report Hyd-554

A. Conduit flowing partially full  
outlet works discharge = 740 cfs  
tailwater elevation 4855.2

B. Conduit flowing full

OUTLET WORKS OPERATION, PRELIMINARY DESIGN

2. The outlet conduits downstream from the gates were enlarged to eliminate surging in the conduits when the outlet works operated alone, Figures 12 and 15.

Operation of the Outlet Works Alone. --The outlet works was operated with the reservoir water surface at the spillway crest and the gates slightly closed to limit the discharge to the design value of 740 cfs. Eddies formed in both sides of the basin, but their intensity and extent were not large enough to cause riverbed material to be pulled into the stilling basin. However, the eddies in the basin caused the opening at the spillway face to alternately flow full then partially full, causing surging in the conduit downstream from the gates. Such surging might damage the gates and the gate controls. Figures 12A and B show the conduit flowing partially full (12A) and full (12B).

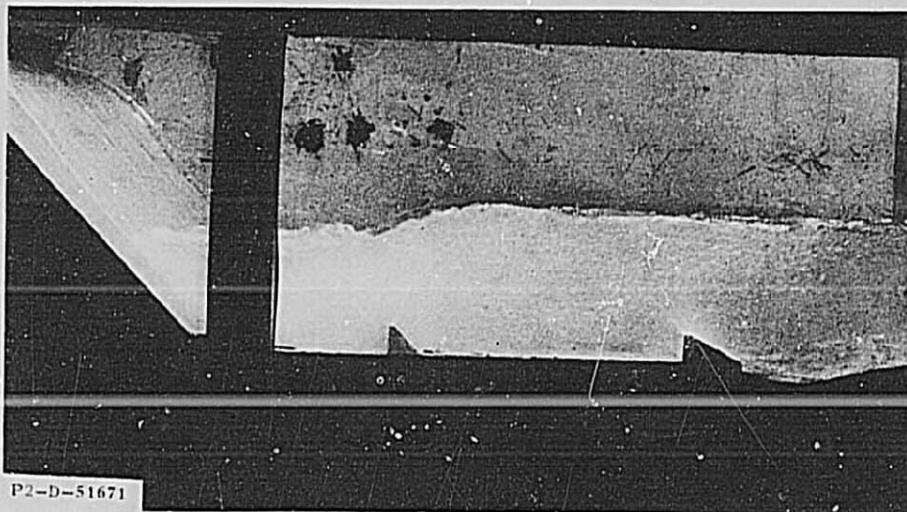
A. Spillway discharge = 20,500 cfs  
Outlet works discharge = 716 cfs

B. After test

SAND EROSION TEST, RECOMMENDED DESIGN

Sand Erosion Test. --A 100-minute test at the maximum combined design discharge of the spillway and outlet works, Figure 13A, indicated a very different erosion pattern than that observed for the preliminary basin without baffle piers. No material was deposited on the downstream side of the end sill; instead the bed immediately downstream from the end sill was lowered slightly, as can be seen in the profile of Figure 13A. The velocity in the downstream channel was sufficient to move material downstream, the same as in the preliminary design.

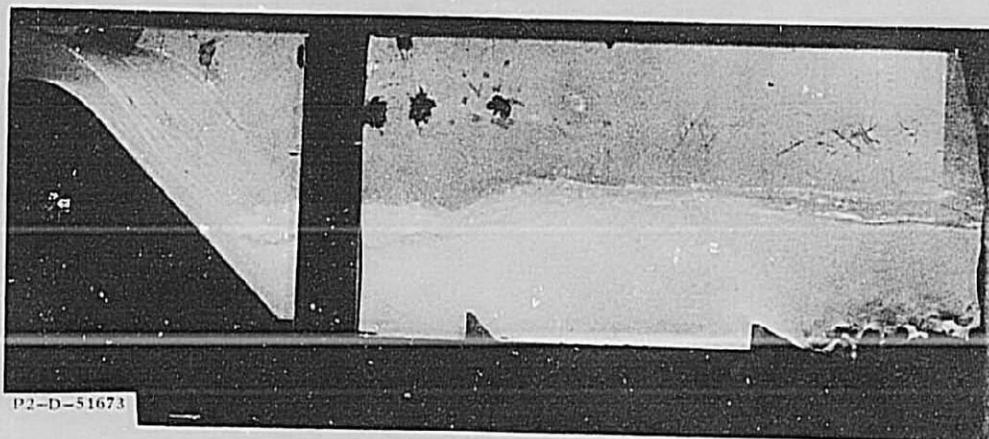
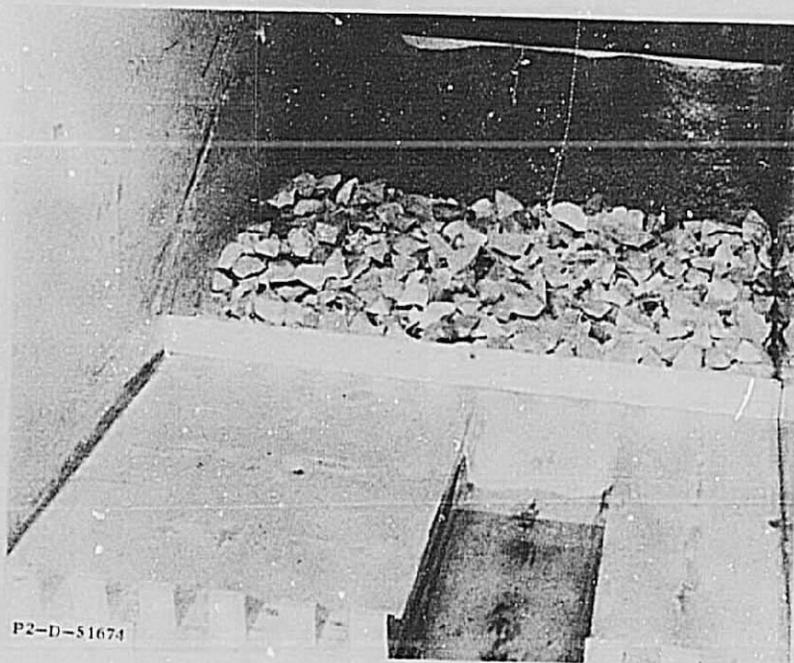
A. Spillway discharge = 20,500 cfs  
Outlet works discharge = 716 cfs

B. After test

RIPRAP TEST, RECOMMENDED DESIGN
